2015 Earthquake Damage Mapping

Hanuman Dhoka Darbar Square Monument Zone
Kathmandu Valley World Heritage Property

December 2015

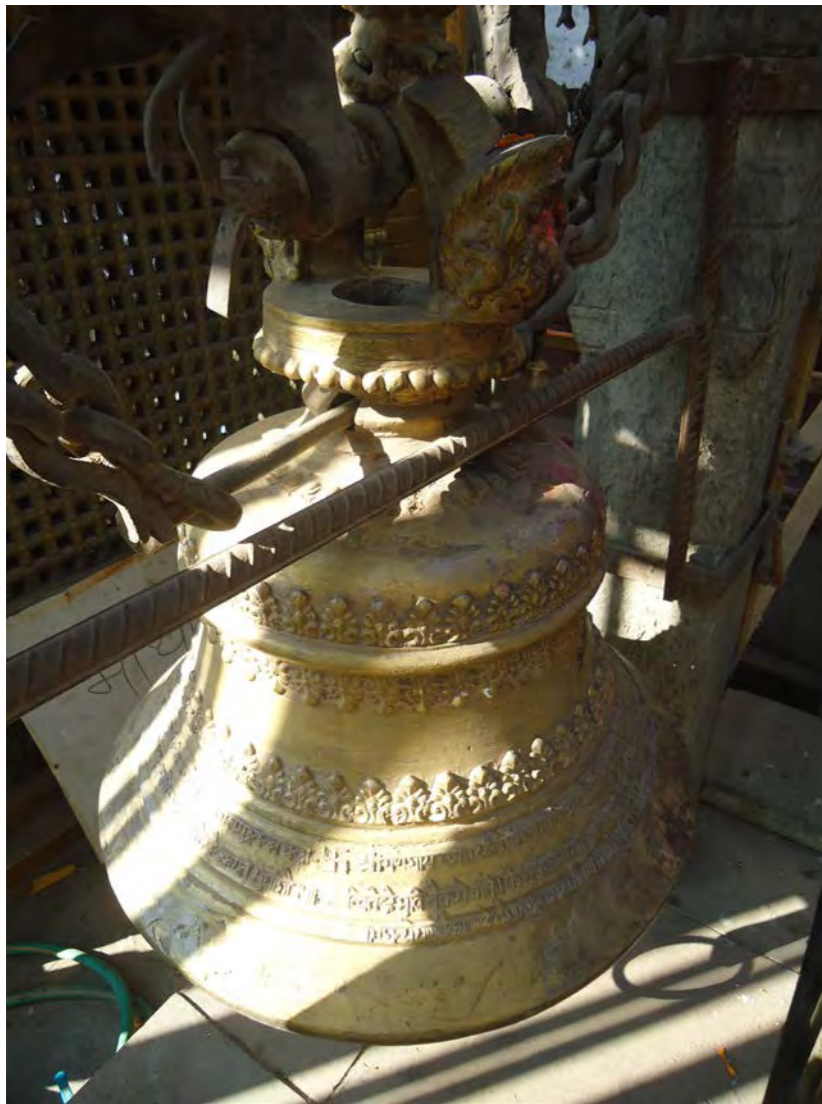
CODE NO	TYOLOGY	MONUMENT NAME	ESTABLISHED/ RENOVATED	STRUCTURAL SYSTEM	MATERIAL	GENERAL DESCRIPTION	PROBLEM DESCRIPTION	DANGER	REMARKS
46e	Bell				Stone;metal	Metal bell on stone frame	No visible damage		
46f	Oil Lamp				Metal	Metal lamp infront of temple	No visible damage		
46g	Mandala				Metal	Metal mandala	No visible damage

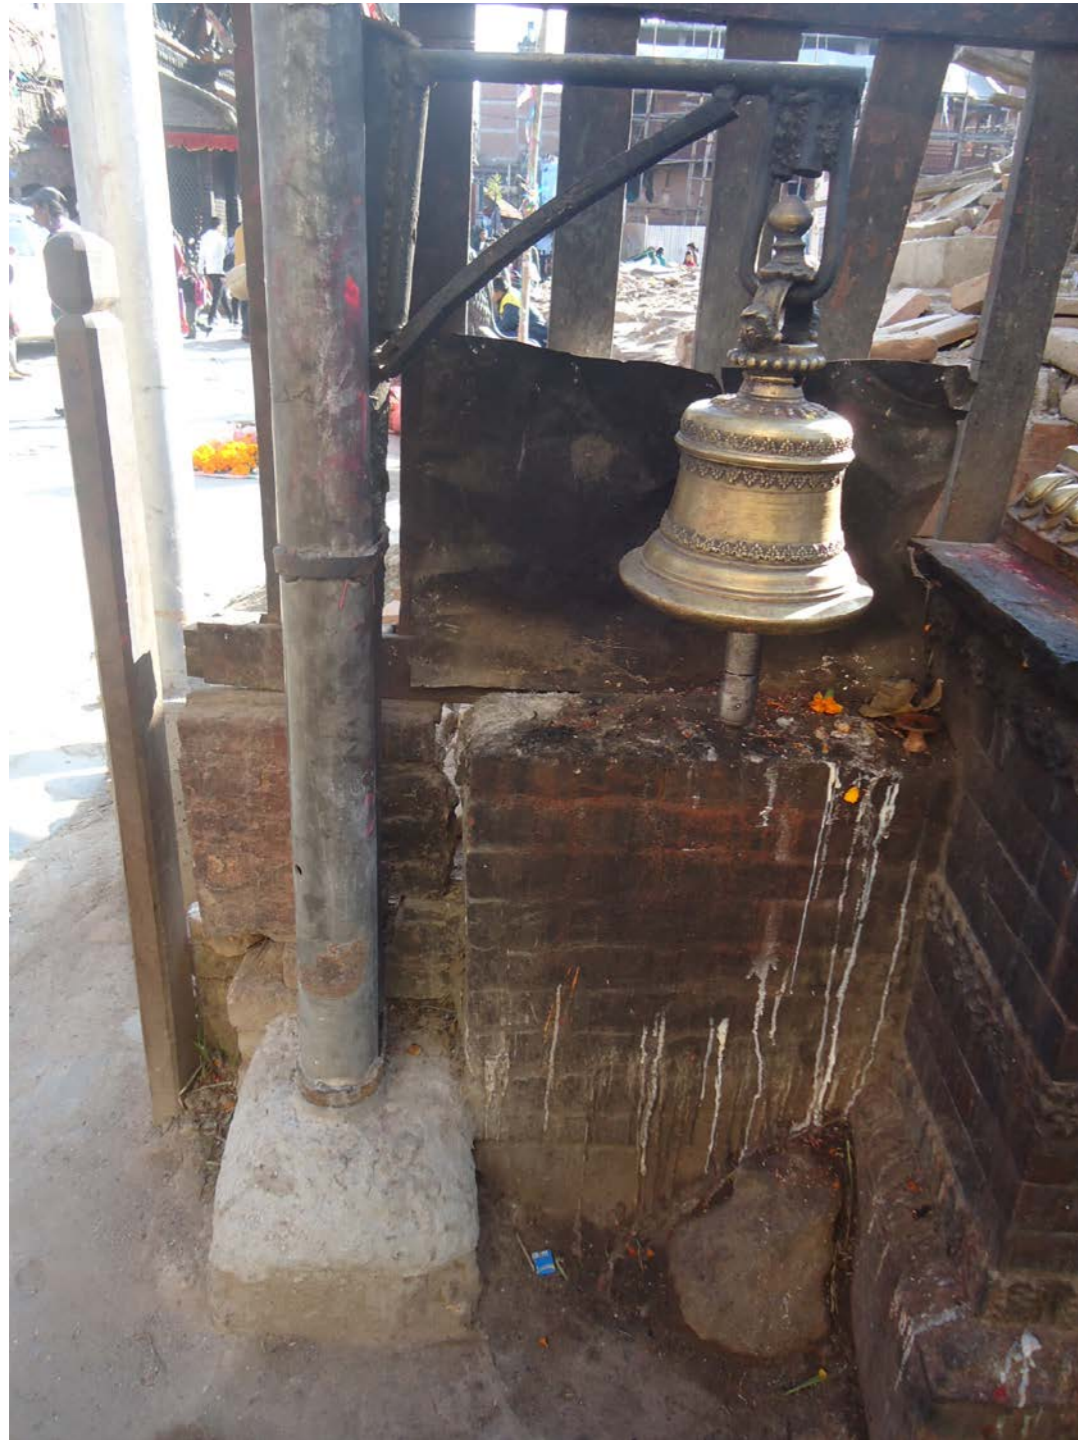
CODE NO	TYOLOGY	MONUMENT NAME	ESTABLISHED/ RENOVATED	STRUCTURAL SYSTEM	MATERIAL	GENERAL DESCRIPTION	PROBLEM DESCRIPTION	DANGER	REMARKS
46h	Bell				Metal	Metal bell in front of temple	No visible damage		
46i	Mouse				Metal	Metal mouse statue	No visible damage		
46j	Mouse				Stone	Stone mouse statue	No visible damage

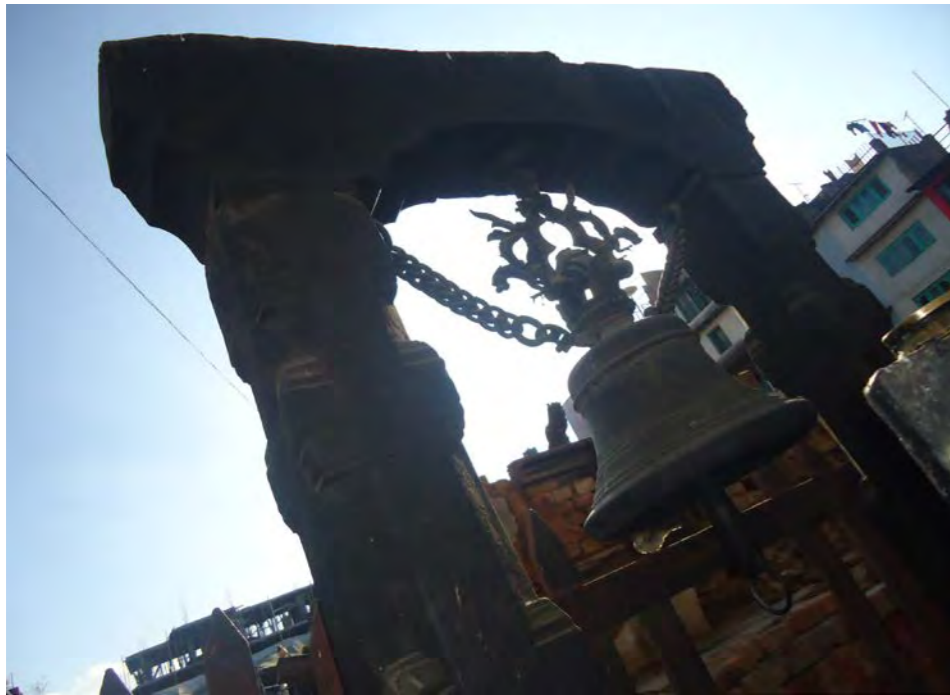
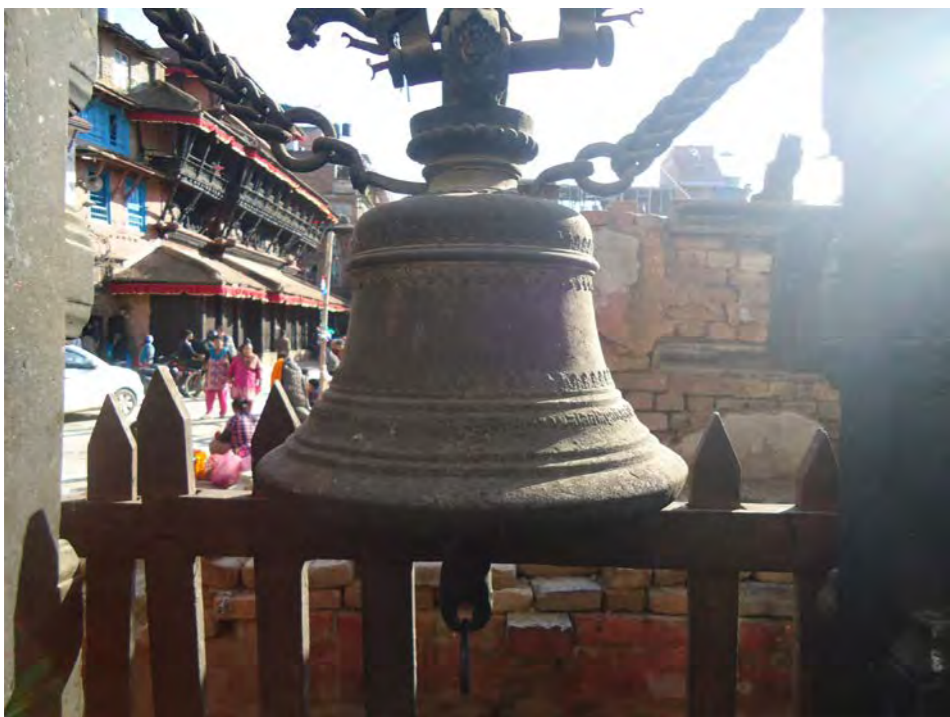
CODE NO	TYOLOGY	MONUMENT NAME	ESTABLISHED/ RENOVATED	STRUCTURAL SYSTEM	MATERIAL	GENERAL DESCRIPTION	PROBLEM DESCRIPTION	DANGER	REMARKS
46k	Bell				Stone	Metal bell in stone and wood frame	No visible damage		
46l	Lamp				Timber	Lamps on wooden frame	No visible damage		
46m	Inscription				Stone	Stone Inscription	No visible damage

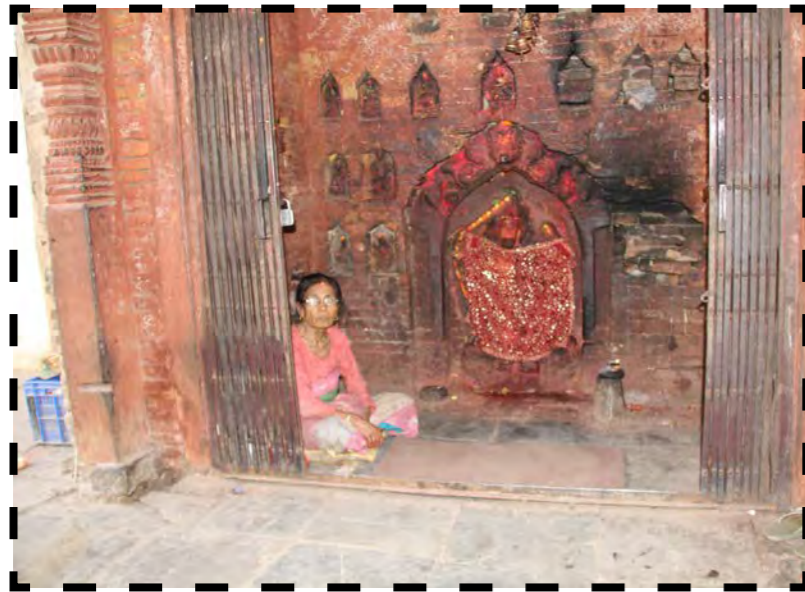
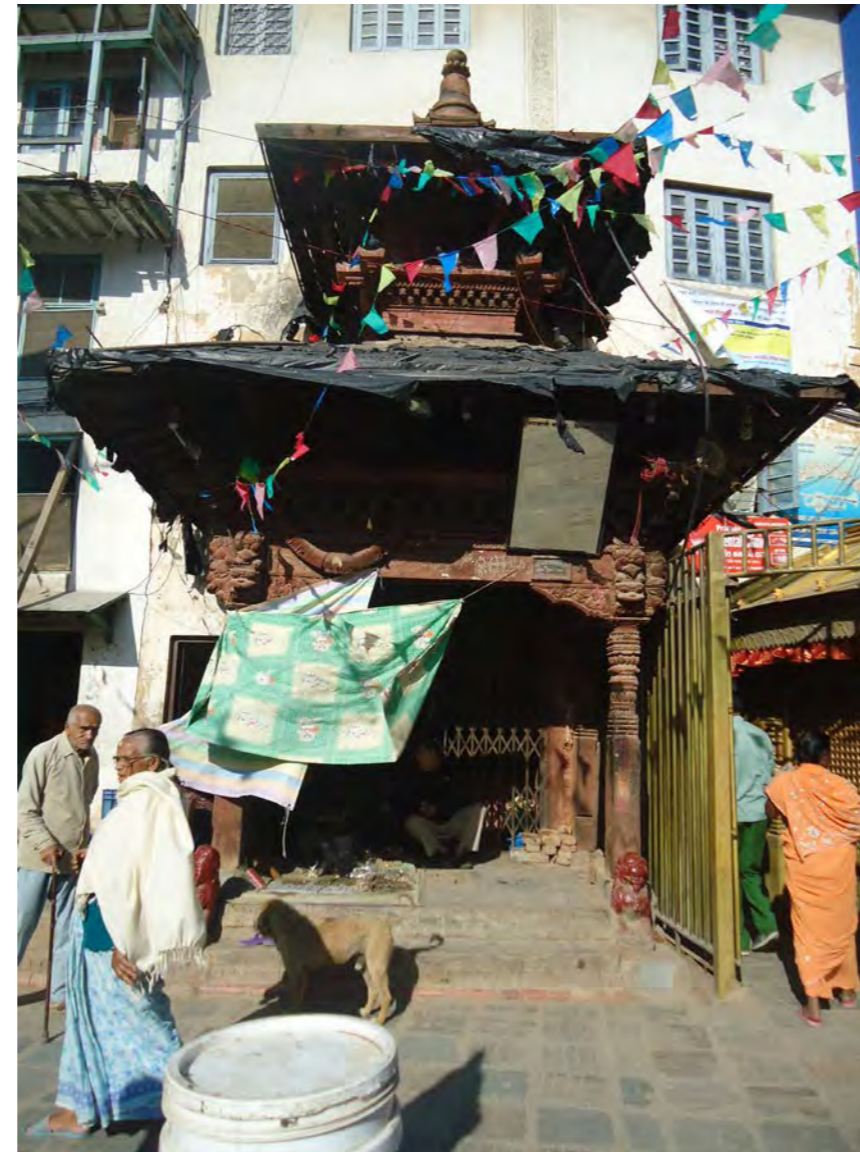
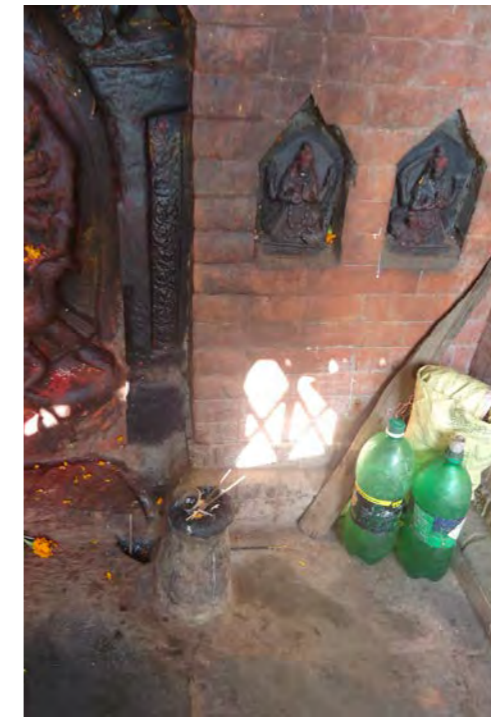
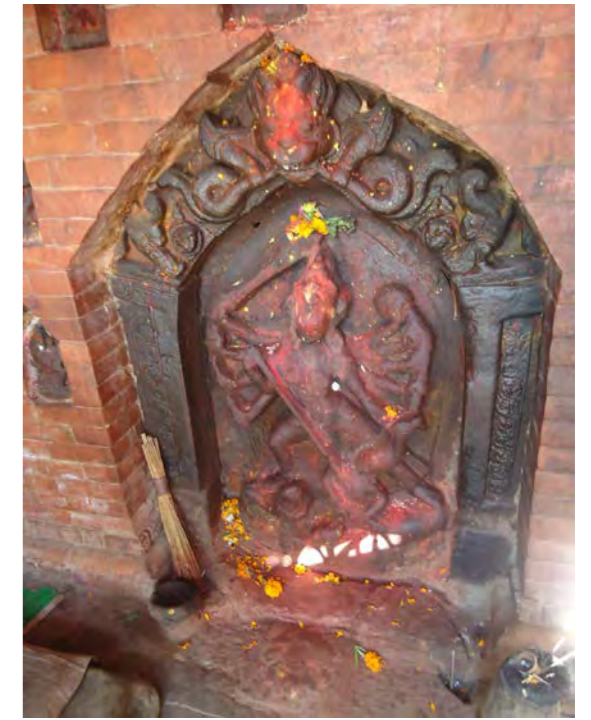
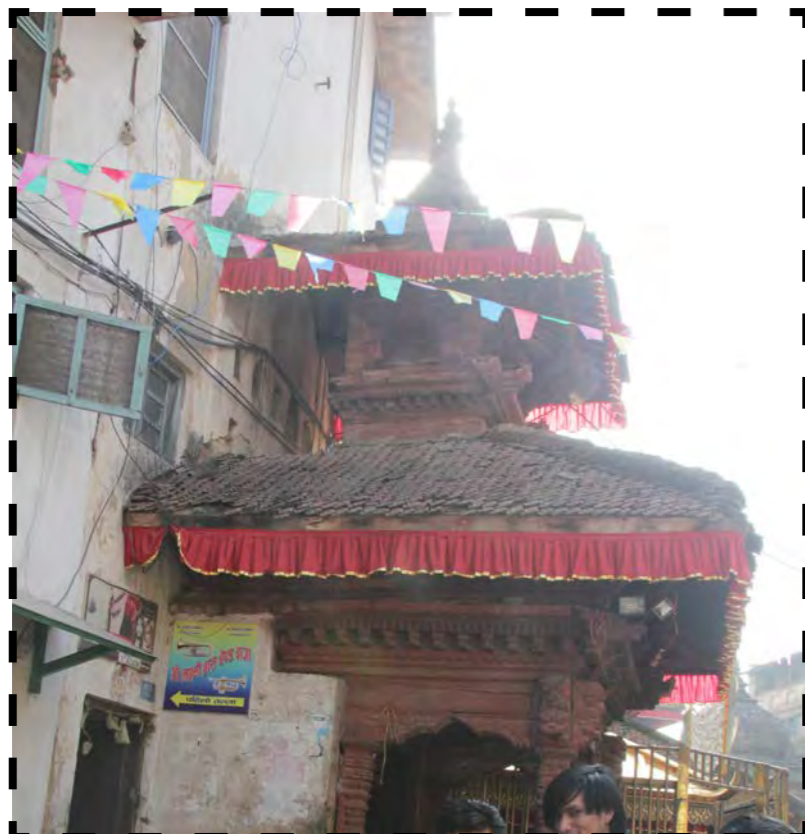
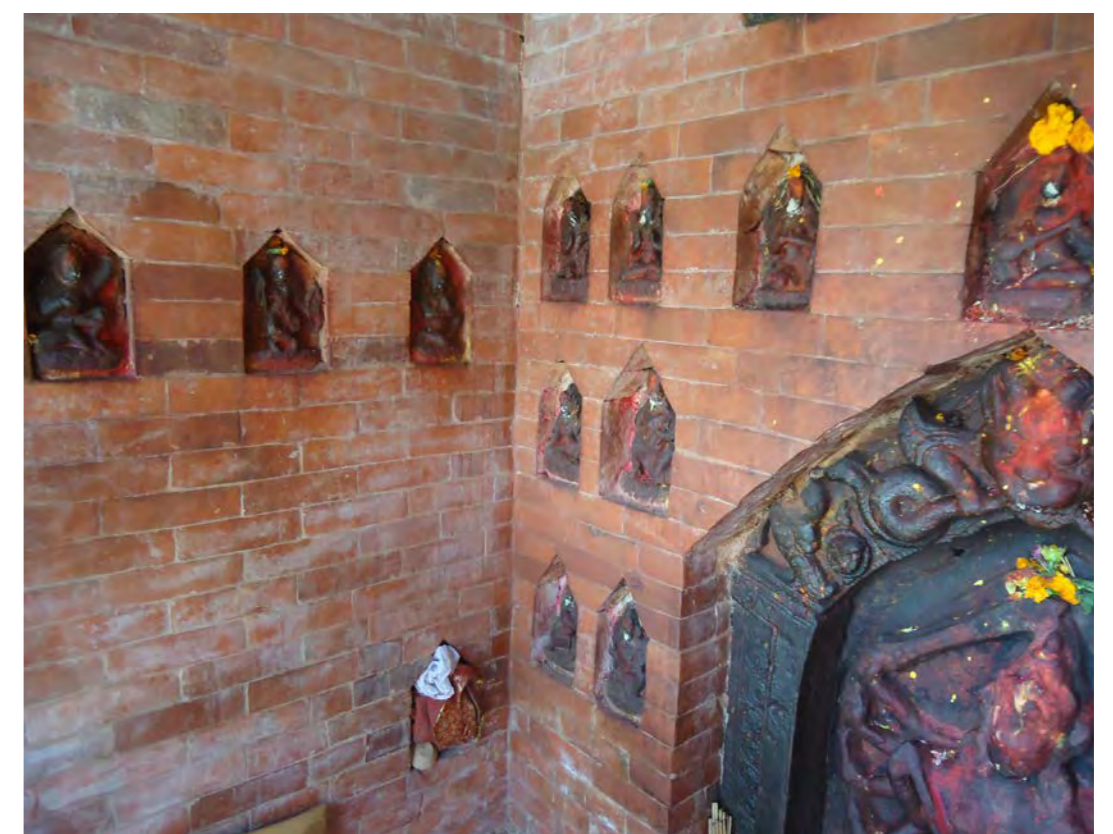
47 DURGA TEMPLE

CODE NO	TYOLOGY	MONUMENT NAME	ESTABLISHED/ RENOVATED	STRUCTURAL SYSTEM	MATERIAL	GENERAL DESCRIPTION	PROBLEM DESCRIPTION	DANGER	REMARKS
47	Two-Storey Temple	Durga Temple		Load Bearing	Brick; Timber	Durga Sculpture on slightly raised platform; Open type structure supported by pillars on four sides	Roof tiles missing and minor cracks on walls

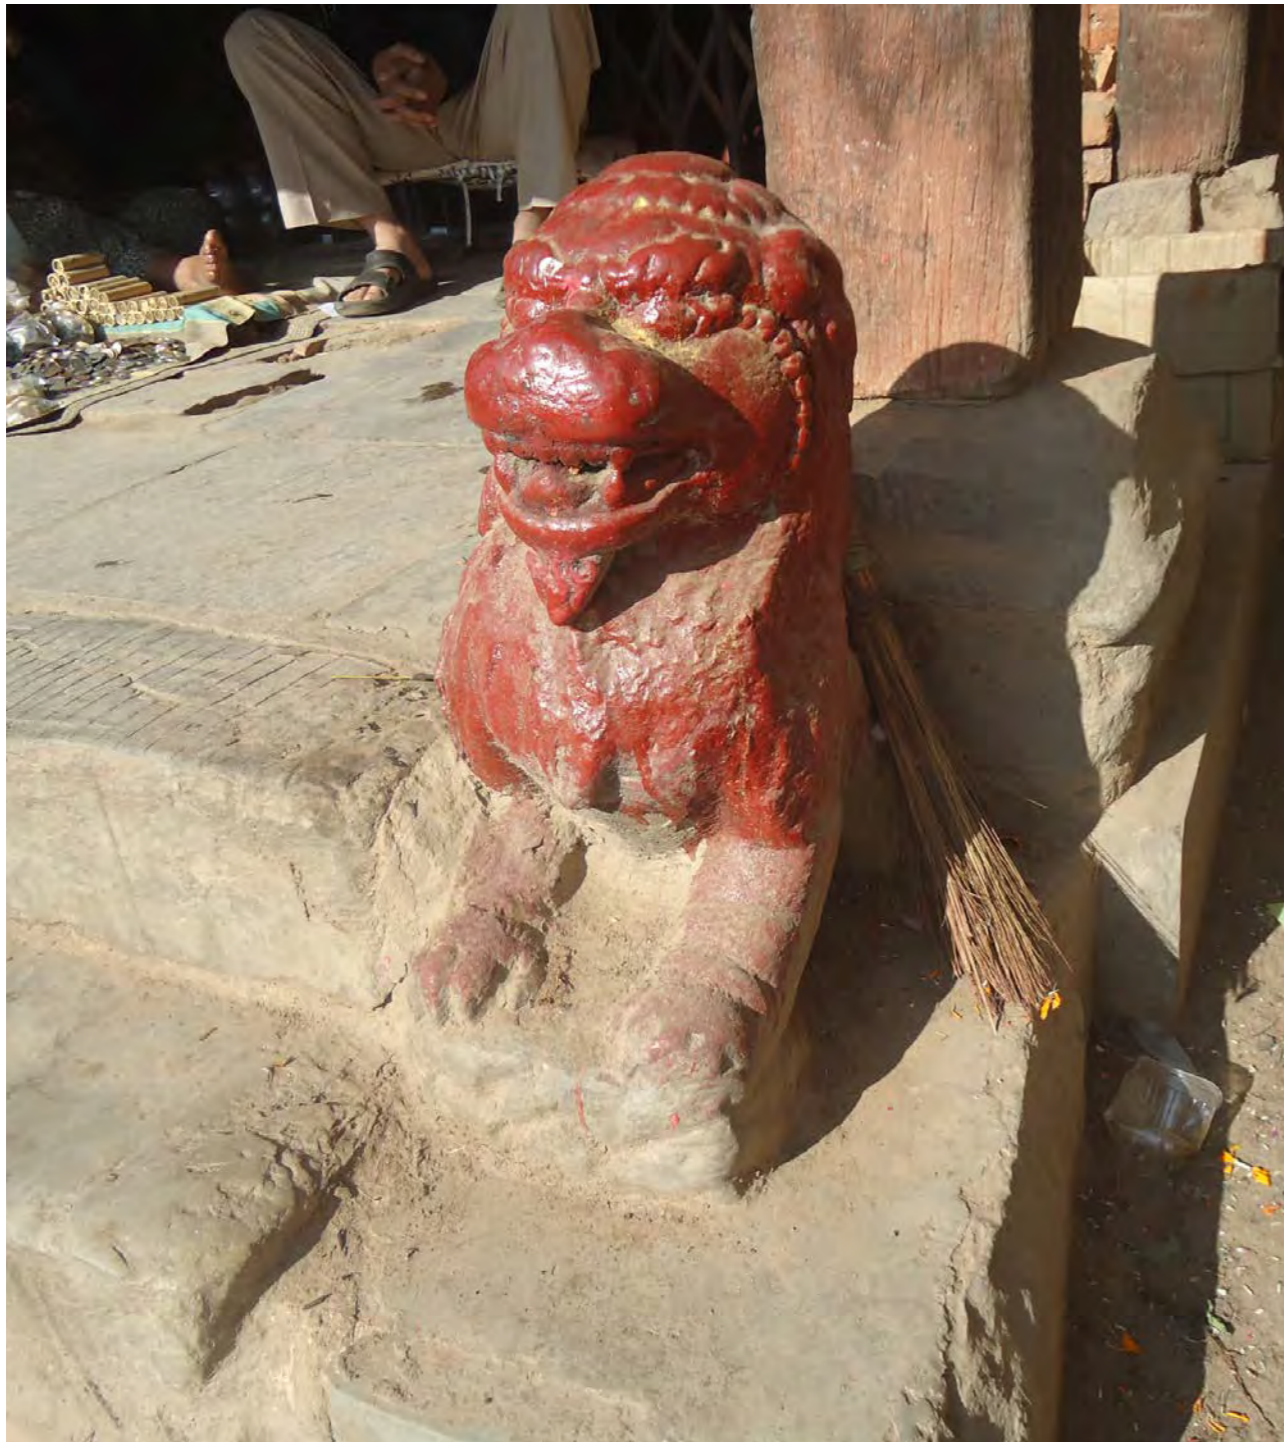
CODE NO	TYOLOGY	MONUMENT NAME	ESTABLISHED/ RENOVATED	STRUCTURAL SYSTEM	MATERIAL	GENERAL DESCRIPTION	PROBLEM DESCRIPTION	DANGER	REMARKS
47a	Guard lion				Stone	Guard lion on right side of entrance	Some parts detached		
47b	Guard lion				Stone	Guard lion on left side of entrance	No visible damage

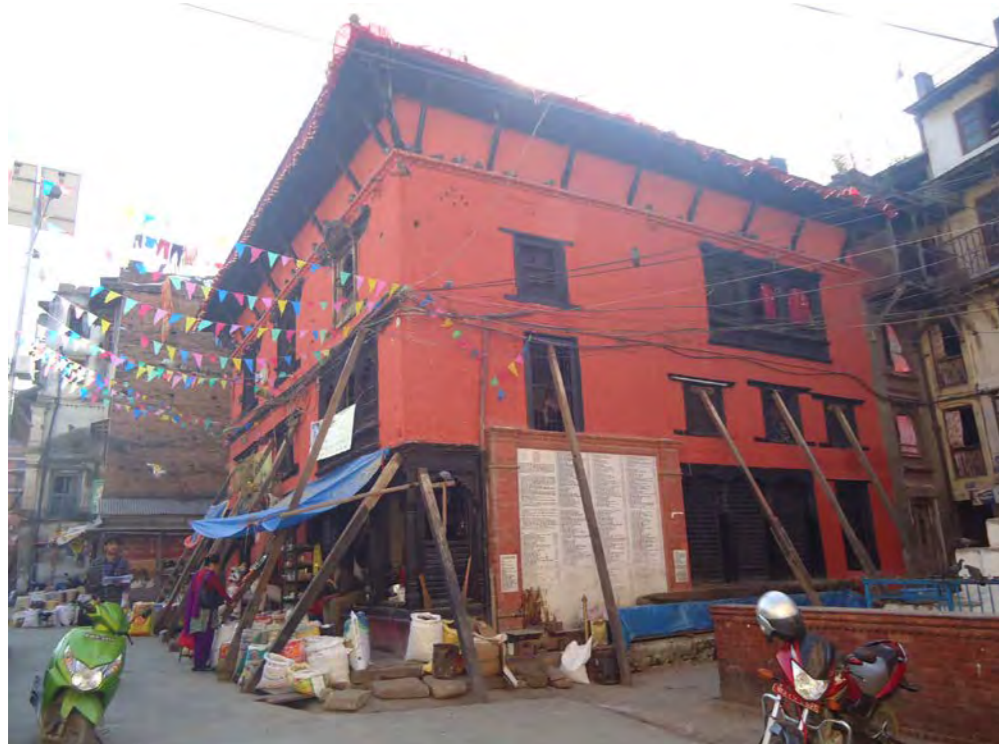
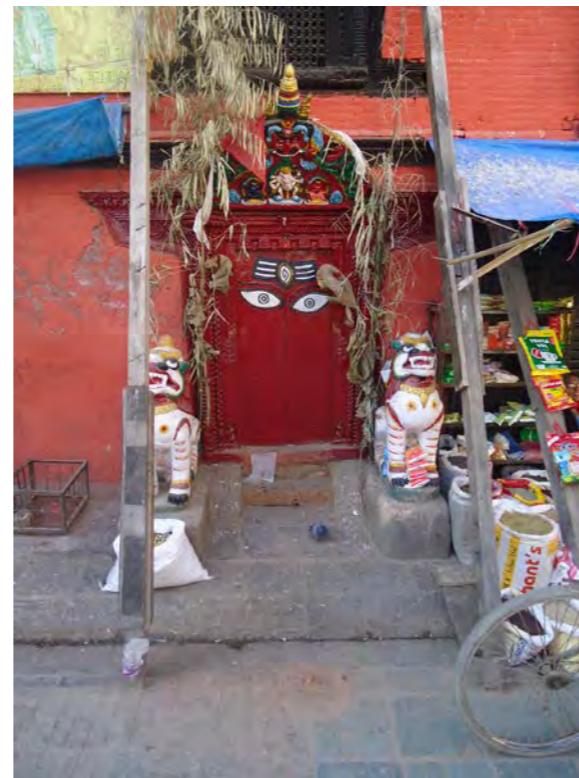
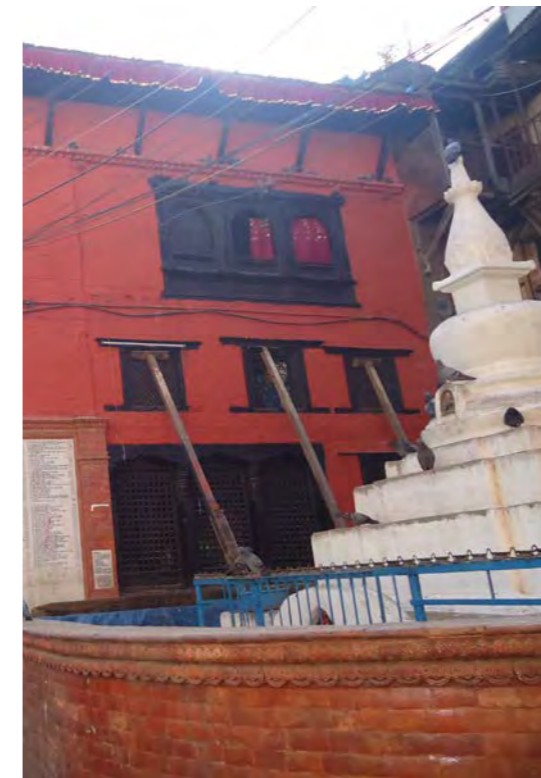
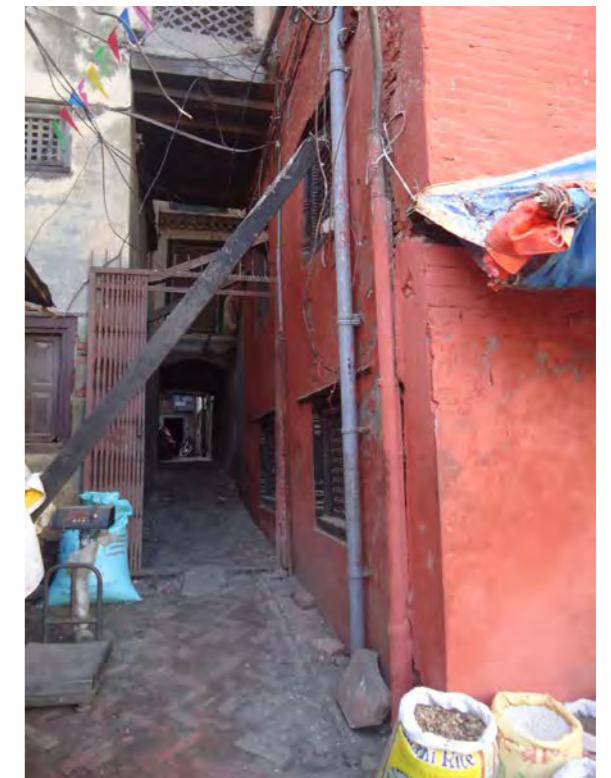
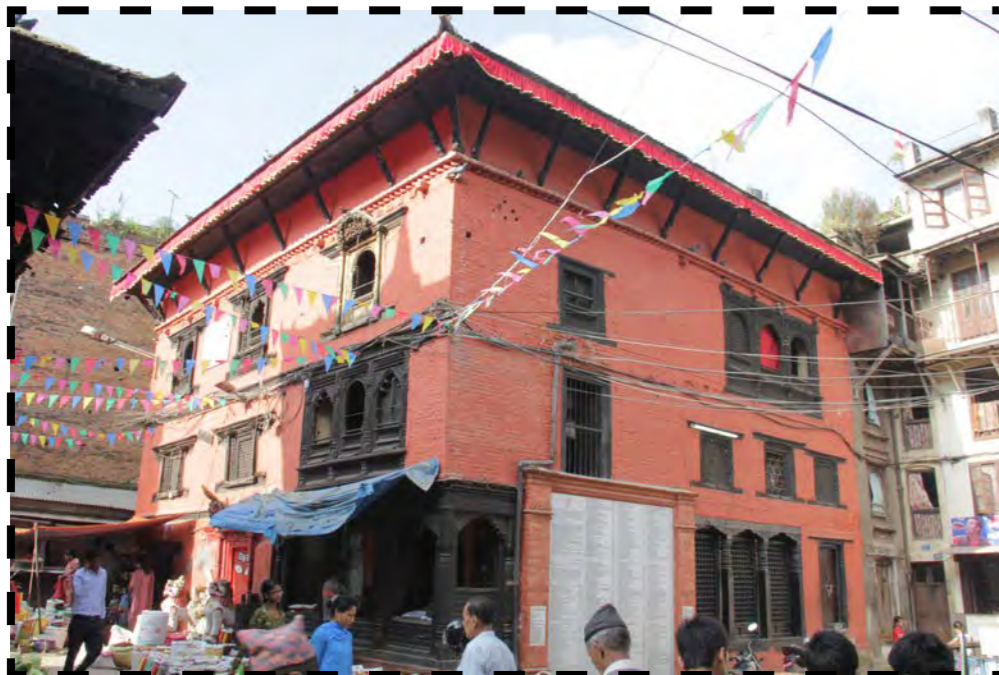
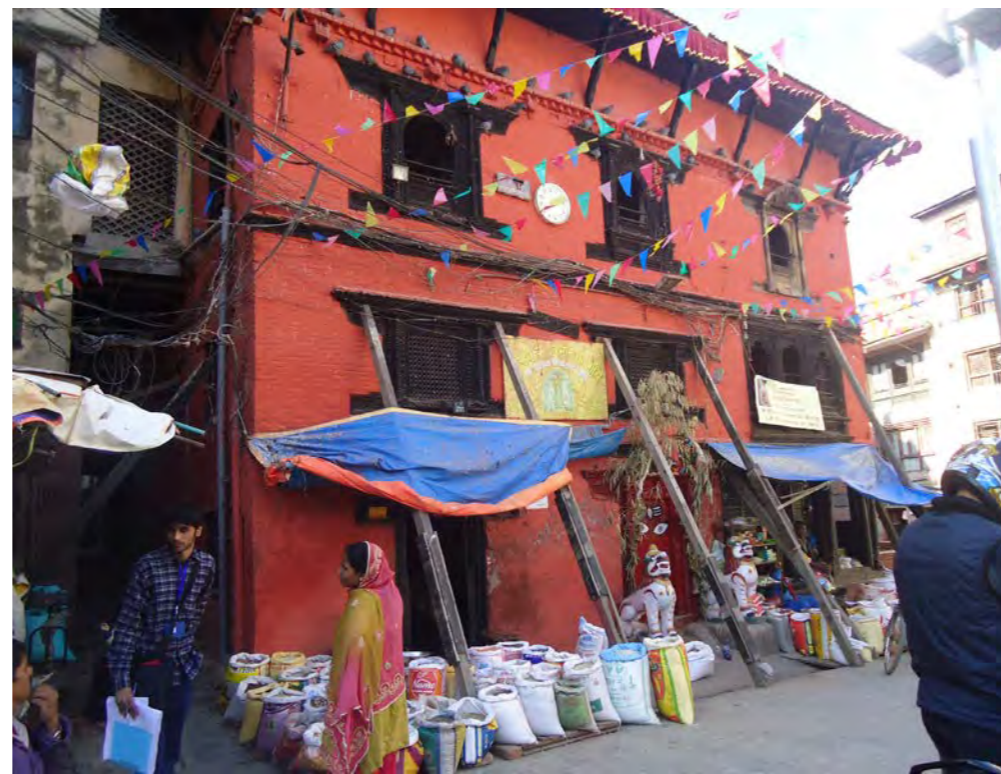
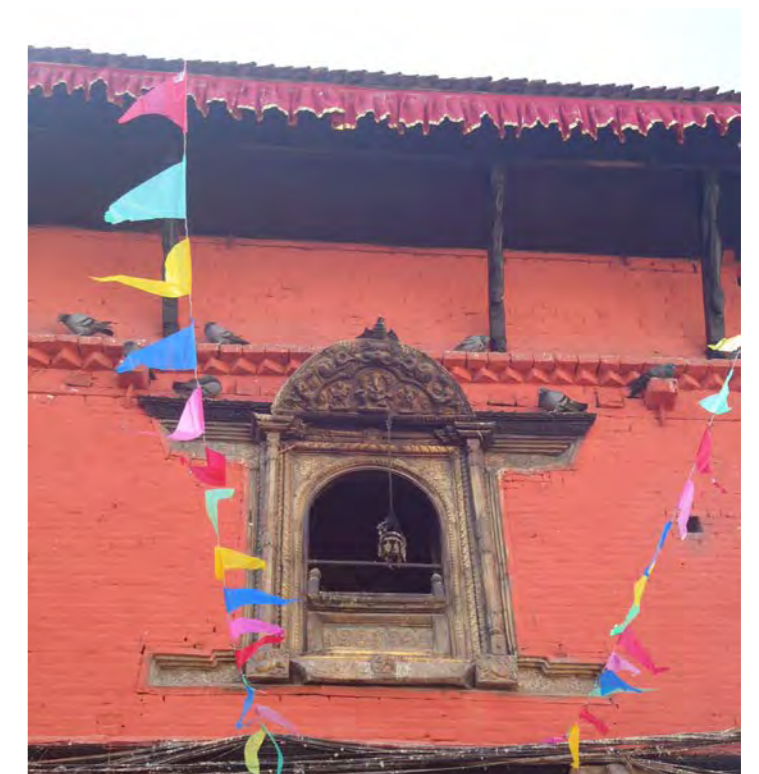
48 AGON DYO

CODE NO	TYOLOGY	MONUMENT NAME	ESTABLISHED/ RENOVATED	STRUCTURAL SYSTEM	MATERIAL	GENERAL DESCRIPTION	PROBLEM DESCRIPTION	DANGER	REMARKS	
48	Dyo chen	Agan Dyo-Agam House	19th century	Load Bearing	Brick;Timber	Three storied with carved wooden dorway guarded by lions;Carved struts with tiled roof	Moderate cracking and bulging of walls.

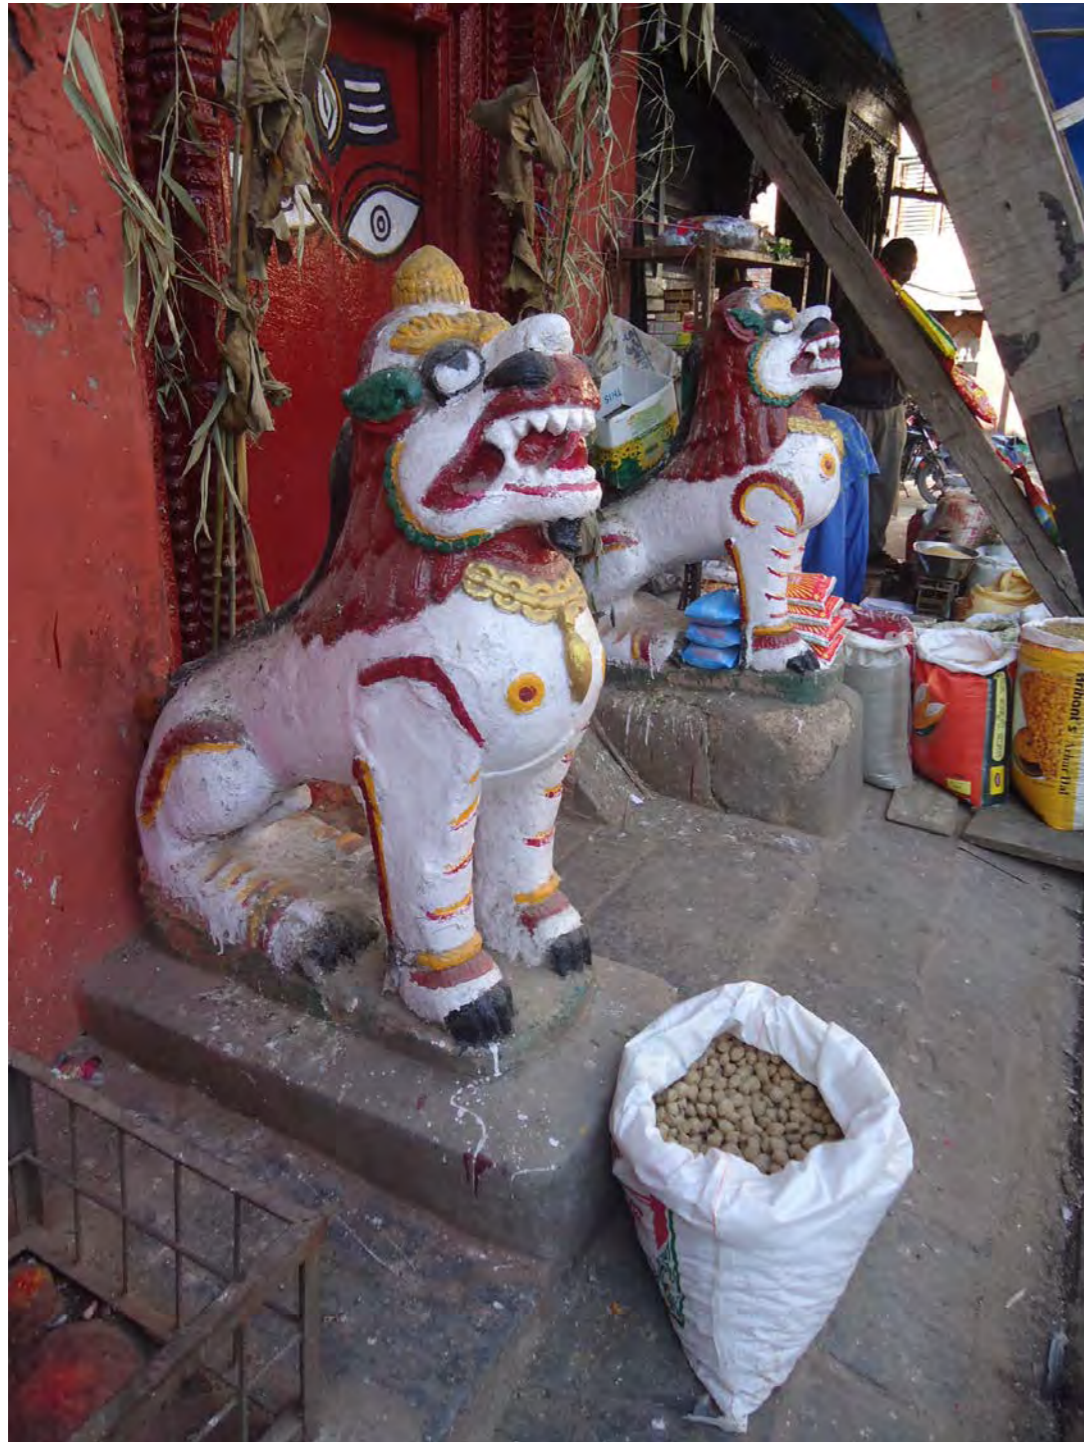
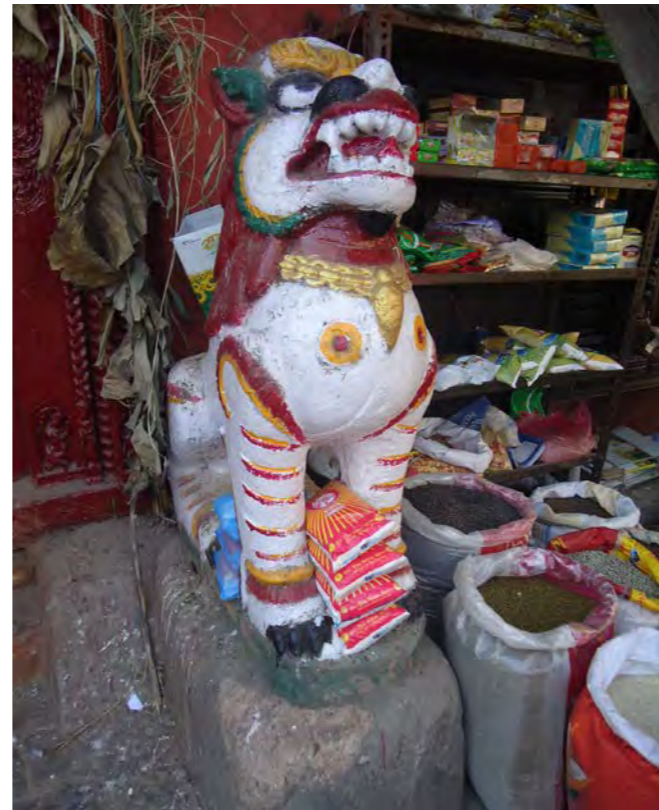
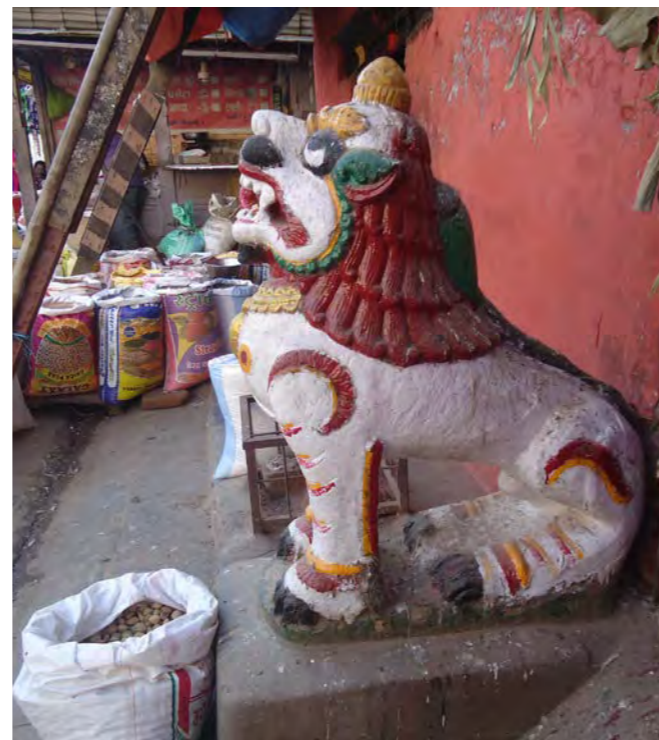
48a,b

CODE NO	TPOLOGY	MONUMENT NAME	ESTABLISHED/ RENOVATED	STRUCTURAL SYSTEM	MATERIAL	GENERAL DESCRIPTION	PROBLEM DESCRIPTION	DANGER	REMARKS
48a	Guard lion				Stone	Left guard lion in front of entrance	No visible damage		
48b	Guard lion				Stone	Left guard lion in front of entrance	No visible damage		
48c	Bhairab				Stone	Small enclosed sculpture	No visible damage

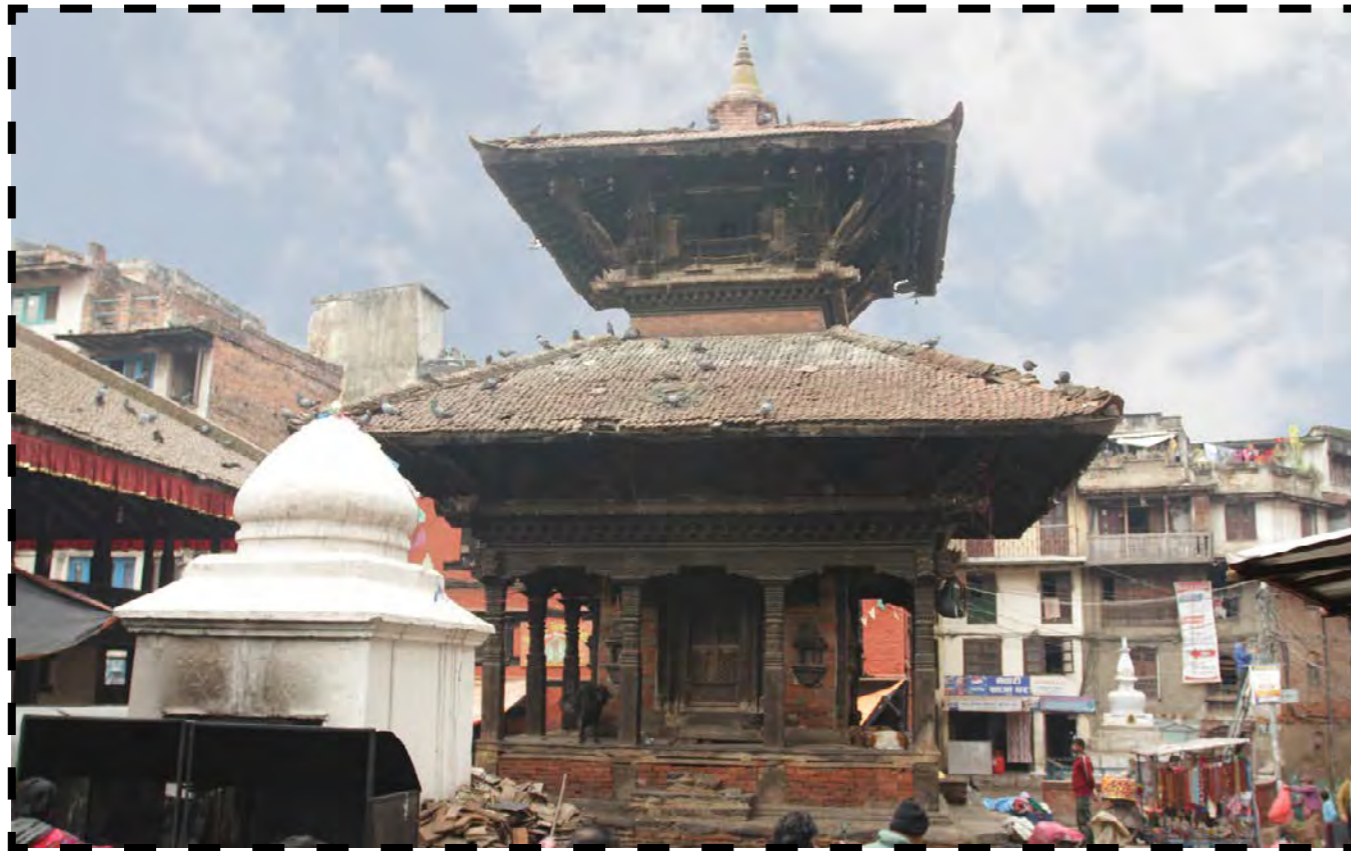
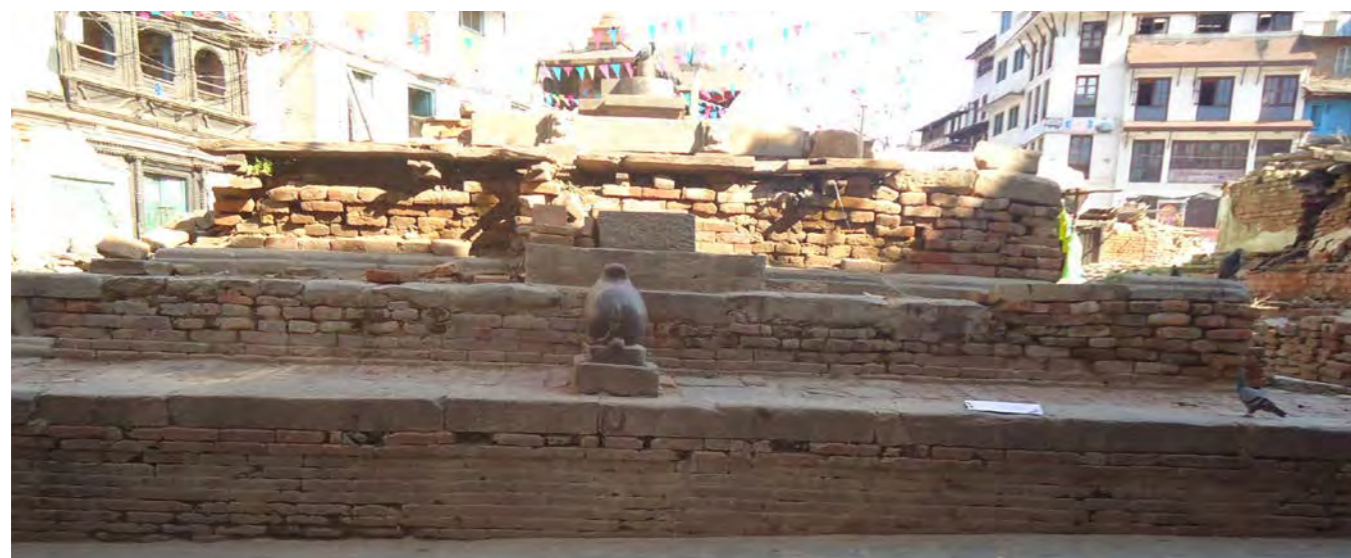
49 SHIVALINGA TEMPLE

CODE NO	TYOLOGY	MONUMENT NAME	ESTABLISHED/ RENOVATED	STRUCTURAL SYSTEM	MATERIAL	GENERAL DESCRIPTION	PROBLEM DESCRIPTION	DANGER	REMARKS	
49	Two Storey Temple	Shiva linga Temple		Load Bearing	Brick;Timber	Shiva linga on raised plinth	Totally collapsed;Extensive cracking on plinth

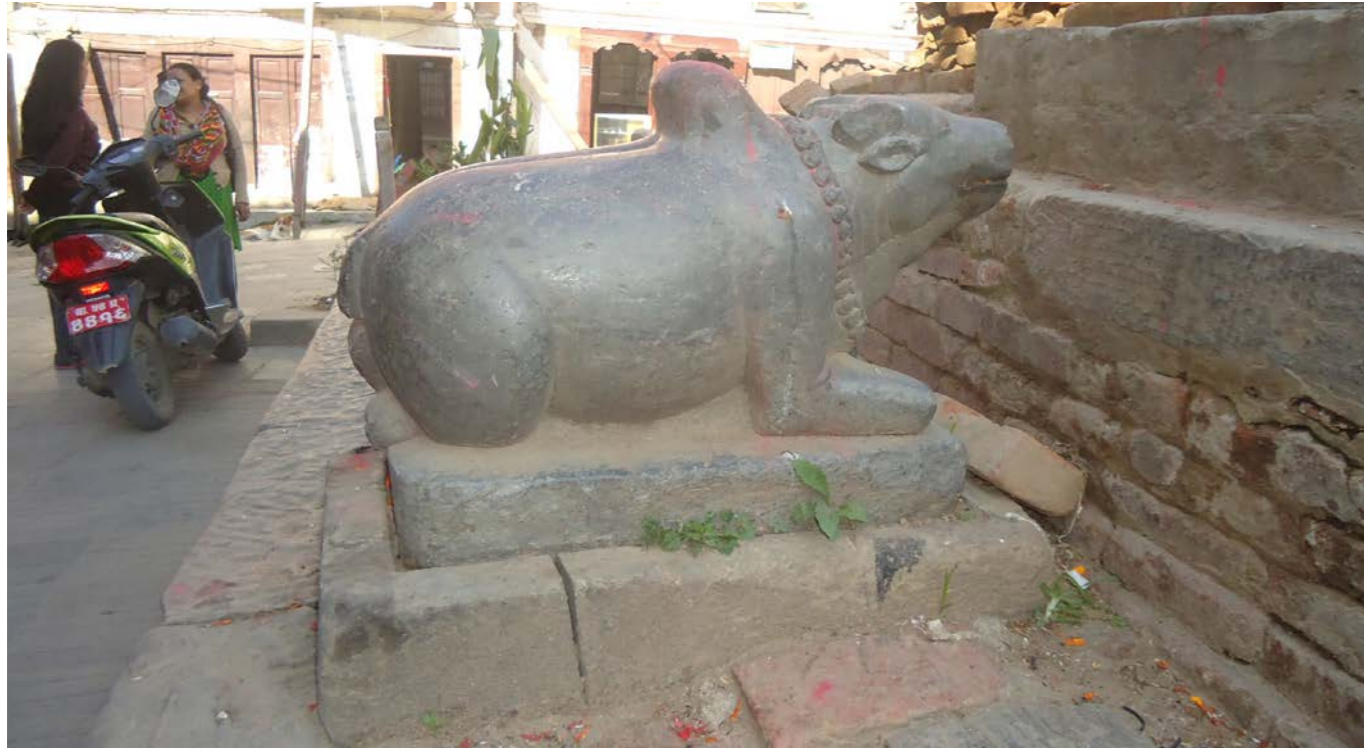
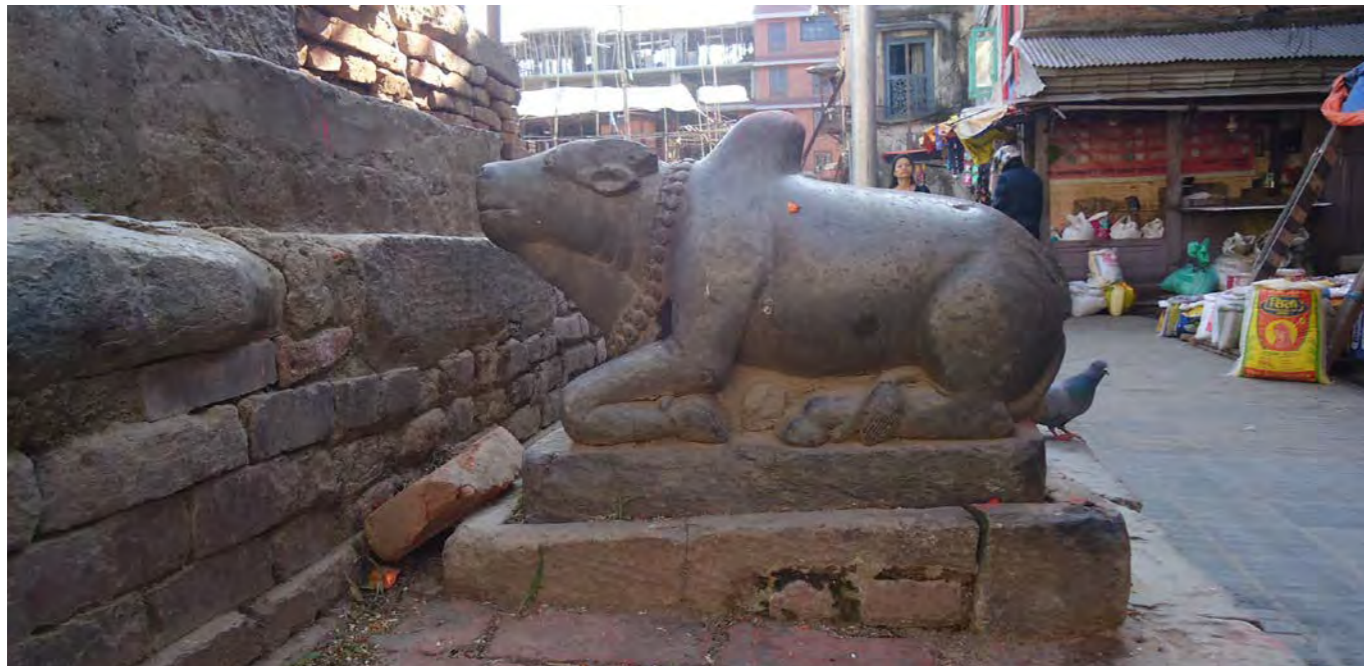
CODE NO	TYOLOGY	MONUMENT NAME	ESTABLISHED/ RENOVATED	STRUCTURAL SYSTEM	MATERIAL	GENERAL DESCRIPTION	PROBLEM DESCRIPTION	DANGER	REMARKS
49a	Bull				Stone		Moderate cracks and vegetation growth		
49b	Closed Shrine				Brick	Closed shrine with ganesh sculpture inside on raised platform	No visible damage
