2015 Earthquake Damage Mapping

Hanuman Dhoka Darbar Square Monument Zone
Kathmandu Valley World Heritage Property

December 2015

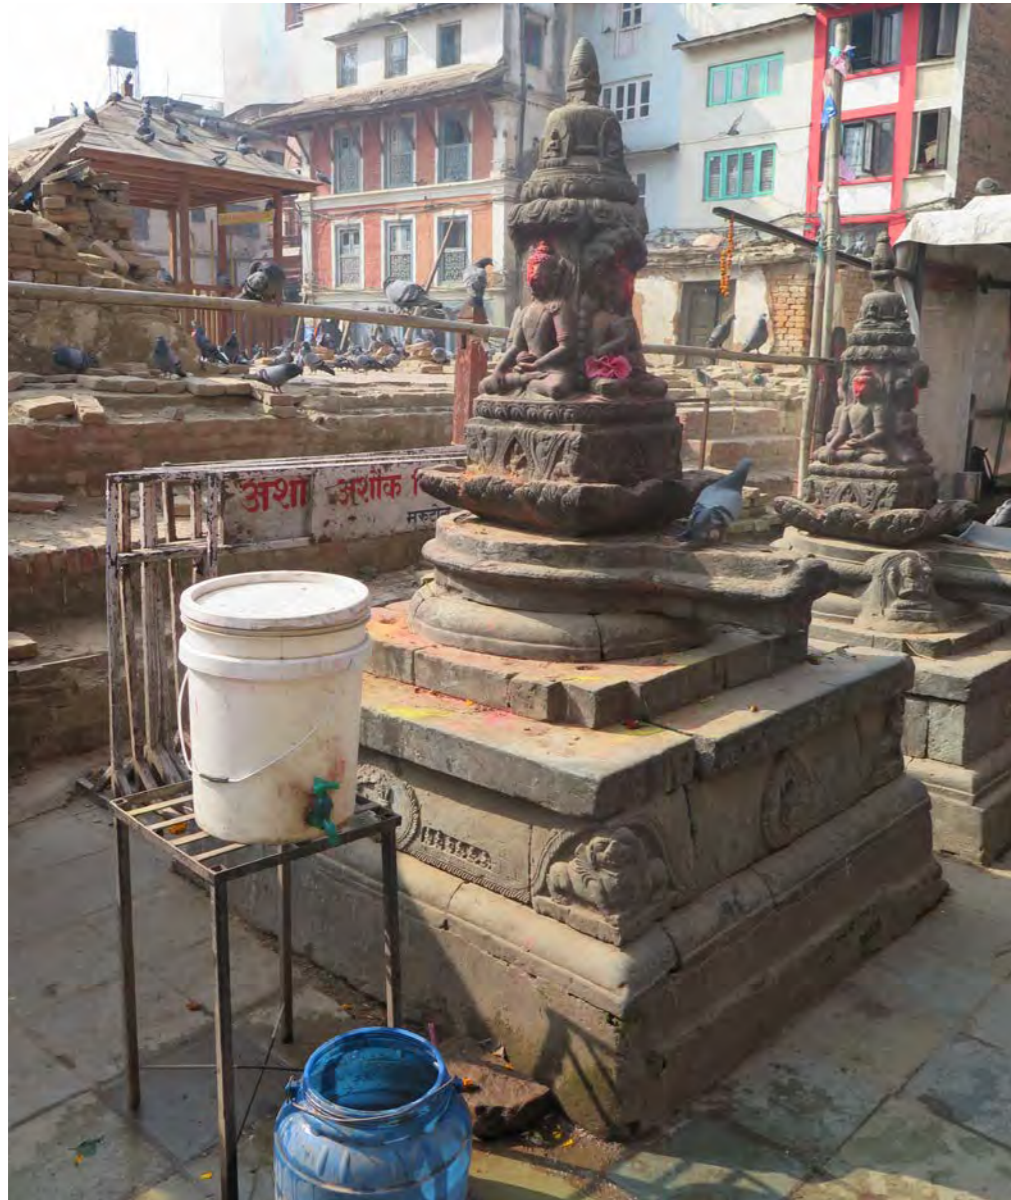
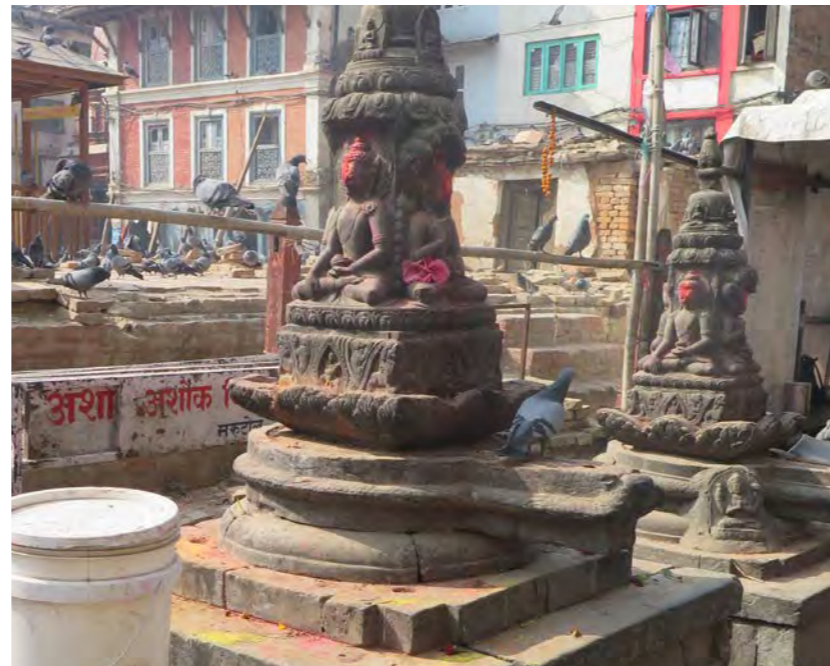
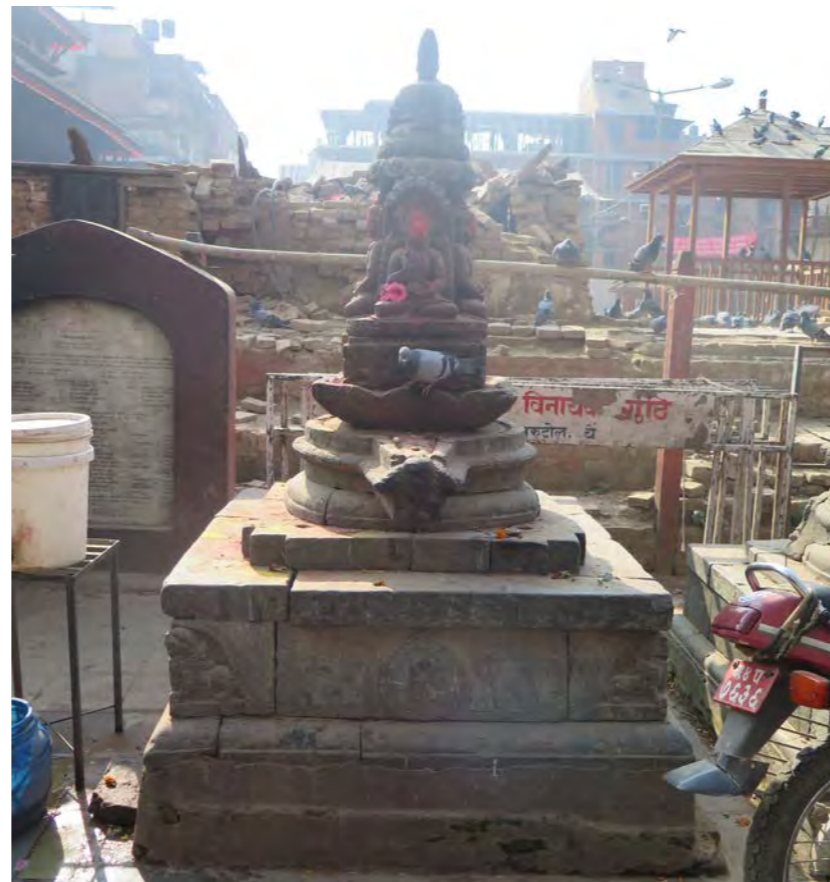
CODE NO	TYOLOGY	MONUMENT NAME	ESTABLISHED/ RENOVATED	STRUCTURAL SYSTEM	MATERIAL	GENERAL DESCRIPTION	PROBLEM DESCRIPTION	DANGER	REMARKS
49c	Chaitya				Stone	Stone chaitya on raised platform with Buddha on four side	Minor cracks on walls		
49d	Chaitya				Stone	"	Minor cracks on base and vegetation growth.

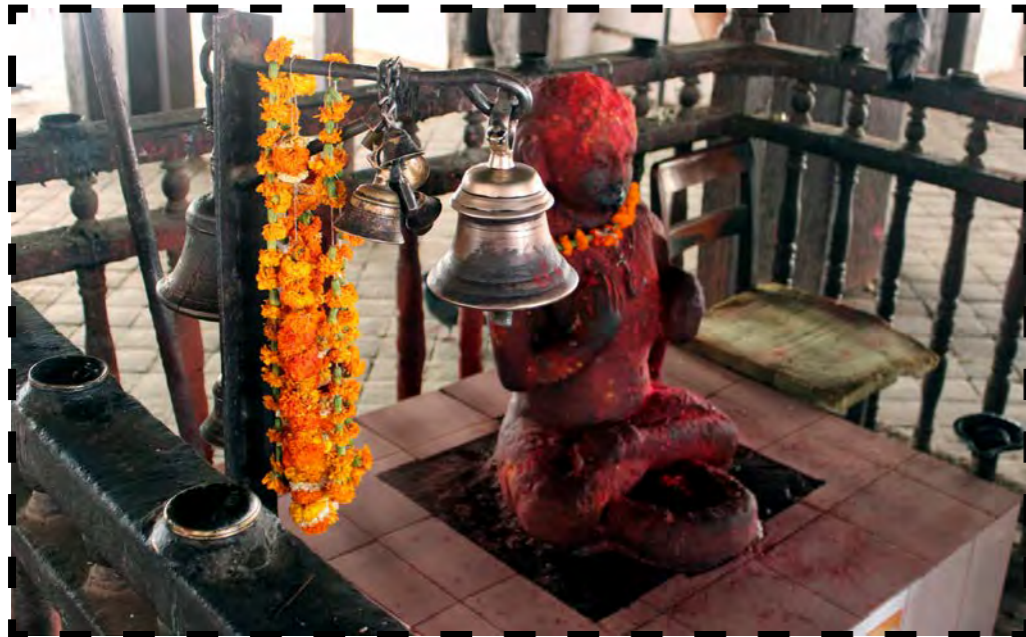
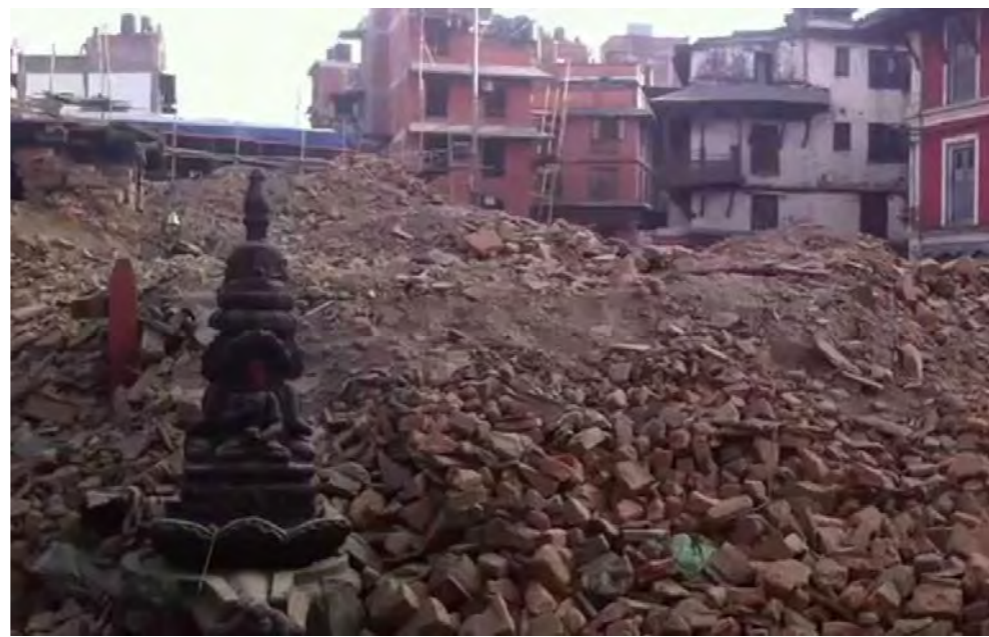
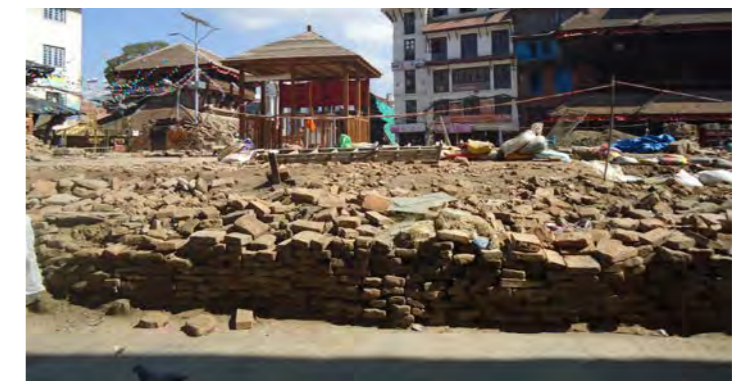
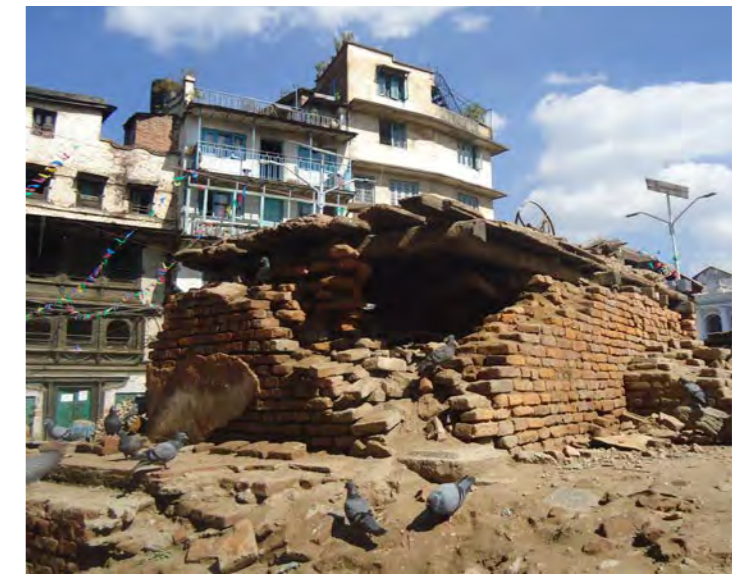
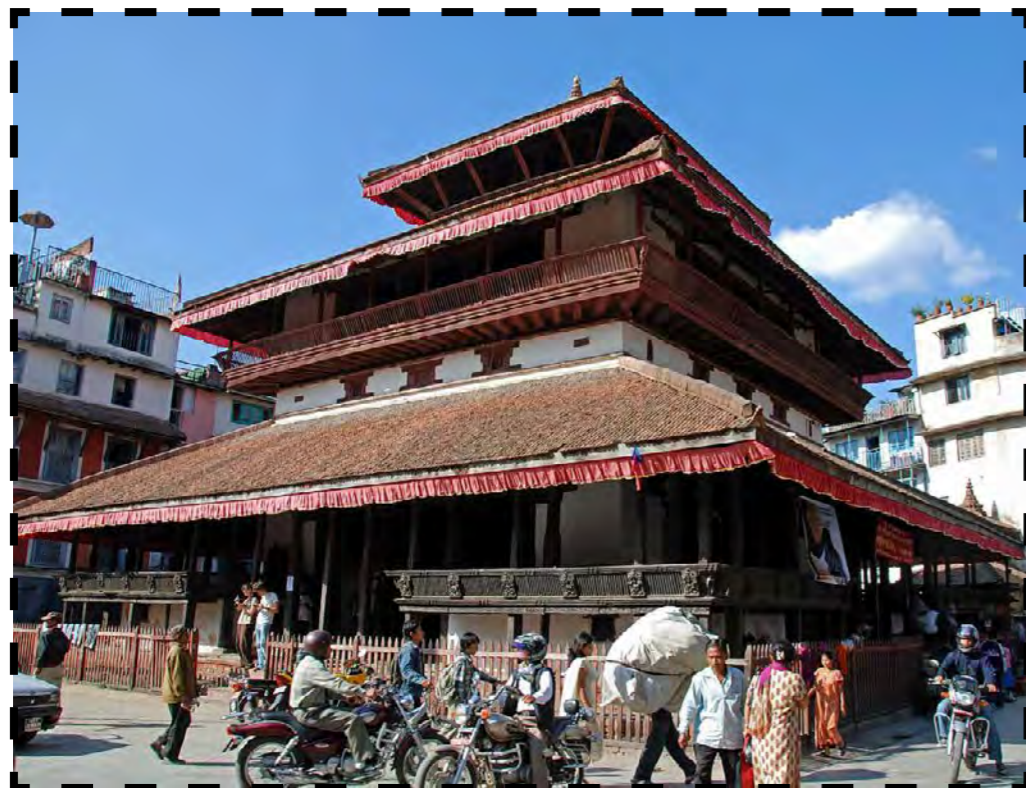
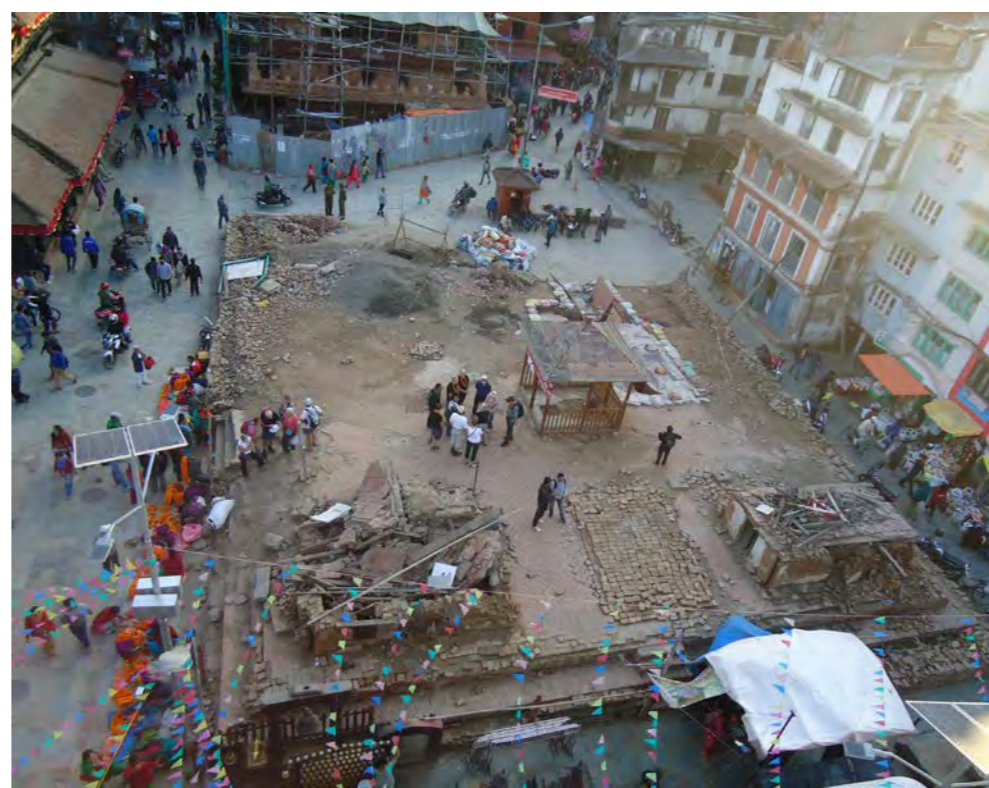
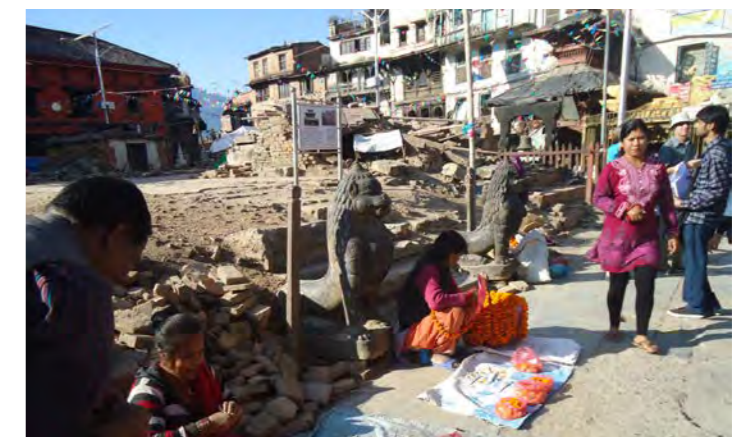
50 KASTHAMANDAP

CODE NO	TYOLOGY	MONUMENT NAME	ESTABLISHED/ RENOVATED	STRUCTURAL SYSTEM	MATERIAL	GENERAL DESCRIPTION	PROBLEM DESCRIPTION	DANGER	REMARKS
50	Three storey temple	Kasthamandap	1620	Load Bearing	Brick;Timber	Located in the center of Maru;Three storied structure with open ground floor	Totally Collapsed

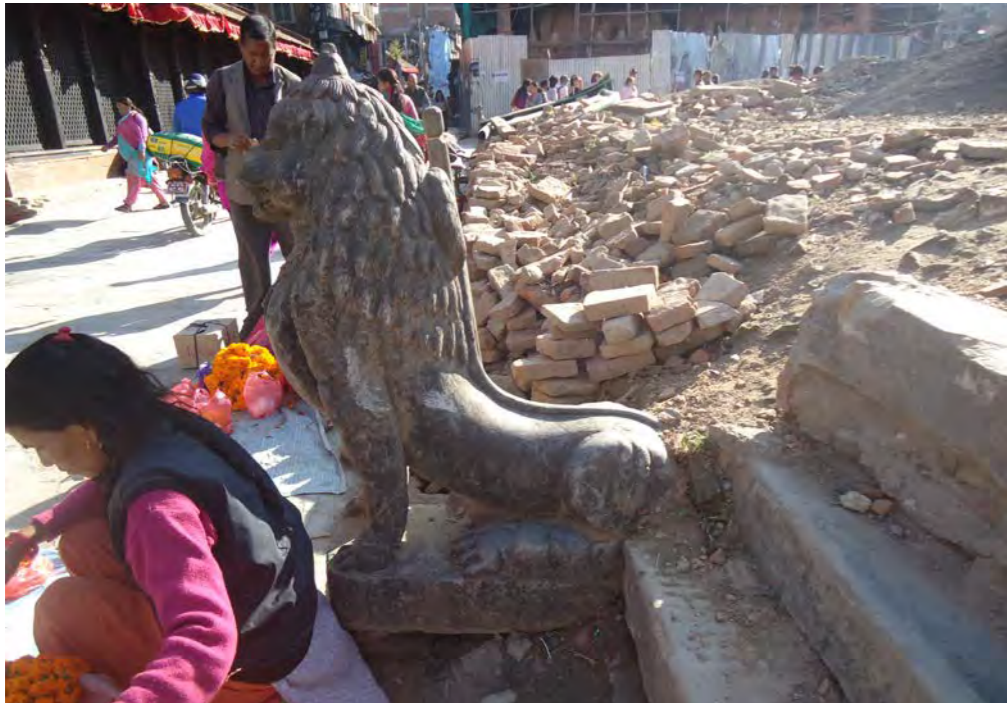
CODE NO	TYOLOGY	MONUMENT NAME	ESTABLISHED/ RENOVATED	STRUCTURAL SYSTEM	MATERIAL	GENERAL DESCRIPTION	PROBLEM DESCRIPTION	DANGER	REMARKS
50a	Guard lion				Stone	Guard lion on right side of kaasthamandap	Face of the lion detached		
50b	Guard lion				Stone	"	Supports missing		
50c	Platform				Stone;brick	Stone platform onbrick base and slightly raised	Vegetation Growth

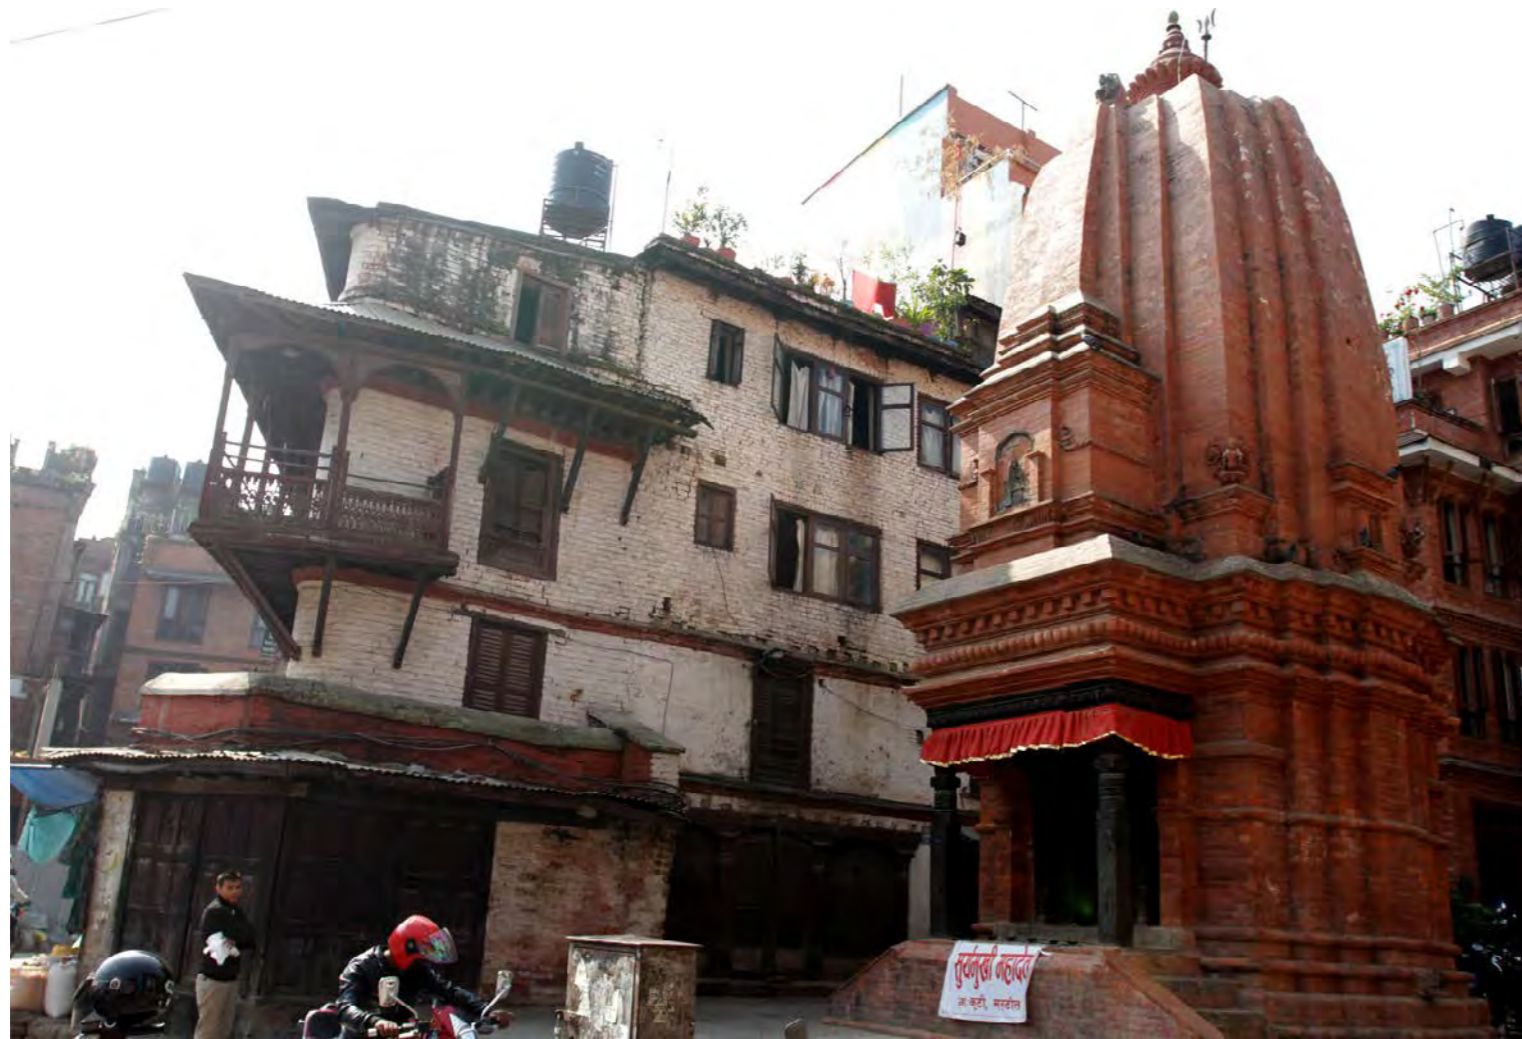
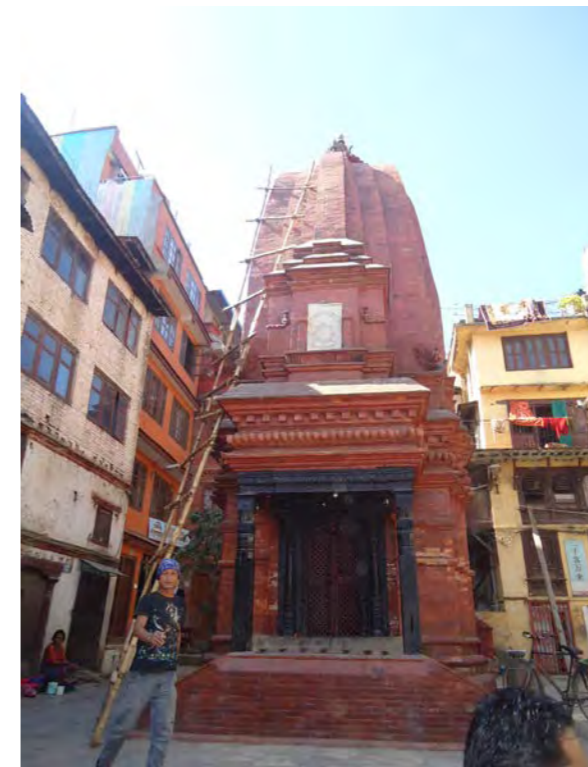
51 MAHADEV TEMPLE

CODE NO	TYOLOGY	MONUMENT NAME	ESTABLISHED/ RENOVATED	STRUCTURAL SYSTEM	MATERIAL	GENERAL DESCRIPTION	PROBLEM DESCRIPTION	DANGER	REMARKS
51	Shikara	Madhev temple	1673	Load Bearing	Brick;Timber	On a slightly raised platform from road;Outer façade recently renovated	No visible damage		
51a	Open shrine	Bishnu Sculoture			Stone		Slightly delapadated and vegetation growth

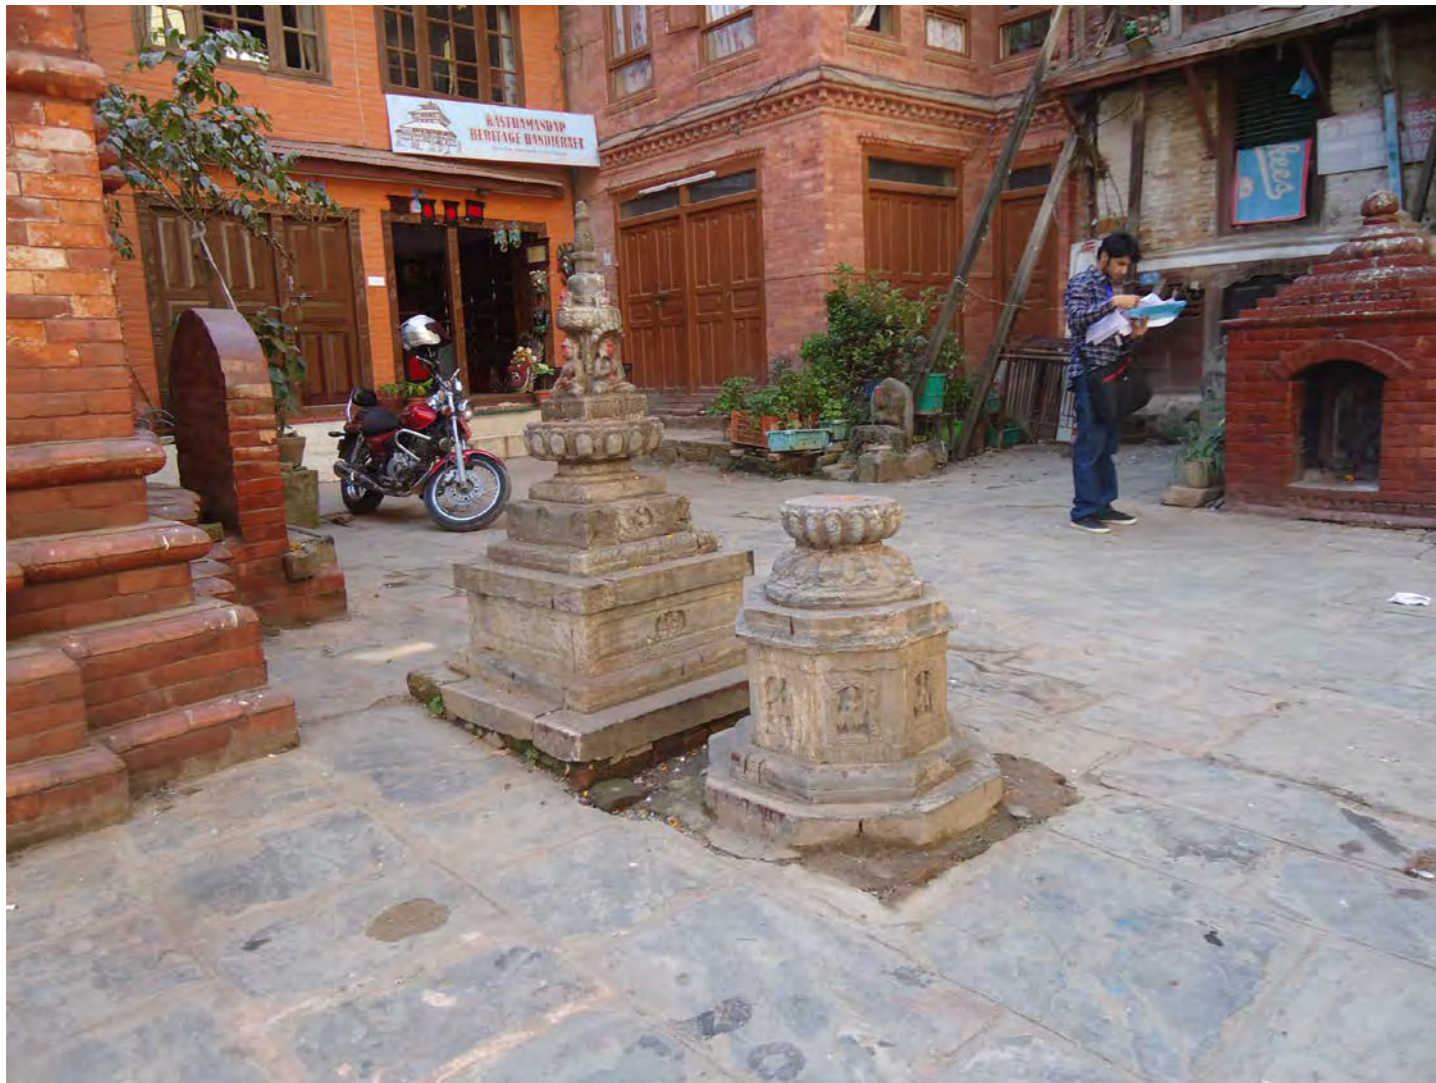
CODE NO	TYOLOGY	MONUMENT NAME	ESTABLISHED/ RENOVATED	STRUCTURAL SYSTEM	MATERIAL	GENERAL DESCRIPTION	PROBLEM DESCRIPTION	DANGER	REMARKS
51b	Chaitya				Stone		Cracks a base;slightly settled;vegetation growth		
51c	Dharmadhatu				Stone	Octagonal in plan with inscription on top, images of various gods on sides	No visible damage

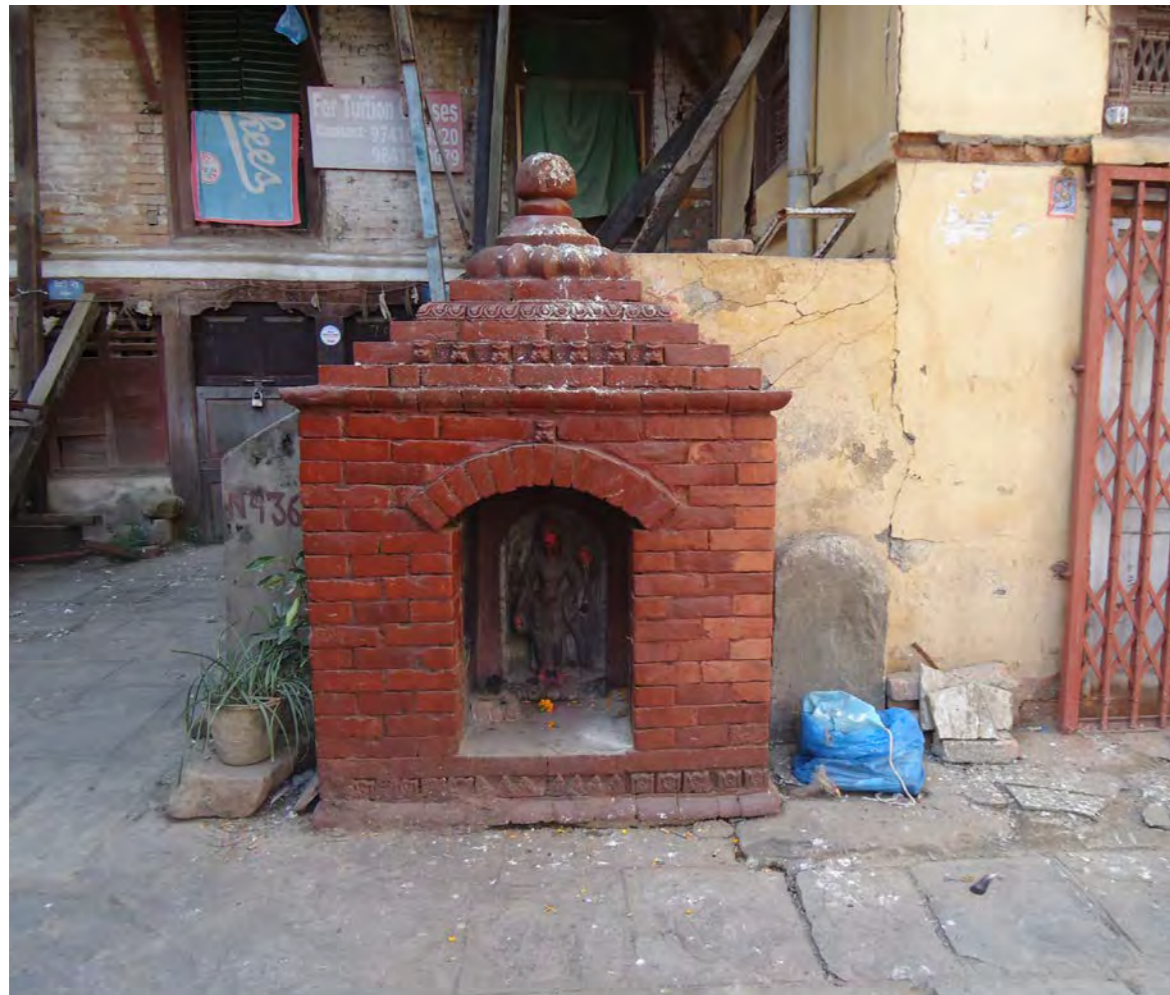
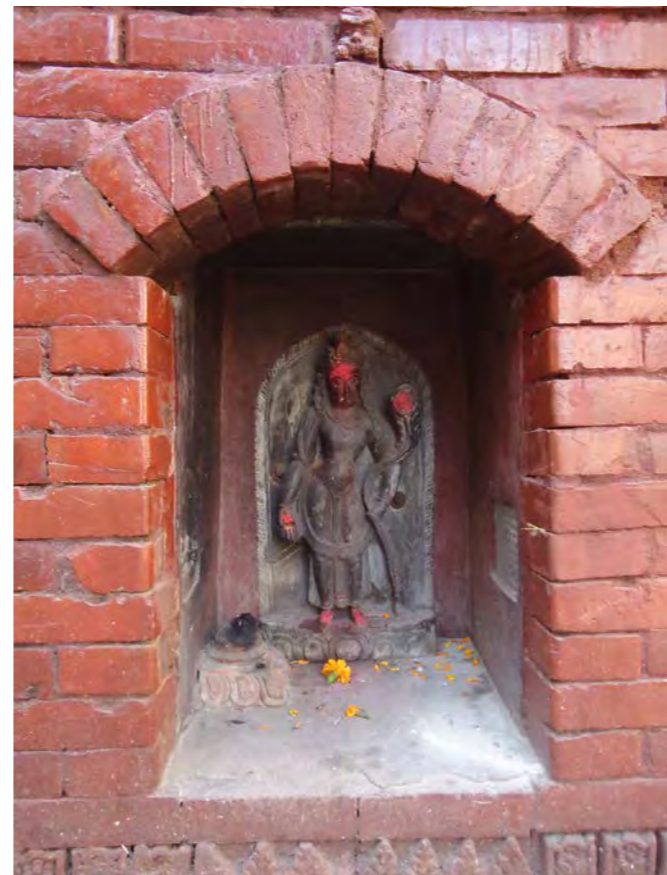
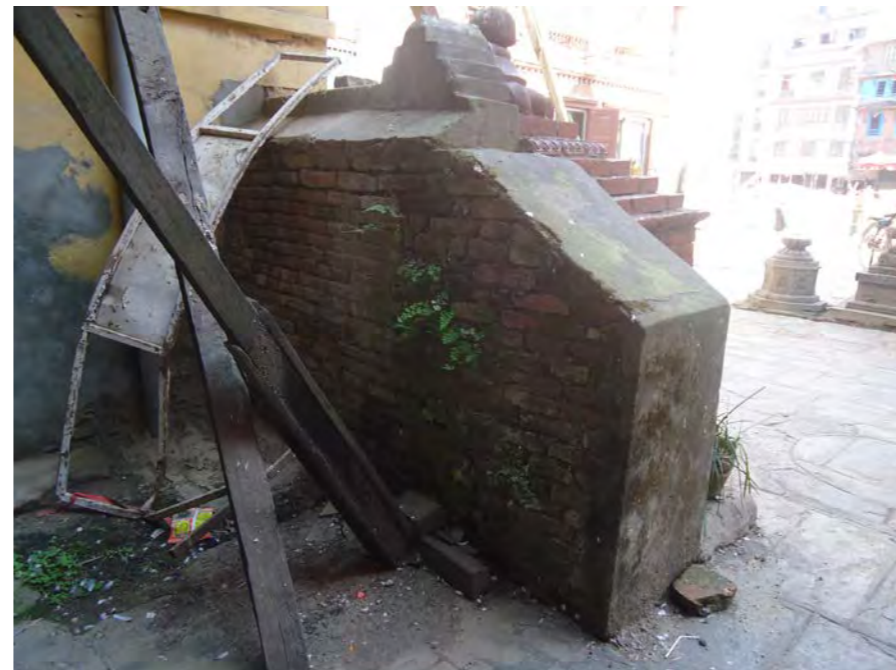
CODE NO	TYOLOGY	MONUMENT NAME	ESTABLISHED/ RENOVATED	STRUCTURAL SYSTEM	MATERIAL	GENERAL DESCRIPTION	PROBLEM DESCRIPTION	DANGER	REMARKS	
51d	Closed Shrine		1118 Nepal Sambat		Brick; Stone	Laxmi goddess with inscription on side	Vegetation growth, cracks on top			
51e	Open Shrine				Stone		Good condition

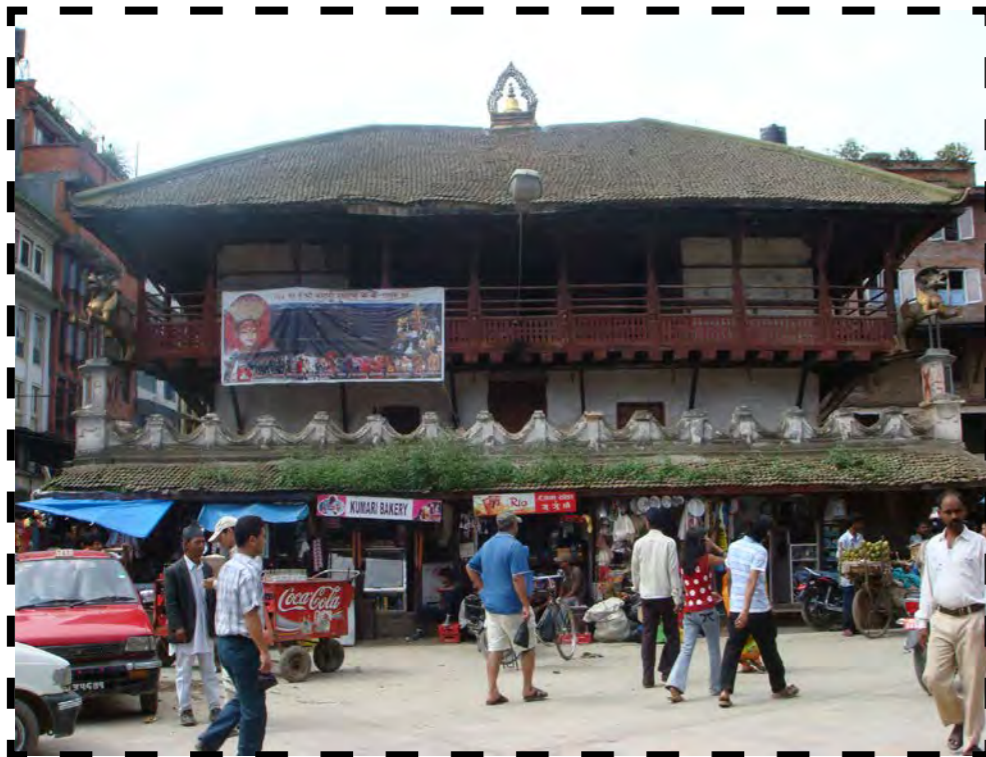
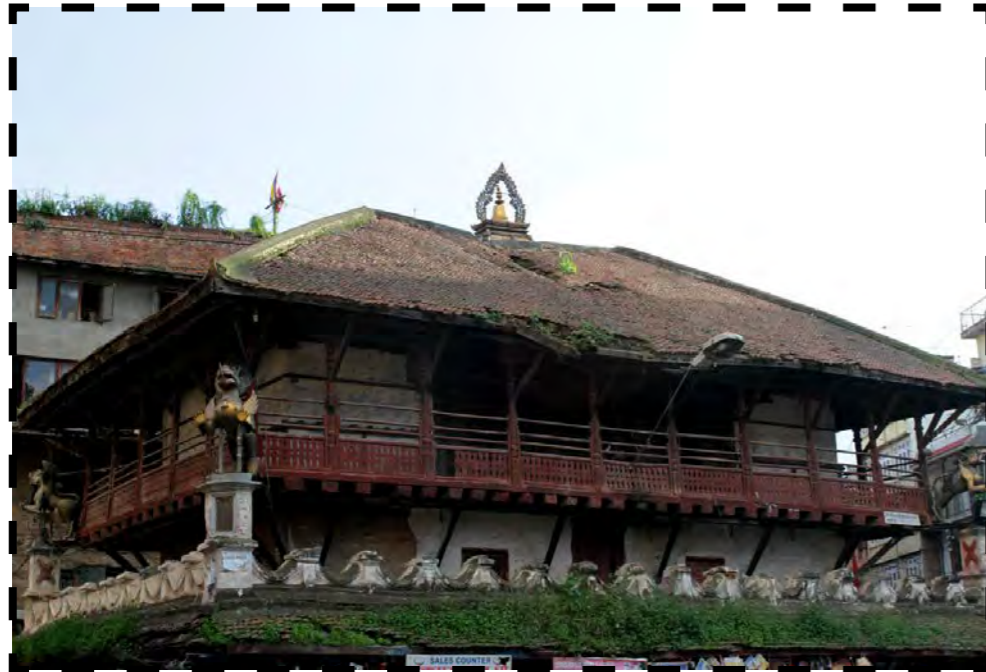
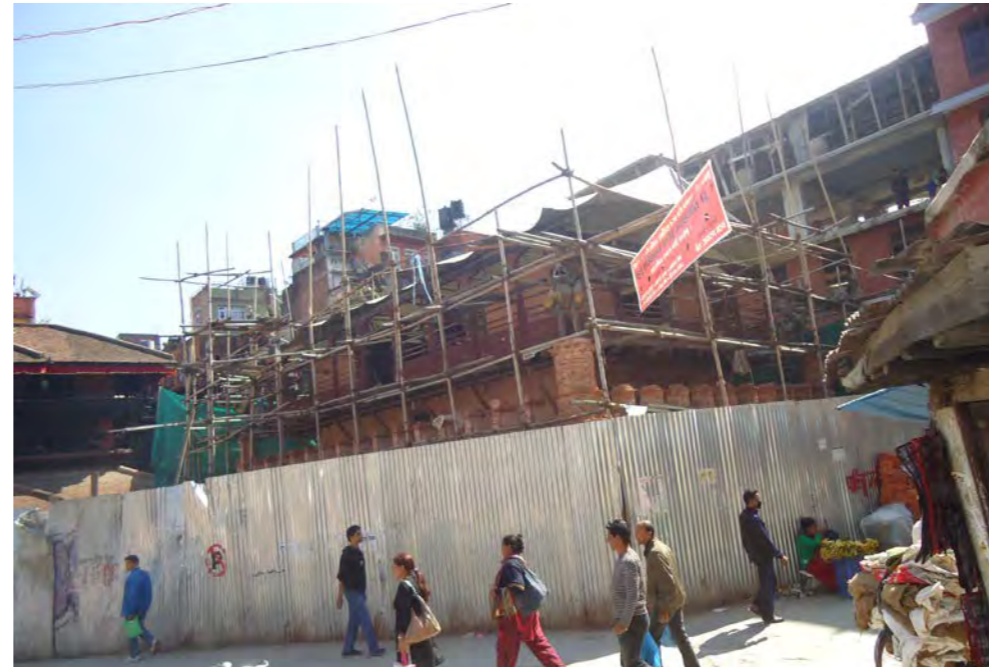
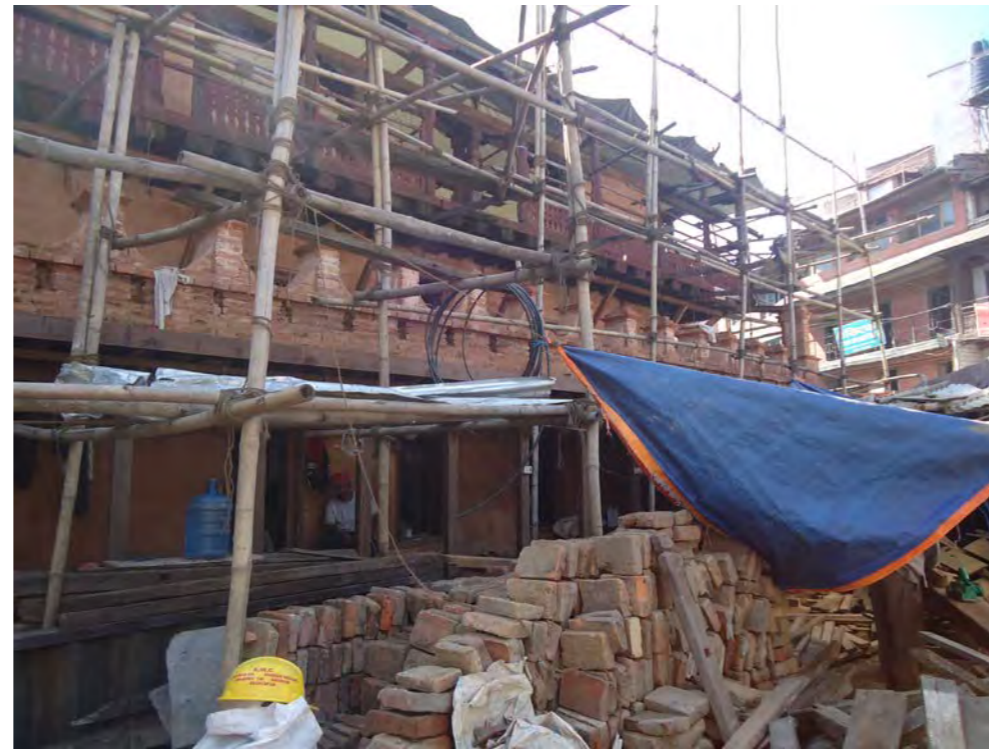
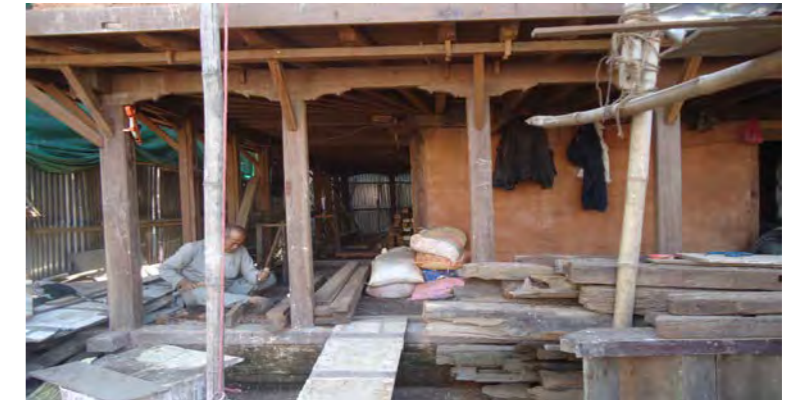
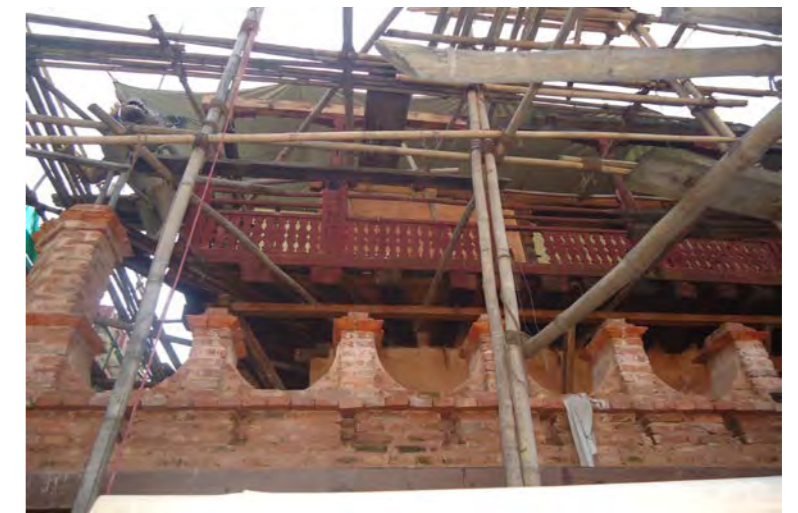
52 SILYAN SATTAL

CODE NO	TYOLOGY	MONUMENT NAME	ESTABLISHED/ RENOVATED	STRUCTURAL SYSTEM	MATERIAL	GENERAL DESCRIPTION	PROBLEM DESCRIPTION	DANGER	REMARKS
52		Silyan Sattal		Load Bearing	Brick; Timber	Being renovated by Guthi Sanstha before earthquake	Suffered minor cracks after earthquake

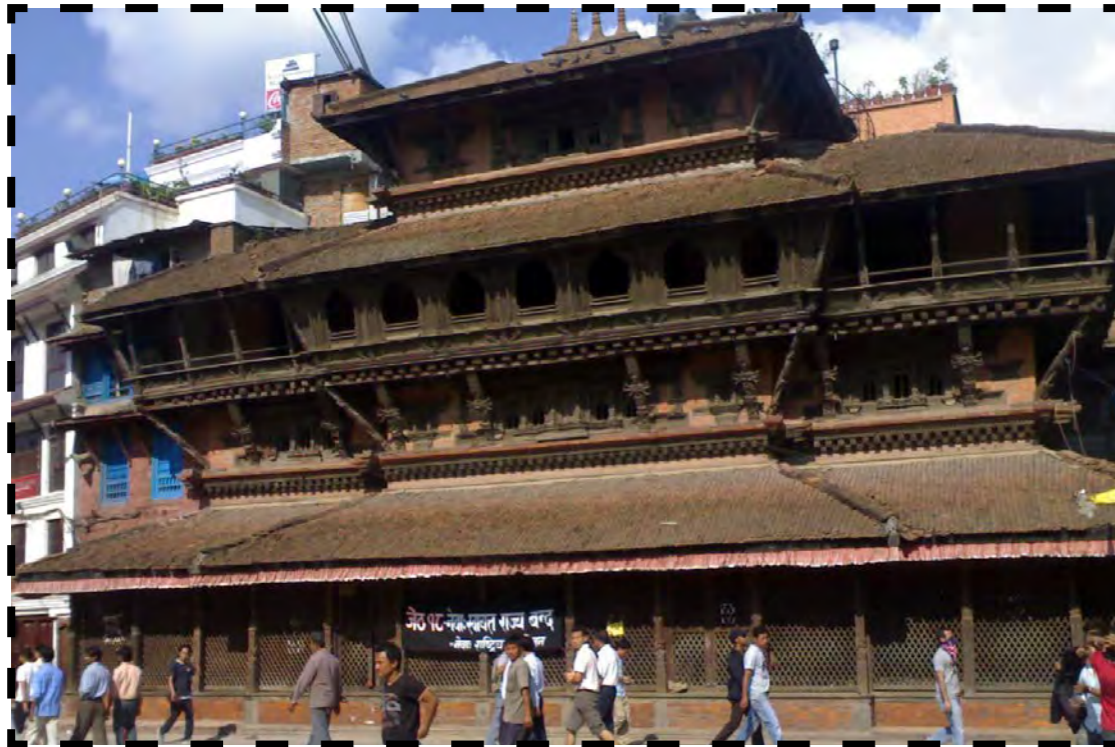
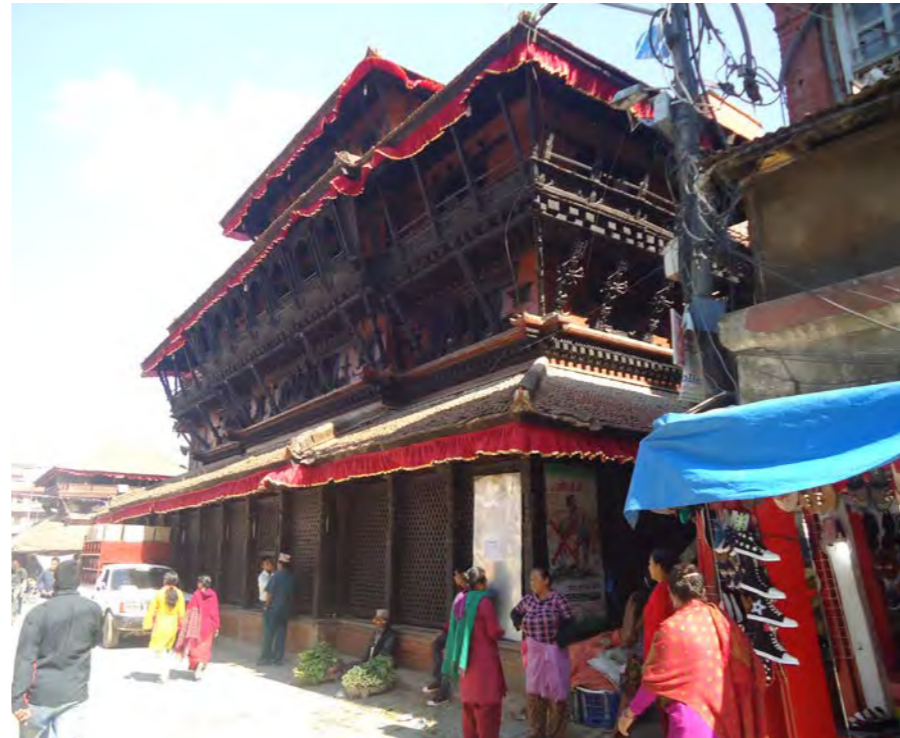
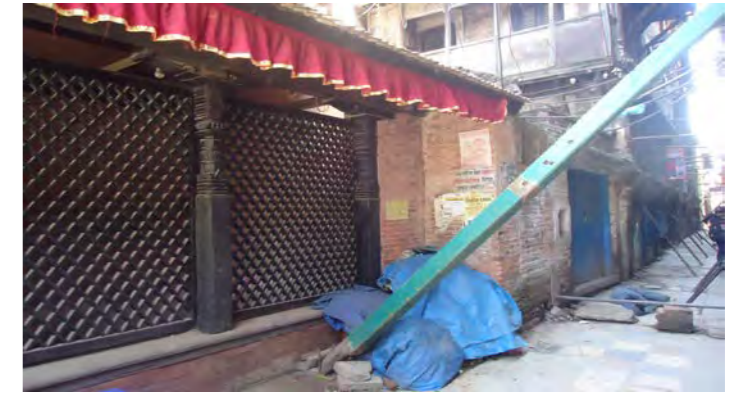
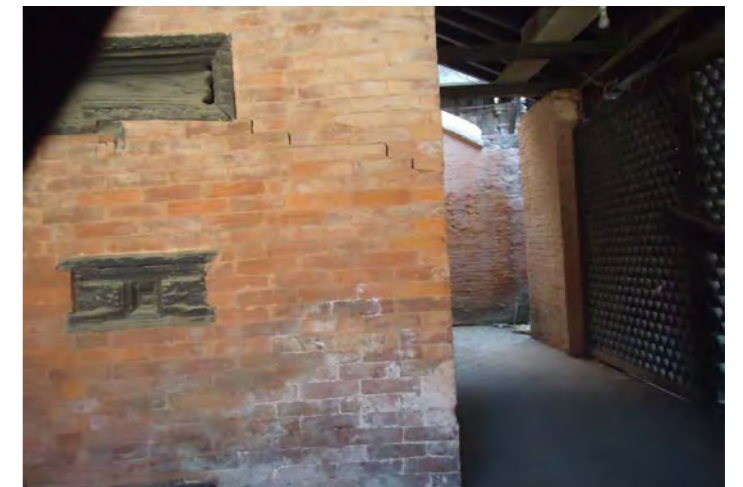
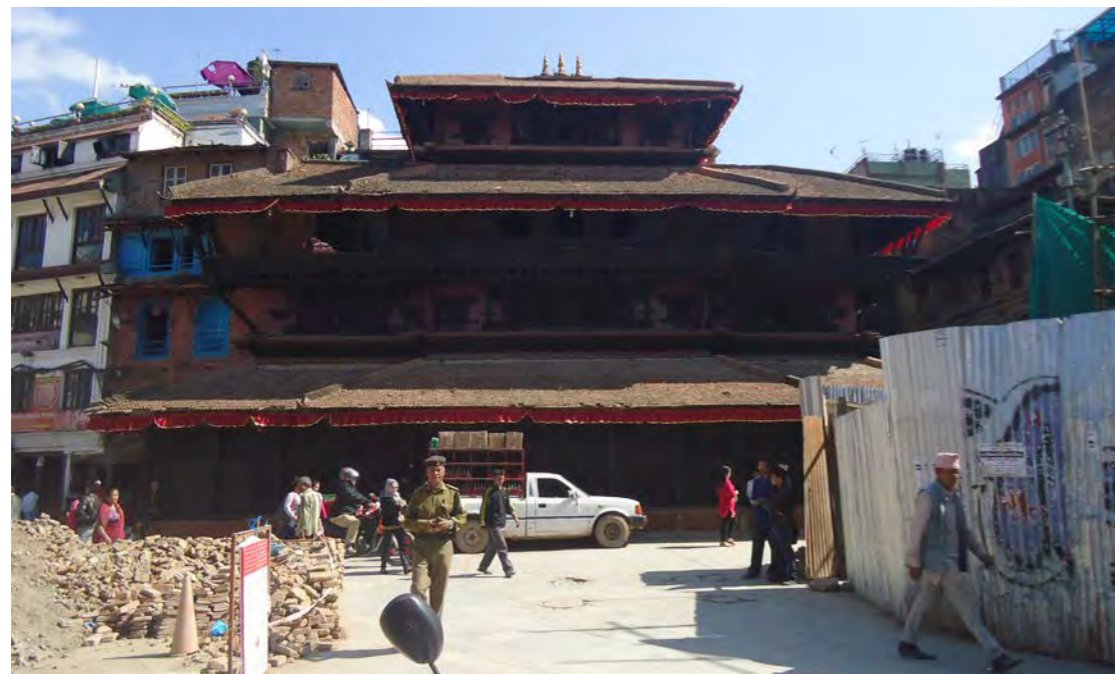
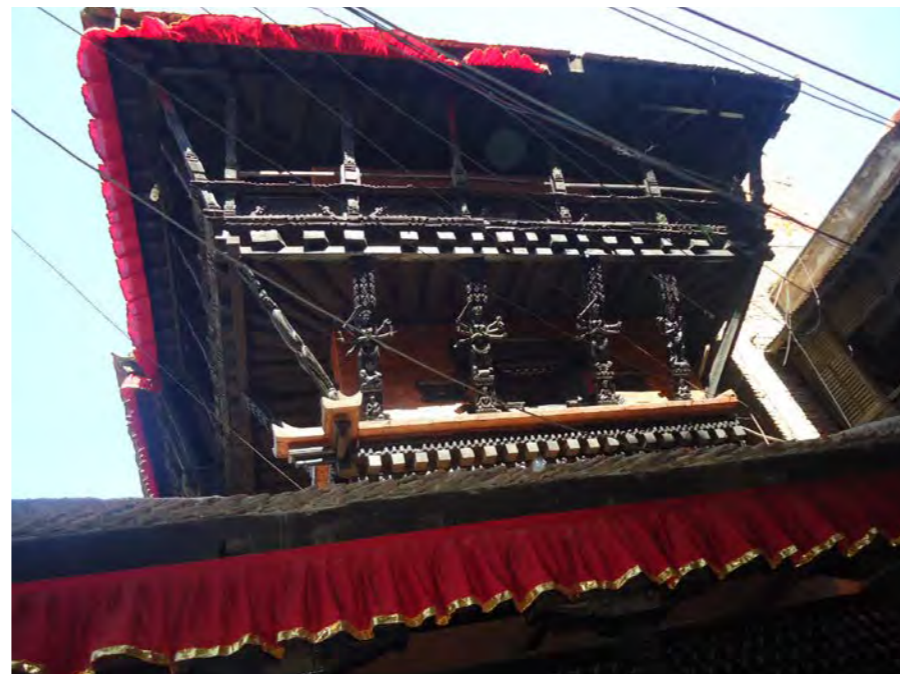
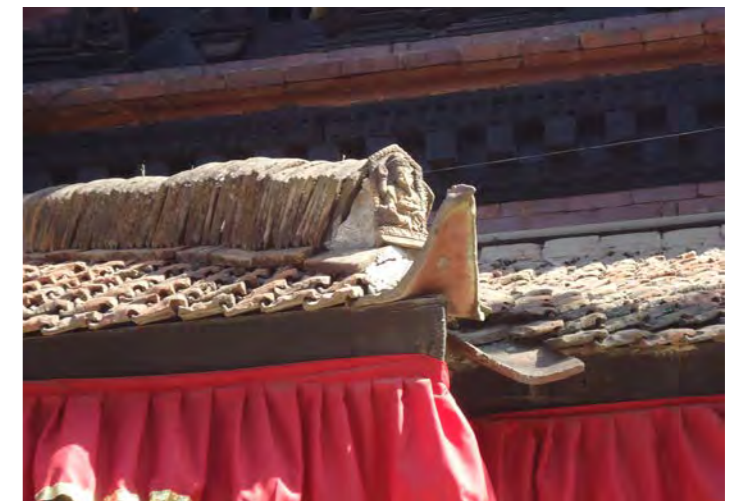
53 DHANSA TEMPLE

CODE NO	TYOLOGY	MONUMENT NAME	ESTABLISHED/ RENOVATED	STRUCTURAL SYSTEM	MATERIAL	GENERAL DESCRIPTION	PROBLEM DESCRIPTION	DANGER	REMARKS	
53	Three-storied temple	Dhansa Temple	1673	Load Bearing	Brick; Timber	Rectangular in plan; Multi storied pagoda style temple with timber roof and struts; erendha on top floor	Minor cracks on walls; cracks on timber columns
