2015 Earthquake Damage Mapping

Hanuman Dhoka Darbar Square Monument Zone
Kathmandu Valley World Heritage Property

December 2015

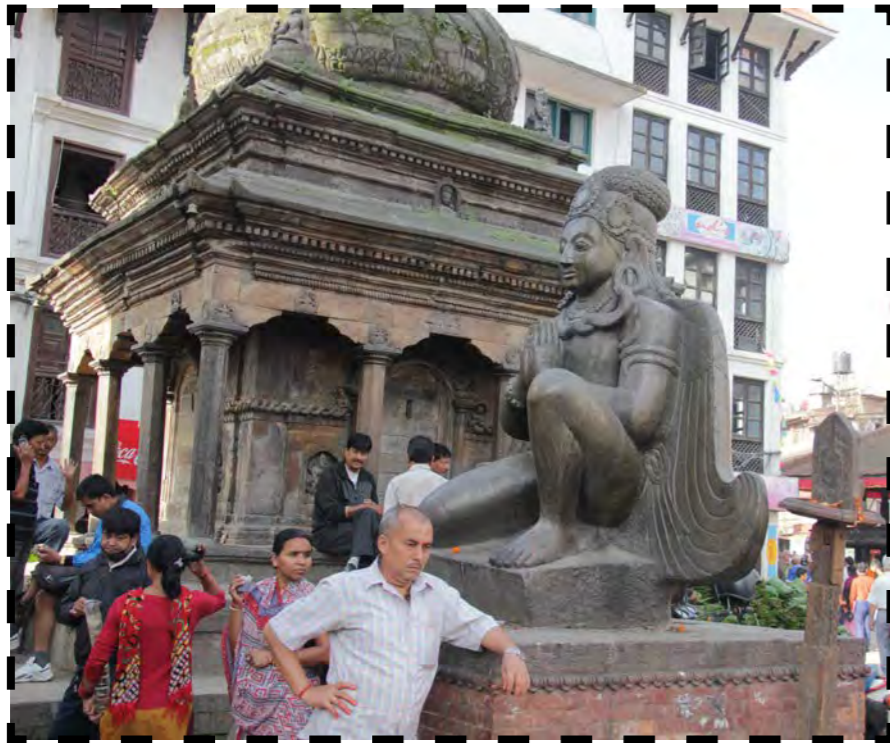
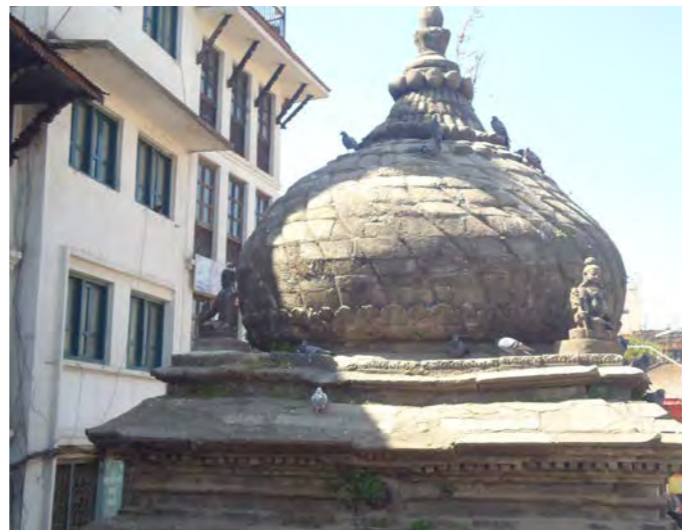
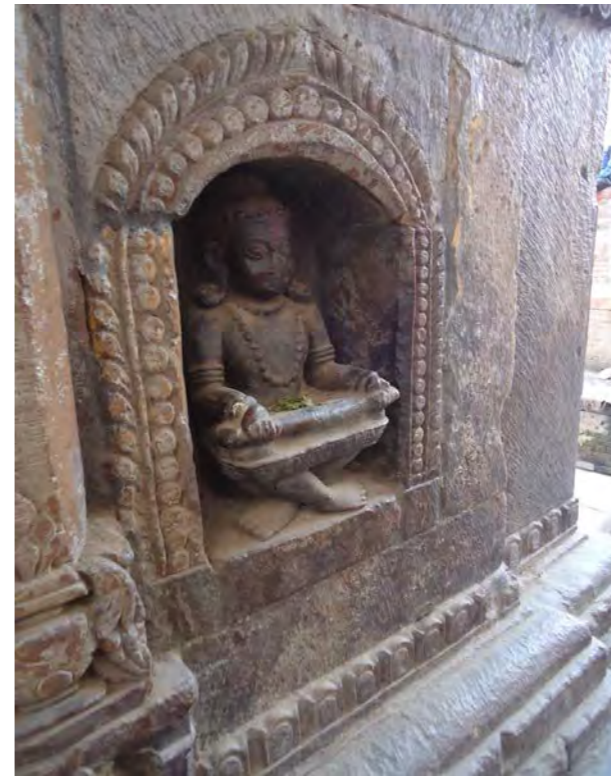
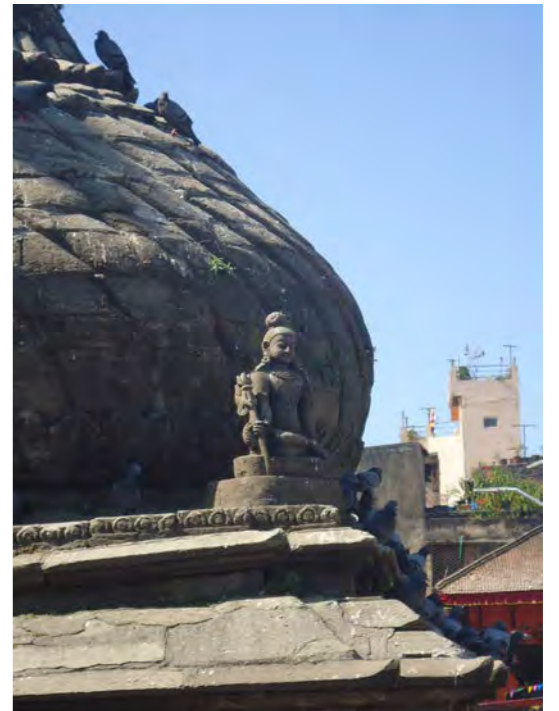
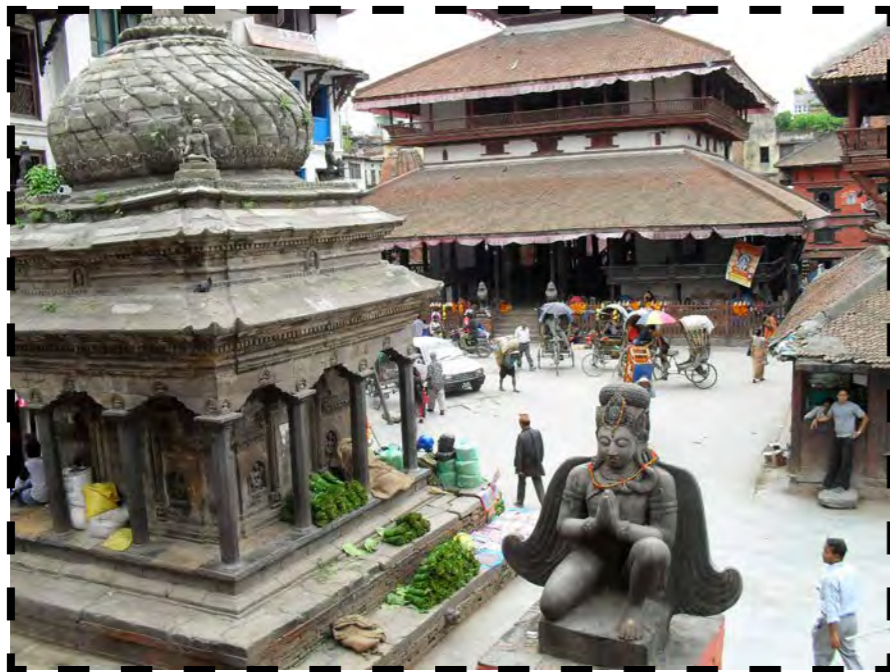
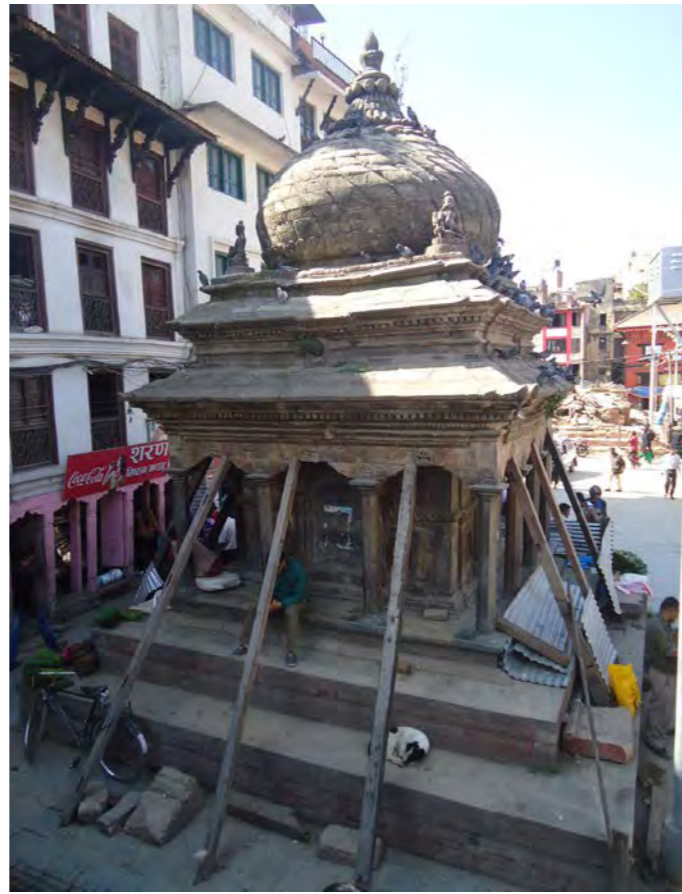
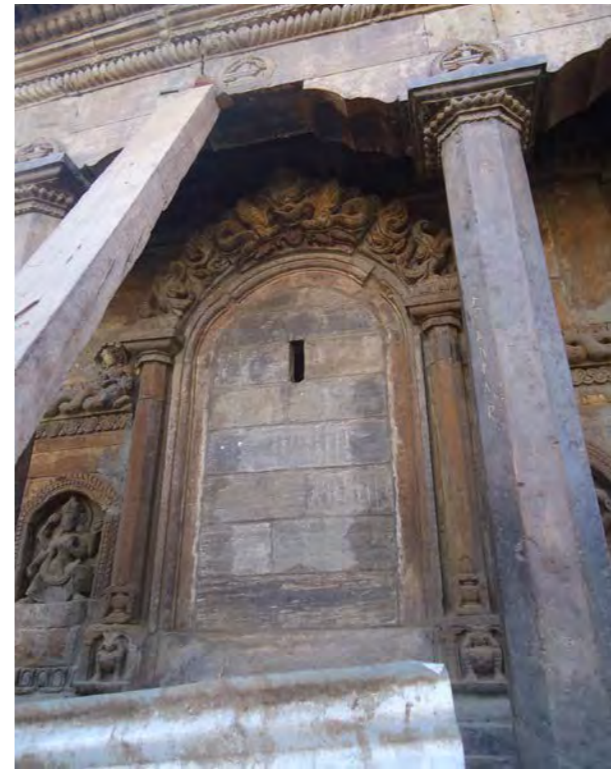
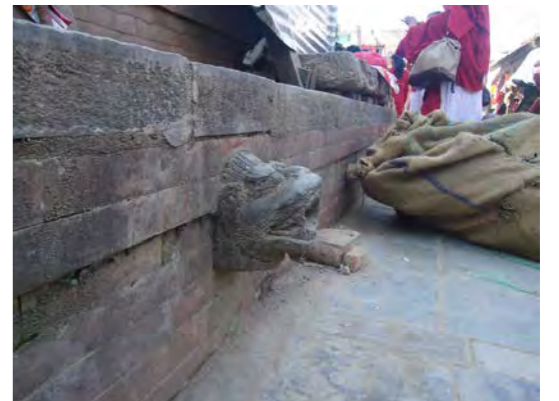
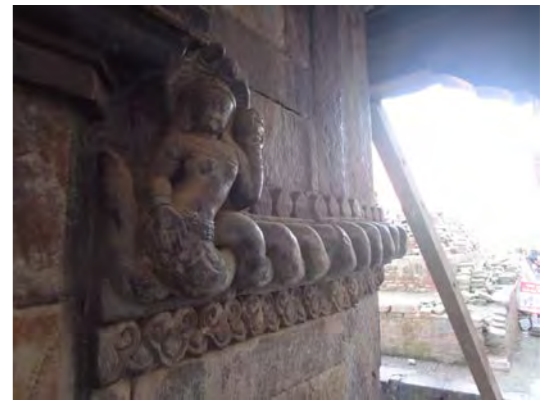
54 BIMALESHWOR MAHADEV

CODE NO	TYOLOGY	MONUMENT NAME	ESTABLISHED/ RENOVATED	STRUCTURAL SYSTEM	MATERIAL	GENERAL DESCRIPTION	PROBLEM DESCRIPTION	DANGER	REMARKS
54	Shikhara	Bimaleshwor Mahadev	1693	Load Bearing	Stone	Temple on raised plinth; Dome on top; Façade with carving of deities	Vegetation growth; Cracks on dome structure and unstable

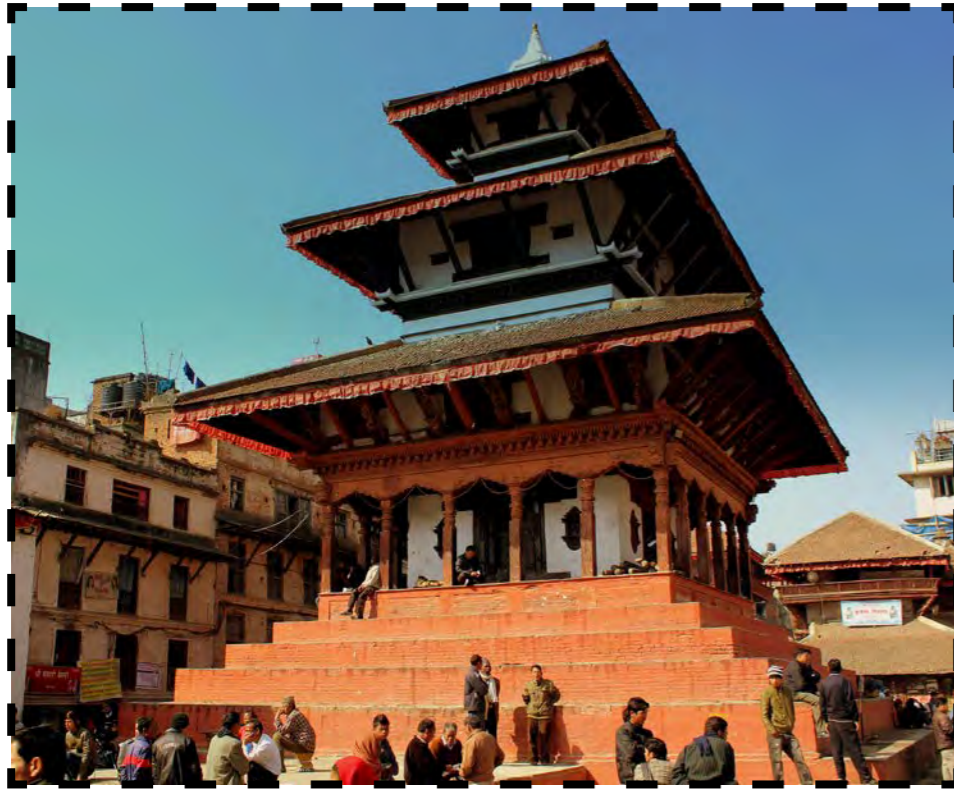
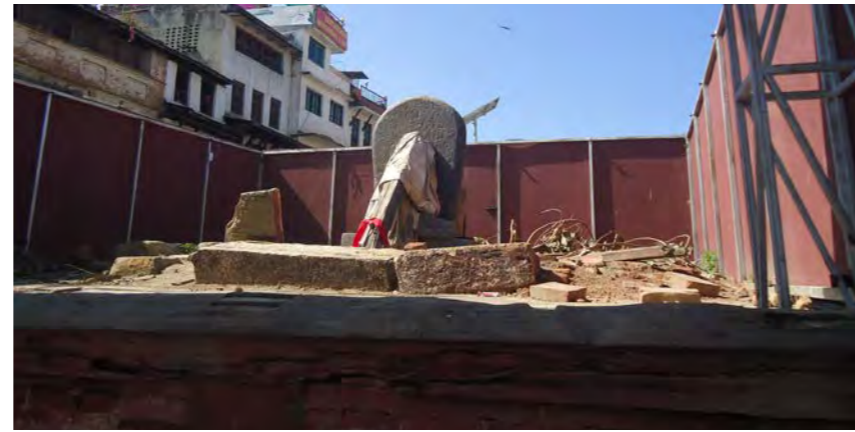
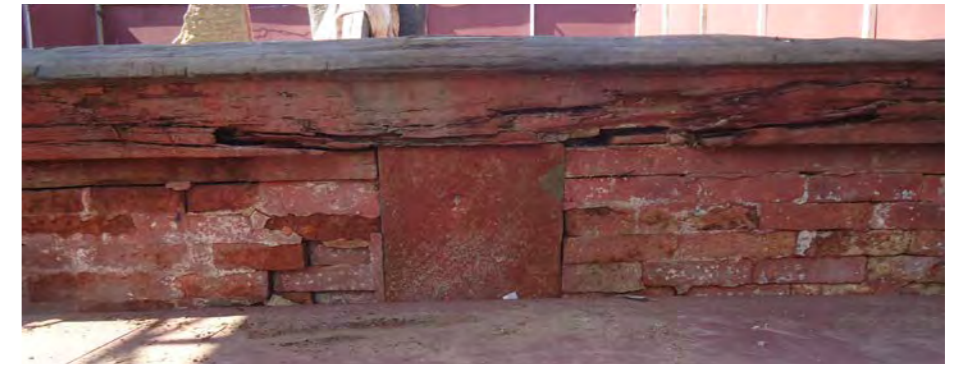
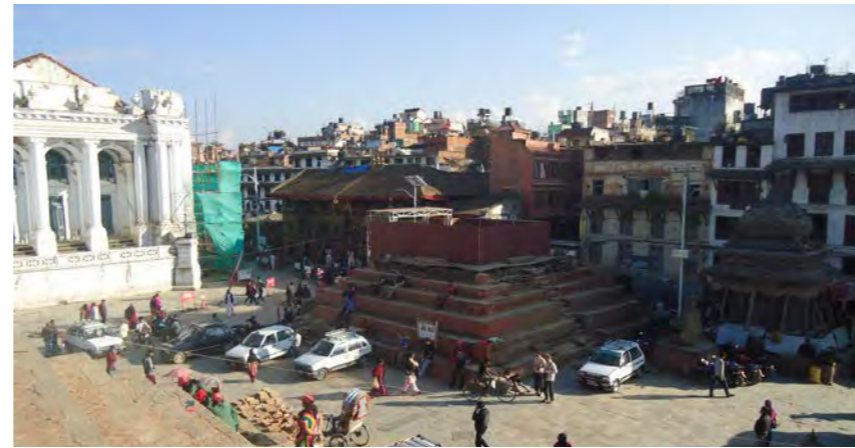
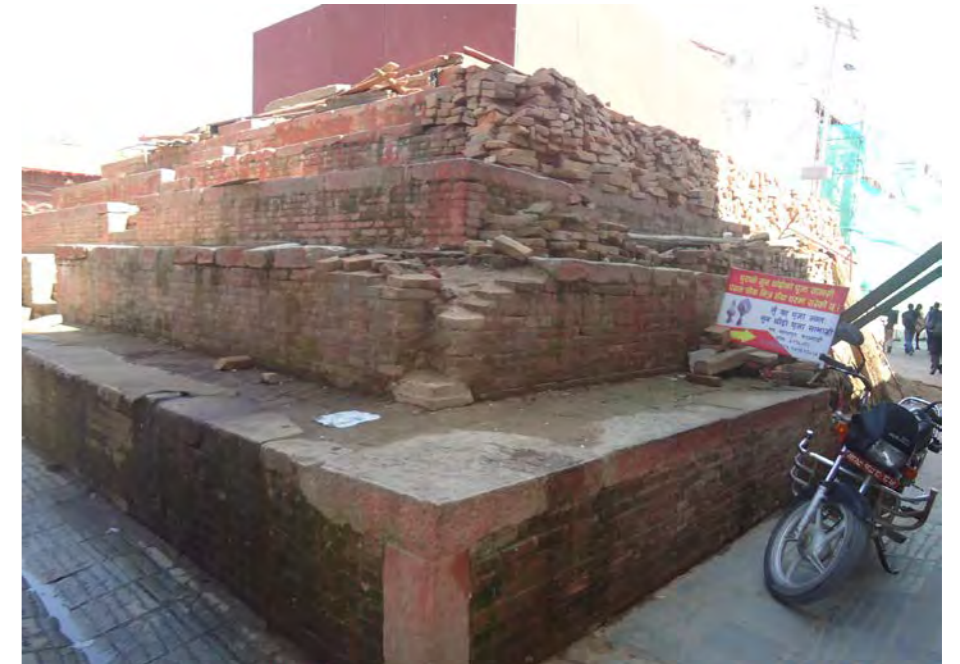
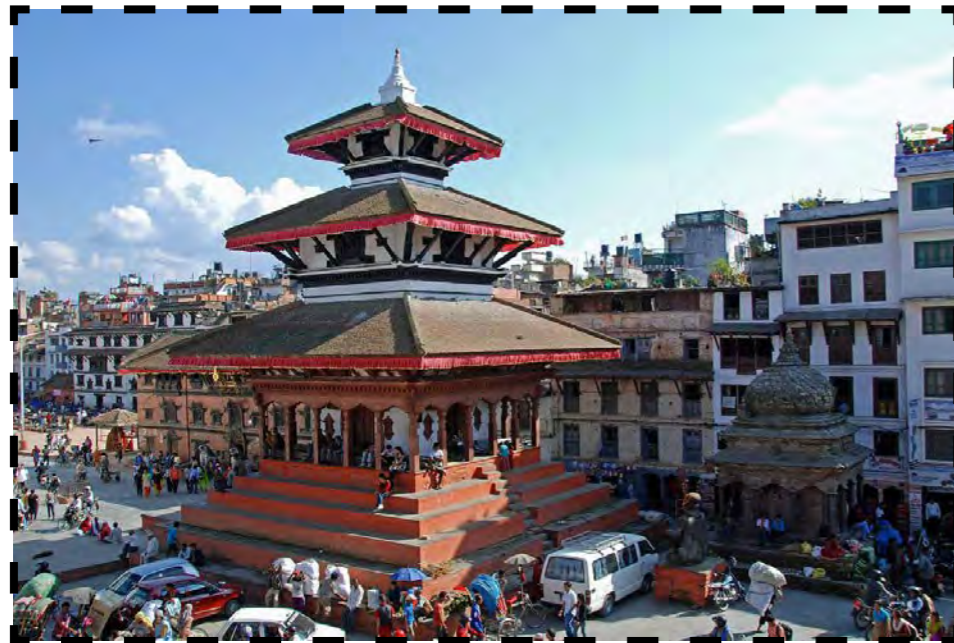
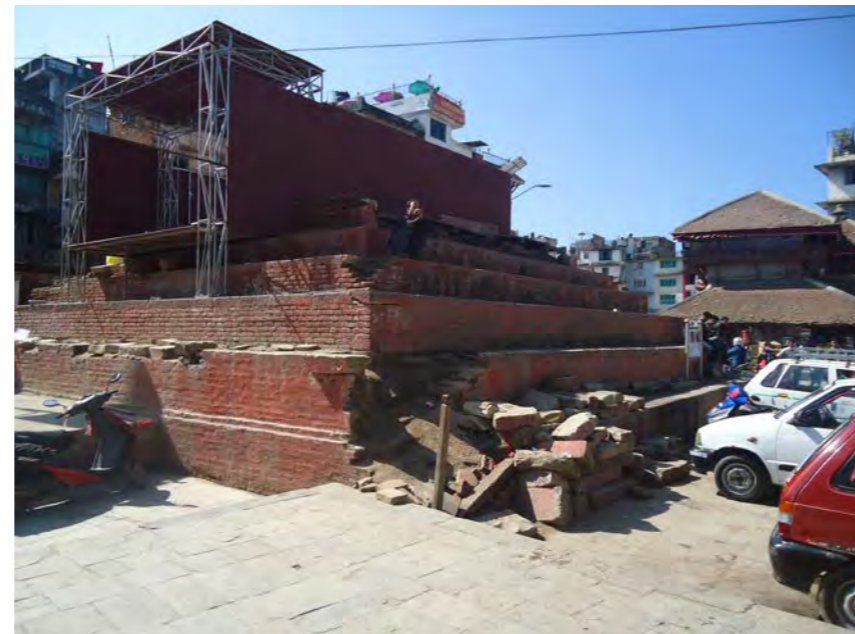
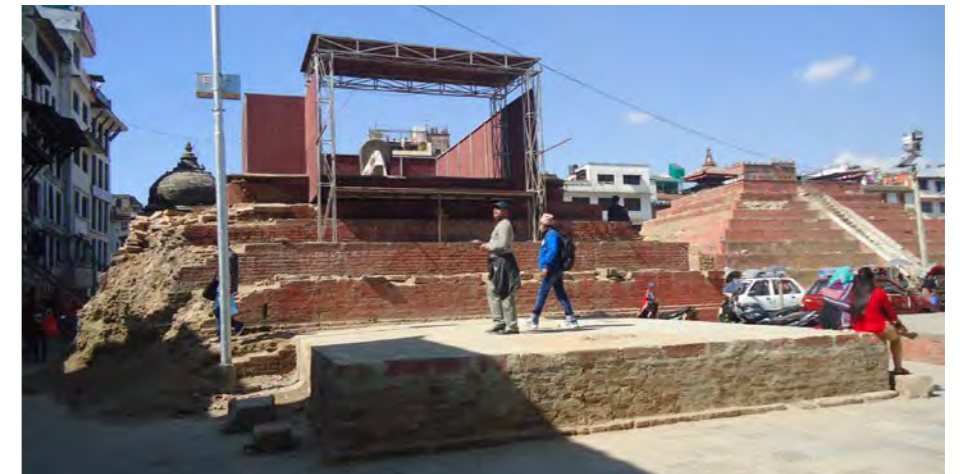
55 NARAYAN TEMPLE

CODE NO	TYOLOGY	MONUMENT NAME	ESTABLISHED/ RENOVATED	STRUCTURAL SYSTEM	MATERIAL	GENERAL DESCRIPTION	PROBLEM DESCRIPTION	DANGER	REMARKS	
55	Three-storied temple	Narayan Temple	1690	Load Bearing	Brick	Raised above road level on plinths of varying height	Totally collapsed with shrine remaining; Extensive cracks on plinth; Certain parts detached.

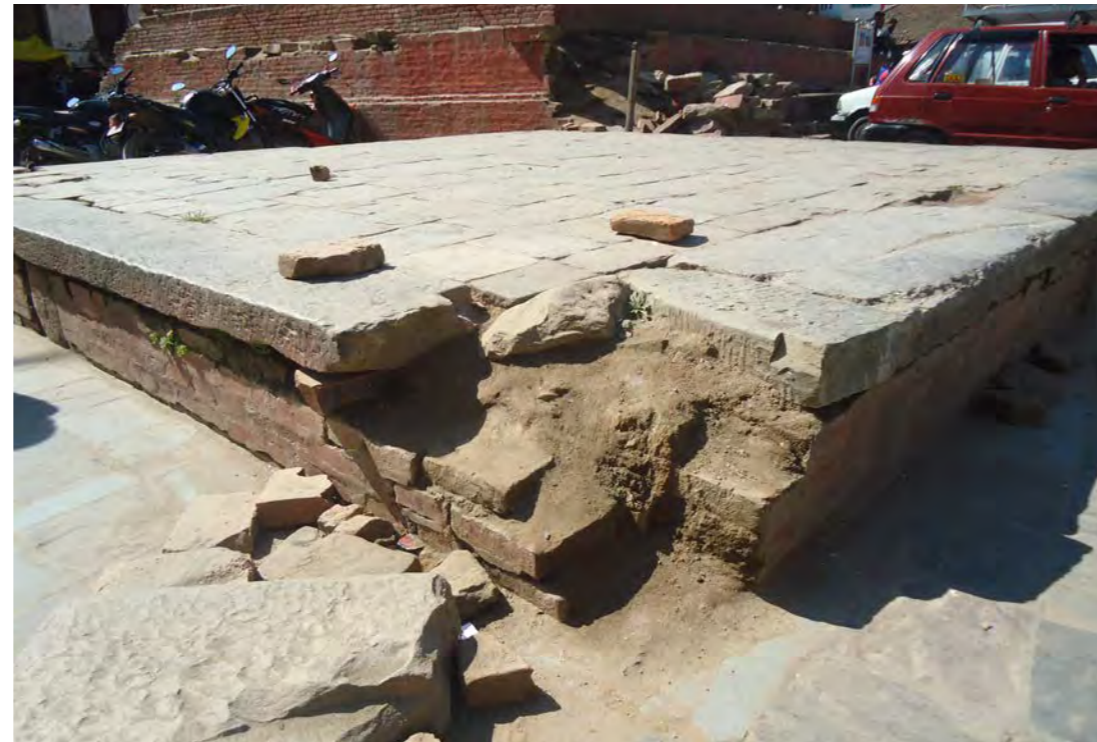
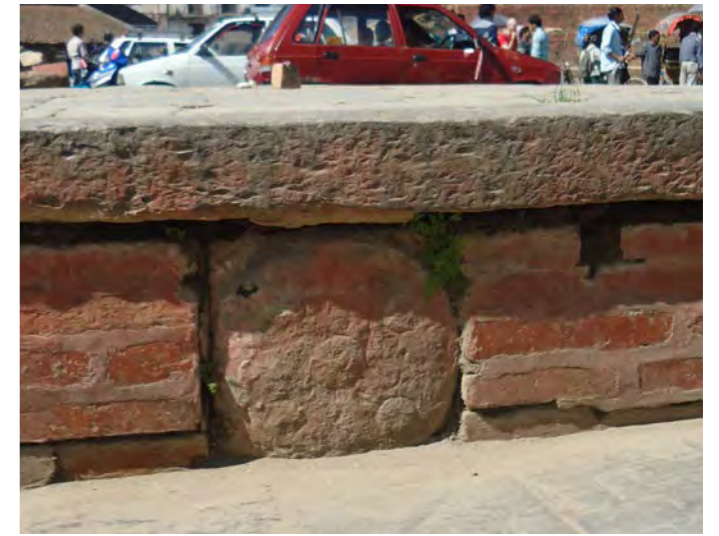
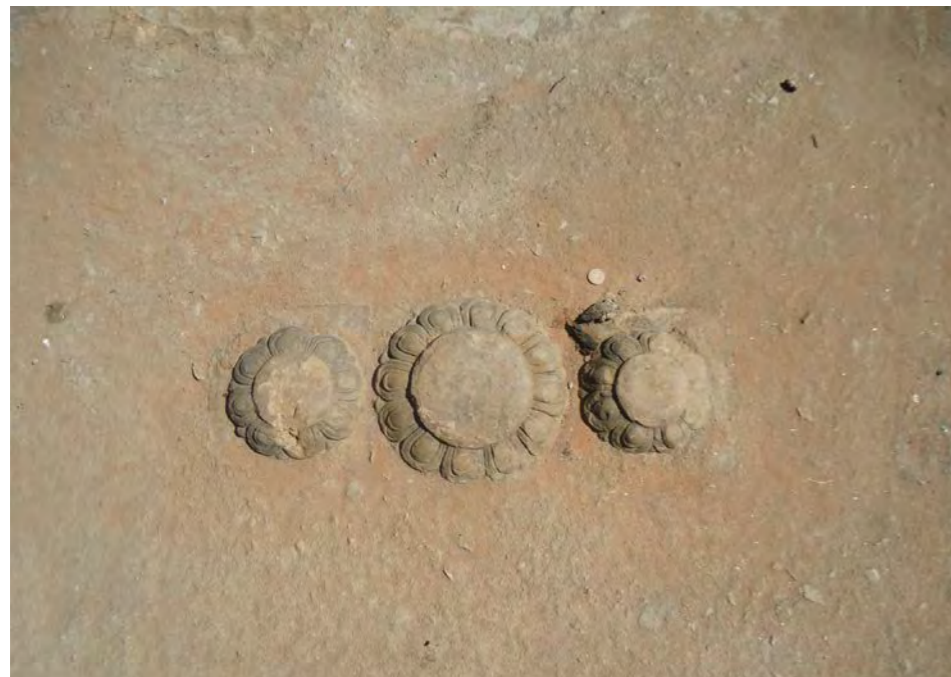
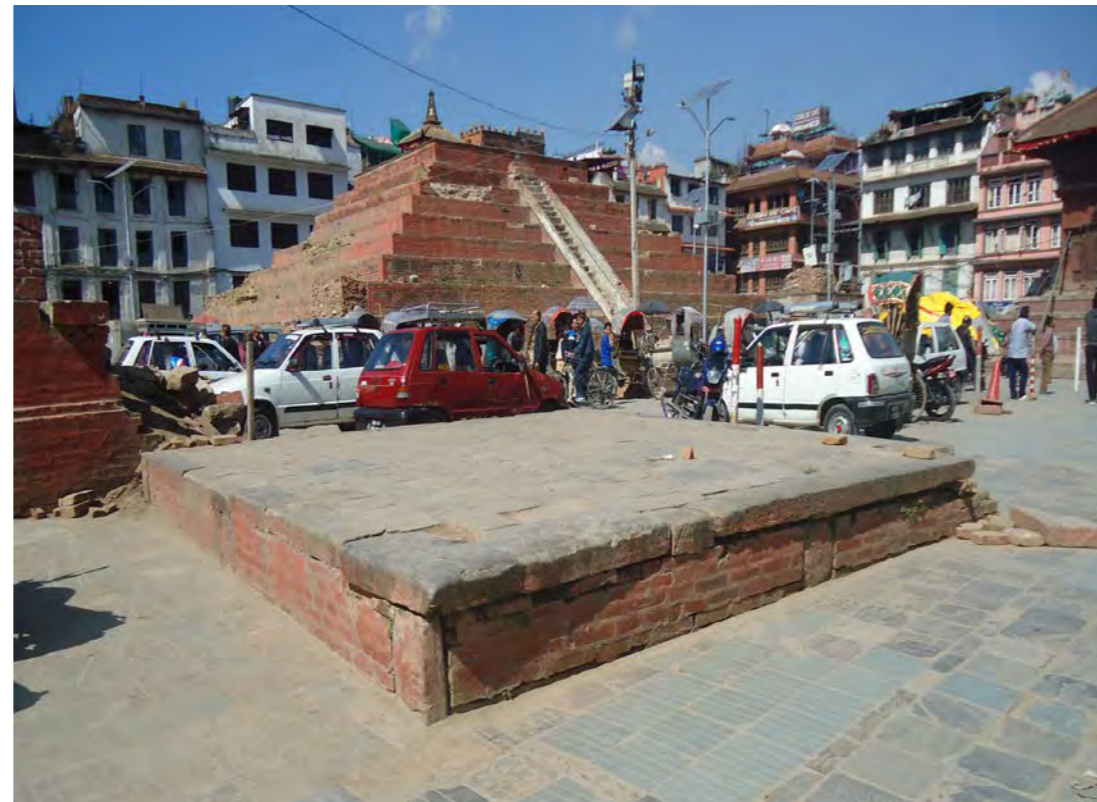
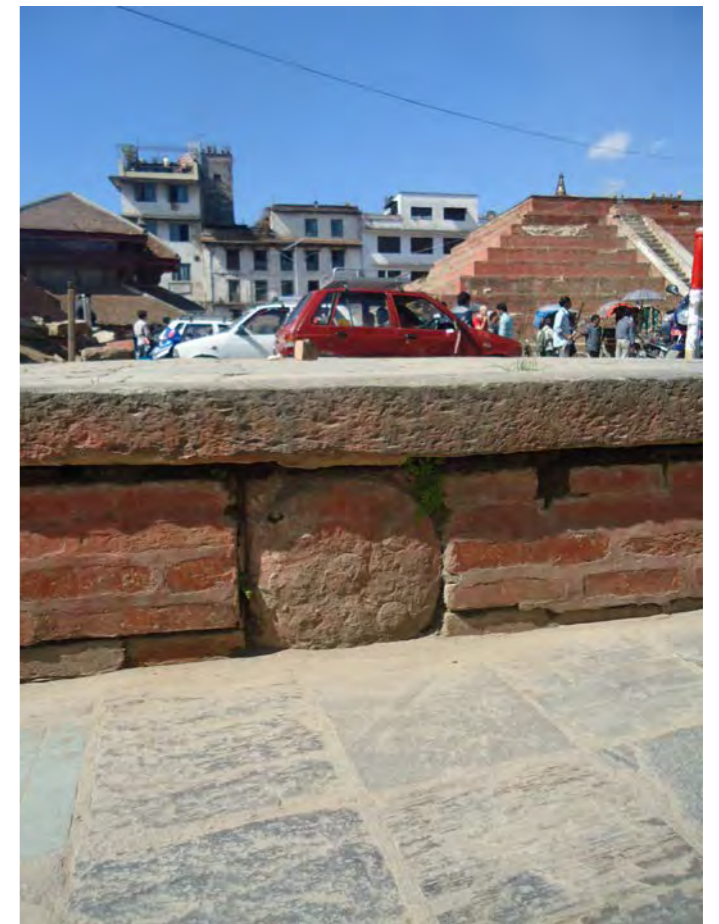
55a,b

CODE NO	TYOLOGY	MONUMENT NAME	ESTABLISHED/ RENOVATED	STRUCTURAL SYSTEM	MATERIAL	GENERAL DESCRIPTION	PROBLEM DESCRIPTION	DANGER	REMARKS
55a	Mandala					3 Mandalas on raised platform in front of temple	No visible damage		
55b	Platform				Stone	Raised stone platform	Vegetation growth; Cracks on four side of wall; Corner collapsed

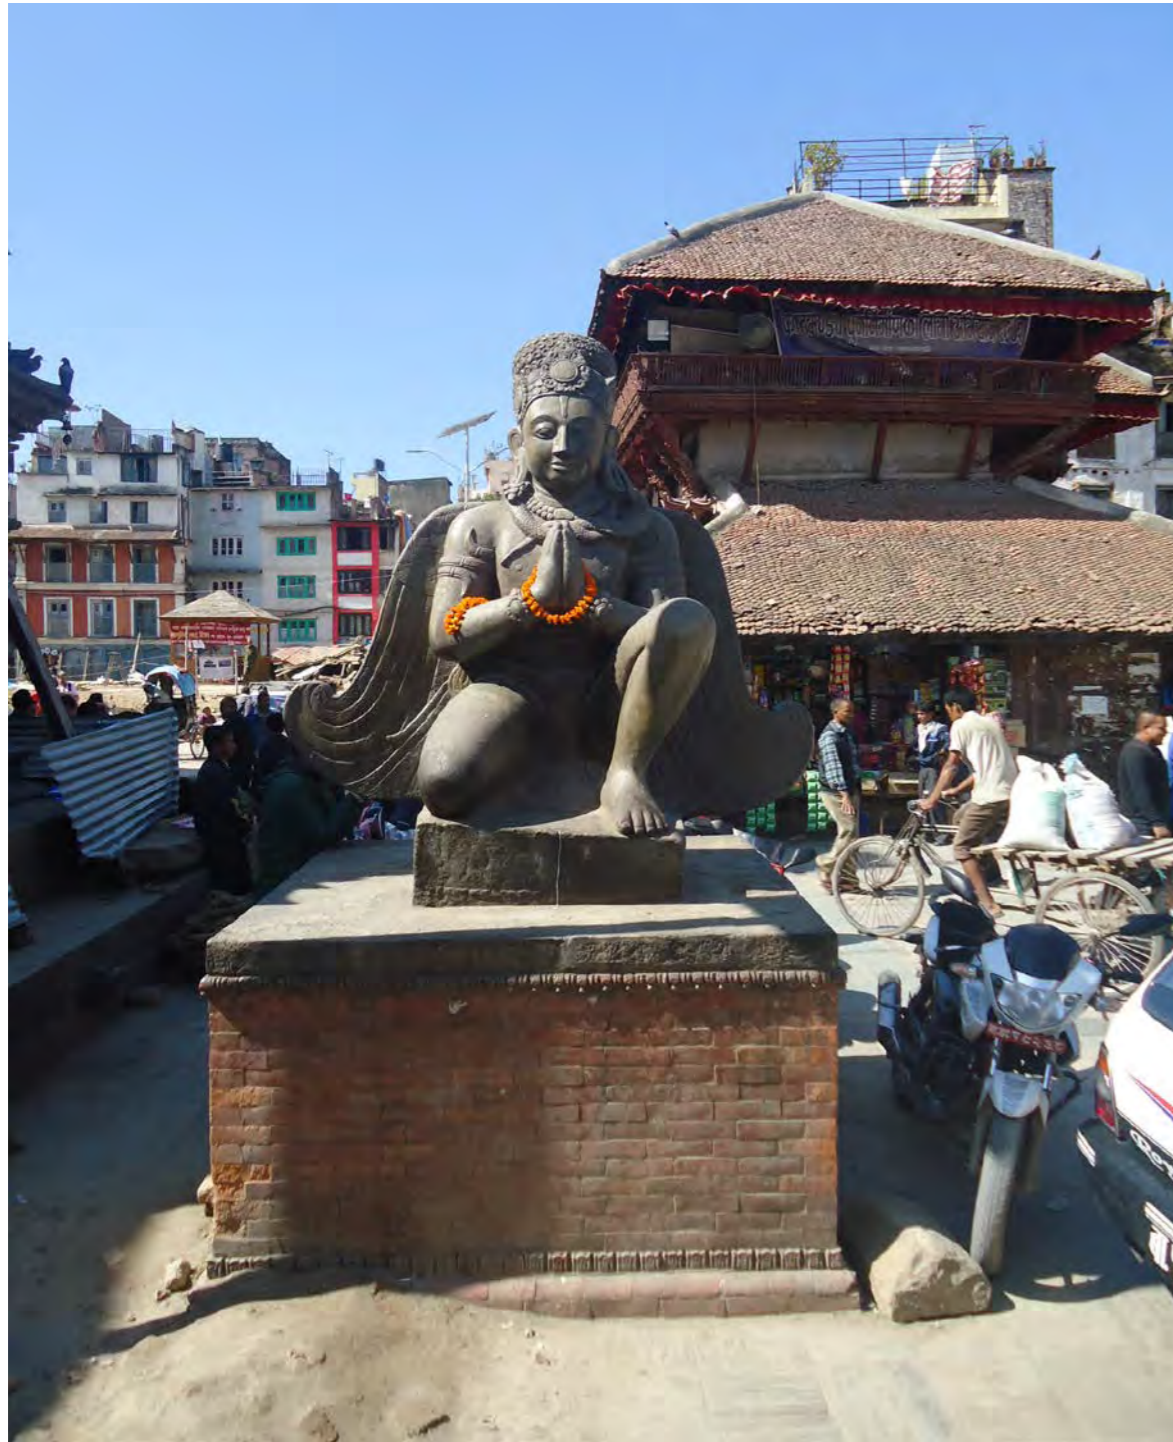
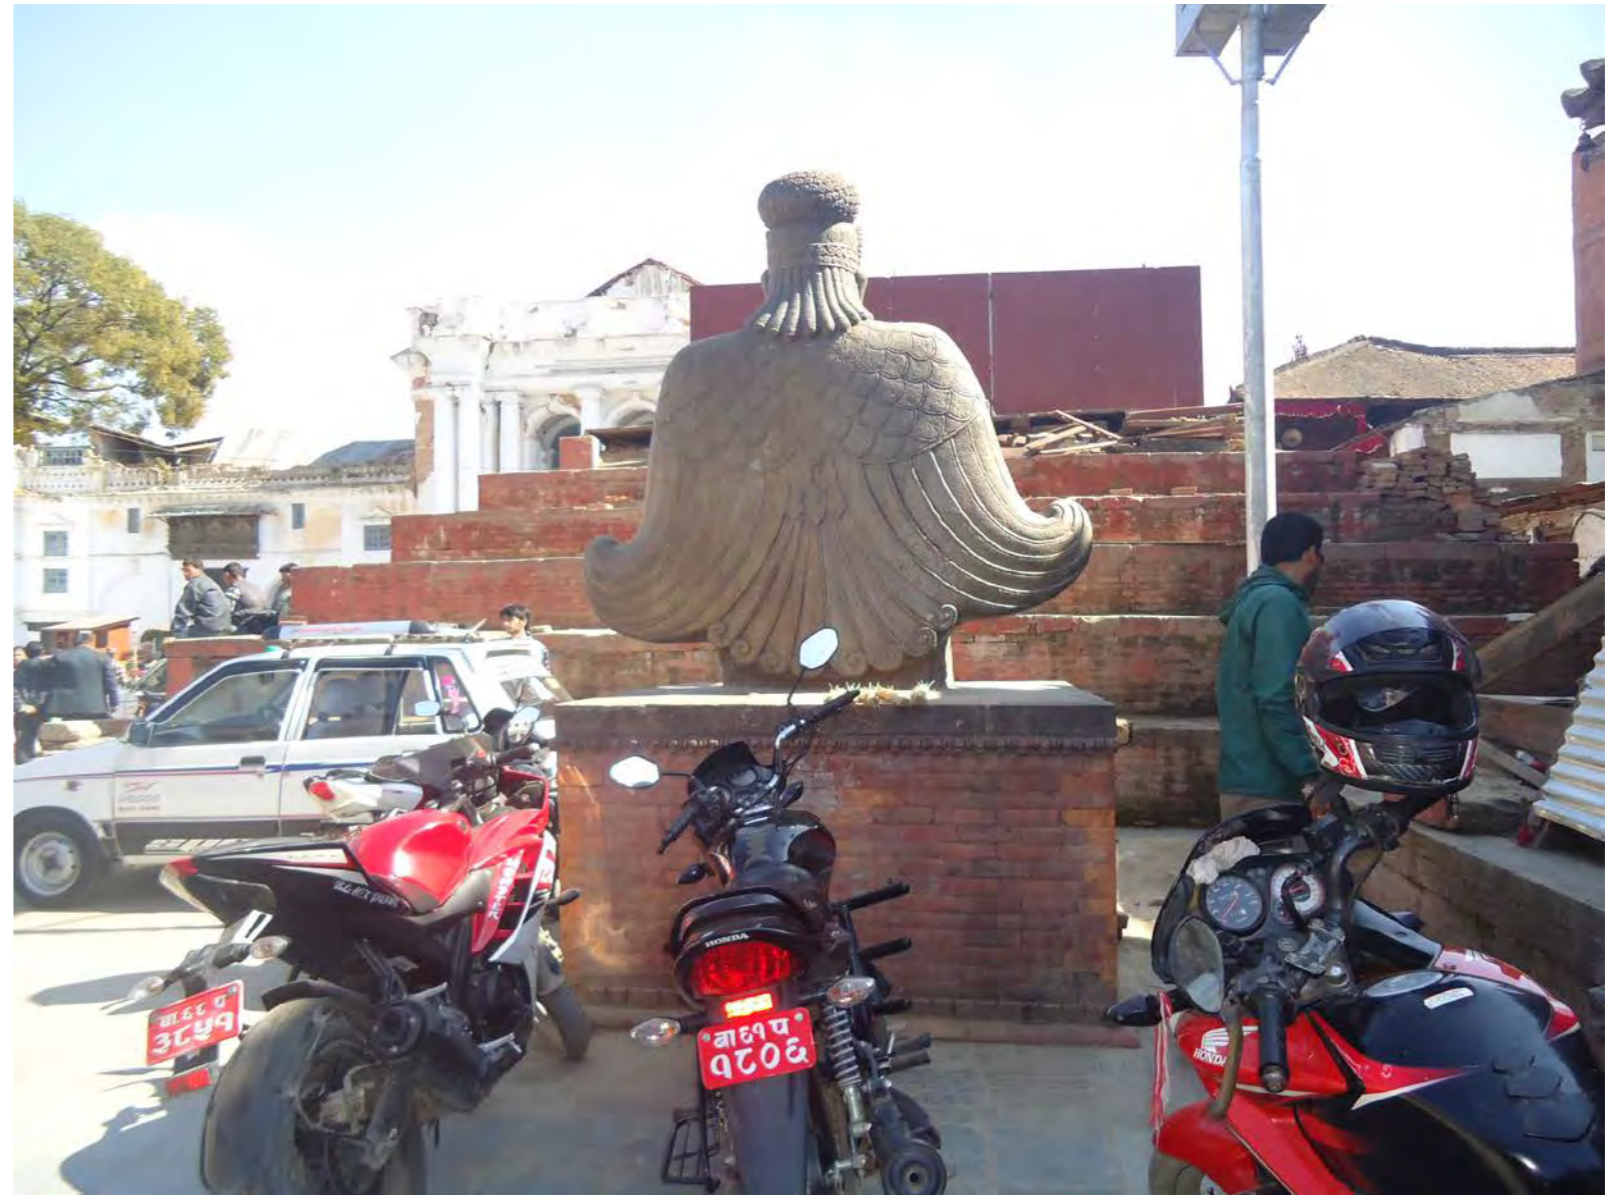
55c GARUD

CODE NO	TPOLOGY	MONUMENT NAME	ESTABLISHED/ RENOVATED	STRUCTURAL SYSTEM	MATERIAL	GENERAL DESCRIPTION	PROBLEM DESCRIPTION	DANGER	REMARKS
55c	Guard				Stone; Brick	Stone guard lion on raised brick platform	Garud settled and bricks in the corner detached.

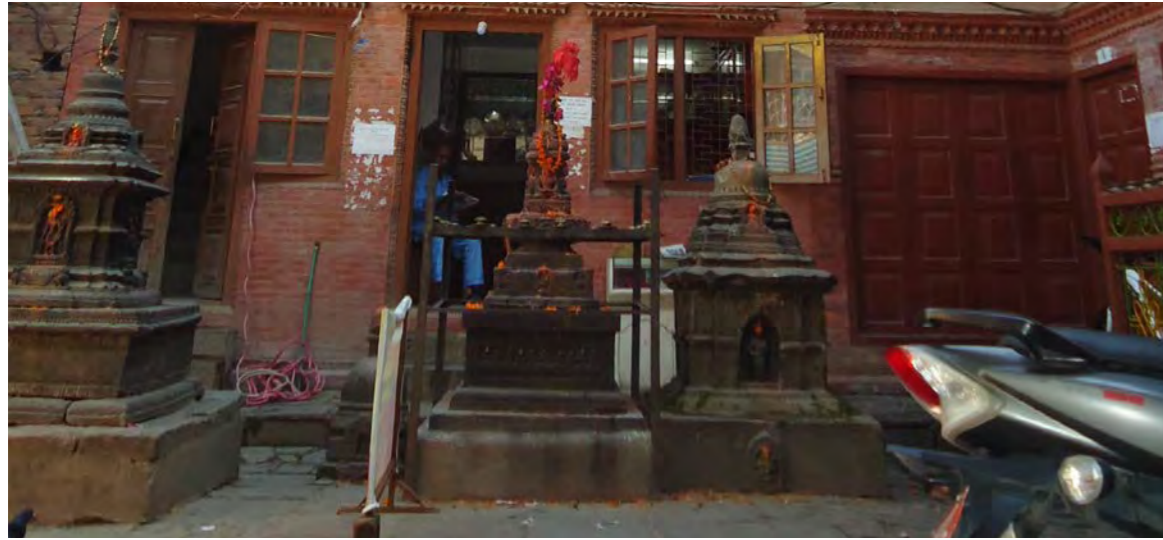
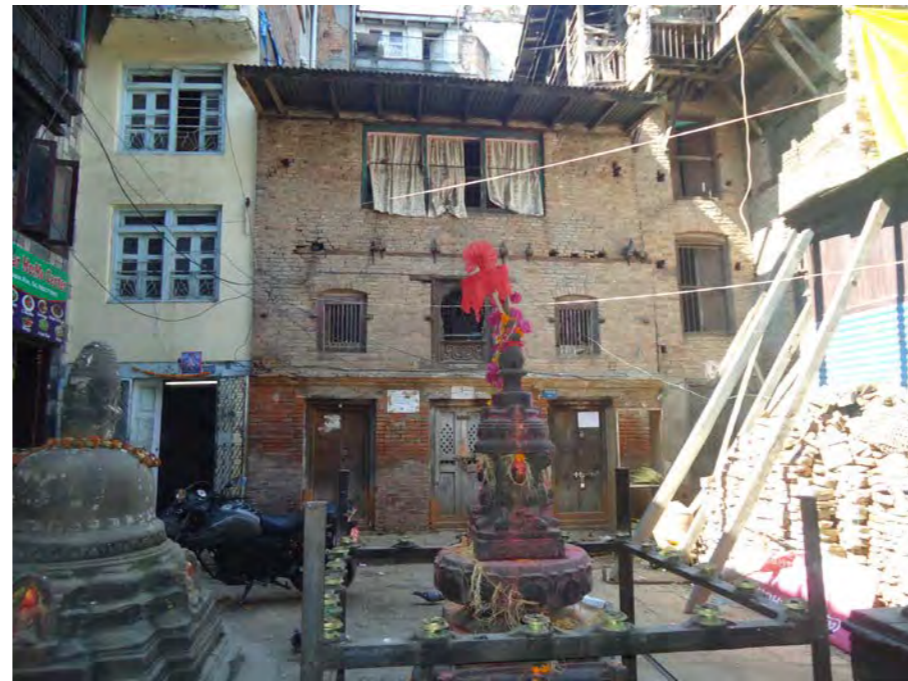
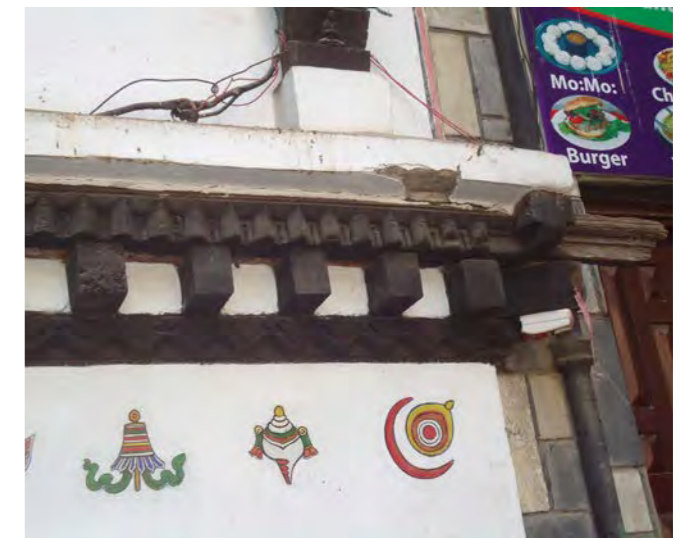
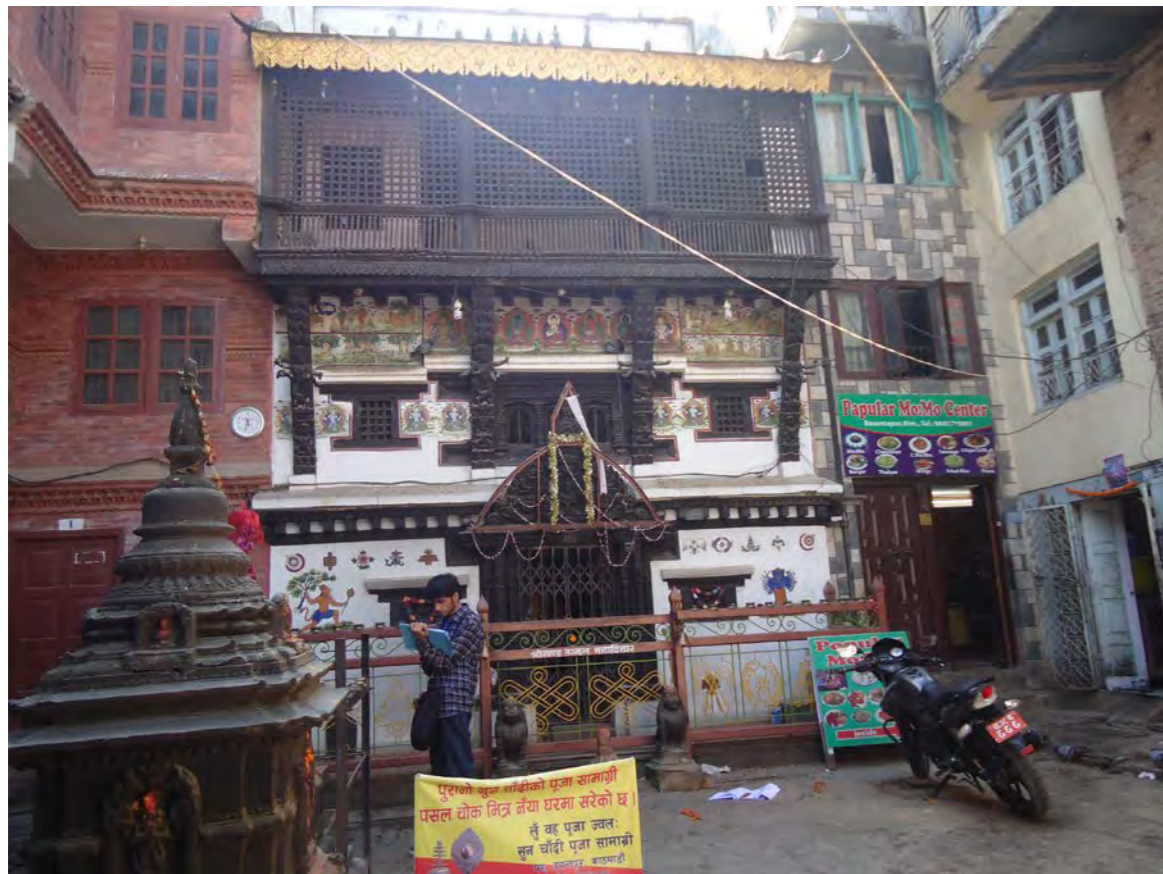
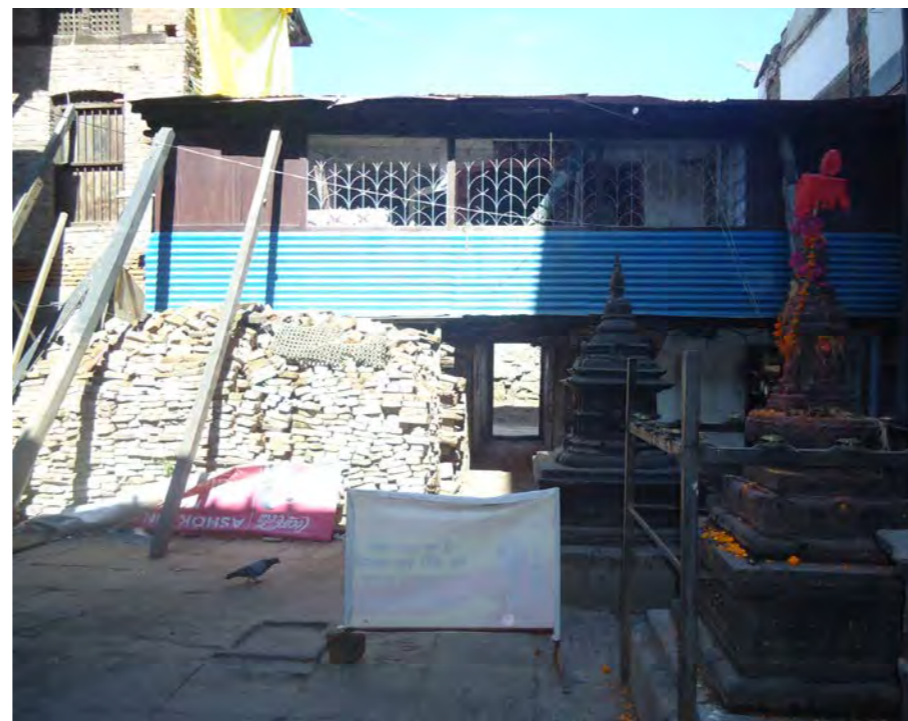
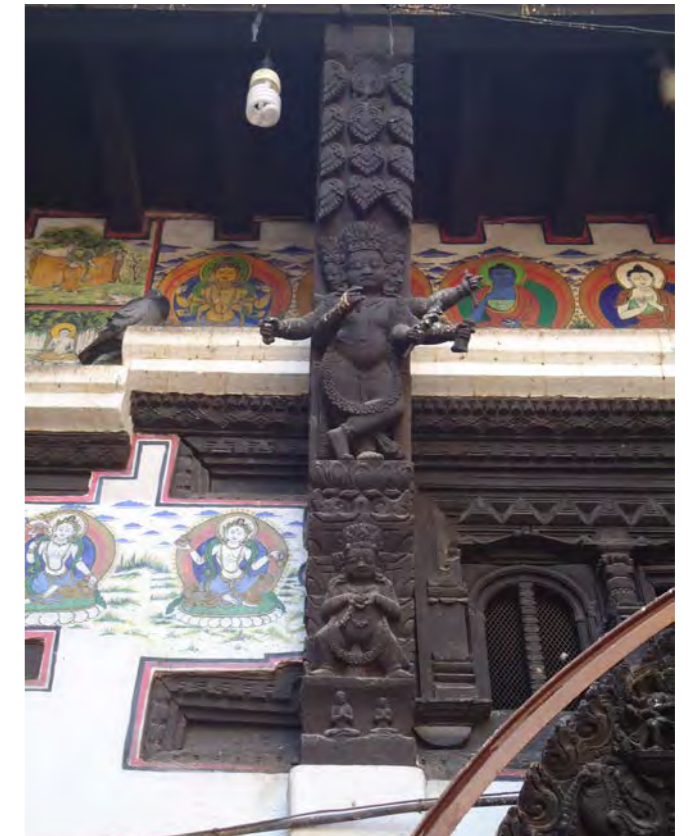
56 SIKHONMU BAHAL

CODE NO	TYOLOGY	MONUMENT NAME	ESTABLISHED/ RENOVATED	STRUCTURAL SYSTEM	MATERIAL	GENERAL DESCRIPTION	PROBLEM DESCRIPTION	DANGER	REMARKS	
56	Bahal	Sikhonmu Bahal		Load Bearing	Brick	Timber roof with carved struts and projection on top floor; dooreay, torna windows represent the ten wraths of Buddhism	Minor cracks on walls

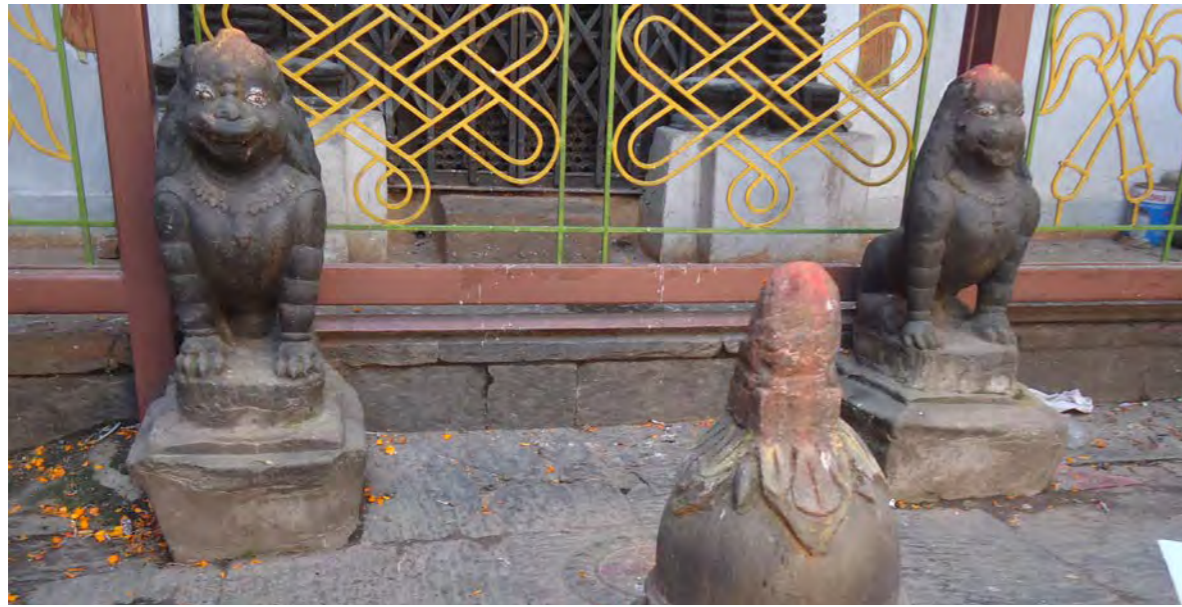
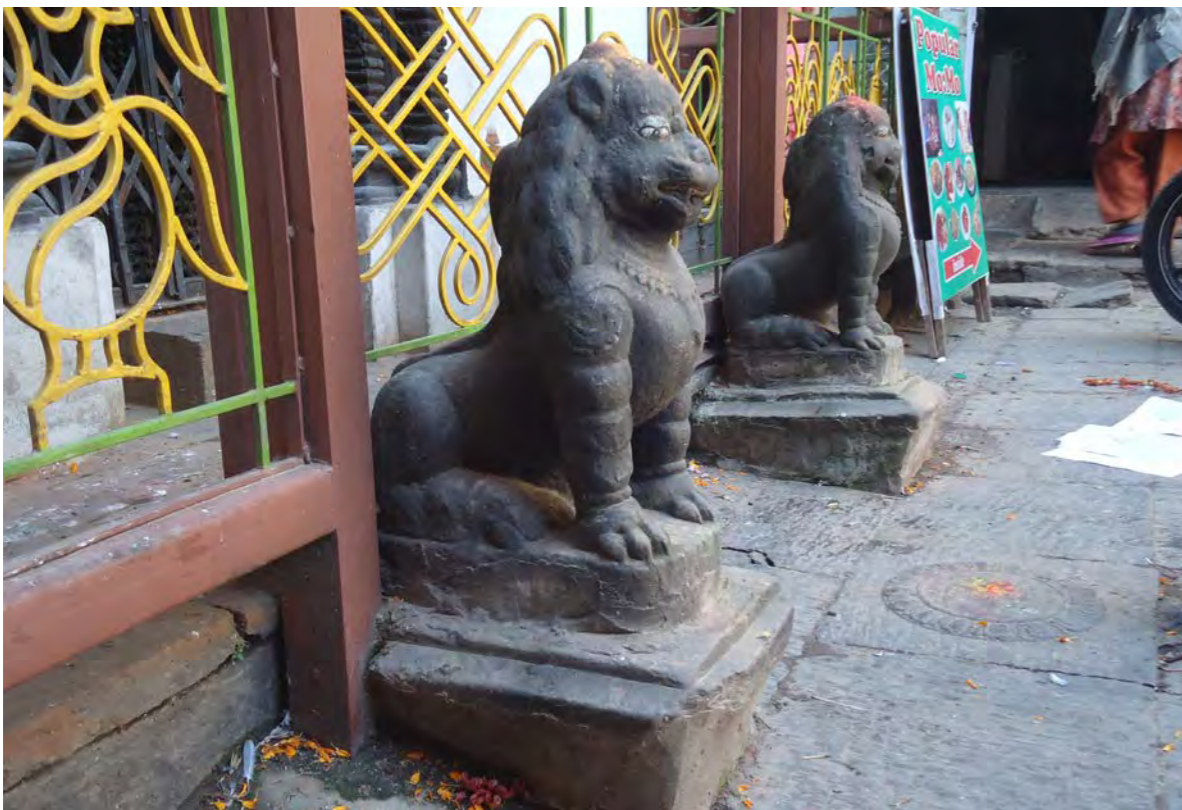
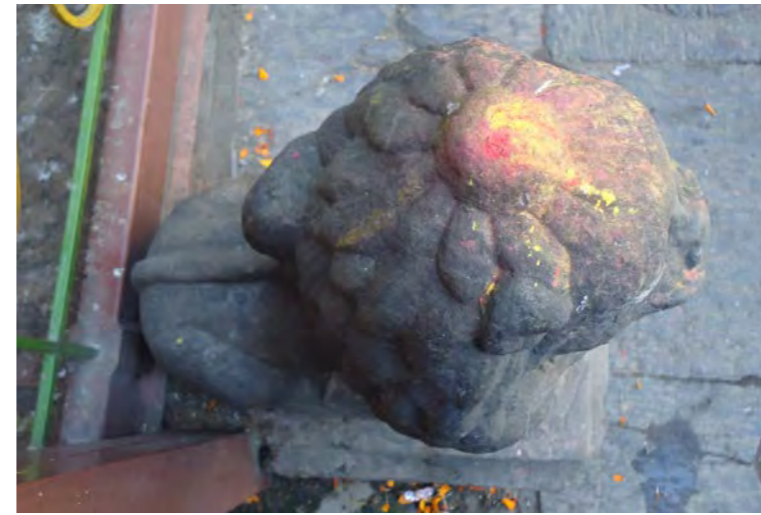
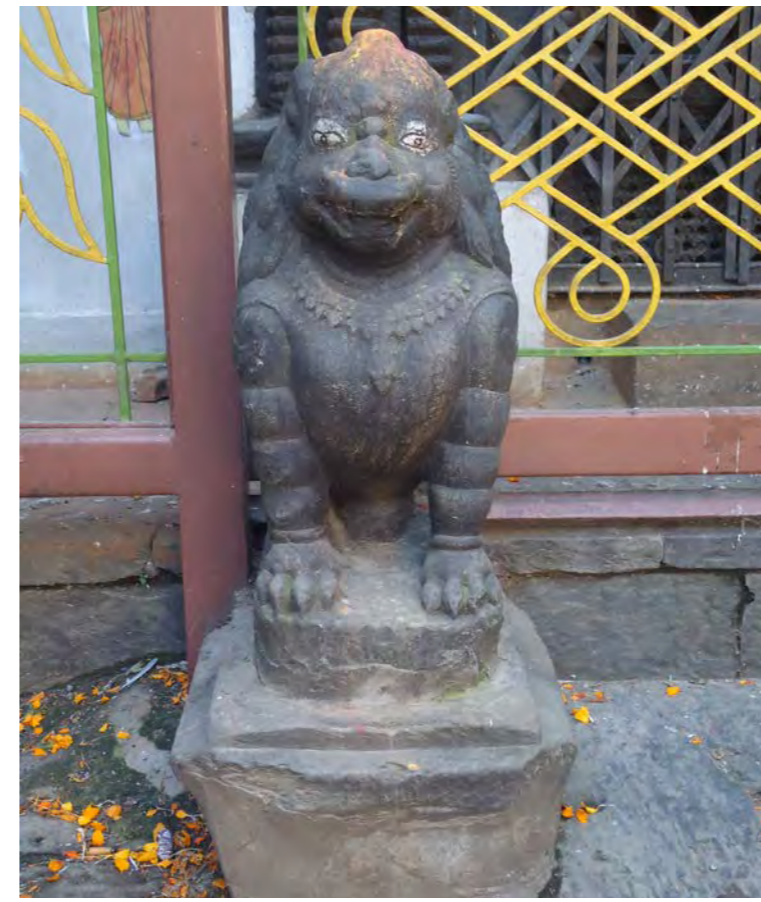
CODE NO	TYOLOGY	MONUMENT NAME	ESTABLISHED/ RENOVATED	STRUCTURAL SYSTEM	MATERIAL	GENERAL DESCRIPTION	PROBLEM DESCRIPTION	DANGER	REMARKS
56a	Guard lion				Stone	Stone guard lion on left side	No visible damage		
56b	Guard lion				Stone	Stone guard lion on right side	No visible damage
