2015 Earthquake Damage Mapping

Hanuman Dhoka Darbar Square Monument Zone
Kathmandu Valley World Heritage Property

December 2015

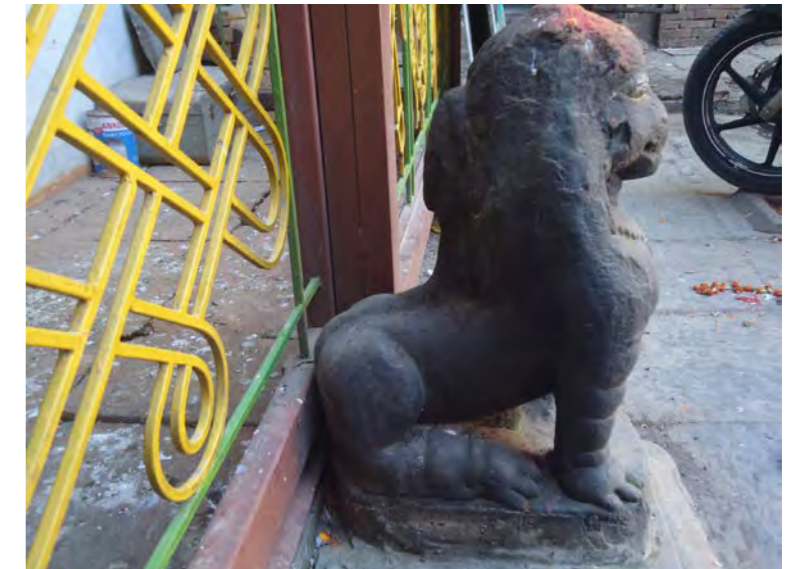
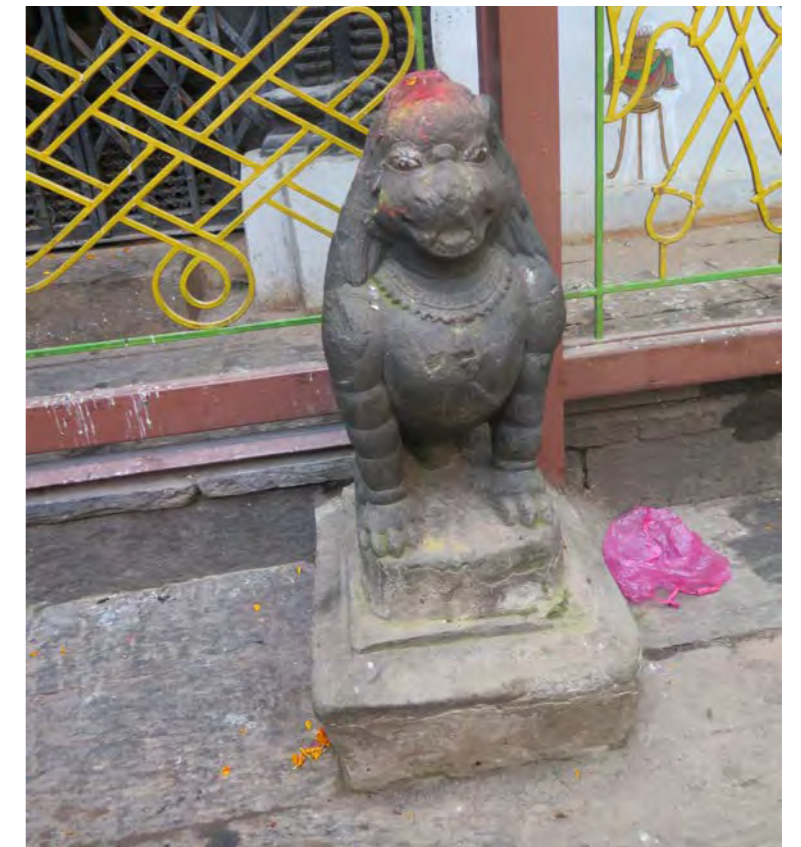
CODE NO	TYOLOGY	MONUMENT NAME	ESTABLISHED/ RENOVATED	STRUCTURAL SYSTEM	MATERIAL	GENERAL DESCRIPTION	PROBLEM DESCRIPTION	DANGER	REMARKS
56a	Guard lion				Stone	Stone guard lion on left side	No visible damage		
56b	Guard lion				Stone	Stone guard lion on right side	No visible damage

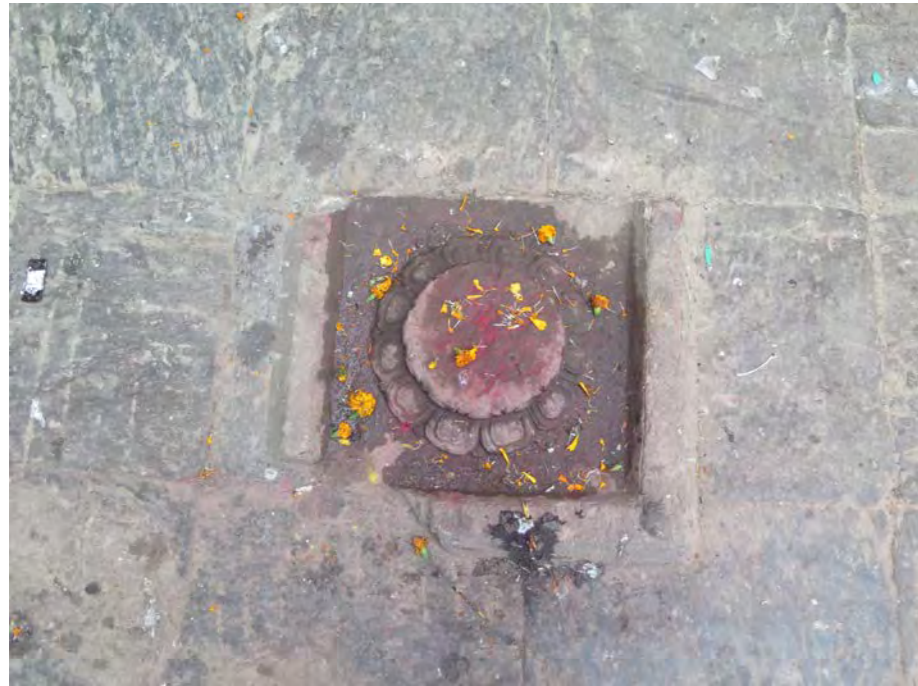
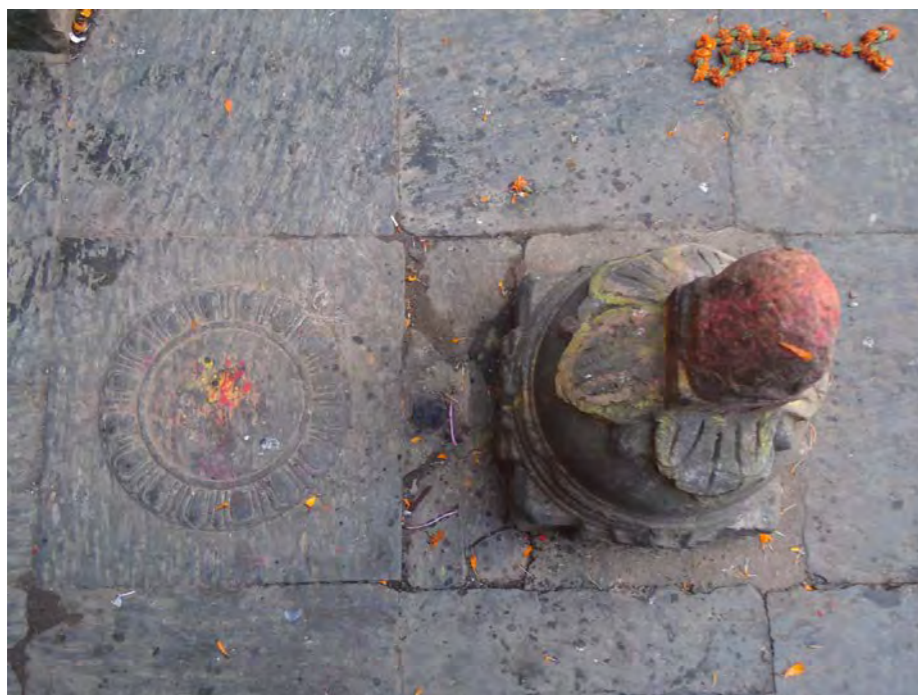
CODE NO	TYOLOGY	MONUMENT NAME	ESTABLISHED/ RENOVATED	STRUCTURAL SYSTEM	MATERIAL	GENERAL DESCRIPTION	PROBLEM DESCRIPTION	DANGER	REMARKS
56c	Mandala				Stone	Mandala infront of temple			
56d	Stupa				Stone		Slightly dilapadated		
56e	Open Shrine				Stone	Stone shrine with Buddha image on four side	Vegetation growth

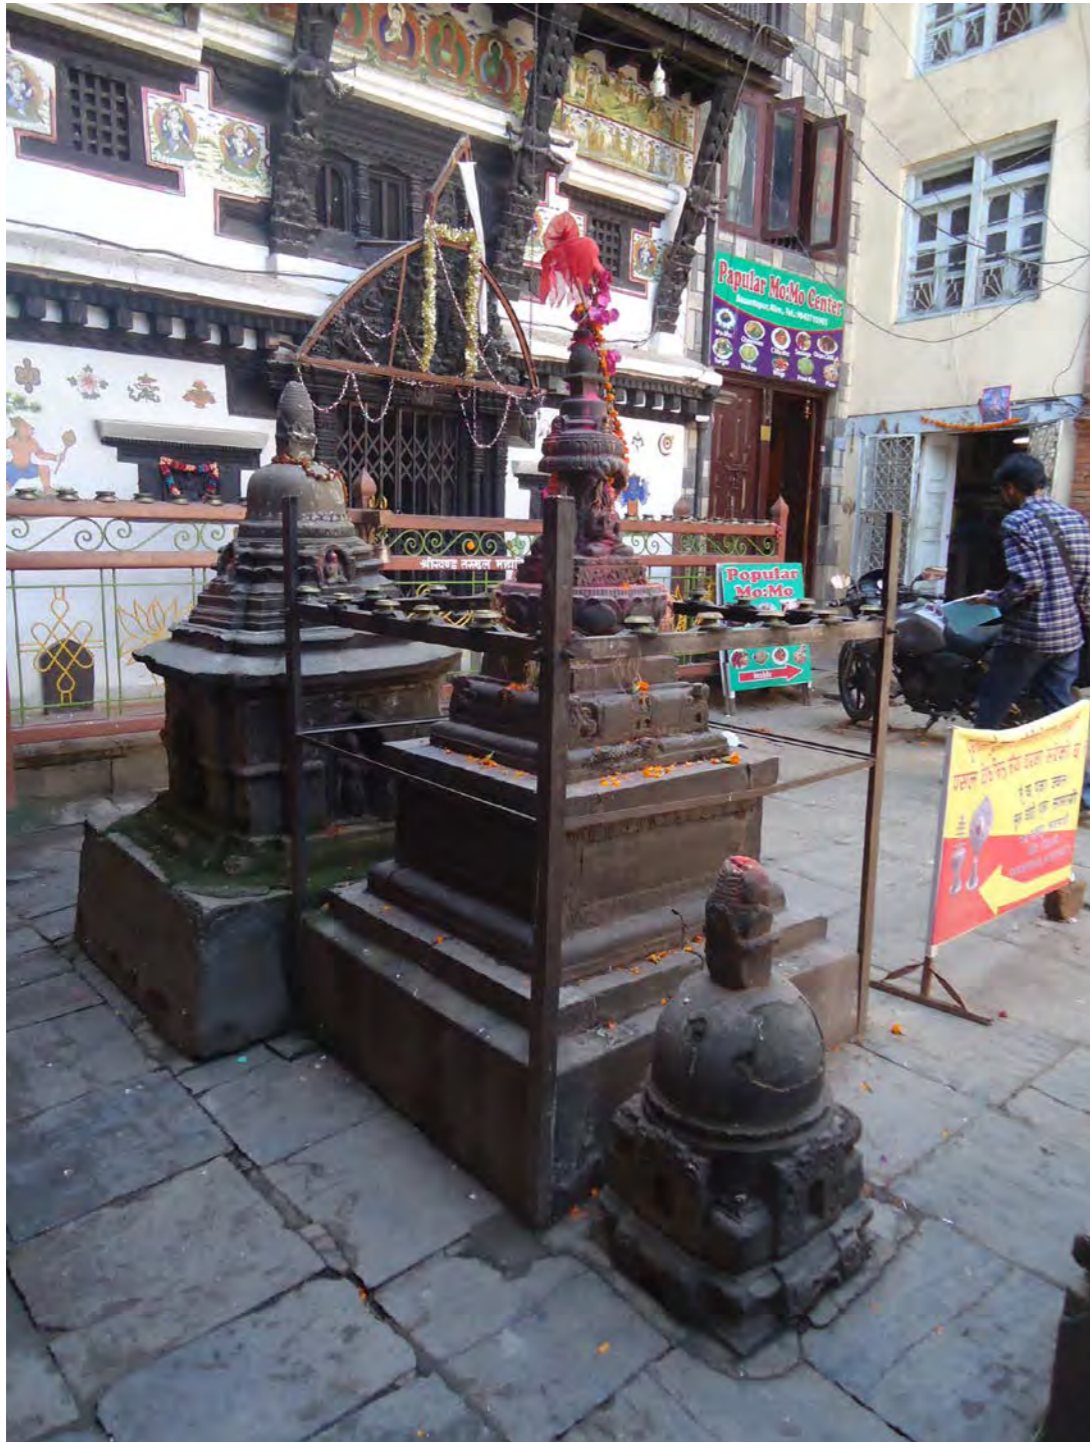
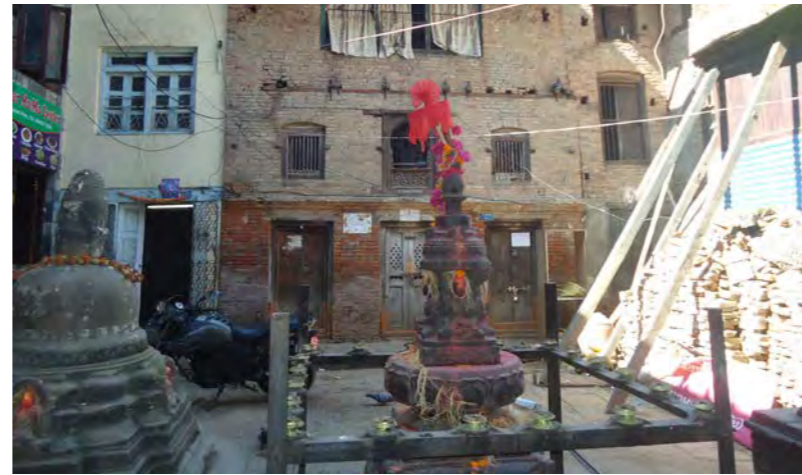
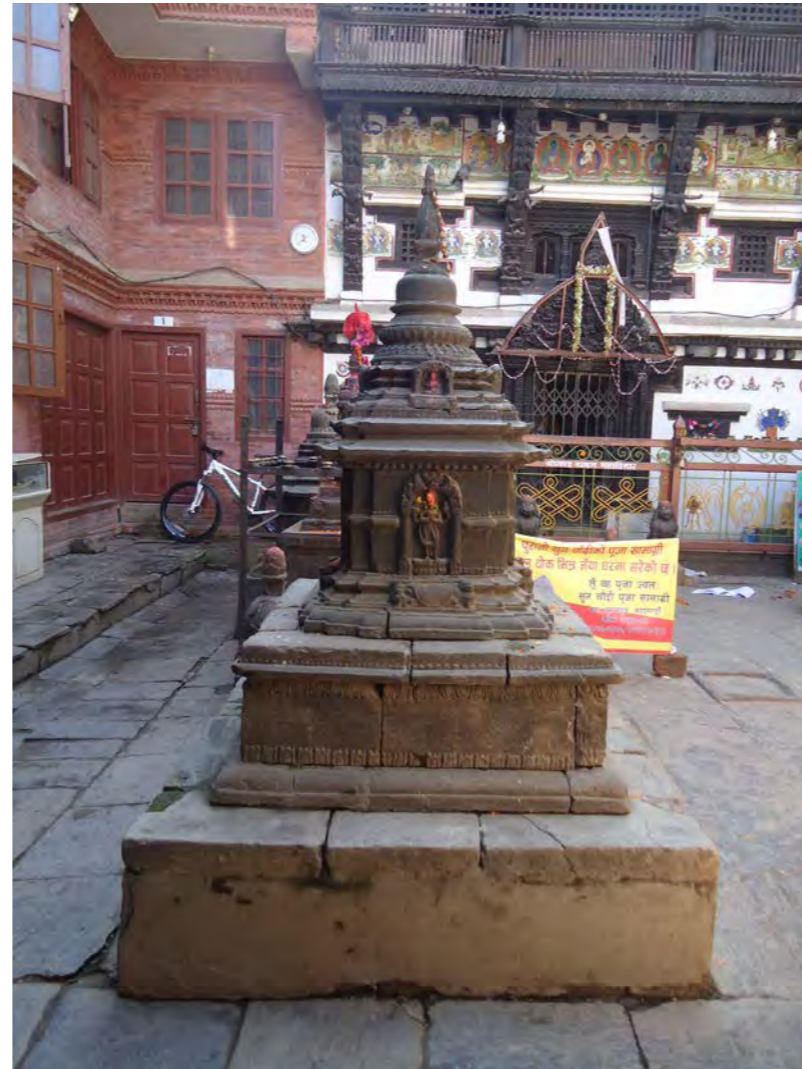
56f,g

CODE NO	TYOLOGY	MONUMENT NAME	ESTABLISHED/ RENOVATED	STRUCTURAL SYSTEM	MATERIAL	GENERAL DESCRIPTION	PROBLEM DESCRIPTION	DANGER	REMARKS	
56f	Open shrine				Stone	Stone shrine with Buddha image on four side	Vegetaion growth and minor cracks at base			
56g	Stupa				Stone	Small stone stupa	Top part dilapadated; stones detoriated;vegetaion growth			
56h	Open shrine				Stone		Cracks at base and vegetation growth

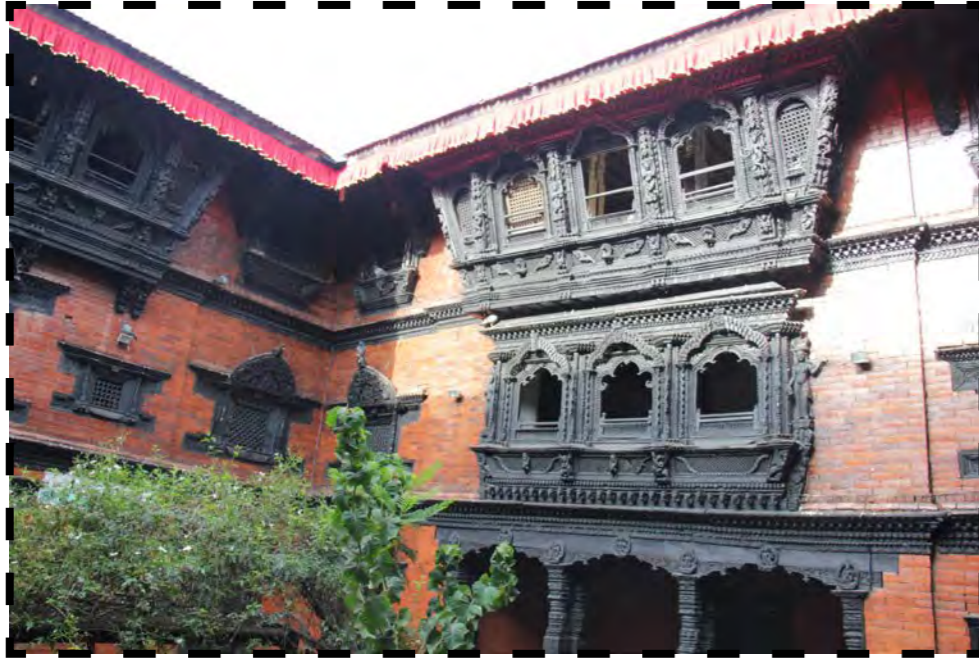
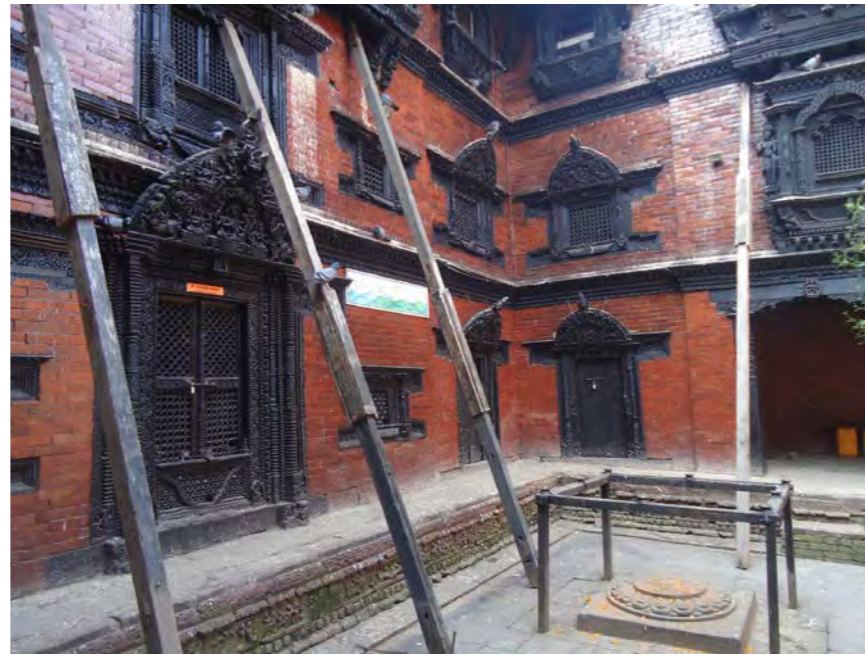
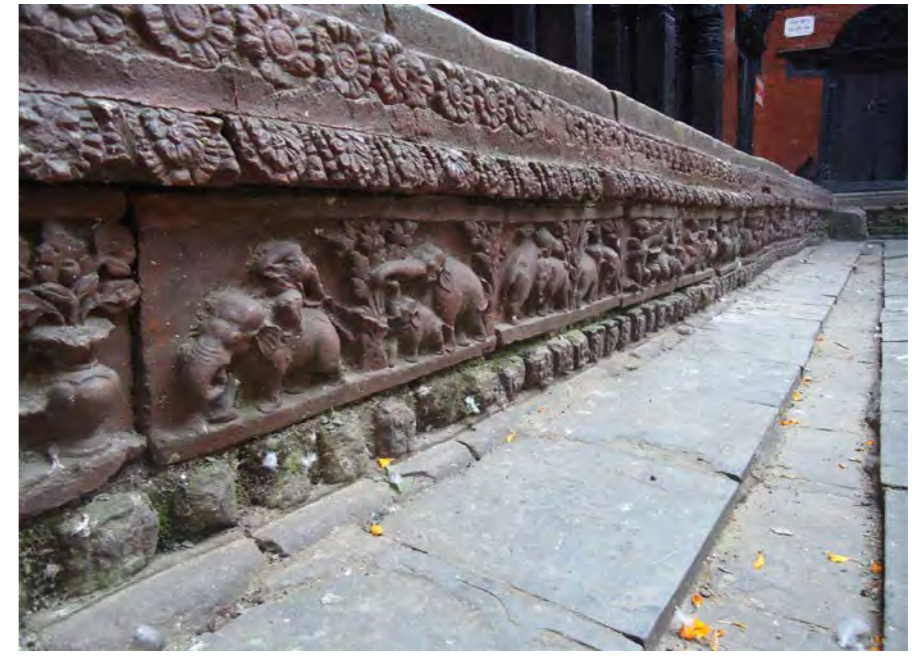
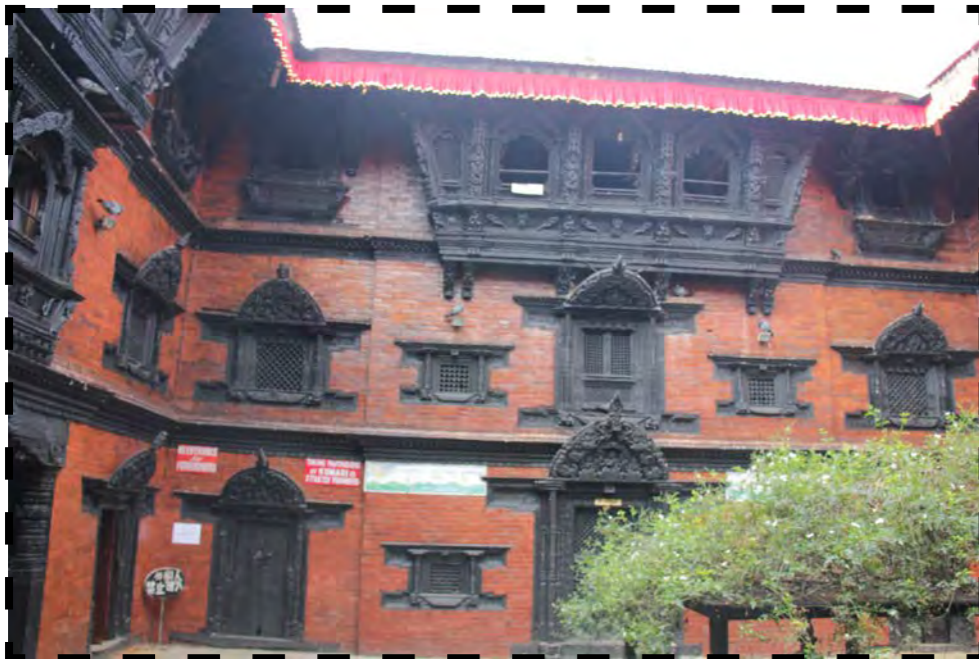
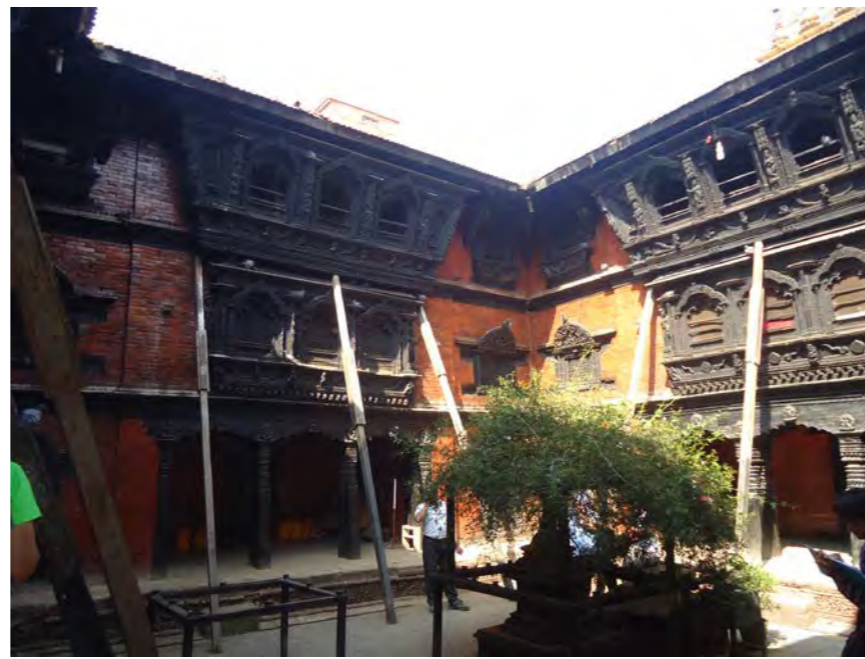
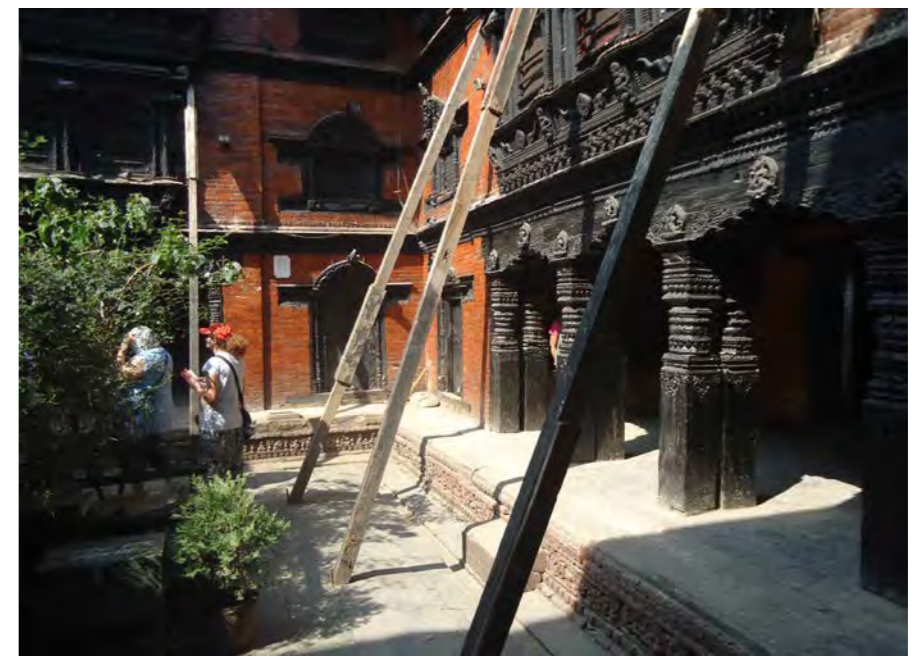
57 KUMARI BAHAL

CODE NO	TYOLOGY	MONUMENT NAME	ESTABLISHED/ RENOVATED	STRUCTURAL SYSTEM	MATERIAL	GENERAL DESCRIPTION	PROBLEM DESCRIPTION	DANGER	REMARKS
57	Bahal	Kumari Baha	18 century	Load Bearing	Brick	Part of the house of Kumari; Shrine of Buddha on sothern side of the courtyard.	Vegetation growth

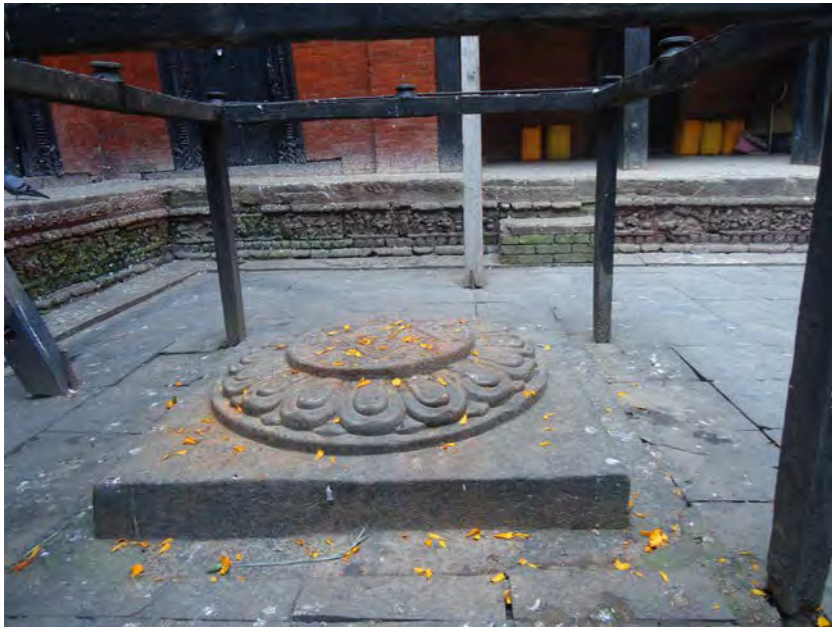
CODE NO	TYOLOGY	MONUMENT NAME	ESTABLISHED/ RENOVATED	STRUCTURAL SYSTEM	MATERIAL	GENERAL DESCRIPTION	PROBLEM DESCRIPTION	DANGER	REMARKS
57a	Mandala				Stone	Sorrounded by wooden frame	No visible damage		
57b	Chaitya				Stone	"	No visible damage		
57c	Dharmadhatu				Stone	Stone inscription with plaster at base	No visible damage

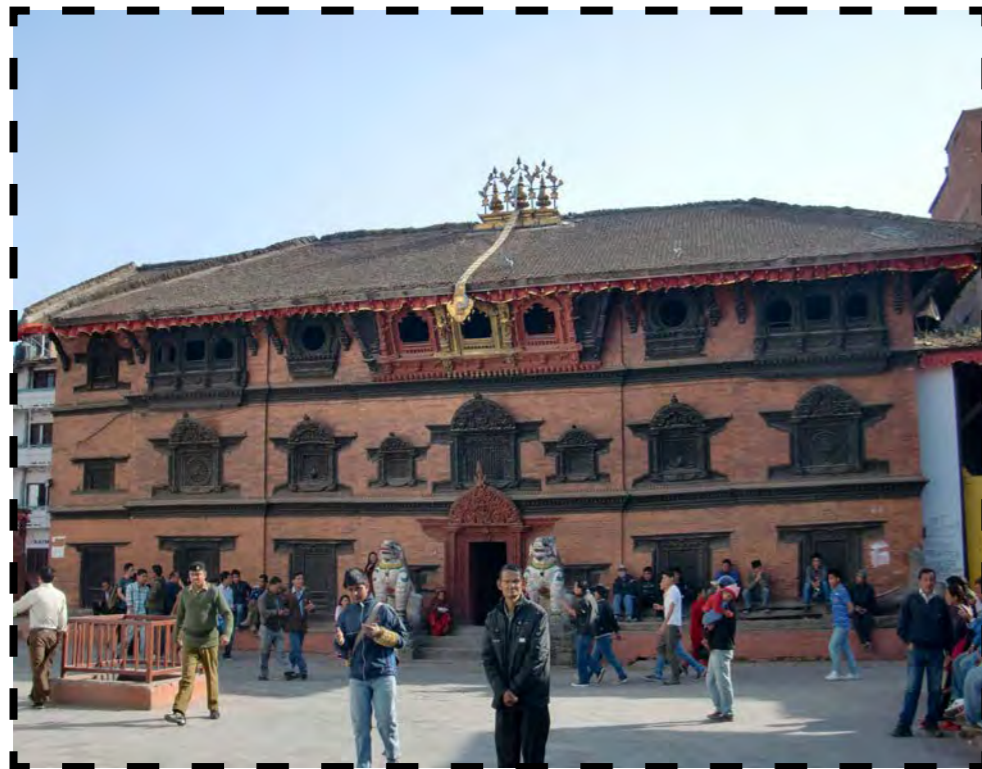
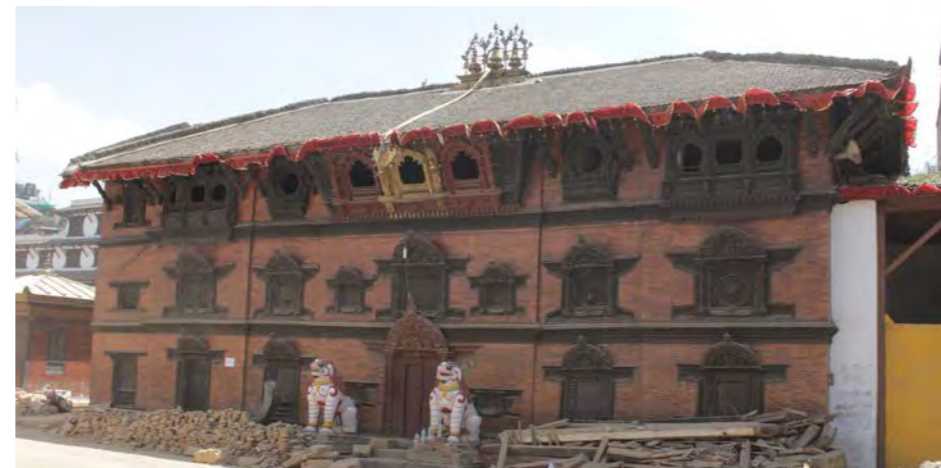
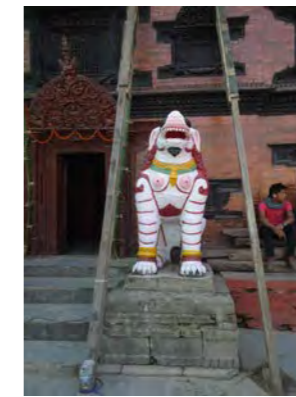
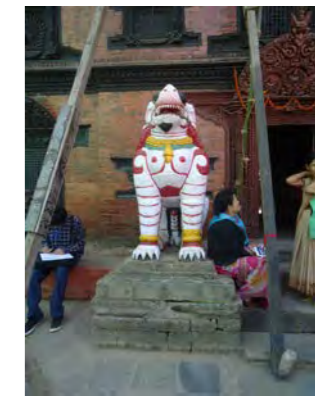
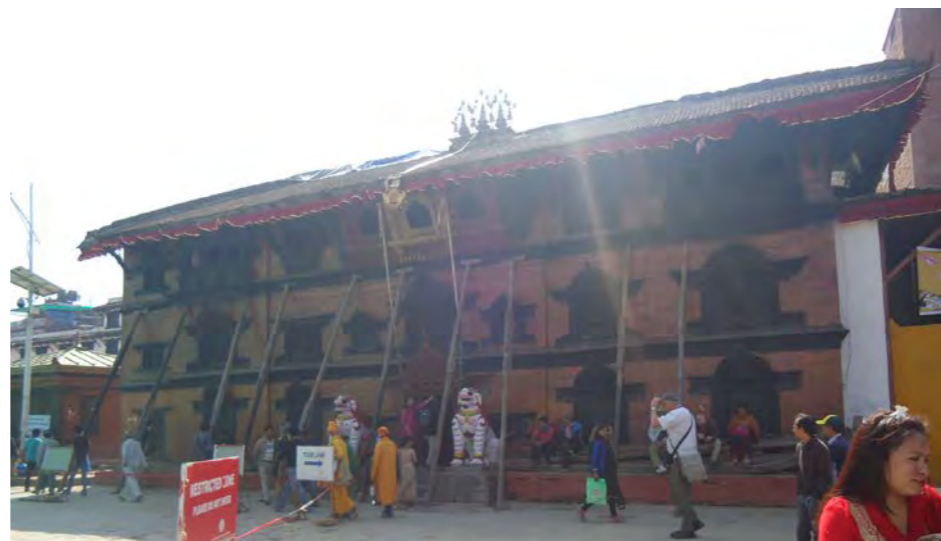
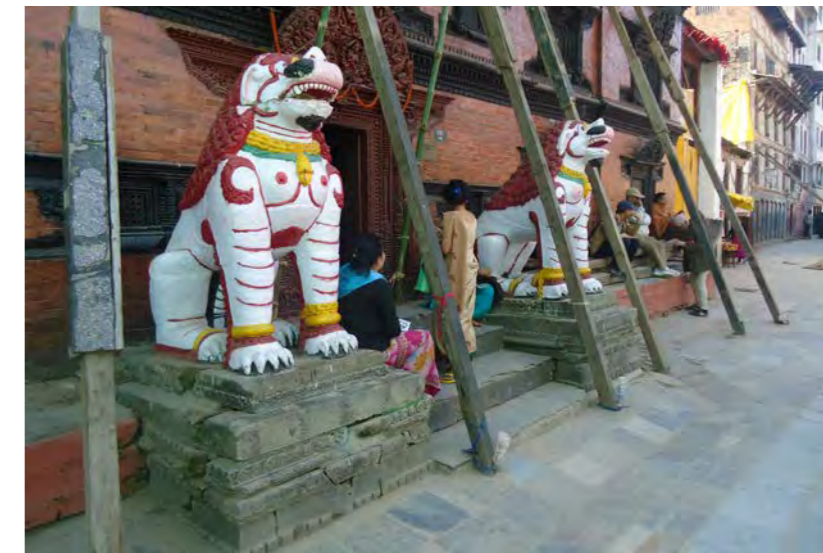
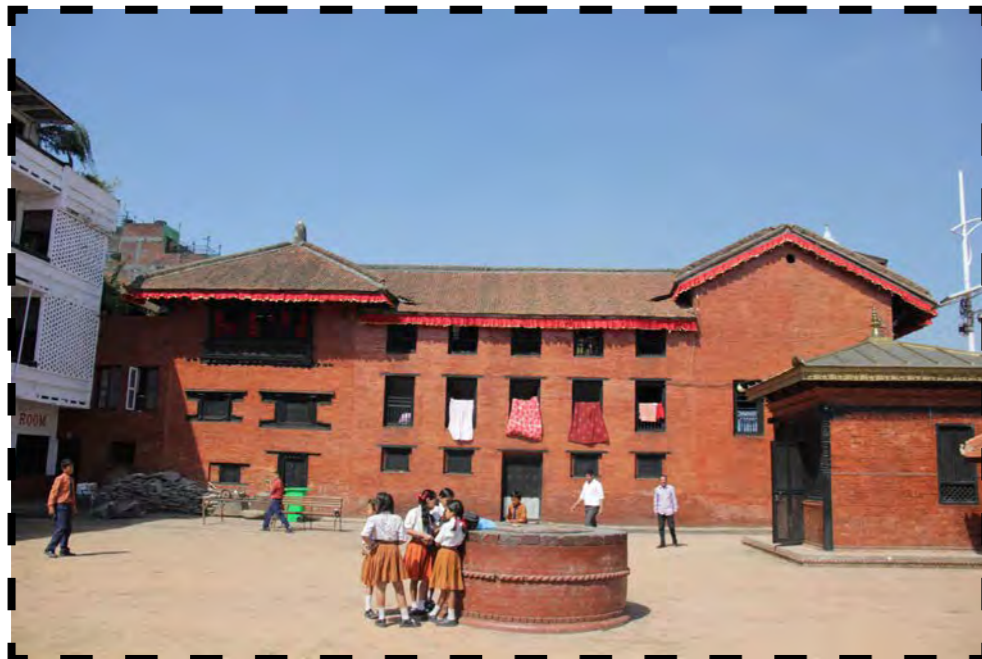
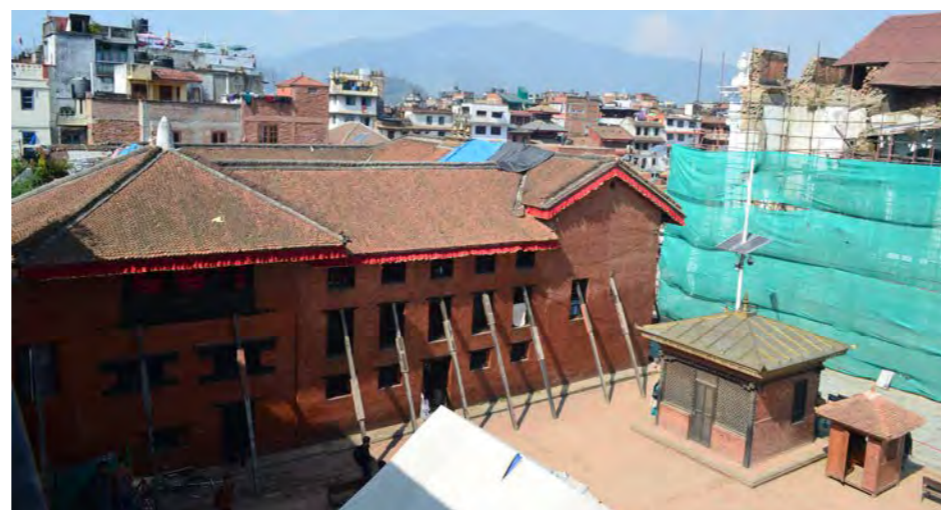
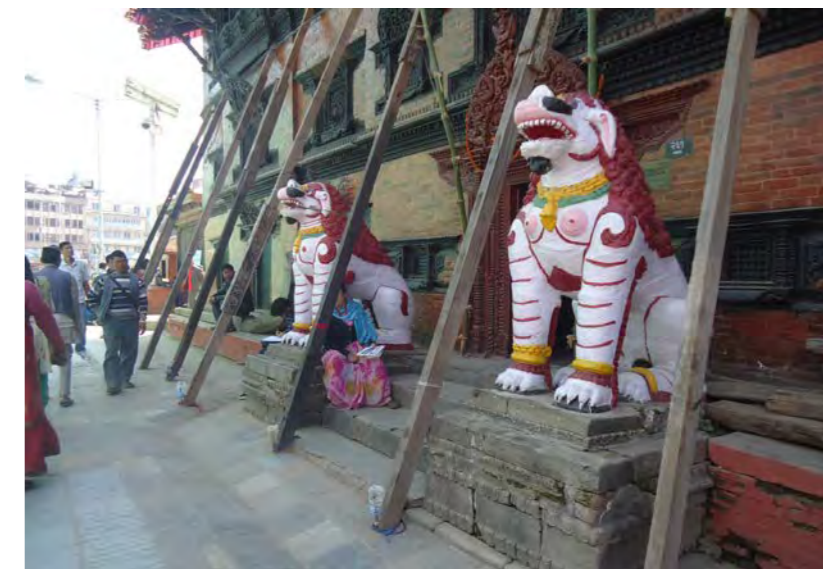
58 KUMARI DYO CHEIN

CODE NO	TYOLOGY	MONUMENT NAME	ESTABLISHED/ RENOVATED	STRUCTURAL SYSTEM	MATERIAL	GENERAL DESCRIPTION	PROBLEM DESCRIPTION	DANGER	REMARKS
58	Dyo chhen	Kumari Dyo chhen	18th century	Load Bearing	Brick; Timber	House of kumari goddess; Lime plastered with latticed windows and a window balcony	Extensive internal cracks; Unstable and currently supported by struts

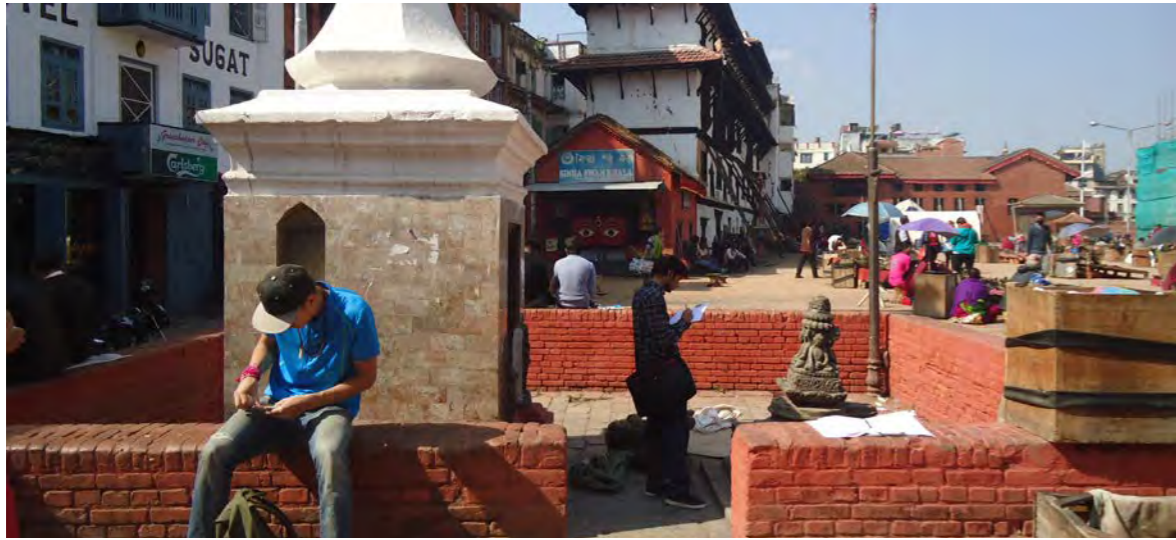
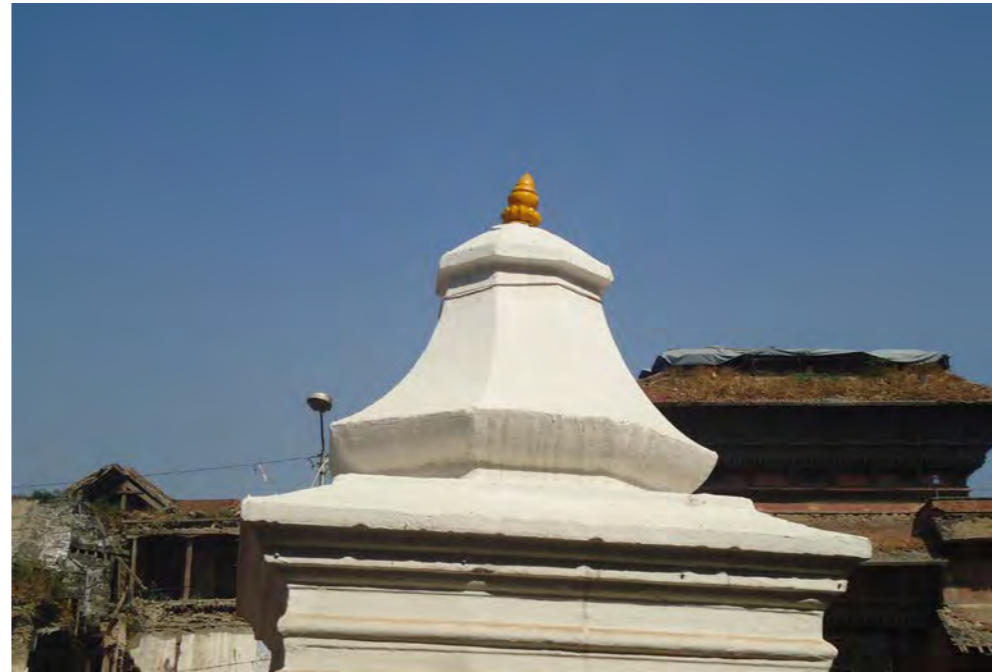
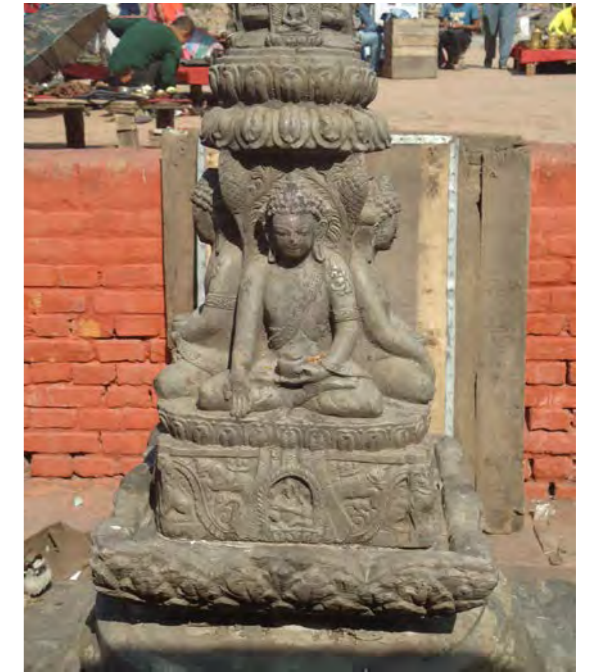
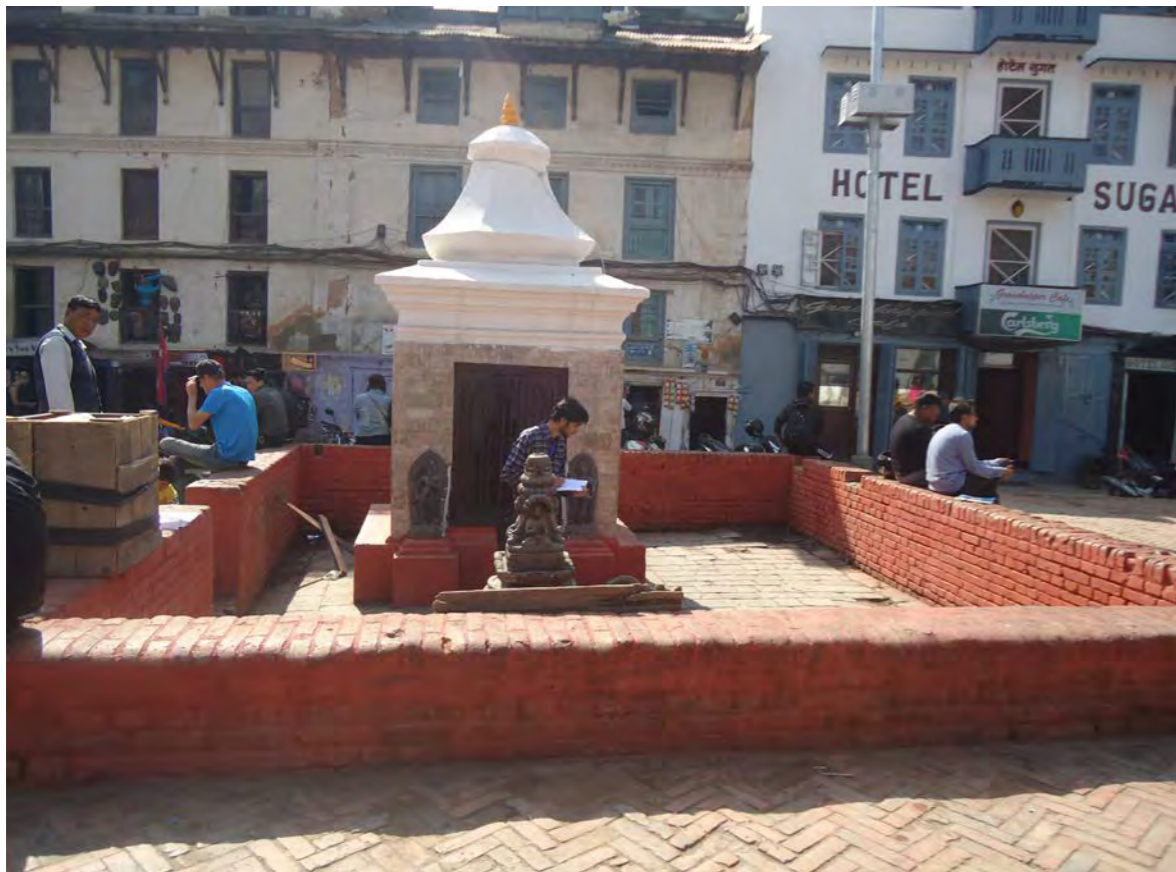
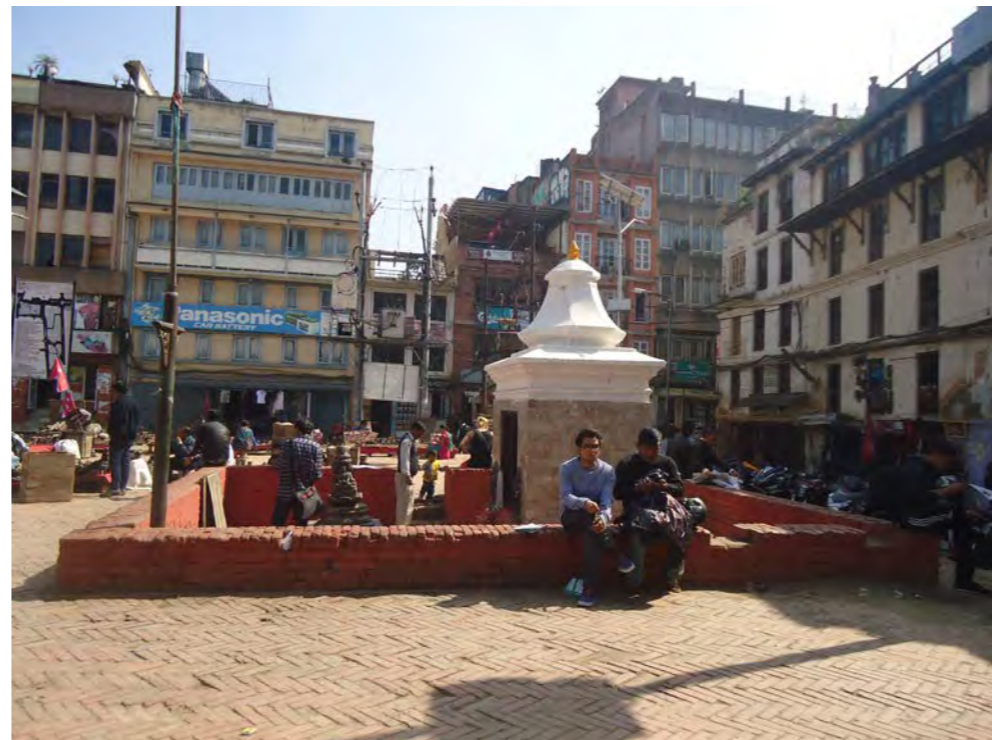
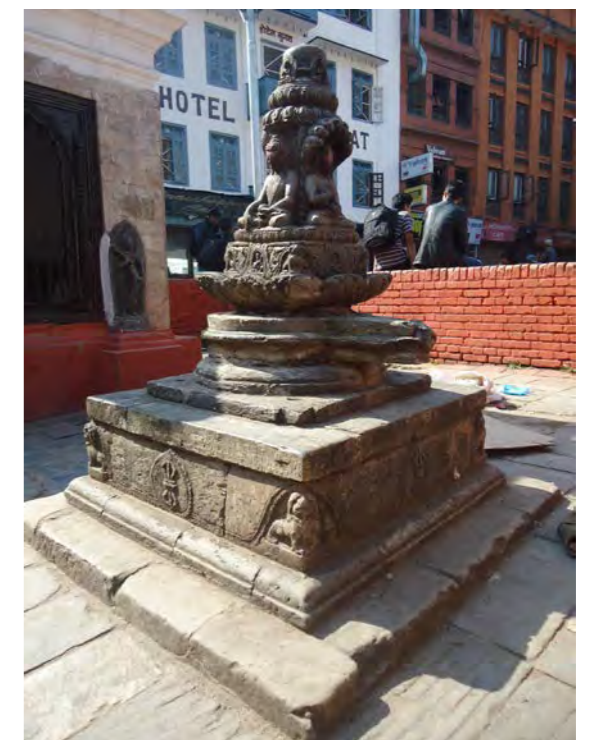
59 BANIYA BAHAL

CODE NO	TYOLOGY	MONUMENT NAME	ESTABLISHED/ RENOVATED	STRUCTURAL SYSTEM	MATERIAL	GENERAL DESCRIPTION	PROBLEM DESCRIPTION	DANGER	REMARKS	
59	Closed Shrine	Baniya bahal		Load Bearing	Brick	Marble cladding on wall;Cement plaster on top;Buddha statue inside	Good condition;Top bajra slightly tilted

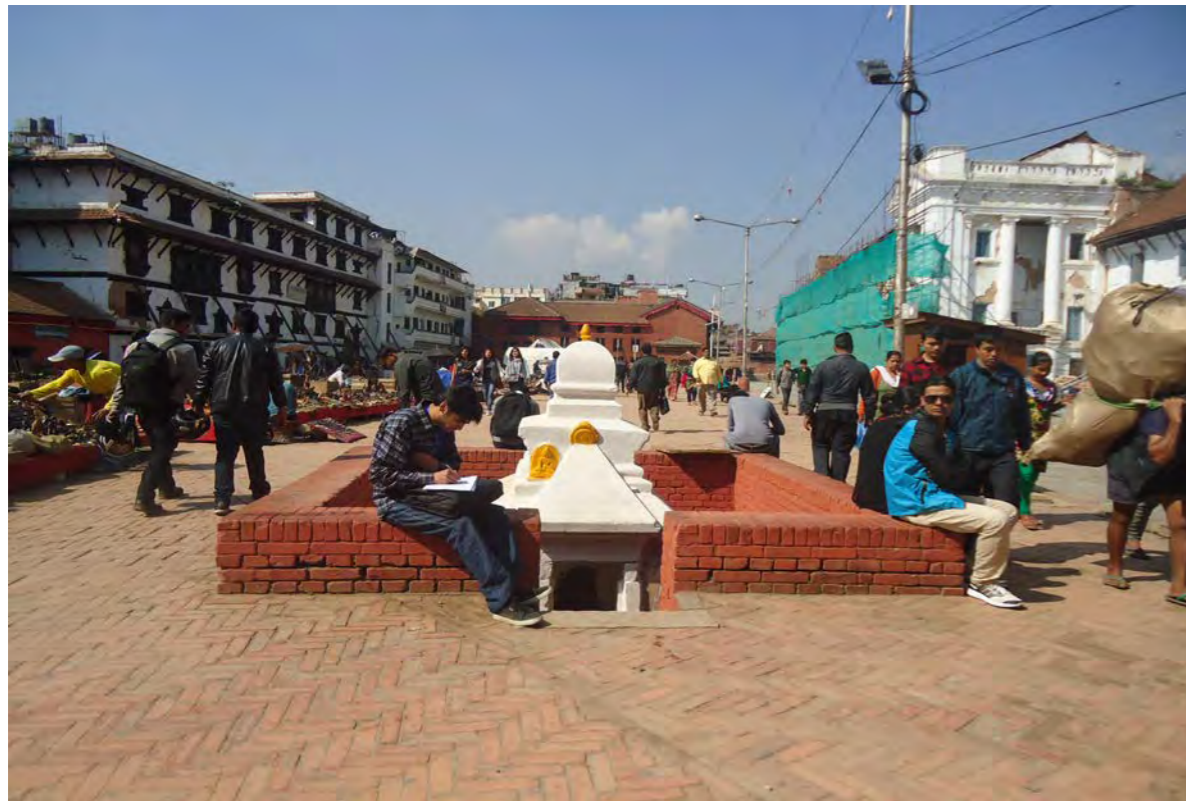
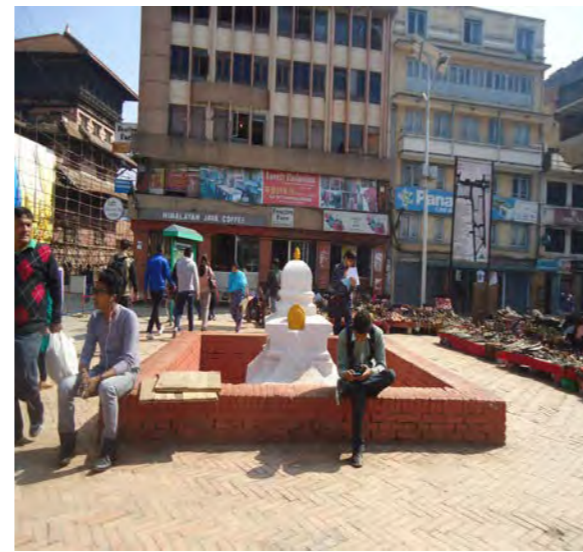
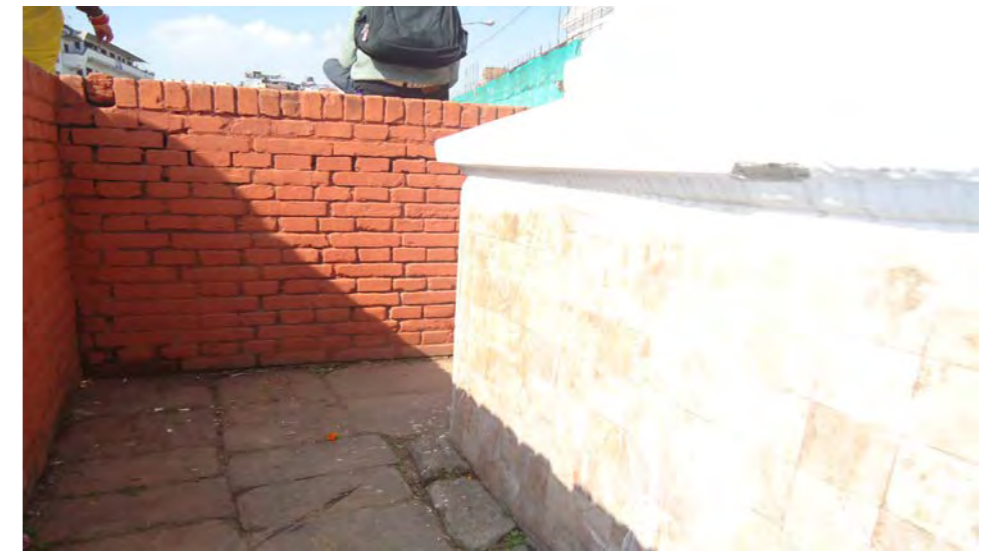
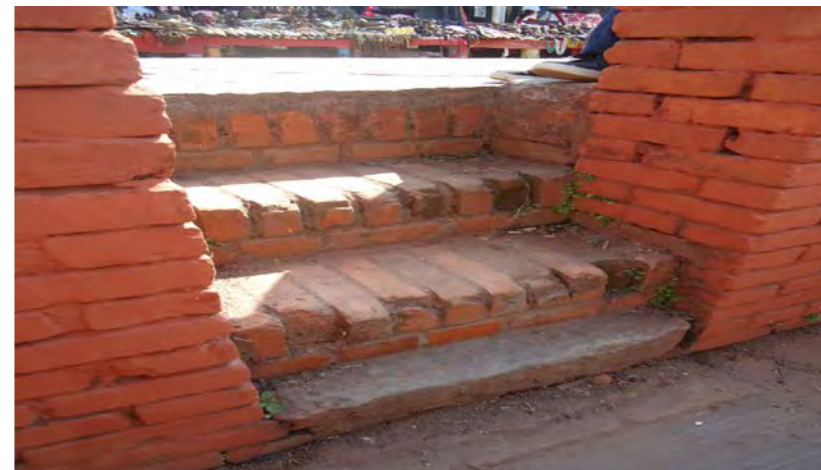
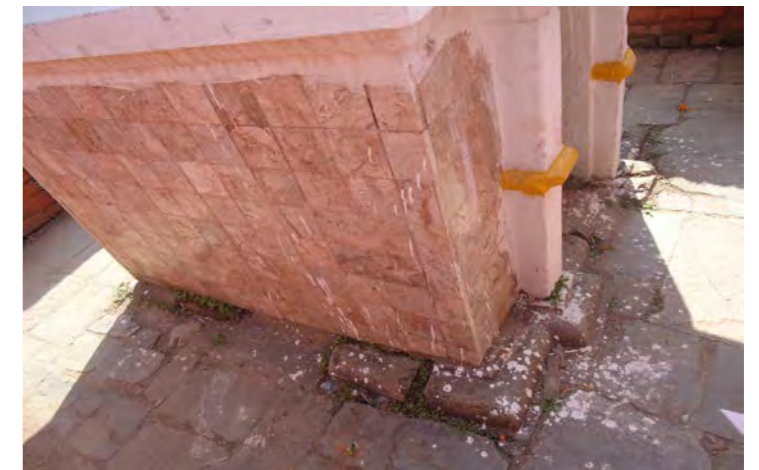
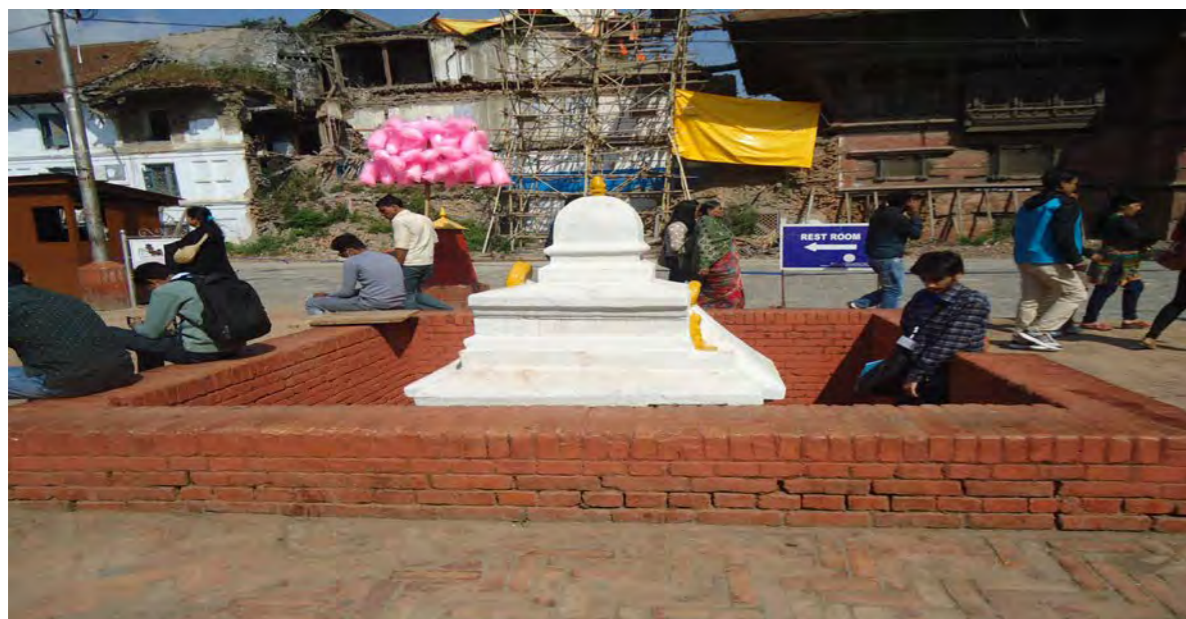
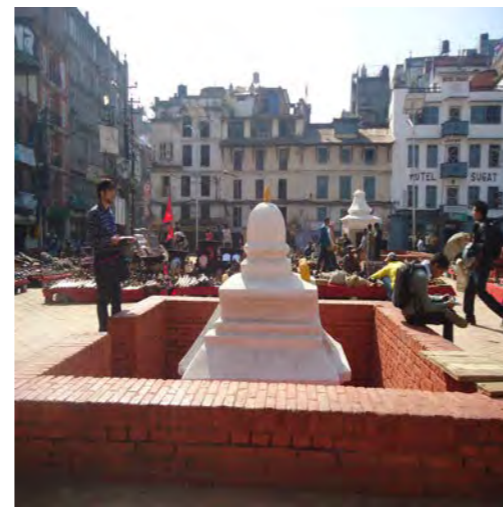
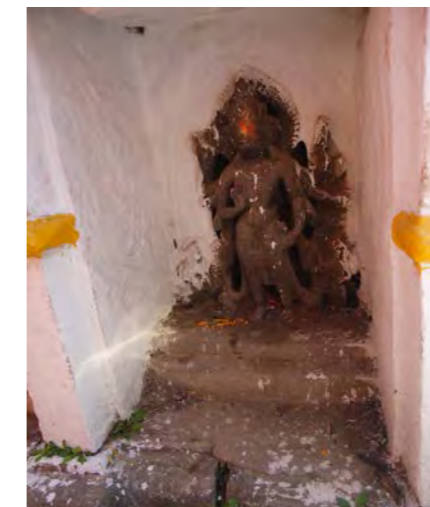
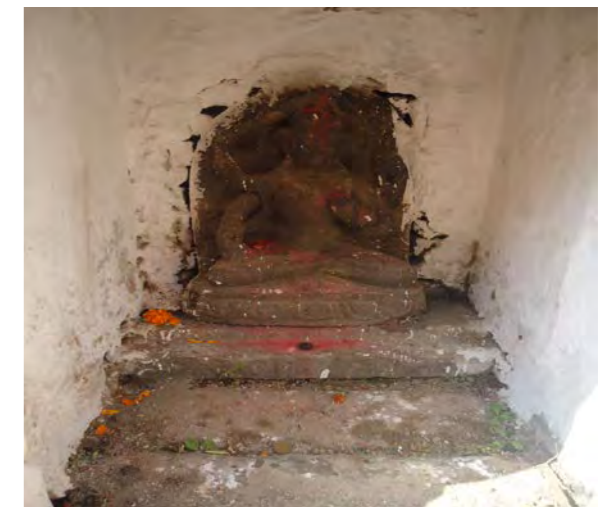
60 Saraswati Temple

CODE NO	TYOLOGY	MONUMENT NAME	ESTABLISHED/ RENOVATED	STRUCTURAL SYSTEM	MATERIAL	GENERAL DESCRIPTION	PROBLEM DESCRIPTION	DANGER	REMARKS	
60	Closed Shrine	Saraswati temple		Load Bearing	Brick	At a lower level from ground level; Marble cladding on wall; Cement plaster on top and two stone sculptures of saraswati	No visible damage
