2015 Earthquake Damage Mapping

Hanuman Dhoka Darbar Square Monument Zone
Kathmandu Valley World Heritage Property

December 2015

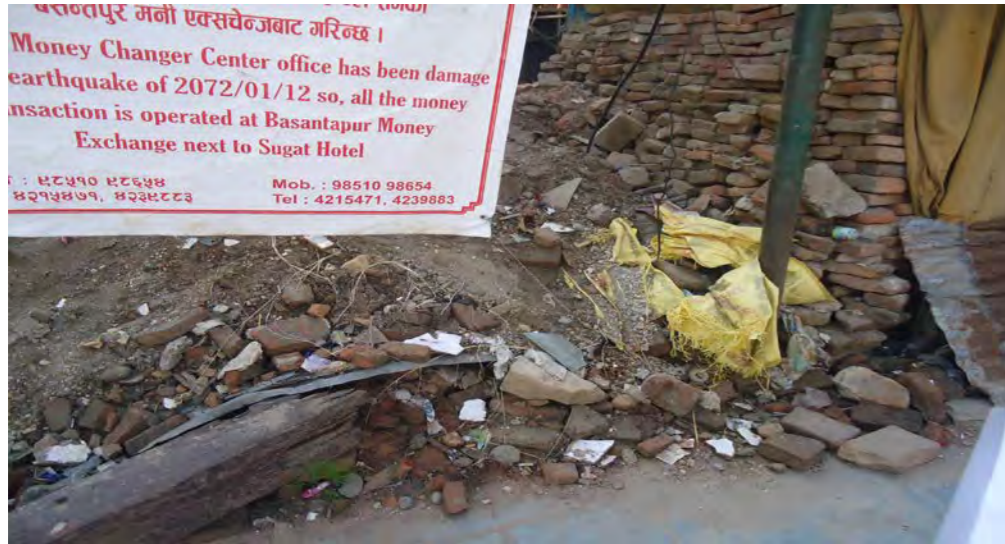
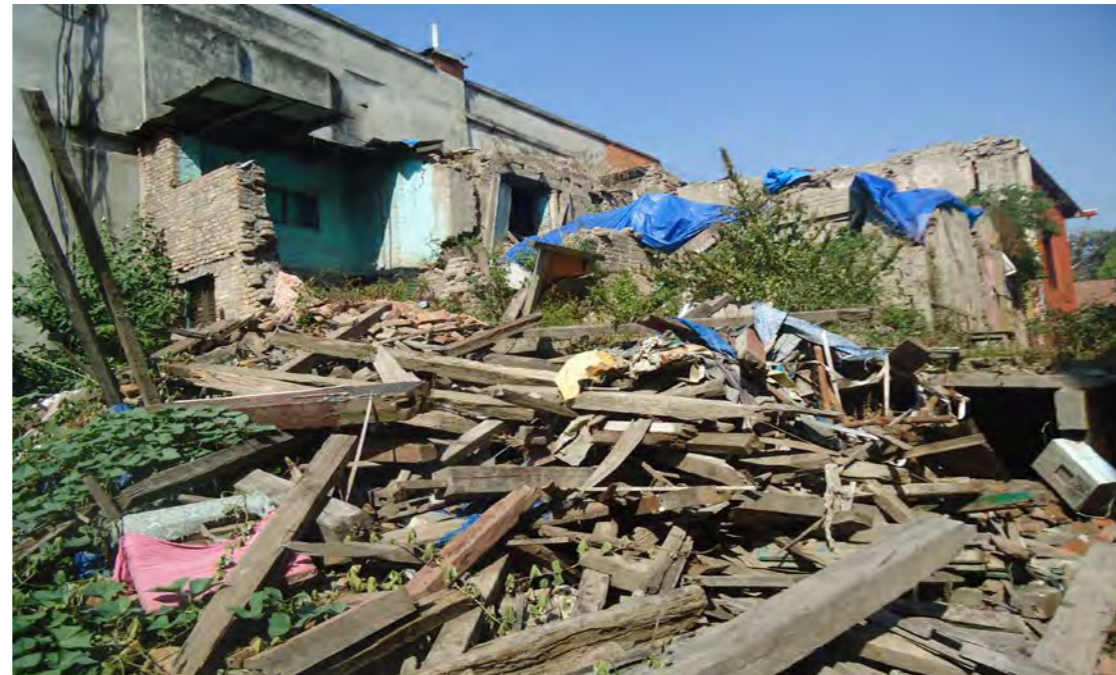
CODE NO	TYOLOGY	MONUMENT NAME	ESTABLISHED/ RENOVATED	STRUCTURAL SYSTEM	MATERIAL	GENERAL DESCRIPTION	PROBLEM DESCRIPTION	DANGER	REMARKS
61		Krishna Temple			Brick		Totally collapsed

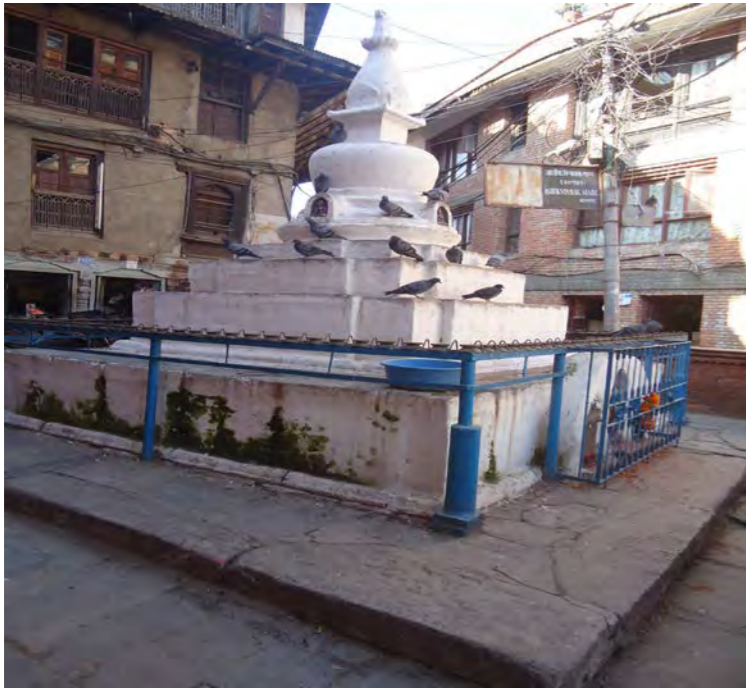
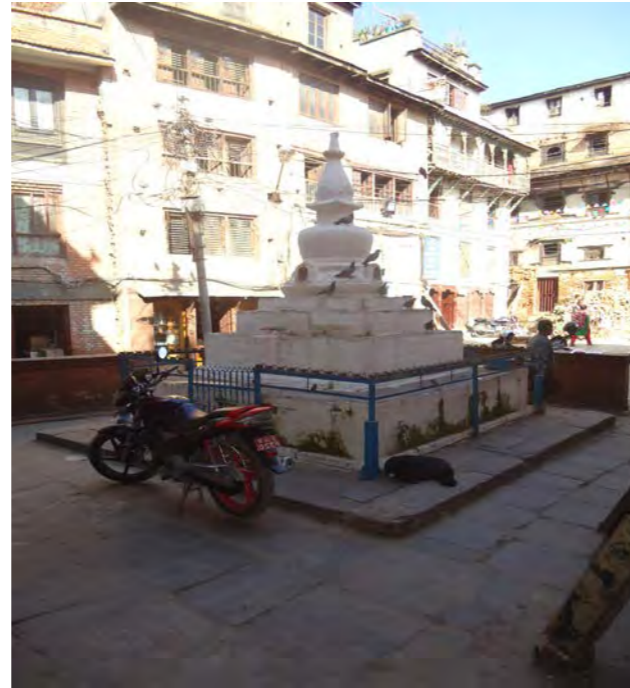
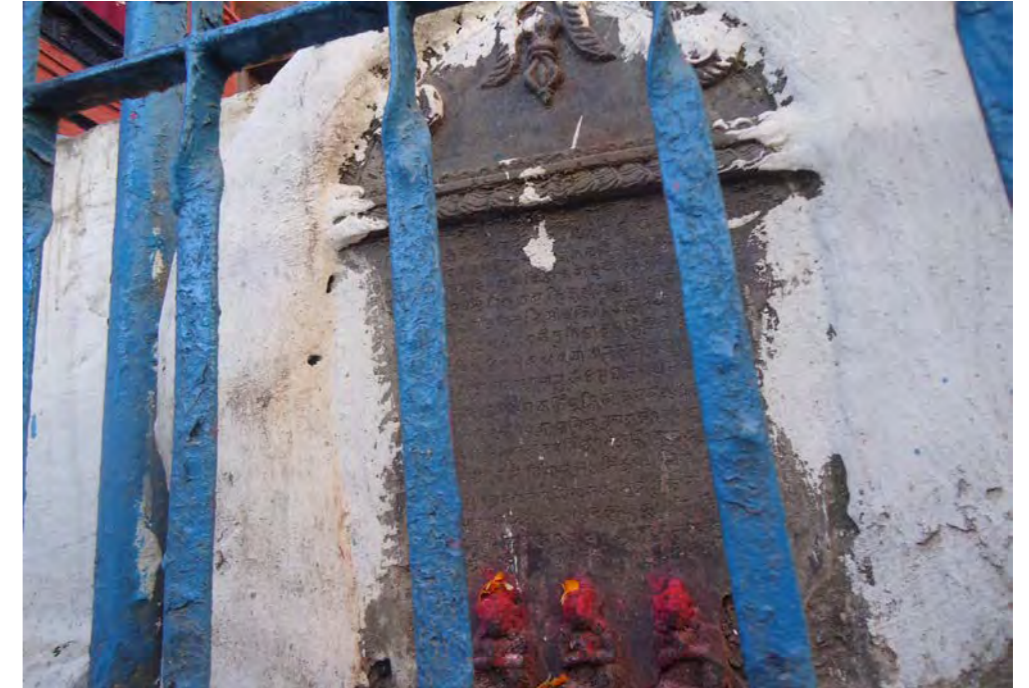
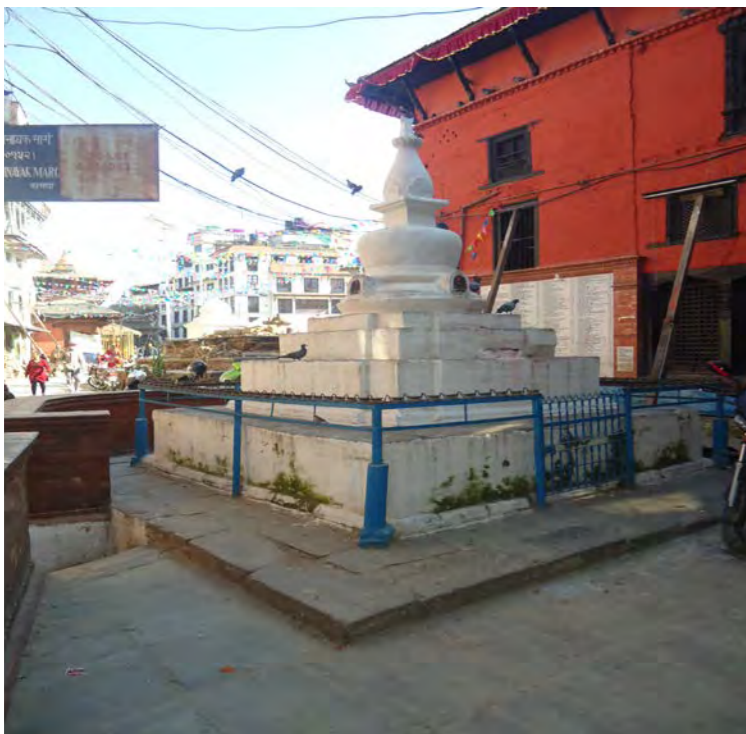
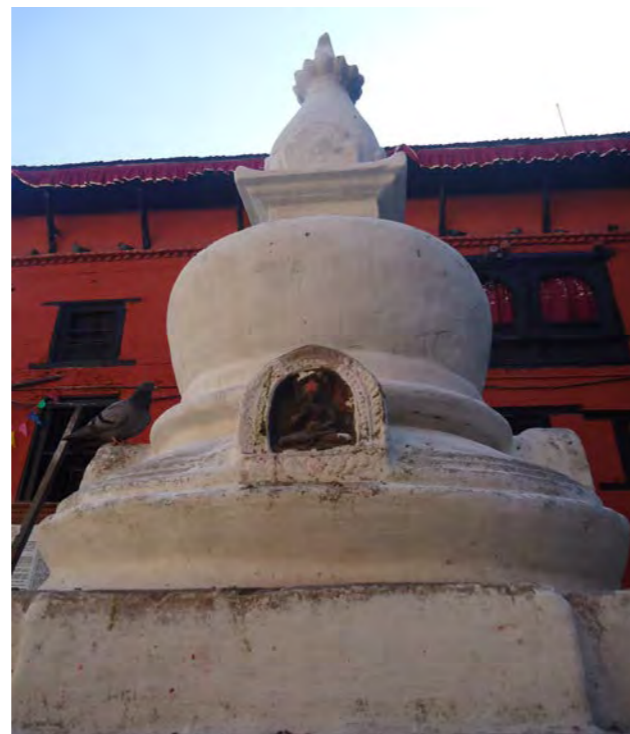
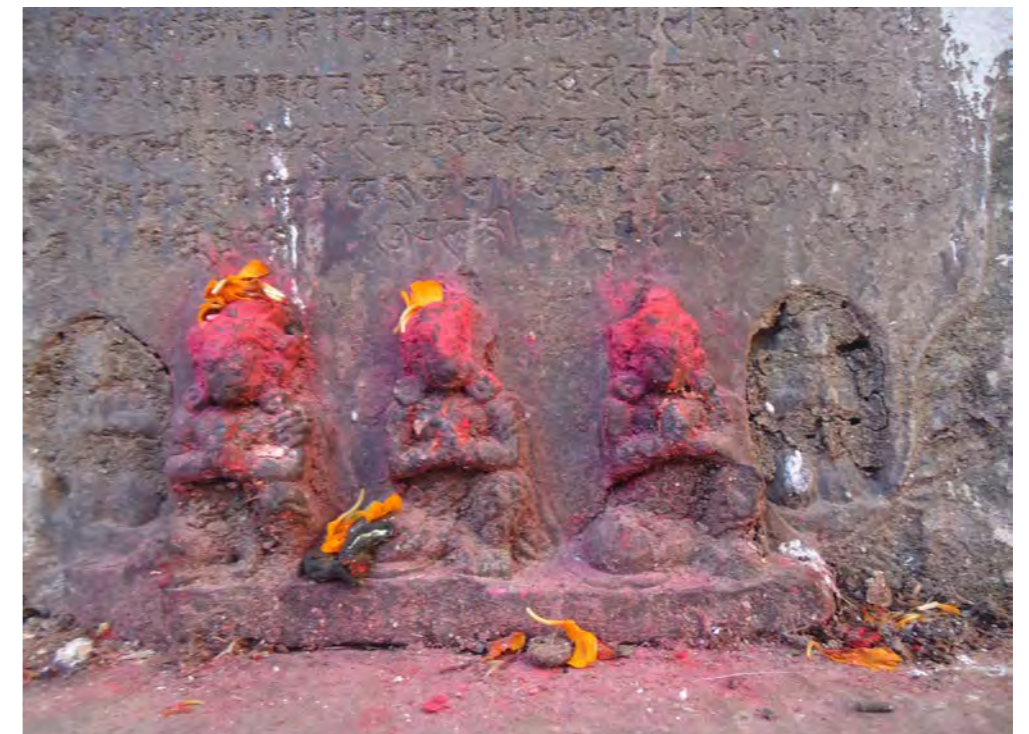
CODE NO	TYOLOGY	MONUMENT NAME	ESTABLISHED/ RENOVATED	STRUCTURAL SYSTEM	MATERIAL	GENERAL DESCRIPTION	PROBLEM DESCRIPTION	DANGER	REMARKS
62	Stupa			Load Bearing	Brick	Cement stupa with white washing;Sculpture of bud-dha on both side	Rising damp;Vegetation growth		
62a	Inscription				Stone	Inscription on front face	No visible damage

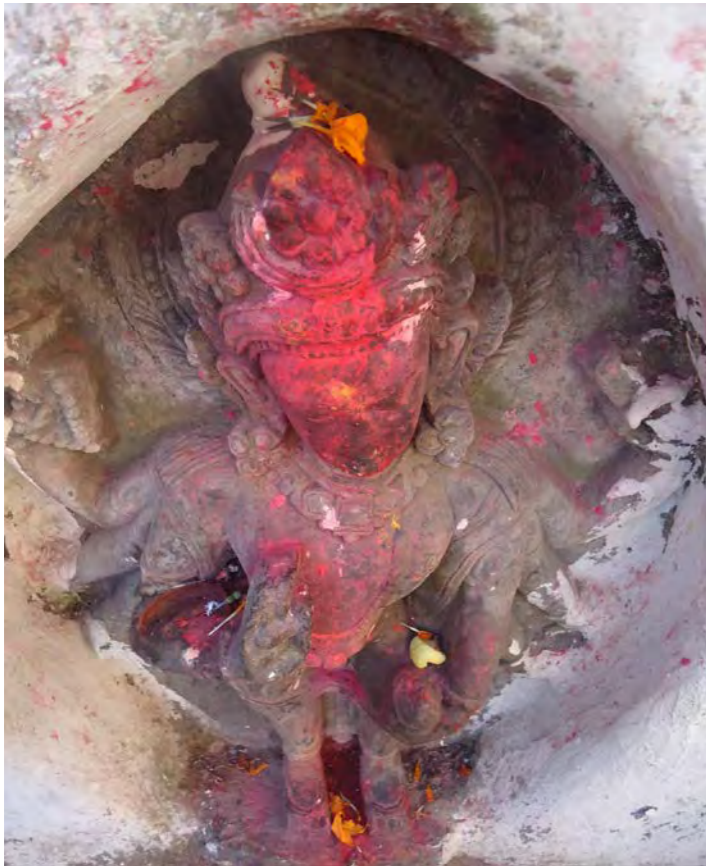
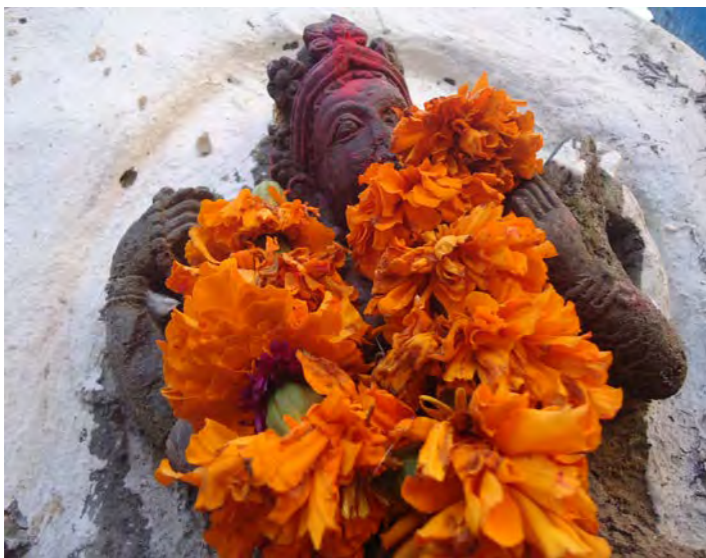
CODE NO	TYOLOGY	MONUMENT NAME	ESTABLISHED/ RENOVATED	STRUCTURAL SYSTEM	MATERIAL	GENERAL DESCRIPTION	PROBLEM DESCRIPTION	DANGER	REMARKS
62b 62c	Statue				Stone		No visible damage		
62d	Open shrine	Bajrakaal Bhai-rab		Load Bearing	Brick	Small stone sculpture	No visible damage

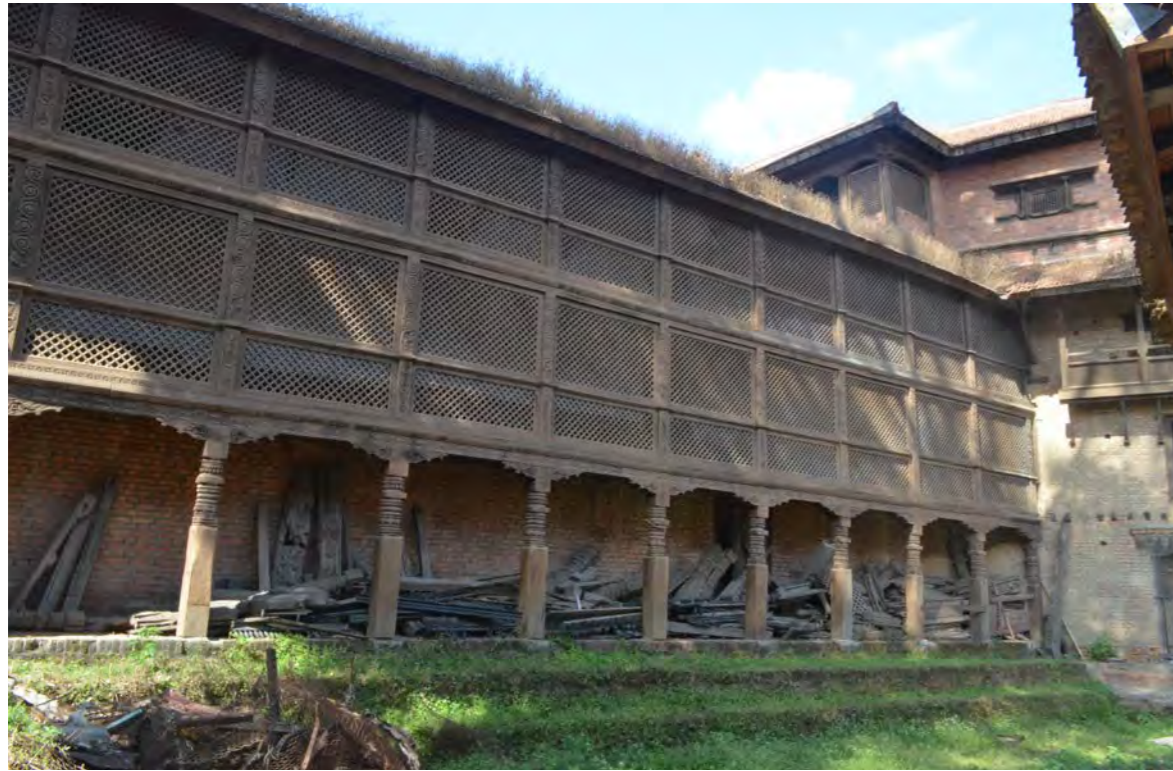
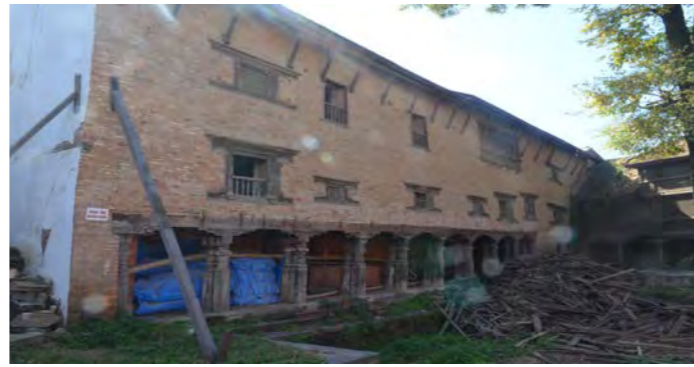
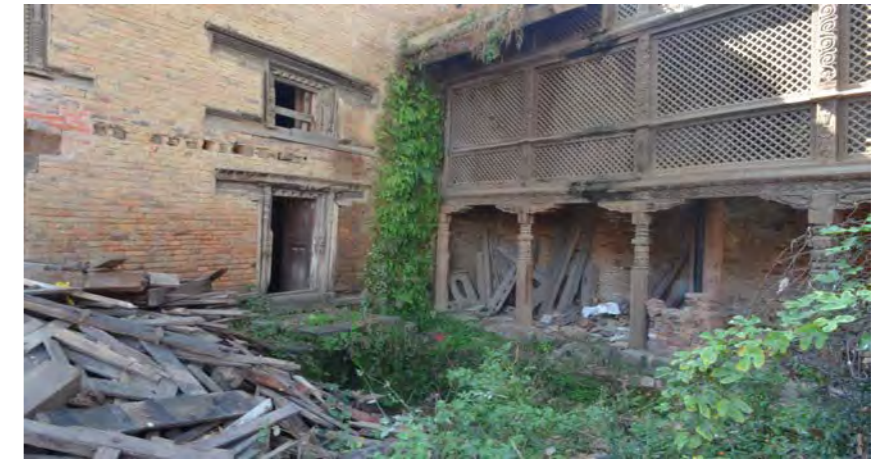
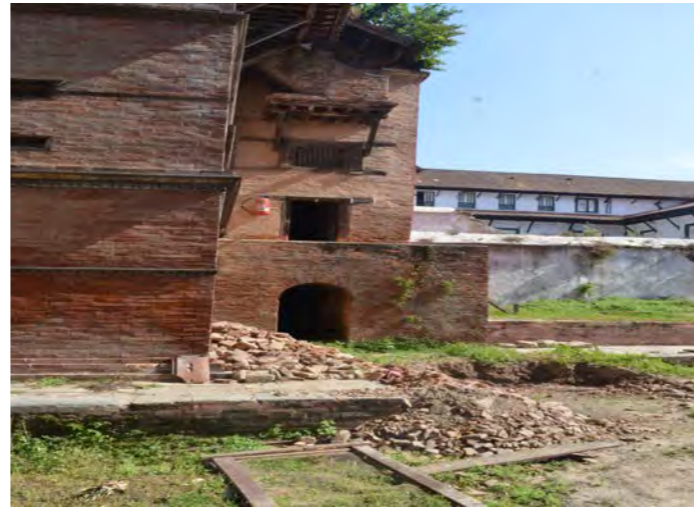
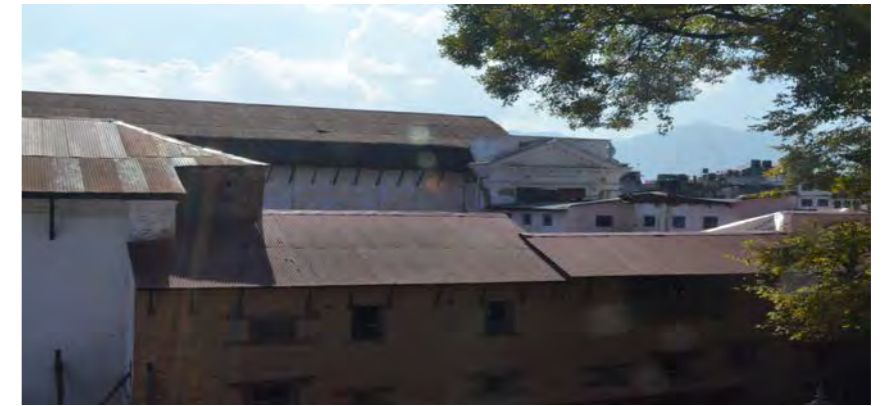
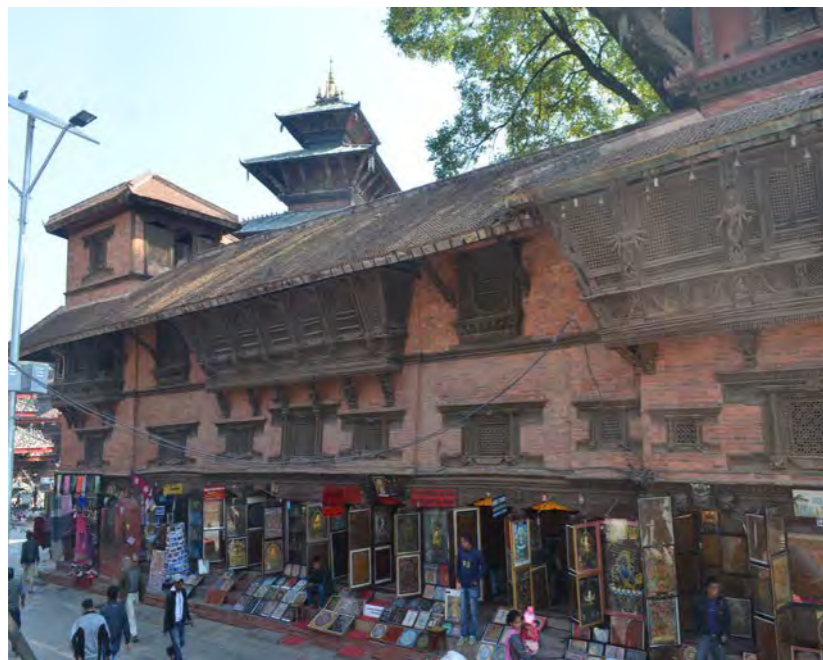
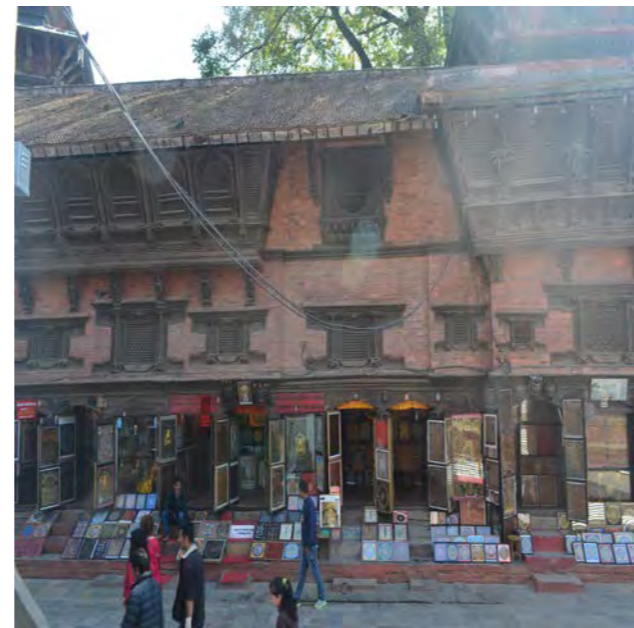
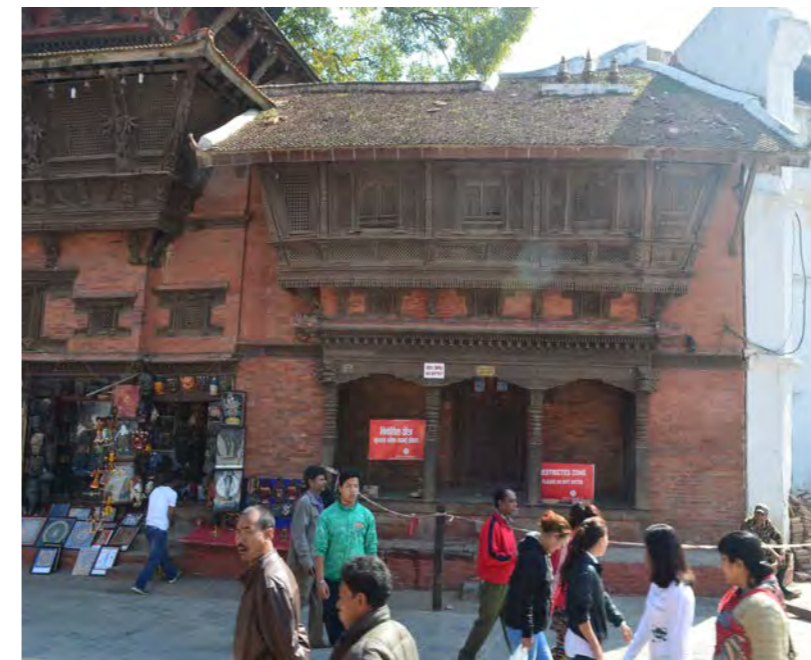
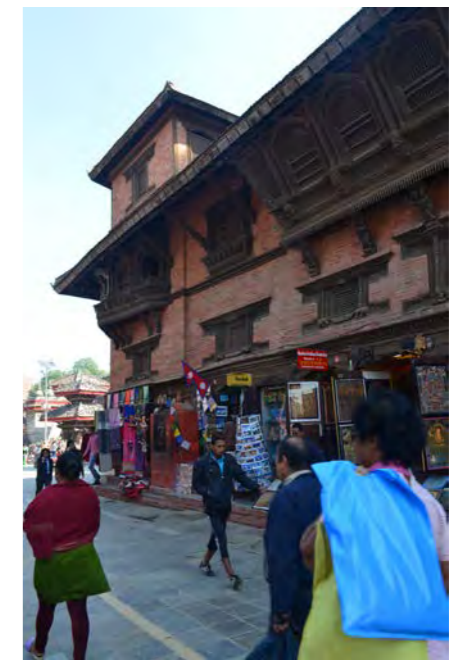
63 Masan Chowk

CODE NO	TYOLOGY	MONUMENT NAME	ESTABLISHED/ RENOVATED	STRUCTURAL SYSTEM	MATERIAL	GENERAL DESCRIPTION	PROBLEM DESCRIPTION	DANGER	REMARKS
63	Courtyard	Masan Chowk					Vegetation growth;Dampness problem

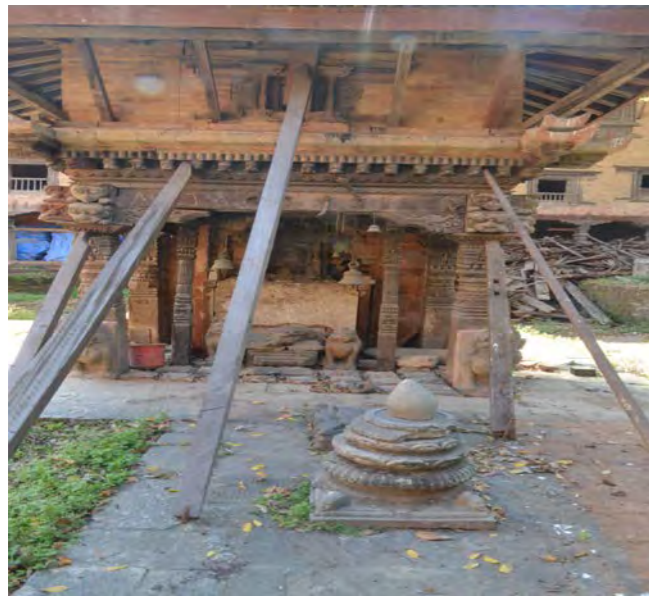
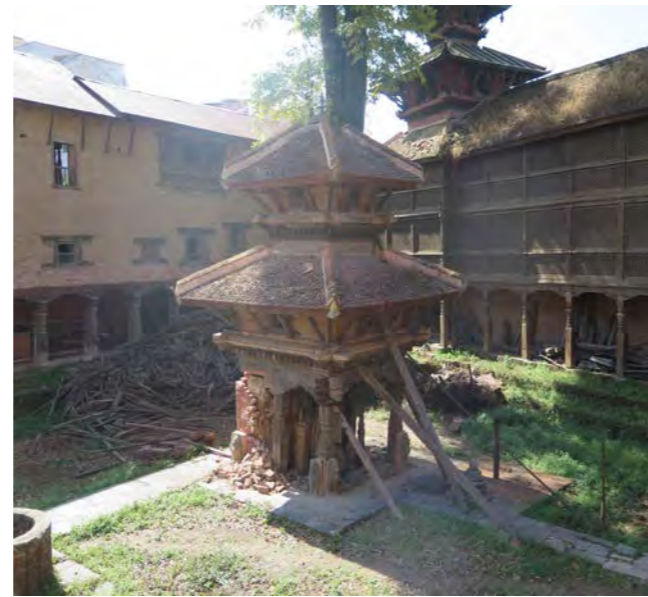
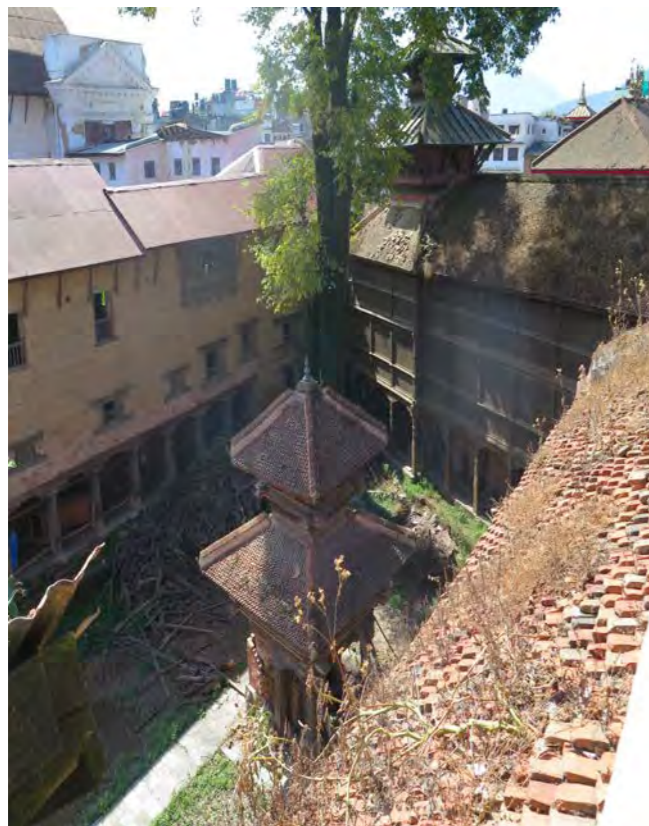
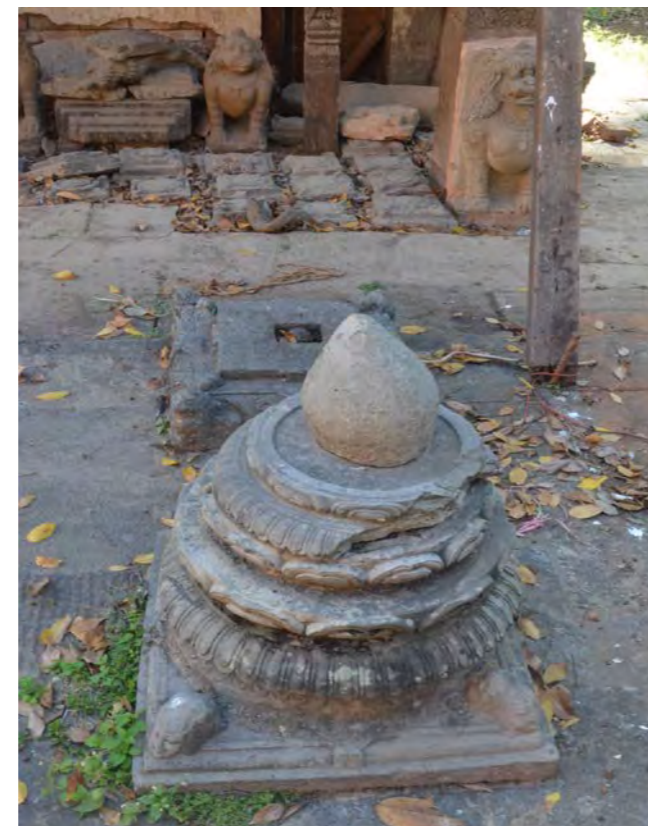
63a Nashal Temple

CODE NO	TYOLOGY	MONUMENT NAME	ESTABLISHED/ RENOVATED	STRUCTURAL SYSTEM	MATERIAL	GENERAL DESCRIPTION	PROBLEM DESCRIPTION	DANGER	REMARKS
63a	Three storey temple	Nashal Temple		Load Bearing	Brick		Slightly tilted towards north;vegetation growth		
63b		Well			Brick		Vegetation growth

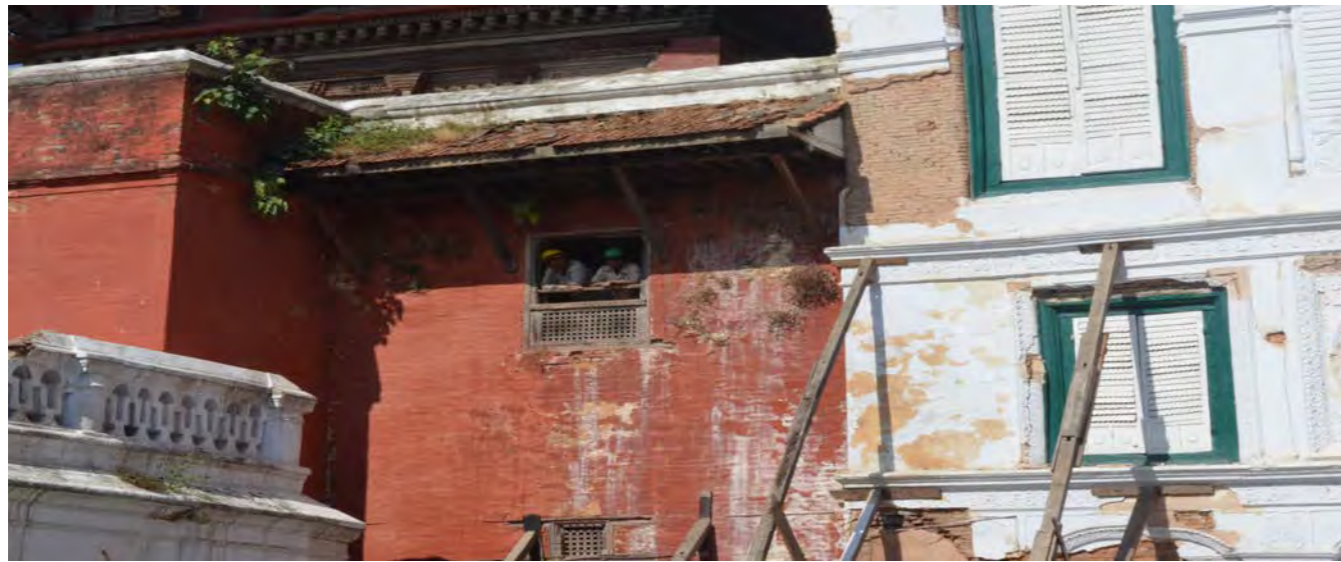
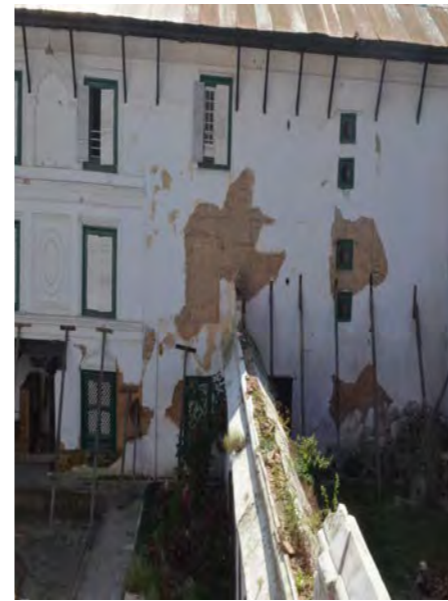
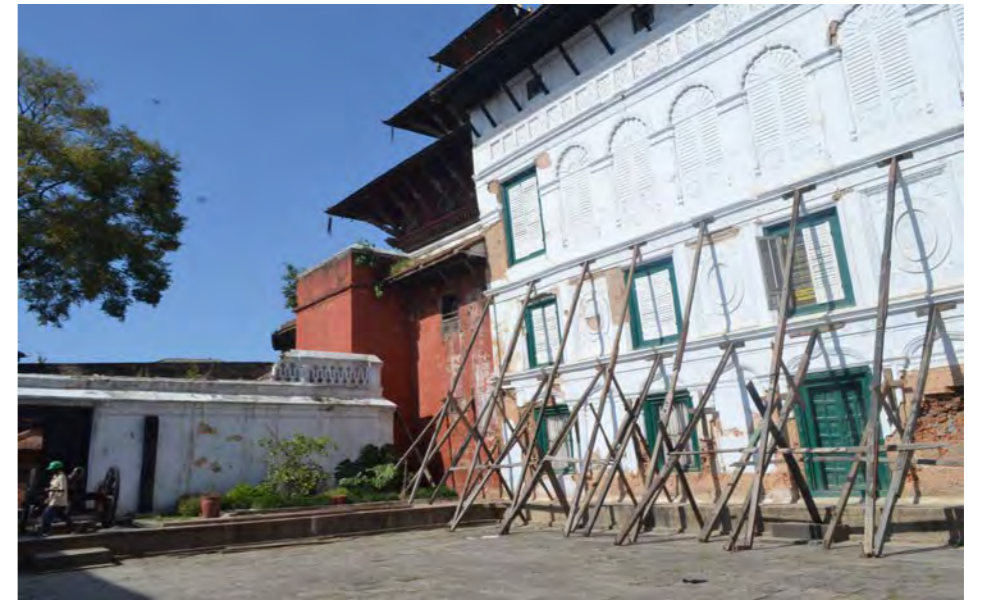
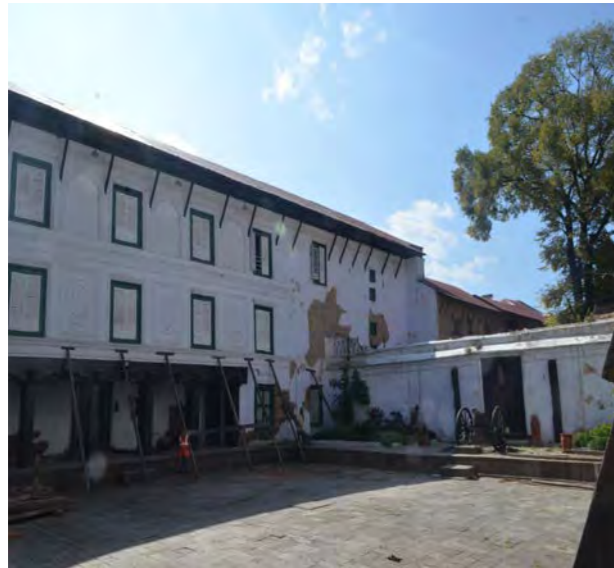
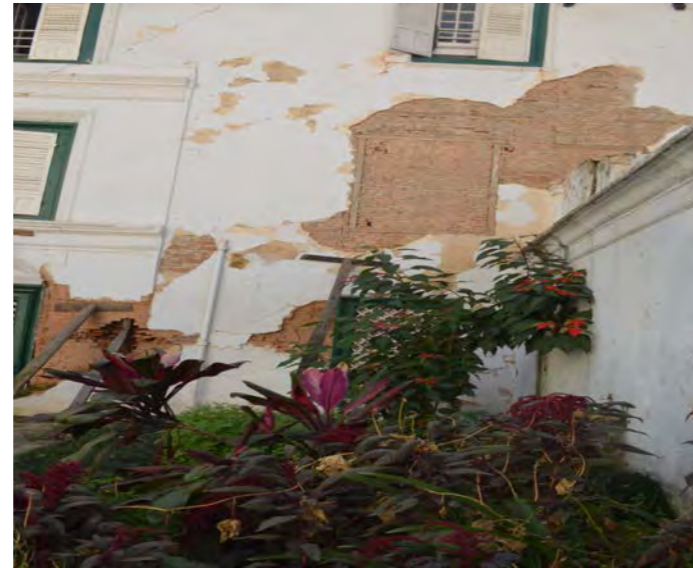
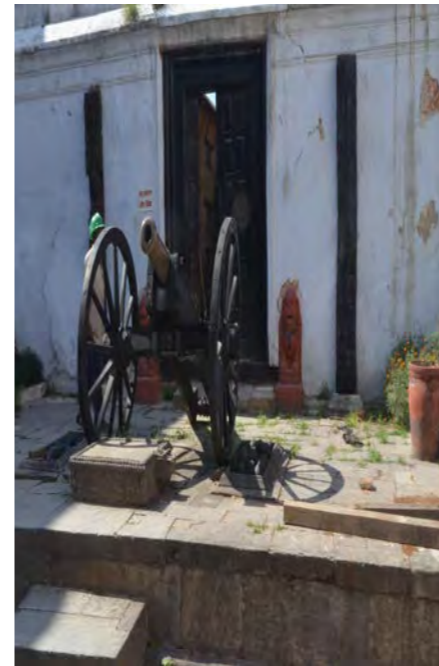
64 Dhak Chwok

CODE NO	TYOLOGY	MONUMENT NAME	ESTABLISHED/ RENOVATED	STRUCTURAL SYSTEM	MATERIAL	GENERAL DESCRIPTION	PROBLEM DESCRIPTION	DANGER	REMARKS	
64	Courtyard	Dhak Chowk					Extensive cracks and bulging in the buildings surrounding the courtyard

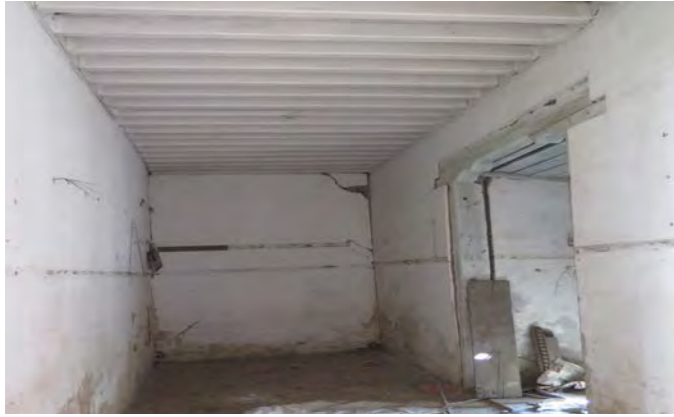
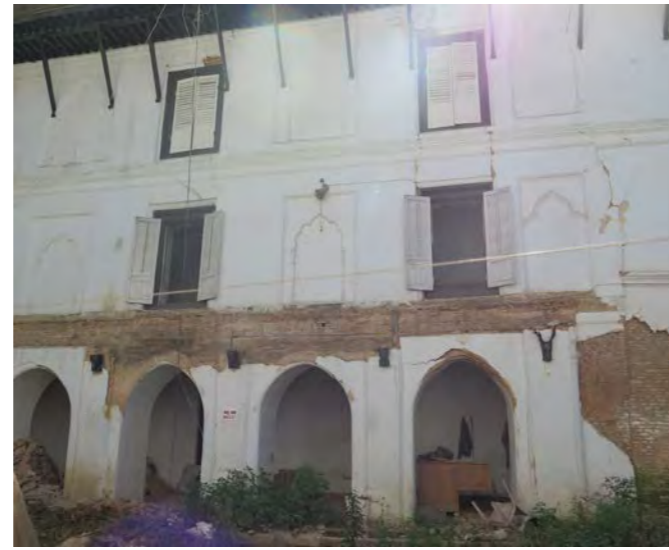
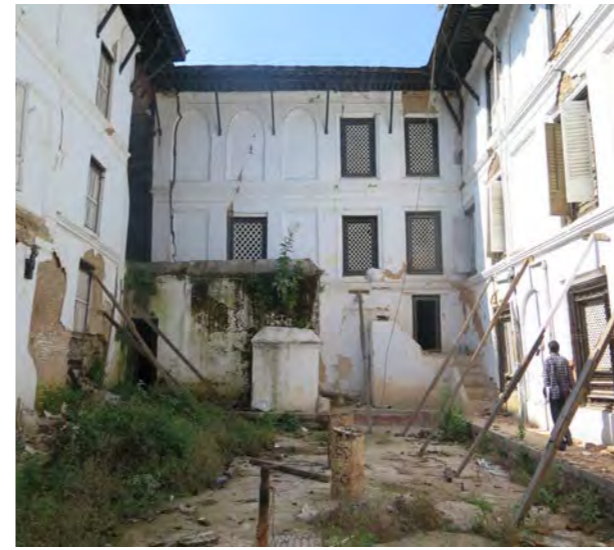
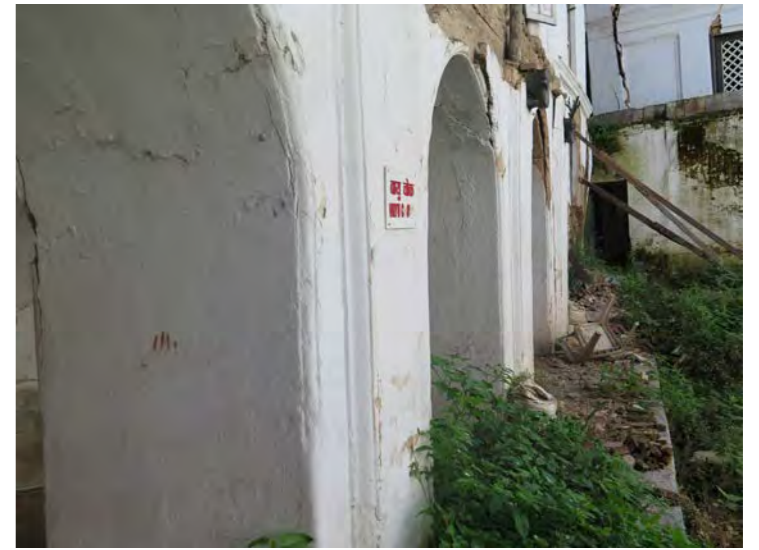
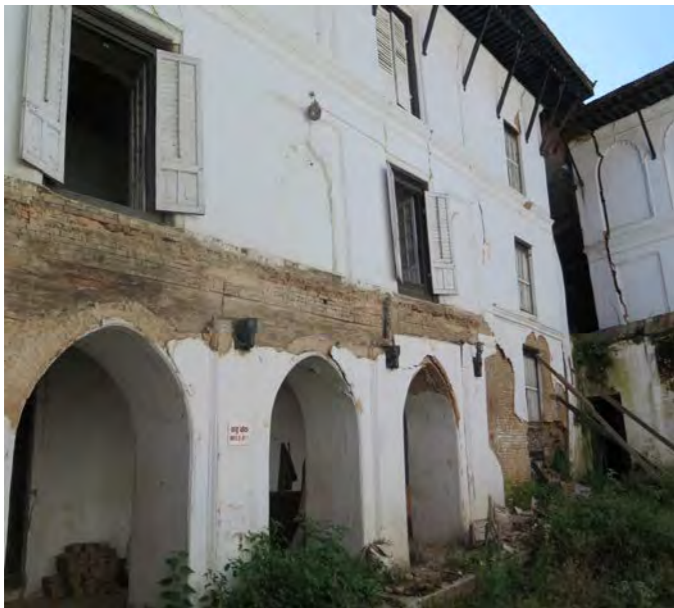
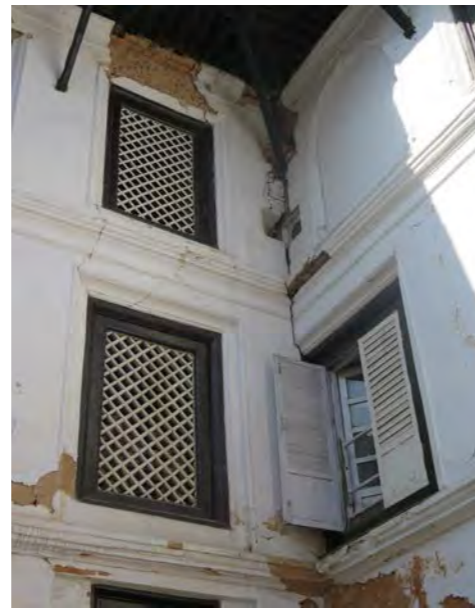
65 Bayou Chwok

CODE NO	TYOLOGY	MONUMENT NAME	ESTABLISHED/ RENOVATED	STRUCTURAL SYSTEM	MATERIAL	GENERAL DESCRIPTION	PROBLEM DESCRIPTION	DANGER	REMARKS	
65	Courtyard	Bayou chowk					Extensive cracks and bulging in the buildings surrounding the courtyard

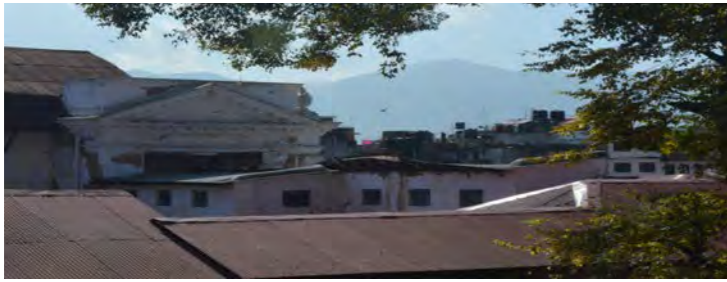
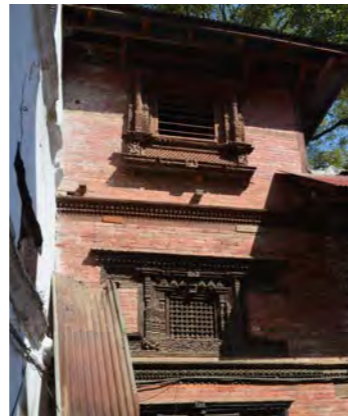
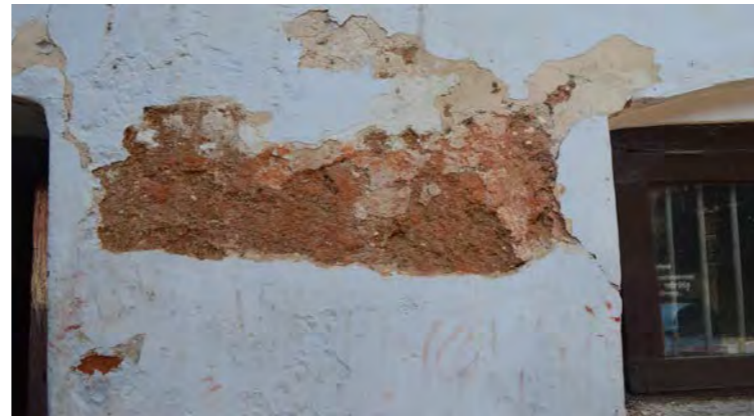
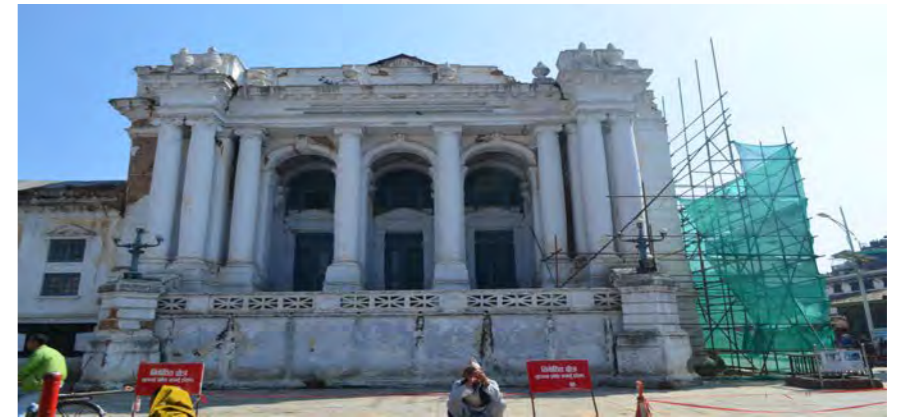
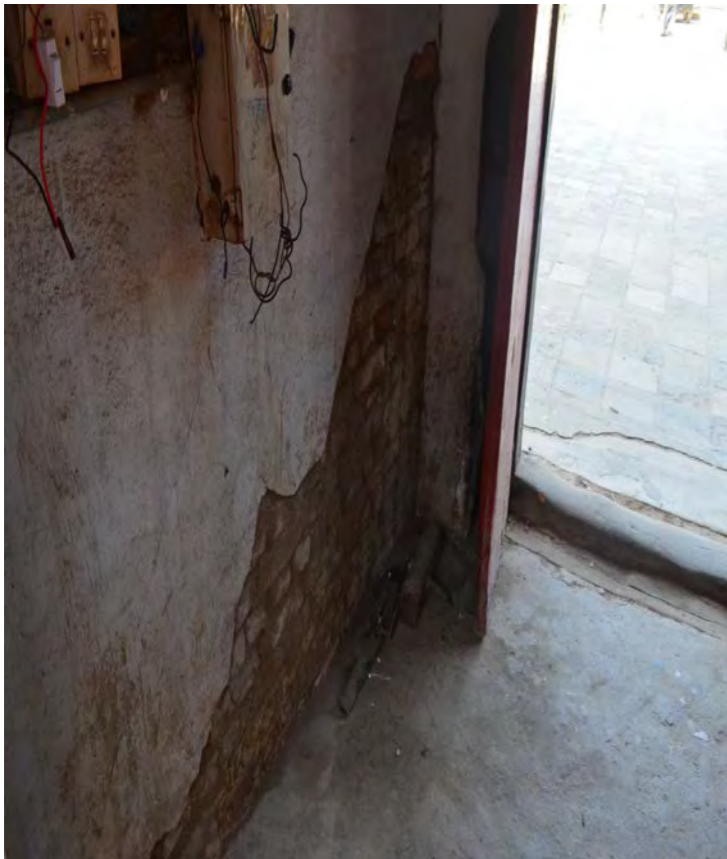
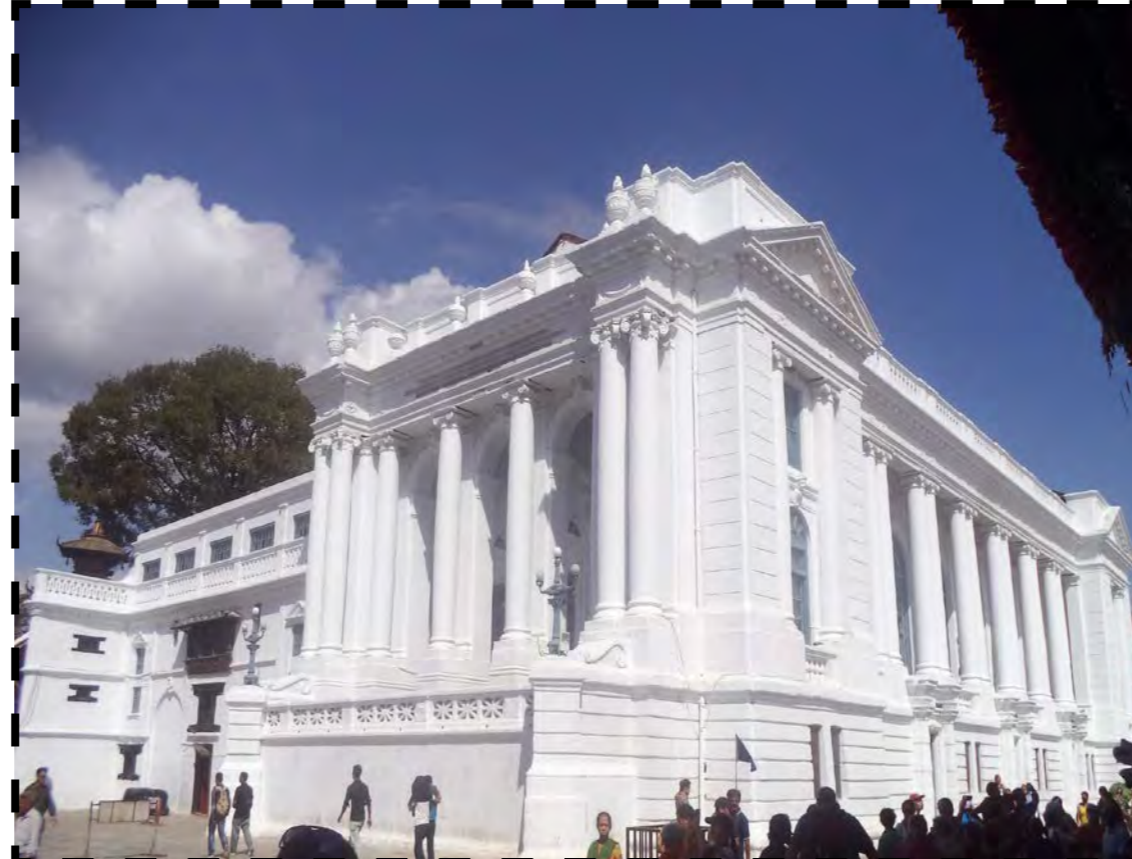
CODE NO	TYOLOGY	MONUMENT NAME	ESTABLISHED/ RENOVATED	STRUCTURAL SYSTEM	MATERIAL	GENERAL DESCRIPTION	PROBLEM DESCRIPTION	DANGER	REMARKS
66		Gaddi Baithak Chowk					Extensive cracks in walls. Bulging of walls; Corner separation in North walls; Wooden posts and columns in building deteriorated.

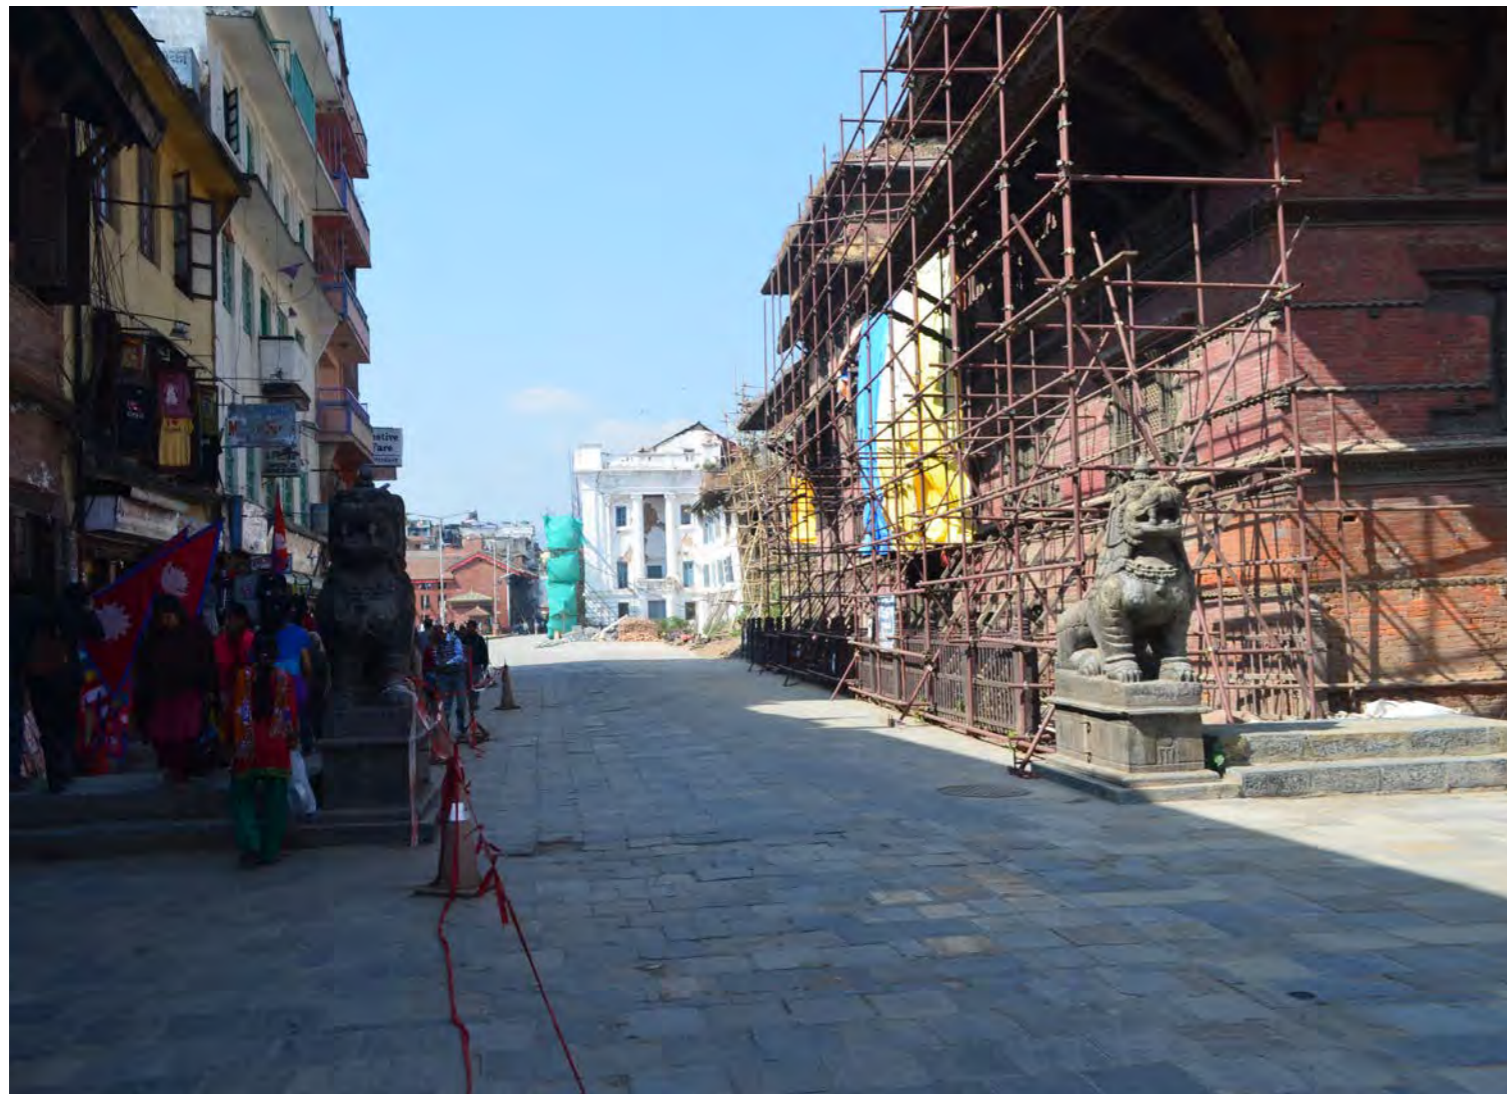
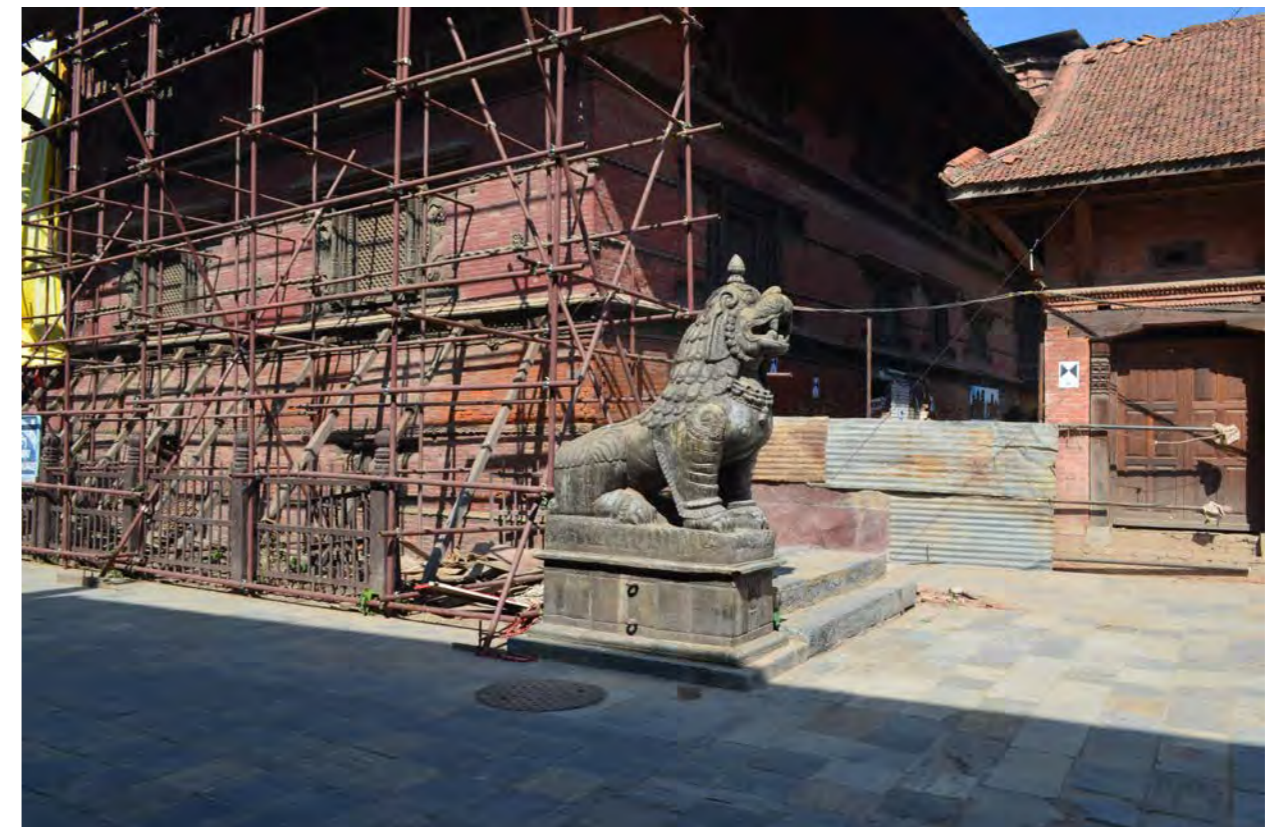
67 GUARDING LIONS

CODE NO	TYOLOGY	MONUMENT NAME	ESTABLISHED/ RENOVATED	STRUCTURAL SYSTEM	MATERIAL	GENERAL DESCRIPTION	PROBLEM DESCRIPTION	DANGER	REMARKS	
67	stone lion					coloured, carved by grill	No visible damage
