2015 Earthquake Damage Mapping

Hanuman Dhoka Darbar Square Monument Zone
Kathmandu Valley World Heritage Property

December 2015

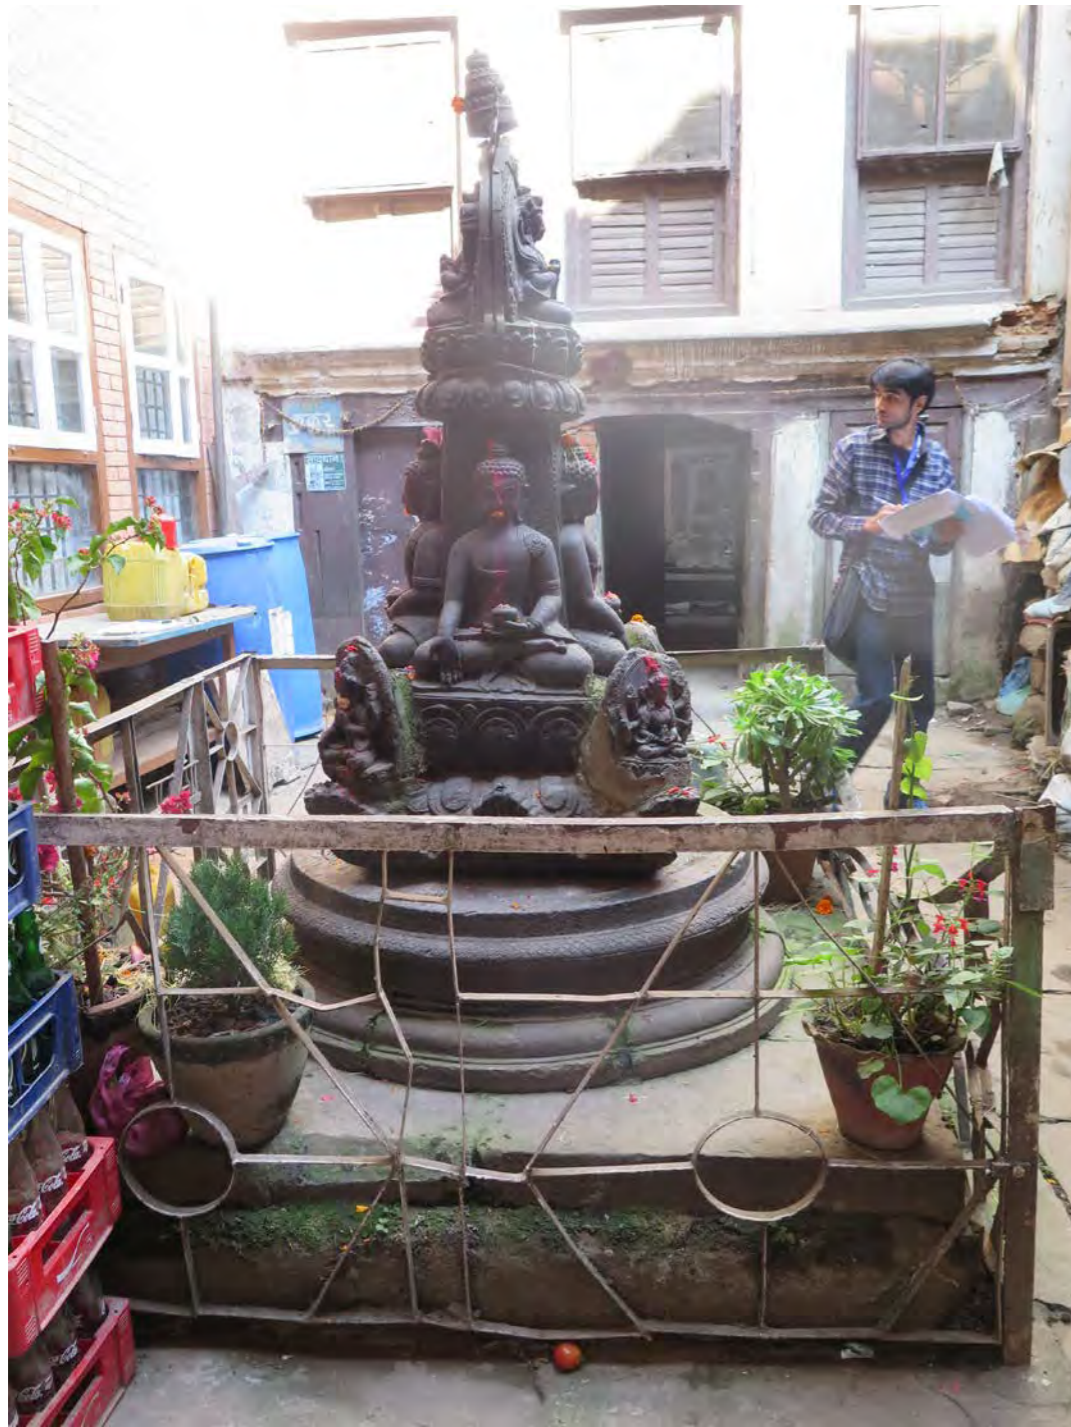
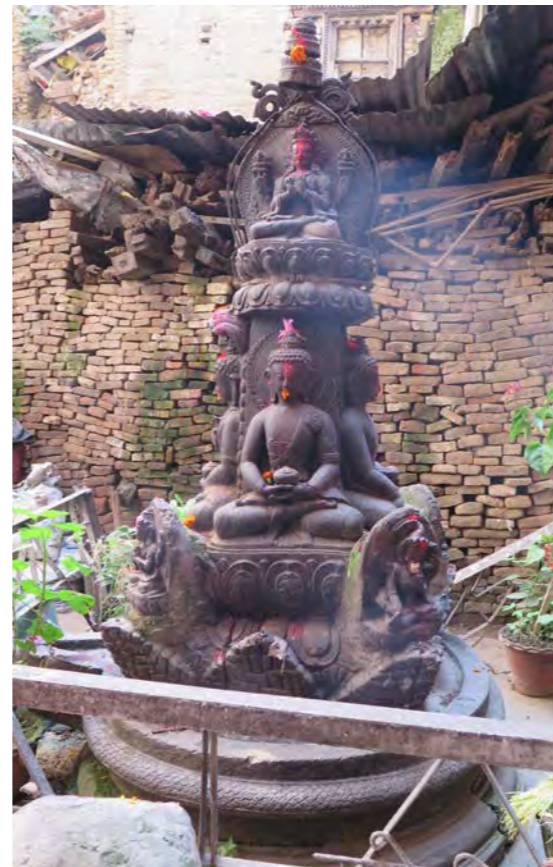
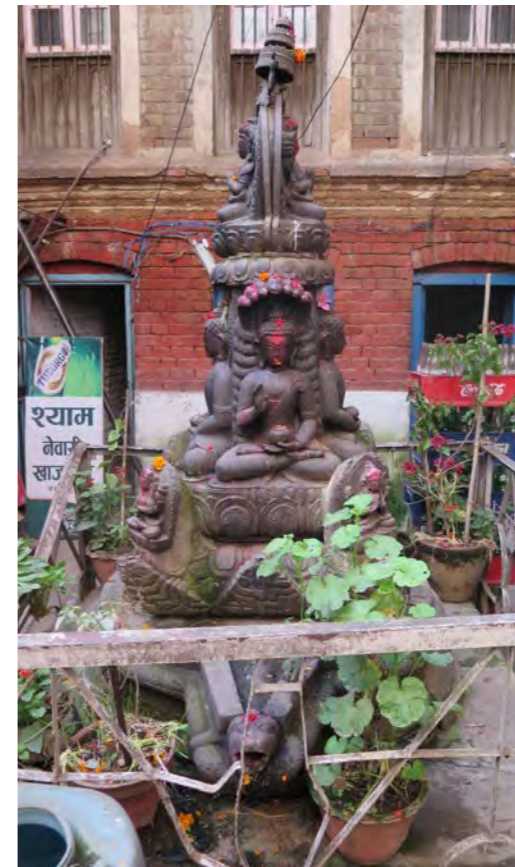
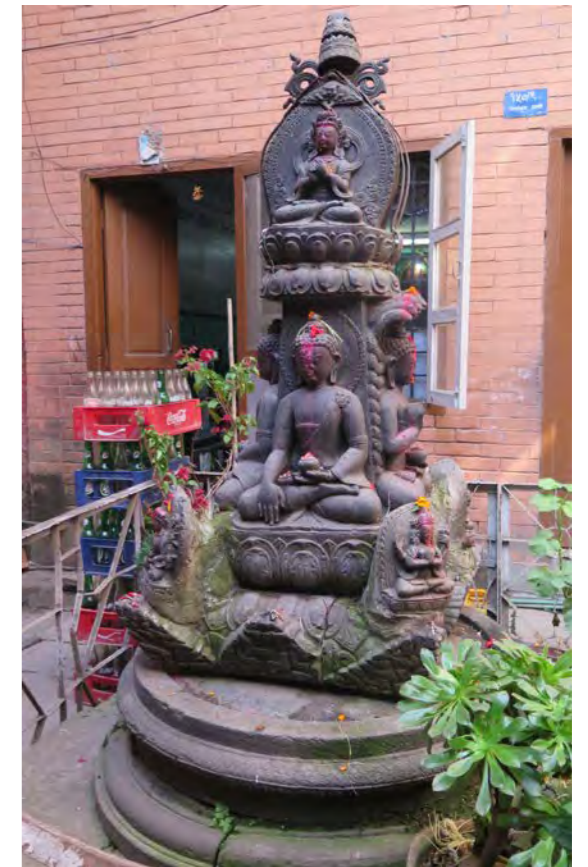
CODE NO	TYOLOGY	MONUMENT NAME	ESTABLISHED/ RENOVATED	STRUCTURAL SYSTEM	MATERIAL	GENERAL DESCRIPTION	PROBLEM DESCRIPTION	DANGER	REMARKS
A1	Chaitya				Stone	Stone chaitya with buddha image on four side surrounded by metal fence	Cracks at base and vegetation growth

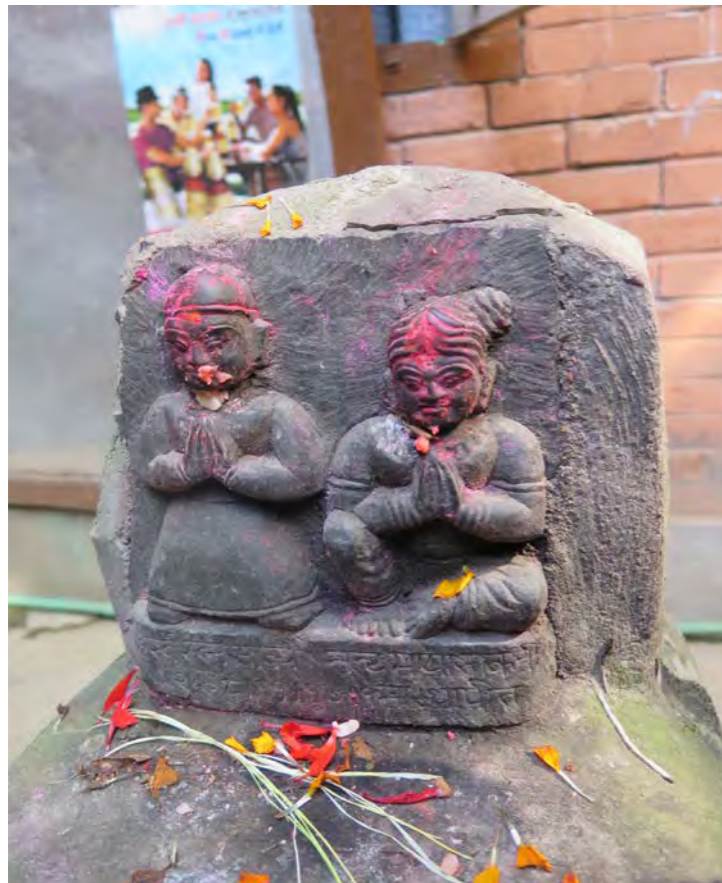
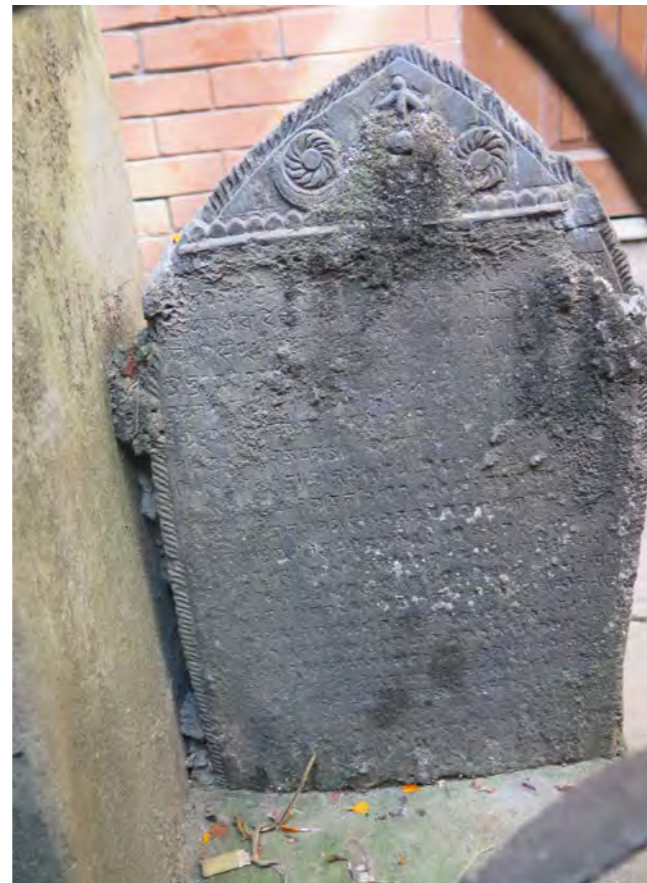
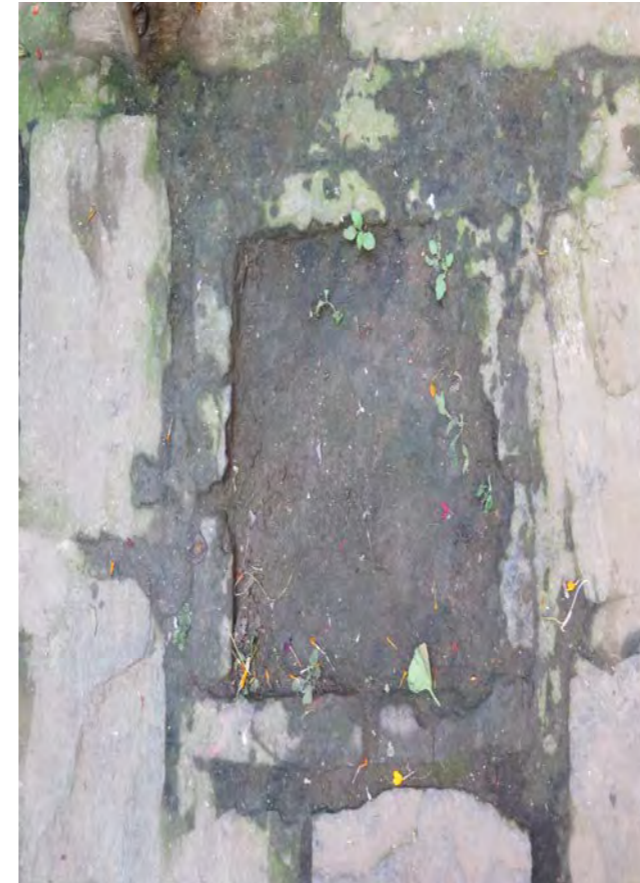
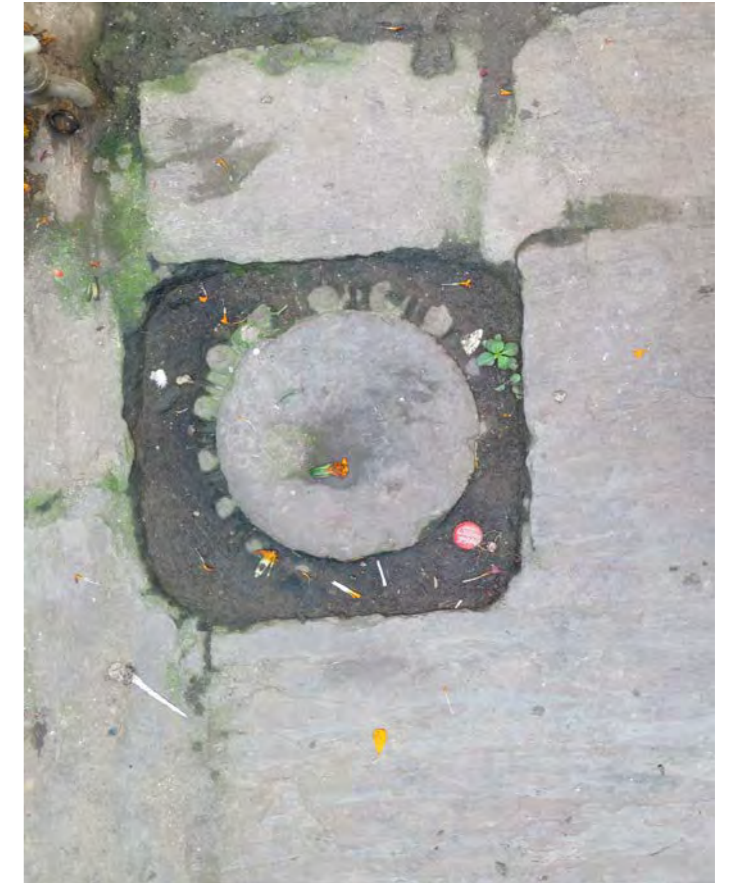
CODE NO	TYOLOGY	MONUMENT NAME	ESTABLISHED/ RENOVATED	STRUCTURAL SYSTEM	MATERIAL	GENERAL DESCRIPTION	PROBLEM DESCRIPTION	DANGER	REMARKS
A2	Statue				Stone	Cement plastered stone statue of owners	No visible damage		
A3	Inscription				Stone	Cement plastered stone statue of owners	No visible damage		
A4	Yagya				Brick	yagya sorrouned by brick	No visible damage		
A5	Mandala				Stone	Stone mandala	No visble damage

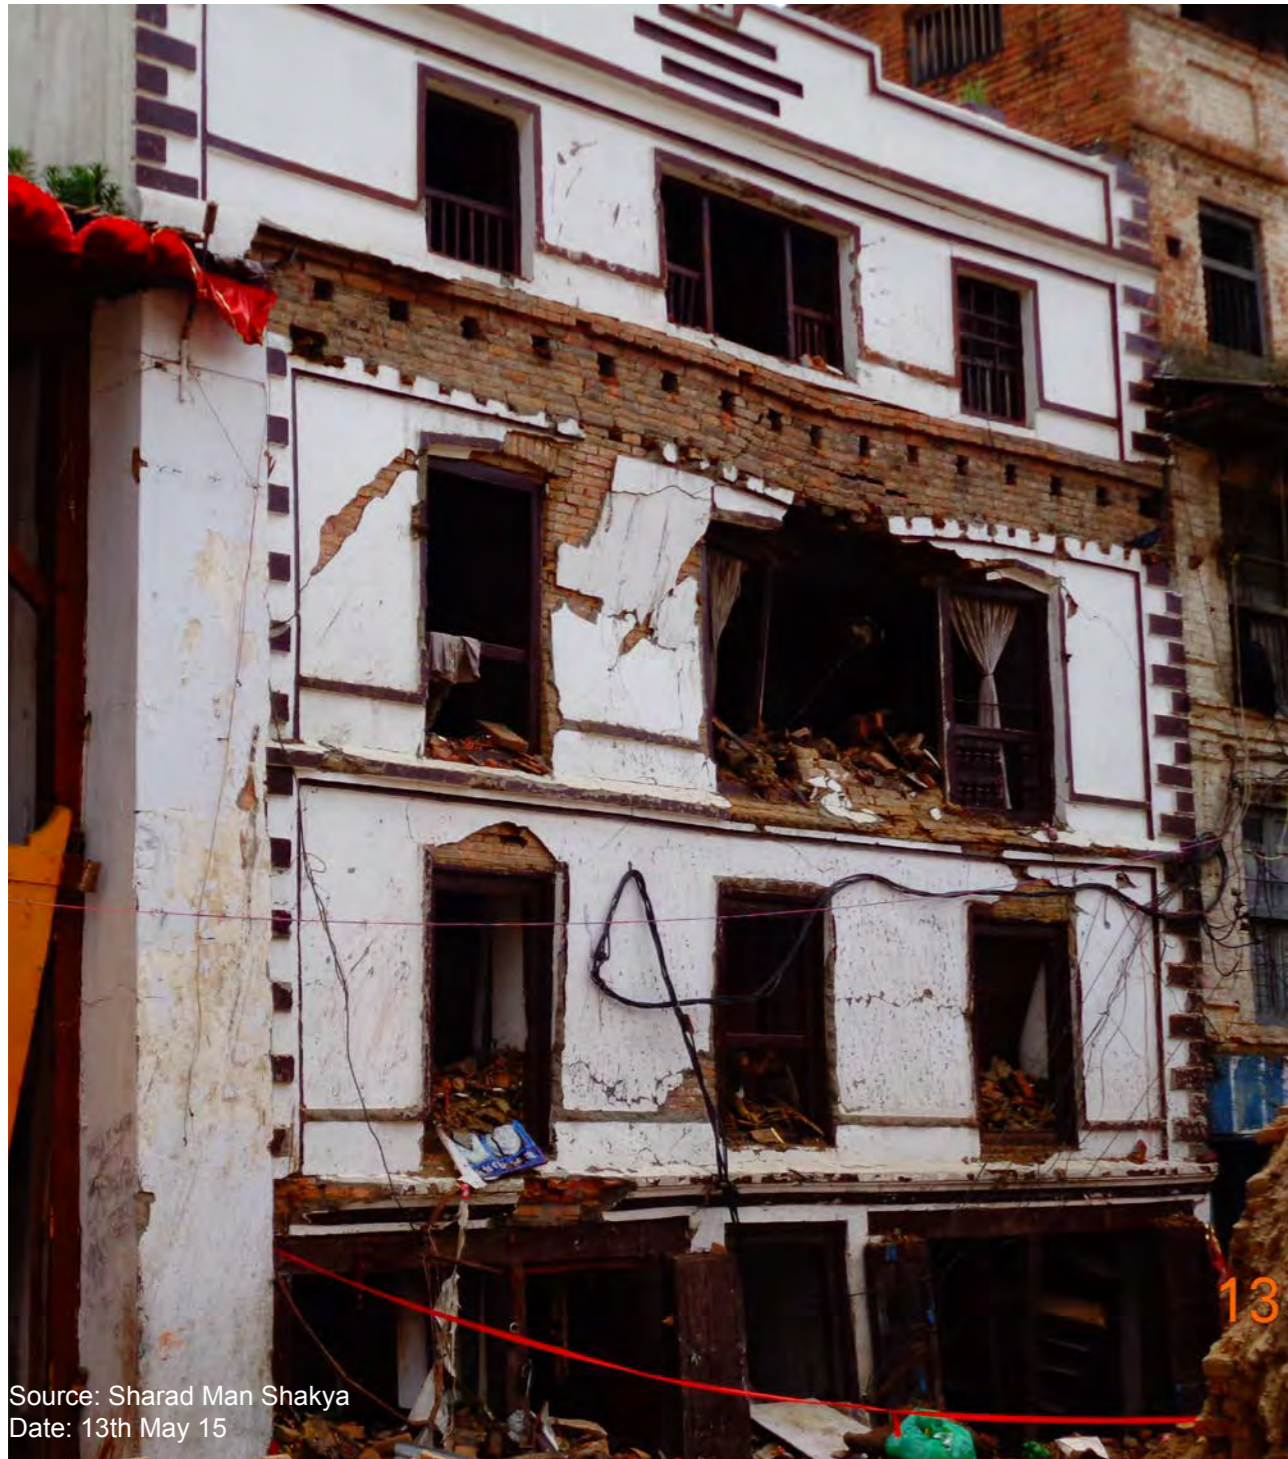
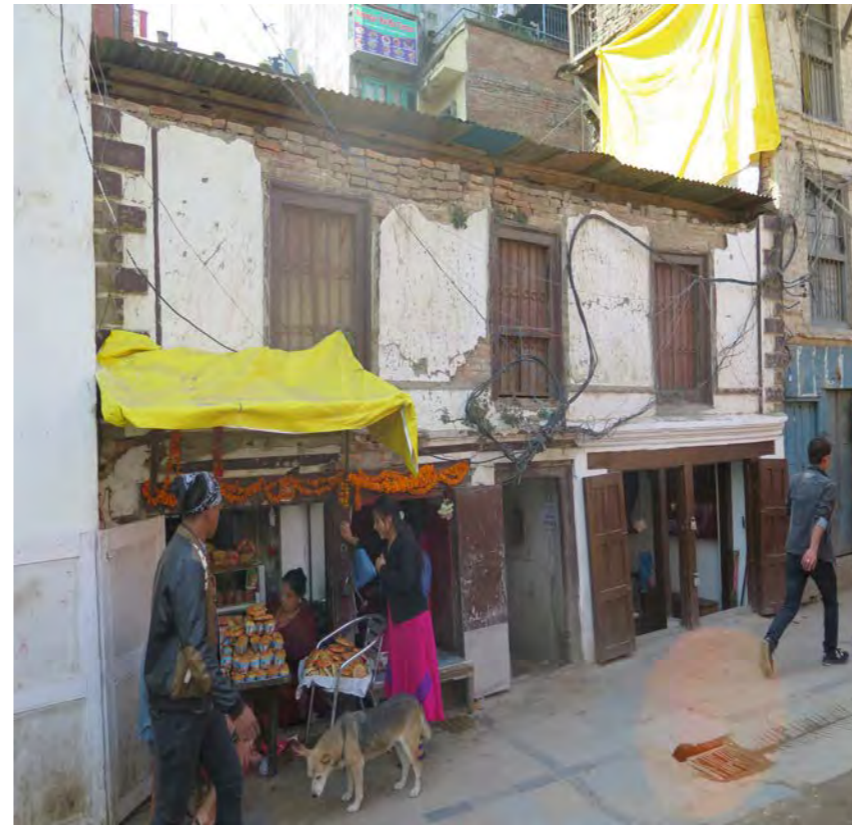
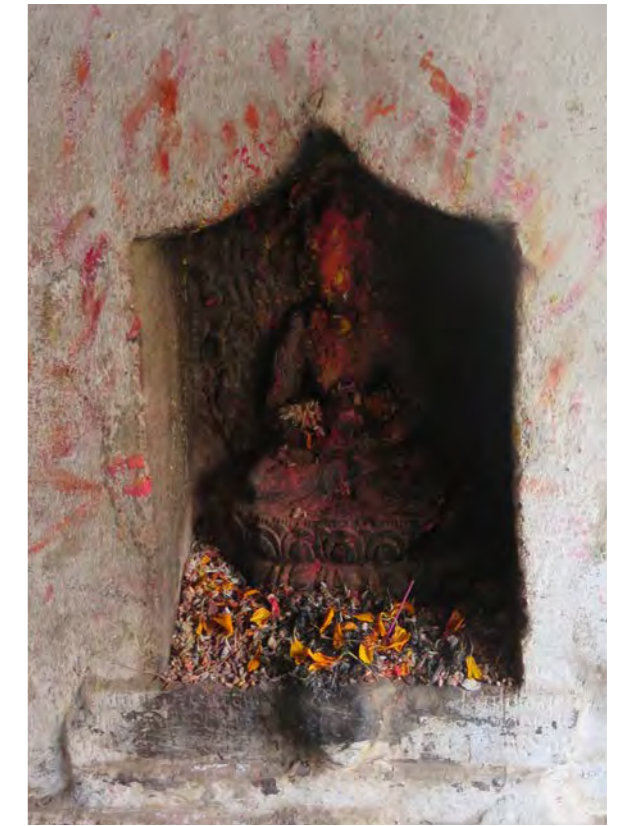
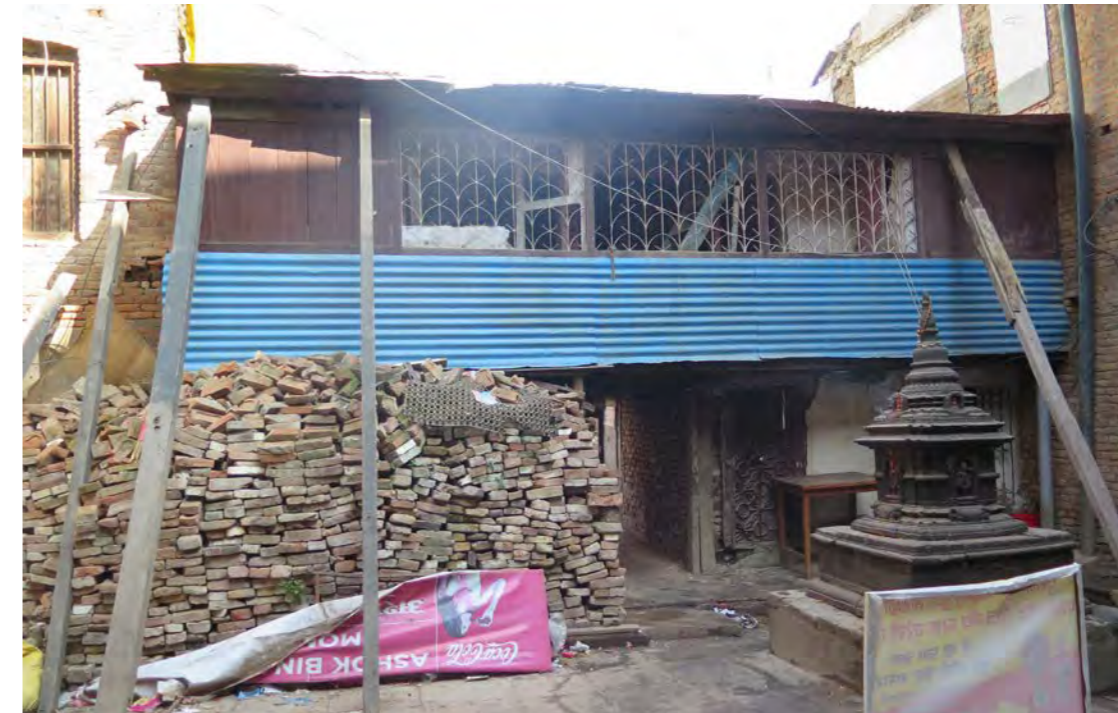
CODE NO	OWNERS NAME/CONTACT	STOREY NUMBER	PRESENT STOREY NUMBER	STRUCTURAL SYSTEM	MATERIAL	GENERAL DESCRIPTION	PROBLEM DESCRIPTION	DANGER	Heritage Significance	REMARKS
a01	Nani Maya Joshi	G+3	G+1	Load Bearing	Uncooked Brick		Two storey collapsed;Cracks in found floor;Rising damp;Vegetation growth

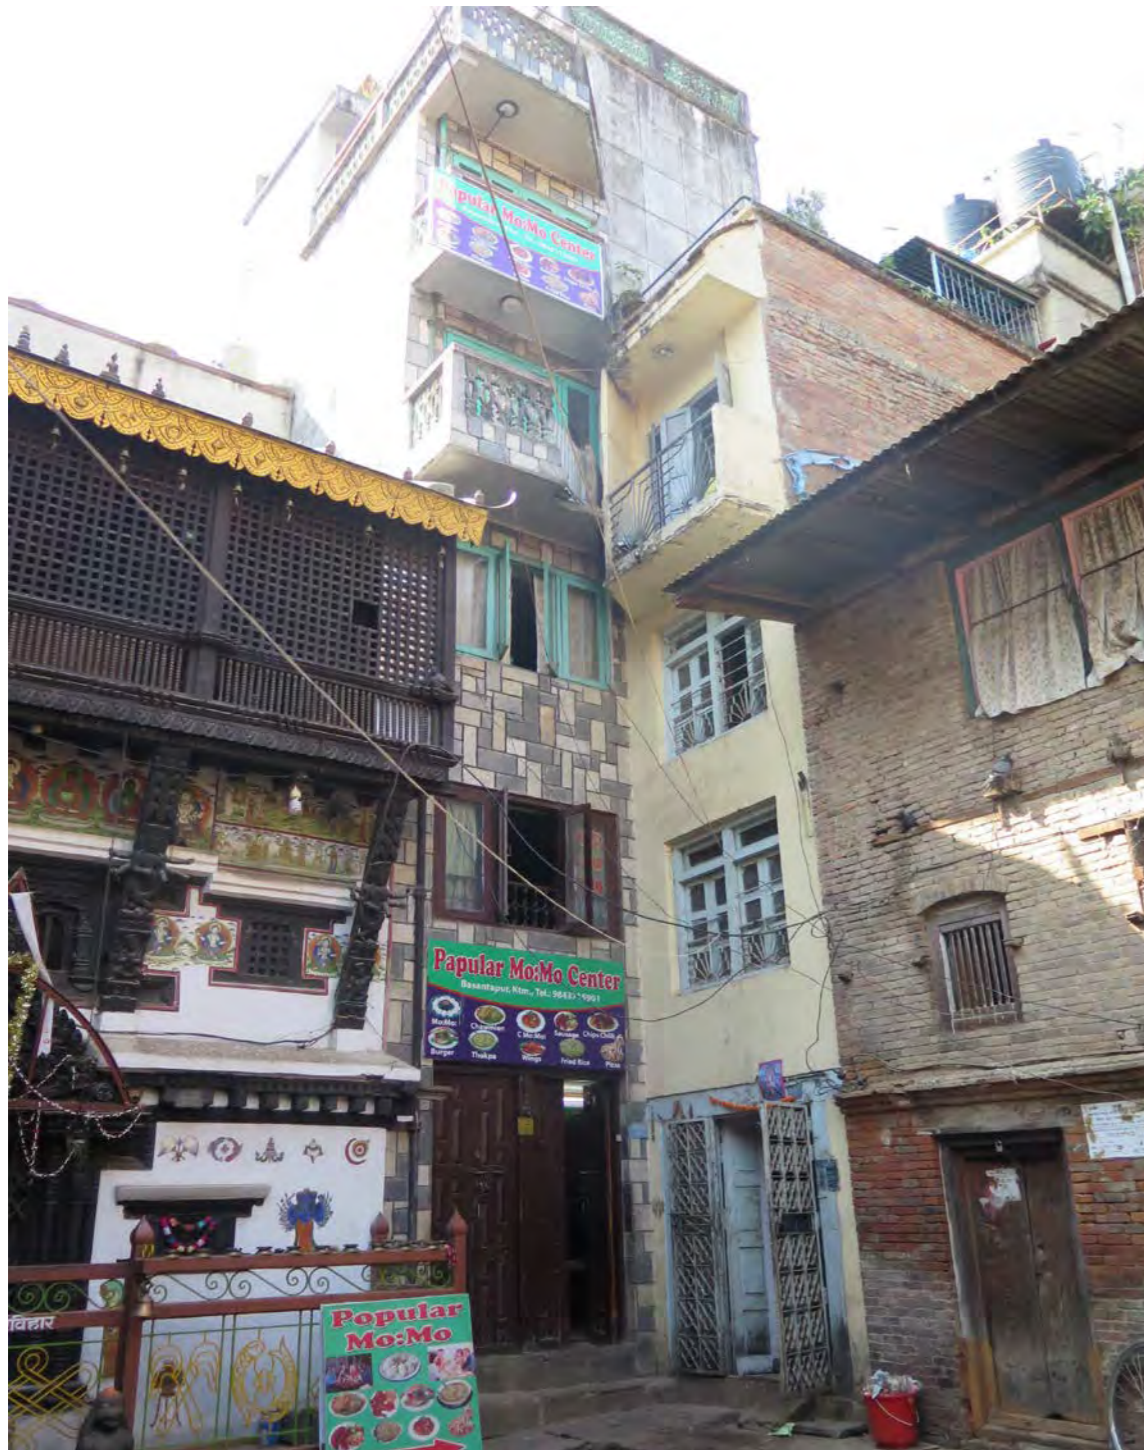
a04 a05

CODE NO	OWNERS NAME/CONTACT	STOREY NUMBER	PRESENT STOREY NUMBER	STRUCTURAL SYSTEM	MATERIAL	GENERAL DESCRIPTION	PROBLEM DESCRIPTION	DANGER	Heritage Significance	REMARKS
a04	Iaxmi Shakya	G+4	G+4	Frame	Cement	Rcc slab roof with marble cladding	Minor cracks in walls			
a05	Prem Shova Tuladhar	G+3	G+3	Frame	Cement	Cement Plastered	Minor cracks in walls

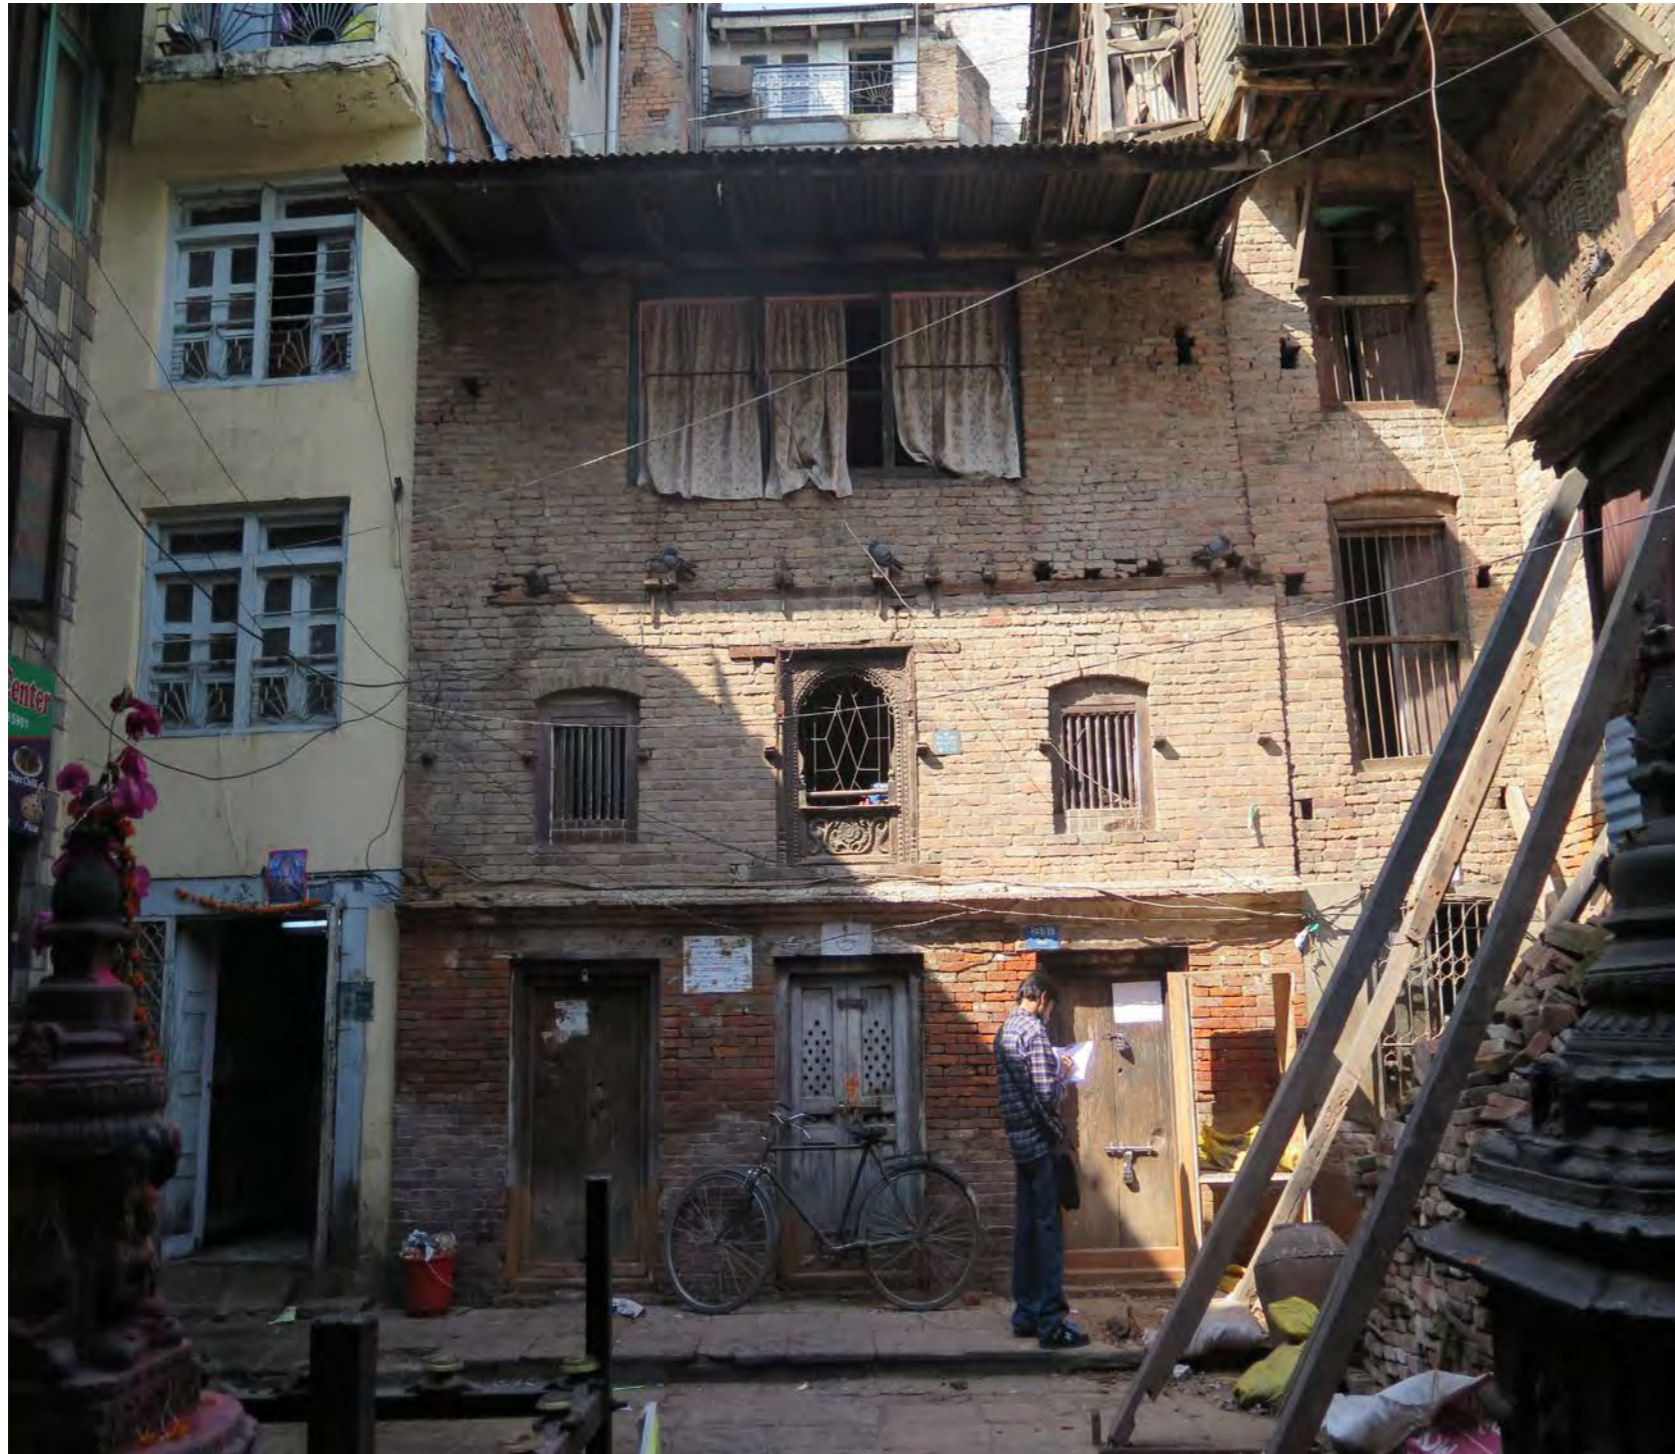
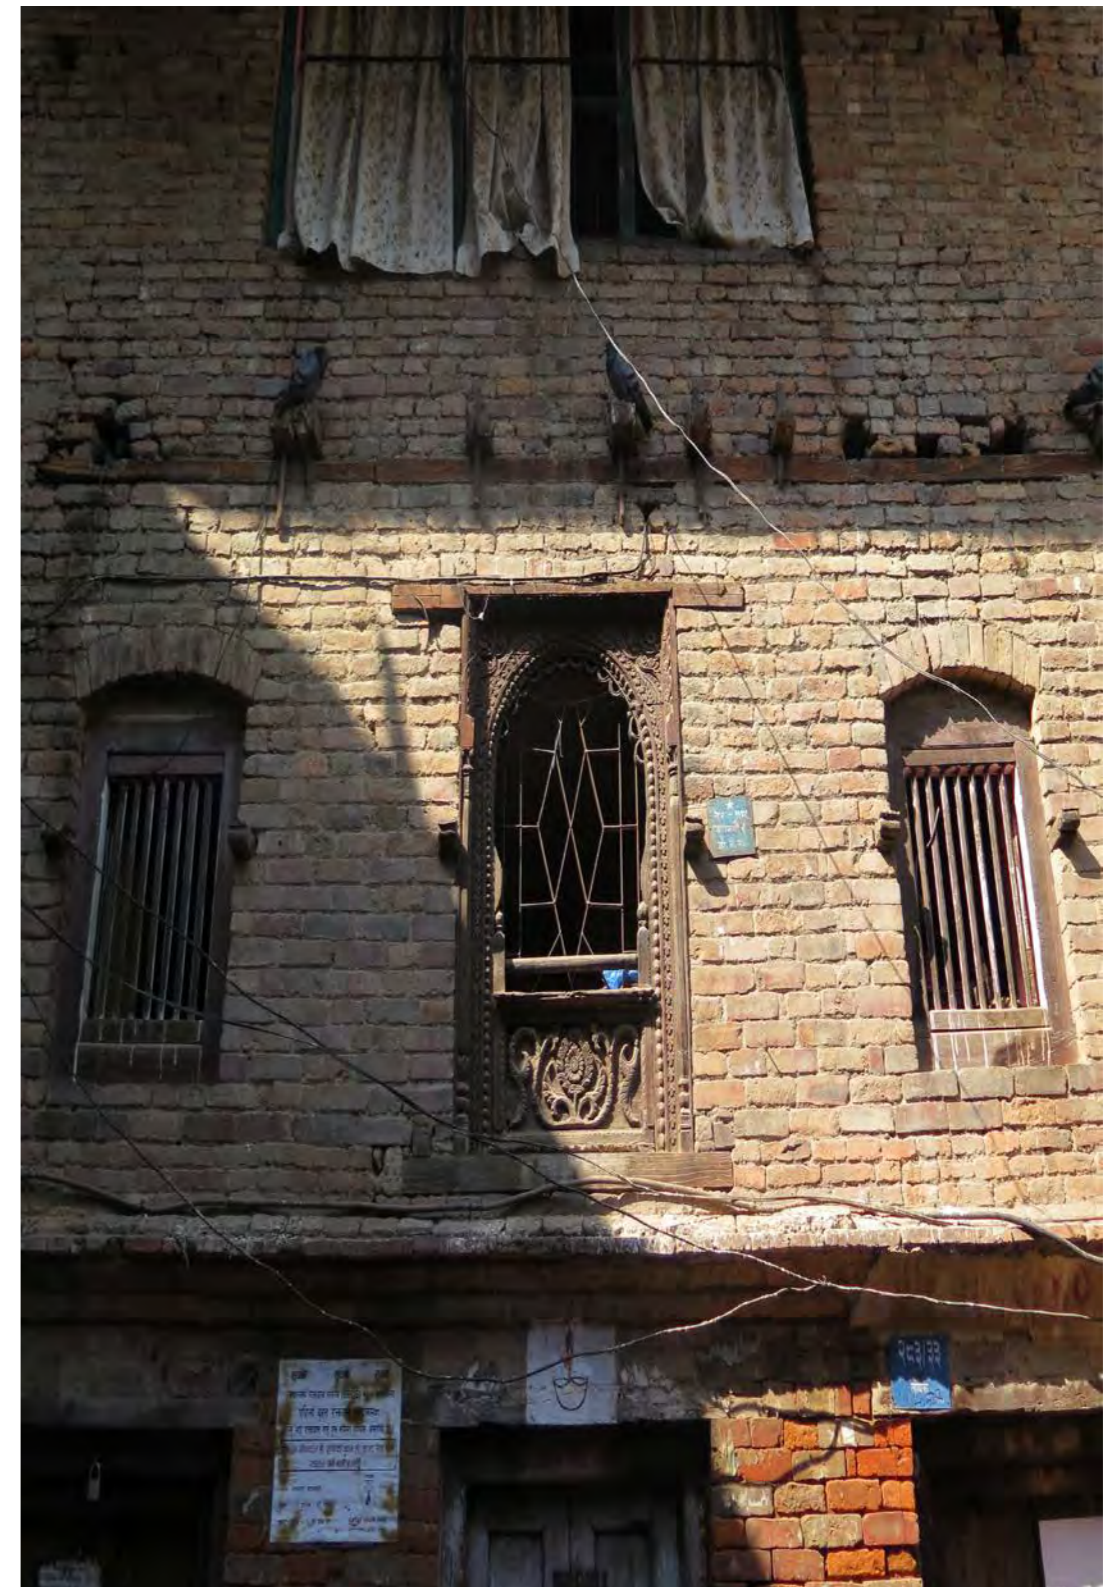
CODE NO	OWNERS NAME/CONTACT	STOREY NUMBER	PRESENT STOREY NUMBER	STRUCTURAL SYSTEM	MATERIAL	GENERAL DESCRIPTION	PROBLEM DESCRIPTION	DANGER	Heritage Significance	REMARKS
a06	Pushpa Ratna Bajracharya	G+2	G+2	Load Bearing	Brick	Tin roof; Timber doors and window with carving	Bulging of walls in ground and first floor	D!	+

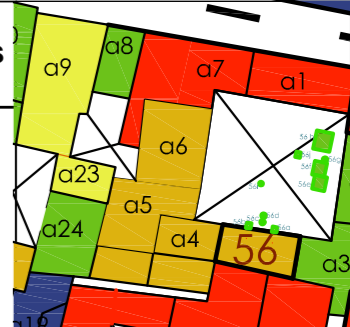
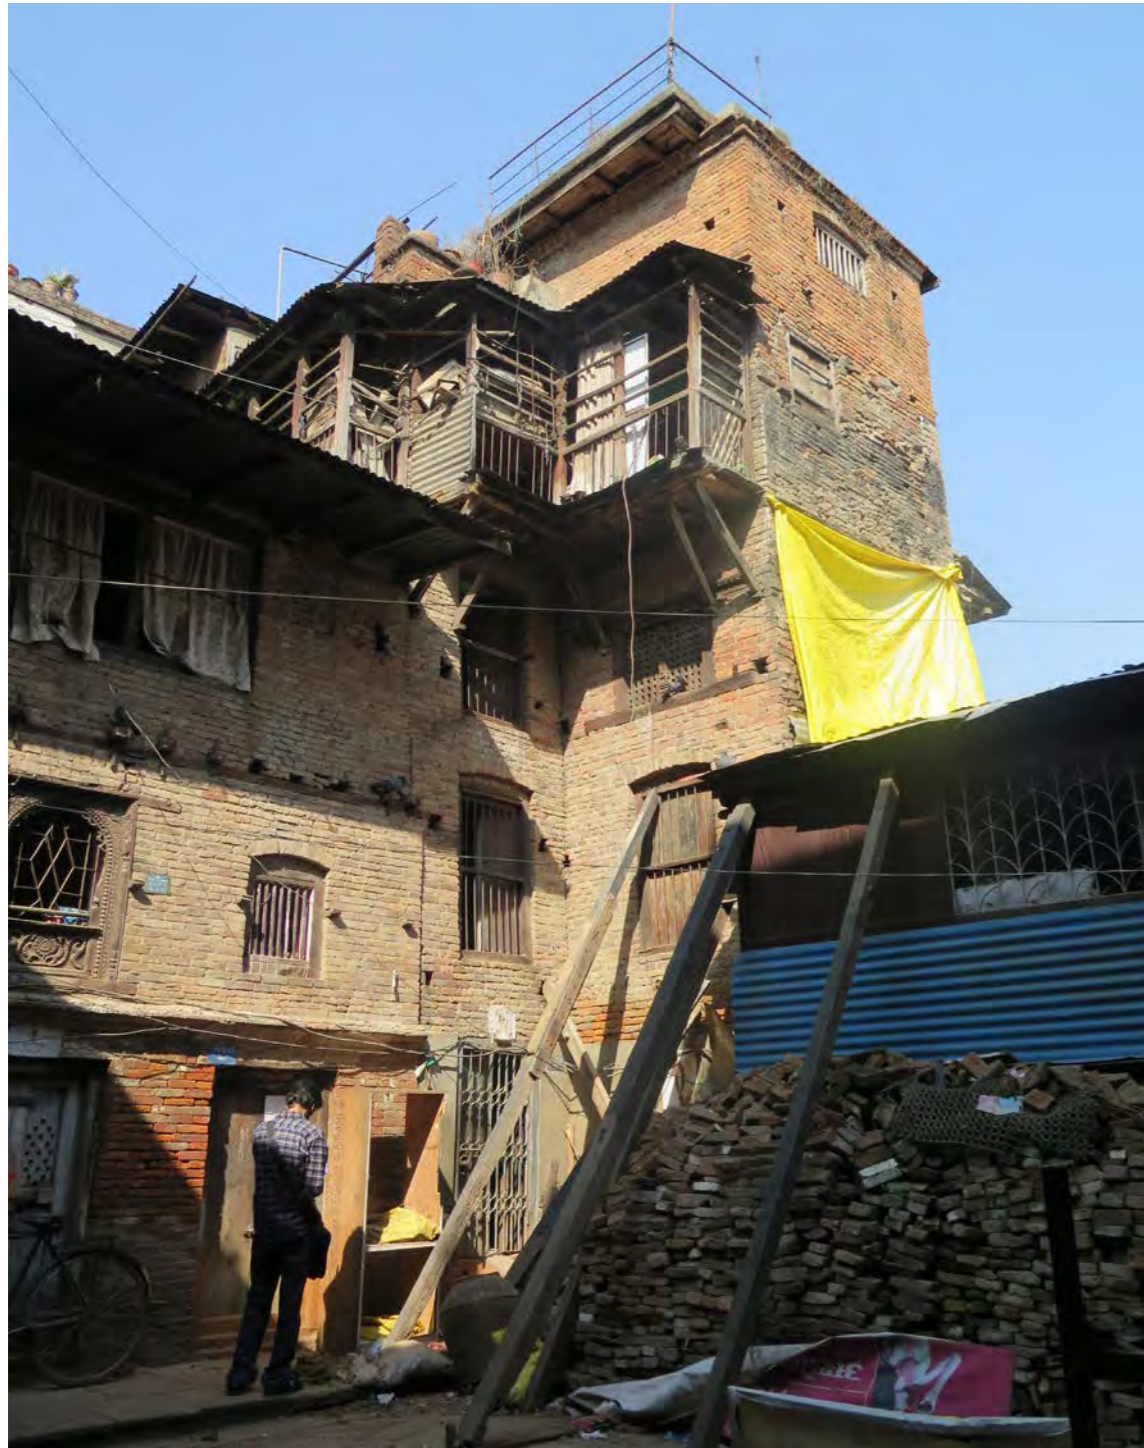
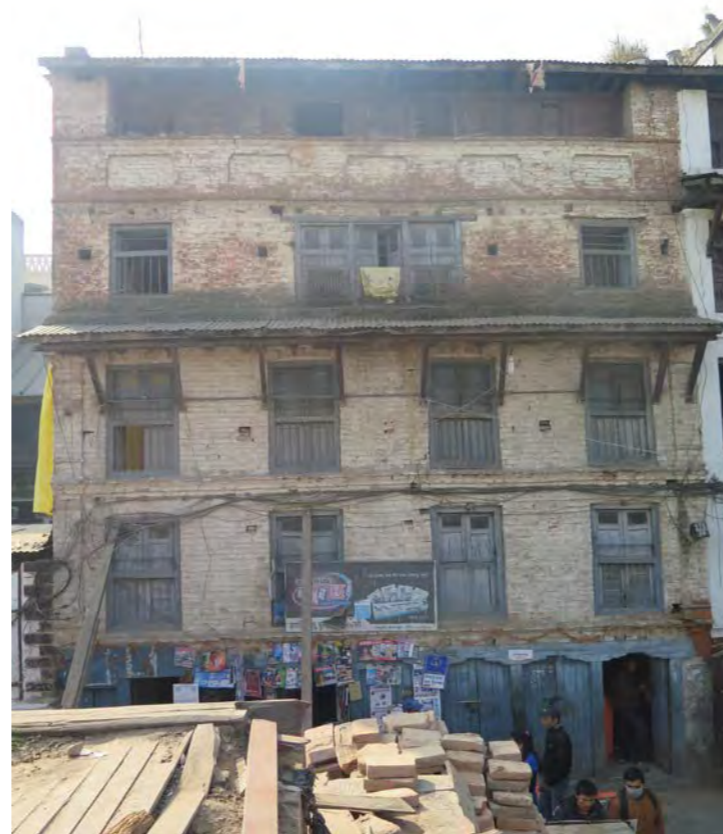
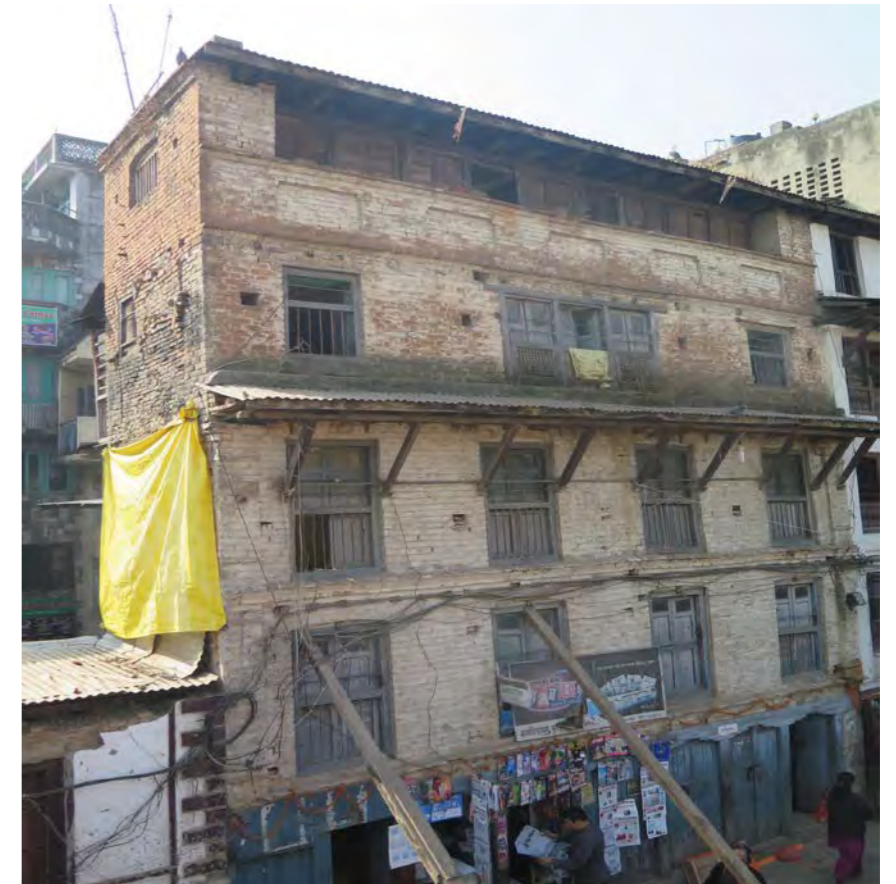
CODE NO	OWNERS NAME/CONTACT	STOREY NUMBER	PRESENT STOREY NUMBER	STRUCTURAL SYSTEM	MATERIAL	GENERAL DESCRIPTION	PROBLEM DESCRIPTION	DANGER	Heritage Significance	REMARKS
a07	Ganesh Dev Pantha	G+4	G+4	Load Bearing	Brick	Tin roof; Timber doors and window with carving	Bulging of walls and currently supported by struts	D!

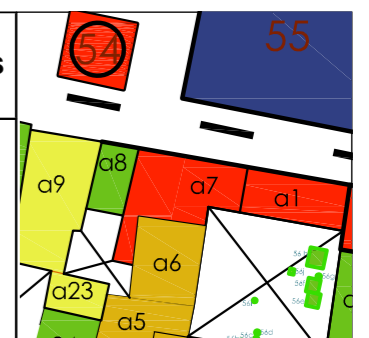
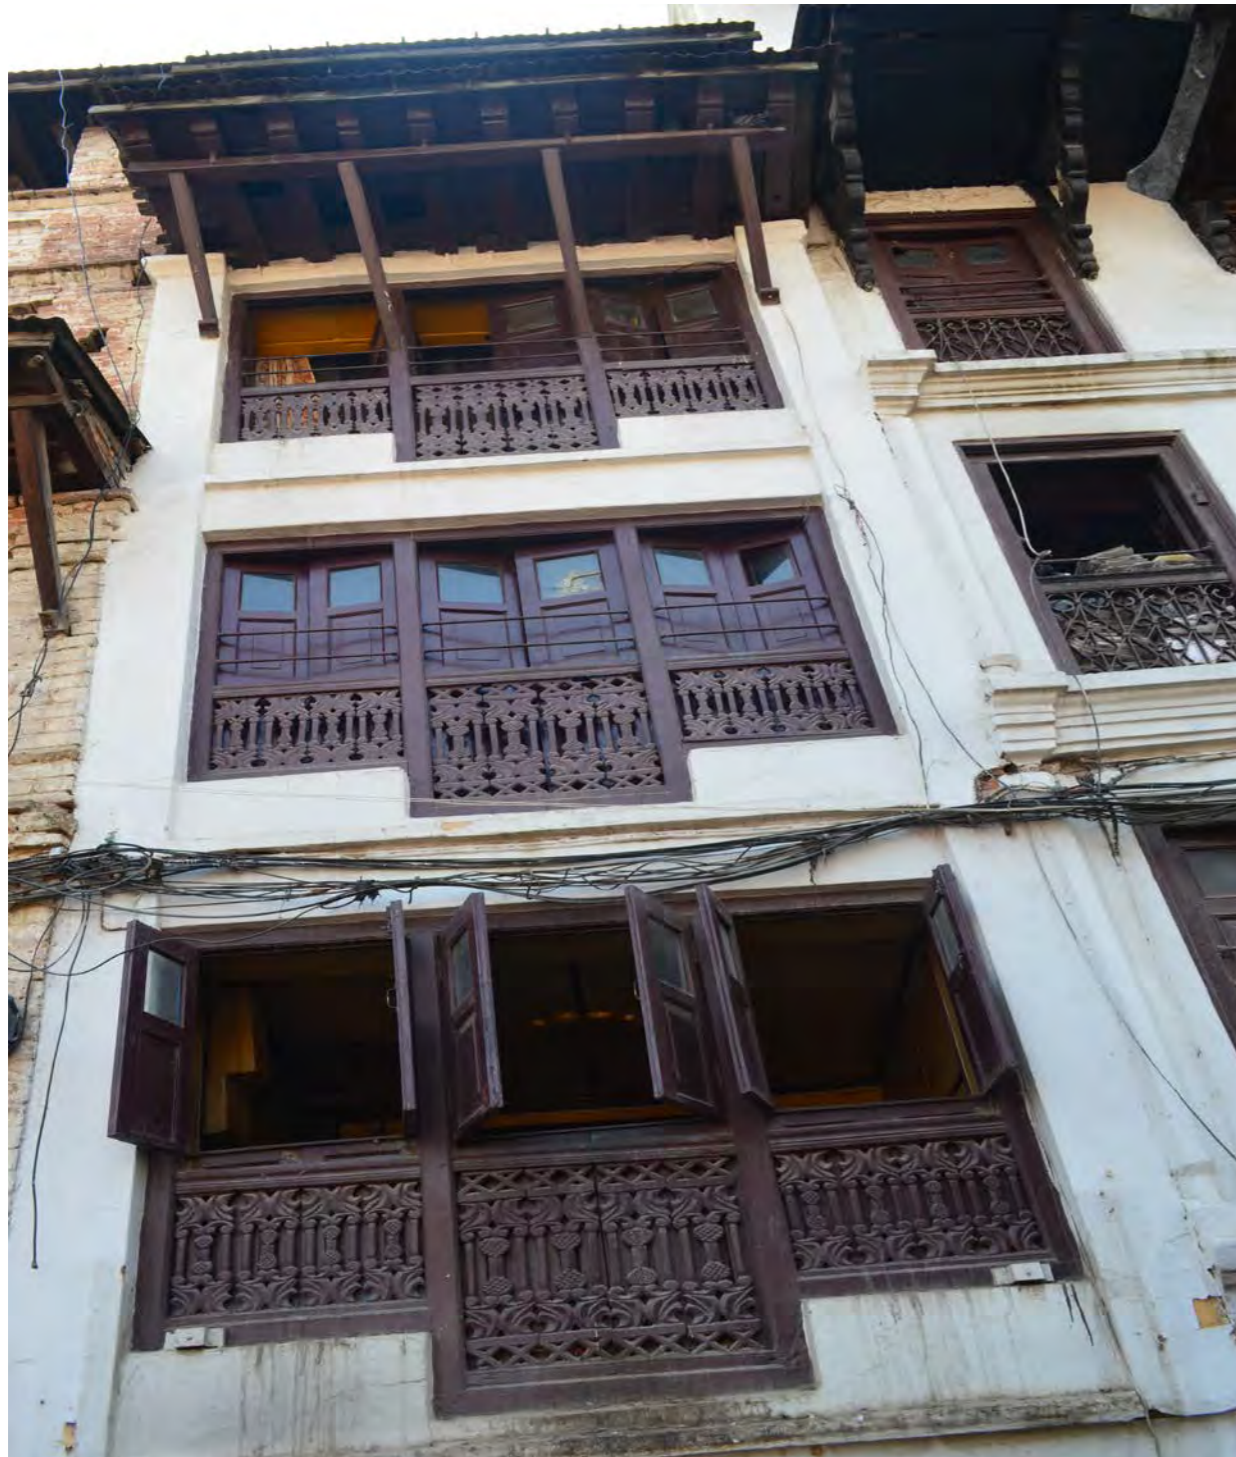
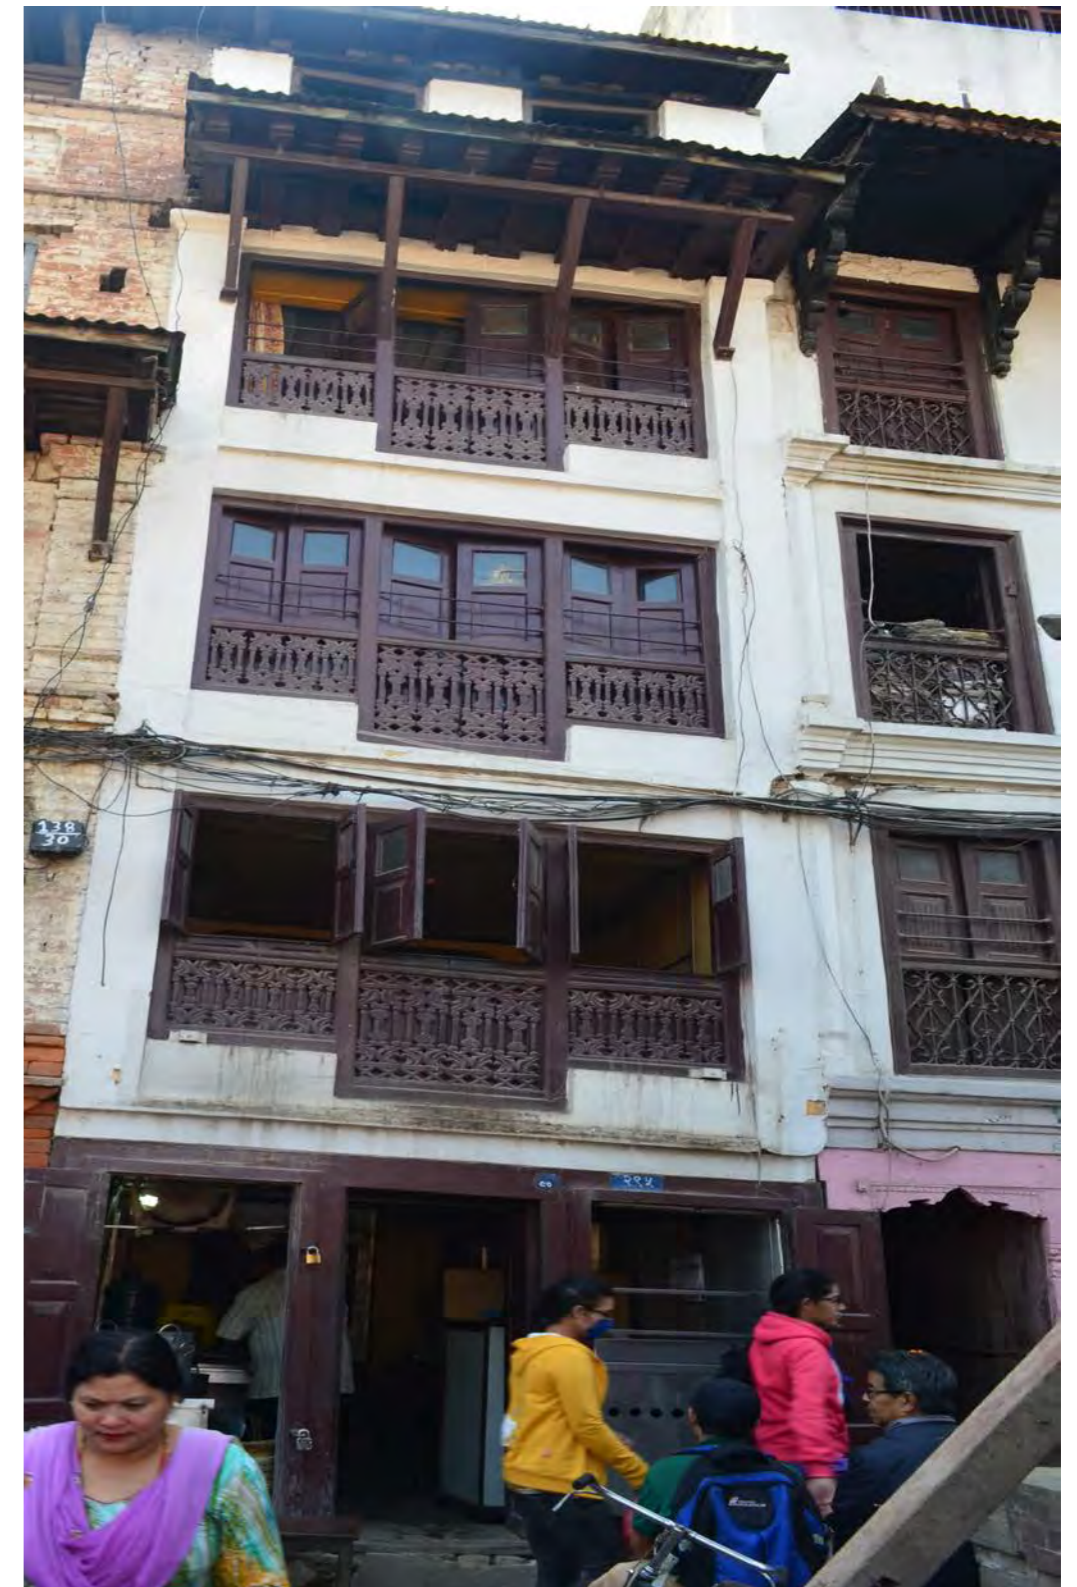
CODE NO	OWNERS NAME/CONTACT	STOREY NUMBER	PRESENT STOREY NUMBER	STRUCTURAL SYSTEM	MATERIAL	GENERAL DESCRIPTION	PROBLEM DESCRIPTION	DANGER	Heritage Significance	REMARKS
a08	Narayan Maharjan	G+4	G+4	Load Bearing	Brick; Timber		No visible damage
