2015 Earthquake Damage Mapping

Hanuman Dhoka Darbar Square Monument Zone
Kathmandu Valley World Heritage Property

December 2015

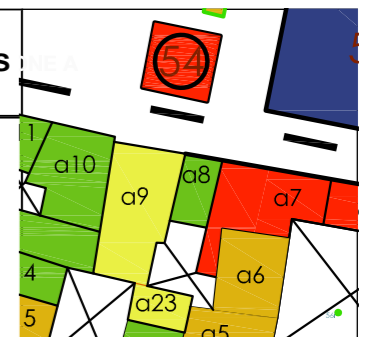
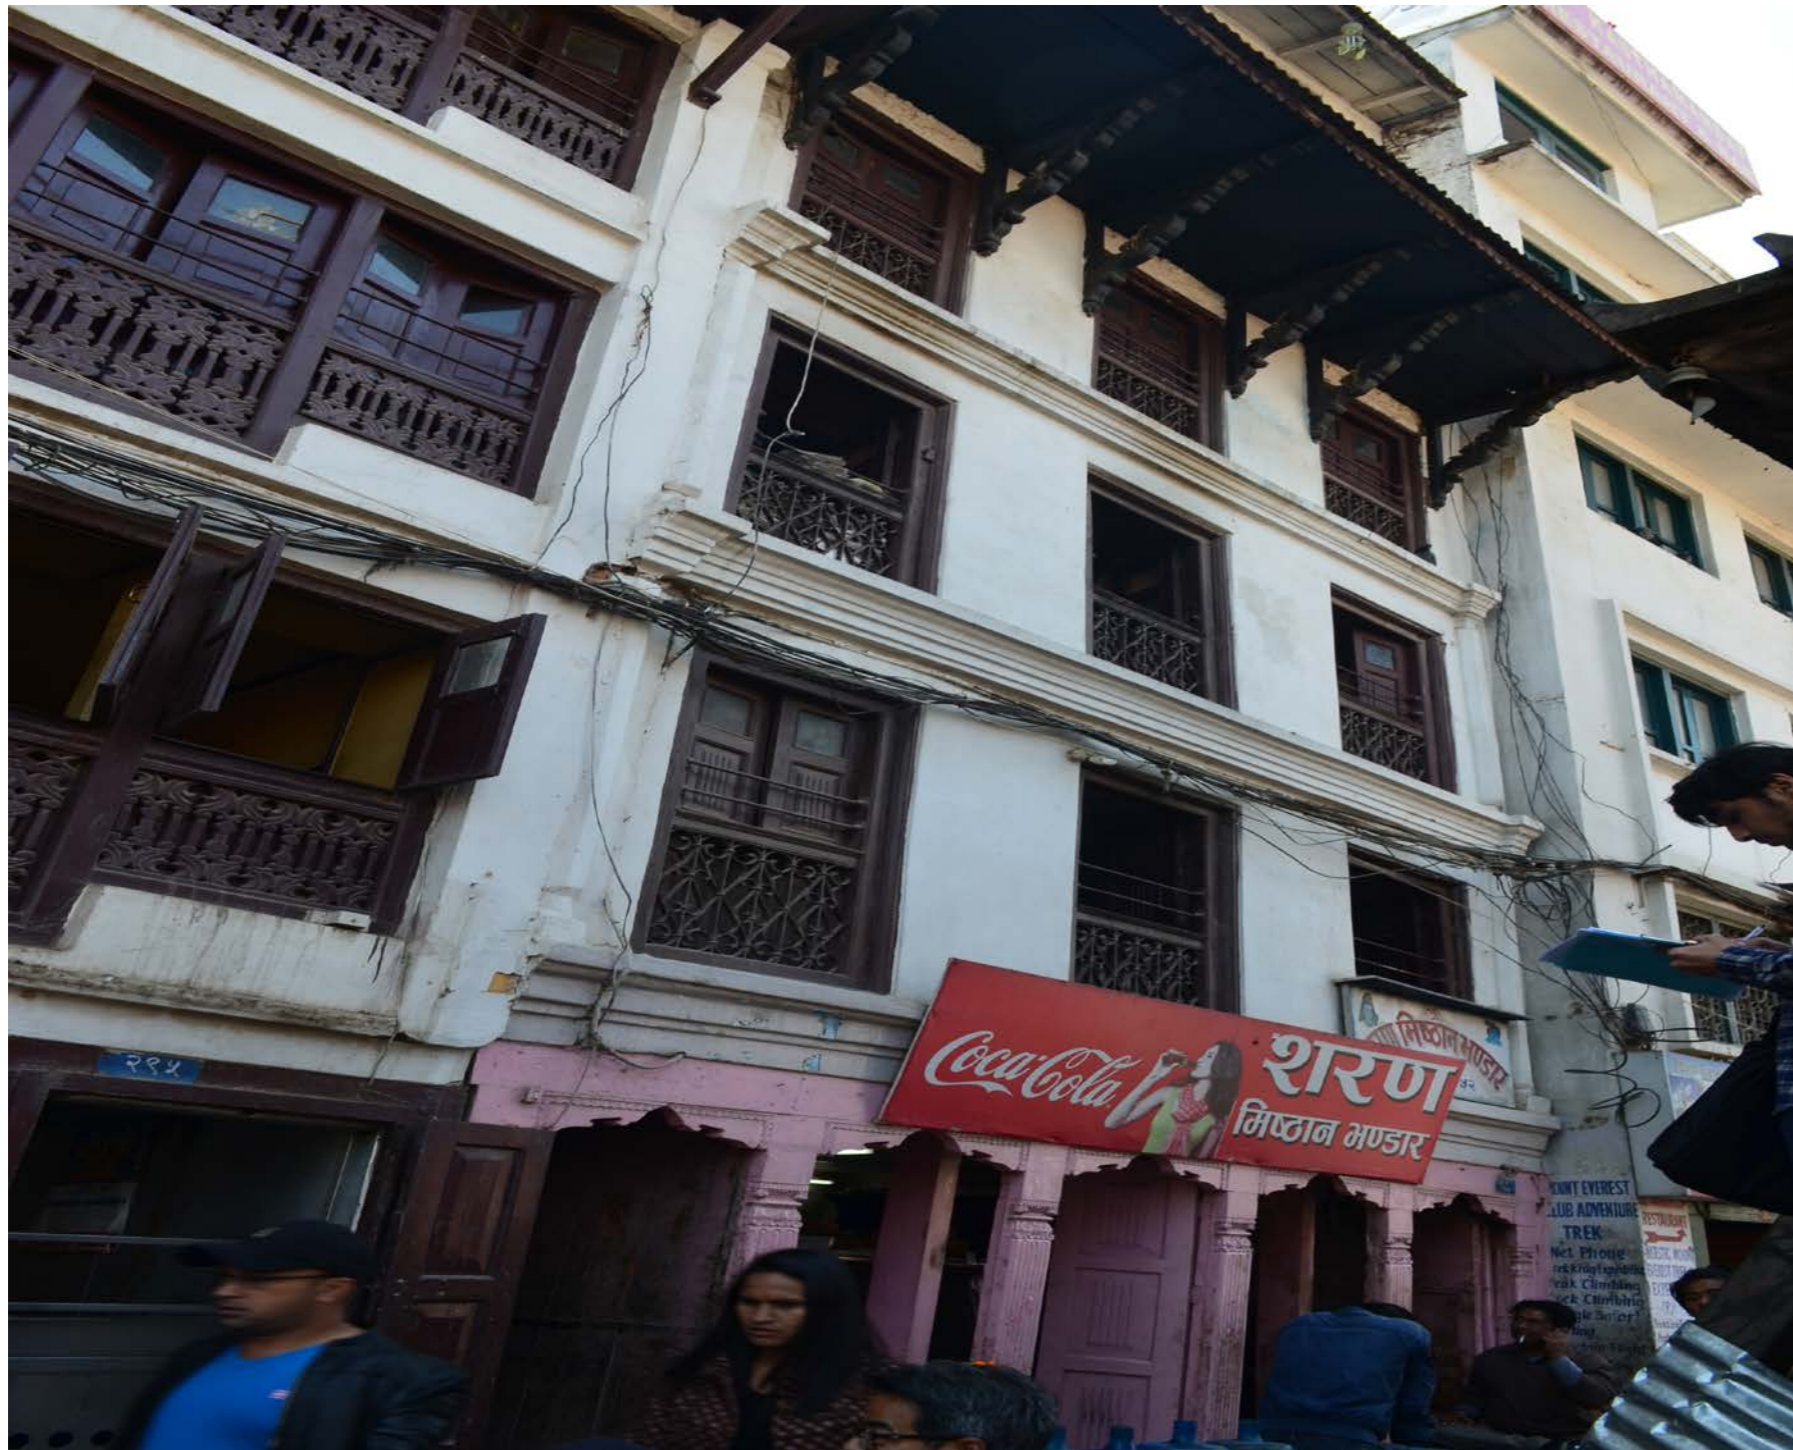
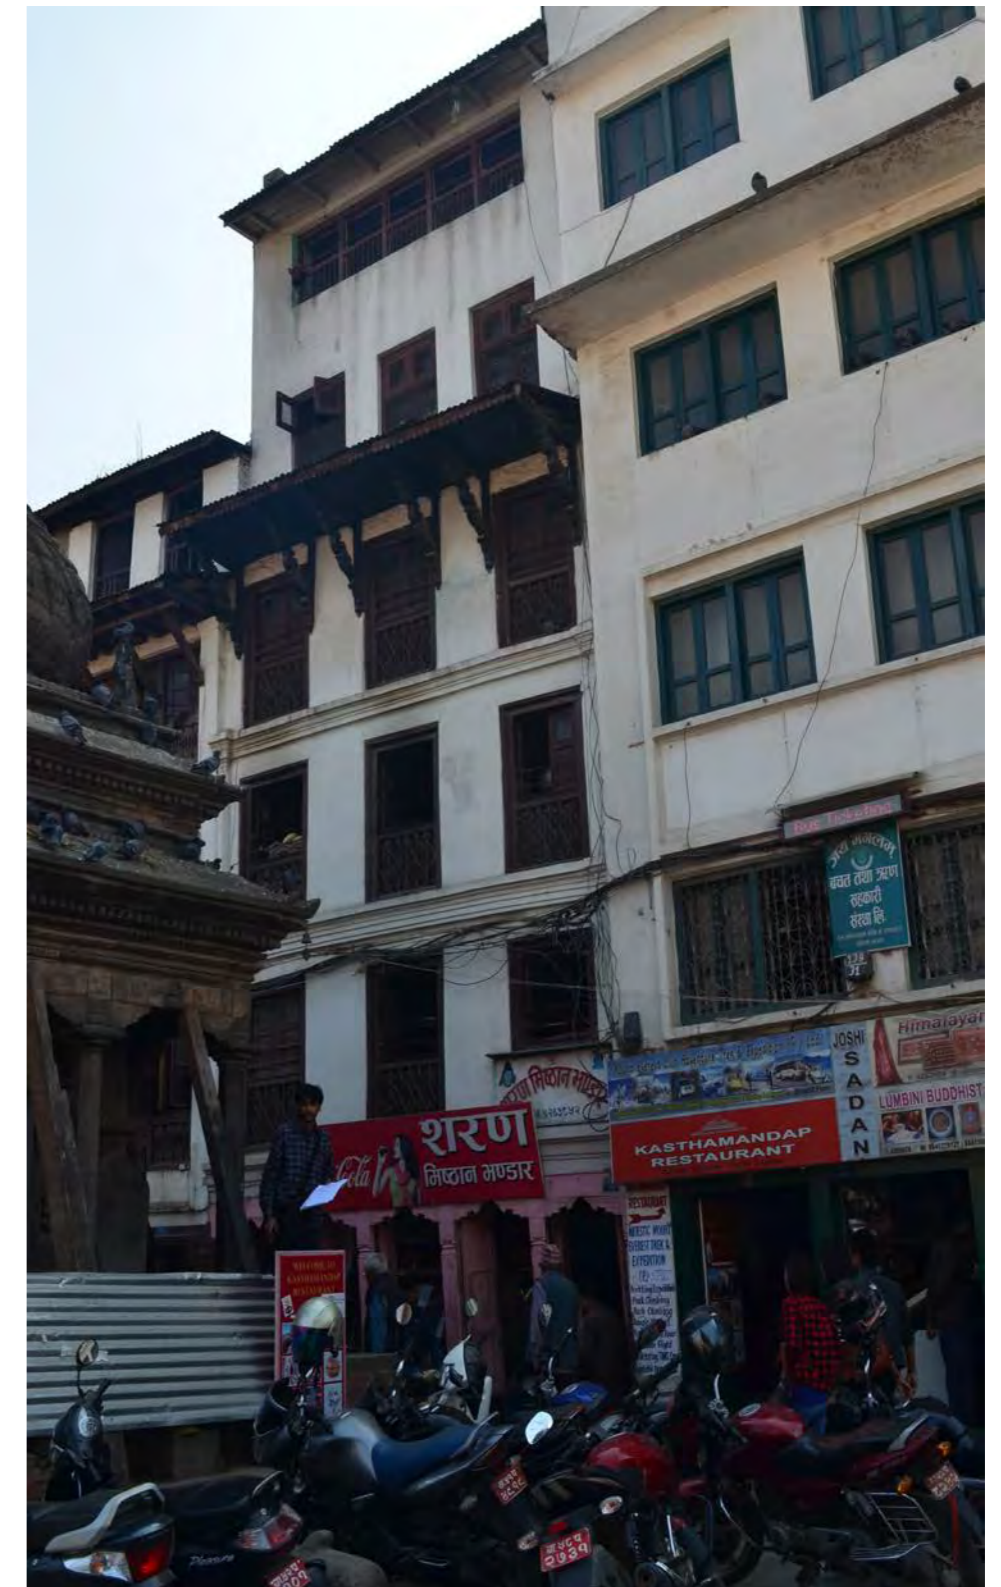
CODE NO	OWNERS NAME/CONTACT	STOREY NUMBER	PRESENT STOREY NUMBER	STRUCTURAL SYSTEM	MATERIAL	GENERAL DESCRIPTION	PROBLEM DESCRIPTION	DANGER	Heritage Significance	REMARKS
a09	Deepak kani-kar	G+4	G+4	Load Bearing	Brick;TImber	Minor Internal cracks	Moderate internal cracks present

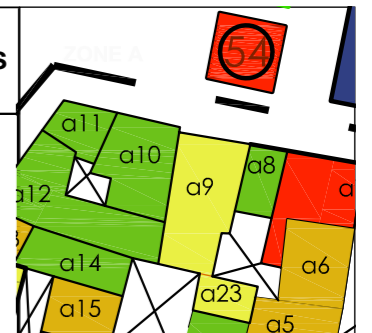
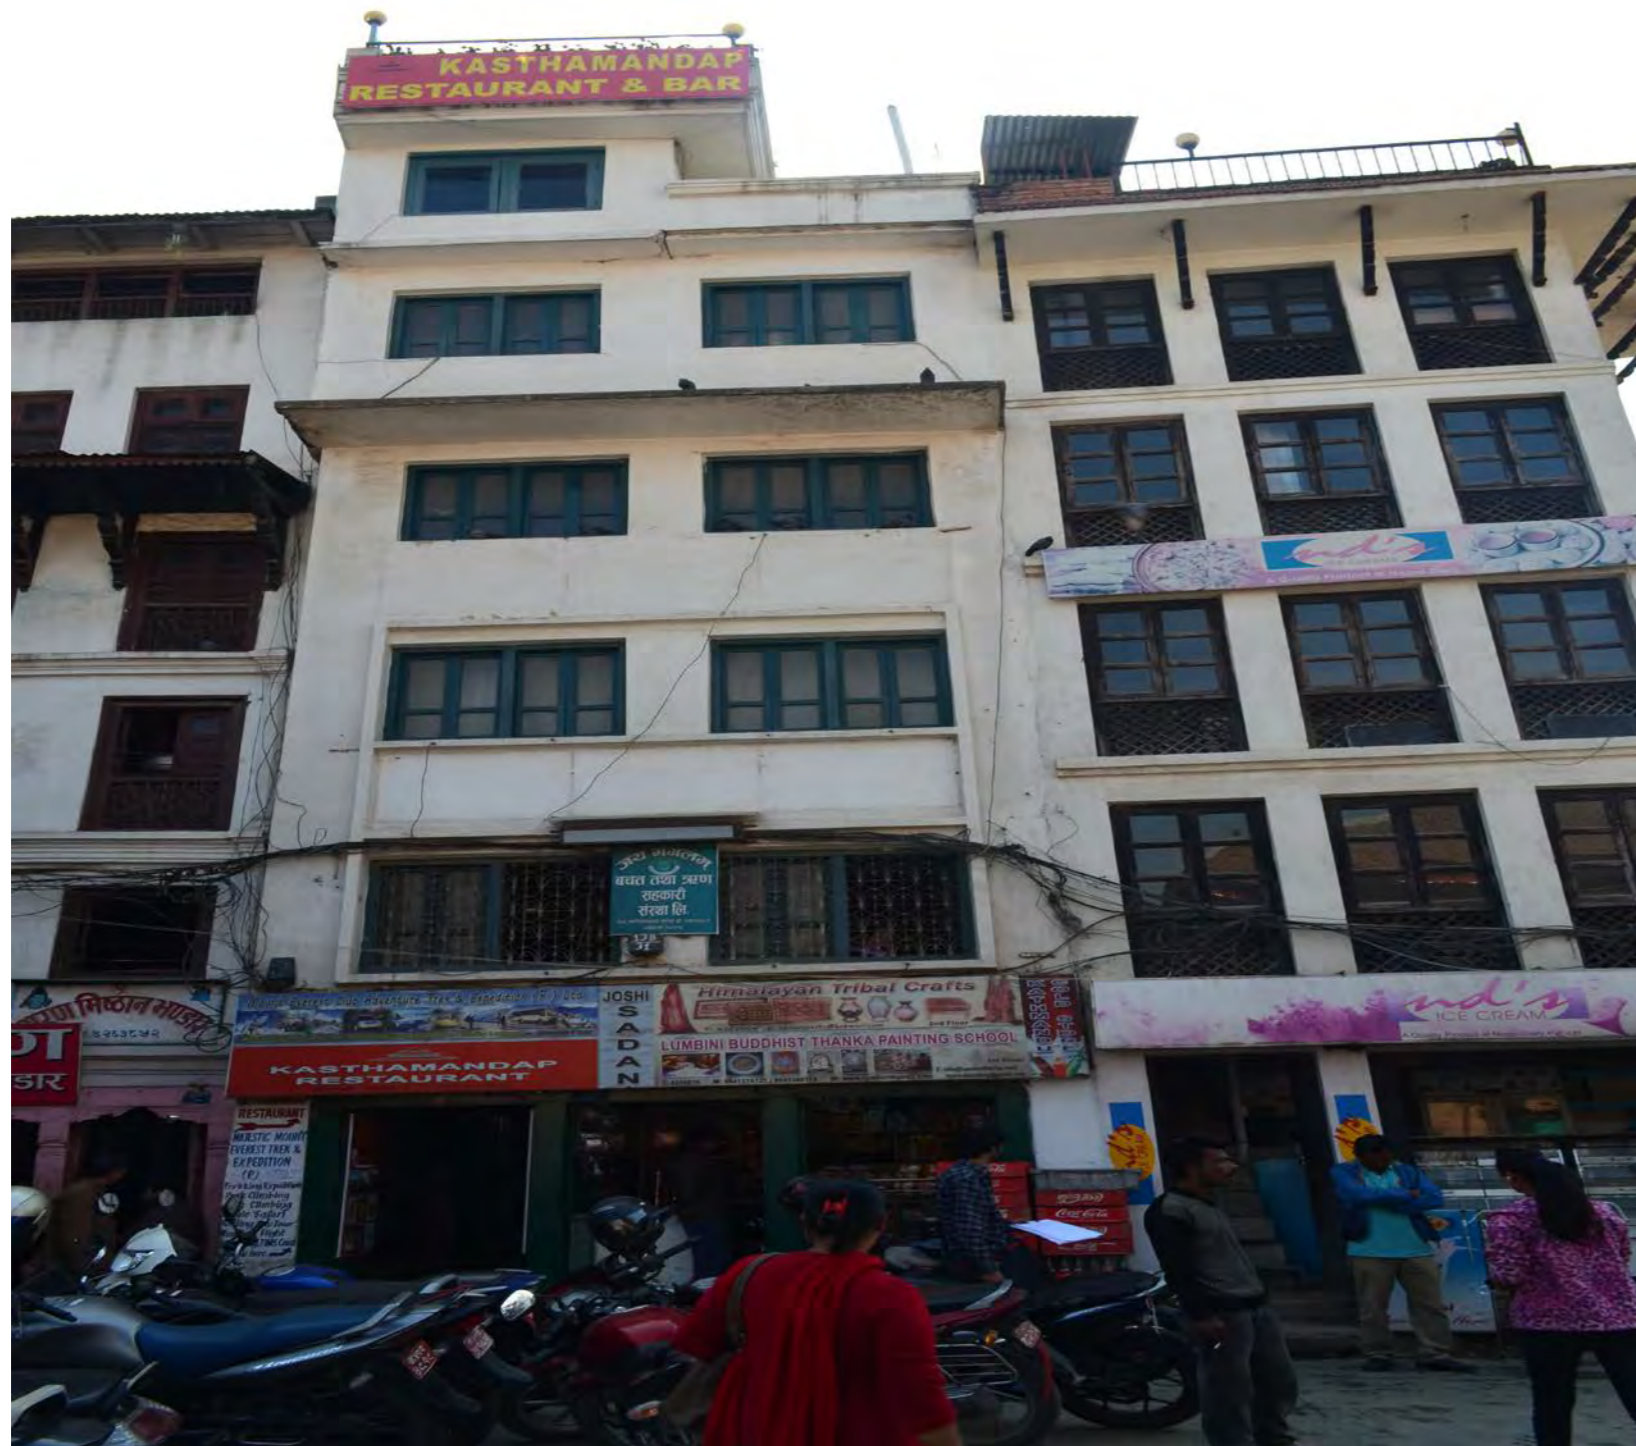
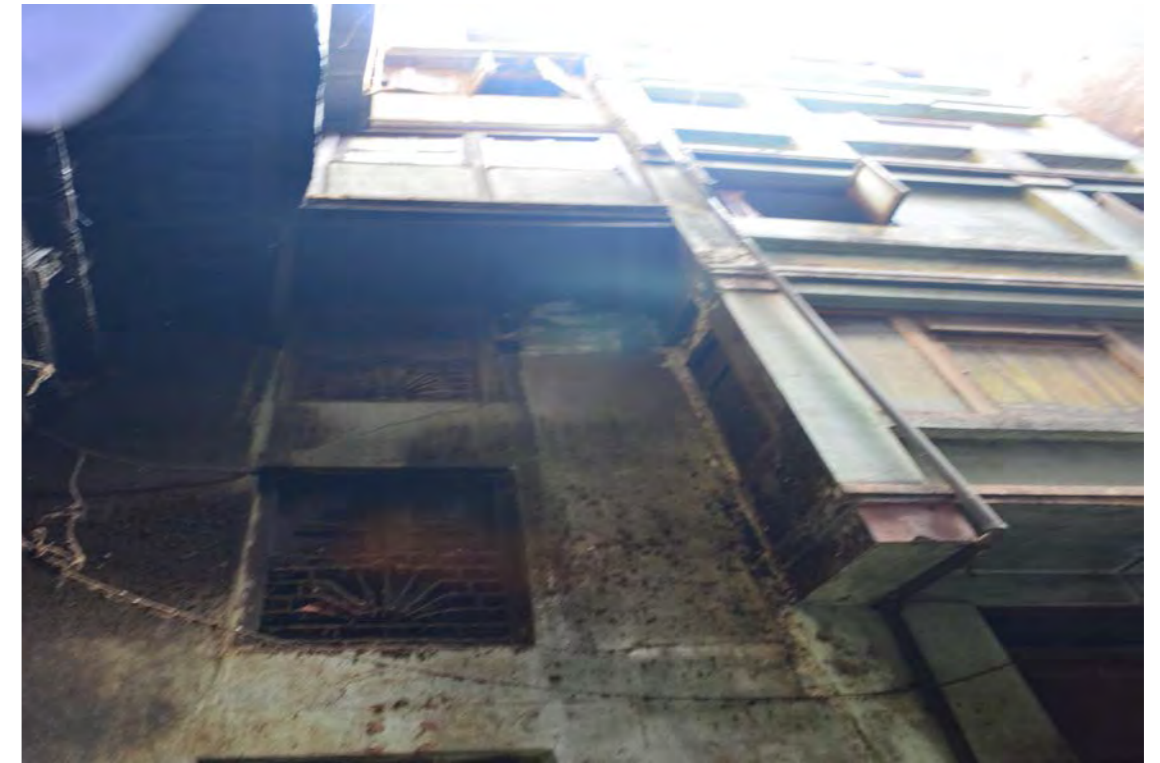
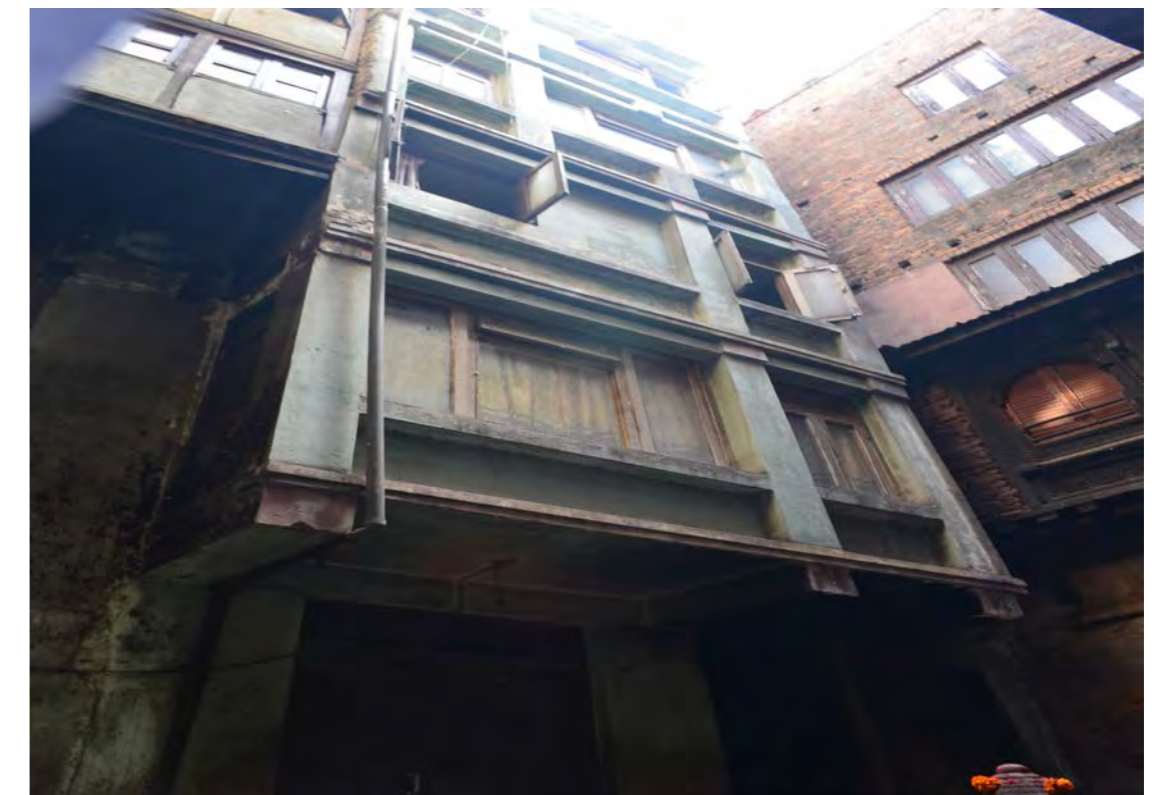
CODE NO	OWNERS NAME/CONTACT	STOREY NUMBER	PRESENT STOREY NUMBER	STRUCTURAL SYSTEM	MATERIAL	GENERAL DESCRIPTION	PROBLEM DESCRIPTION	DANGER	Heritage Significance	REMARKS
a10	Bhagwati Joshi	G+5	G+5	Load Bearing	Brick; Timber		No visible damage

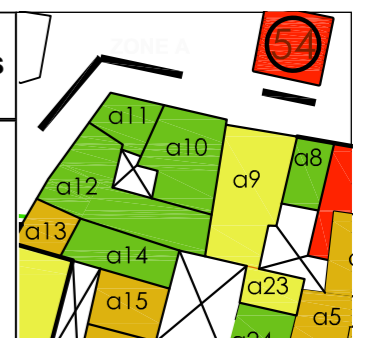
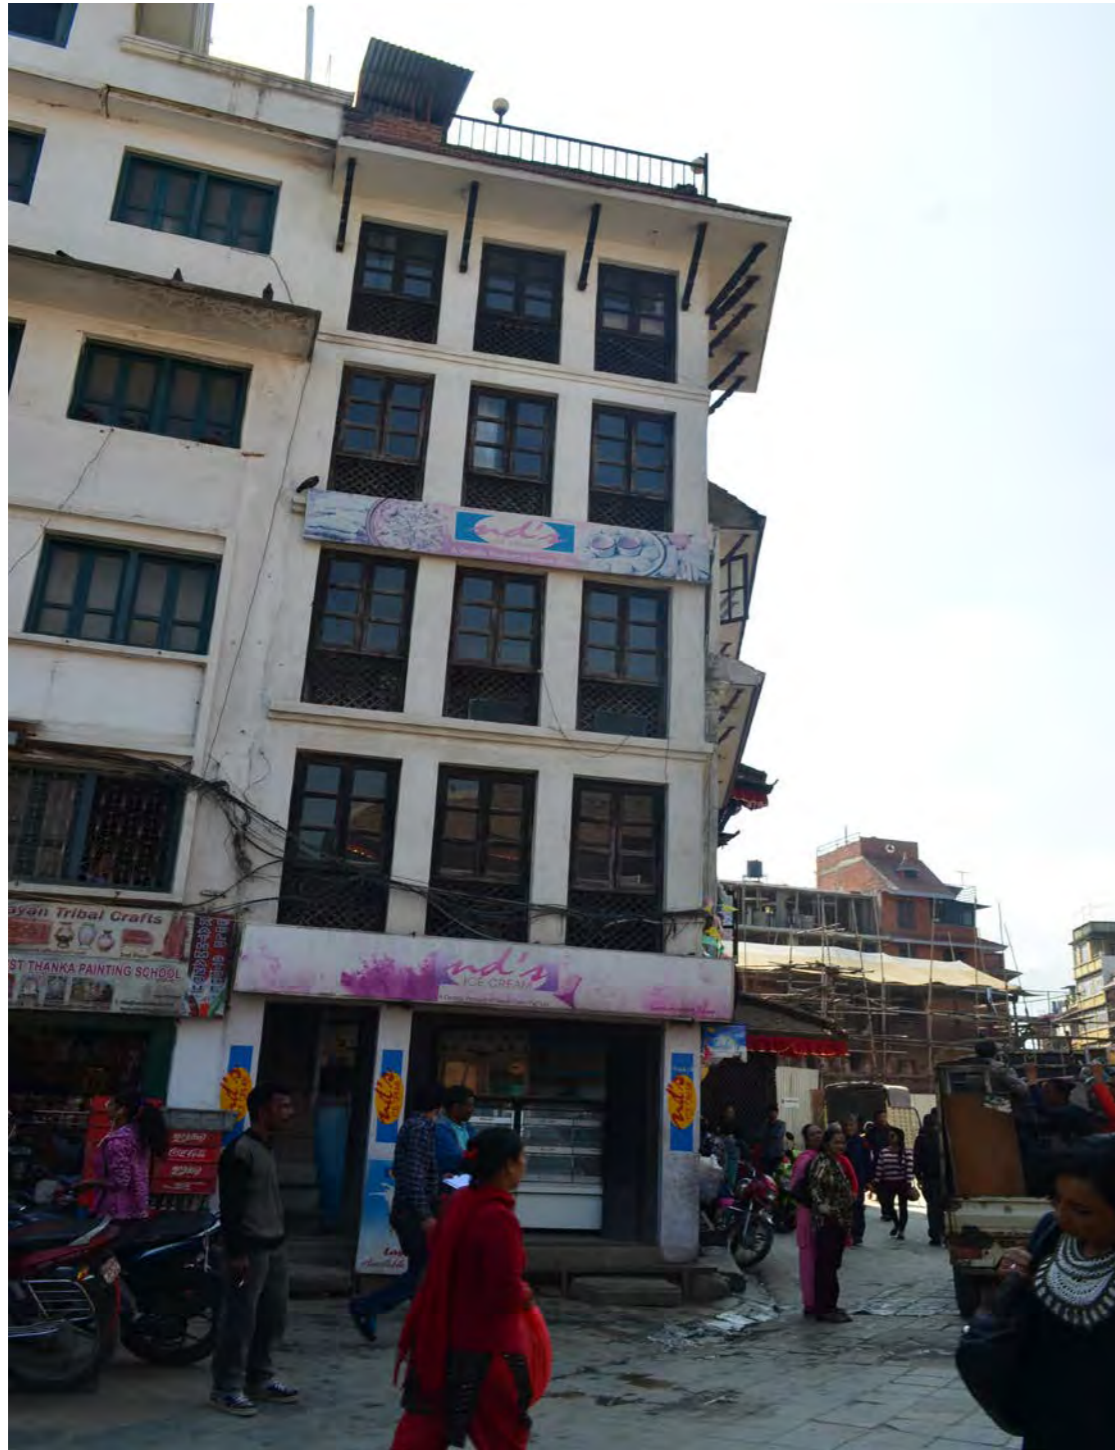
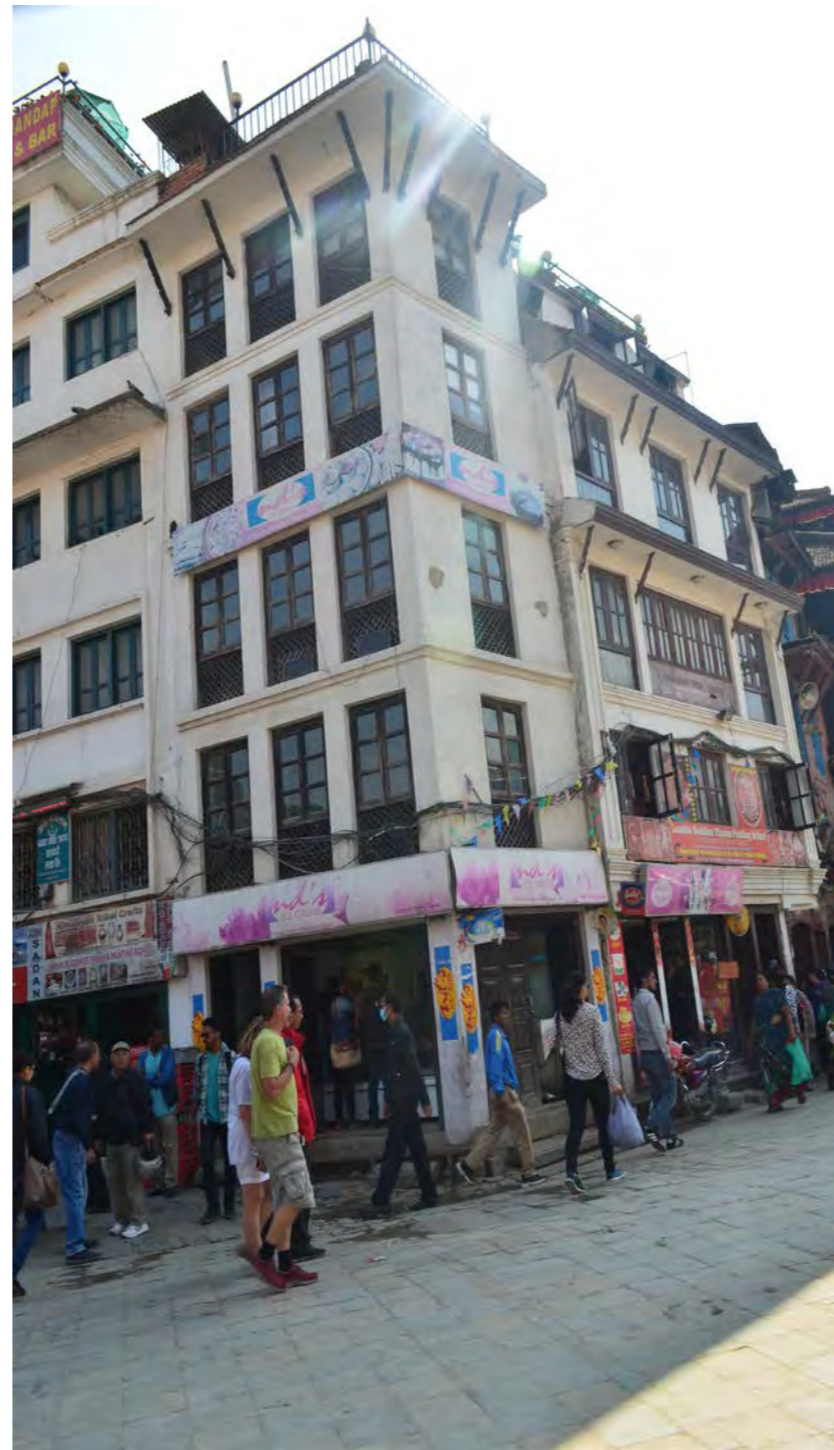
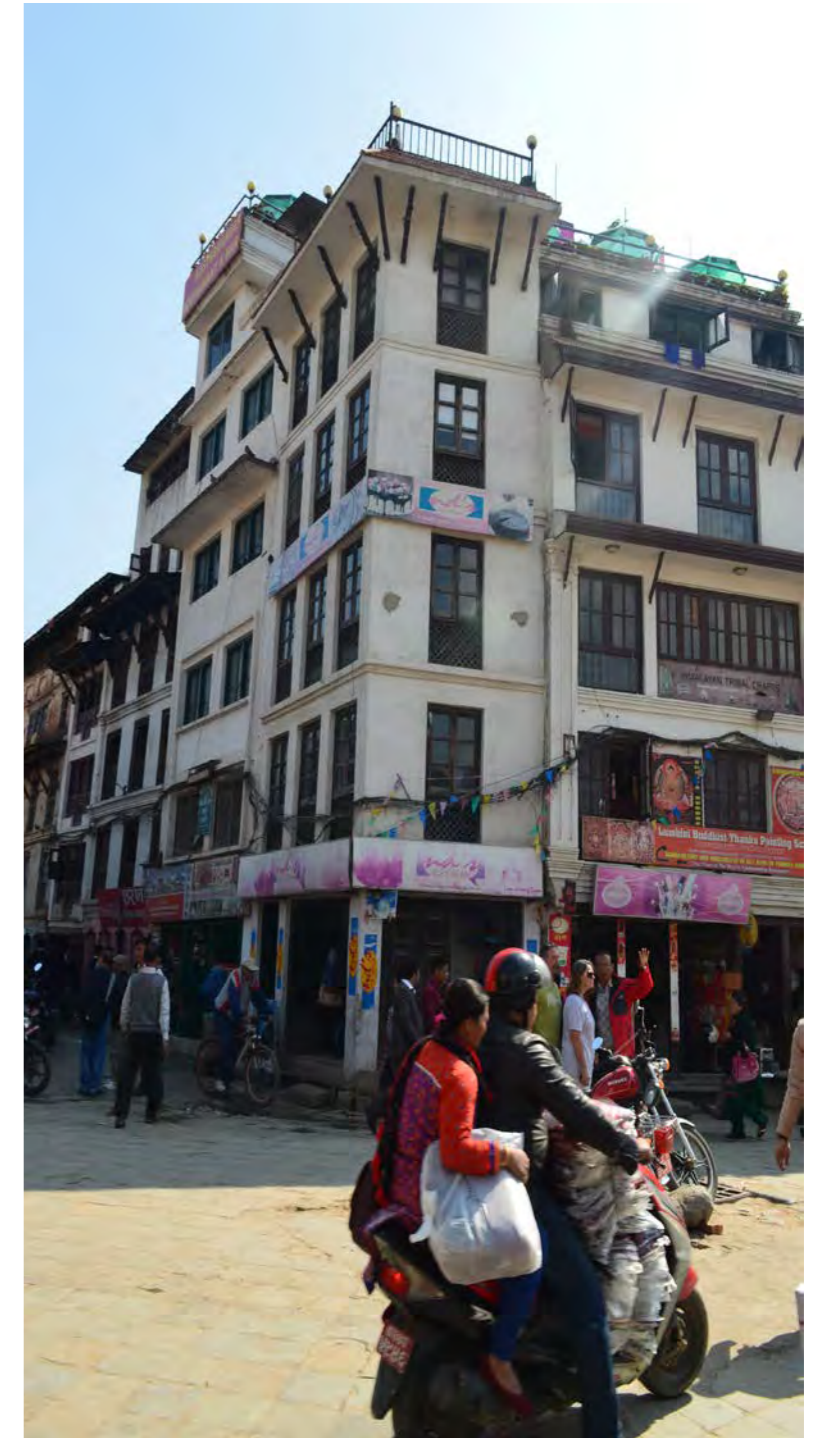
CODE NO	OWNERS NAME/CONTACT	STOREY NUMBER	PRESENT STOREY NUMBER	STRUCTURAL SYSTEM	MATERIAL	GENERAL DESCRIPTION	PROBLEM DESCRIPTION	DANGER	Heritage Significance	REMARKS
a11	ND's	G+4	G+4	Frame	Cement		No visible damage

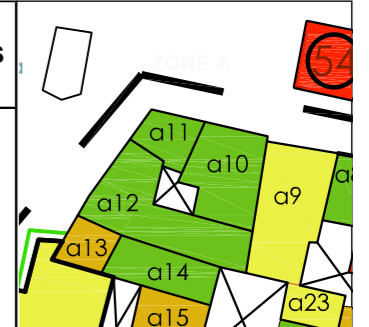
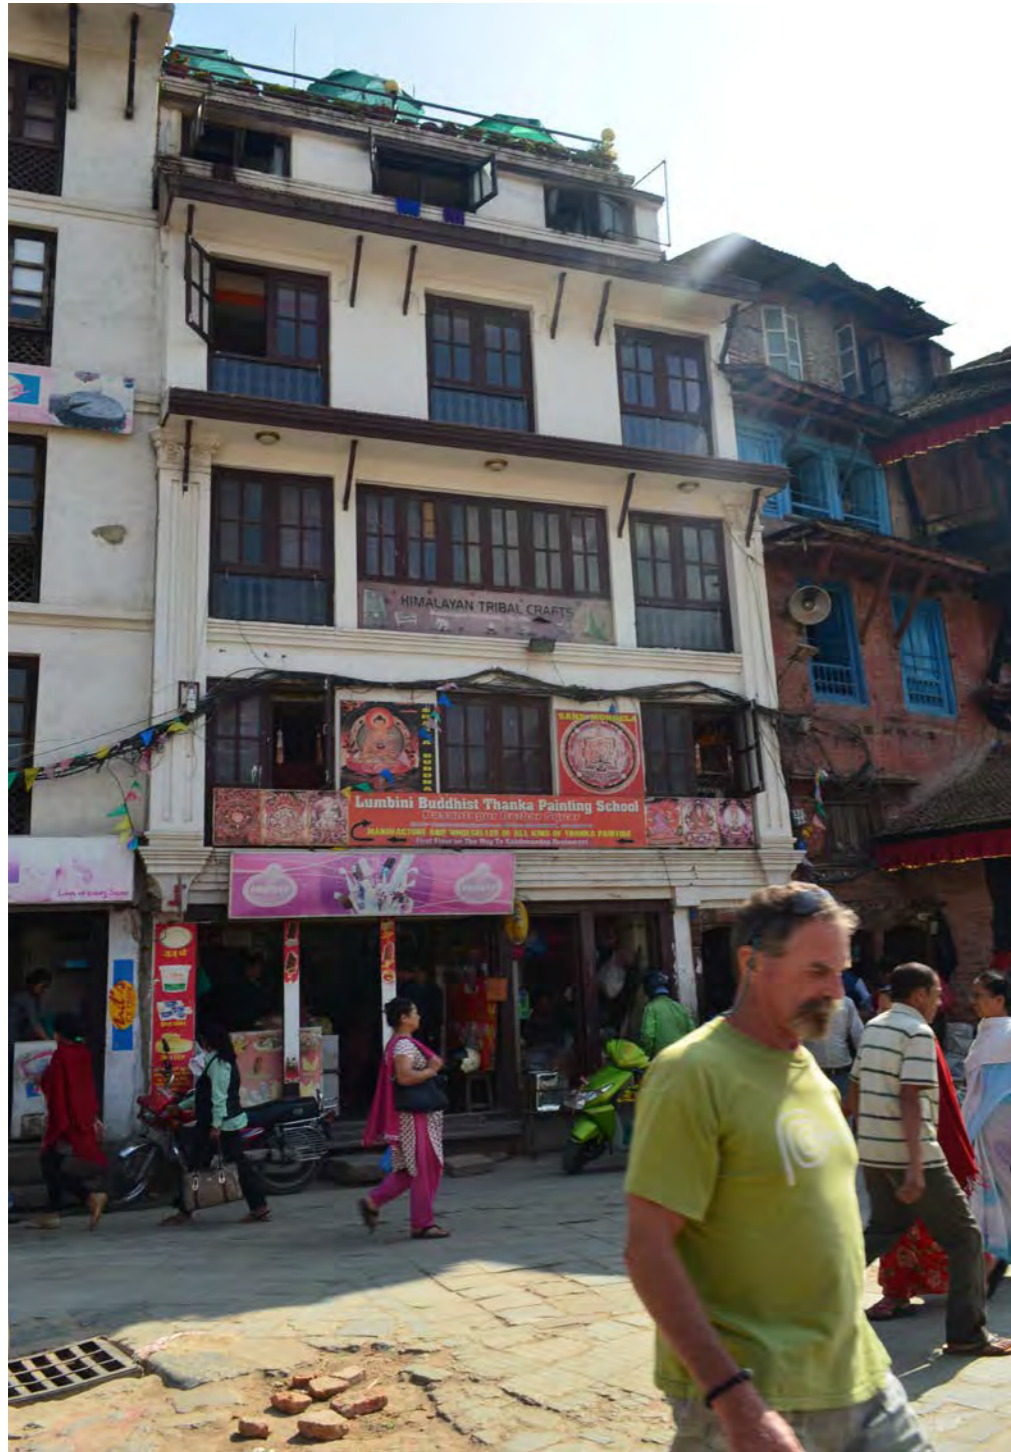
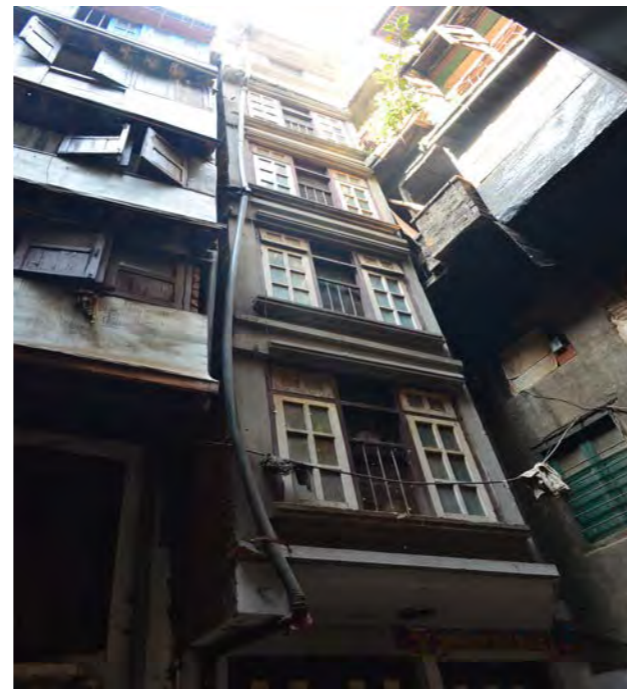
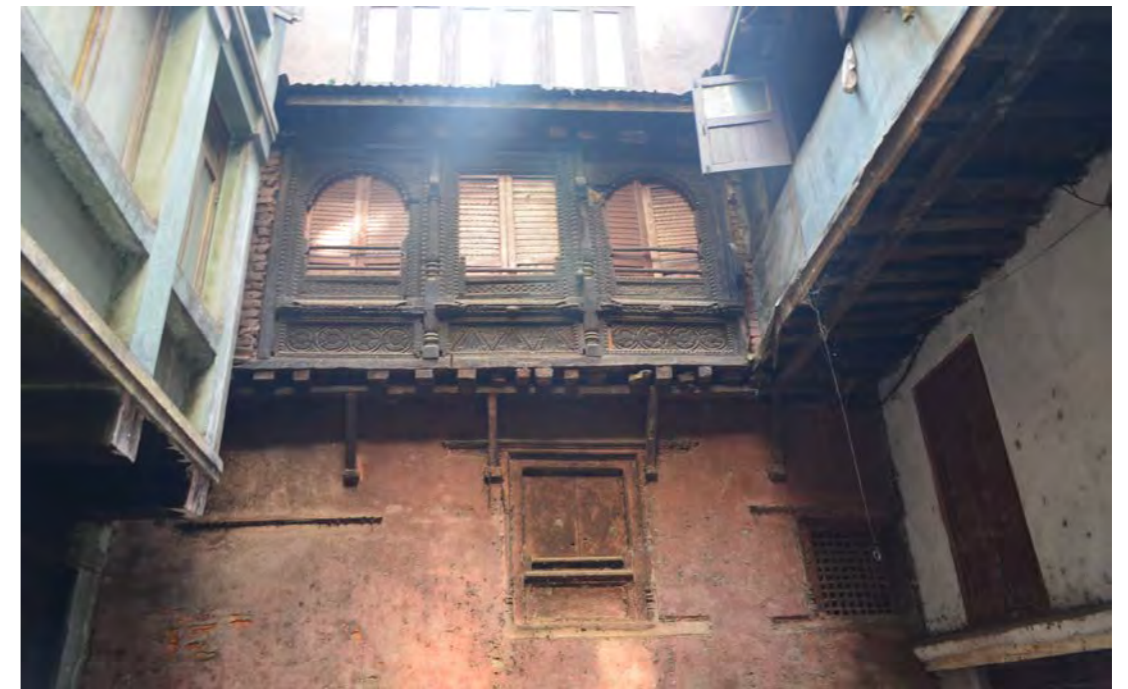
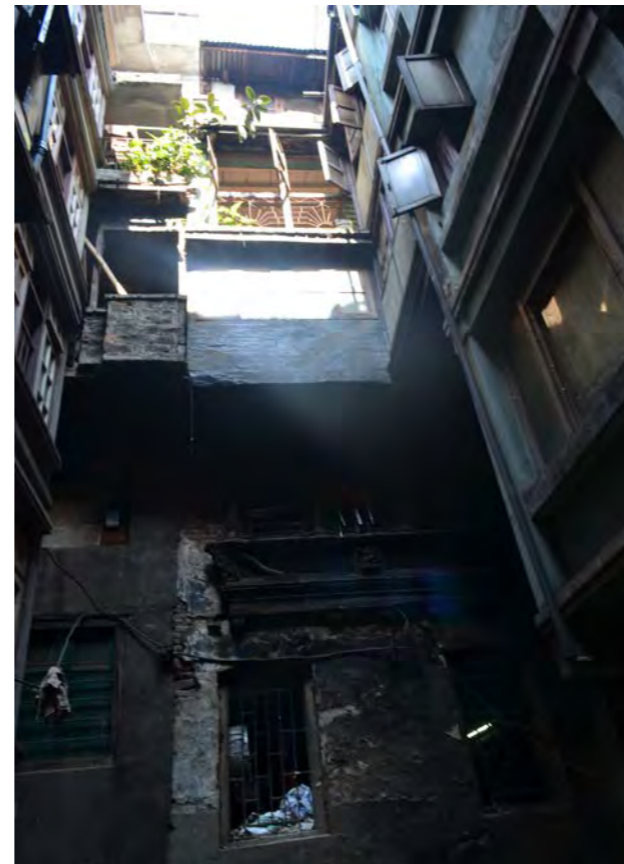
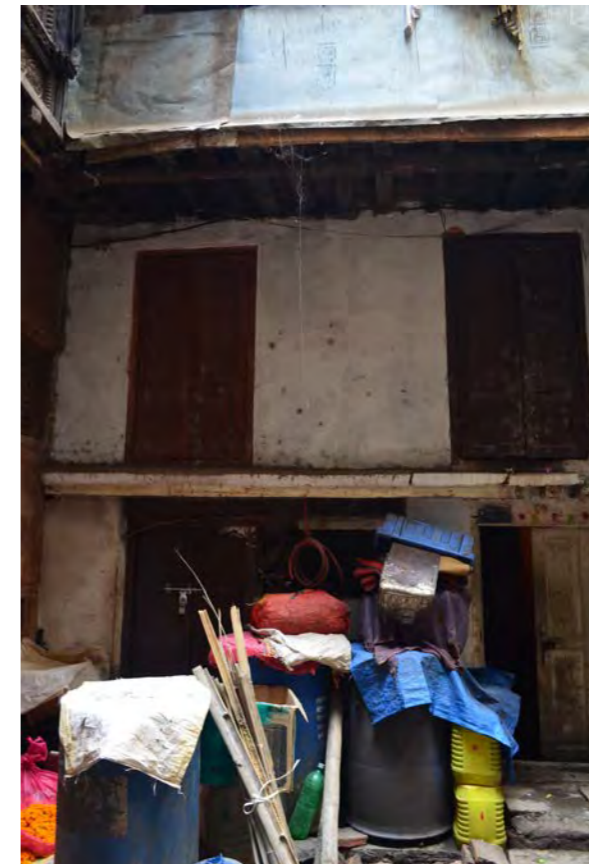
CODE NO	OWNERS NAME/CONTACT	STOREY NUMBER	PRESENT STOREY NUMBER	STRUCTURAL SYSTEM	MATERIAL	GENERAL DESCRIPTION	PROBLEM DESCRIPTION	DANGER	Heritage Significance	REMARKS
a12	Bhagwati Joshi	G+4	G+4	Frame	Cement		No visible damage

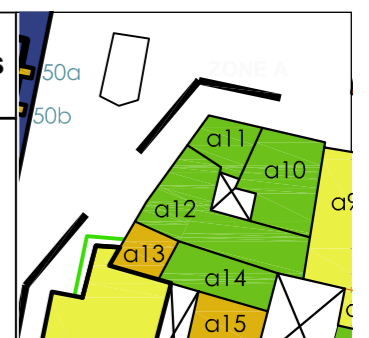
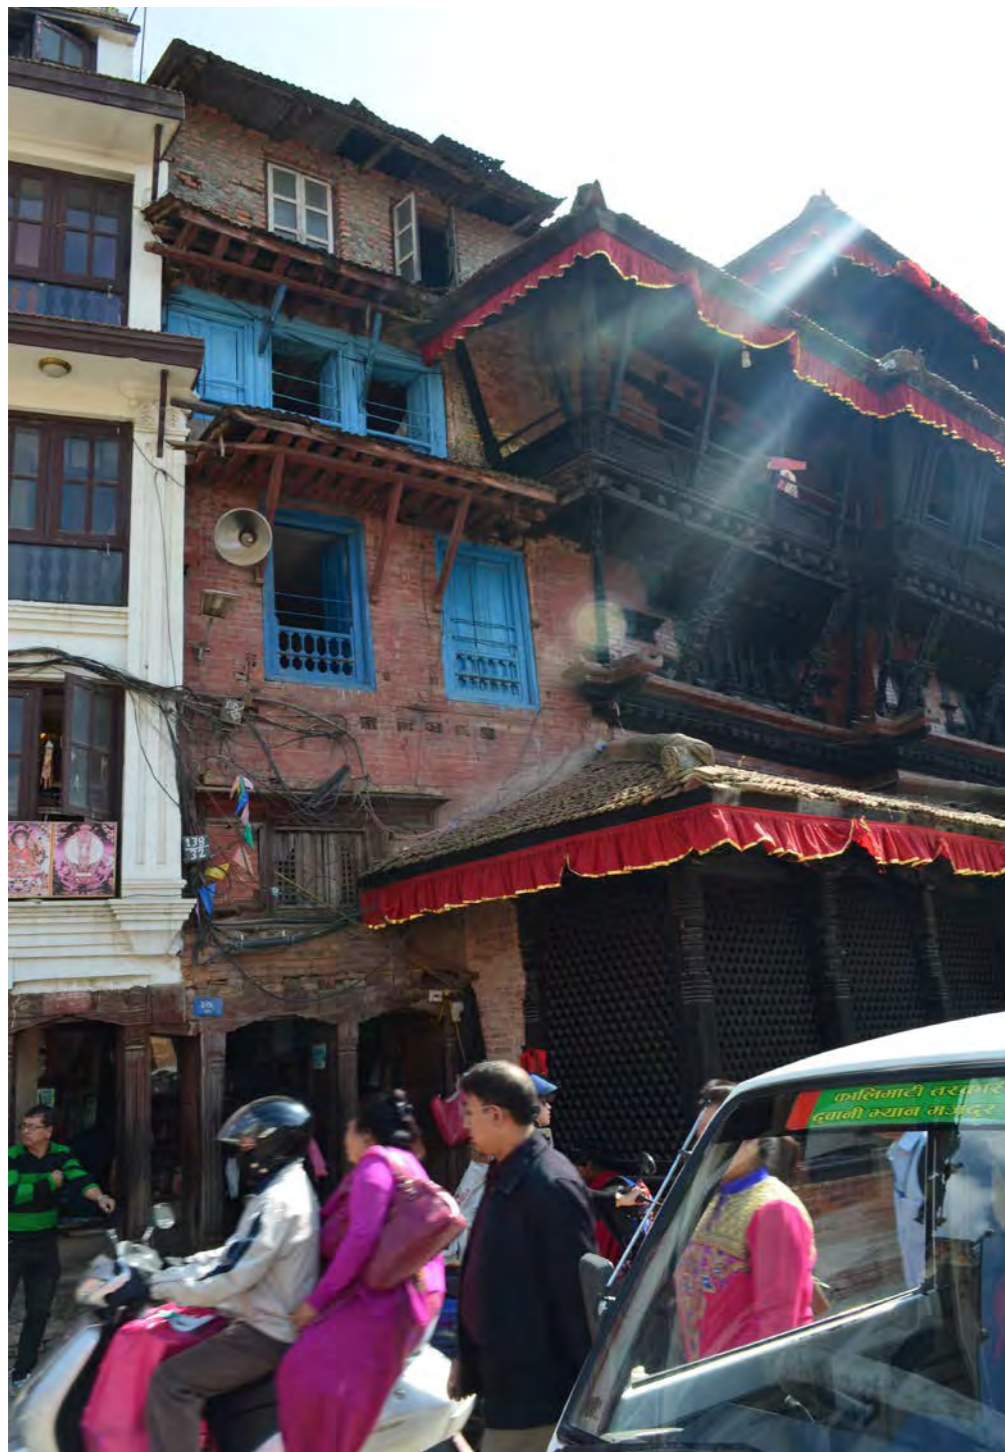
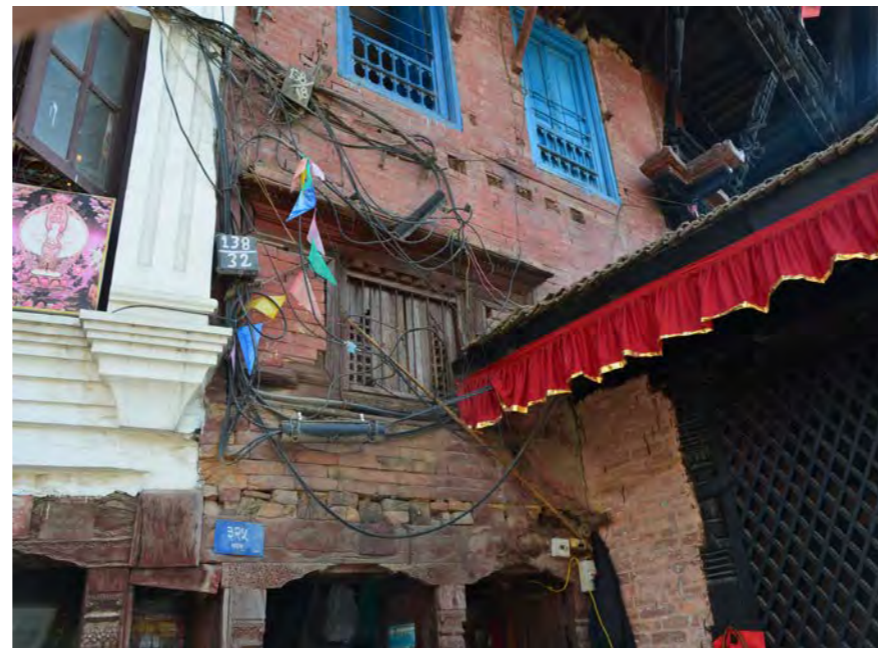
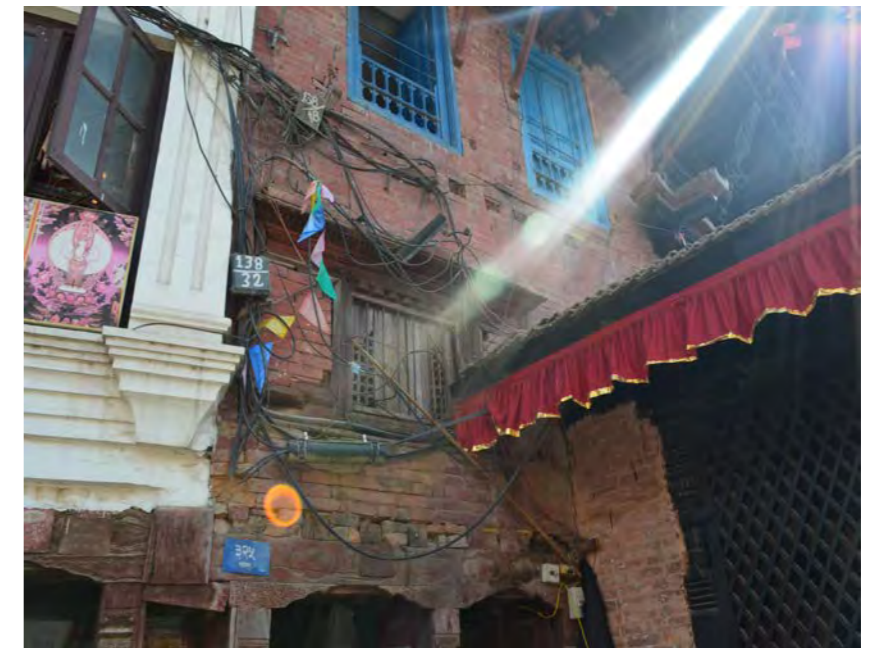
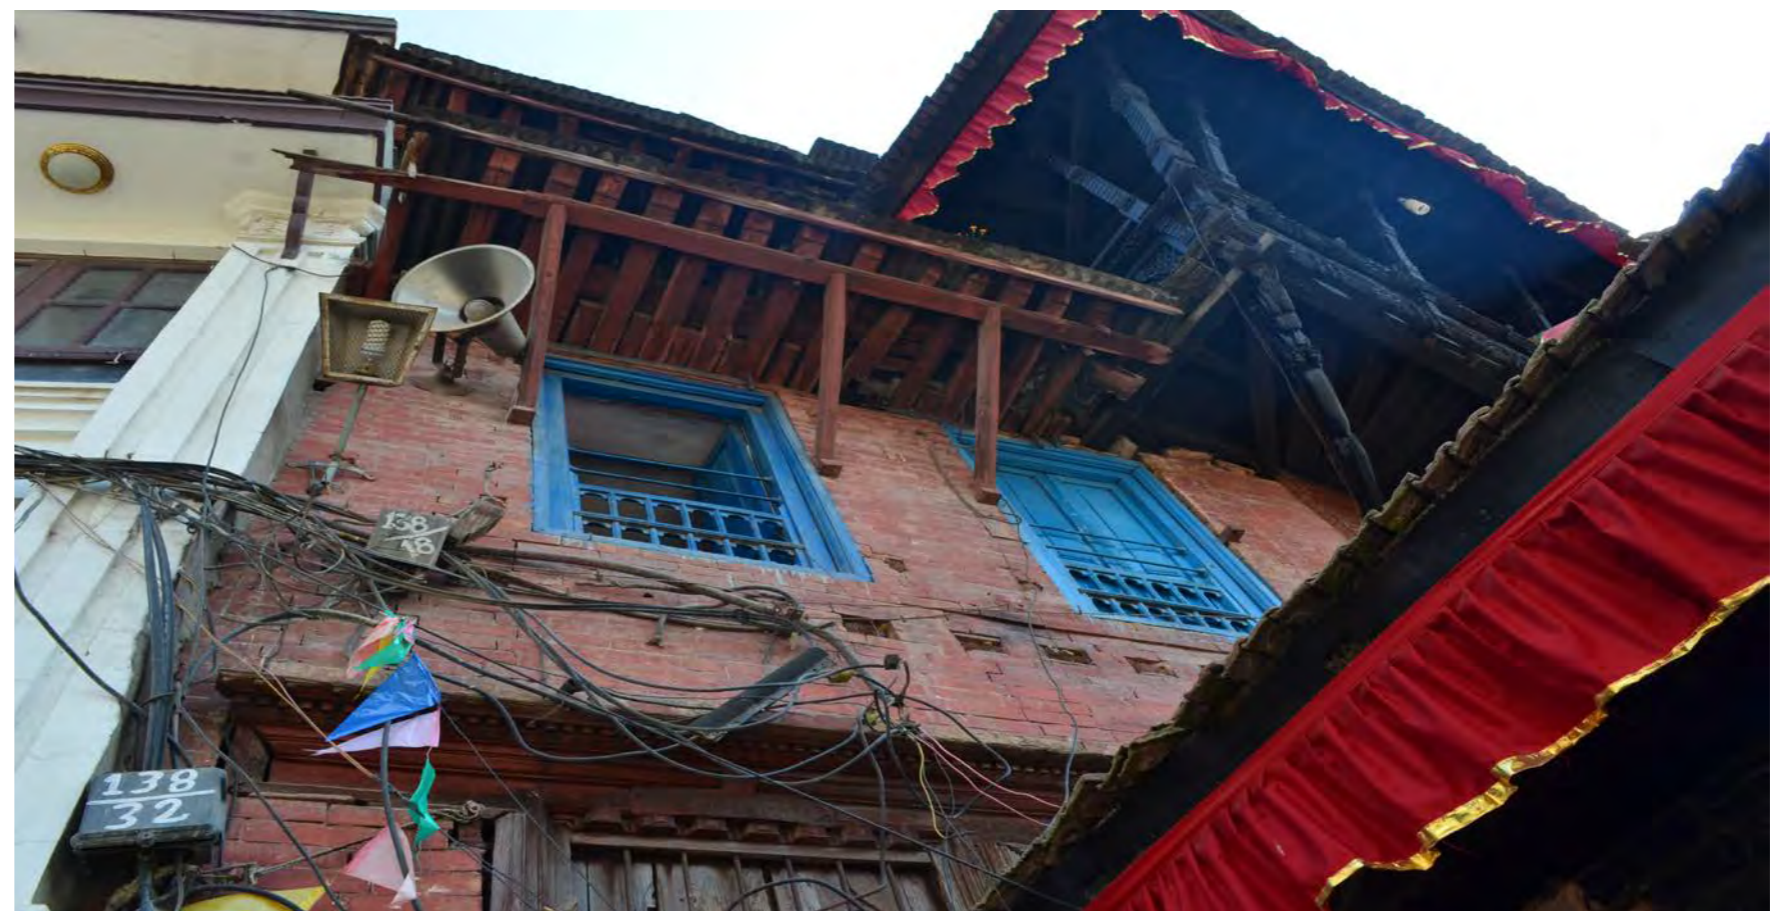
CODE NO	OWNERS NAME/CONTACT	STOREY NUMBER	PRESENT STOREY NUMBER	STRUCTURAL SYSTEM	MATERIAL	GENERAL DESCRIPTION	PROBLEM DESCRIPTION	DANGER	Heritage Significance	REMARKS
a13	Indu Kumari Maya	G+4	G+4	Frame	Cement		No visible damage
