2015 Earthquake Damage Mapping

Hanuman Dhoka Darbar Square Monument Zone
Kathmandu Valley World Heritage Property

December 2015

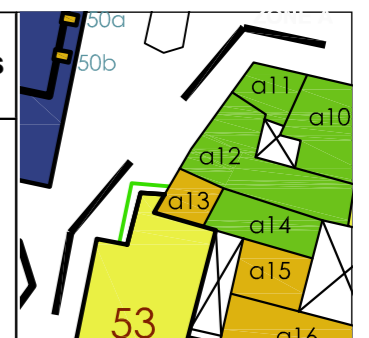
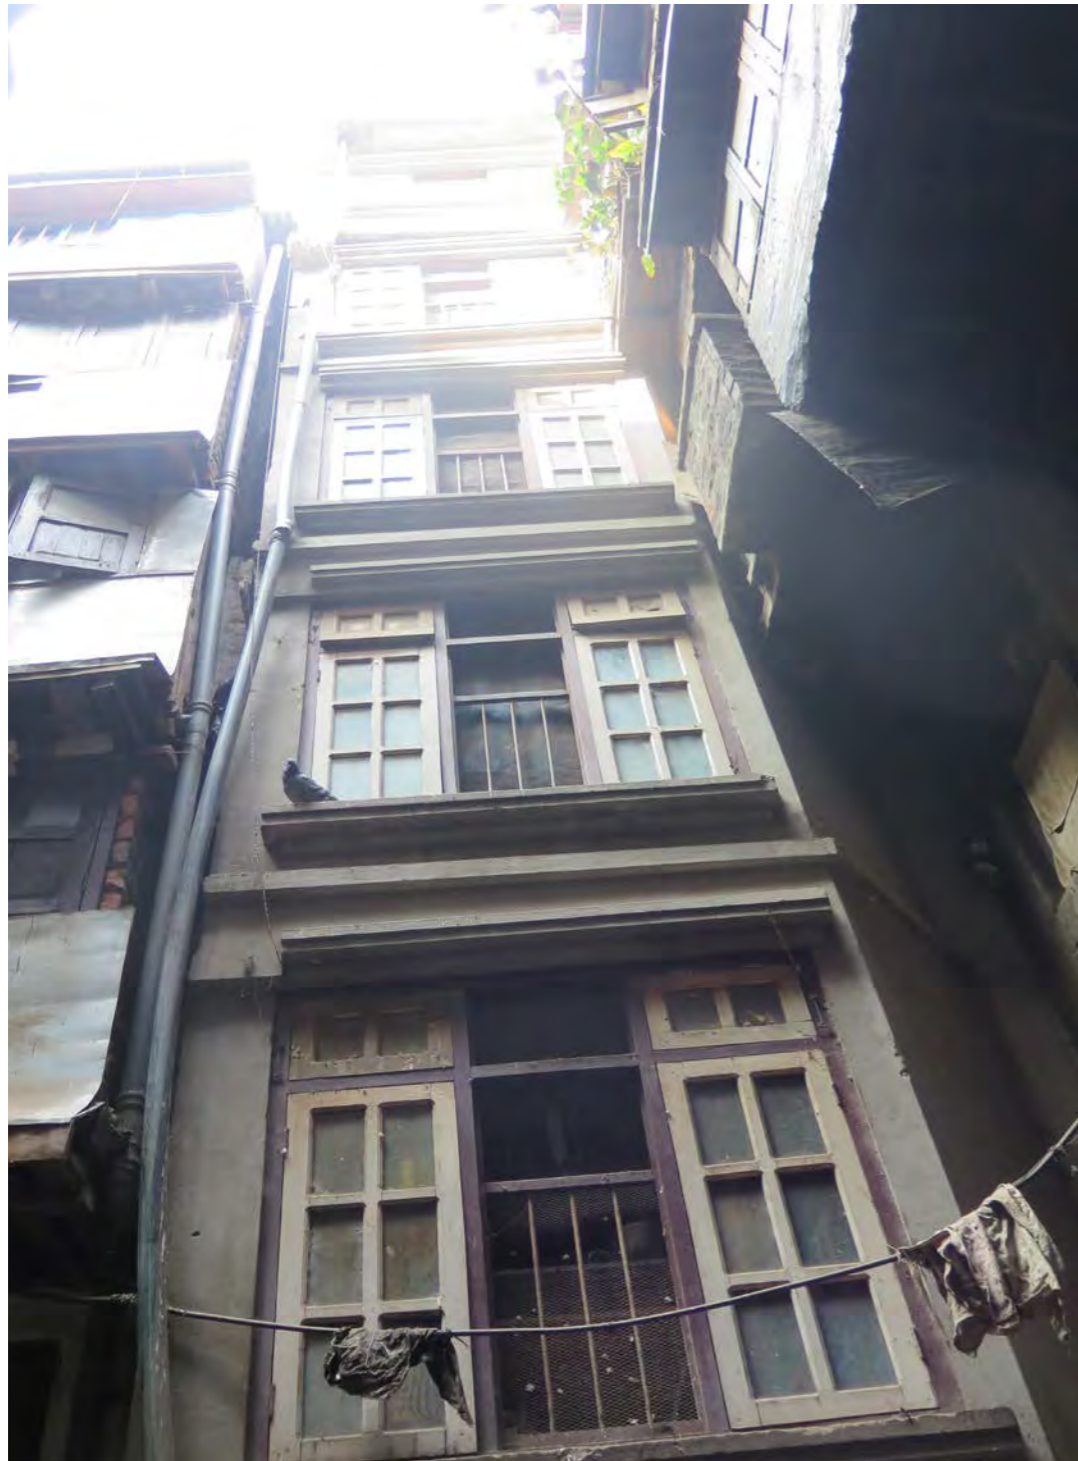
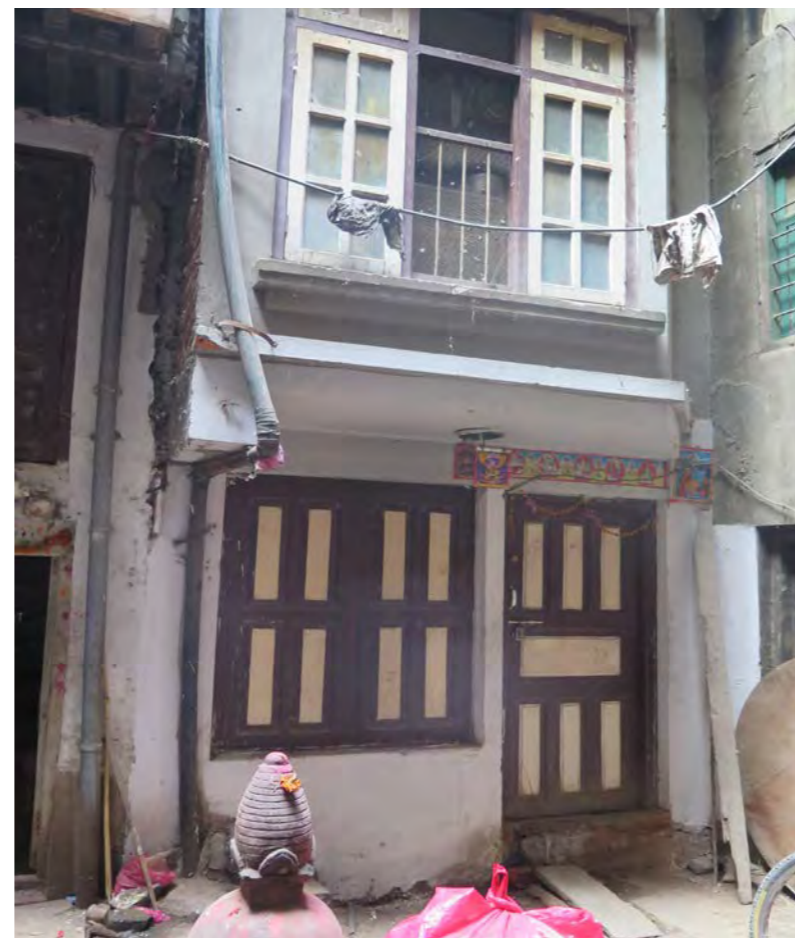
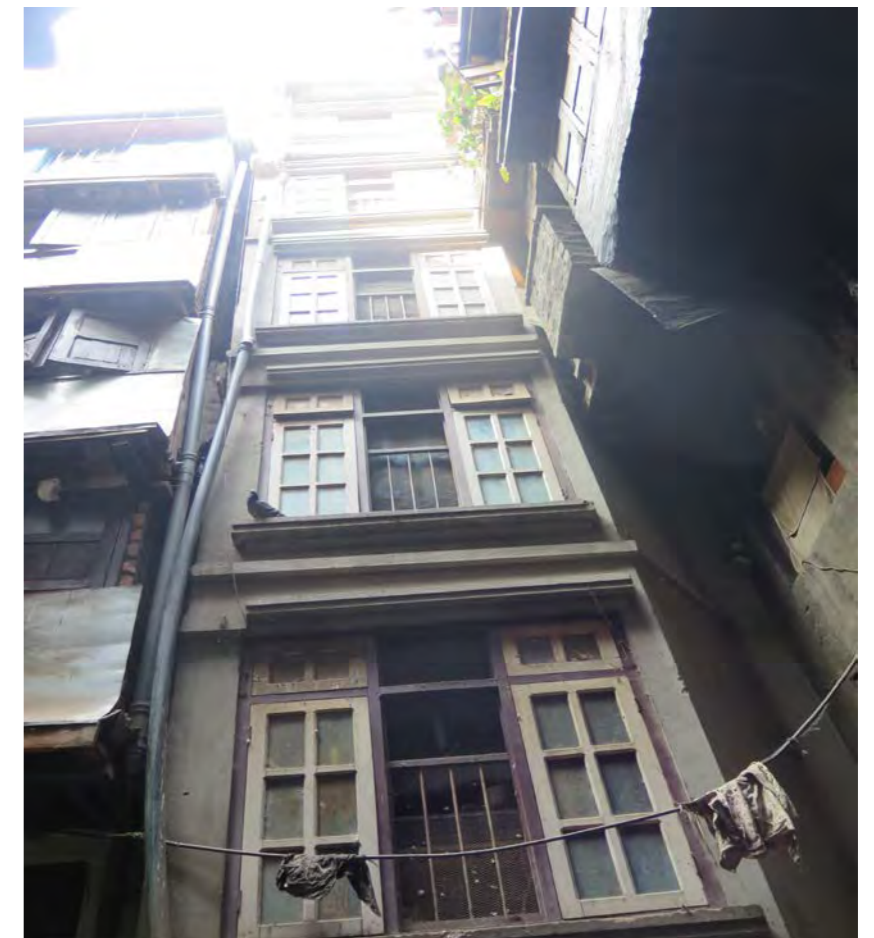
CODE NO	OWNERS NAME/CONTACT	STOREY NUMBER	PRESENT STOREY NUMBER	STRUCTURAL SYSTEM	MATERIAL	GENERAL DESCRIPTION	PROBLEM DESCRIPTION	DANGER	Heritage Significance	REMARKS
a14	Indu kKumari Maya	G+5	G+5	Frame	Cement		No visible damage

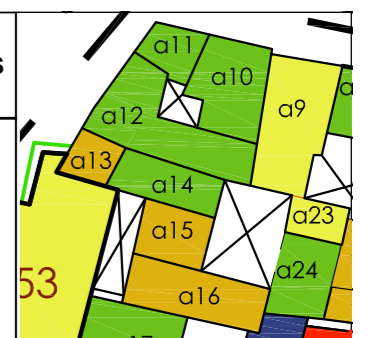
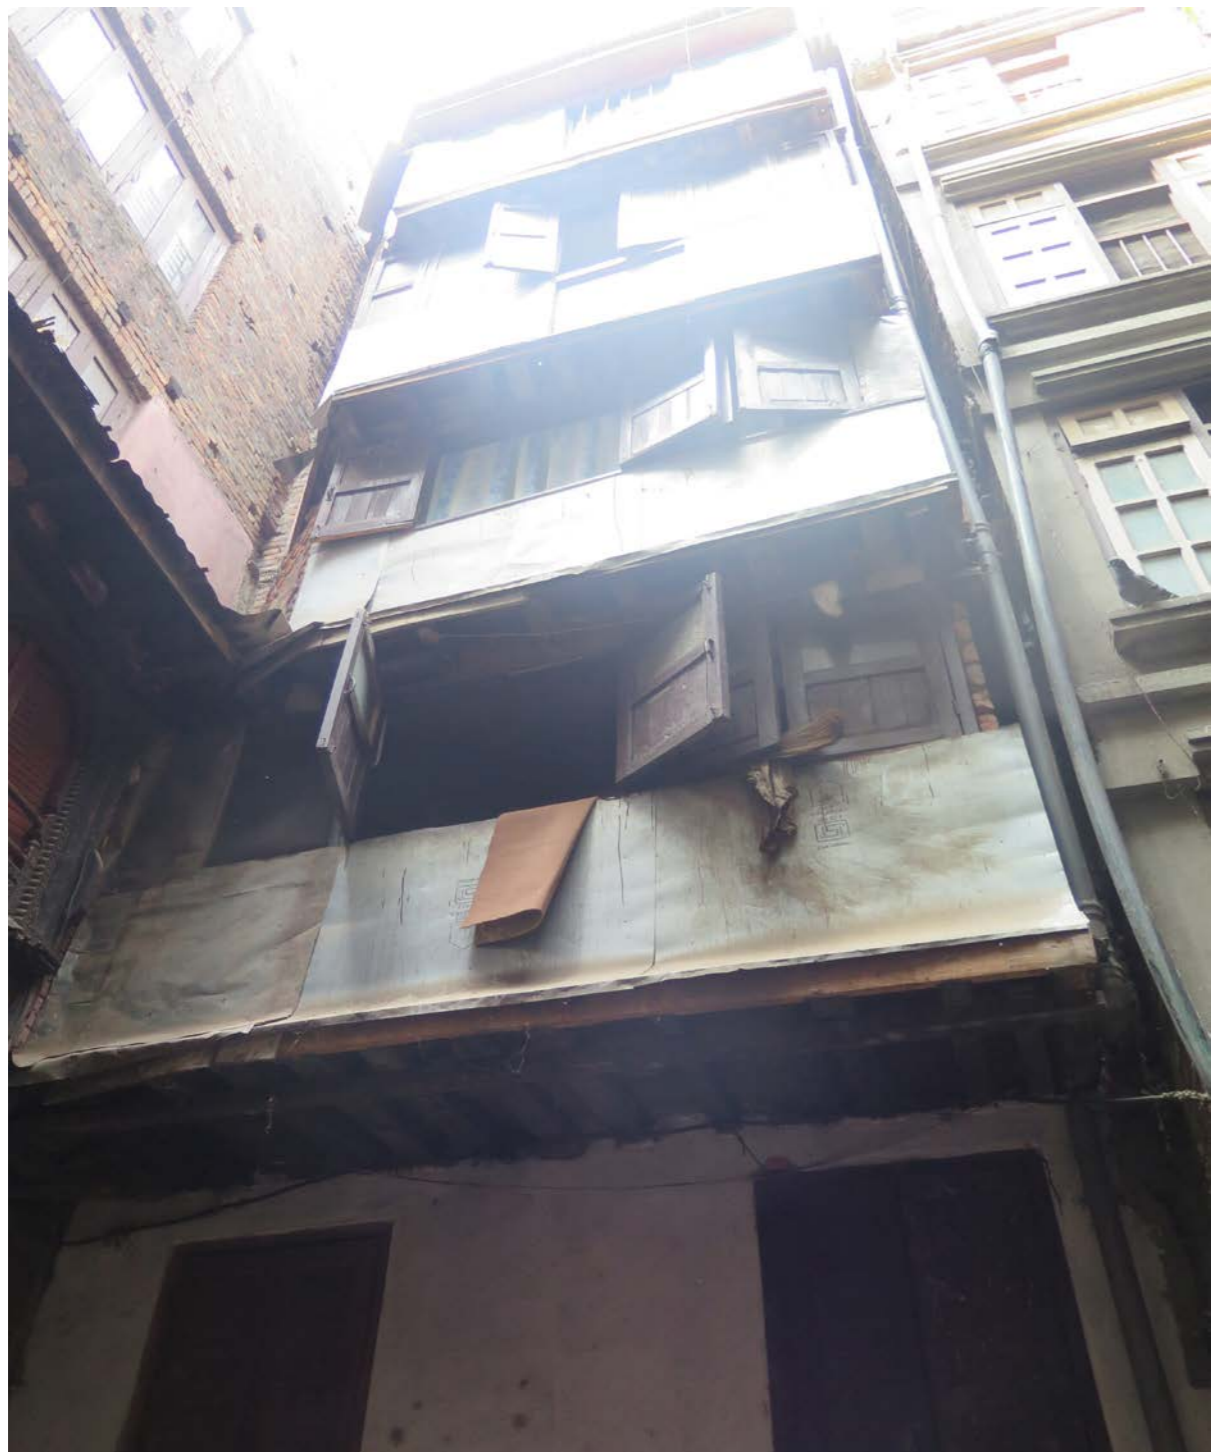
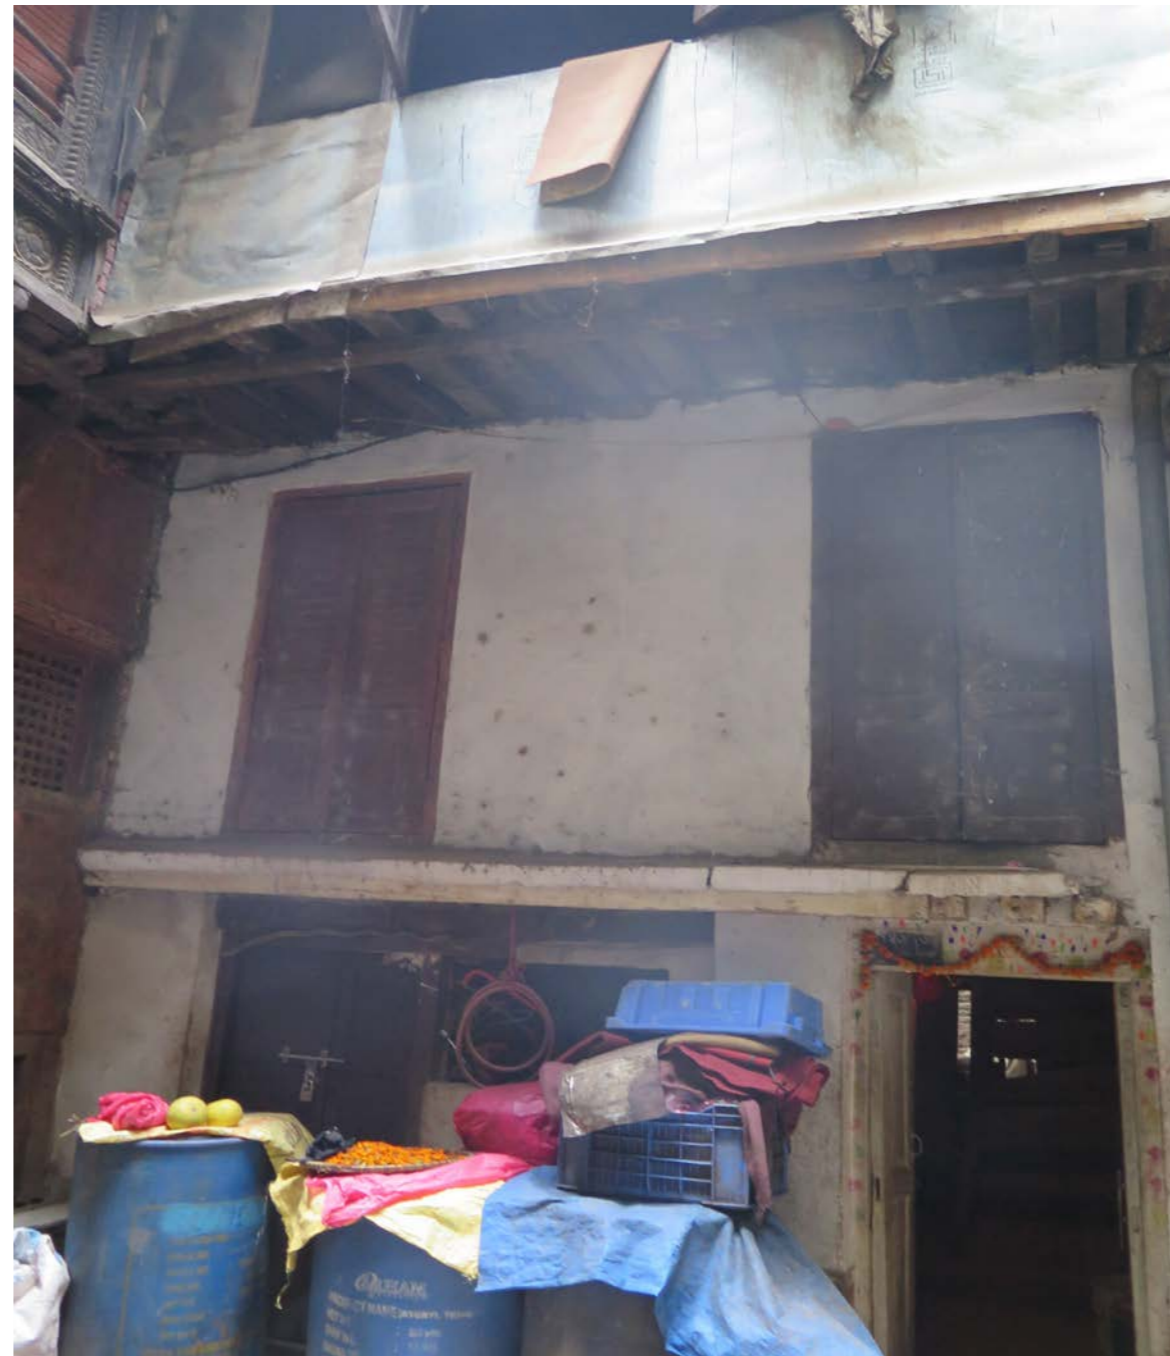
CODE NO	OWNERS NAME/CONTACT	STOREY NUMBER	PRESENT STOREY NUMBER	STRUCTURAL SYSTEM	MATERIAL	GENERAL DESCRIPTION	PROBLEM DESCRIPTION	DANGER	Heritage Significance	REMARKS
a15	Ranjana Maya Shakya	G+5	G+5	Frame	Cement		No visible damage

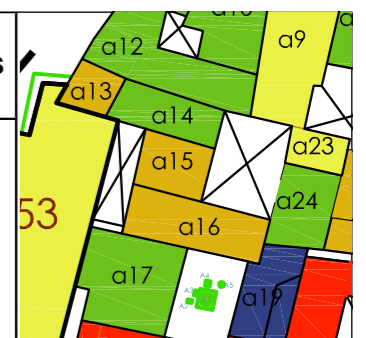
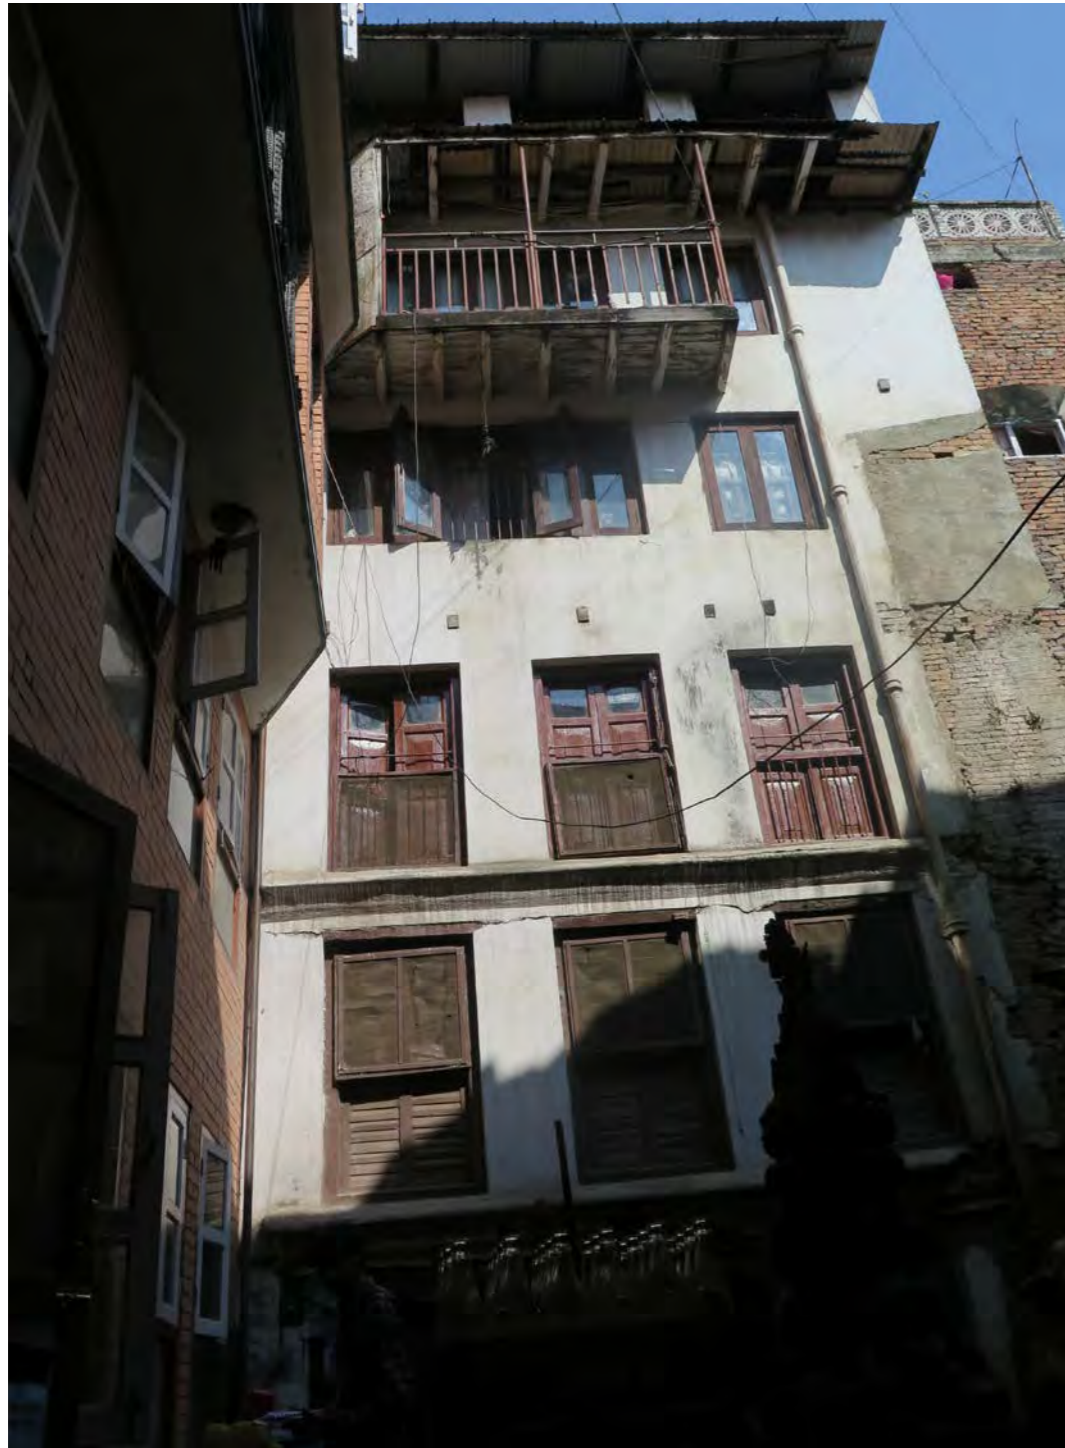
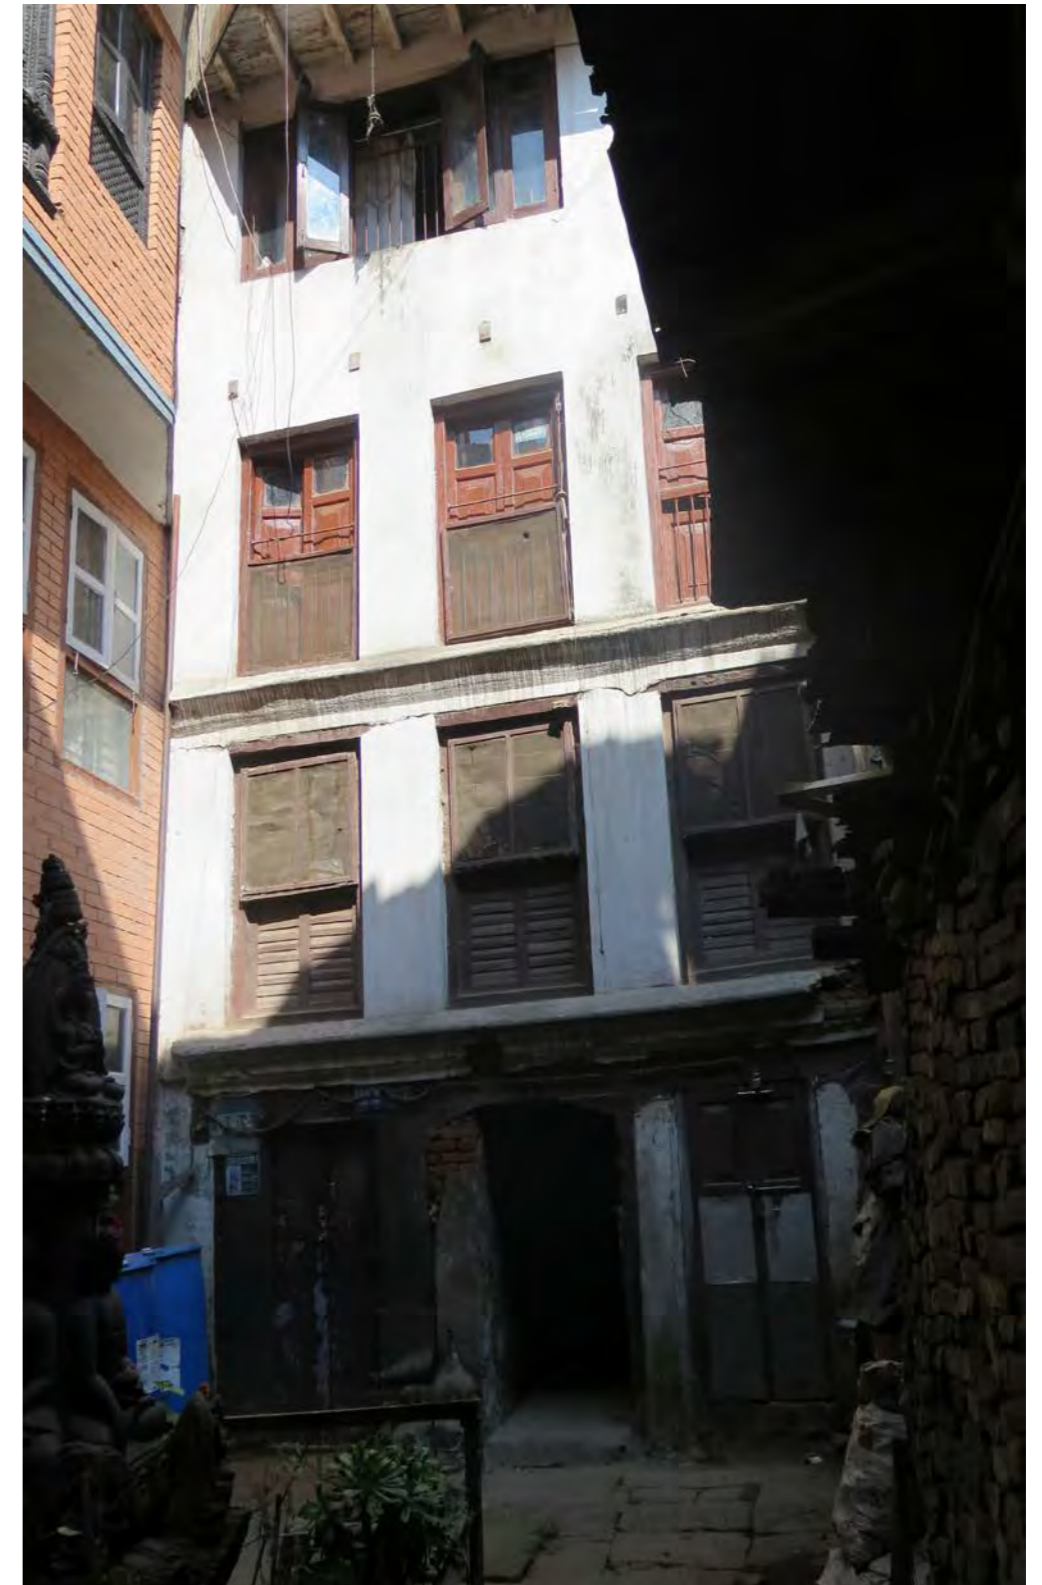
CODE NO	OWNERS NAME/CONTACT	STOREY NUMBER	PRESENT STOREY NUMBER	STRUCTURAL SYSTEM	MATERIAL	GENERAL DESCRIPTION	PROBLEM DESCRIPTION	DANGER	Heritage Significance	REMARKS
a16	Narendra Bahadur Chitrakar	G+4	G+4	Load Bearing	Brick	Tin roof with Verendha on top floor	Moderate internal cracks		+

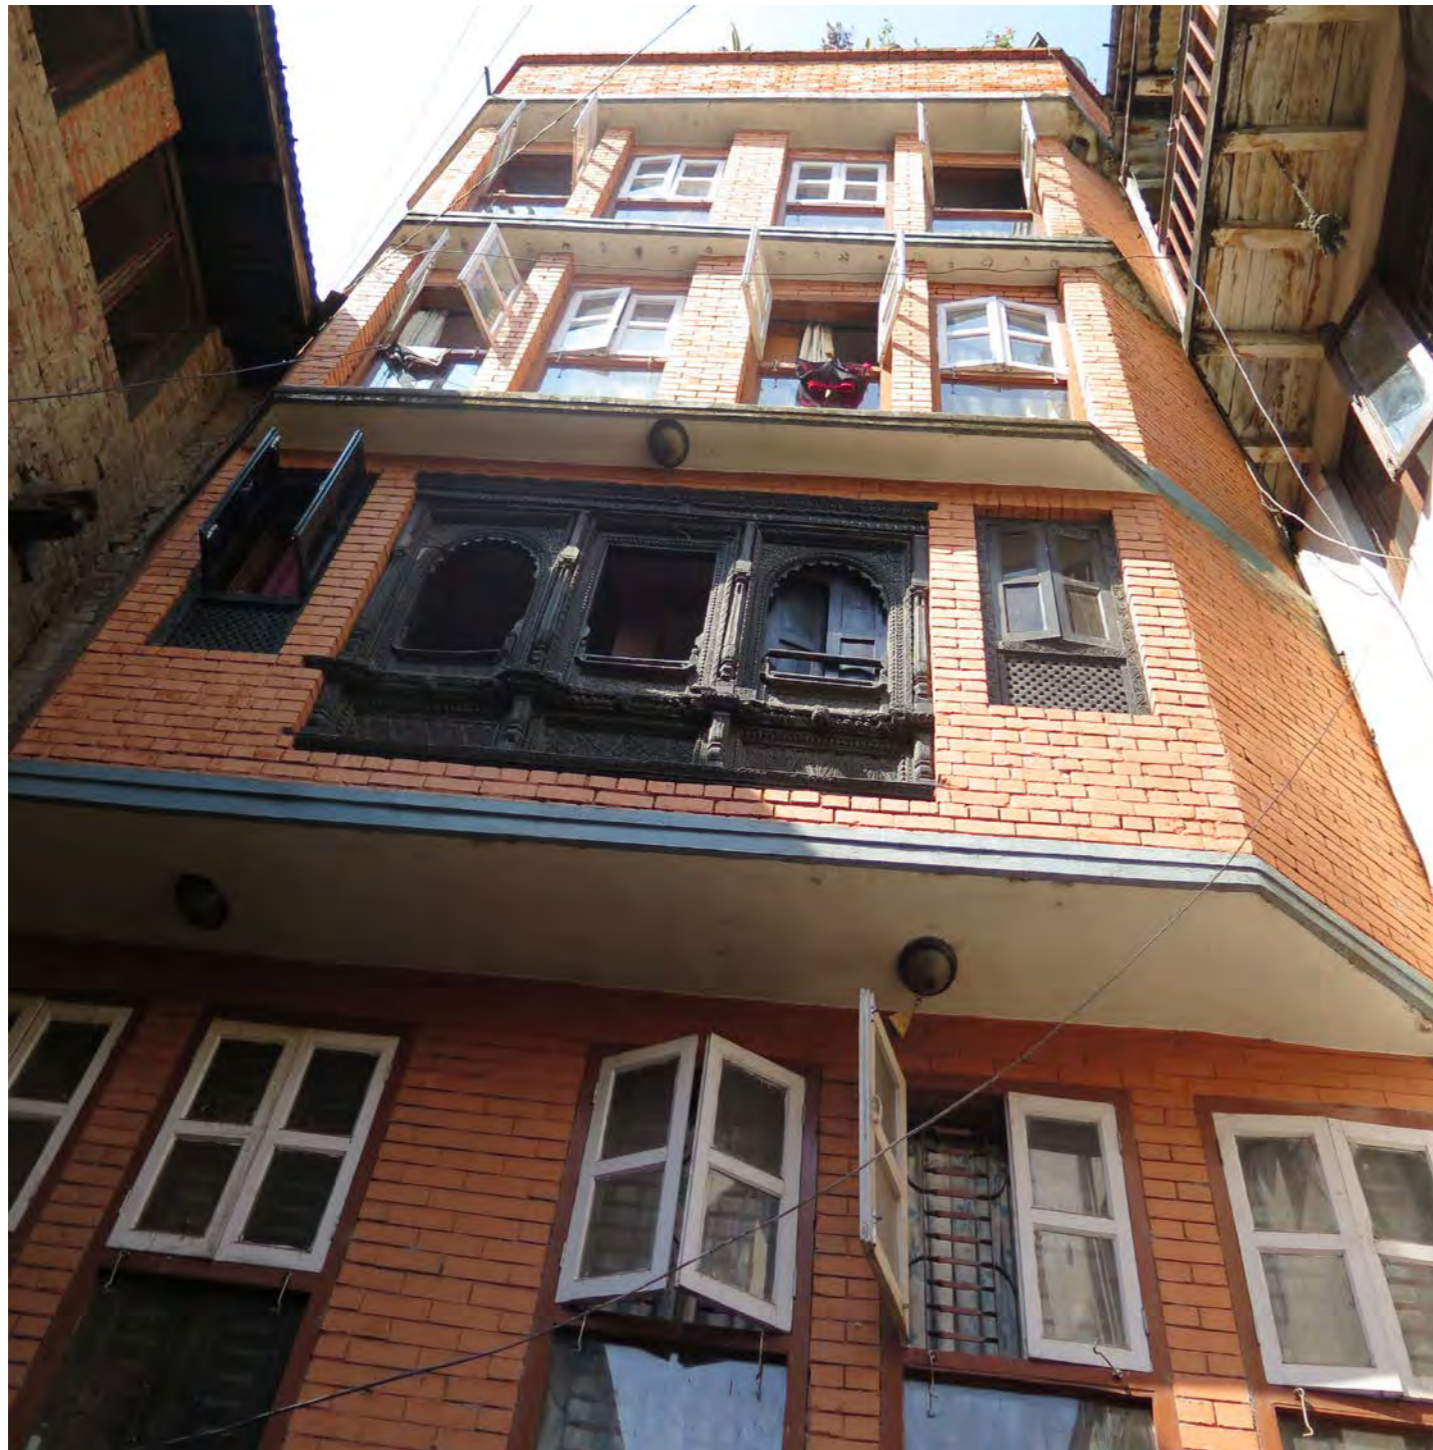
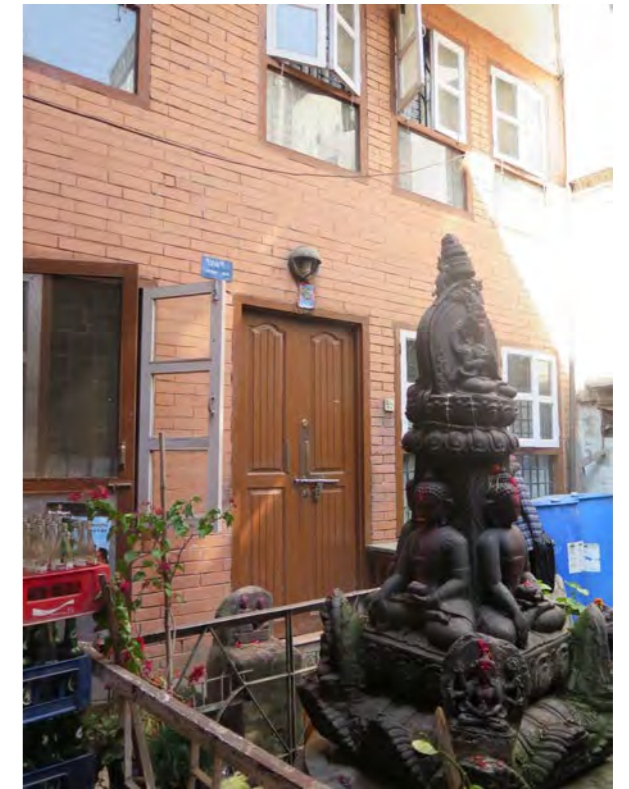
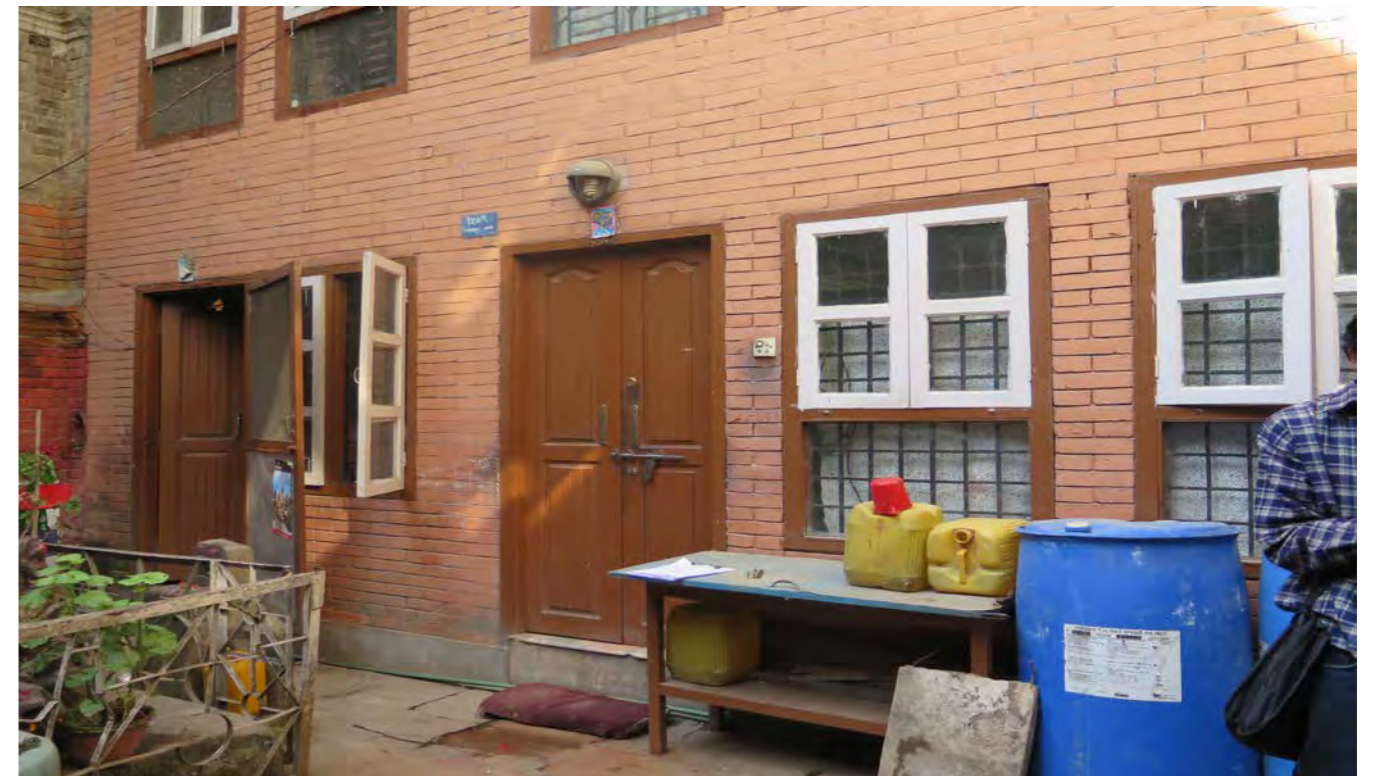
CODE NO	OWNERS NAME/CONTACT	STOREY NUMBER	PRESENT STOREY NUMBER	STRUCTURAL SYSTEM	MATERIAL	GENERAL DESCRIPTION	PROBLEM DESCRIPTION	DANGER	Heritage Significance	REMARKS
a17	Gopal Das Manandhar	G+4	G+4	Frame	Cement	Modern building with RCC frame, brick cladding and carved windows	Minor Internal Cracks

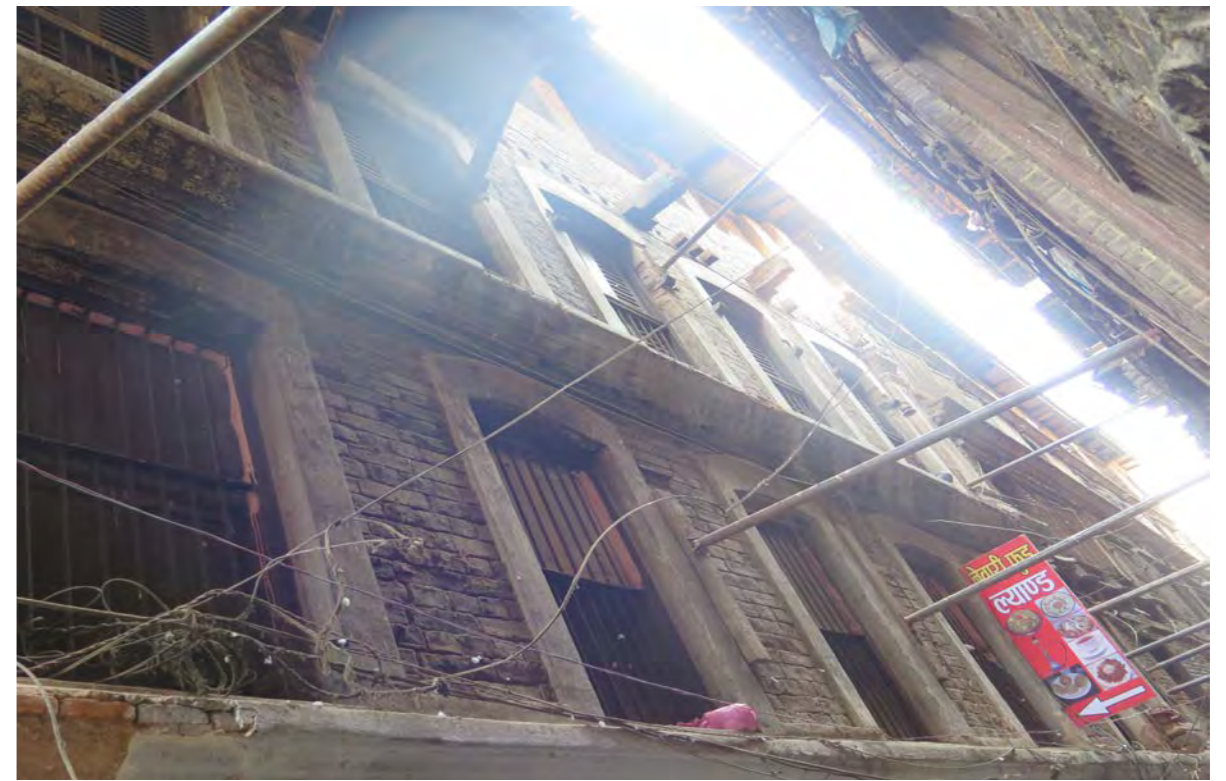
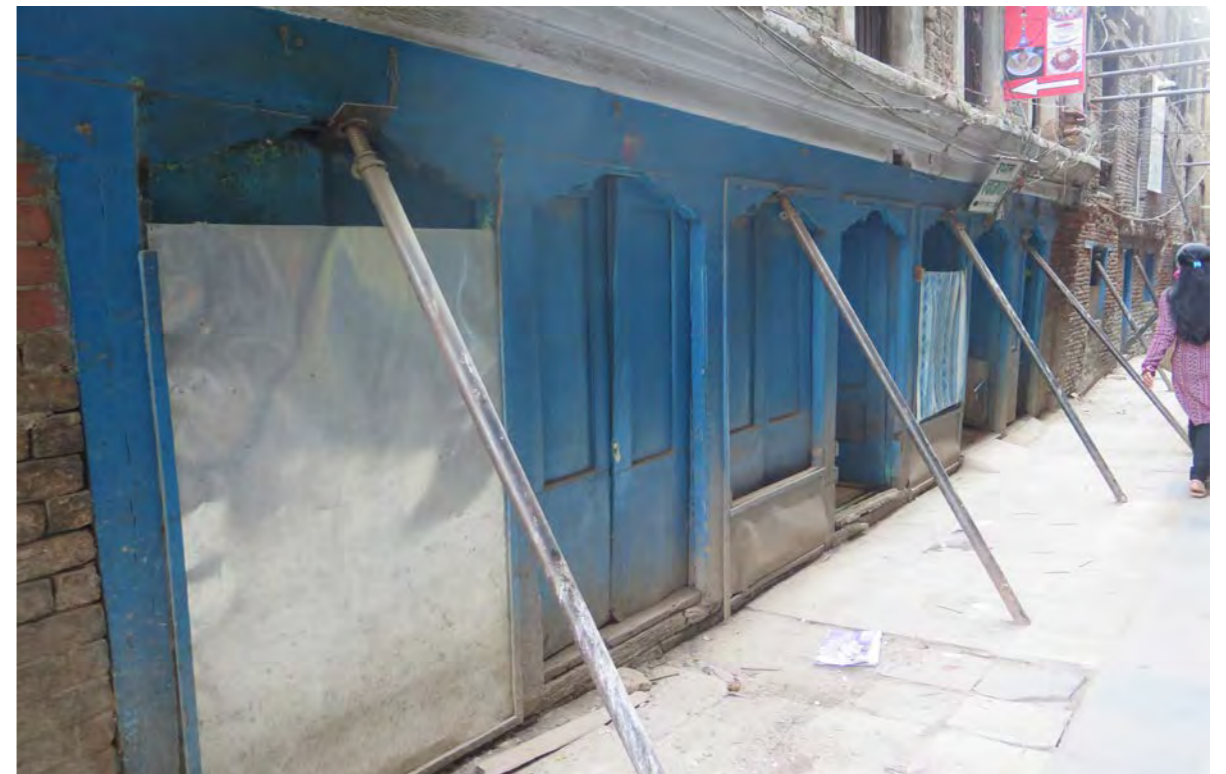
CODE NO	OWNERS NAME/CONTACT	STOREY NUMBER	PRESENT STOREY NUMBER	STRUCTURAL SYSTEM	MATERIAL	GENERAL DESCRIPTION	PROBLEM DESCRIPTION	DANGER	Heritage Significance	REMARKS
a18	Basundhara Bhakta Manandhar	G+3	G+3	Load Bearing	Brick		Partly collapsed; Extensive cracking and bulging of walls		+

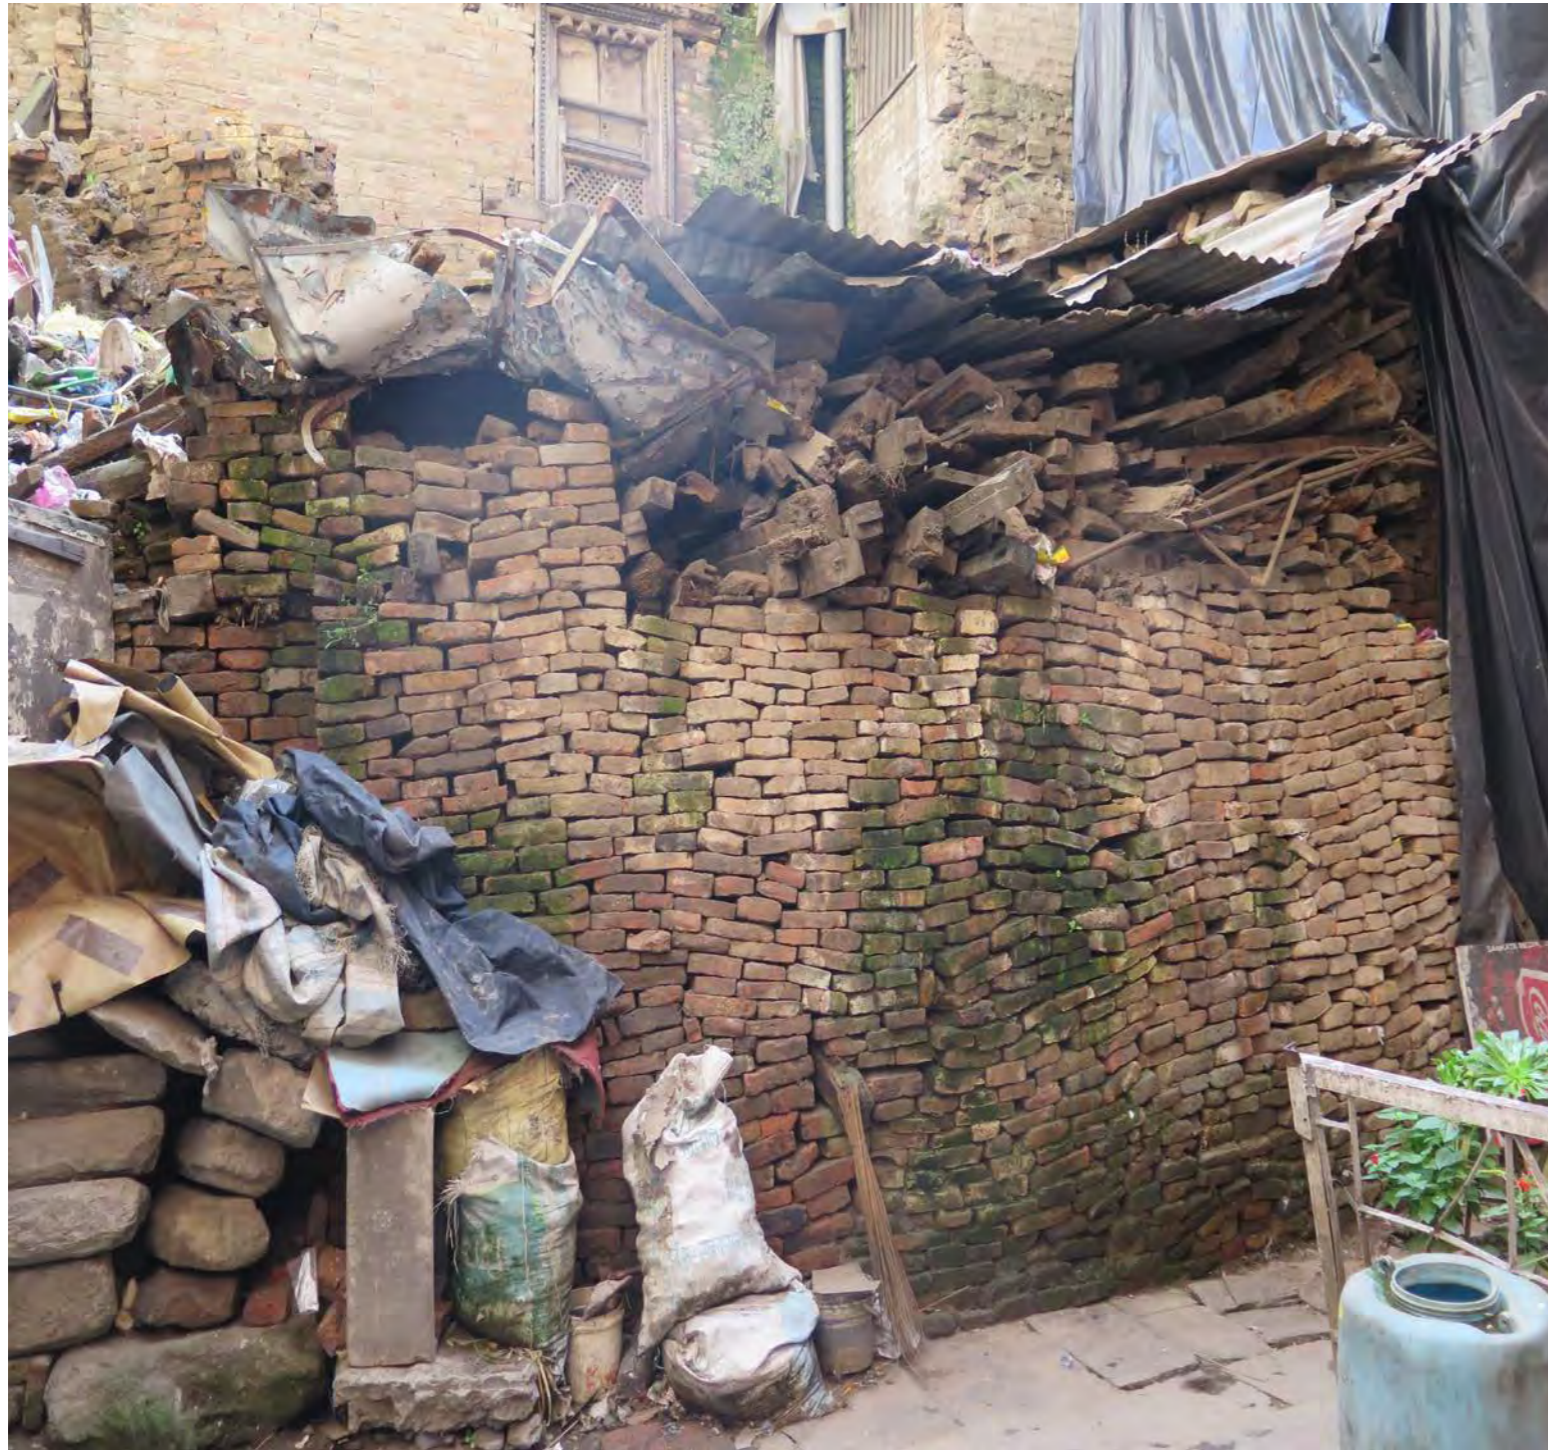
CODE NO	OWNERS NAME/CONTACT	STOREY NUMBER	PRESENT STOREY NUMBER	STRUCTURAL SYSTEM	MATERIAL	GENERAL DESCRIPTION	PROBLEM DESCRIPTION	DANGER	Heritage Significance	REMARKS
a19	Rajendra Bajracharya	G+2	-	Load Bearing	Brick		Totally Collapsed

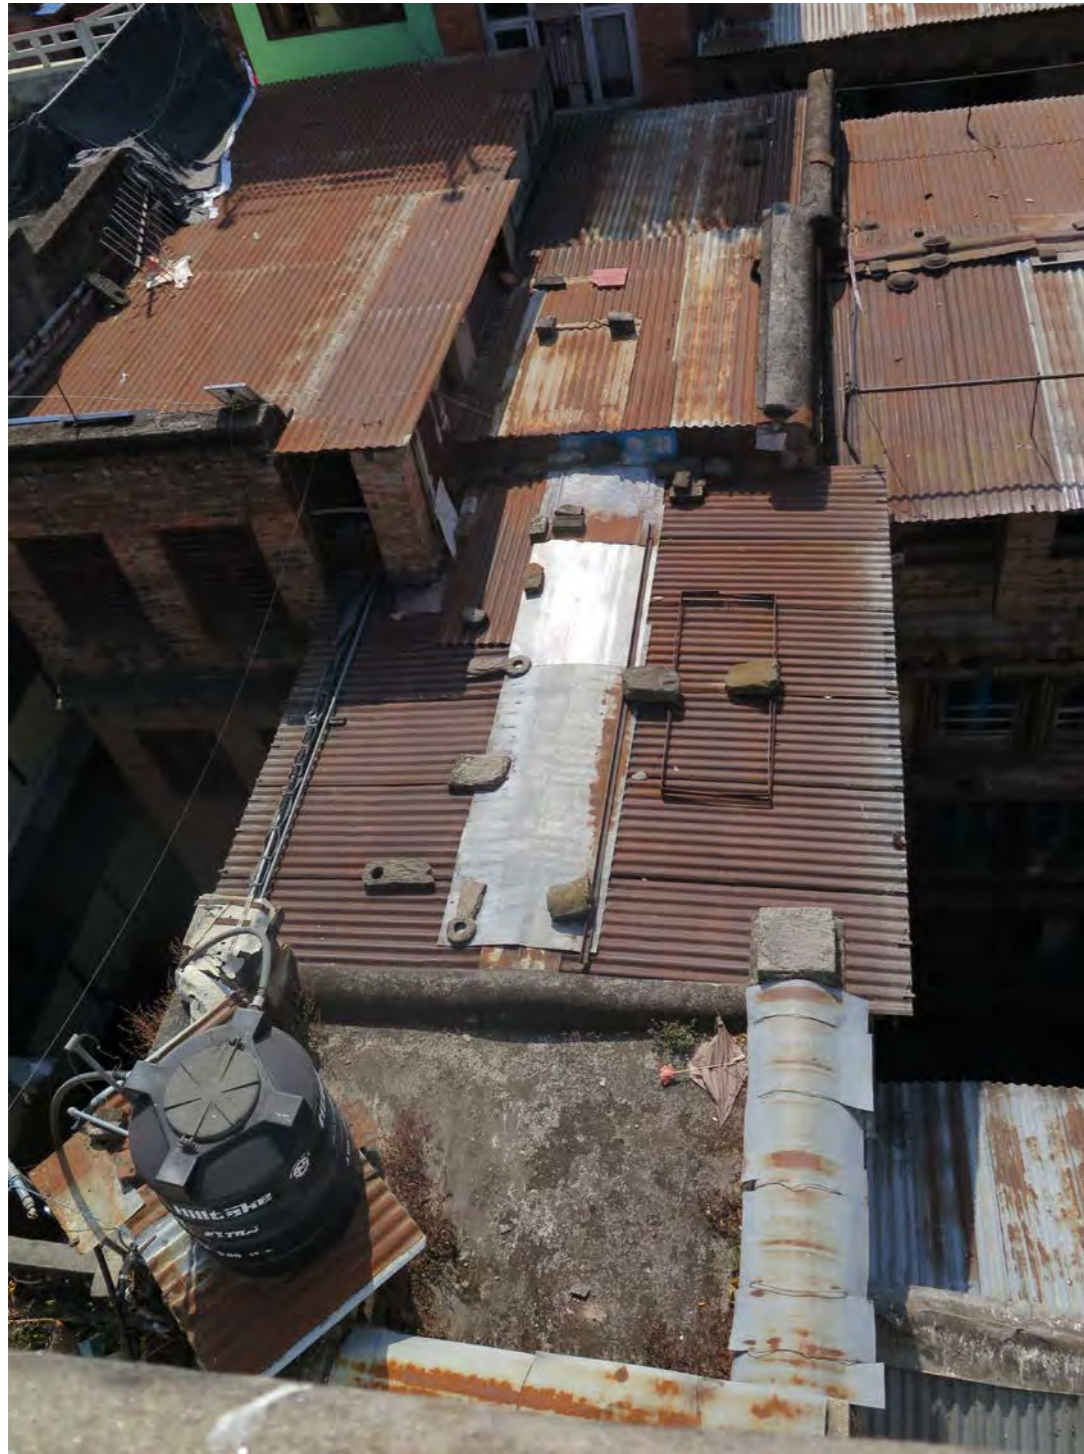
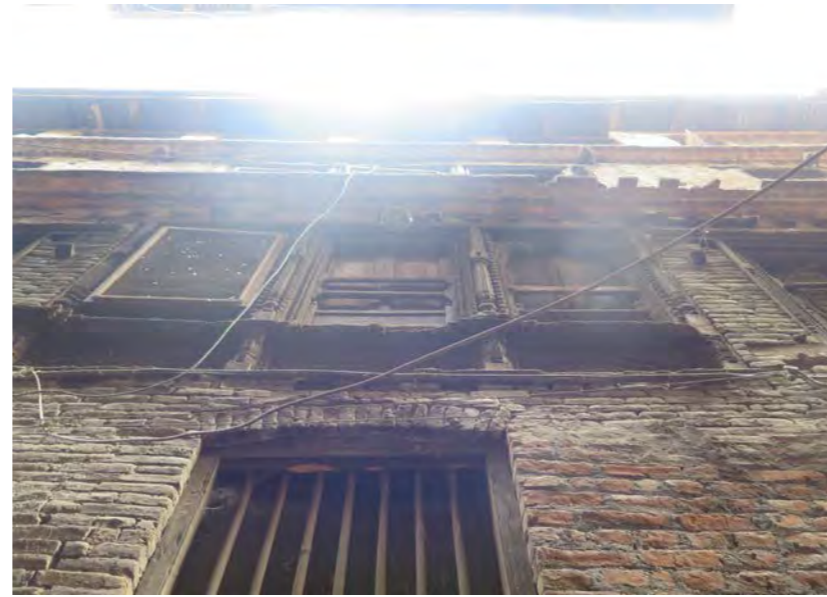
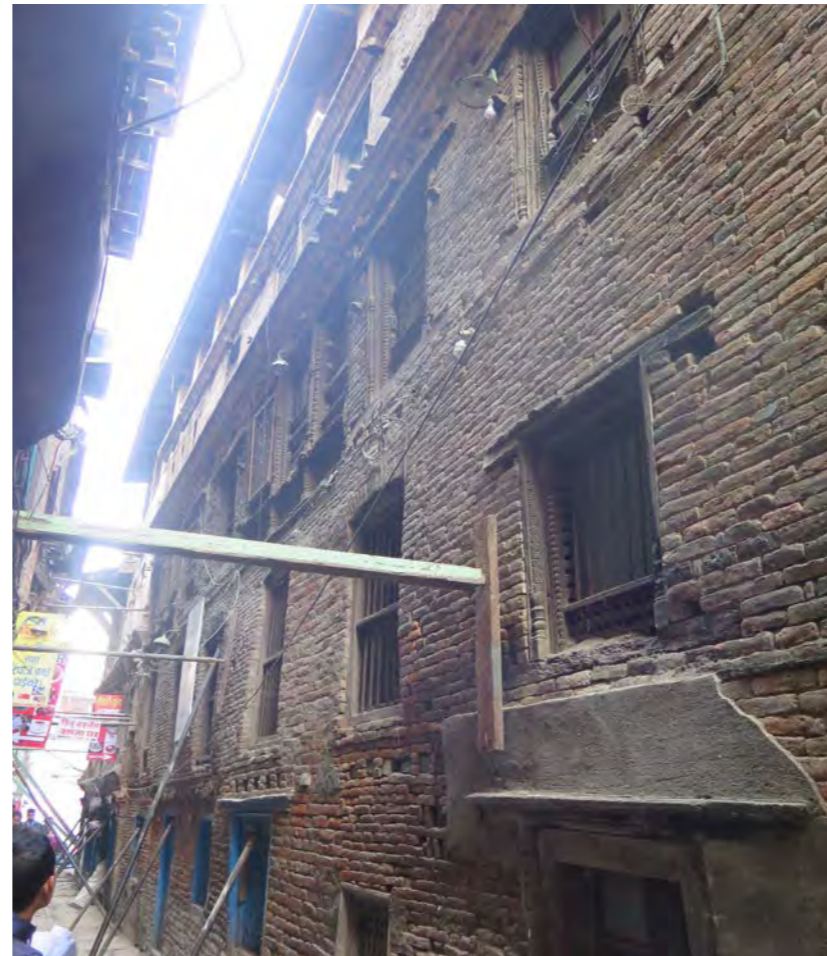
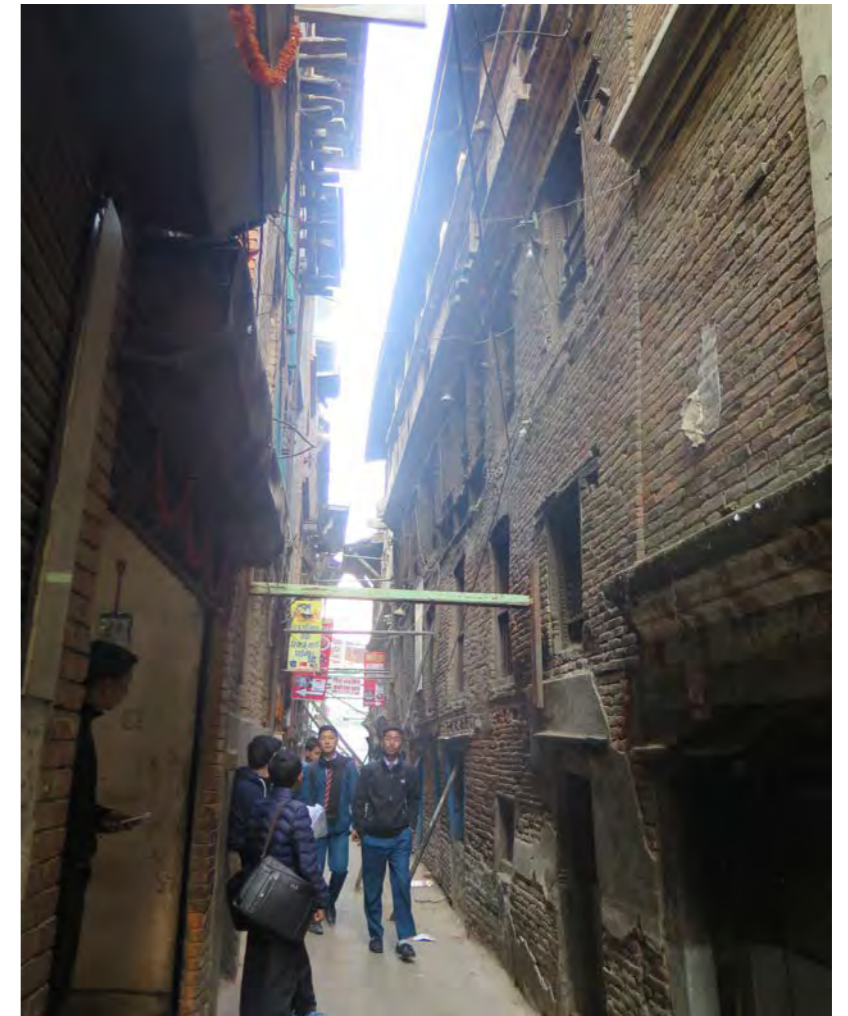
CODE NO	OWNERS NAME/CONTACT	STOREY NUMBER	PRESENT STOREY NUMBER	STRUCTURAL SYSTEM	MATERIAL	GENERAL DESCRIPTION	PROBLEM DESCRIPTION	DANGER	Heritage Significance	REMARKS
a21		G+4	G+4	Load Bearing	Brick		No visible damage
