2015 Earthquake Damage Mapping

Hanuman Dhoka Darbar Square Monument Zone
Kathmandu Valley World Heritage Property

December 2015

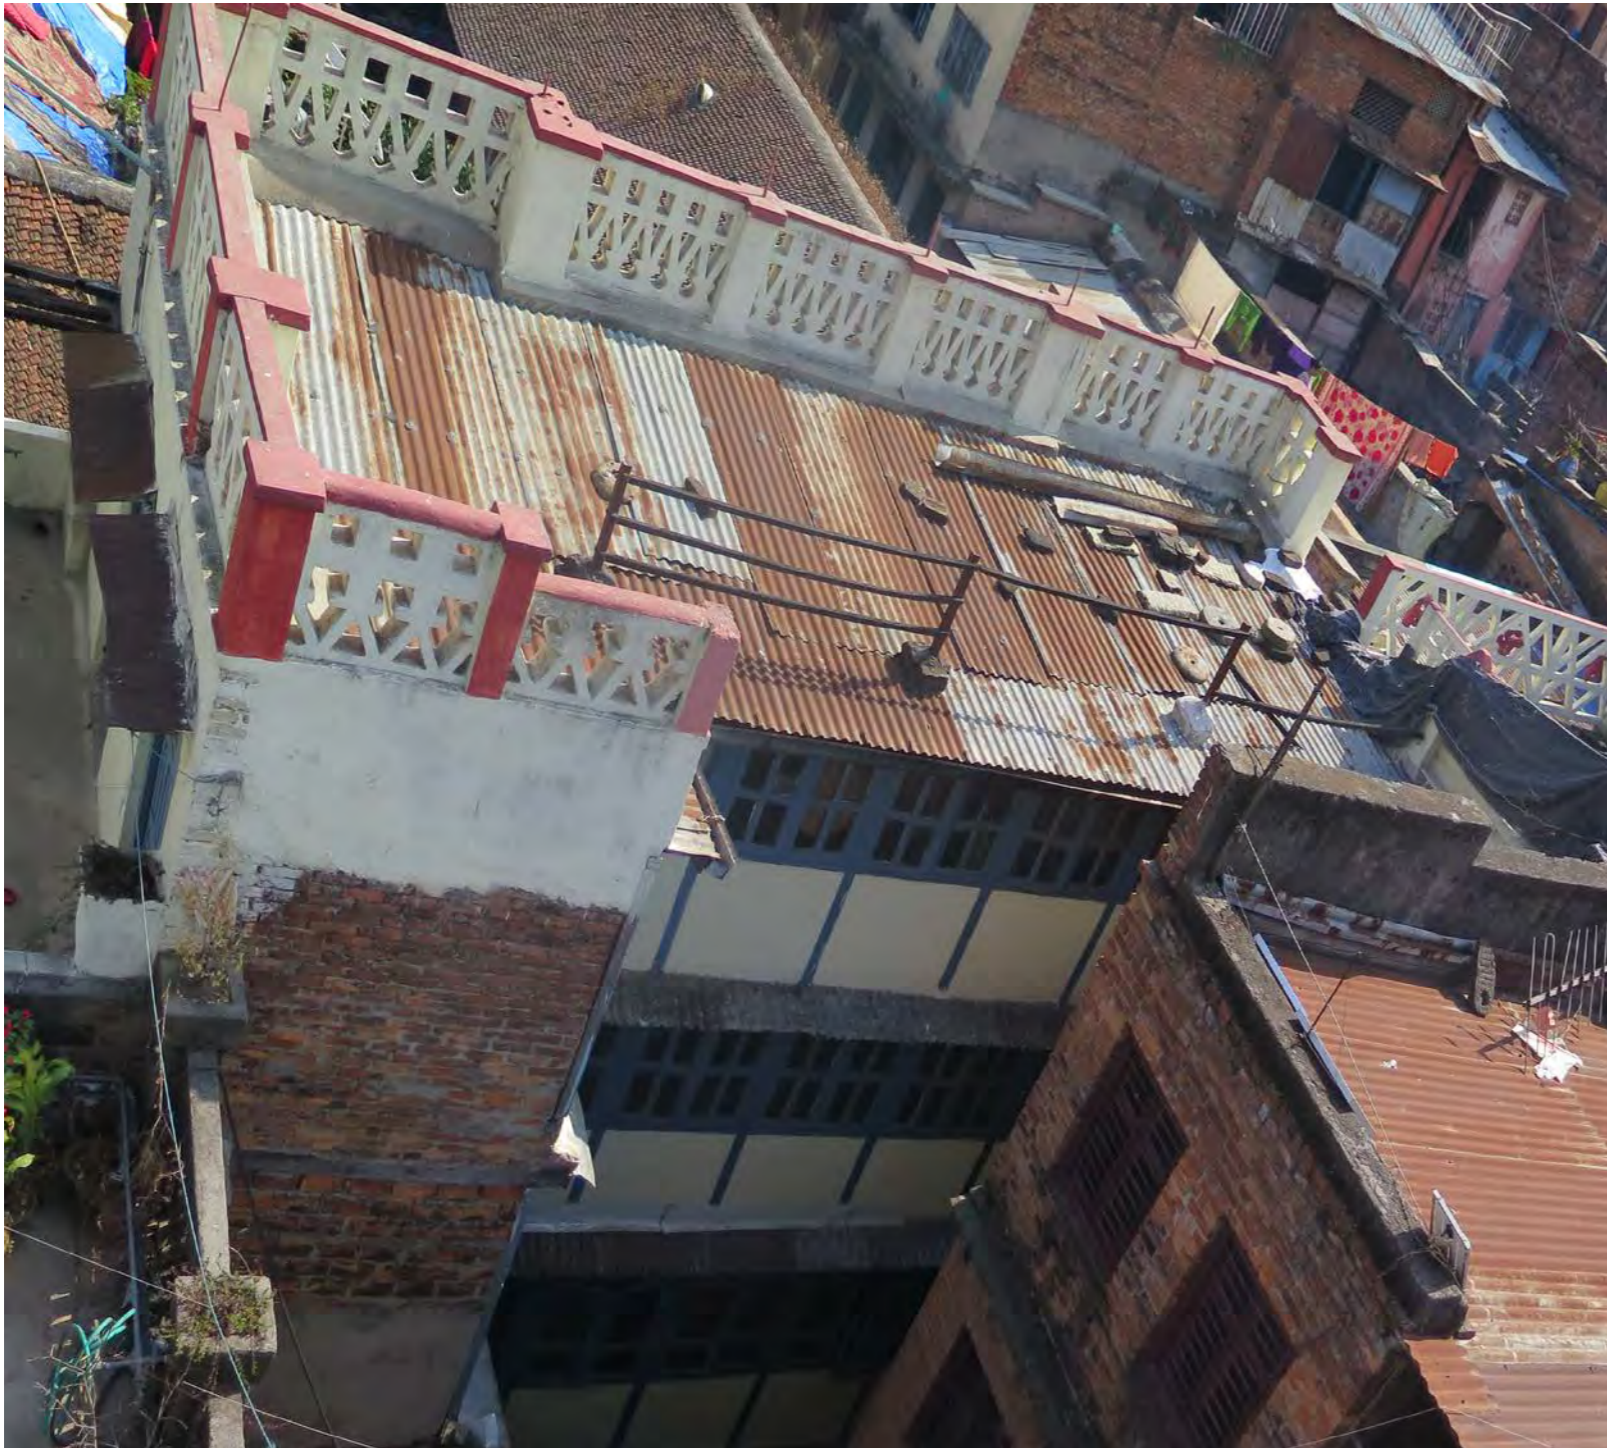
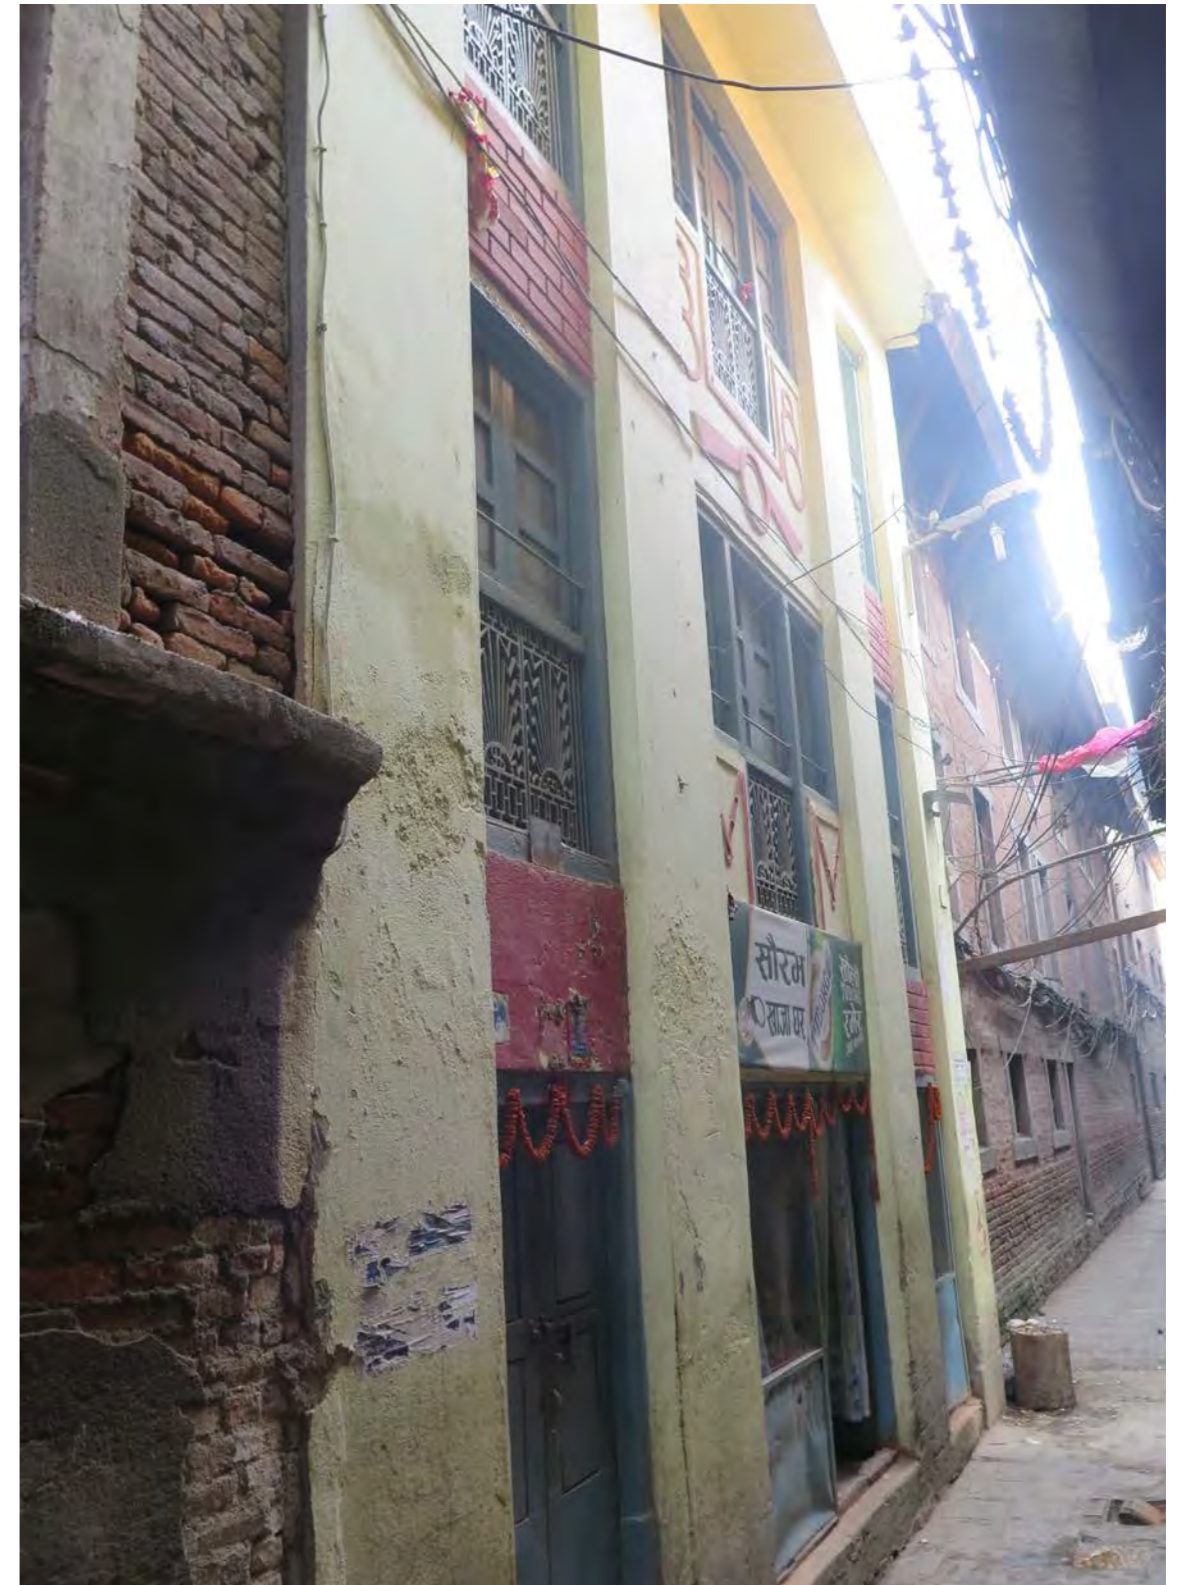
CODE NO	OWNERS NAME/CONTACT	STOREY NUMBER	PRESENT STOREY NUMBER	STRUCTURAL SYSTEM	MATERIAL	GENERAL DESCRIPTION	PROBLEM DESCRIPTION	DANGER	Heritage Significance	REMARKS
a22		G+4	G+4	Load Bearing	Brick		No visible damage

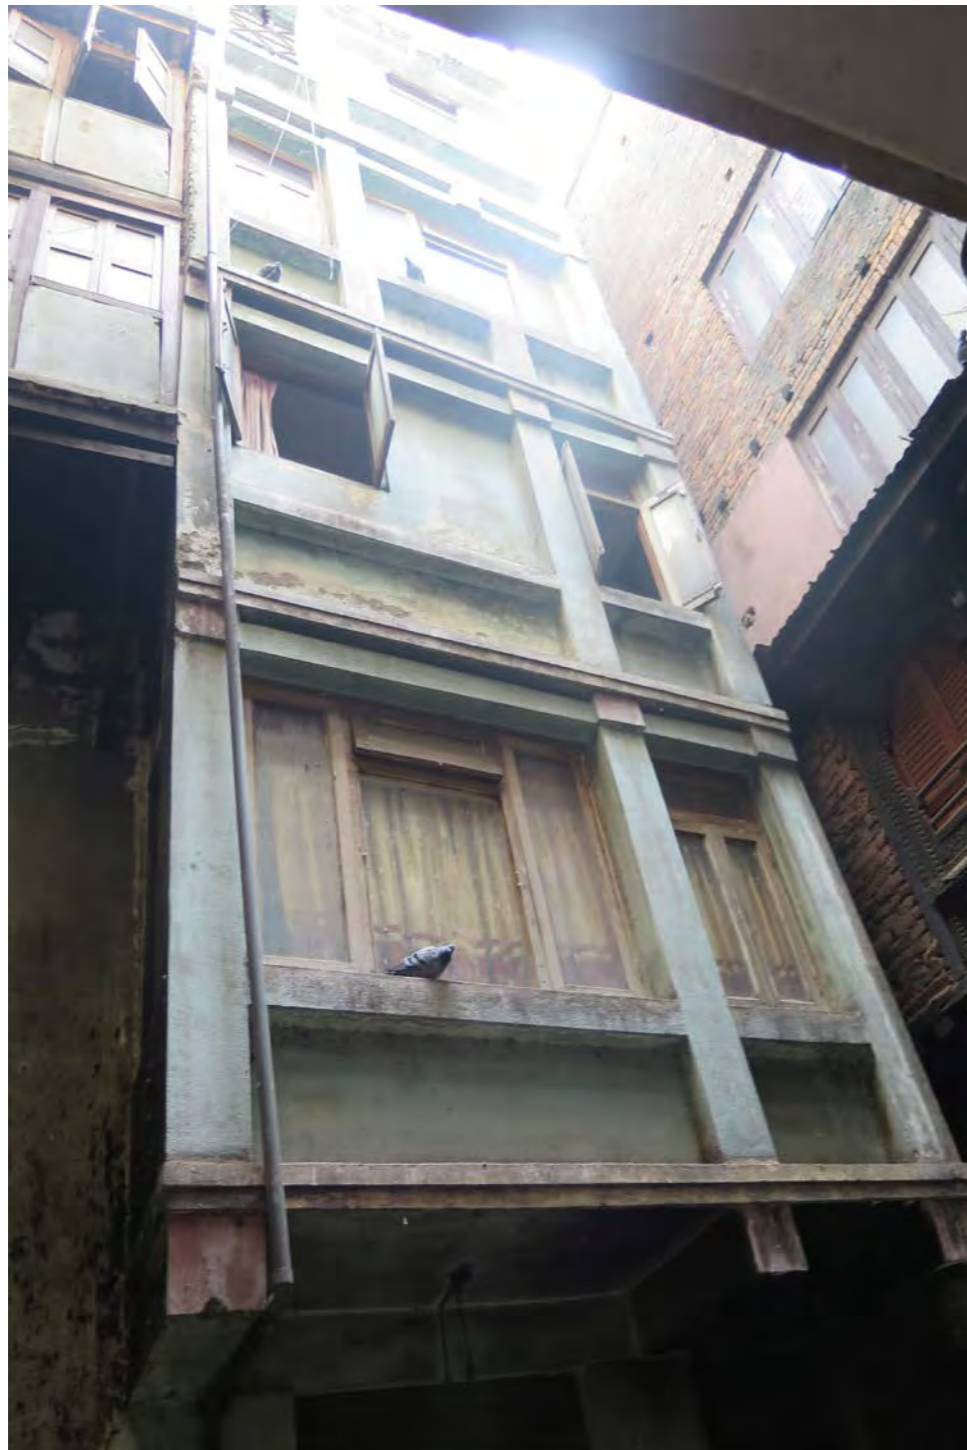
CODE NO	OWNERS NAME/CONTACT	STOREY NUMBER	PRESENT STOREY NUMBER	STRUCTURAL SYSTEM	MATERIAL	GENERAL DESCRIPTION	PROBLEM DESCRIPTION	DANGER	Heritage Significance	REMARKS
a23		G+4	G+4	Frame	Cement		No visible damage			
a24		G+4	G+4	Frame	Cement		No visible damage

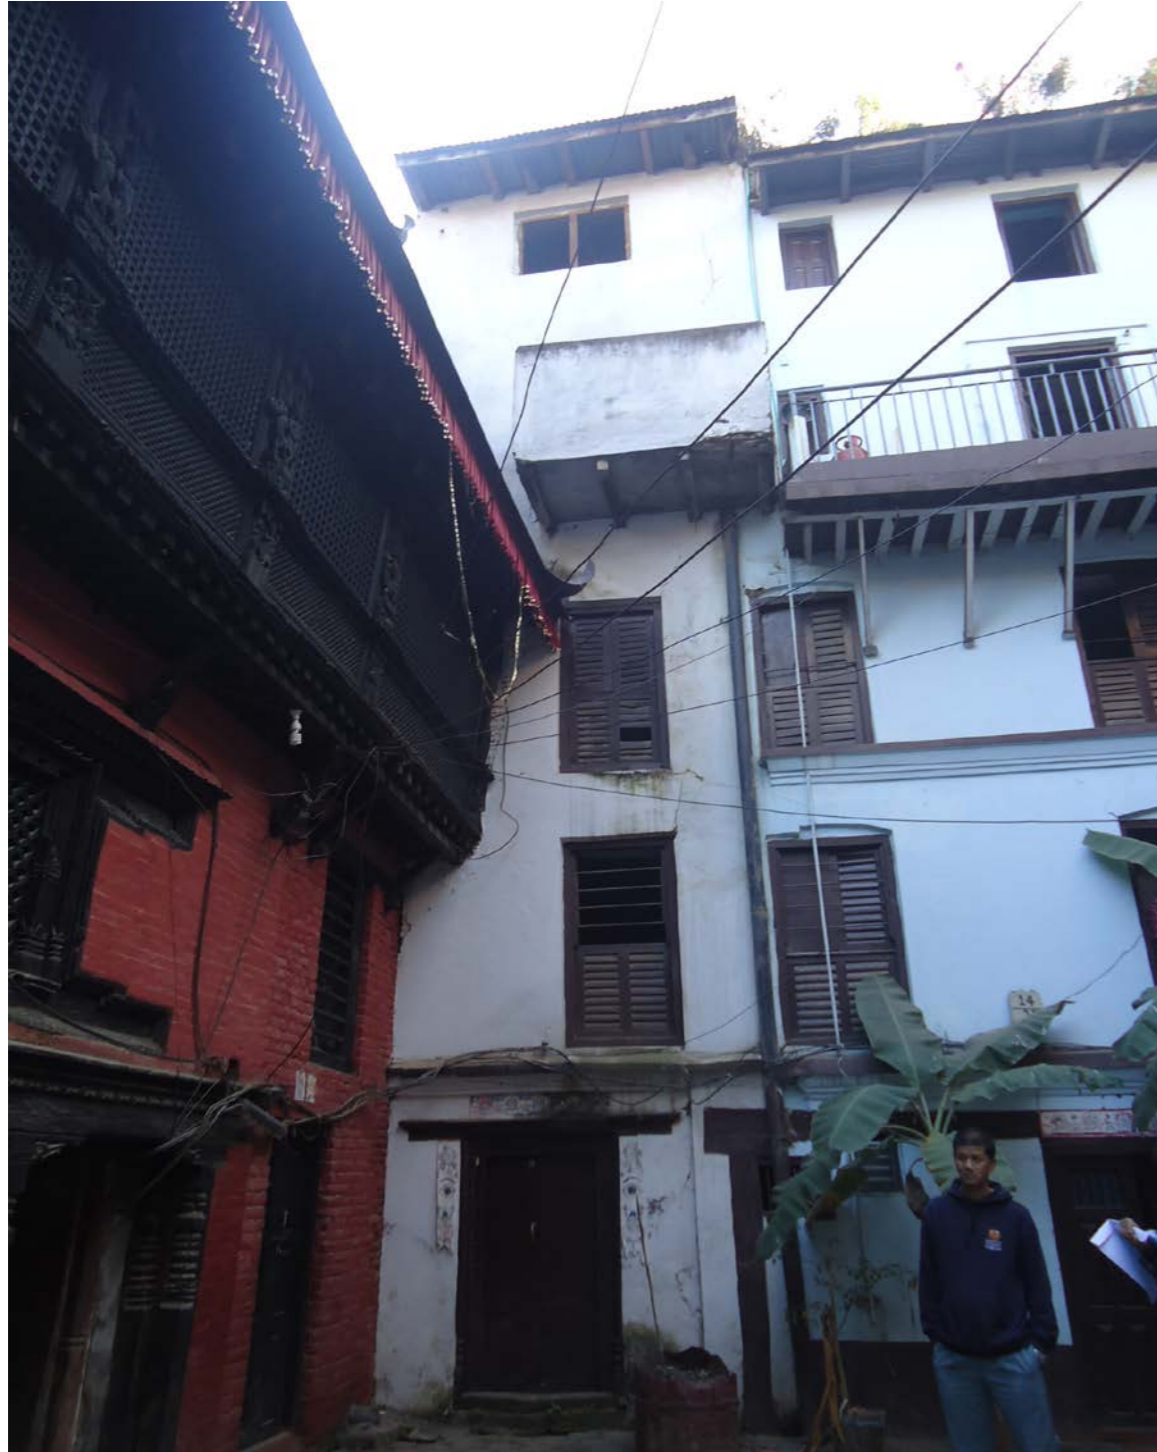
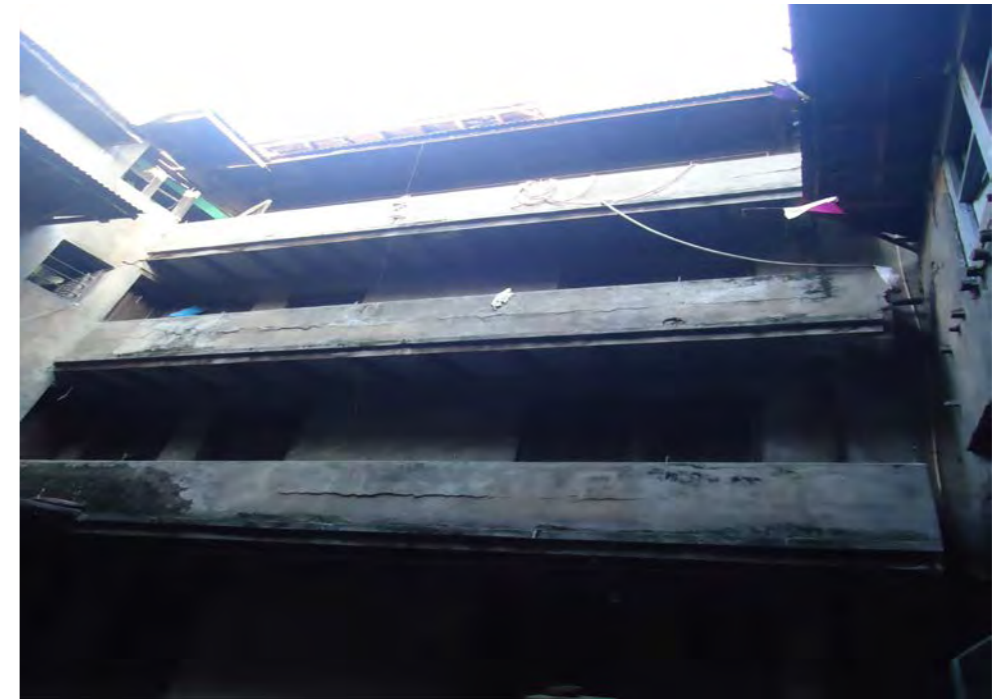
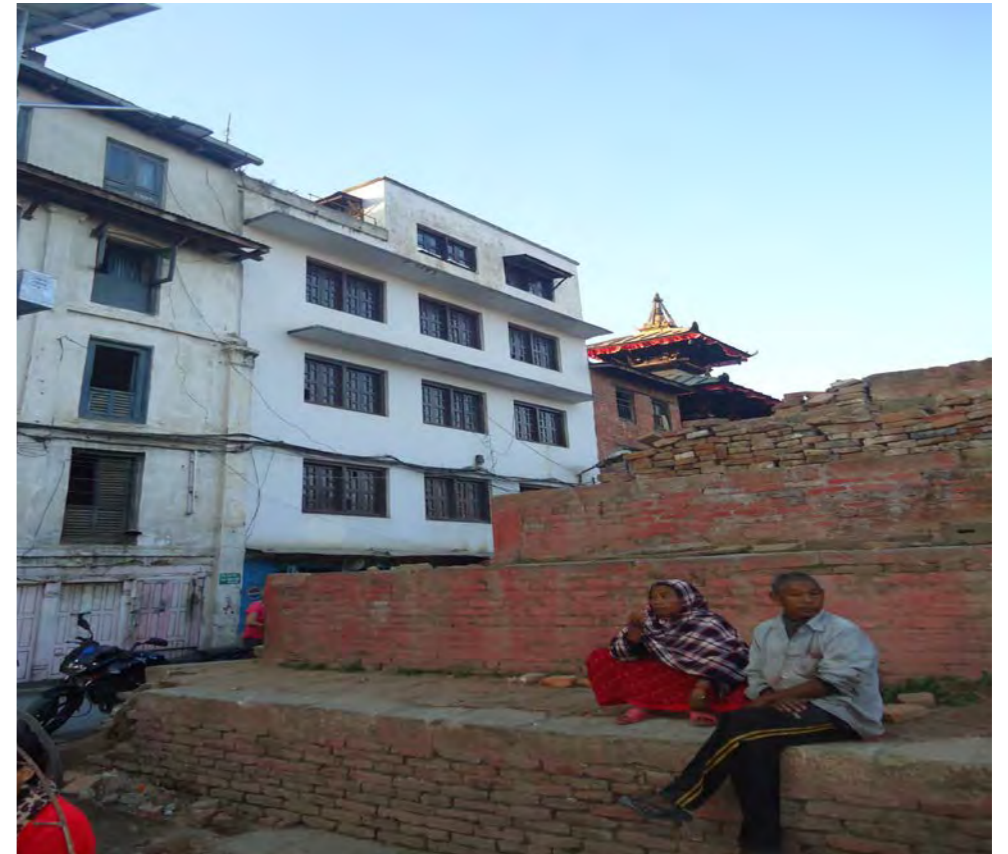
b1

CODE NO	OWNERS NAME/ CONTACT	STOREY NUM- BER	PRESENT STO- REY NUMBER	STRUCTURAL SYSTEM	MATERIAL	GENERAL DESCEIPTION	PROBLEM DESCRIPTION	DANGER	Heritage Sig- nificance	REMARKS
b01	Narayan Dhoj Joshi	G+4	G+4	Load Bearing	Brick	Tin roof with cement plaster	Extensive internal cracks; Currently inhabitaed

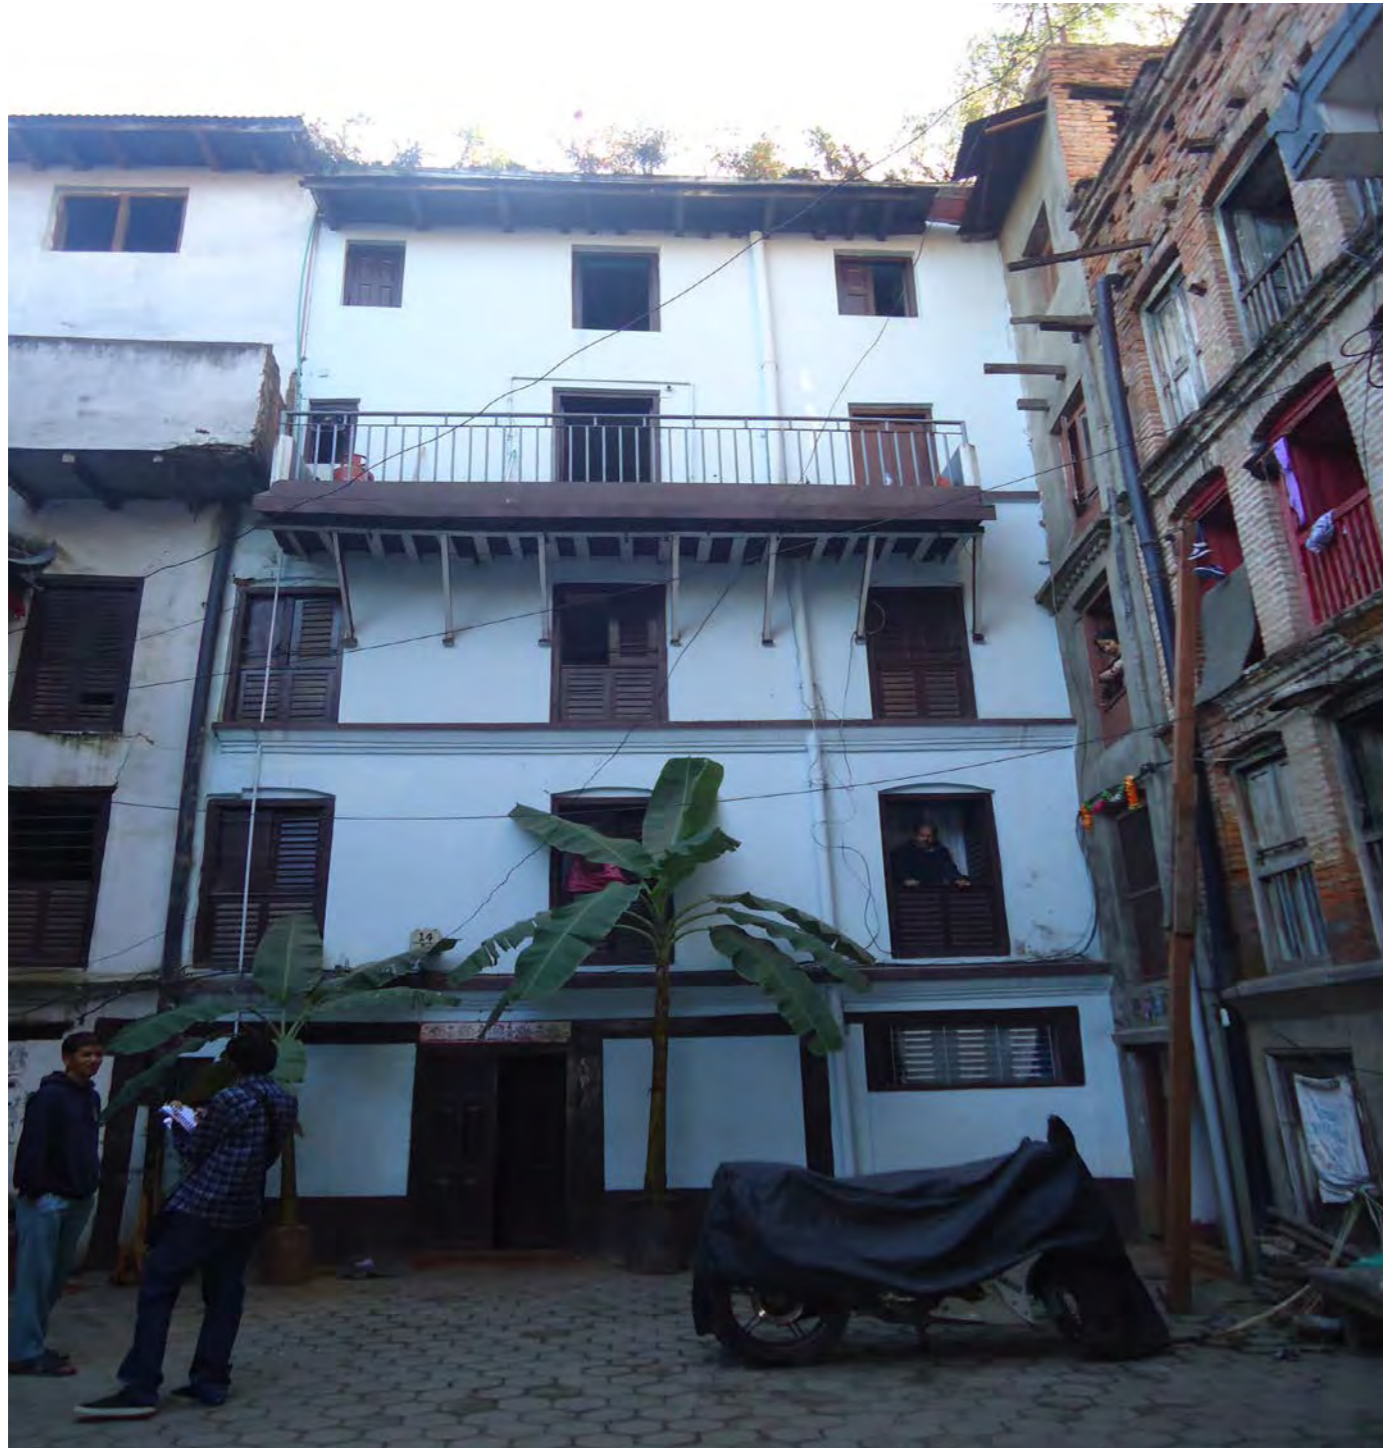
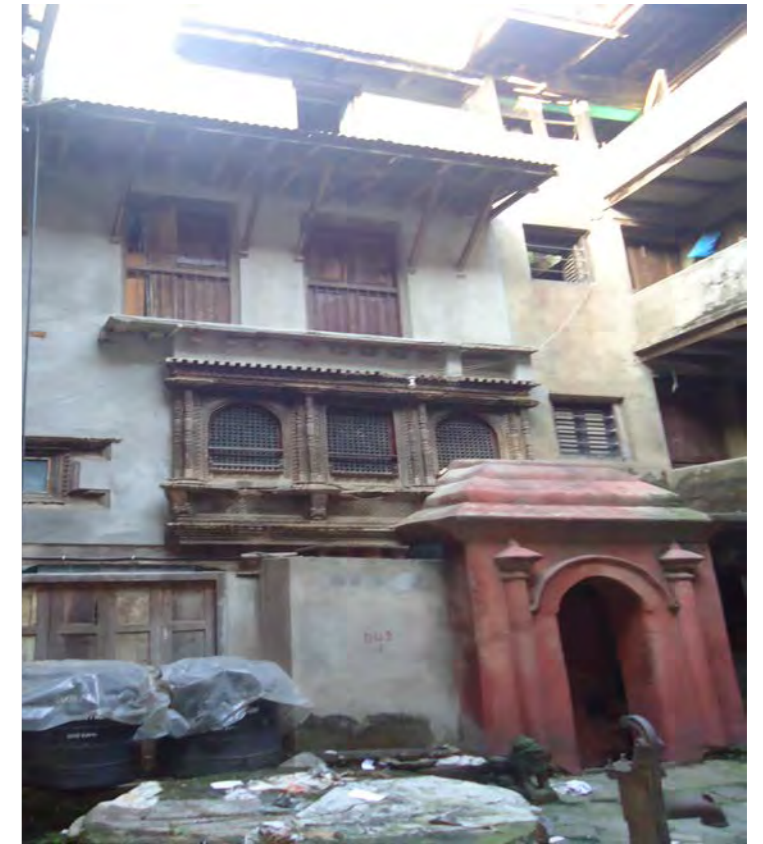
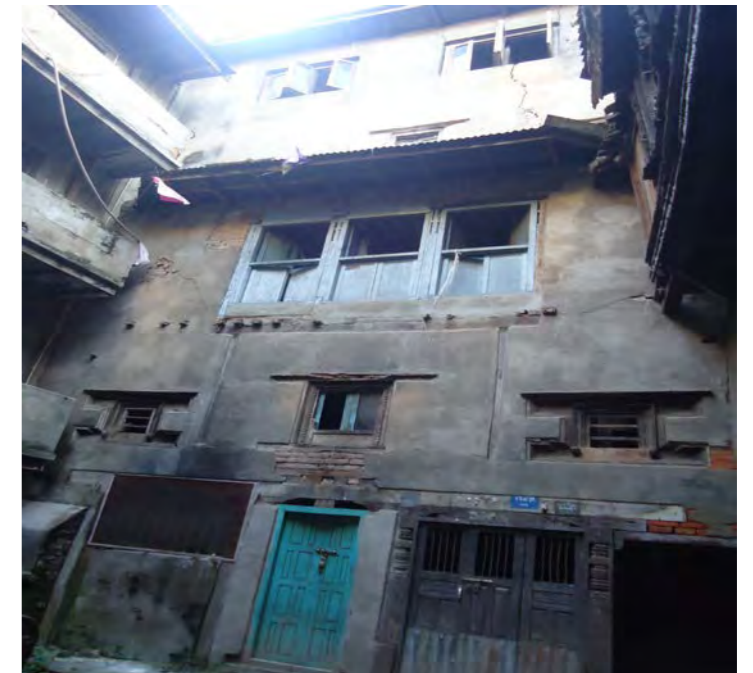
b2

CODE NO	OWNERS NAME/ CONTACT	STOREY NUM- BER	PRESENT STO- REY NUMBER	STRUCTURAL SYSTEM	MATERIAL	GENERAL DESCEIPTION	PROBLEM DESCRIPTION	DANGER	Heritage Sig- nificance	REMARKS
b02	Bijay Dhoj Joshi	G+4	G+4	Load Bearing	Brick	Tin roof with cement plaster	Extensive internal cracks

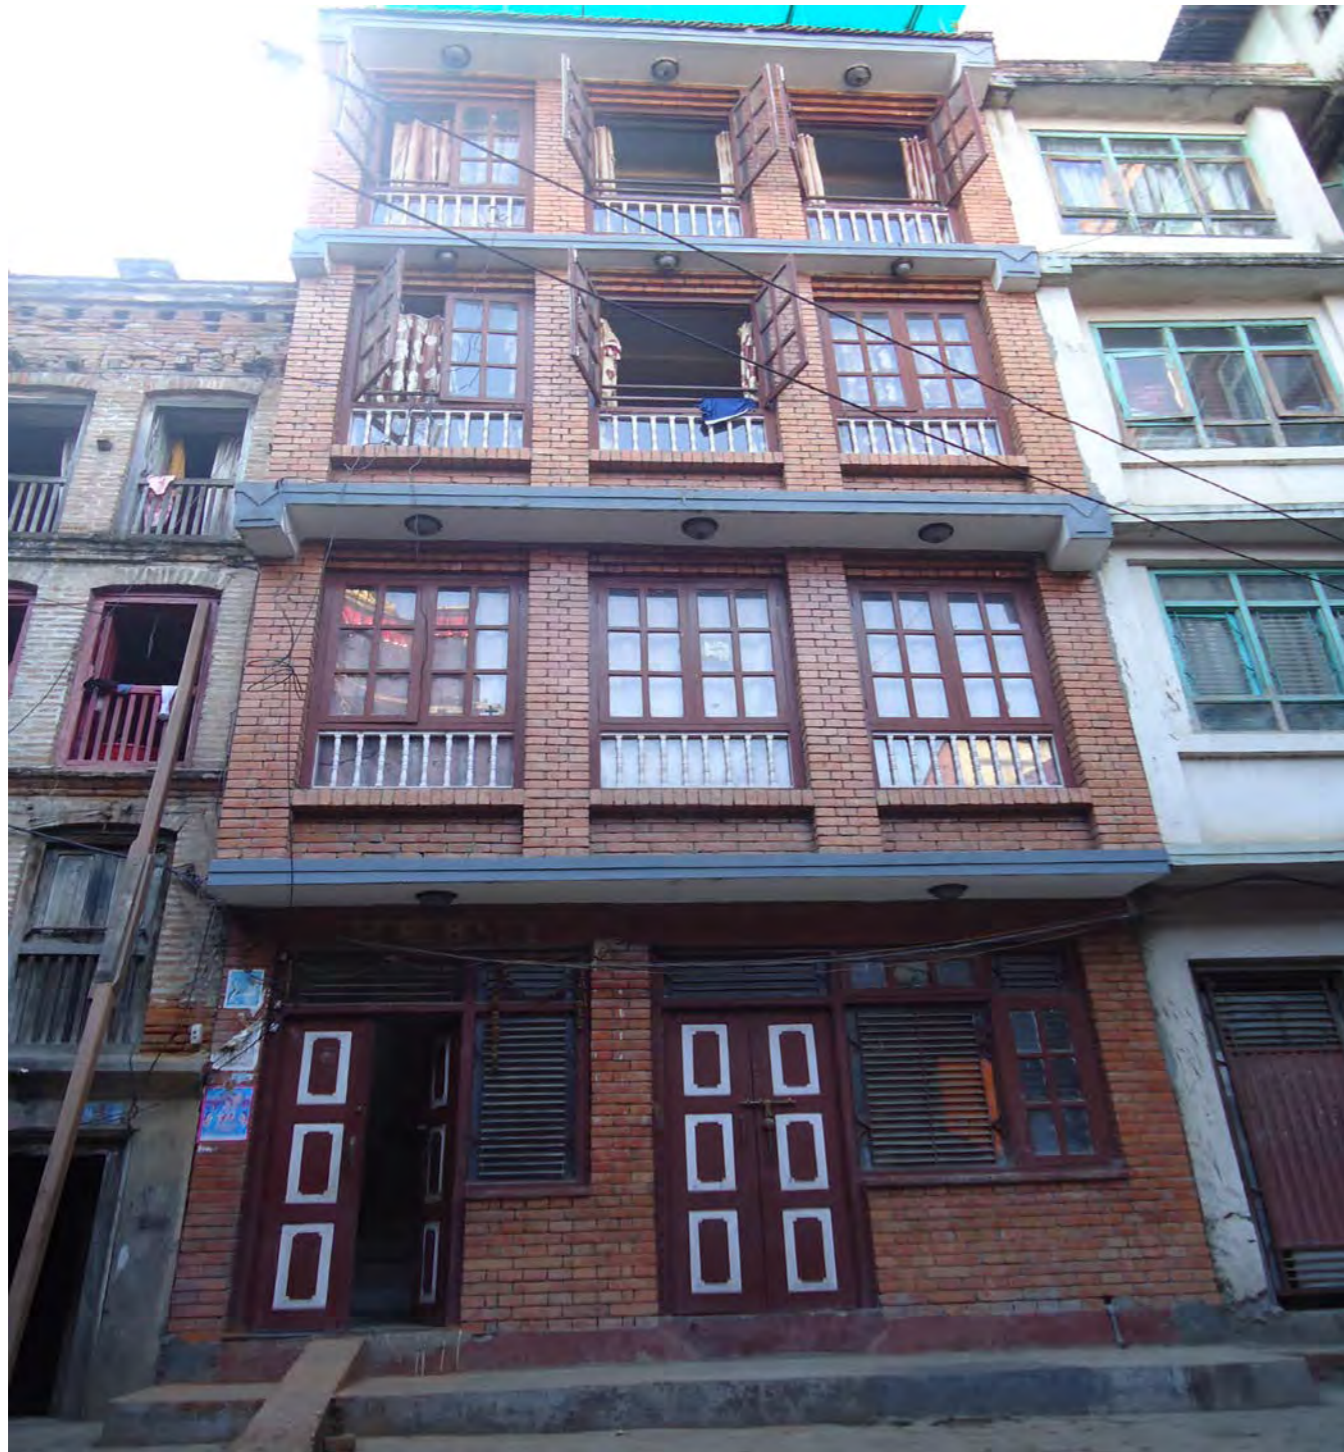
b5

CODE NO	OWNERS NAME/ CONTACT	STOREY NUM- BER	PRESENT STO- REY NUMBER	STRUCTURAL SYSTEM	MATERIAL	GENERAL DESCEIPTION	PROBLEM DESCRIPTION	DANGER	Heritage Sig- nificance	REMARKS
b05	Biswa Bikram Joshi	G+3	G+3	Frame	Cement;Brick	RCC frame with brick facade	No visible damage

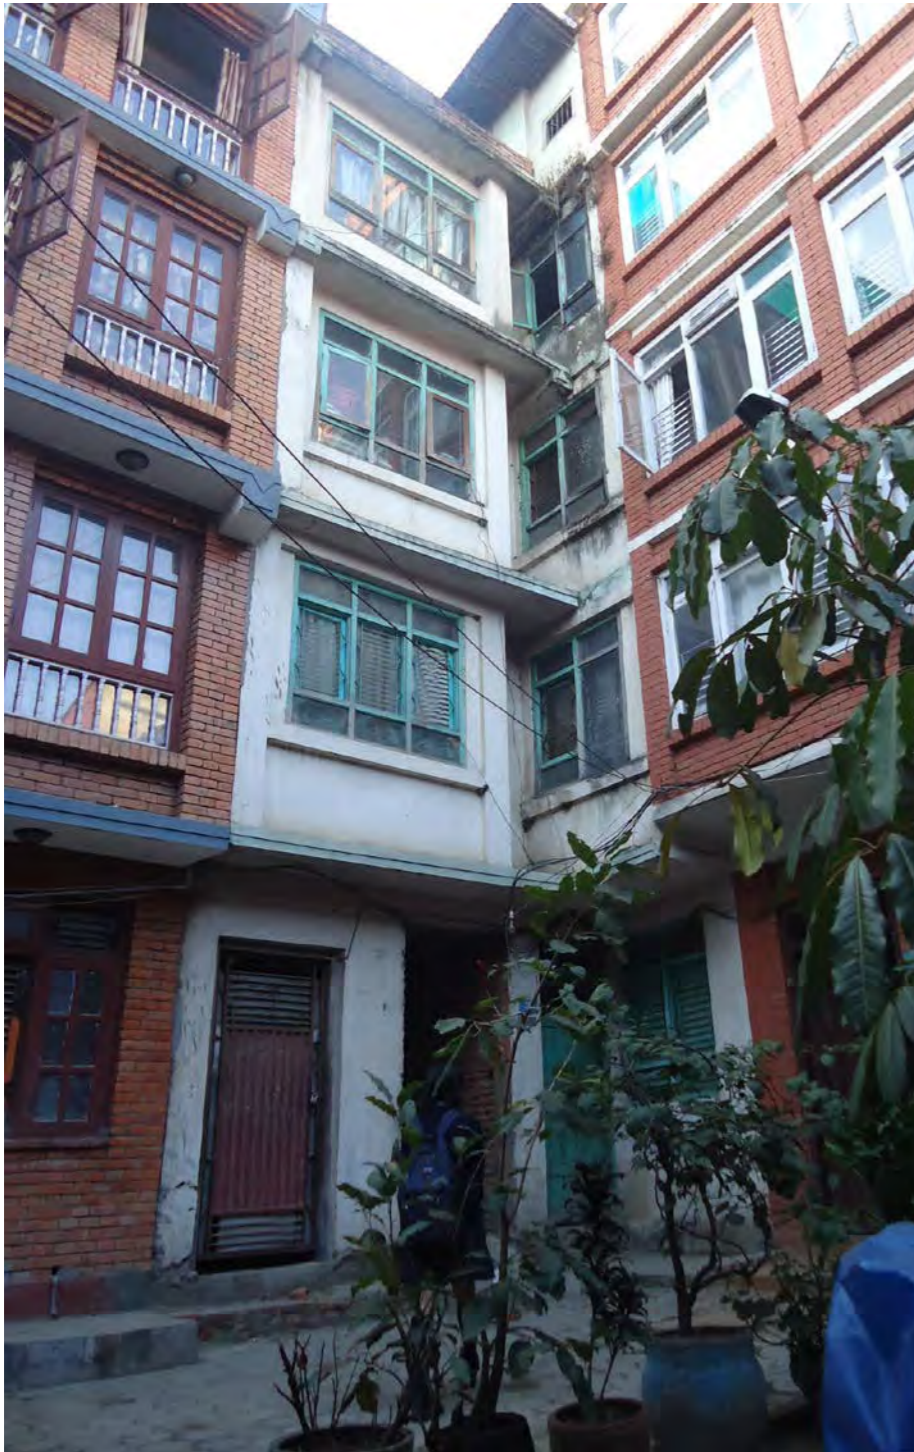
CODE NO	OWNERS NAME/ CONTACT	STOREY NUM- BER	PRESENT STO- REY NUMBER	STRUCTURAL SYSTEM	MATERIAL	GENERAL DESCEIPTION	PROBLEM DESCRIPTION	DANGER	Heritage Sig- nificance	REMARKS	
b6	Sashi Bikram Joshi	G+3	G+3	Frame	Cement	RCC slab roof	Minor cracks in walls present				A site plan diagram showing the layout of buildings. Units are labeled b4, b5, b6, b7, b8, and b9. Unit b6 is highlighted in green. A yellow area is labeled 4. The diagram shows the relative positions of the buildings and units.

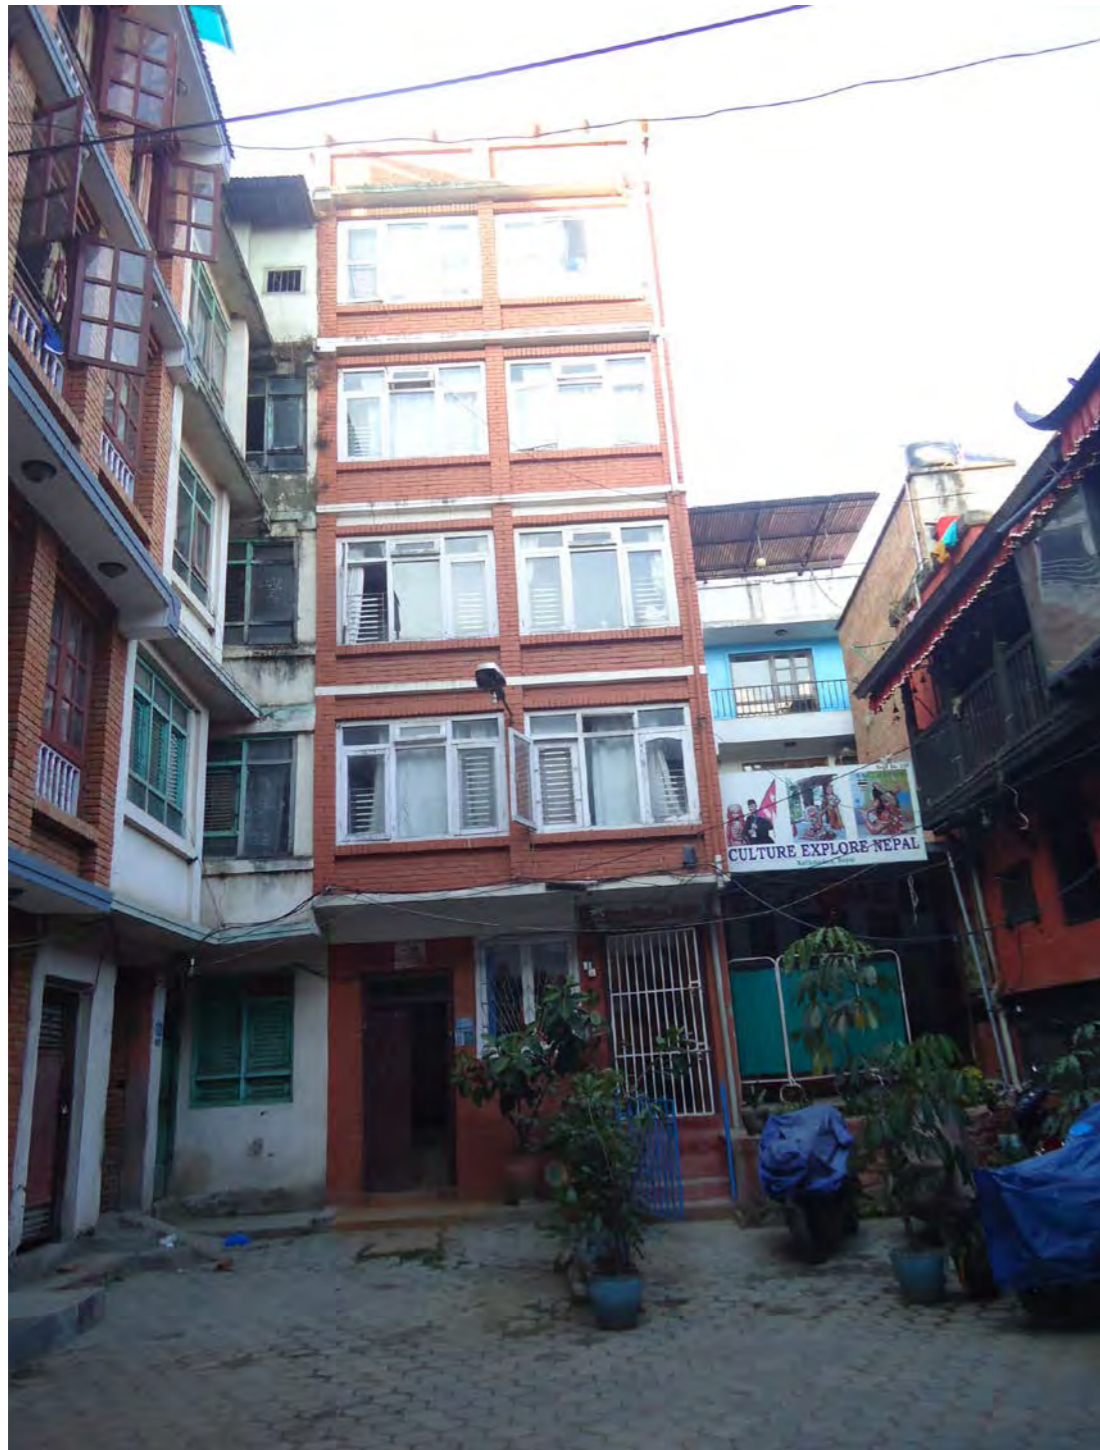
b7, b8, b9

CODE NO	OWNERS NAME/ CONTACT	STOREY NUM- BER	PRESENT STO- REY NUMBER	STRUCTURAL SYSTEM	MATERIAL	GENERAL DESCEIPTION	PROBLEM DESCRIPTION	DANGER	Heritage Sig- nificance	REMARKS
b07	Sashi Bikram Joshi	G+4	G+4	Frame	Cement	RCC slab roof	Minor cracks in walls			
b08	Devendra Raj Joshi	G+4	G+4	Frame	Cement;Brick	RCC frame with brick facade	No visible damage			
b09		G	G	Load Bearing	Brick	Used as shelter	No visible damage

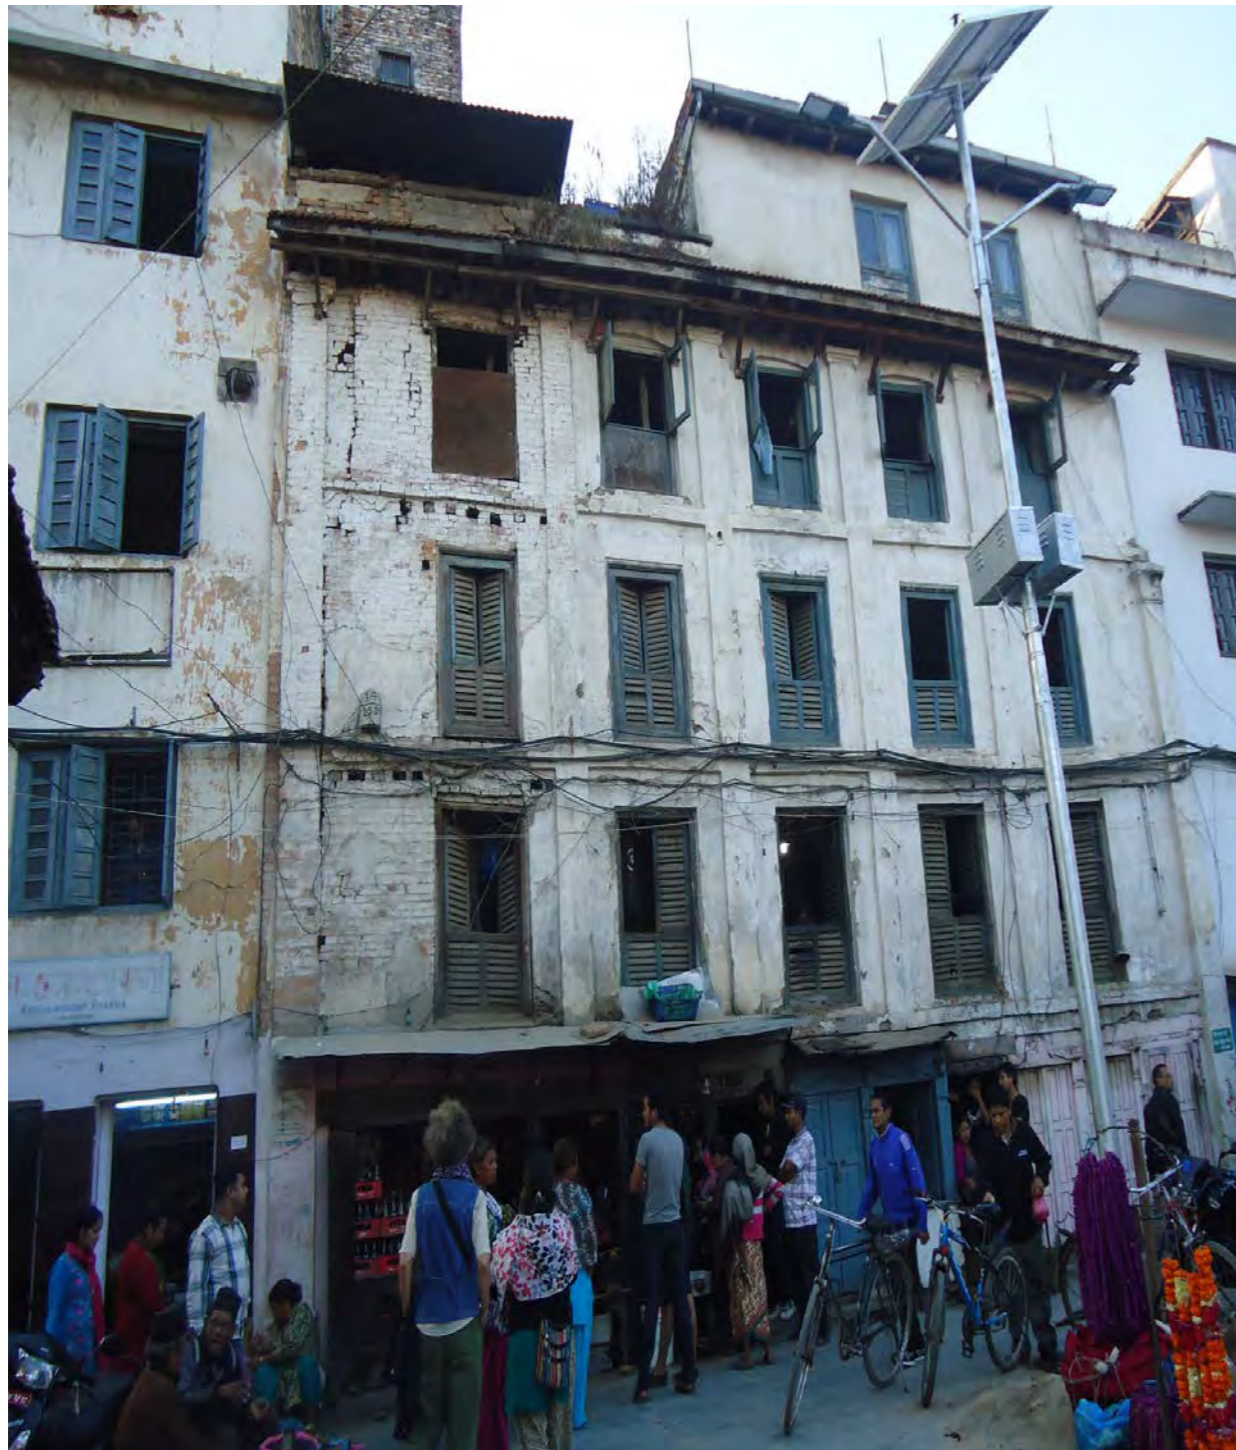
CODE NO	OWNERS NAME/ CONTACT	STOREY NUM- BER	PRESENT STO- REY NUMBER	STRUCTURAL SYSTEM	MATERIAL	GENERAL DESCEIPTION	PROBLEM DESCRIPTION	DANGER	Heritage Sig- nificance	REMARKS
b10		G+3	G+3	Load Bearing	Brick		Extensive vertical Cracks

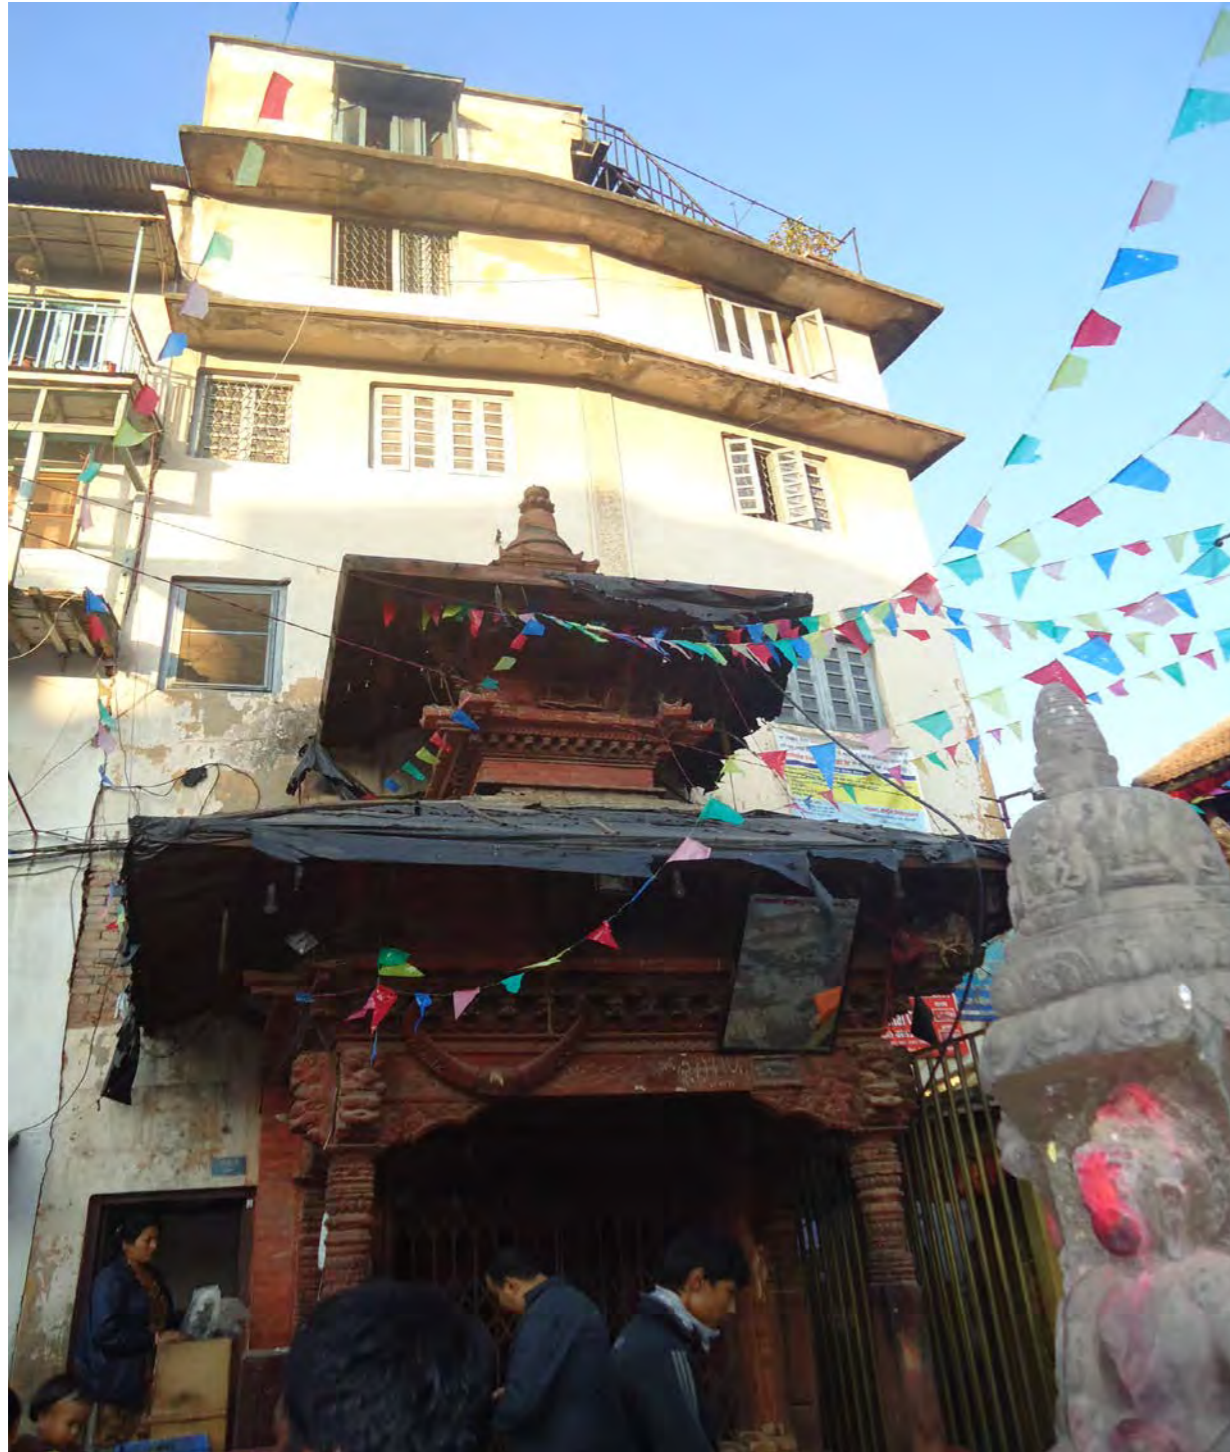
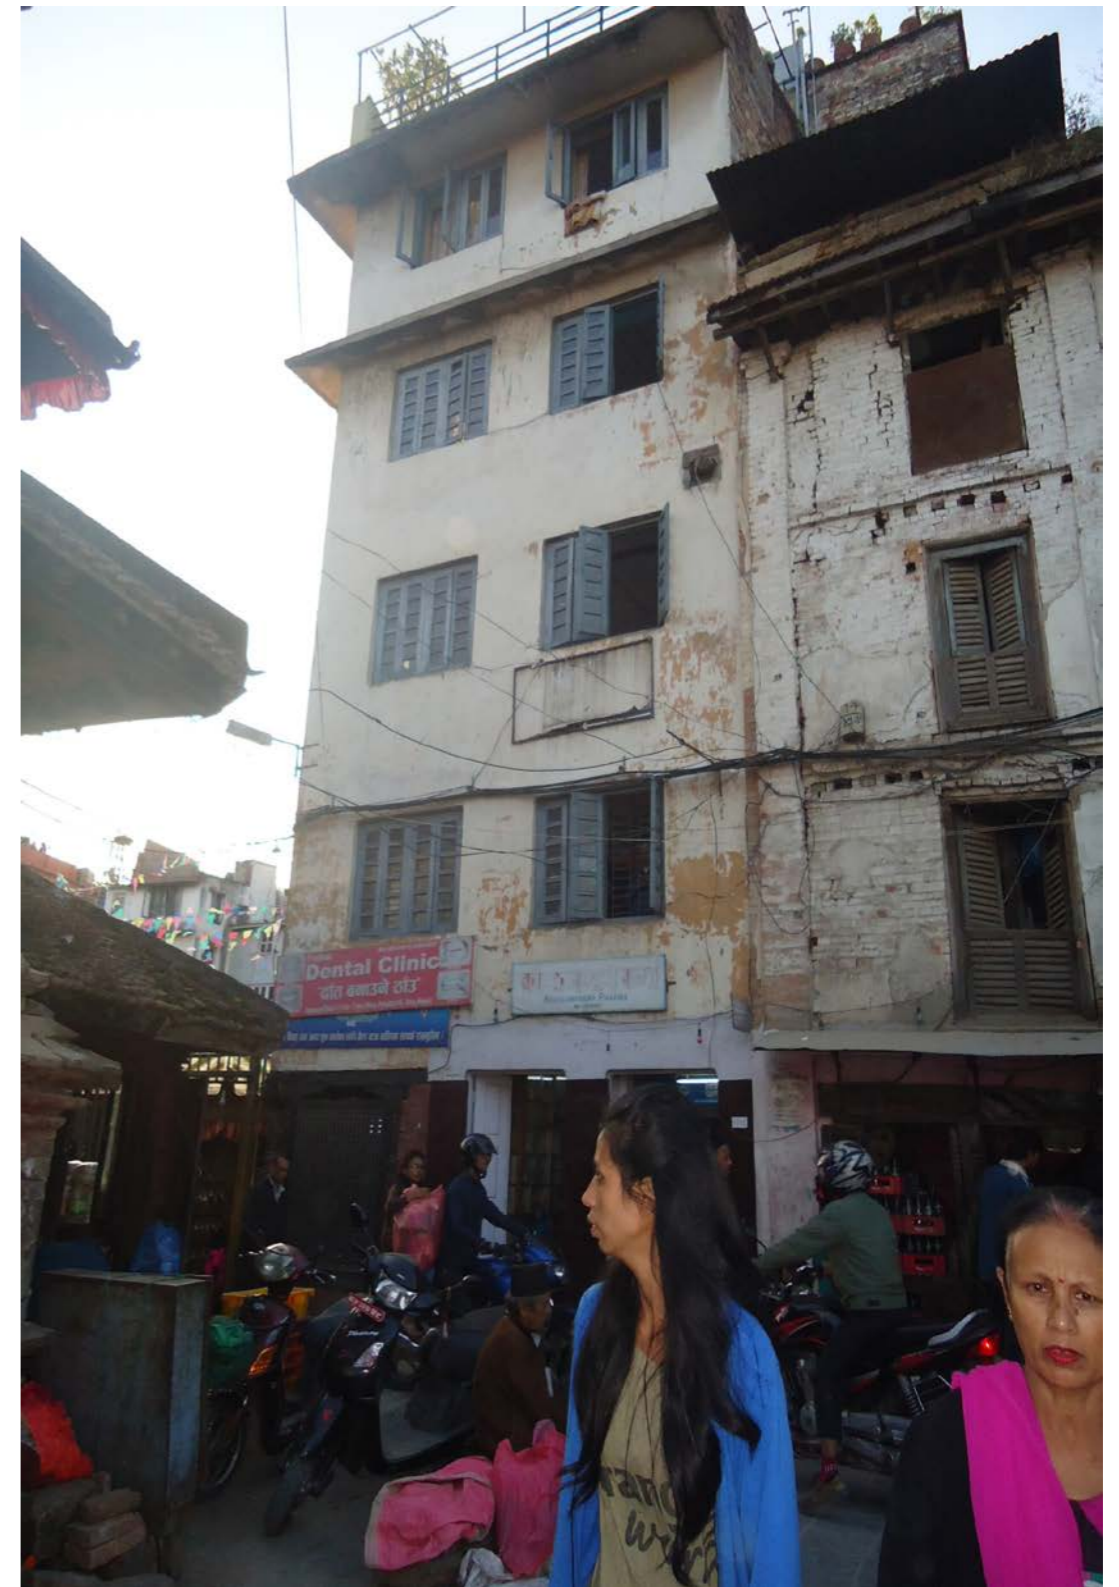
CODE NO	OWNERS NAME/ CONTACT	STOREY NUMBER	PRESENT STOREY NUMBER	STRUCTURAL SYSTEM	MATERIAL	GENERAL DESCRIPTION	PROBLEM DESCRIPTION	DANGER	Heritage Significance	REMARKS
b11	Kishor Shrestha	G+4.5	G+4	Load Bearing	Brick		Extensive cracking present
