2015 Earthquake Damage Mapping

Hanuman Dhoka Darbar Square Monument Zone
Kathmandu Valley World Heritage Property

December 2015

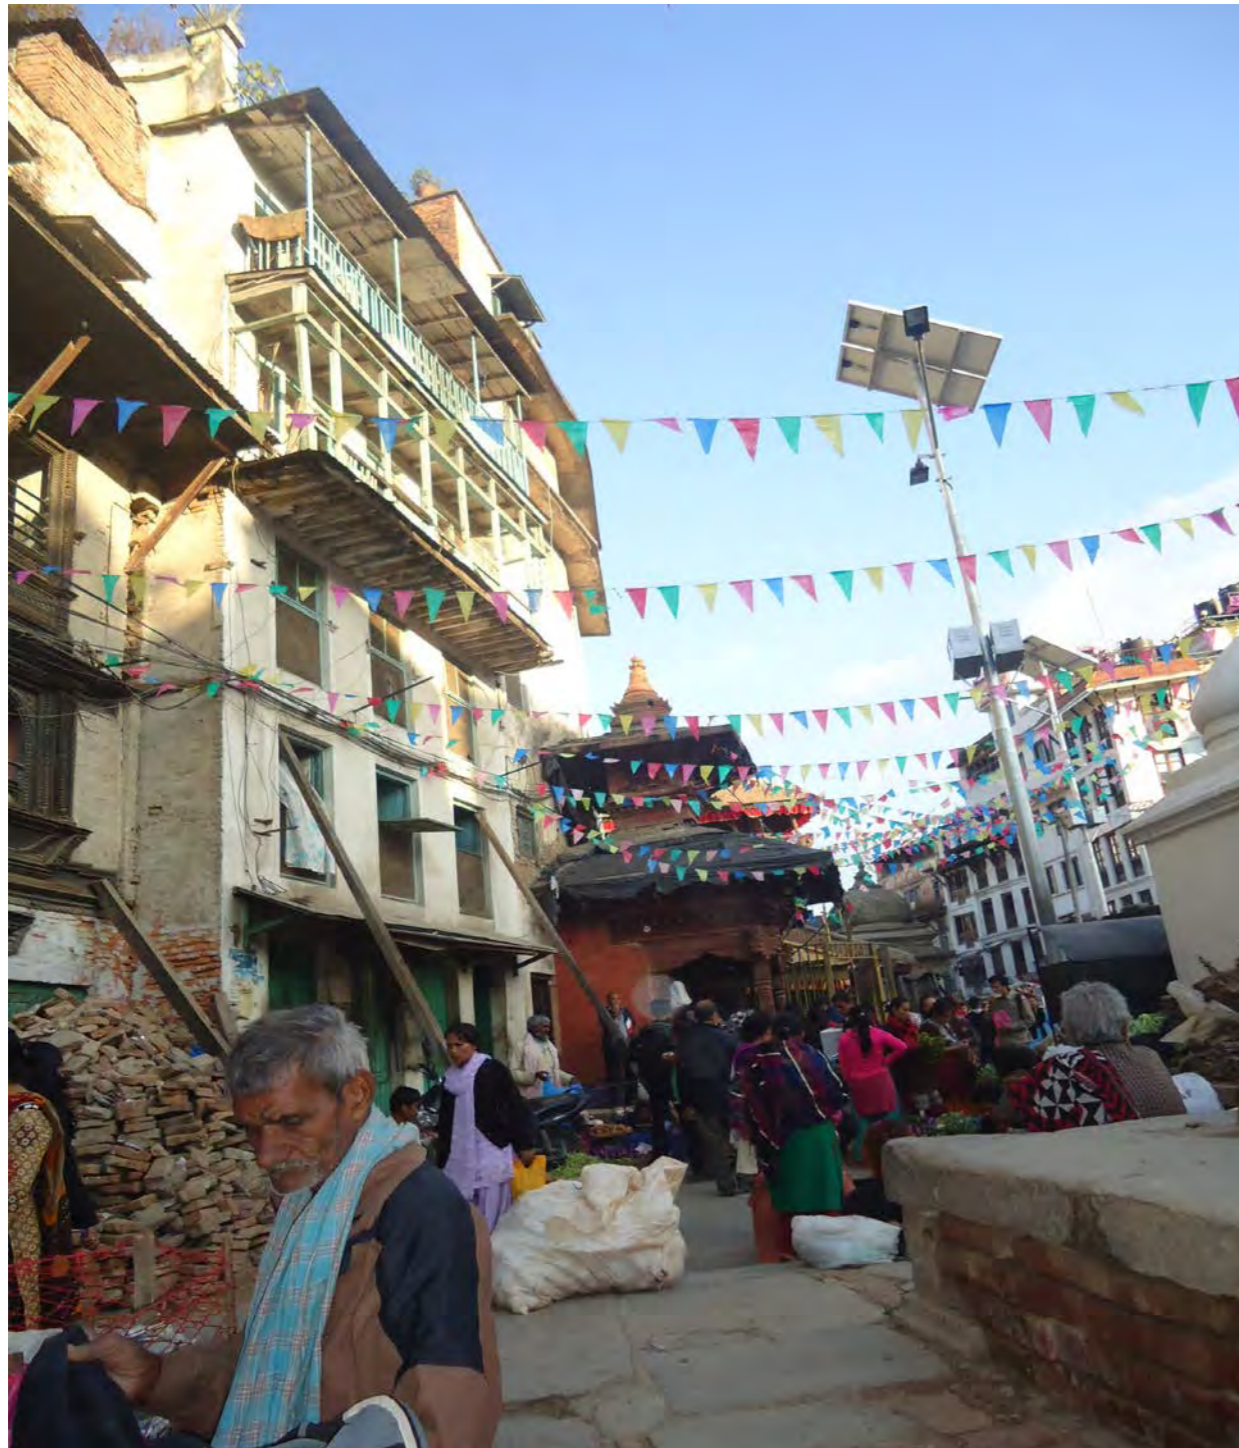
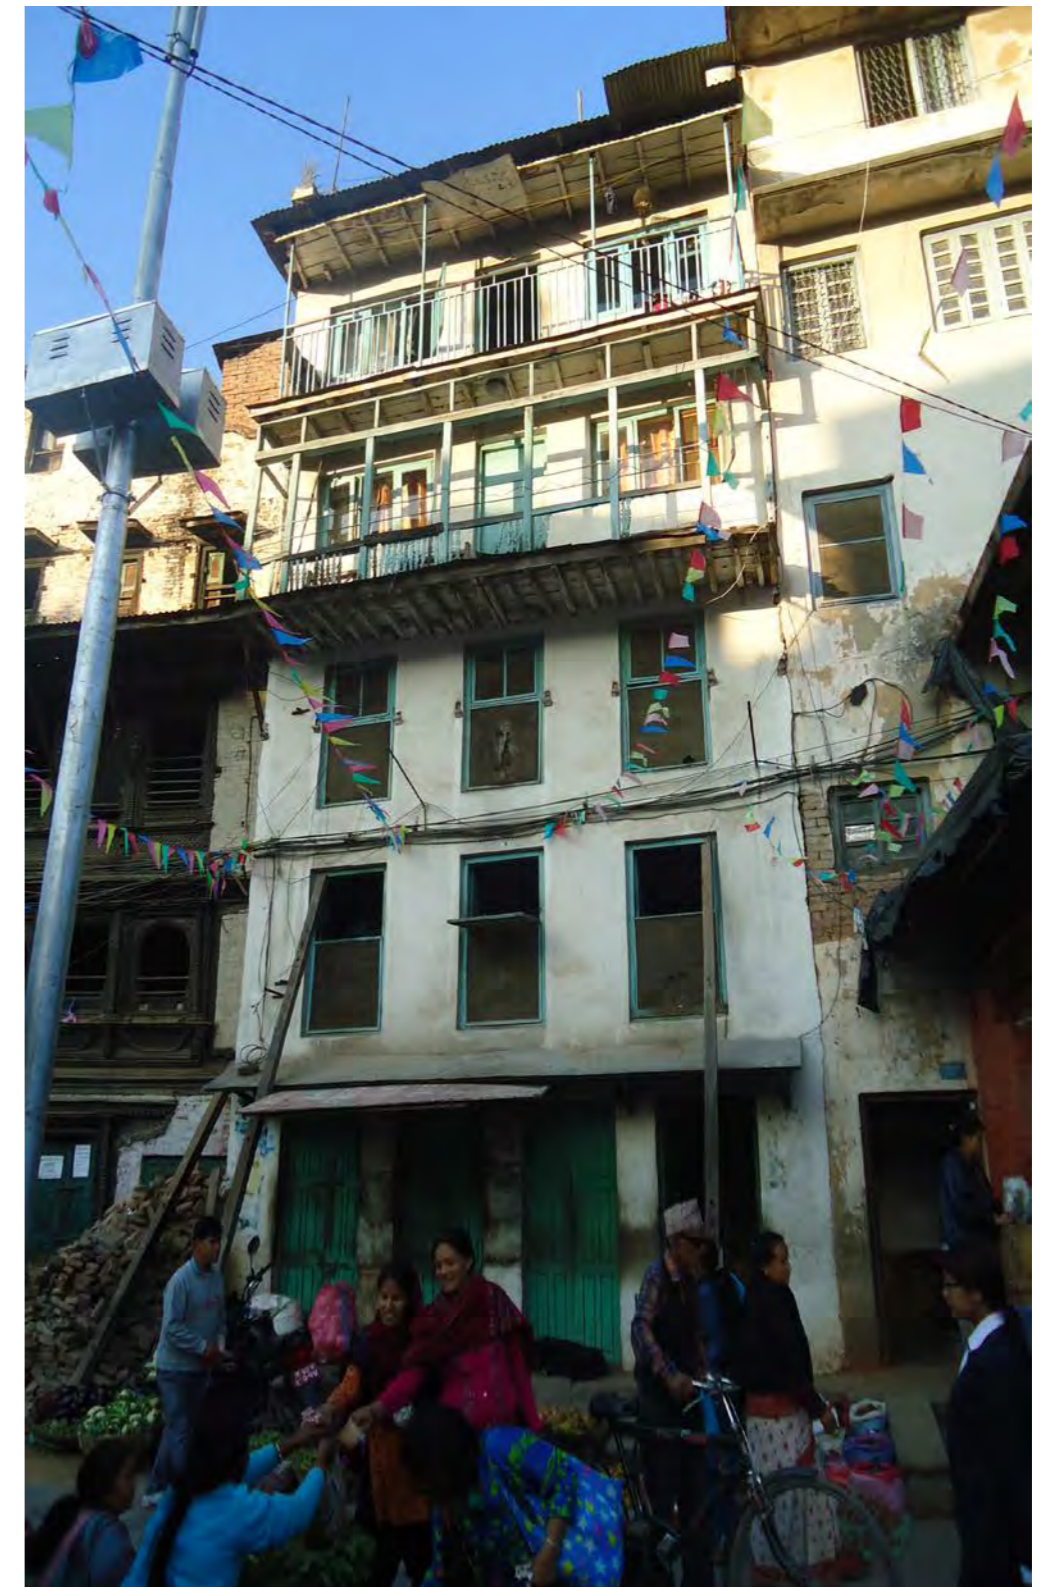
CODE NO	OWNERS NAME/ CONTACT	STOREY NUM- BER	PRESENT STO- REY NUMBER	STRUCTURAL SYSTEM	MATERIAL	GENERAL DESCEIPTION	PROBLEM DESCRIPTION	DANGER	Heritage Sig- nificance	REMARKS
b12		G+4.5		Load Bearing	Brick		Minor cracks and bulging of walls

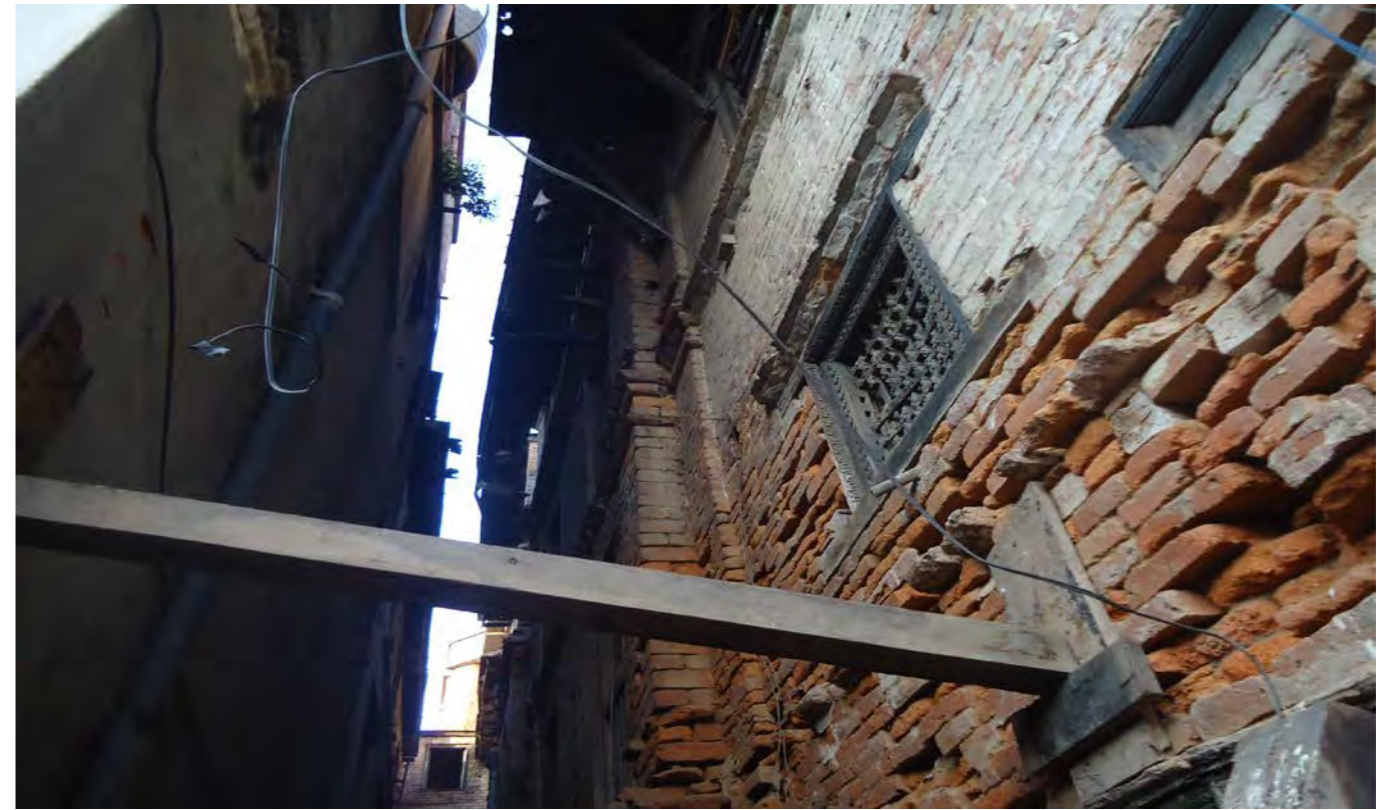
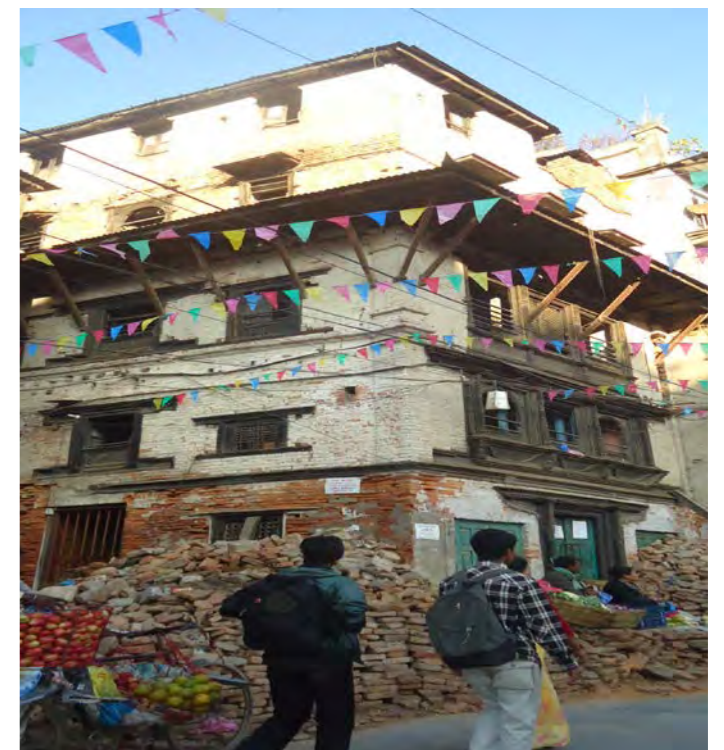
CODE NO	OWNERS NAME/ CONTACT	STOREY NUM- BER	PRESENT STO- REY NUMBER	STRUCTURAL SYSTEM	MATERIAL	GENERAL DESCEIPTION	PROBLEM DESCRIPTION	DANGER	Heritage Sig- nificance	REMARKS
b13	Bidhya Vaidya	G+4	G+4	Load Bearing	Brick; Timber		Extensive cracking of walls; Settlement and bulging of walls

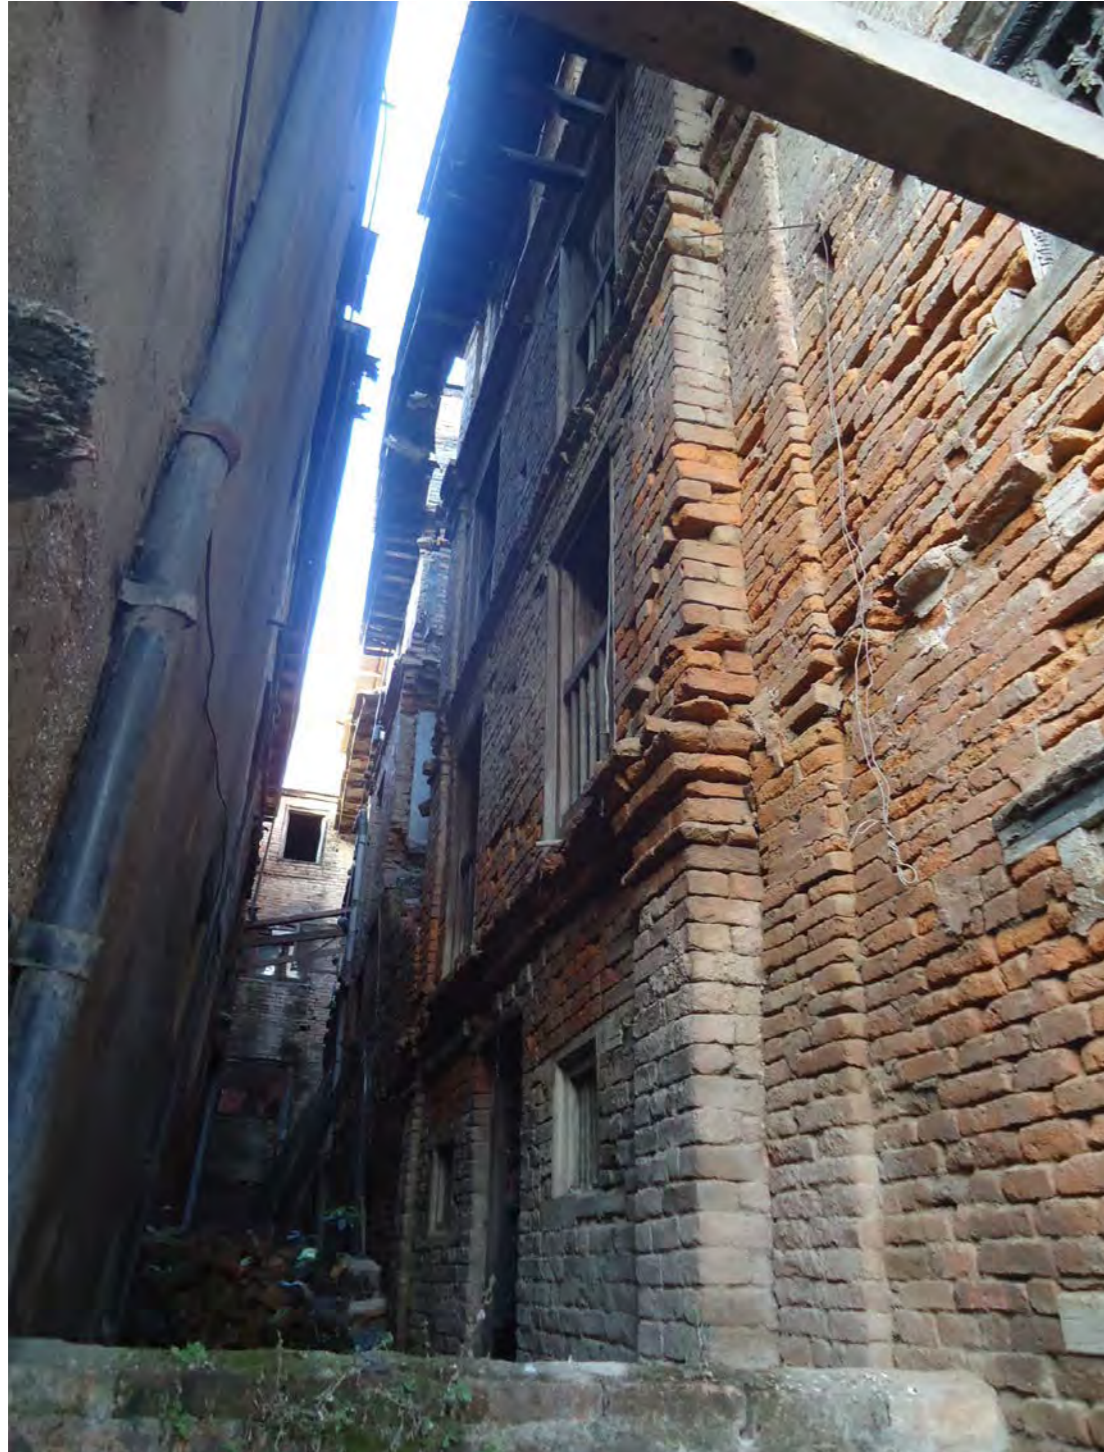
CODE NO	OWNERS NAME/ CONTACT	STOREY NUM- BER	PRESENT STO- REY NUMBER	STRUCTURAL SYSTEM	MATERIAL	GENERAL DESCEIPTION	PROBLEM DESCRIPTION	DANGER	Heritage Sig- nificance	REMARKS
b14		G+4	G+4	Load Bearing	Brick;Timber		Top floor collapsed;Bulging of walls in remaining floors.

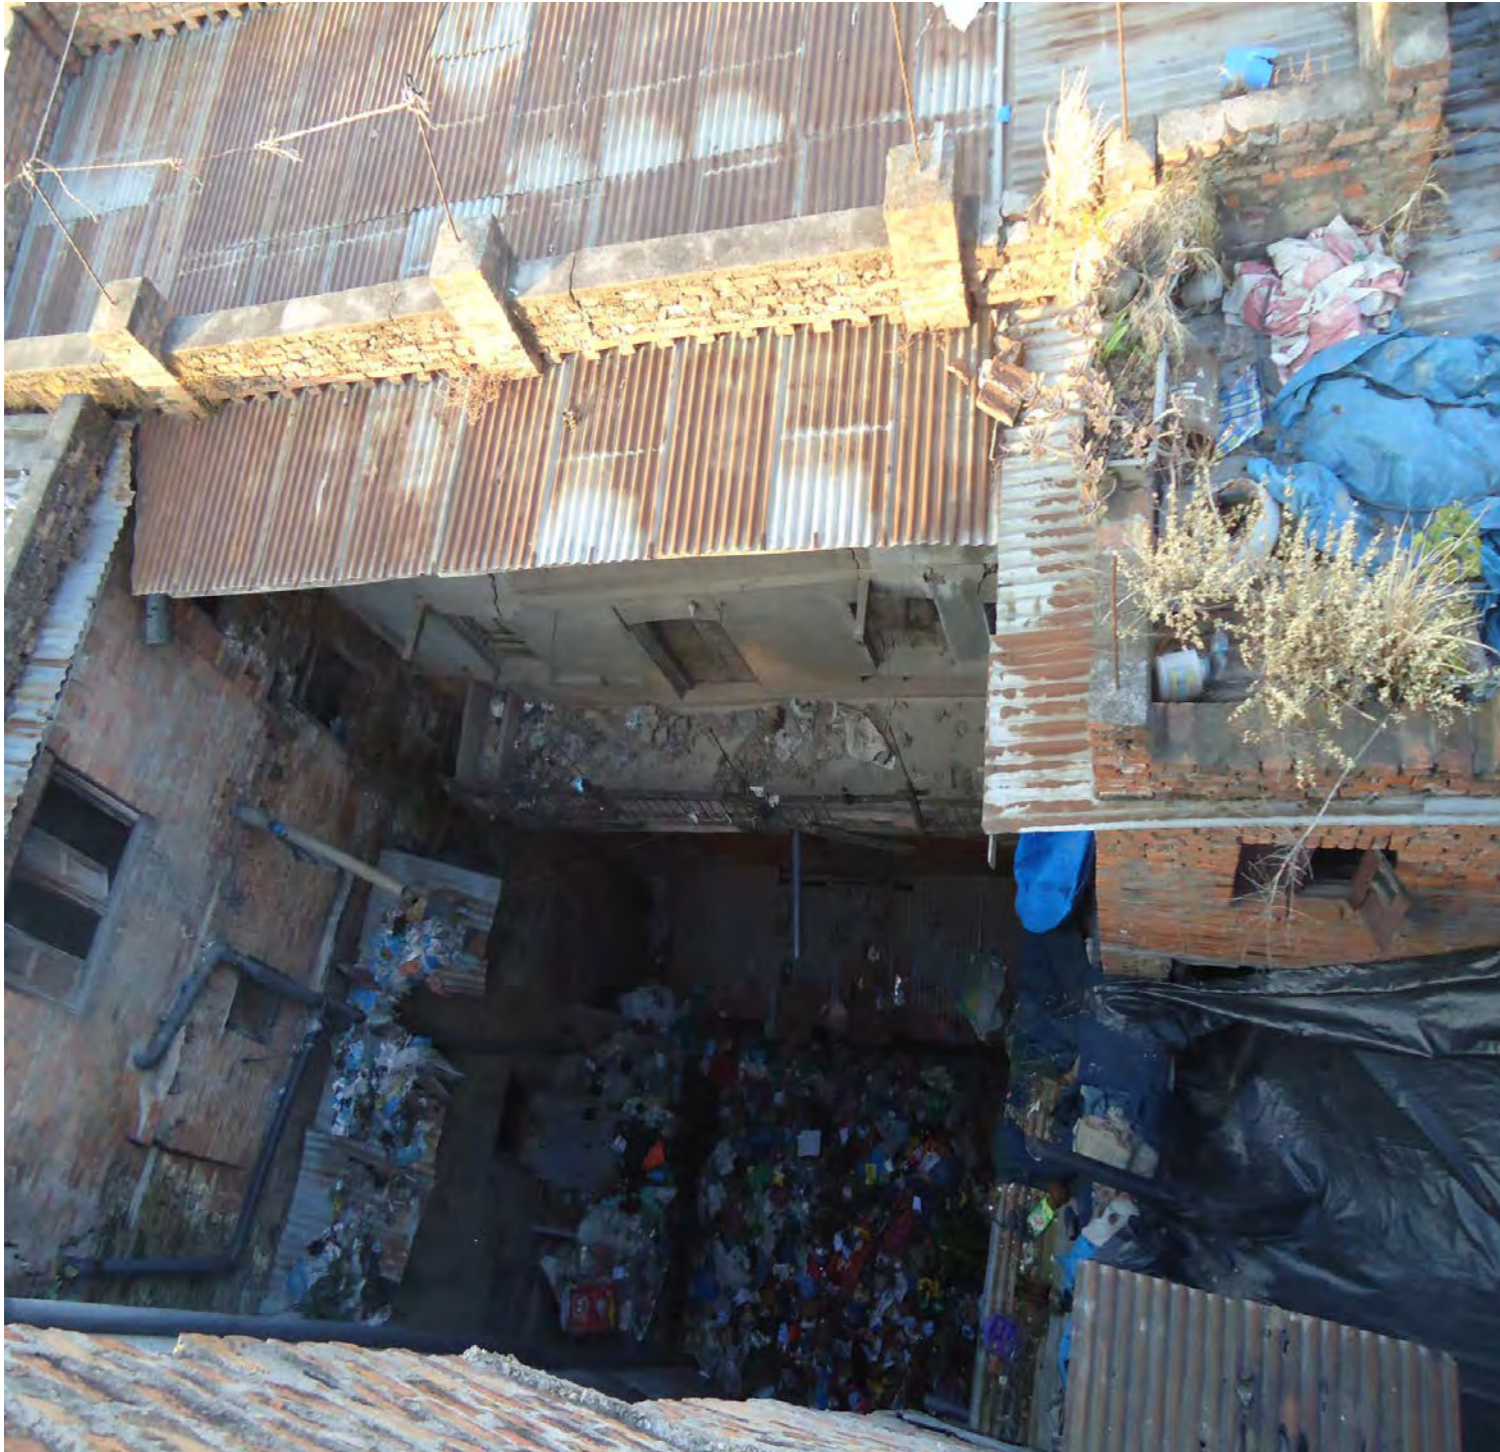
CODE NO	OWNERS NAME/ CONTACT	STOREY NUM- BER	PRESENT STO- REY NUMBER	STRUCTURAL SYSTEM	MATERIAL	GENERAL DESCEIPTION	PROBLEM DESCRIPTION	DANGER	Heritage Sig- nificance	REMARKS
b15	Ramesh maha- rjan	G+2	G+2	Load Bearing	Brick		Extensive cracking of walls

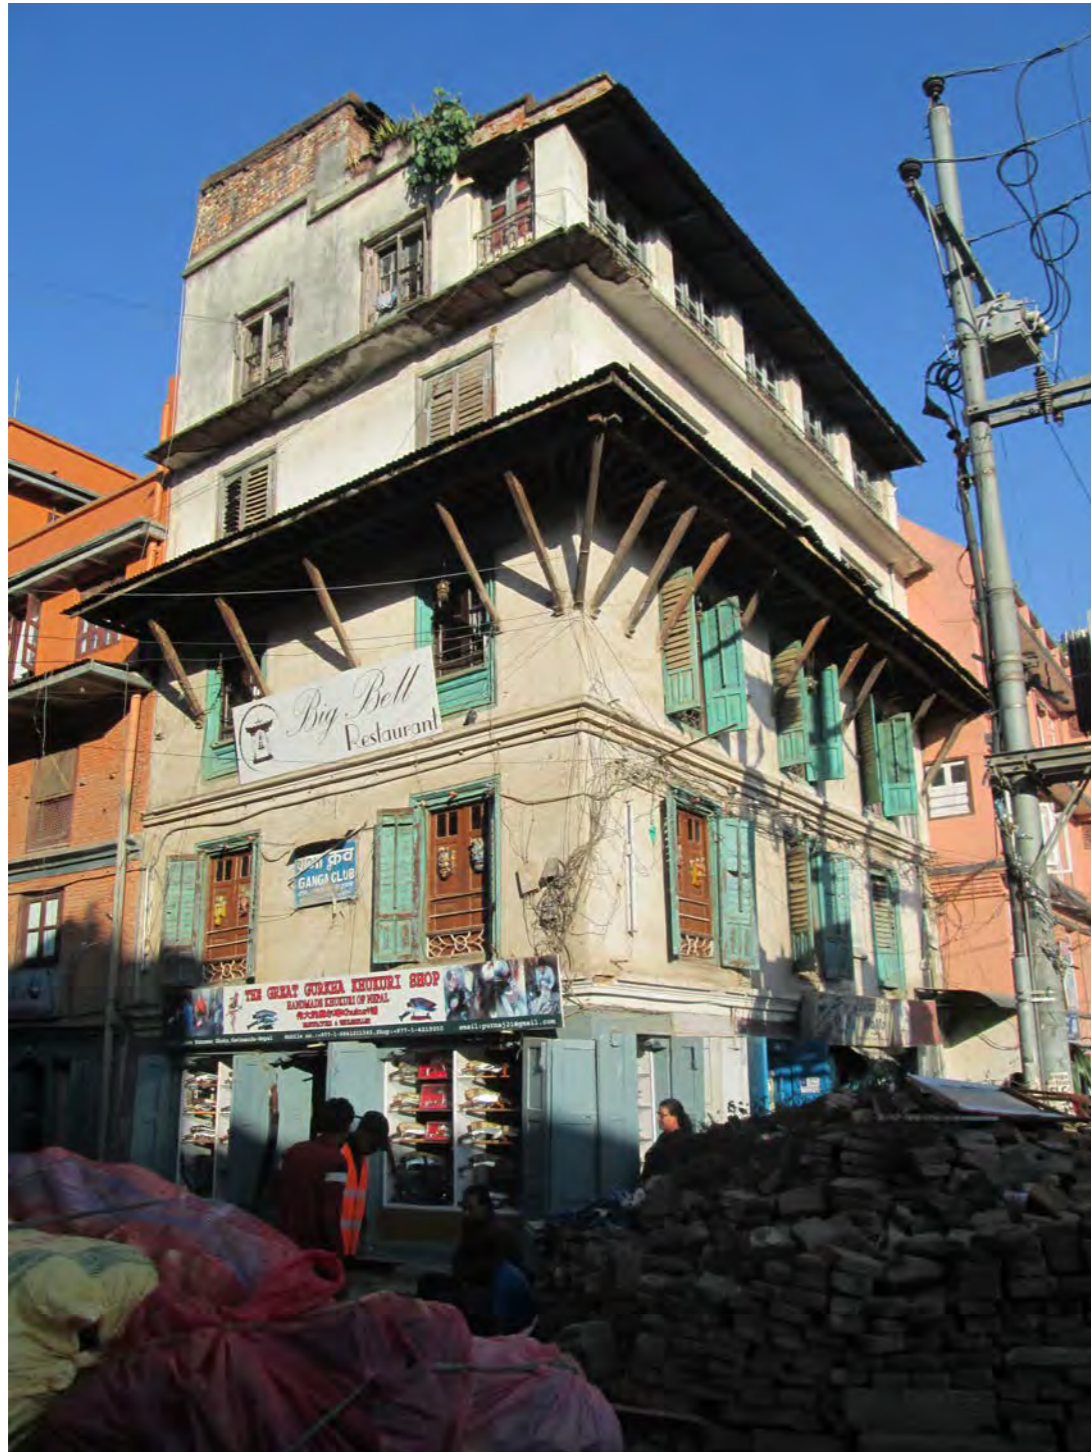
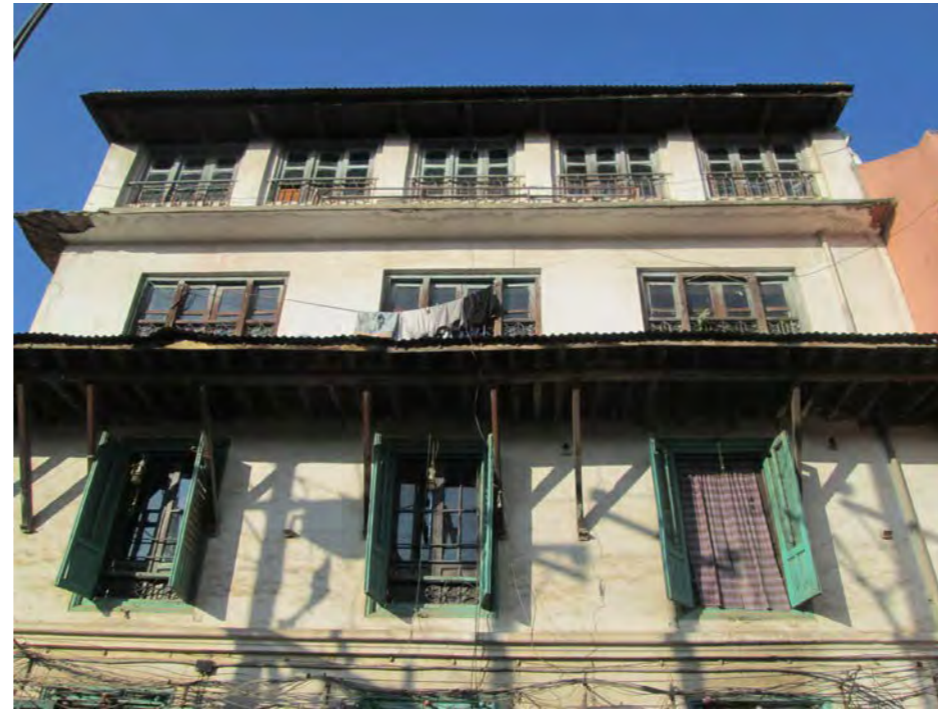
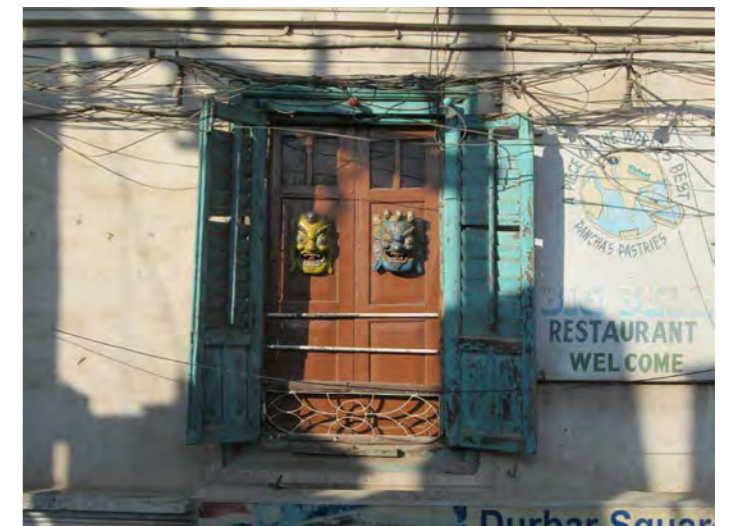
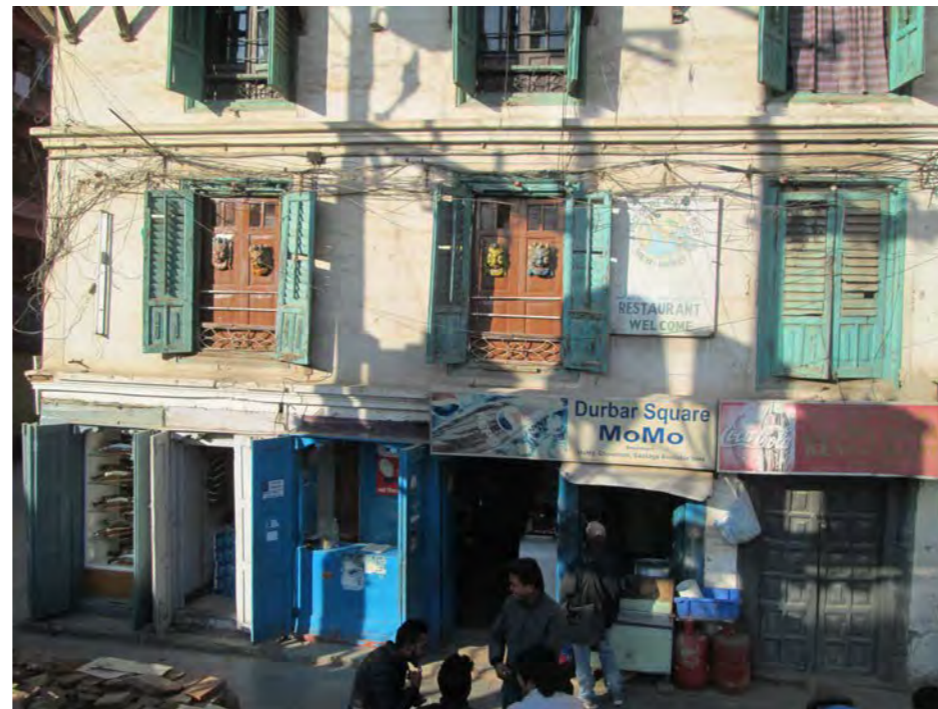
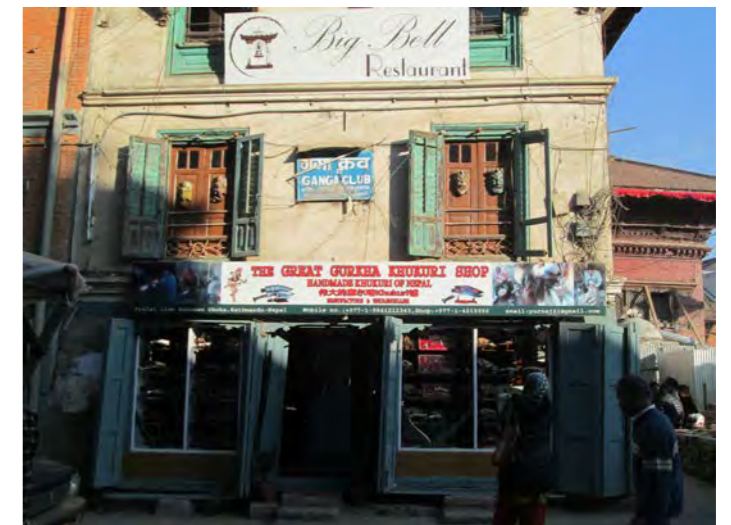
c1

CODE NO.	OWNERS NAME/ CONTACT NO.	STOREY NO.	PRESENT STOREY NO	STRUCTURAL SYS- TEM	MATERIAL	GENERAL DESCRIPTION	PROBLEM DESCRIPTION	DANGER	HERITAGE SIGNIFICANCE	REMARKS
c01	Shree Krishna Shrestha	G+5/2EL	G+5	LB	B	CH	Vegetation growth at top floor

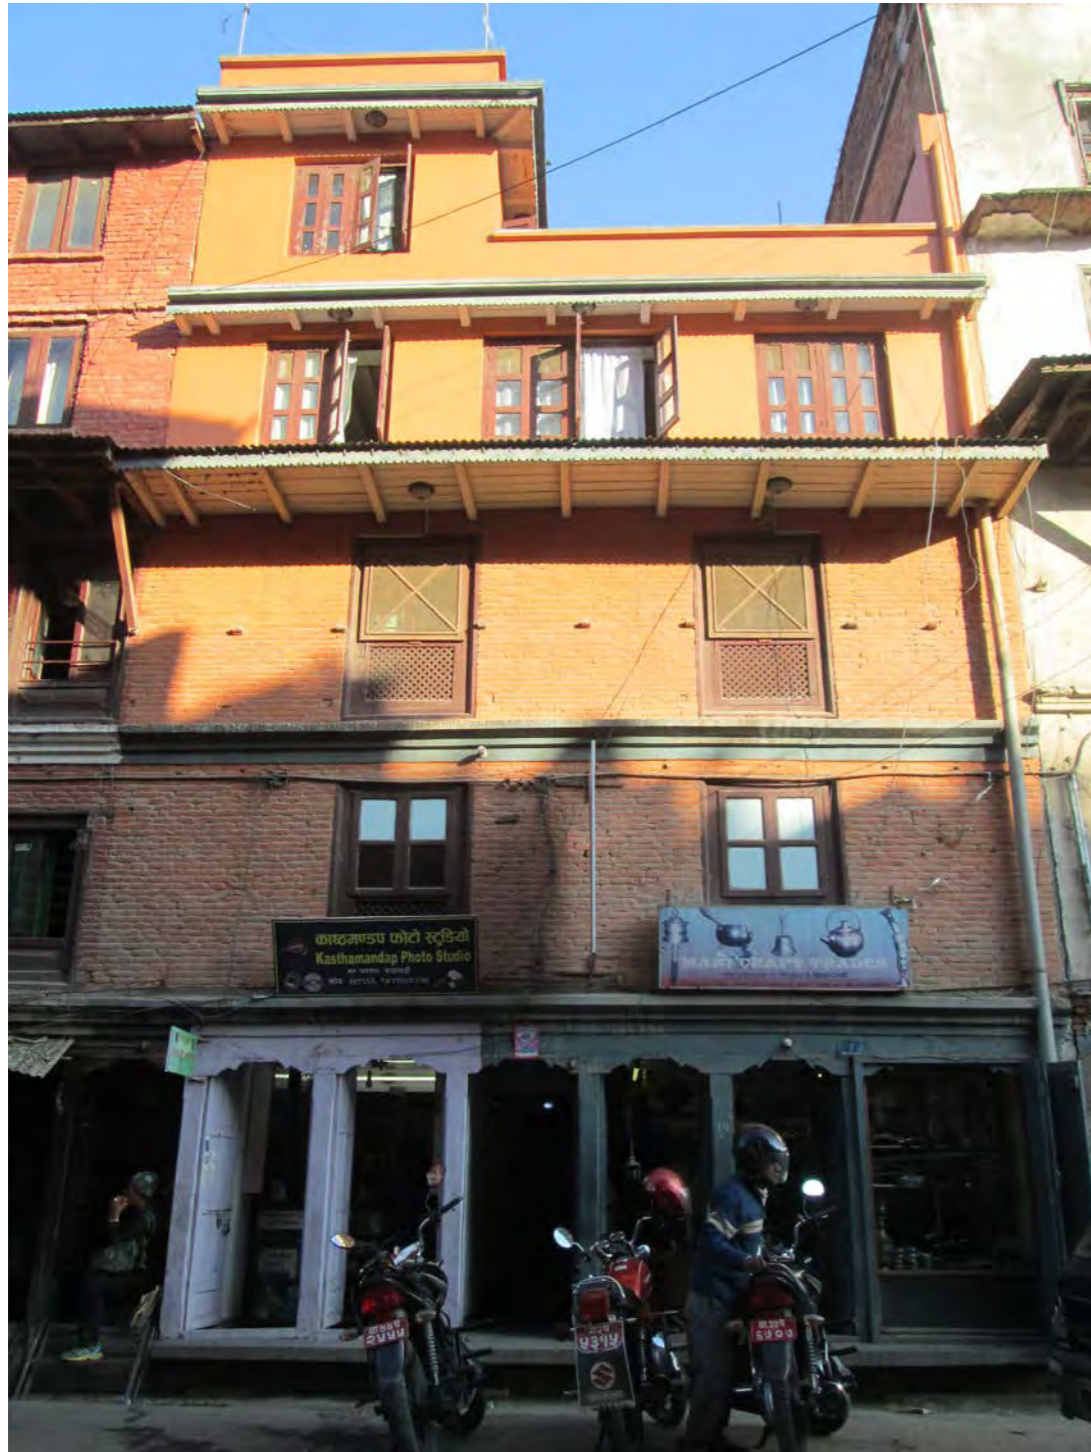
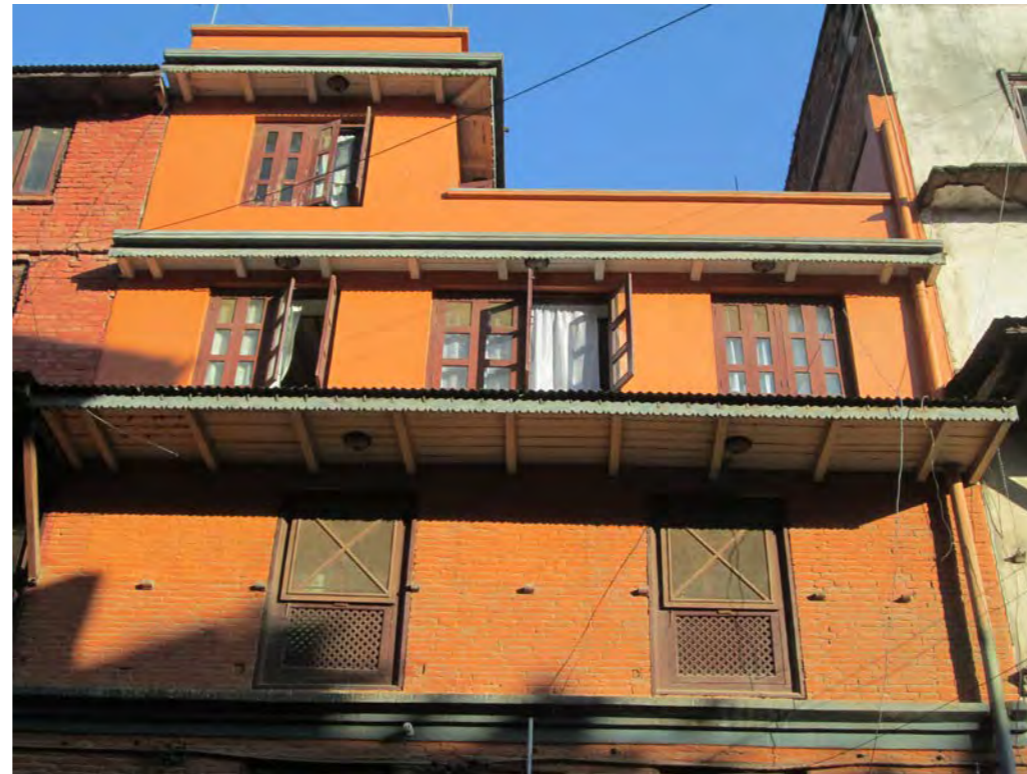
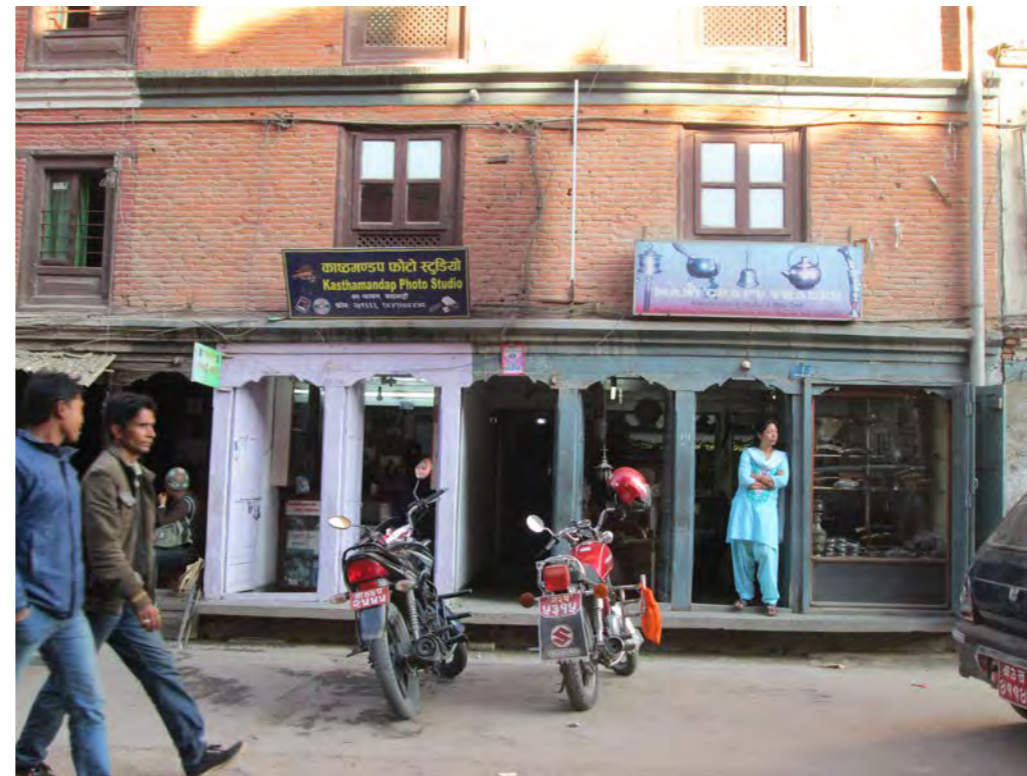
c2

CODE NO.	OWNERS NAME/ CONTACT NO.	STOREY NO.	PRESENT STOREY NO	STRUCTURAL SYS- TEM	MATERIAL	GENERAL DESCRIPTION	PROBLEM DESCRIPTION	DANGER	HERITAGE SIGNIFICANCE	REMARKS
c02	Shree Krishna Shrestha	G+4/2EL	G+4	LB	B	CH	Internal wall cracks

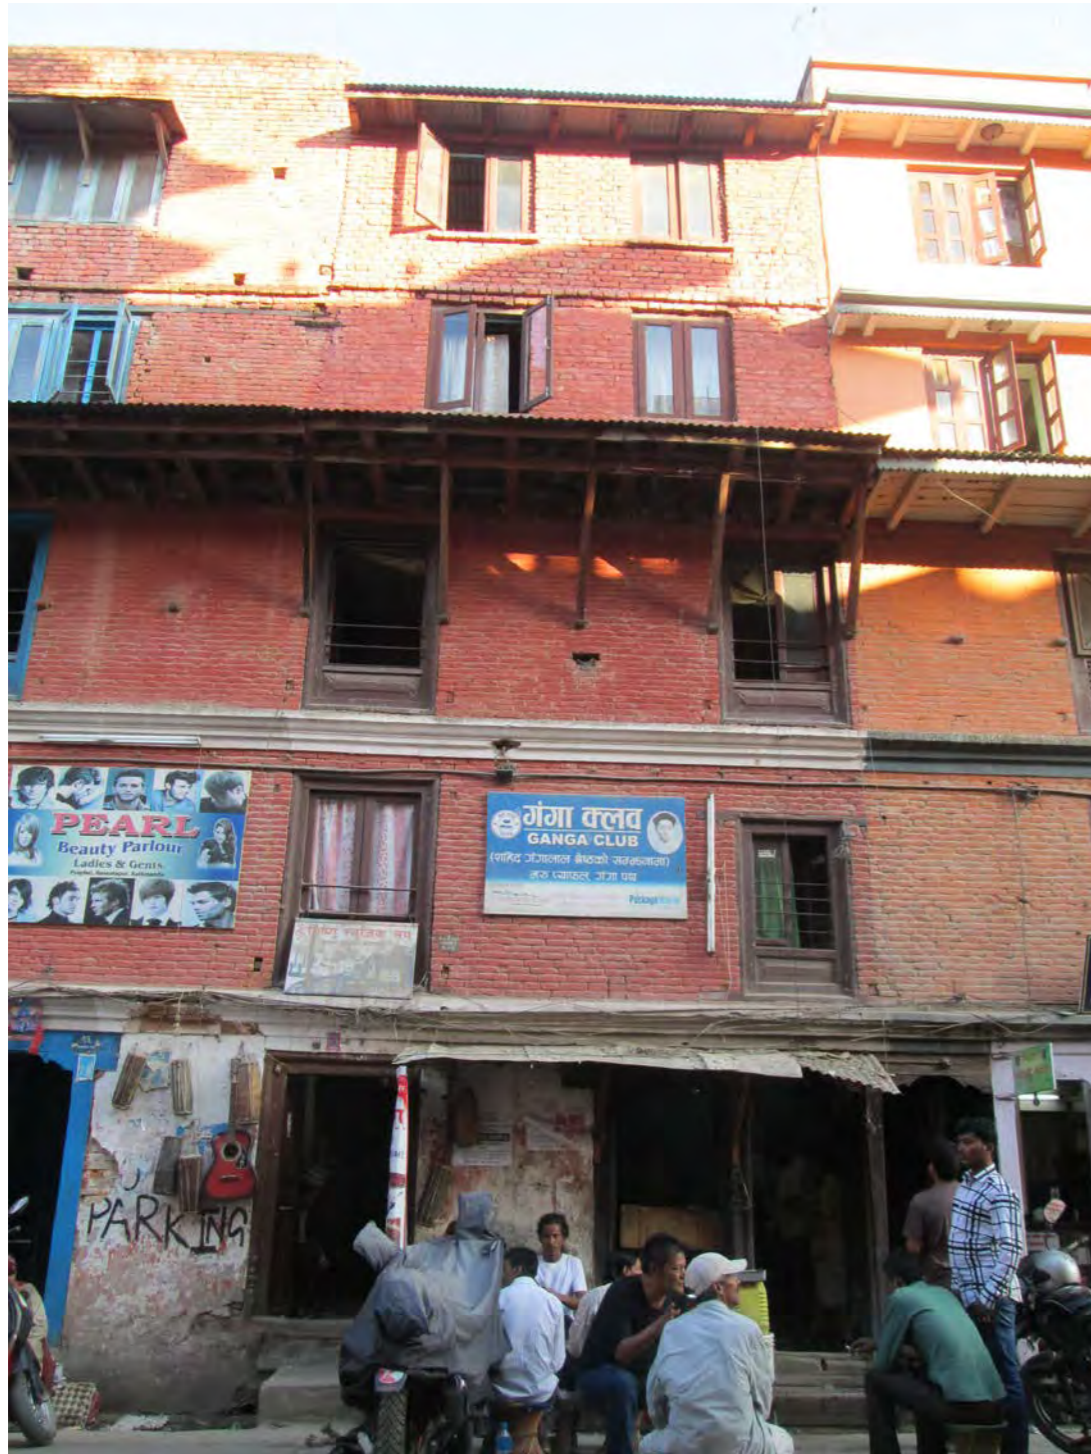
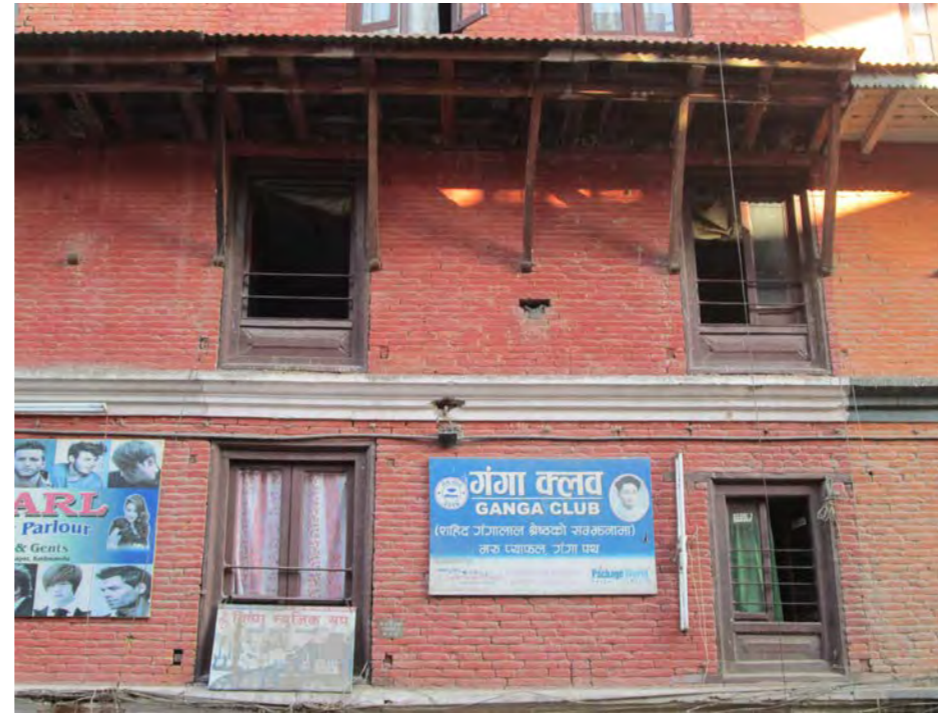
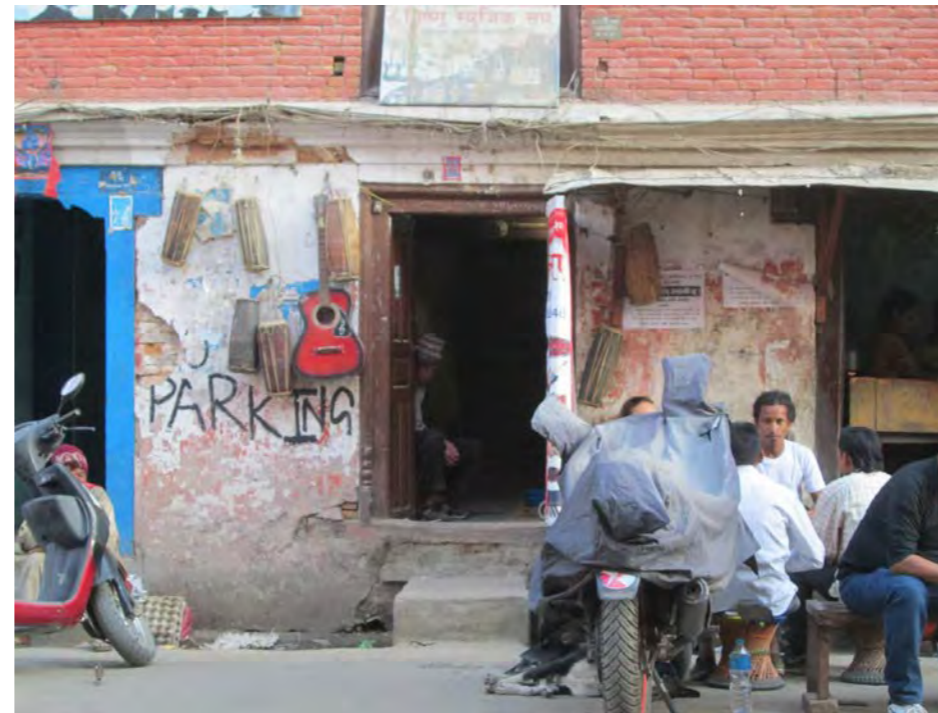
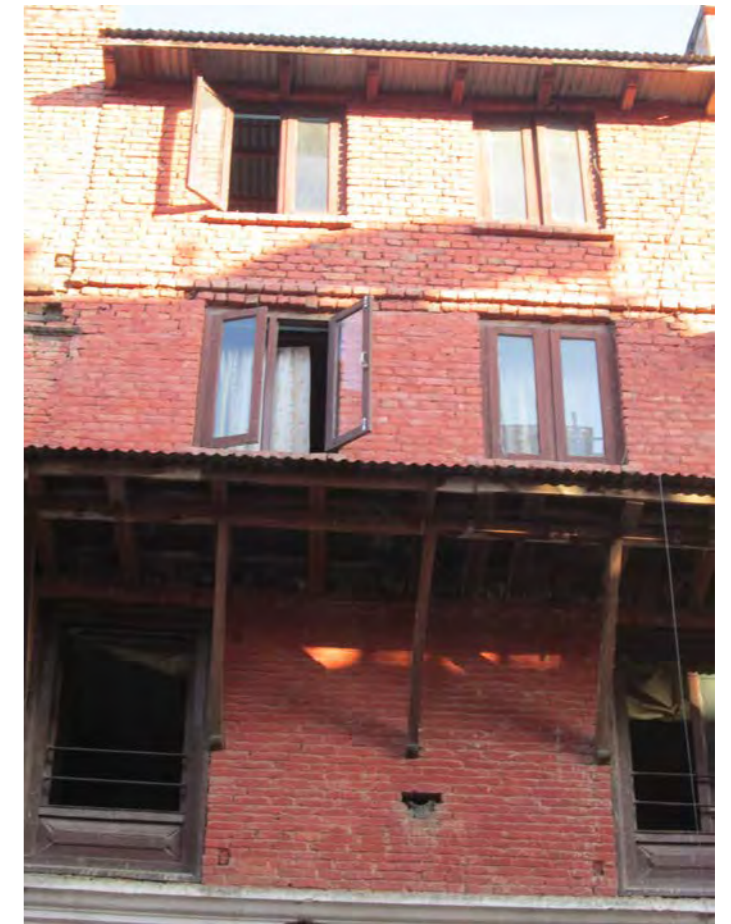
c3

CODE NO.	OWNERS NAME/ CONTACT NO.	STOREY NO.	PRESENT STOREY NO	STRUCTURAL SYS- TEM	MATERIAL	GENERAL DESCRIPTION	PROBLEM DESCRIPTION	DANGER	HERITAGE SIGNIFICANCE	REMARKS
c03	Sambhu Malla	G+4/2EL	G+4	LB	B		No visible damage
