2015 Earthquake Damage Mapping

Hanuman Dhoka Darbar Square Monument Zone
Kathmandu Valley World Heritage Property

December 2015

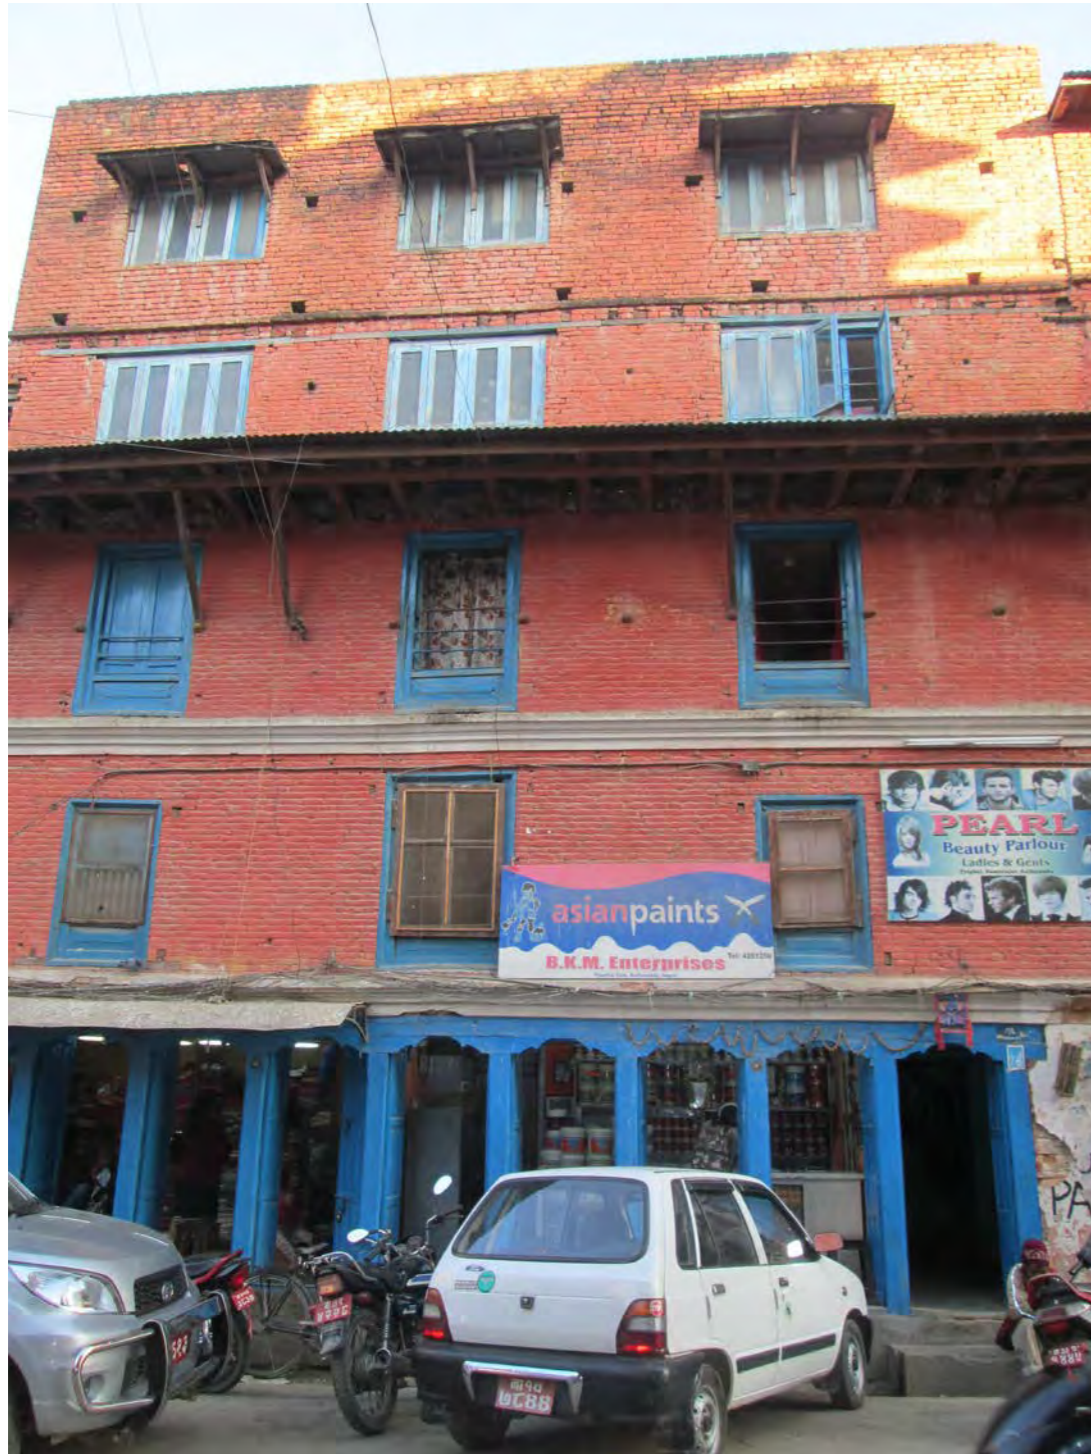
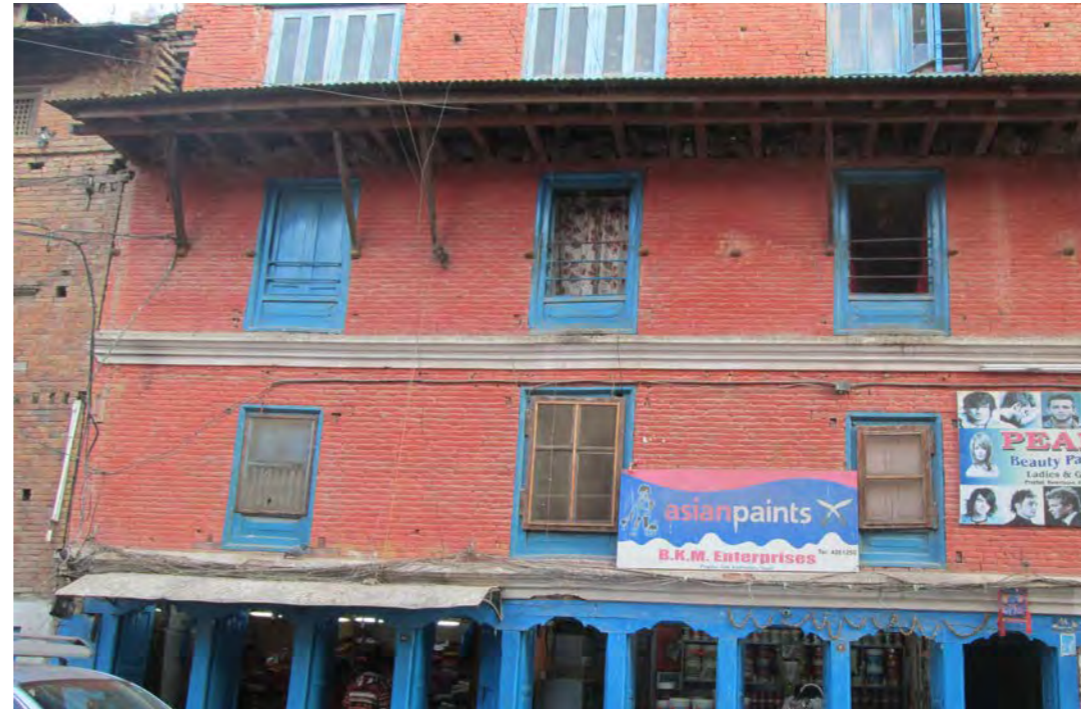
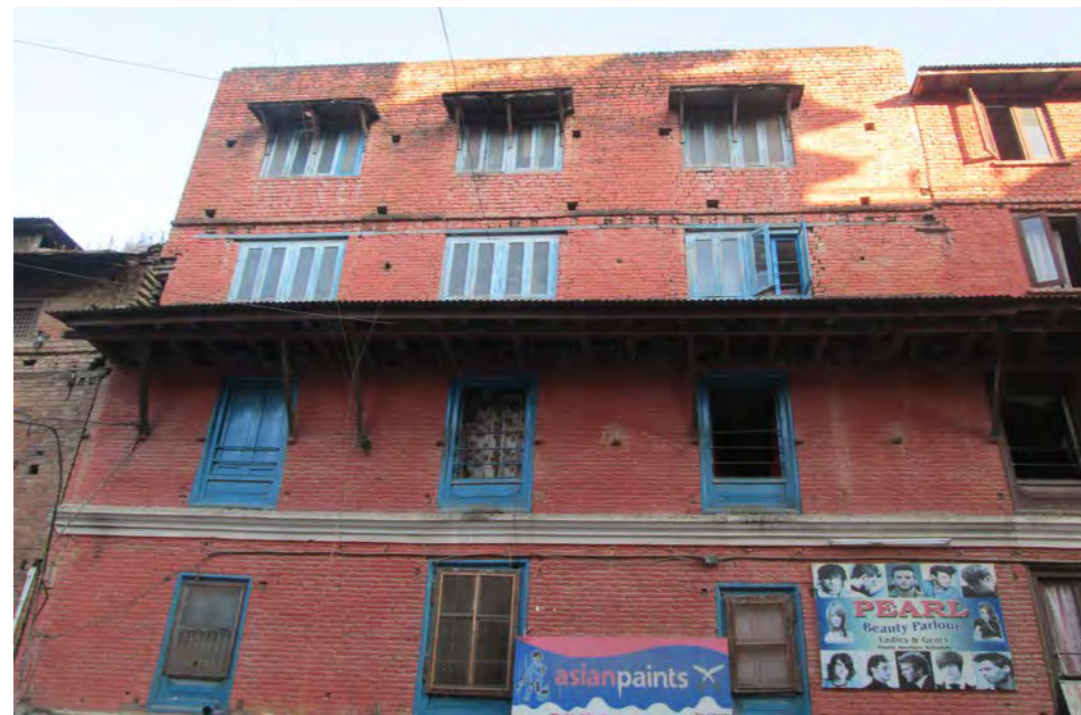
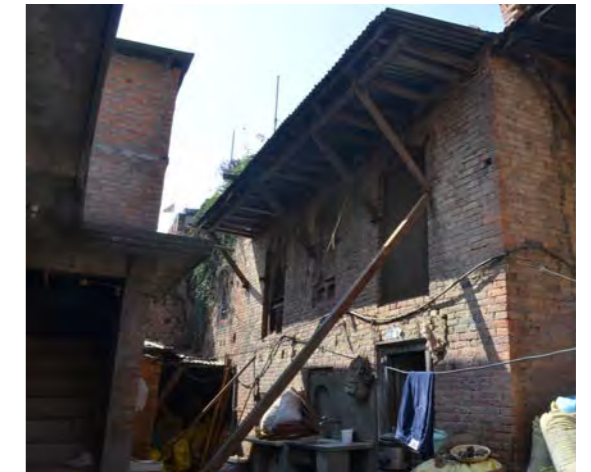
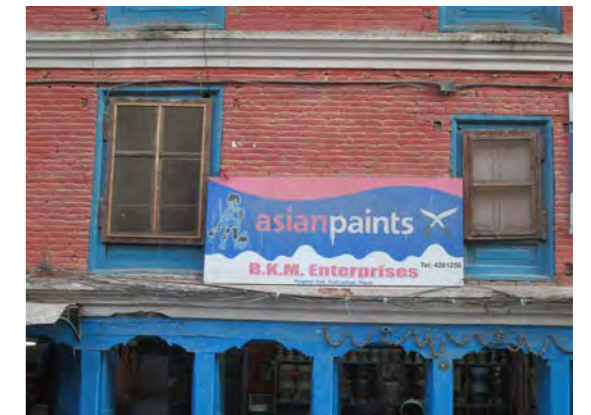
c4

CODE NO.	OWNERS NAME/ CONTACT NO.	STOREY NO.	PRESENT STOREY NO	STRUCTURAL SYS- TEM	MATERIAL	GENERAL DESCRIPTION	PROBLEM DESCRIPTION	DANGER	HERITAGE SIGNIFICANCE	REMARKS
c04	Binay Krishna Mathema (9841149328)	G+4/2EL	G+4	LB	B		No visible damage

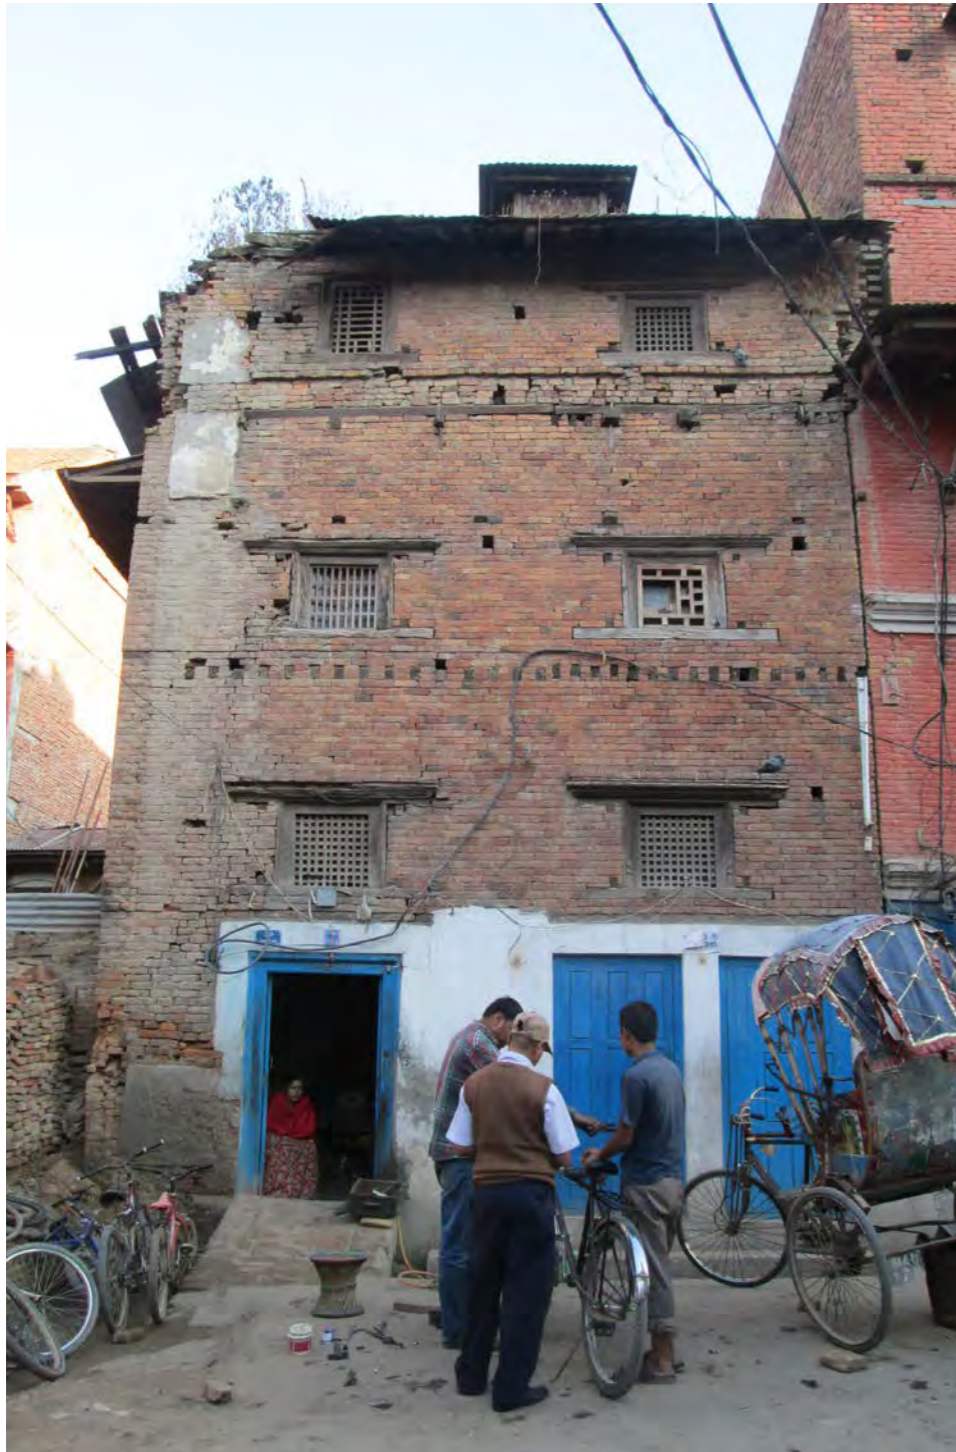
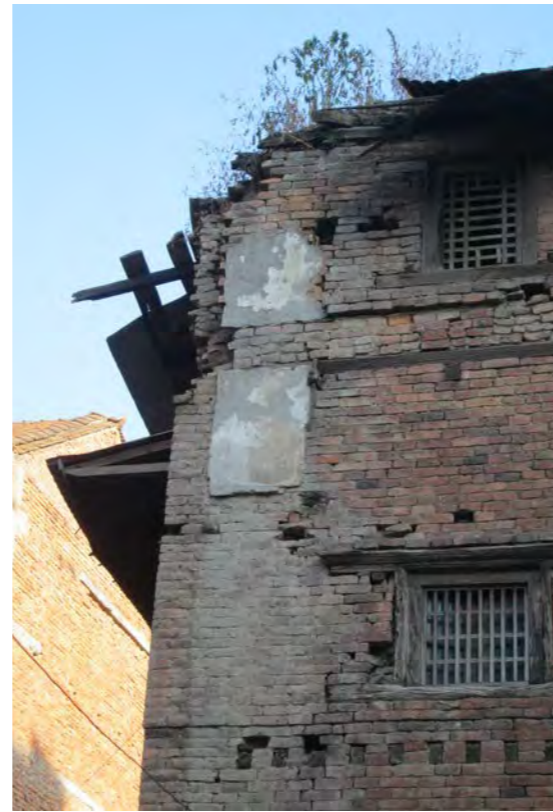
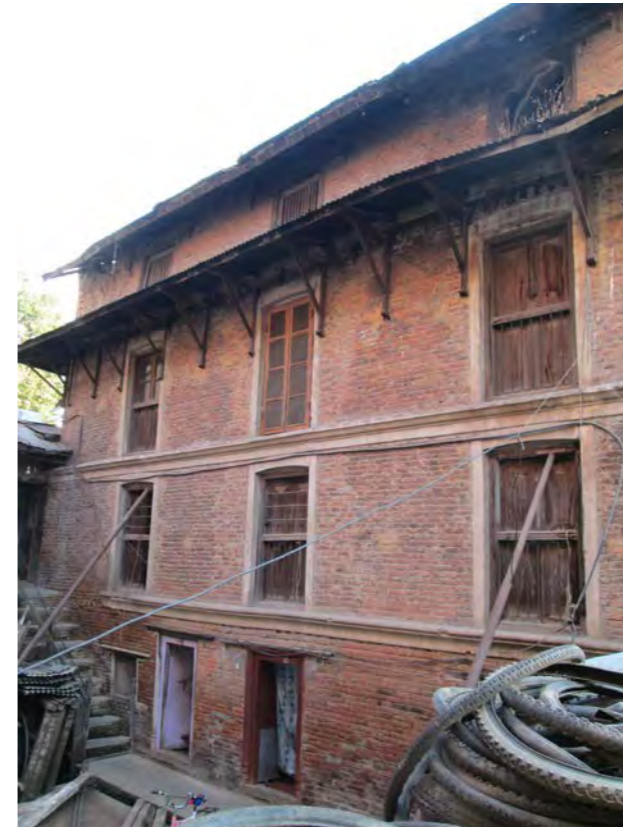
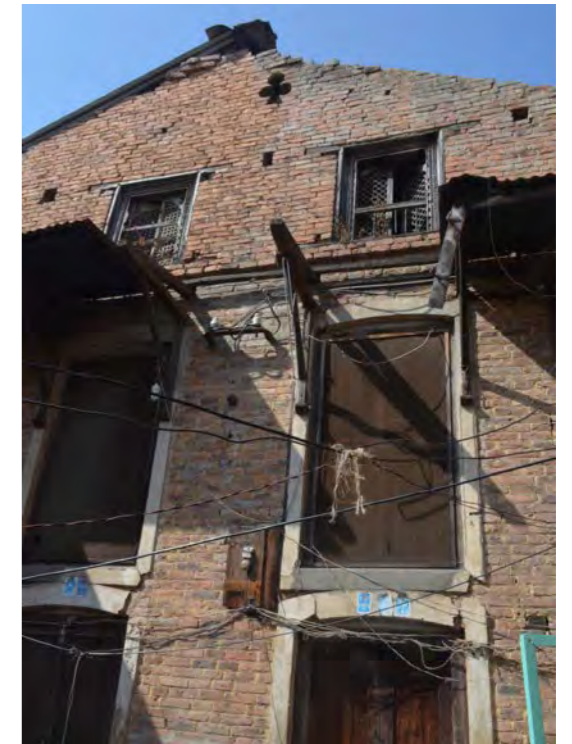
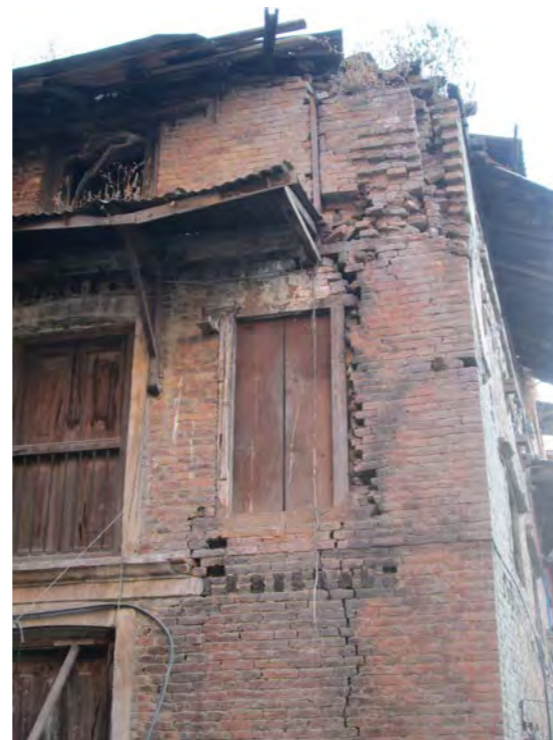
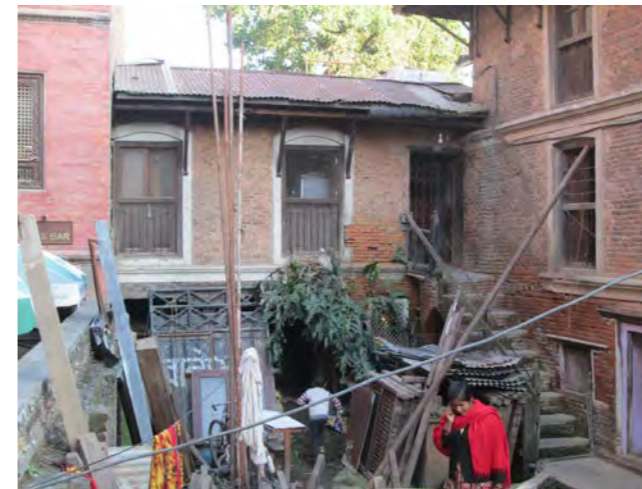
c5a, c5b

CODE NO.	OWNERS NAME/ CONTACT NO.	STOREY NO.	PRESENT STOREY NO	STRUCTURAL SYS- TEM	MATERIAL	GENERAL DESCRIPTION	PROBLEM DESCRIPTION	DANGER	HERITAGE SIGNIFICANCE	REMARKS
c05a	Gautam Manandhar	G+3	G+3	LB	B	EH	NE corner top part collapsed			
c05b	Gautam Manandhar	G+1	G+1	LB	B		Internal cracks

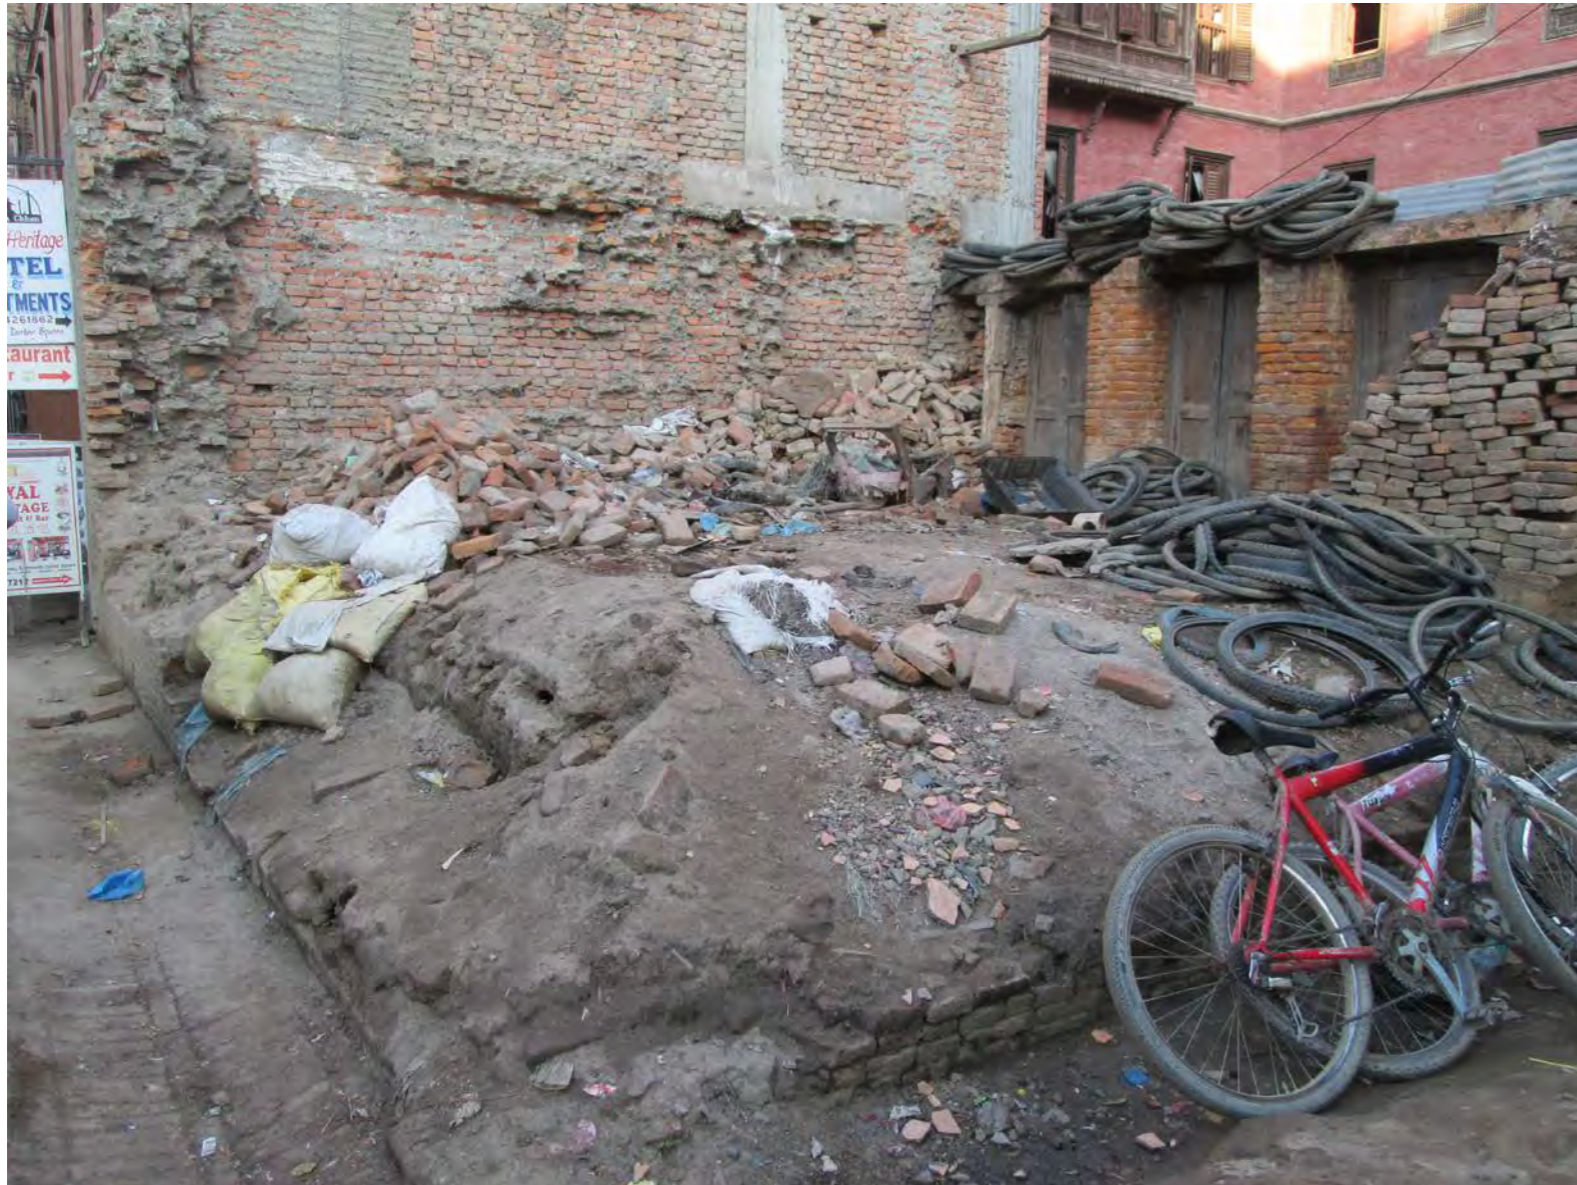
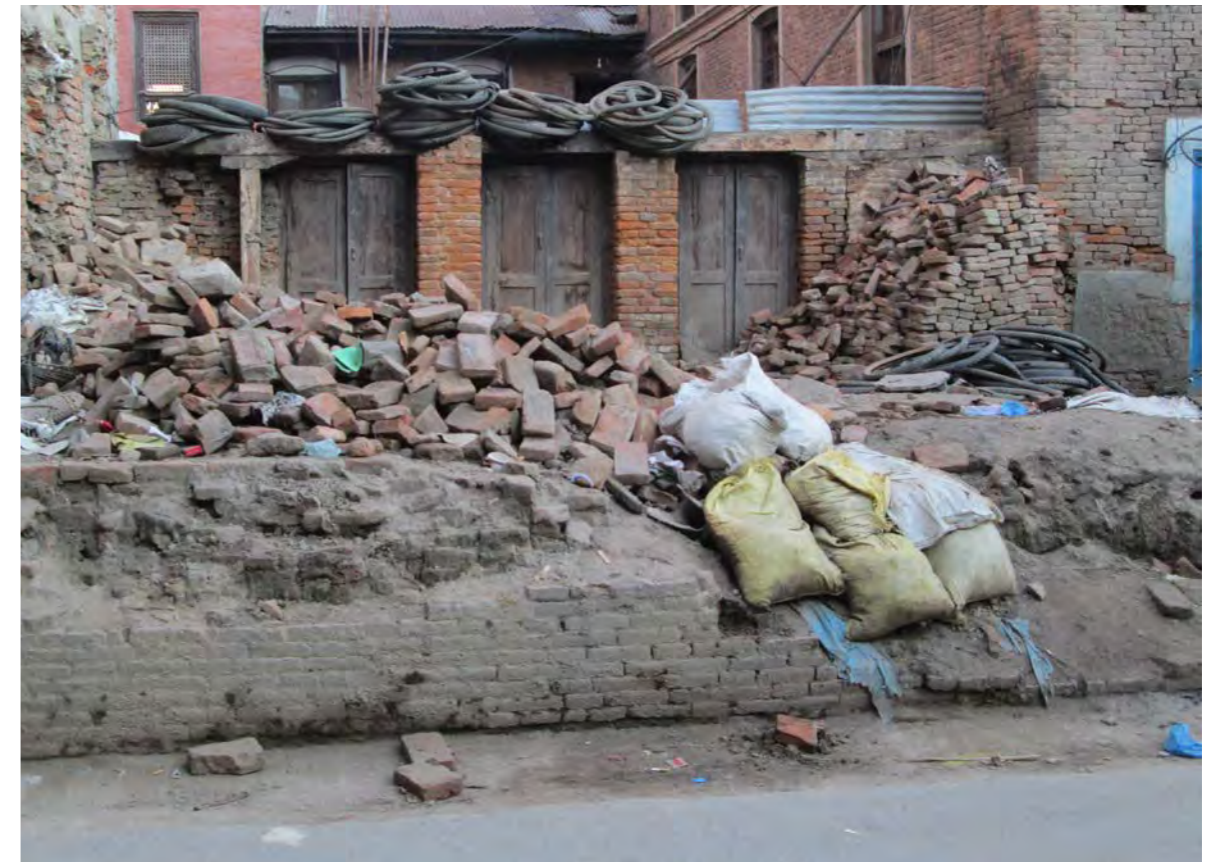
c6

CODE NO.	OWNERS NAME/ CONTACT NO.	STOREY NO.	PRESENT STOREY NO	STRUCTURAL SYS- TEM	MATERIAL	GENERAL DESCRIPTION	PROBLEM DESCRIPTION	DANGER	HERITAGE SIGNIFICANCE	REMARKS
c06	Gautam Manandhar	G+2		LB	B	CH	Totally collapsed

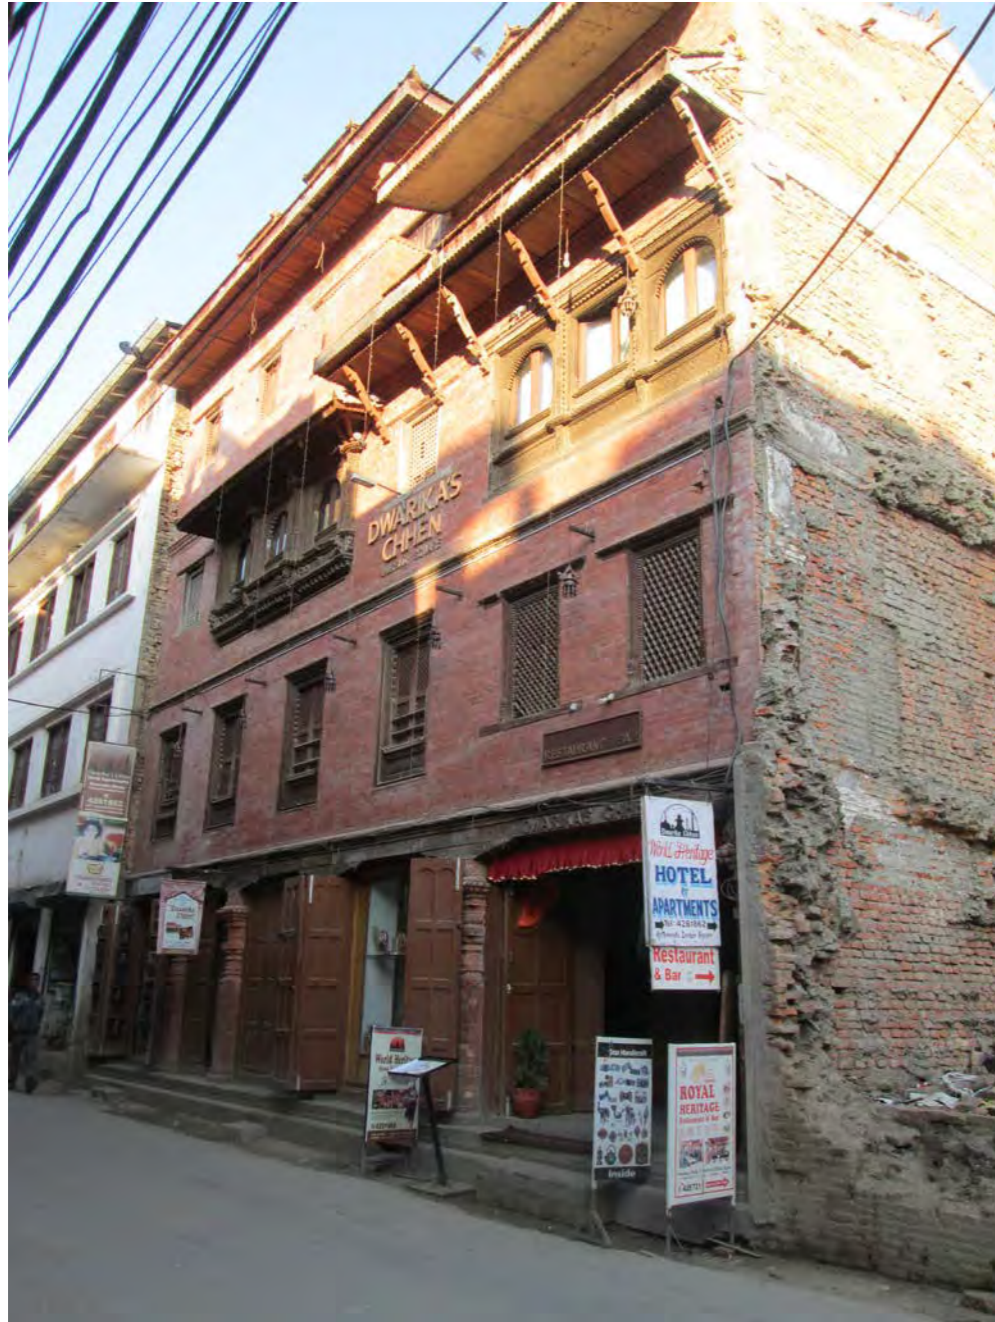
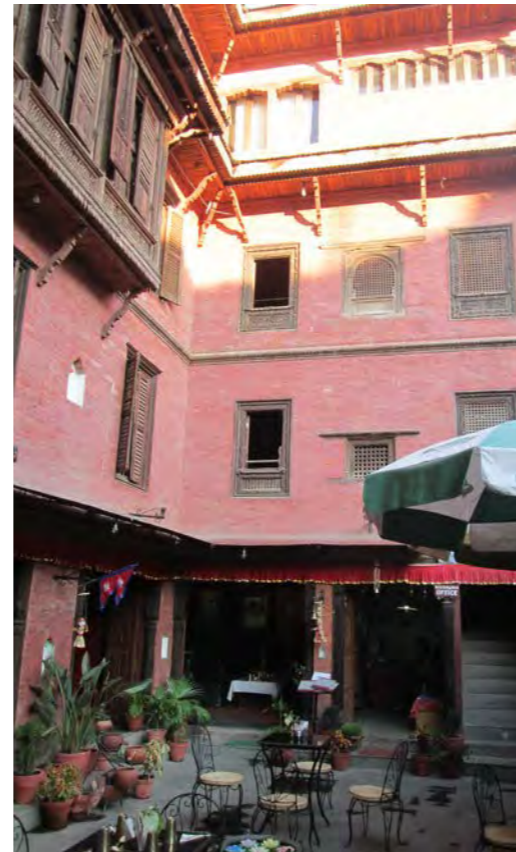
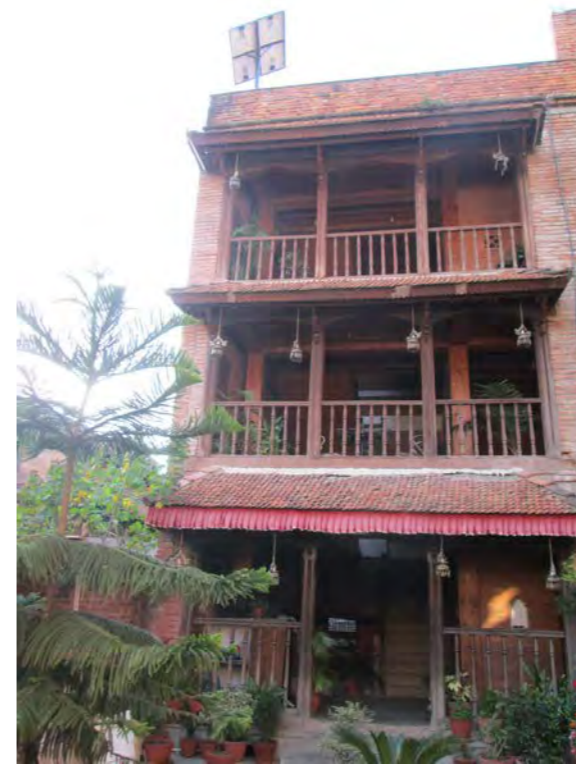
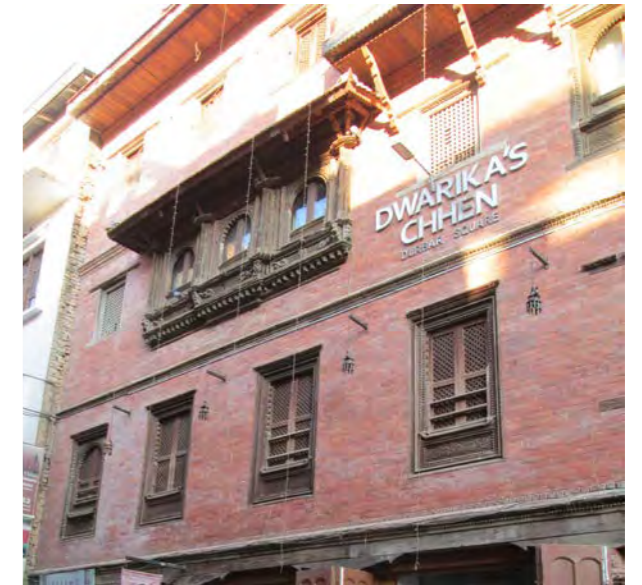
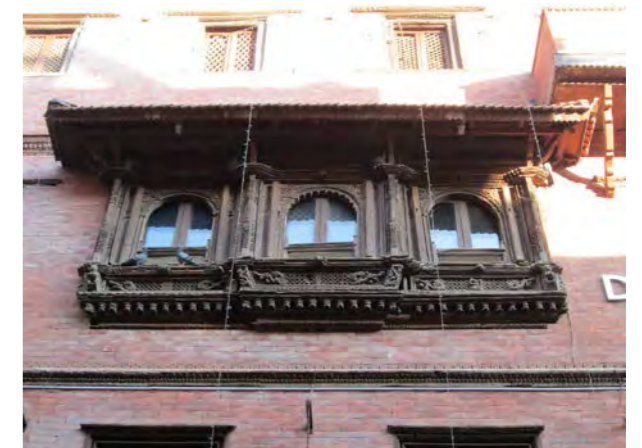
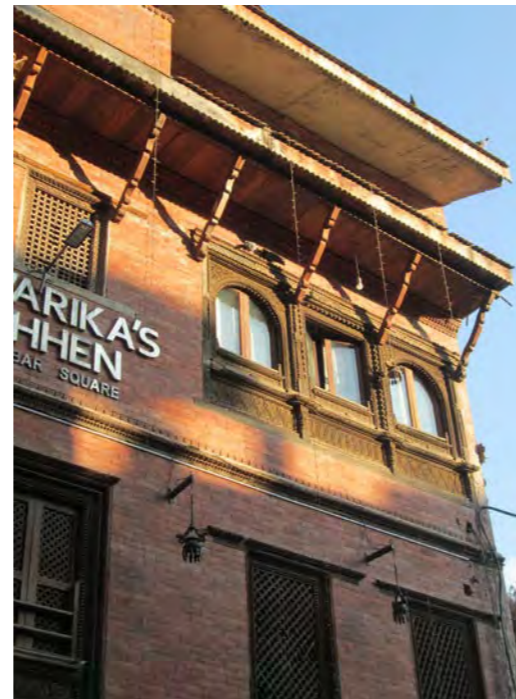
c7a

CODE NO.	OWNERS NAME/ CONTACT NO.	STOREY NO.	PRESENT STOREY NO	STRUCTURAL SYS- TEM	MATERIAL	GENERAL DESCRIPTION	PROBLEM DESCRIPTION	DANGER	HERITAGE SIGNIFICANCE	REMARKS
c07a	Dwarikas chein Sa- gal Manandhar (9851066000)	G+3.5	G+3.5	F	B+C	Hotel & Apartment	No visible damage

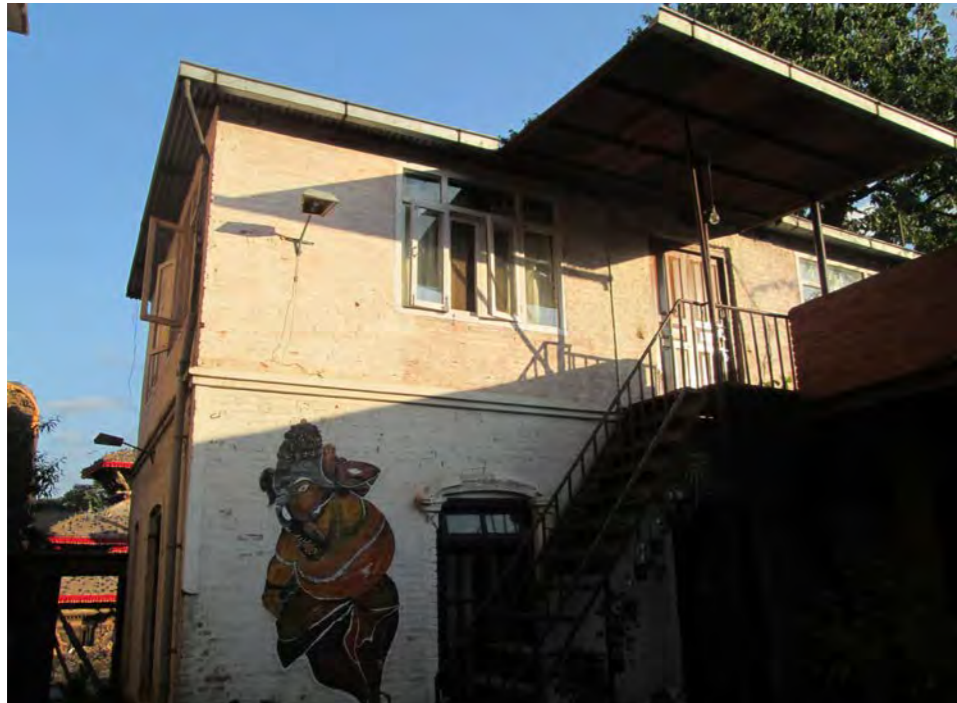
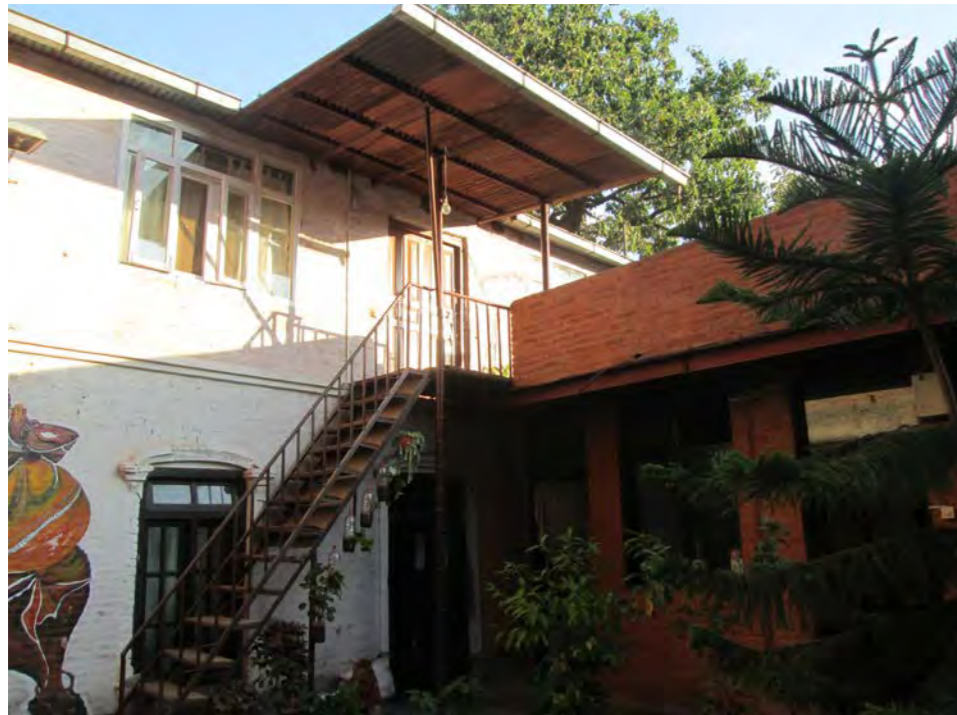
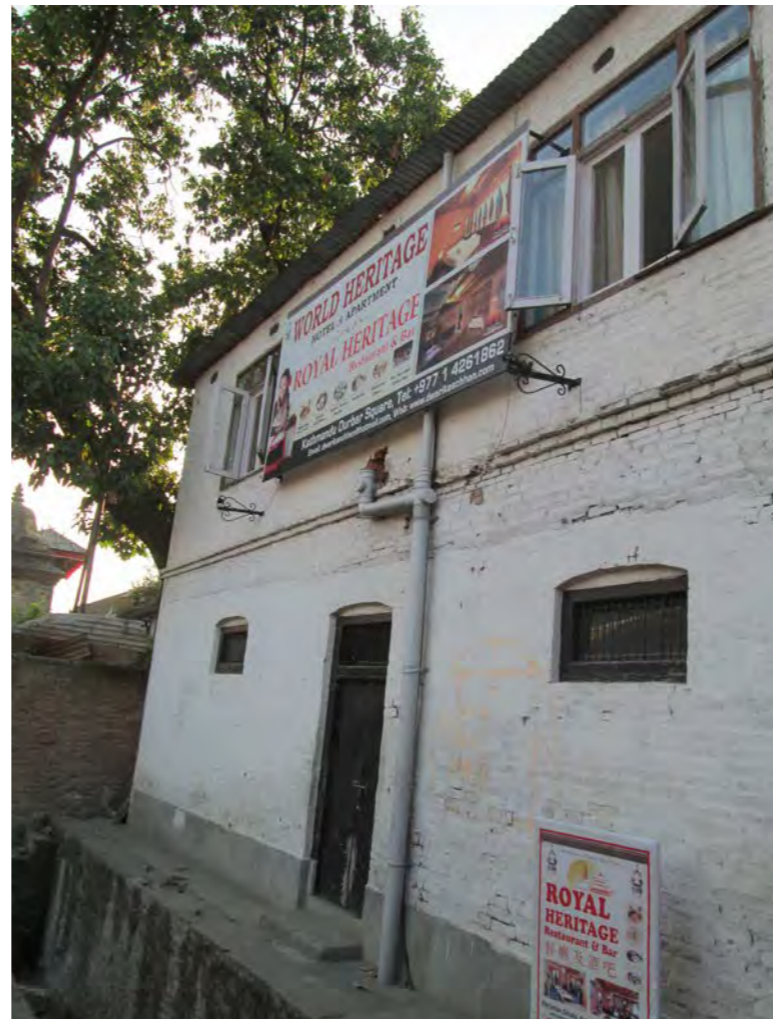
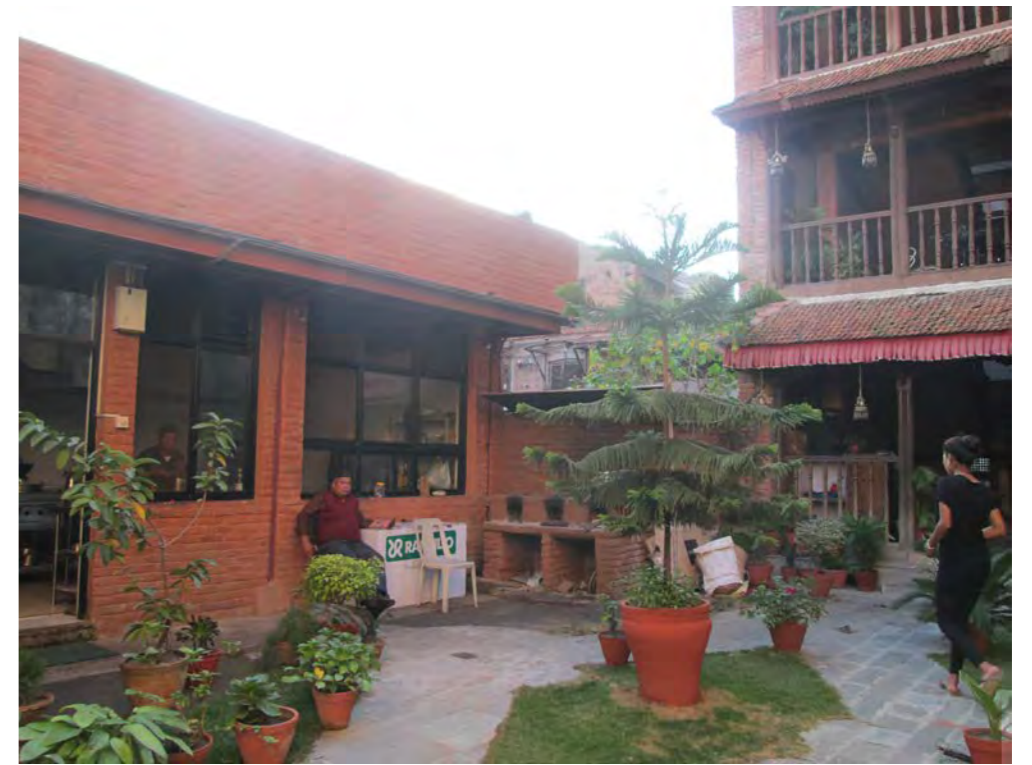
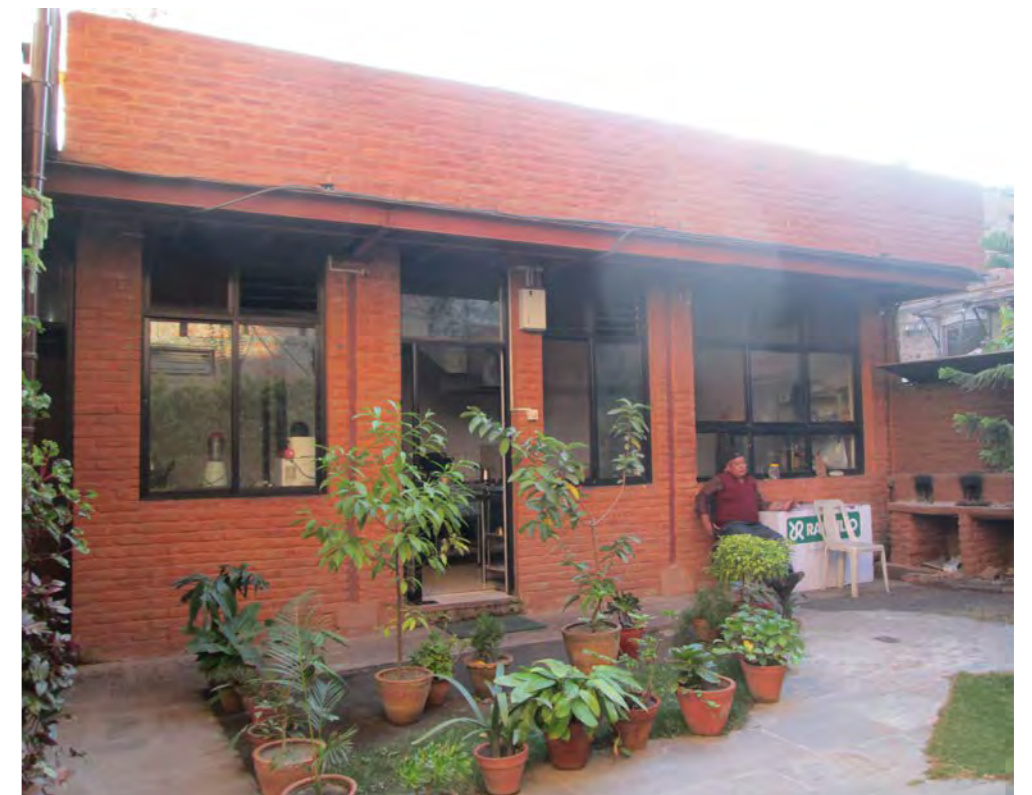
c7b, c7c

CODE NO.	OWNERS NAME/ CONTACT NO.	STOREY NO.	PRESENT STOREY NO	STRUCTURAL SYS- TEM	MATERIAL	GENERAL DESCRIPTION	PROBLEM DESCRIPTION	DANGER	HERITAGE SIGNIFICANCE	REMARKS
c07b	Sagal Manandhar (9851066000)	G+1	G+1	LB	B		No visible damage			
c07c	Sagal Manandhar (9851066000)	G	G				No visible damage

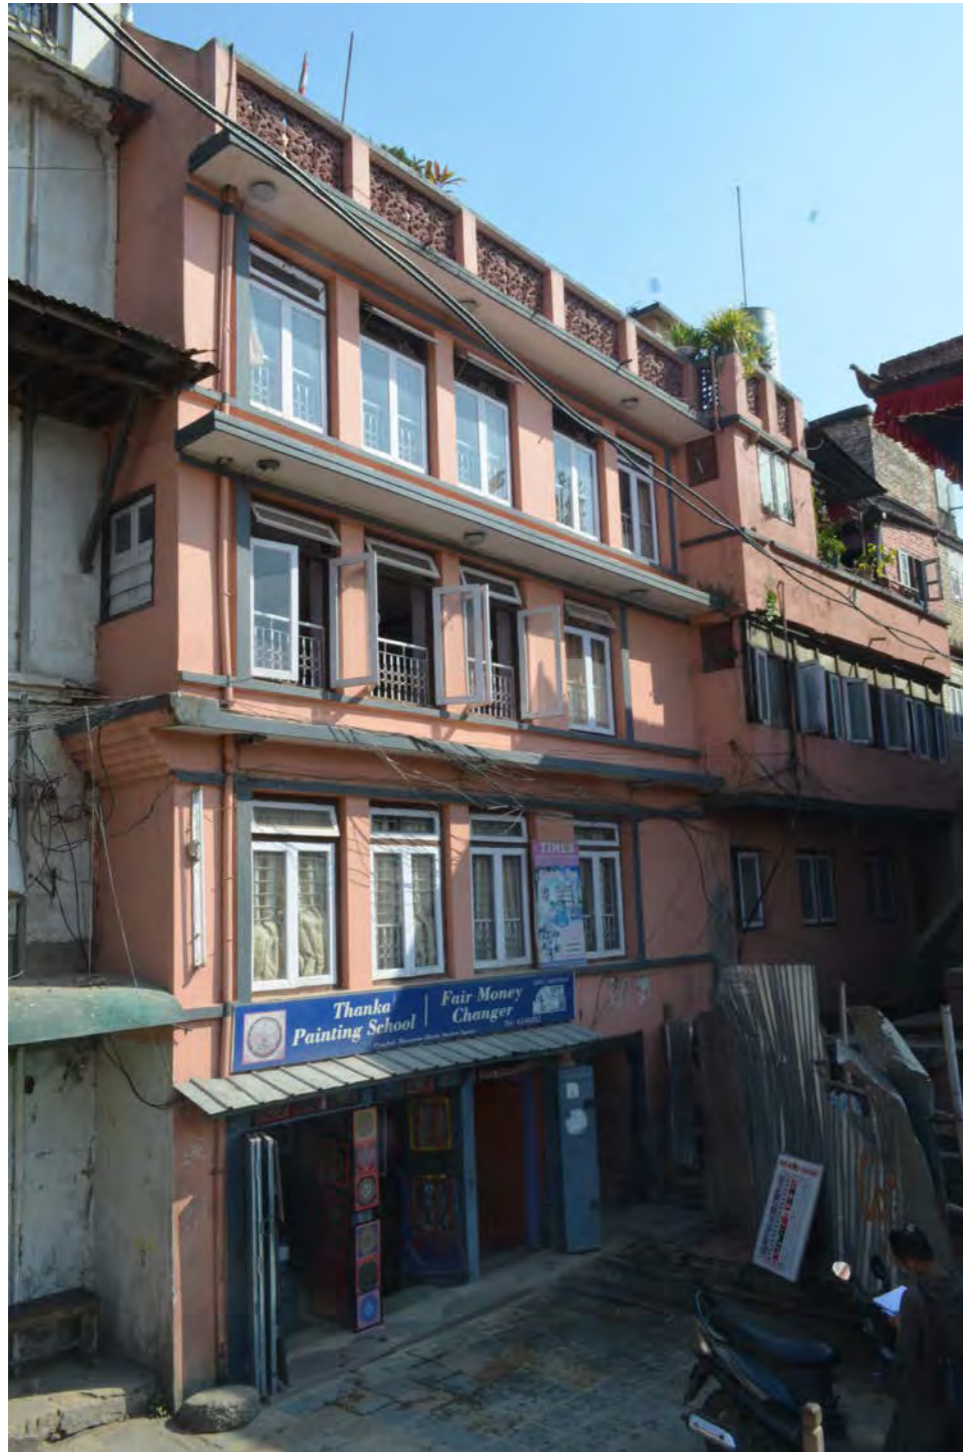
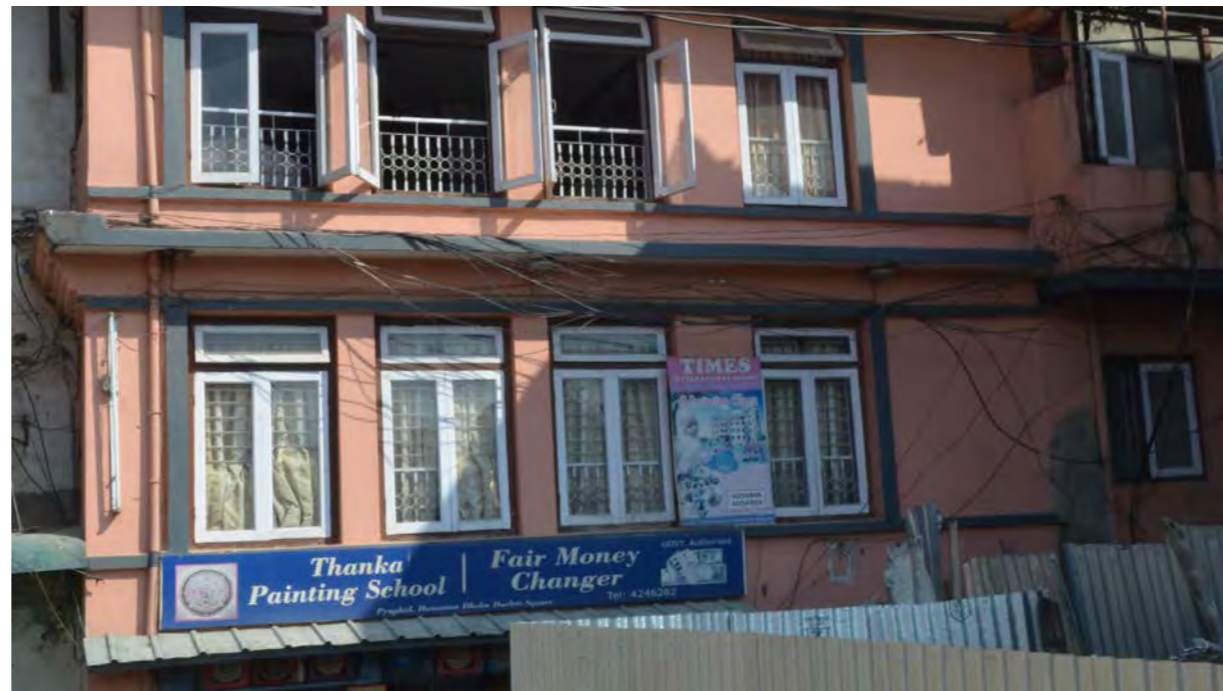
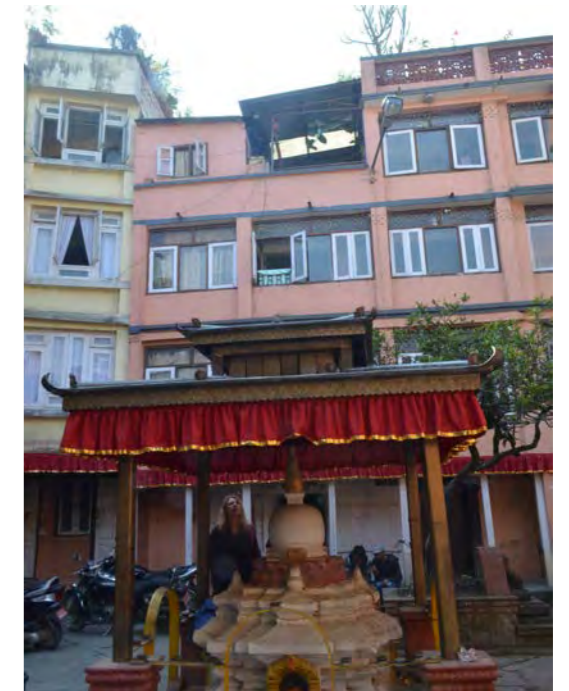
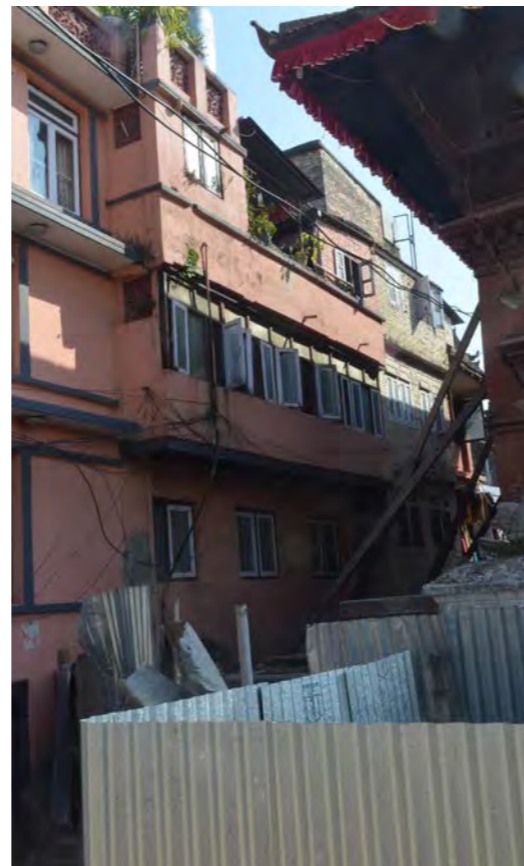
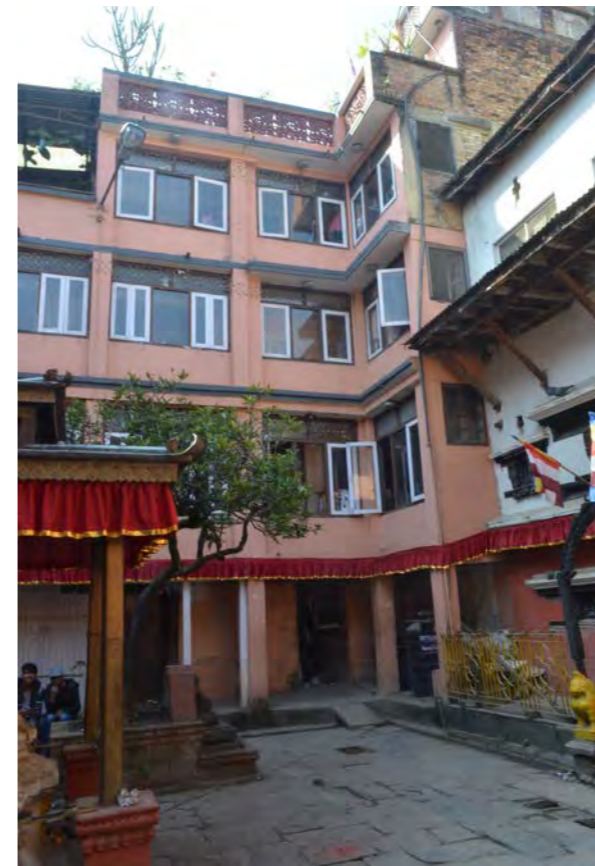
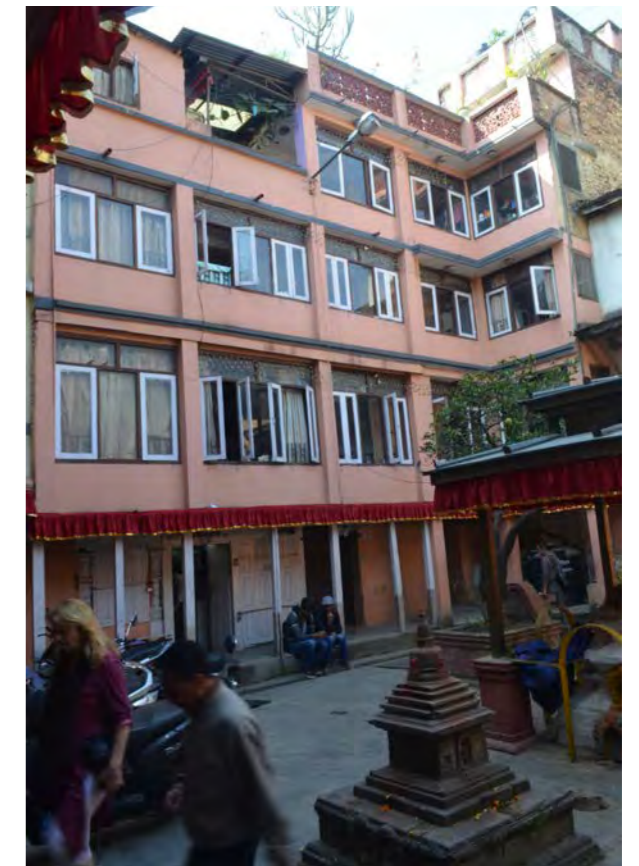
c8

CODE NO.	OWNERS NAME/ CONTACT NO.	STOREY NO.	PRESENT STOREY NO	STRUCTURAL SYS- TEM	MATERIAL	GENERAL DESCRIPTION	PROBLEM DESCRIPTION	DANGER	HERITAGE SIGNIFICANCE	REMARKS
c08	Gyan Man Bajracharya	G+3.5	G+3.5	LB	B+C		No visible damage from outside, internal hair line crack on wall
