2015 Earthquake Damage Mapping

Hanuman Dhoka Darbar Square Monument Zone
Kathmandu Valley World Heritage Property

December 2015

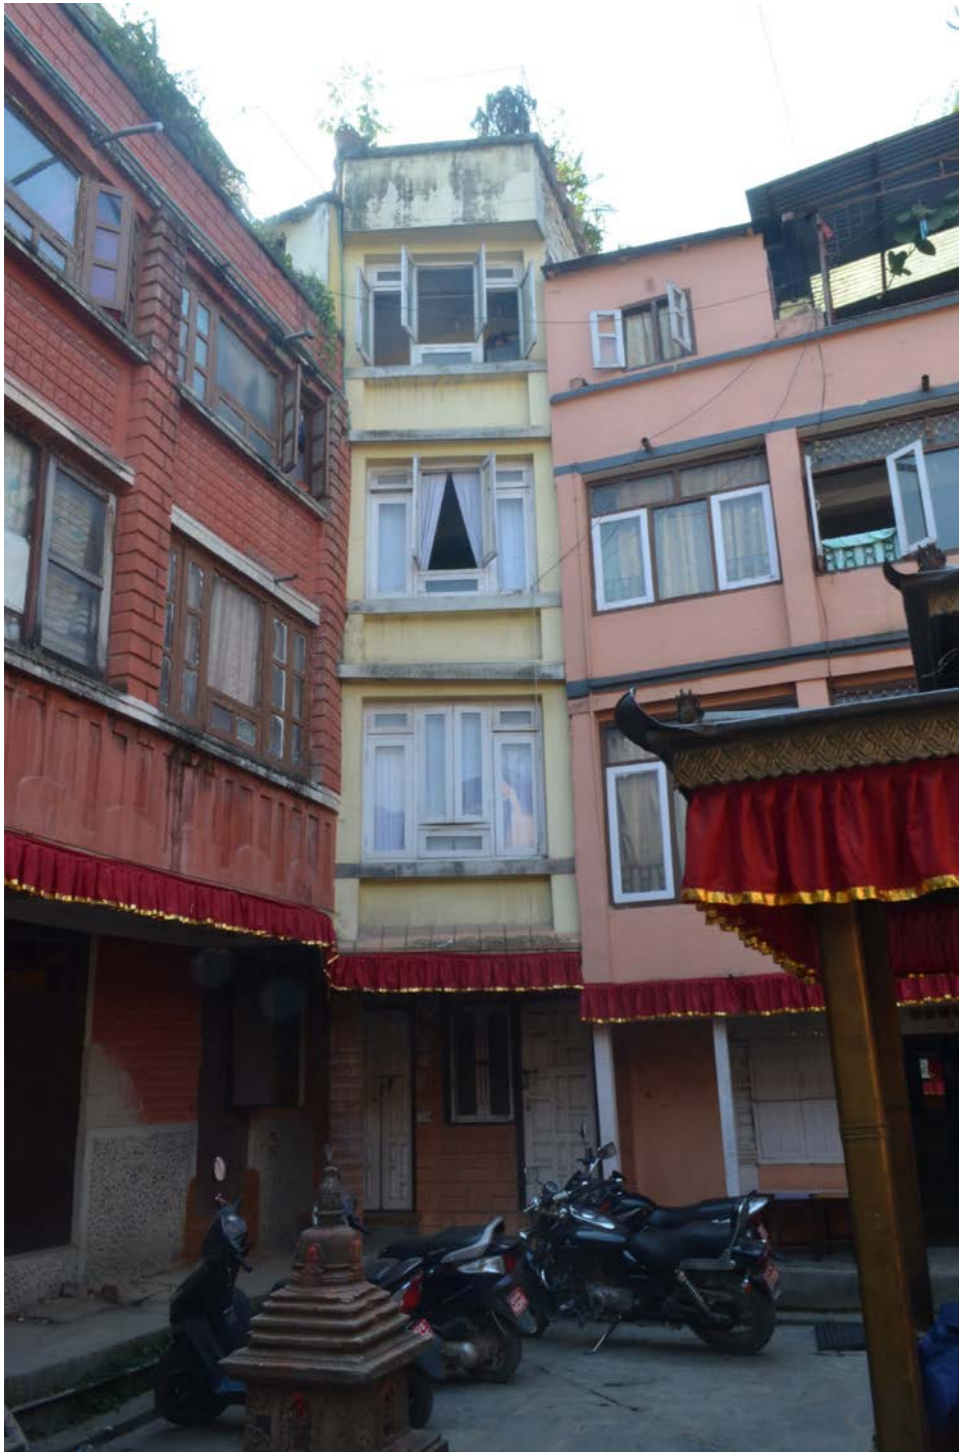
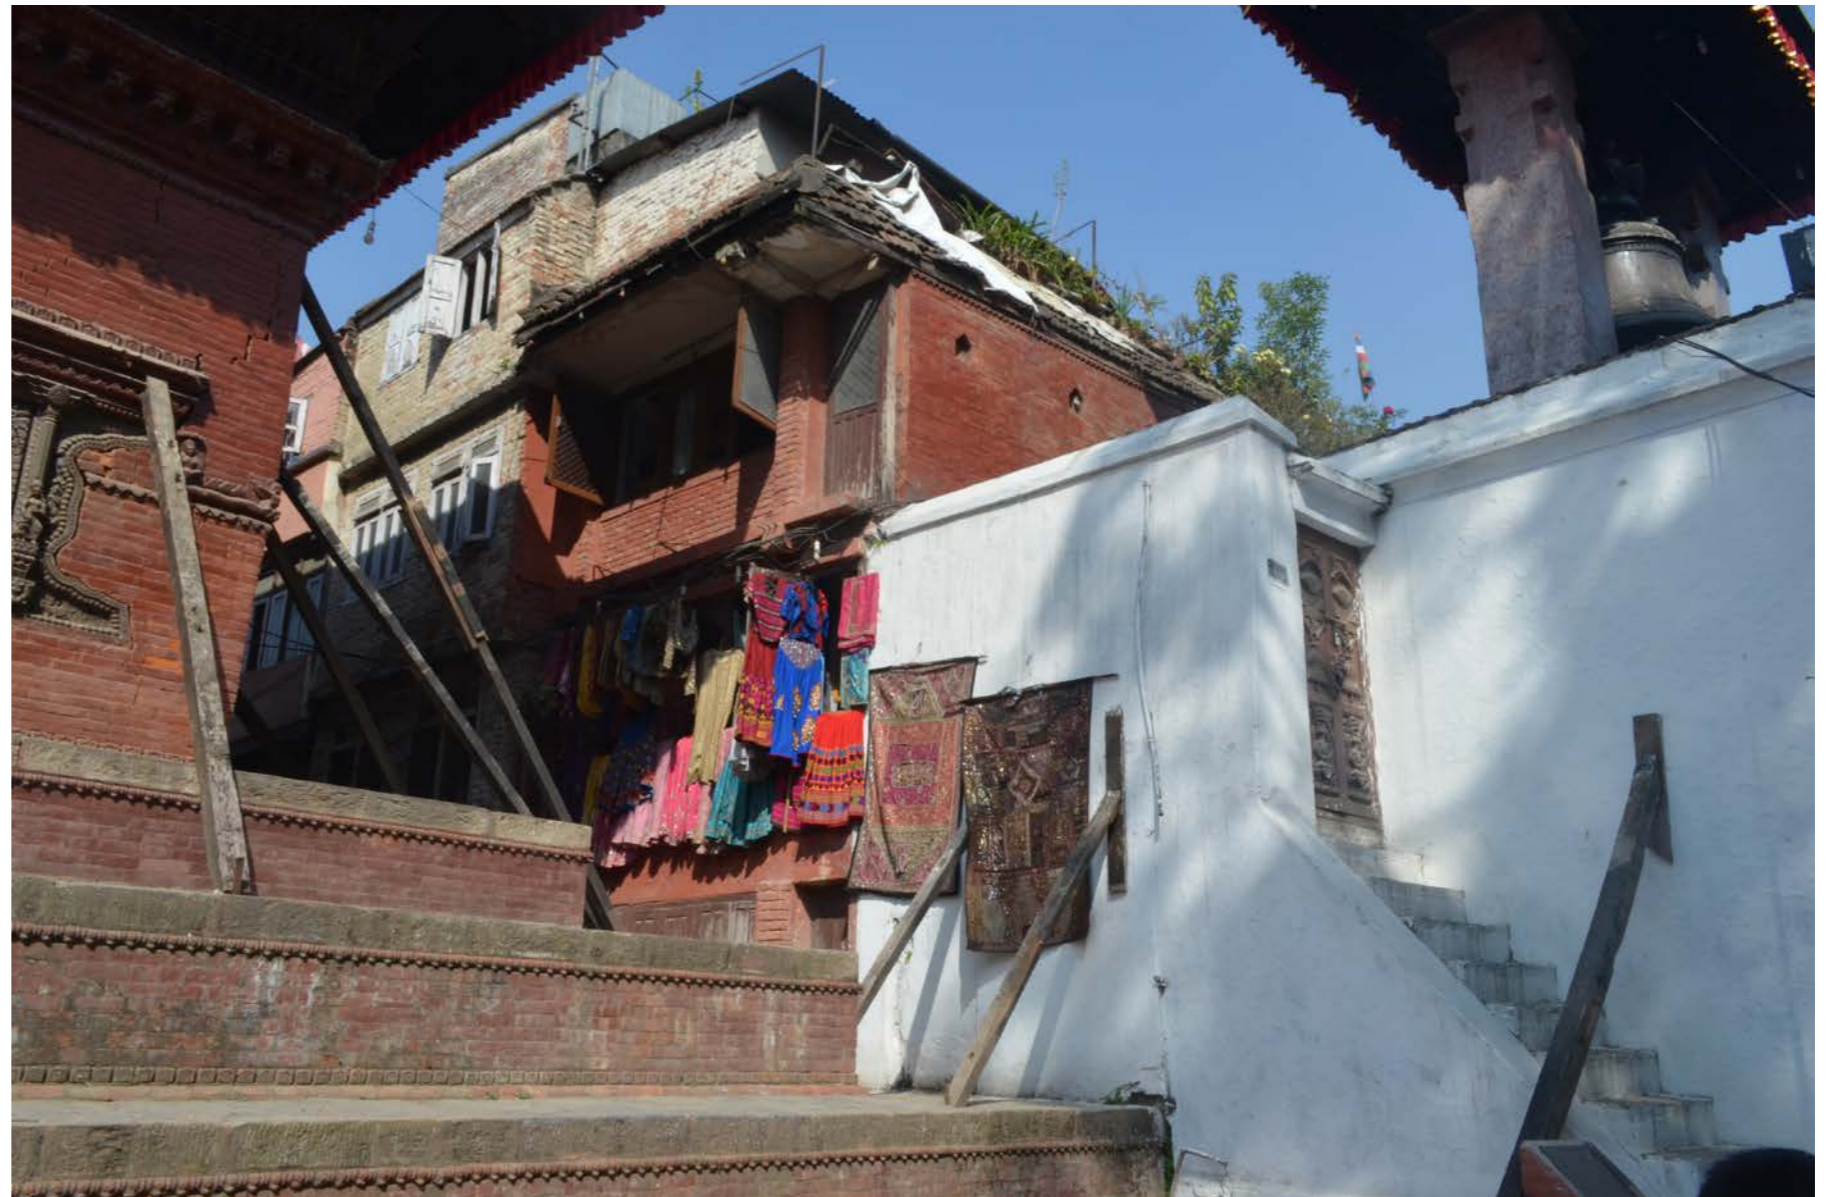
c9

CODE NO.	OWNERS NAME/ CONTACT NO.	STOREY NO.	PRESENT STOREY NO	STRUCTURAL SYS- TEM	MATERIAL	GENERAL DESCRIPTION	PROBLEM DESCRIPTION	DANGER	HERITAGE SIGNIFICANCE	REMARKS
c09	Krishna Man Bajracharya	G+3.5	G+3.5	F	B+C	cement plaster, glass window	No visible damage from outside, internal hair line crack on wall

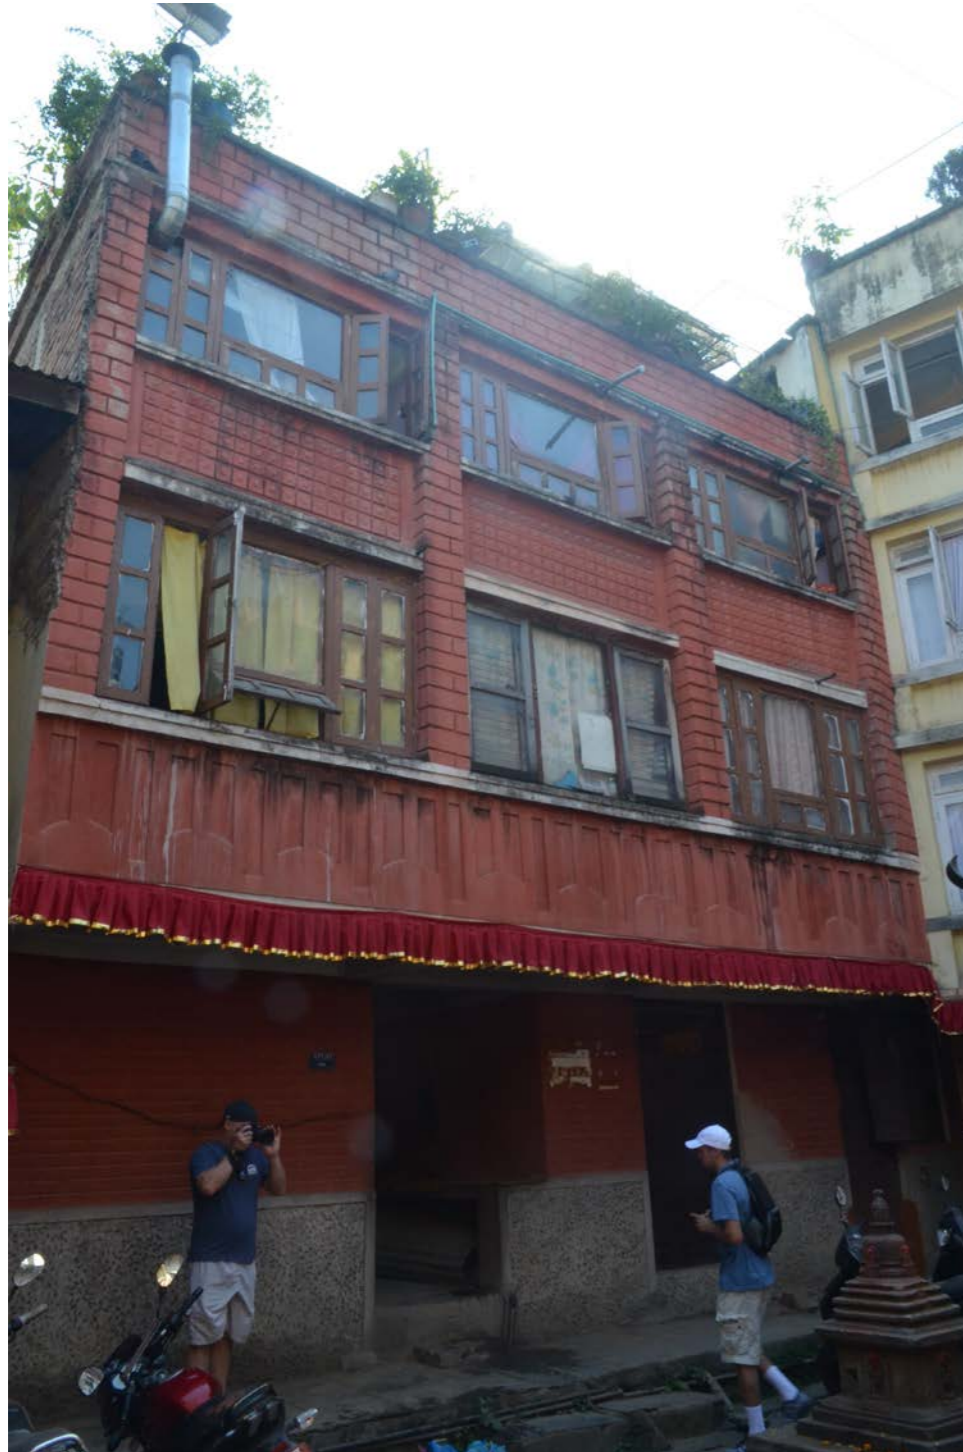
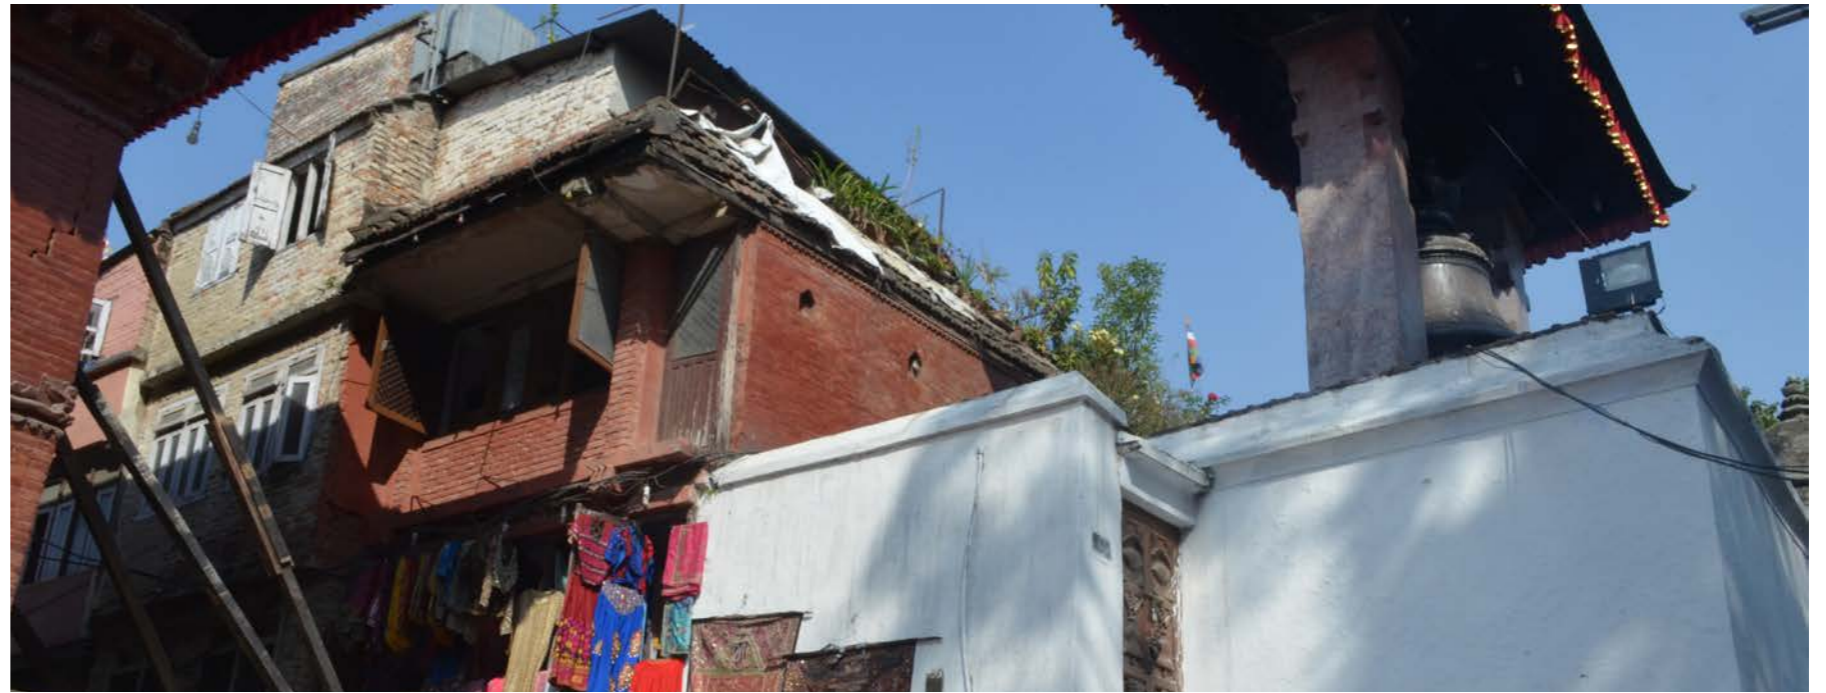
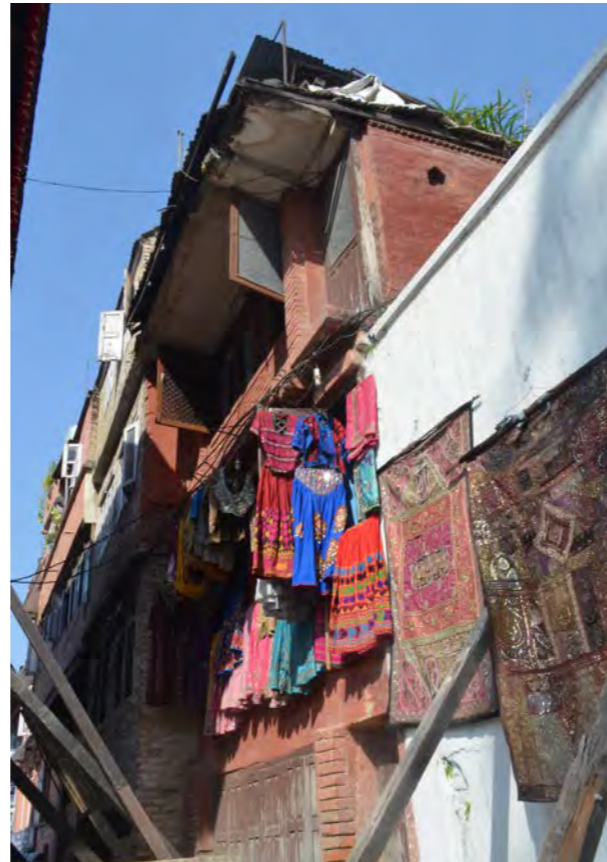
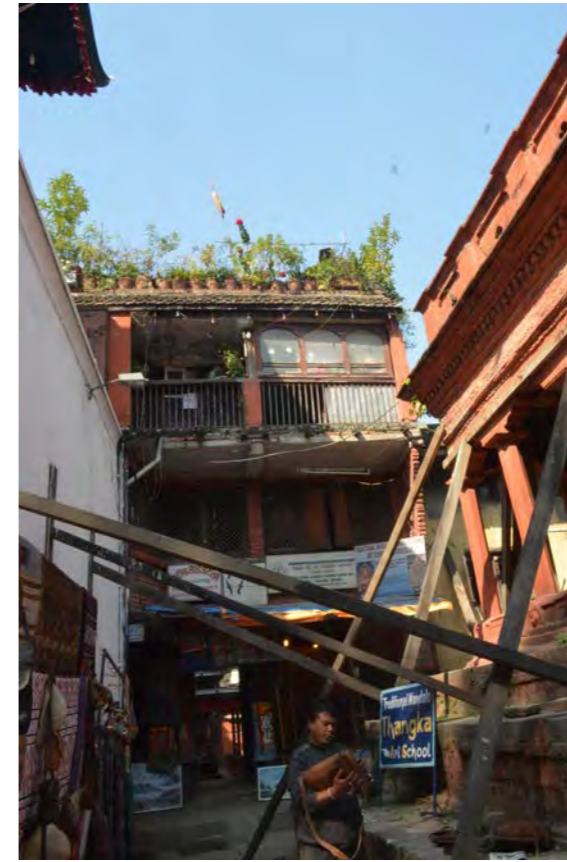
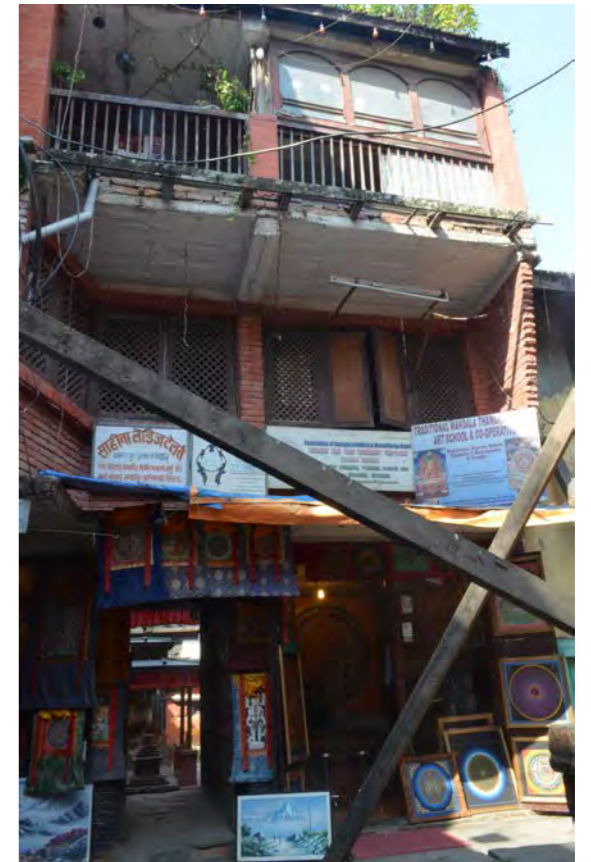
CODE NO.	OWNERS NAME/ CONTACT NO.	STOREY NO.	PRESENT STOREY NO	STRUCTURAL SYS- TEM	MATERIAL	GENERAL DESCRIPTION	PROBLEM DESCRIPTION	DANGER	HERITAGE SIGNIFICANCE	REMARKS
c10	Rajendra Man Bajracha- rya	G+2.5	G+2.5	F	B	cement plaster, glass window	No visible damage from outside

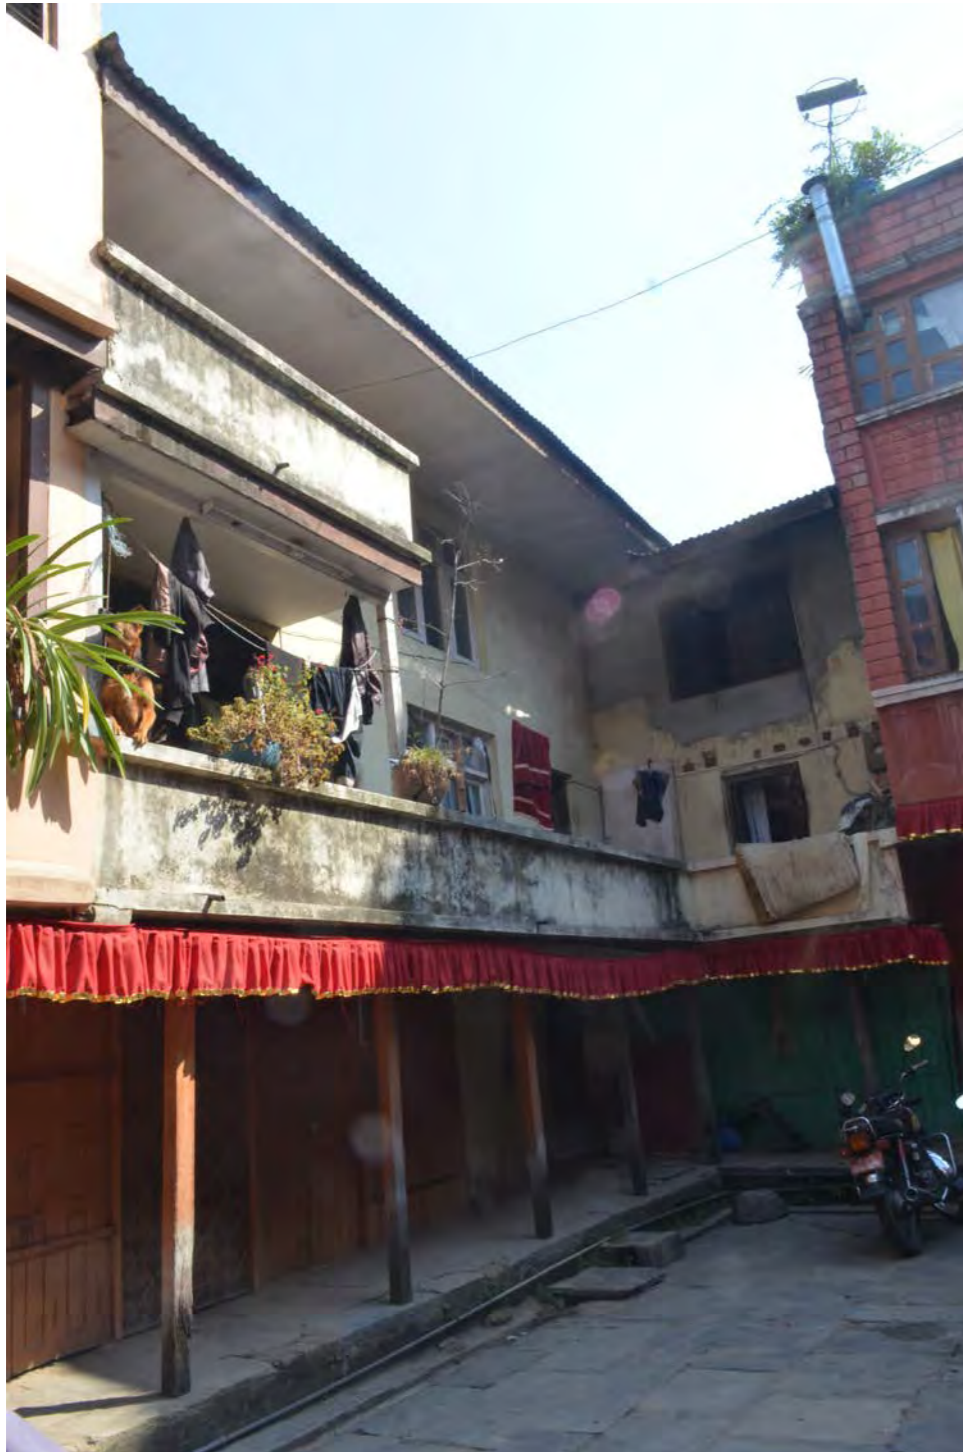
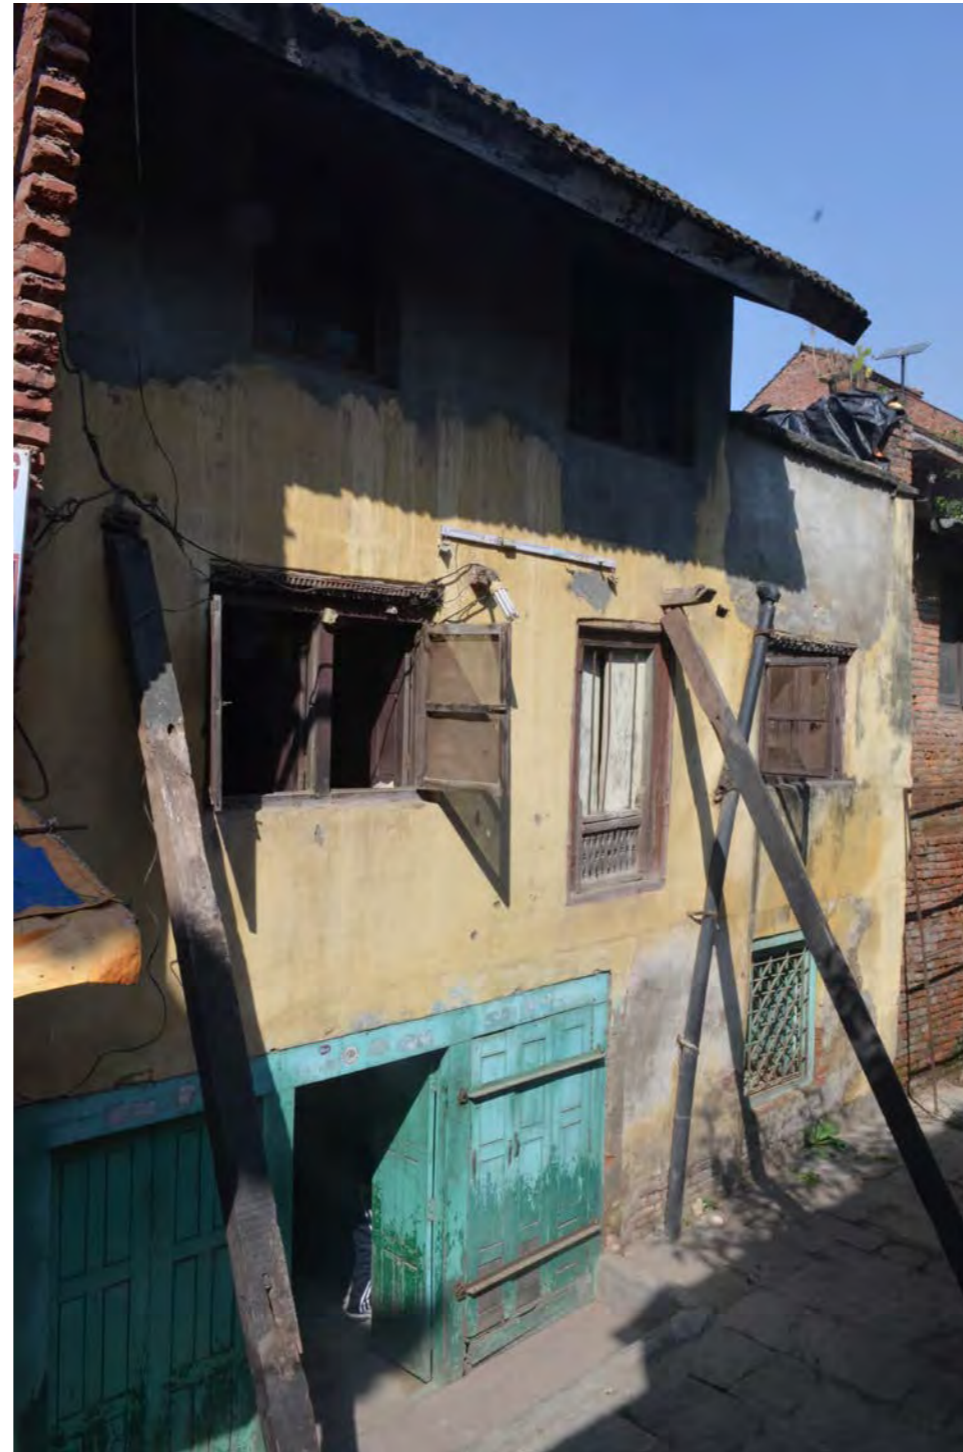
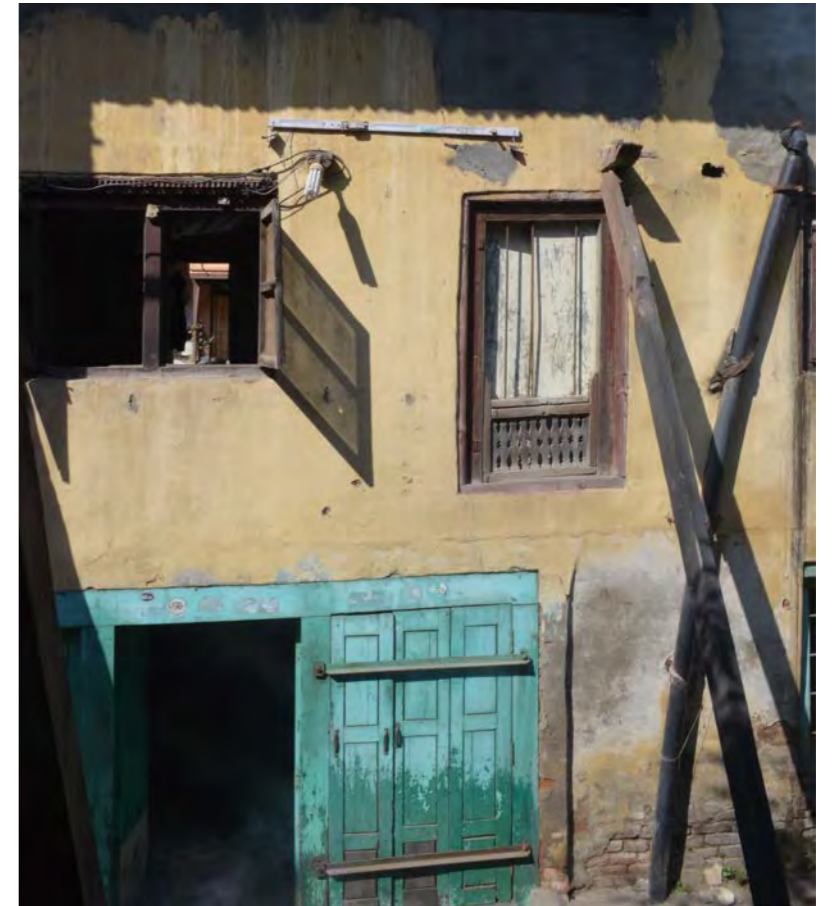
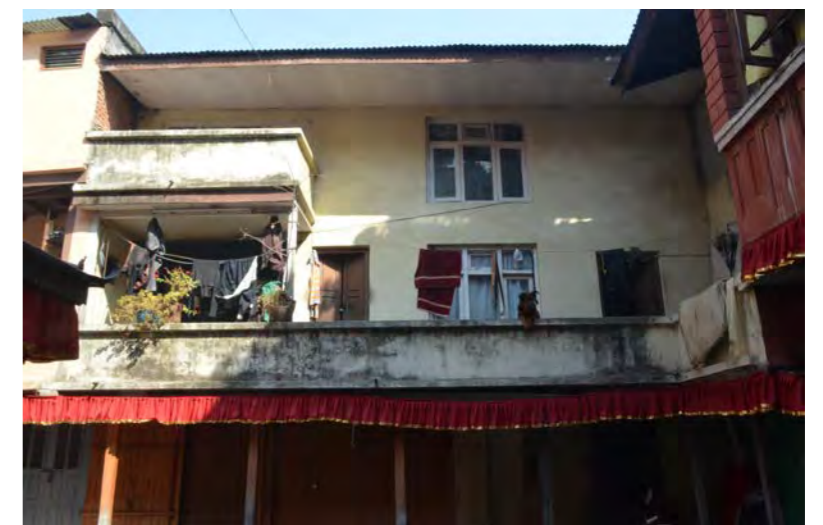
CODE NO.	OWNERS NAME/ CONTACT NO.	STOREY NO.	PRESENT STOREY NO	STRUCTURAL SYS- TEM	MATERIAL	GENERAL DESCRIPTION	PROBLEM DESCRIPTION	DANGER	HERITAGE SIGNIFICANCE	REMARKS
c11	Dilli Man Bajracharya (9849411157)	G+2	G+2	LB	B+C	cement plaster	plaster cracks vertically, dampness rises

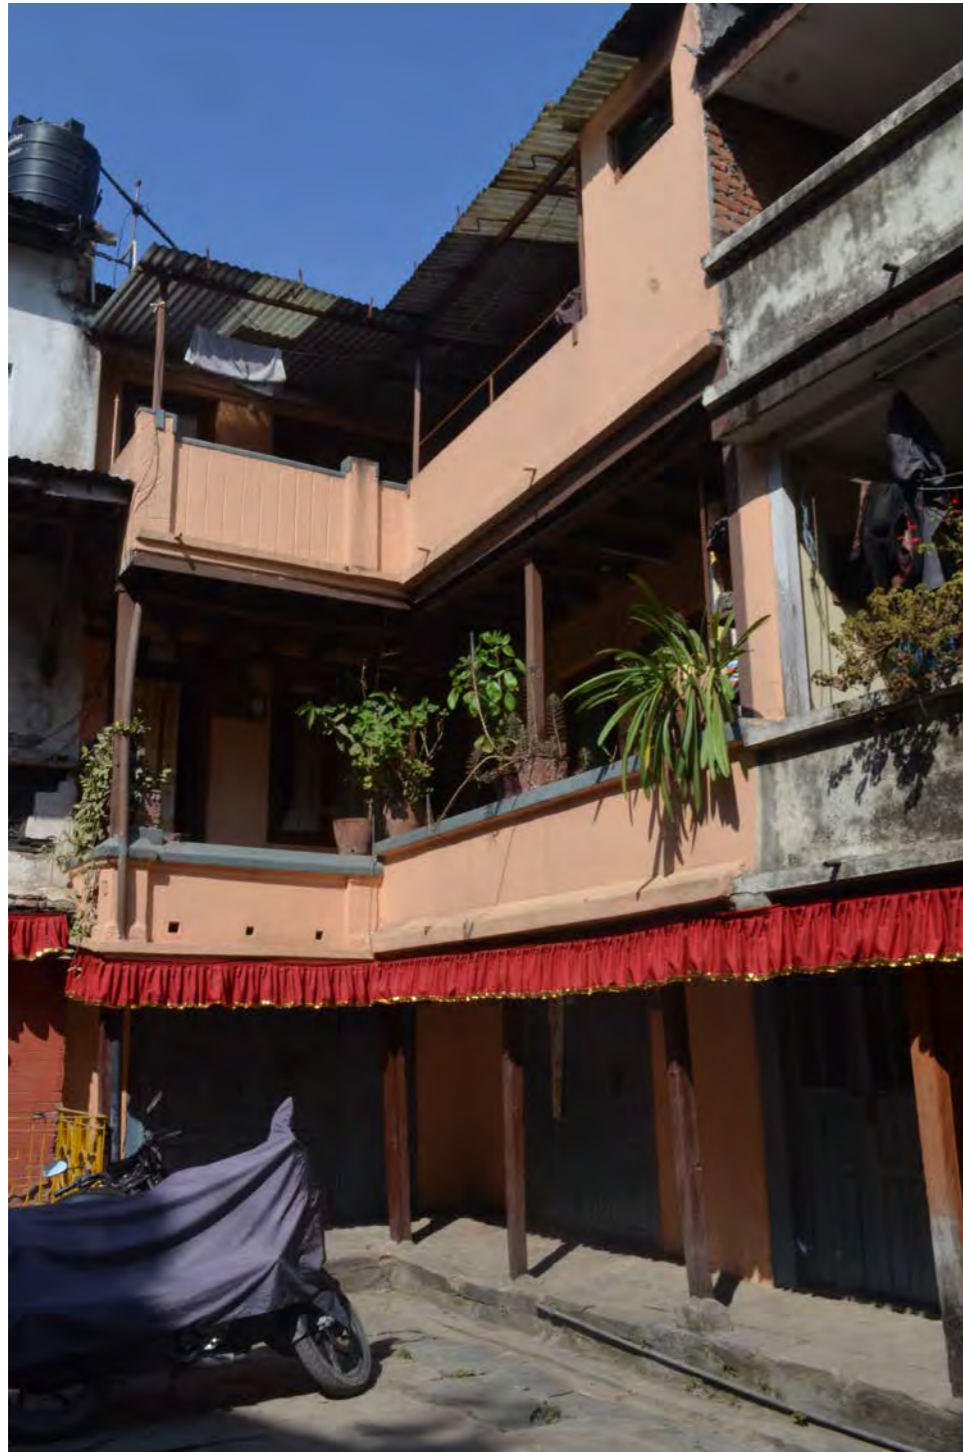
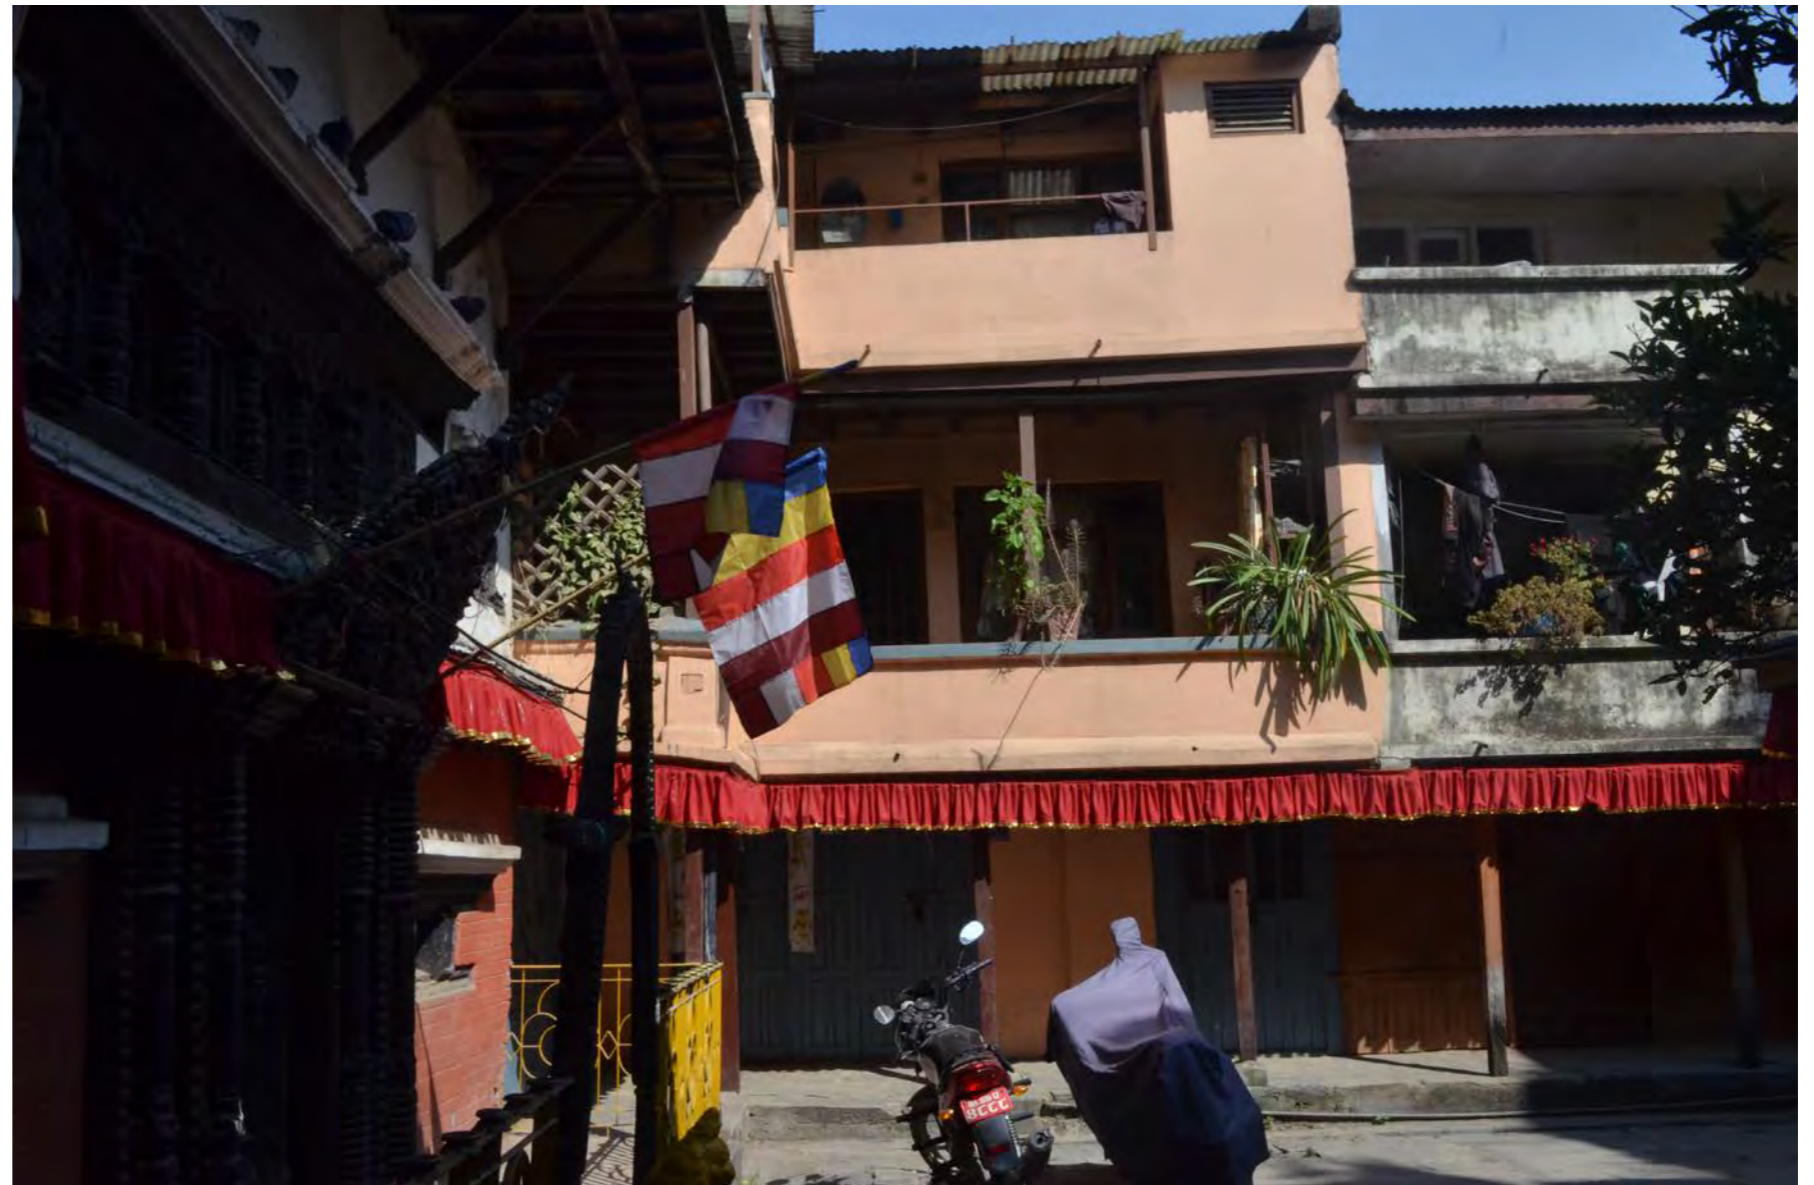
CODE NO.	OWNERS NAME/ CONTACT NO.	STOREY NO.	PRESENT STOREY NO	STRUCTURAL SYS- TEM	MATERIAL	GENERAL DESCRIPTION	PROBLEM DESCRIPTION	DANGER	HERITAGE SIGNIFICANCE	REMARKS
c12	Uday Man Bajracharya (4261242)	G+2	G+2	LB	B	cement plaster	No visible damage, hair line crack in internal wall

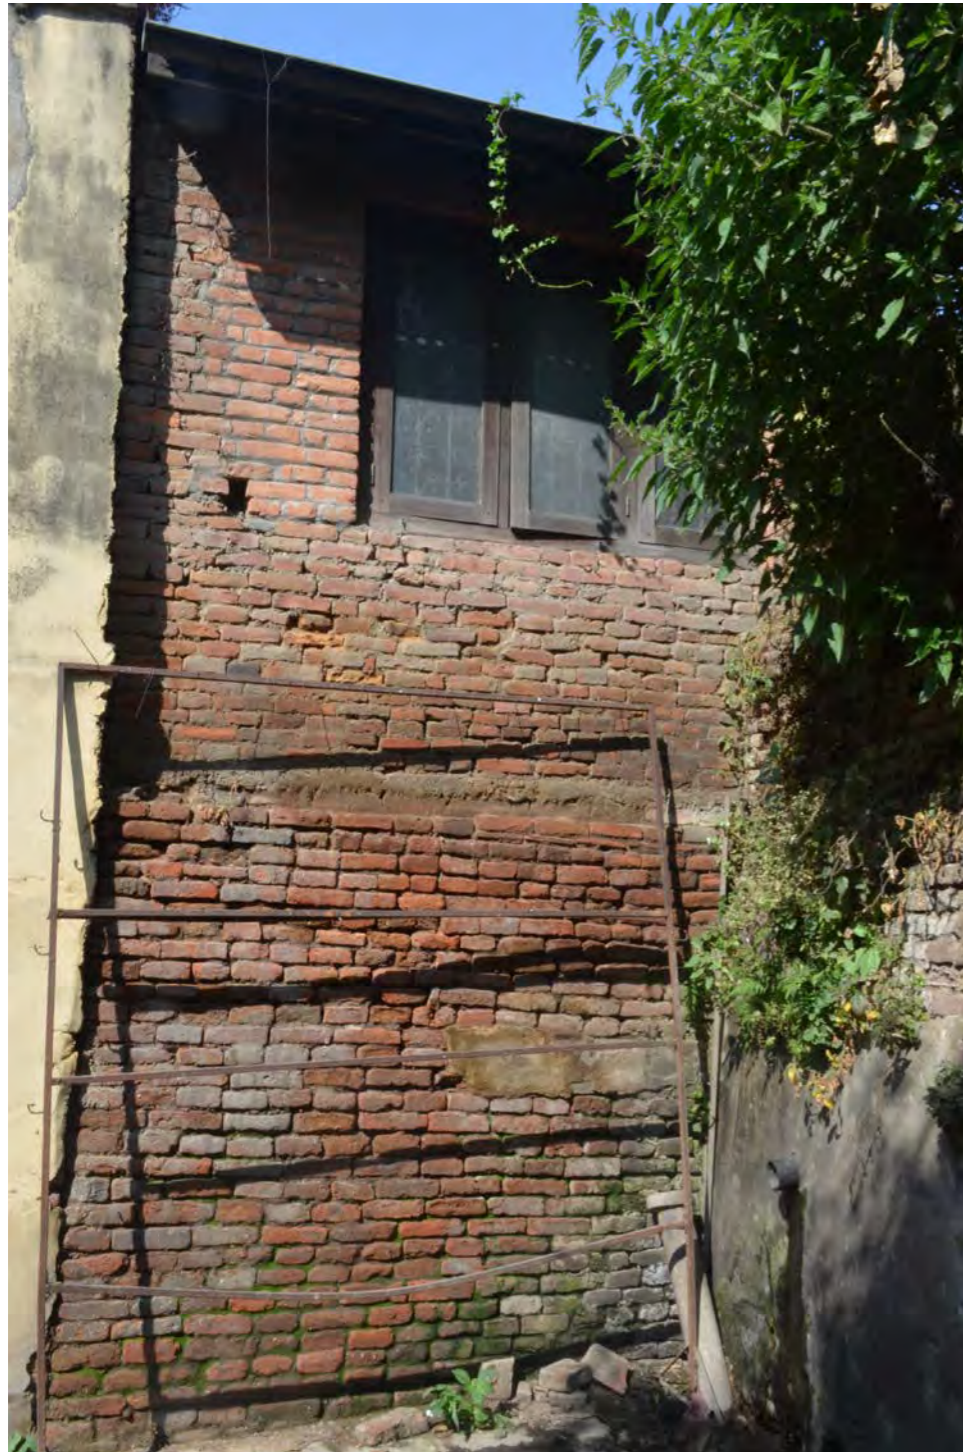
CODE NO.	OWNERS NAME/ CONTACT NO.	STOREY NO.	PRESENT STOREY NO	STRUCTURAL SYS- TEM	MATERIAL	GENERAL DESCRIPTION	PROBLEM DESCRIPTION	DANGER	HERITAGE SIGNIFICANCE	REMARKS
c13		G+1	G+1	LB	B		Dampness rises, vegetation growth			
c14	Gautam Manandhar	G	G	F	B		No visible damage

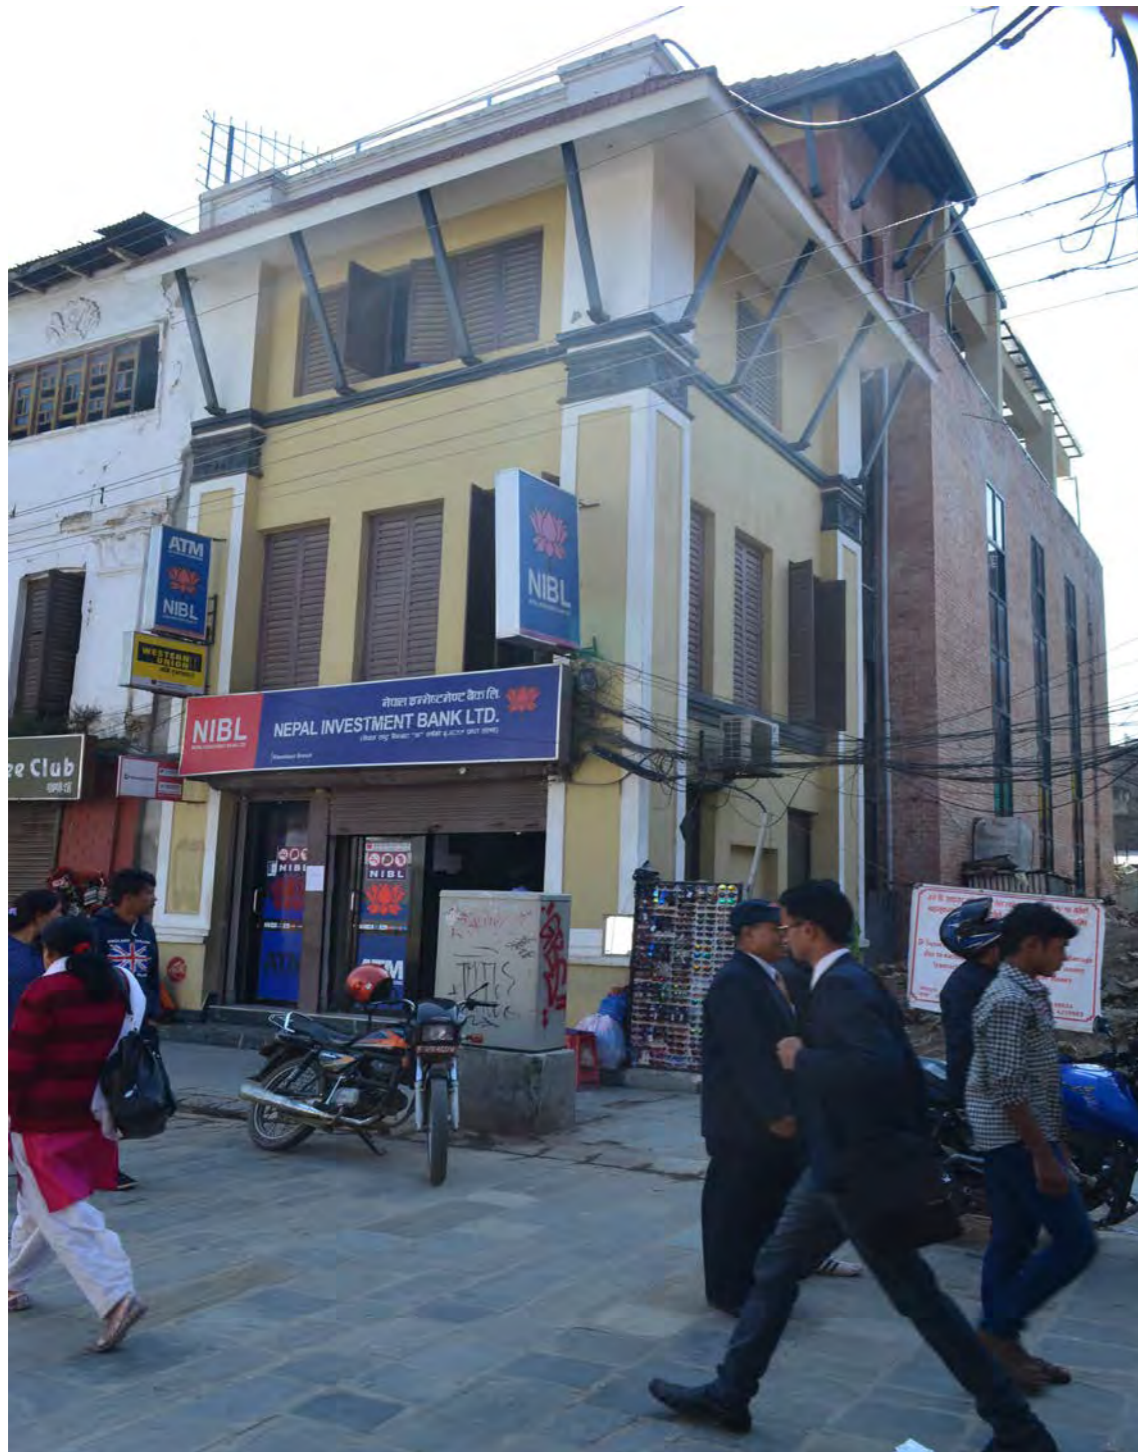
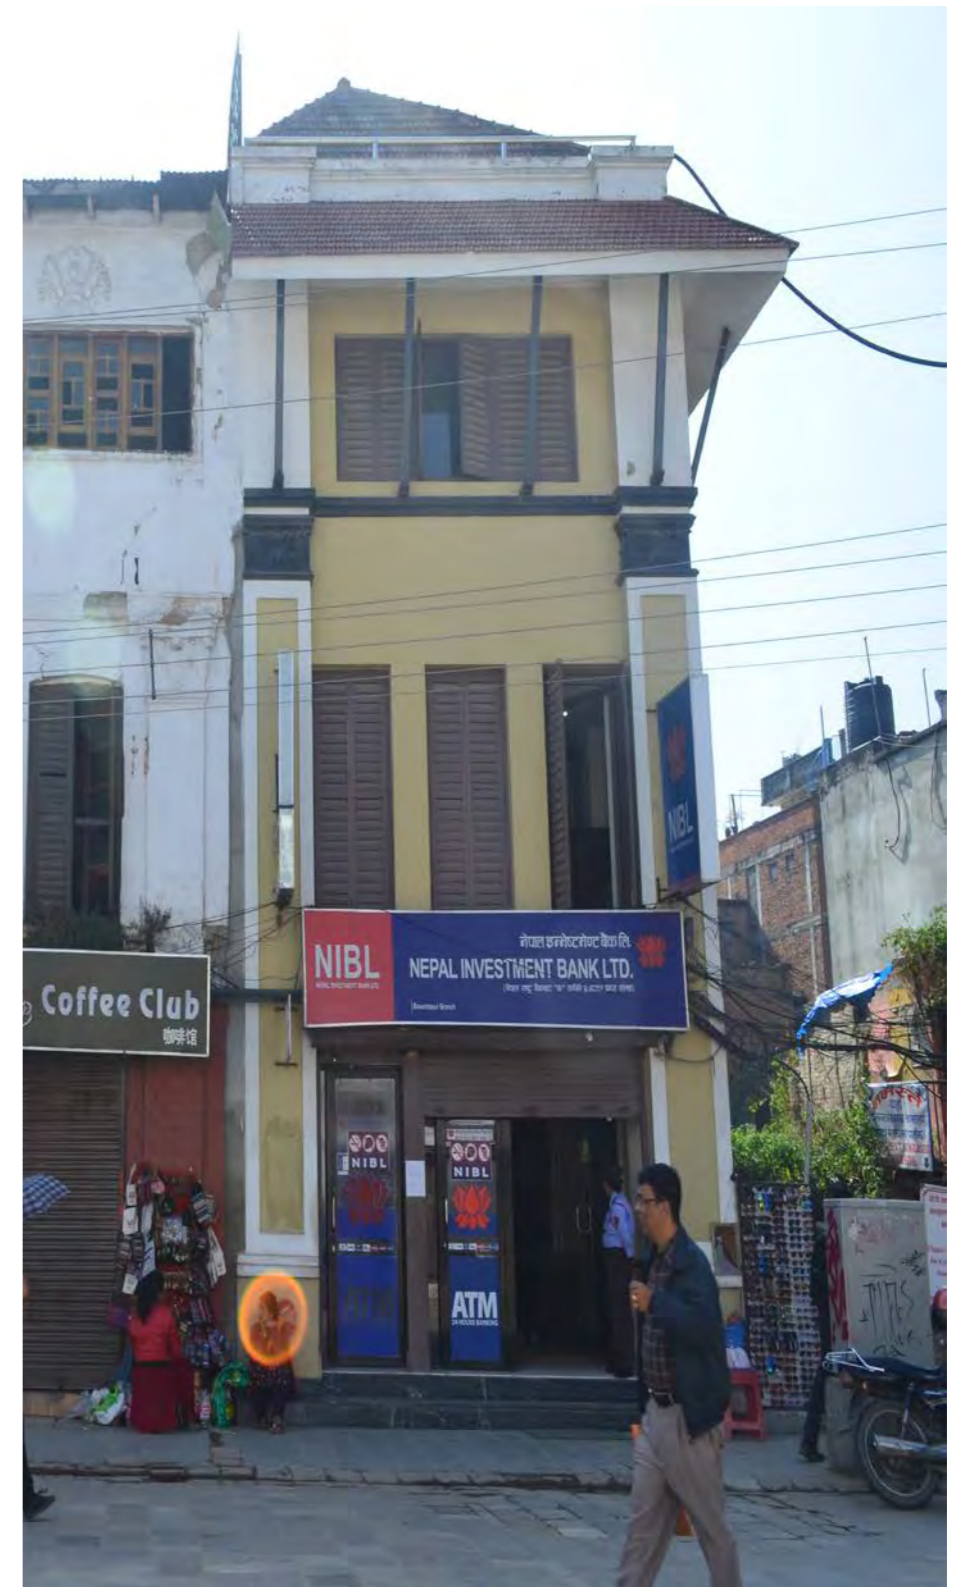
d1

CODE NO	OWNERS NAME/ CONTACT	STOREY NUM- BER	PRESENT STO- REY NUMBER	STRUCTURAL SYSTEM	MATERIAL	GENERAL DESCEIPTION	PROBLEM DESCRIPTION	DANGER	Heritage Sig- nificance	REMARKS	
d01		G+3	G+3	Load Bearing	Brick	Cement Plastered with tiled roof	Minor cracks in top floor

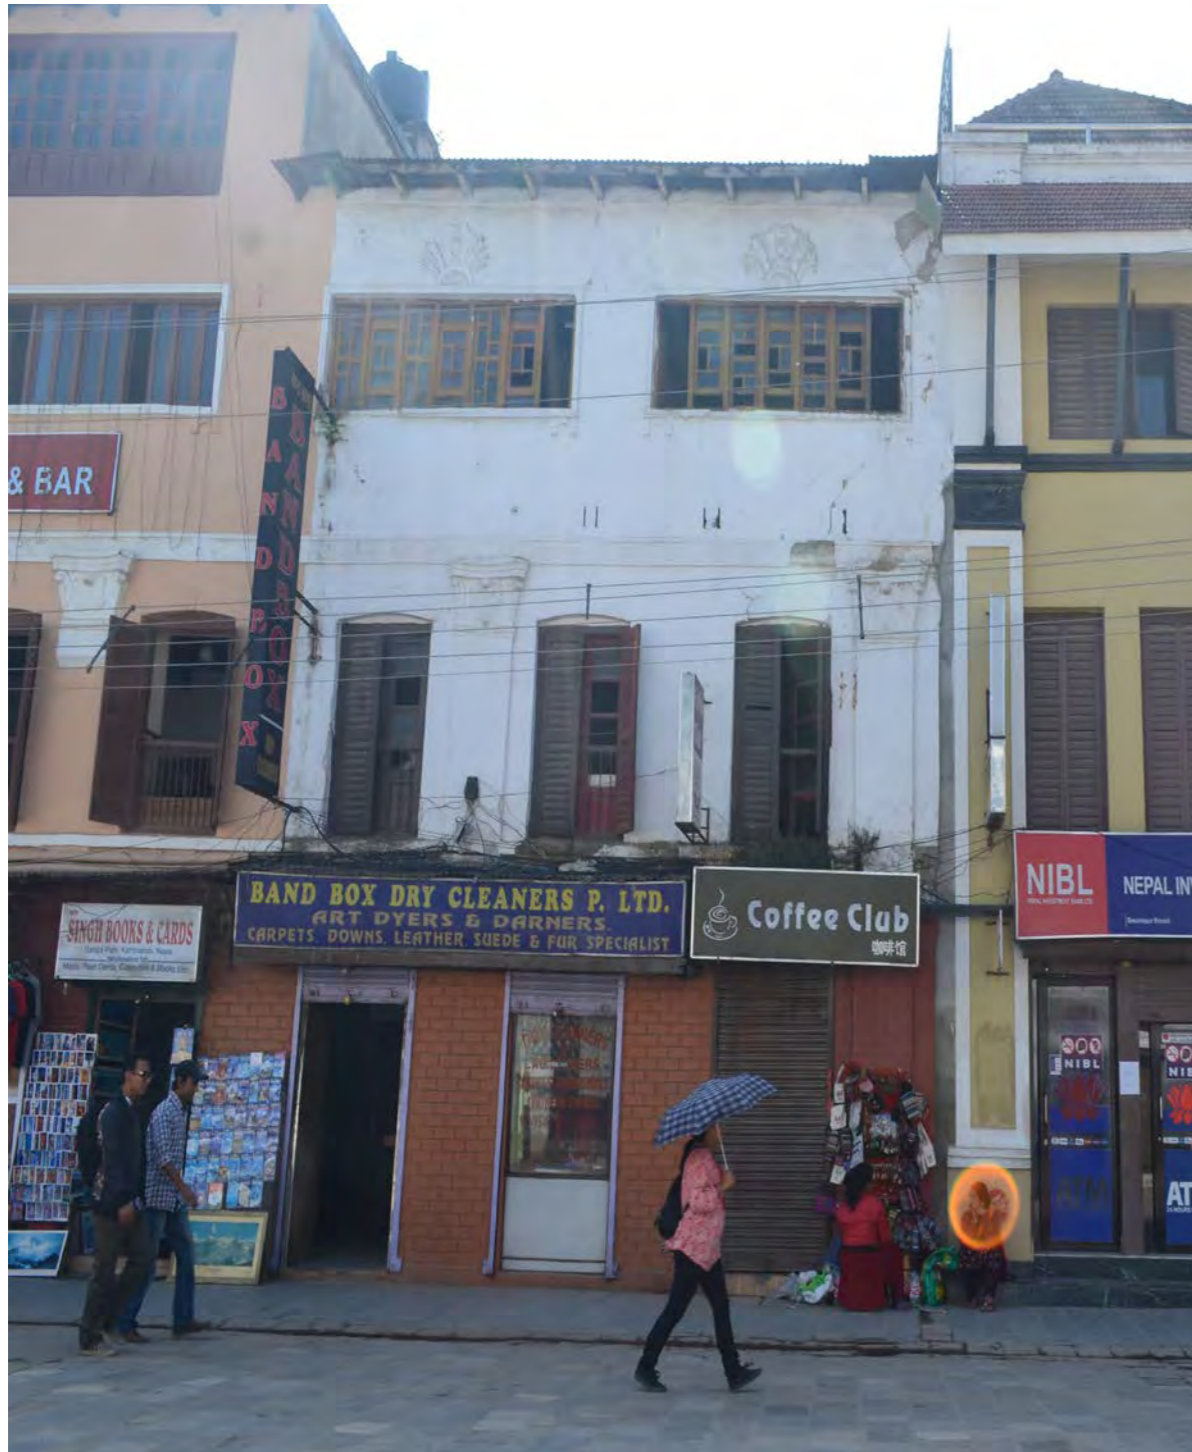
d2

CODE NO	OWNERS NAME/ CONTACT	STOREY NUM- BER	PRESENT STO- REY NUMBER	STRUCTURAL SYSTEM	MATERIAL	GENERAL DESCEIPTION	PROBLEM DESCRIPTION	DANGER	Heritage Sig- nificance	REMARKS
d02	Lab Dhoj Joshi	G+2	G+2	Load Bearing	Brick	Rana Style House with white housing	Extensive cracking on walls
