2015 Earthquake Damage Mapping

Hanuman Dhoka Darbar Square Monument Zone
Kathmandu Valley World Heritage Property

December 2015

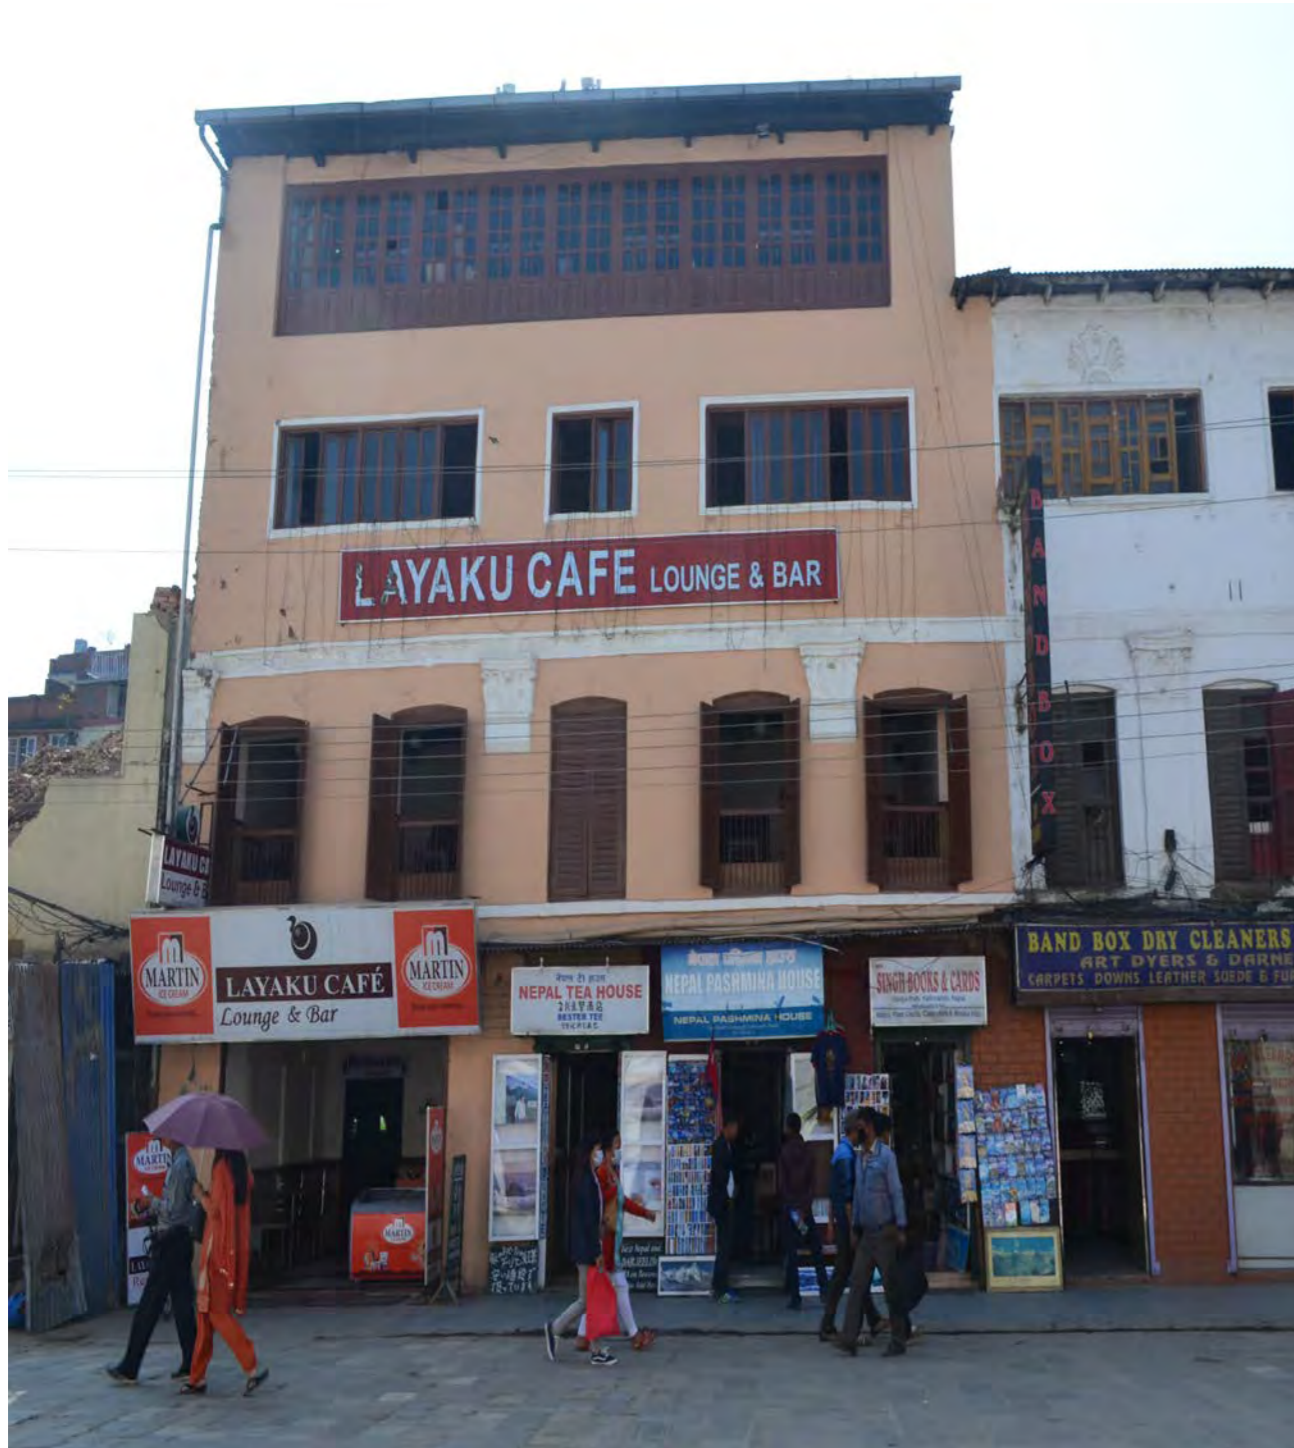
d3

CODE NO	OWNERS NAME/ CONTACT	STOREY NUMBER	PRESENT STOREY NUMBER	STRUCTURAL SYSTEM	MATERIAL	GENERAL DESCRIPTION	PROBLEM DESCRIPTION	DANGER	Heritage Significance	REMARKS
d03	Govind Chipang	G+4	G+4	Load Bearing	Brick; Timber	Timber roof	Minor cracks

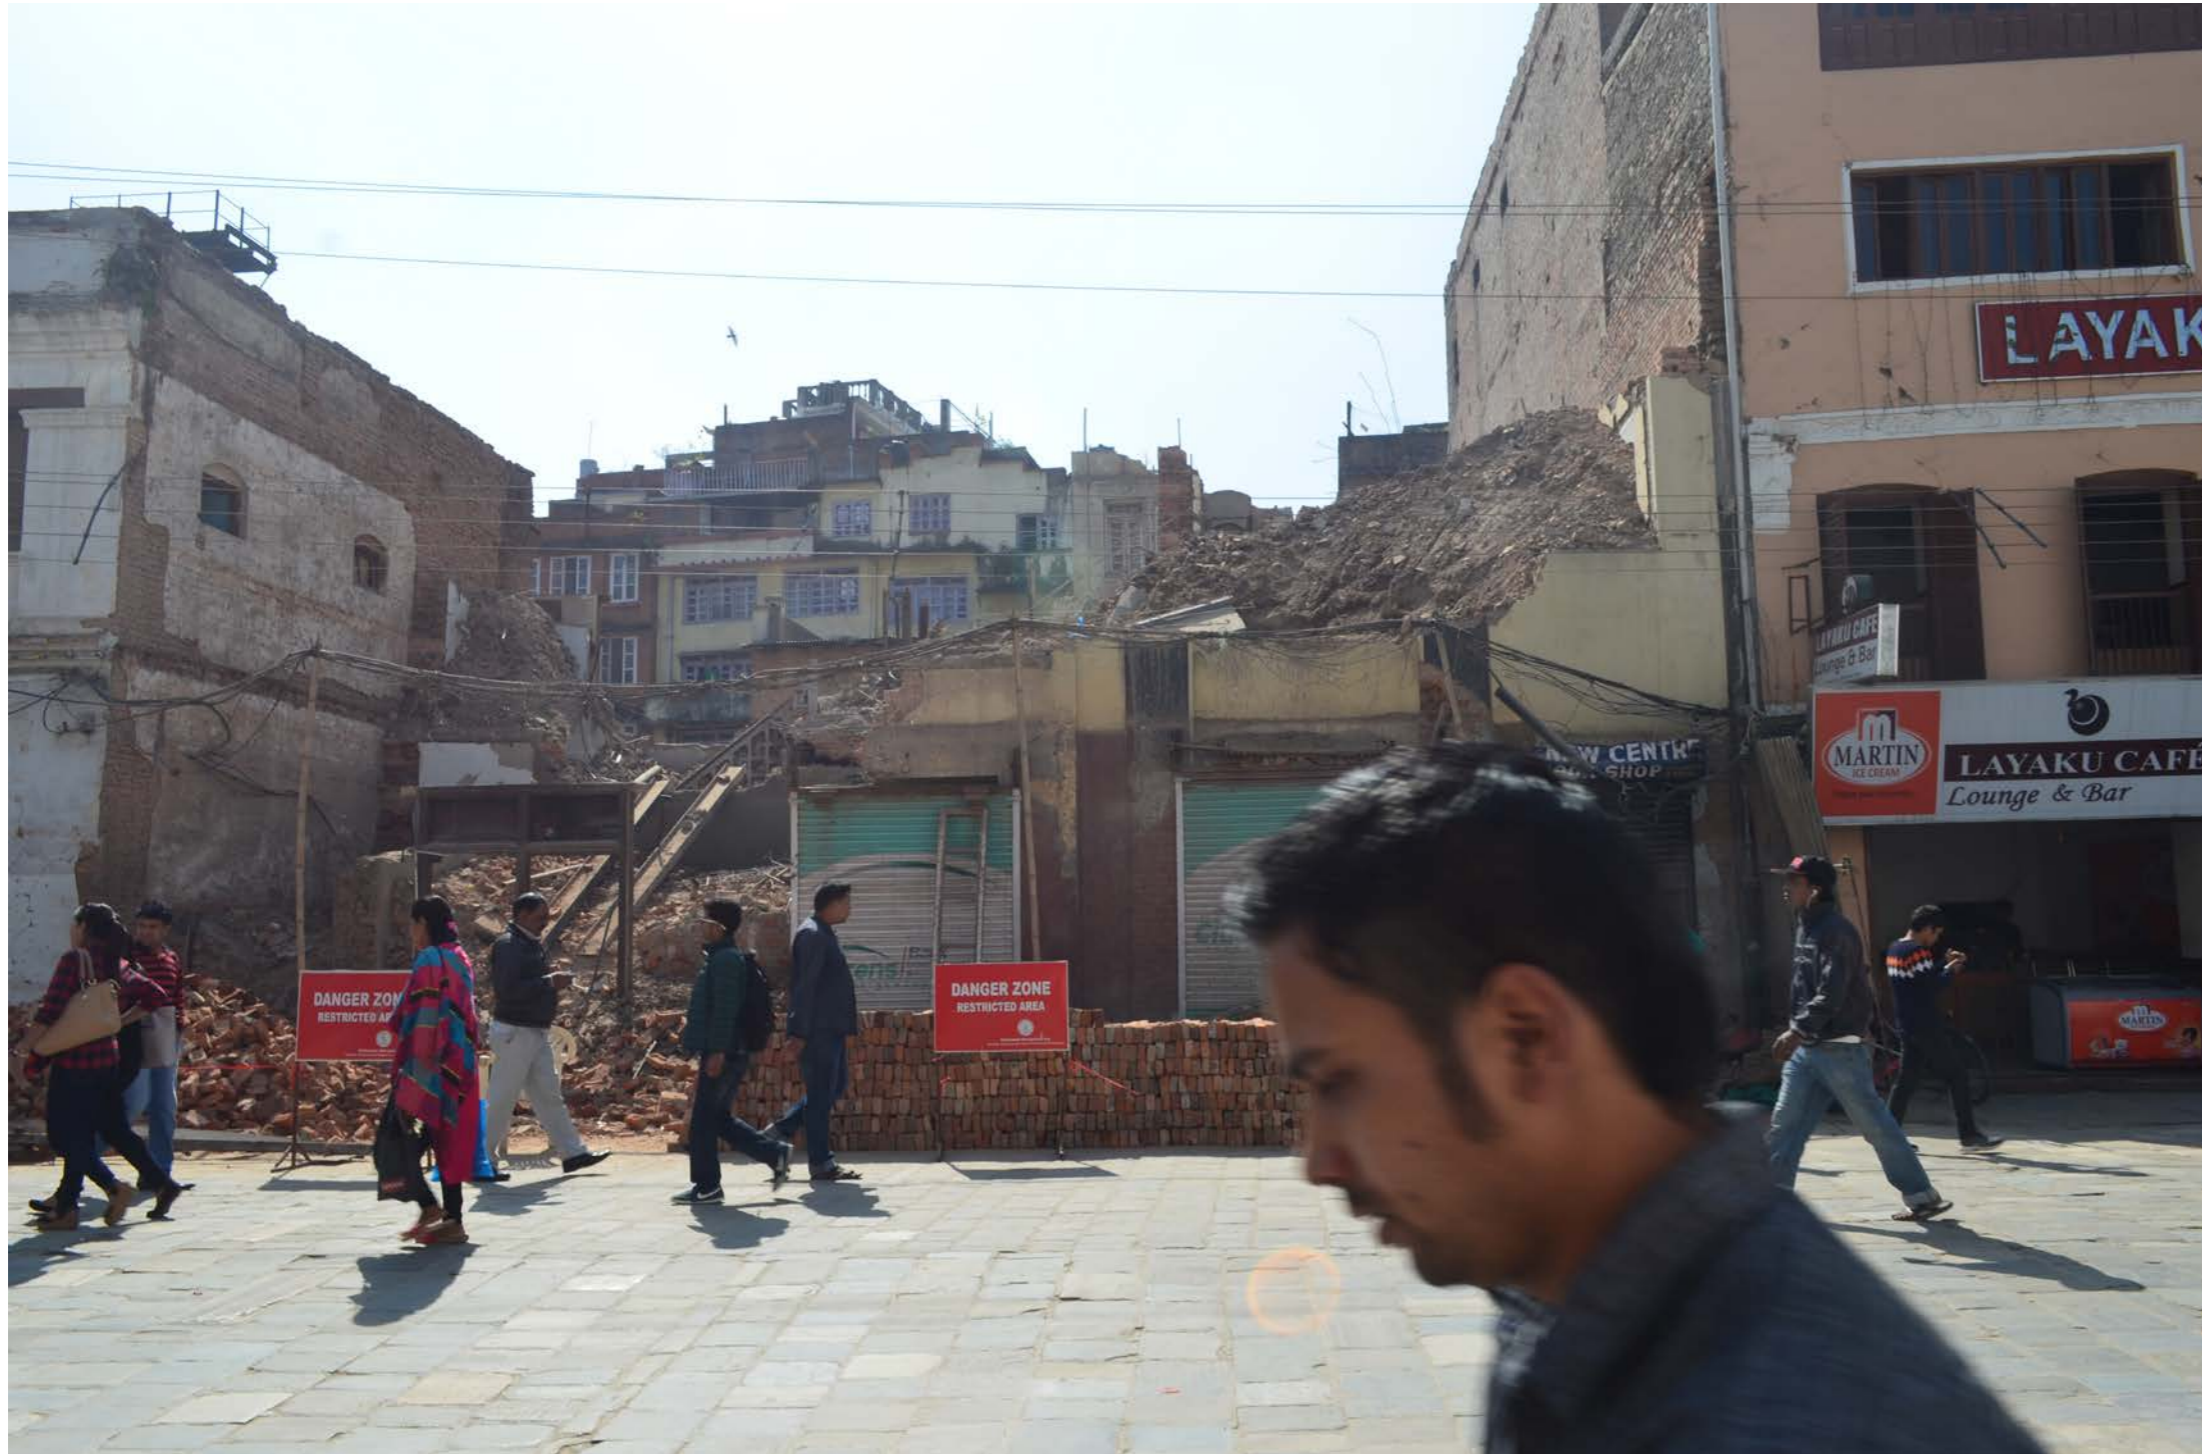
d4

CODE NO	OWNERS NAME/ CONTACT	STOREY NUM- BER	PRESENT STO- REY NUMBER	STRUCTURAL SYSTEM	MATERIAL	GENERAL DESCEIPTION	PROBLEM DESCRIPTION	DANGER	Heritage Sig- nificance	REMARKS
d04		G+4	G	Load Bearing	Brick	Building being demolished be- cause of being too tall

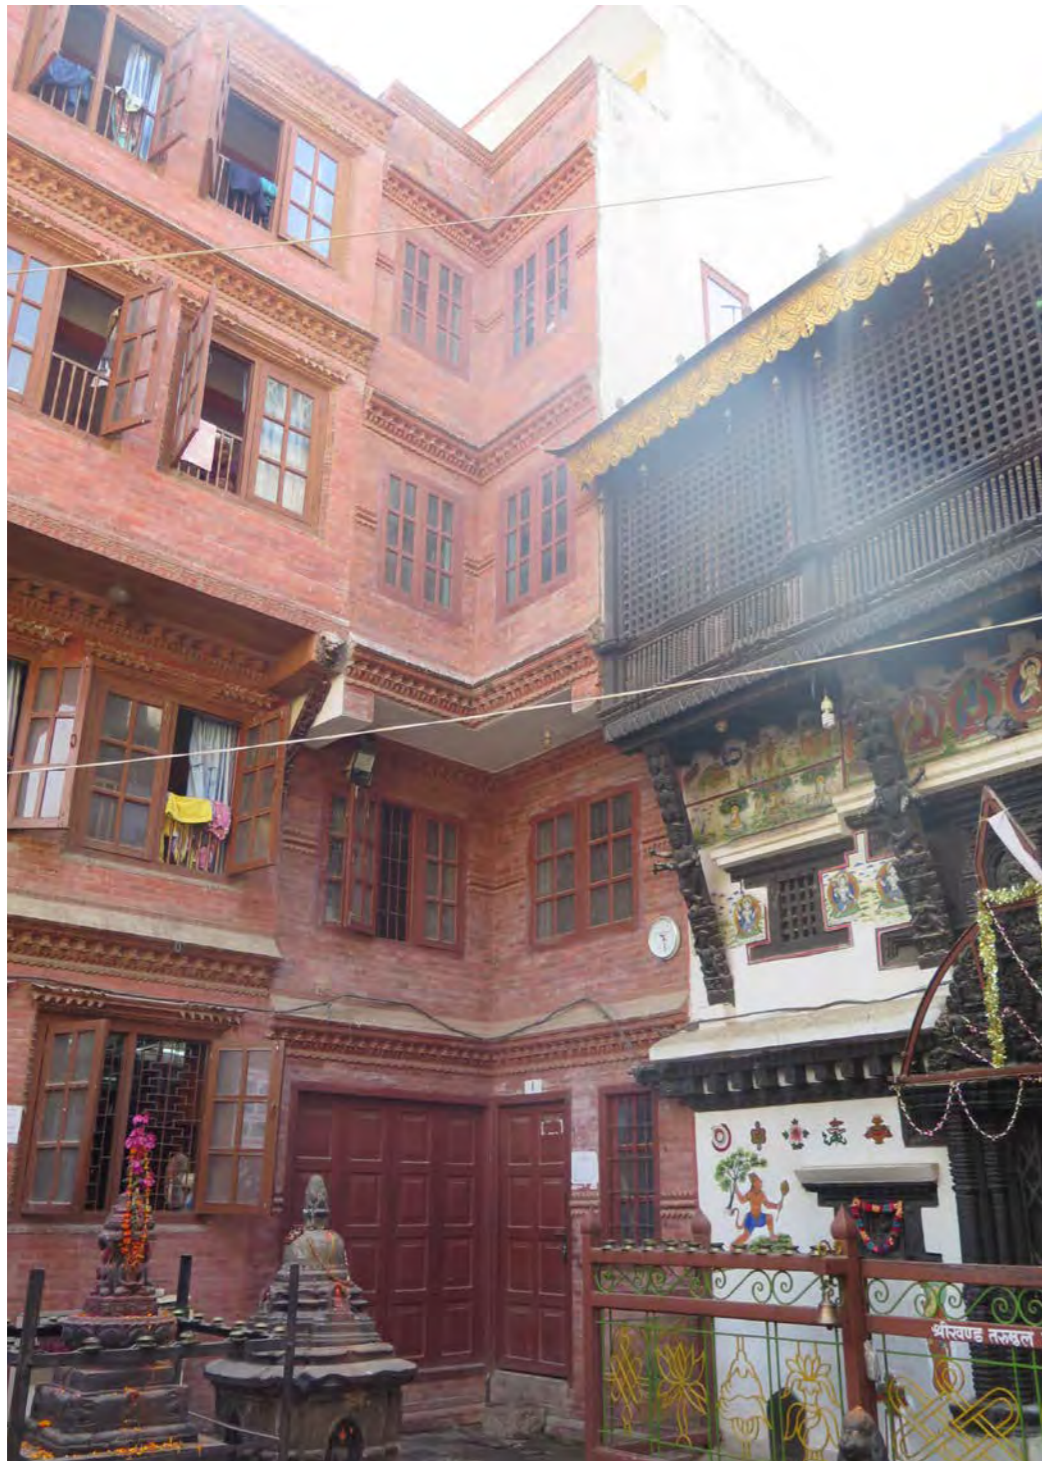
A3

CODE NO	TYPOLOGY	MONUMENT NAME	ESTABLISHED/RENOVATED DATE	STRUCTURAL SYSTEM	MATERIAL	GENERAL DESCRIPTION	PROBLEM DESCRIPTION	DANGER	REMARKS
a03	Community Building			Frame	Cement	Rcc Frame with brick cladding	No visible damage

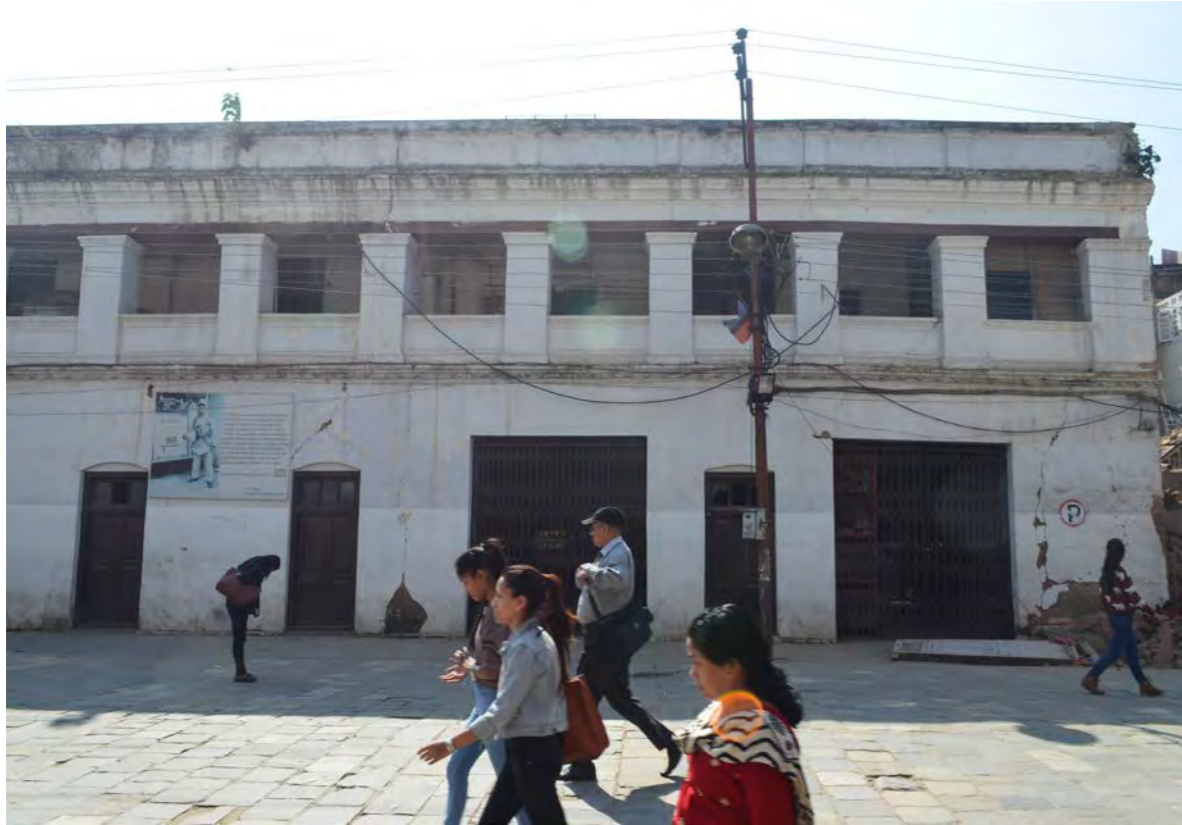
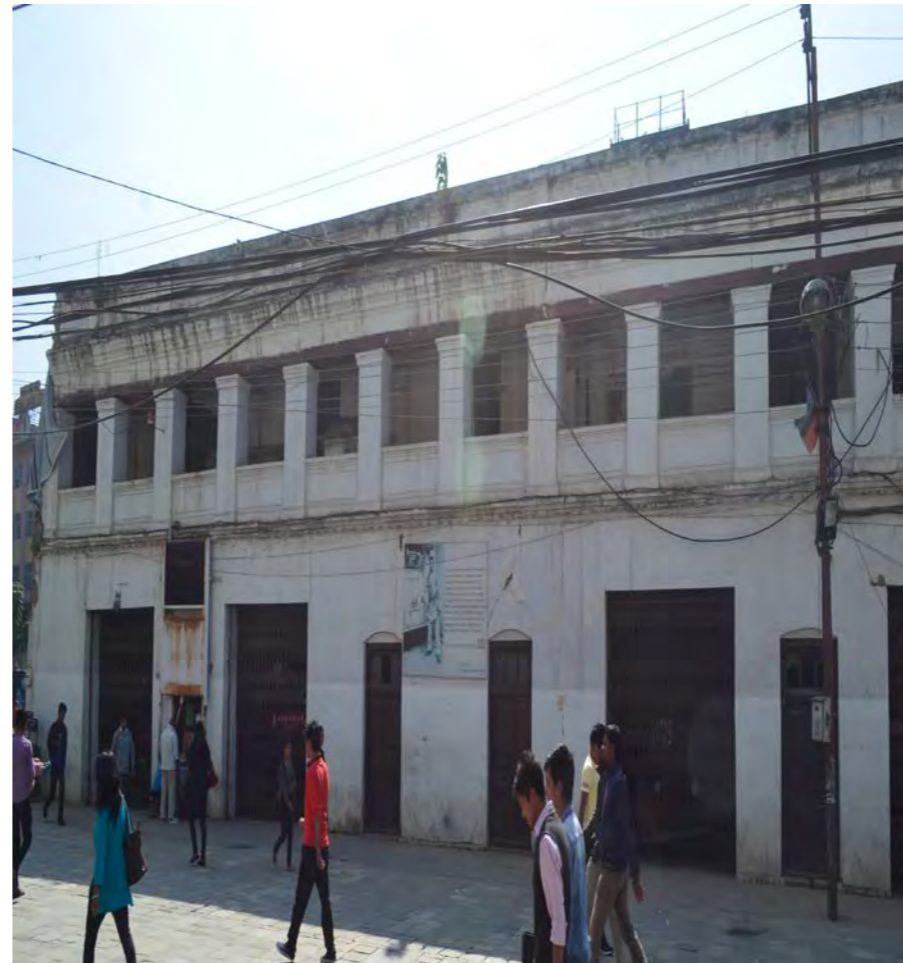
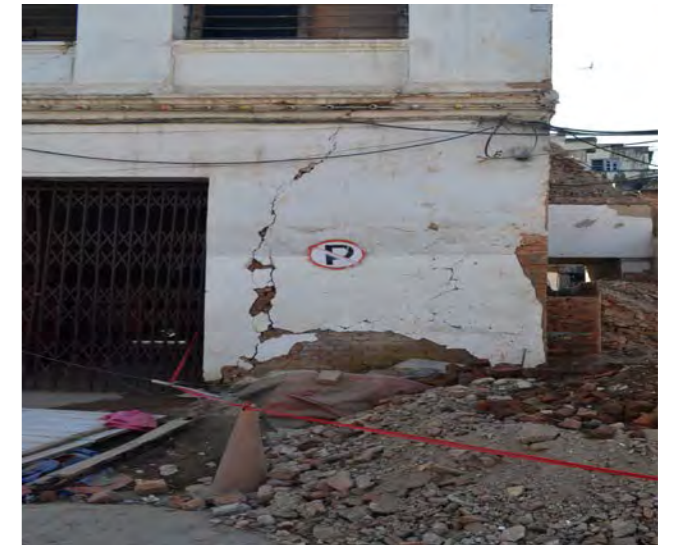
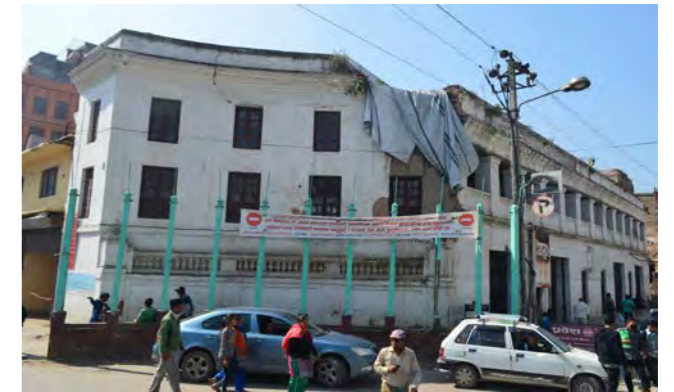
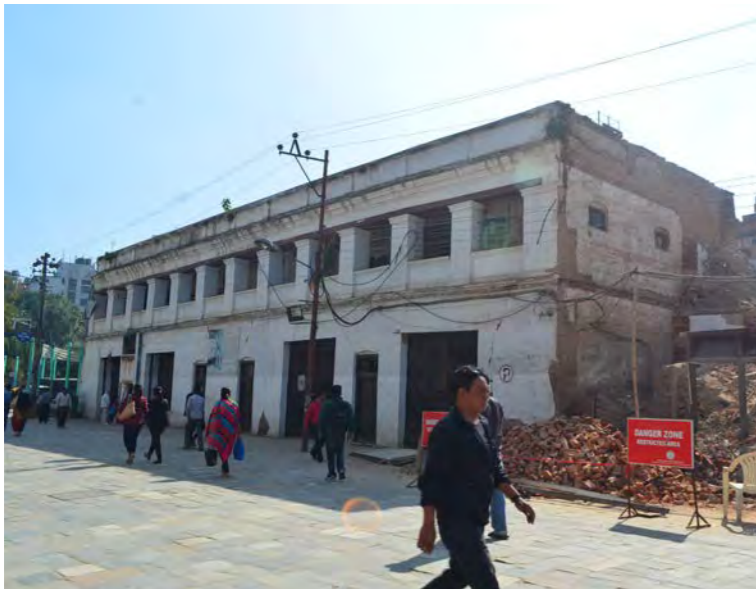
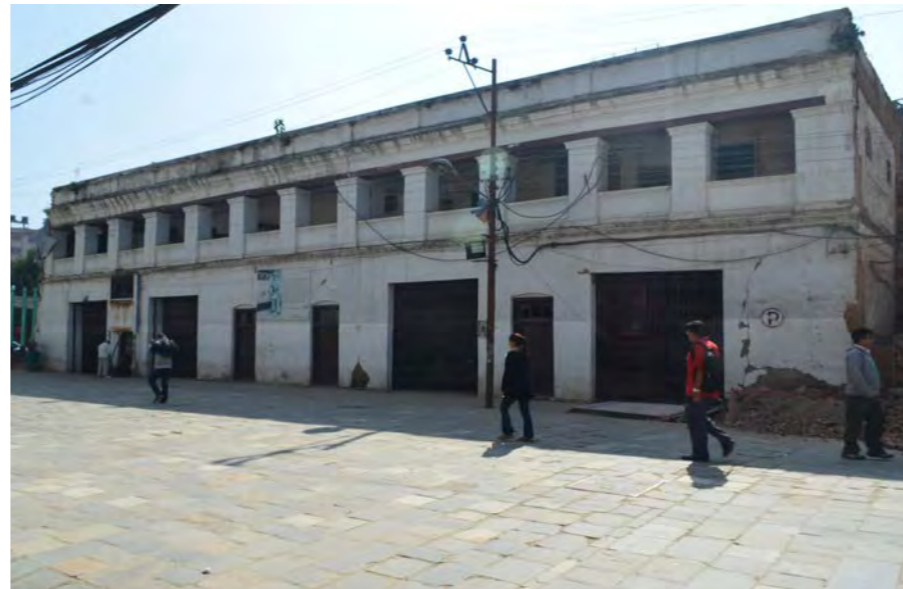
D5

CODE NO	TYPOLOGY	MONUMENT NAME	ESTABLISHED/RENOVATED DATE	STRUCTURAL SYSTEM	MATERIAL	GENERAL DESCRIPTION	PROBLEM DESCRIPTION	DANGER	REMARKS
d05		Damkal house		Load Bearing	Brick	Rana style house with white washing on outer façade	Extensive horizontal and diagonal cracks in walls. Northern corner collapsed.

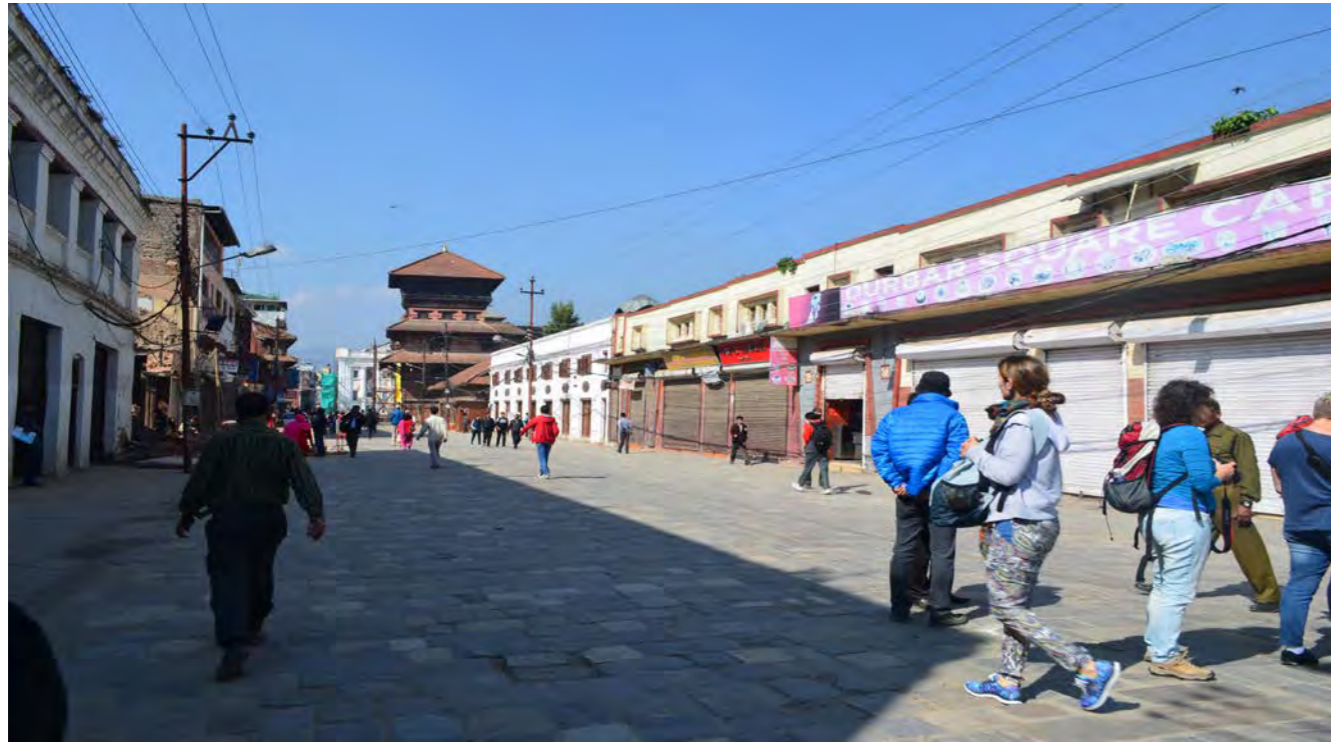
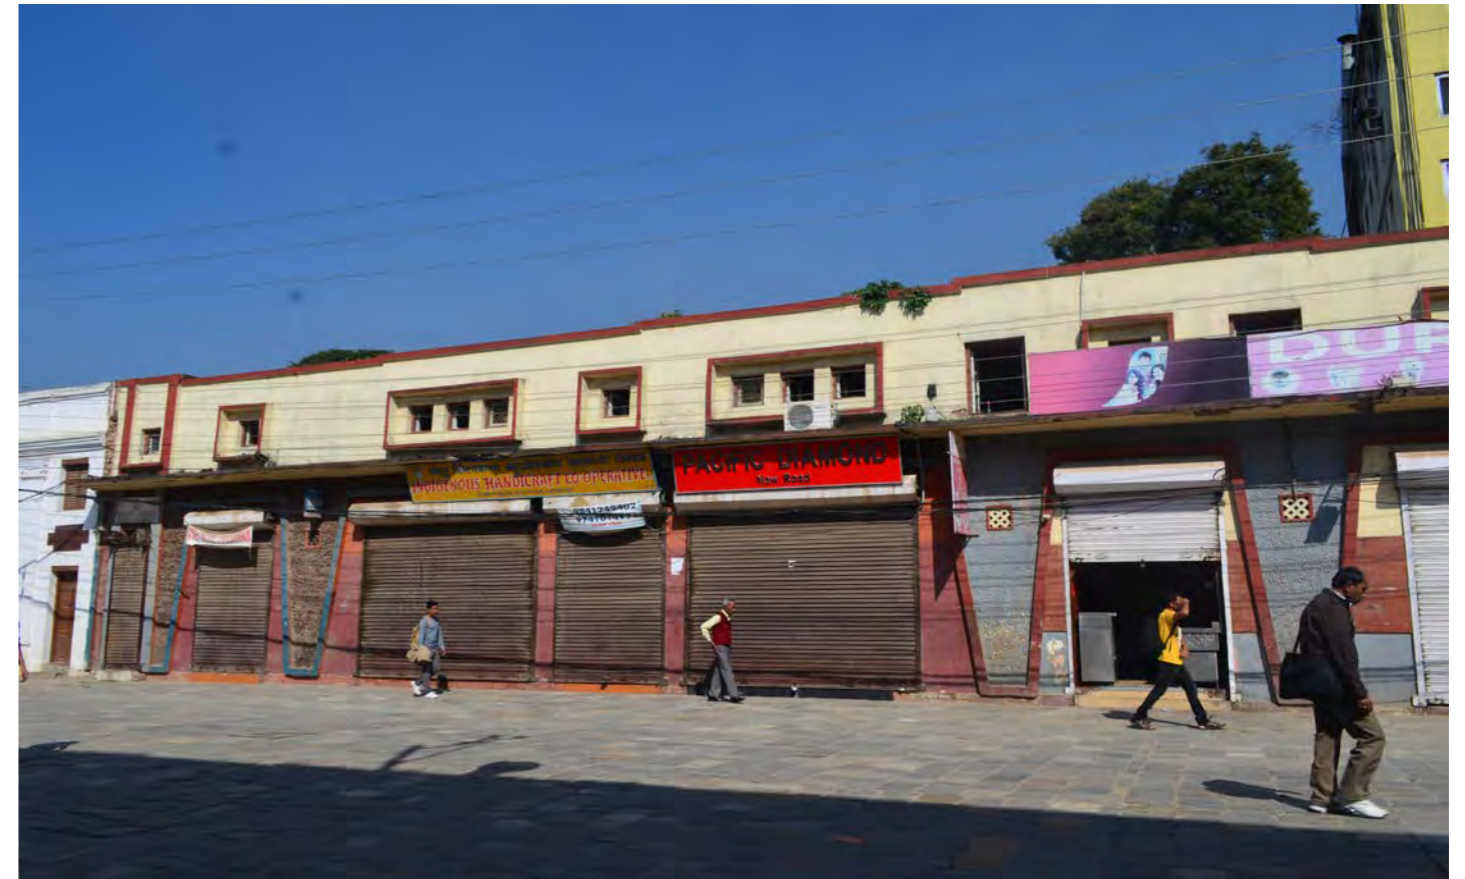
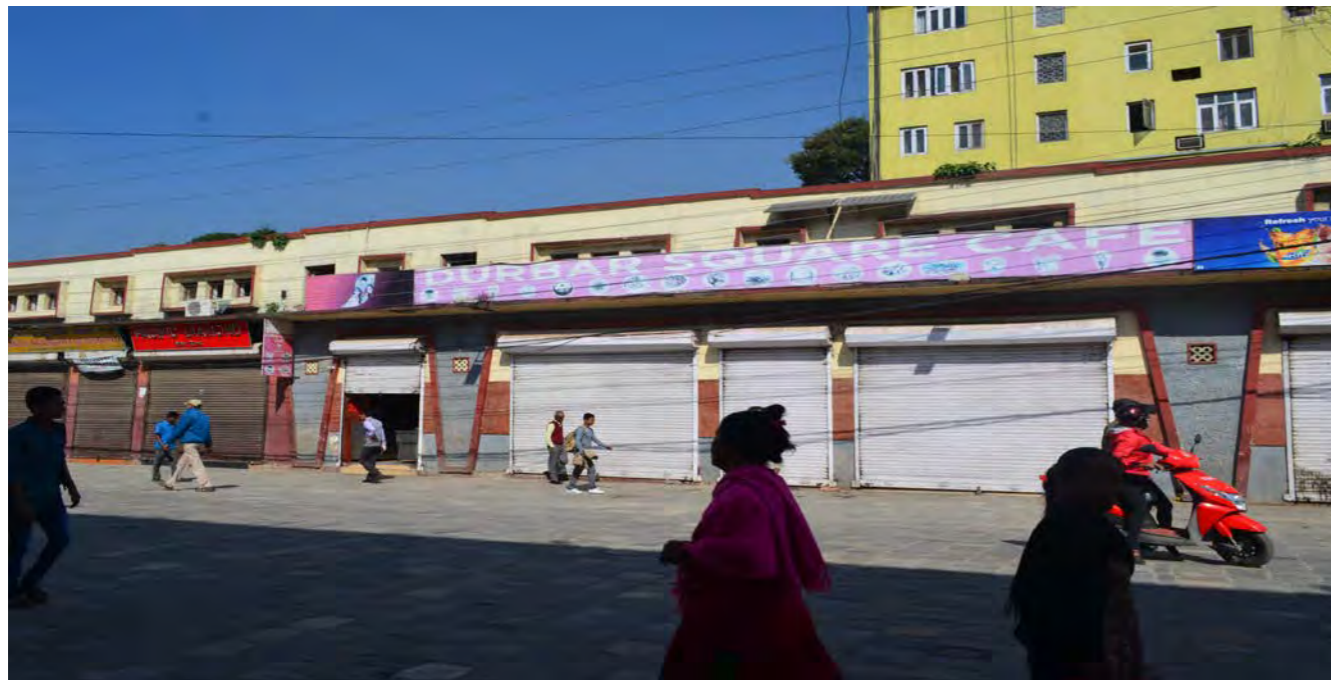
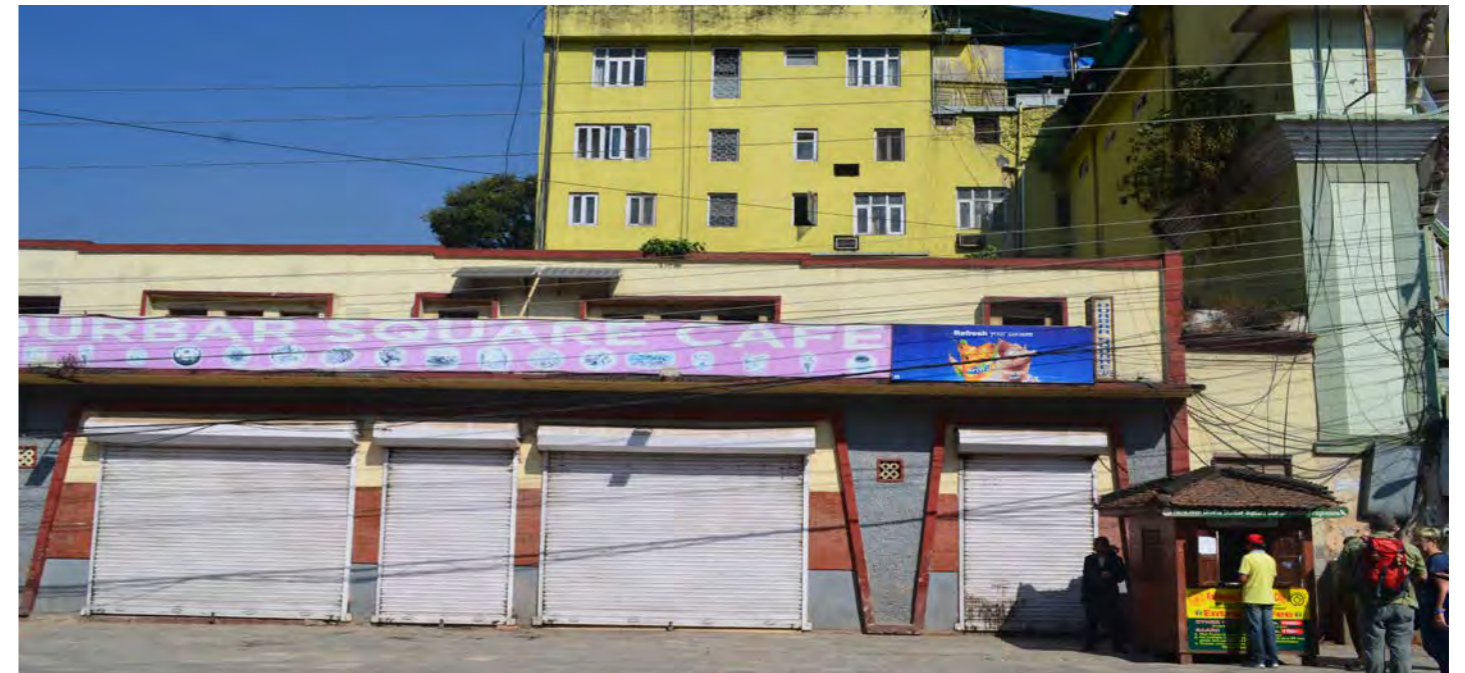
D6

CODE NO	TYPOLOGY	MONUMENT NAME	ESTABLISHED/ RENOVATED DATE	STRUCTURAL SYSTEM	MATERIAL	GENERAL DESCRIPTION	PROBLEM DESCRIPTION	DANGER	REMARKS	
d06				Load Bearing	Brick	Single storey structure used as shop	No visible damage

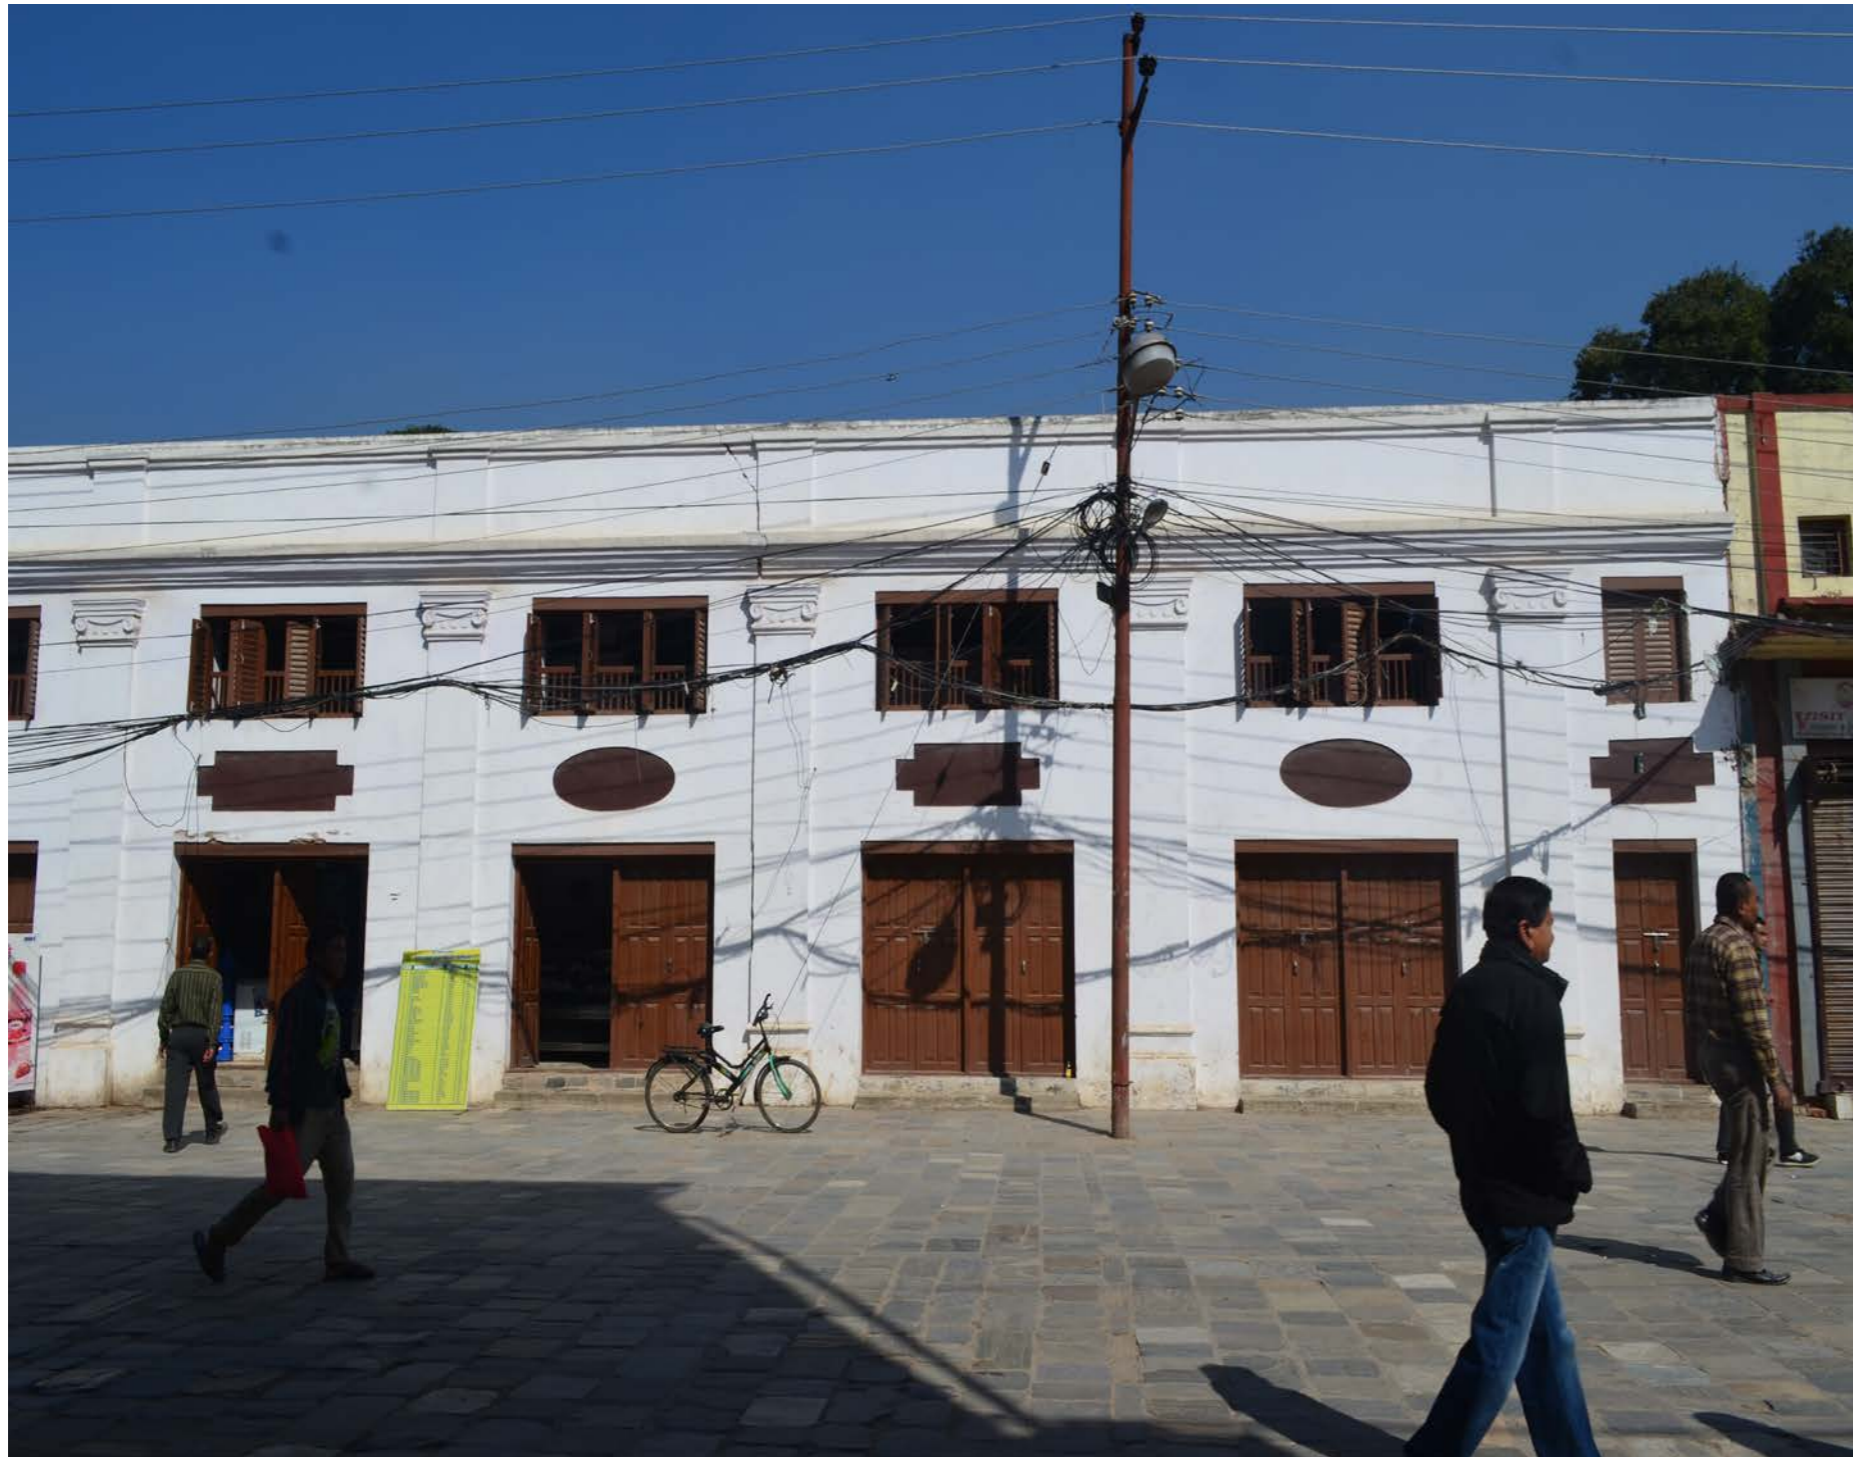
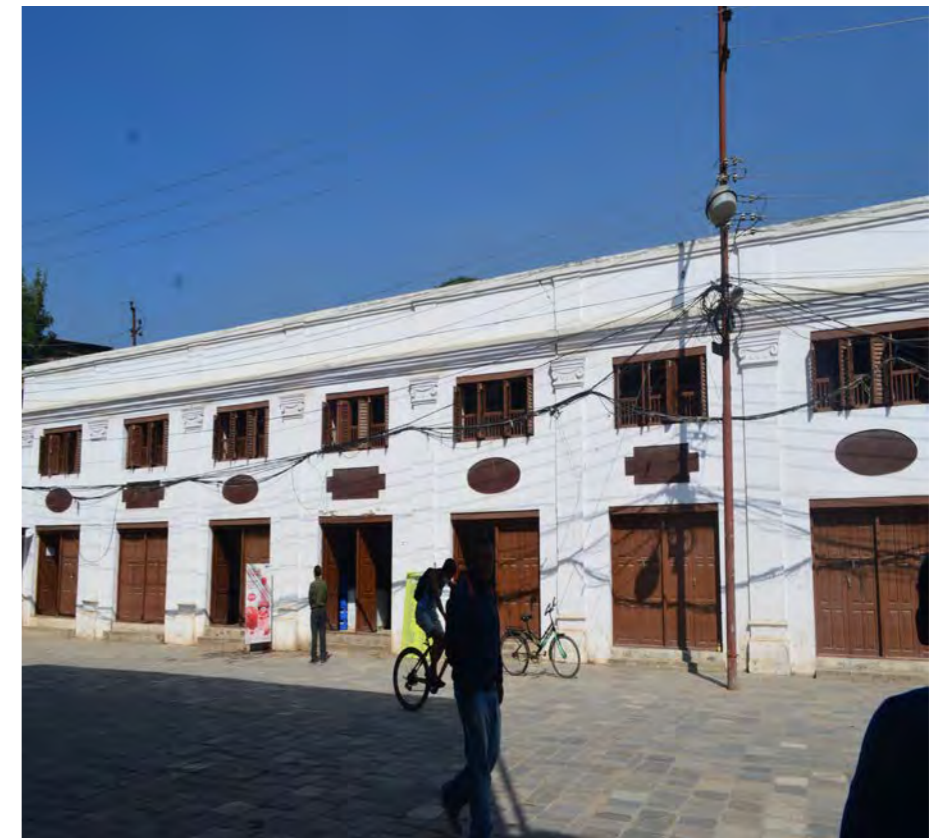
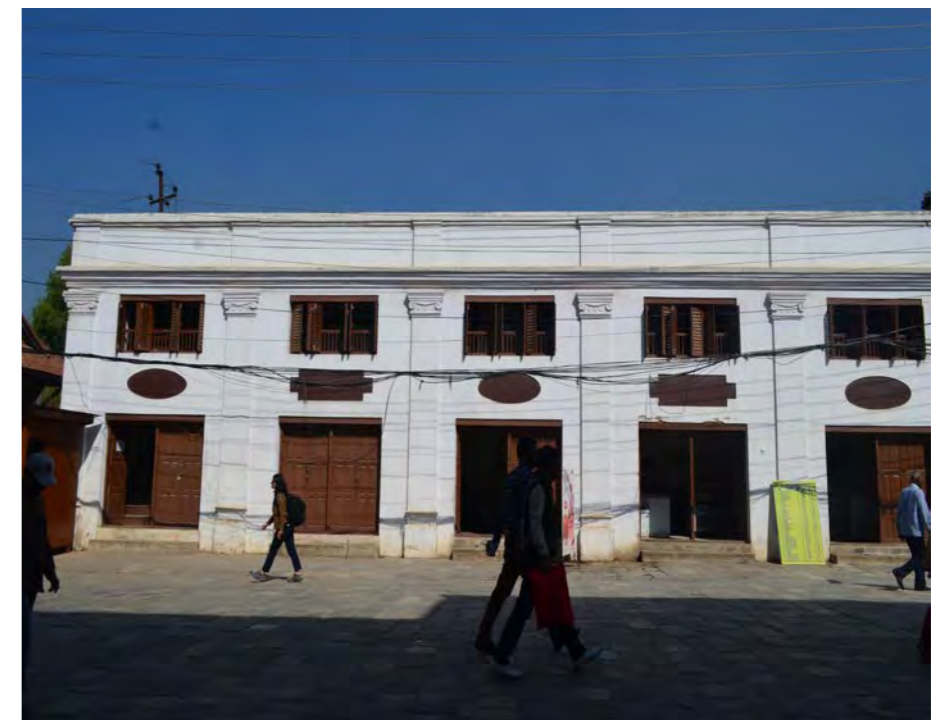
D7

CODE NO	TYPOLOGY	MONUMENT NAME	ESTABLISHED/RENOVATED DATE	STRUCTURAL SYSTEM	MATERIAL	GENERAL DESCRIPTION	PROBLEM DESCRIPTION	DANGER	REMARKS
d07				Load Bearing	Brick	Single storey structure used as shop	No visible damage

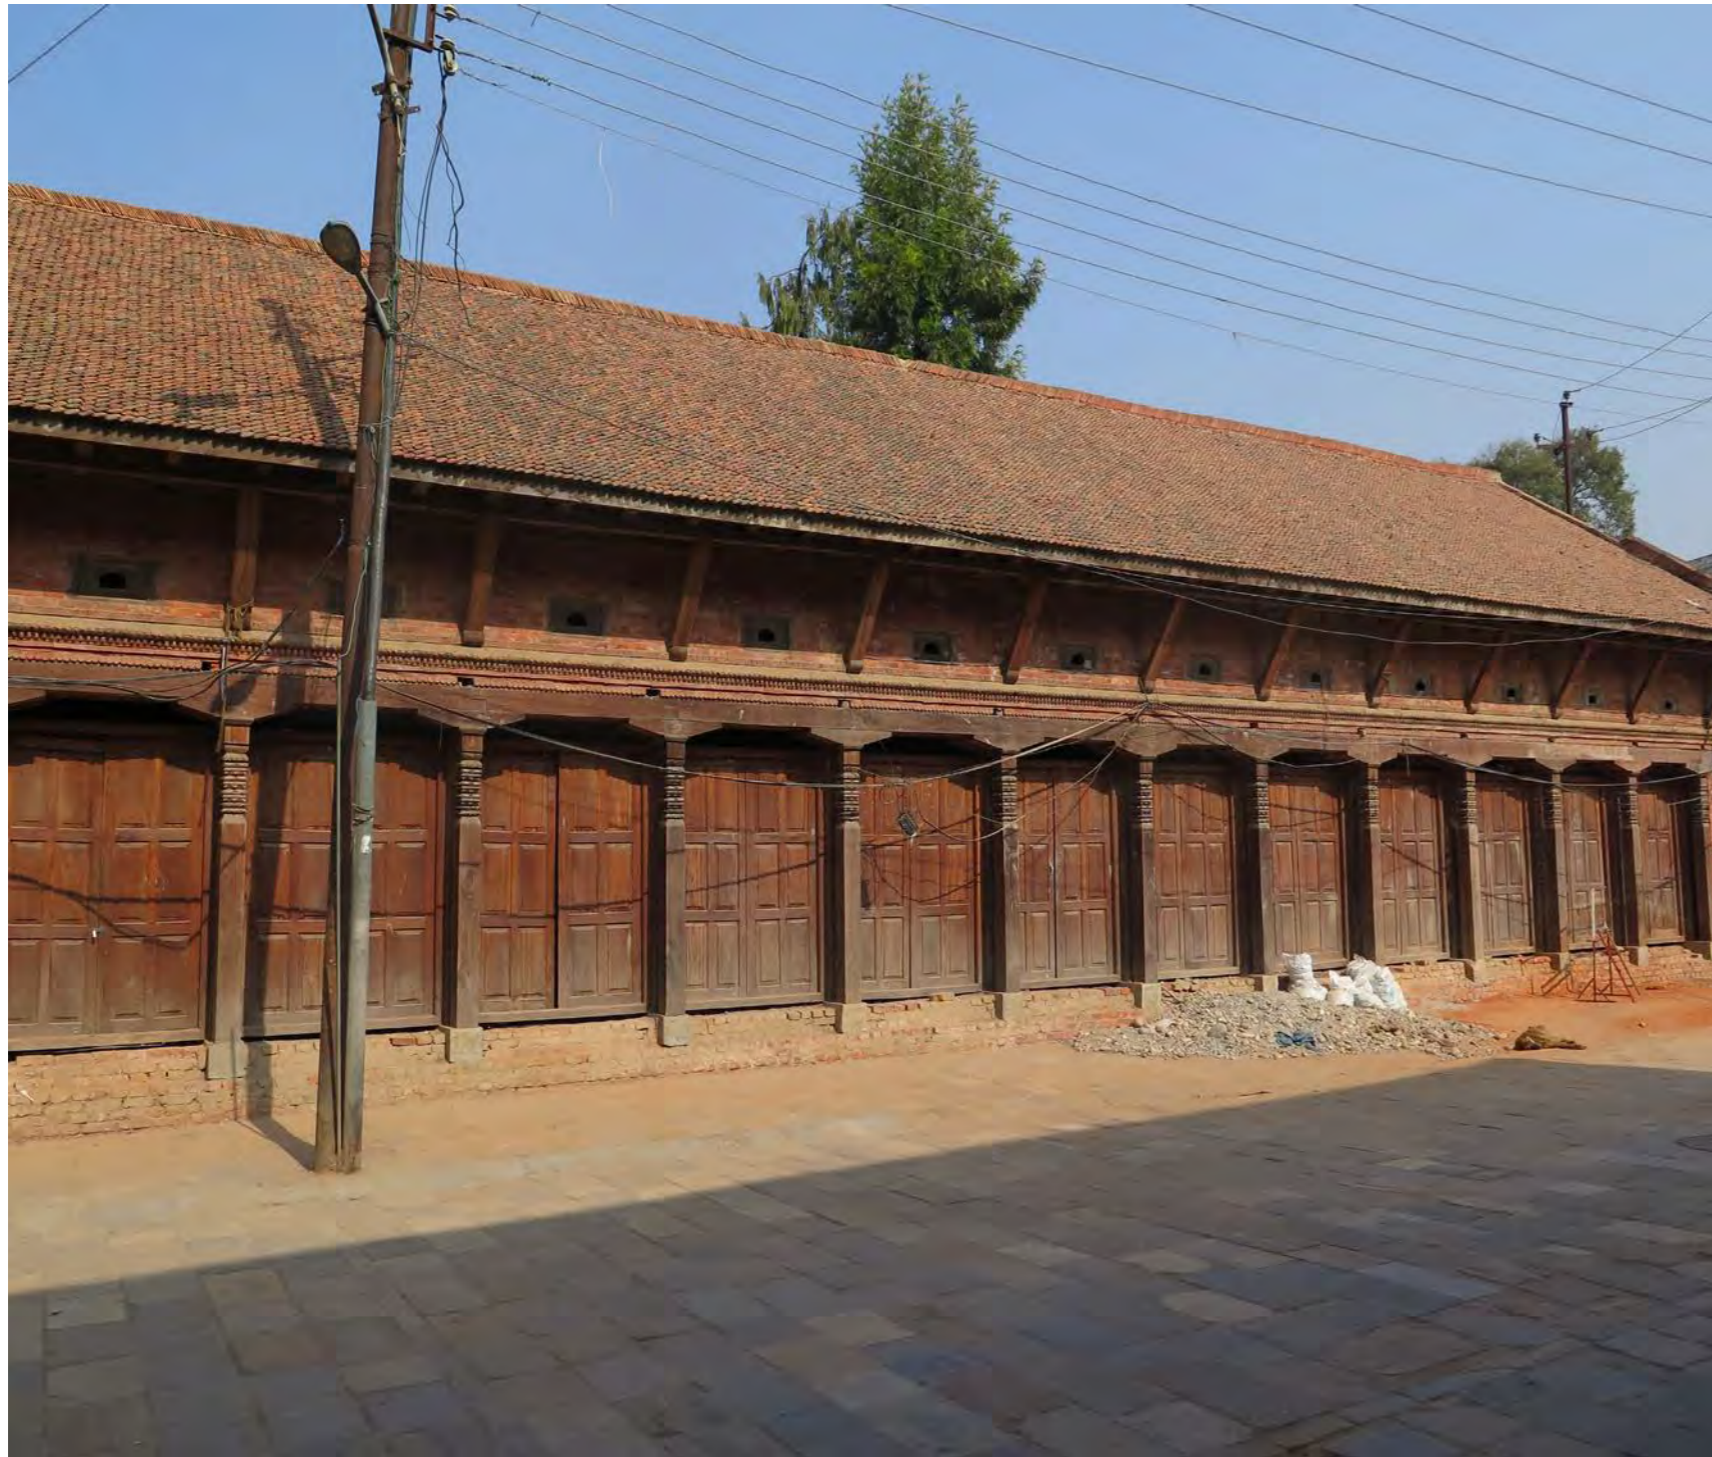
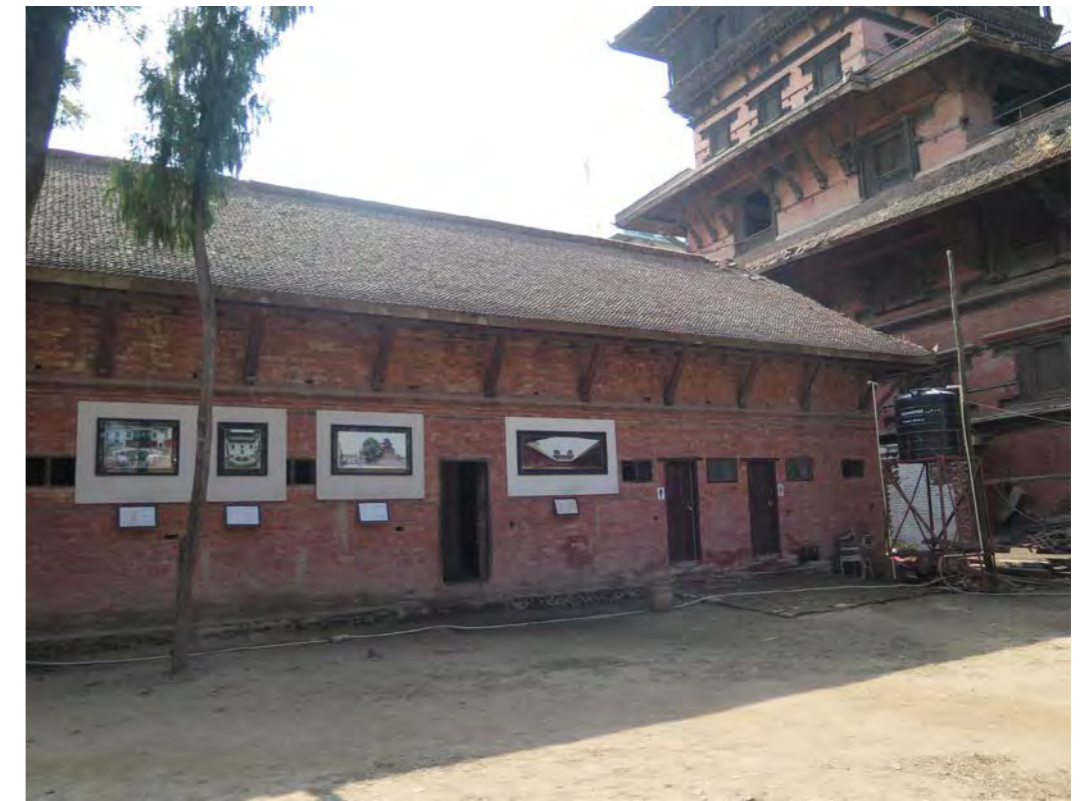
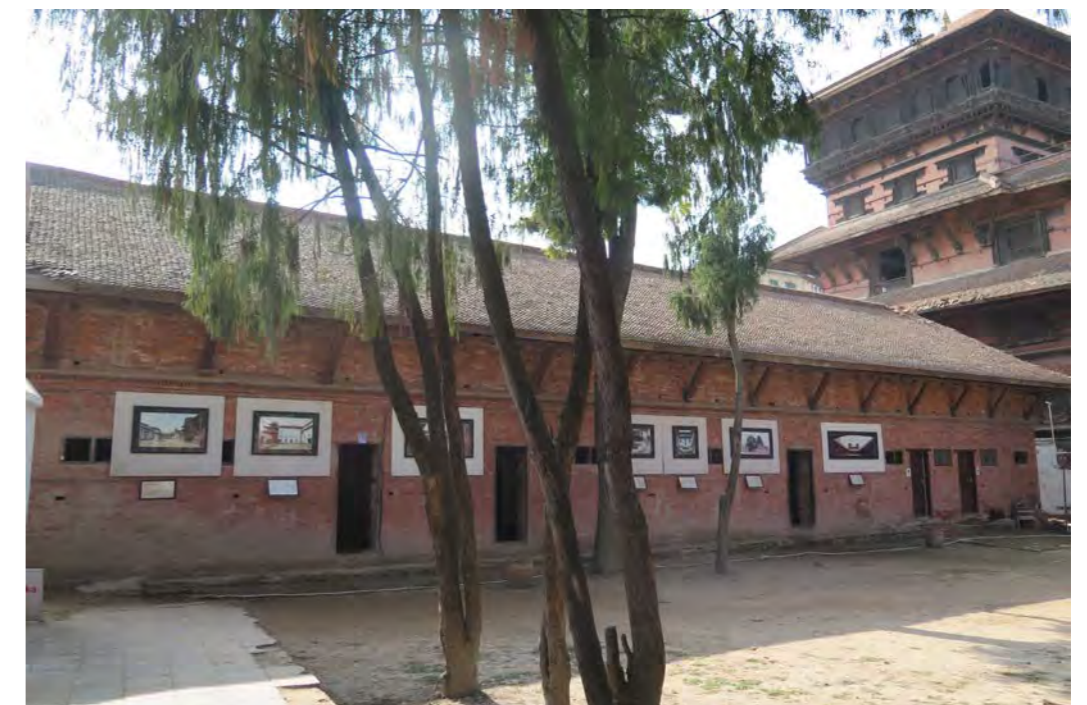
D8

CODE NO	TPOLOGY	MONUMENT NAME	ESTABLISHED/RENOVATED DATE	STRUCTURAL SYSTEM	MATERIAL	GENERAL DESCEIPTION	PROBLEM DESCRIPTION	DANGER	REMARKS	
d08				Load Bearing	Brick	Single storey structure with tiled roof and timber columns in front facade. Used as restroom.	No visible damage
