2015 Earthquake Damage Mapping

Hanuman Dhoka Darbar Square Monument Zone
Kathmandu Valley World Heritage Property

December 2015

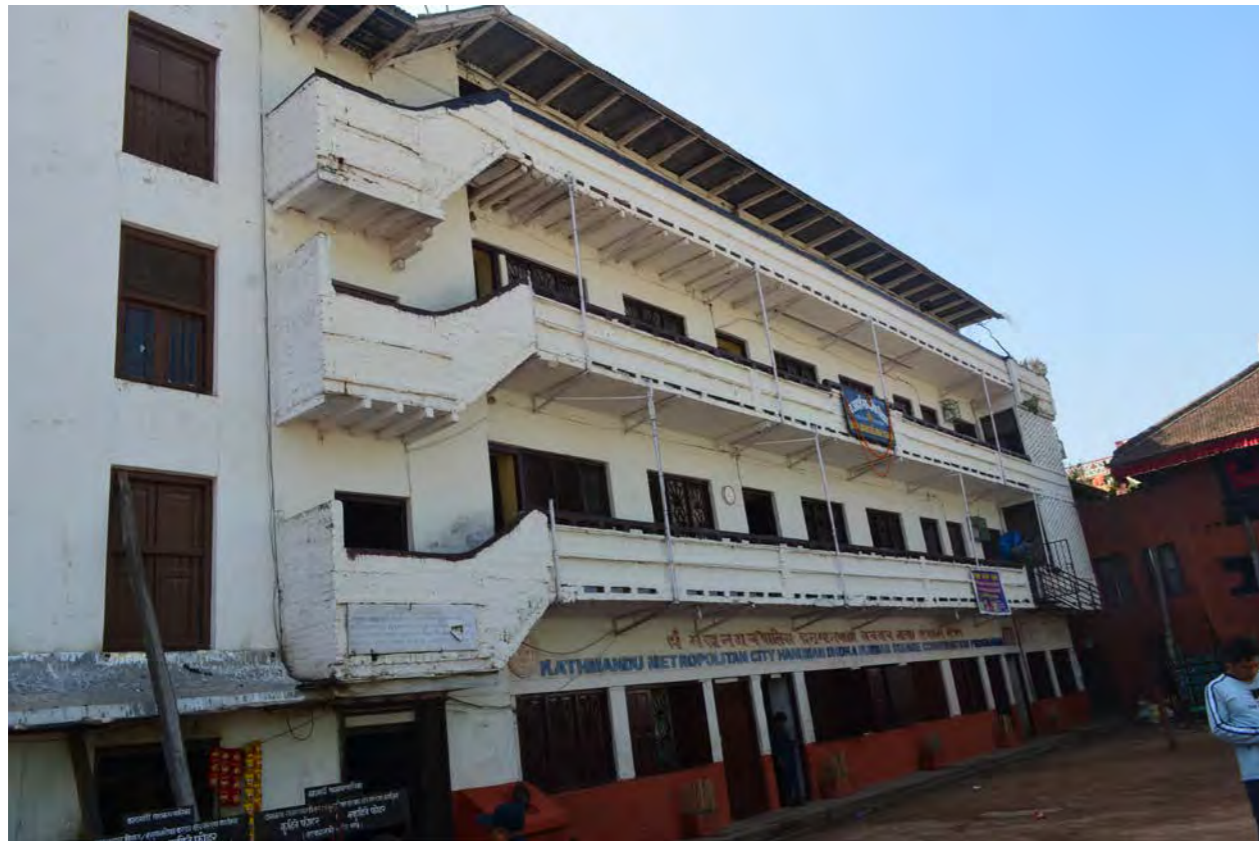
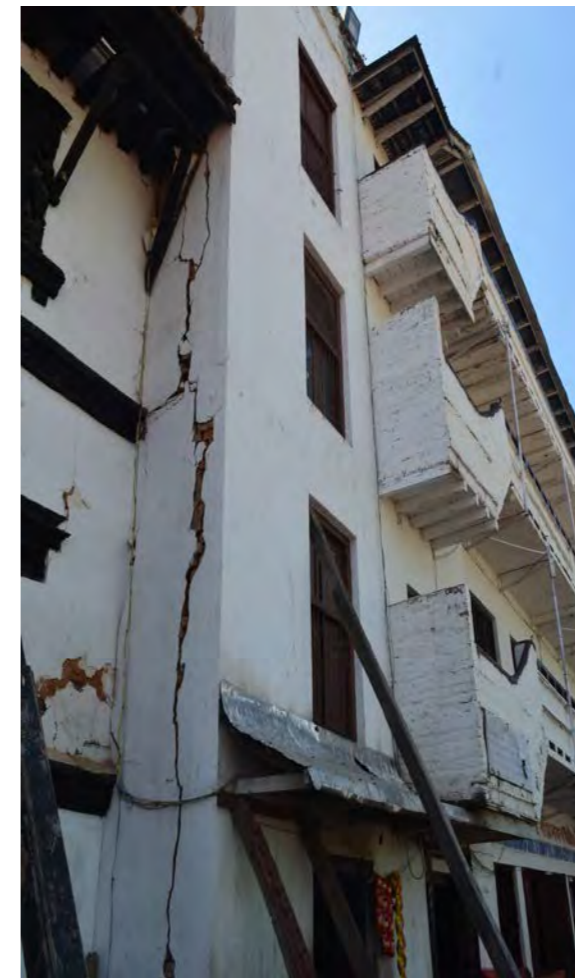
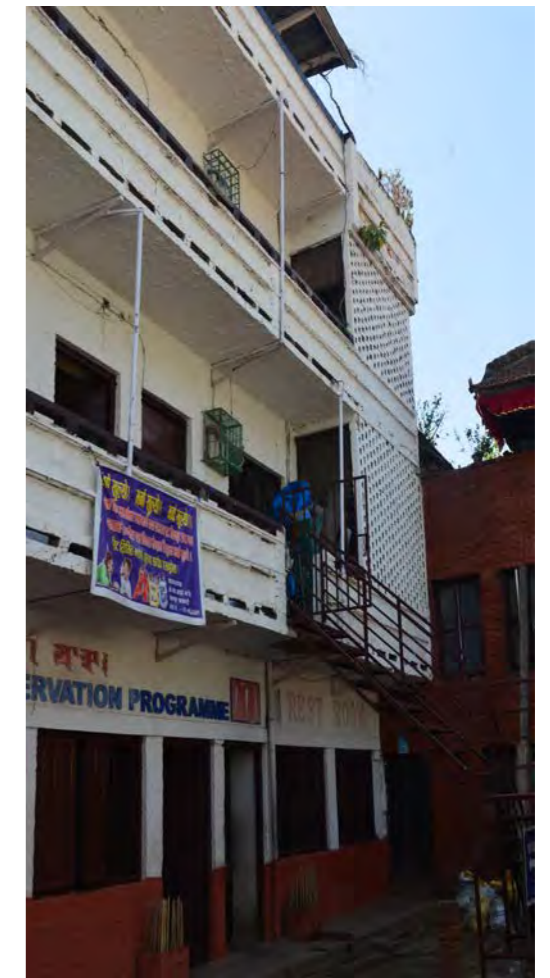
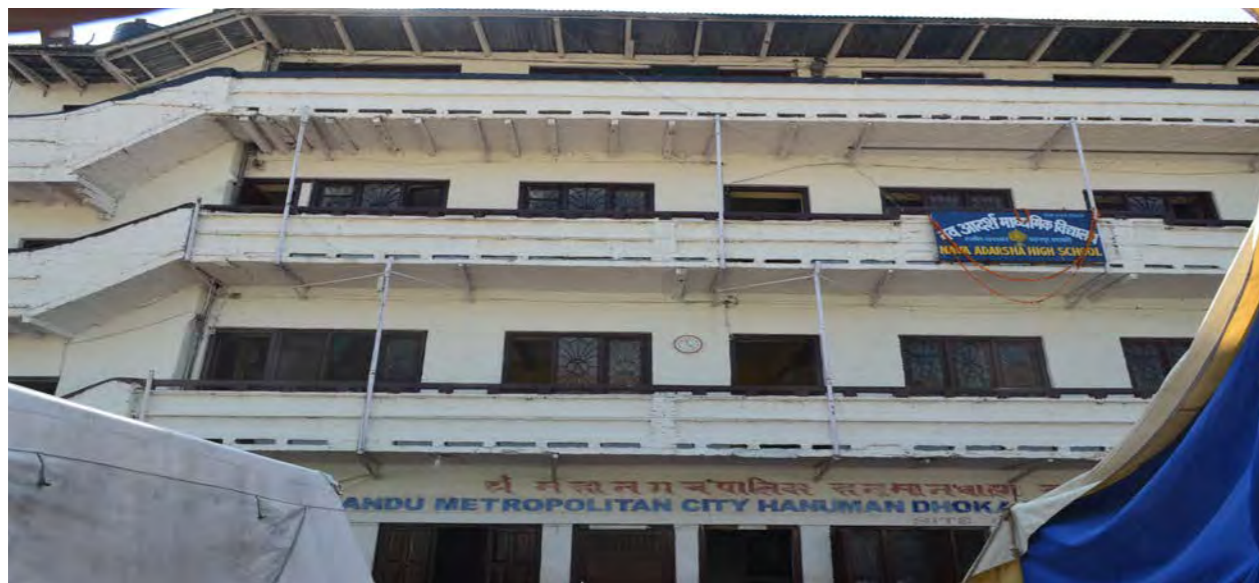
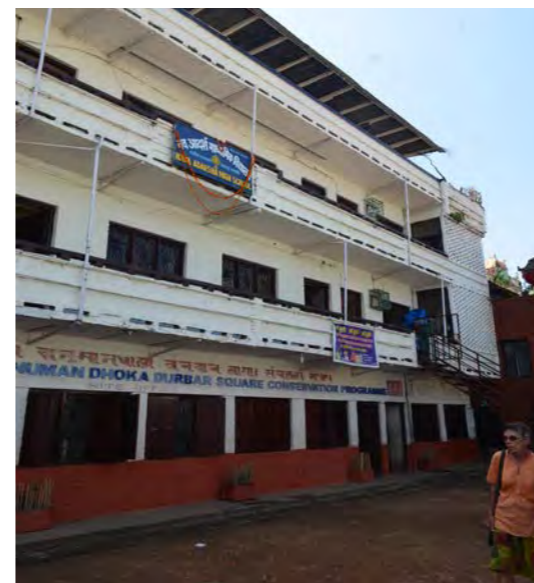
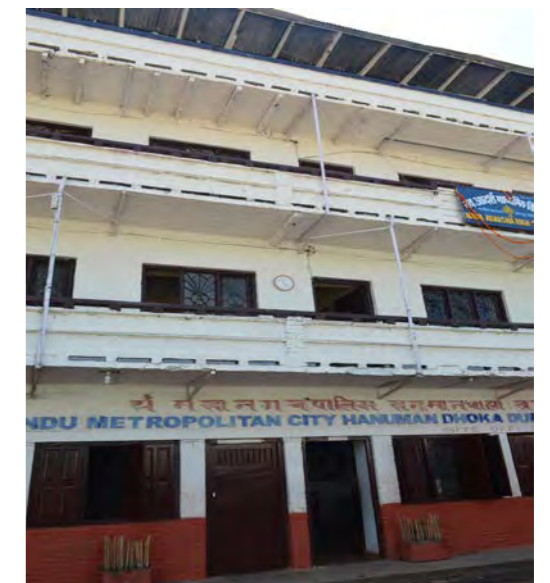
E1

CODE NO	TYPOLOGY	MONUMENT NAME	ESTABLISHED/RENOVATED DATE	STRUCTURAL SYSTEM	MATERIAL	GENERAL DESCRIPTION	PROBLEM DESCRIPTION	DANGER	REMARKS
e01	Community Building	Nava Adarsha High School	2025	Load Bearing	Brick	Ground floor used as office and upper floor used as school	Corner cracking and extensive cracking of walls of upper floors

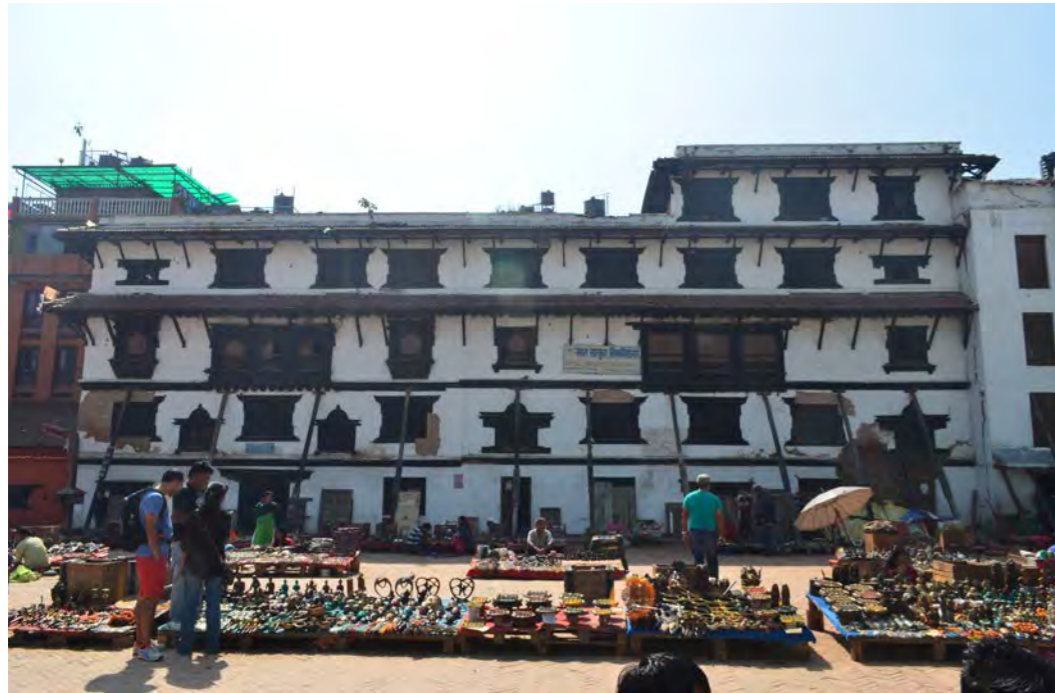
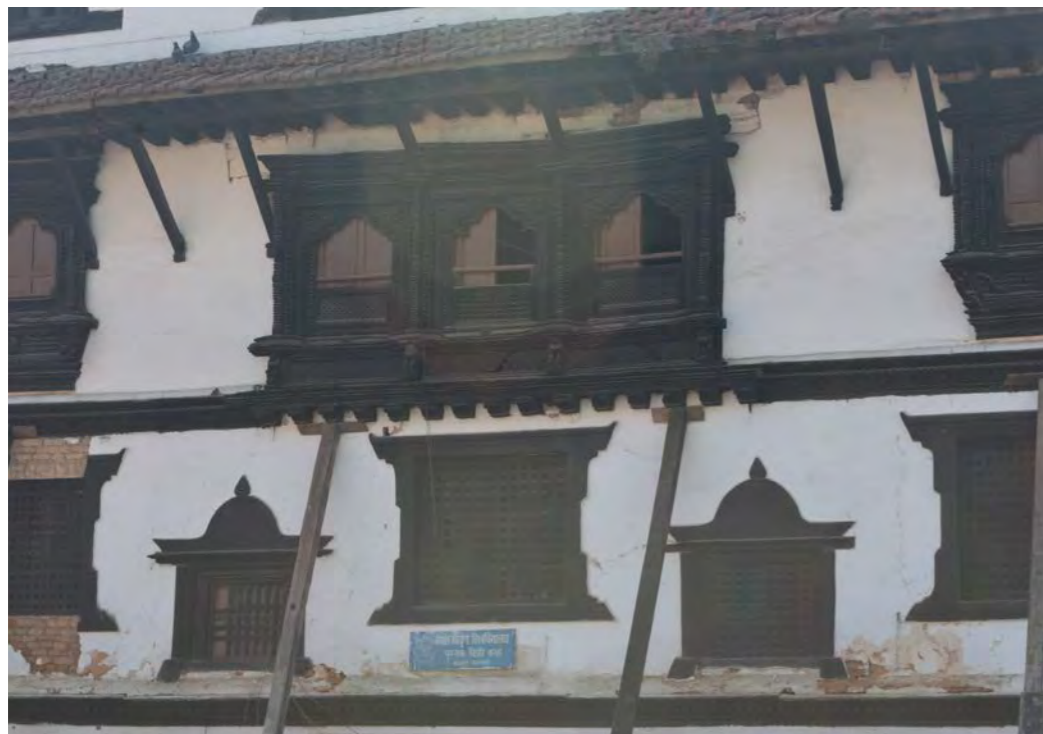
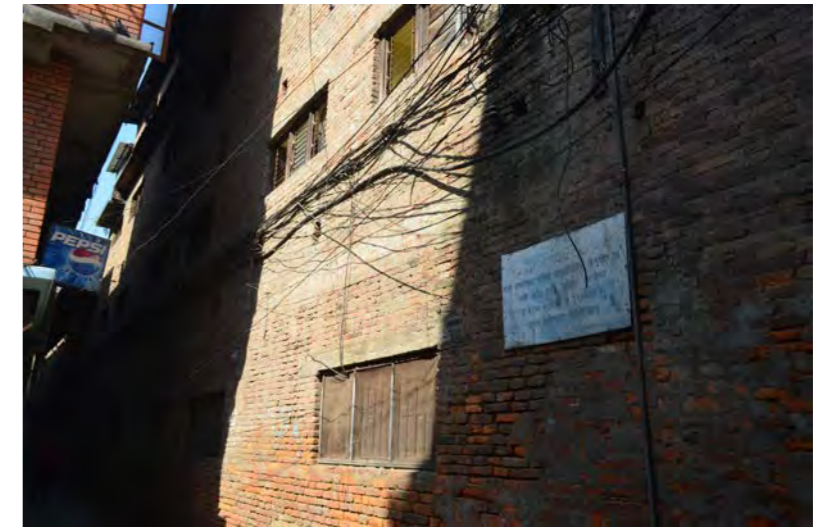
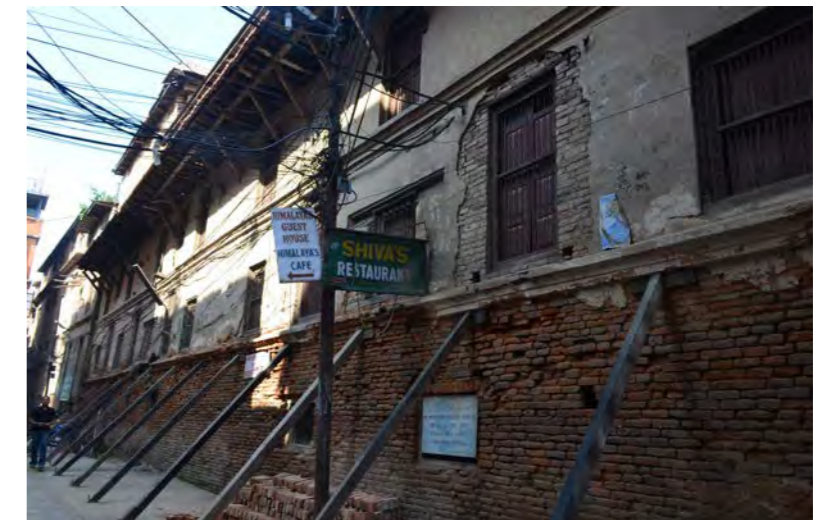
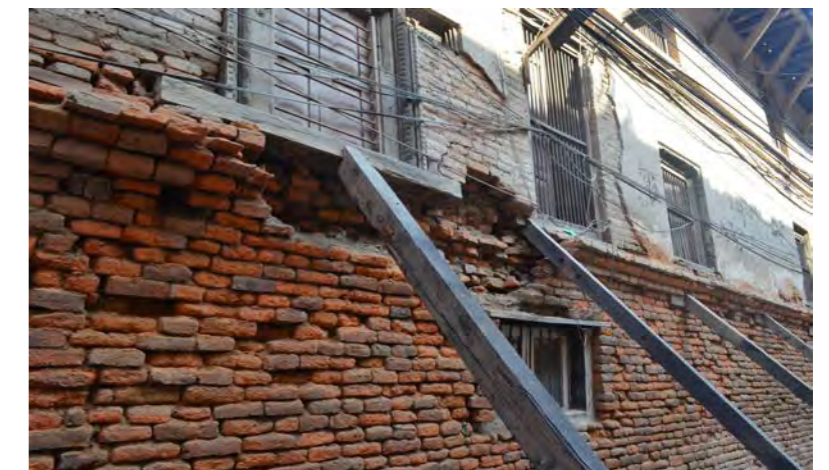
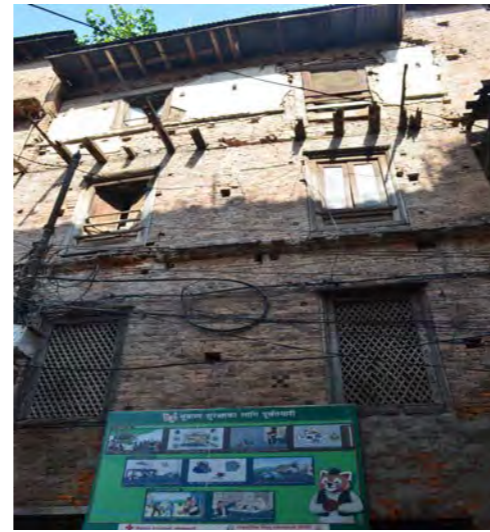
E2

CODE NO	TYPOLOGY	MONUMENT NAME	ESTABLISHED/RENOVATED DATE	STRUCTURAL SYSTEM	MATERIAL	GENERAL DESCRIPTION	PROBLEM DESCRIPTION	DANGER	REMARKS
e02	Community Building	Nepal Sanskrit University		Load Bearing	Brick; Timber		Extensive cracking and bulging of walls; Ground floor walls delaminated and unstable

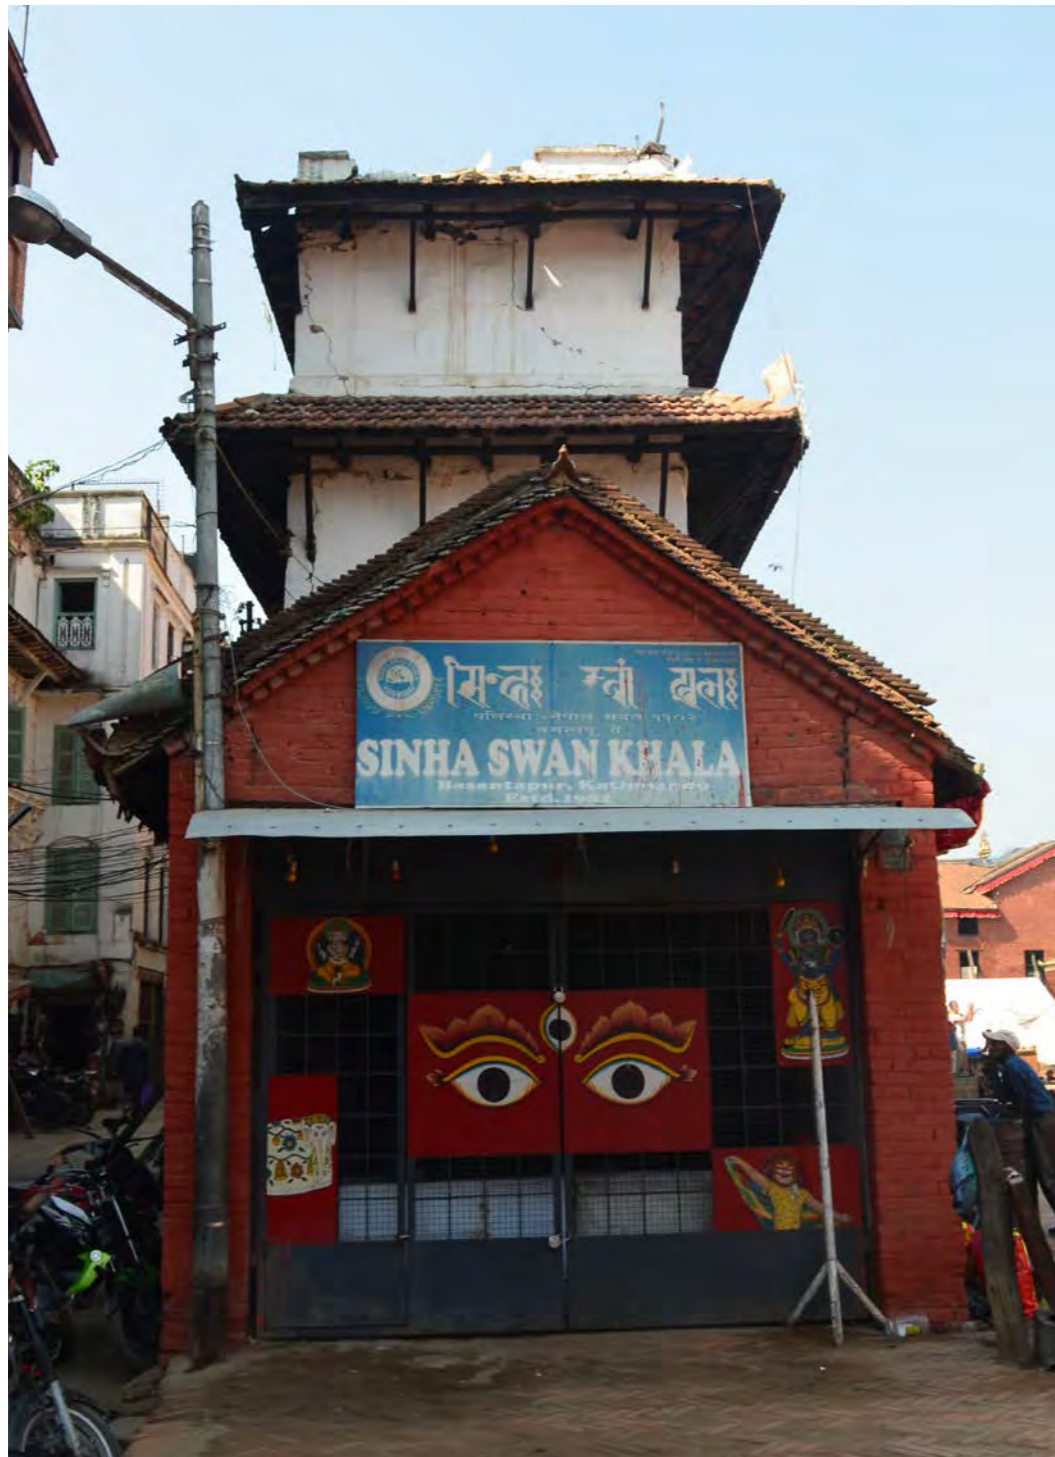
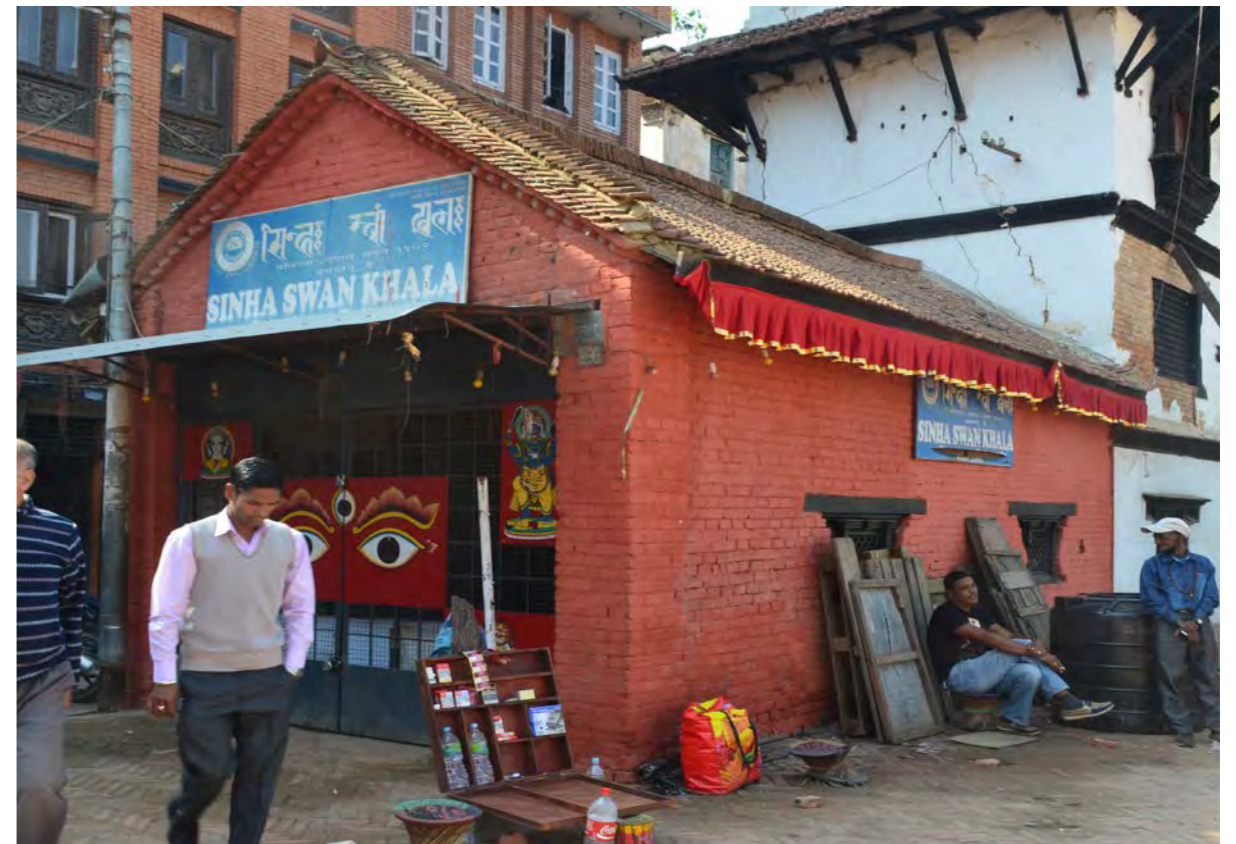
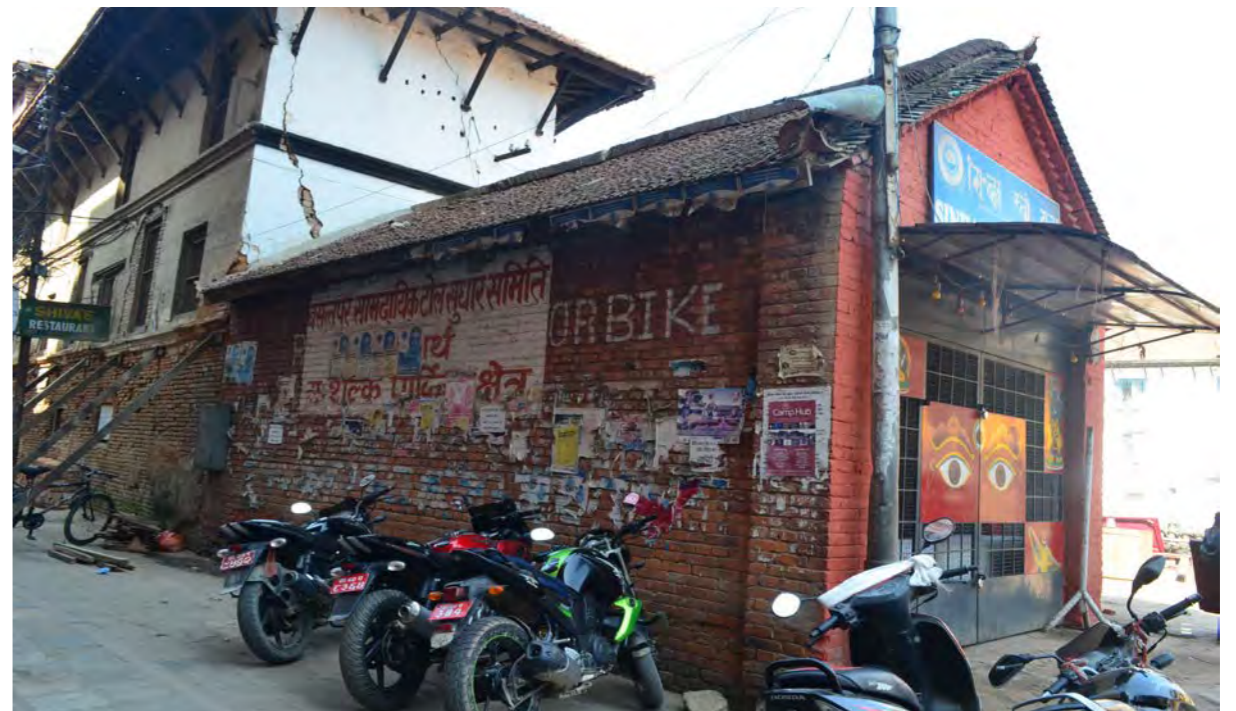
E3

CODE NO	TPOLOGY	MONUMENT NAME	ESTABLISHED/ RENOVATED DATE	STRUCTURAL SYSTEM	MATERIAL	GENERAL DESCEIPTION	PROBLEM DESCRIPTION	DANGER	REMARKS
e03		Shina Swan Khala		Load Bearing	brick	Used as storage for chariot	Roof tiles Detached but overall structure is in good condition
