2015 Earthquake Damage Mapping

Swayambhu Monument Zone
Kathmandu Valley World Heritage Property

Submitted to UNESCO by

June 2015

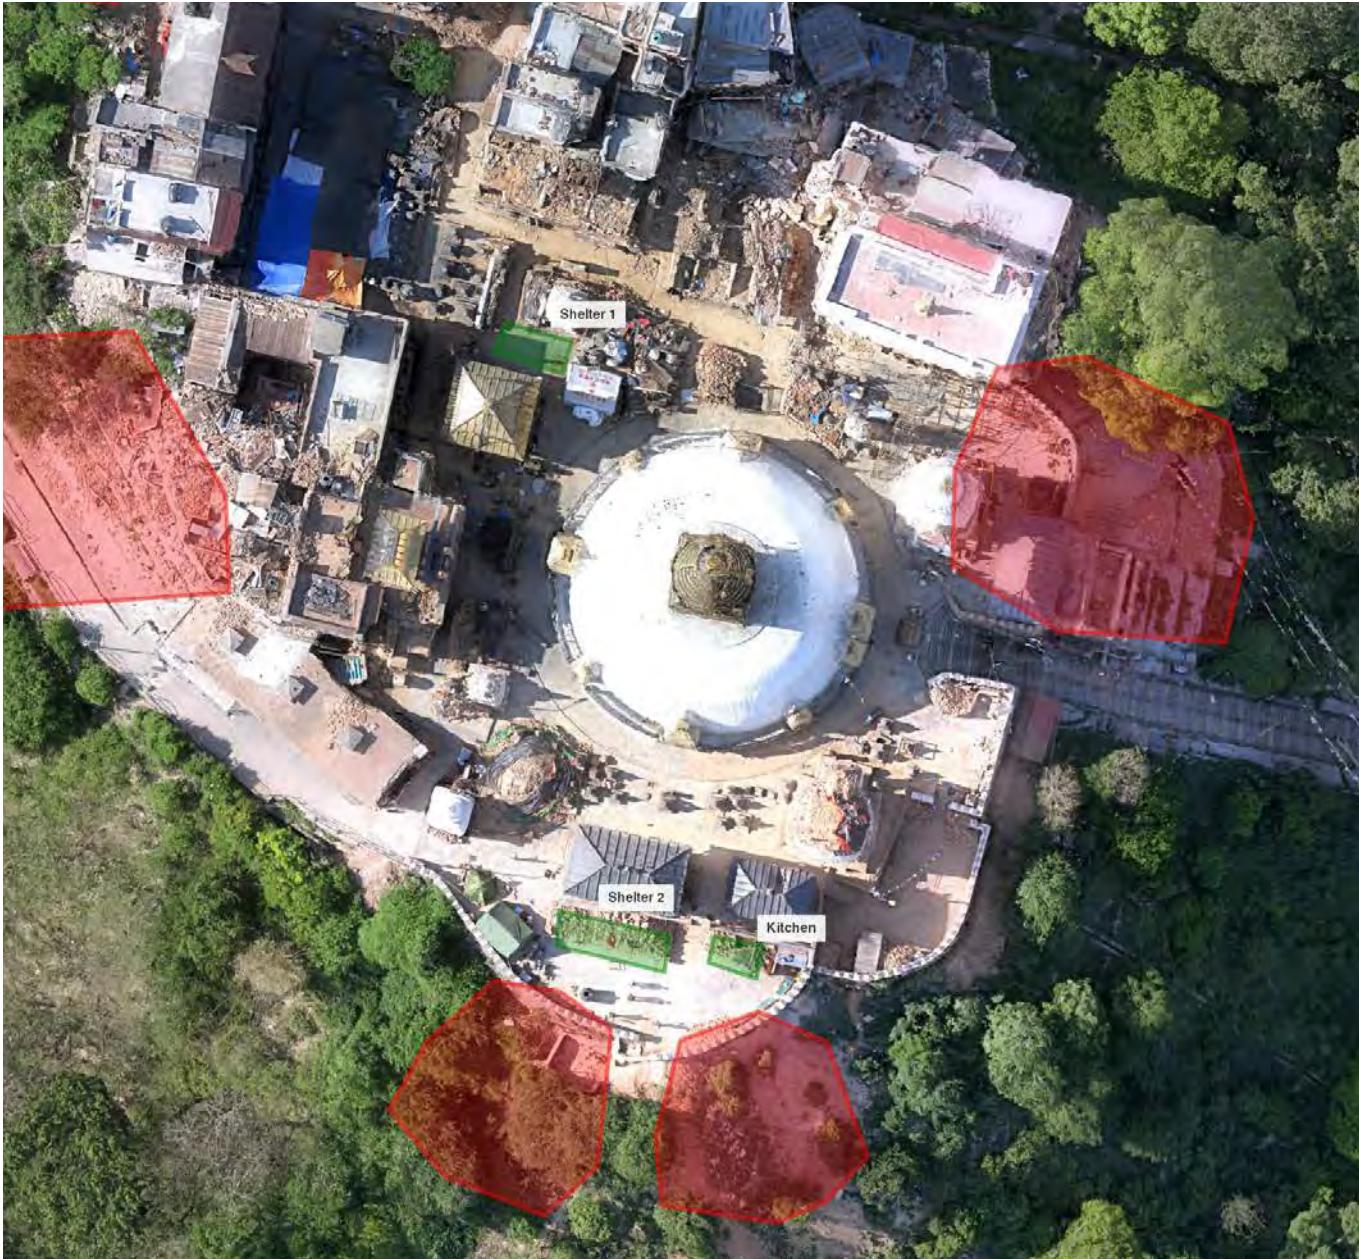
Skycatch image
landslide areas indicated in red

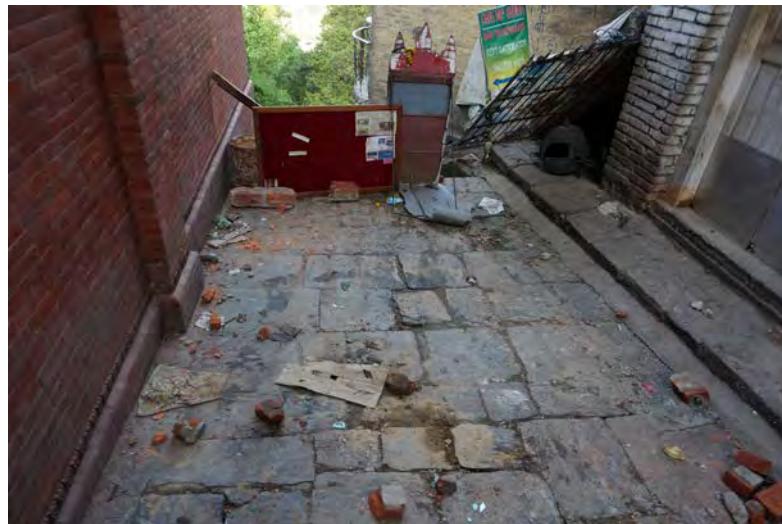
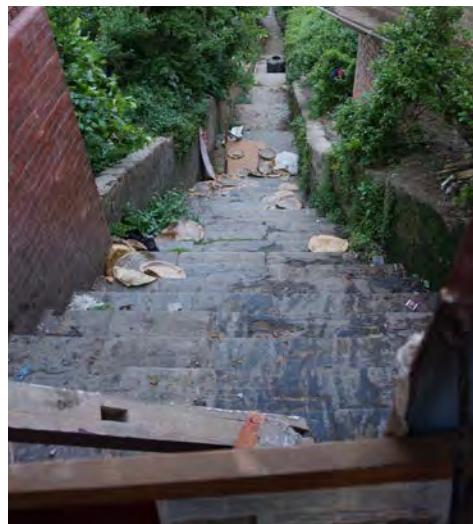
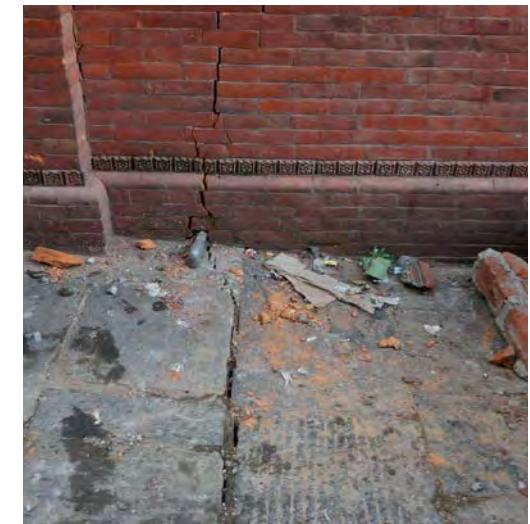
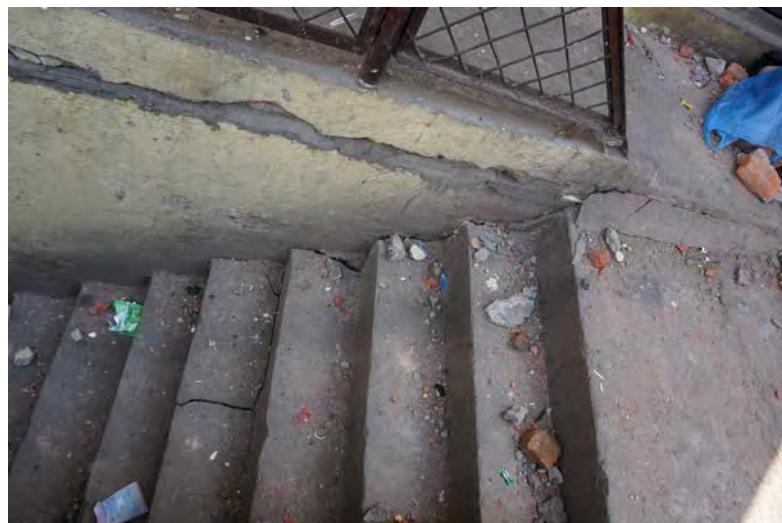
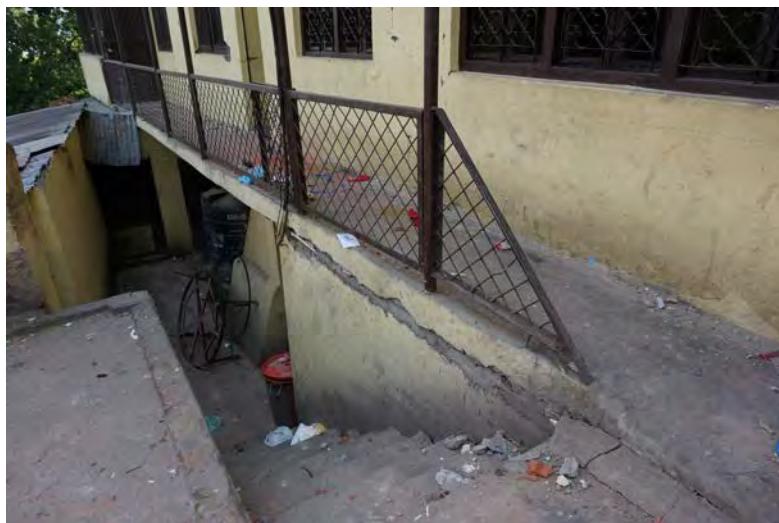
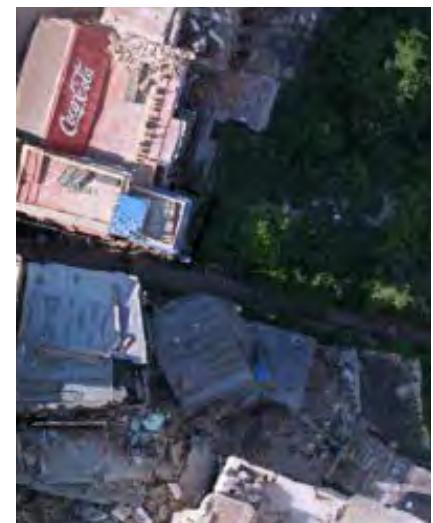
NUMBER NAME	CONSTRUCTION MATERIAL	GENERAL DESCRIPTION	PLAN 1/500
C D	Concrete staircase and stone paved walkway	Longitudinal and horizontal cracks on stone paved staircase with additional cracks along the concrete and wall junctions

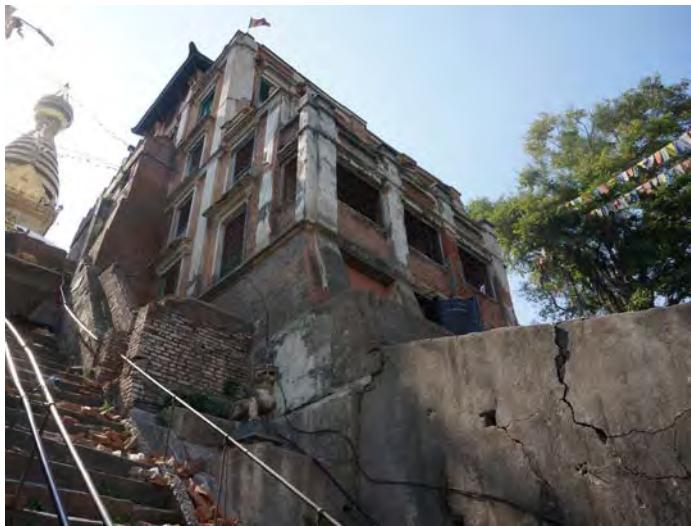
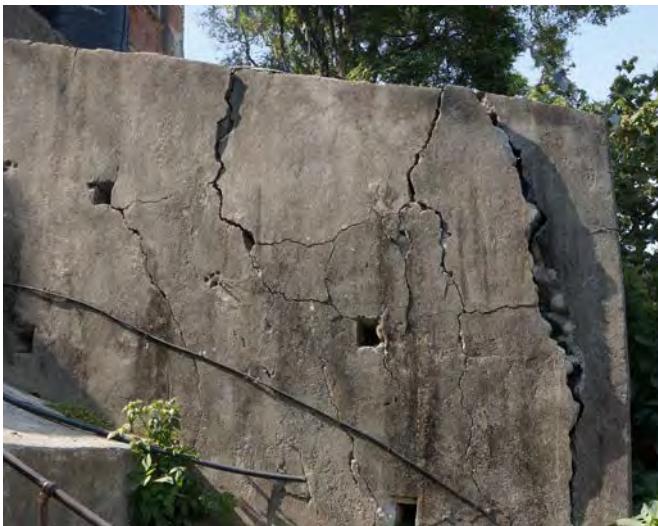
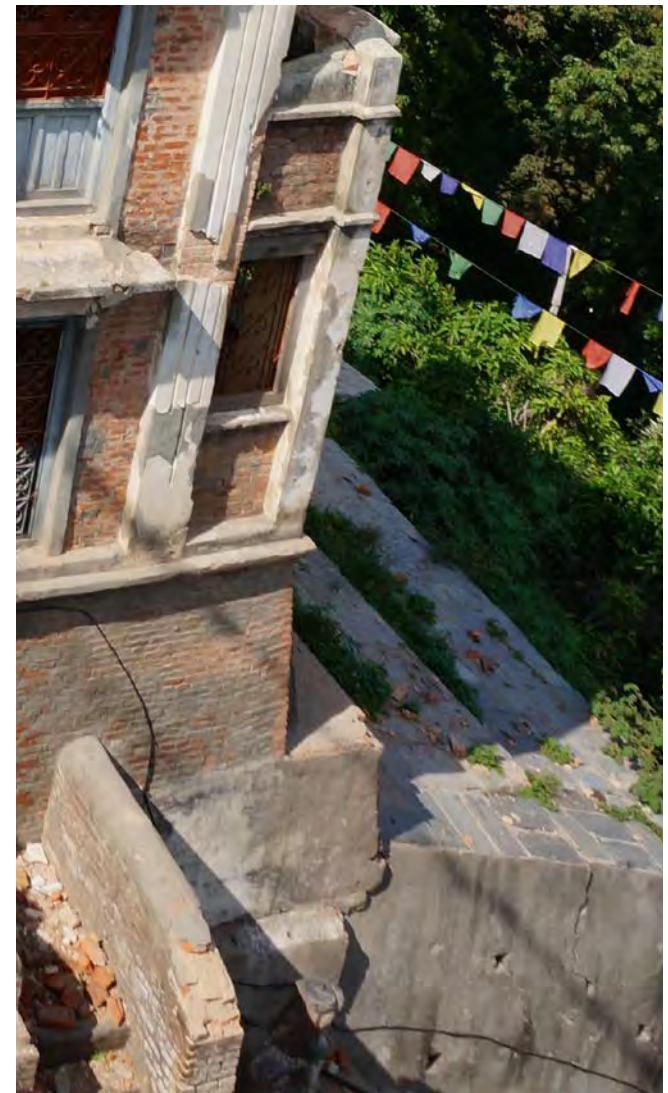
NUMBER NAME	CONSTRUCTION MATERIAL	GENERAL DESCRIPTION
G	Brick wall and cement plaster	Random cracks in corners and plastered walls

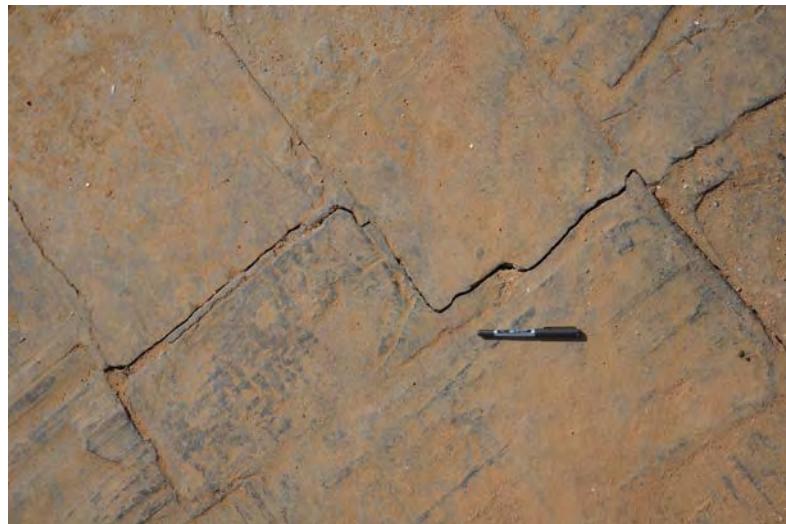
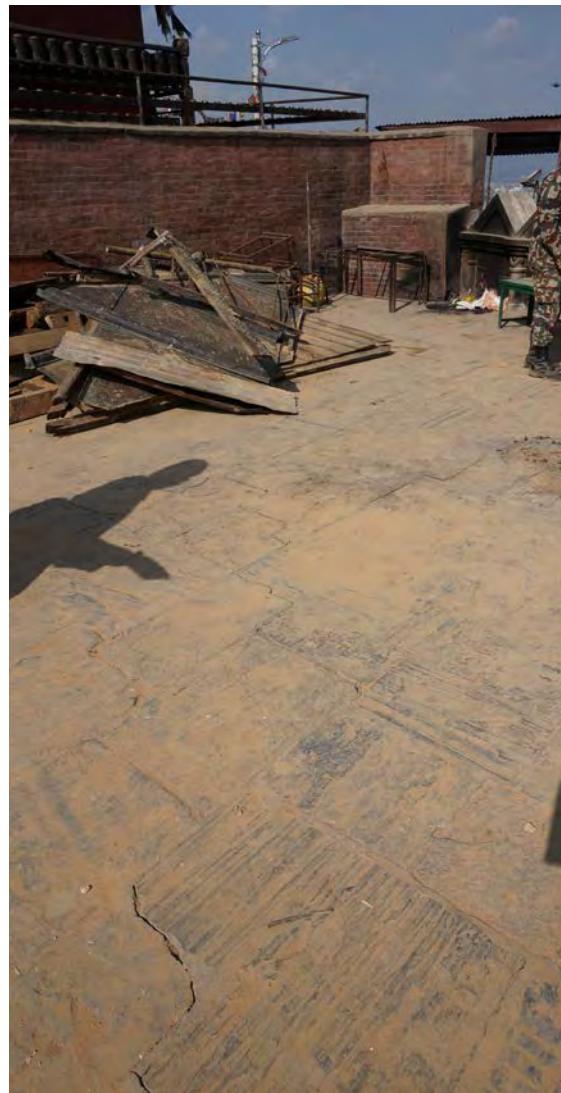
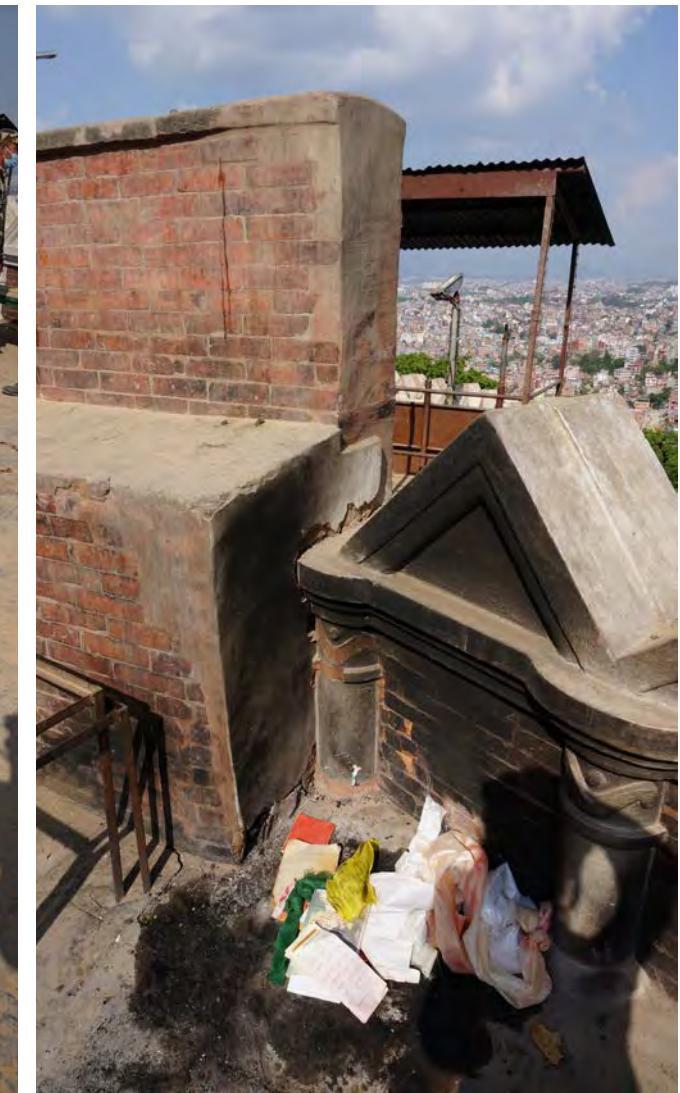
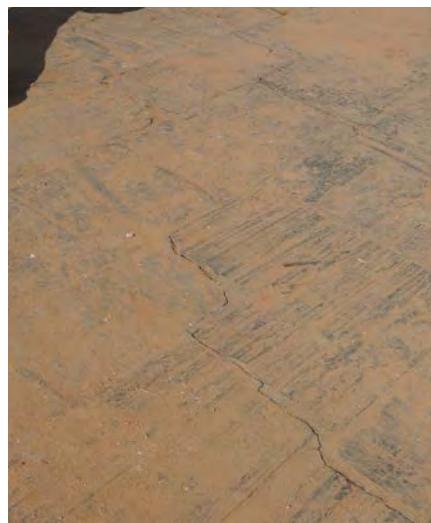
NUMBER NAME	CONSTRUCTION MATERIAL	GENERAL DESCRIPTION
H I	Stone paved walkway platform	Longitudinal cracks of about 0.5 cm wide seen on the joints of stone

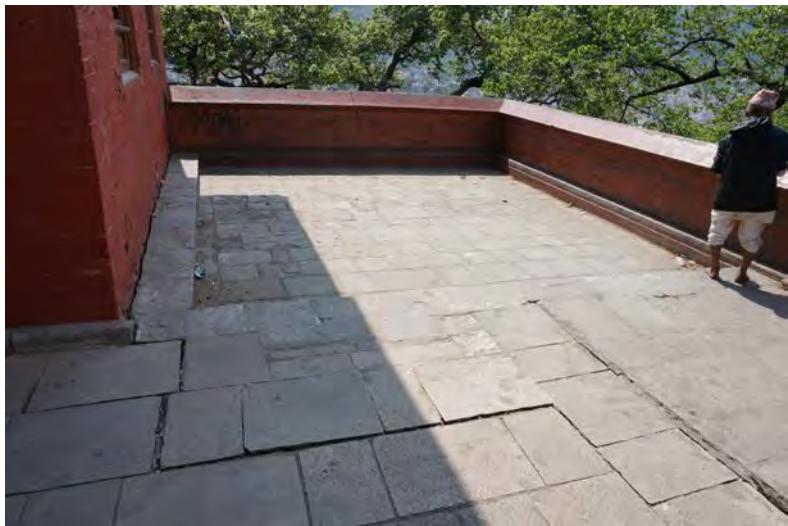
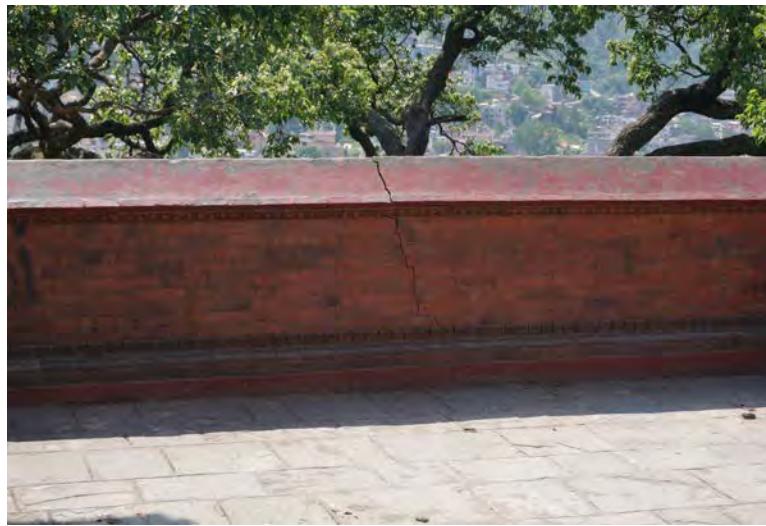
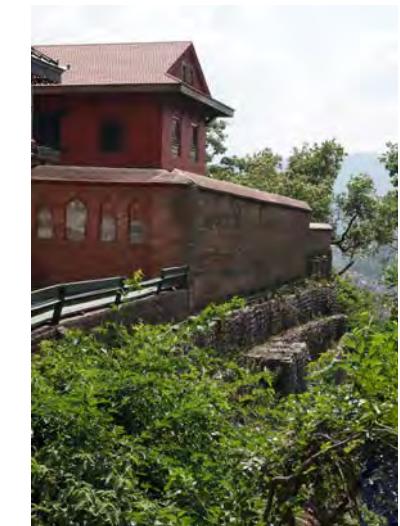
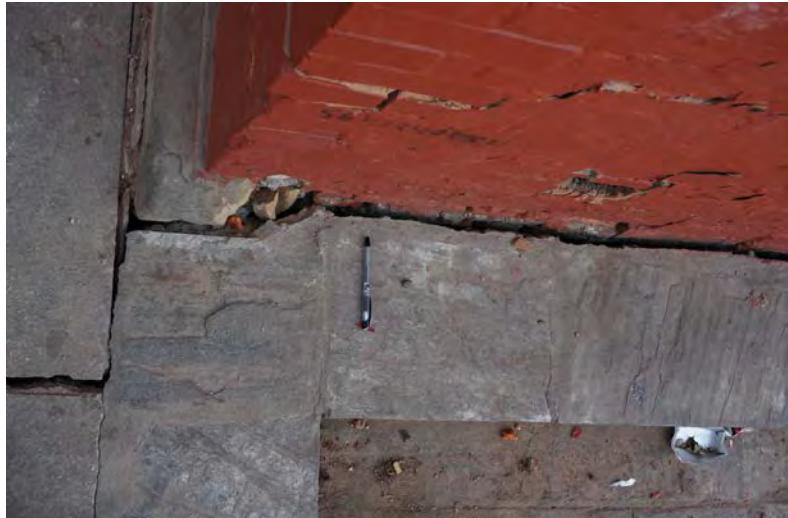
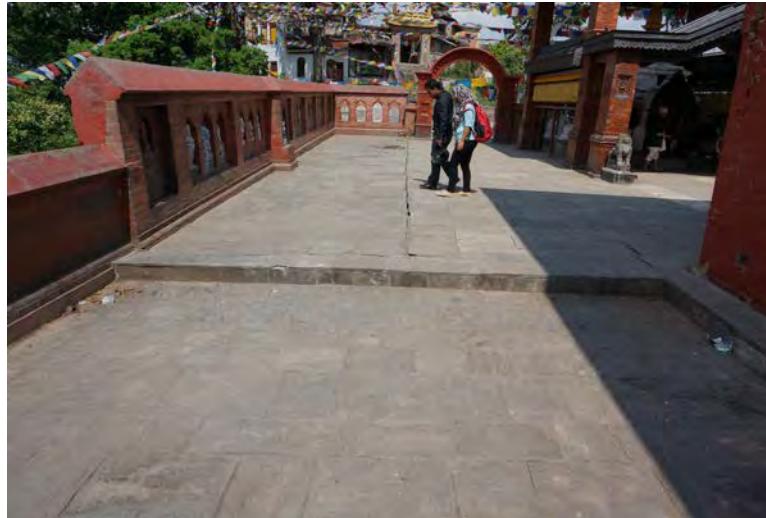
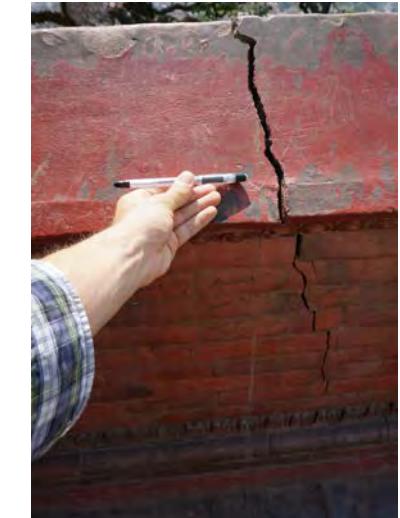
NUMBER NAME	CONSTRUCTION MATERIAL	GENERAL DESCRIPTION
M L	Stone paved platform and brick boundary walls	Longitudinal cracks of 10-20 mm width extending along the North side of platform

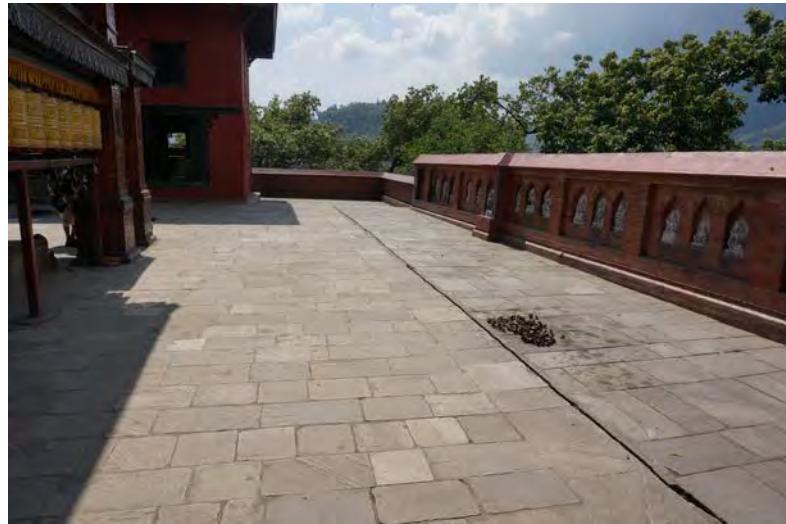
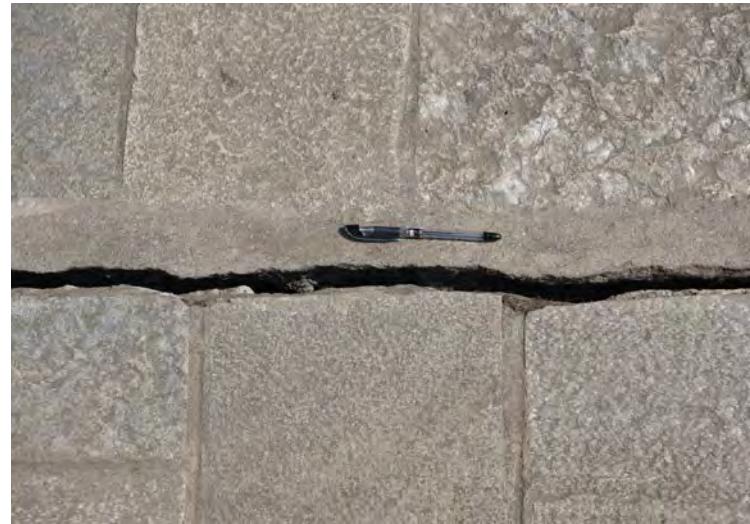
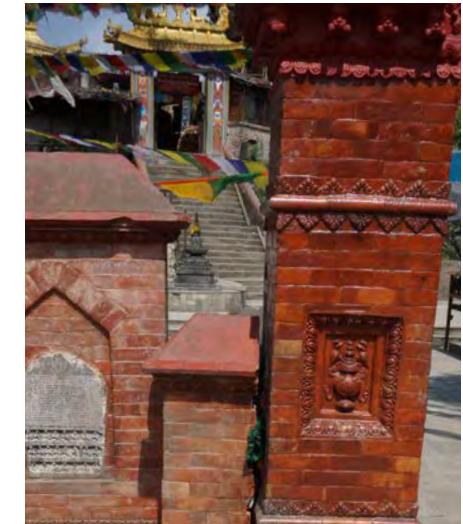
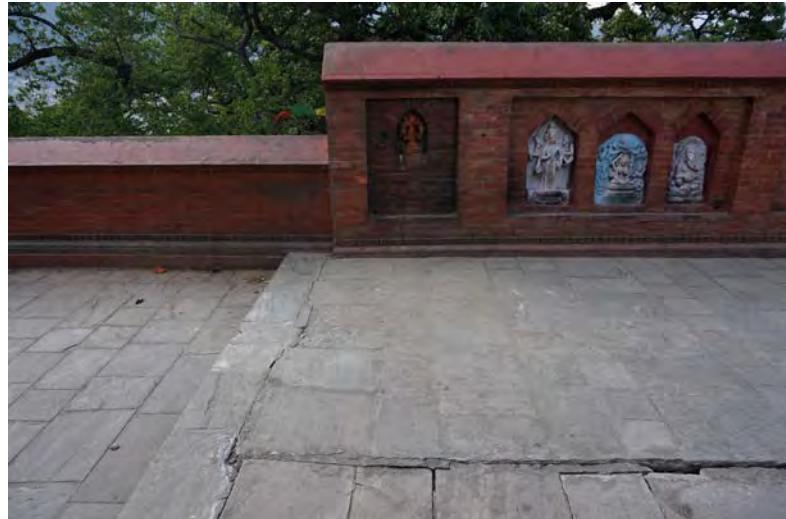
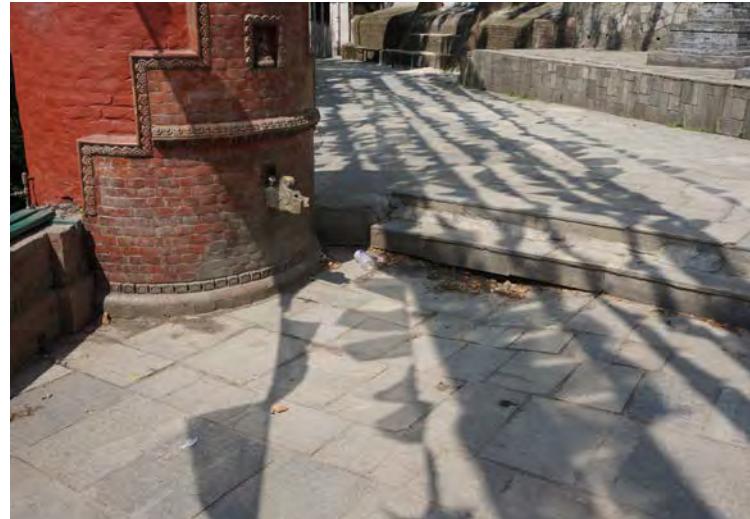
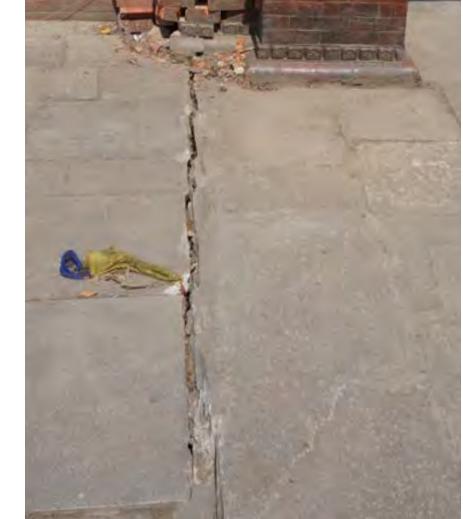
NUMBER NAME	CONSTRUCTION MATERIAL	GENERAL DESCRIPTION	
M L	Stone paved walkway platform and brick boundary walls	<p>Longitudinal cracks of about 1-2 cm extending along the whole North side of platform with certain degree of tilting and subsidence</p> <p>Longitudinal cracks of about 1.5 cm wide seen on the joints of stone 3-4 cm of subsidence below the stairs on crack L</p>

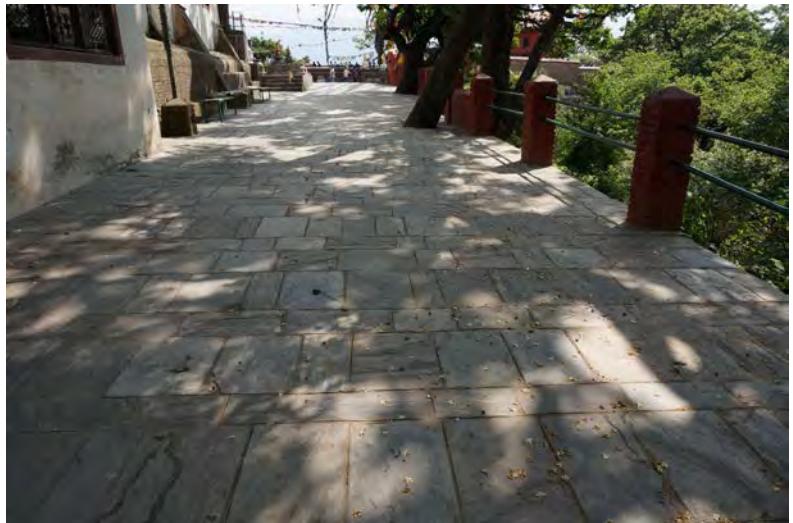
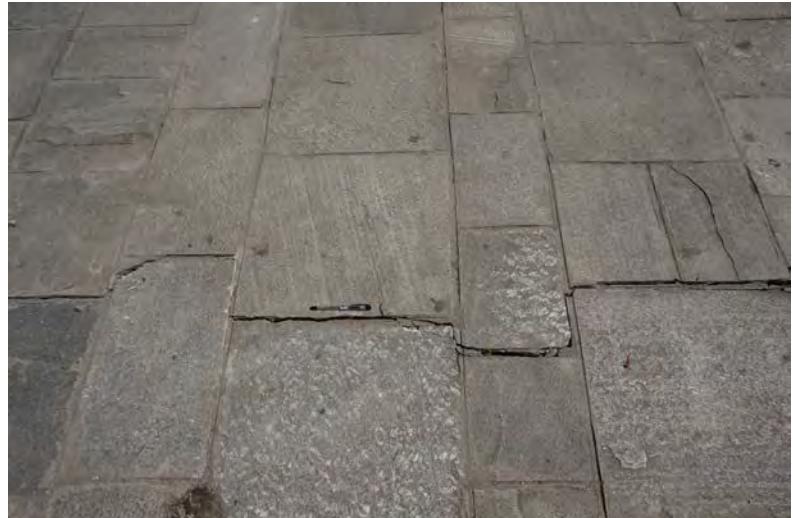
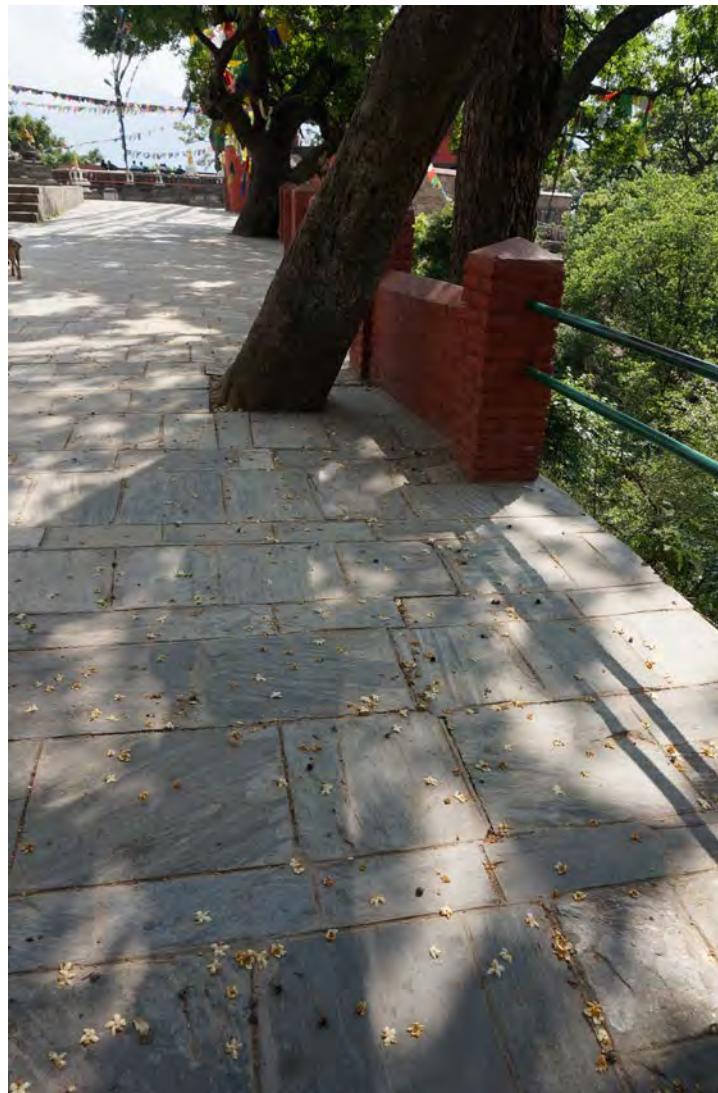
NUMBER NAME	CONSTRUCTION MATERIAL	GENERAL DESCRIPTION
J	Stone paved walkway platform	Two parallel longitudinal cracks near the edge extending from trees

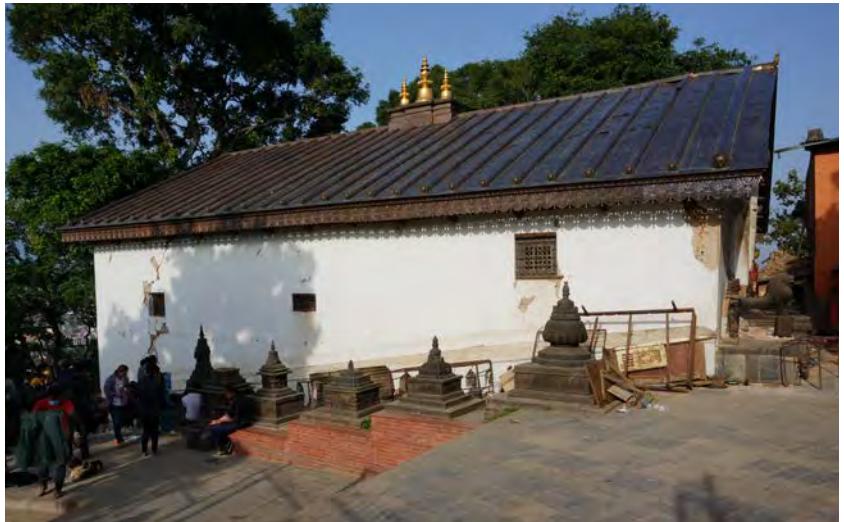
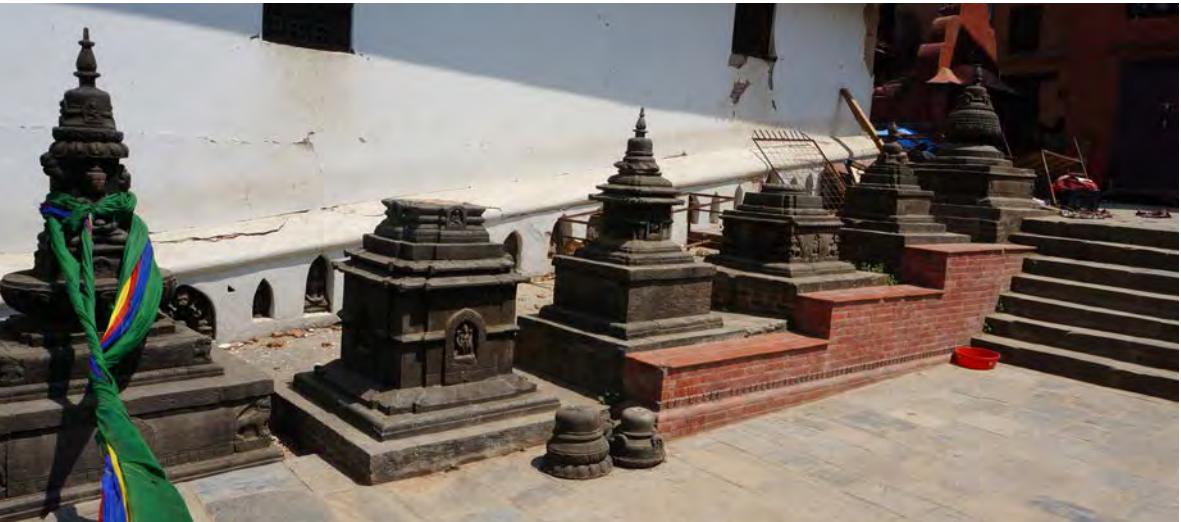
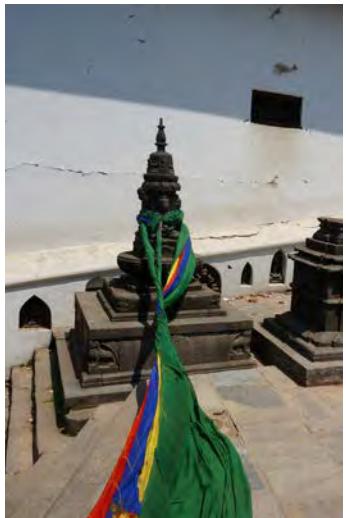
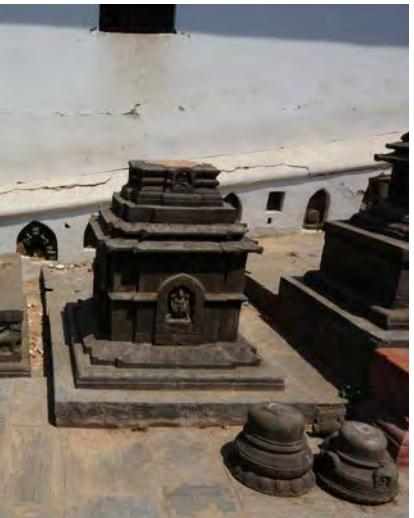
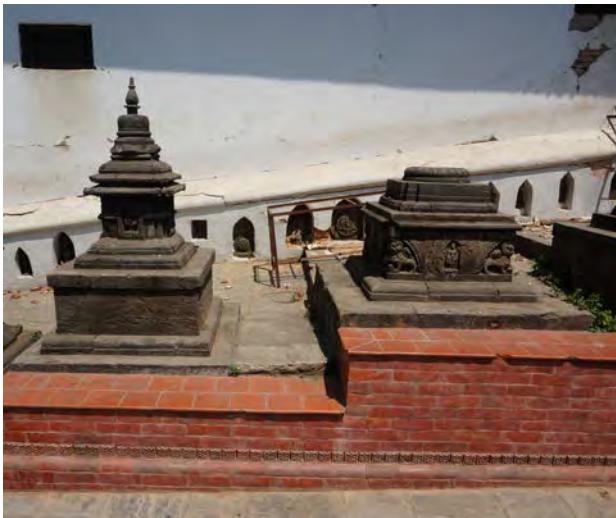
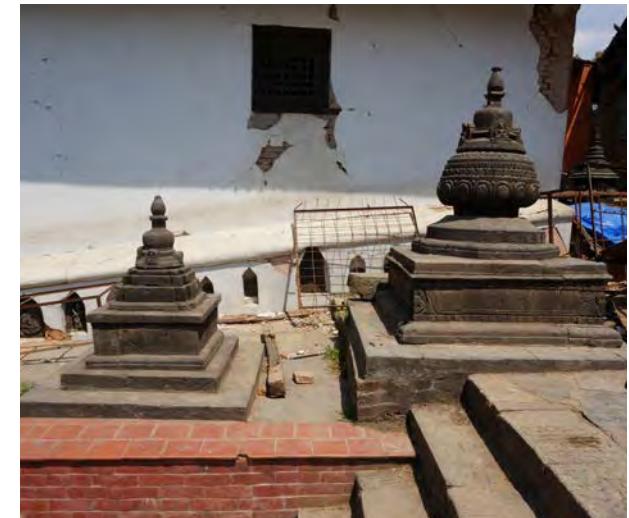
NUMBER NAME	DATE A.D.	TYPE OF MONUMENT HERITAGE SIGNIFICANCE	GENERAL DESCRIPTION	DESCRIPTION OF DAMAGE	DANGER DESTROY	N ↑
1 (K-326) Shantipur Temple		Temple	G+1 Building Structure Brick laid in mud mortar, timber roof framing, metal roof	W and E wall with diagonal and horizontal cracks N wall with major diagonal cracks and gable wall collapsed	1/2 X N Wall

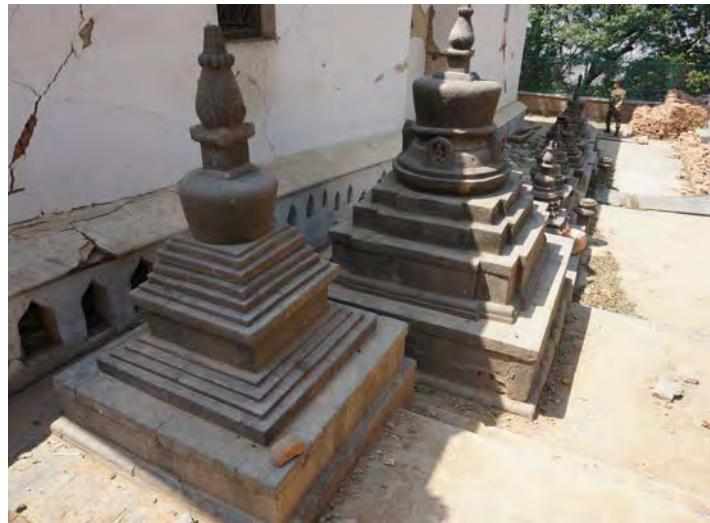
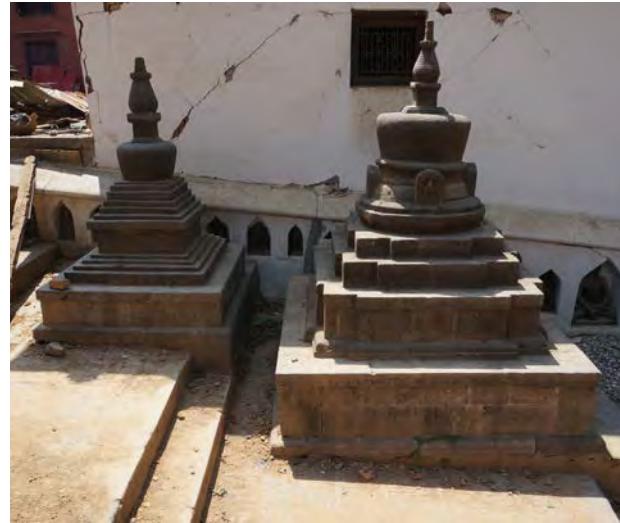
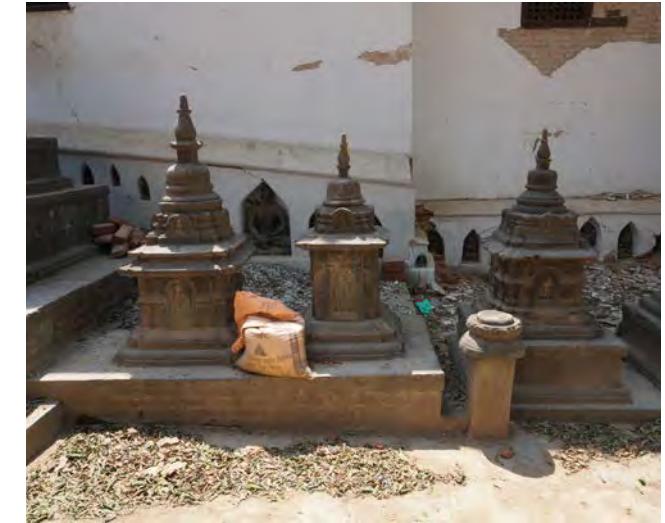
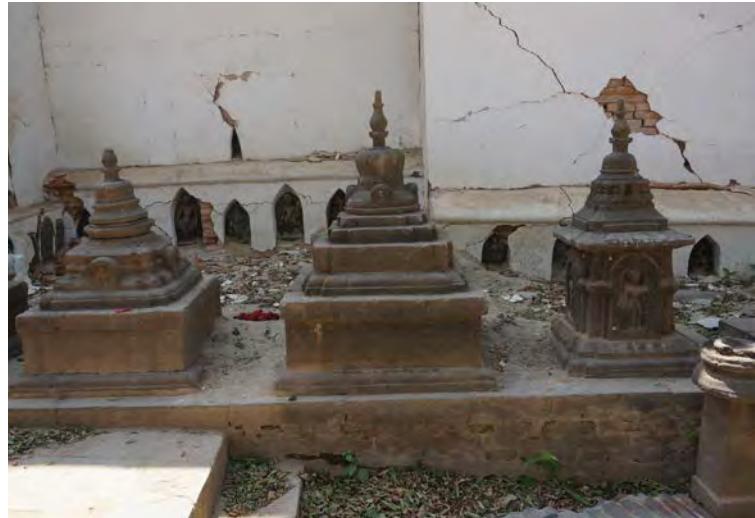
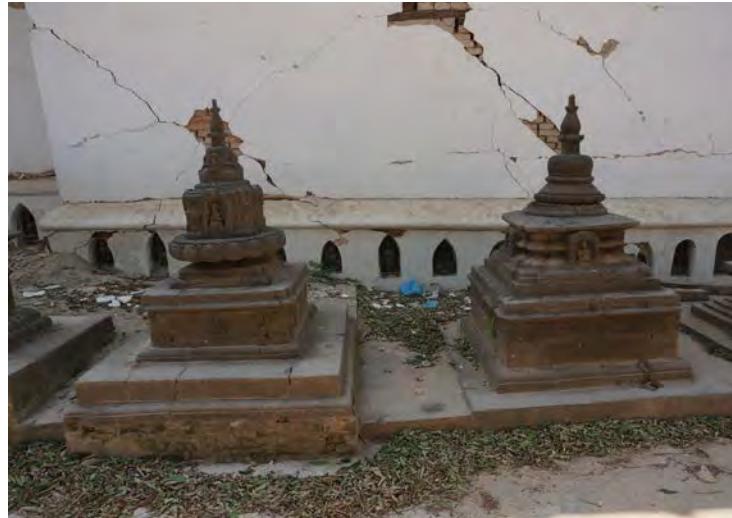
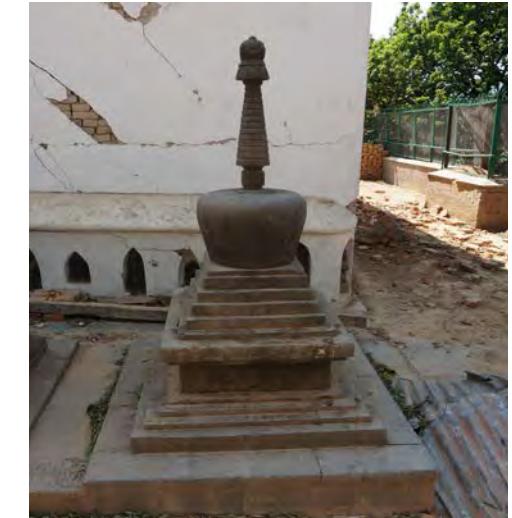
NUMBER NAME	DATE A.D.	TYPE OF MONUMENT HERITAGE SIGNIFICANCE	GENERAL DESCRIPTION	DESCRIPTION OF DAMAGE	DANGER DESTROY	N ↑
2		Chaityas	Group of 6 Chaityas Stone and brick structures	No visible damage except for some missing finials and small parts.

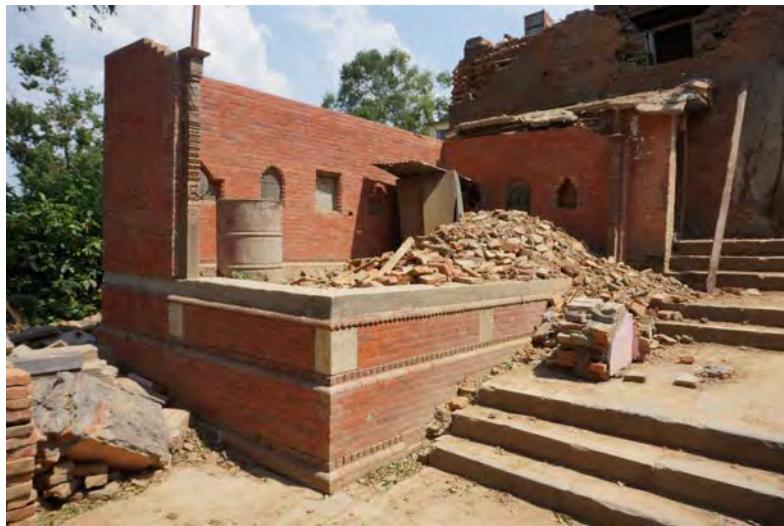
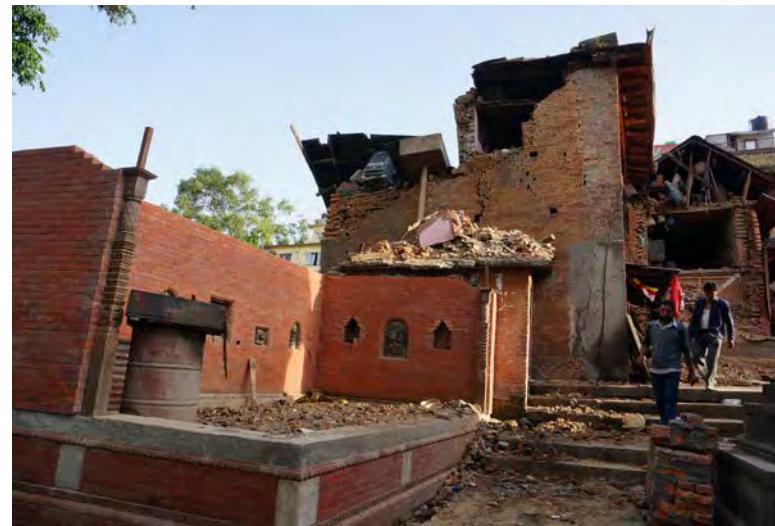
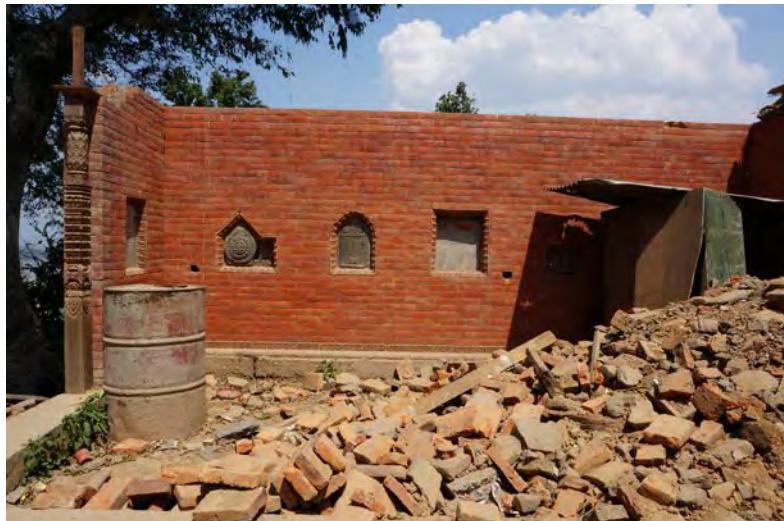
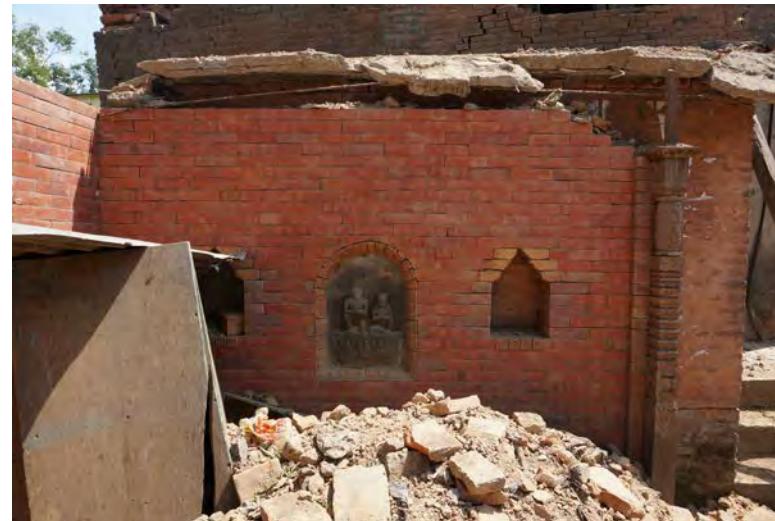
NUMBER NAME	DATE A.D.	TYPE OF MONUMENT HERITAGE SIGNIFICANCE	GENERAL DESCRIPTION	DESCRIPTION OF DAMAGE	DANGER DESTROY	N
4		Sattal (public rest house)	G+1 Building Structure Brick and wooden joist system construction	N-E corners with major cracks and falling off N wall with half of wall collapsed E wall with major diagonal cracks	1/2 X N WALL

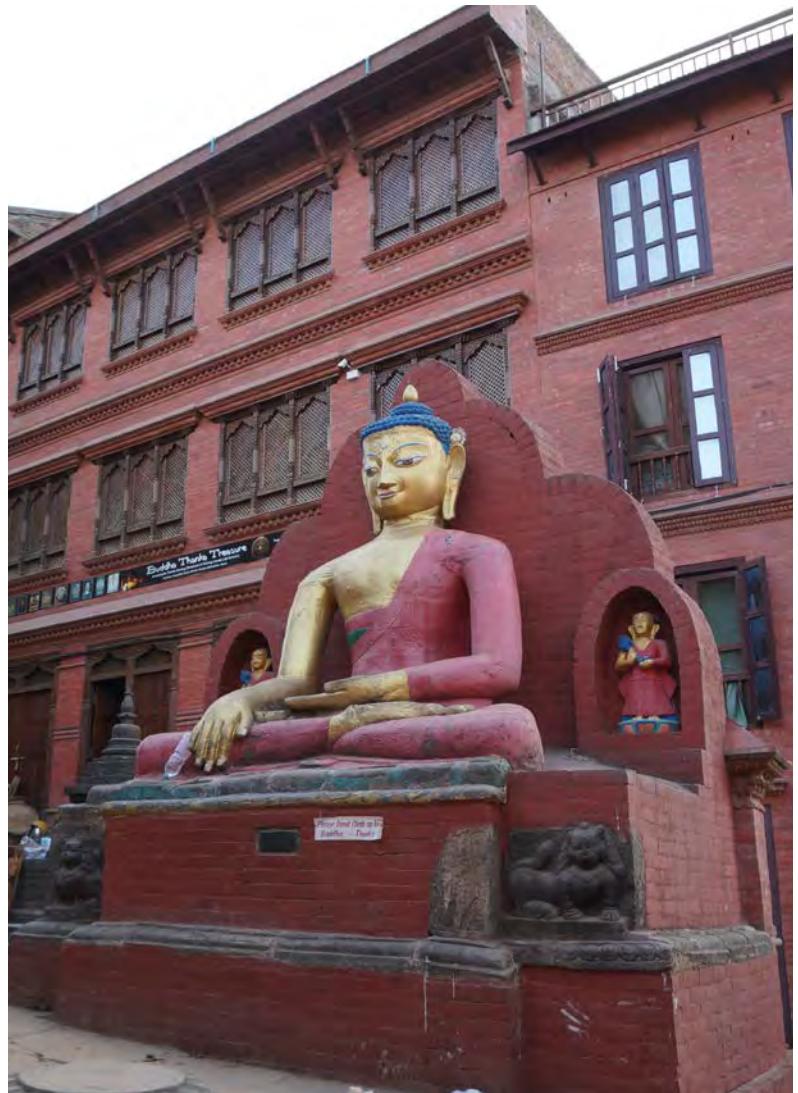
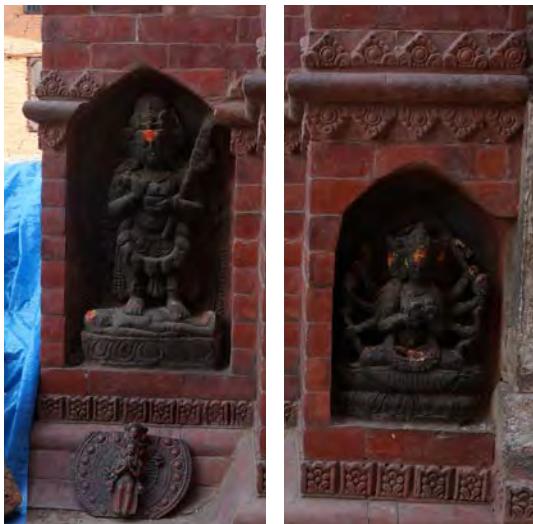
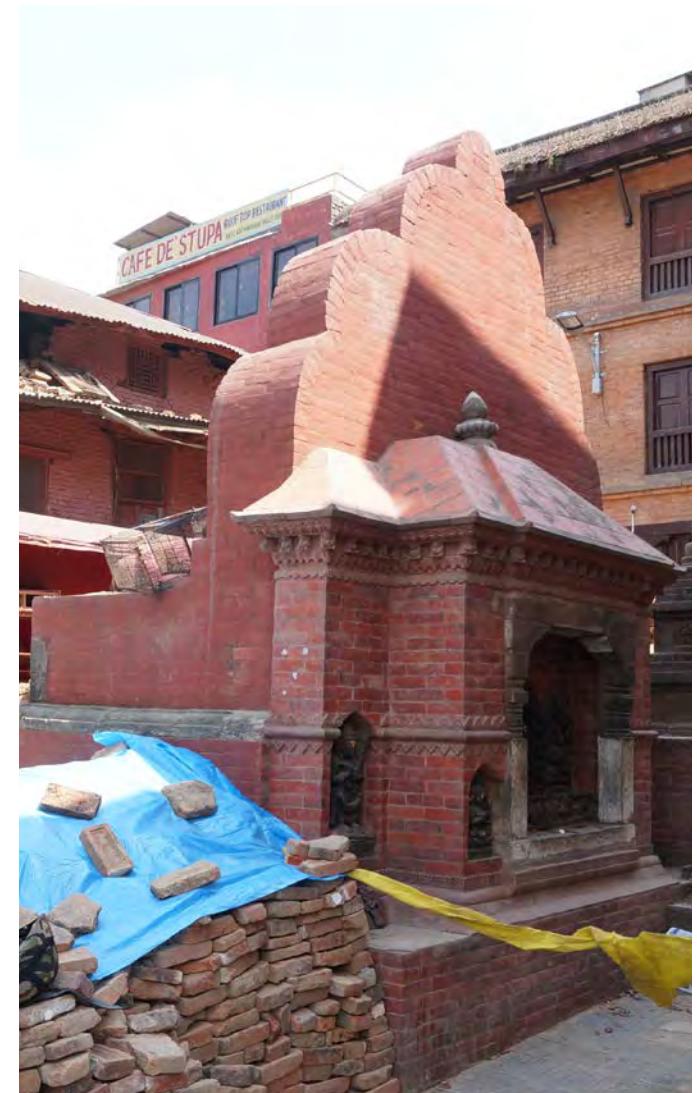
NUMBER NAME	DATE A.D.	TYPE OF MONUMENT HERITAGE SIGNIFICANCE	GENERAL DESCRIPTION	DESCRIPTION OF DAMAGE	DANGER DESTROY	N ↑
6 Buddha Statue		Statue	Statue of Buddha Concrete, stone, and brick structure	No visible damage

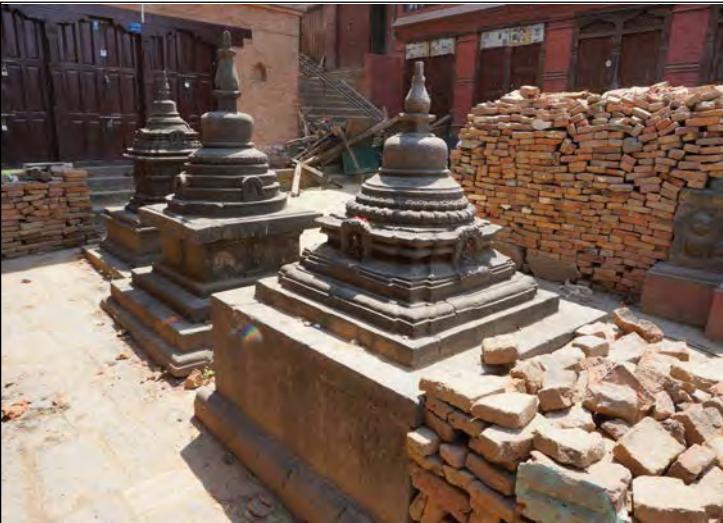
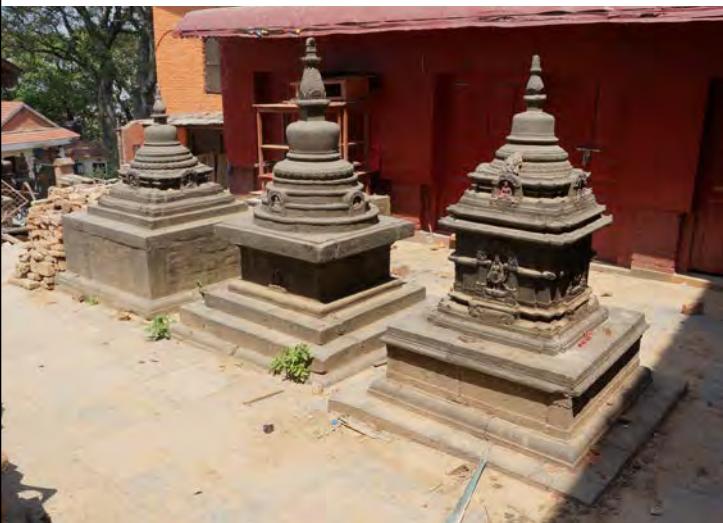
NUMBER NAME	DATE A.D.	TYPE OF MONUMENT HERITAGE SIGNIFICANCE	GENERAL DESCRIPTION	DESCRIPTION OF DAMAGE	DANGER DESTROY	N ↑
7		Chaityas	Group of 4 Chaityas Stone structures	No visible damage
