2015 Earthquake Damage Mapping

Swayambhu Monument Zone
Kathmandu Valley World Heritage Property

Submitted to UNESCO by

June 2015

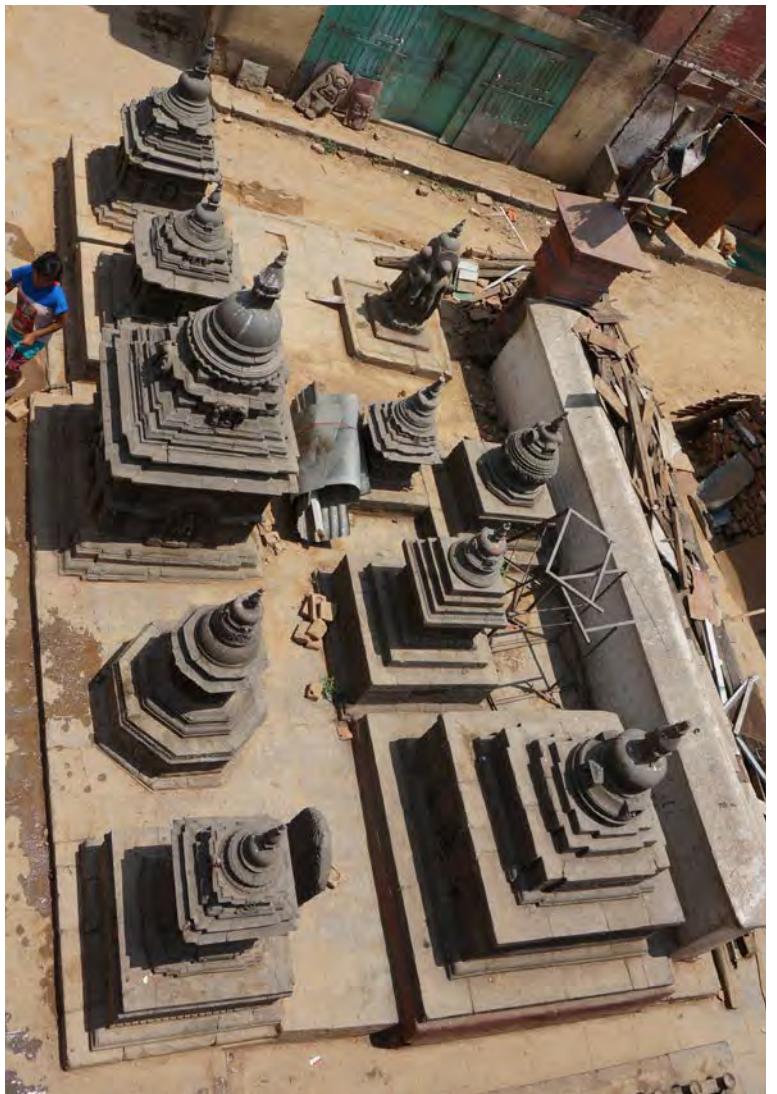
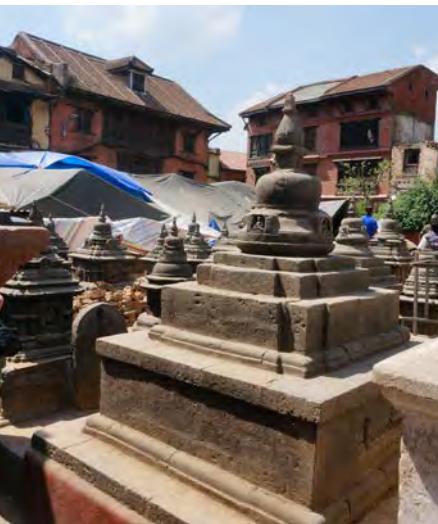
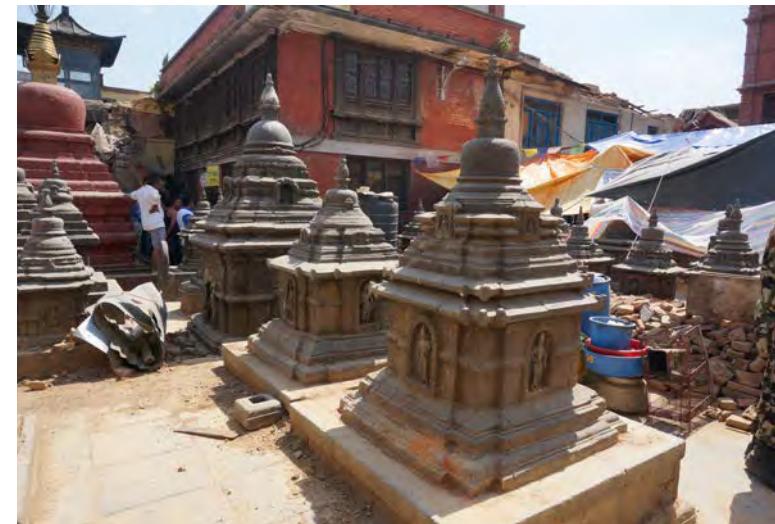
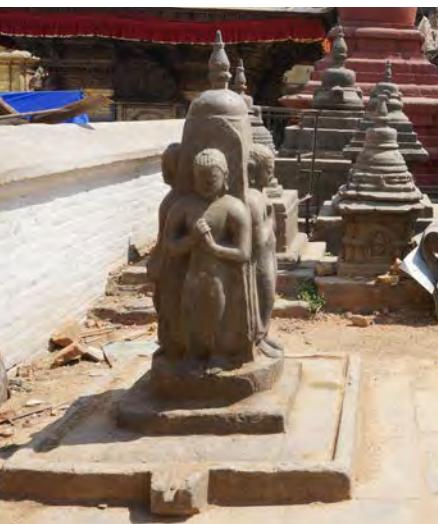
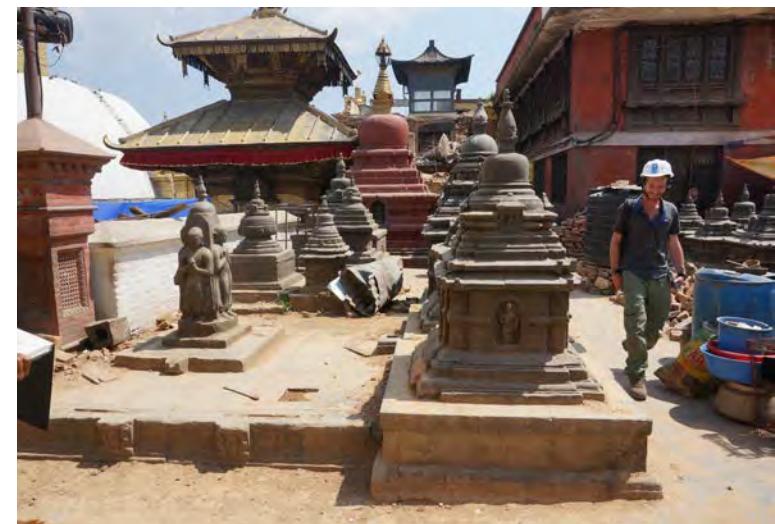
NUMBER NAME	DATE A.D.	TYPE OF MONUMENT HERITAGE SIGNIFICANCE	GENERAL DESCRIPTION	DESCRIPTION OF DAMAGE	DANGER DESTROY	N ↑
8		Chaityas	Group of 10+ Chaityas Stone and brick structures	No visible damage

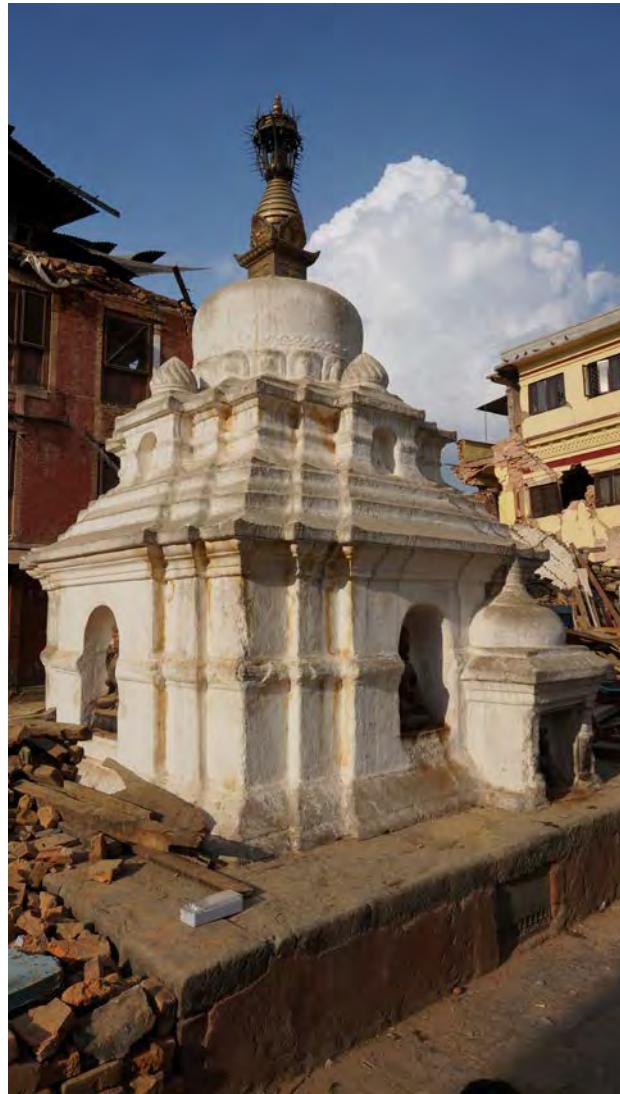
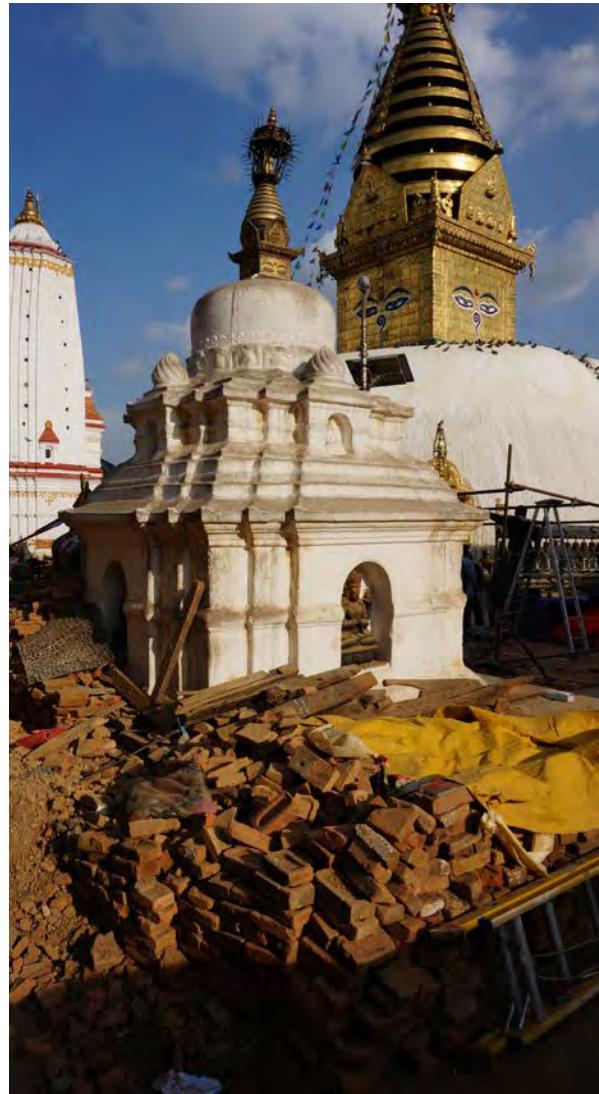
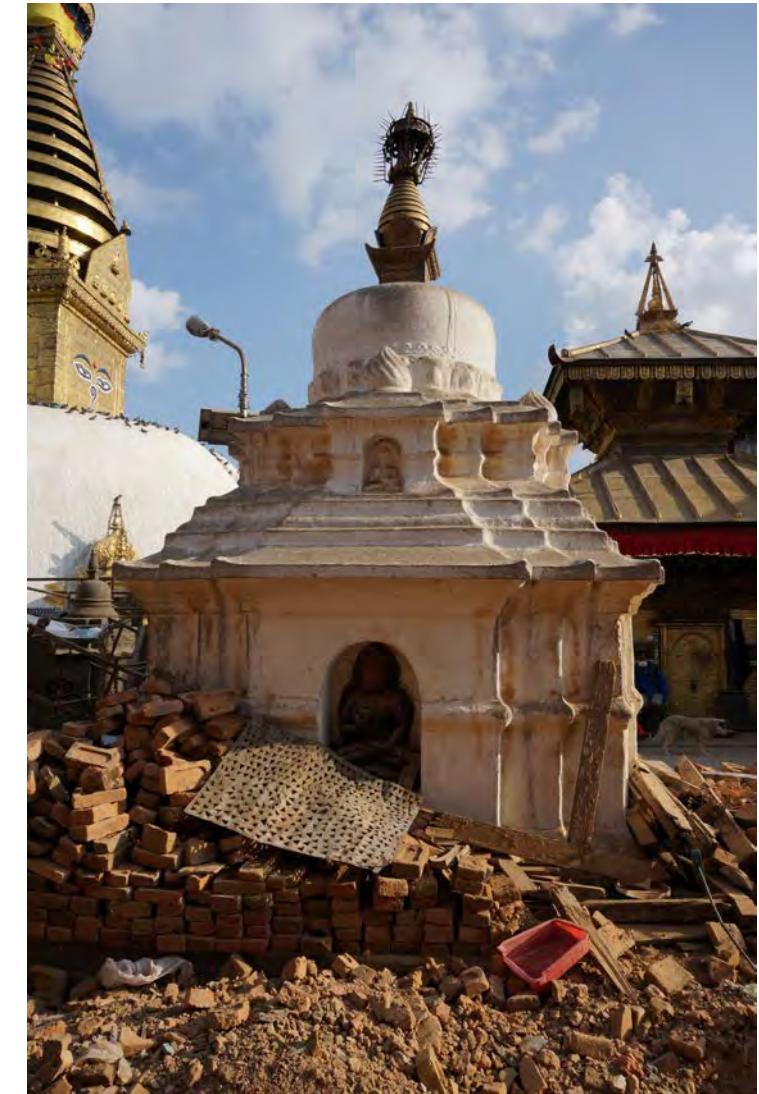
NUMBER NAME	DATE A.D.	TYPE OF MONUMENT HERITAGE SIGNIFICANCE	GENERAL DESCRIPTION	DESCRIPTION OF DAMAGE	DANGER DESTROY	N ↑
9		Stupa	Brick and lime made stupa	No visible damage

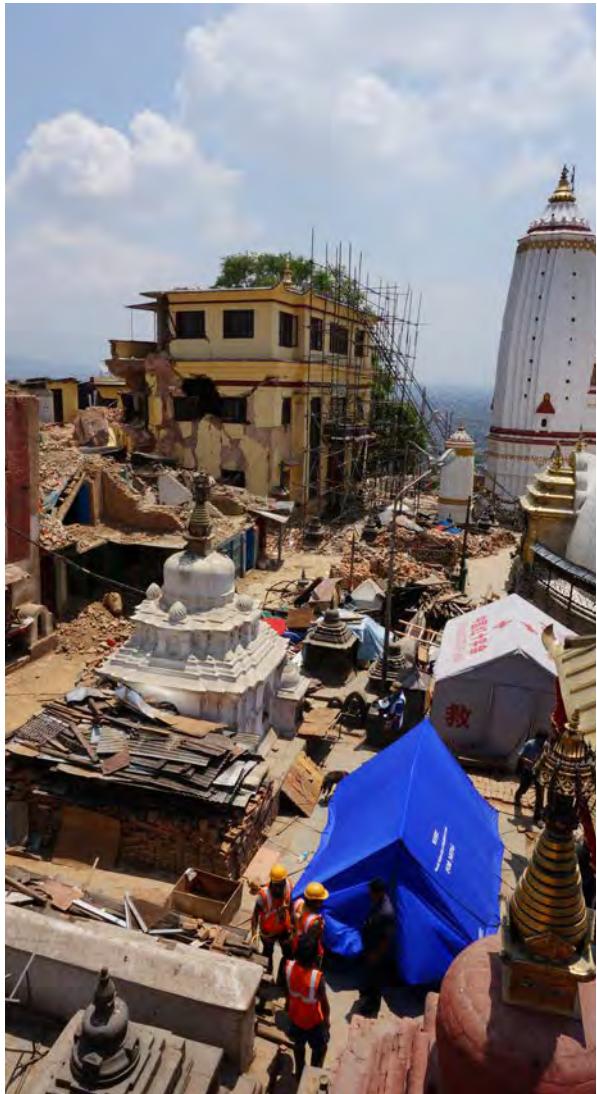
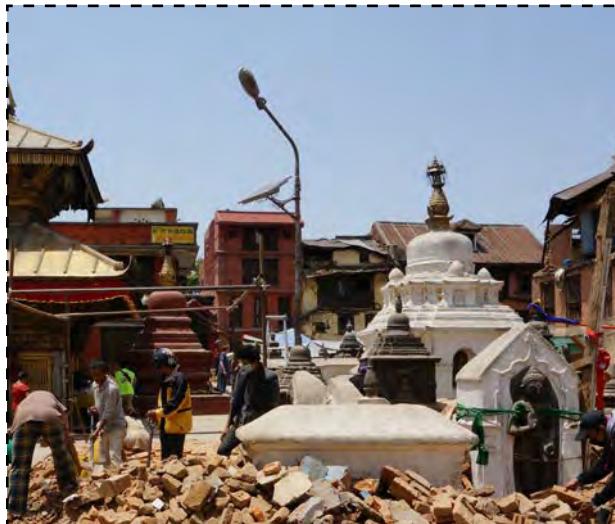
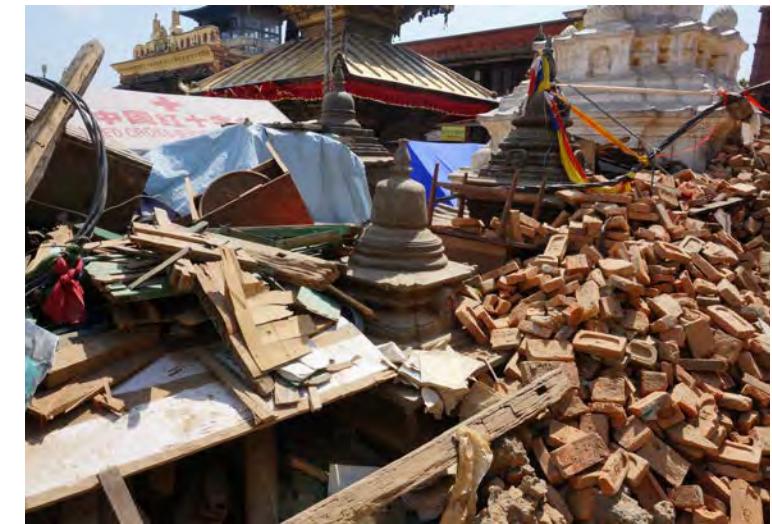
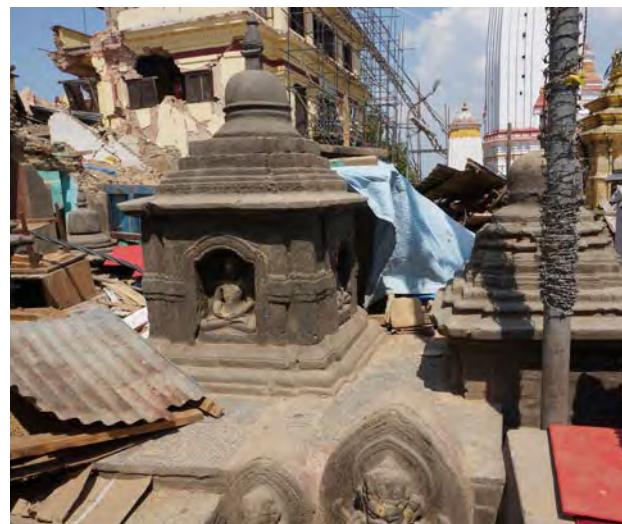
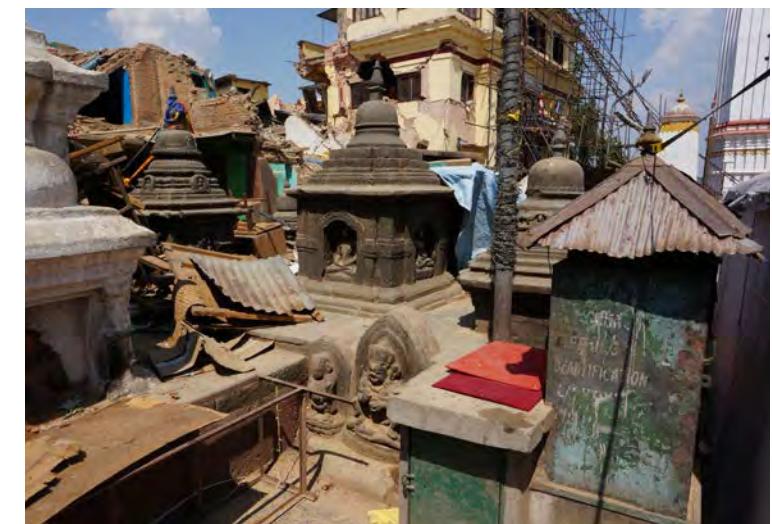
NUMBER NAME	DATE A.D.	TYPE OF MONUMENT HERITAGE SIGNIFICANCE	GENERAL DESCRIPTION	DESCRIPTION OF DAMAGE	DANGER DESTROY	N ↑	PLAN 1/500
10		Chaityas and small stupa	Group of 8+ Chaityas Stone and brick structures	No visible damage except for some missing finials and small parts.

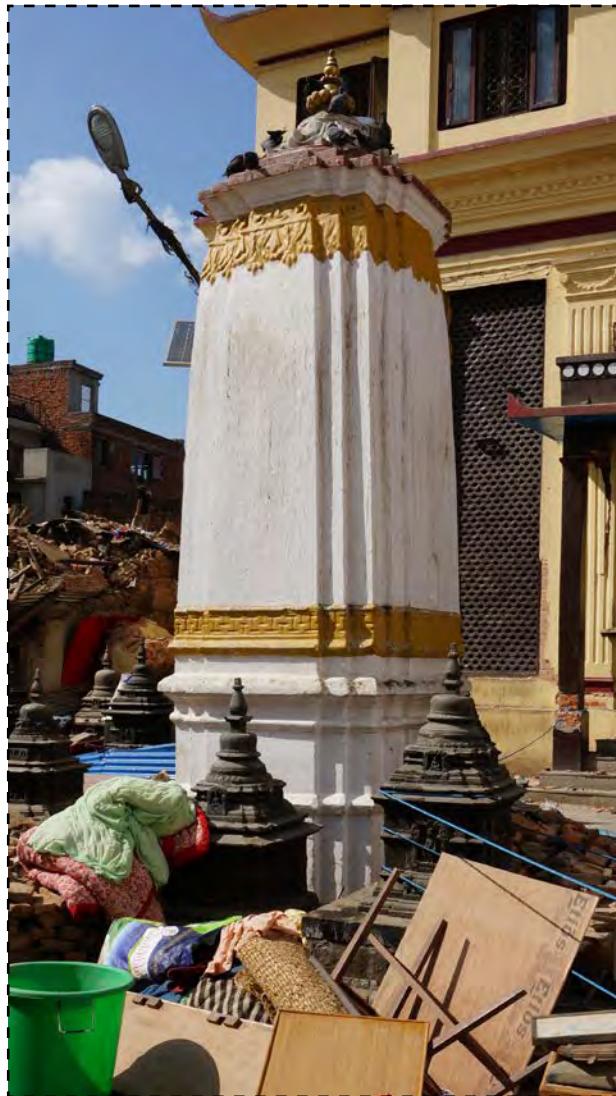
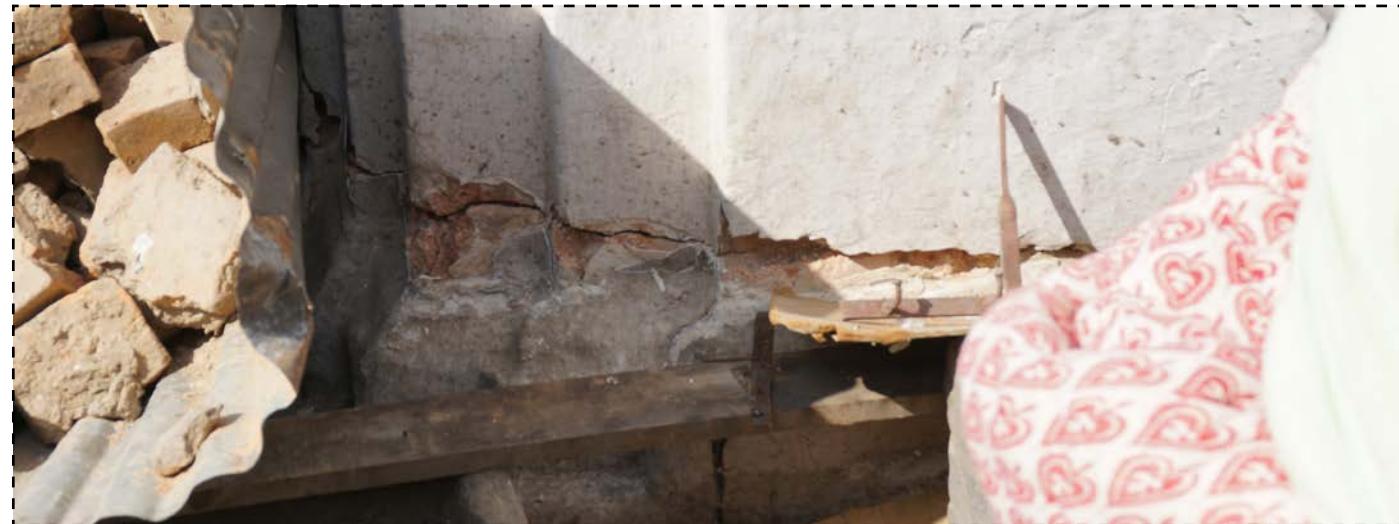
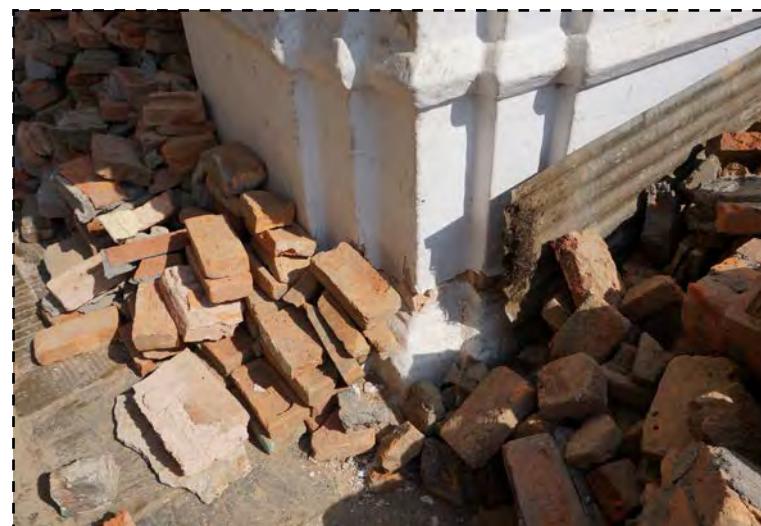
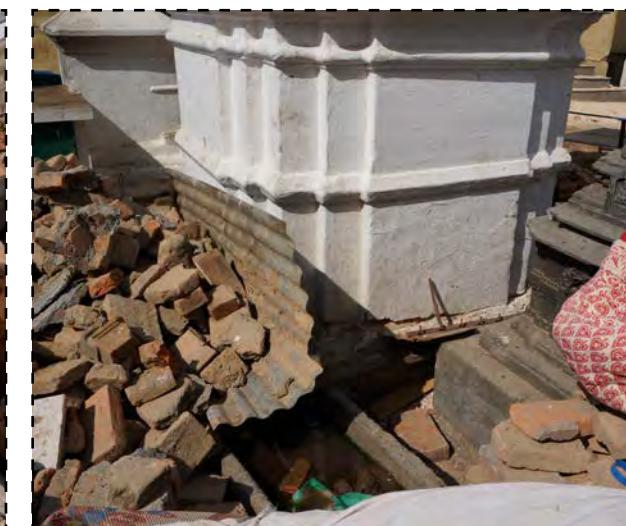
NUMBER NAME	DATE A.D.	TYPE OF MONUMENT HERITAGE SIGNIFICANCE	GENERAL DESCRIPTION	DESCRIPTION OF DAMAGE	DANGER DESTROY	N E
11		Shikhara style	Brick and lime structure about 6 m height	Horizontal cracks in lower section

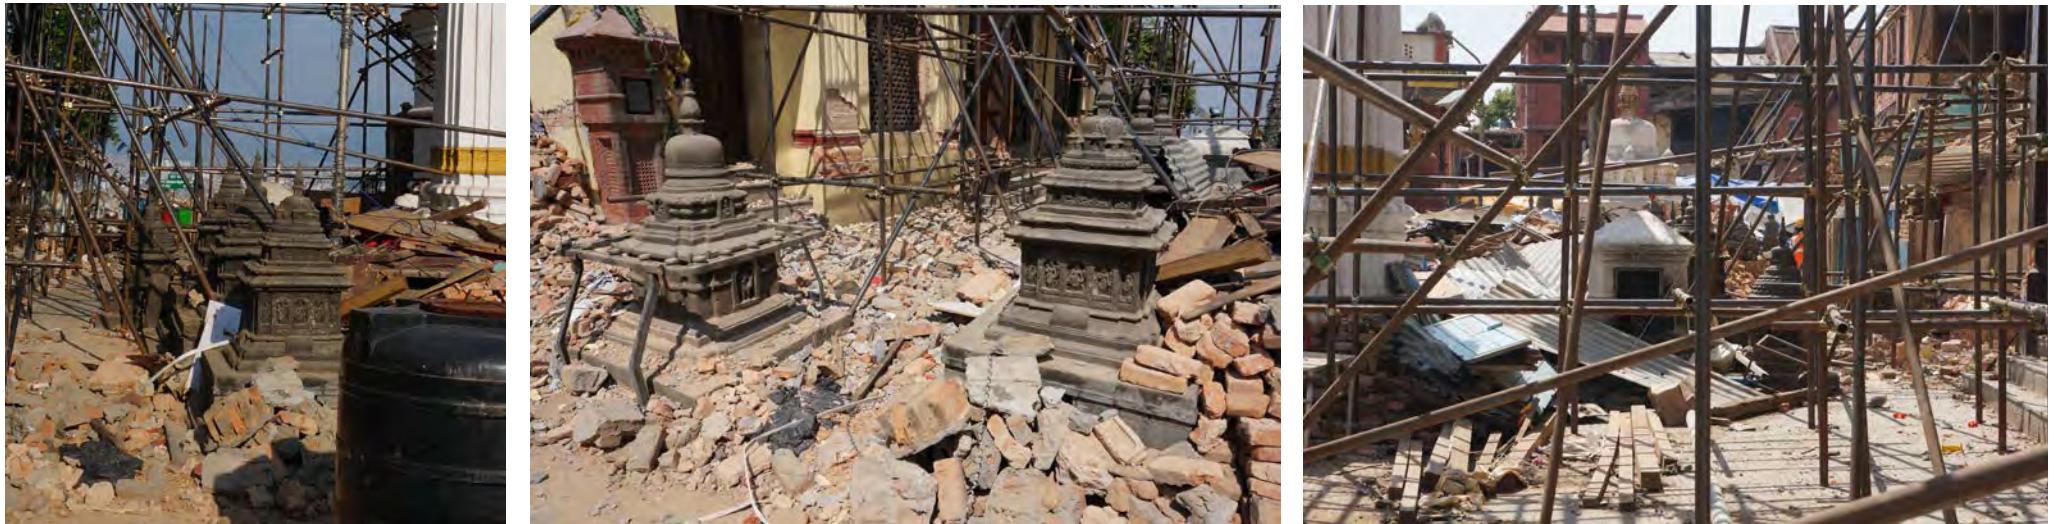
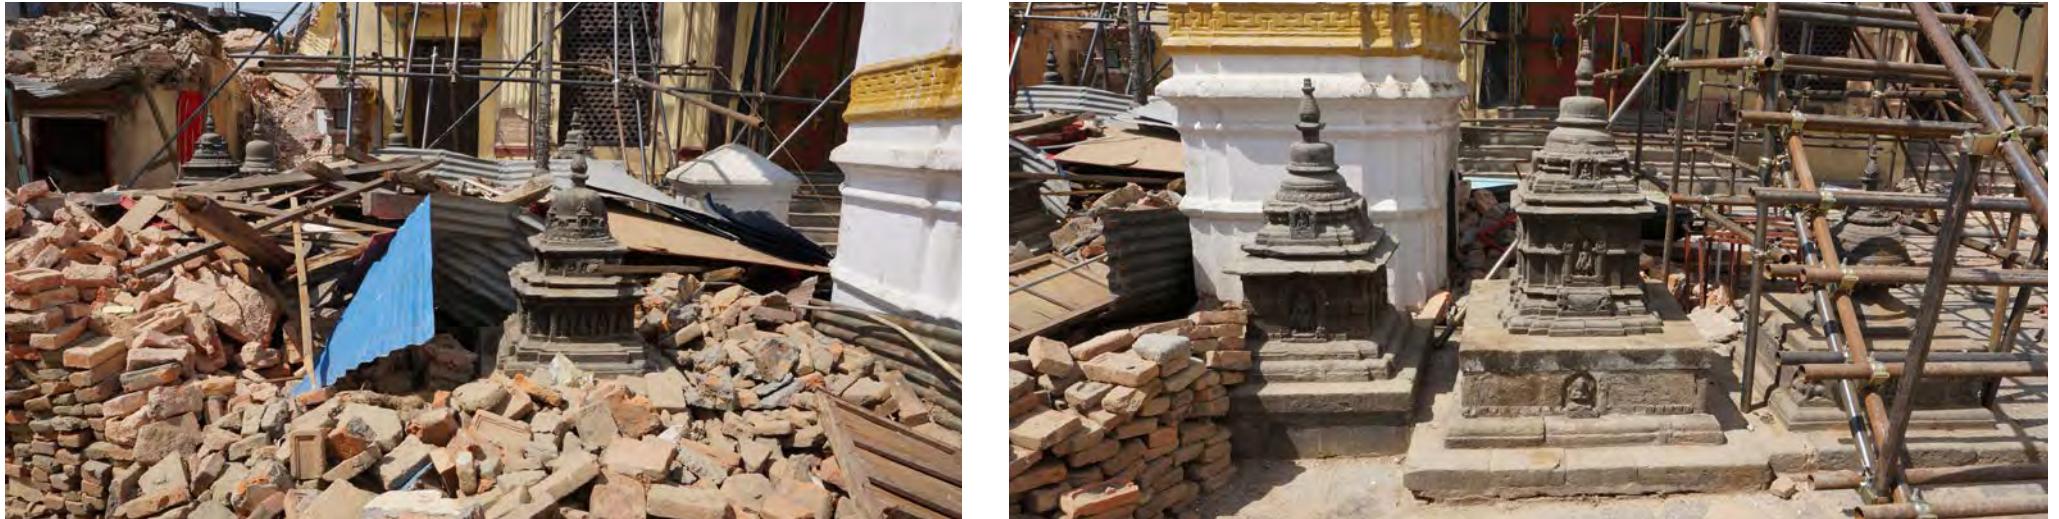
NUMBER NAME	DATE A.D.	TYPE OF MONUMENT HERITAGE SIGNIFICANCE	GENERAL DESCRIPTION	DESCRIPTION OF DAMAGE	DANGER DESTROY	PLAN 1/500
12		Chaityas	Group of 6+ chaityas Stone and brick structures	No visible damage

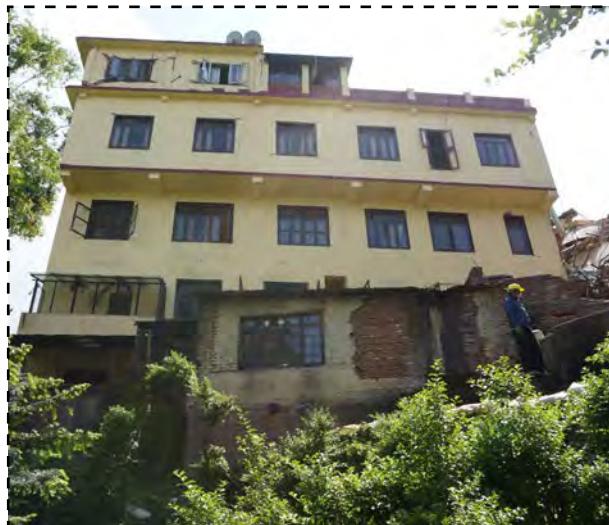
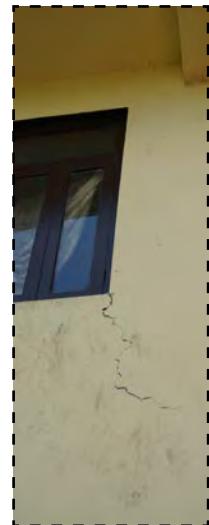
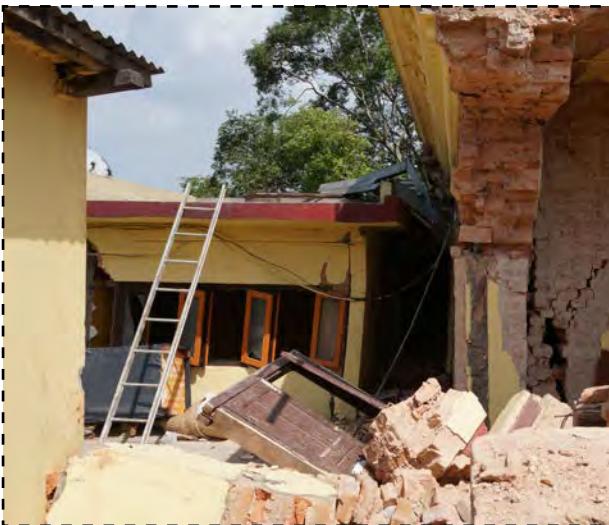
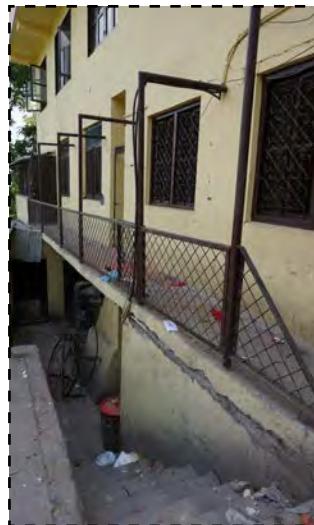
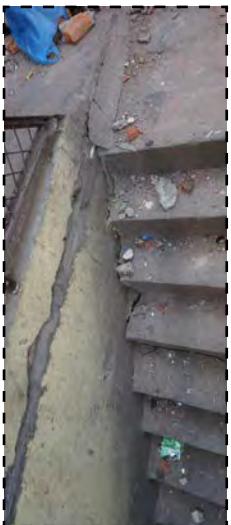
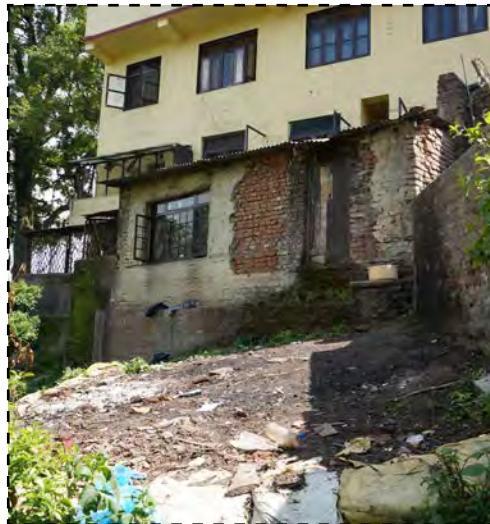
NUMBER NAME	DATE A.D.	TYPE OF MONUMENT HERITAGE SIGNIFICANCE	GENERAL DESCRIPTION	DESCRIPTION OF DAMAGE	DANGER DESTROY	N ↑
13		Monastery at back of Karmaras Gumba	G+4 Concrete structure	Upper part damaged Cracks and separation from stairs Some minor cracks at wall and plaster

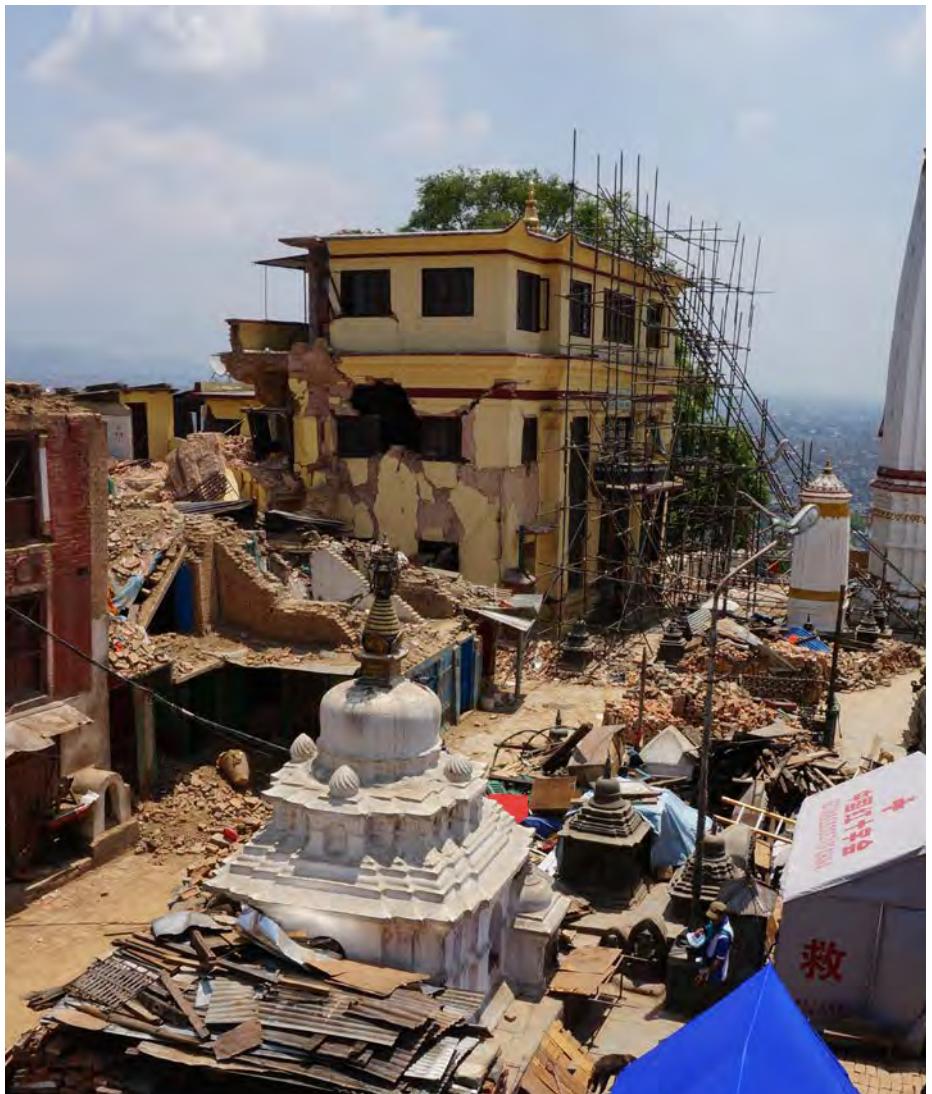
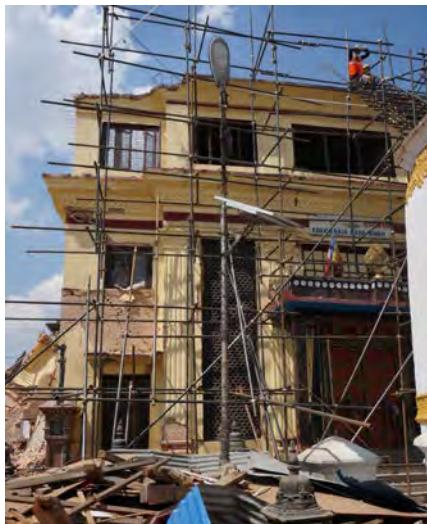
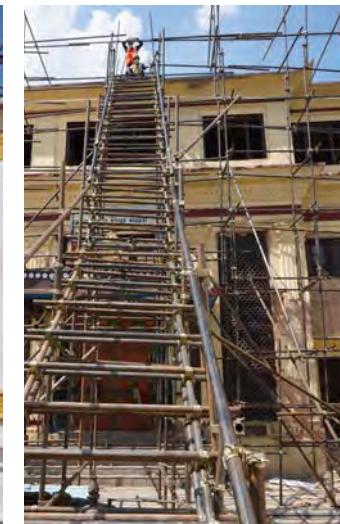
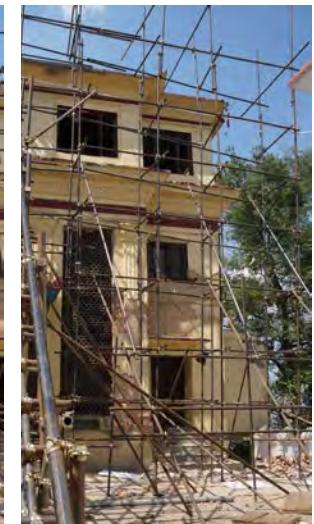
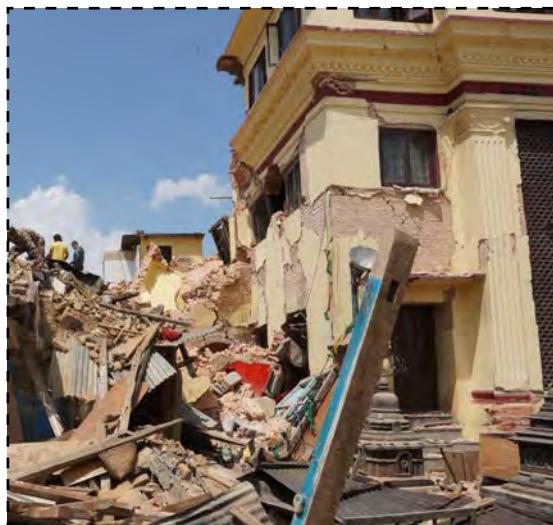
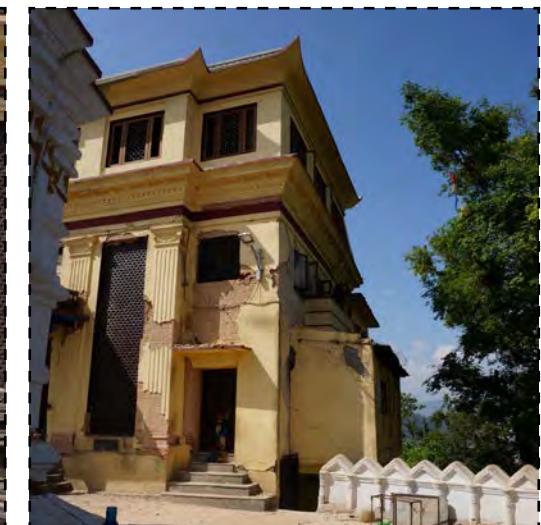
NUMBER NAME	DATE A.D.	TYPE OF MONUMENT HERITAGE SIGNIFICANCE	GENERAL DESCRIPTION	DESCRIPTION OF DAMAGE	DANGER DESTROY	PLAN 1/1000
14 (K-327) Karmaraj Gumba		Gumba	G+2(EL) Ground and 1st storey brick made 2nd storey concrete made Big Buddha statue is established and big Buddhist wheel	N-W and N-E corner is half collapsed Over weight due to over elevation S-E corner with diagonal cracks	1/2

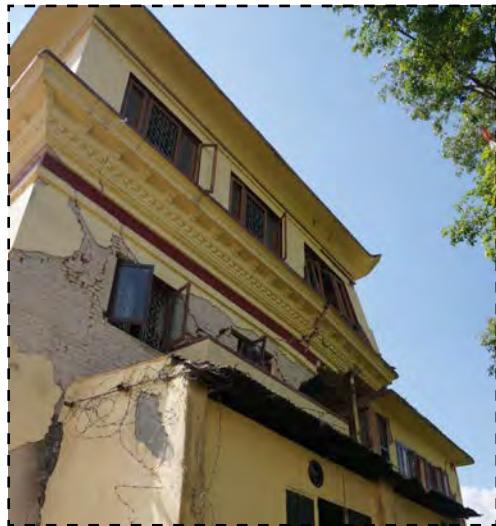
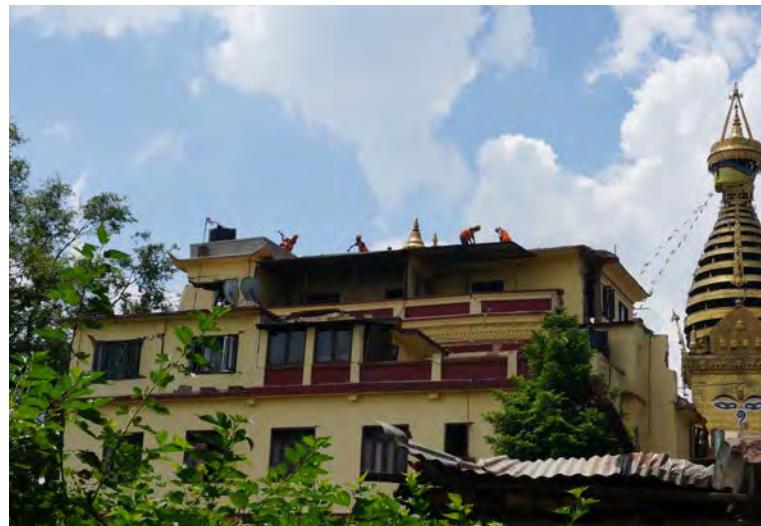
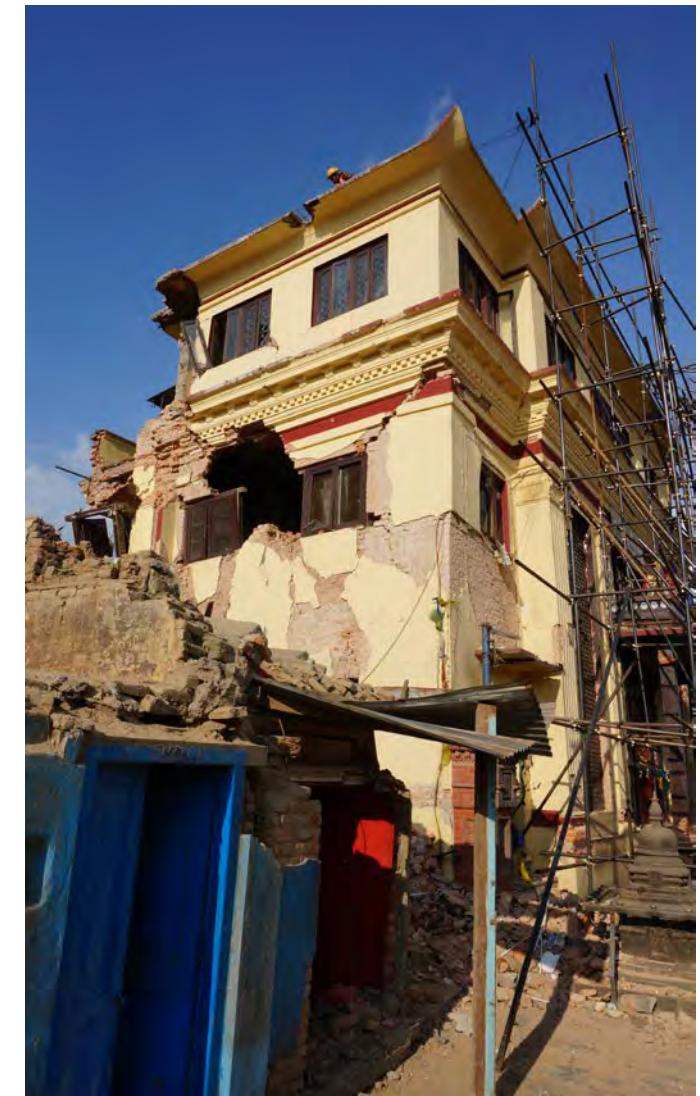
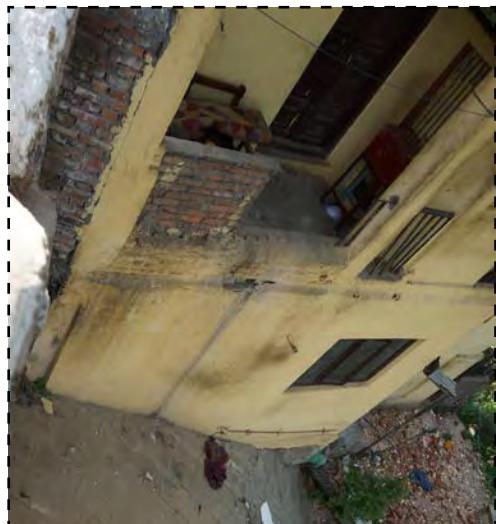
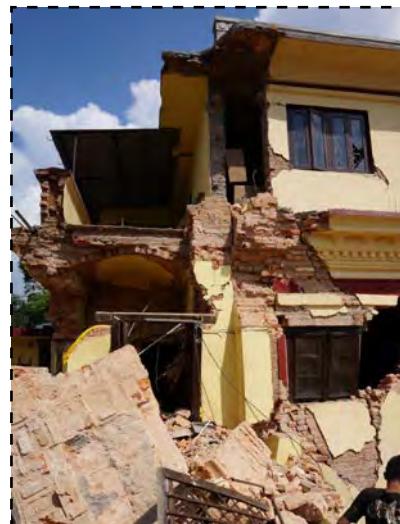
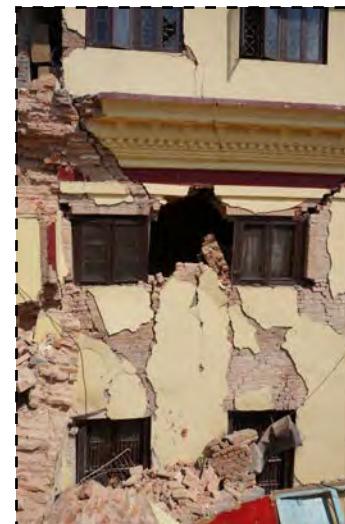
NUMBER NAME	DATE A.D.	TYPE OF MONUMENT HERITAGE SIGNIFICANCE	GENERAL DESCRIPTION	DESCRIPTION OF DAMAGE	DANGER DESTROY	N ↑	PLAN 1/1000
14 (K-327) Karmaraj Gumba		Gumba	G+2(EL) Ground and 1st storey brick made 2nd storey concrete made Big Buddha statue is established and big Buddhist wheel	N-W and N-E corner is half collapsed Over weight due to over elevation S-E corner with diagonal cracks	1/2 X

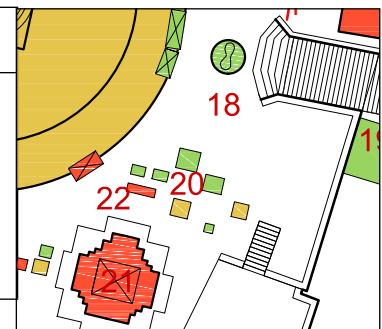
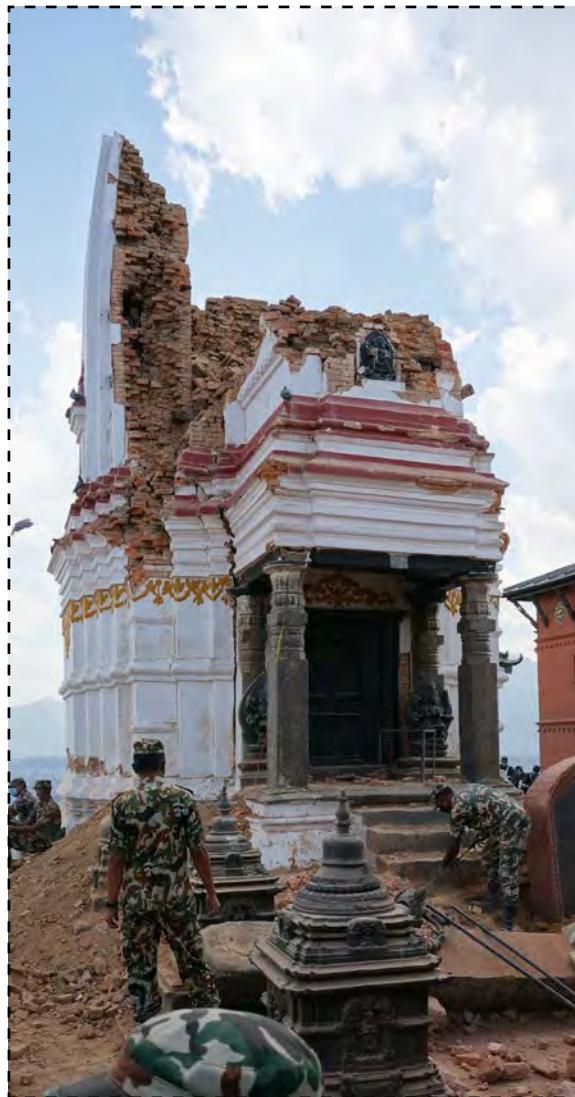
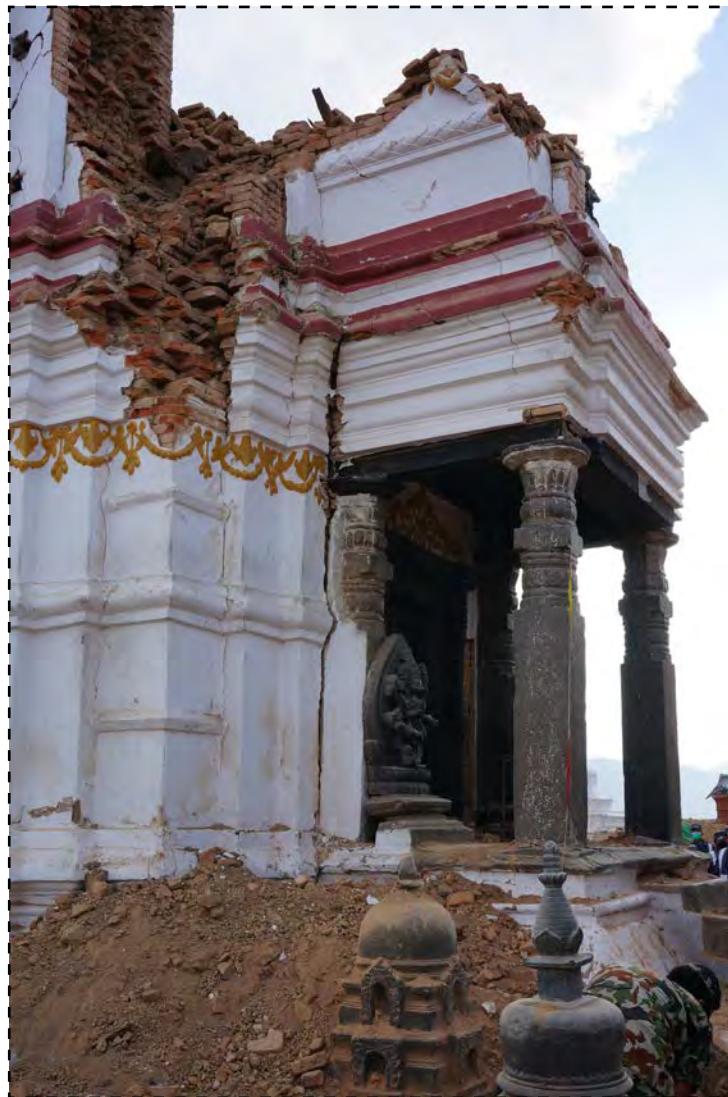
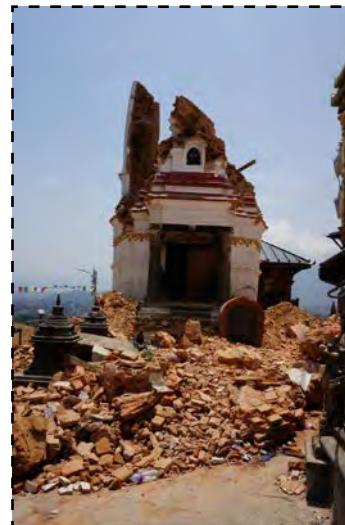
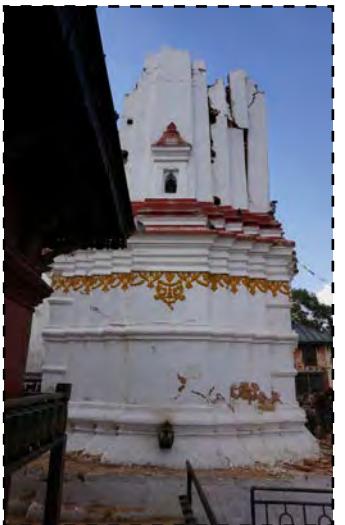
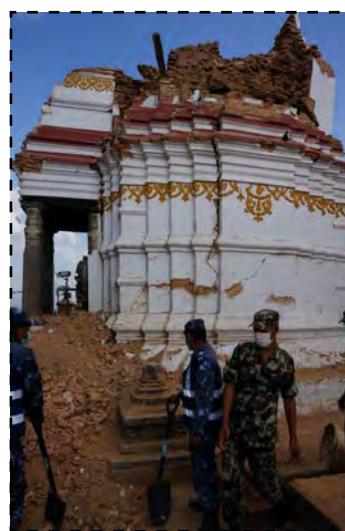
NUMBER NAME	DATE A.D.	TYPE OF MONUMENT HERITAGE SIGNIFICANCE	GENERAL DESCRIPTION	DESCRIPTION OF DAMAGE	DANGER DESTROY	N
21 (K-329) Anantapur Temple		Granthakut style	Brick, lime and stone structure approx. 15 m tall	Upper part collapsed Pillars and door are tilted	1/2

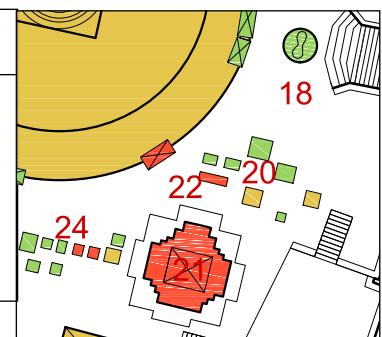
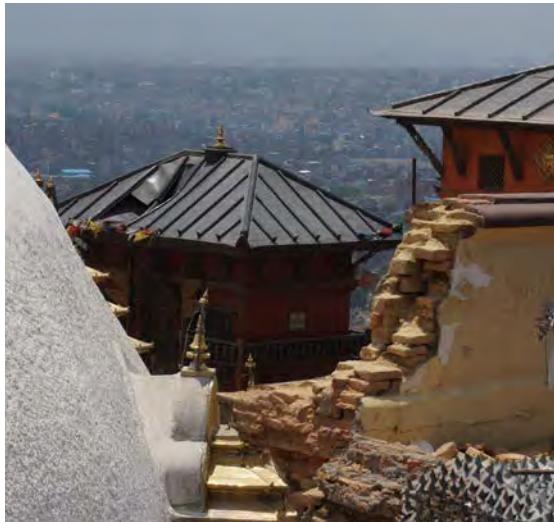
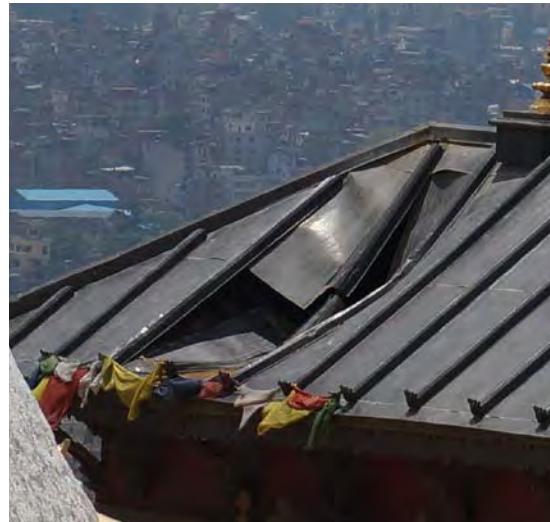
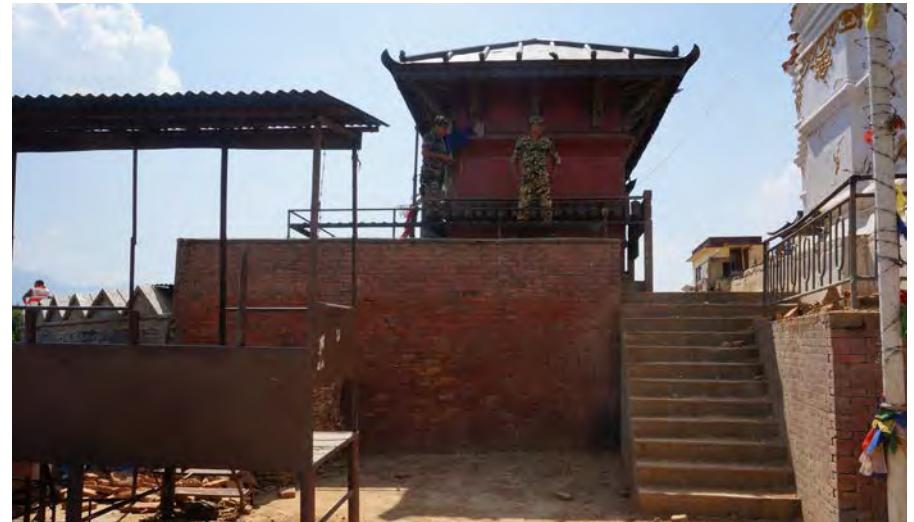
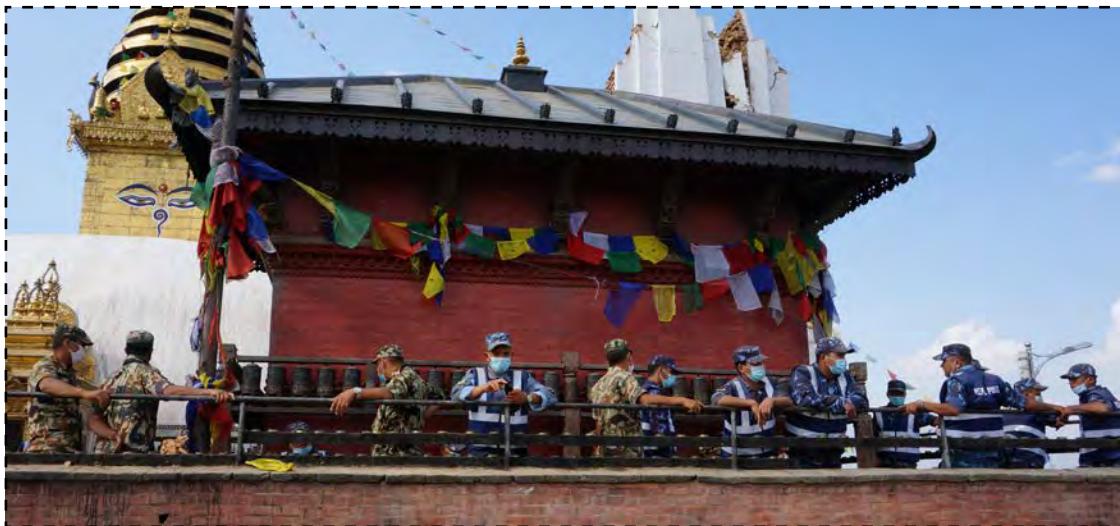
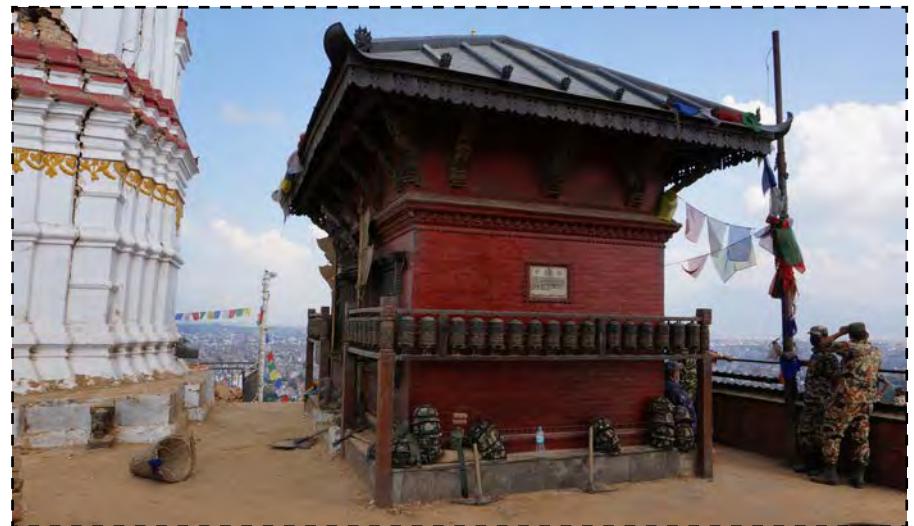
NUMBER NAME	DATE A.D.	TYPE OF MONUMENT HERITAGE SIGNIFICANCE	GENERAL DESCRIPTION	DESCRIPTION OF DAMAGE	DANGER DESTROY	N ↑
22 Big bell		Bell	Stone and metal structure	Stone support frame collapsed Bell not damaged

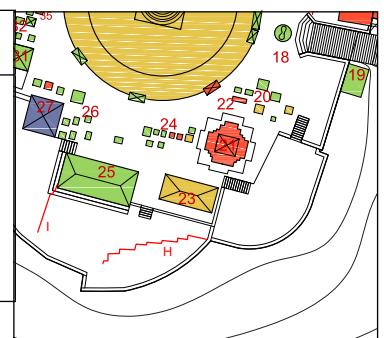
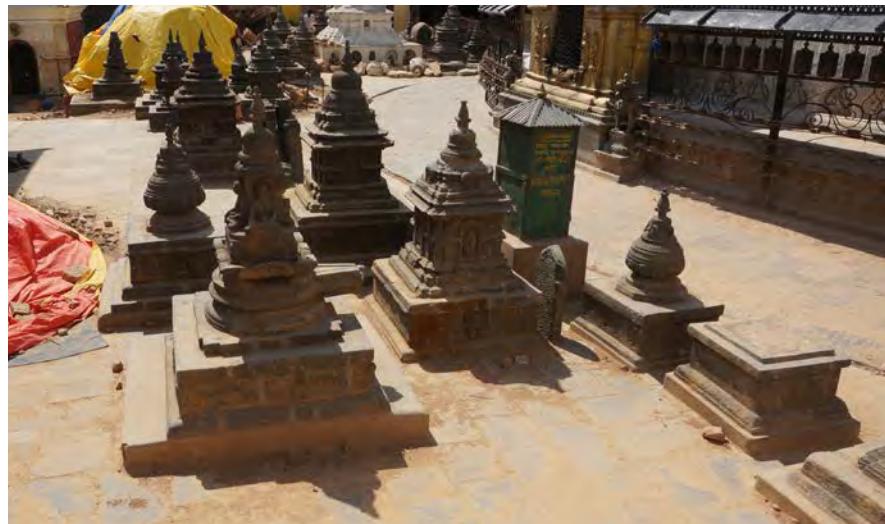
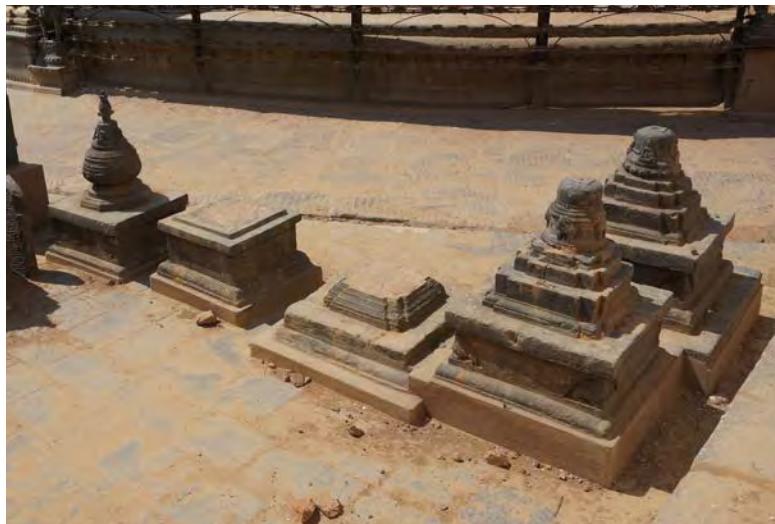
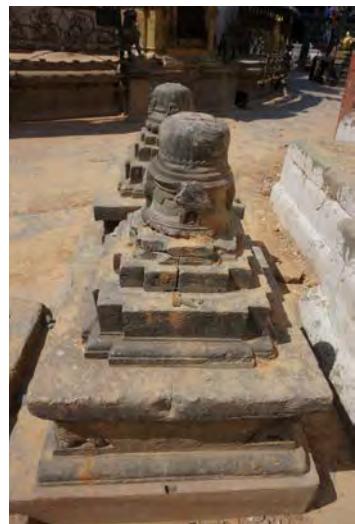
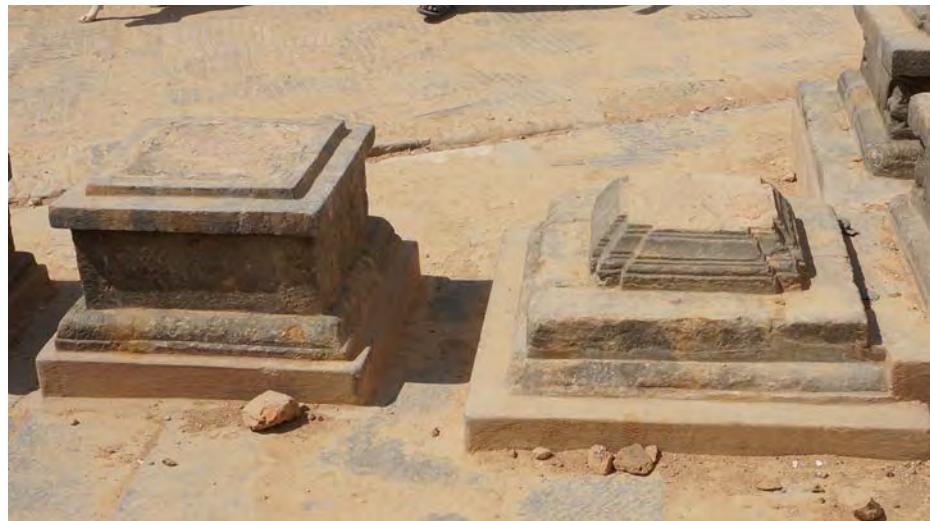
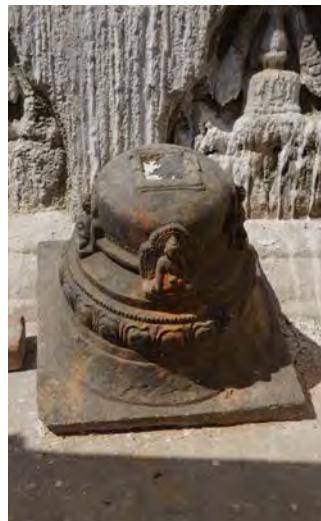
NUMBER NAME	DATE A.D.	TYPE OF MONUMENT HERITAGE SIGNIFICANCE	GENERAL DESCRIPTION	DESCRIPTION OF DAMAGE	DANGER DESTROY	PLAN 1/1000
23 Basundhara Temple		Temple	Single storey brick made temple with metal roof and wooden supports and gajur.	Roof was partly damaged by falling parts of temple no 9 Need repair of roof to prevent water damage
