2015 Earthquake Damage Mapping

Swayambhu Monument Zone
Kathmandu Valley World Heritage Property

Submitted to UNESCO by

June 2015

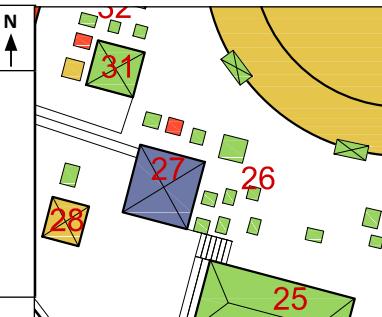
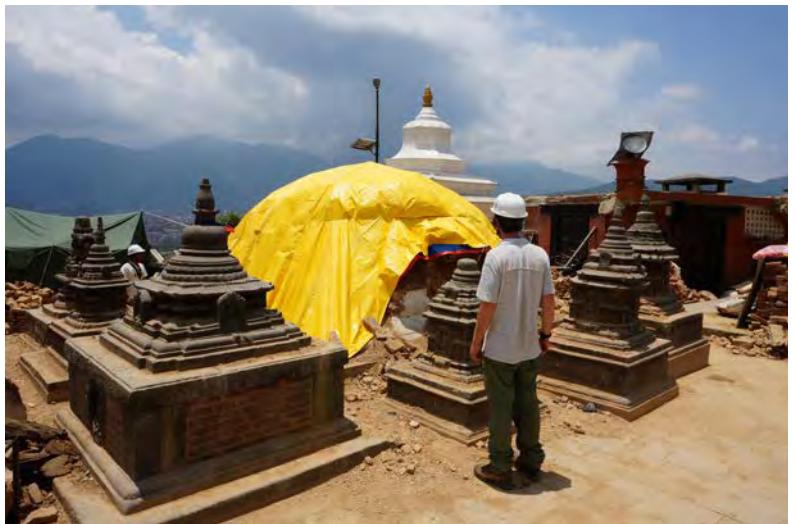
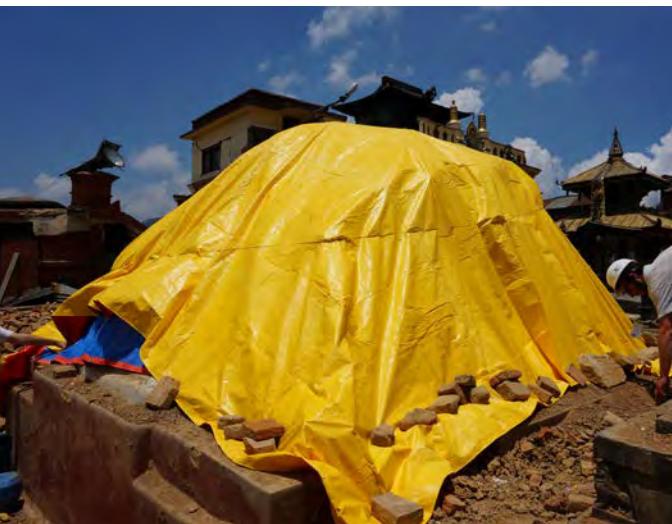
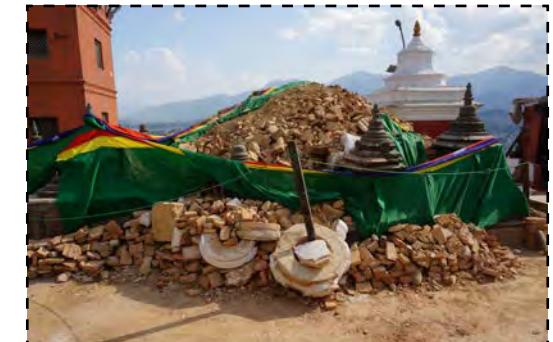
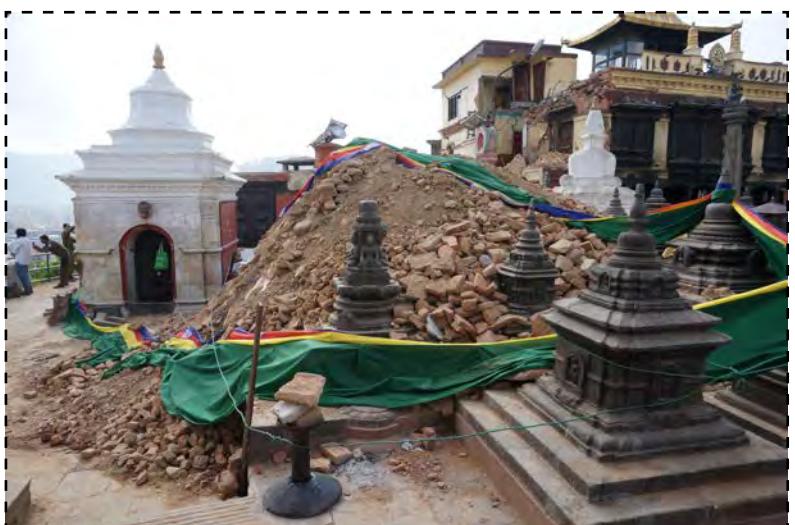
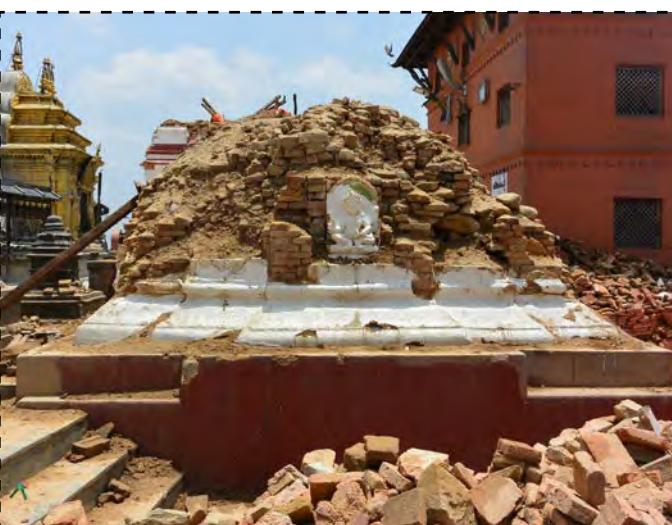
NUMBER NAME	DATE A.D.	TYPE OF MONUMENT HERITAGE SIGNIFICANCE	GENERAL DESCRIPTION	DESCRIPTION OF DAMAGE	DANGER DESTROY	N ↑
26		Chaityas	Group of 10+ Chaityas Stone and brick	No visible damage except for second chaitya in front of temple no. 27

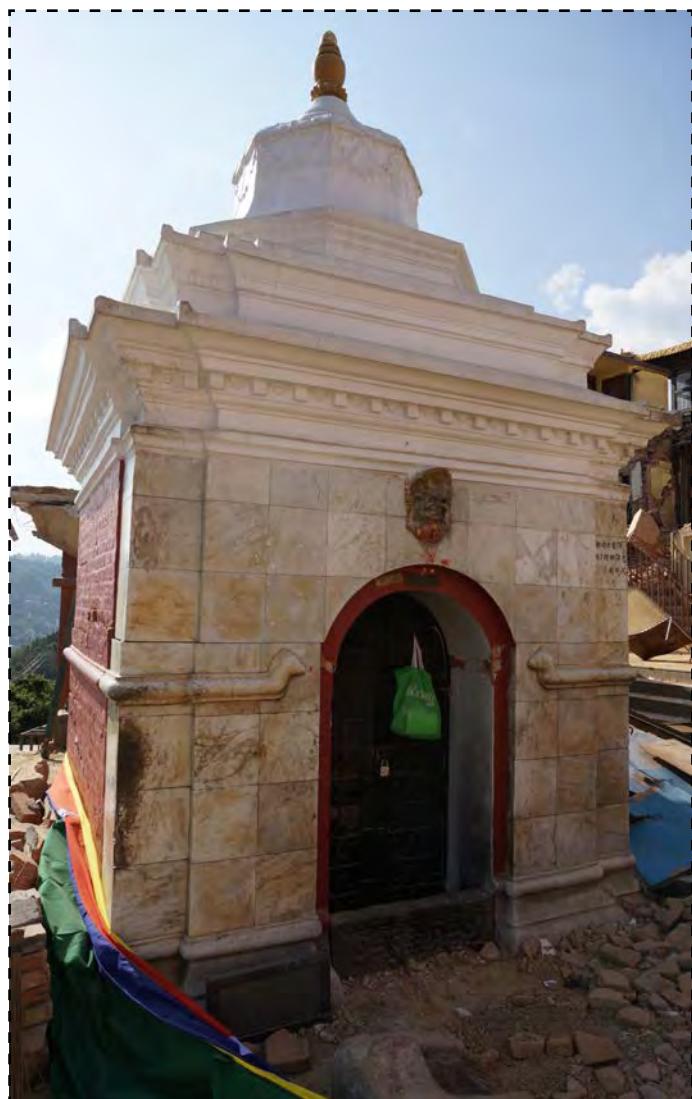
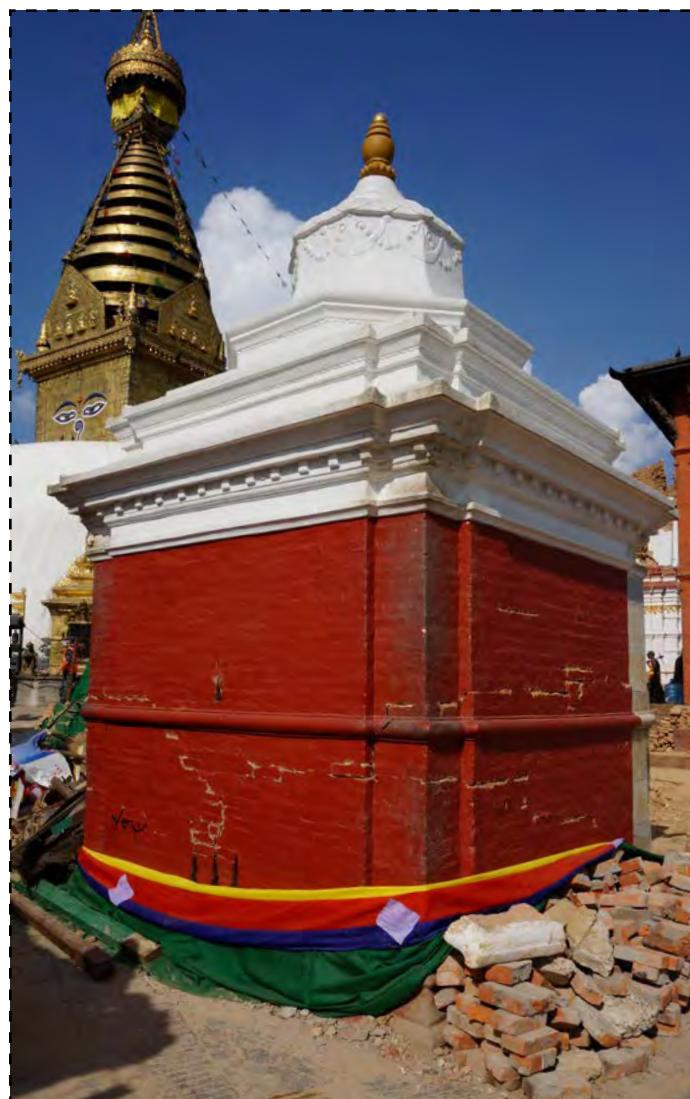
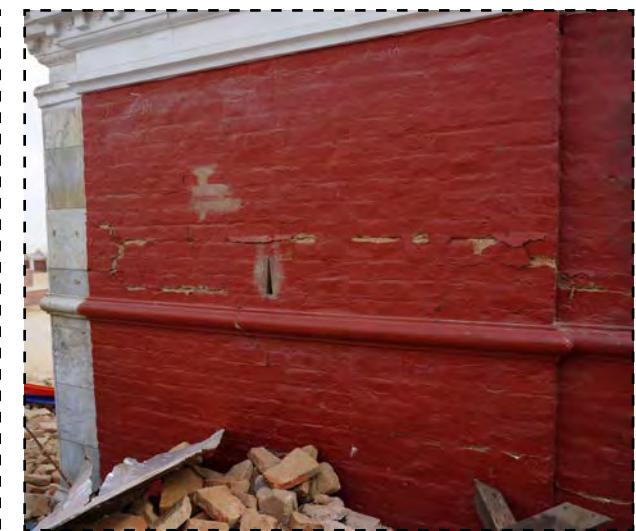
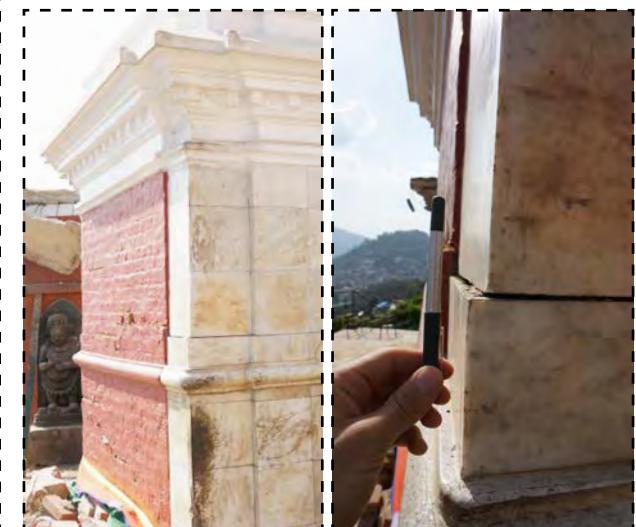
NUMBER NAME	DATE A.D.	TYPE OF MONUMENT HERITAGE SIGNIFICANCE	GENERAL DESCRIPTION	DESCRIPTION OF DAMAGE	DANGER DESTROY	N ↑
28		Enclosed shrine	Little Shivalaya with brick made walls and tile covering on all four sides Dome roof painted white	Horizontal cracks on all four sides Upper half part of temple is leaning towards N by about 1-2cm

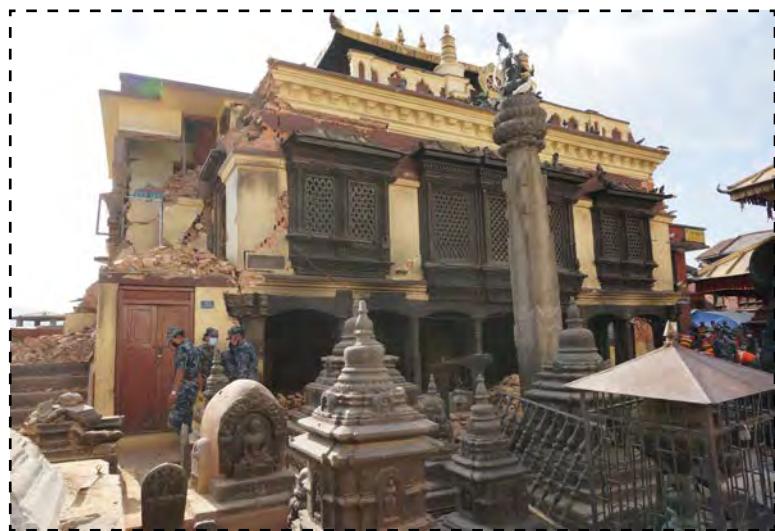
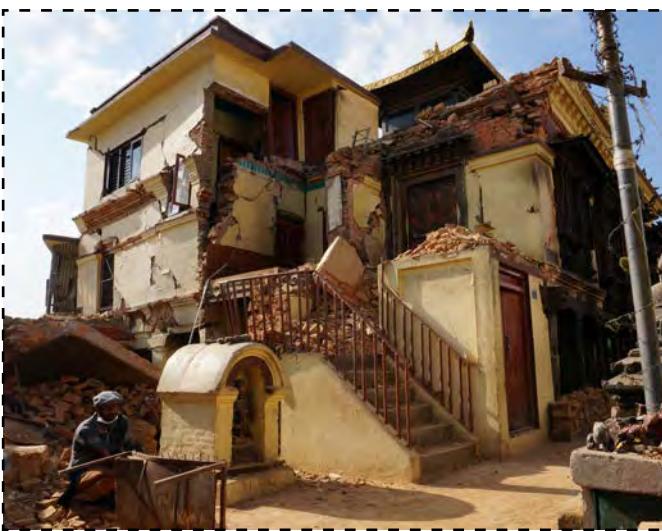
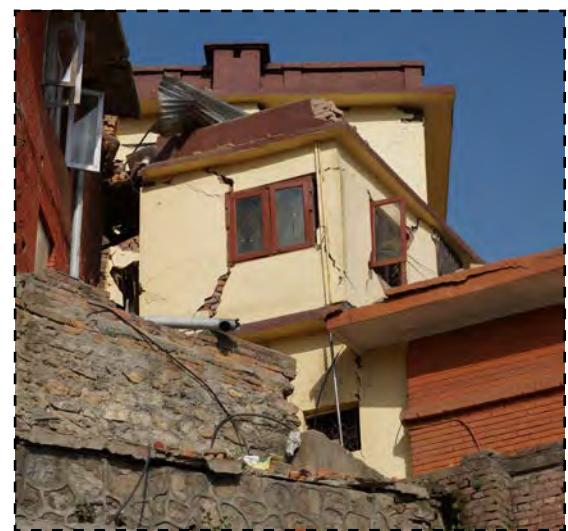
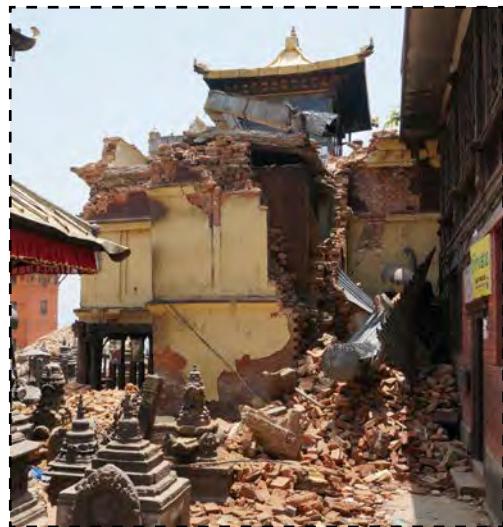
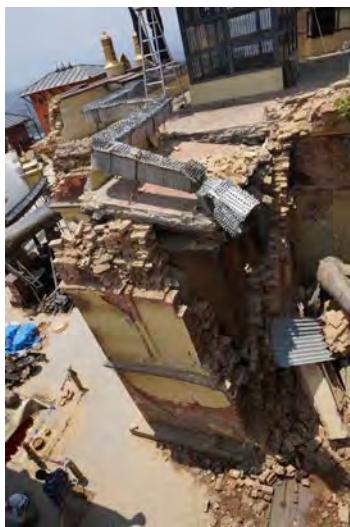
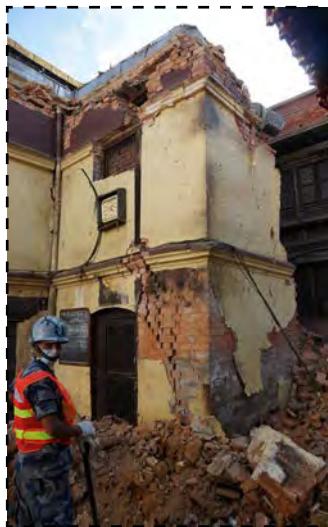
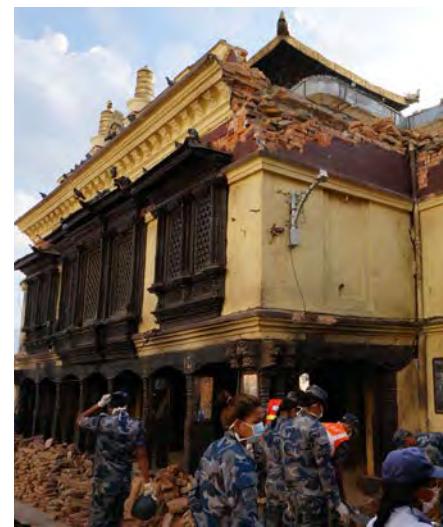
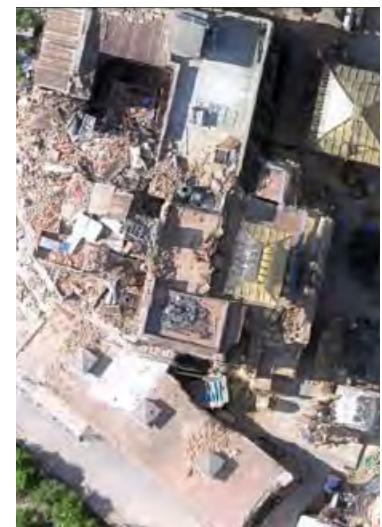
NUMBER NAME	DATE A.D.	TYPE OF MONUMENT HERITAGE SIGNIFICANCE	GENERAL DESCRIPTION	DESCRIPTION OF DAMAGE	DANGER DESTROY	N ↑
29		Museum	G+1, RCC structure and cantilevered slabs	Partially collapsed wall Cantilever part of slab is partly collapsed which caused some damage to the monuments

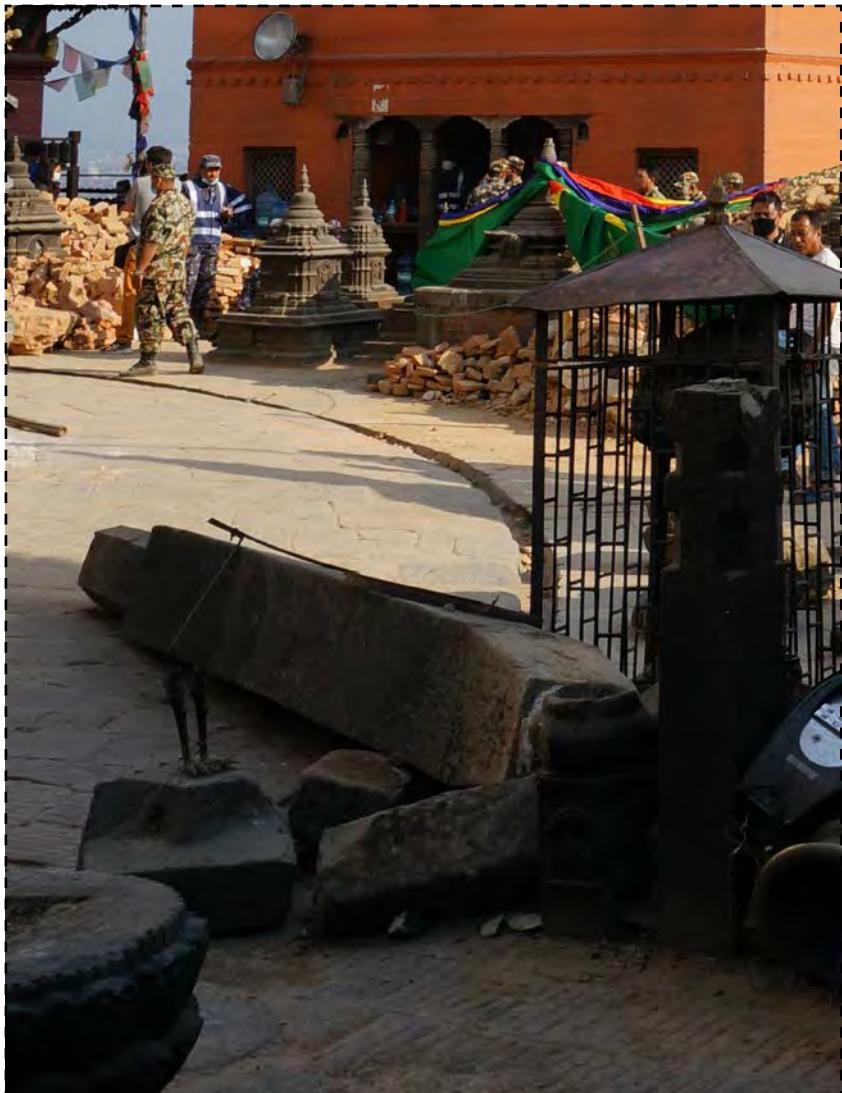
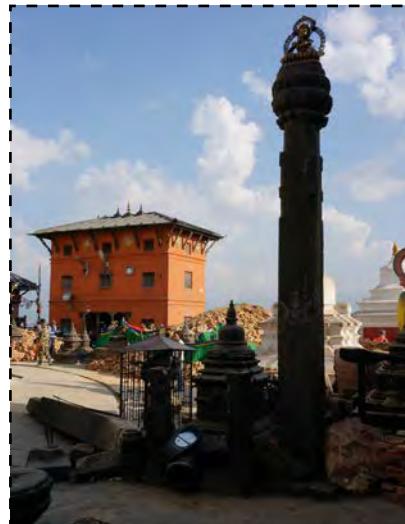
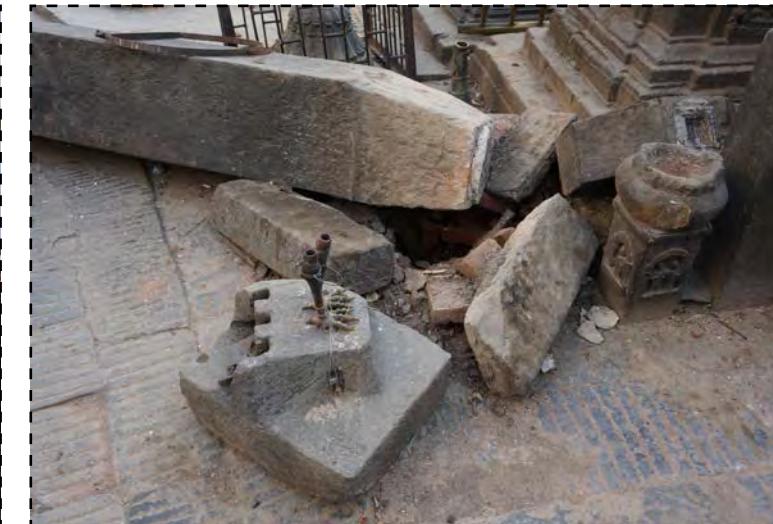
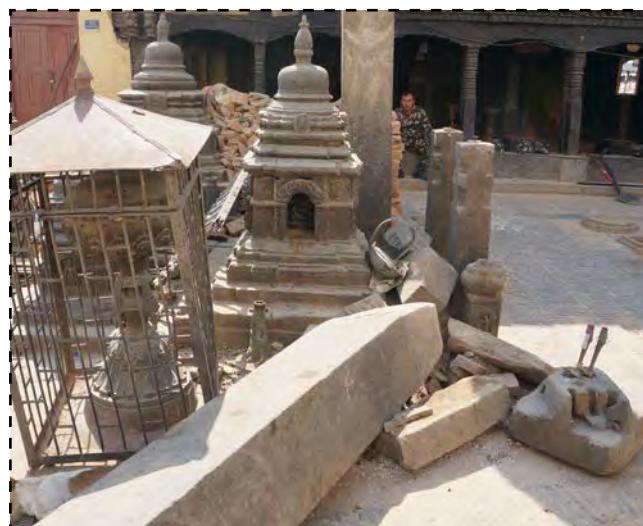
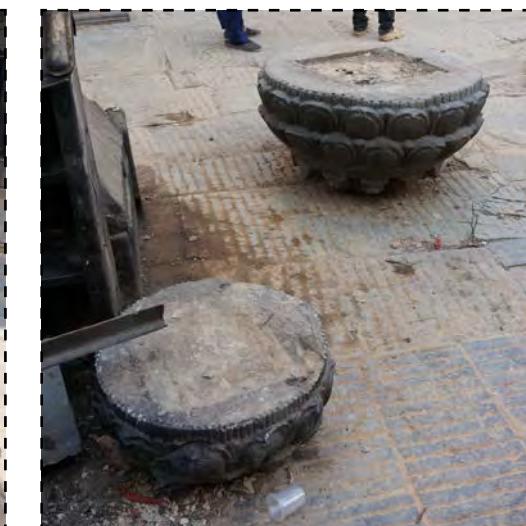
NUMBER NAME	DATE A.D.	TYPE OF MONUMENT HERITAGE SIGNIFICANCE	GENERAL DESCRIPTION	DESCRIPTION OF DAMAGE	DANGER DESTROY	N ↑
34		Bell	Big metal bell supported by tone frame Stone and metal Structure	Stone cross beam and bell collapsed

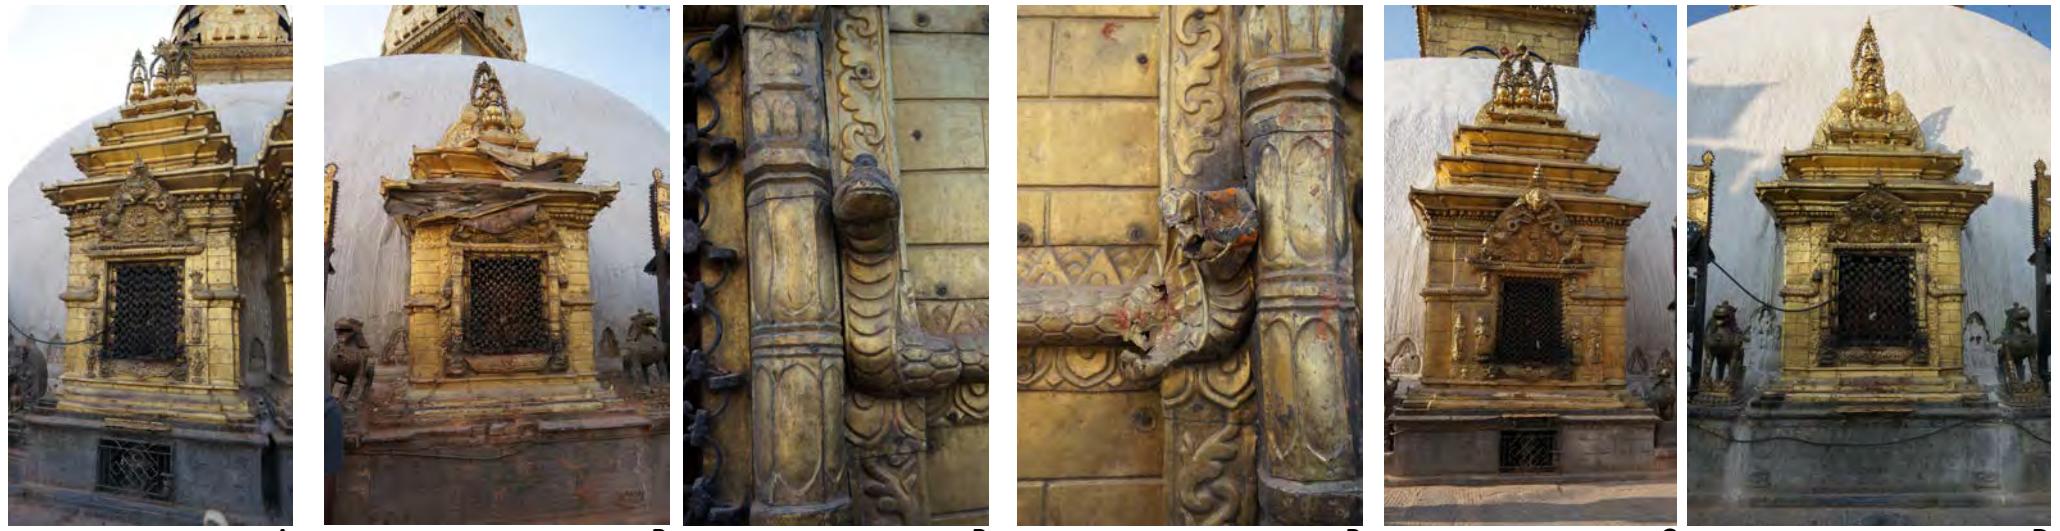
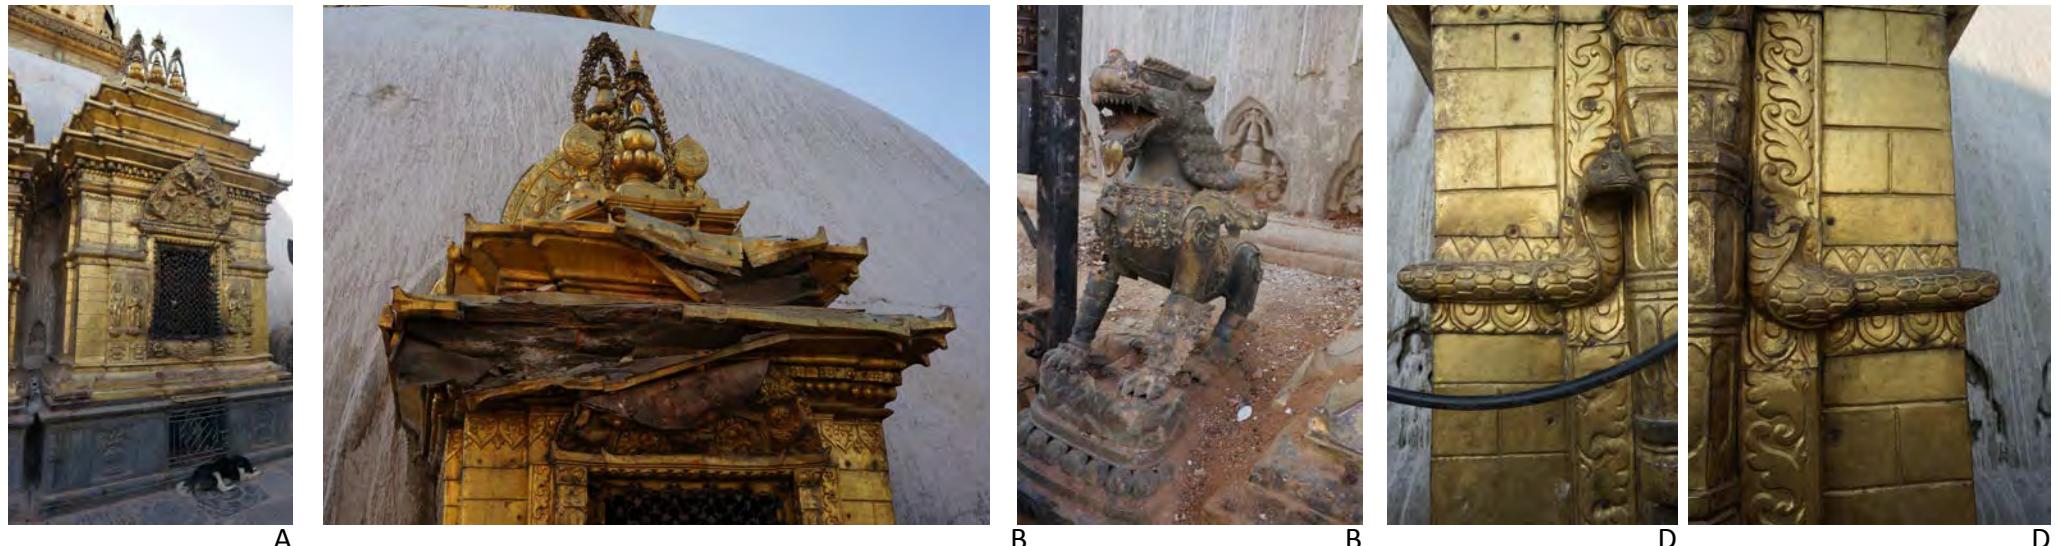
NUMBER NAME	DATE A.D.	TYPE OF MONUMENT HERITAGE SIGNIFICANCE	GENERAL DESCRIPTION	DESCRIPTION OF DAMAGE	DANGER DESTROY	N ↑
37 (K-322) Shyambhu Stupa		Stupa	Brick, stone, mud and lime made structure	No visible damage to shrines a, c, e, f and g Shrines b and d with some damages due to fallen parts from temple no. 9 Shrine h with damage on lower part of left lion

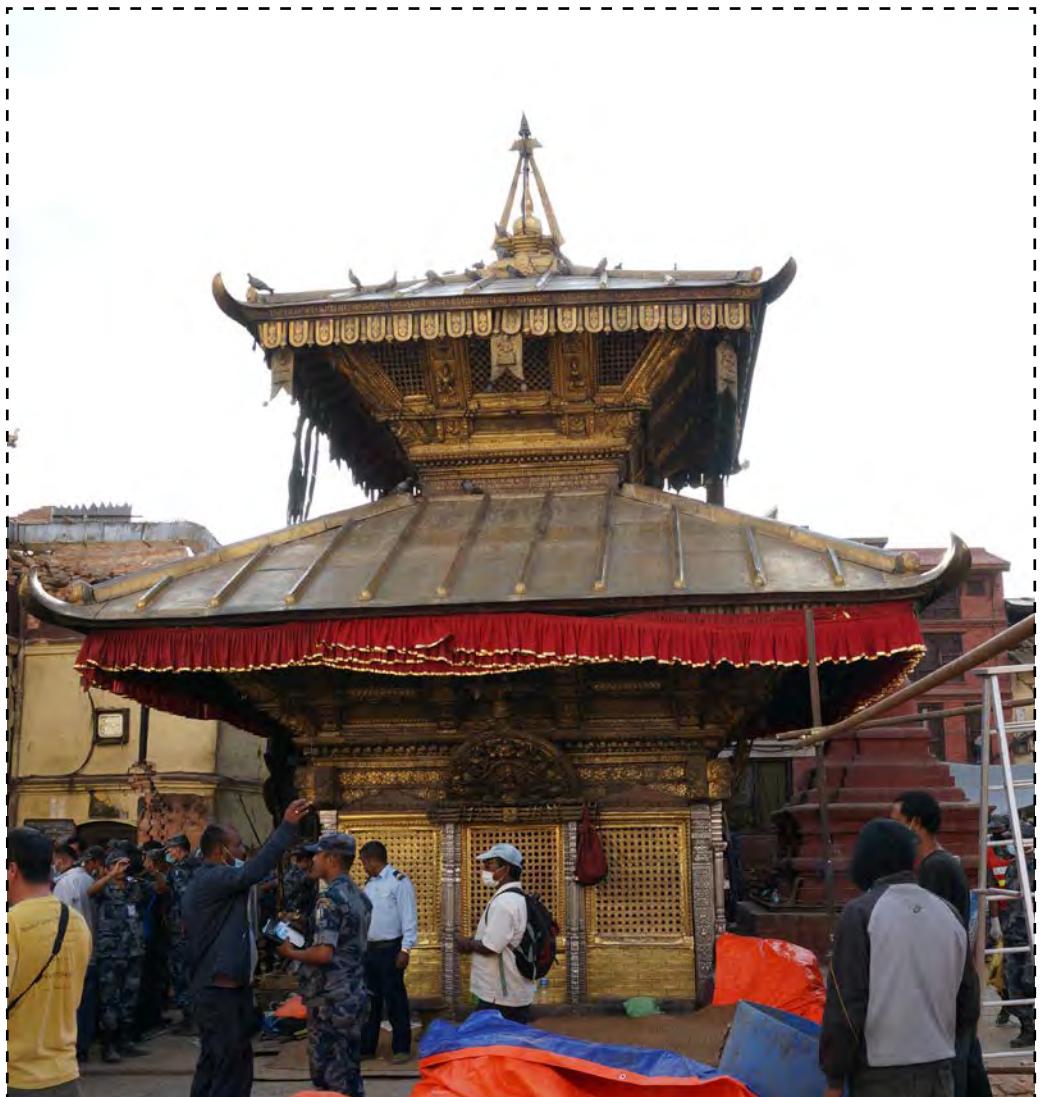
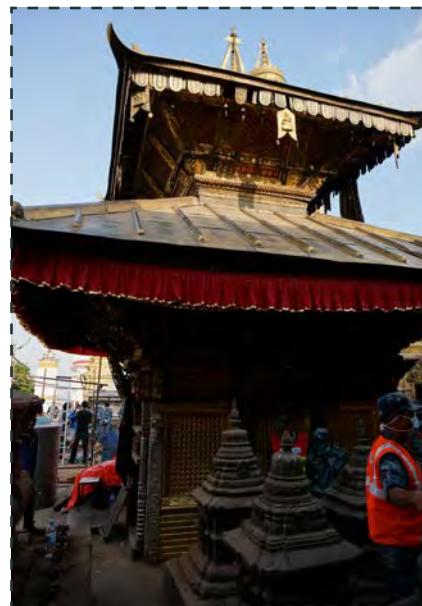
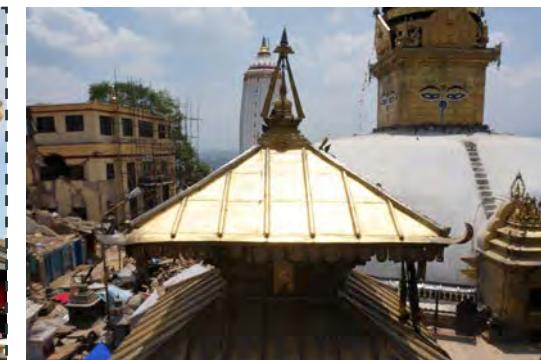
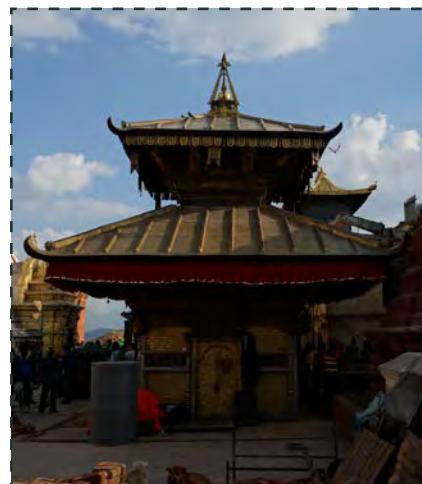
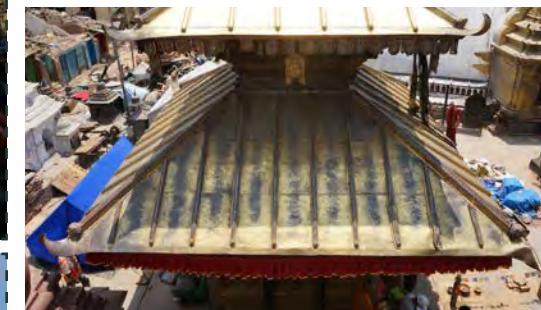
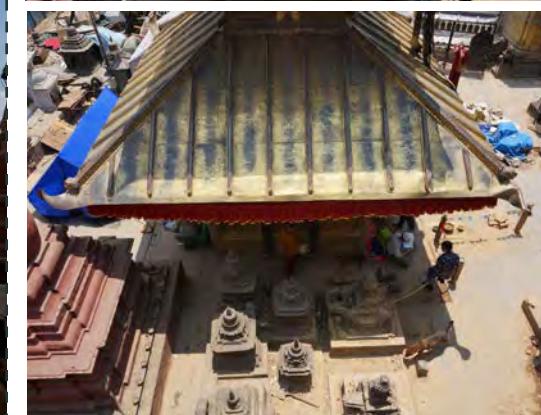
NUMBER NAME	DATE A.D.	TYPE OF MONUMENT HERITAGE SIGNIFICANCE	GENERAL DESCRIPTION	DESCRIPTION OF DAMAGE	DANGER DESTROY	N ↑
38 (K-325) Harati Ajima Temple		Two-tiered Pagoda style temple	Brick structure with wooden joist and tunals Gold plated metal roof and gajur	no apparent damage

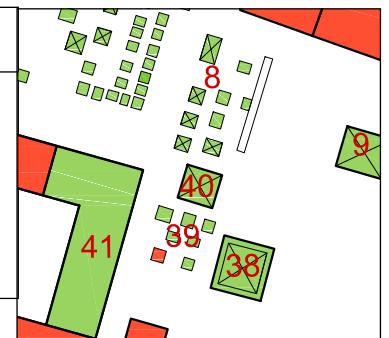
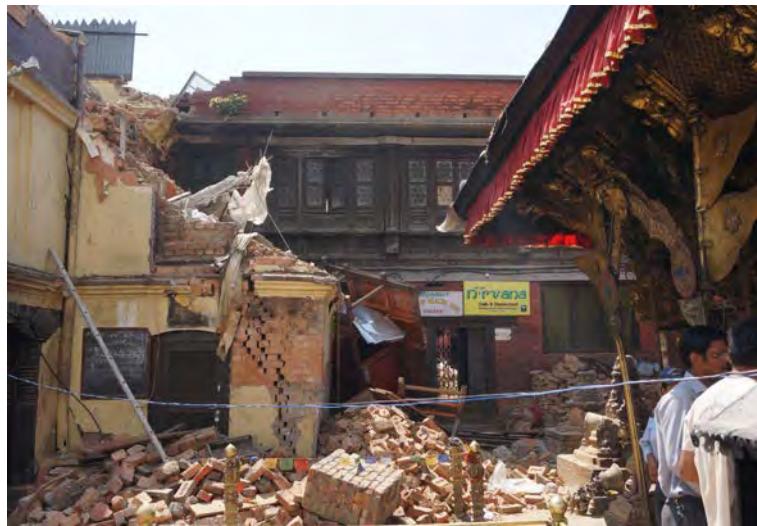
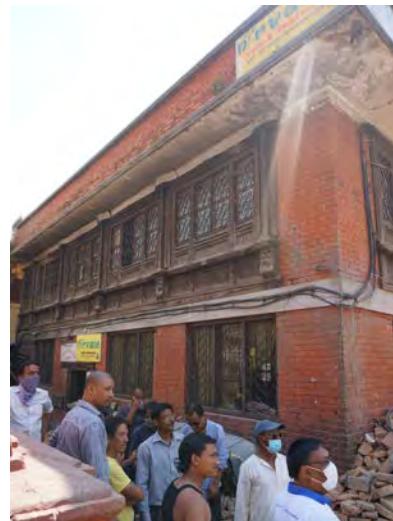
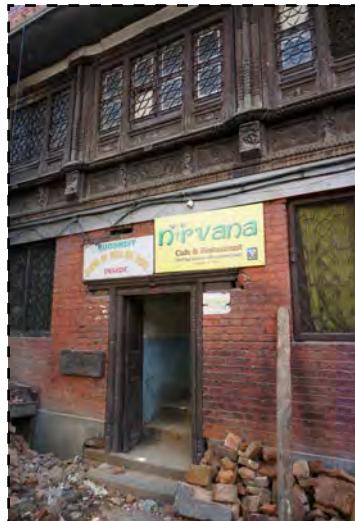
NUMBER NAME	DATE A.D.	TYPE OF MONUMENT HERITAGE SIGNIFICANCE	GENERAL DESCRIPTION	DESCRIPTION OF DAMAGE	DANGER DESTROY	N ↑
40		Stupa	Brick and lime made stupa	No visible damage

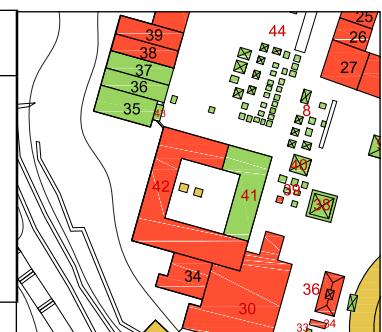
NUMBER NAME	DATE A.D.	TYPE OF MONUMENT HERITAGE SIGNIFICANCE	GENERAL DESCRIPTION	DESCRIPTION OF DAMAGE	DANGER DESTROY	N ↑
41 Singu Bahal		Bahal	G+1 Right corner and entry portion of the bahal Concrete and brick structure	No visible damage

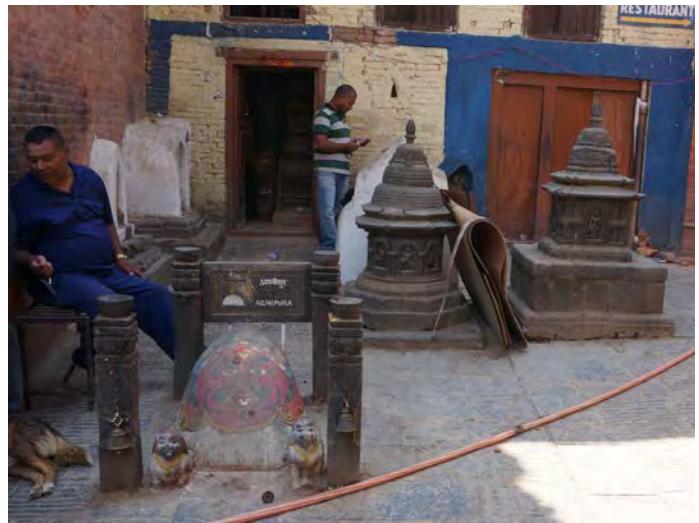
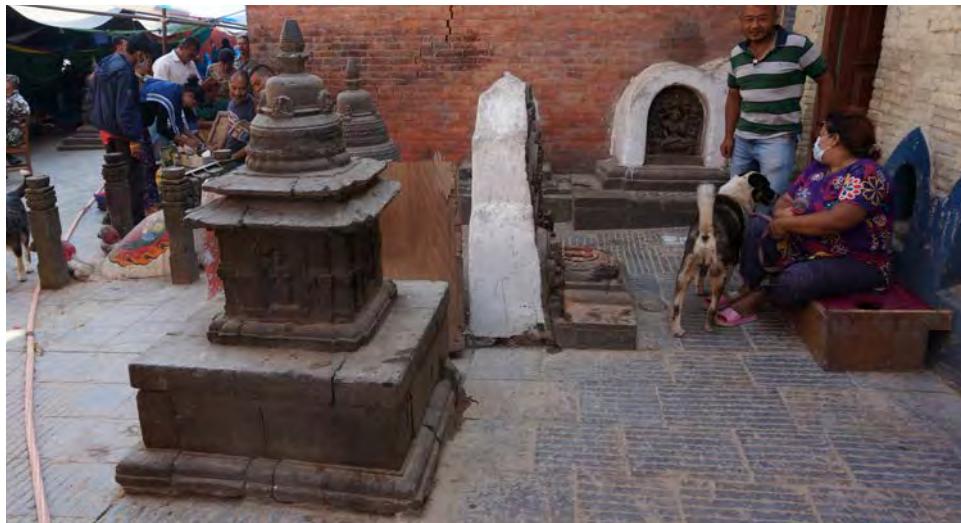
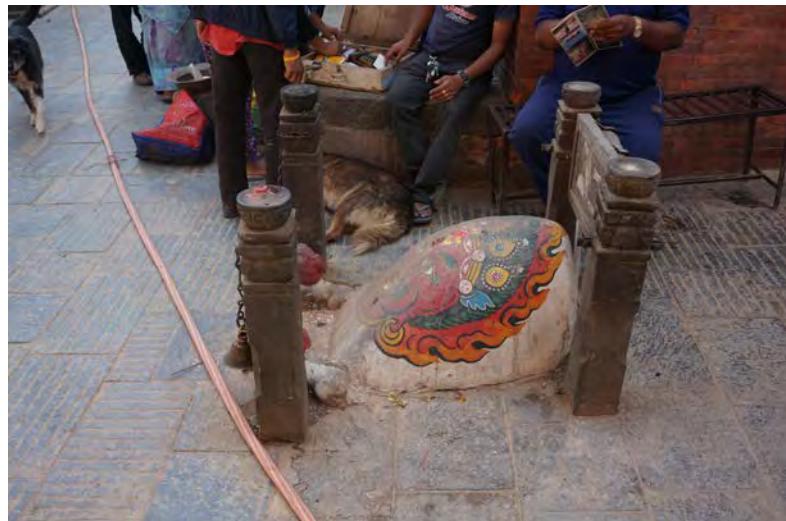
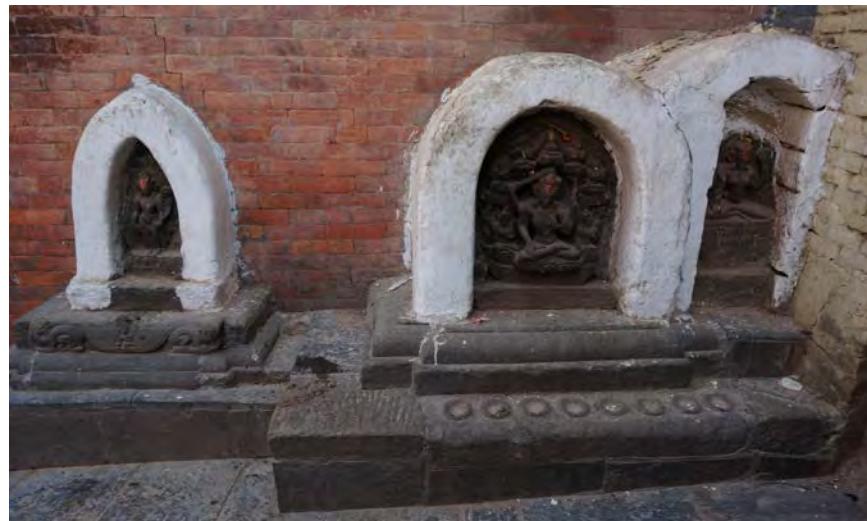
NUMBER NAME	DATE A.D.	TYPE OF MONUMENT HERITAGE SIGNIFICANCE	GENERAL DESCRIPTION	DESCRIPTION OF DAMAGE	DANGER DESTROY	N ↑
44		Chaityas	Group of Chaityas (about or more than 30) Stone and Brick structure	No visible damage

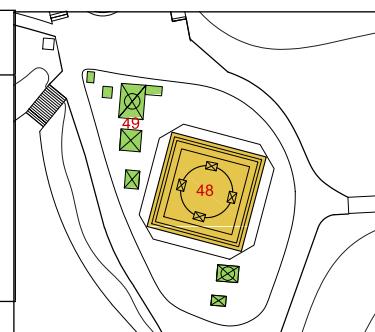
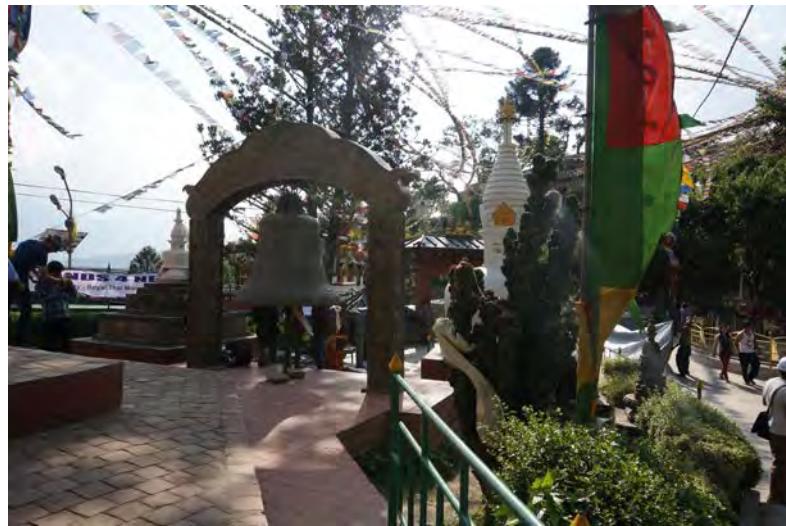
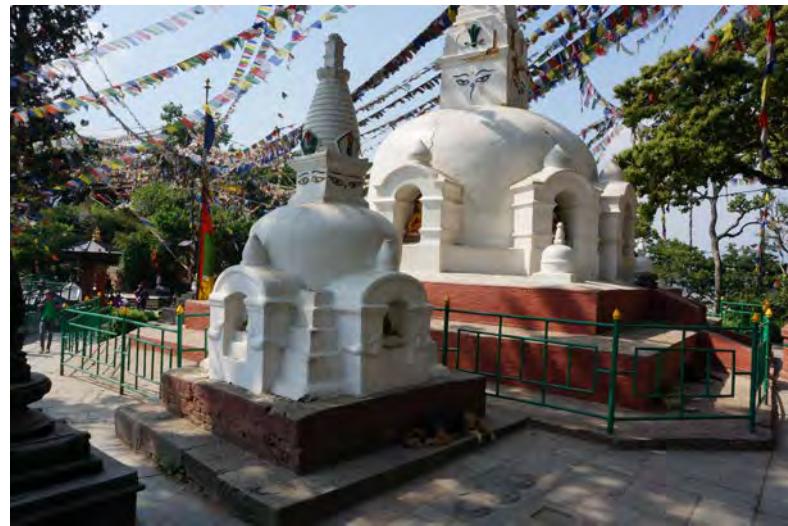
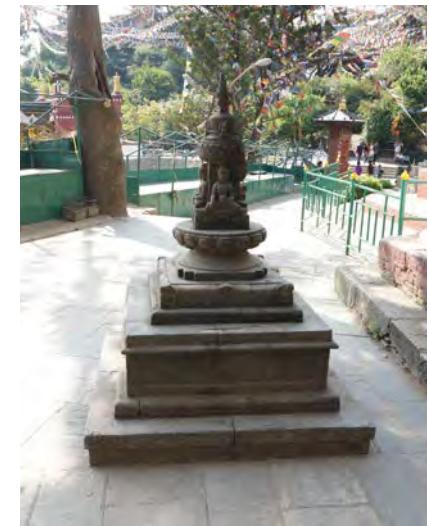
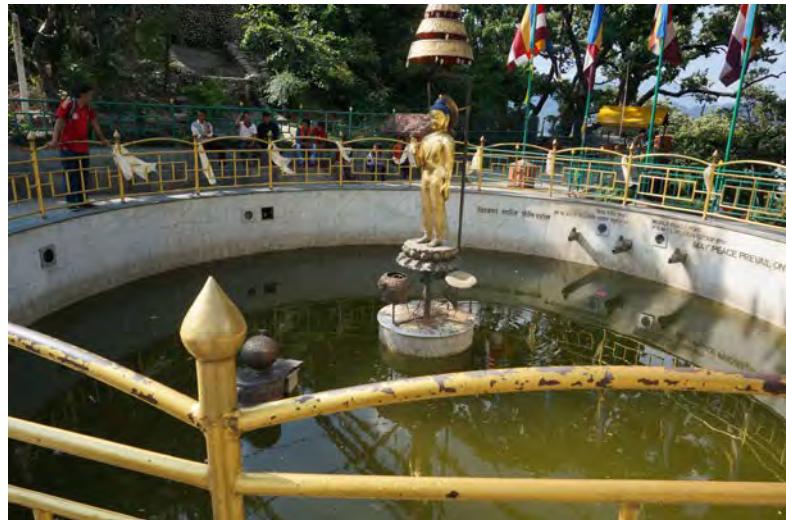
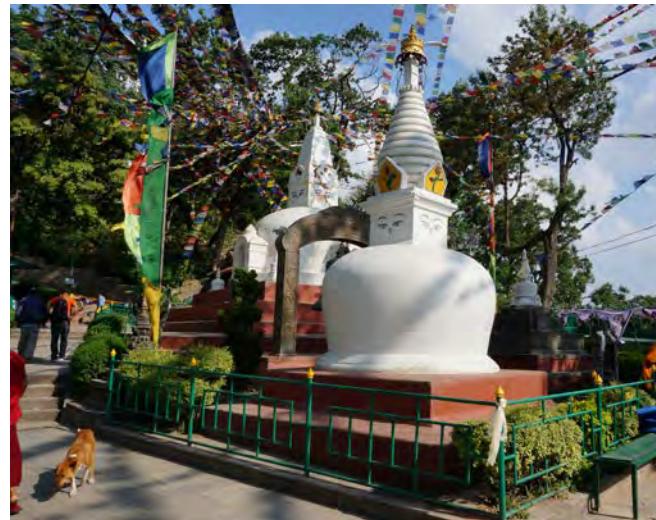
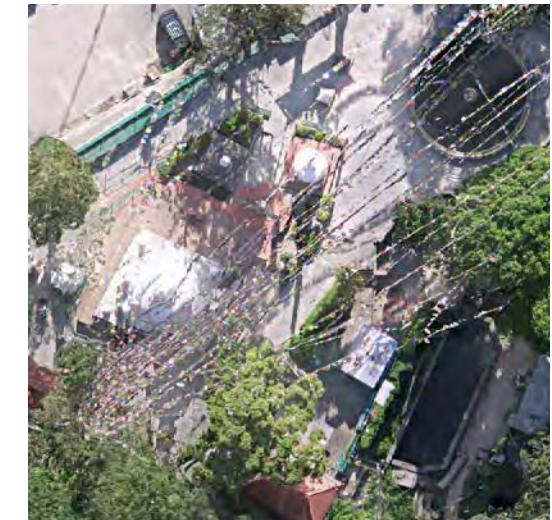
NUMBER NAME	DATE A.D.	TYPE OF MONUMENT HERITAGE SIGNIFICANCE	GENERAL DESCRIPTION	DESCRIPTION OF DAMAGE	DANGER DESTROY	N ↑
48		Stupa	Brick and lime made stupa. Stone statues which were initially used in main Swayambhu were brought down and installed in this stupa.	Vertical and diagonal stepped cracks at the upper parts. Vertical cracks on the dome

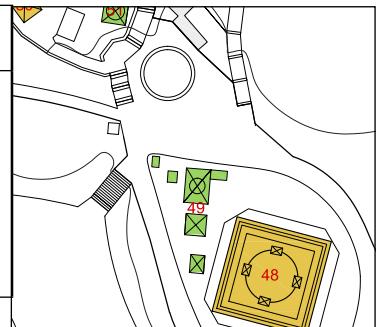
NUMBER NAME	DATE A.D.	TYPE OF MONUMENT HERITAGE SIGNIFICANCE	GENERAL DESCRIPTION	DESCRIPTION OF DAMAGE	DANGER DESTROY	N ↑
49		Stupa, bell and water fountain	Stupa, bell and water fountain	No visible damage

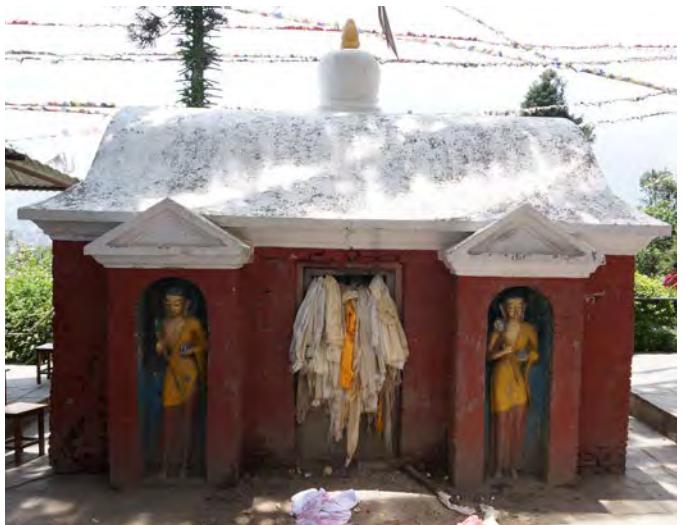
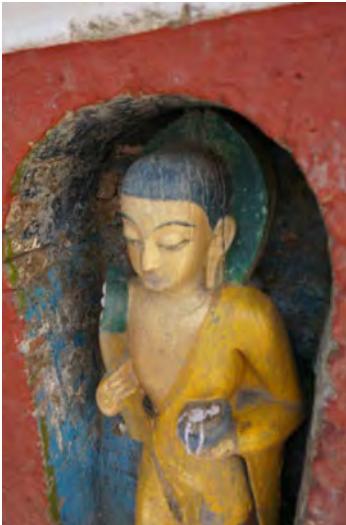
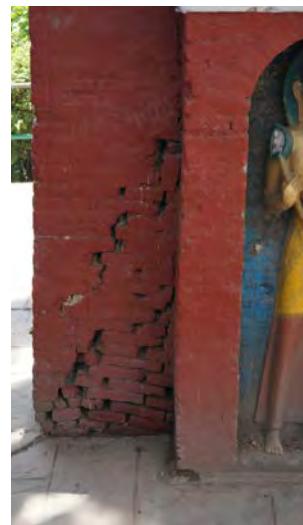
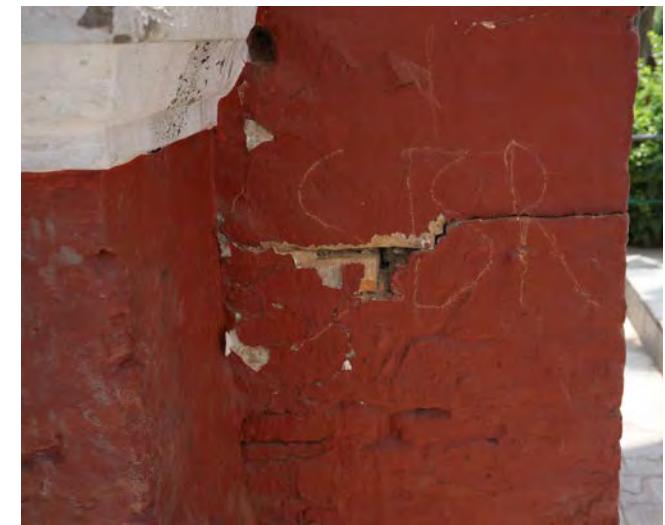
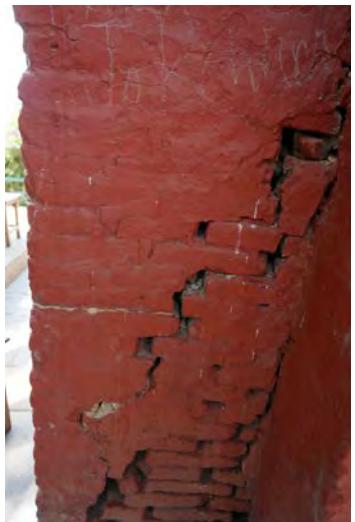
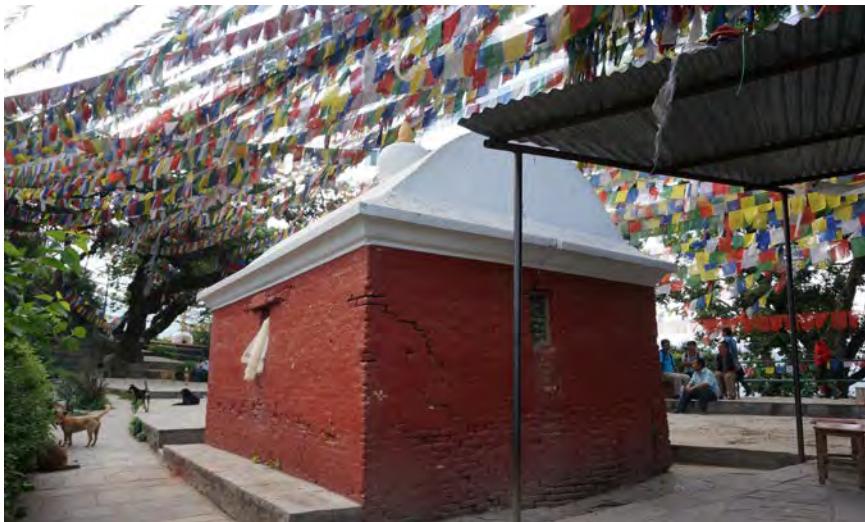
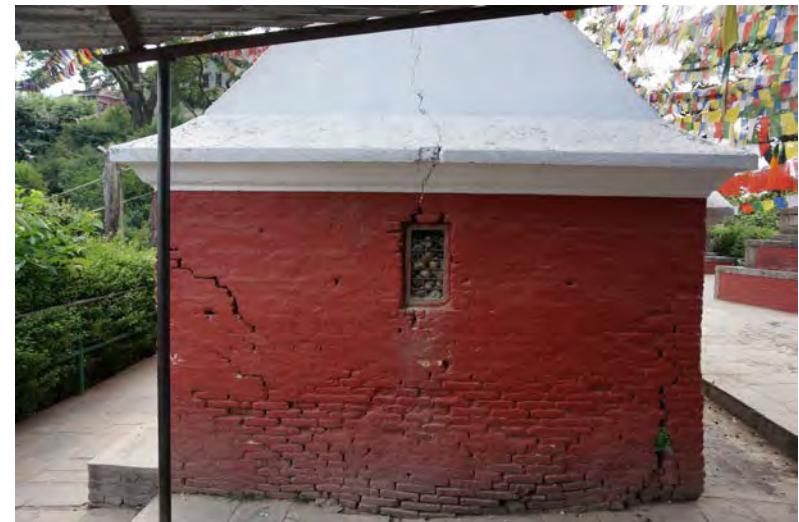
NUMBER NAME	DATE A.D.	TYPE OF MONUMENT HERITAGE SIGNIFICANCE	GENERAL DESCRIPTION	DESCRIPTION OF DAMAGE	DANGER DESTROY	N ↑
50/ Aaustu House		Public Place	Brick made small house where people store little mud made stupas and stone for their dead relatives	Roof with vertical cracks in near gable wall Protection from rain water is necessary to protect little stupas stored N wall corner with cracks and small settlement W wall with diagonal cracks

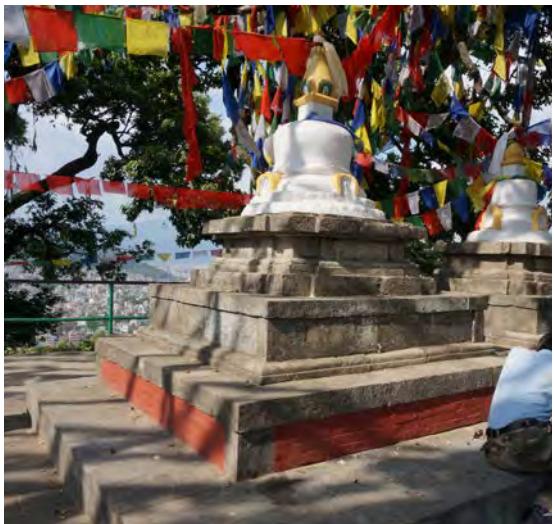
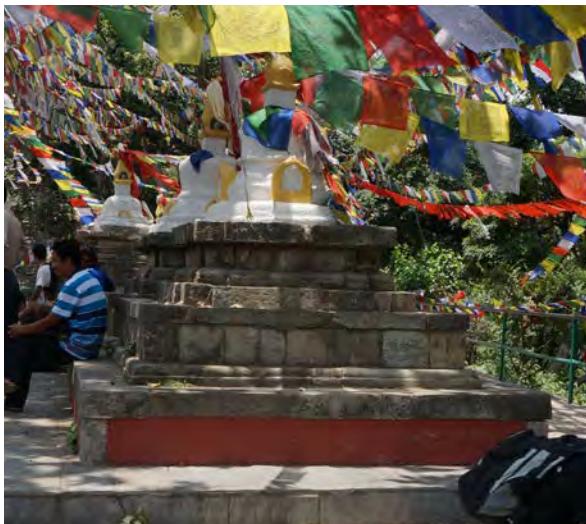
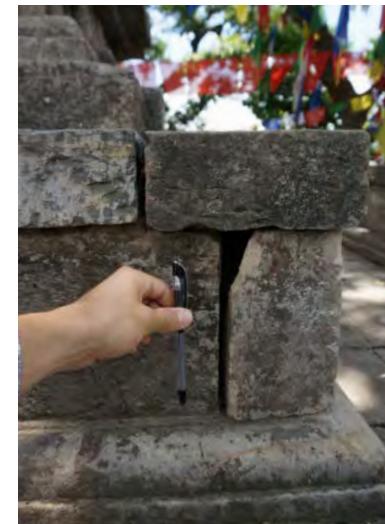
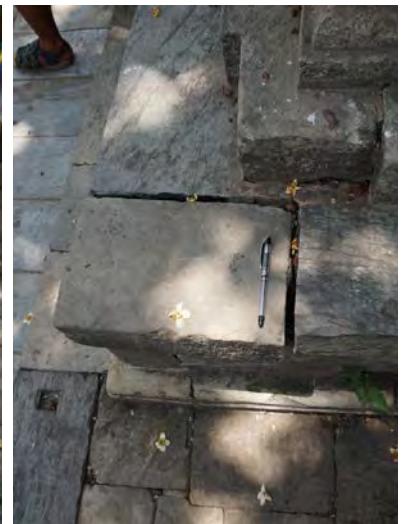
NUMBER NAME	DATE A.D.	TYPE OF MONUMENT HERITAGE SIGNIFICANCE	GENERAL DESCRIPTION	DESCRIPTION OF DAMAGE	DANGER DESTROY	N ↑
54			54-55) Stone made Chaitya 56) Two Chaityas constructed on same base Stone made Chaitya	54: some cracks at the corner of the second step of the basement 55: No visible damage 56: Minor cracks at upper parts		
55						
56

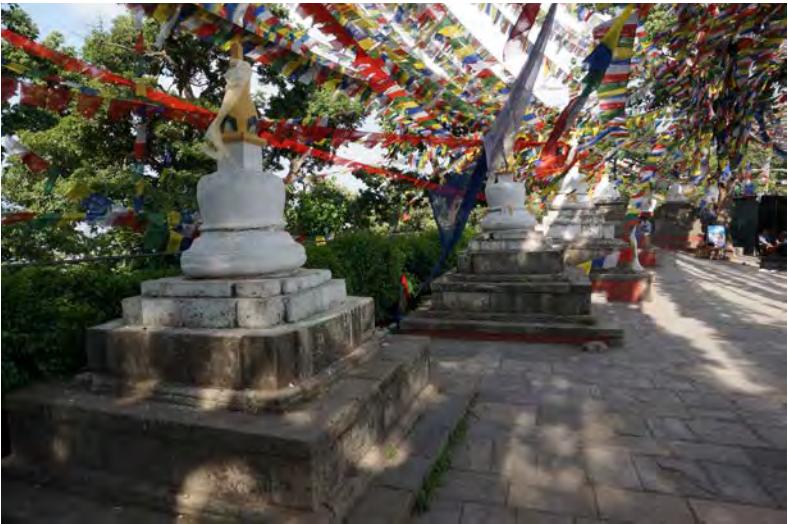
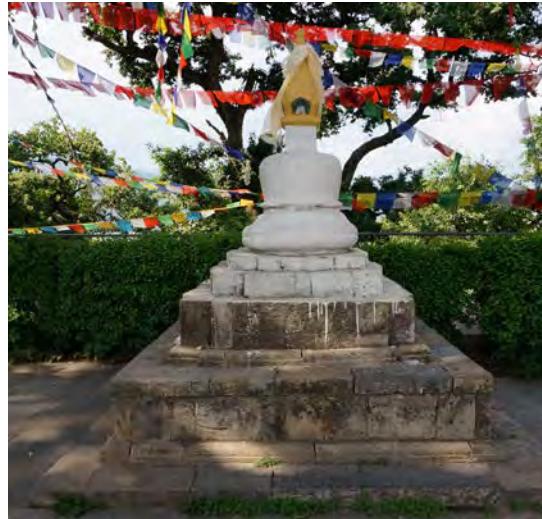
NUMBER NAME	DATE A.D.	TYPE OF MONUMENT HERITAGE SIGNIFICANCE	GENERAL DESCRIPTION	DESCRIPTION OF DAMAGE	DANGER DESTROY	N ↑
57 58		Chaitya	Stone chaityas	57: Minor cracks at upper parts 58: Minor cracks in horizontal and vertical direction at the upper part
