2015 Earthquake Damage Mapping

Swayambhu Monument Zone
Kathmandu Valley World Heritage Property

Submitted to UNESCO by

June 2015

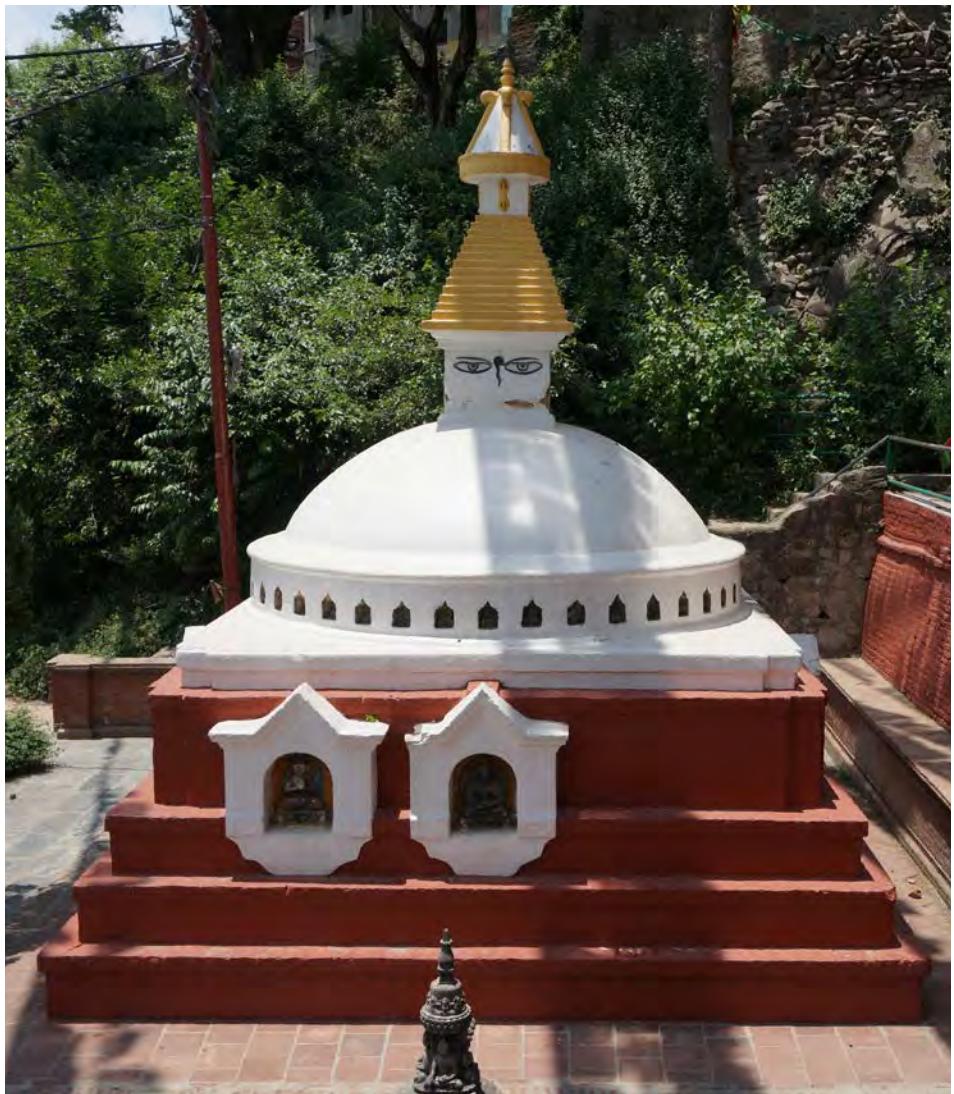
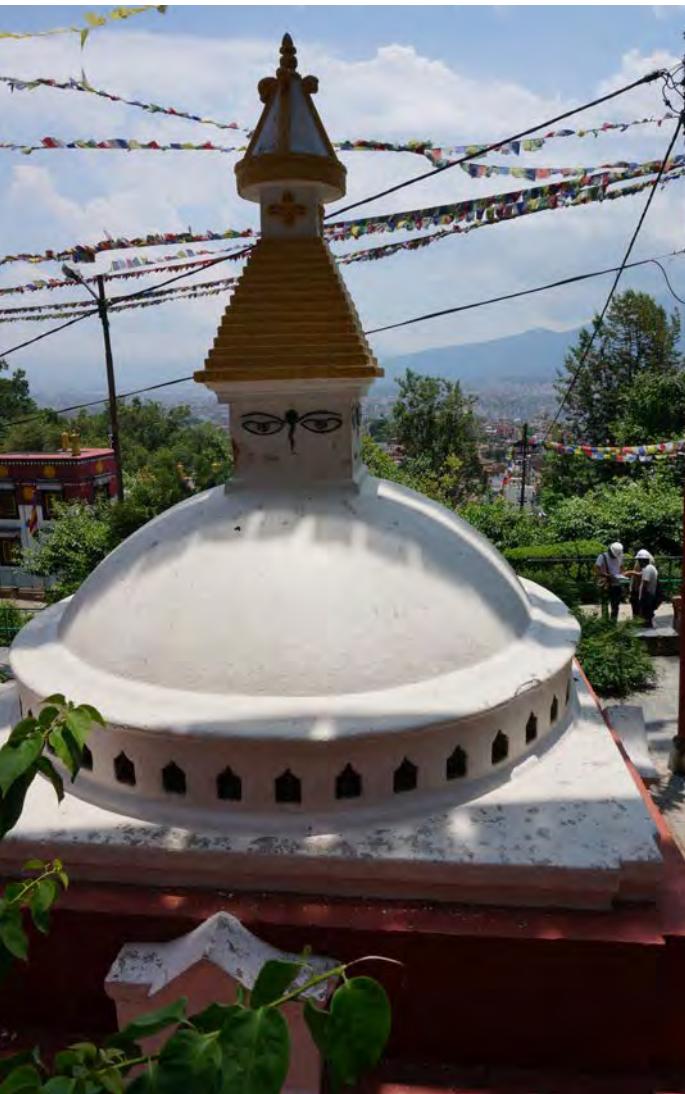
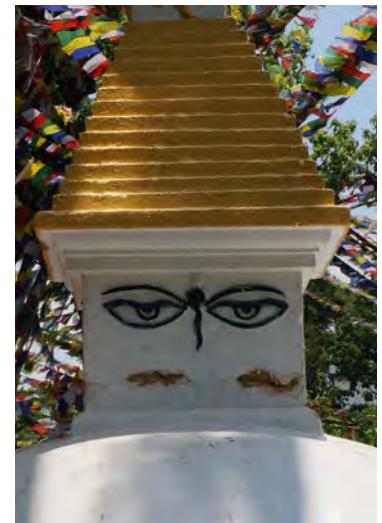
NUMBER NAME	DATE A.D.	TYPE OF MONUMENT HERITAGE SIGNIFICANCE	GENERAL DESCRIPTION	DESCRIPTION OF DAMAGE	DANGER DESTROY	N ↑
59		Stupa	Brick and stone made stupa, lime wash	Horizontal cracks on four faces above the dome of stupa

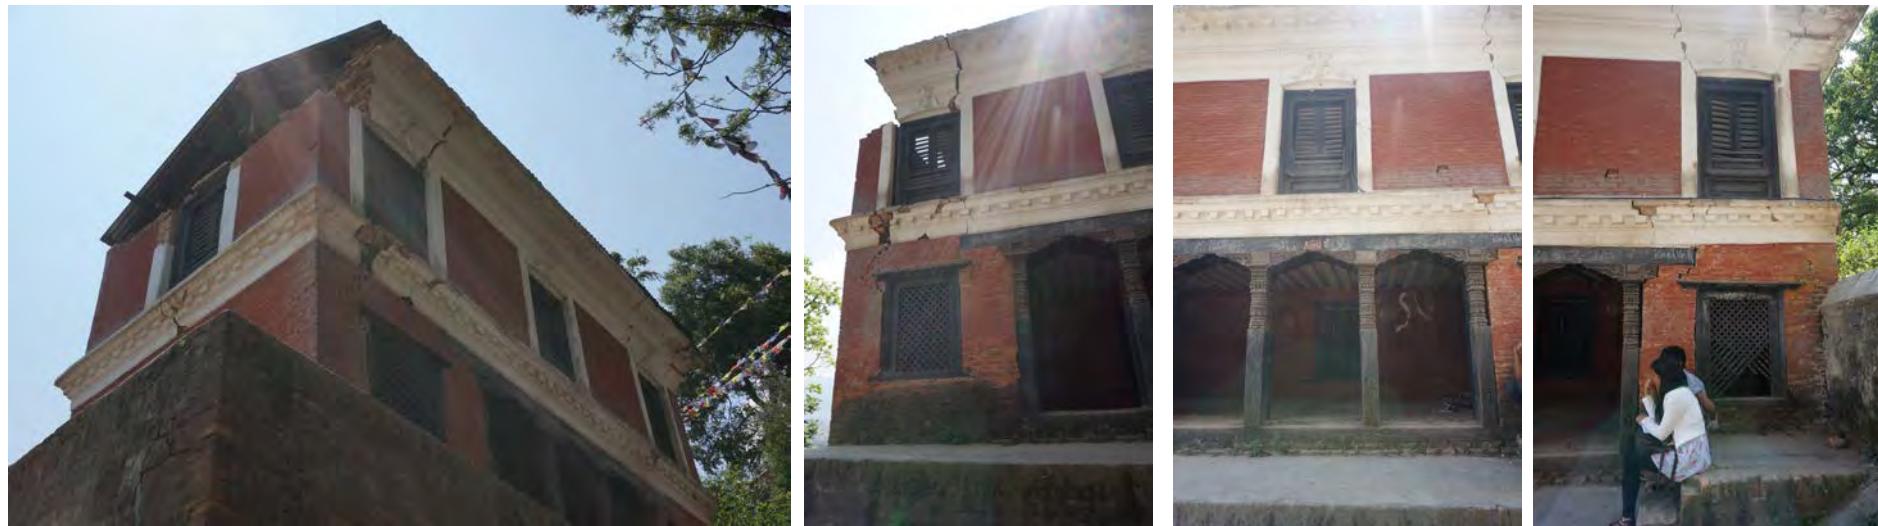
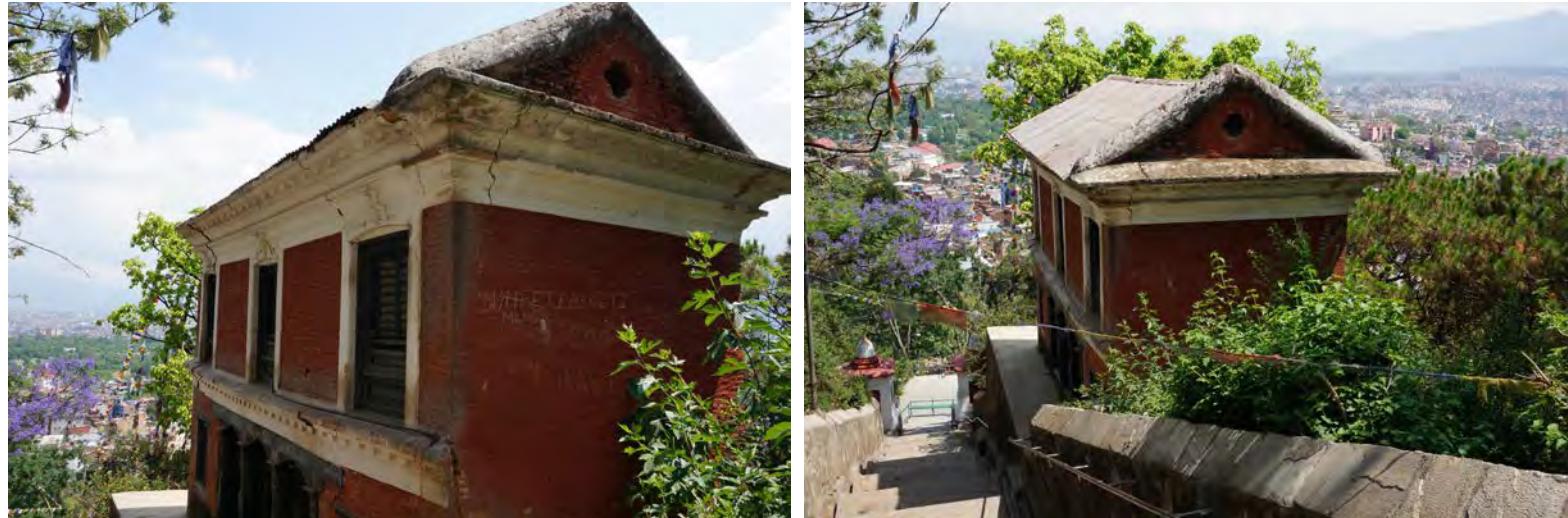
NUMBER NAME	DATE A.D.	TYPE OF MONUMENT HERITAGE SIGNIFICANCE	GENERAL DESCRIPTION	DESCRIPTION OF DAMAGE	DANGER DESTROY	N ↗	PLAN 1/1000
60		Public house	G+1 Brick made structure	Rising damp Soft storey system in ground floor Major vertical cracks about 5cm Major vertical cracks all over	1/2 W Wall

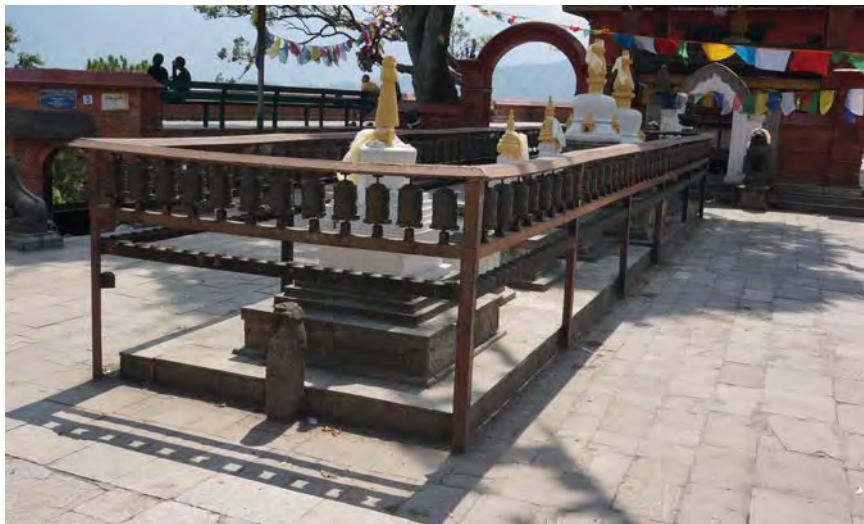
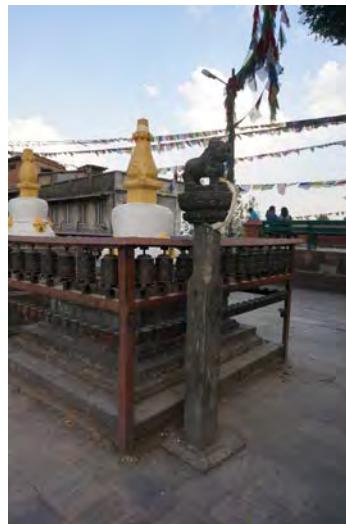
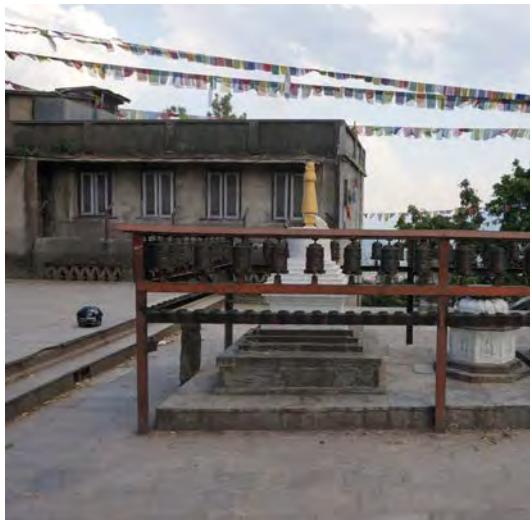
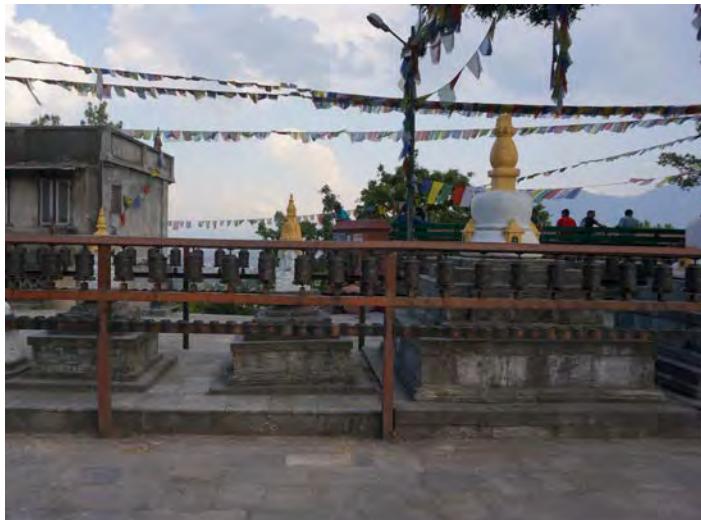
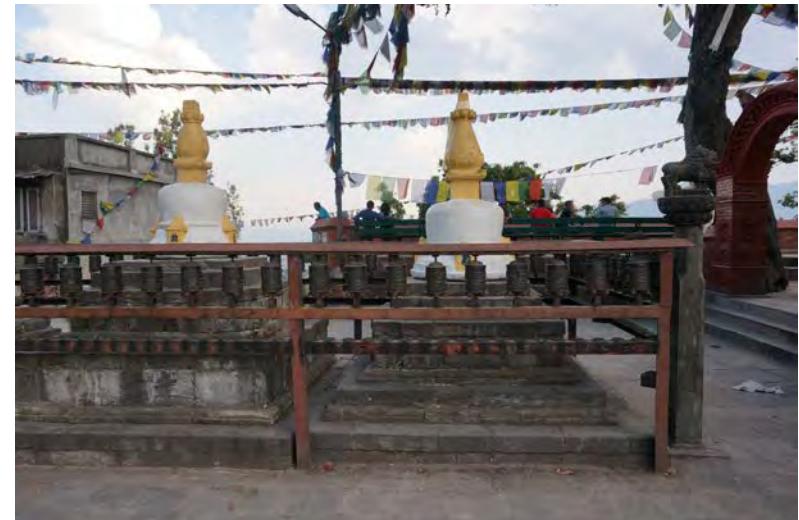
NUMBER NAME	DATE A.D.	TYPE OF MONUMENT HERITAGE SIGNIFICANCE	GENERAL DESCRIPTION	DESCRIPTION OF DAMAGE	DANGER DESTROY	N ↑
63		Chaitya	Small Chaityas in front of Manjusree Stupa Stone made and lime painted Chaityas	No visible damage

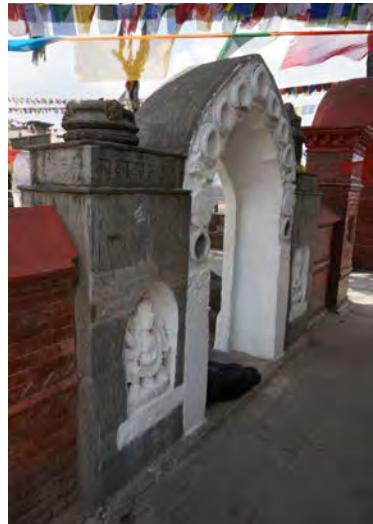
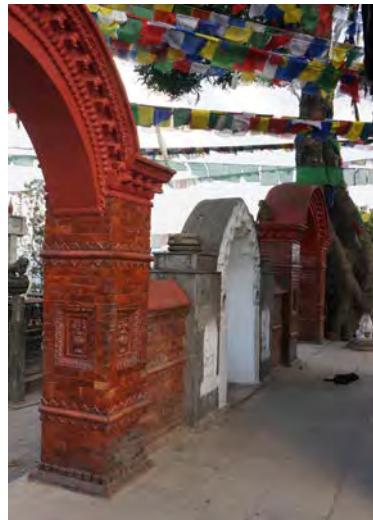
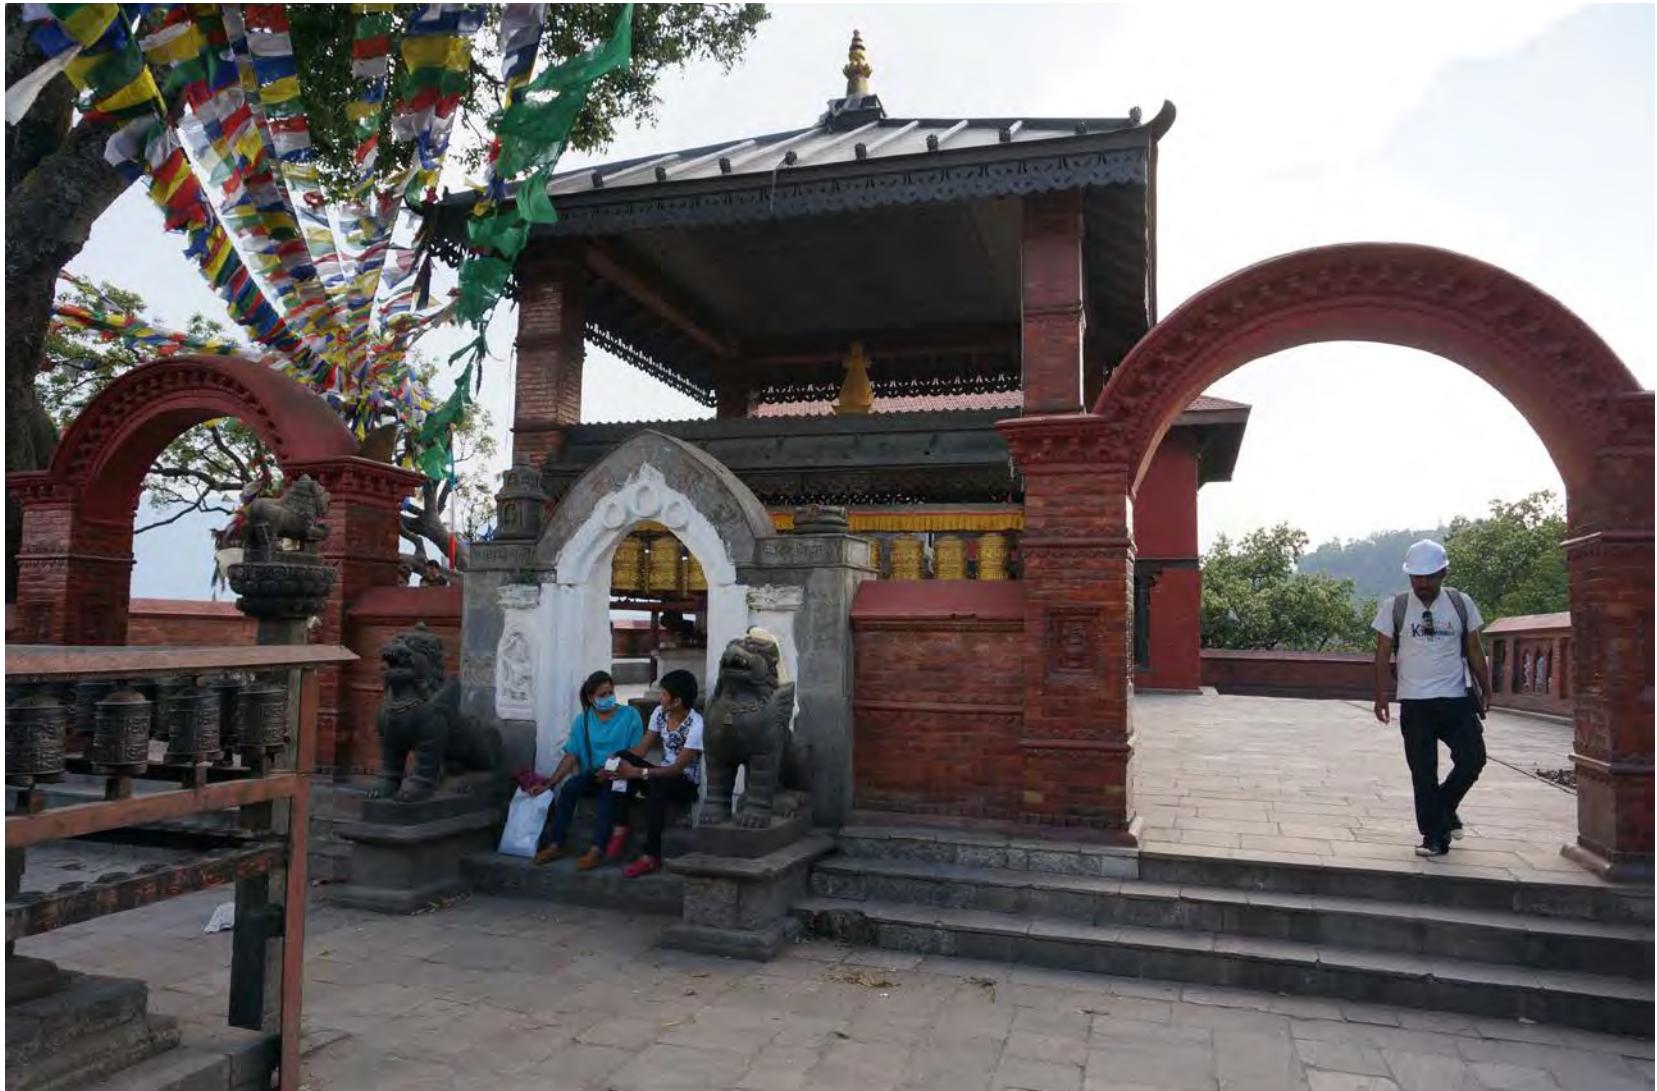
NUMBER NAME	DATE A.D.	TYPE OF MONUMENT HERITAGE SIGNIFICANCE	GENERAL DESCRIPTION	DESCRIPTION OF DAMAGE	DANGER DESTROY	N ↑
64		Gates	3 brick entrance gates to Manjusree Stupa	Newly built and with minor cracks

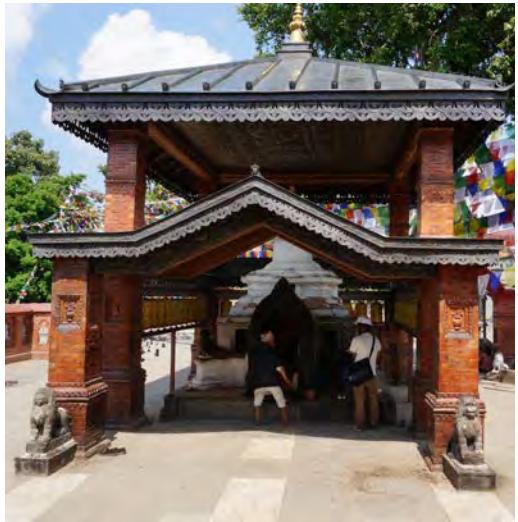
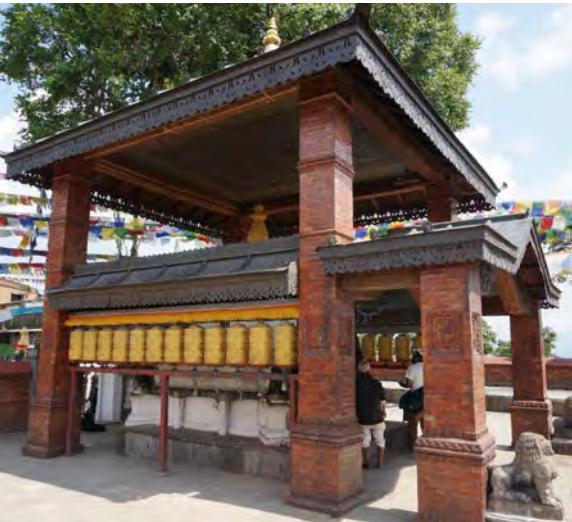
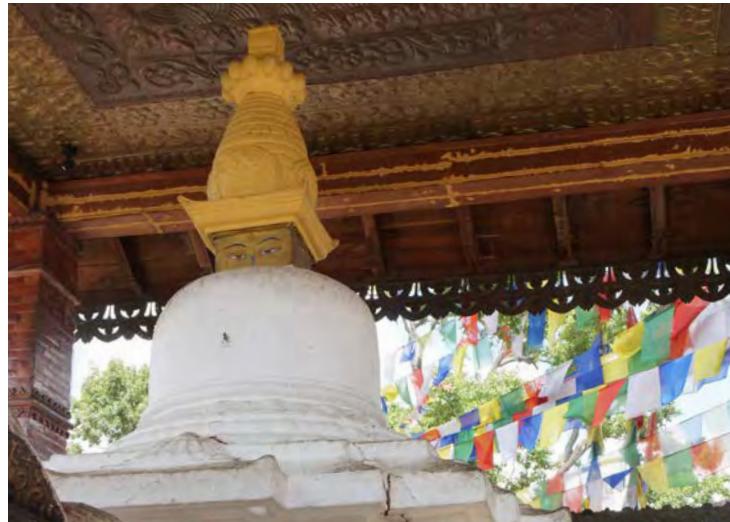
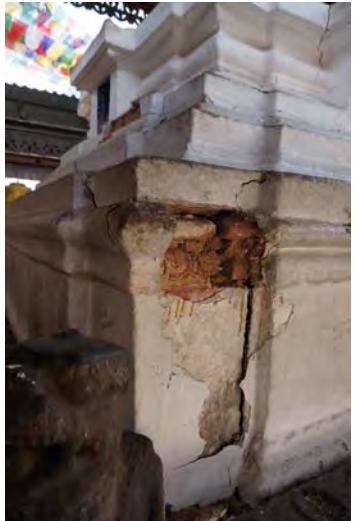
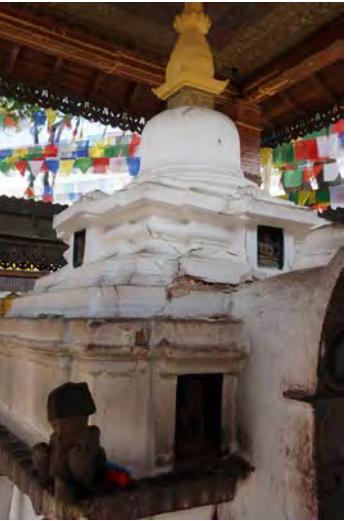
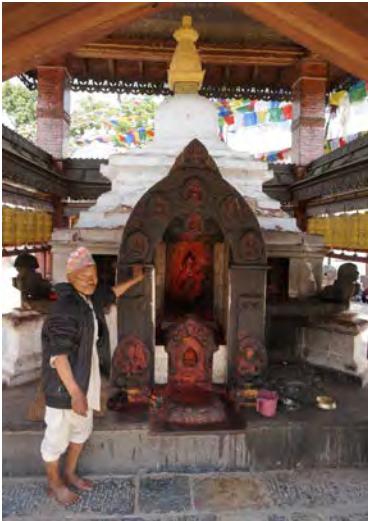
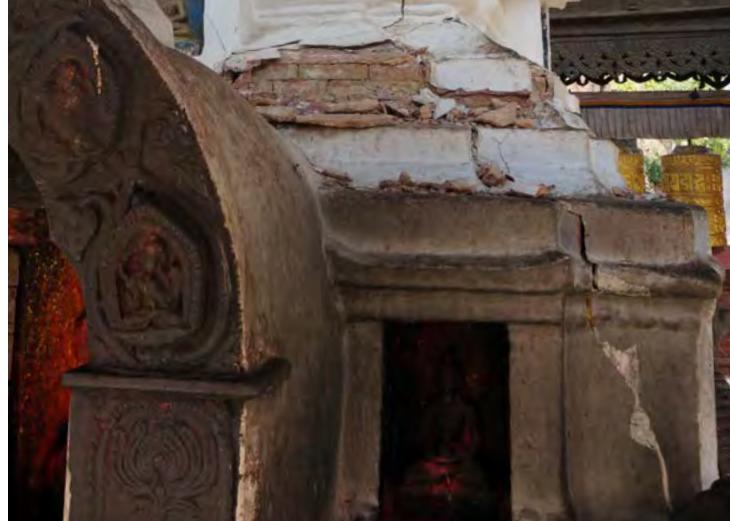
NUMBER NAME	DATE A.D.	TYPE OF MONUMENT HERITAGE SIGNIFICANCE	GENERAL DESCRIPTION	DESCRIPTION OF DAMAGE	DANGER DESTROY	N ↑
65 (K-331) Manjusree Shrine		Shrine	Brick and lime structure New wooden and metal structures installed	Vertical cracks extending from below to top in all the corners and mainly in front face New wooden structures and metallic roof constructed

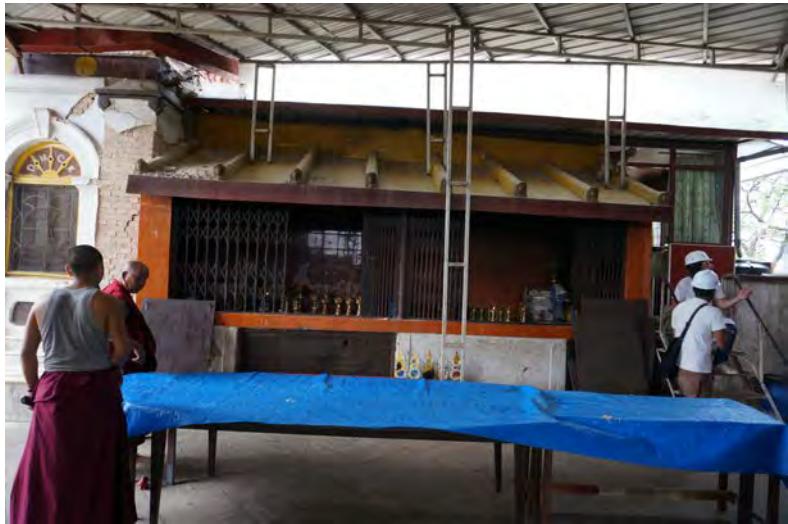
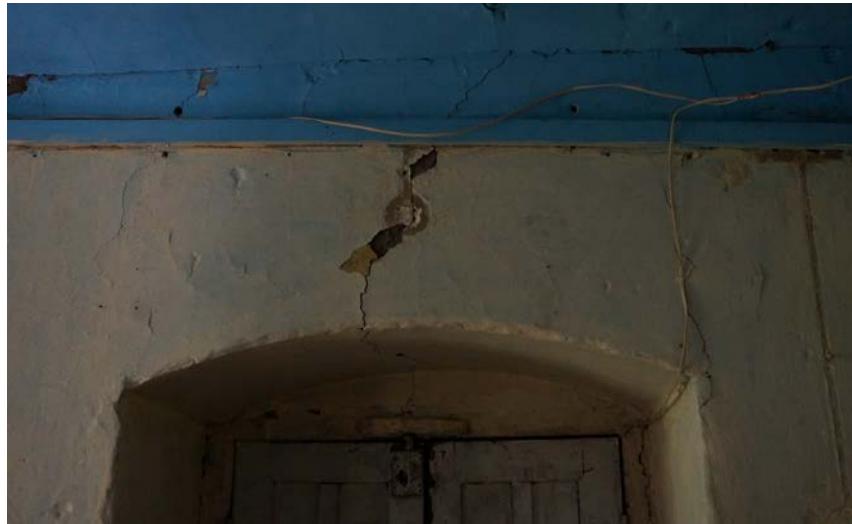
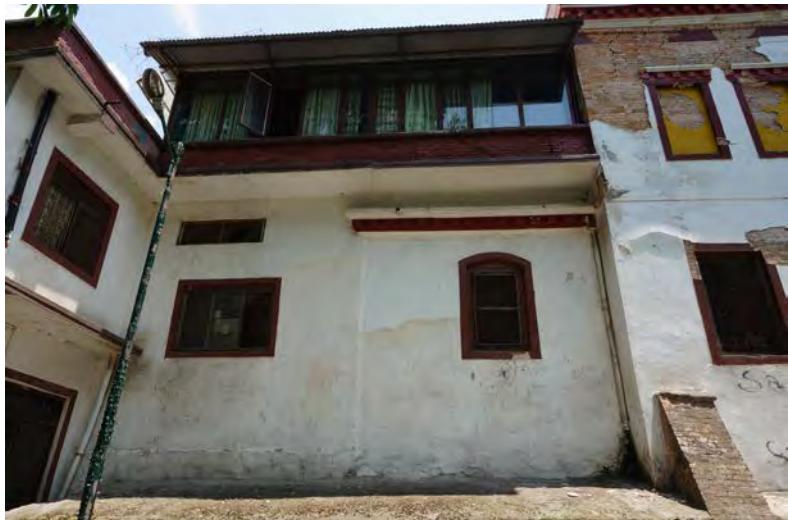
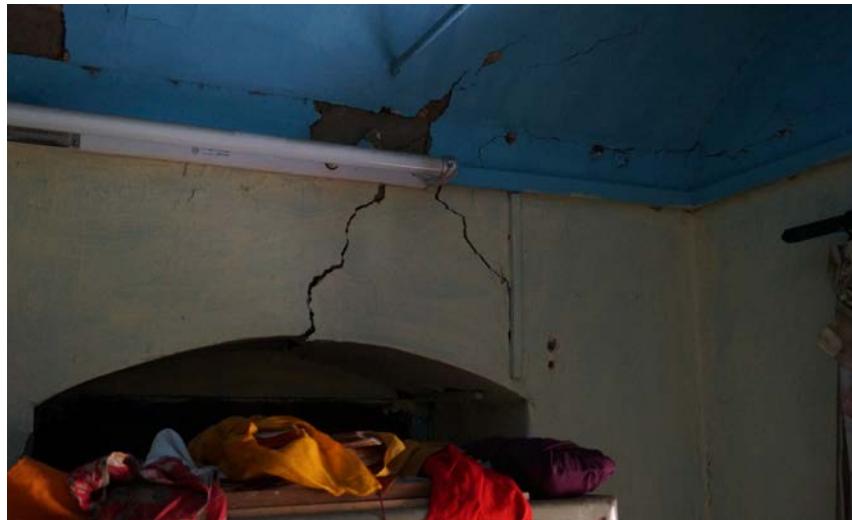
NUMBER NAME	DATE A.D.	TYPE OF MONUMENT HERITAGE SIGNIFICANCE	GENERAL DESCRIPTION	DESCRIPTION OF DAMAGE	DANGER DESTROY	N ↑
70 (K-332) Dharma Chakra Bihar	1947		G+2 Brick made monastery	No visible damage

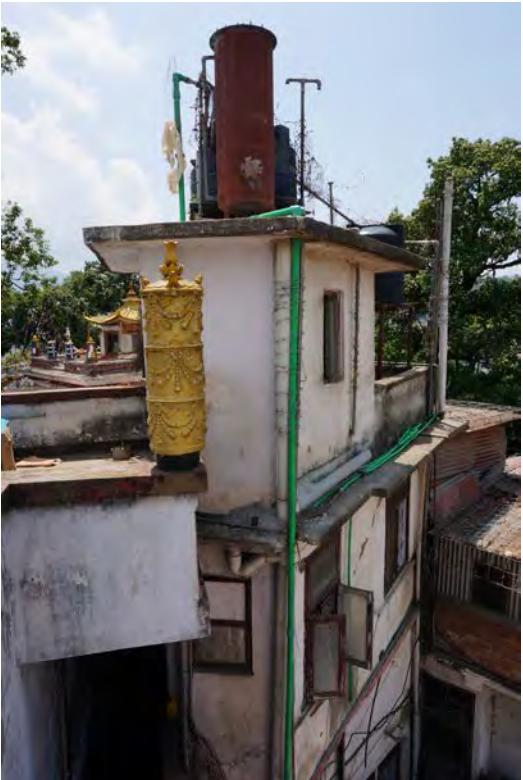
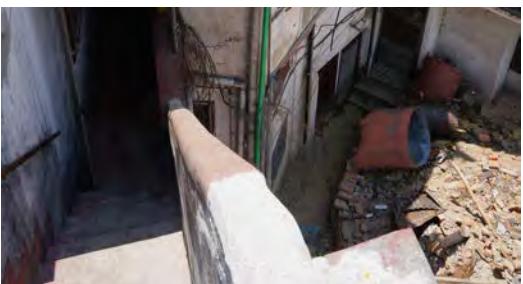
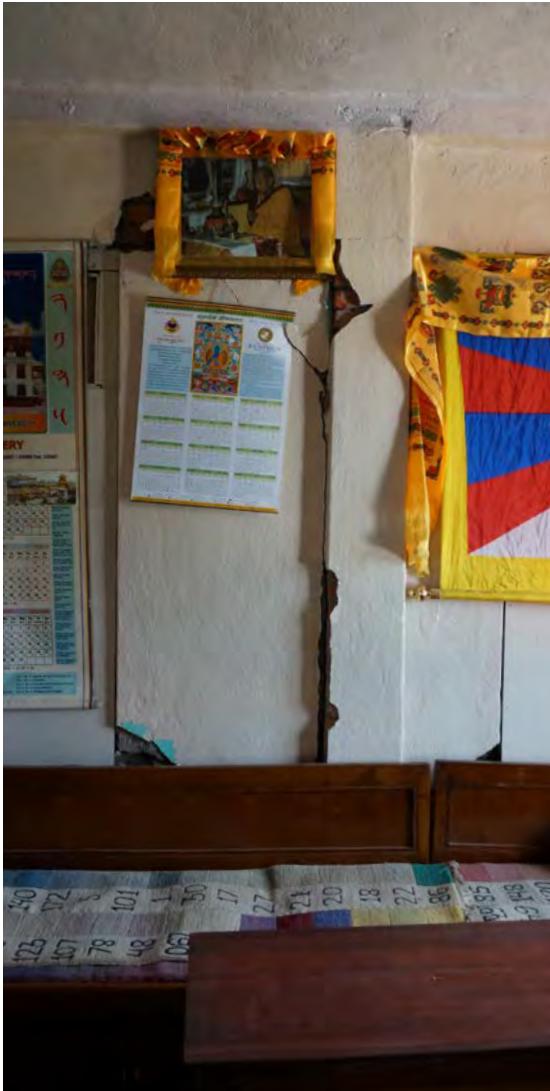
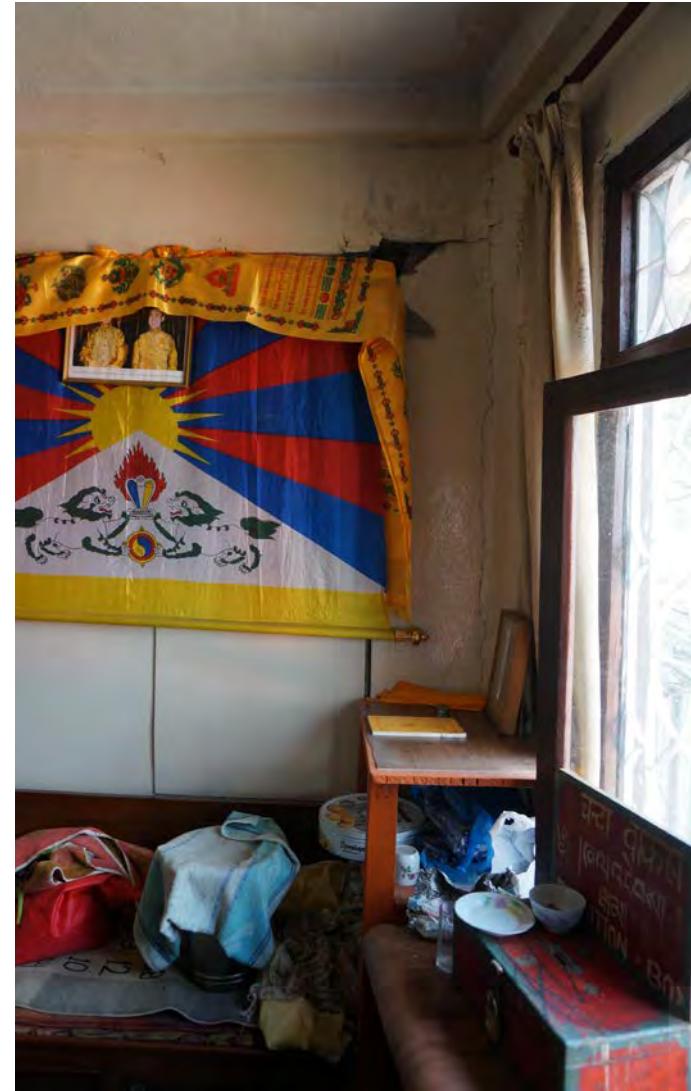
NUMBER NAME	DATE A.D.	TYPE OF MONUMENT HERITAGE SIGNIFICANCE	GENERAL DESCRIPTION	DESCRIPTION OF DAMAGE	DANGER DESTROY	N ↑
71 Dharma Chakra Bihar		Public house	Small house for light burning Brick and cement plastered structure	Minor cracks

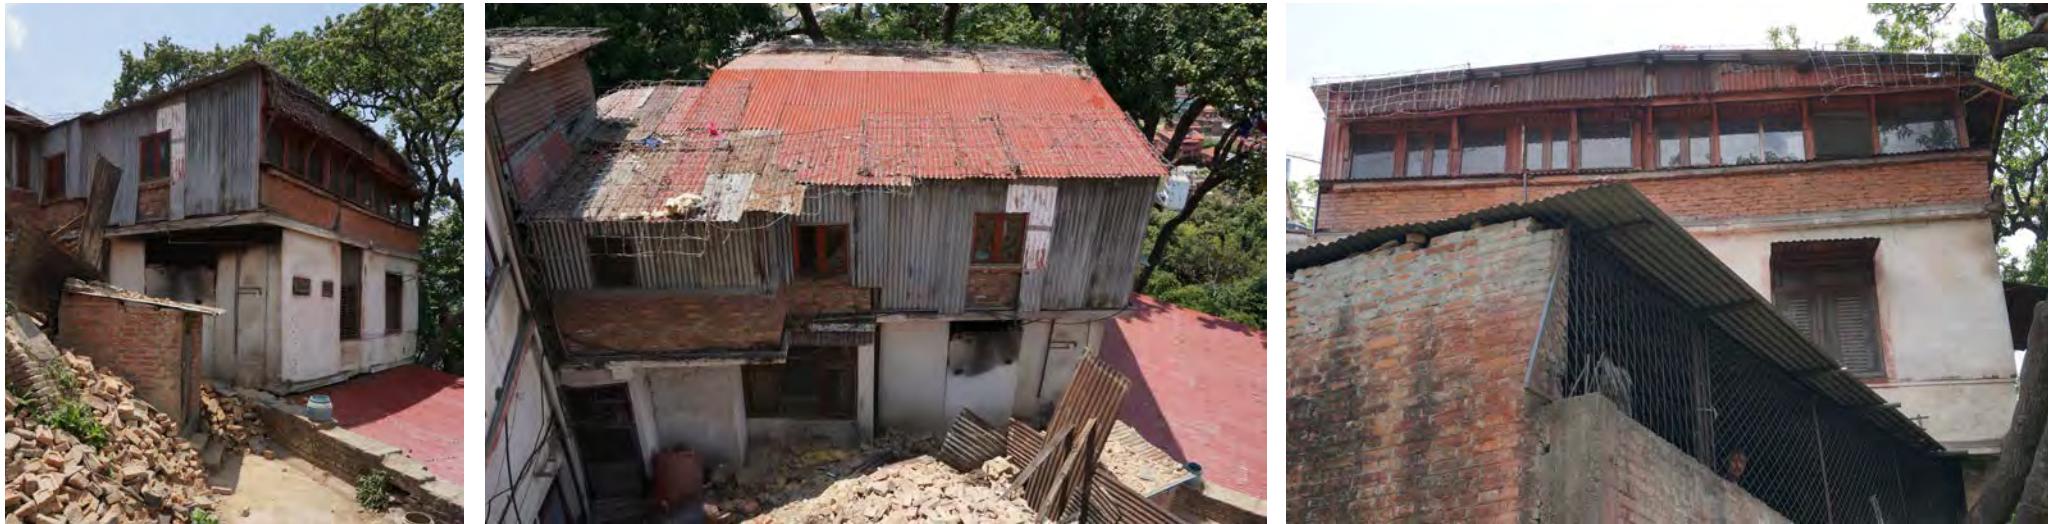
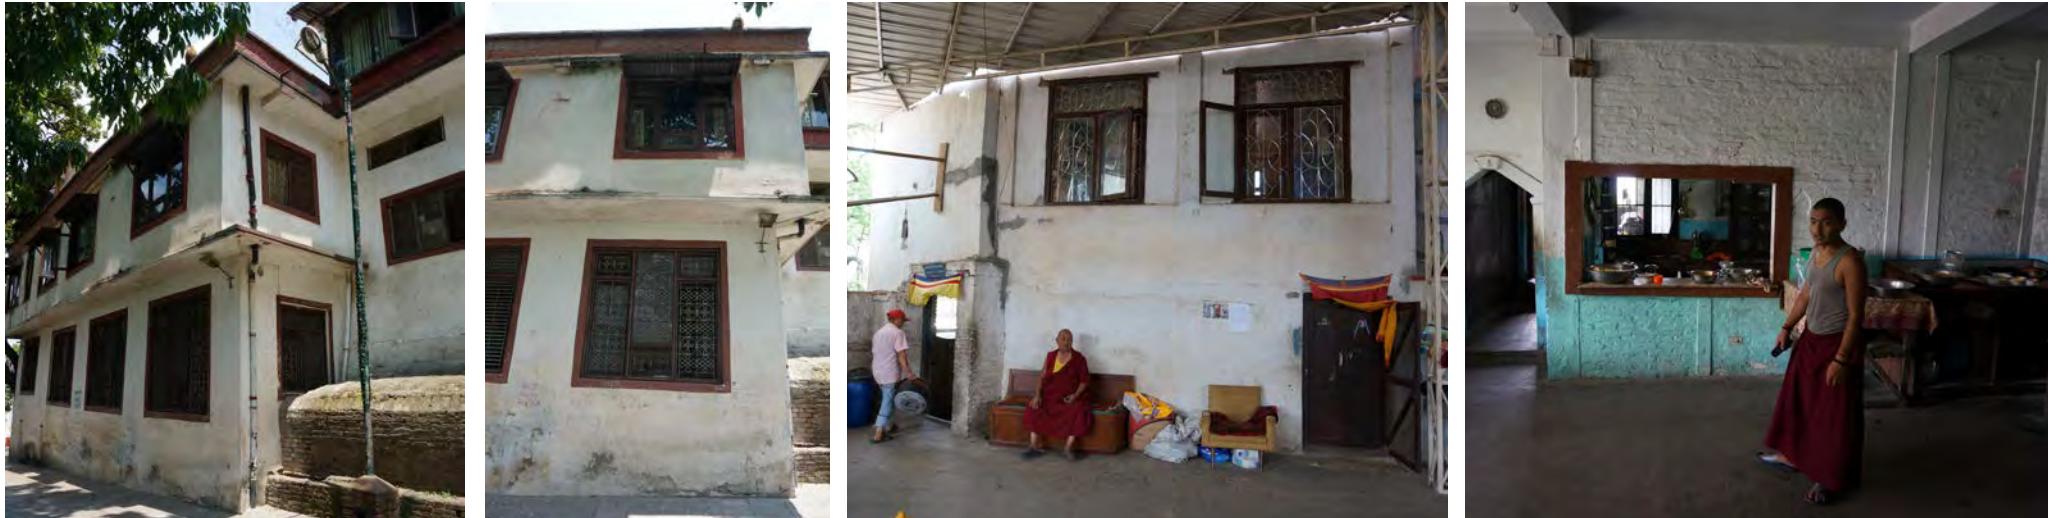
NUMBER NAME	DATE A.D.	TYPE OF MONUMENT HERITAGE SIGNIFICANCE	GENERAL DESCRIPTION	DESCRIPTION OF DAMAGE	DANGER DESTROY	N ↑
72 Dharma Chakra Bihar		Public House	G+2 Brick structure	Minor cracks

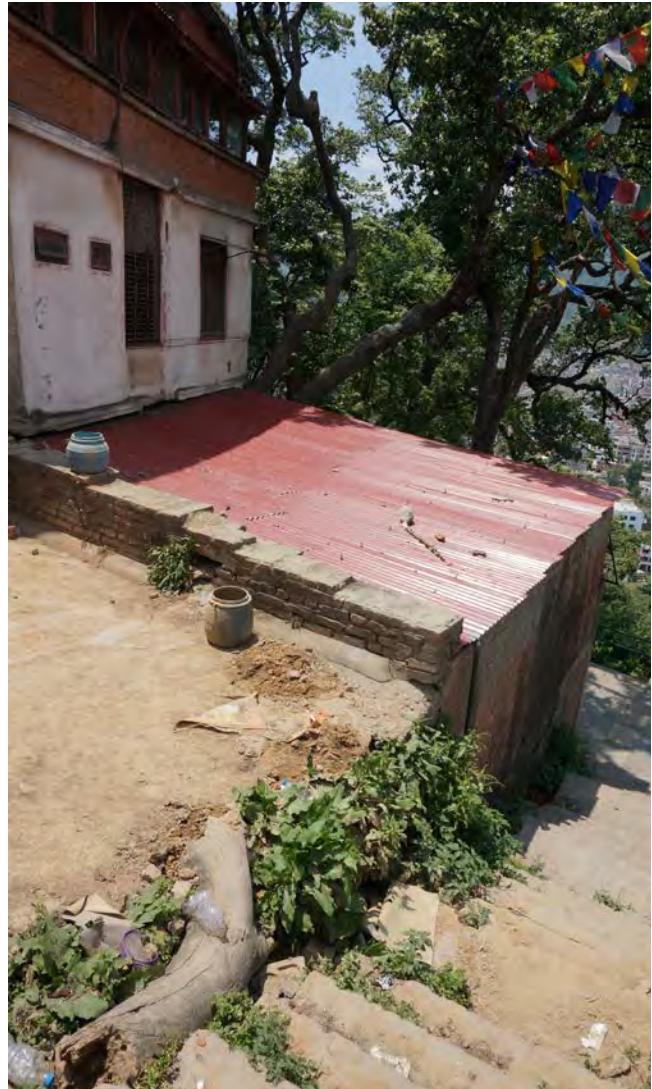
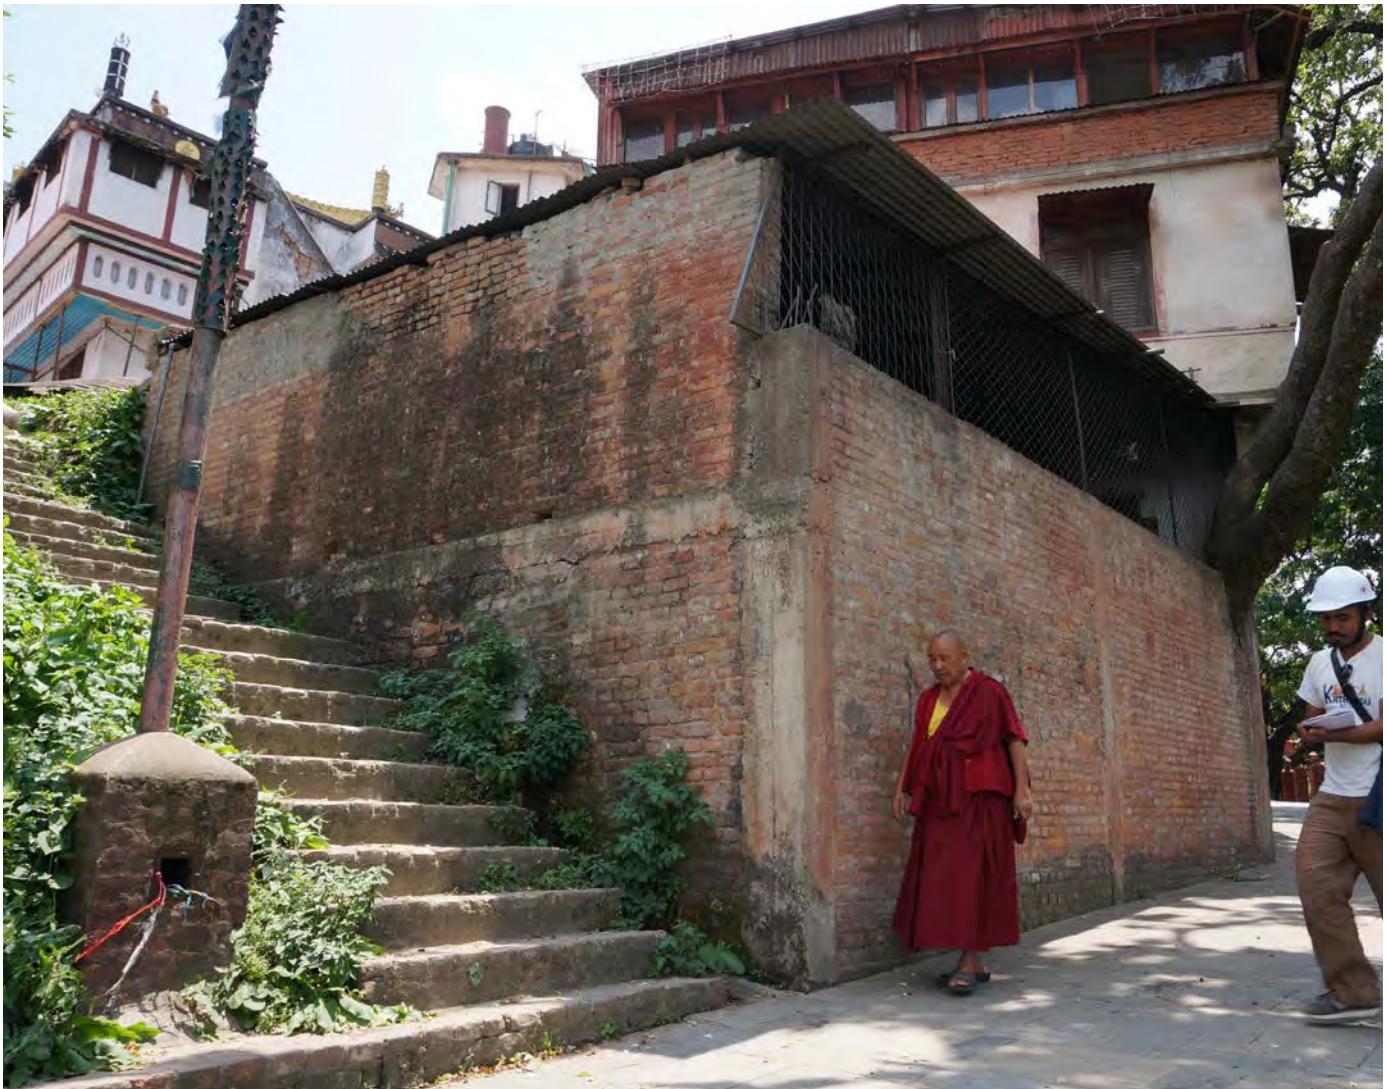
NUMBER NAME	DATE A.D.	TYPE OF MONUMENT HERITAGE SIGNIFICANCE	GENERAL DESCRIPTION	DESCRIPTION OF DAMAGE	DANGER DESTROY	N ↗
73/ Dharma Chakra Bihar		Public House	G+2 Brick structure (concrete pillars)	Kitchen hall Minor cracks No visible damage

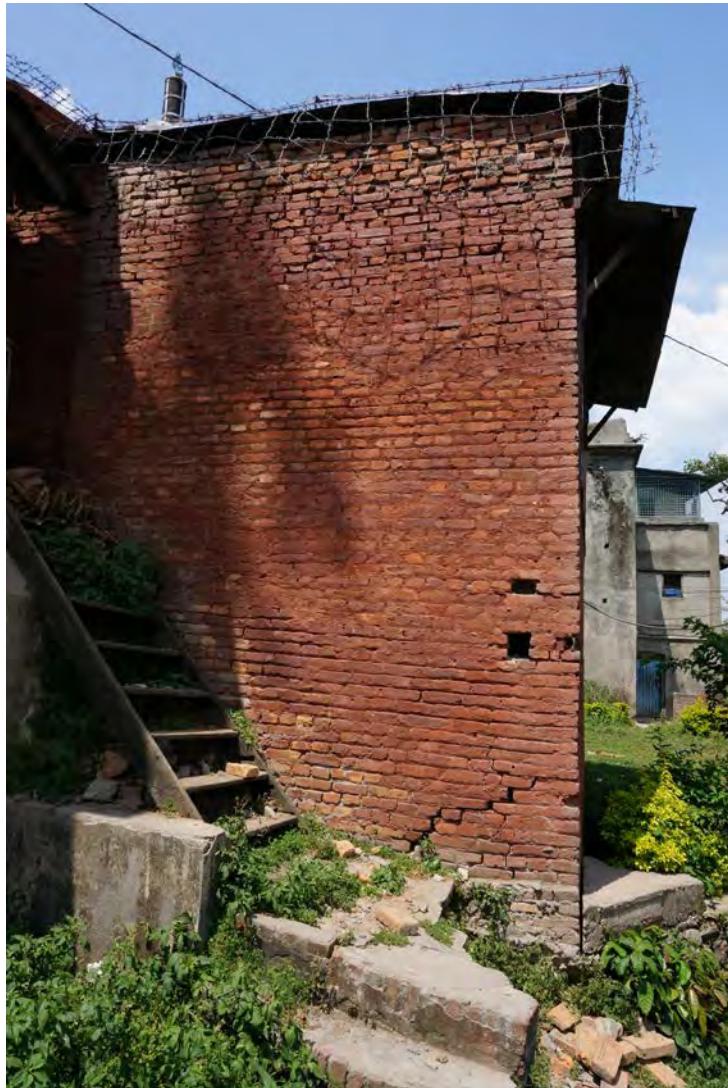
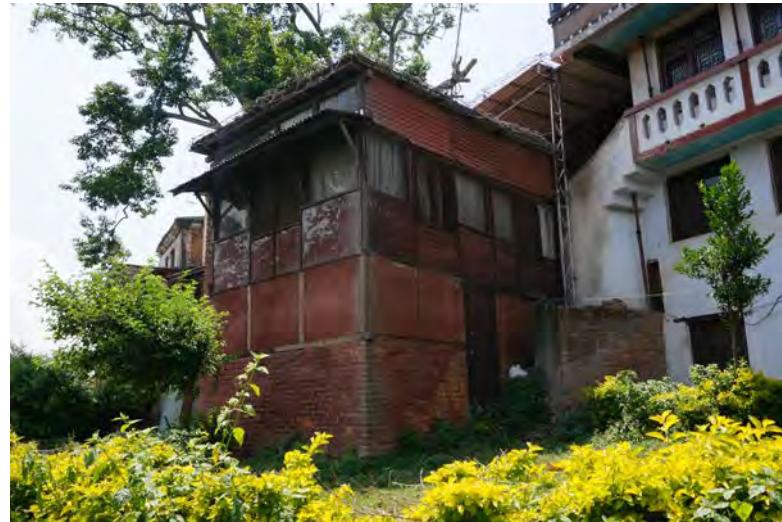
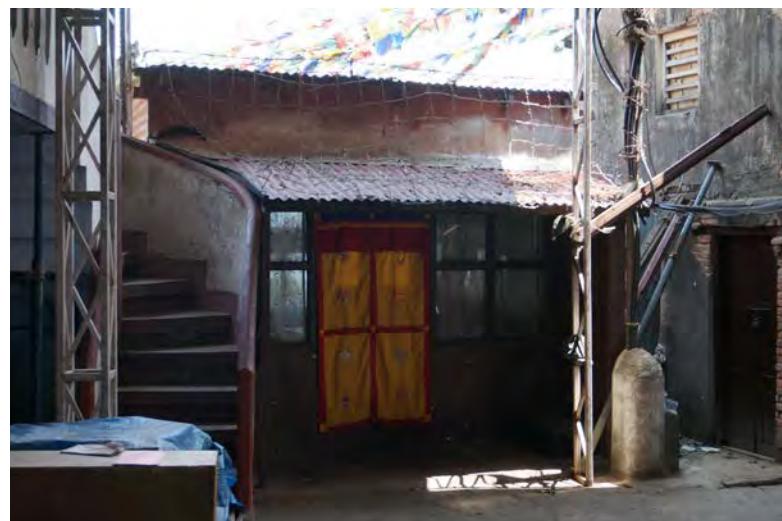
NUMBER NAME	DATE A.D.	TYPE OF MONUMENT HERITAGE SIGNIFICANCE	GENERAL DESCRIPTION	DESCRIPTION OF DAMAGE	DANGER DESTROY	N ↑
75 Dharma Chakra Bihar		Public house	G+2 Concrete structure	Cracks (mostly horizontal) above doors and windows and in stairs Balcony tends to fall down Suspect of over-weight Metal Poles are provided to support at 2nd floor but seems to not very useful

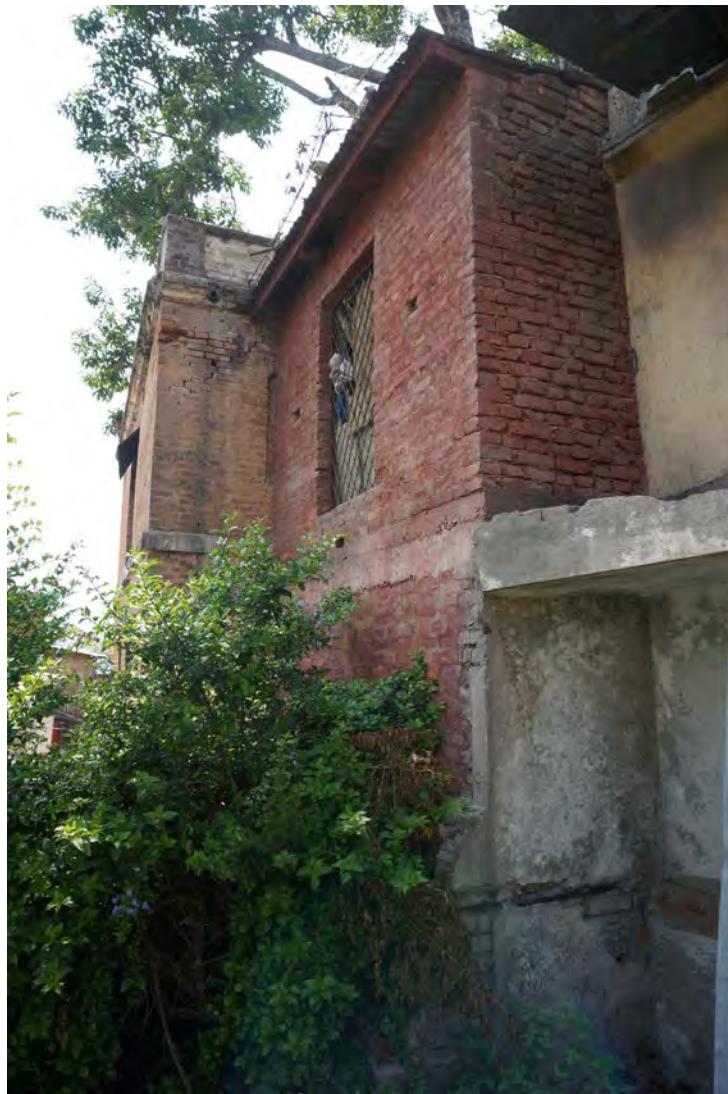
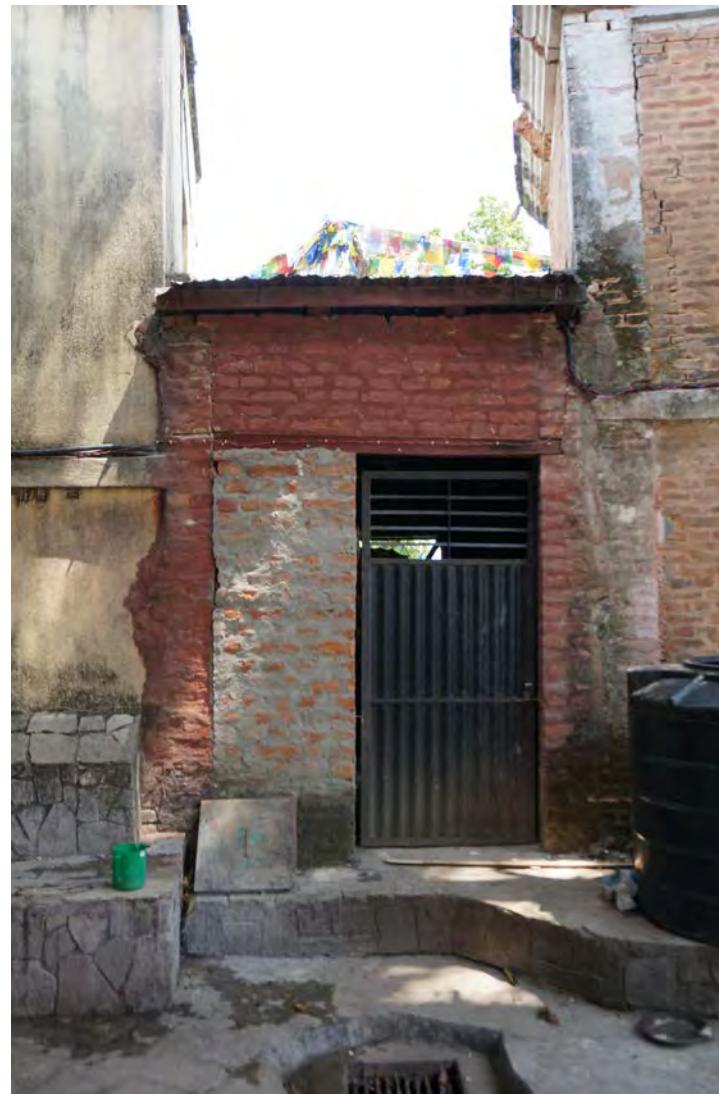
NUMBER NAME	DATE A.D.	TYPE OF MONUMENT HERITAGE SIGNIFICANCE	GENERAL DESCRIPTION	DESCRIPTION OF DAMAGE	DANGER DESTROY	N ↑
77 Dharma Chakra Bihar		Public house	G+2 Brick structure	Owned by Manandhar family and now used by nuns. Roof partially collapsed Wall with vertical cracks
