2015 Earthquake Damage Mapping

Swayambhu Monument Zone
Kathmandu Valley World Heritage Property

Submitted to UNESCO by

June 2015

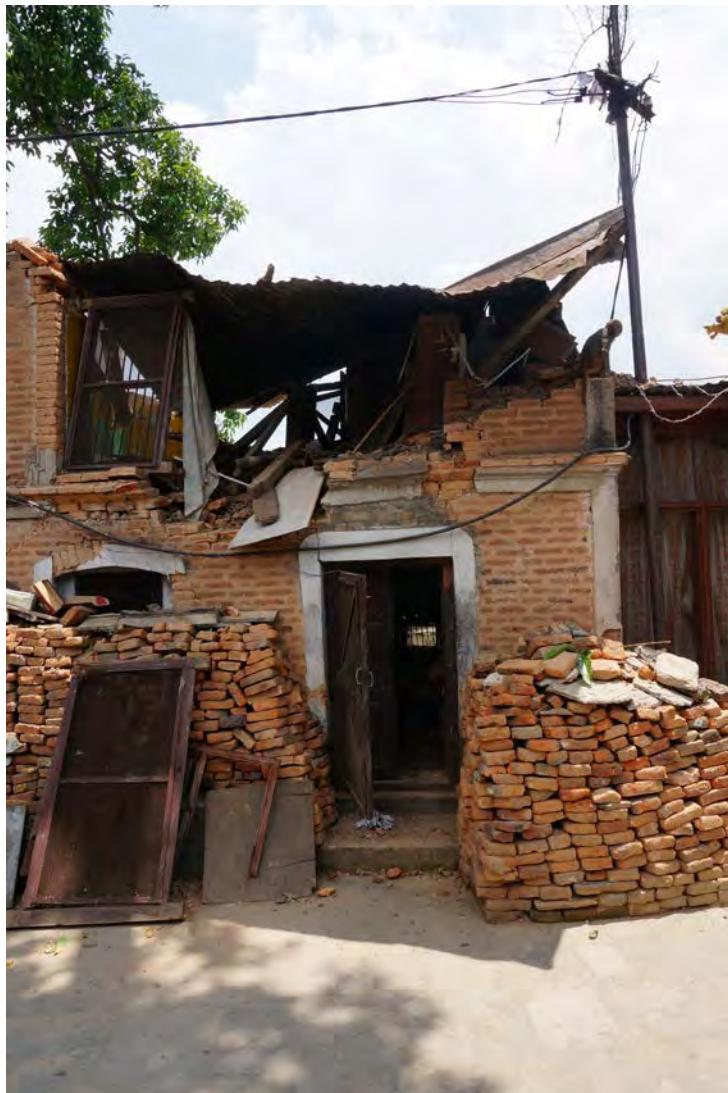
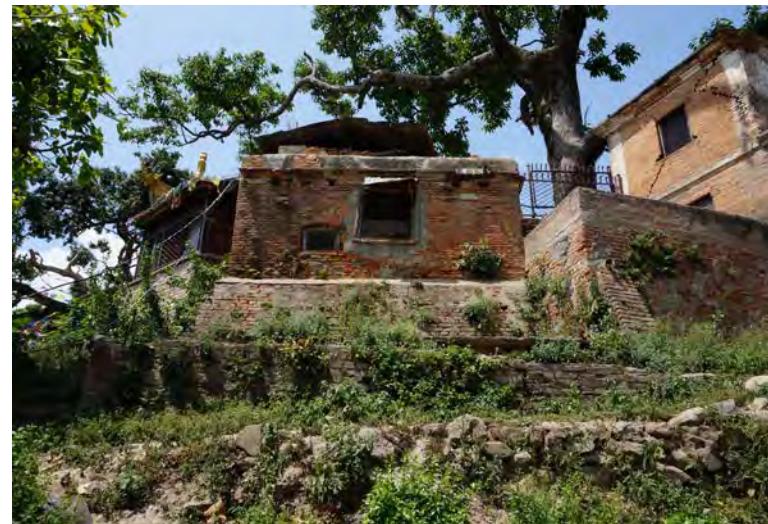
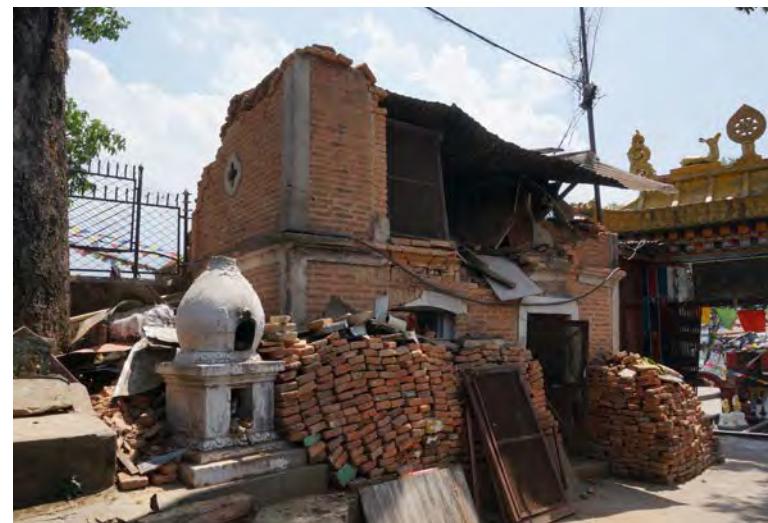
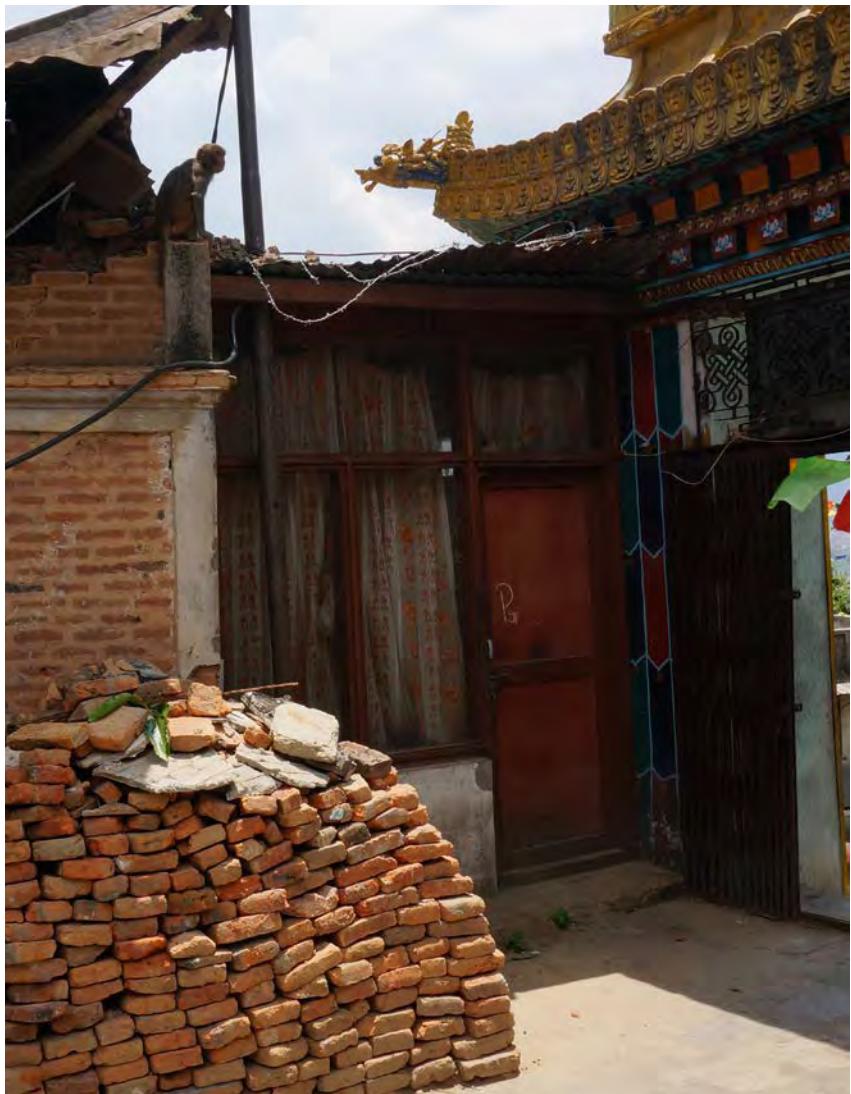
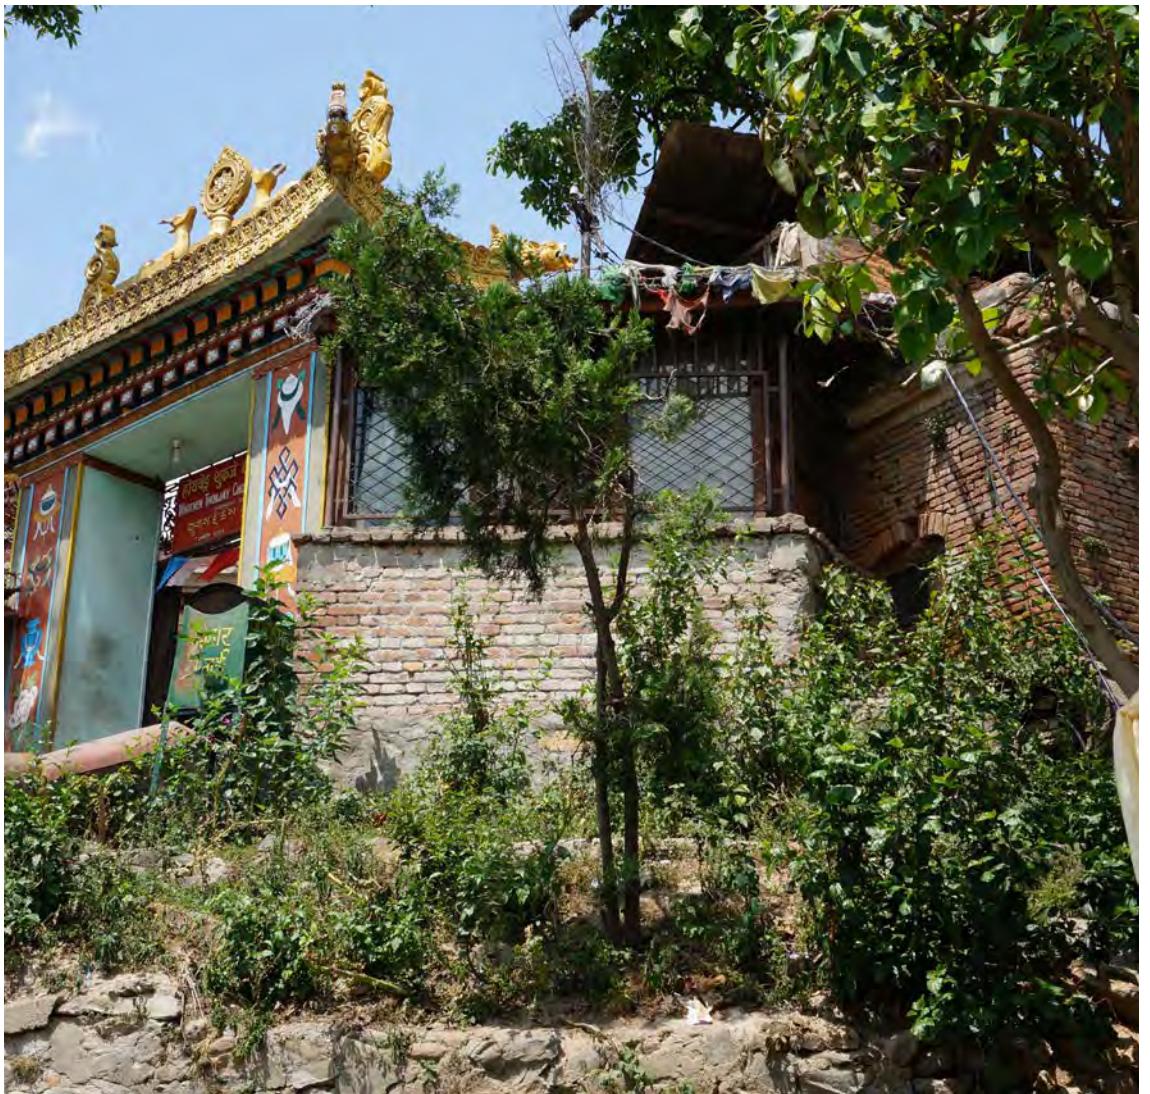
NUMBER NAME	DATE A.D.	TYPE OF MONUMENT HERITAGE SIGNIFICANCE	GENERAL DESCRIPTION	DESCRIPTION OF DAMAGE	DANGER DESTROY	N ↑
79 Dharma Chakra Bihar		Public house	G+1 Brick structure	Diagonal cracks Roof partially collapsed	1/2

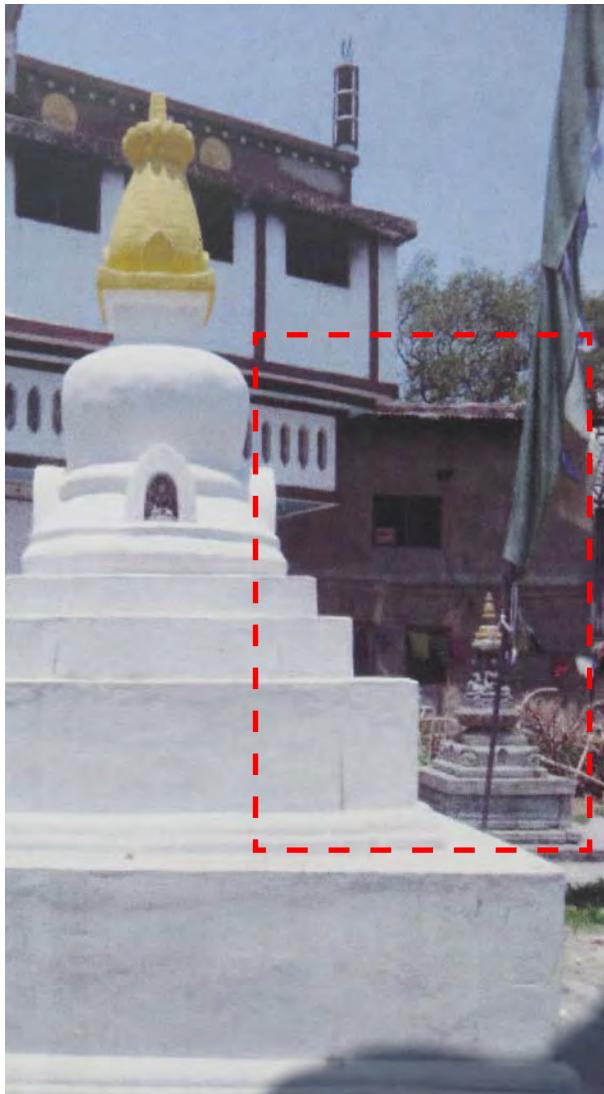
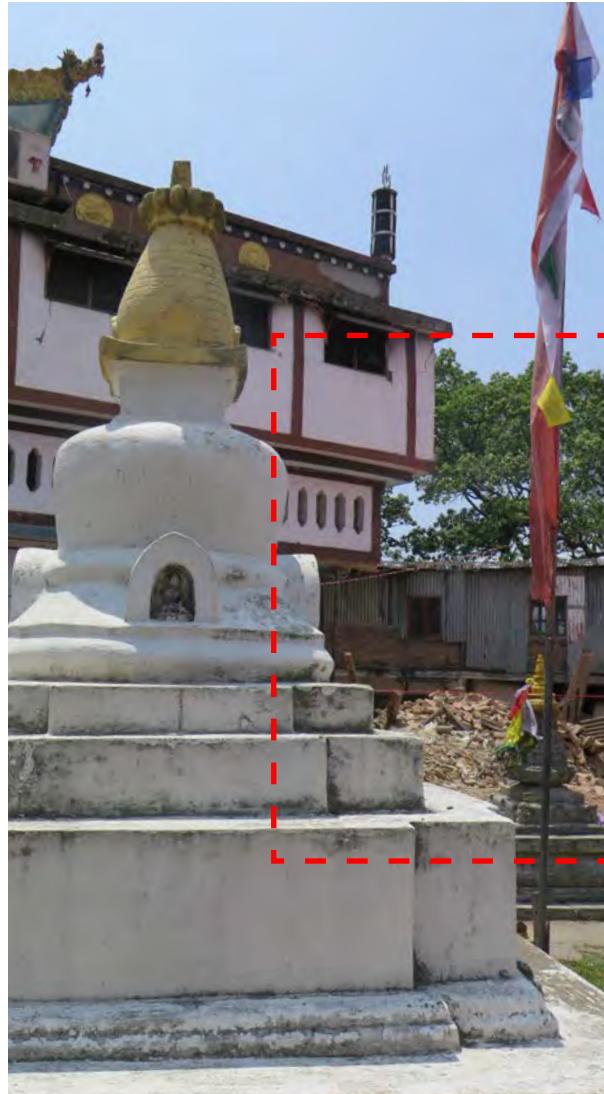
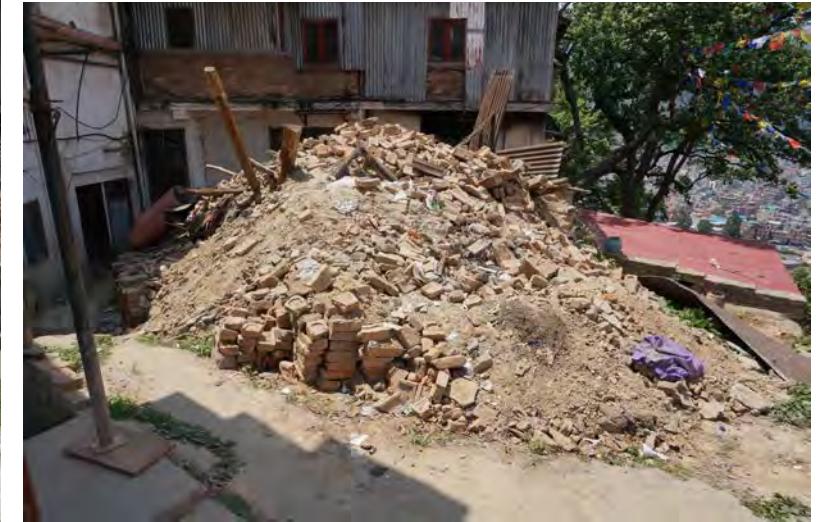
NUMBER NAME	DATE A.D.	TYPE OF MONUMENT HERITAGE SIGNIFICANCE	GENERAL DESCRIPTION	DESCRIPTION OF DAMAGE	DANGER DESTROY	N ↑
84/ Dharma Chakra Bihar		Chaityas	Stone chaityas	No visible damage		A site plan showing the locations of numbered points 71 through 85. The plan includes a north arrow pointing upwards. The areas are color-coded in green, yellow, and red. A small building complex is shown in the center-right of the plan.

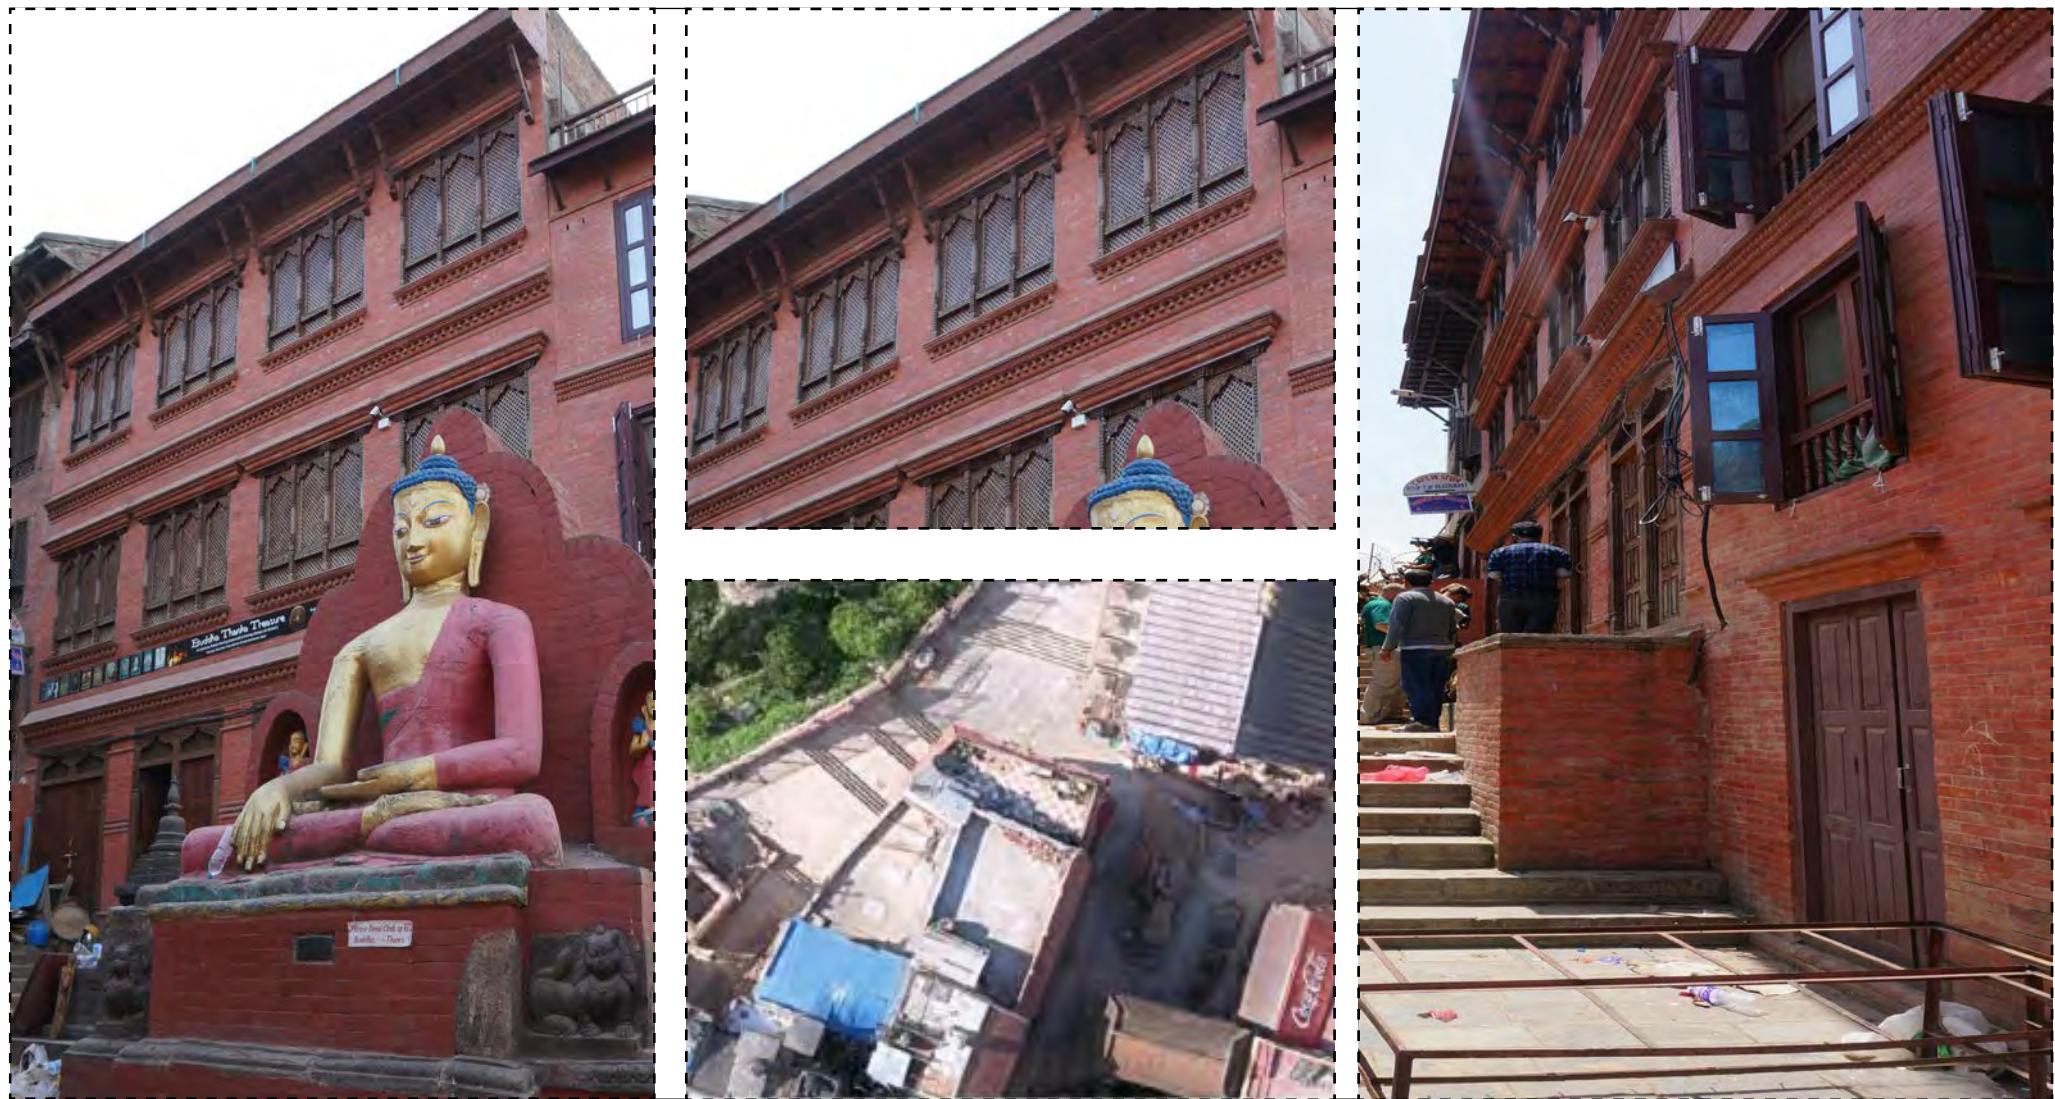
NUMBER NAME	NUMBER OF STOREYS RELATIVE POSITION	STRUCTURAL SYSTEM	DESCRIPTION OF DAMAGE	DANGER DESTROY	HERITAGE SIGNIFICANCE	N ↑
1	G+1	C	No visible damage

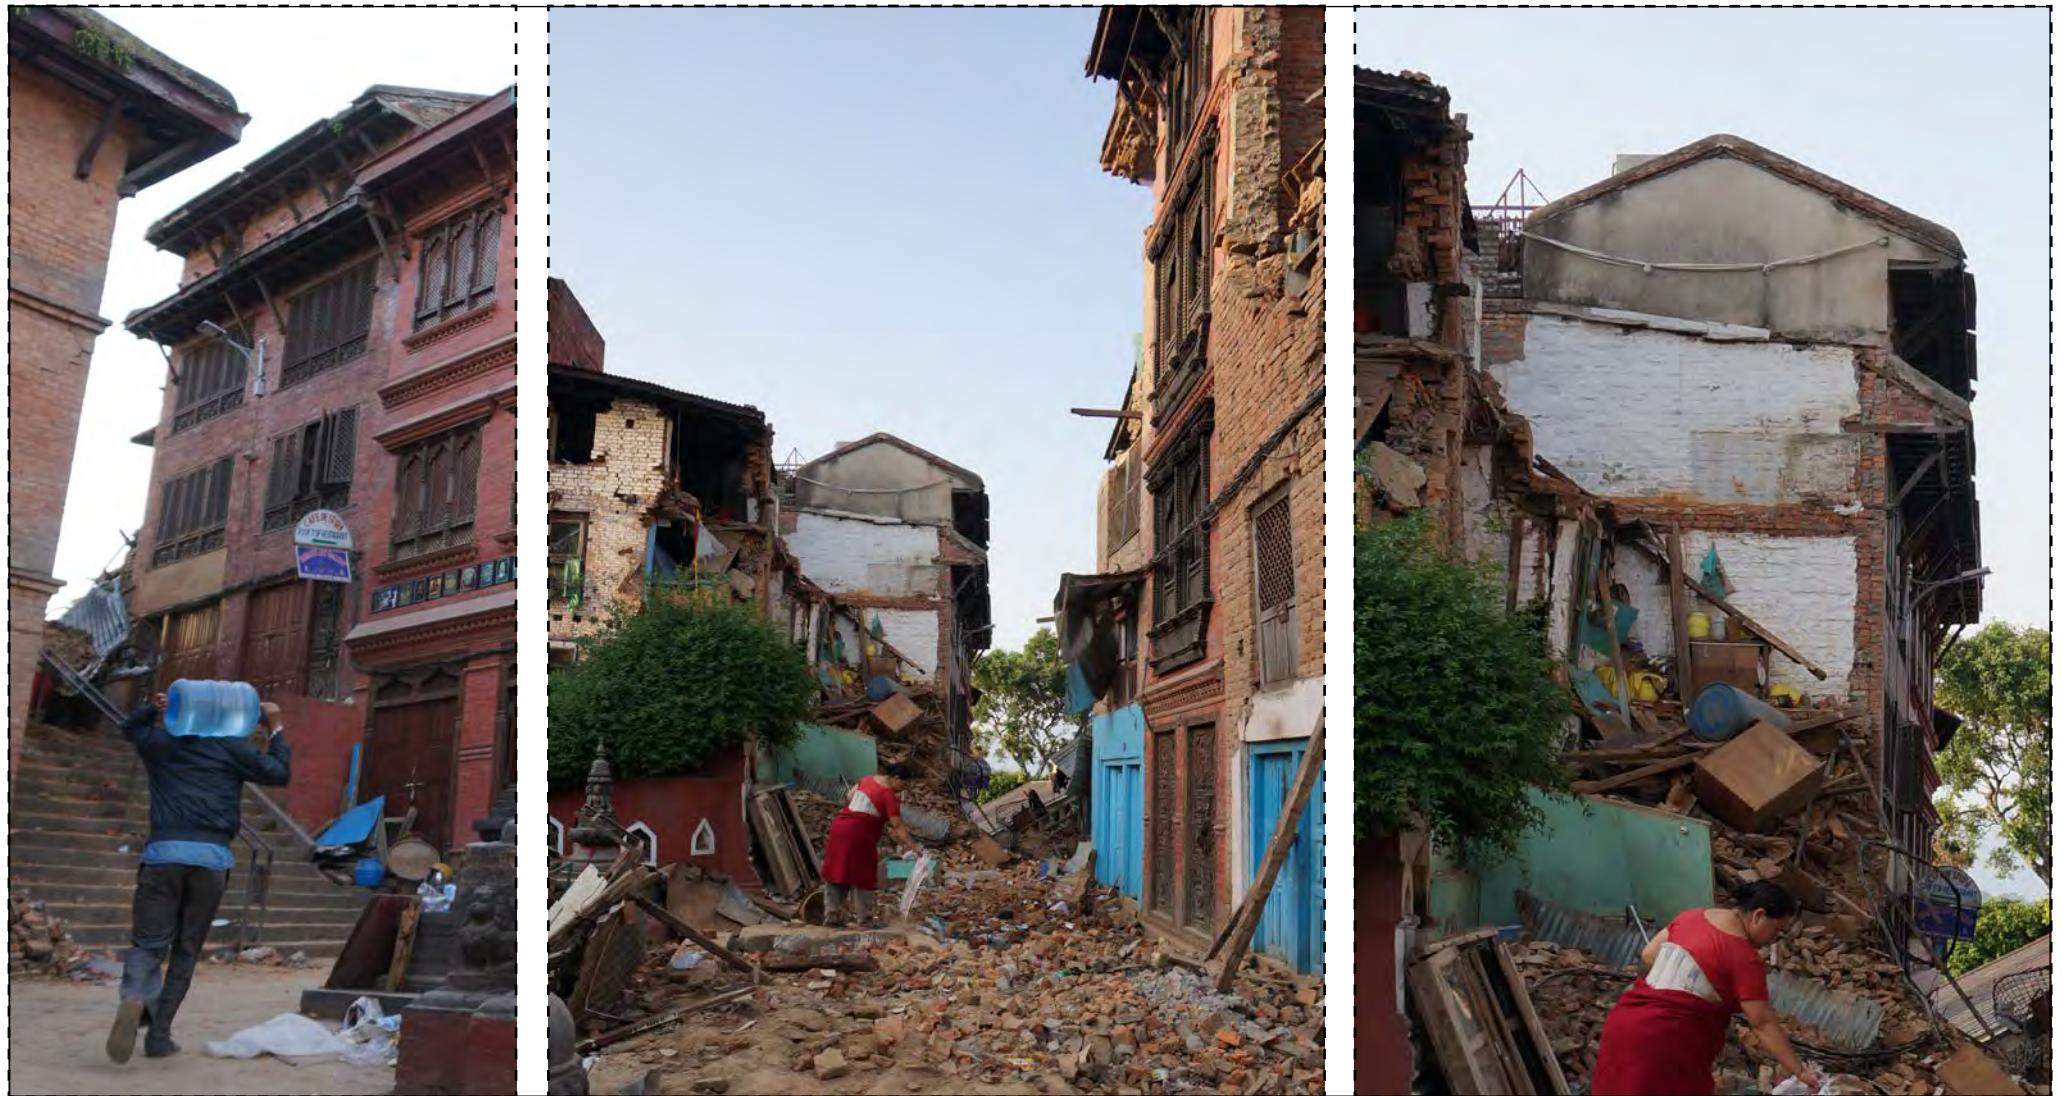
NUMBER NAME	NUMBER OF STORIES RELATIVE POSITION	STRUCTURAL SYSTEM	DESCRIPTION OF DAMAGE	DANGER DESTROY	HERITAGE SIGNIFICANCE	N ↑
2	G+3	C	No visible damage

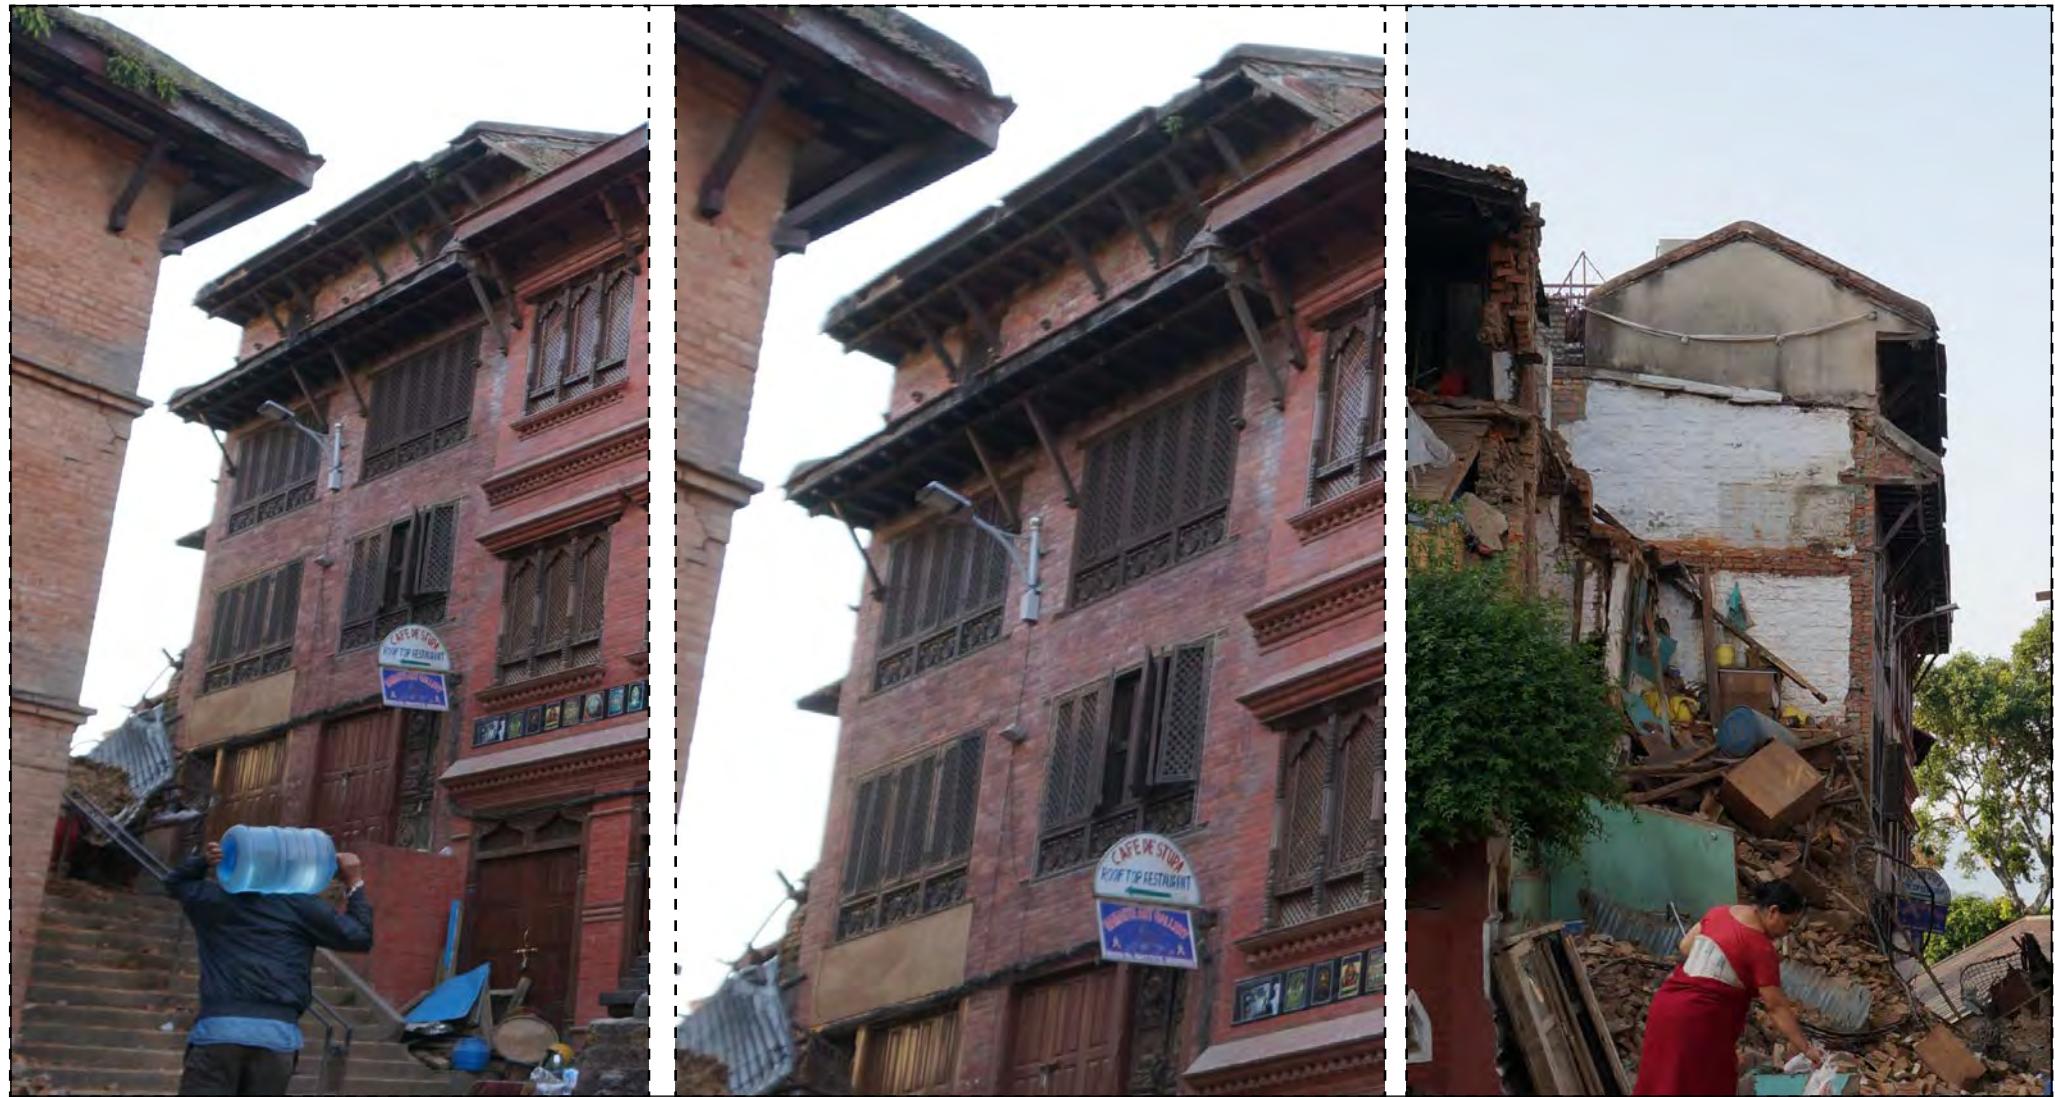
NUMBER NAME	NUMBER OF STOREYS RELATIVE POSITION	STRUCTURAL SYSTEM	DESCRIPTION OF DAMAGE	DANGER DESTROY	HERITAGE SIGNIFICANCE	N ↑
3	G+2	C	No visible damage

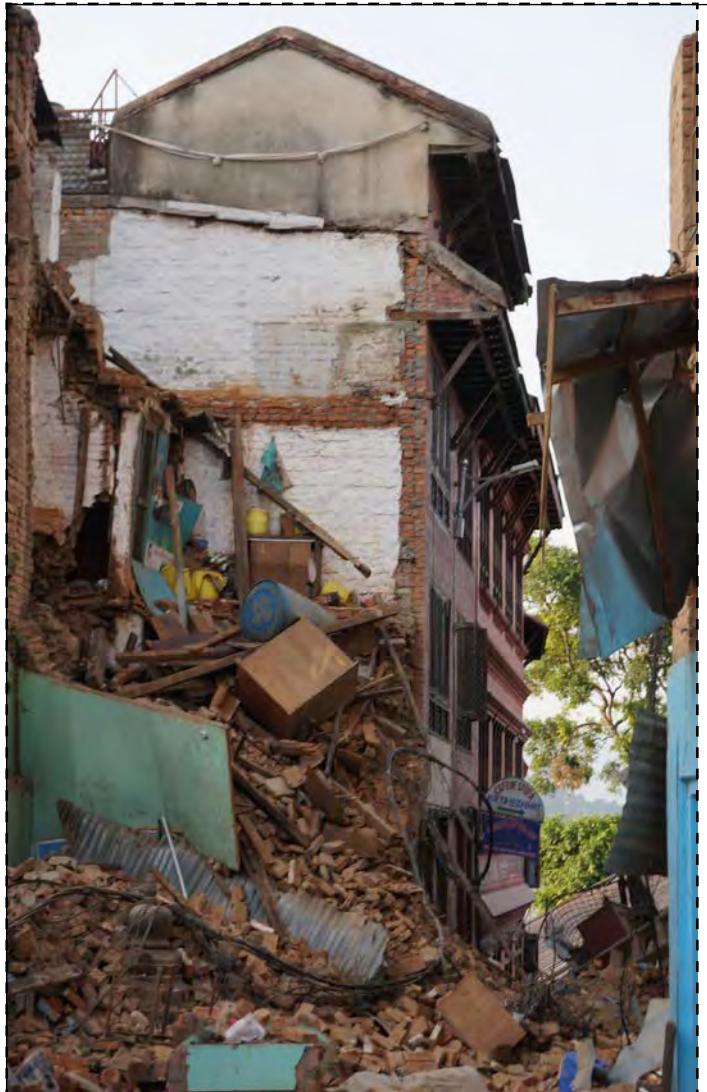
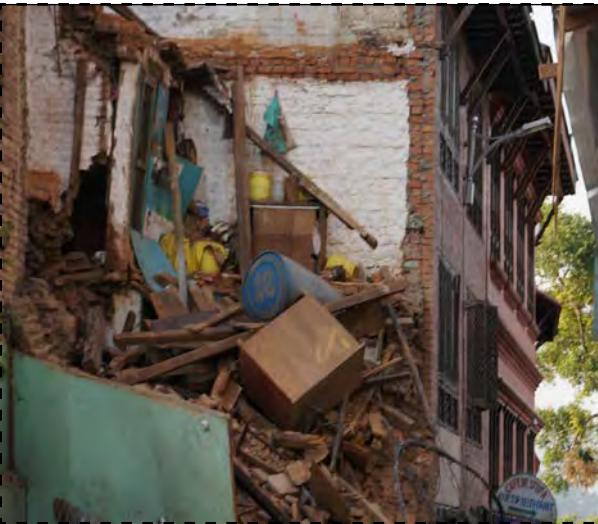
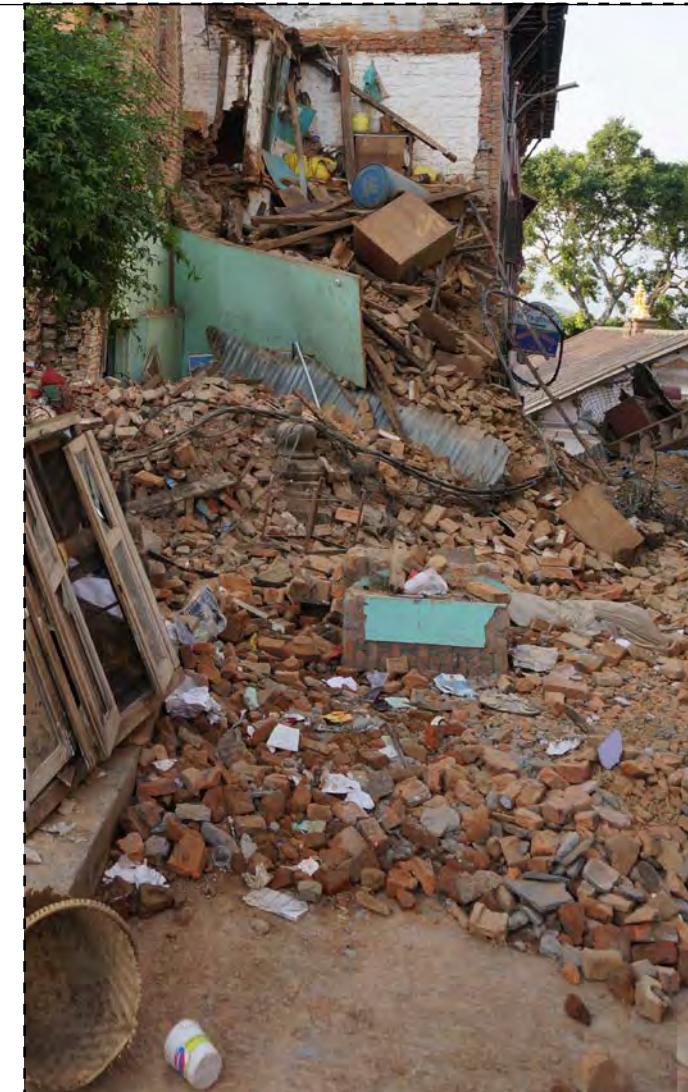
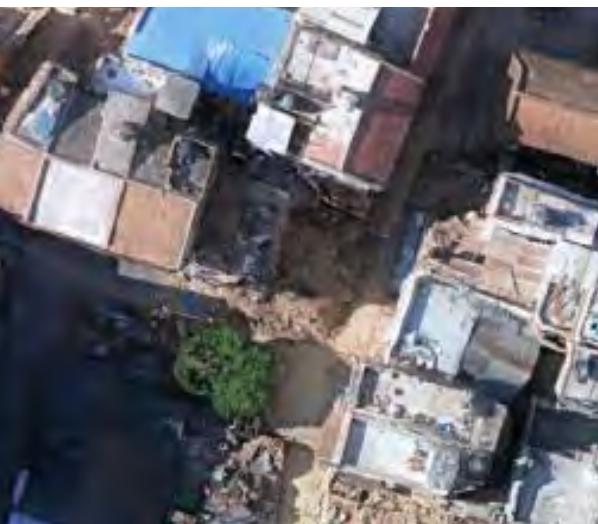
NUMBER NAME	NUMBER OF STORIES RELATIVE POSITION	STRUCTURAL SYSTEM	DESCRIPTION OF DAMAGE	DANGER DESTROY	HERITAGE SIGNIFICANCE	N ↑
4	G+3	C	No visible damage

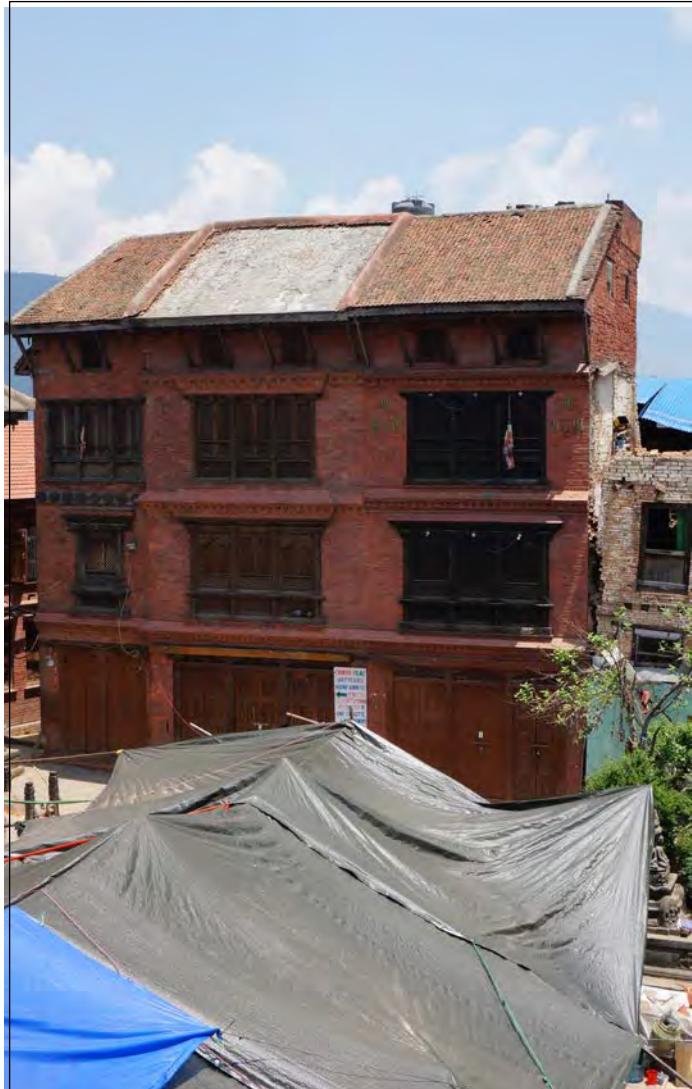
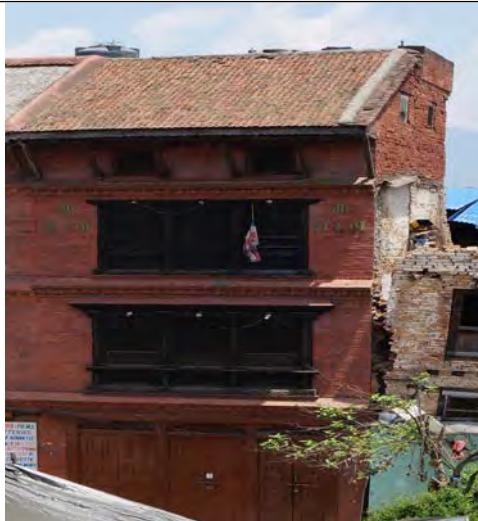
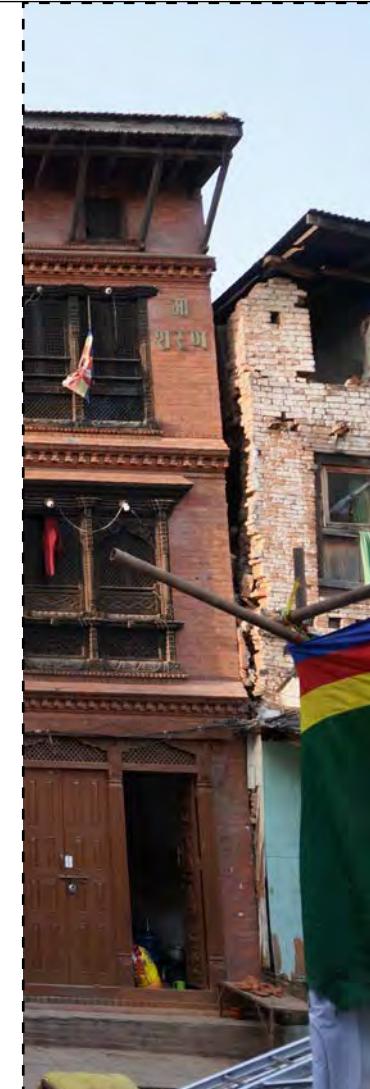
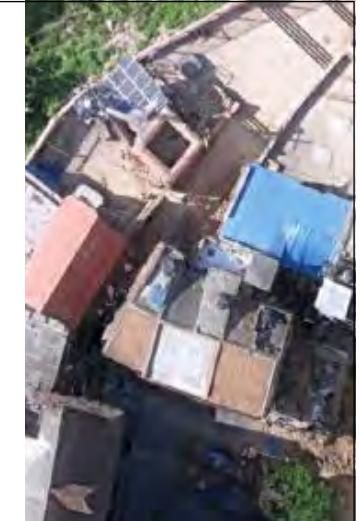
NUMBER NAME	NUMBER OF STORIES RELATIVE POSITION	STRUCTURAL SYSTEM	DESCRIPTION OF DAMAGE	DANGER DESTROY	HERITAGE SIGNIFICANCE	N ↑
6	G+2	B	S-E corner collapsed E wall heavily damaged	1/2 ✗ ⚠

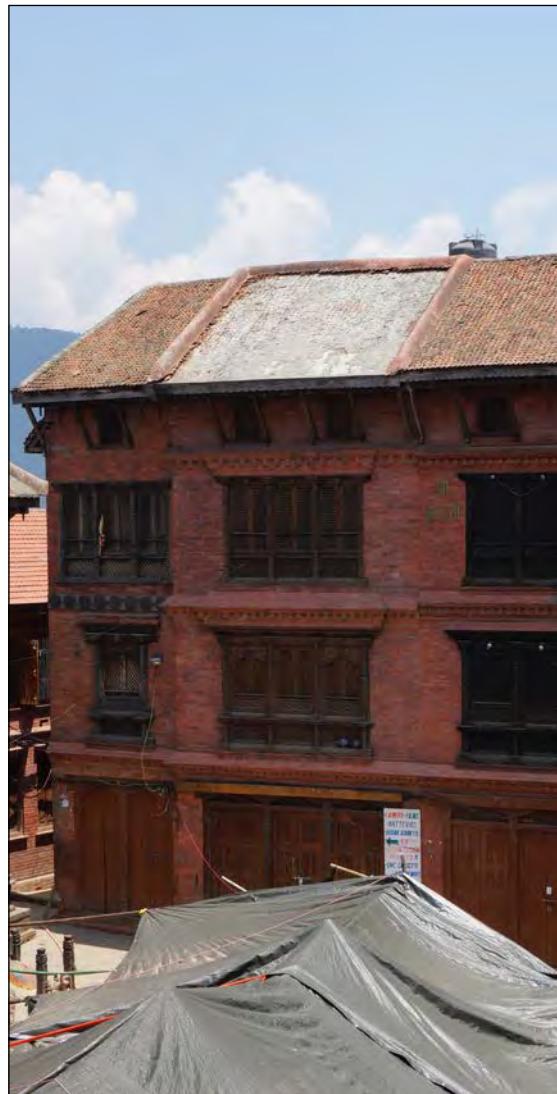
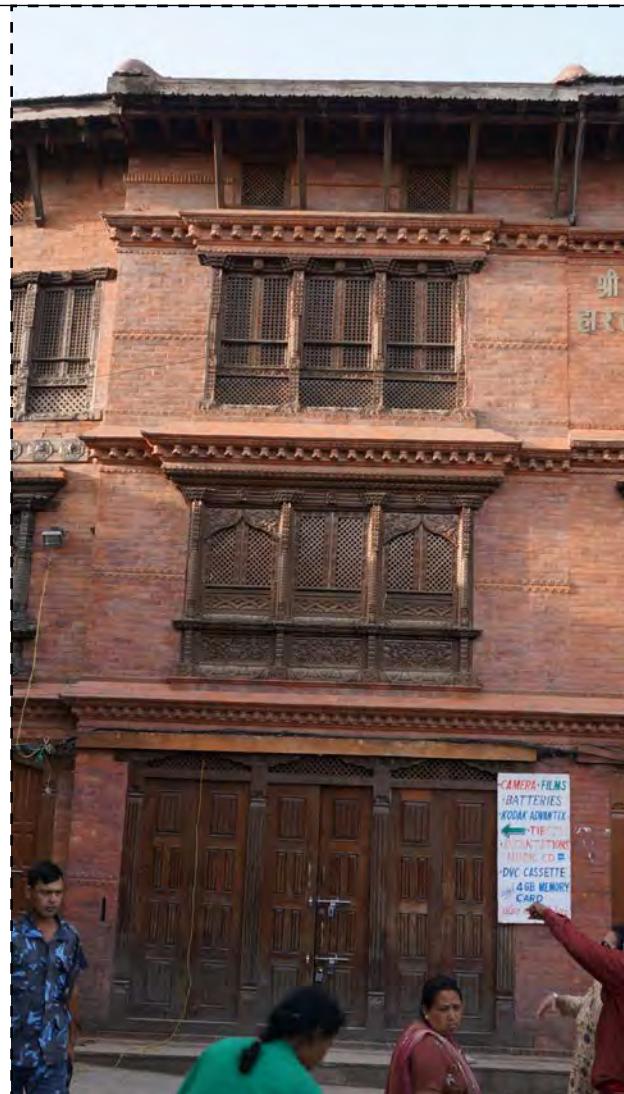
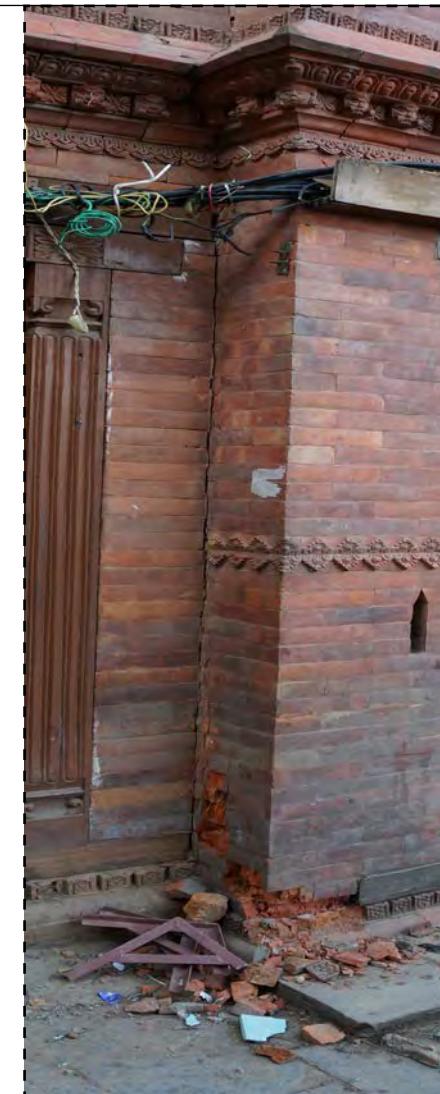
NUMBER NAME	NUMBER OF STORIES RELATIVE POSITION	STRUCTURAL SYSTEM	DESCRIPTION OF DAMAGE	DANGER DESTROY	HERITAGE SIGNIFICANCE	N ↑
8	G+3	C	No visible damage		+

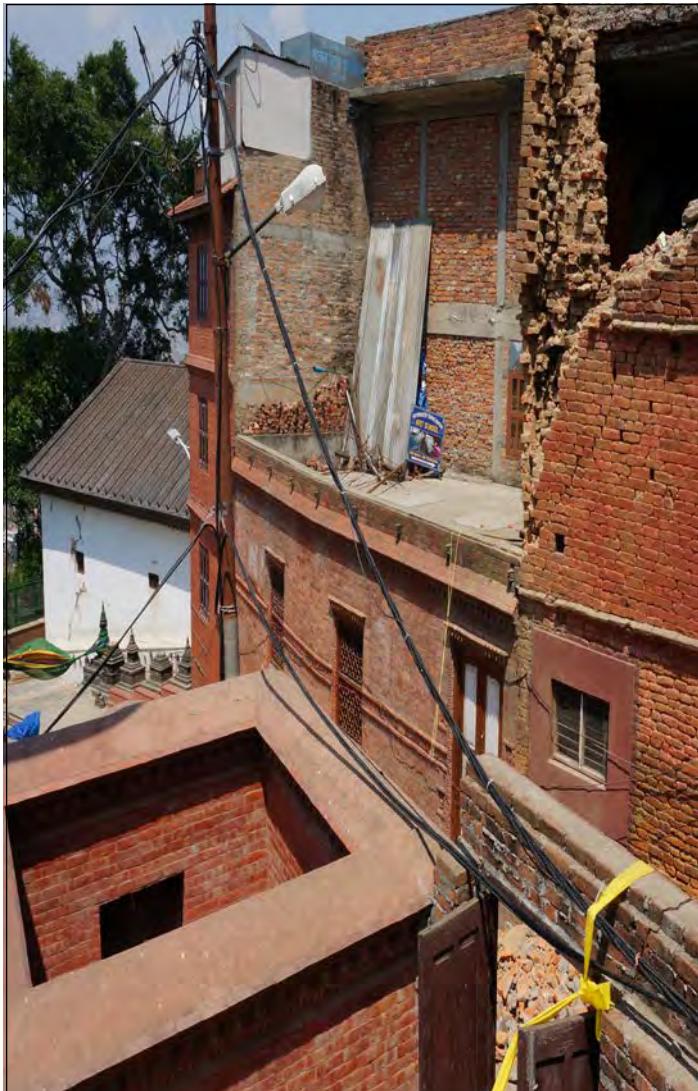
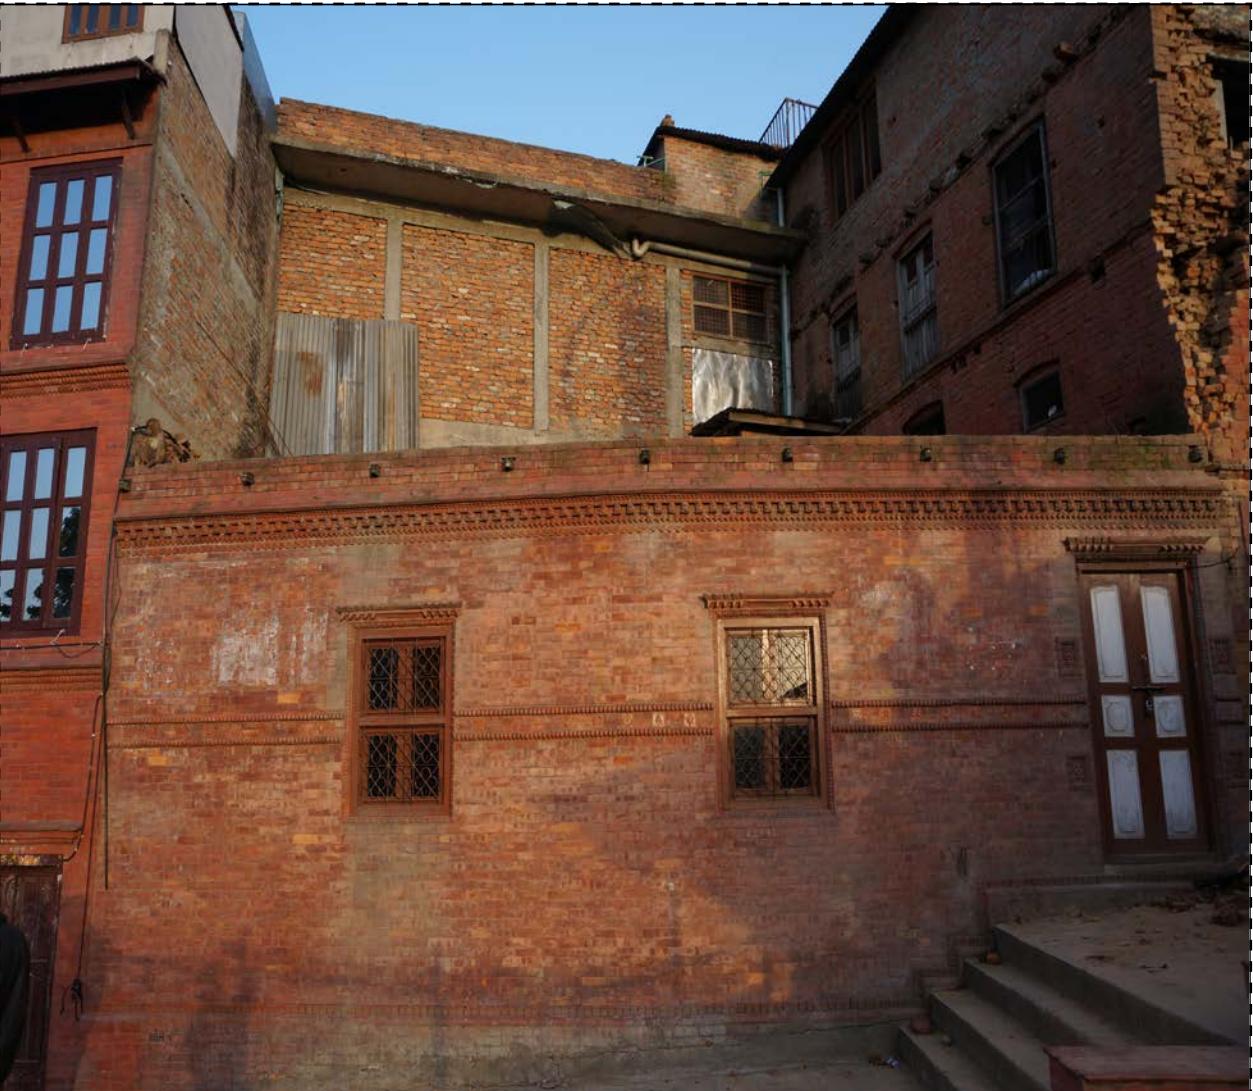
NUMBER NAME	NUMBER OF STORIES RELATIVE POSITION	STRUCTURAL SYSTEM	DESCRIPTION OF DAMAGE	DANGER DESTROY	HERITAGE SIGNIFICANCE	N ↑
10	G+3(EL)	B	W wall partially collapsed N wall heavily bulging out	⚠

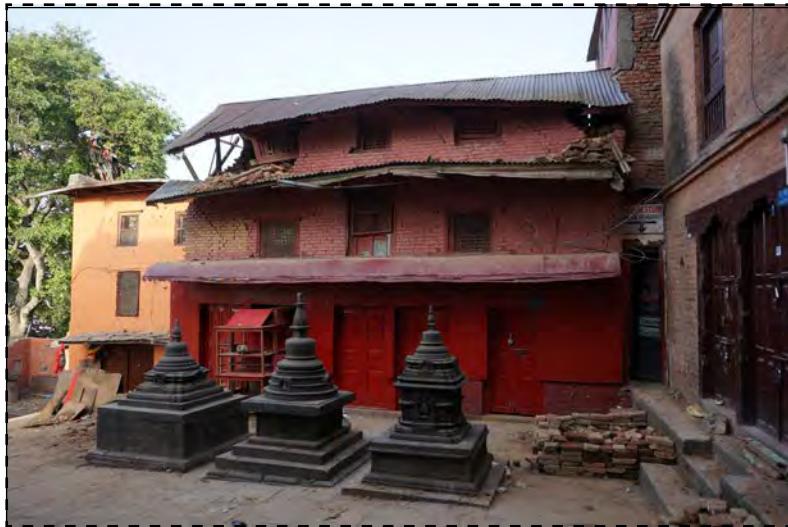
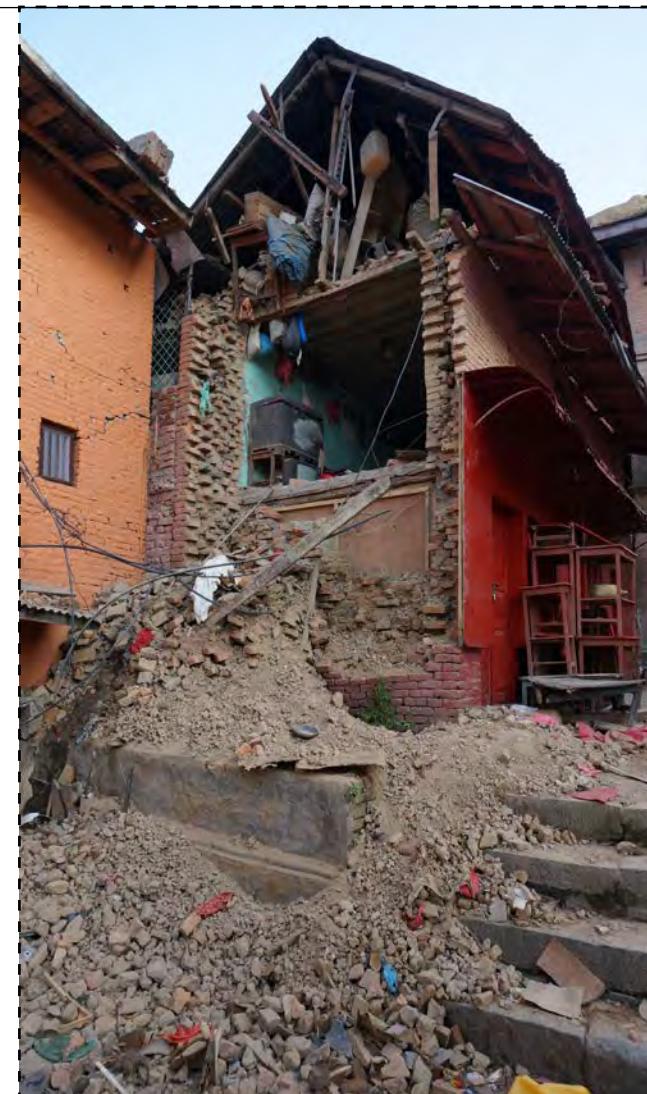
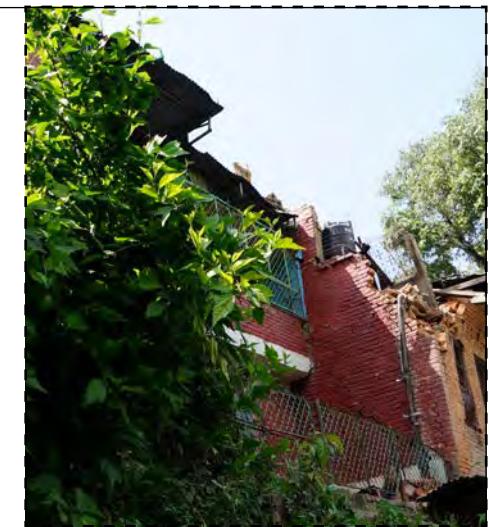
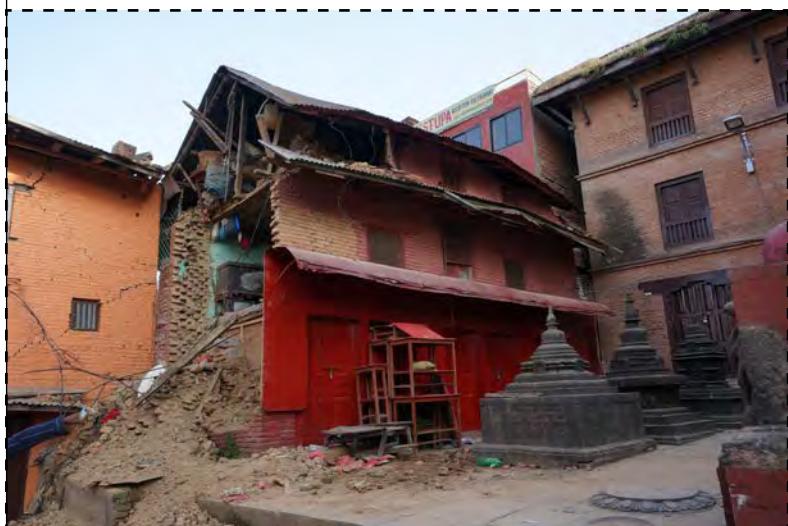
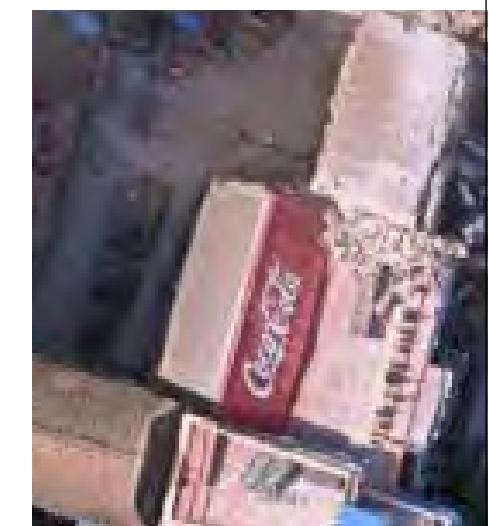
NUMBER NAME	NUMBER OF STORIES RELATIVE POSITION	STRUCTURAL SYSTEM	DESCRIPTION OF DAMAGE	DANGER DESTROY	HERITAGE SIGNIFICANCE	N ↑
12	G+2	B	N wall is collapsed W wall with severe cracks (Mostly vertical and diagonal cracks)
