2015 Earthquake Damage Mapping

Swayambhu Monument Zone
Kathmandu Valley World Heritage Property

Submitted to UNESCO by

June 2015

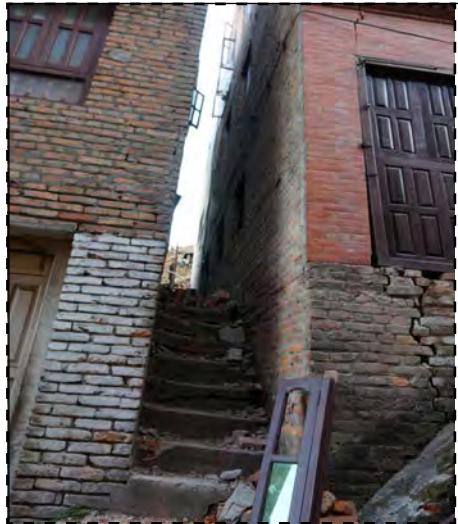
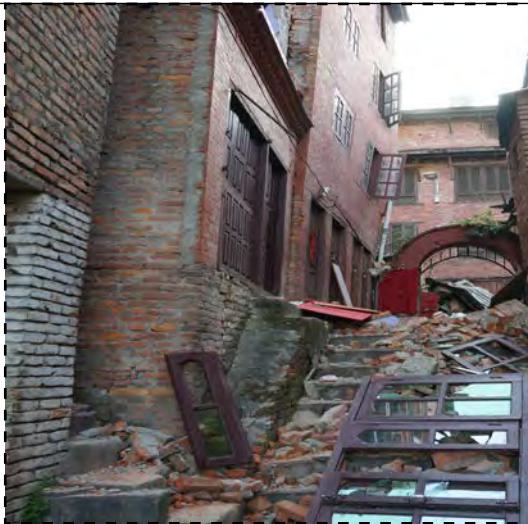
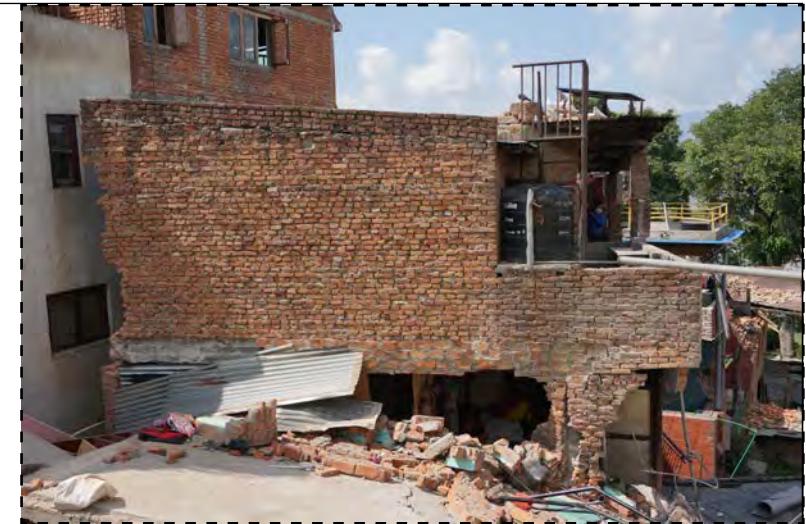
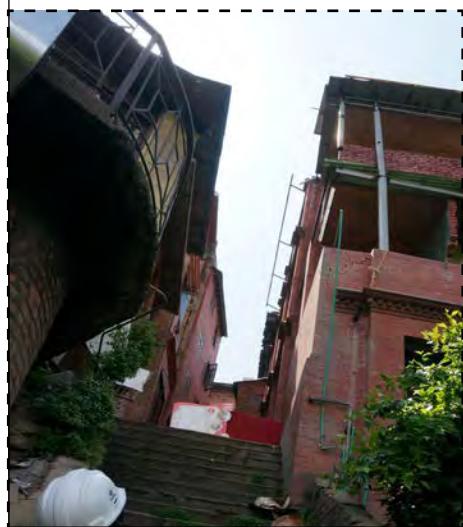
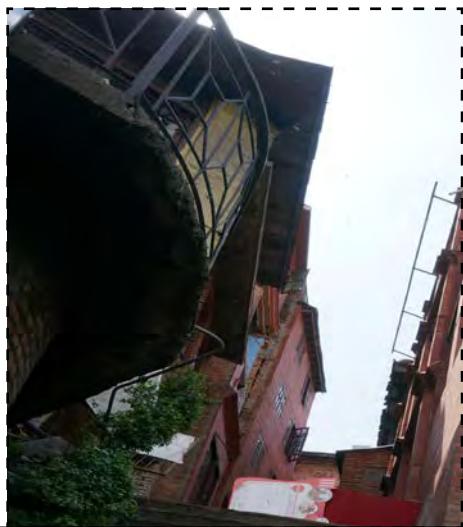
NUMBER NAME	NUMBER OF STOREYS RELATIVE POSITION	STRUCTURAL SYSTEM	DESCRIPTION OF DAMAGE	DANGER DESTROY	HERITAGE SIGNIFICANCE	N ↑
15	G+2	B	Foundation in unstable condition Half portion of building about to fall on E side	⚠

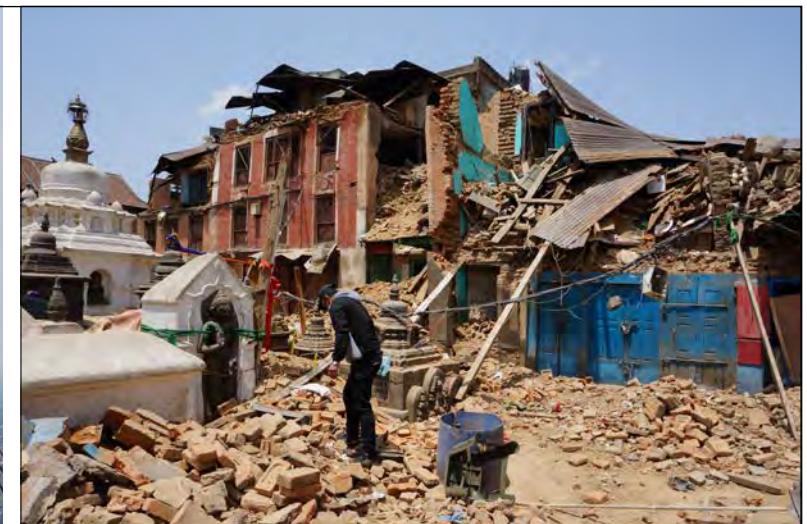
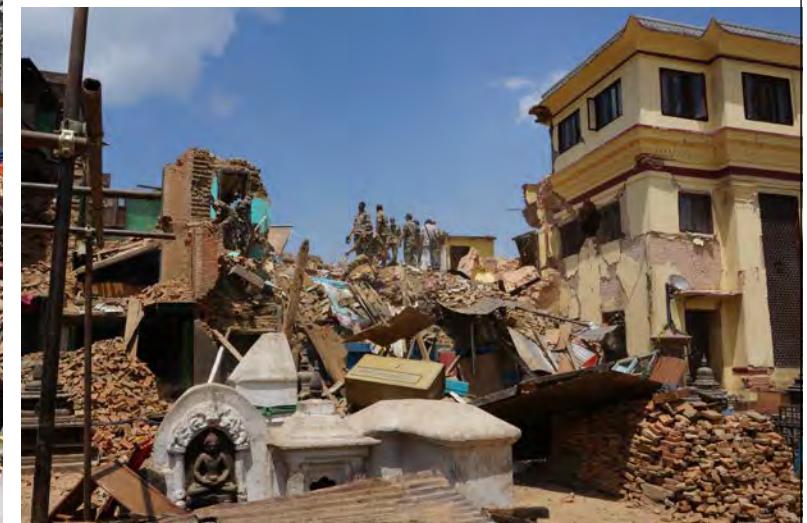
NUMBER NAME	NUMBER OF STORIES RELATIVE POSITION	STRUCTURAL SYSTEM	DESCRIPTION OF DAMAGE	DANGER DESTROY	HERITAGE SIGNIFICANCE	N ↑
16	G+2	B	E wall damaged Inner portion were not possible to make an assessment	⚠

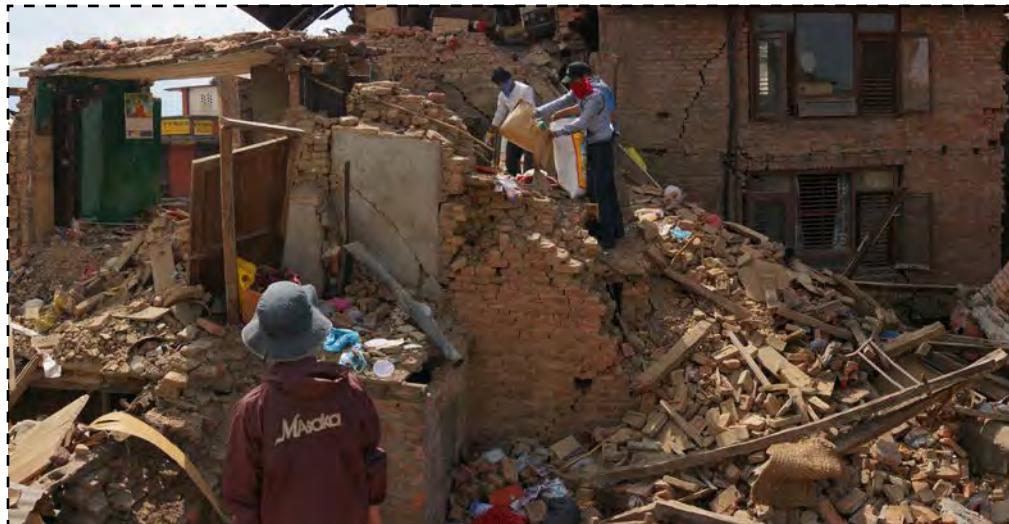
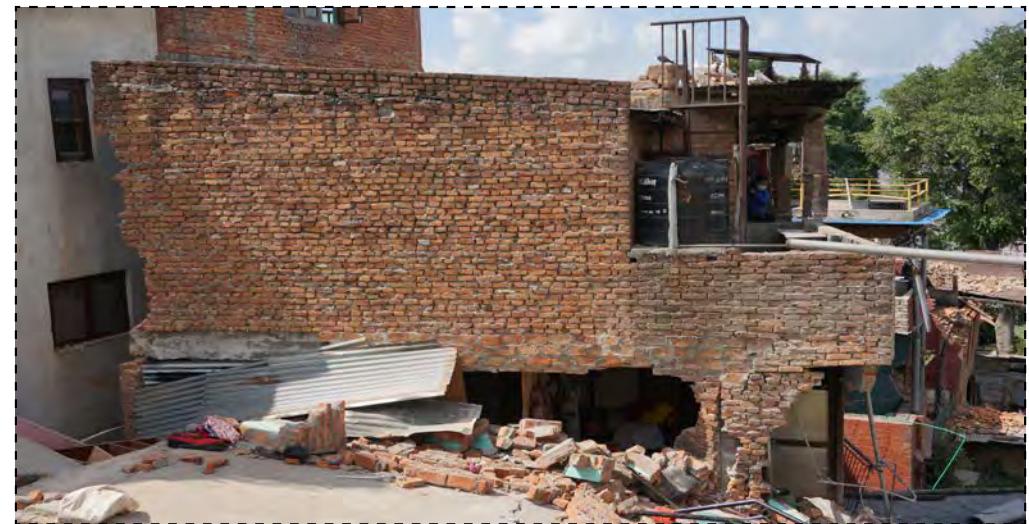
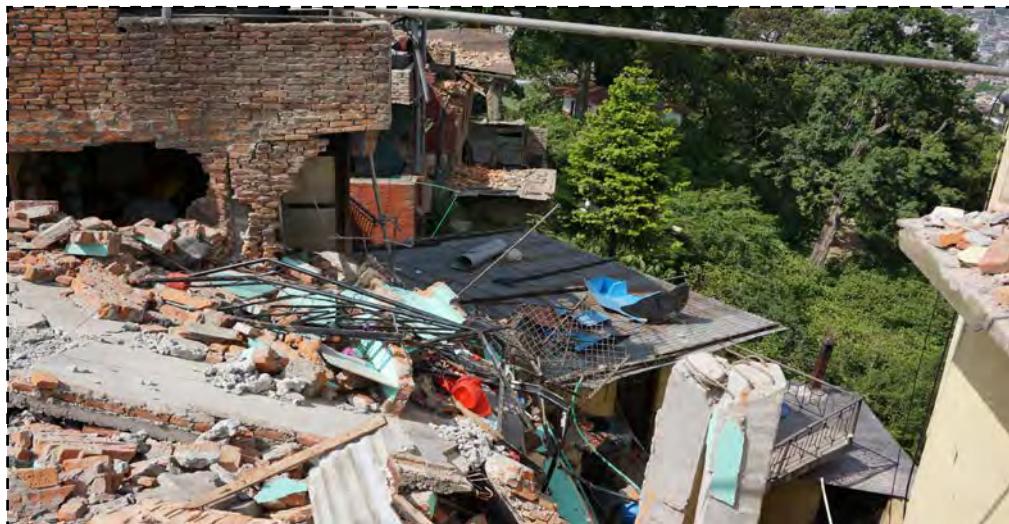
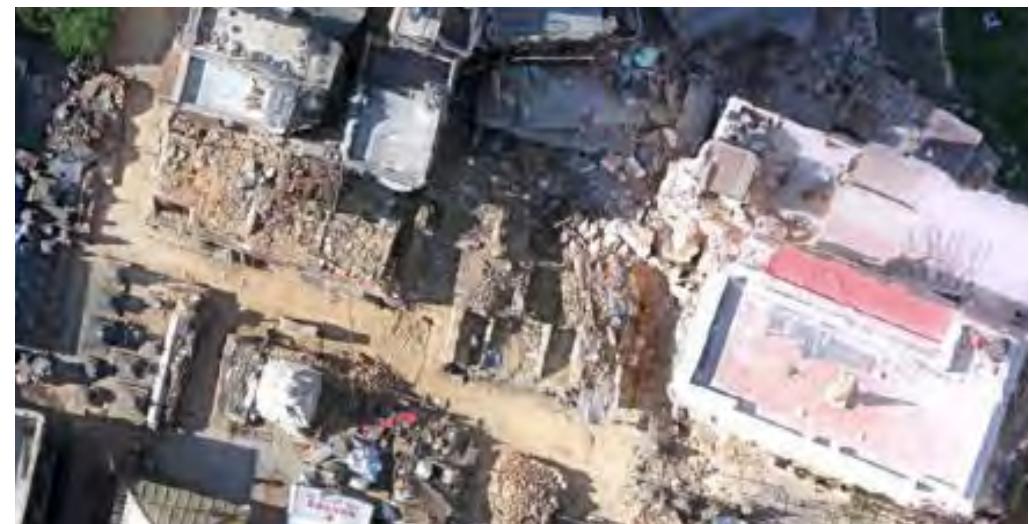
NUMBER NAME	NUMBER OF STOREYS RELATIVE POSITION	STRUCTURAL SYSTEM	DESCRIPTION OF DAMAGE	DANGER DESTROY	HERITAGE SIGNIFICANCE	N ↑
17 18 19 29 30 31 32 33	G+2	B	Totally collapsed	☒

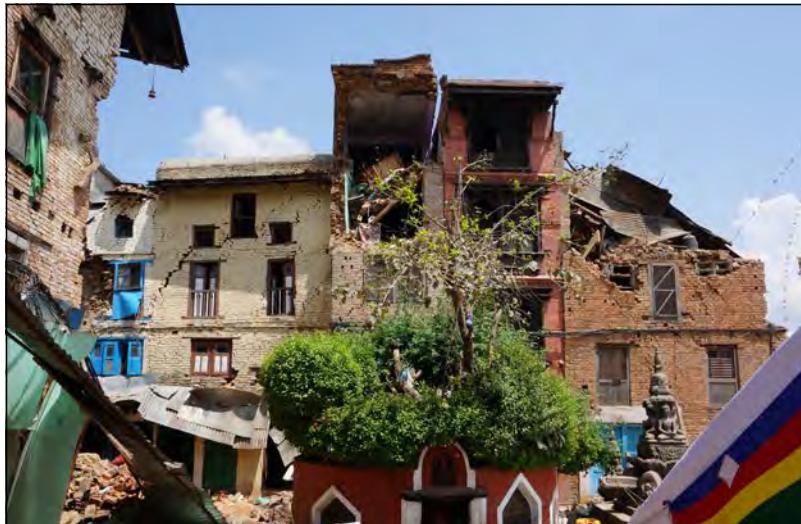
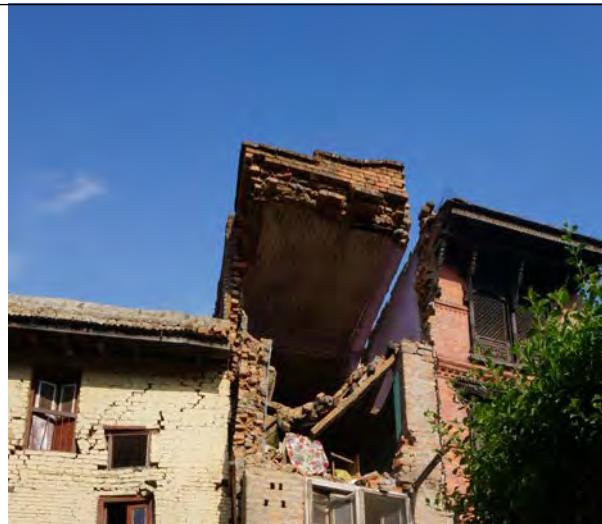
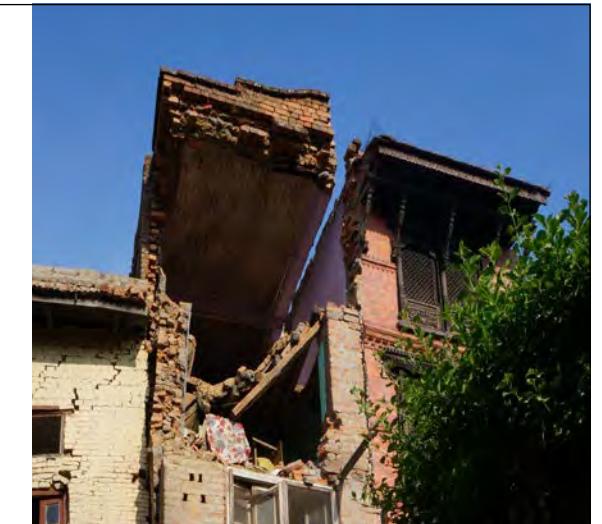
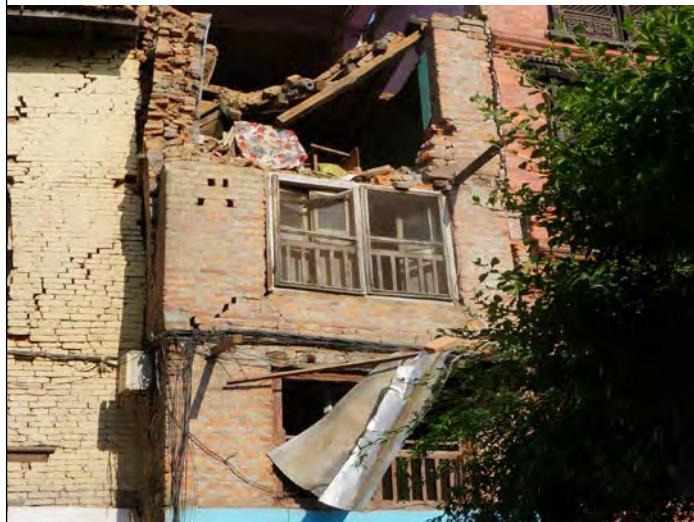
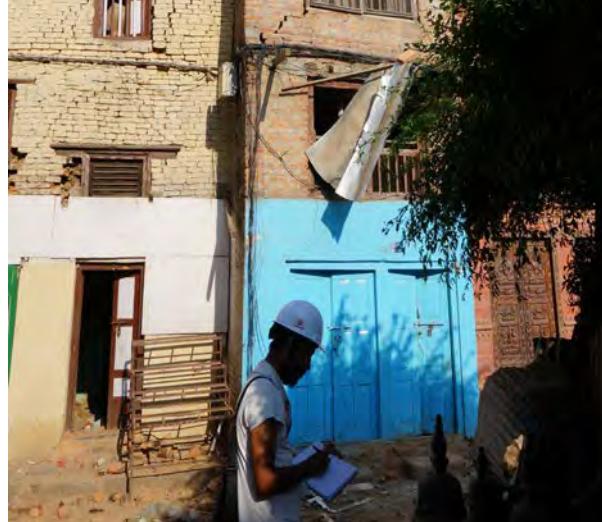
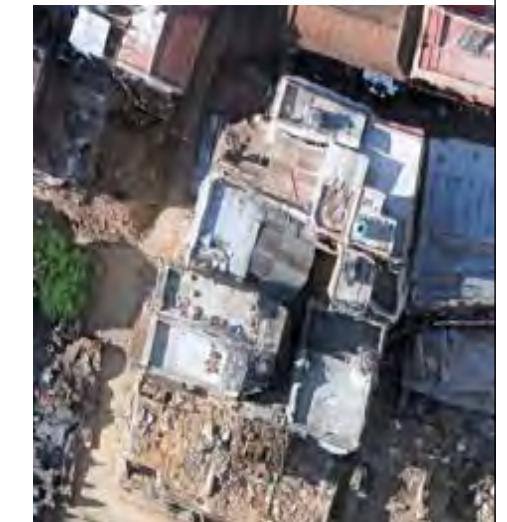
NUMBER NAME	NUMBER OF STORIES RELATIVE POSITION	STRUCTURAL SYSTEM	DESCRIPTION OF DAMAGE	DANGER DESTROY	HERITAGE SIGNIFICANCE	N ↑
24	G+2	B	W wall bulging and cracks	⚠

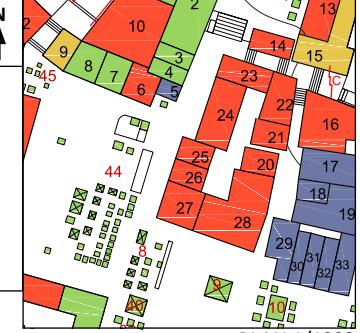
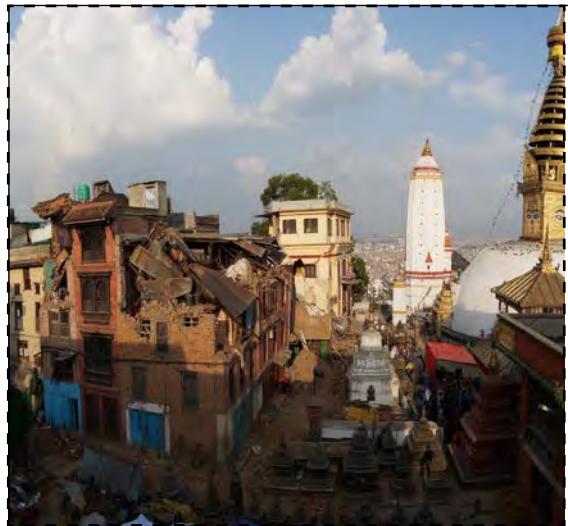
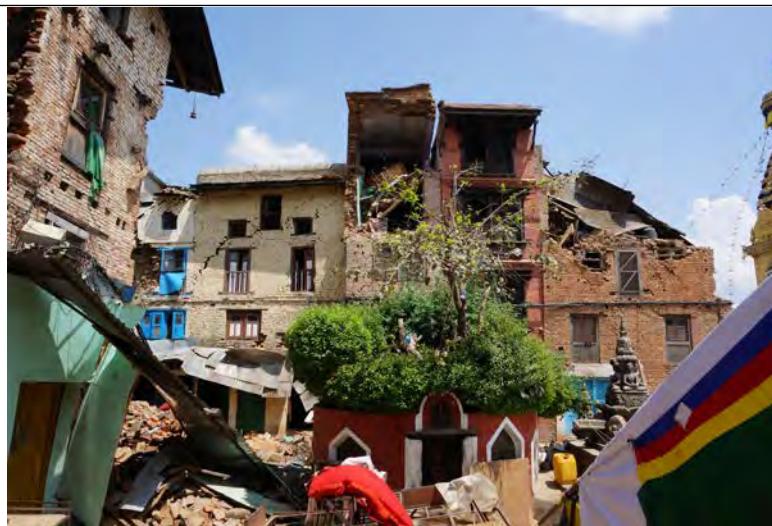
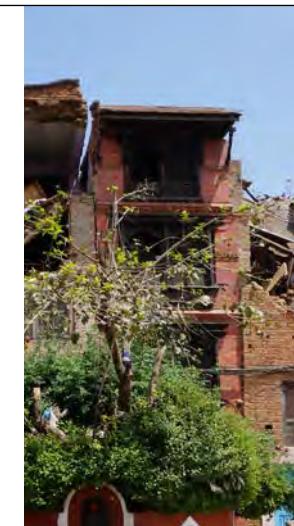
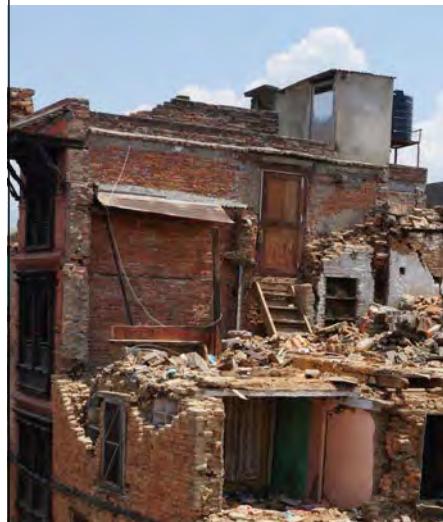
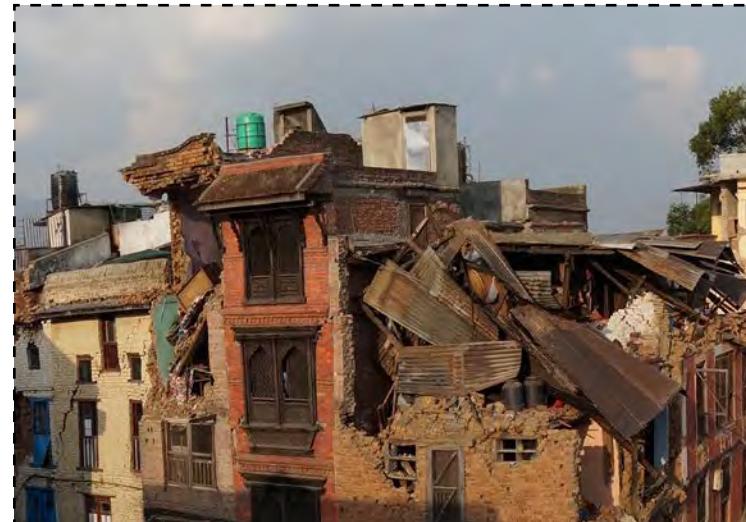
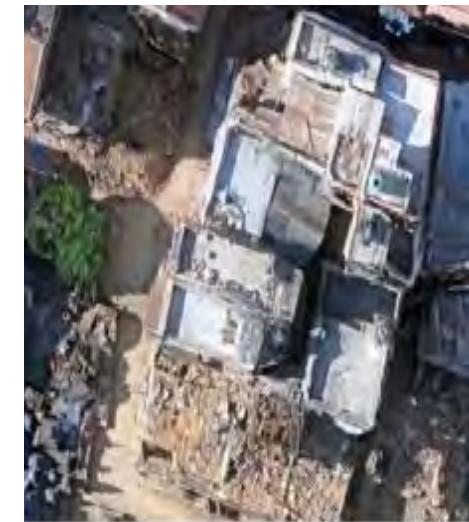
NUMBER NAME	NUMBER OF STOREYS RELATIVE POSITION	STRUCTURAL SYSTEM	DESCRIPTION OF DAMAGE	DANGER DESTROY	HERITAGE SIGNIFICANCE	N ↑
25	G+4	B	Partly collapsed Upper roof is hanging 3rd and 4th floor is collapsed	⚠

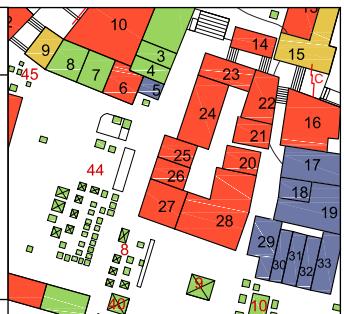
NUMBER NAME	NUMBER OF STORIES RELATIVE POSITION	STRUCTURAL SYSTEM	DESCRIPTION OF DAMAGE	DANGER DESTROY	HERITAGE SIGNIFICANCE	N ↑
26	G+3	B	W wall partly damaged		+

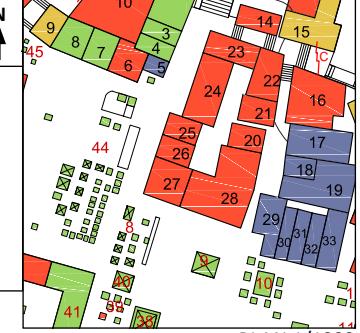
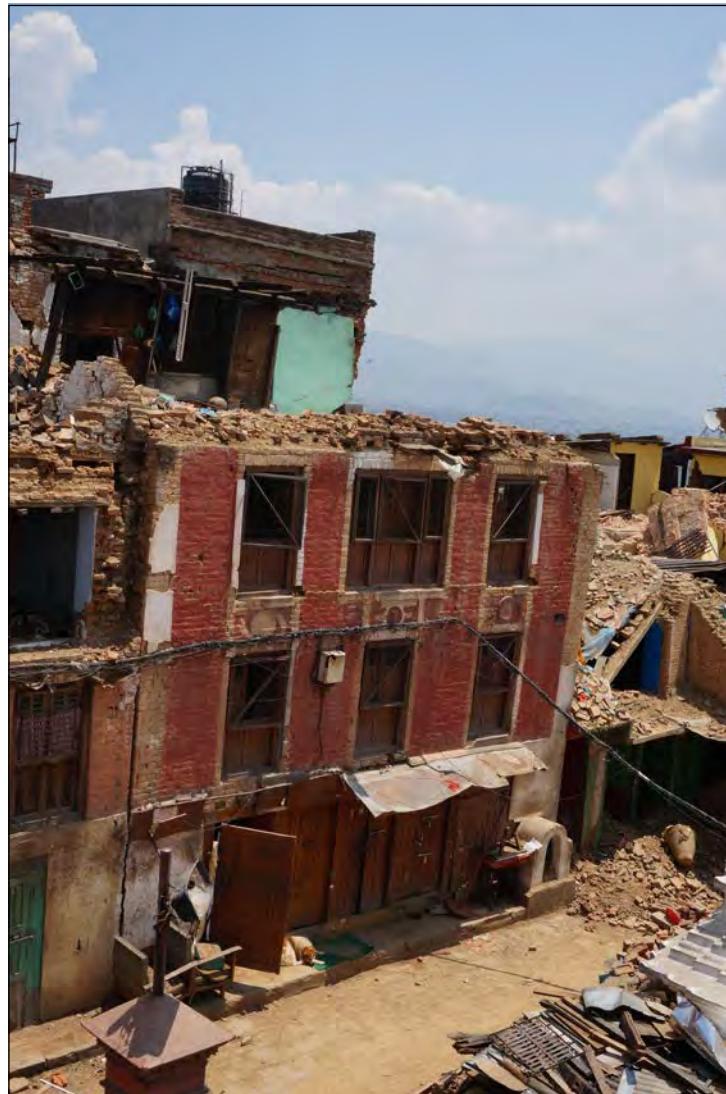
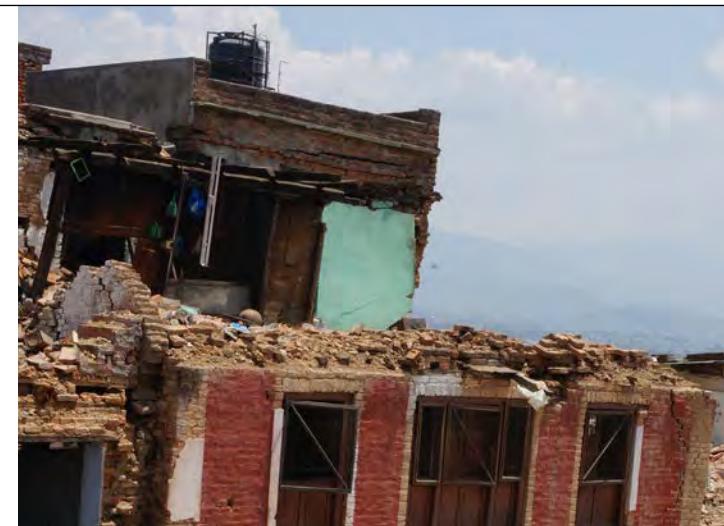
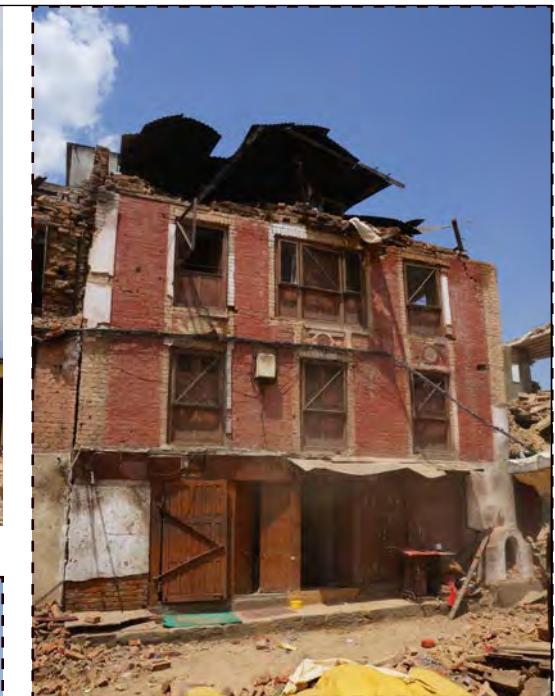
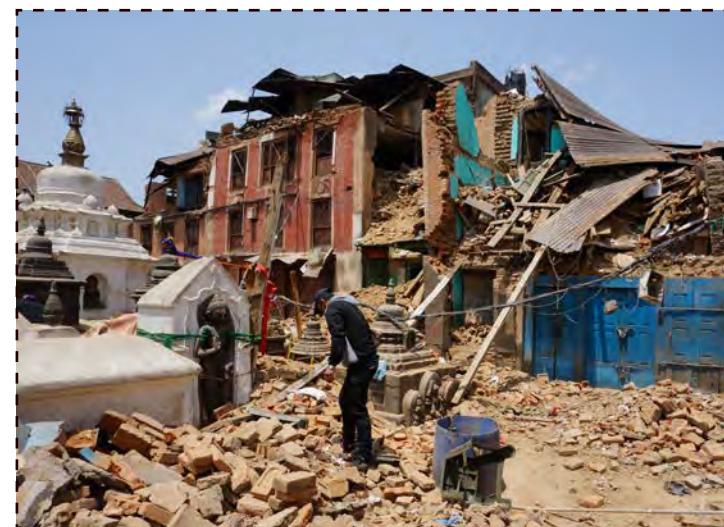
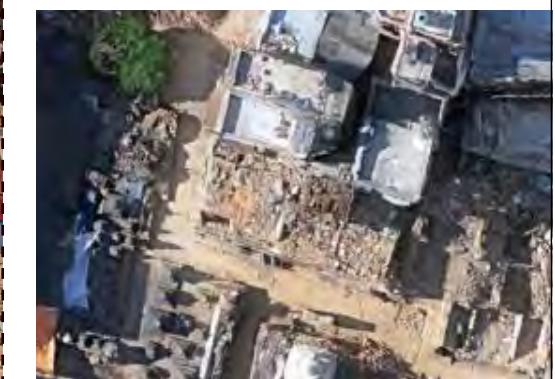
NUMBER NAME	NUMBER OF STOREYS RELATIVE POSITION	STRUCTURAL SYSTEM	DESCRIPTION OF DAMAGE	DANGER DESTROY	HERITAGE SIGNIFICANCE	N ↑
27	G+3	B	2nd, 3rd and 4th floor collapsed Bulging problem	⚠

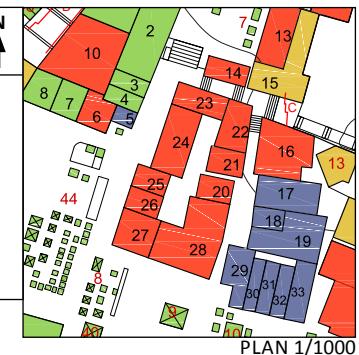
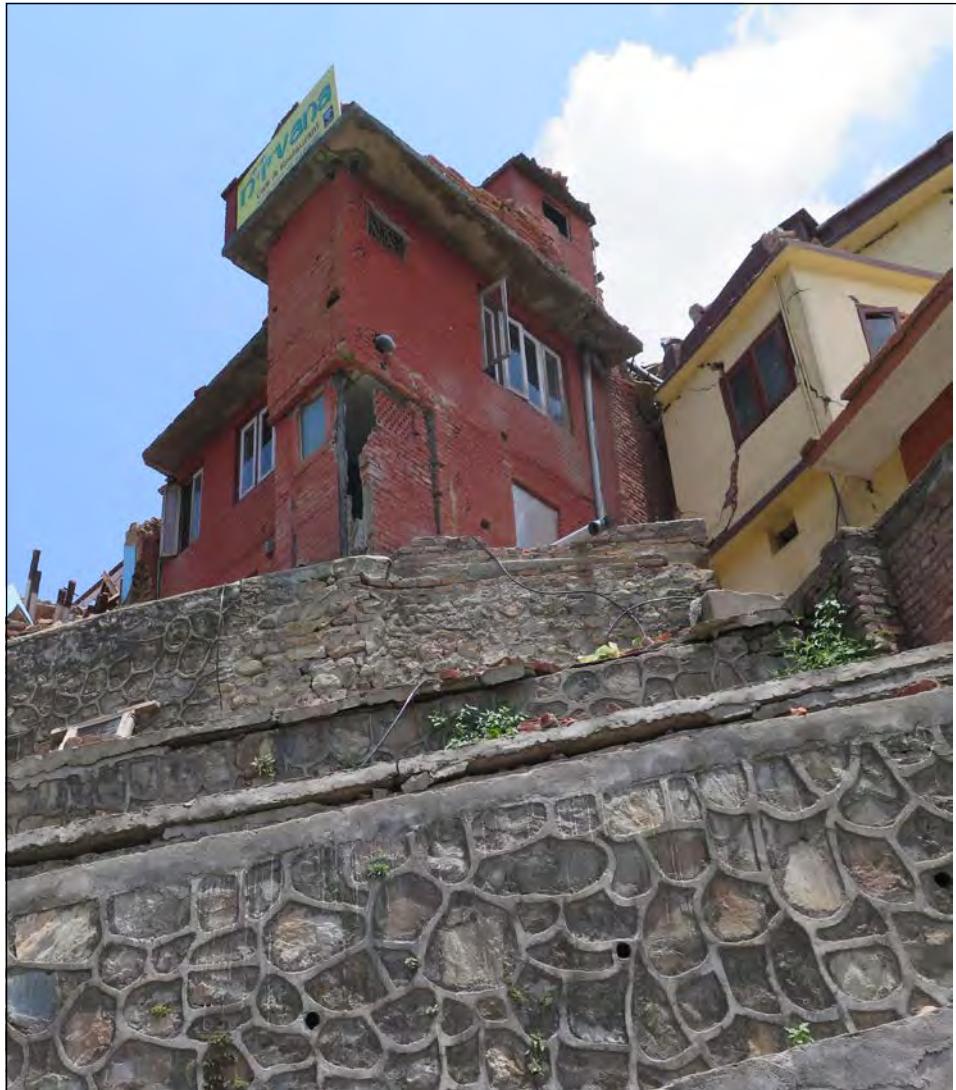
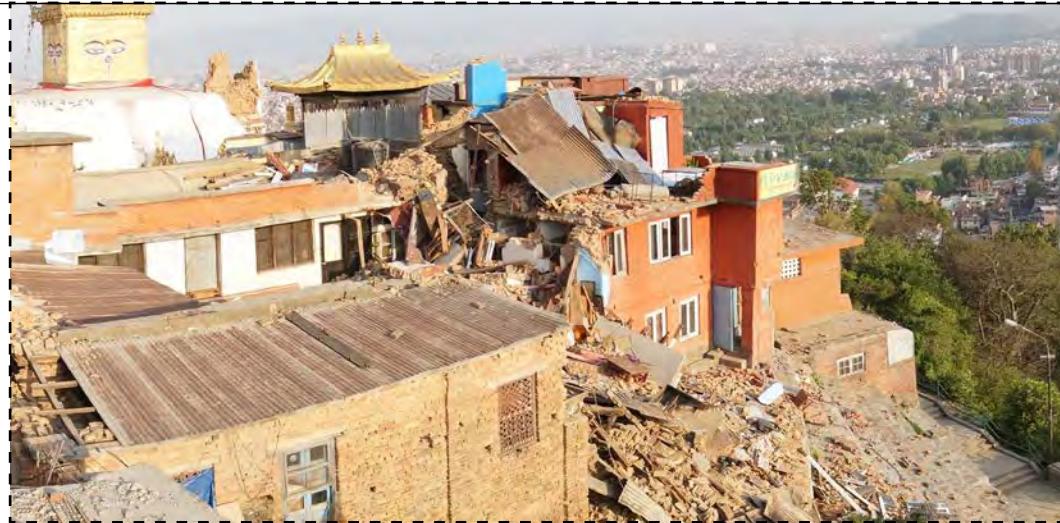
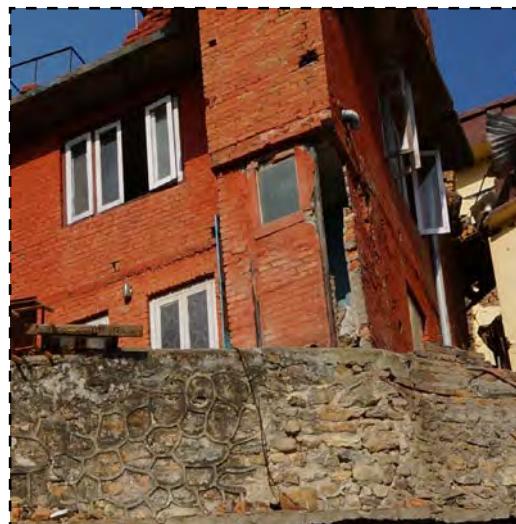
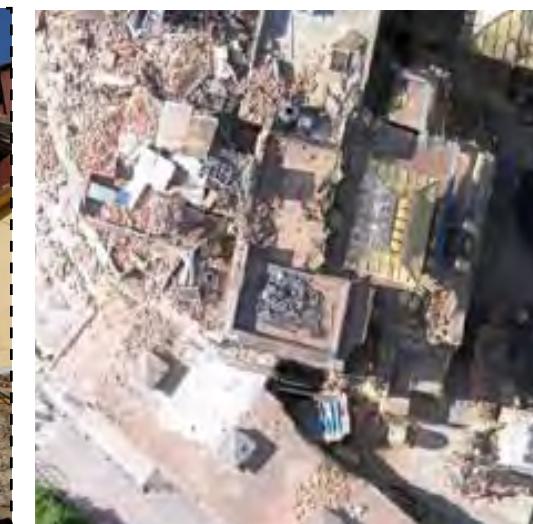
NUMBER NAME	NUMBER OF STORIES RELATIVE POSITION	STRUCTURAL SYSTEM	DESCRIPTION OF DAMAGE	DANGER DESTROY	HERITAGE SIGNIFICANCE	N ↑
20		C				
21						
28	G+3	B	Upper floor collapsed E wall 1/2 collapsed	⚠

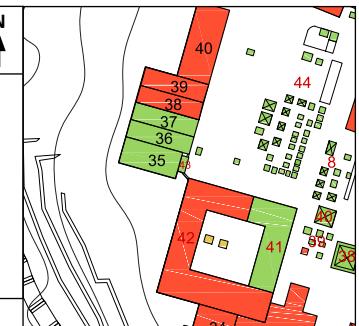
NUMBER NAME	NUMBER OF STORIES RELATIVE POSITION	STRUCTURAL SYSTEM	DESCRIPTION OF DAMAGE	DANGER DESTROY	HERITAGE SIGNIFICANCE	N ↑
35	G+3	C	Major X-shaped cracks in inner walls

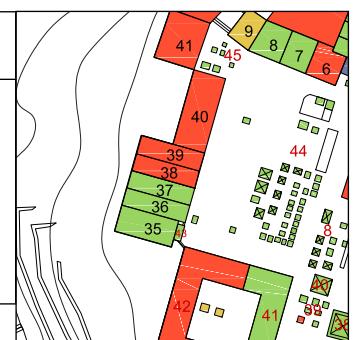
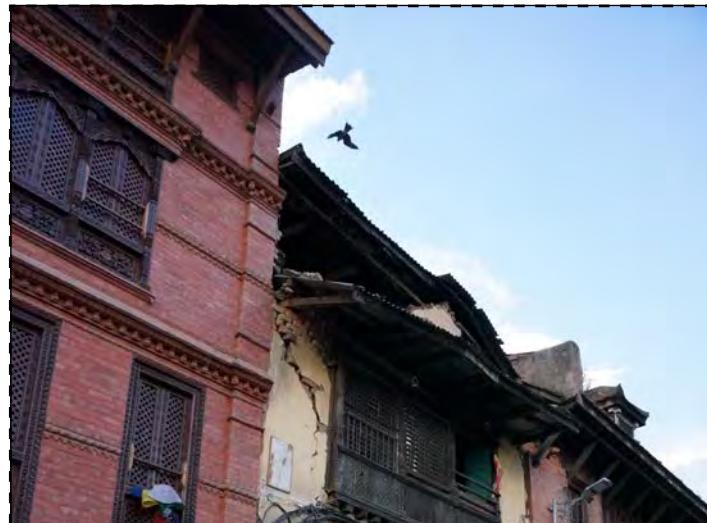
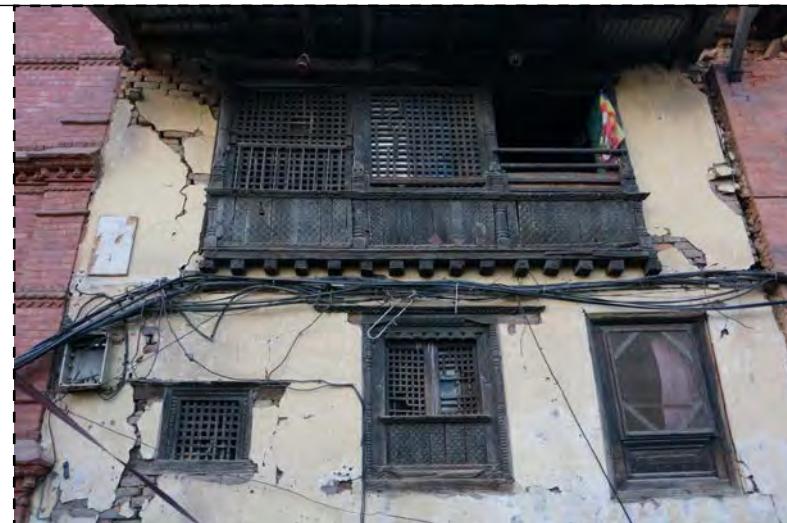
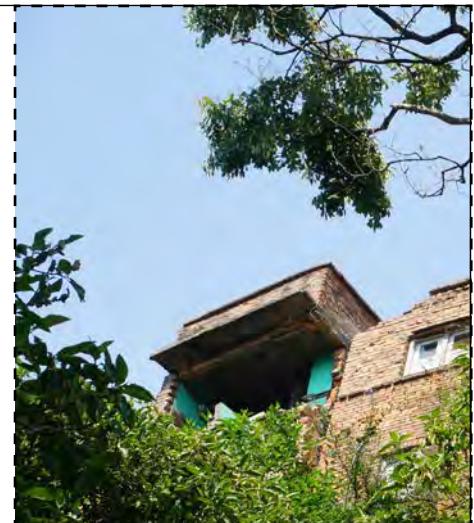
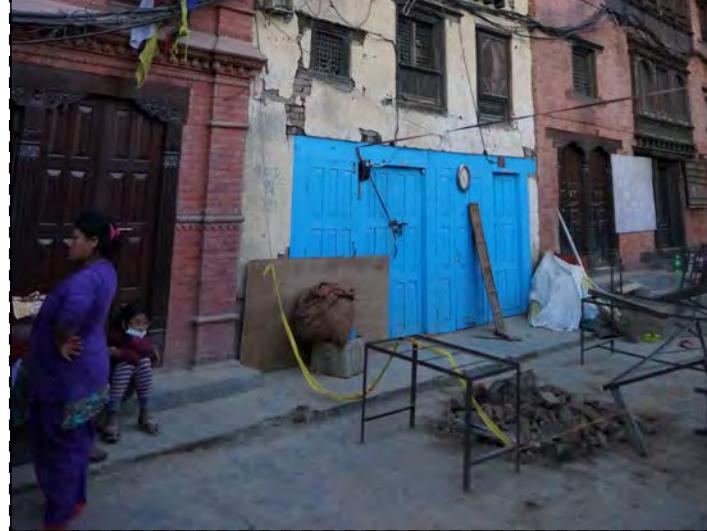
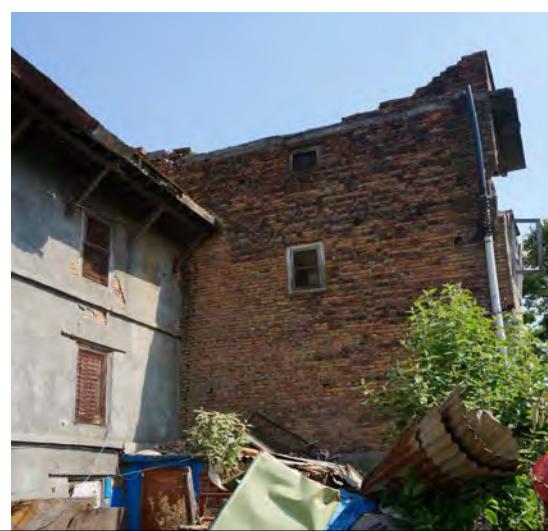
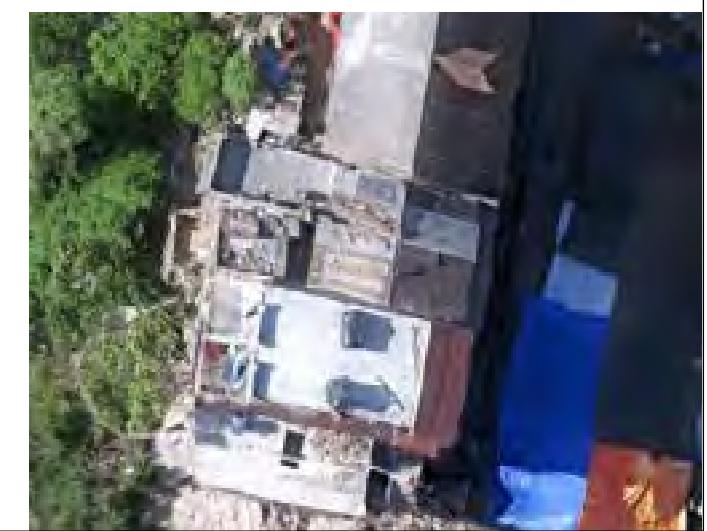
NUMBER NAME	NUMBER OF STOREYS RELATIVE POSITION	STRUCTURAL SYSTEM	DESCRIPTION OF DAMAGE	DANGER DESTROY	HERITAGE SIGNIFICANCE	N ↑
36	G+3	C	Major X-shaped cracks in inner walls		+	
37

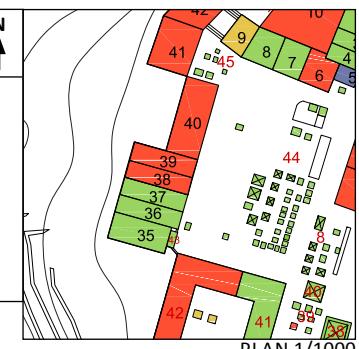
NUMBER NAME	NUMBER OF STORIES RELATIVE POSITION	STRUCTURAL SYSTEM	DESCRIPTION OF DAMAGE	DANGER DESTROY	HERITAGE SIGNIFICANCE	N ↑
38	G+3	B	Major X-shaped cracks in inner walls of House no 38 E wall heavily damaged and Bricks from roof and terrace about to fall on house no 39	⚠	+	
39

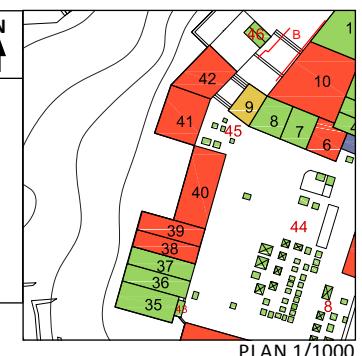
NUMBER NAME	NUMBER OF STOREYS RELATIVE POSITION	STRUCTURAL SYSTEM	DESCRIPTION OF DAMAGE	DANGER DESTROY	HERITAGE SIGNIFICANCE	N ↑
40	G+2	C	N wall with major stepped cracks E wall with stepped cracks from window corners Upper left part of E wall with risk of falling wall bricks		+

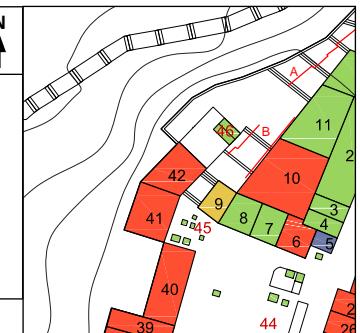
NUMBER NAME	NUMBER OF STOREYS RELATIVE POSITION	STRUCTURAL SYSTEM	DESCRIPTION OF DAMAGE	DANGER DESTROY	HERITAGE SIGNIFICANCE	N ↑
42	G+1	B	N wall with major horizontal floor cracks Offset of walls About to collapsed	⚠

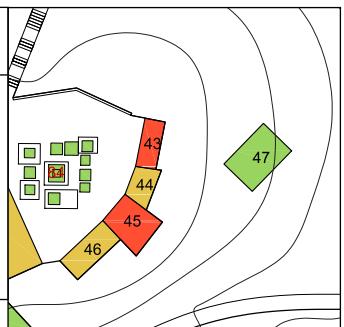
NUMBER NAME	NUMBER OF STORIES RELATIVE POSITION	STRUCTURAL SYSTEM	DESCRIPTION OF DAMAGE	DANGER DESTROY	HERITAGE SIGNIFICANCE	N ↑
43	G+2	B	Half collapsed Imposing danger to neighboring house	⚠ 1/2 ✗

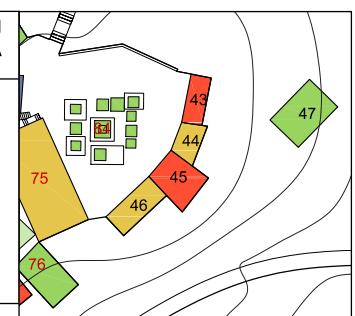
NUMBER NAME	NUMBER OF STORIES RELATIVE POSITION	STRUCTURAL SYSTEM	DESCRIPTION OF DAMAGE	DANGER DESTROY	HERITAGE SIGNIFICANCE	N ↑
45	G+2	B	Standing but in critical state and inner part heavily damaged according to American nun living there for 39 years.

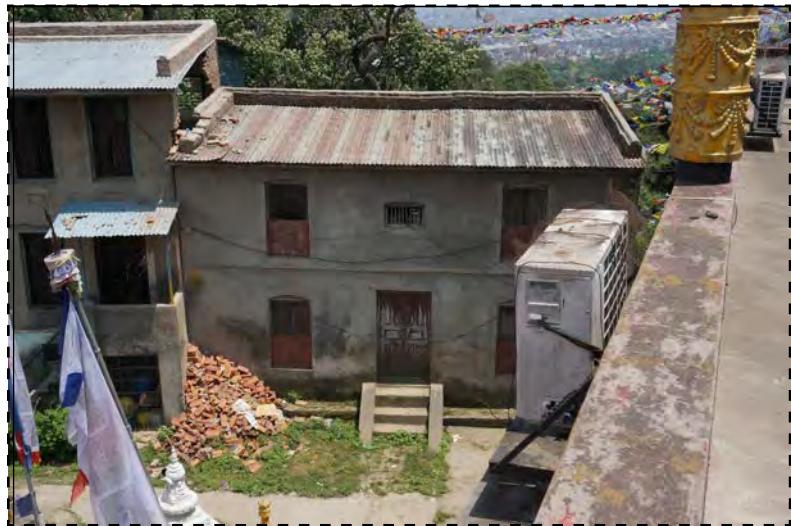
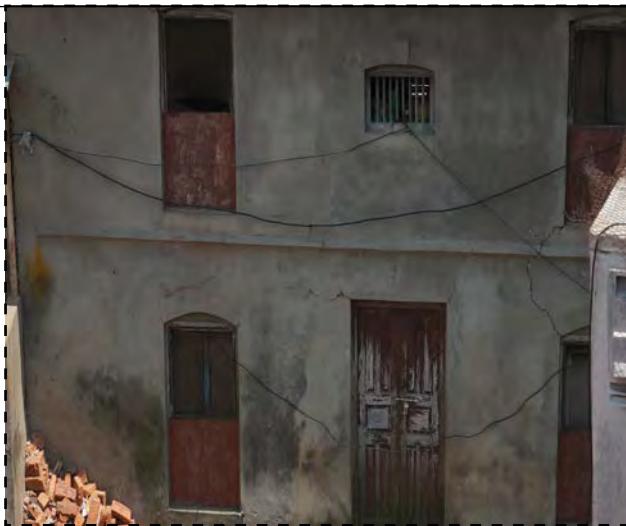
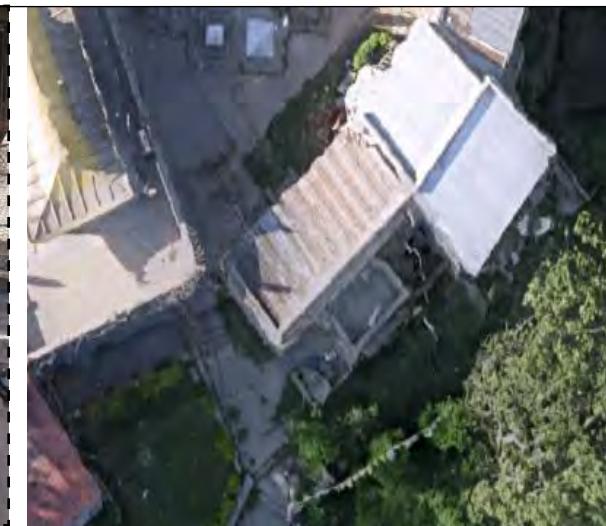
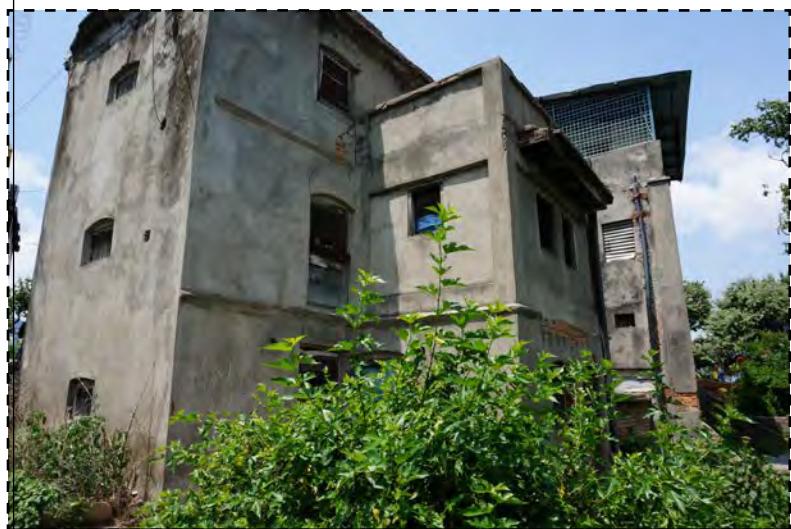
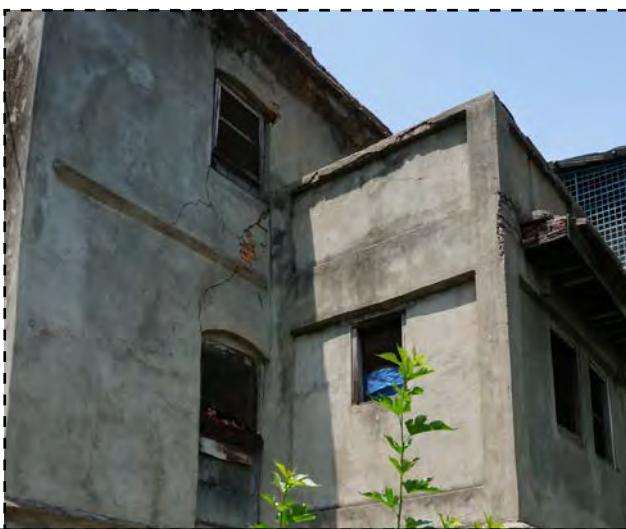
NUMBER NAME	NUMBER OF STOREYS RELATIVE POSITION	STRUCTURAL SYSTEM	DESCRIPTION OF DAMAGE	DANGER DESTROY	HERITAGE SIGNIFICANCE	N ↑
46	G+2	B	Standing but in critical state and inner part heavily damaged

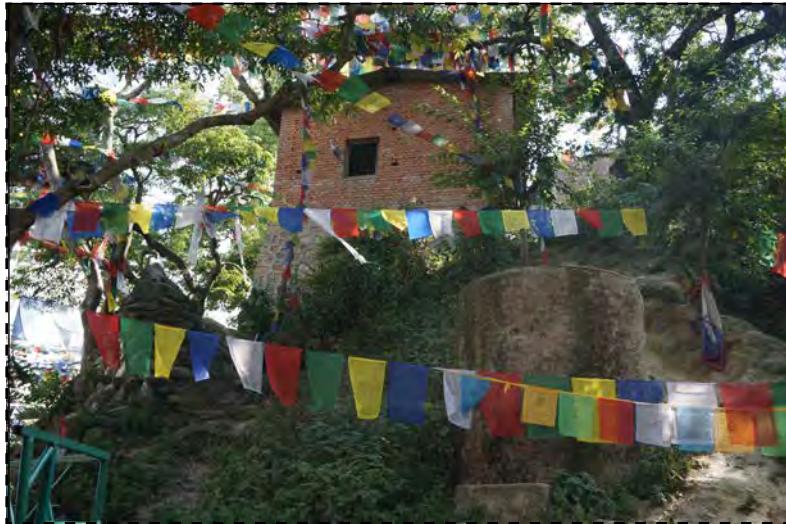
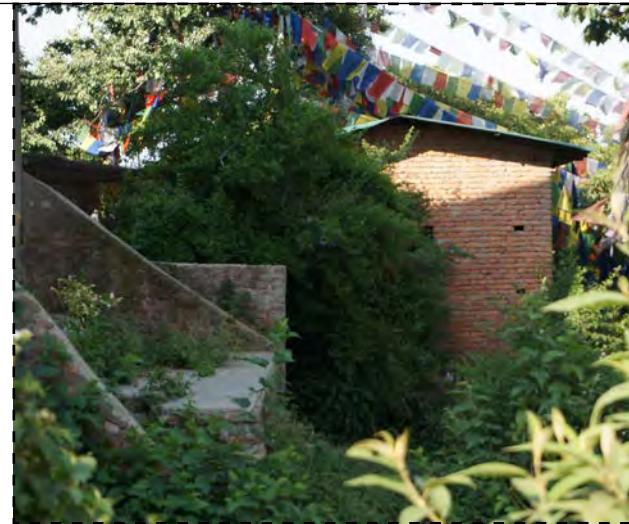
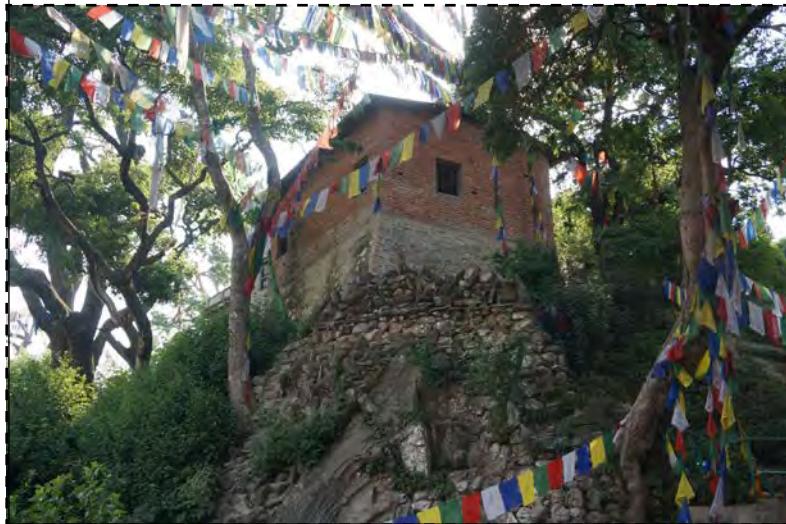
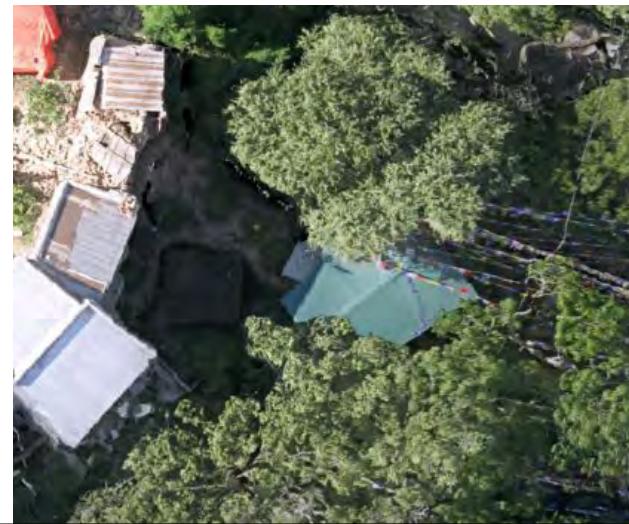
NUMBER NAME	NUMBER OF STORIES RELATIVE POSITION	STRUCTURAL SYSTEM	DESCRIPTION OF DAMAGE	DANGER DESTROY	HERITAGE SIGNIFICANCE	N ↑
47	G	C	House made for water-storage tanks. No visible damage"

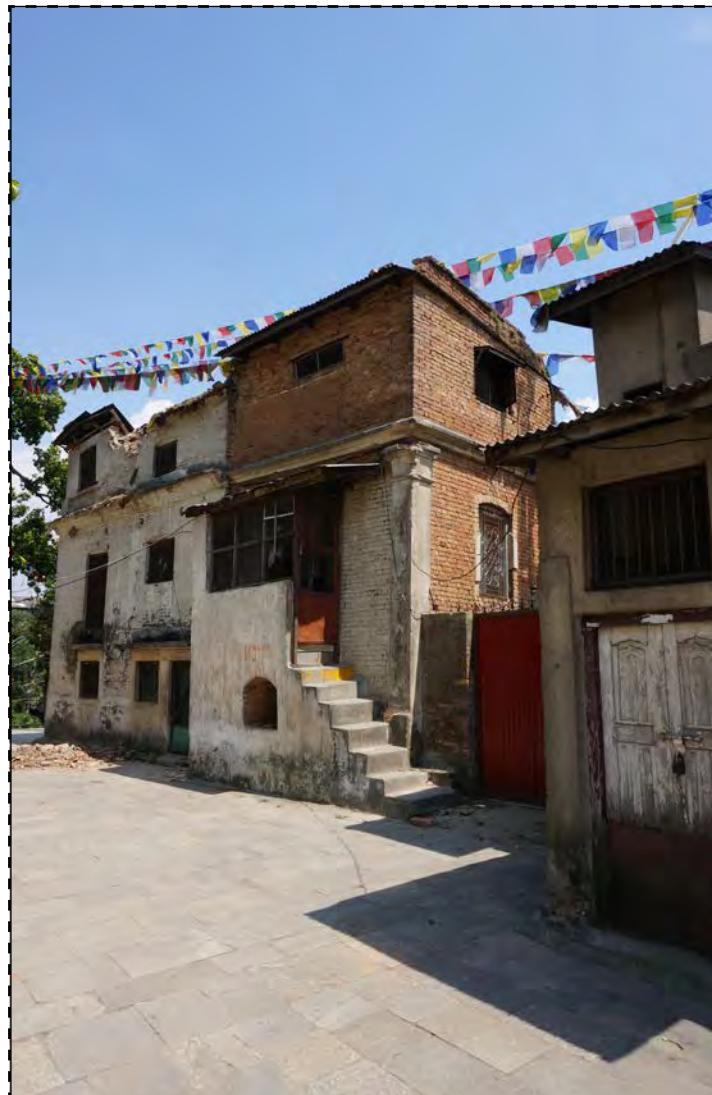
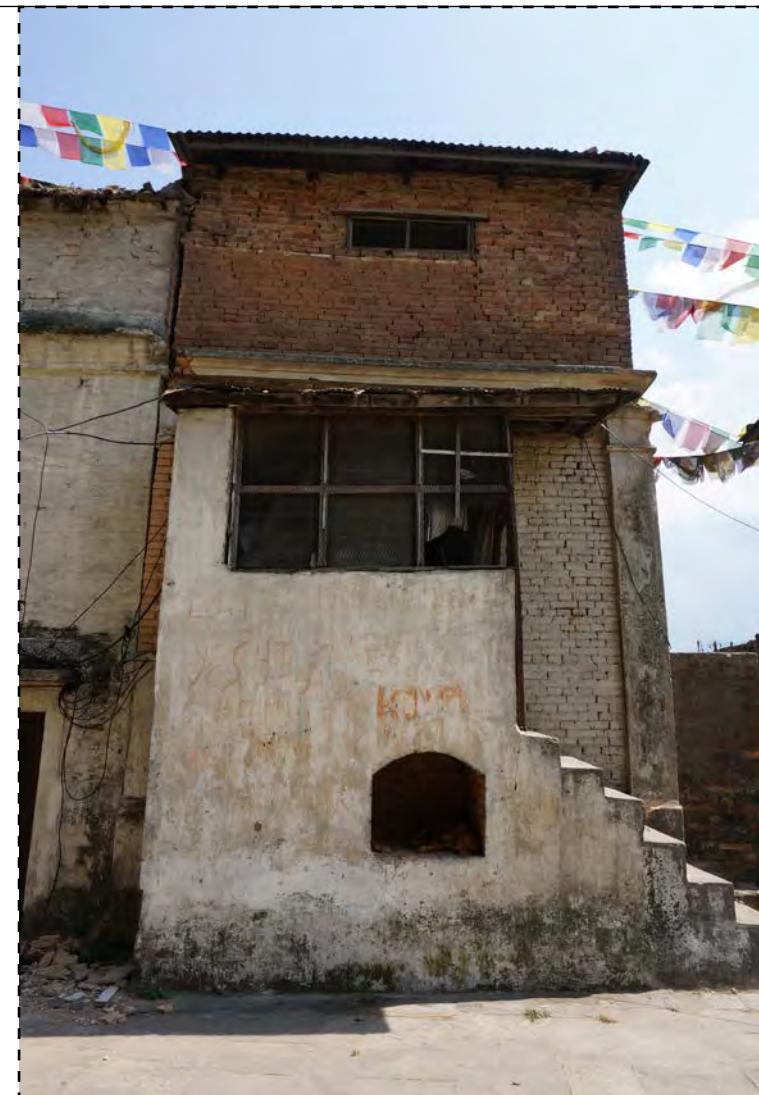
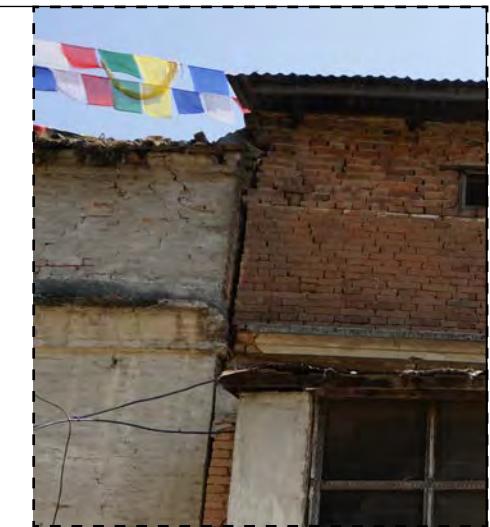
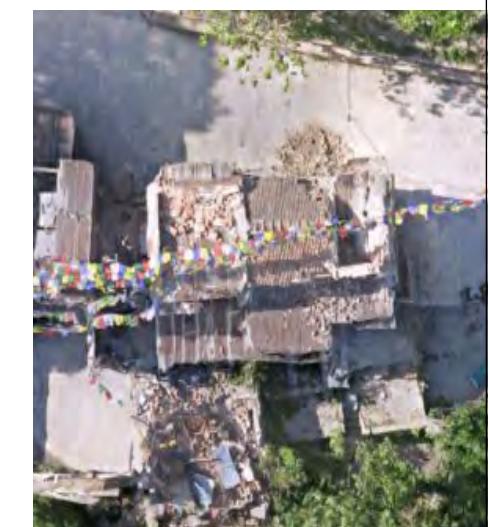
NUMBER NAME	NUMBER OF STORIES RELATIVE POSITION	STRUCTURAL SYSTEM	DESCRIPTION OF DAMAGE	DANGER DESTROY	HERITAGE SIGNIFICANCE	N ↑
49	G+2	B	Major cracks from windows tilting
