2015 Earthquake Damage Mapping

Swayambhu Monument Zone
Kathmandu Valley World Heritage Property

Submitted to UNESCO by

June 2015

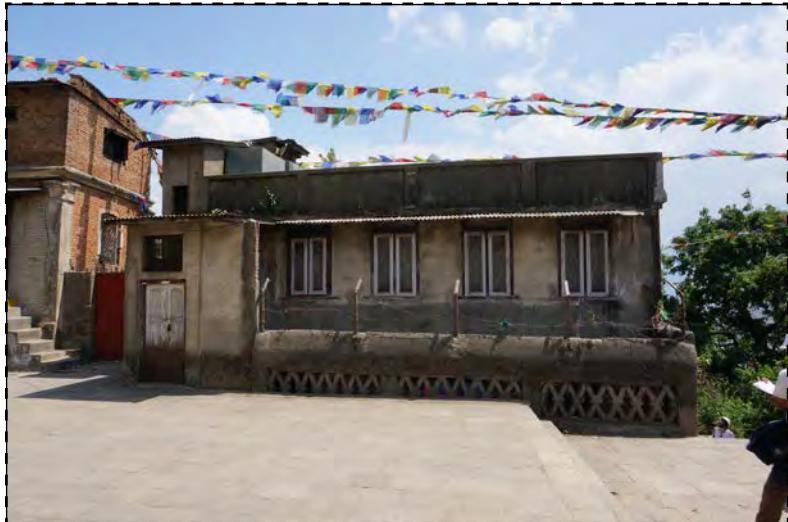
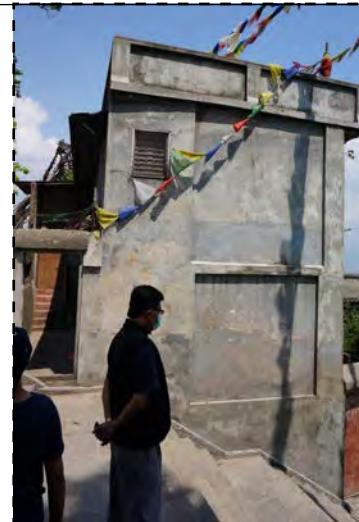
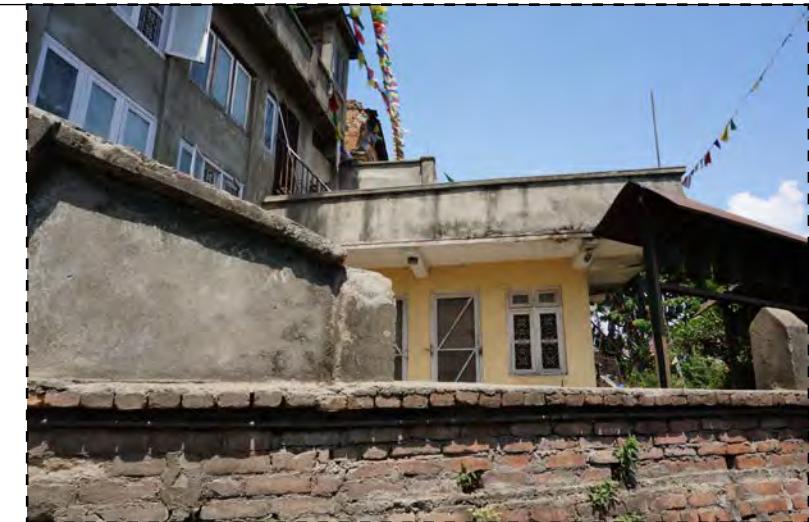
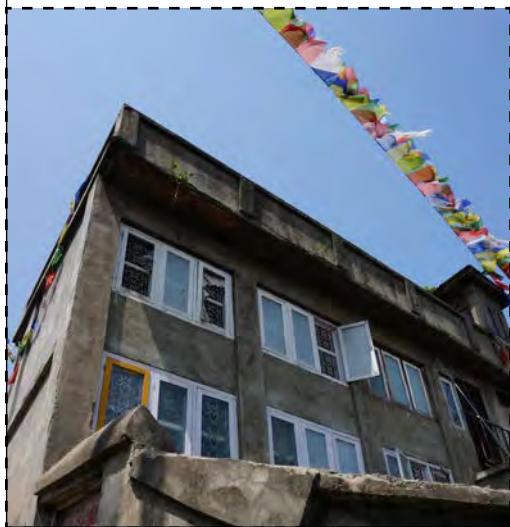
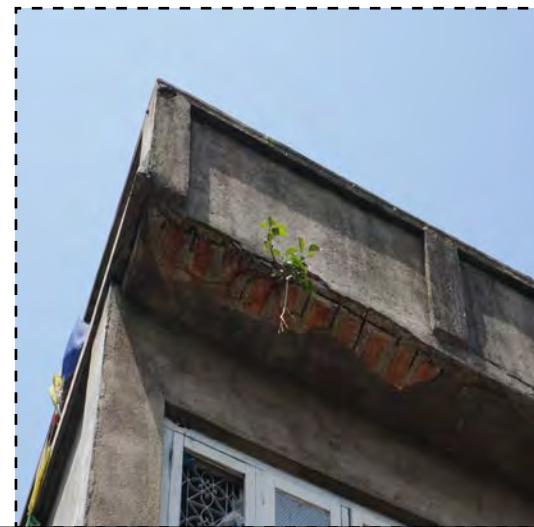
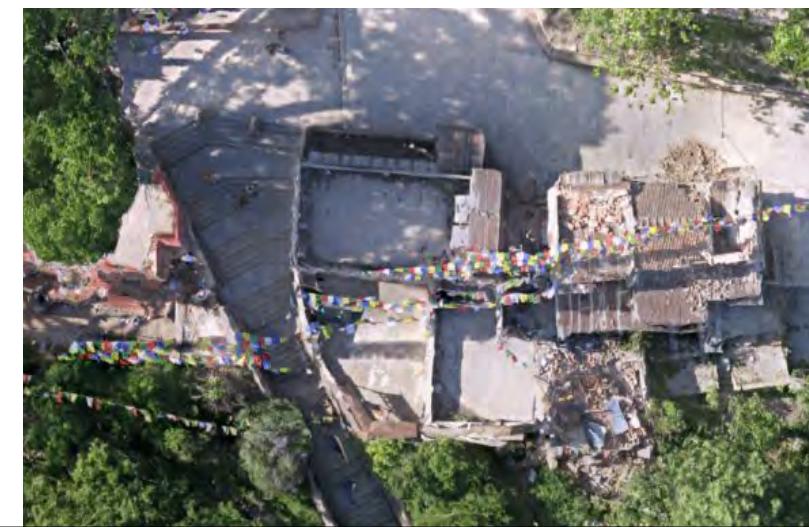
NUMBER NAME	NUMBER OF STOREYS RELATIVE POSITION	STRUCTURAL SYSTEM	DESCRIPTION OF DAMAGE	DANGER DESTROY	HERITAGE SIGNIFICANCE	N ↑	PLAN 1/1000
50	G+2	B	Minor cracks below window Minor floor cracks near door Some defects in construction
