2015 Earthquake Damage Mapping

Sankhu

October 2015

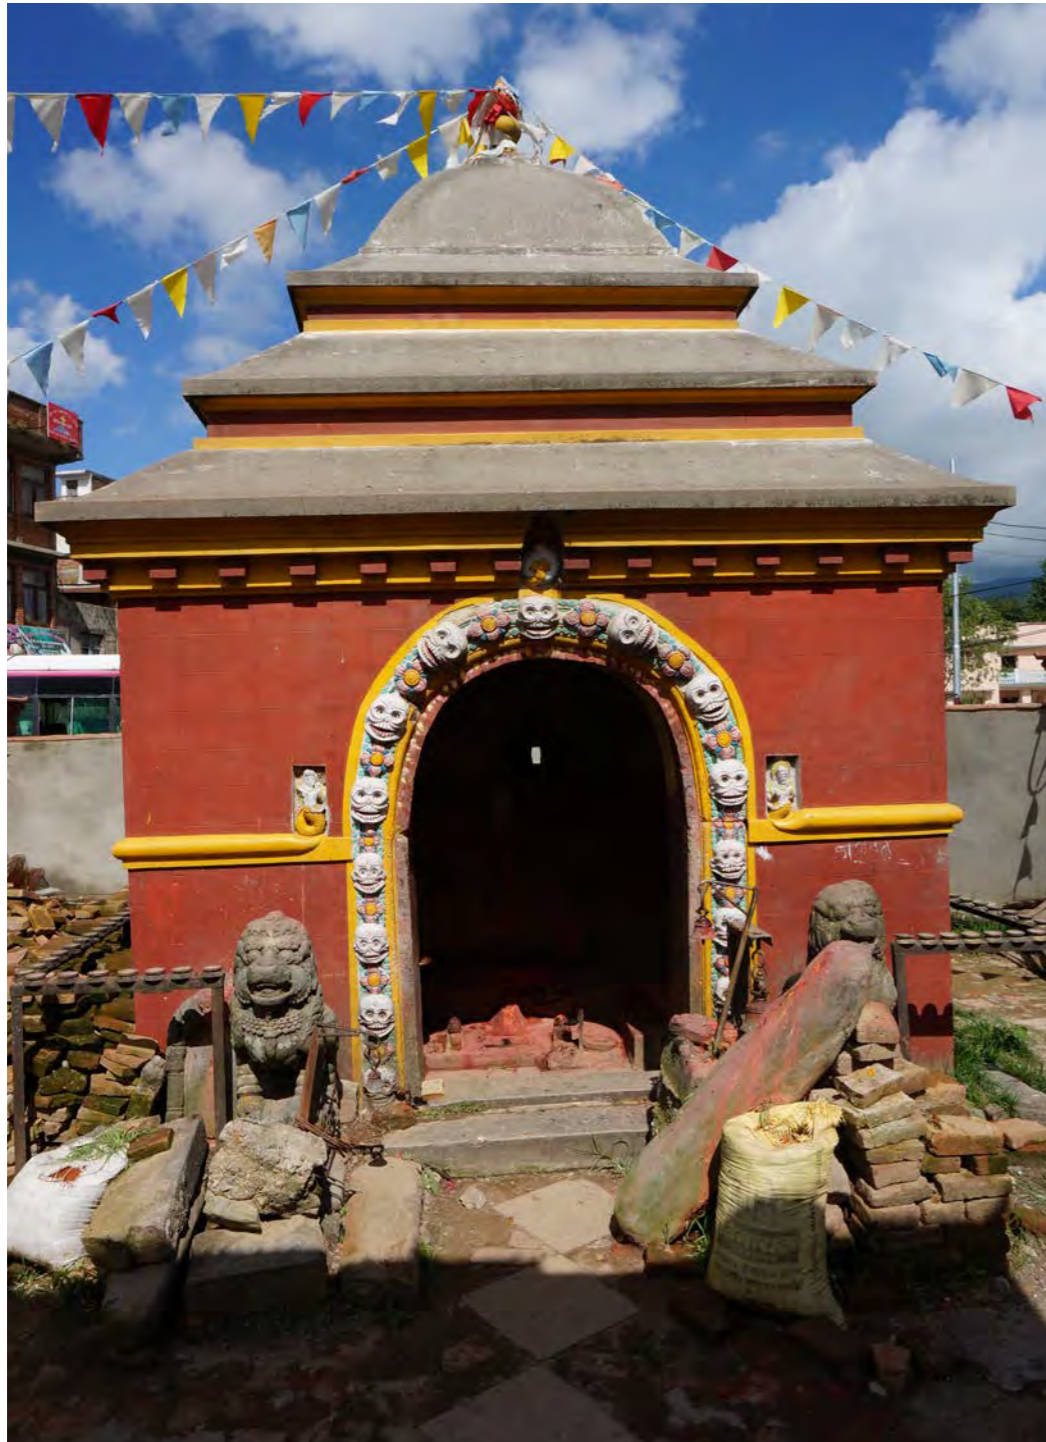
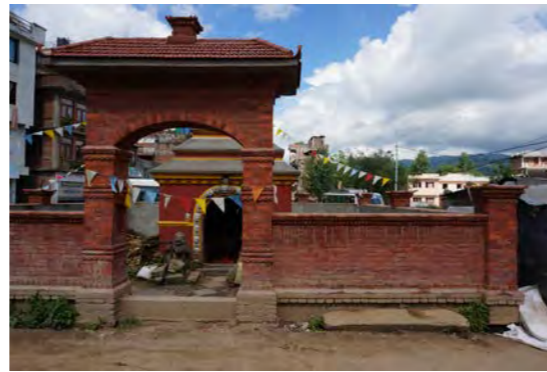
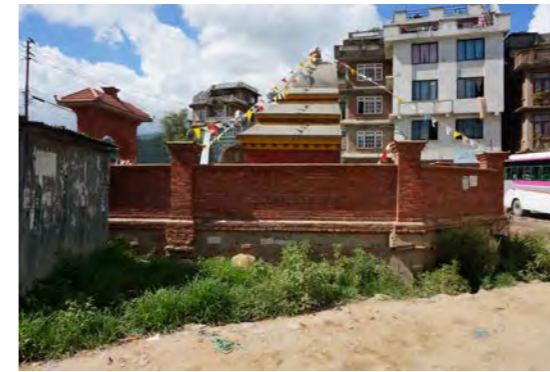
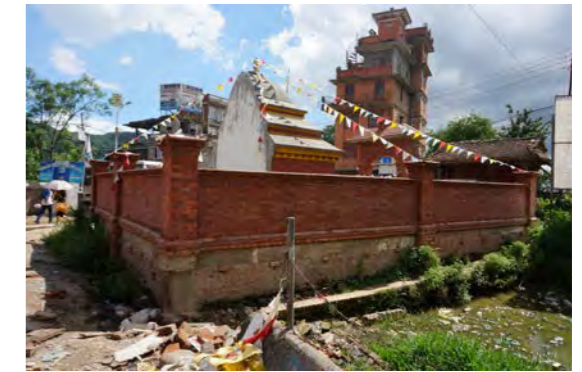
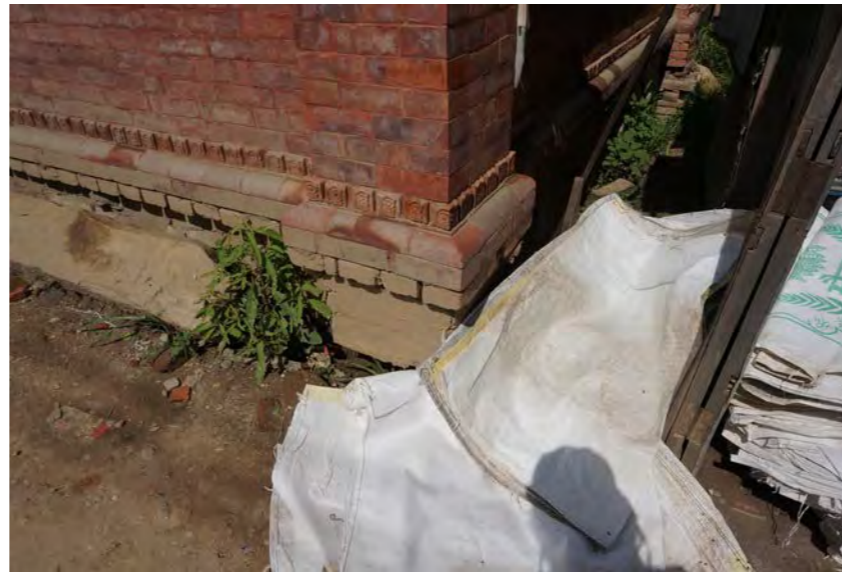
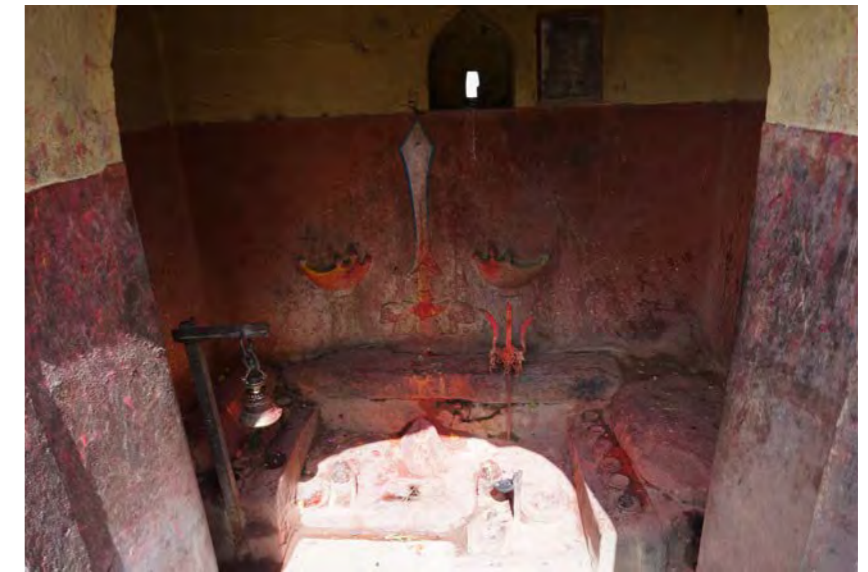
A-04 BHAGWATI MANDIR

NUMBER	NAME	ESTABLISHED DATE (A.D.)	TYPOLOGY	GENERAL DESCRIPTION	PROBLEMS DESCRIPTION	DANGER/ DESTROY
A-04	Bhagwati Mandir		Enclosed Shrine	Enclosed shrine temple made of bricks and cement plastered. The compound wall was constructed 2070 BS (2013 AD)	Few vertical cracks extending above from entrance of main shrine S-wall with major vertical crack of about 2cm width

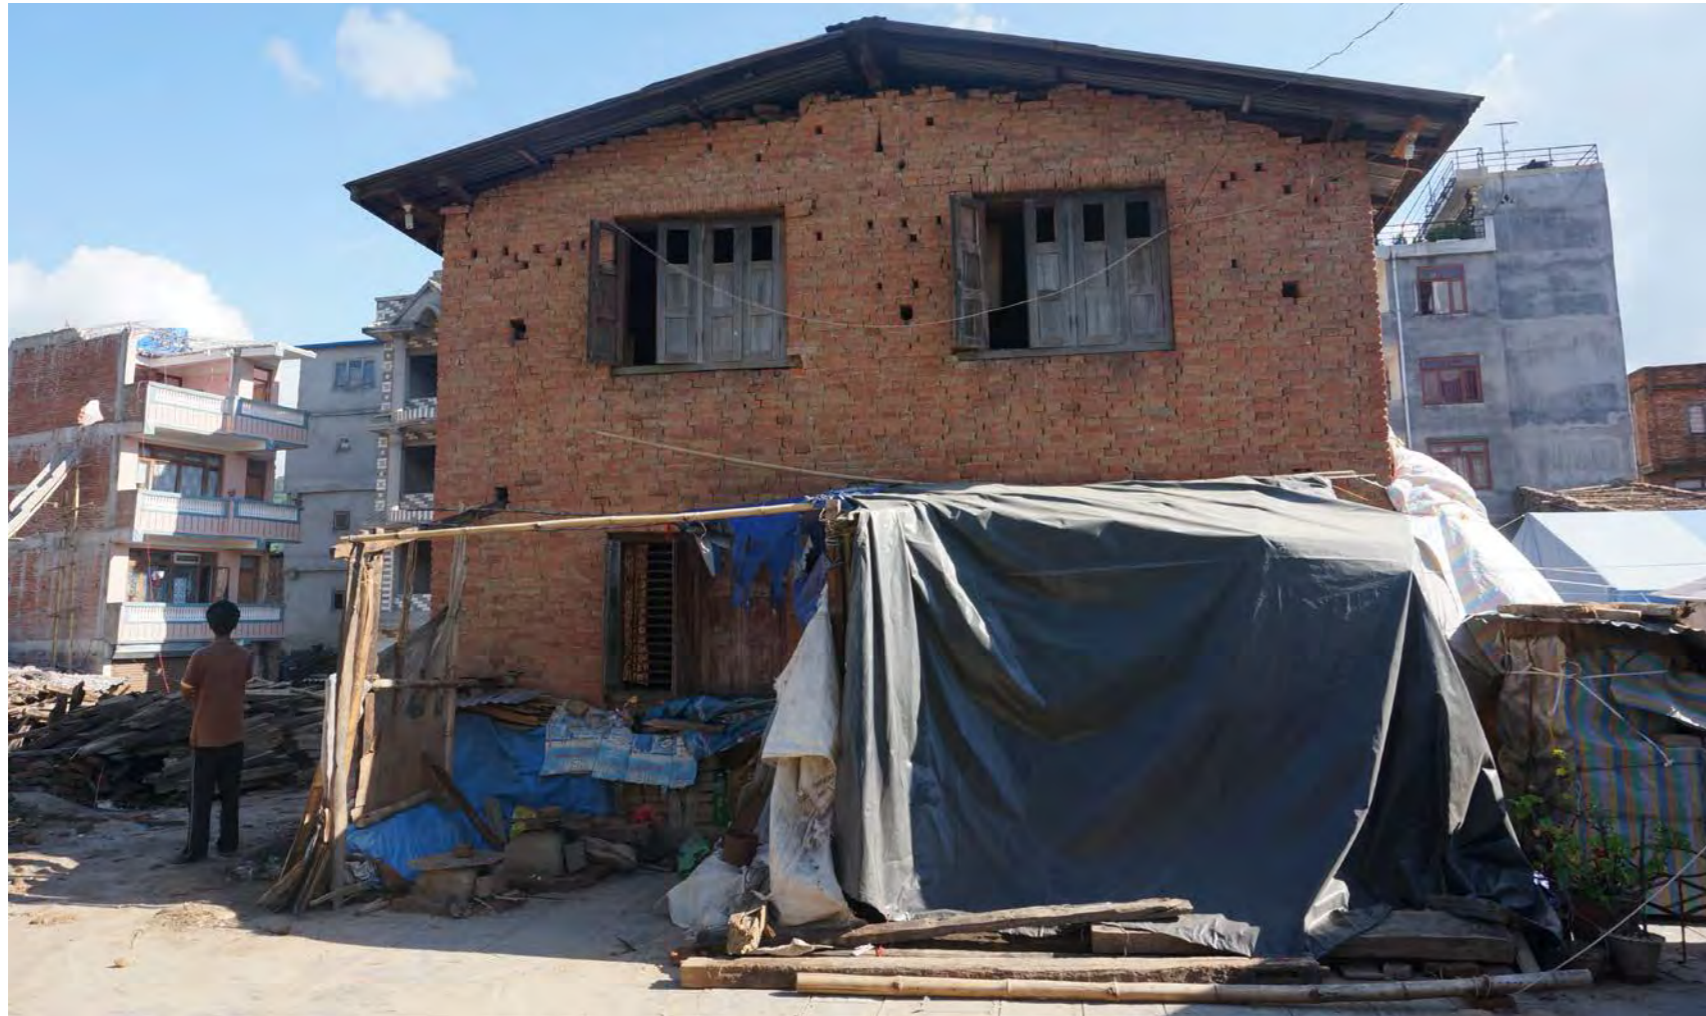
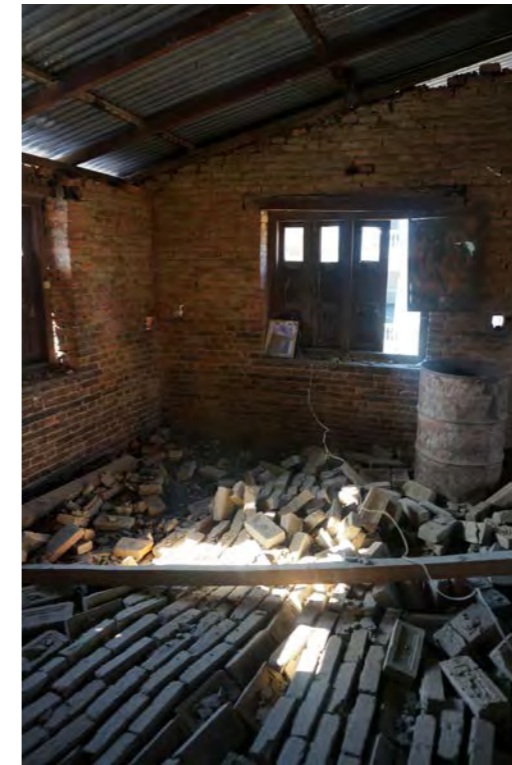
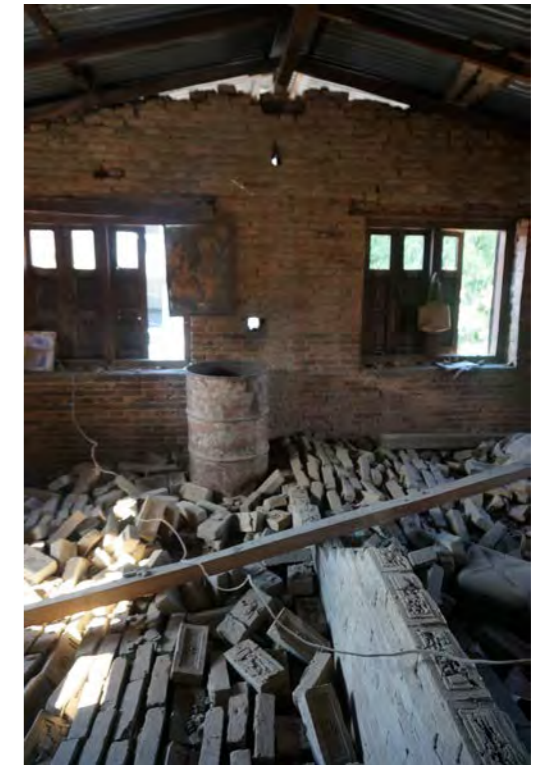
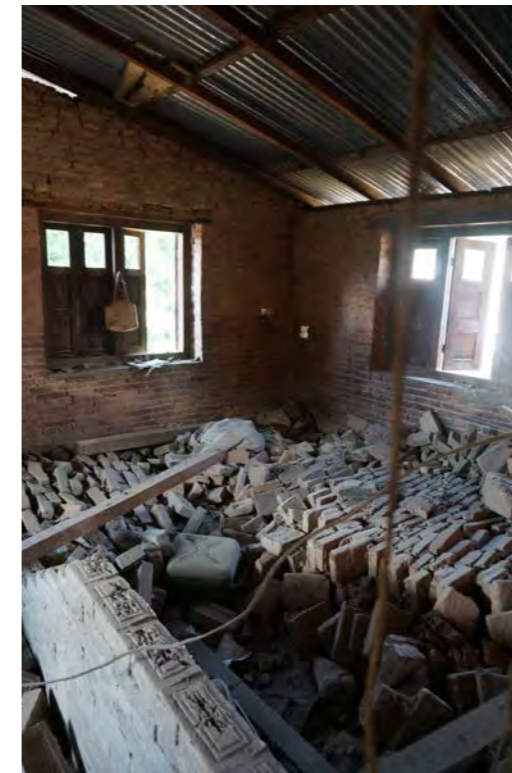
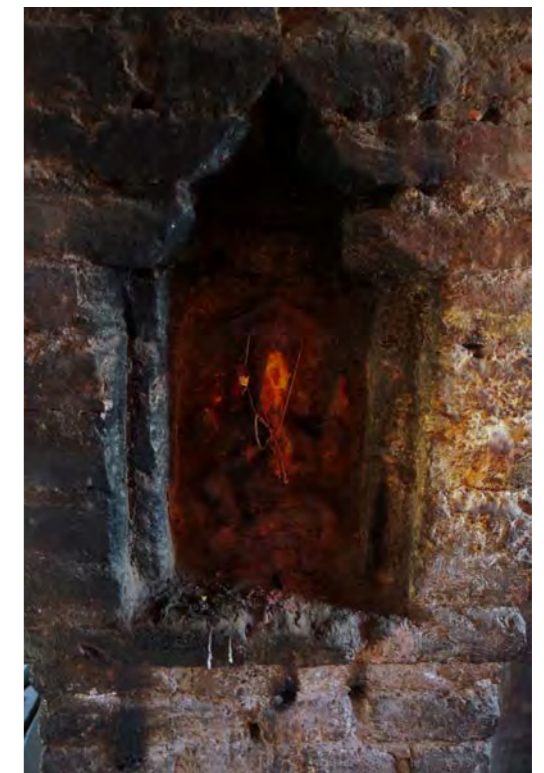
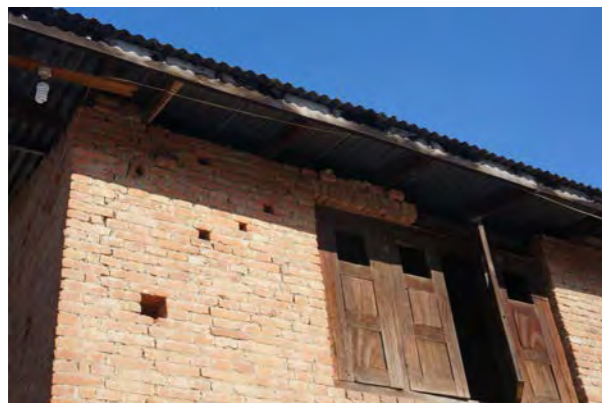
A-07 DYO CHHEN - TALEJU BHAGWAN MANDIR

NUMBER	NAME	DATE A.D.	TYPOLOGY	GENERAL DESCRIPTION	PROBLEMS DESCRIPTION	DANGER/ DESTROY
A-07	Taleju Bhagwan Mandir		Dyo Chhen	Two storey building type temple. Brick and mud made masonry structure with wooden joist and planks as flooring system. Possibly 9 storey pagoda style temple during ancient period	Some of the wooden joist are cracked or broken. Partition walls made of uncooked bricks collapsed. Statue of Taleju Bhagwati is safe (according to priest Rajendra Bh. Shrestha who lives in house # a-32)

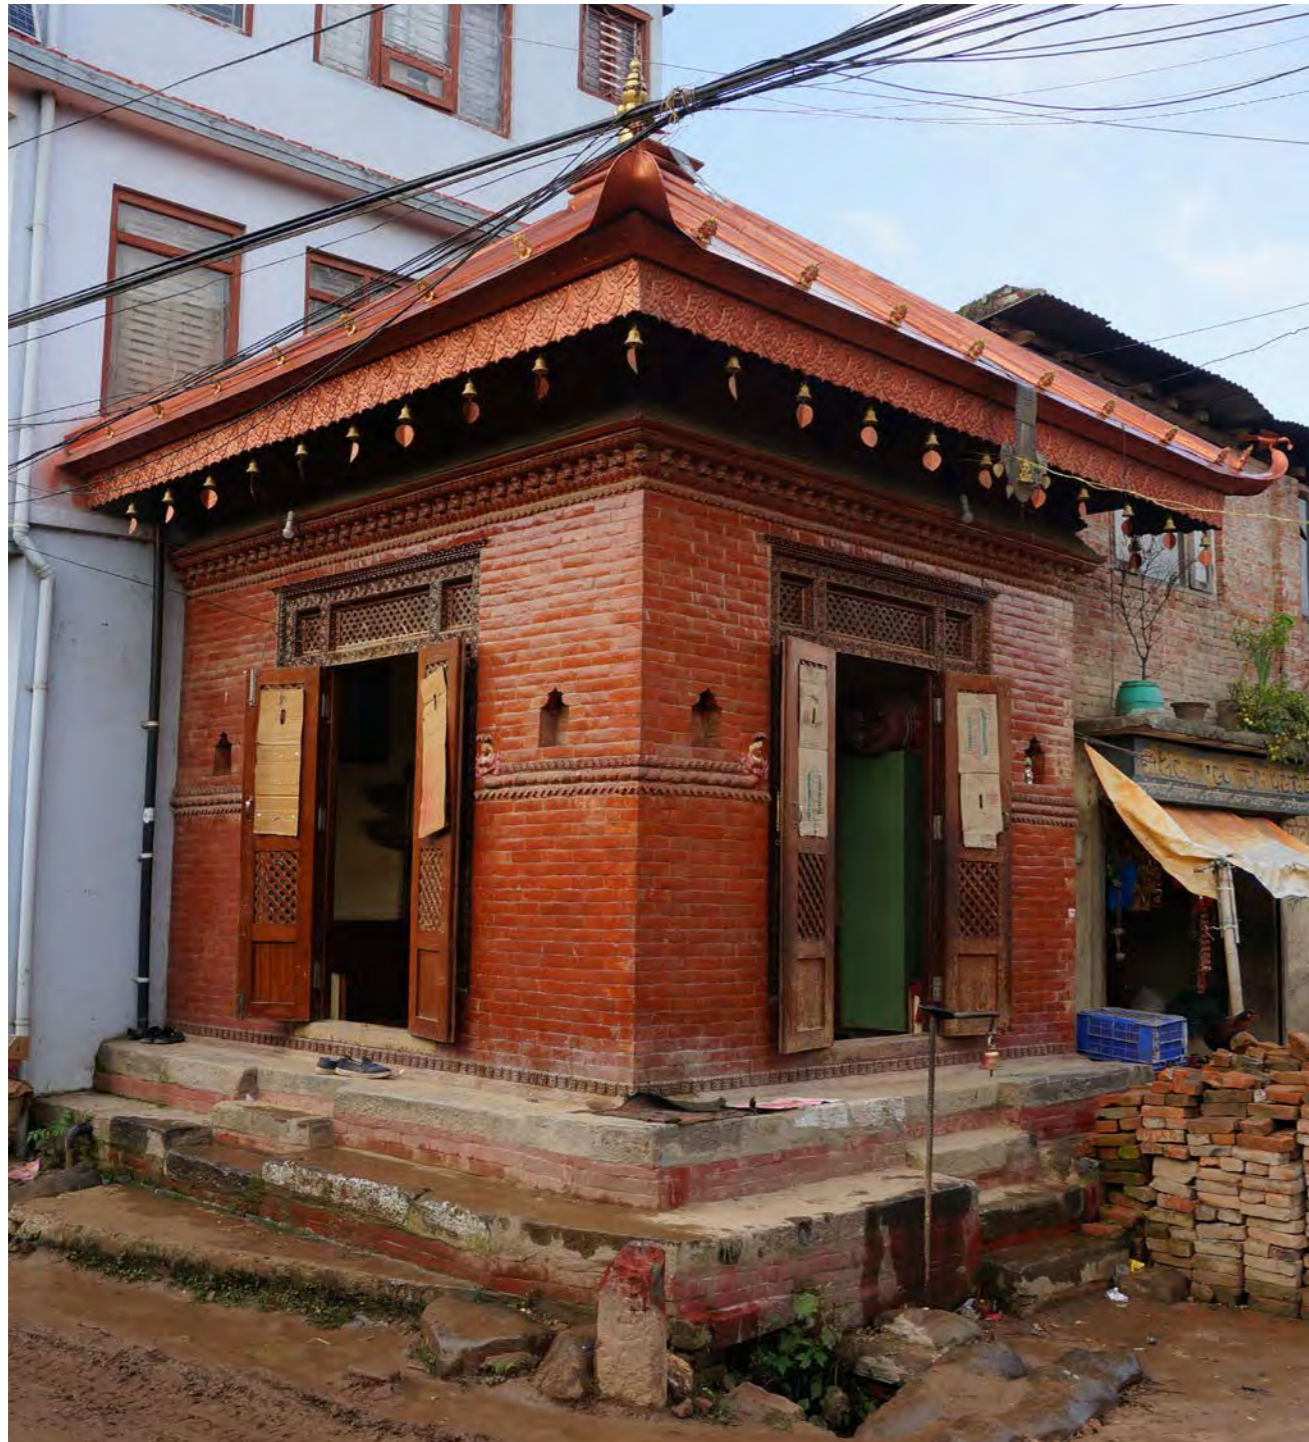
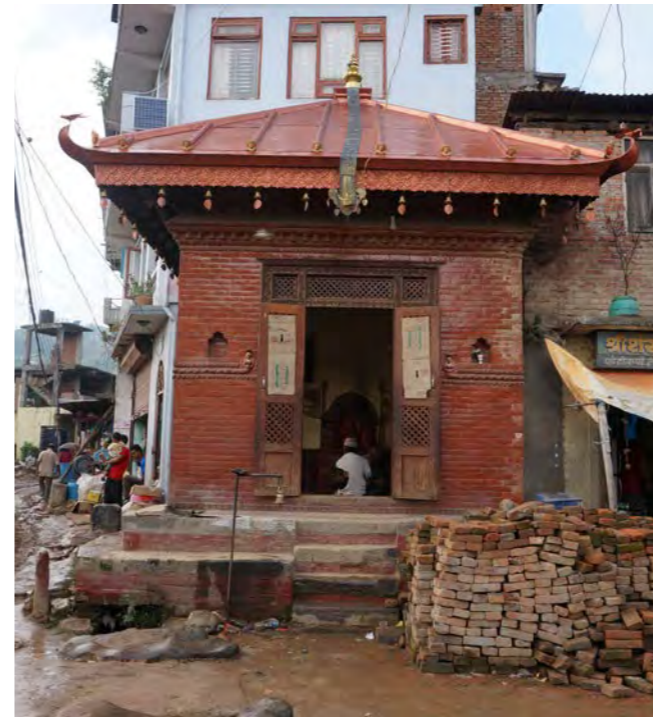
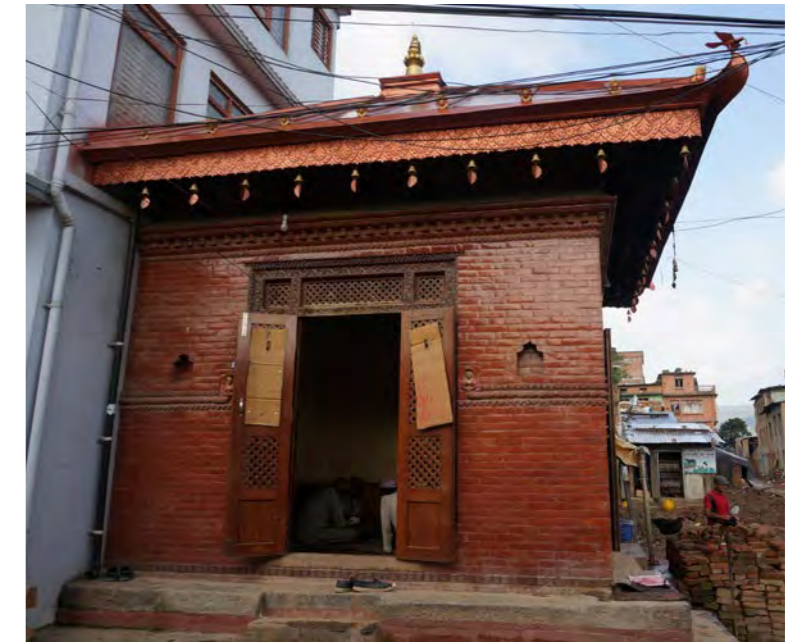
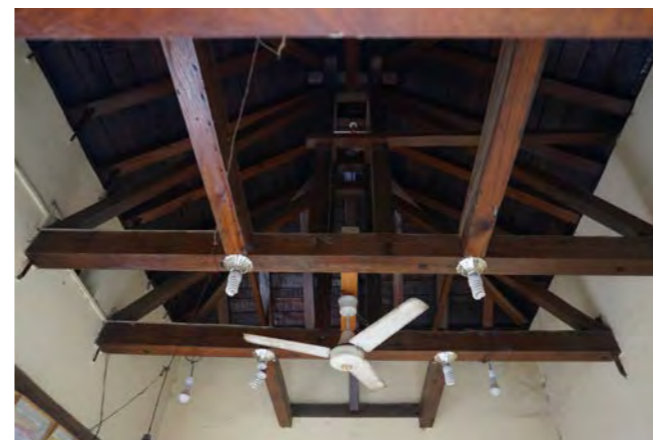
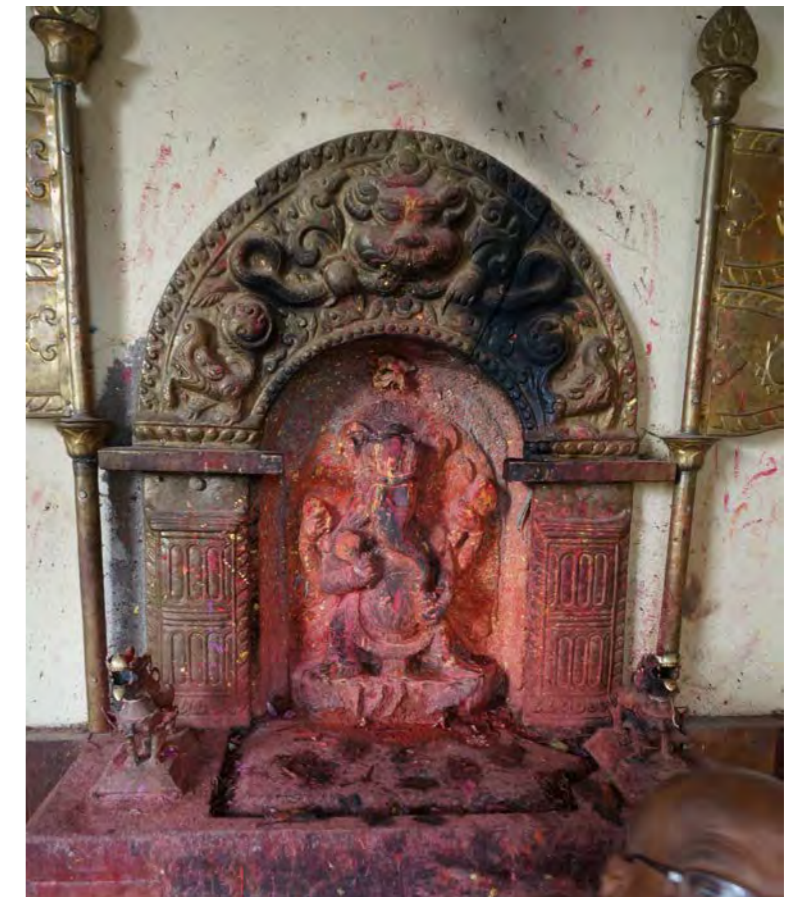
C-01 GANESH TEMPLE

NUMBER	NAME	ESTABLISHED DATE (A.D.)	TYPOLOGY	GENERAL DESCRIPTION	PROBLEMS DESCRIPTION	DANGER/ DESTROY
C-01	Ganesh Temple		Single storey Pagoda temple	Newly constructed temple with Dachhi Appa, wooden joist and gilded metal copper roof	Good Condition

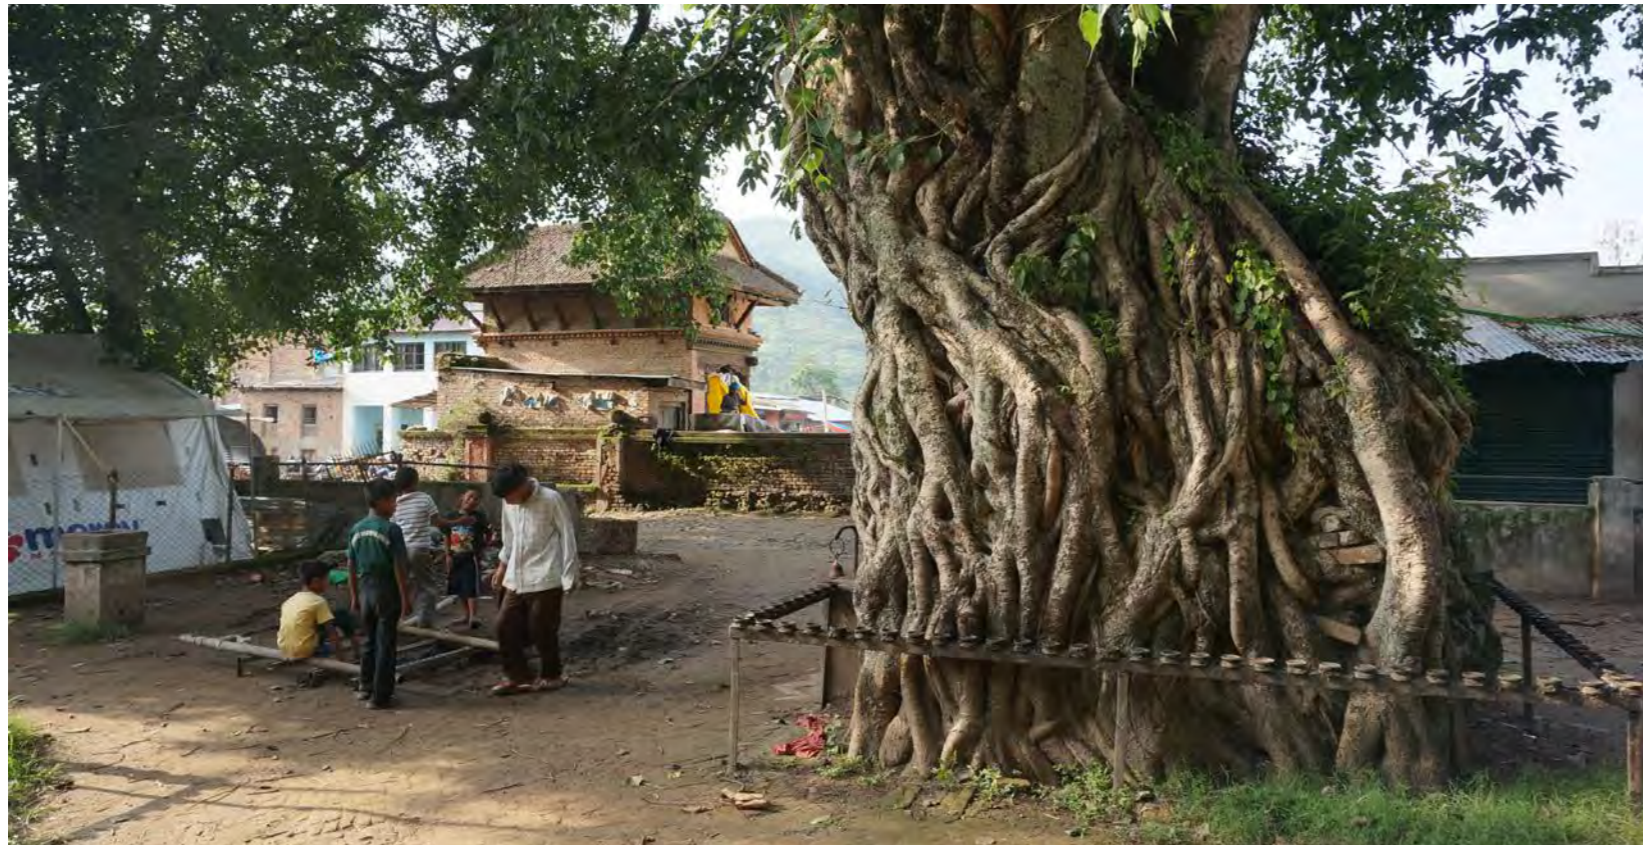
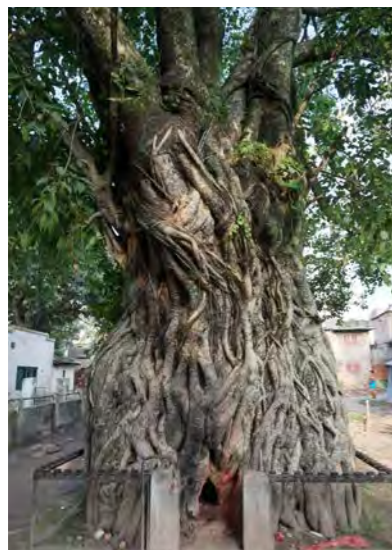
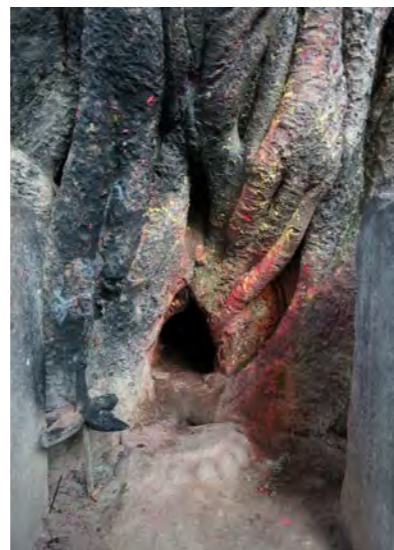
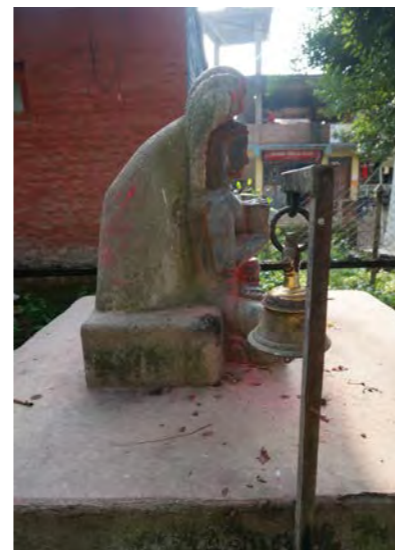
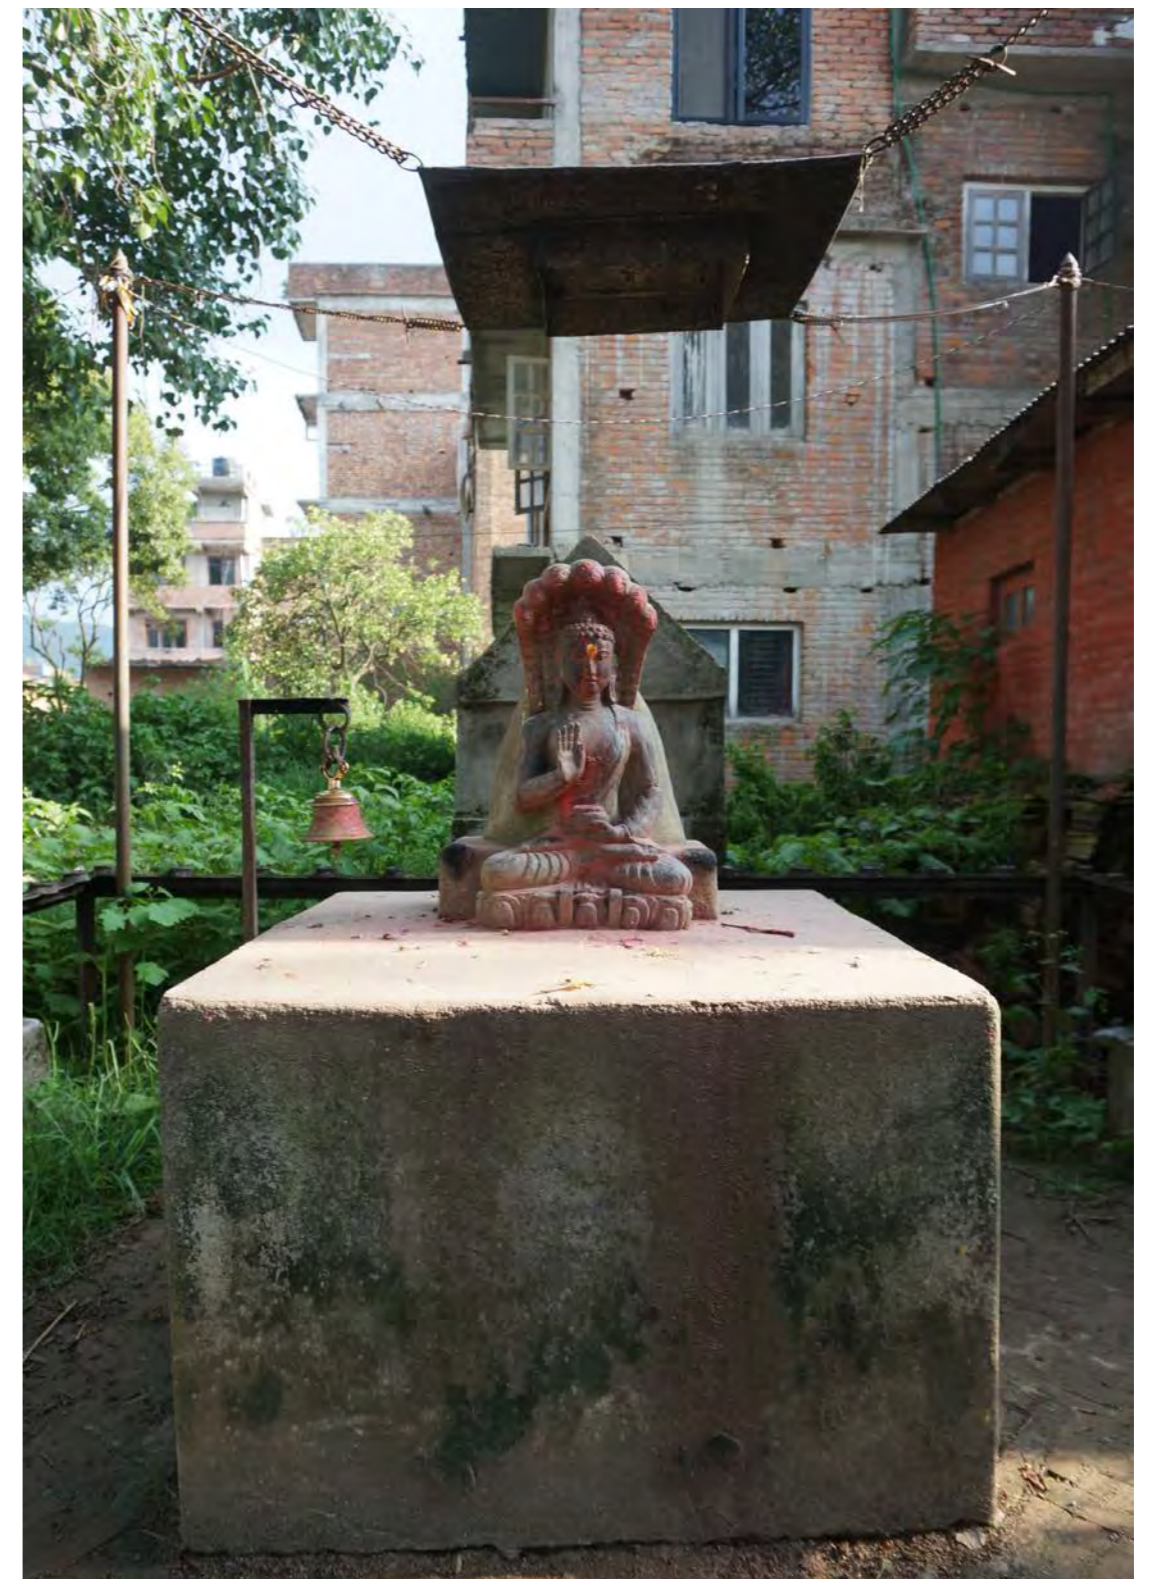
C-03 OPEN SHRINE

NUMBER	NAME	DATE A.D.	TPOLOGY	GENERAL DESCRIPTION	PROBLEMS DESCRIPTION	DANGER/ DESTROY
C-03			Open Shrine	Stone statue of Buddha under peepal tree with inscription in cement-tile	Good Condition

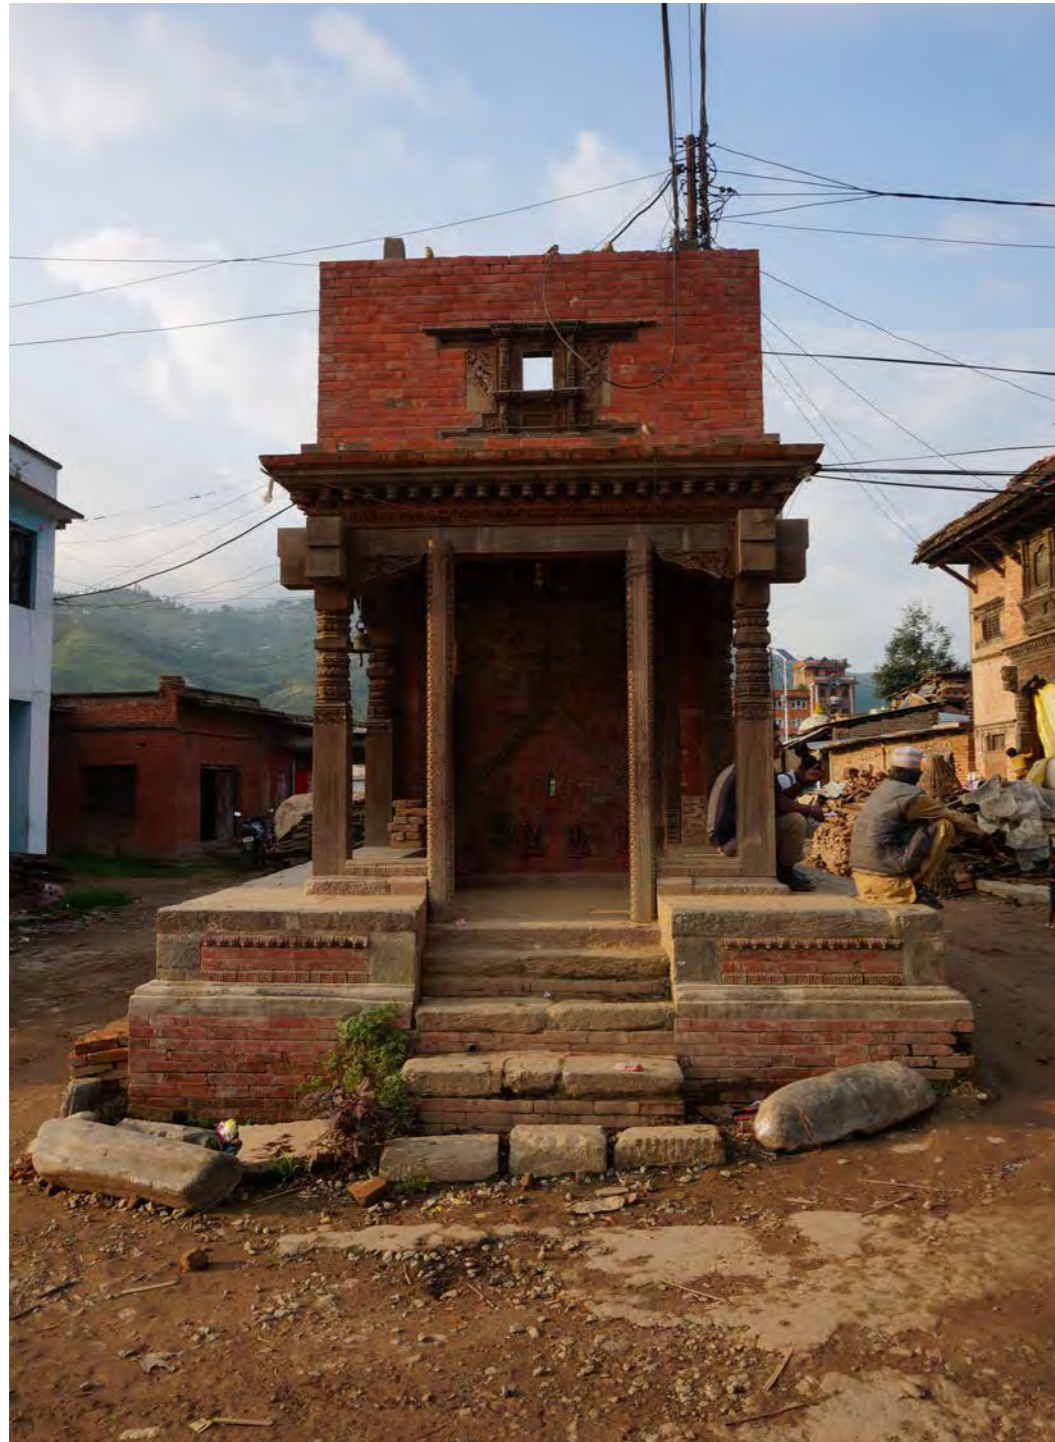
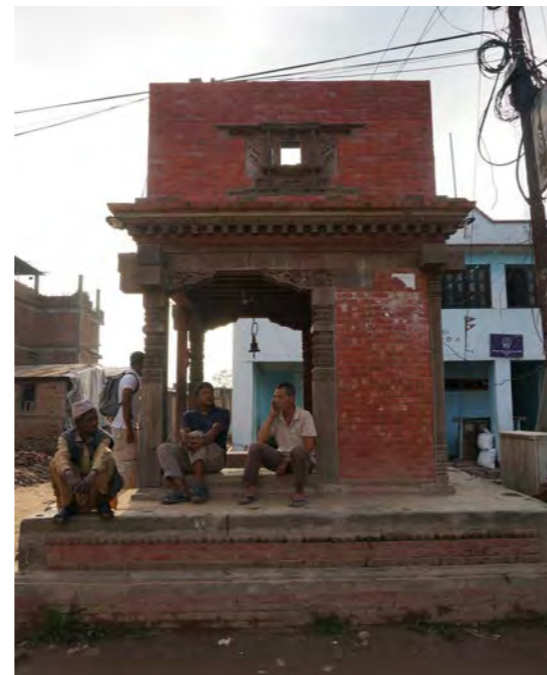
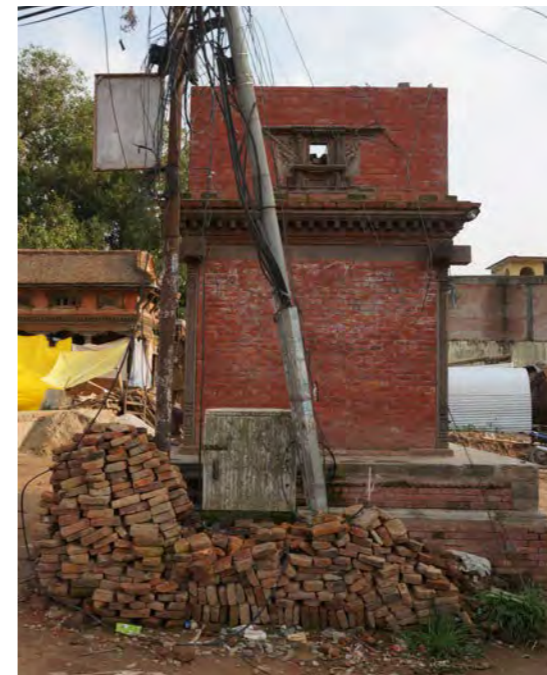
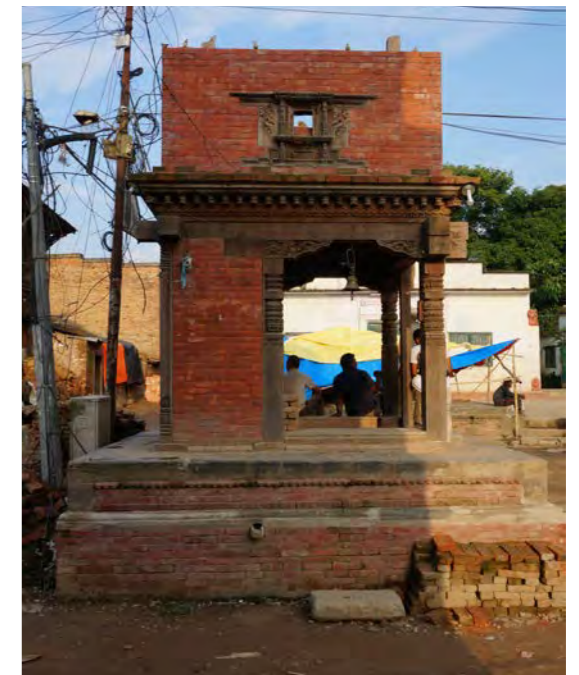
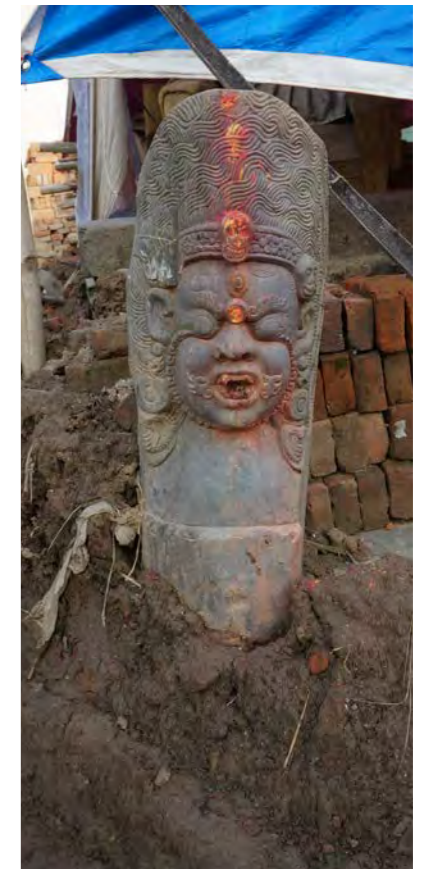
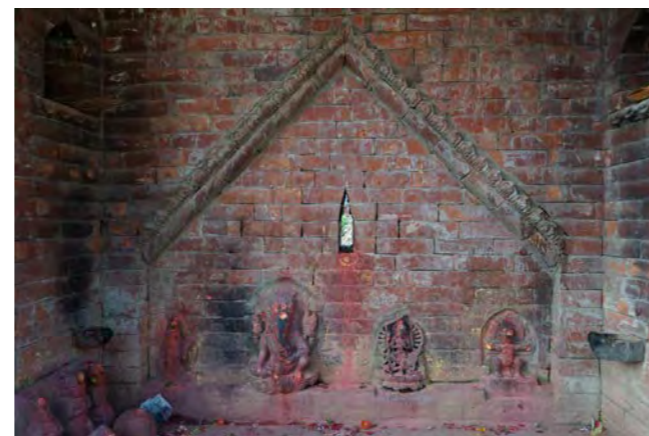
C-06 GANESH TEMPLE

NUMBER	NAME	ESTABLISHED DATE (A.D.)	TYPOLOGY	GENERAL DESCRIPTION	PROBLEMS DESCRIPTION	DANGER/ DESTROY
C-06	Ganesh Temple (Bahal Tole)		Single Storey Temple	Statues of Ganesh, Durpati, Kumari, Bhagwati within the temple. Stone statue of Bhairav is located opposite of Temple	Under construction temple with new bricks, wooden joist and posts. Roof remains incomplete. No visible earthquake damage

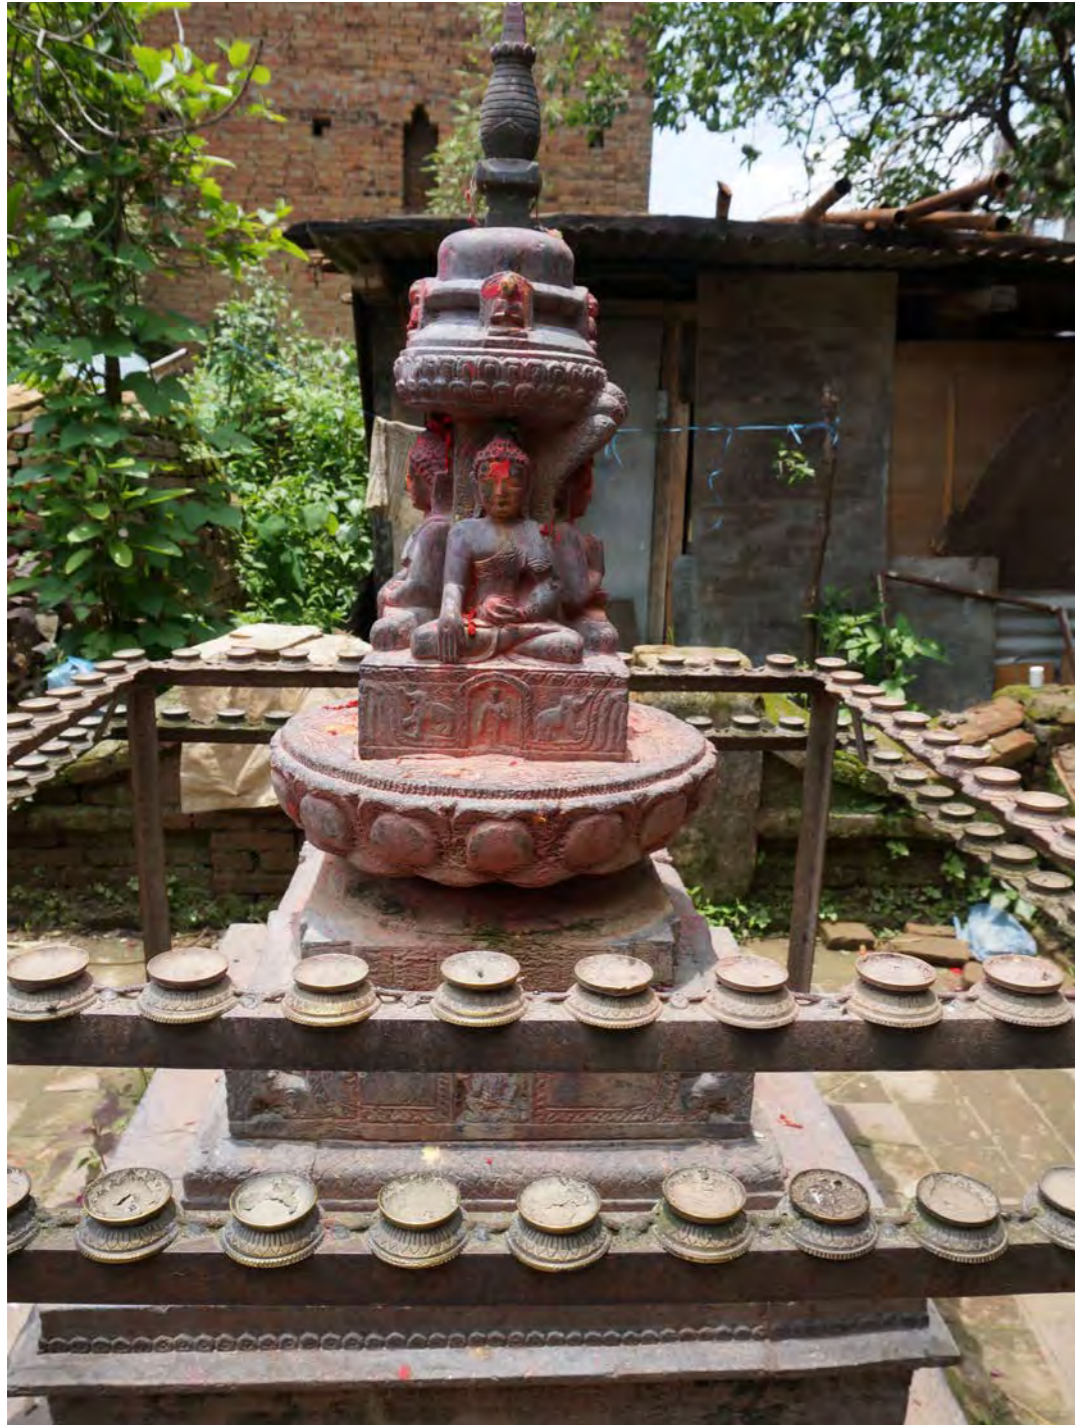
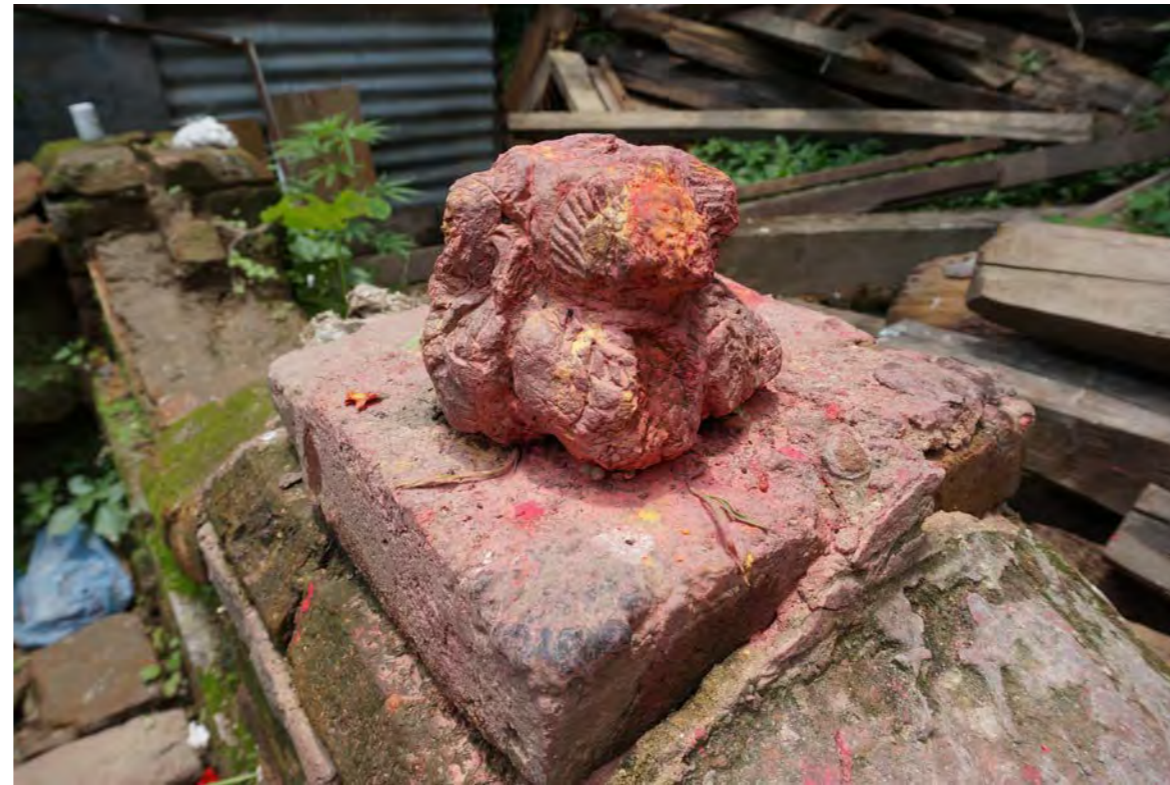
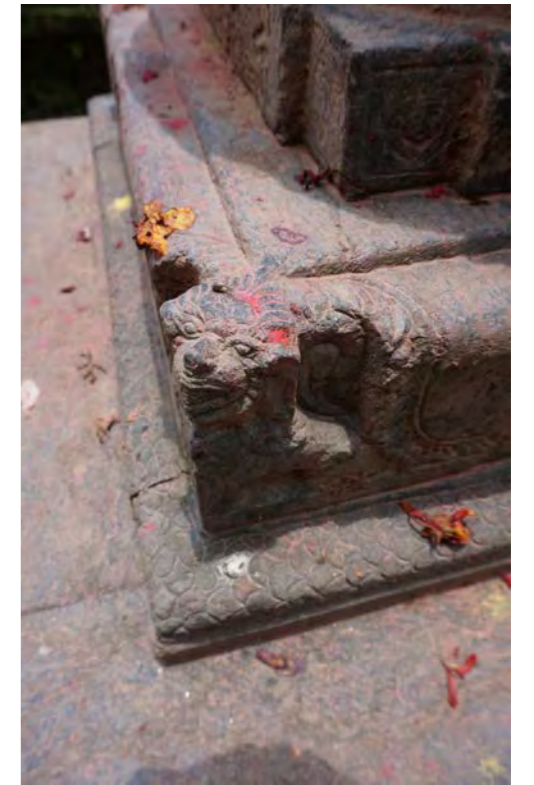
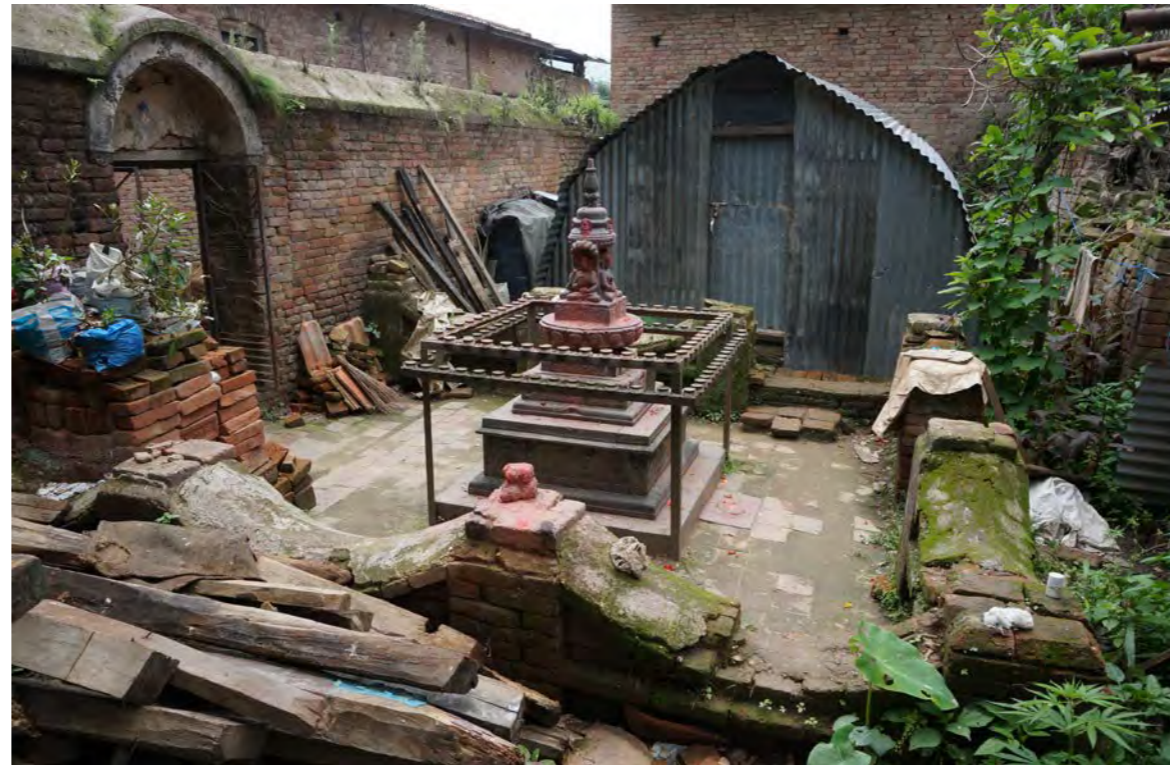
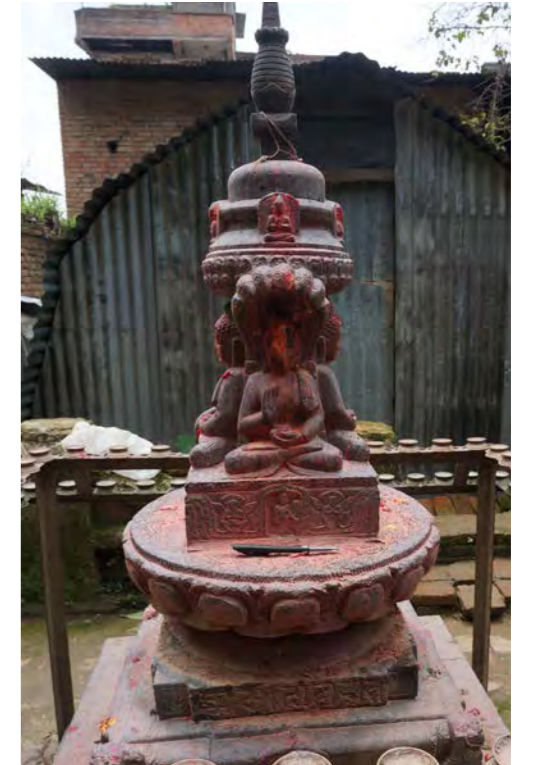
C-07 CHAITYA

NUMBER	NAME	DATE A.D.	TPOLOGY	GENERAL DESCRIPTION	PROBLEMS DESCRIPTION	DANGER/ DESTROY
C-07			Chaitya	Stone Chaitya	Some minor damages which needs repair and maintainance
