2015 Earthquake Damage Mapping

Sankhu

October 2015

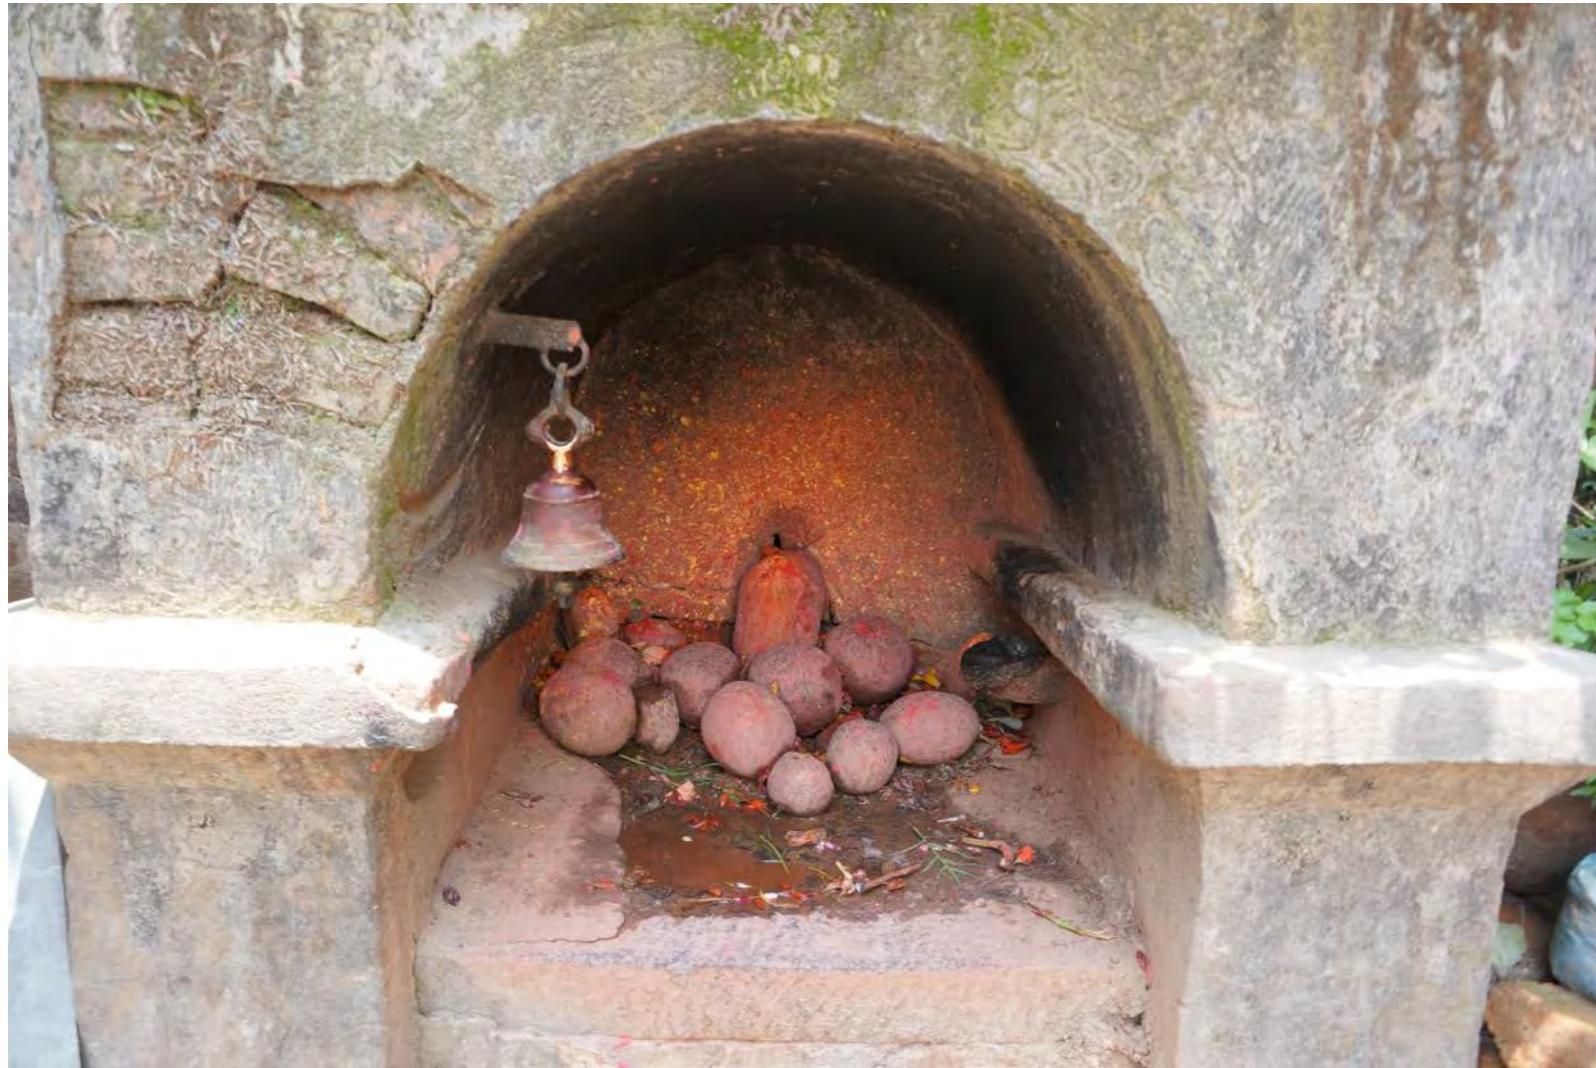
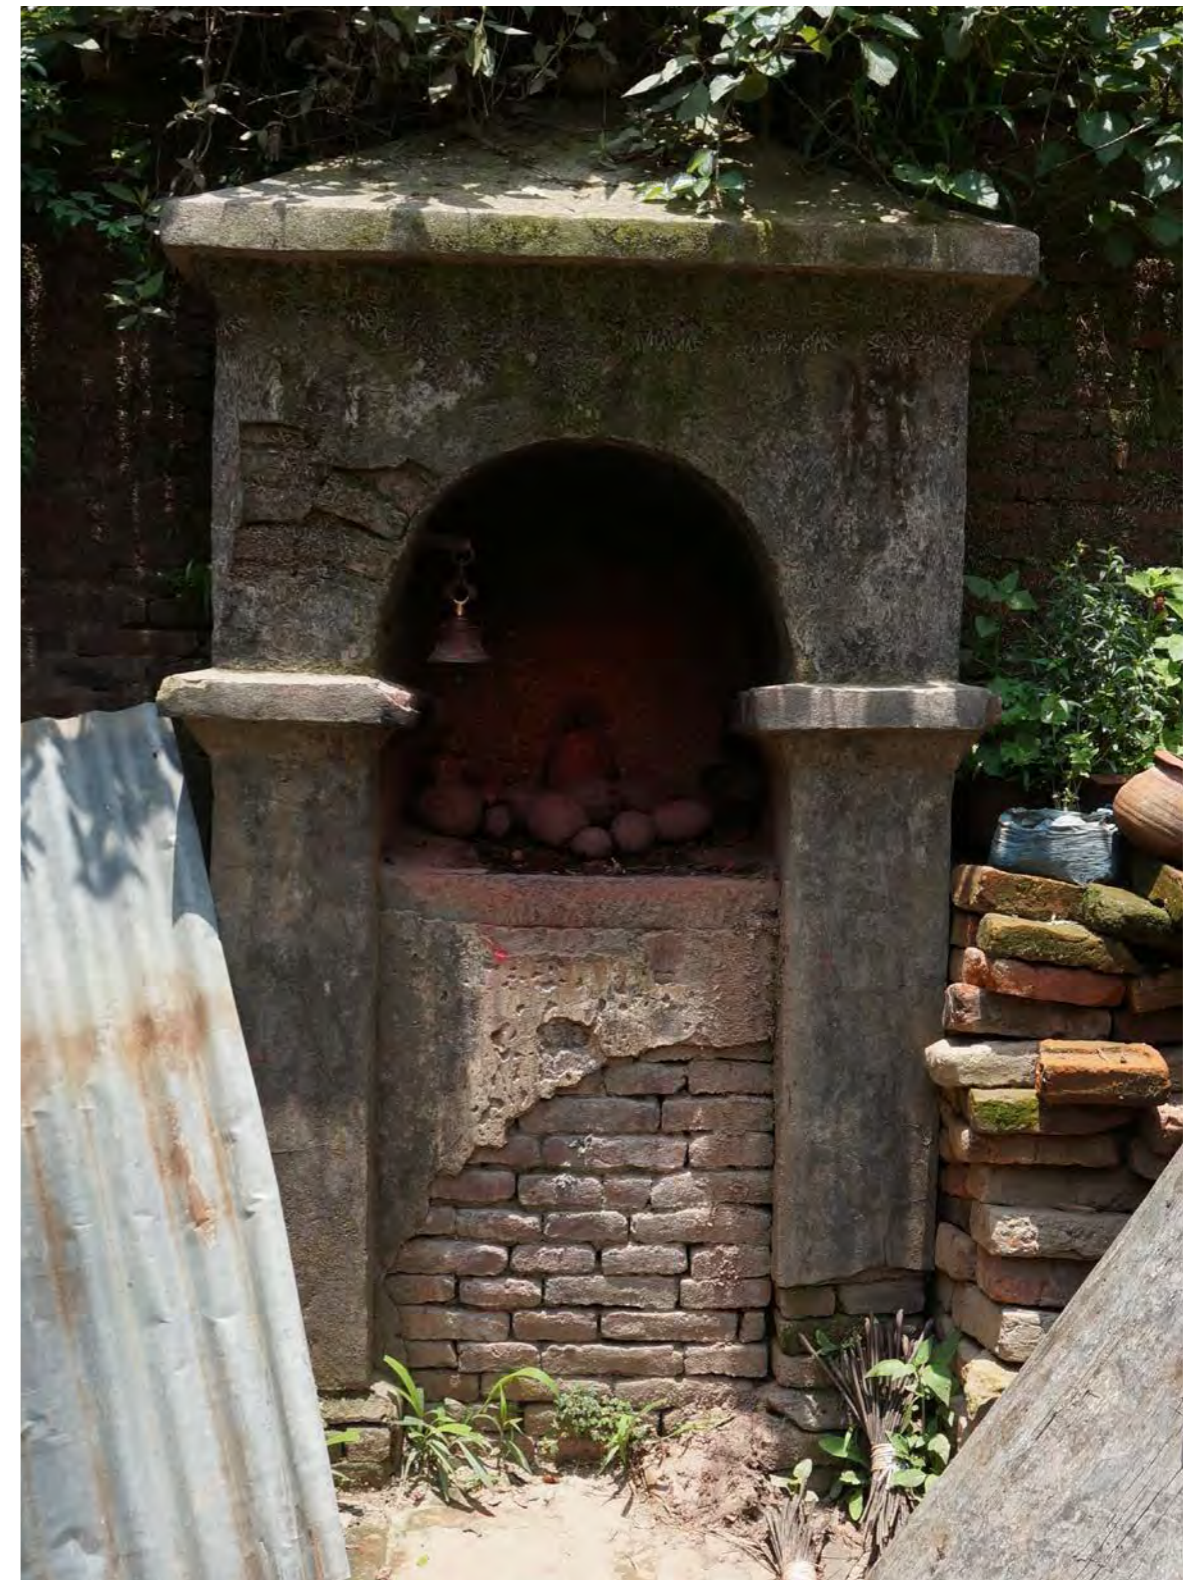
C-08 SHRINE

NUMBER	NAME	ESTABLISHED DATE (A.D.)	TYPOLOGY	GENERAL DESCRIPTION	PROBLEMS DESCRIPTION	DANGER/ DESTROY
C-08			Enclosed Shrine	Shrine made in brick and stone Some circular stones are established	Needs maintaiance

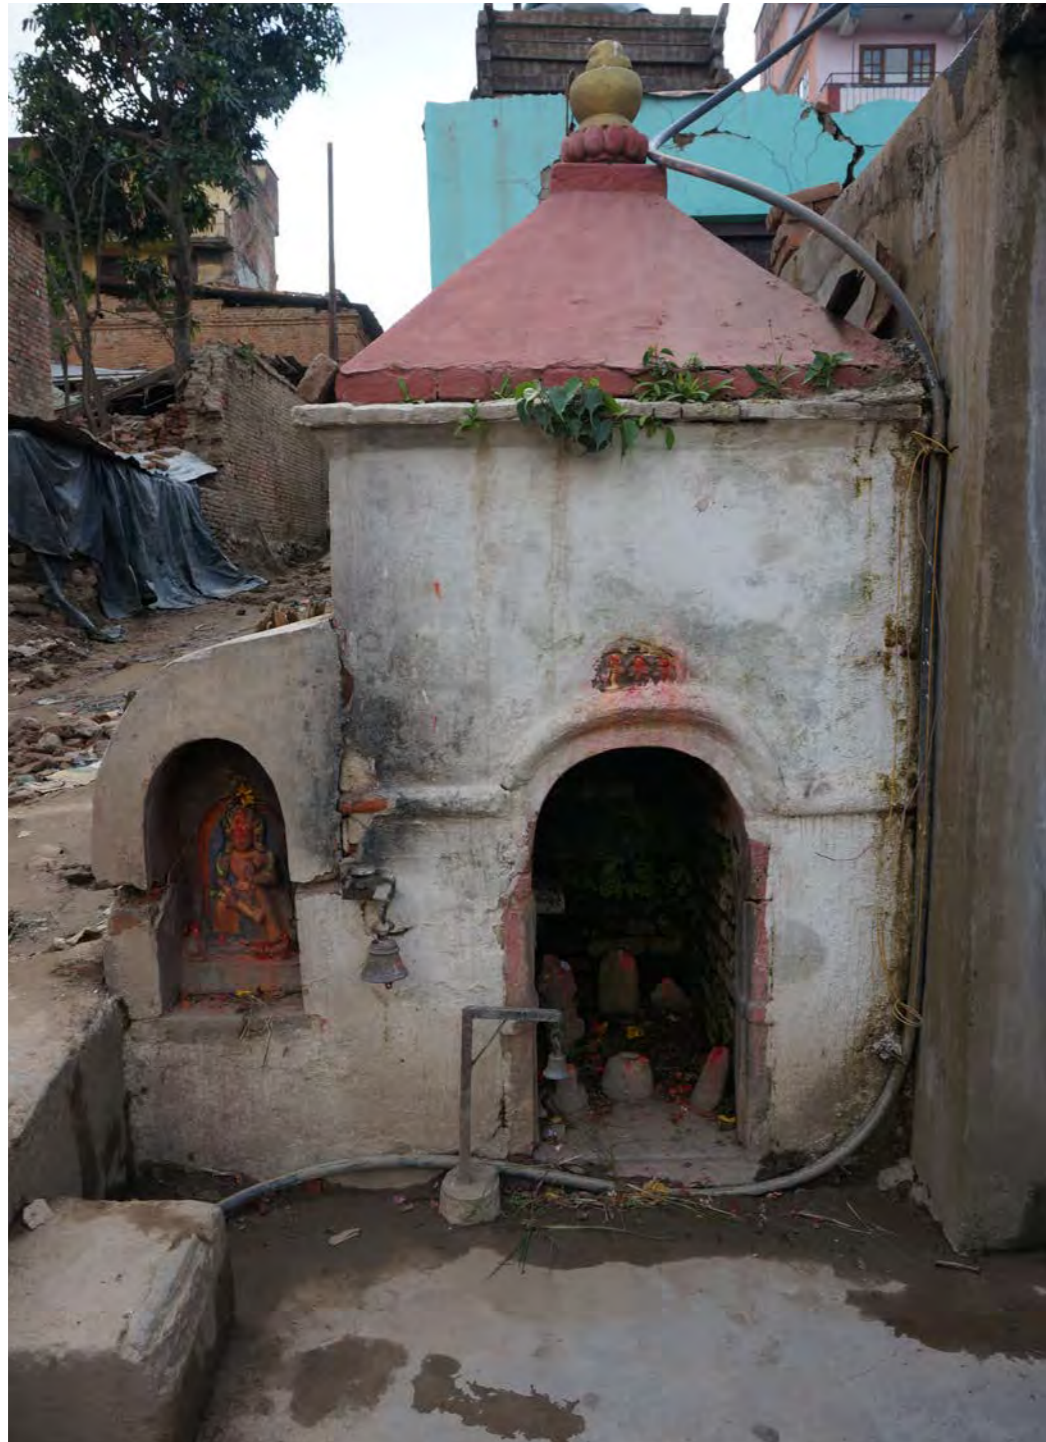
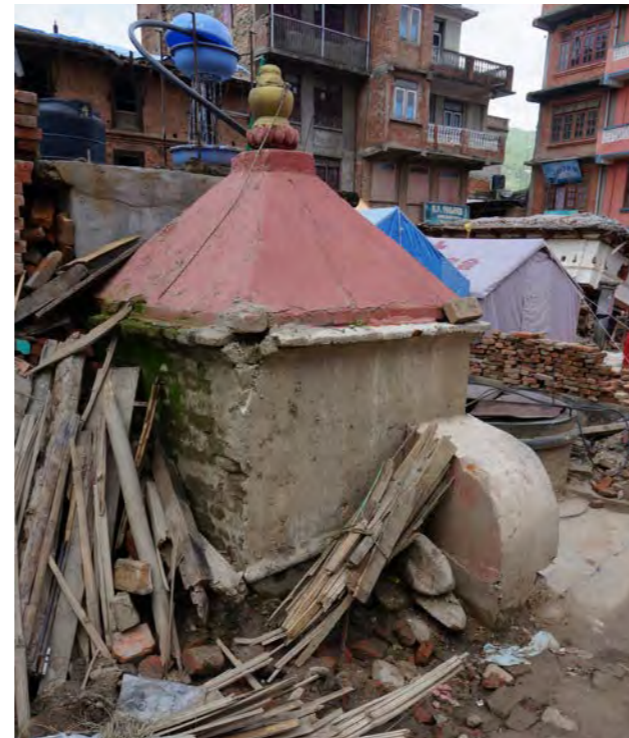
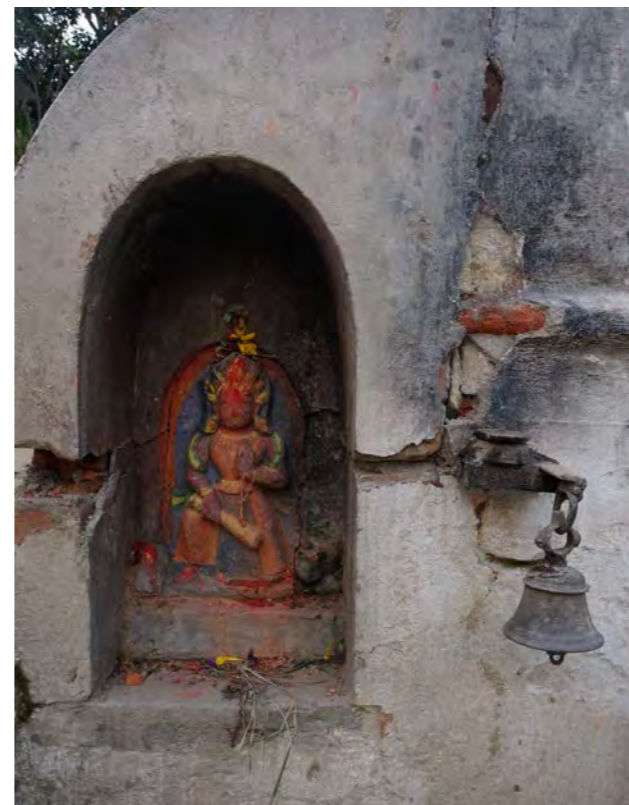
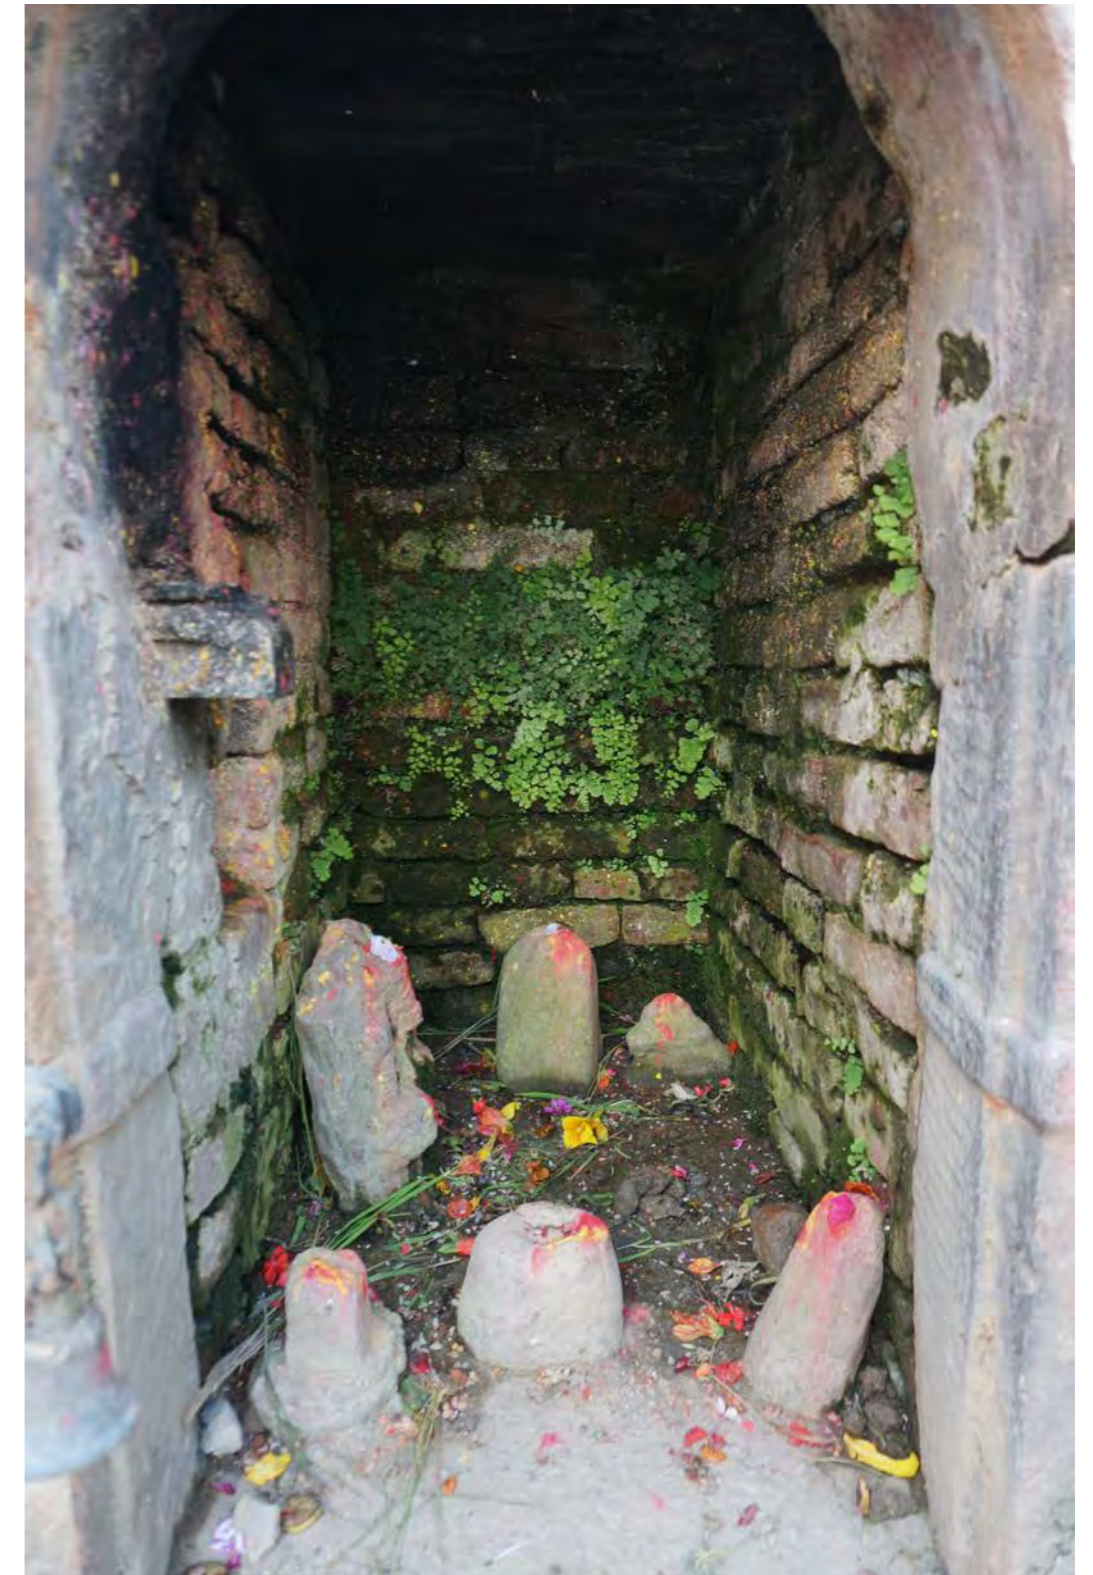
C-09 BHIMSEN SHRINE

NUMBER	NAME	DATE A.D.	TYOLOGY	GENERAL DESCRIPTION	PROBLEMS DESCRIPTION	DANGER/ DESTROY
C-09	Bhimsen Shrine		Enclosed Shrine	Some old monuments and holy stones established. Brick with cement plastered.	South part is cracking out Minor wall cracks Needs immediate repair and maintainance

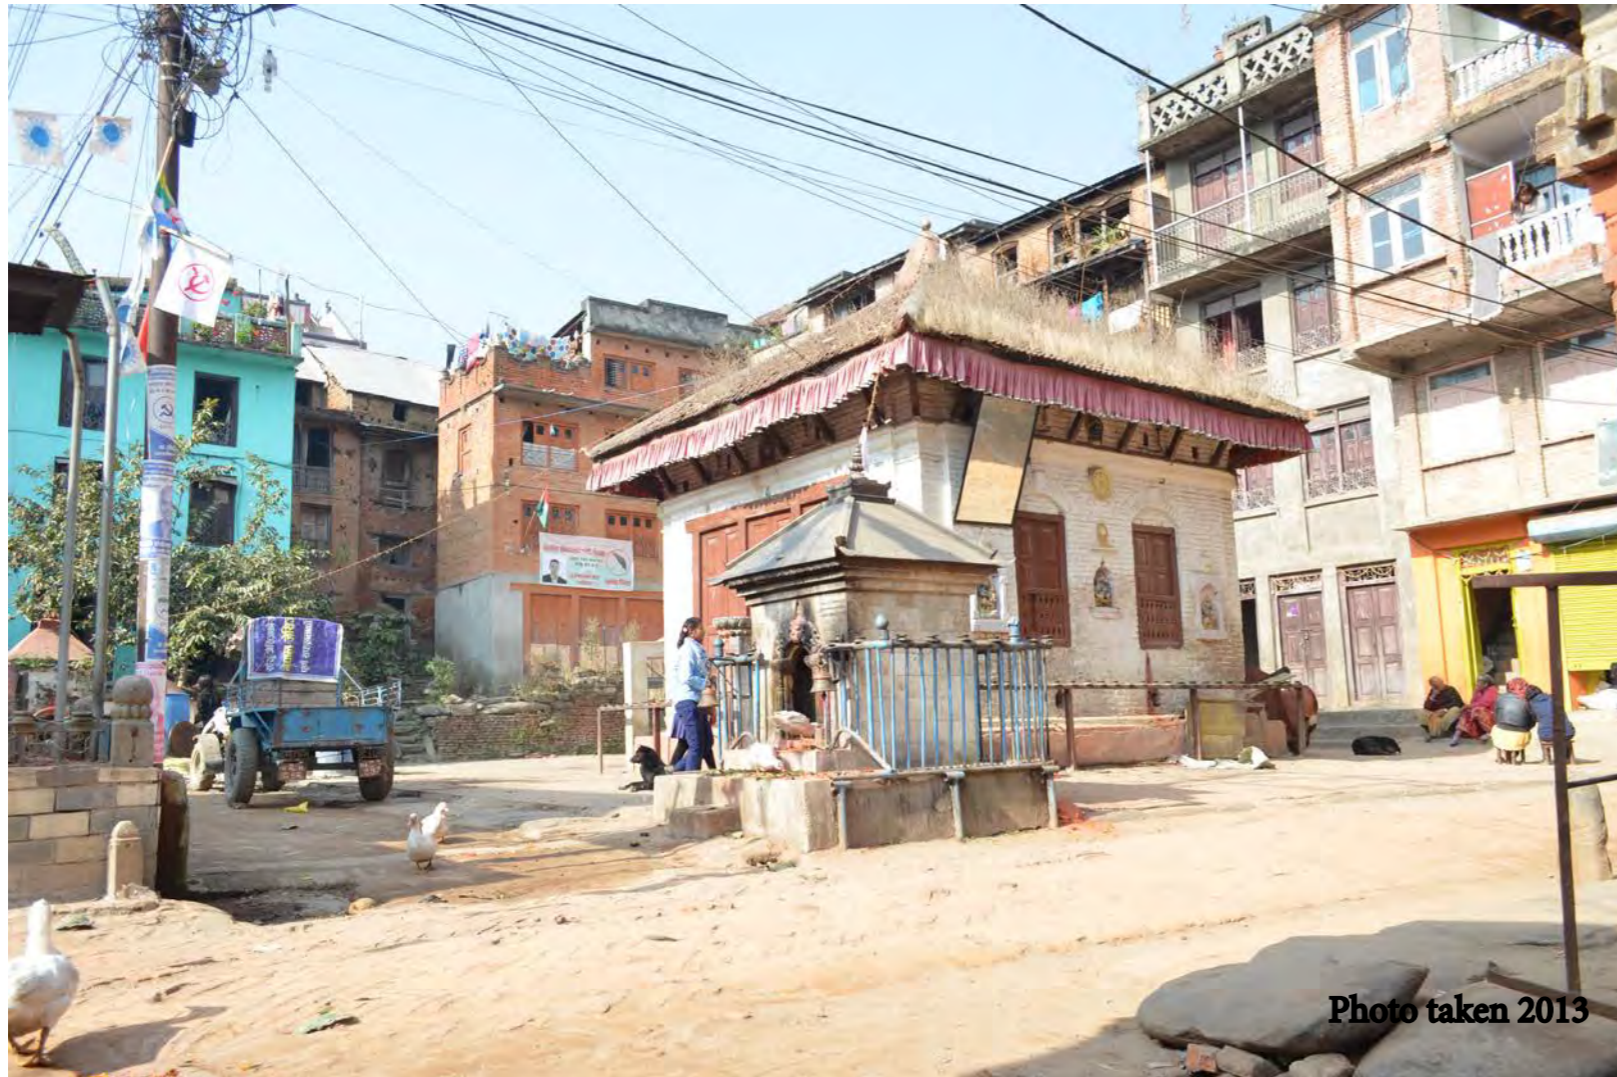
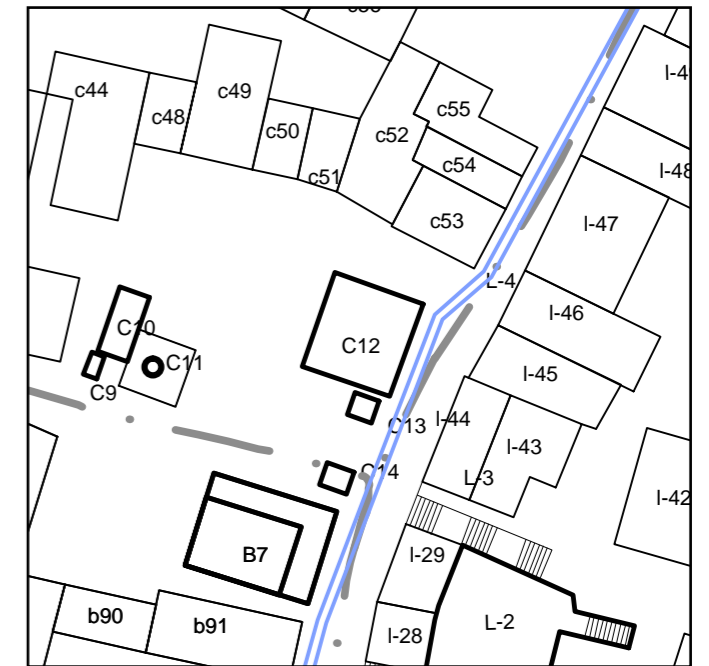
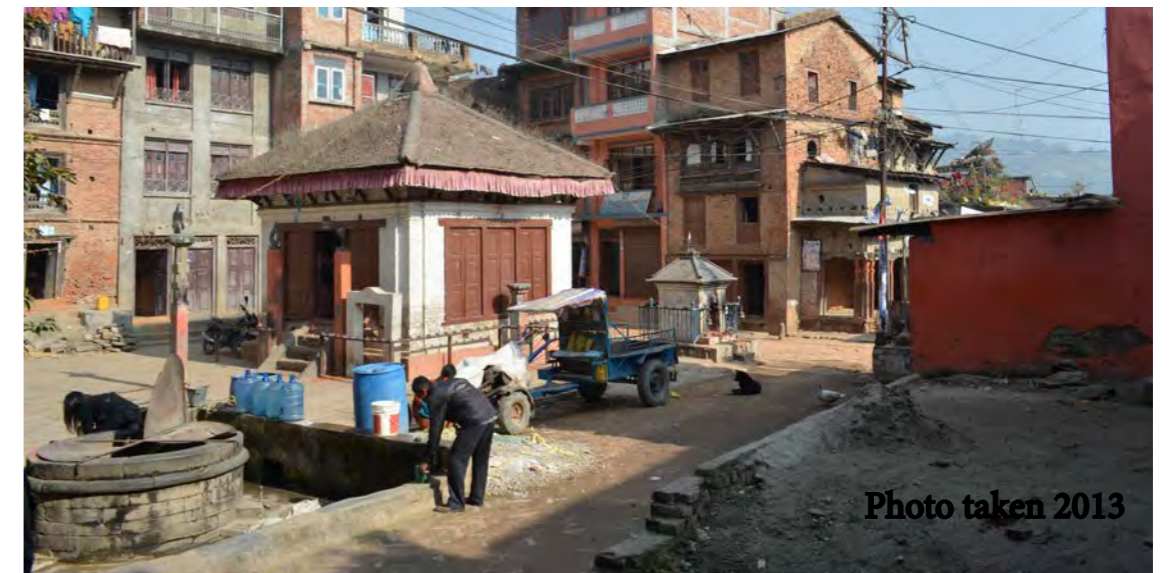
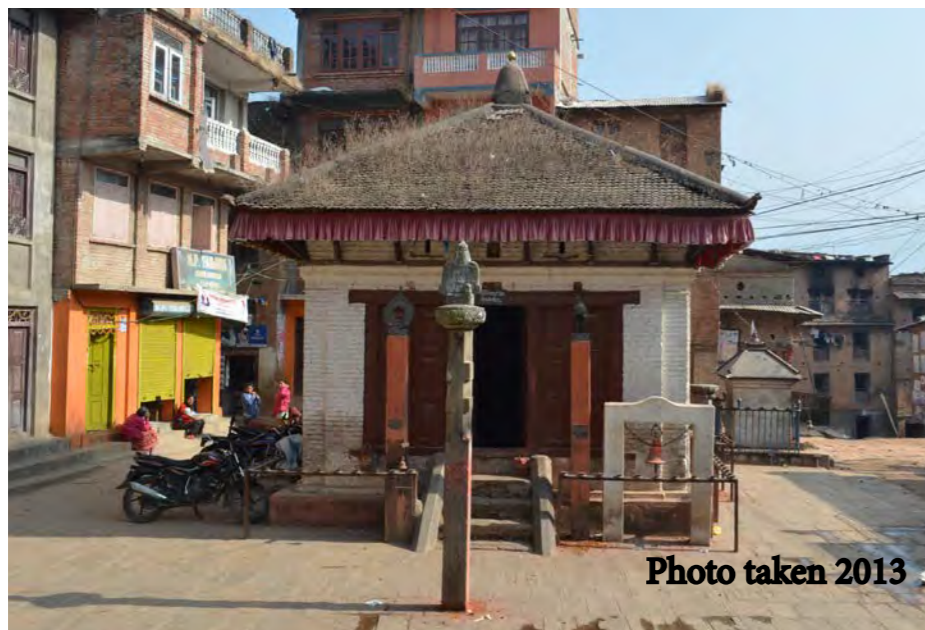
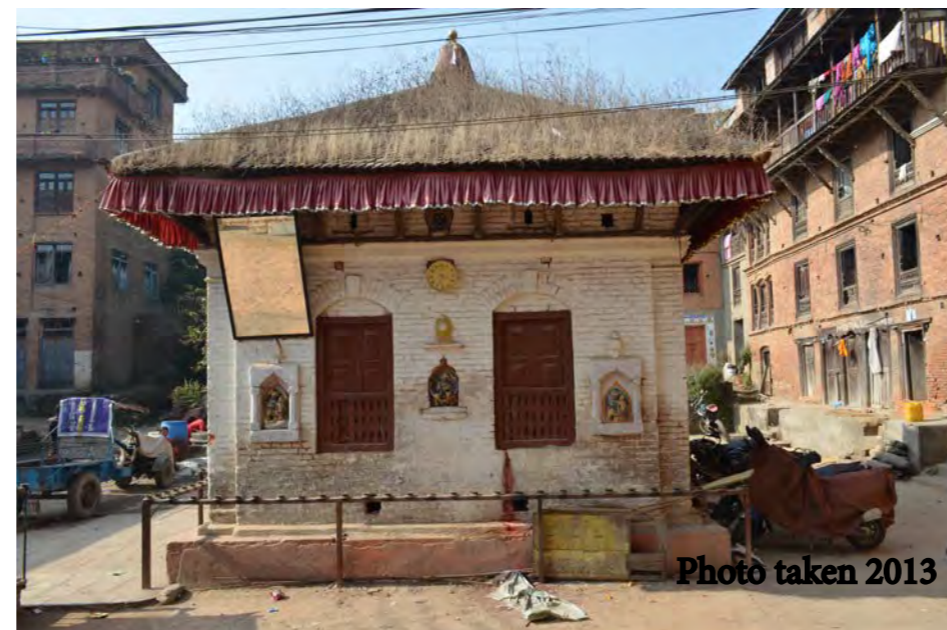
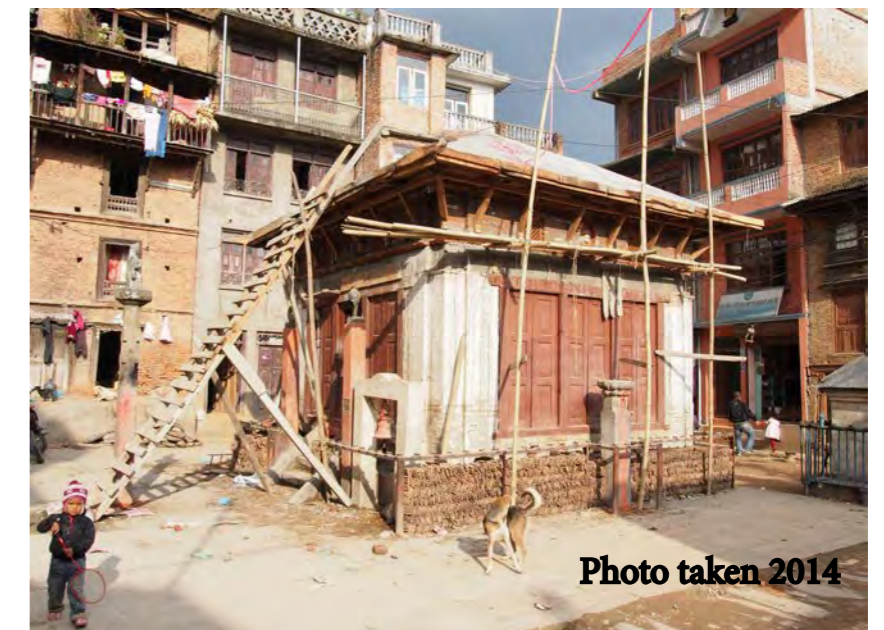
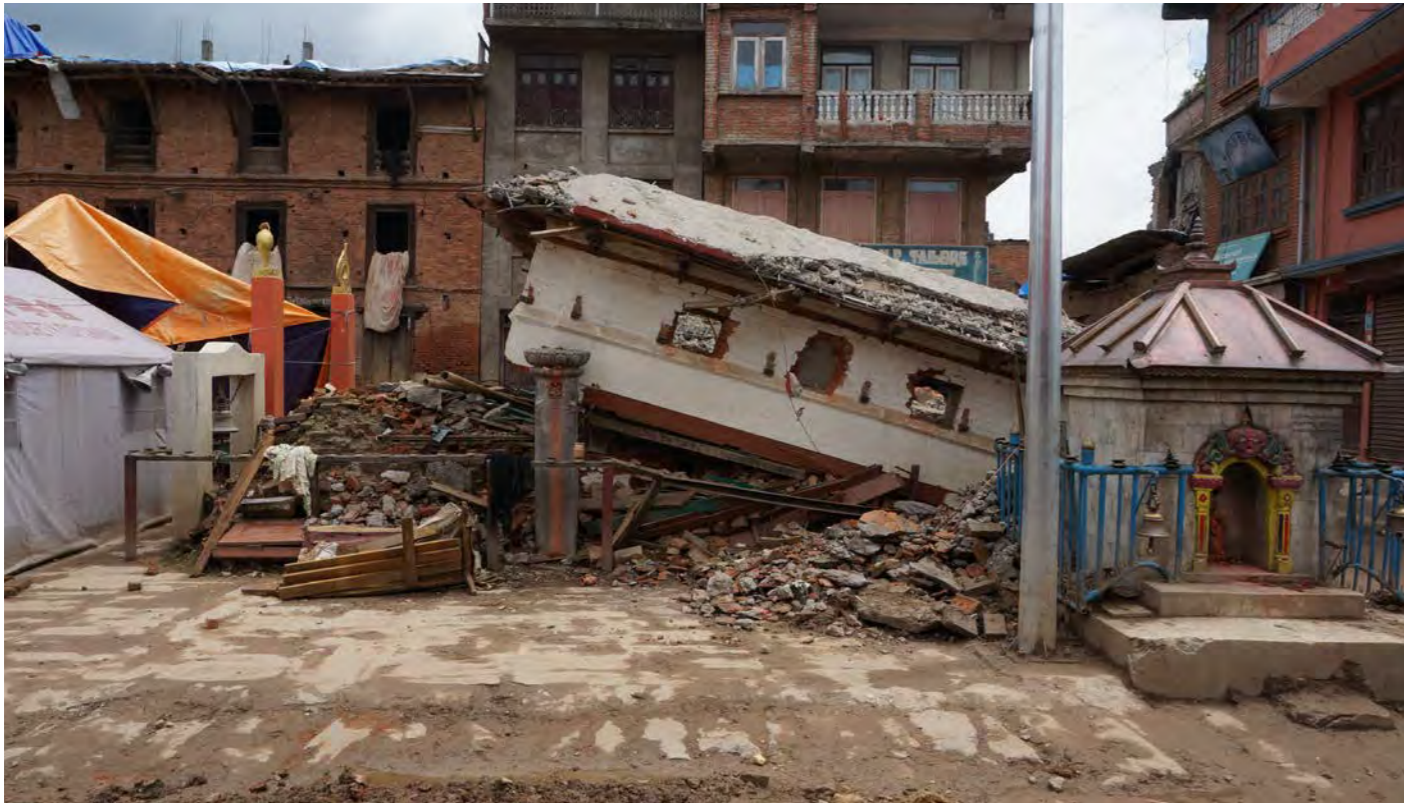
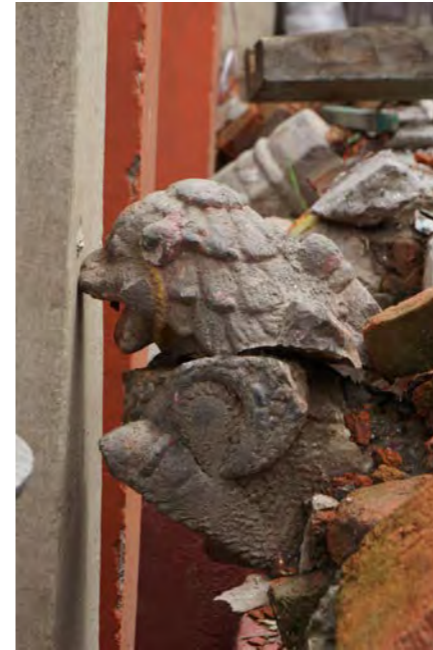
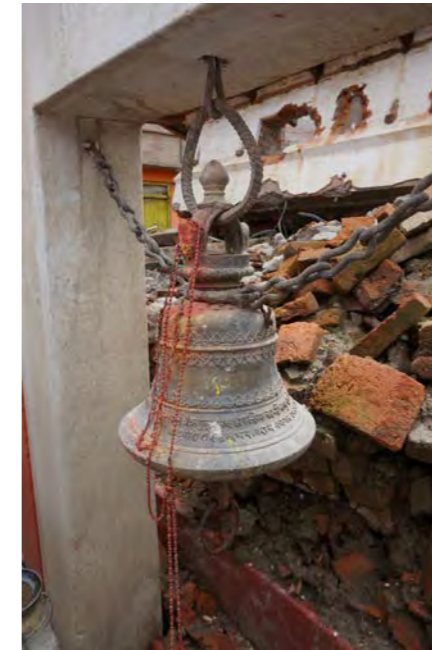
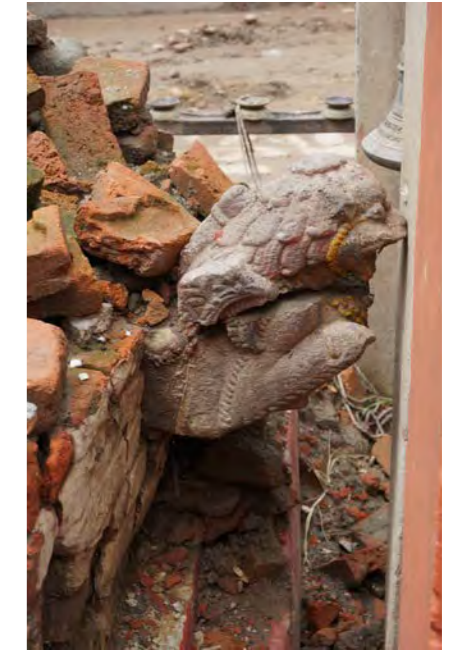
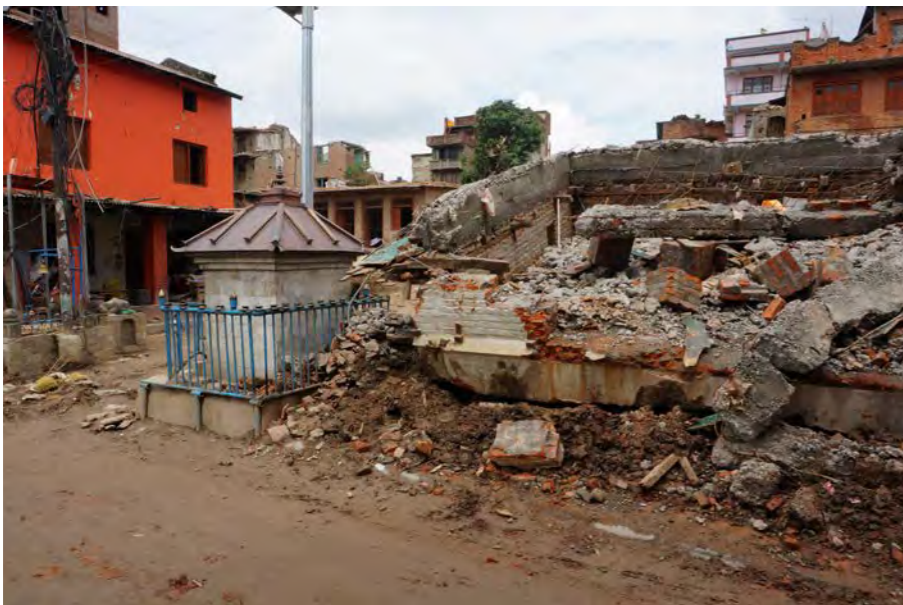
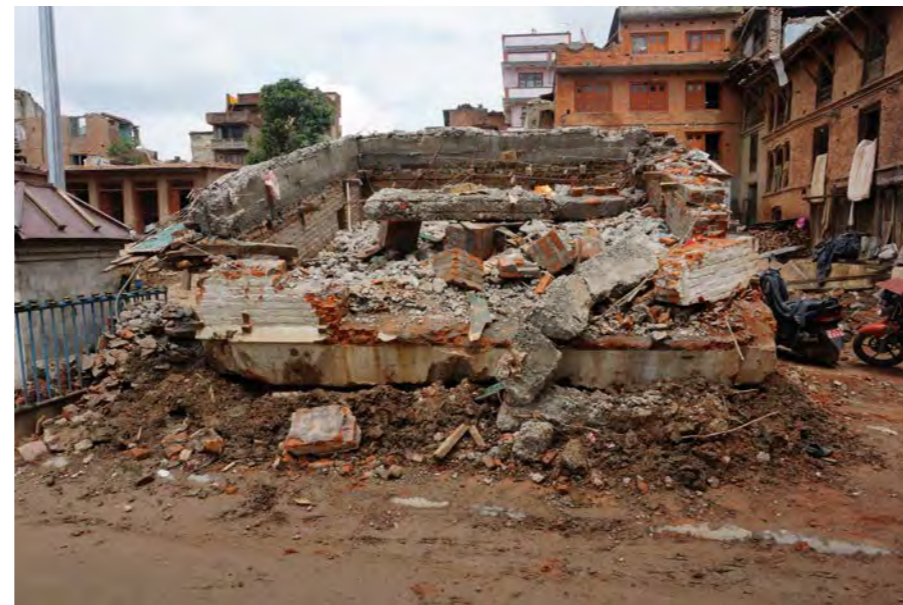
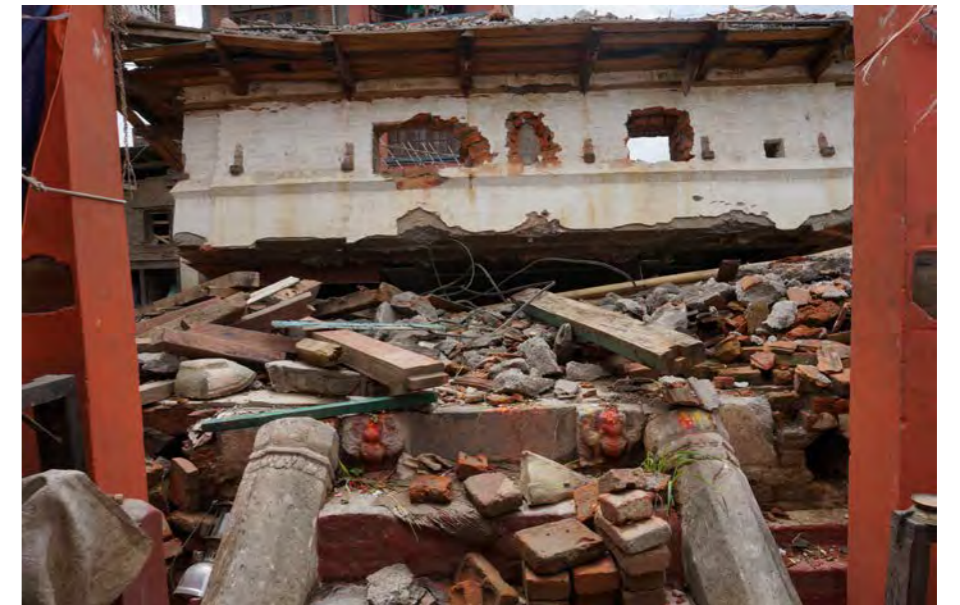
C-12 NARAYAN TEMPLE

NUMBER	NAME	DATE A.D.	TYPOLOGY	GENERAL DESCRIPTION	PROBLEMS DESCRIPTION	DANGER/ DESTROY
C-12	Narayan Temple		Single storey temple	Narayan temple made in brick masonry and pillars with concrete slabs	Totally Collapsed

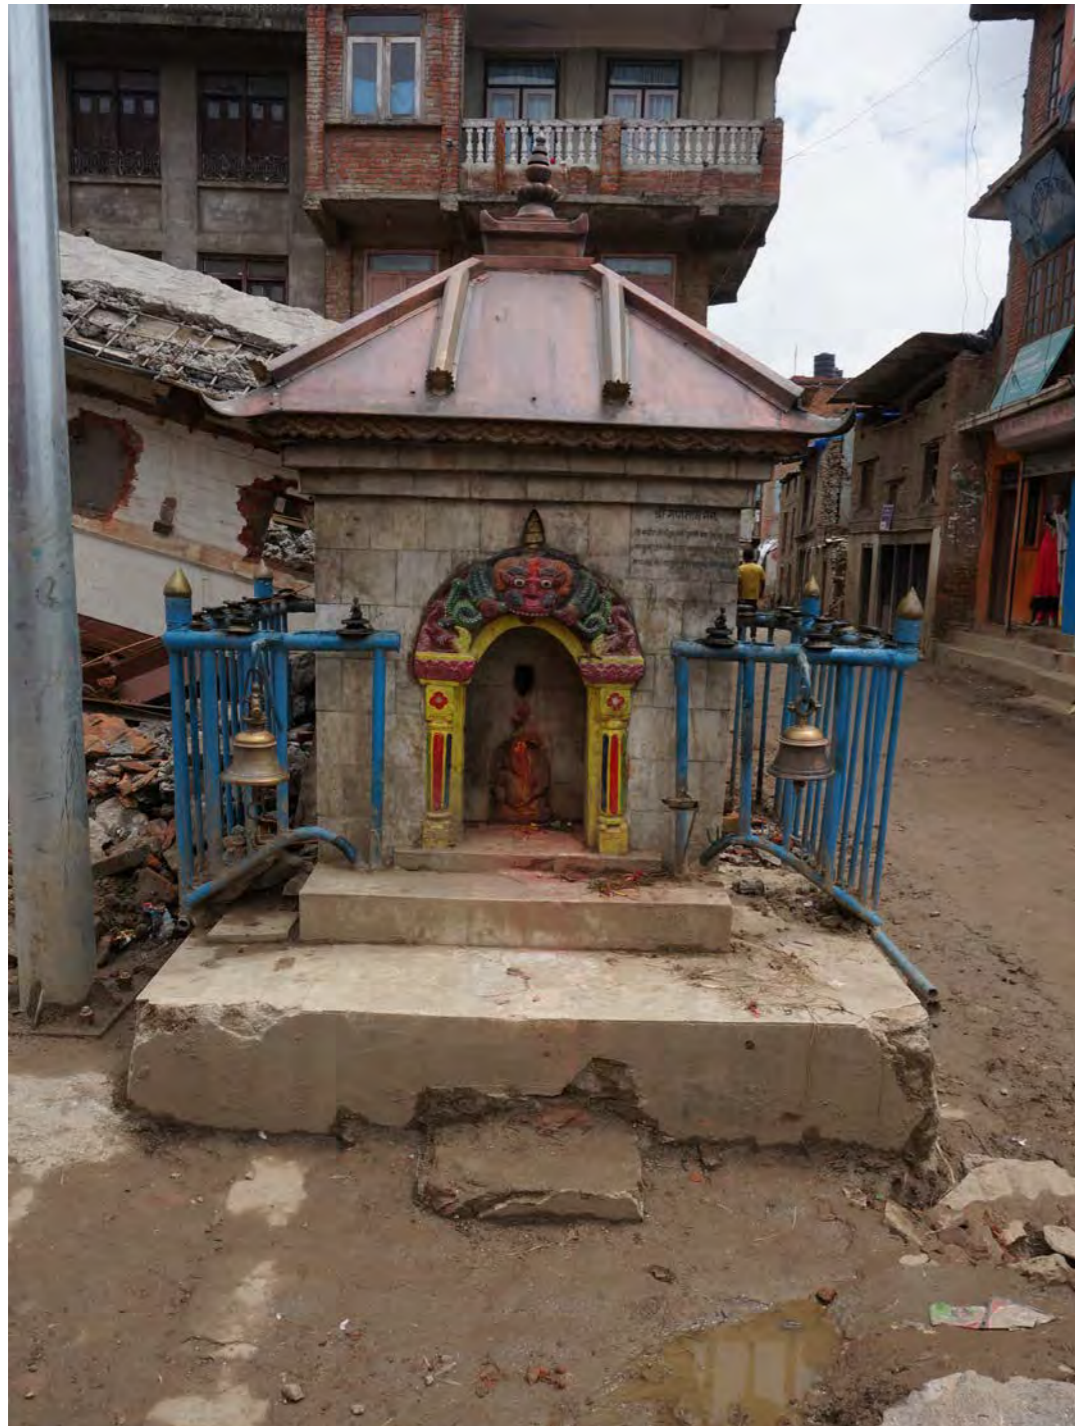
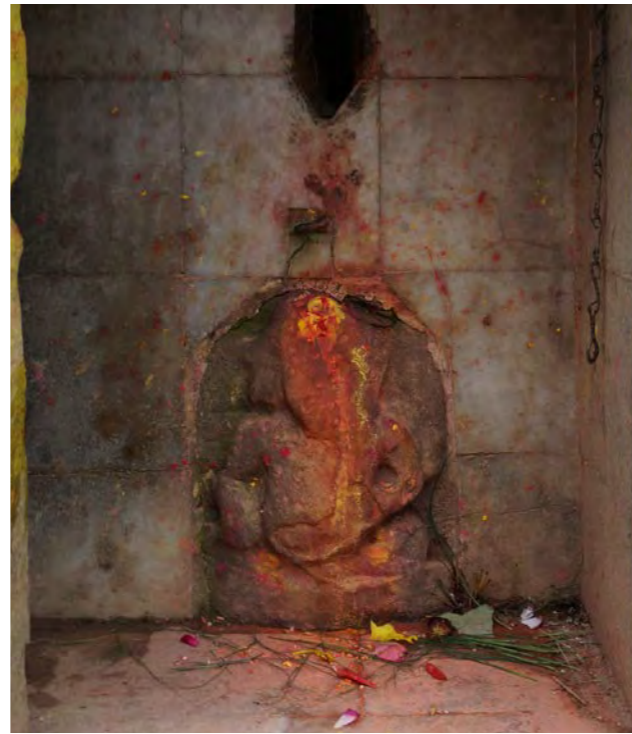
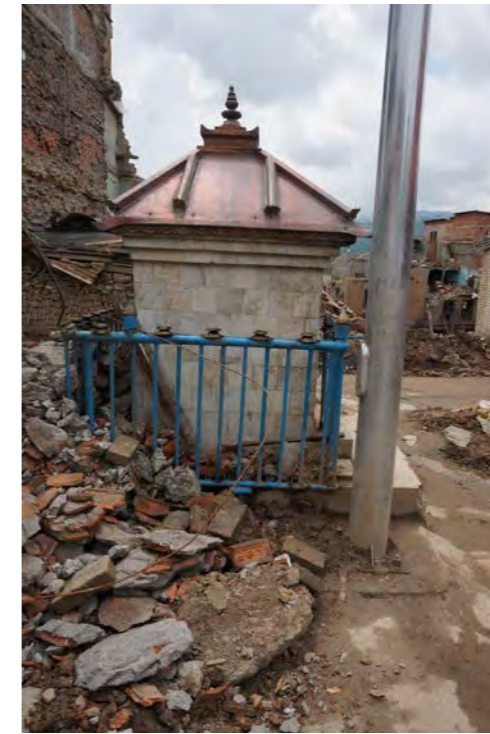
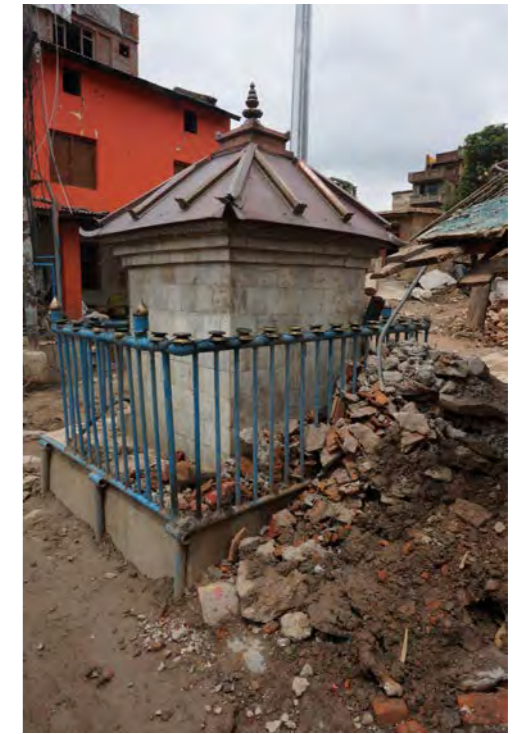
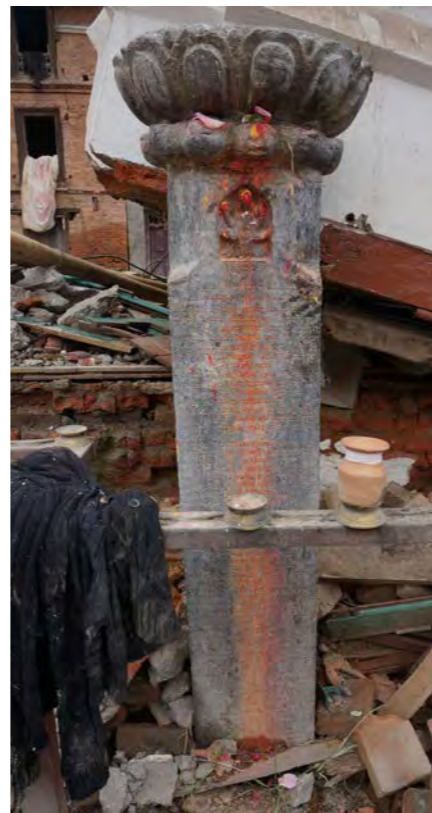
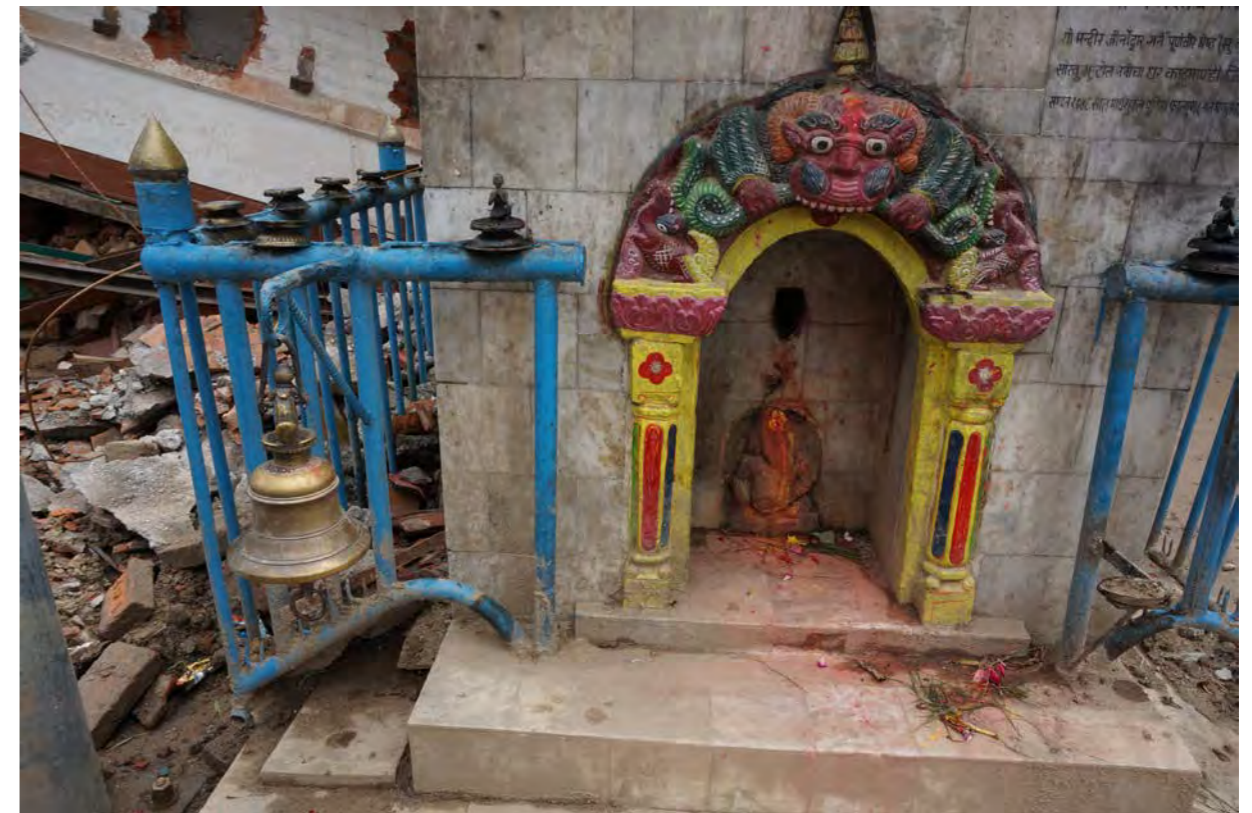
C-13 GANESH SHRINE

NUMBER	NAME	ESTABLISHED DATE (A.D.)	TYPOLOGY	GENERAL DESCRIPTION	PROBLEMS DESCRIPTION	DANGER/ DESTROY
C-13	Ganesh Shrine		Enclosed Shrine	Tiled construction in brick/stone with gilded copper roof	Good Condition Some minor damages
