2015 Earthquake Damage Mapping

Sankhu

October 2015

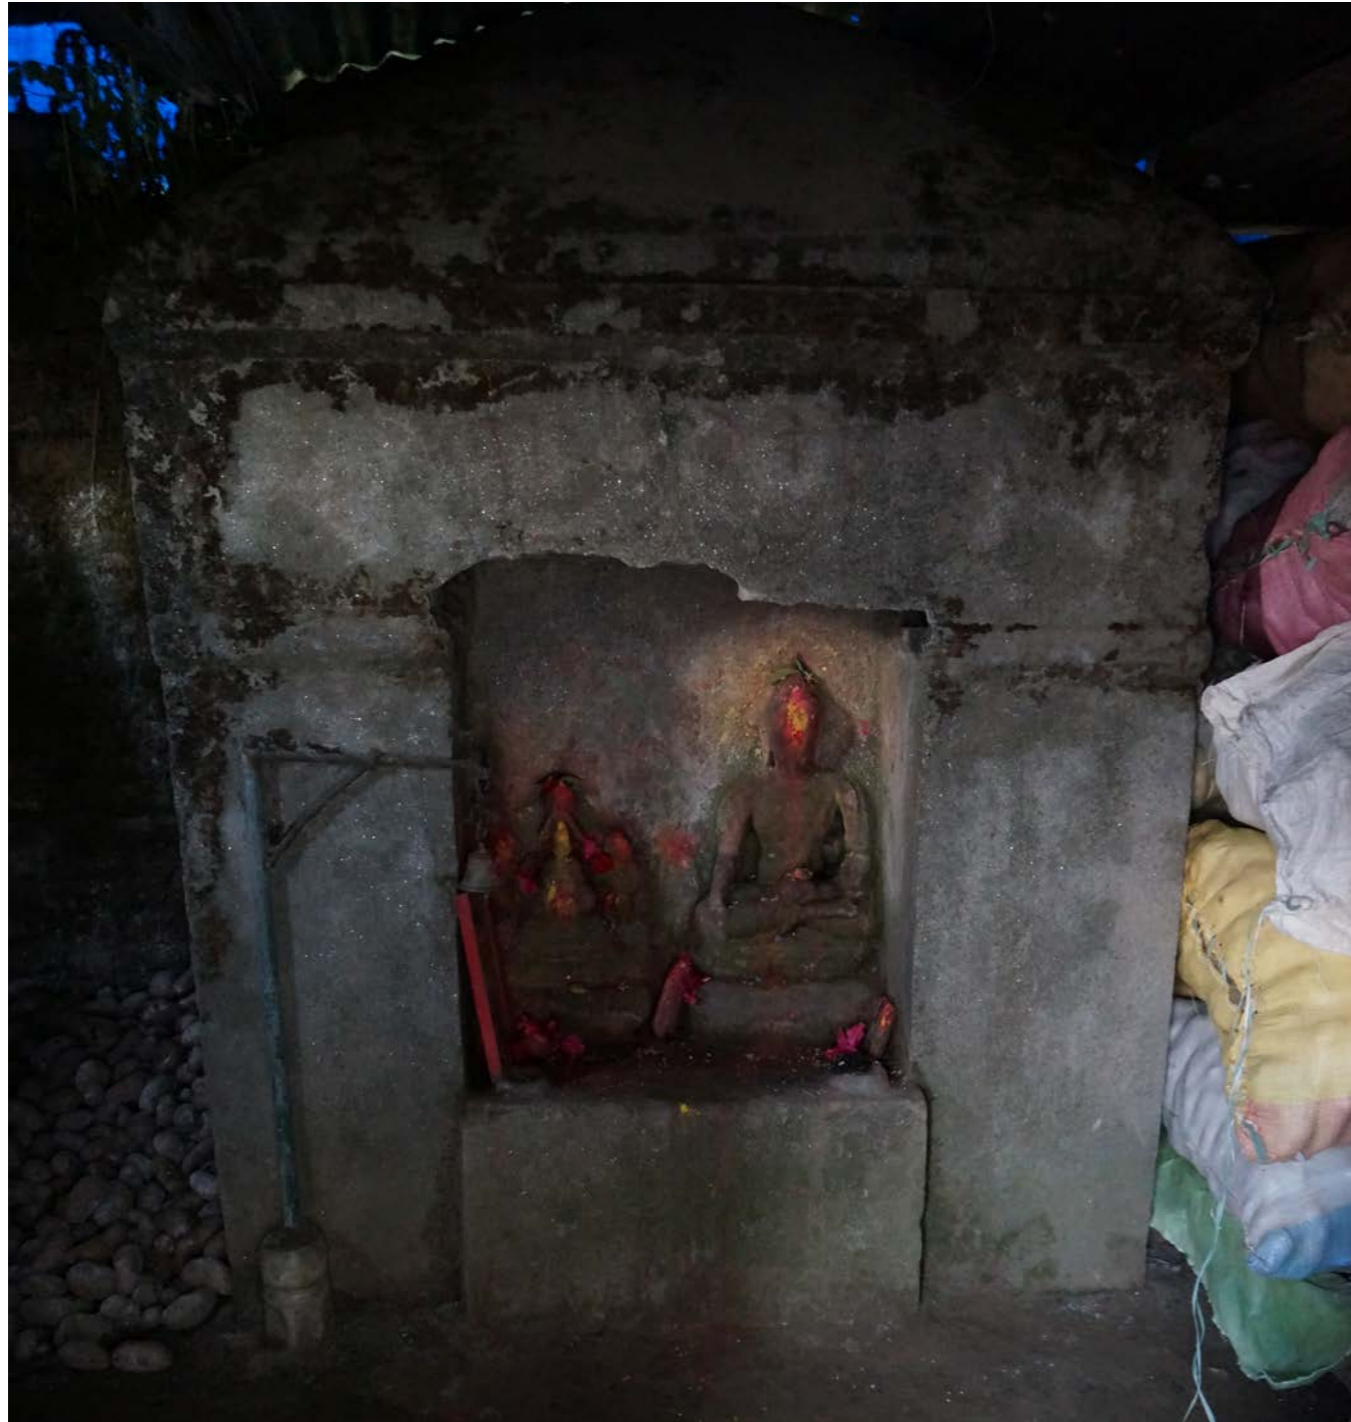
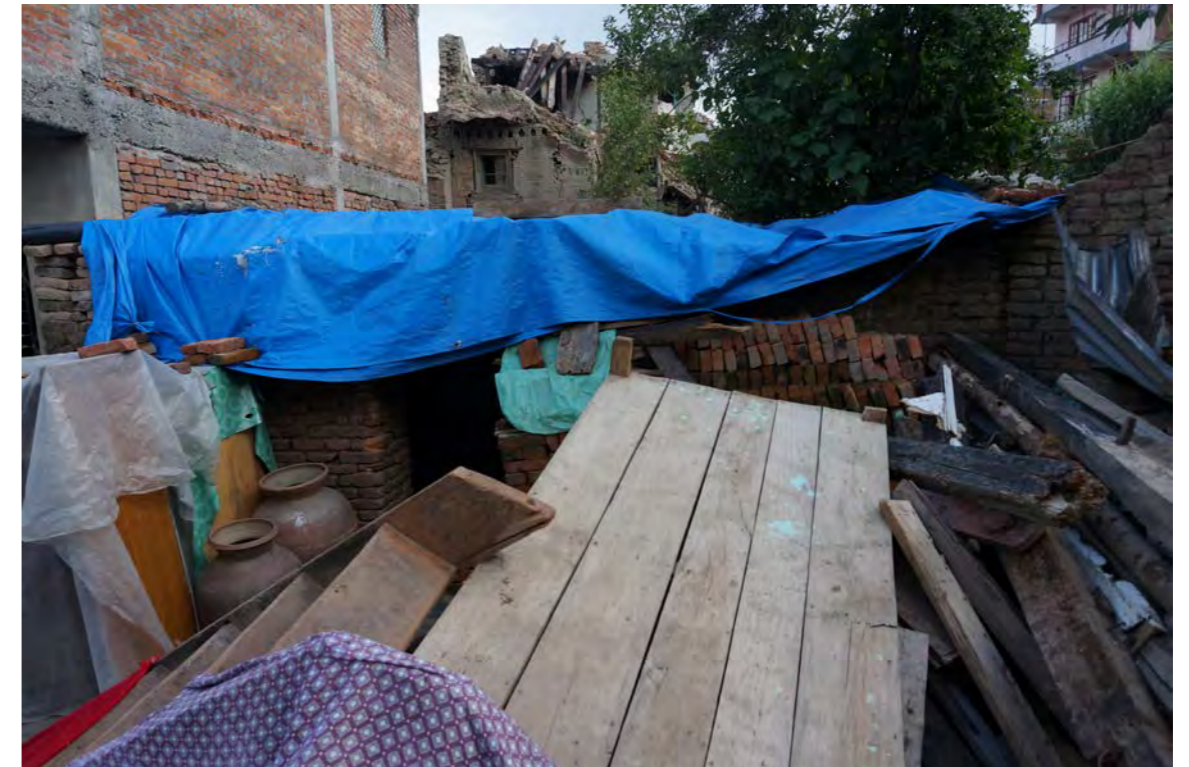
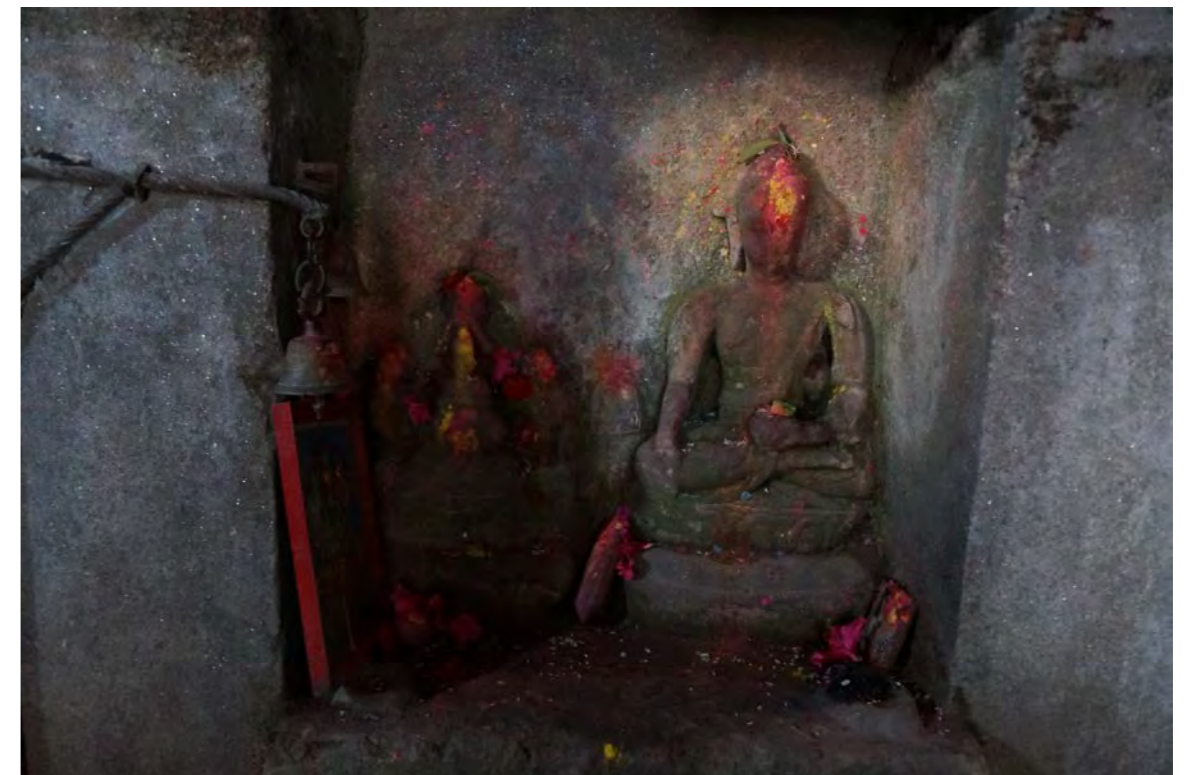
C-15 BUDDHA SHRINE

NUMBER	NAME	DATE A.D.	TPOLOGY	GENERAL DESCRIPTION	PROBLEMS DESCRIPTION	DANGER/ DESTROY
C-15	Buddha Shrine		Open Shrine	Shrine made in brick masonry with concrete frames	No Major damages Used by locals as temporary shelter using plastic tarps

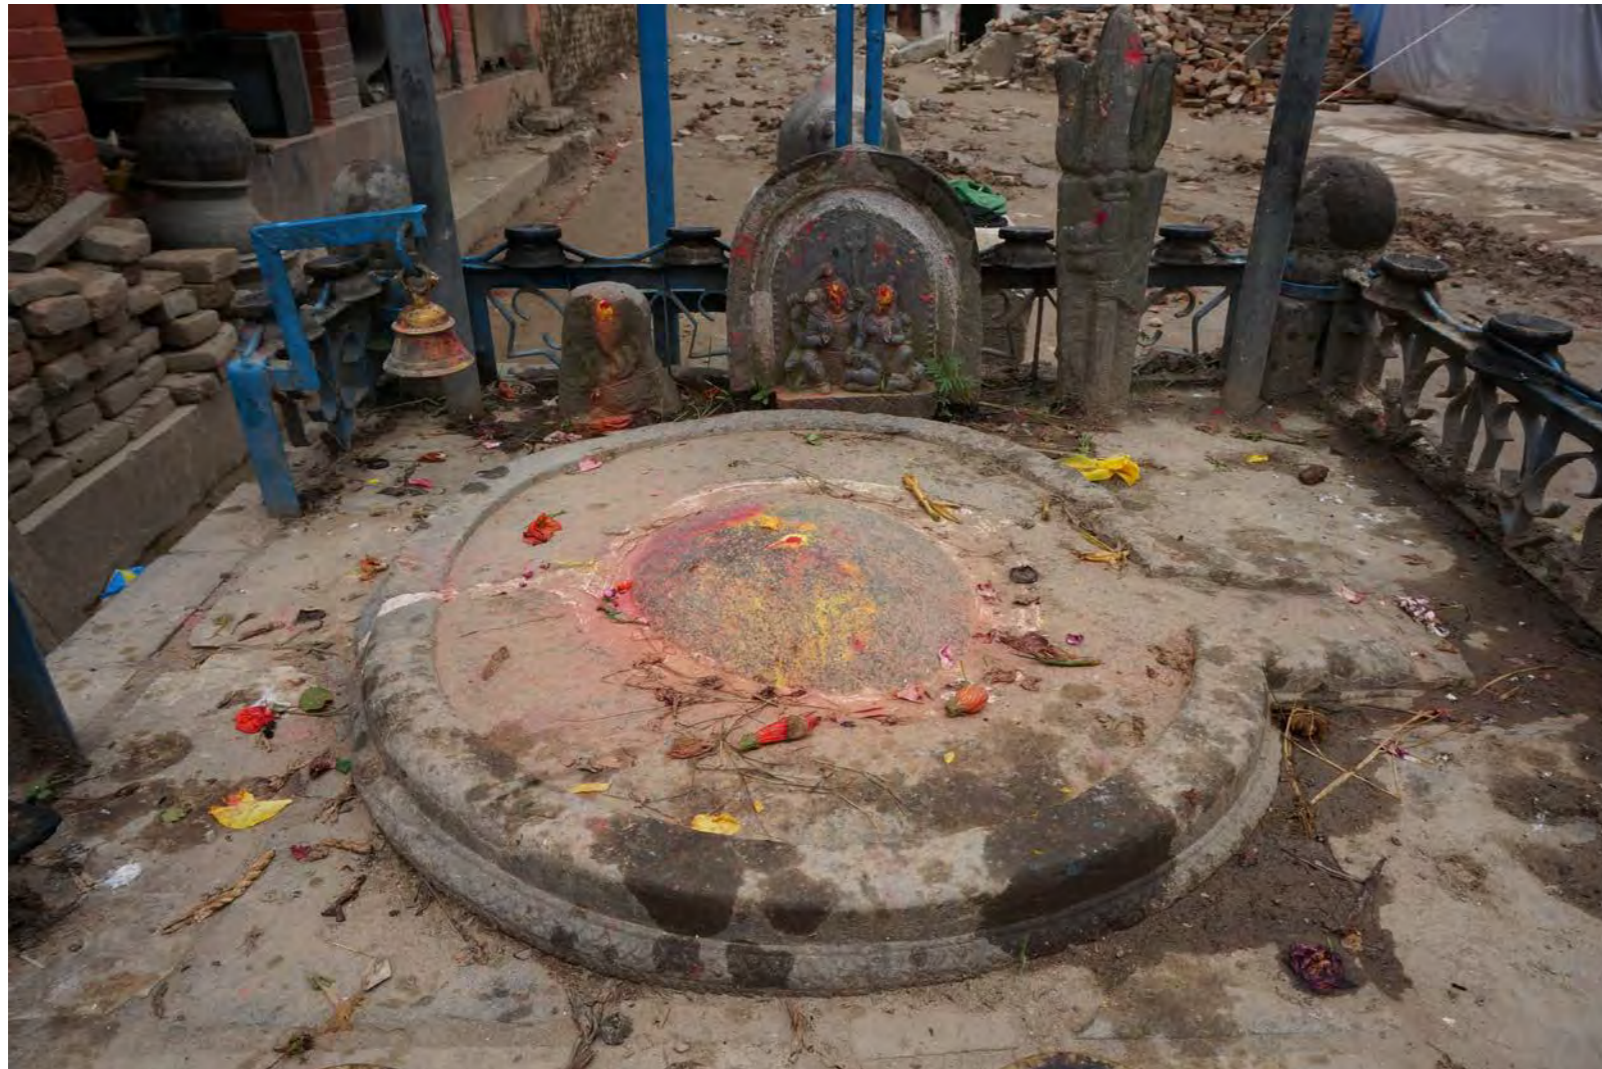
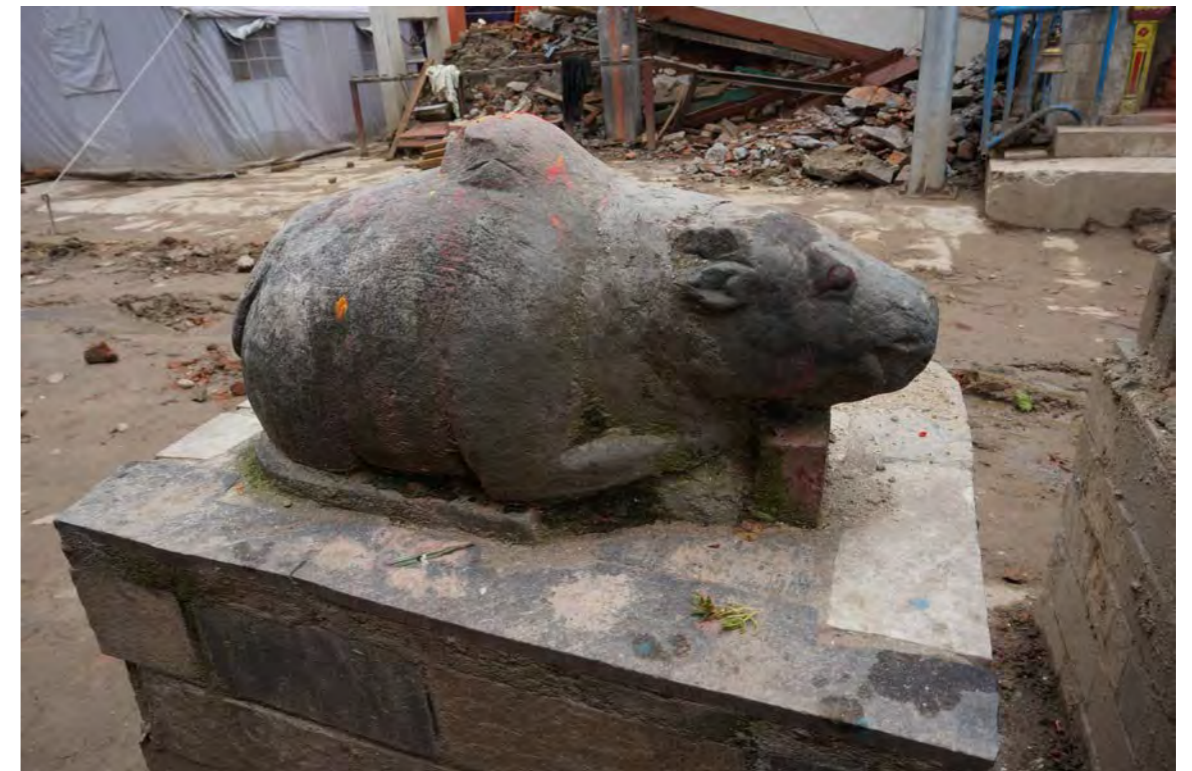
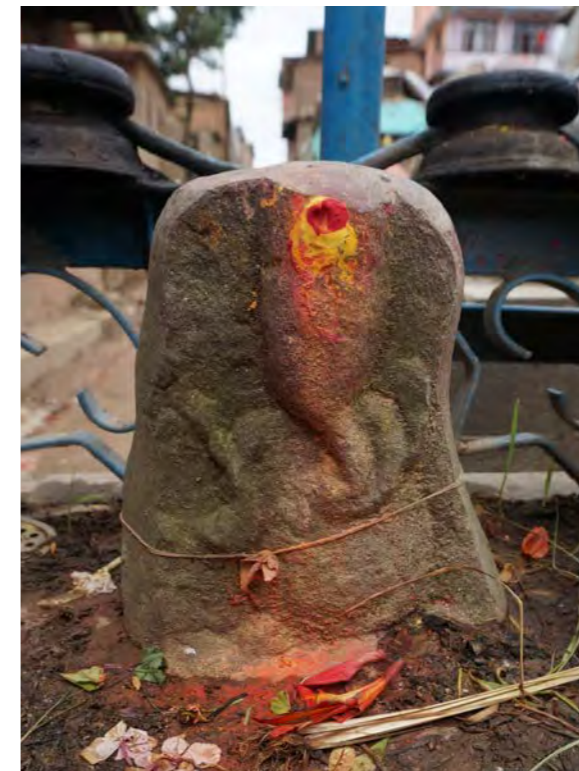
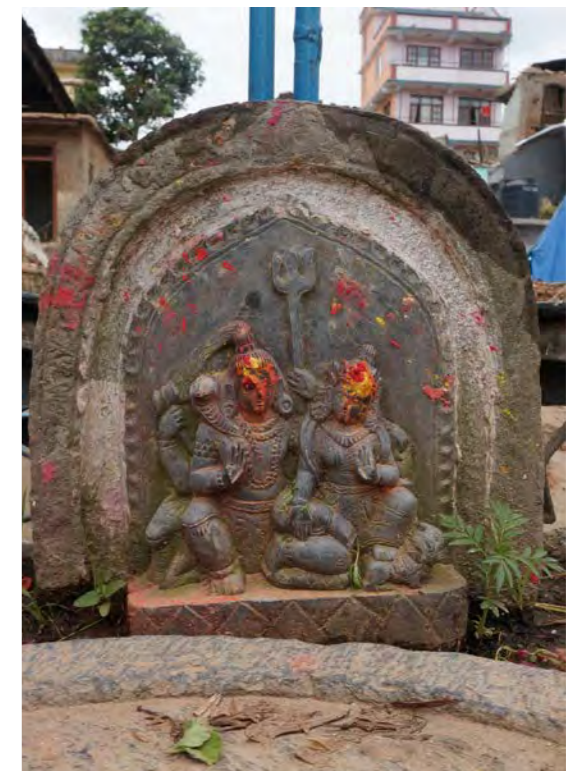
C-14 SHIVA LINGA

NUMBER	NAME	ESTABLISHED DATE (A.D.)	TPOLOGY	GENERAL DESCRIPTION	PROBLEMS DESCRIPTION	DANGER/ DESTROY
C-14			Shiva Linga	Stone Shiva Linga with metal roof	Good Condition

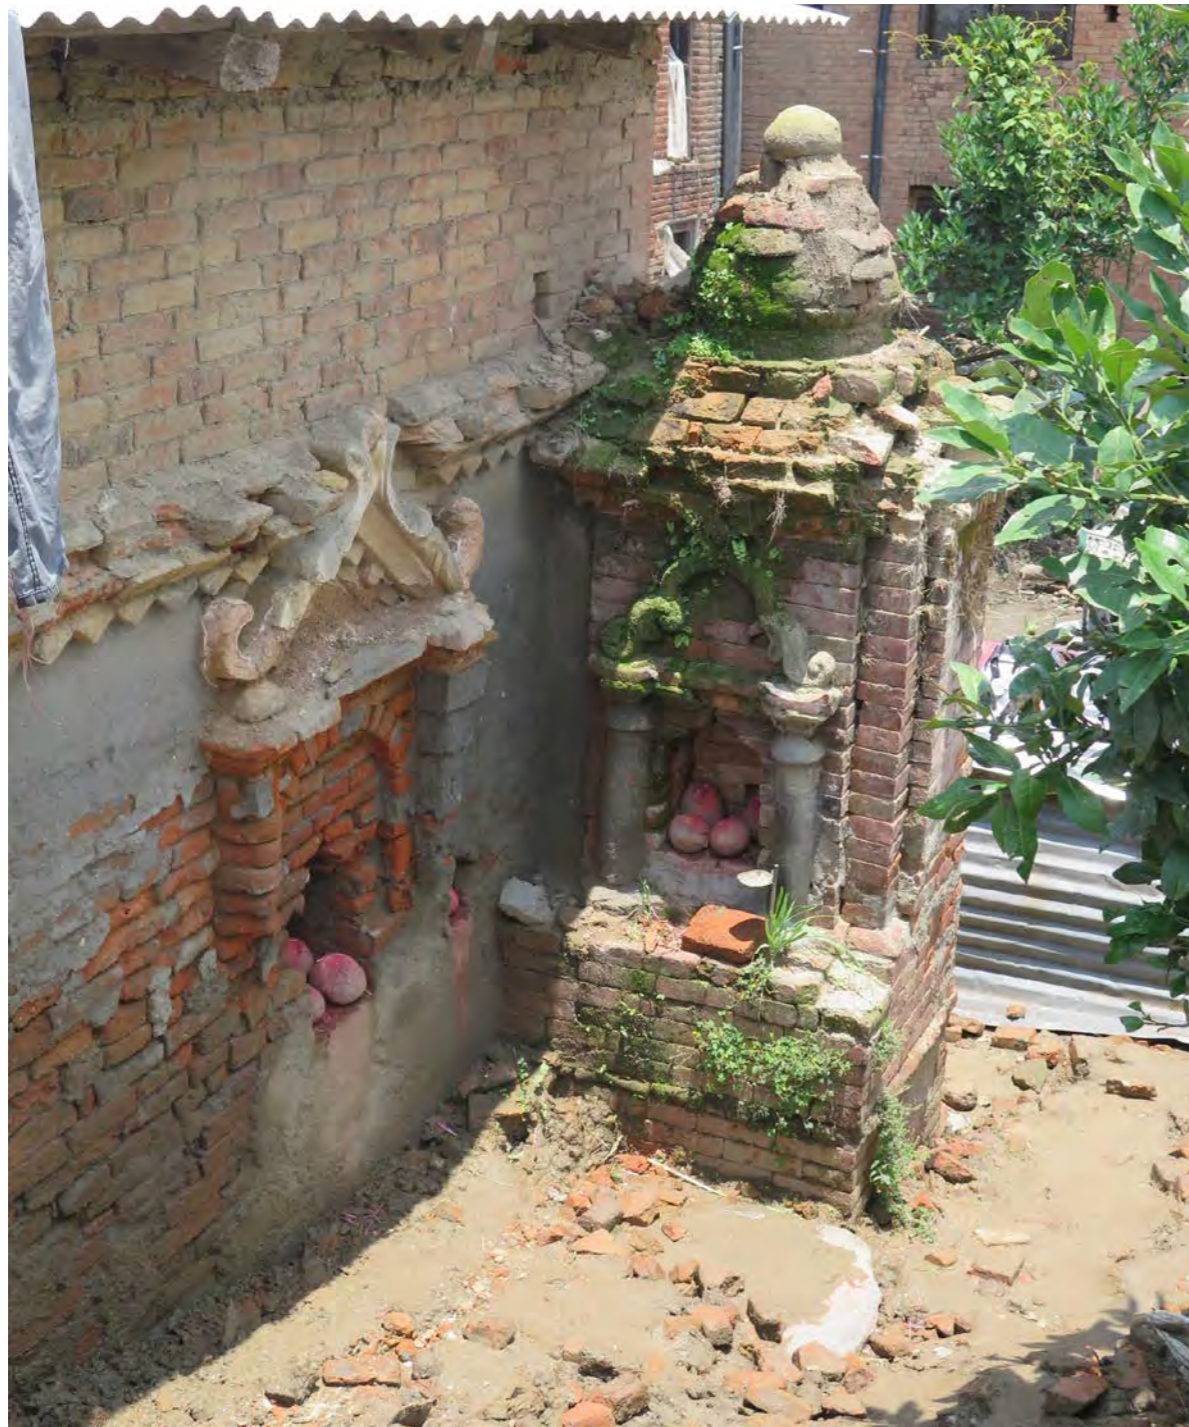
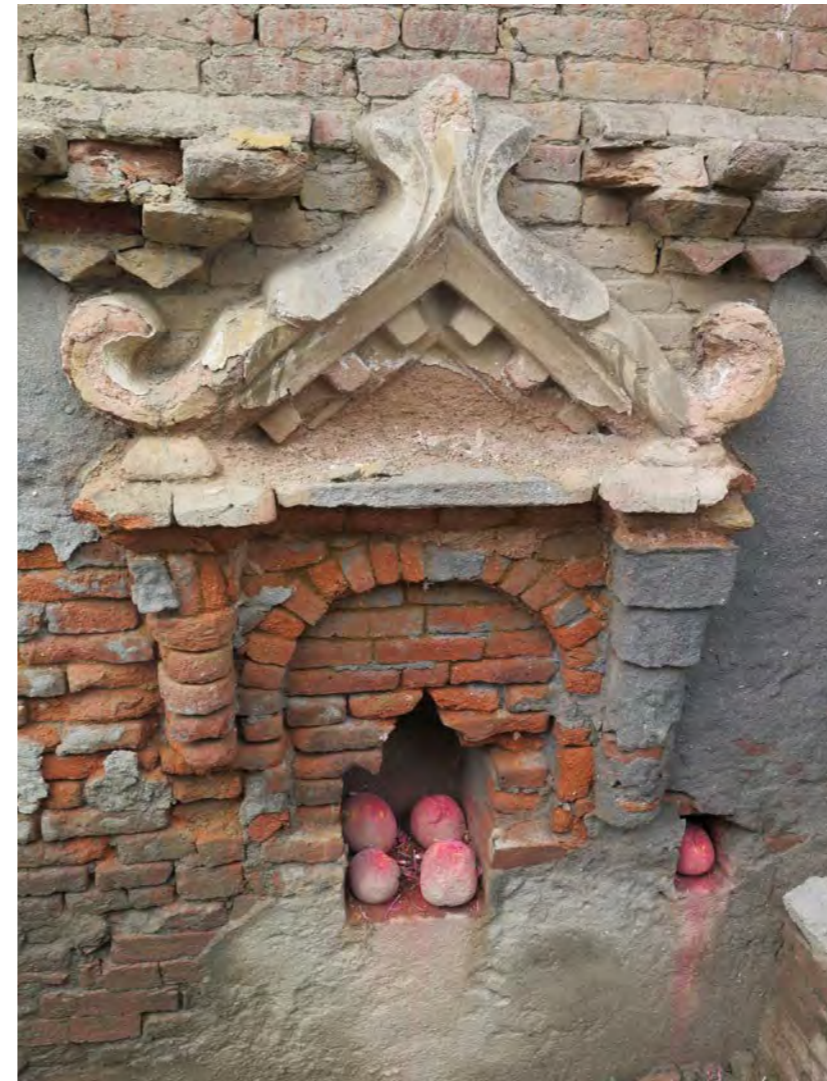
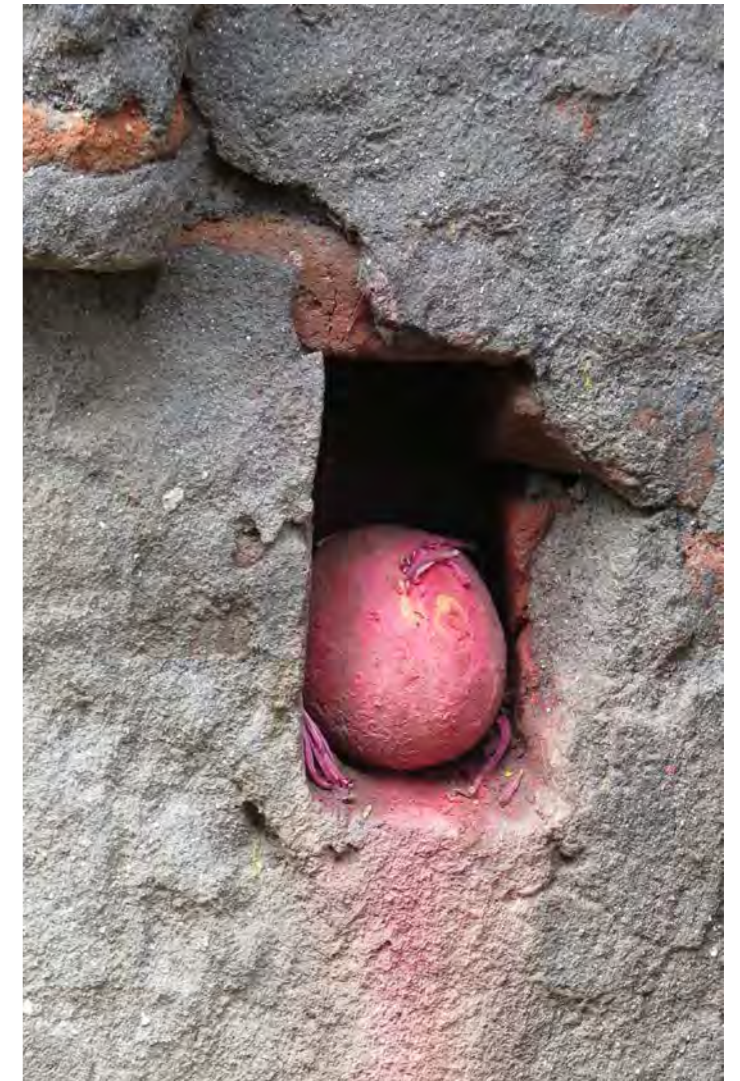
D-03 NASA DYA

NUMBER	NAME	DATE A.D.	TYPOLOGY	GENERAL DESCRIPTION	PROBLEMS DESCRIPTION	DANGER/ DESTROY
D-03	Nasa Dya		Enclosed Shrine	Small private shrine	No visible damage

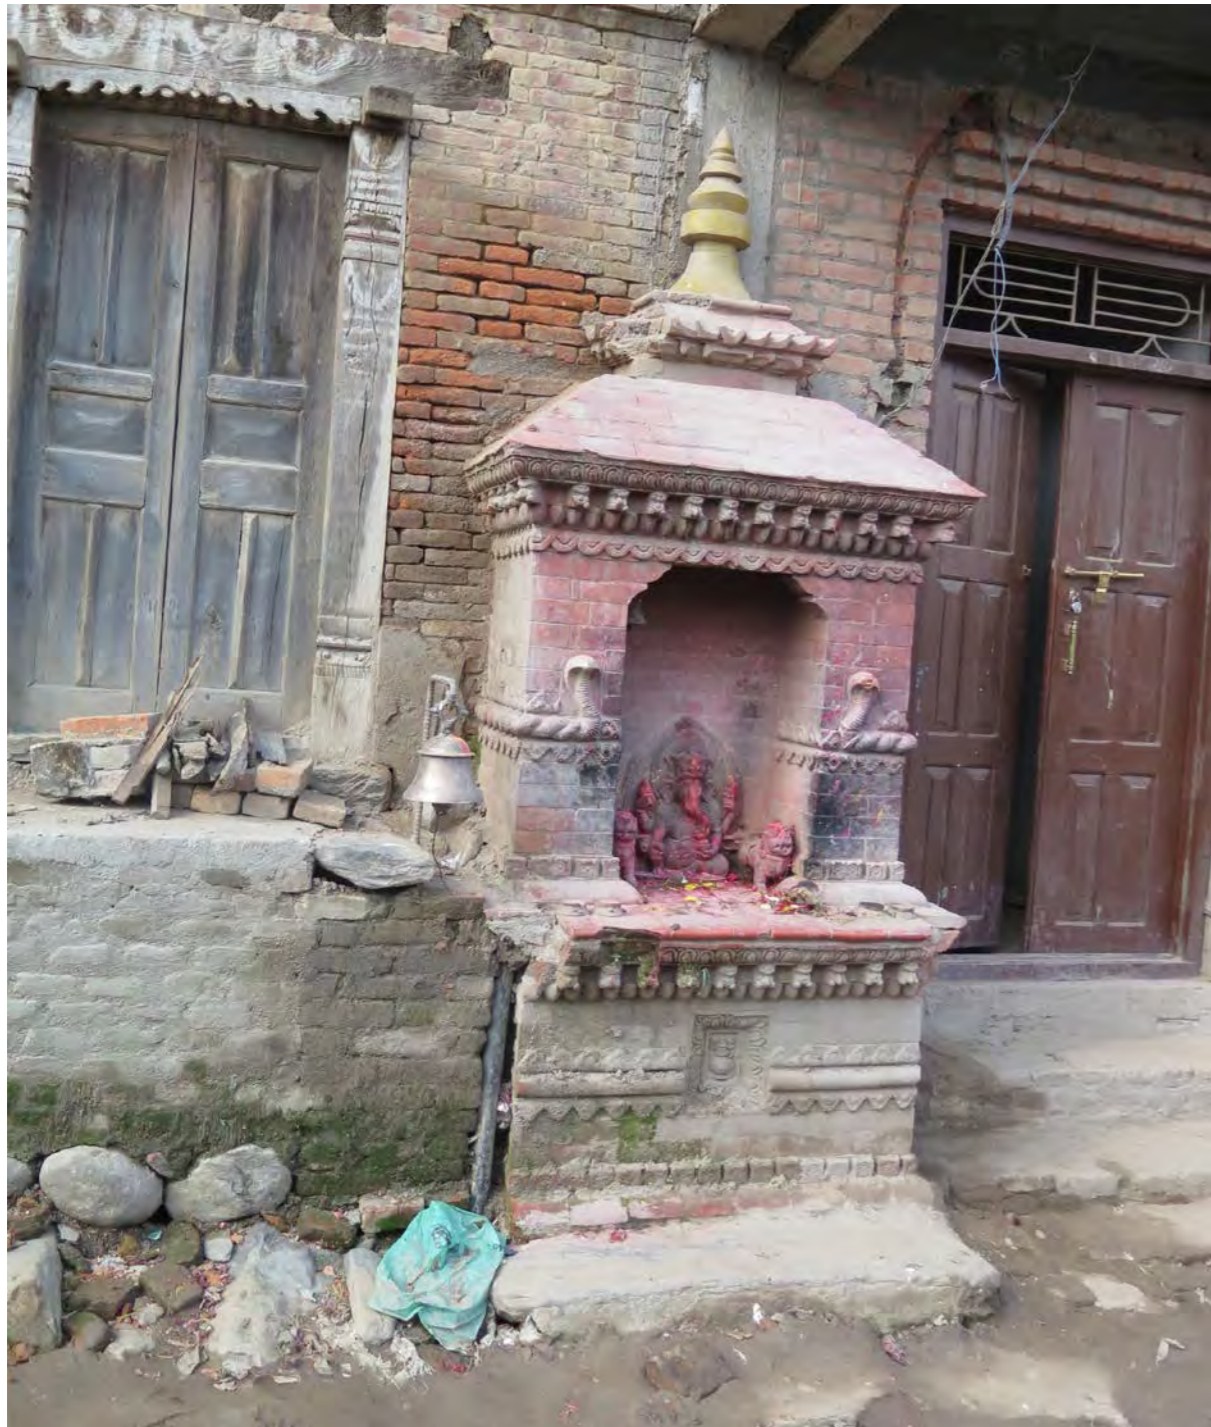
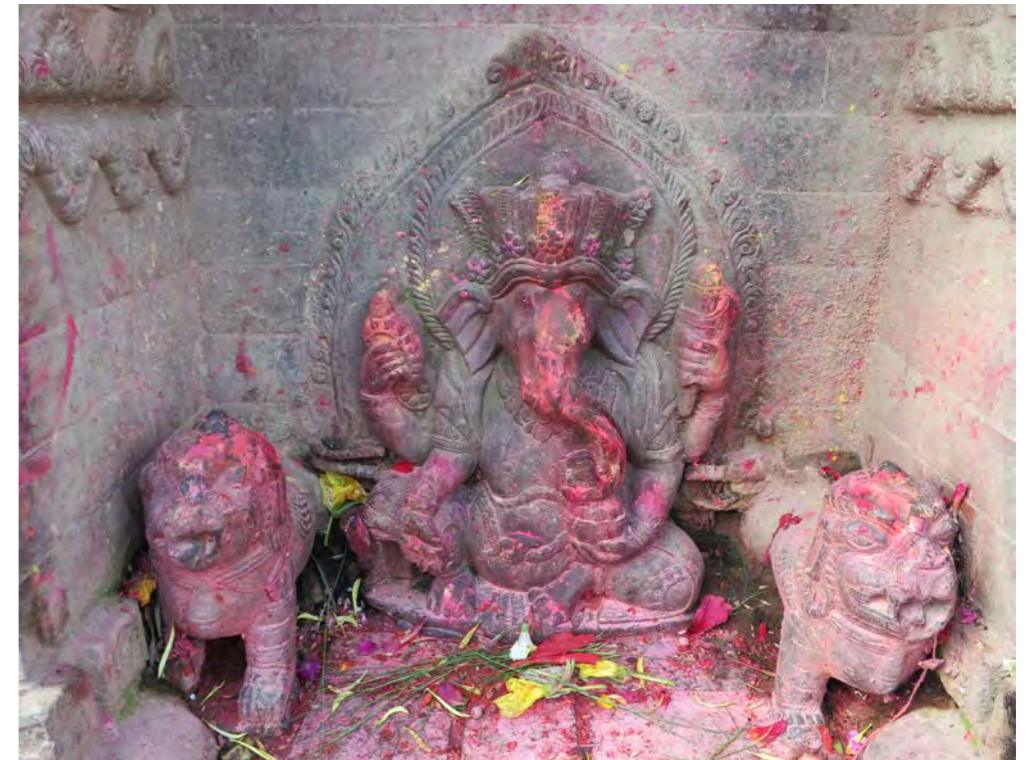
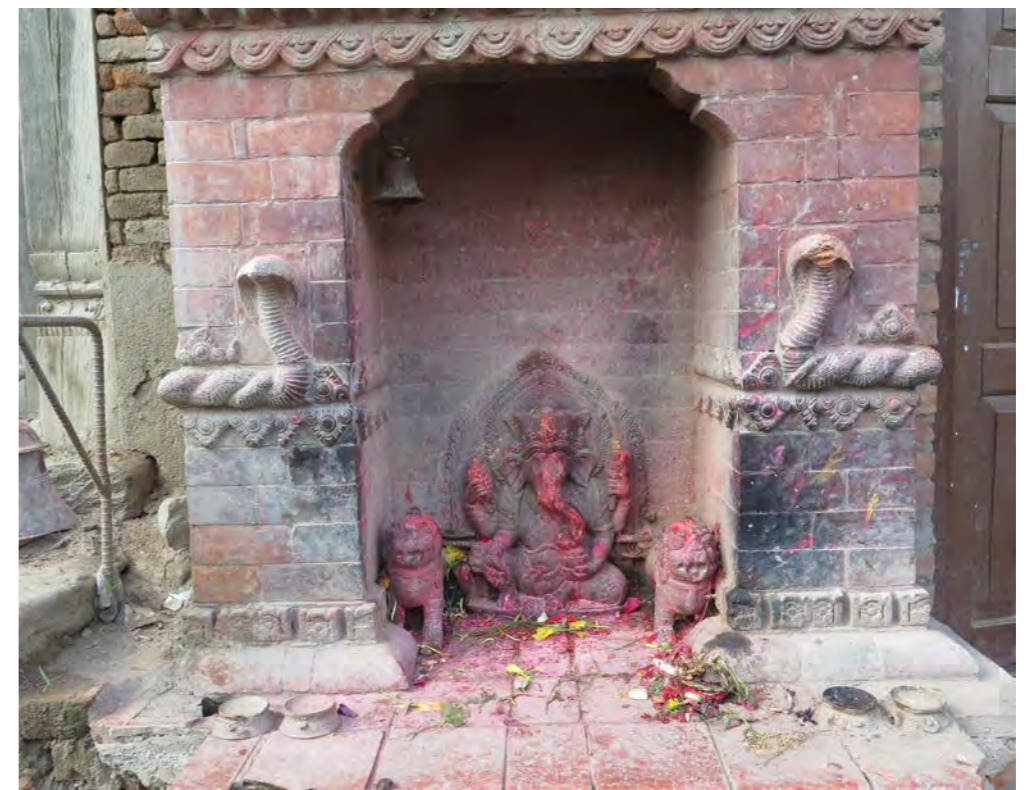
D-04 GANESH SHRINE

NUMBER	NAME	ESTABLISHED DATE (A.D.)	TYPOLOGY	GENERAL DESCRIPTION	PROBLEMS DESCRIPTION	DANGER/ DESTROY
D-04	Ganesh Shrine		Enclosed Shrine		Some carved bricks missing

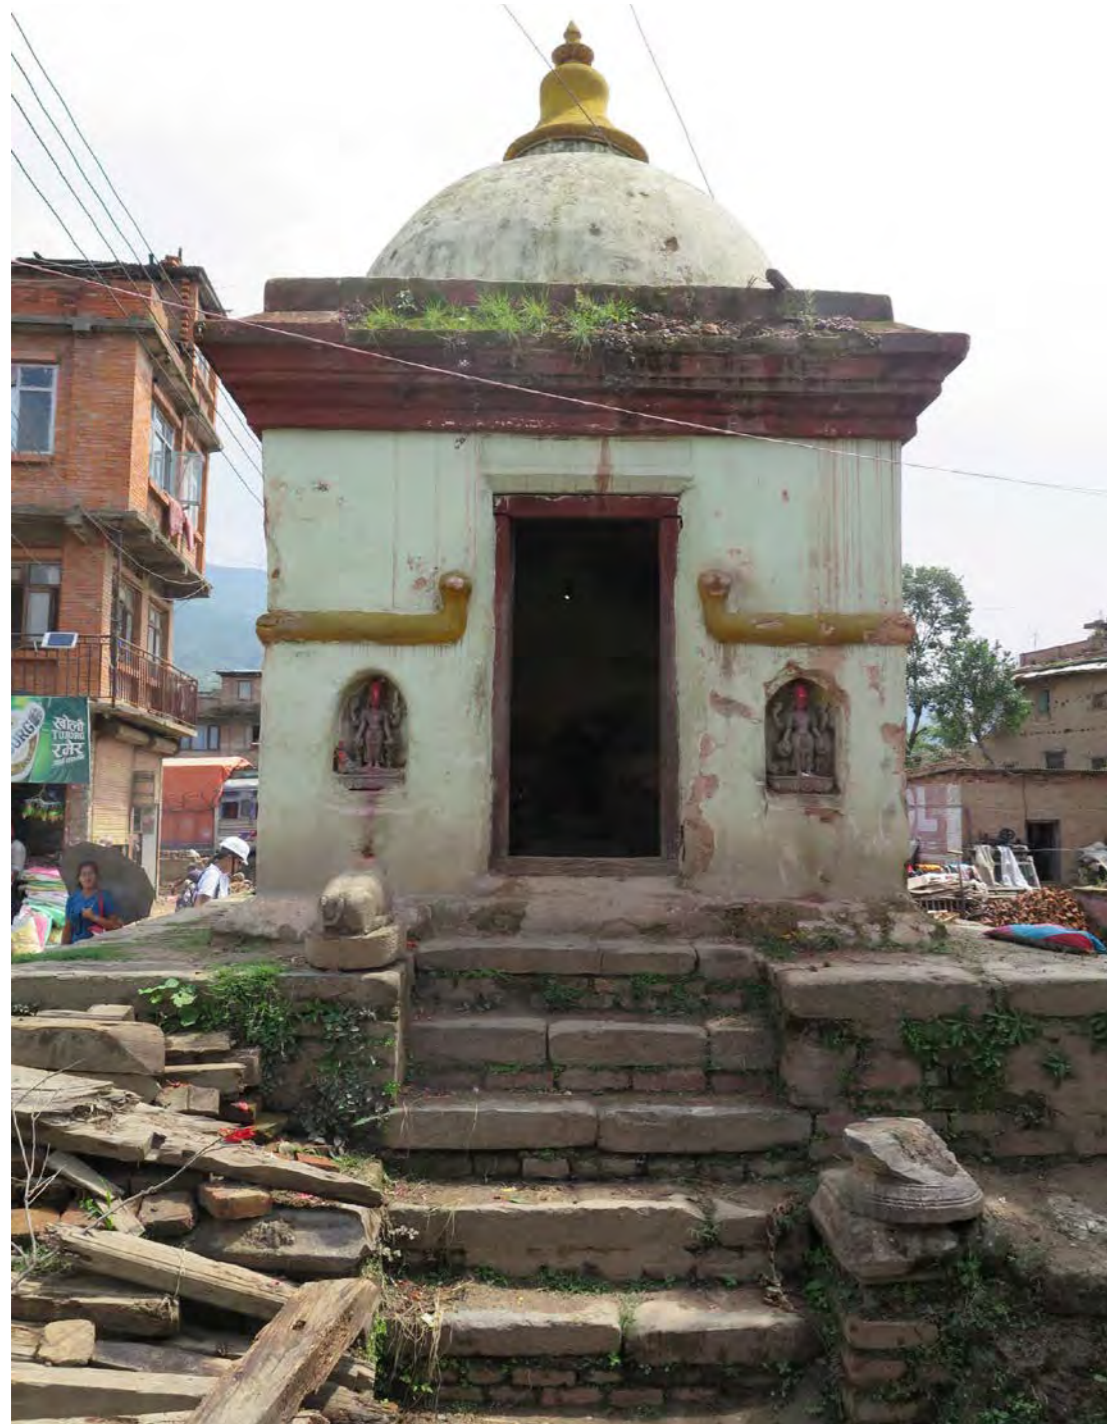
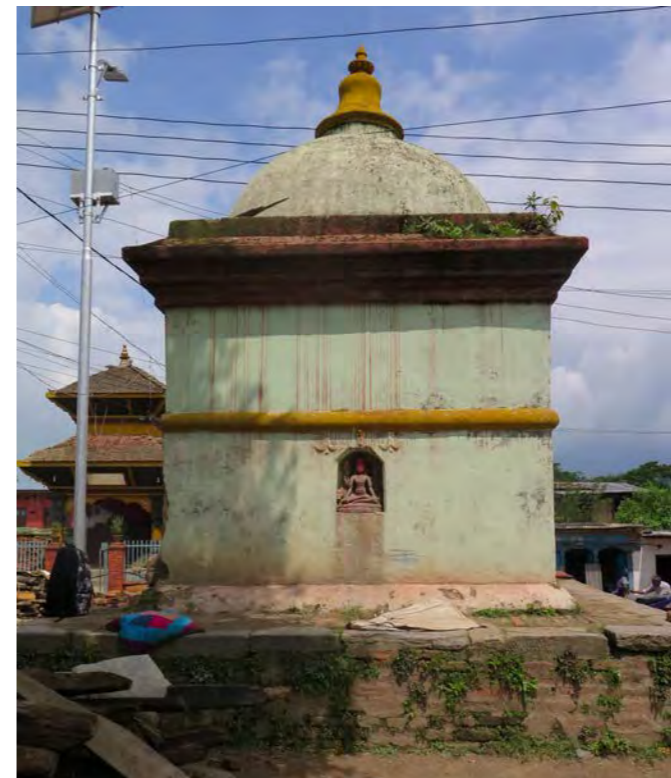
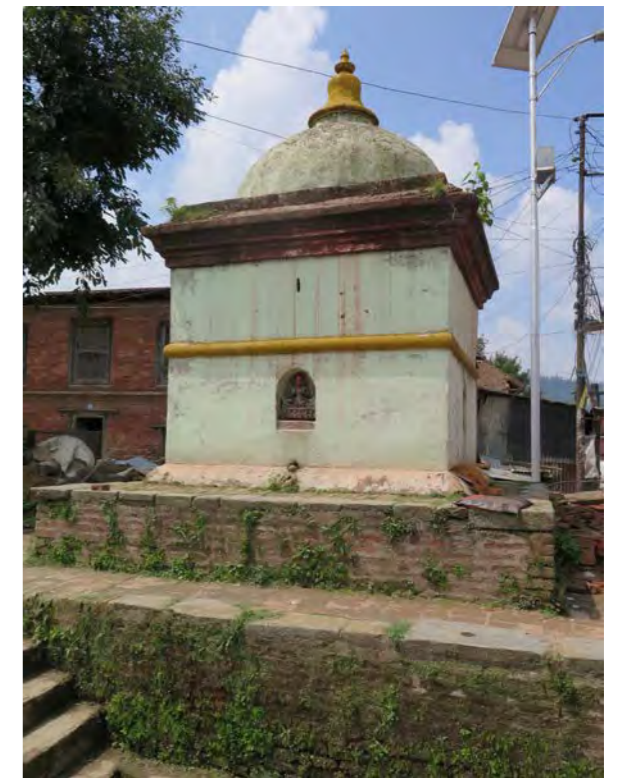
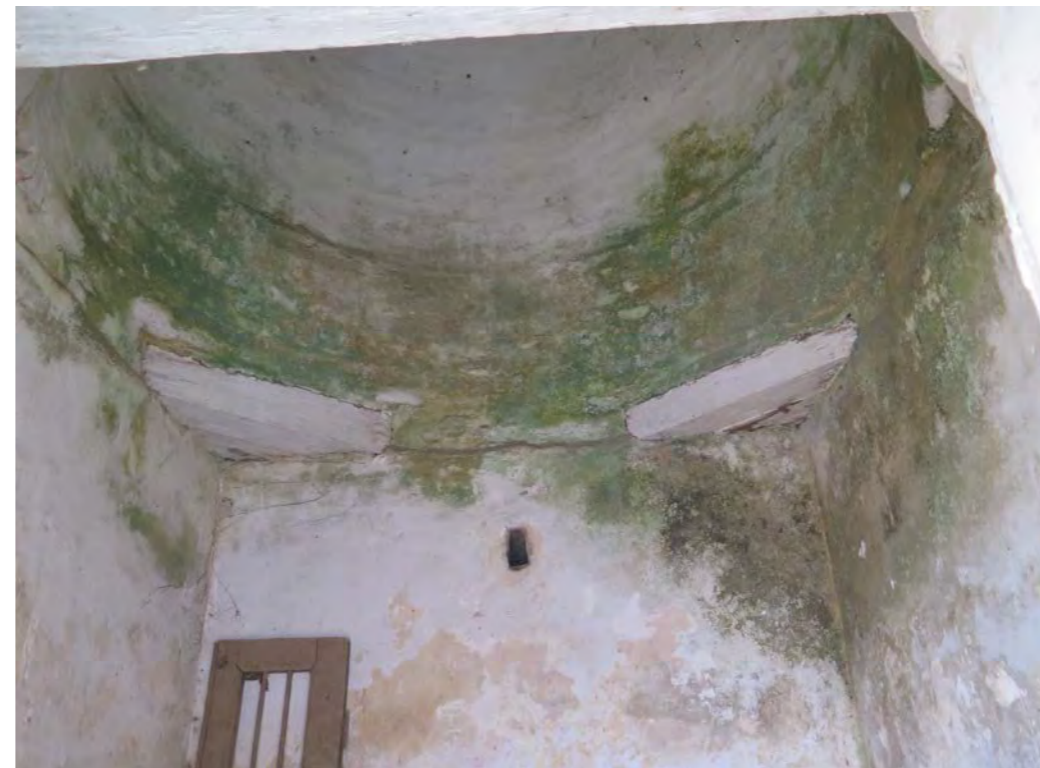
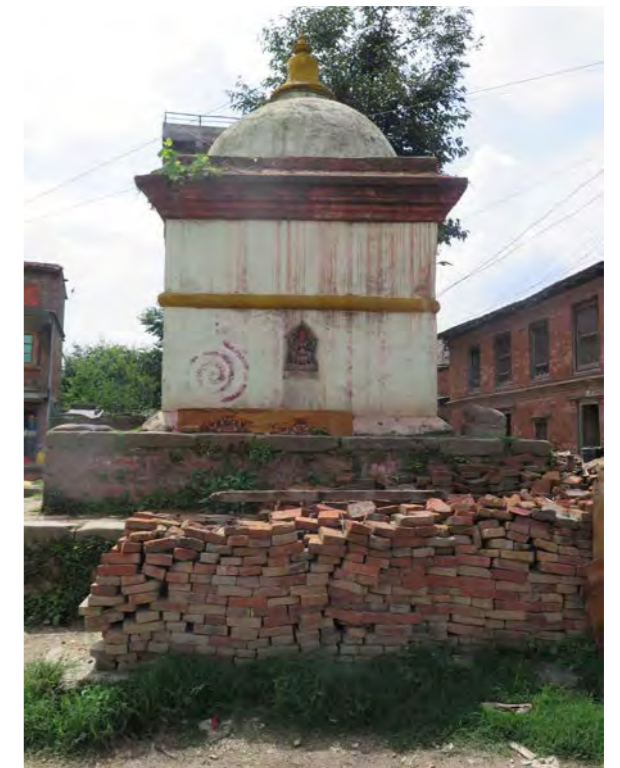
E-02 TRIKON MAHADEV

NUMBER	NAME	DATE A.D.	TPOLOGY	GENERAL DESCRIPTION	PROBLEMS DESCRIPTION	DANGER/ DESTROY
E-02	Trikon Mahadev		Enclosed Shrine	Enclosed shrine with dome roof.	Some idols damaged and missing. Vegetation Growing on roof.

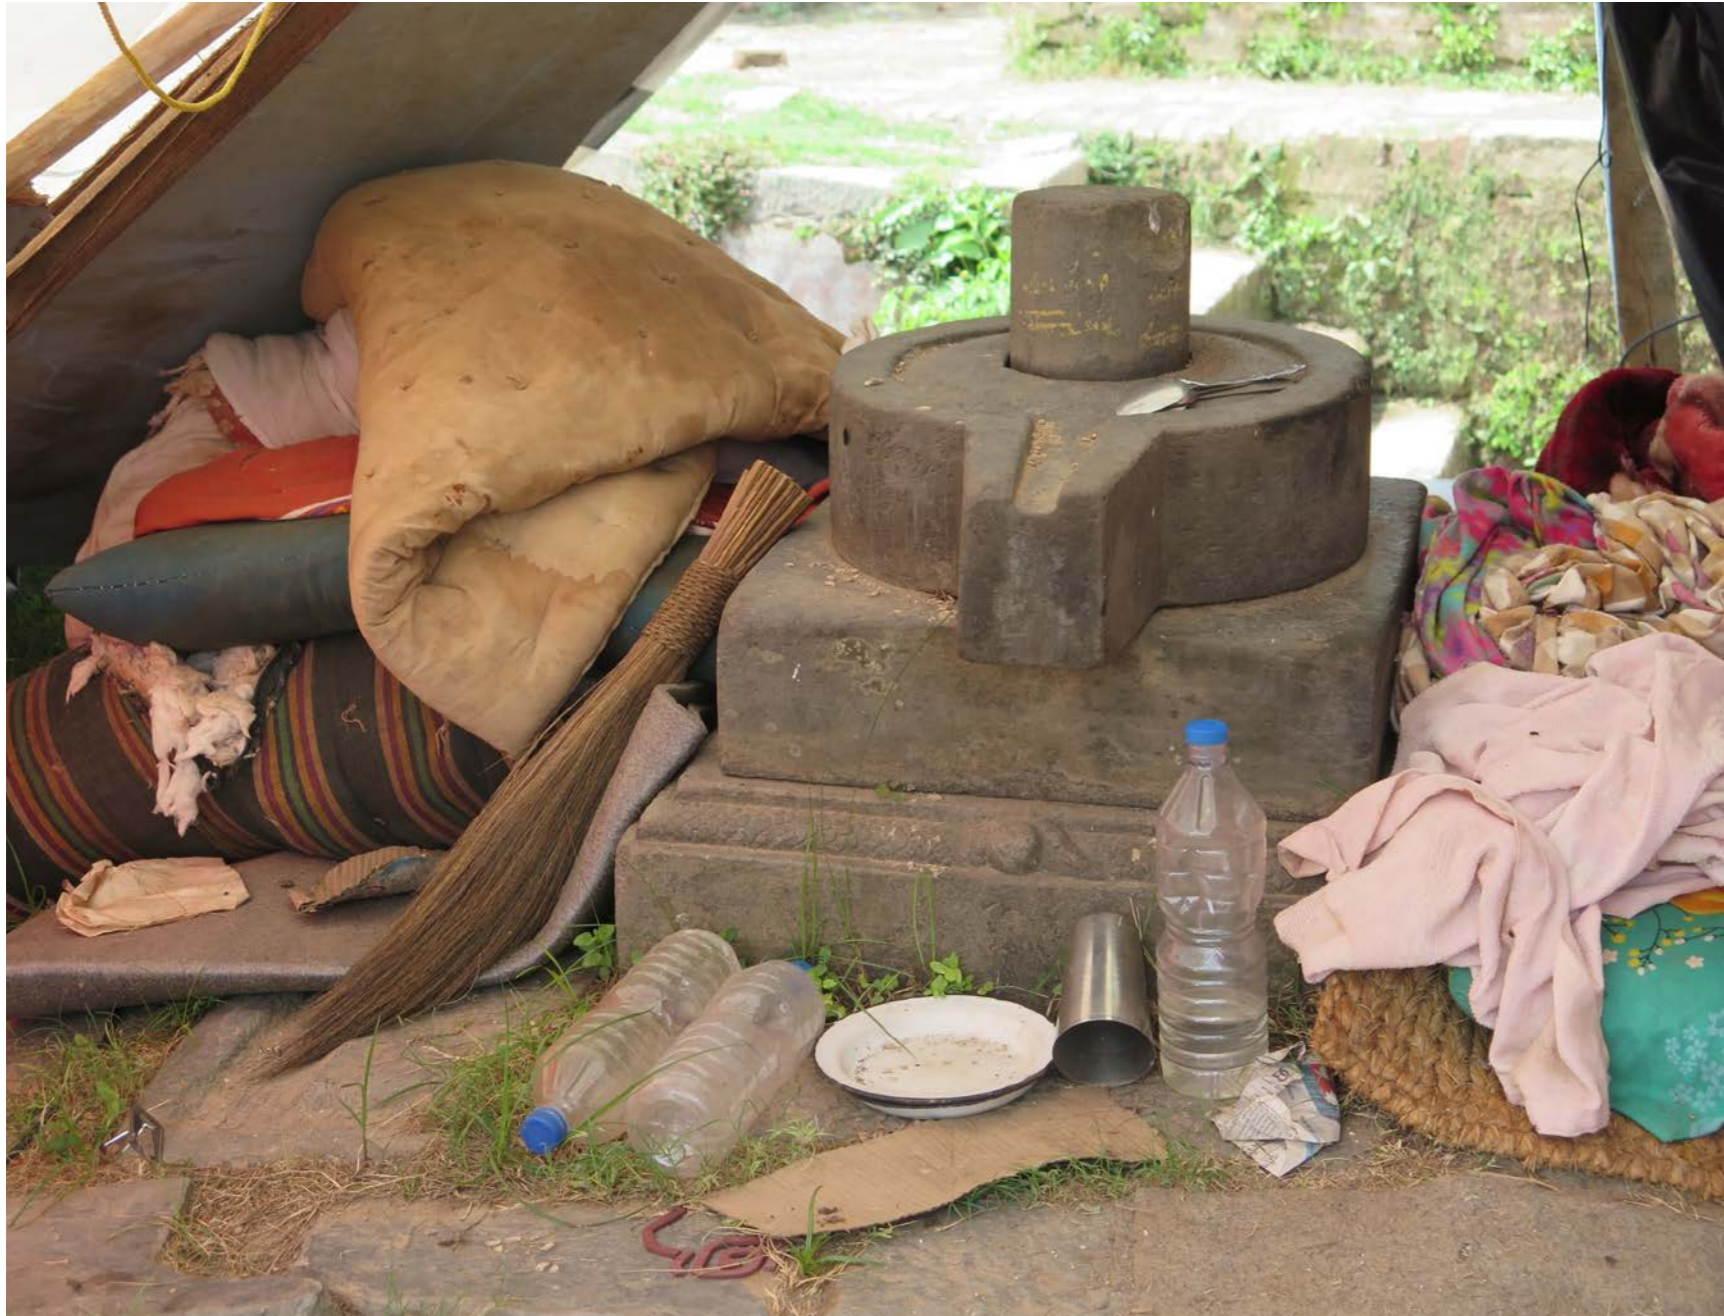
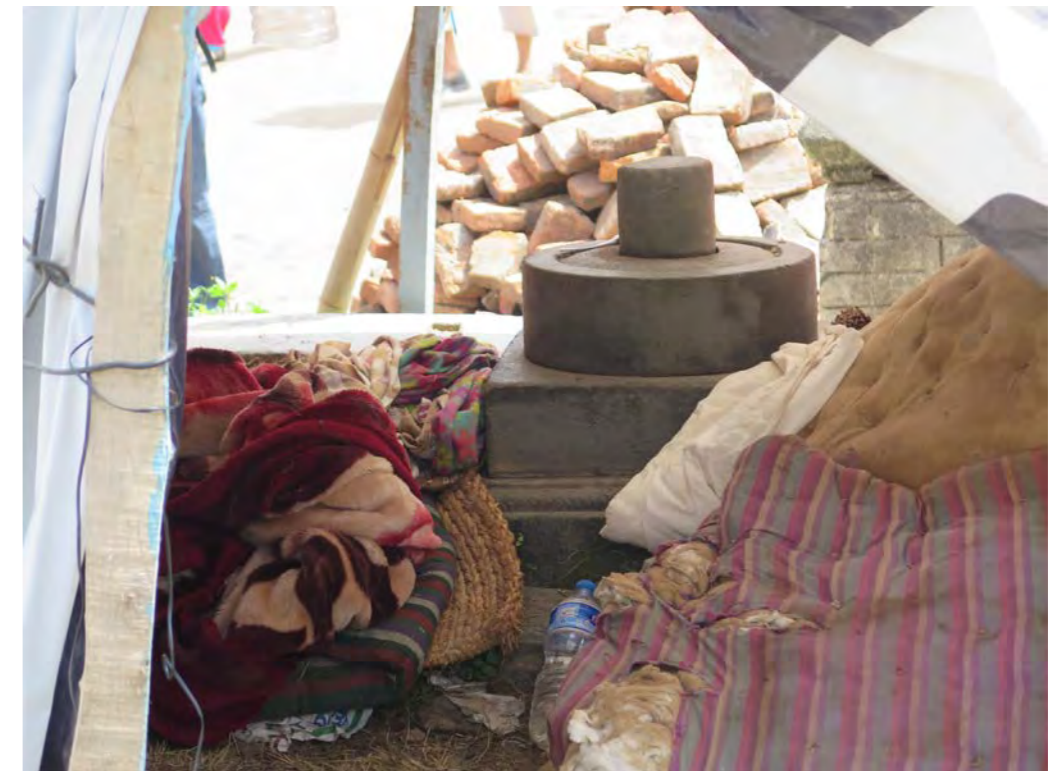
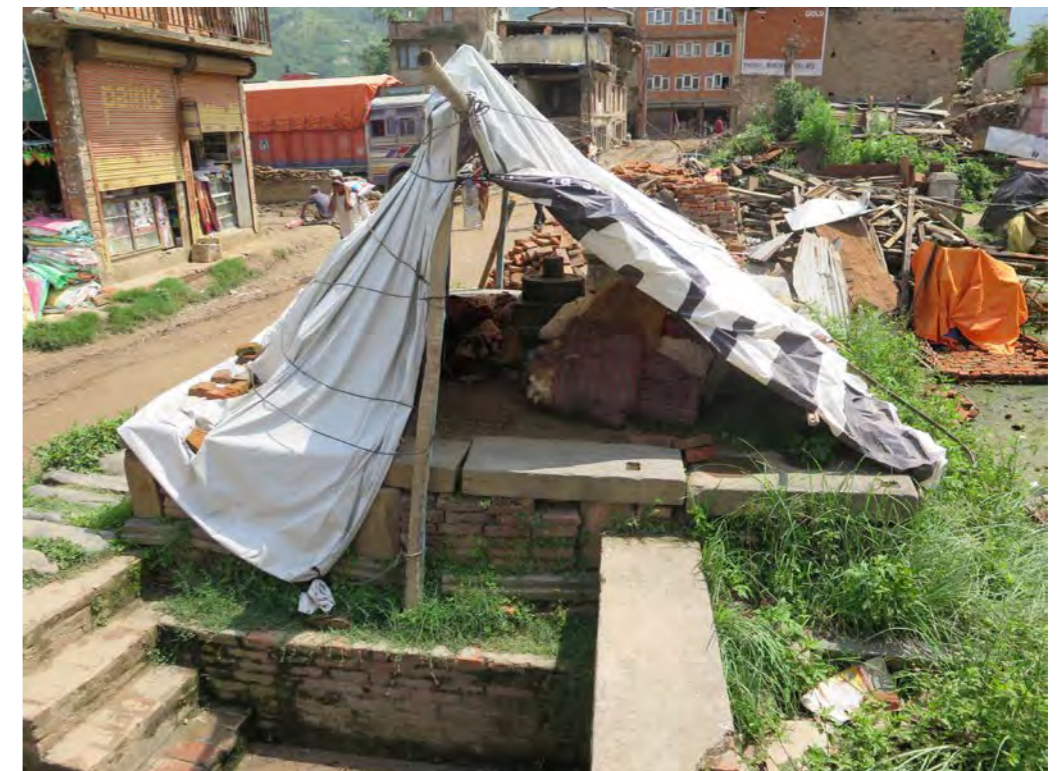
E-04 SHIVA LINGA - TRIKON MAHADEV

NUMBER	NAME	DATE A.D.	TPOLOGY	GENERAL DESCRIPTION	PROBLEMS DESCRIPTION	DANGER/ DESTROY
E-04	Trikon Mahadev		Shiva Linga	2 stone Shiva Linga	Plinth stones out of place
