2015 Earthquake Damage Mapping

Sankhu

October 2015

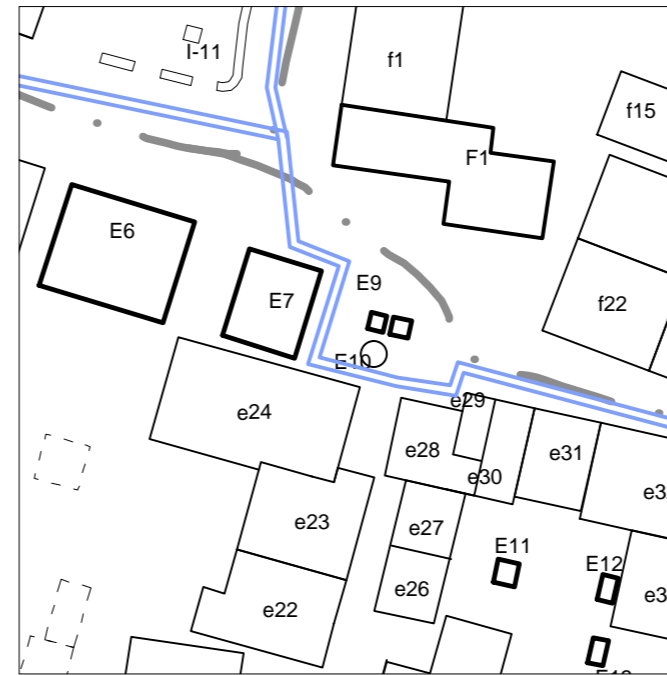
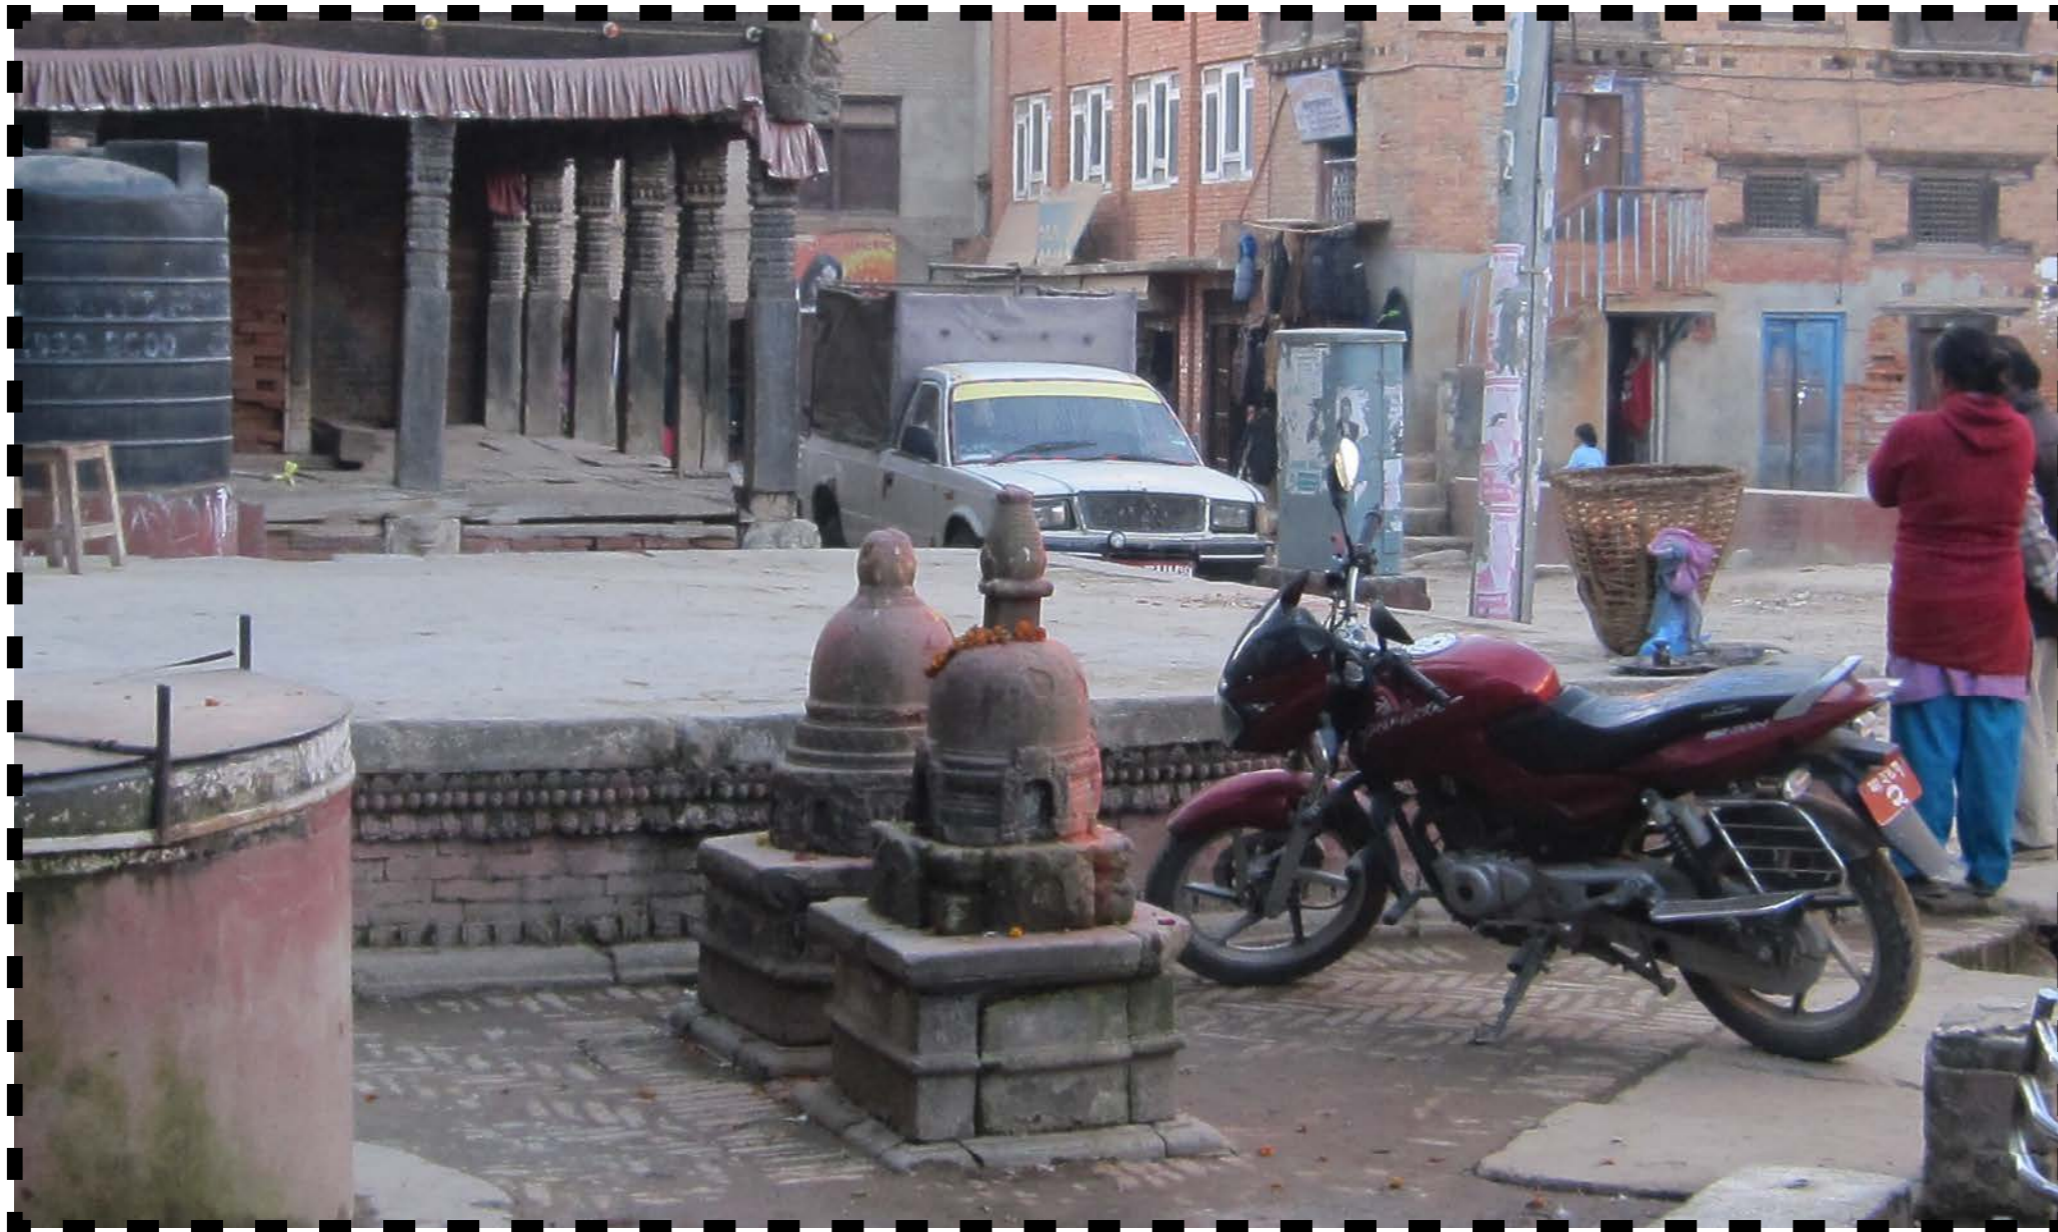
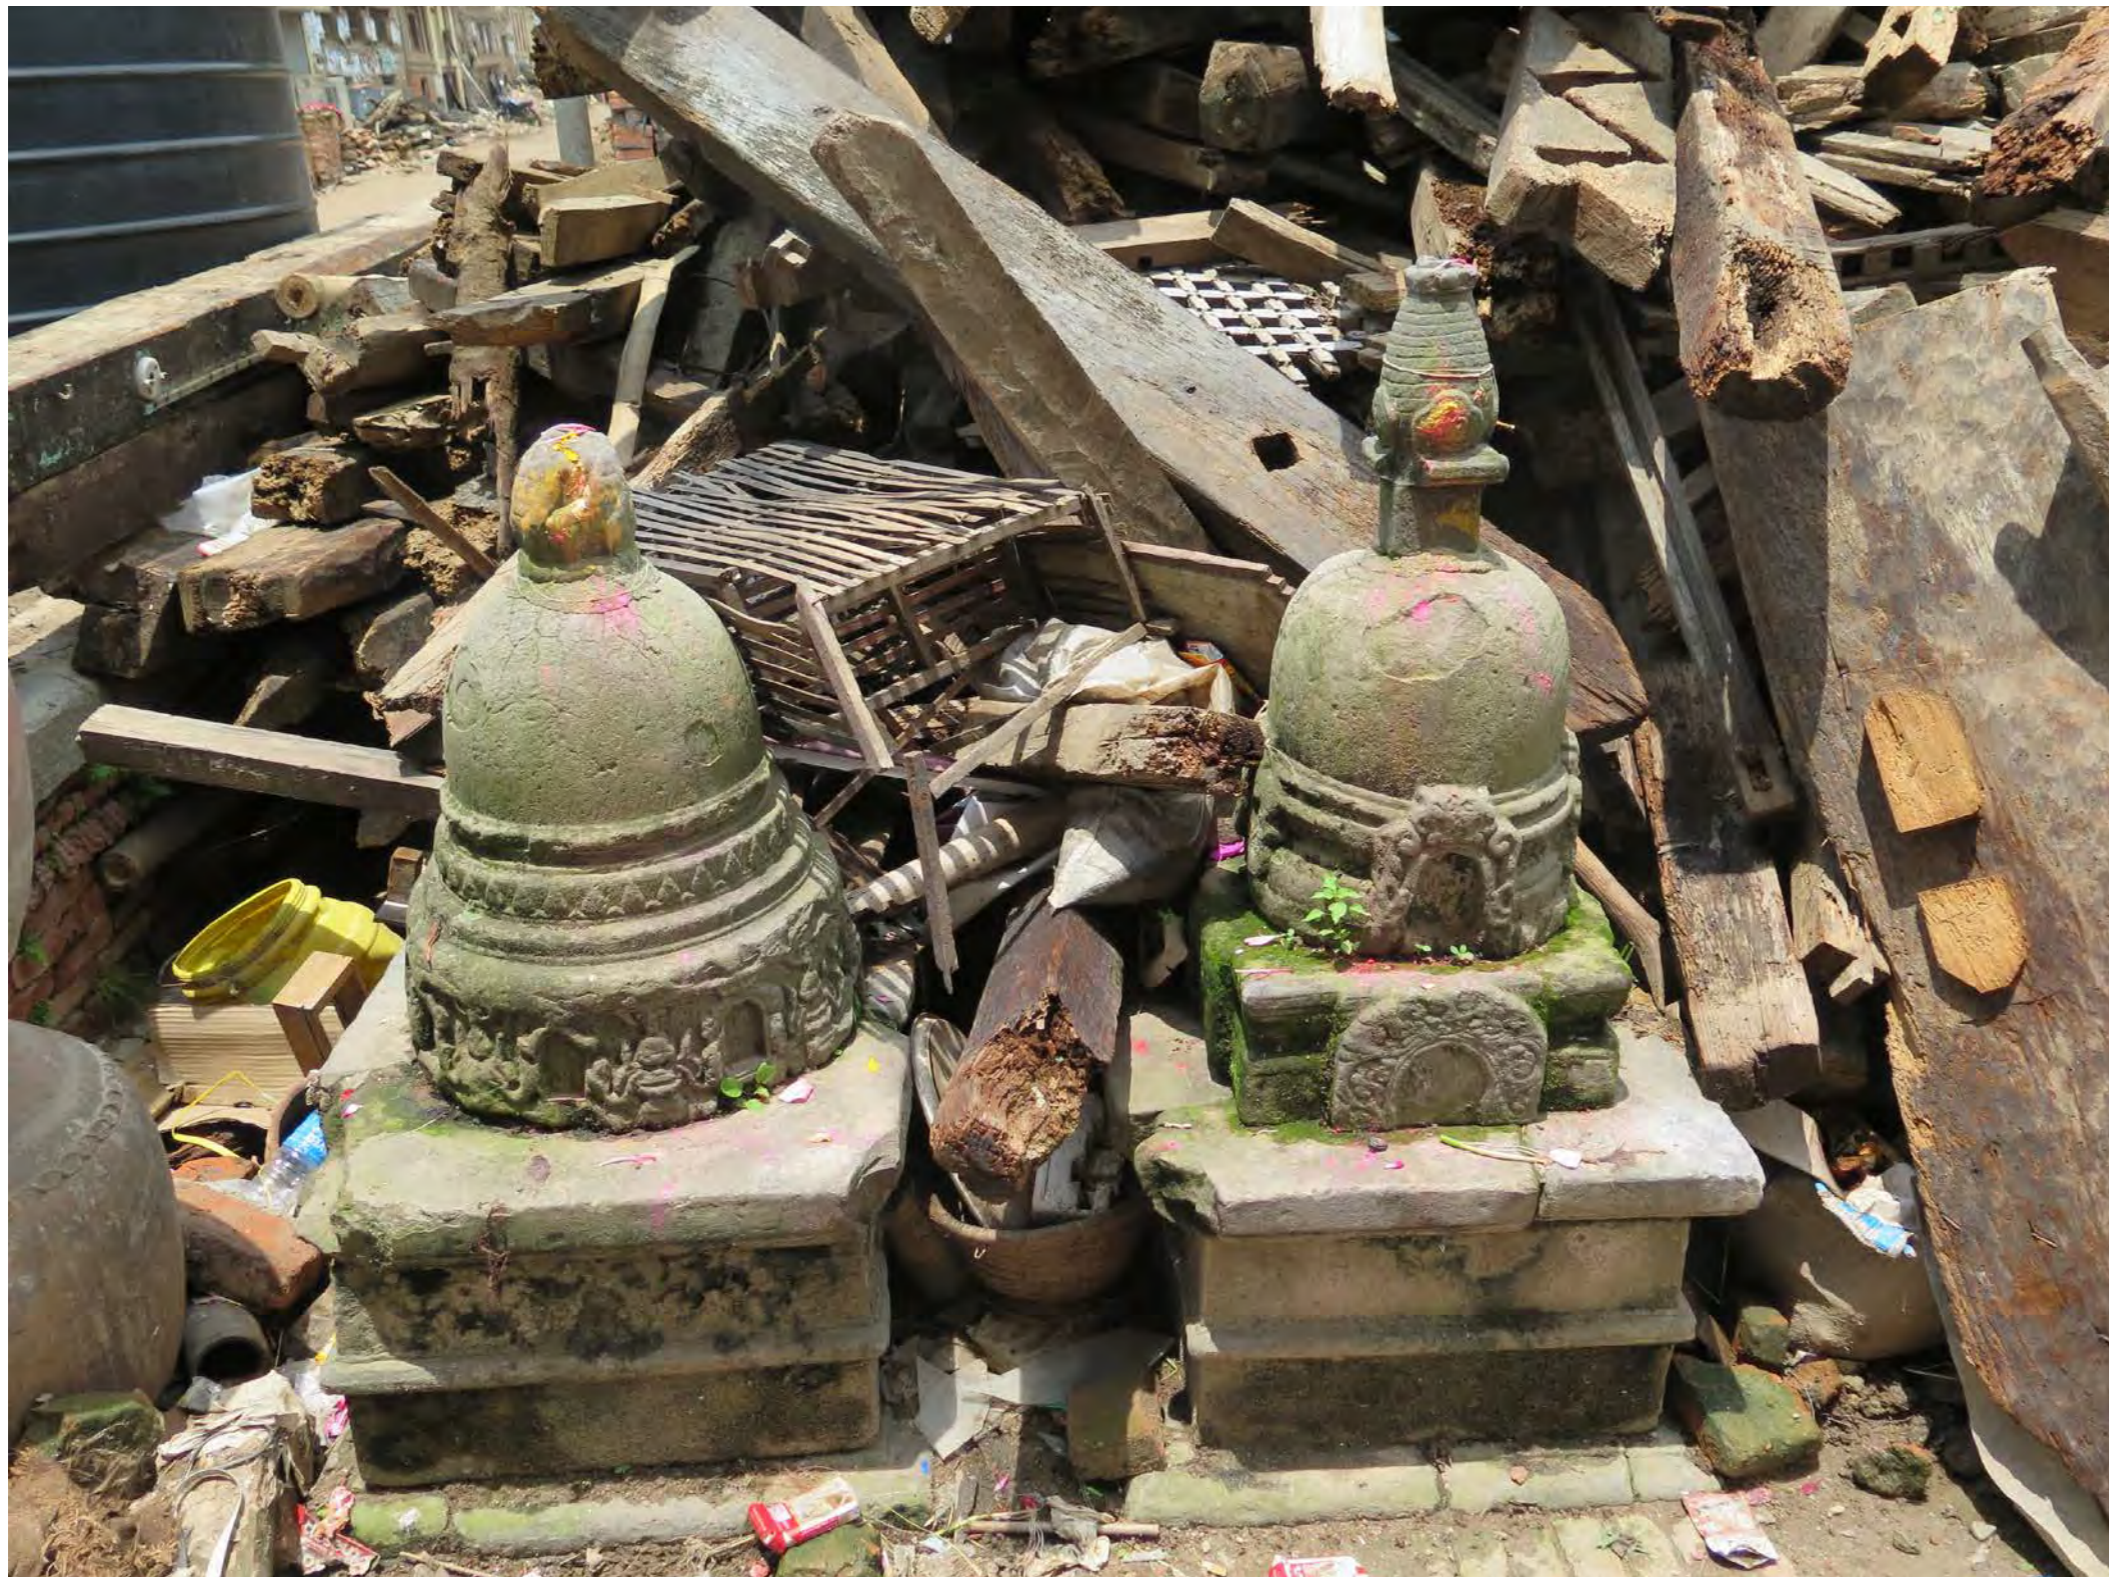
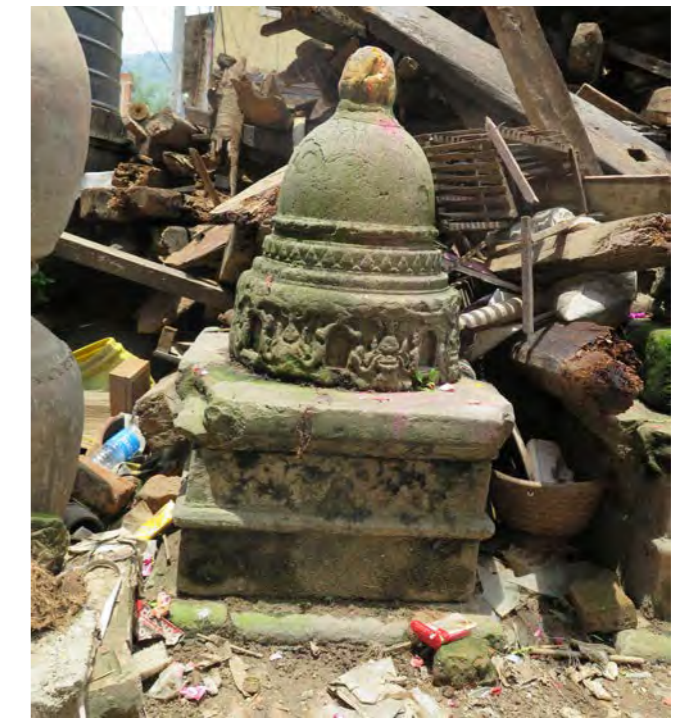
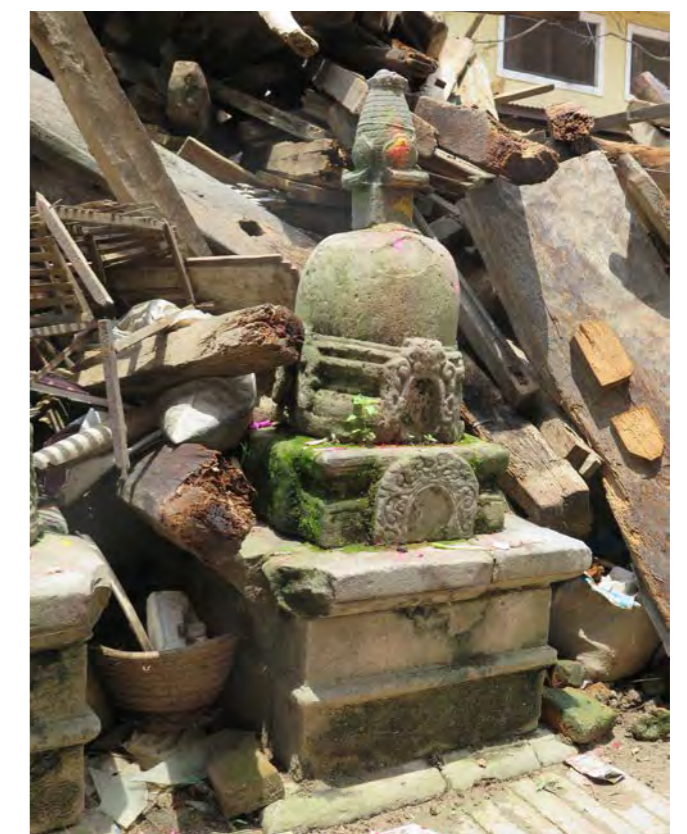
E-09 CHAITYA

NUMBER	NAME	DATE A.D.	TYPOLOGY	GENERAL DESCRIPTION	PROBLEMS DESCRIPTION	DANGER/ DESTROY
E-09			Chaityas	2 lichchhavi chaityas	Covered by wood and rubbles form demolished buildings

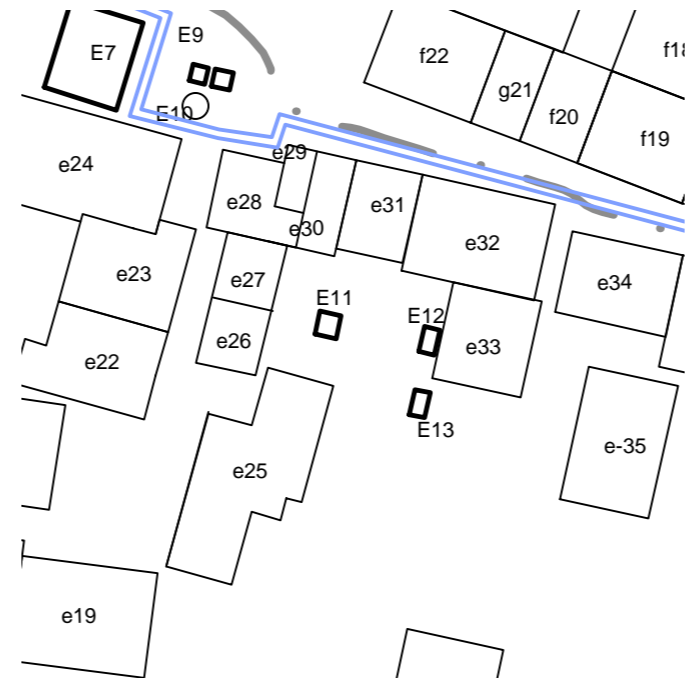
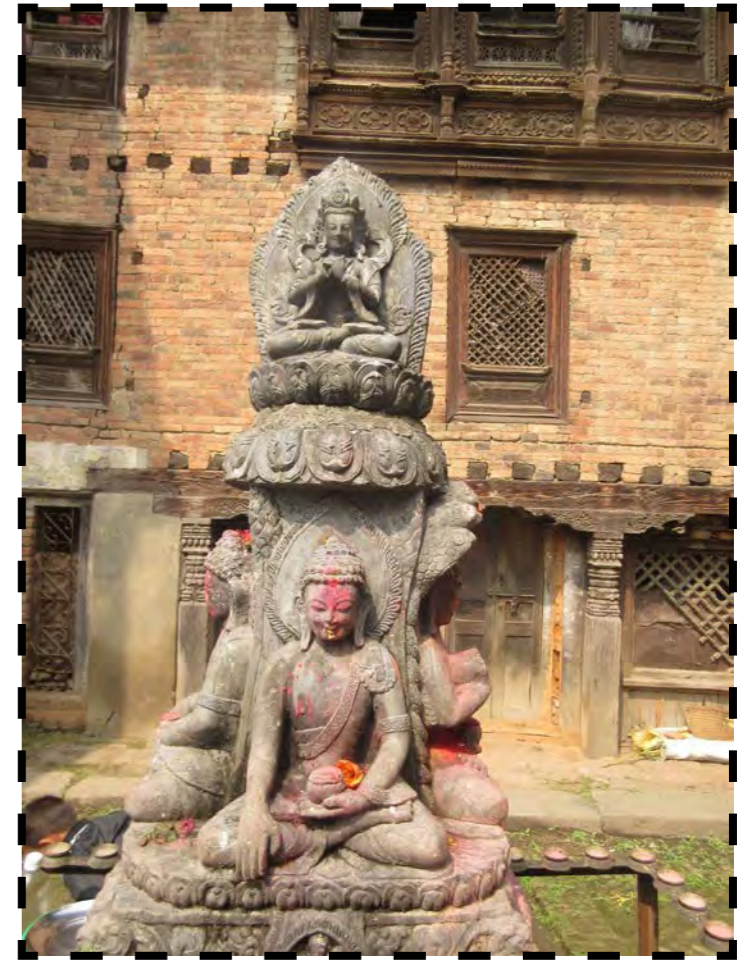
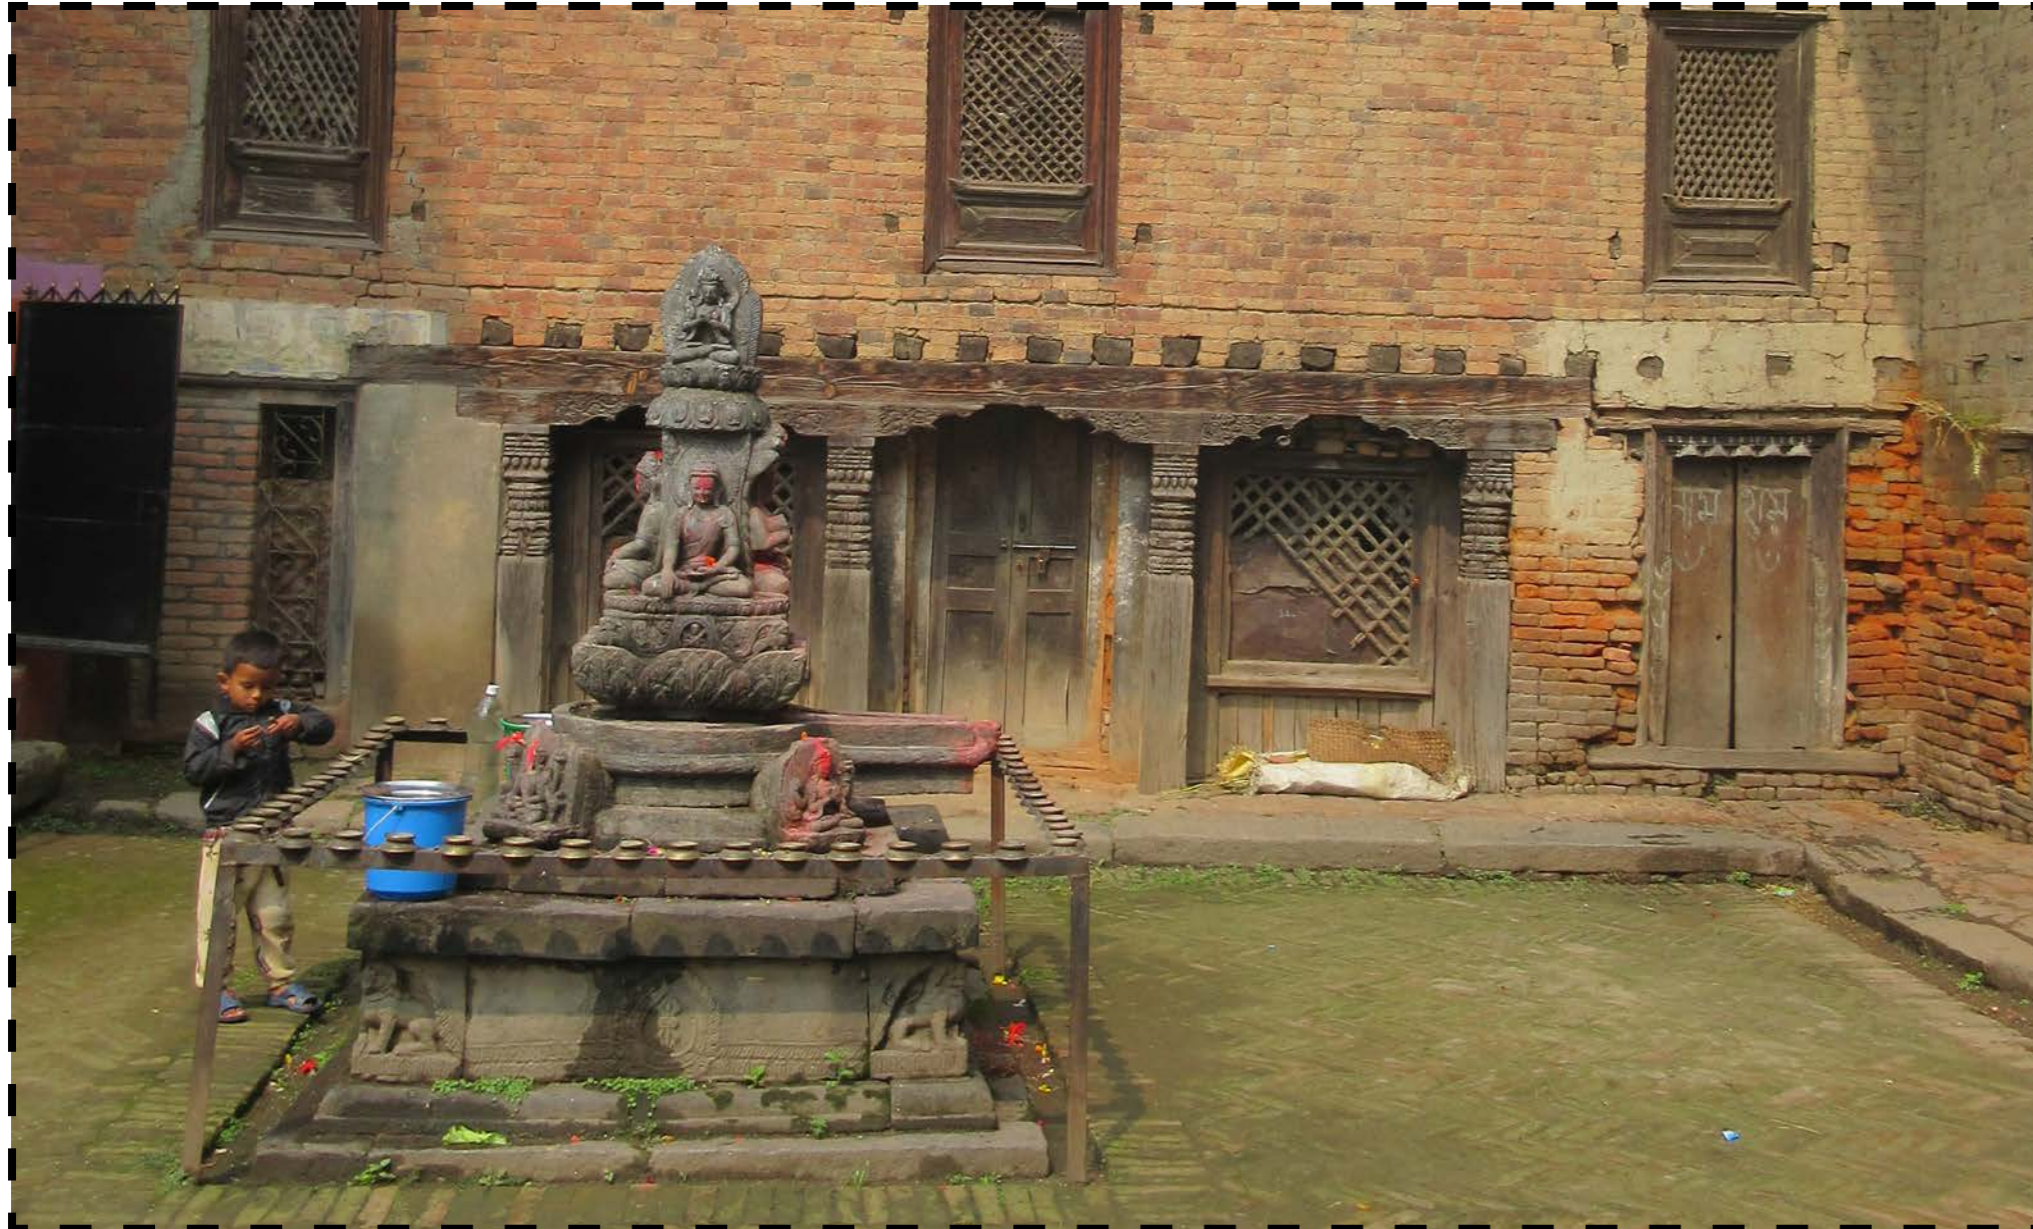
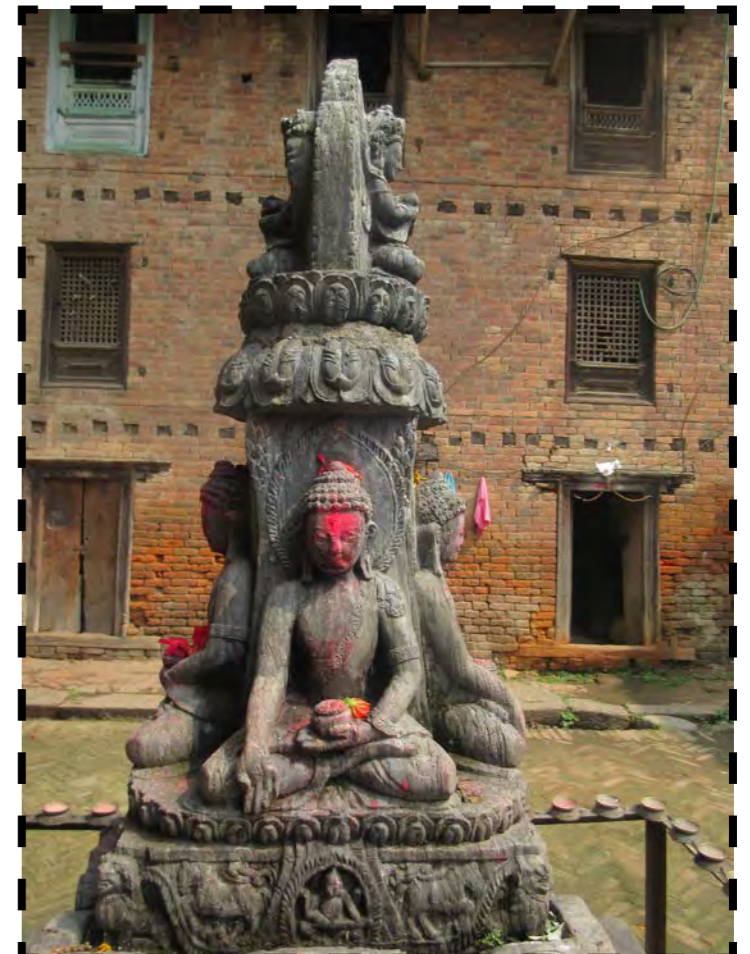
E-11 CHAITYA

NUMBER	NAME	DATE A.D.	TPOLOGY	GENERAL DESCRIPTION	PROBLEMS DESCRIPTION	DANGER/ DESTROY
E-11	Chaitya			Chiba with Shiva Linga base and two idols on Pinnacle. Four idols at corner of base	Covered by wood upto plinth

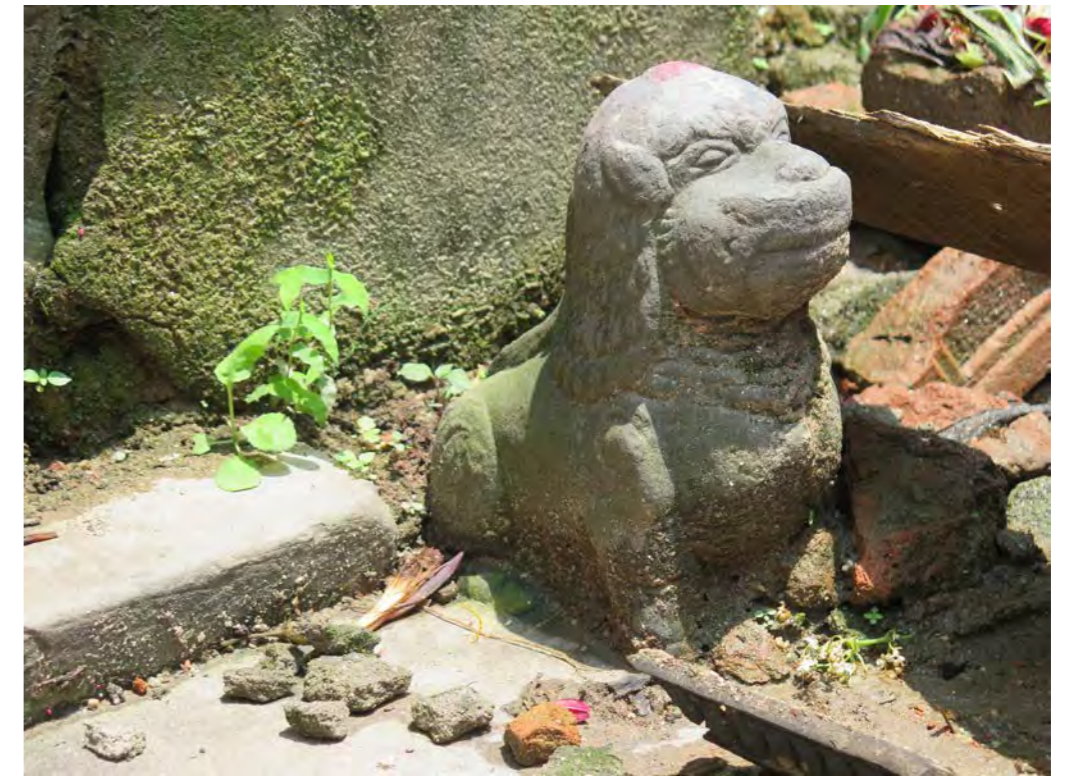
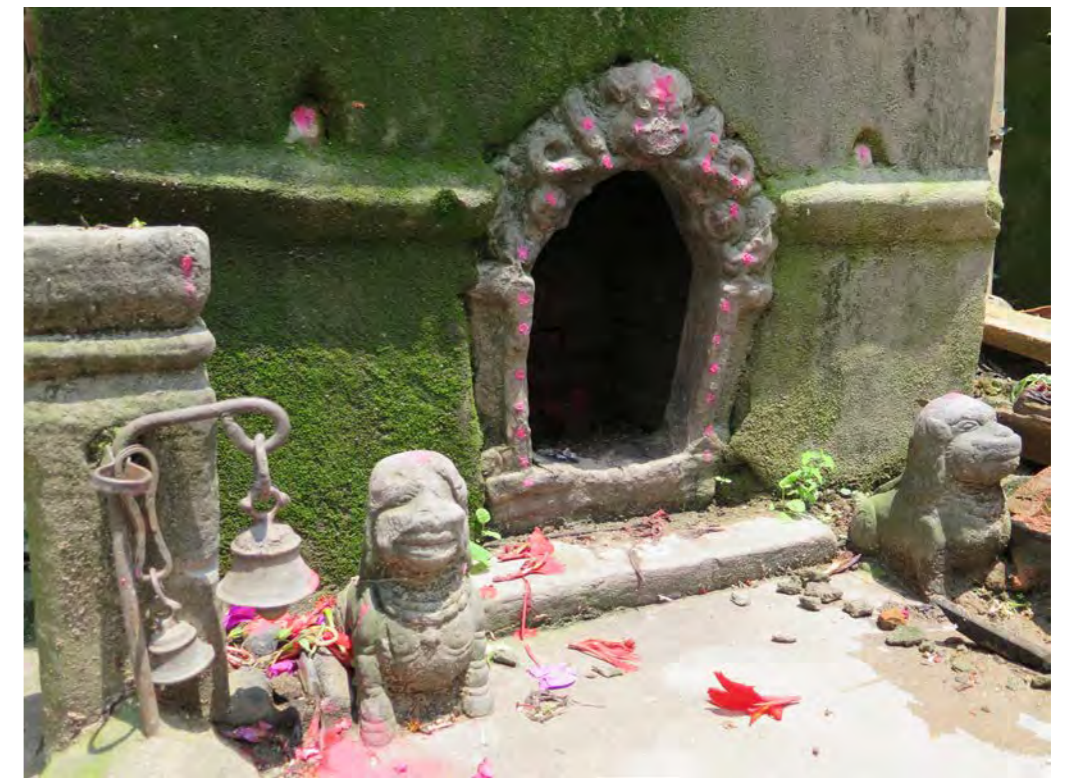
E-12 NASA DYA SHRINE

NUMBER	NAME	ESTABLISHED DATE (A.D.)	TPOLOGY	GENERAL DESCRIPTION	PROBLEMS DESCRIPTION	DANGER/ DESTROY
E-12	Nasa Dya		Enclosed Shrine	Cement plastered	No visible damage

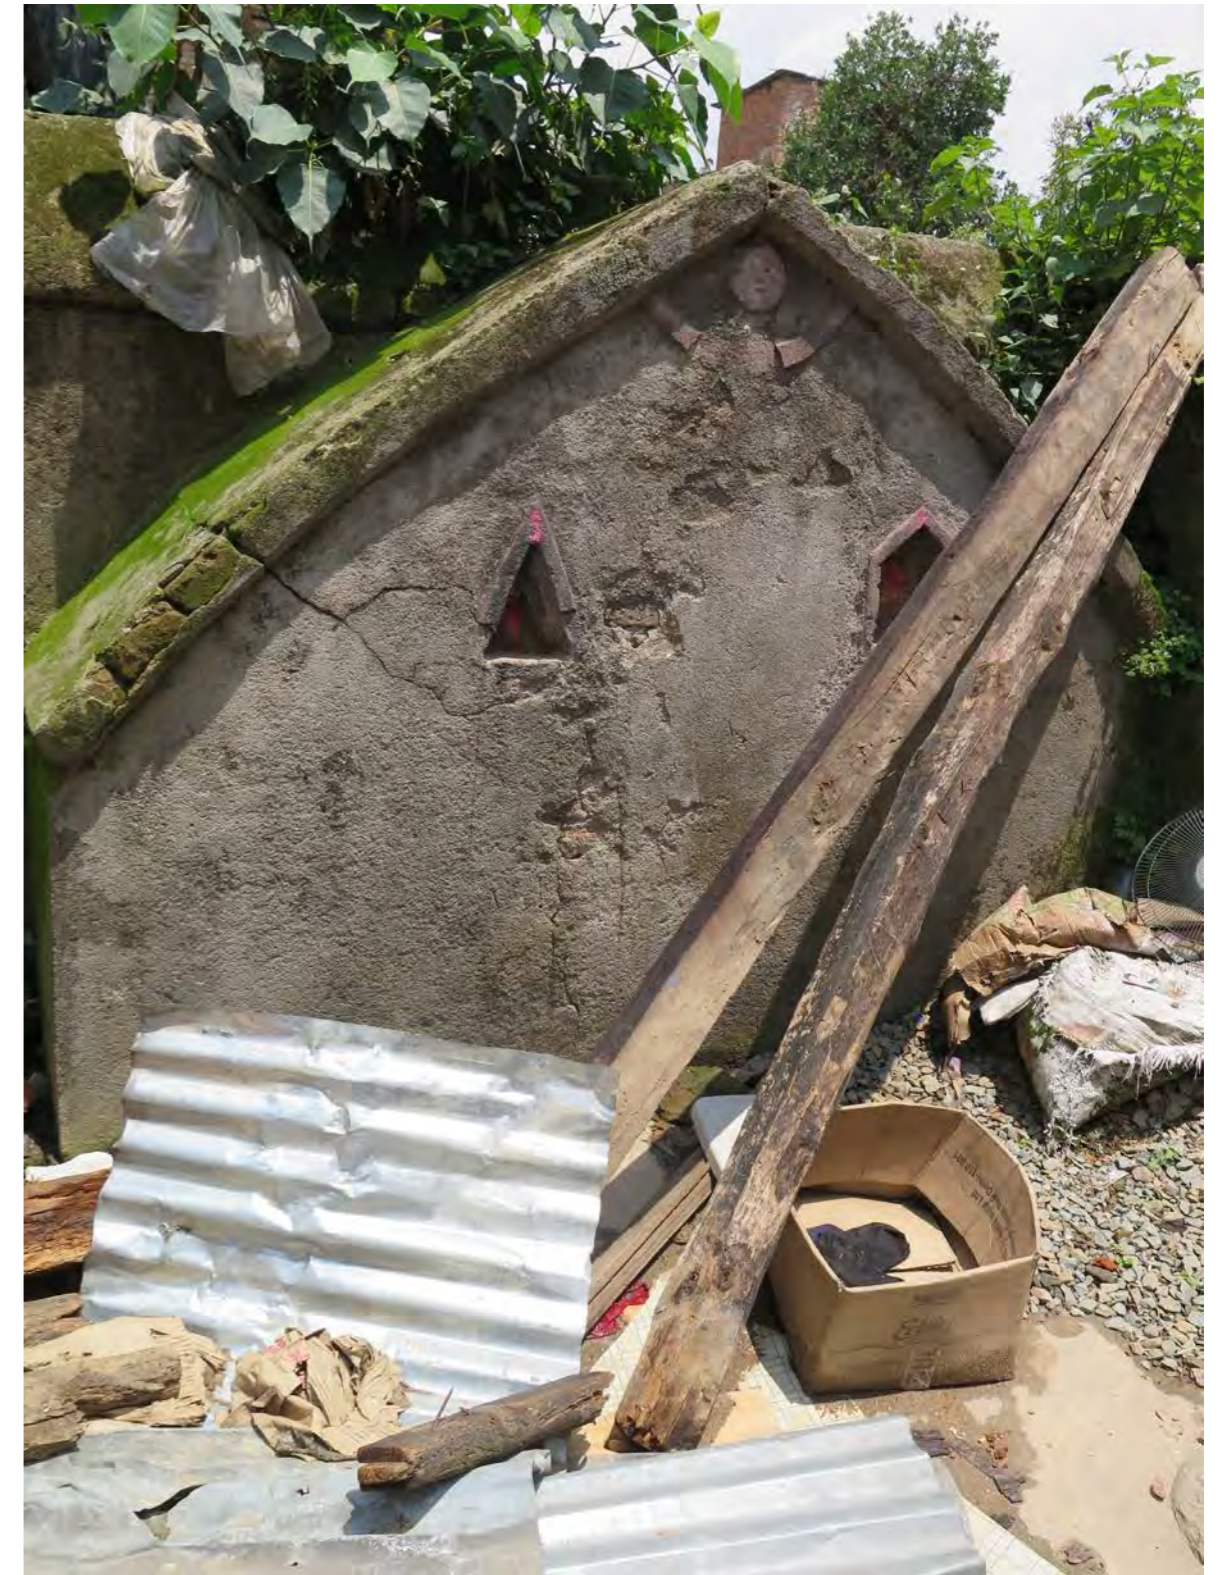
E-13 OPEN SHRINE

NUMBER	NAME	DATE A.D.	TPOLOGY	GENERAL DESCRIPTION	PROBLEMS DESCRIPTION	DANGER/ DESTROY
E-13			Open Shrine	2 Stone sculpture on wall and shiva linga type image in the ground	No visible damage

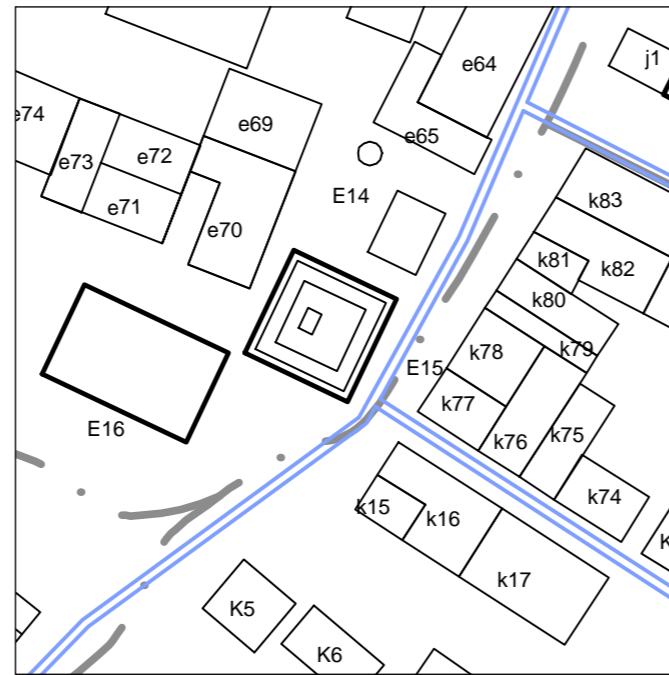
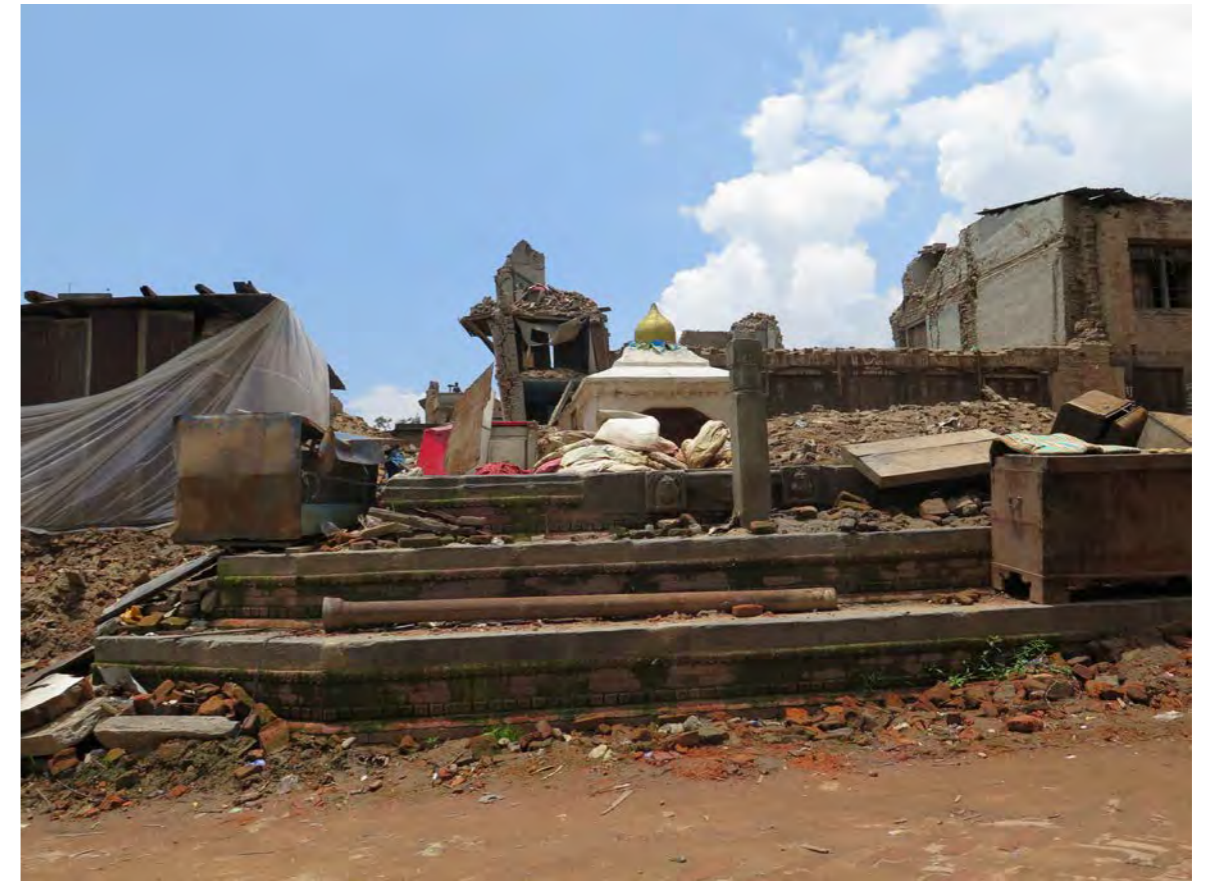
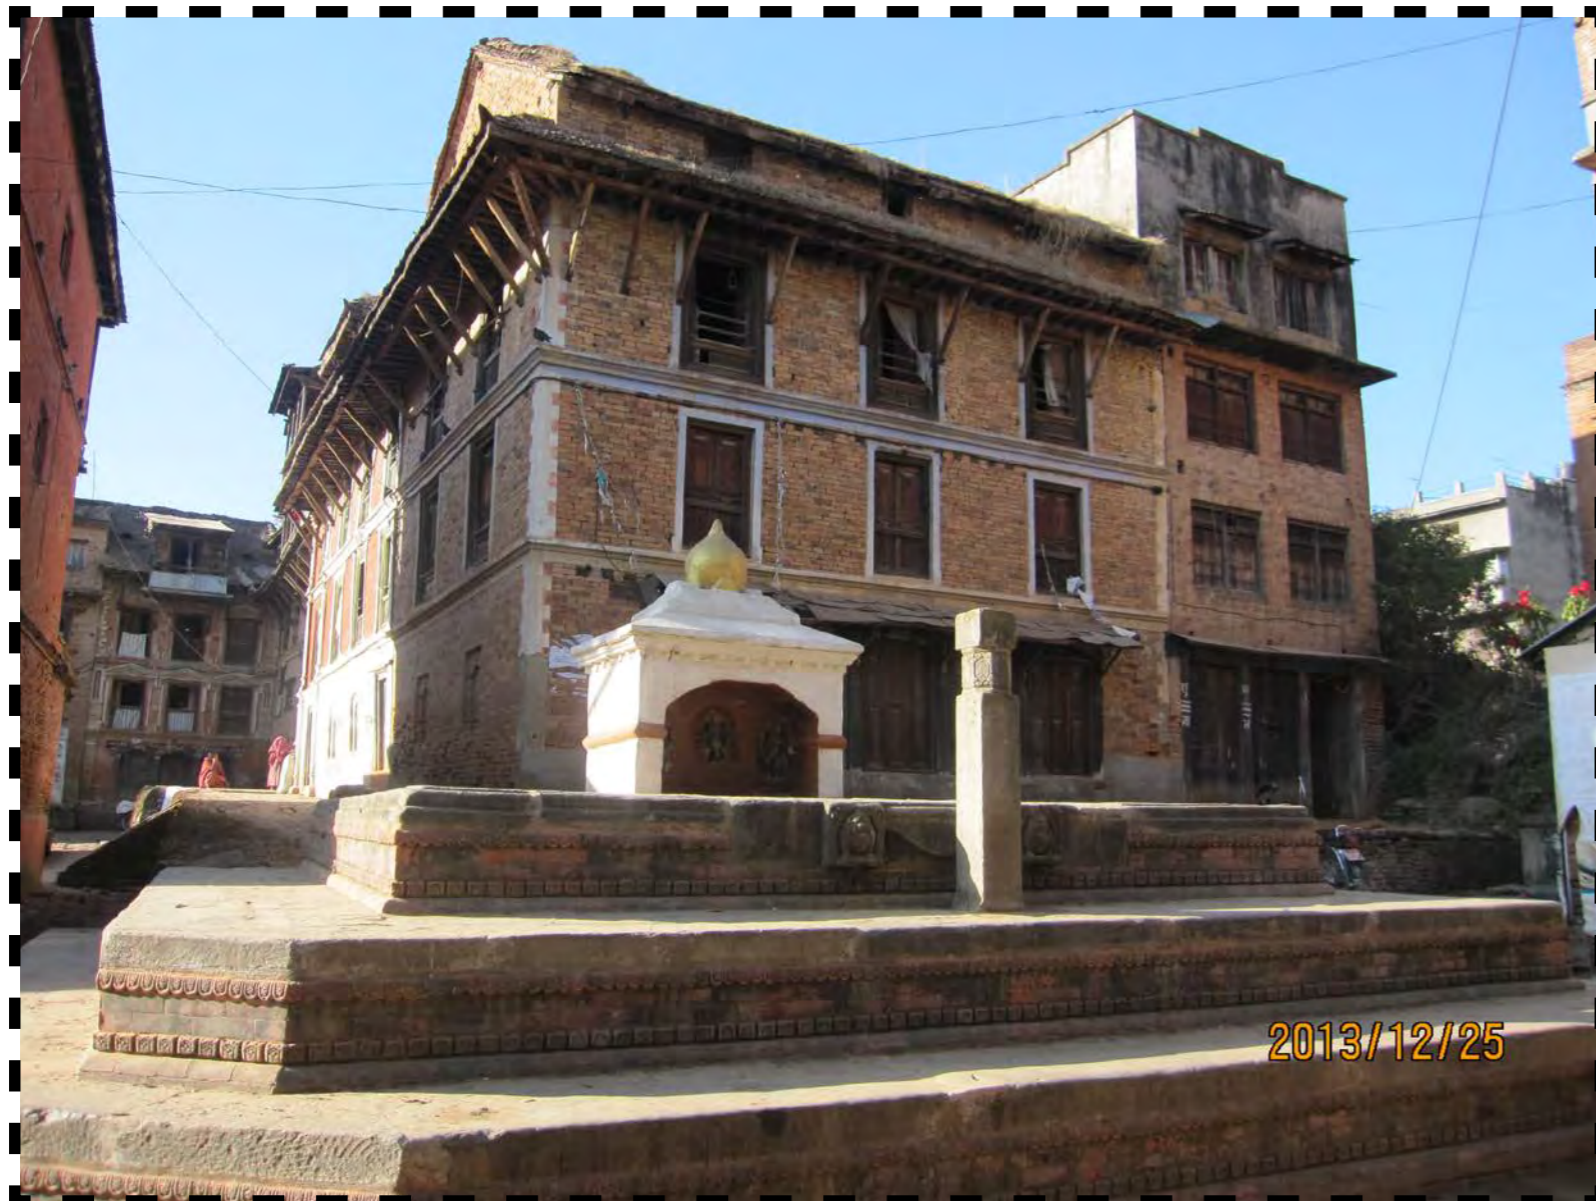
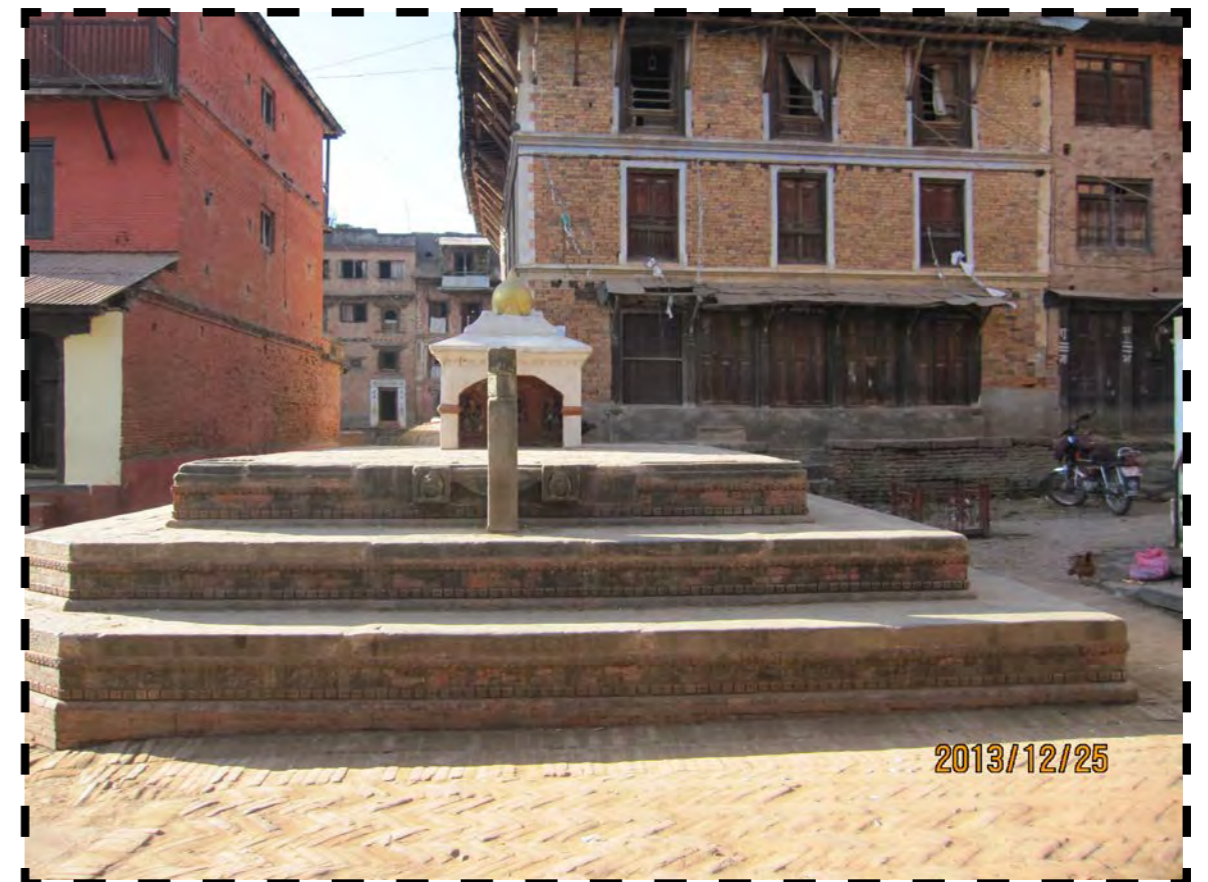
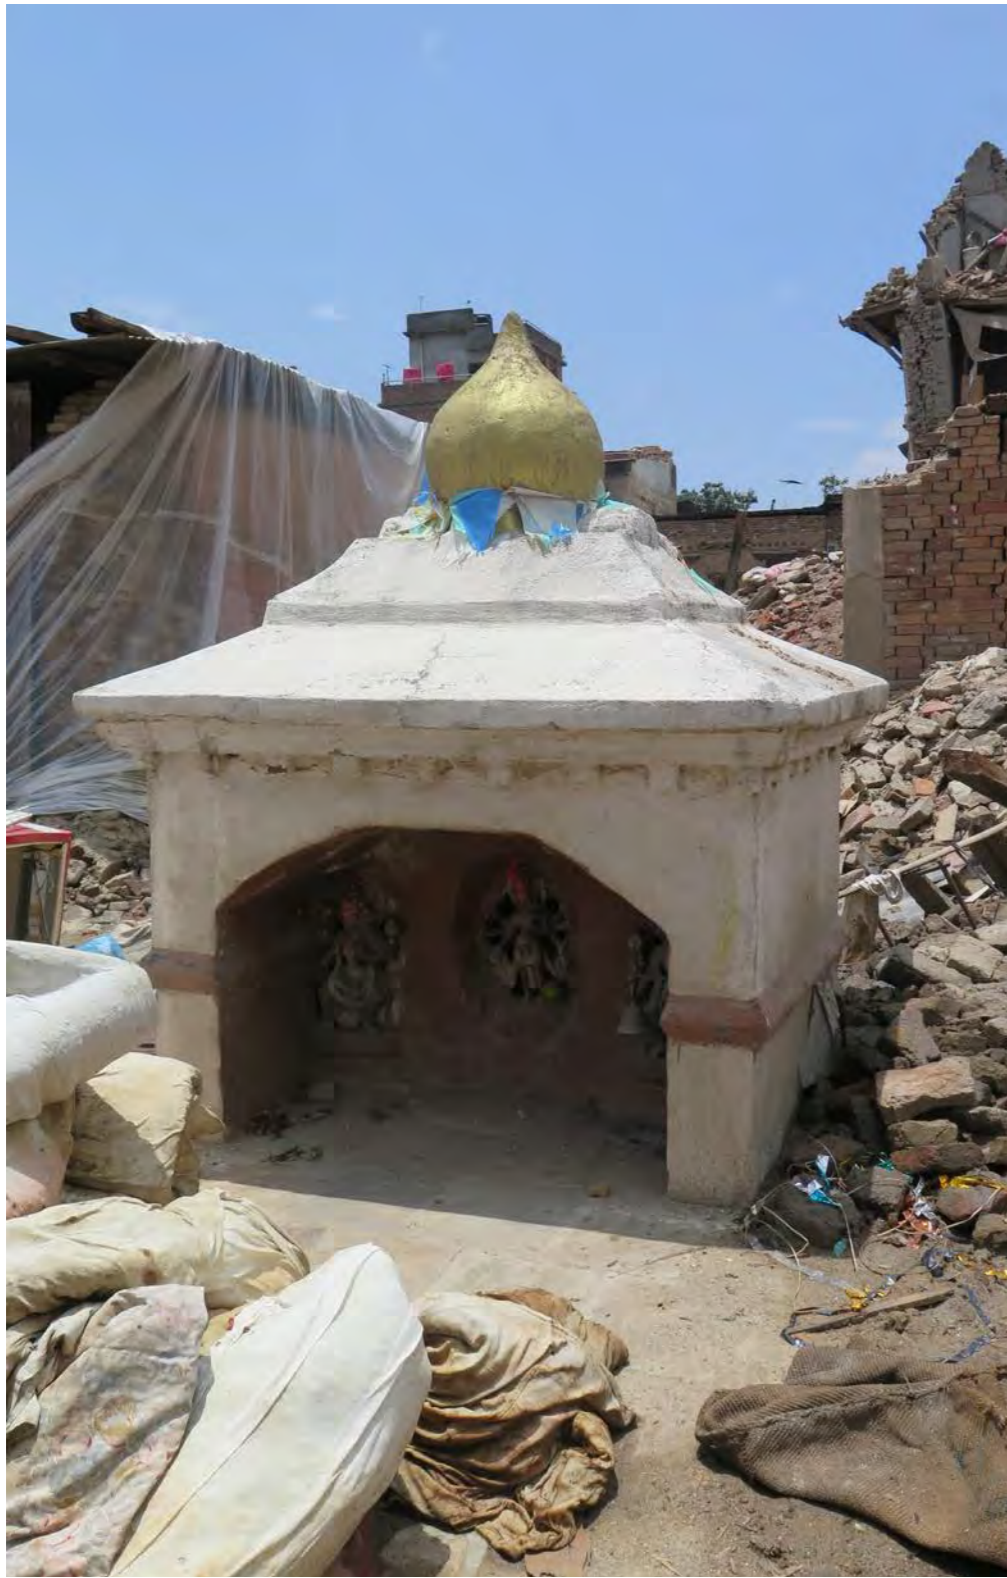
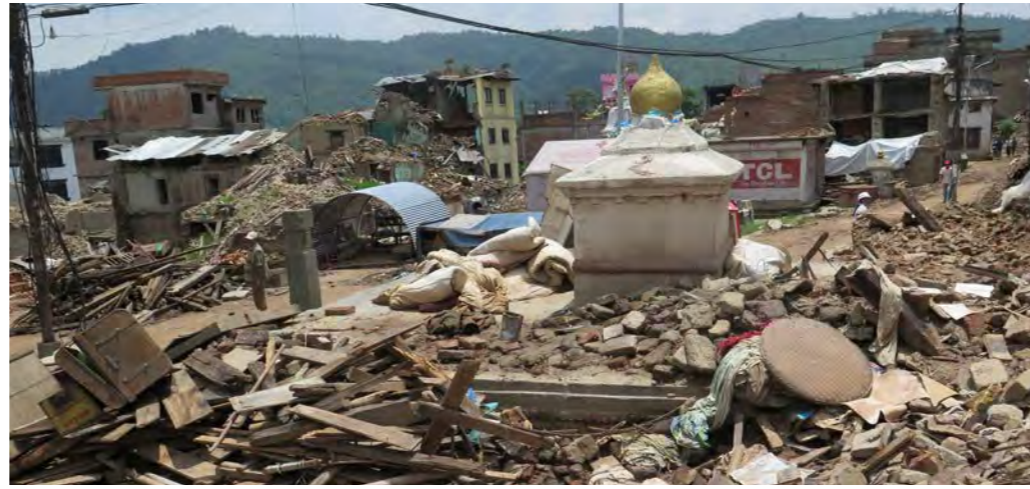
E-15 NARAYAN TEMPLE

NUMBER	NAME	DATE A.D.	TYPOLOGY	GENERAL DESCRIPTION	PROBLEMS DESCRIPTION	DANGER/ DESTROY
E-15	Narayan Temple		Enclosed shrine	Temple with platform	Covered by rubbles from nearby buildings. South west corner stone missing.
