2015 Earthquake Damage Mapping

Sankhu

October 2015

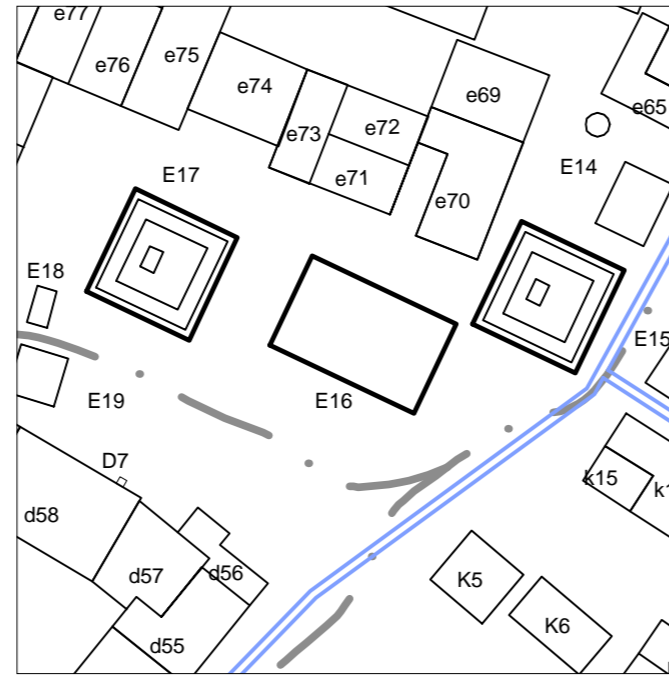
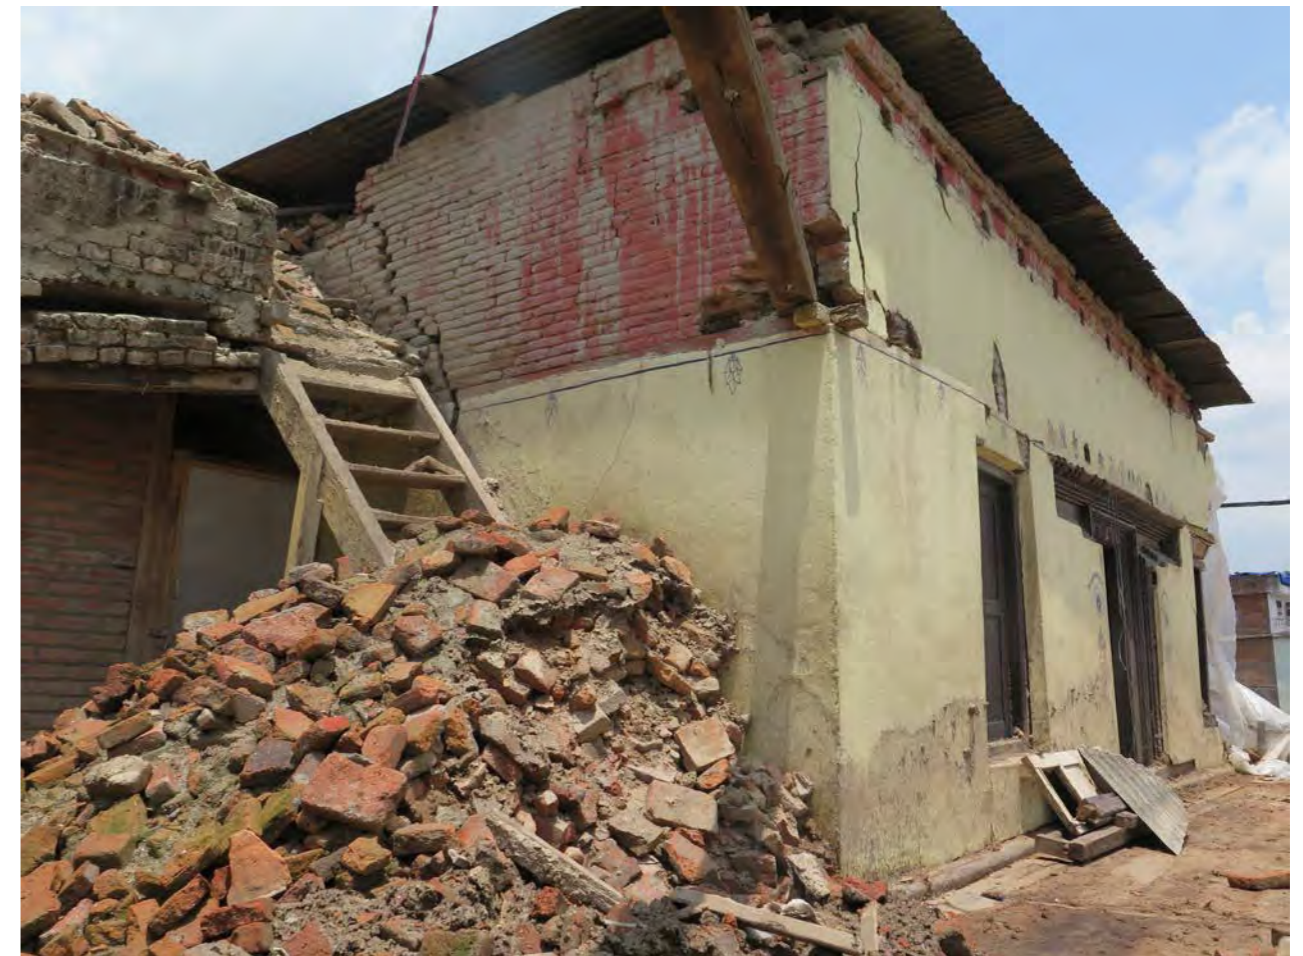
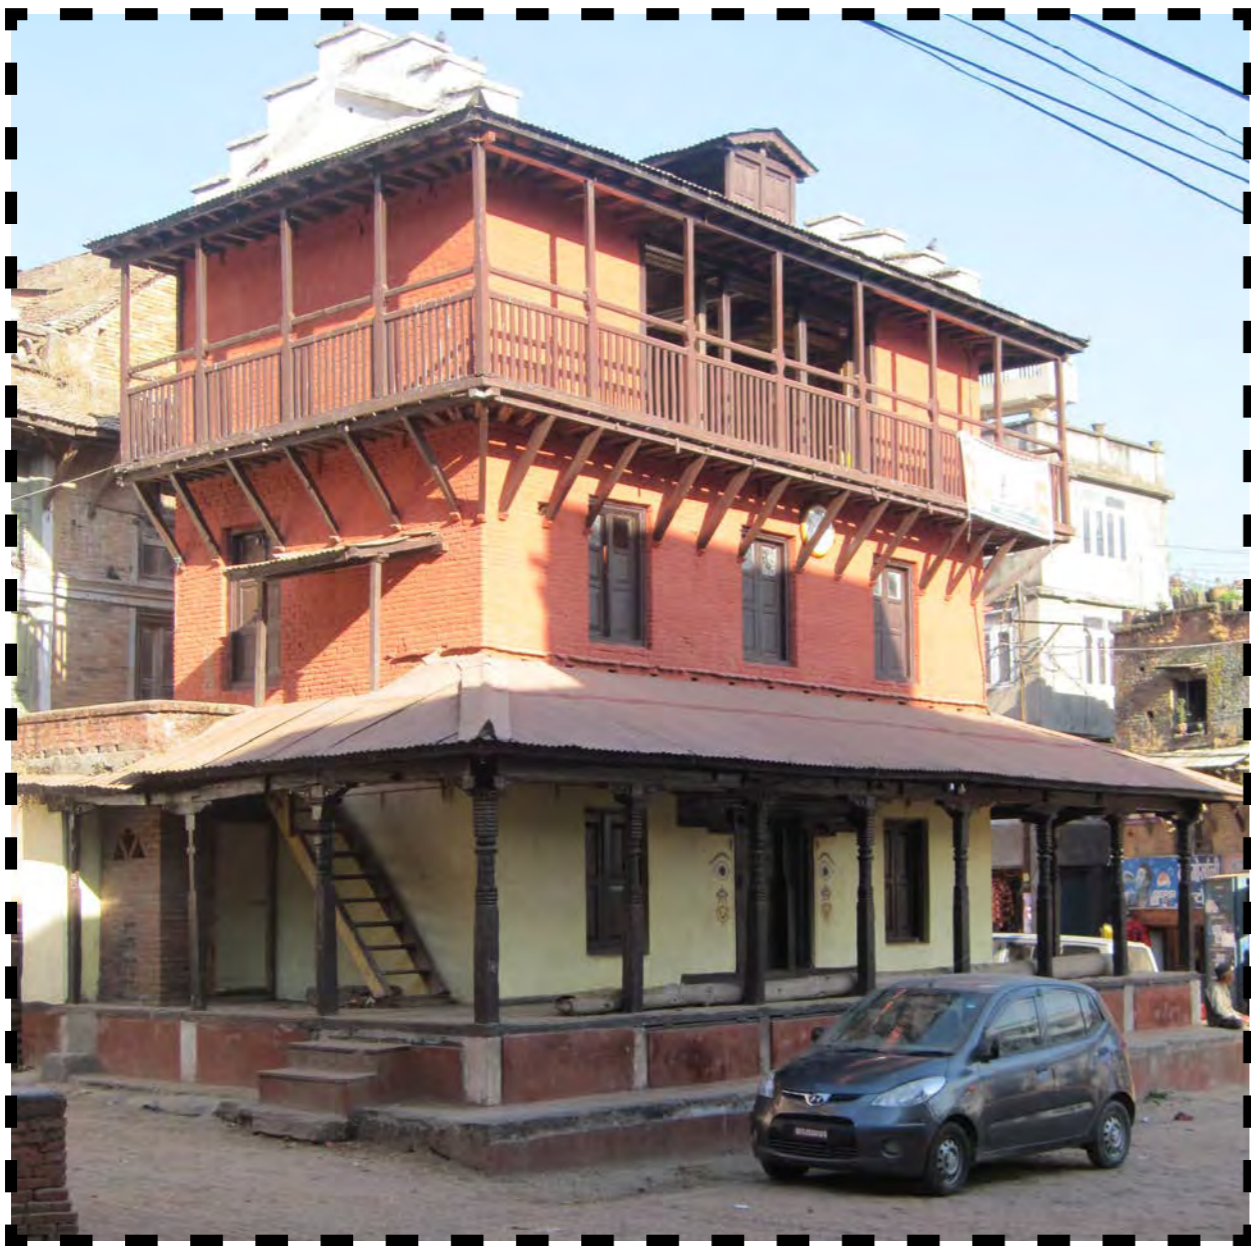
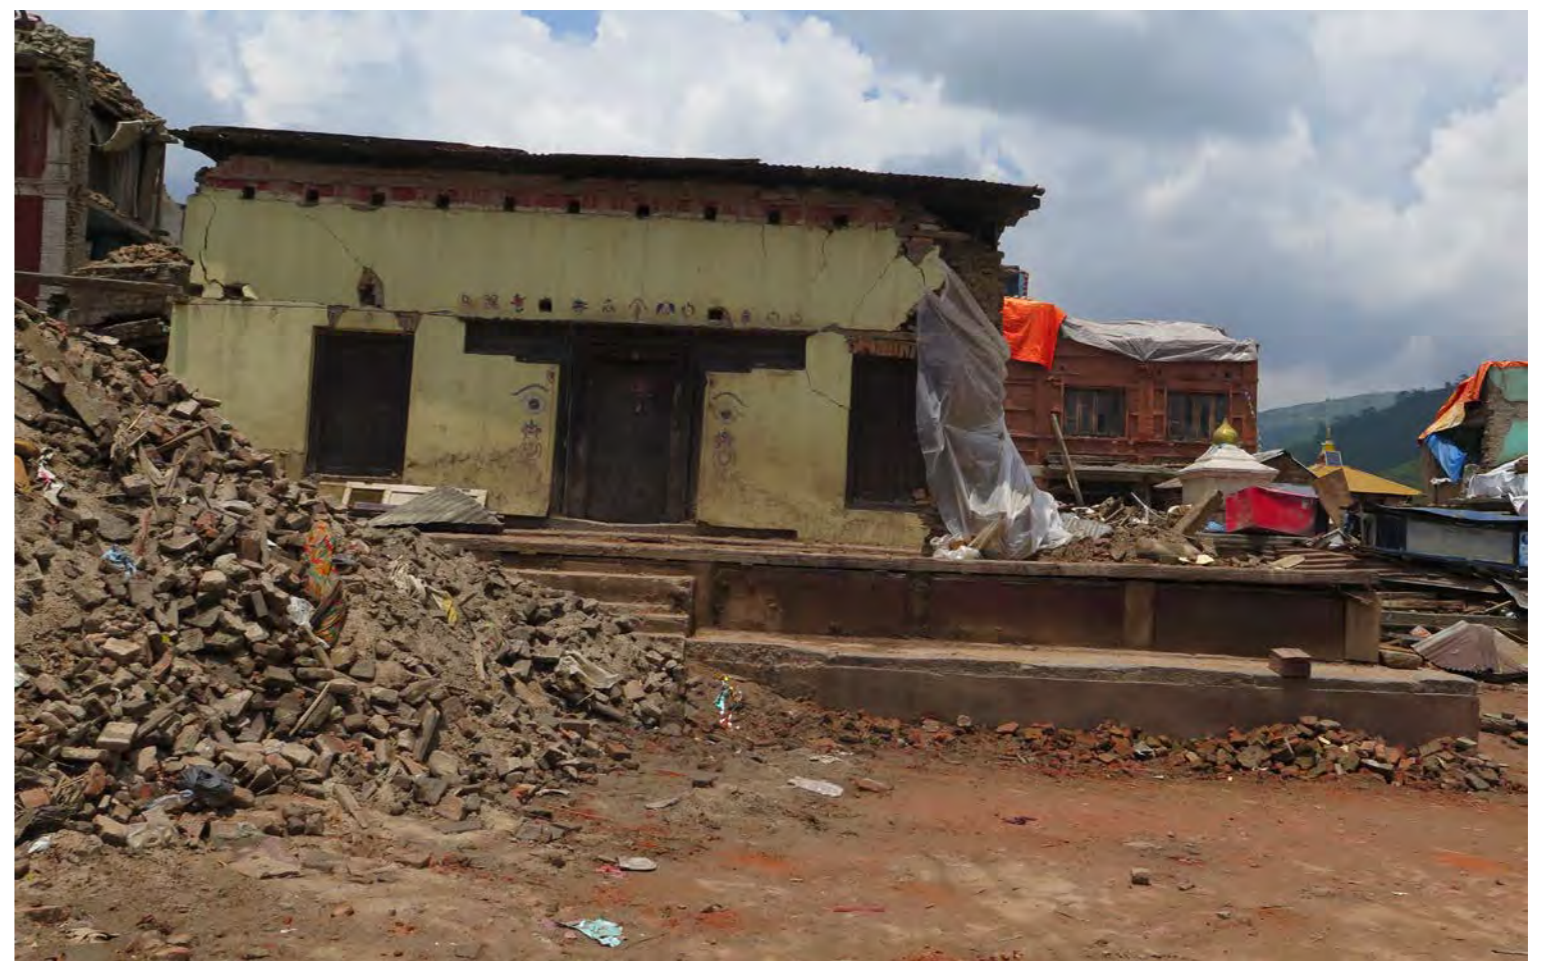
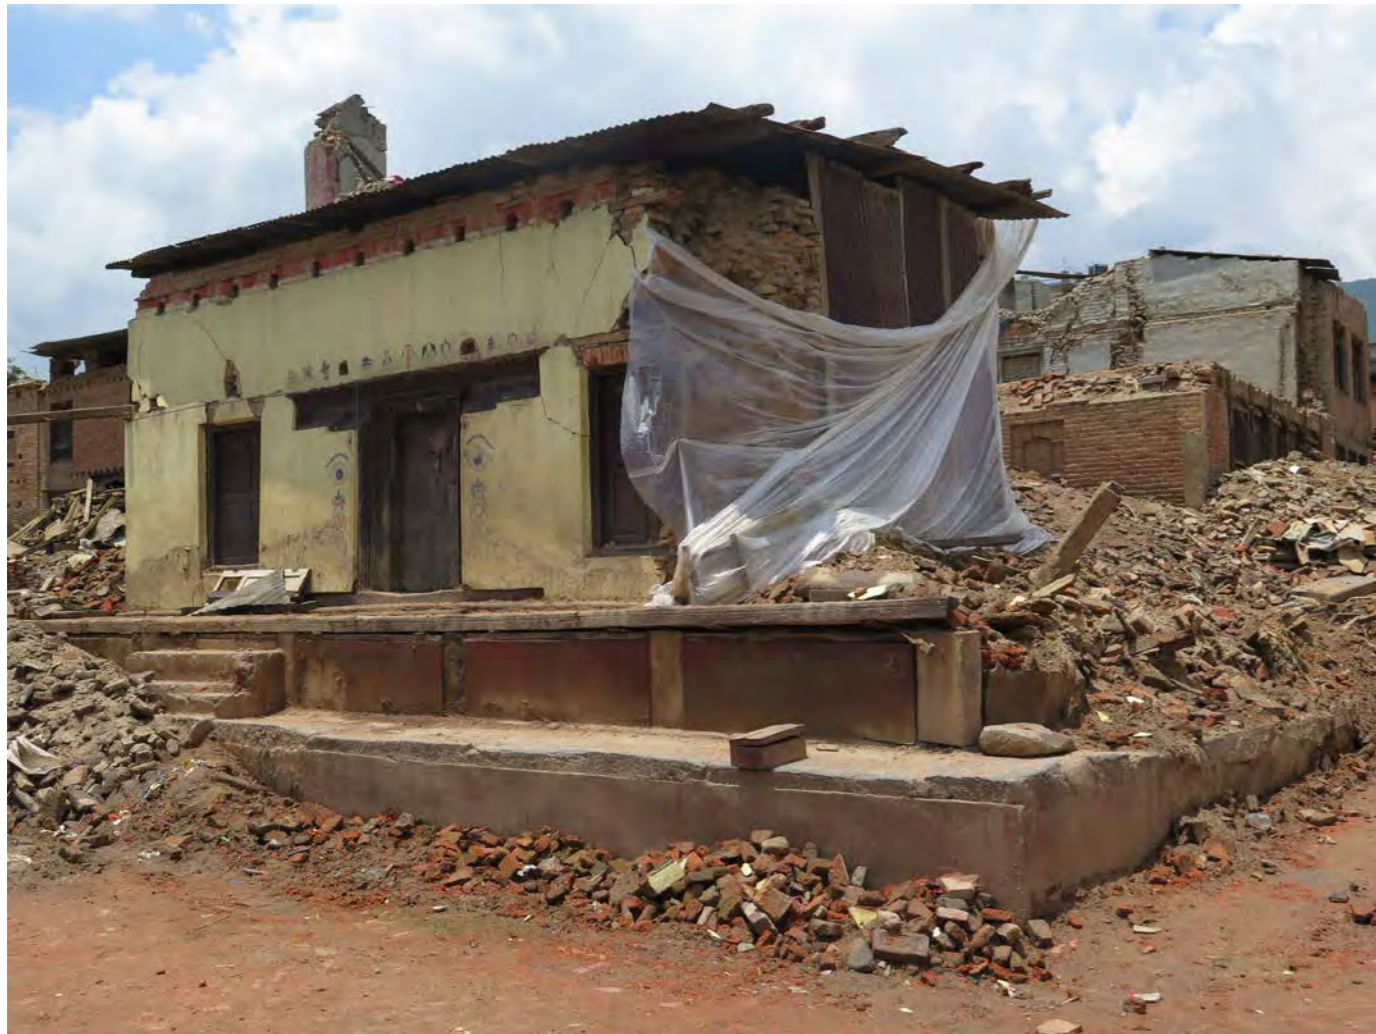
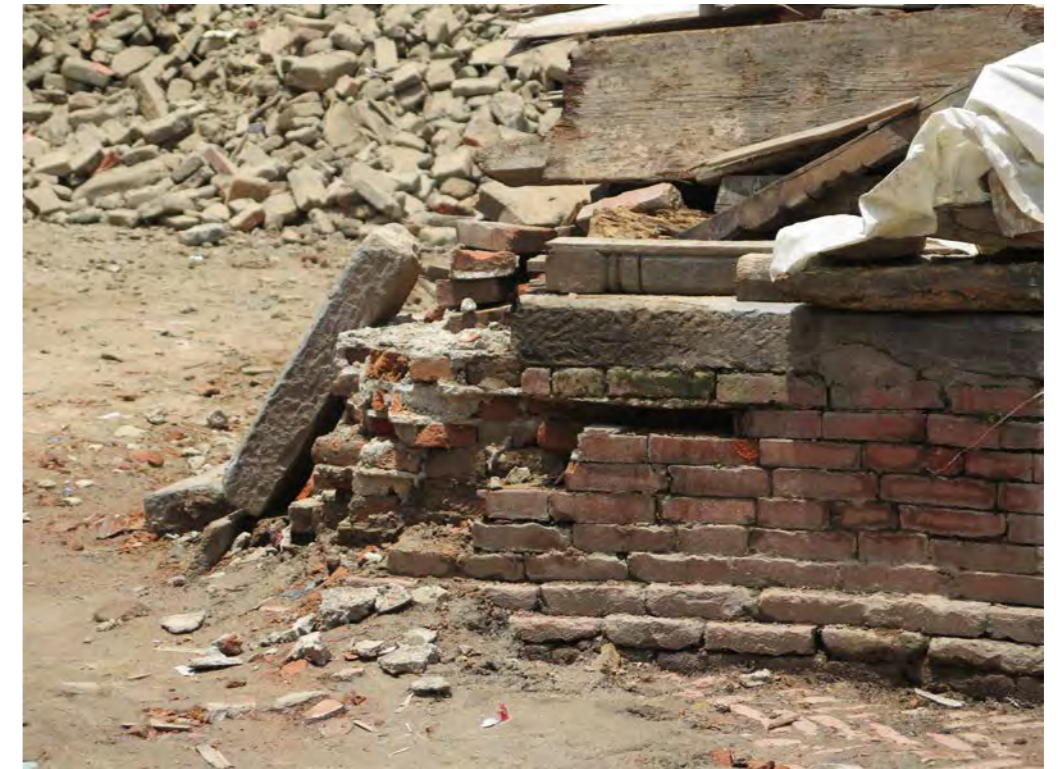
E-16 DYO CHHEN- GANSI FALCHA

NUMBER	NAME	DATE A.D.	TPOLOGY	GENERAL DESCRIPTION	PROBLEMS DESCRIPTION	DANGER/ DESTROY
E-16	Gansi Falcha at Chalakhu		Dyo Chhen		Roof collapsed. Eastern part collapsed to plinth. Major diagonal cracks on south wall. Western wall collapsed.	D!

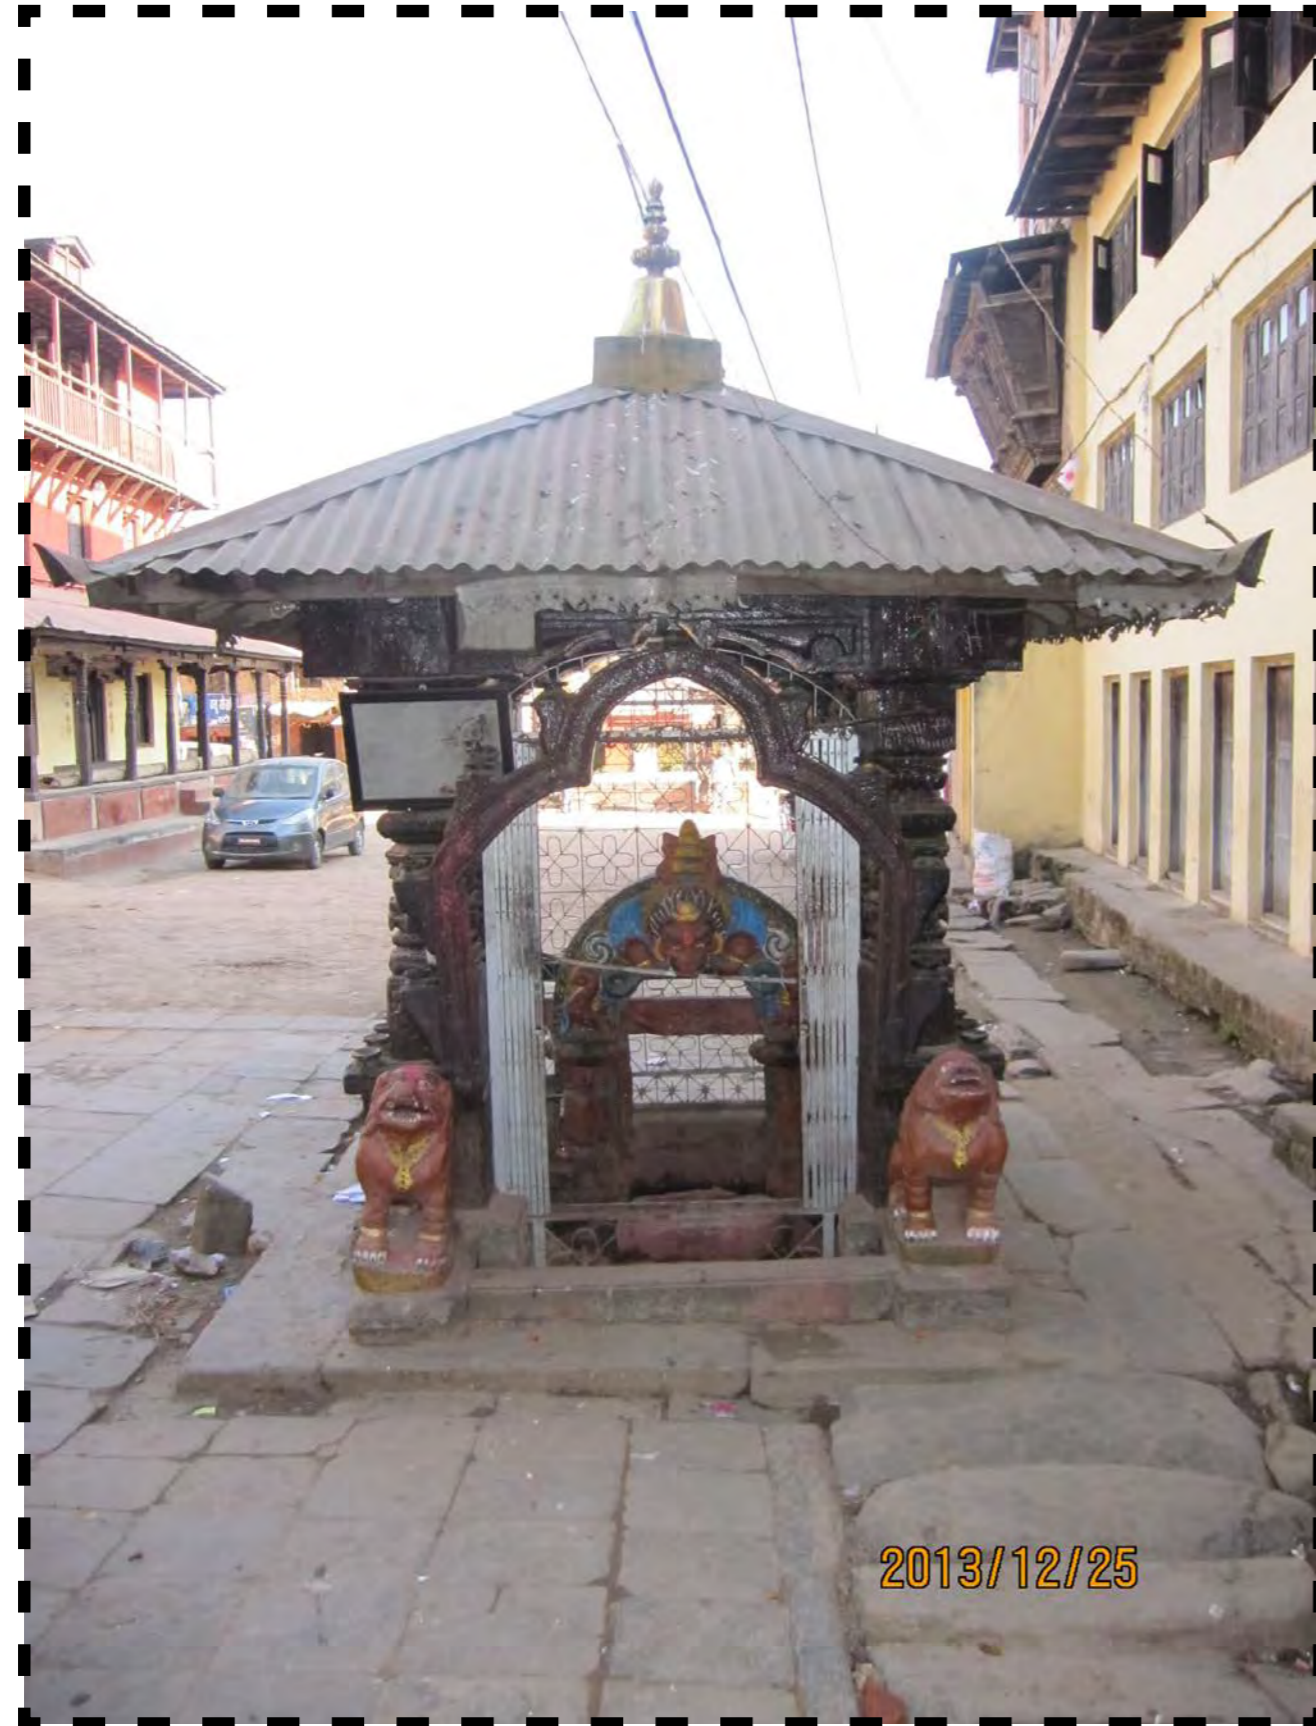
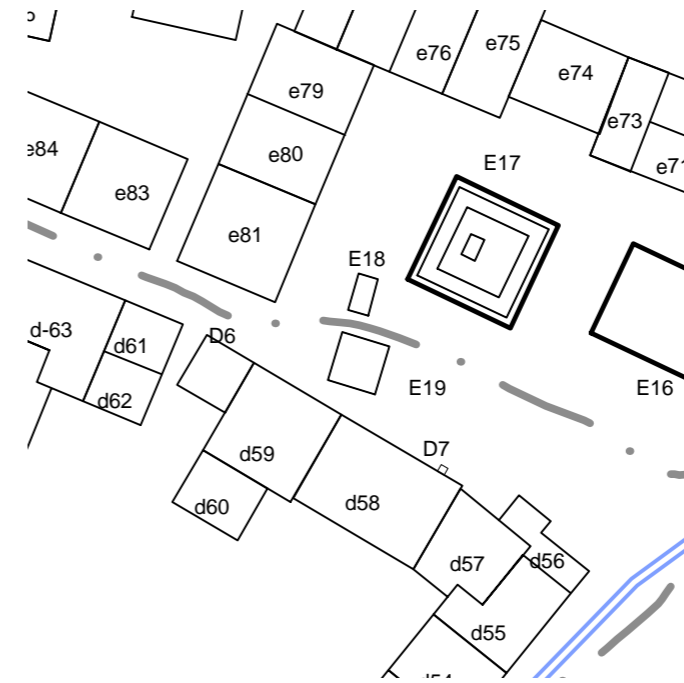
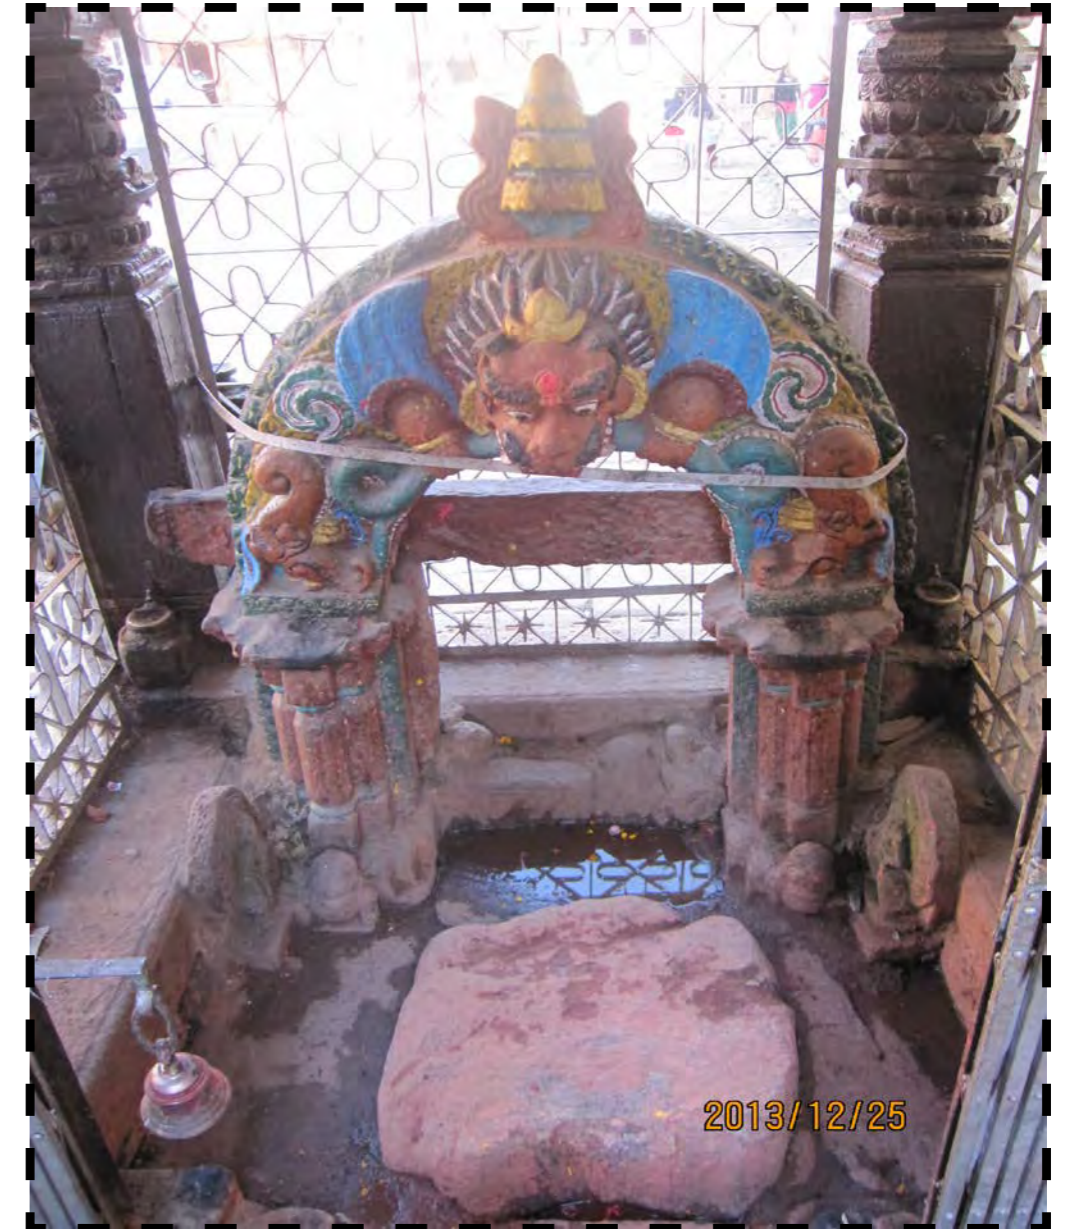
E-19 NARAYAN TEMPLE

NUMBER	NAME	DATE A.D.	TYPOLOGY	GENERAL DESCRIPTION	PROBLEMS DESCRIPTION	DANGER/ DESTROY
E-19	Aajima Temple		Temple	Single tiered temple with CGI roofing	Roof damaged at south west corner. Temple bounded by iron channels. Base of Pinnacle damaged.

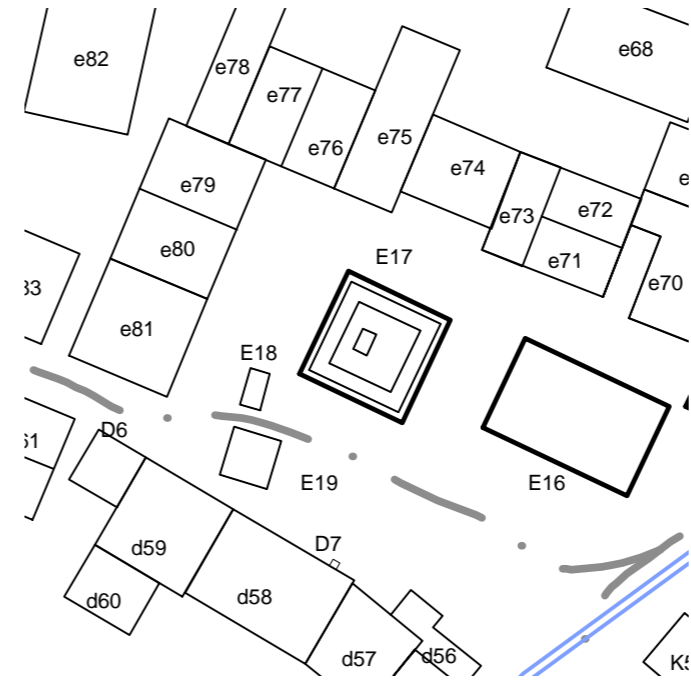
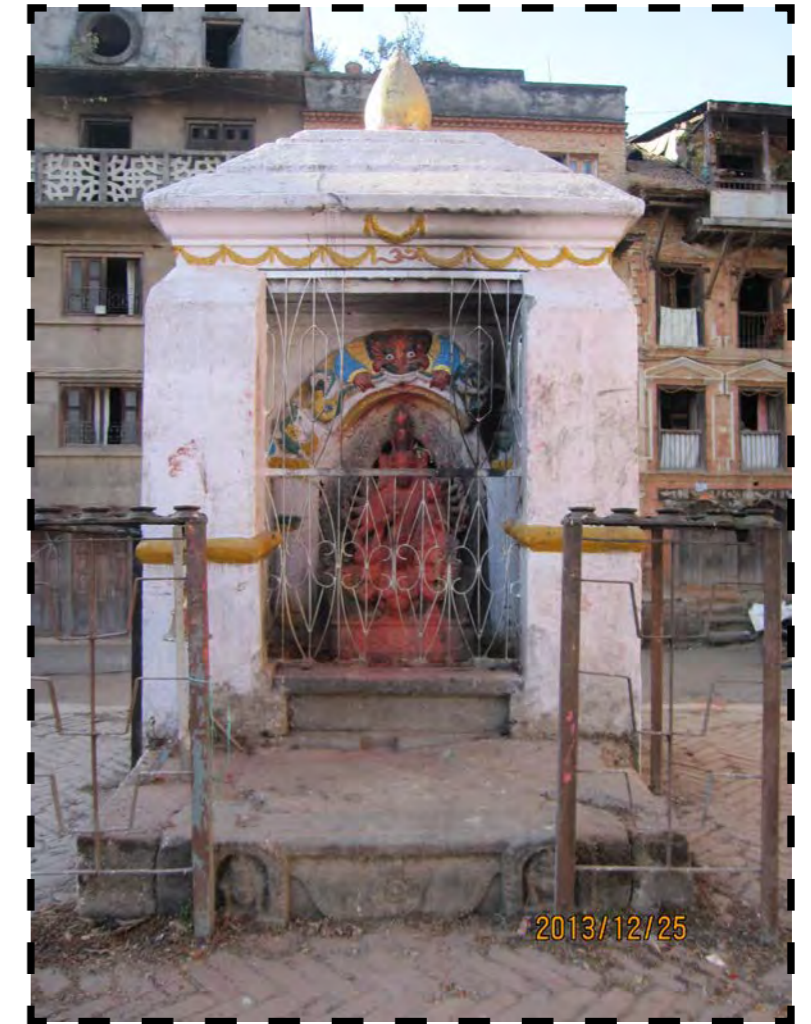
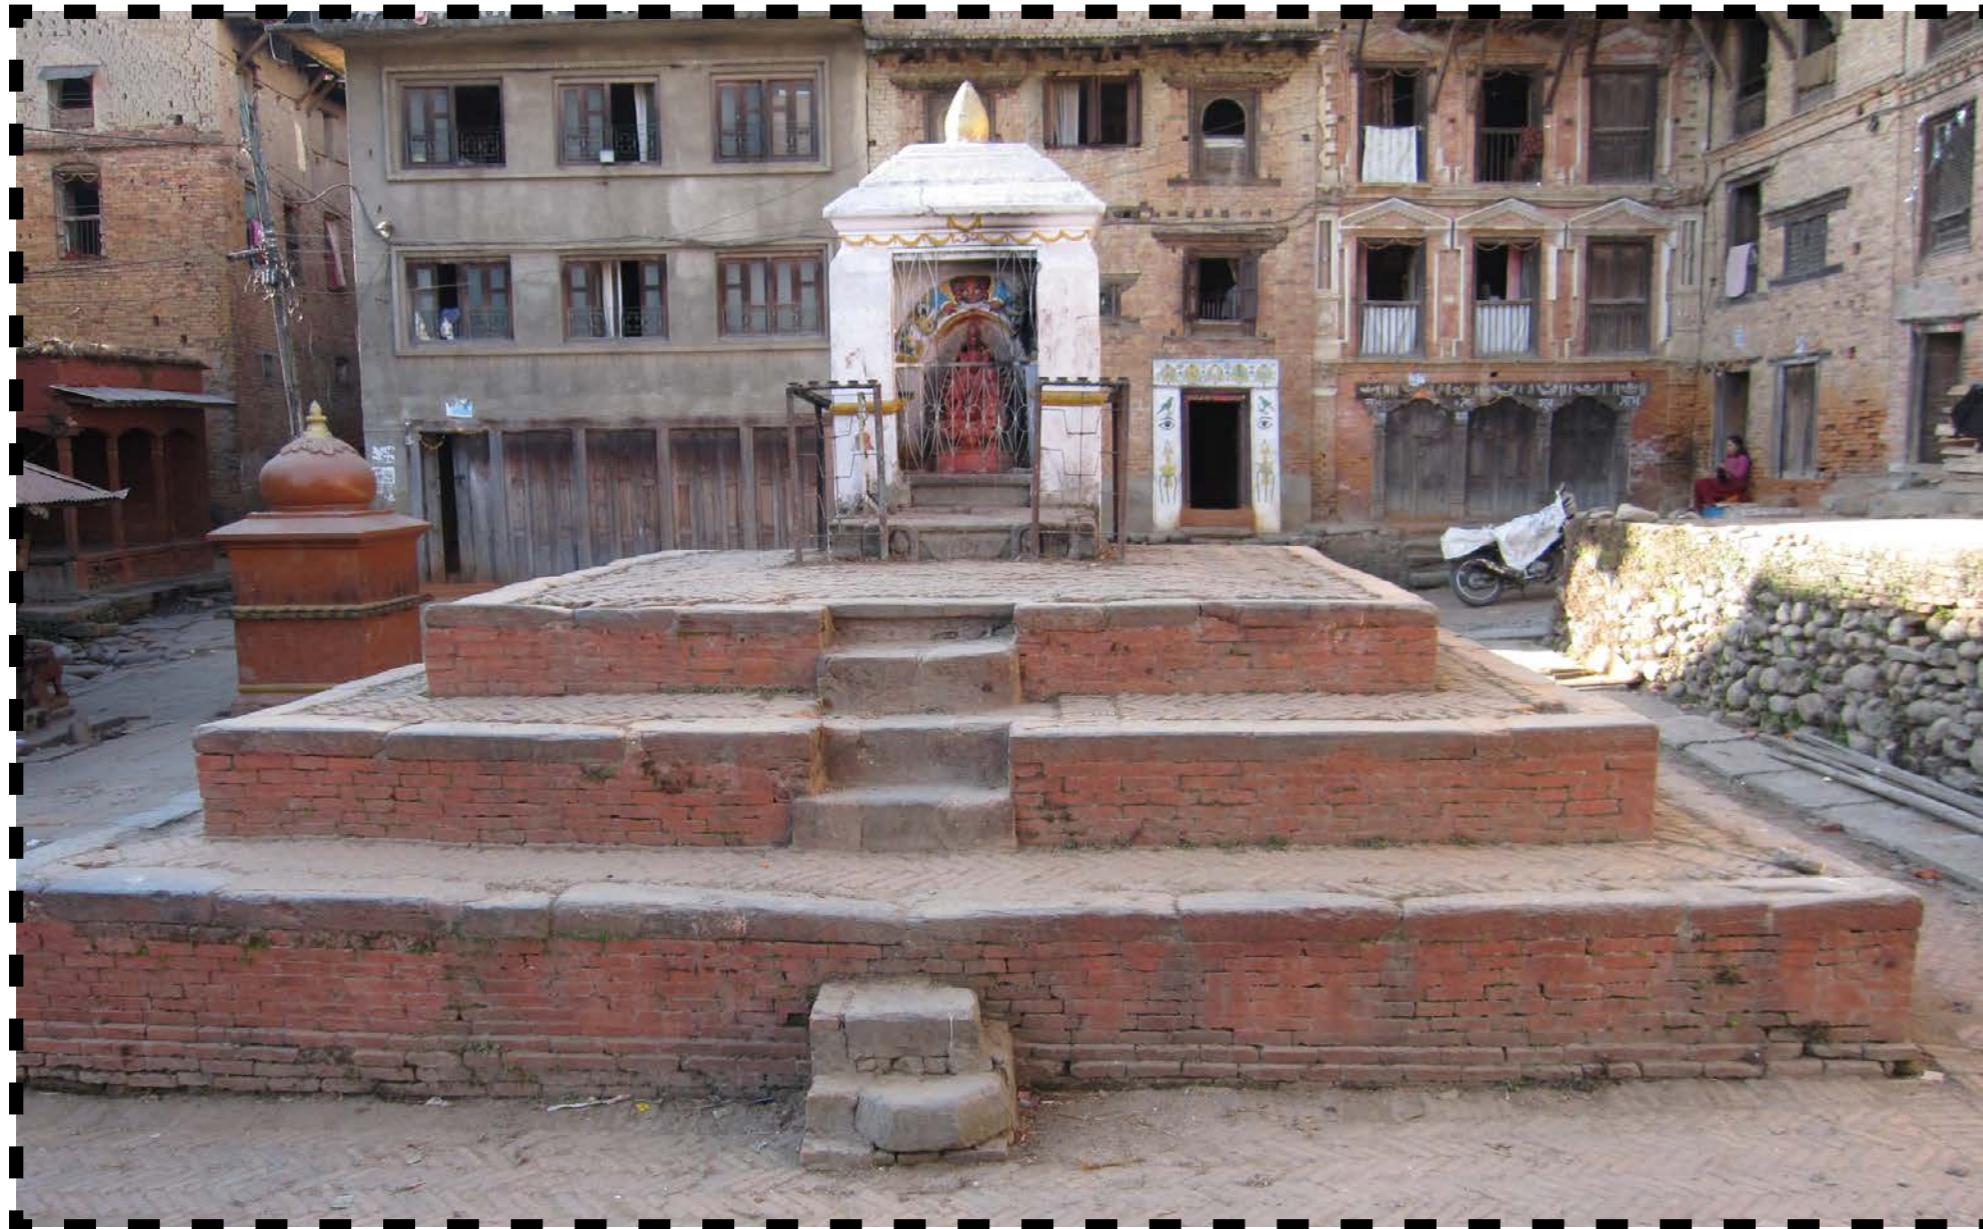
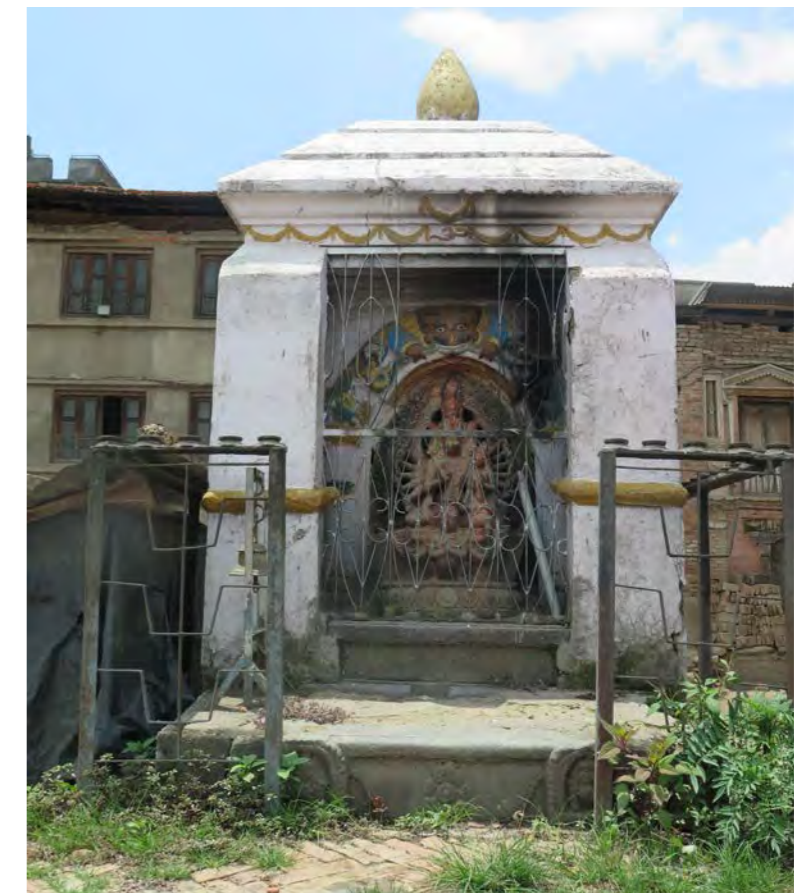
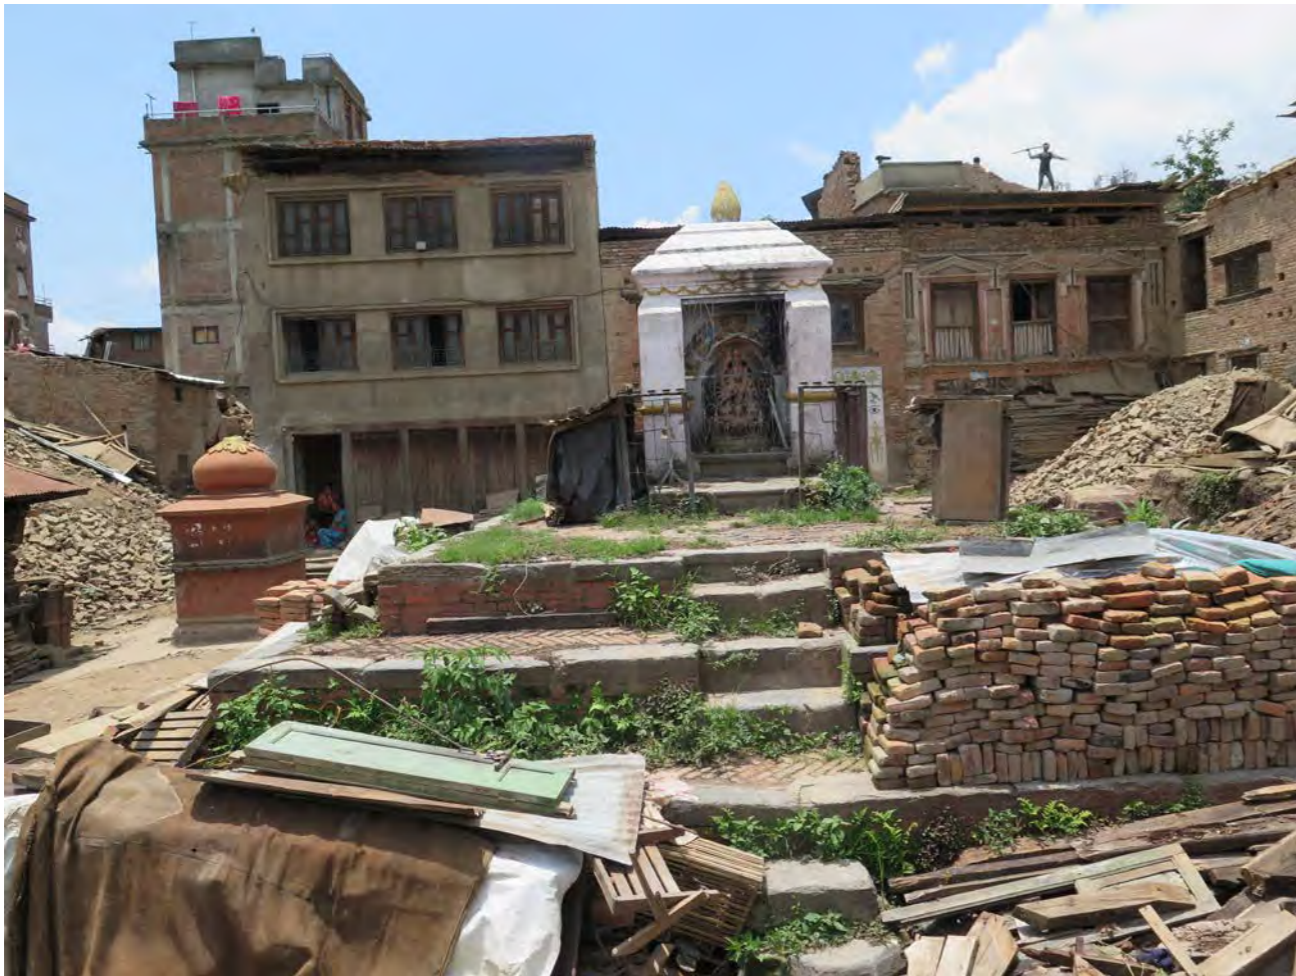
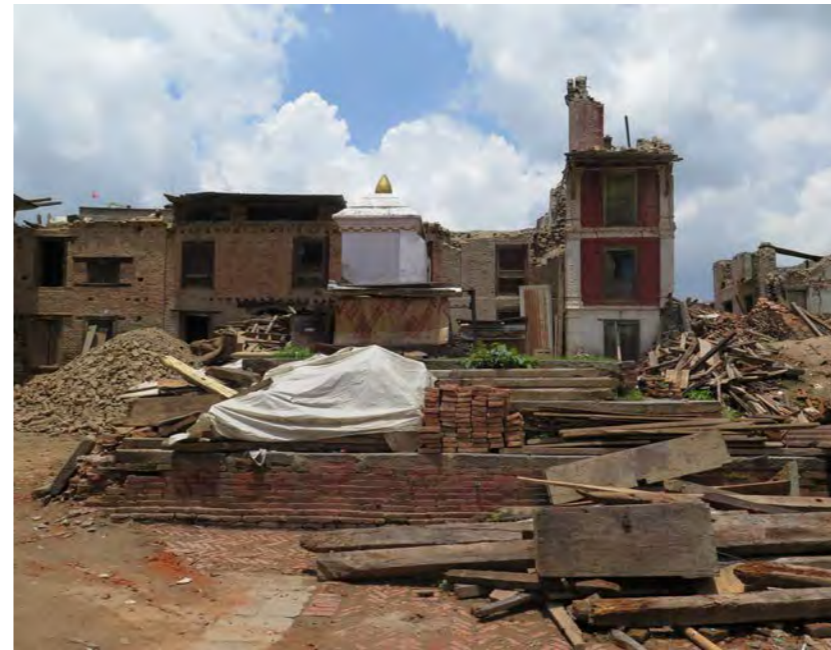
E-17 NARAYAN TEMPLE

NUMBER	NAME	ESTABLISHED DATE (A.D.)	TYPOLOGY	GENERAL DESCRIPTION	PROBLEMS DESCRIPTION	DANGER/ DESTROY
E-17	Narayan Shrine		Enclosed Shrine	Platform with Idol of Narayan	Platform covered by rubbles from nearby buildings. Plaster fall on South West corner. Plinth damaged on South west corner. Vegetation growth on plinth. Minor crack on top east.
