2015 Earthquake Damage Mapping

Sankhu

October 2015

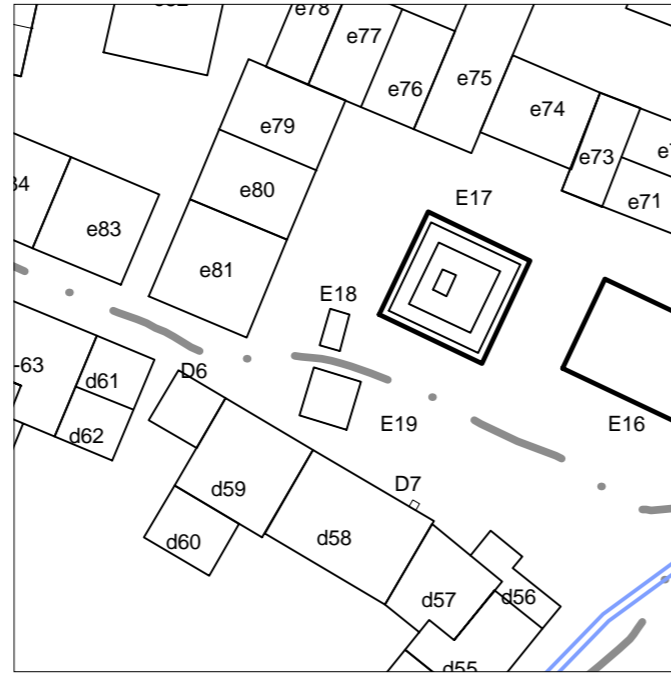
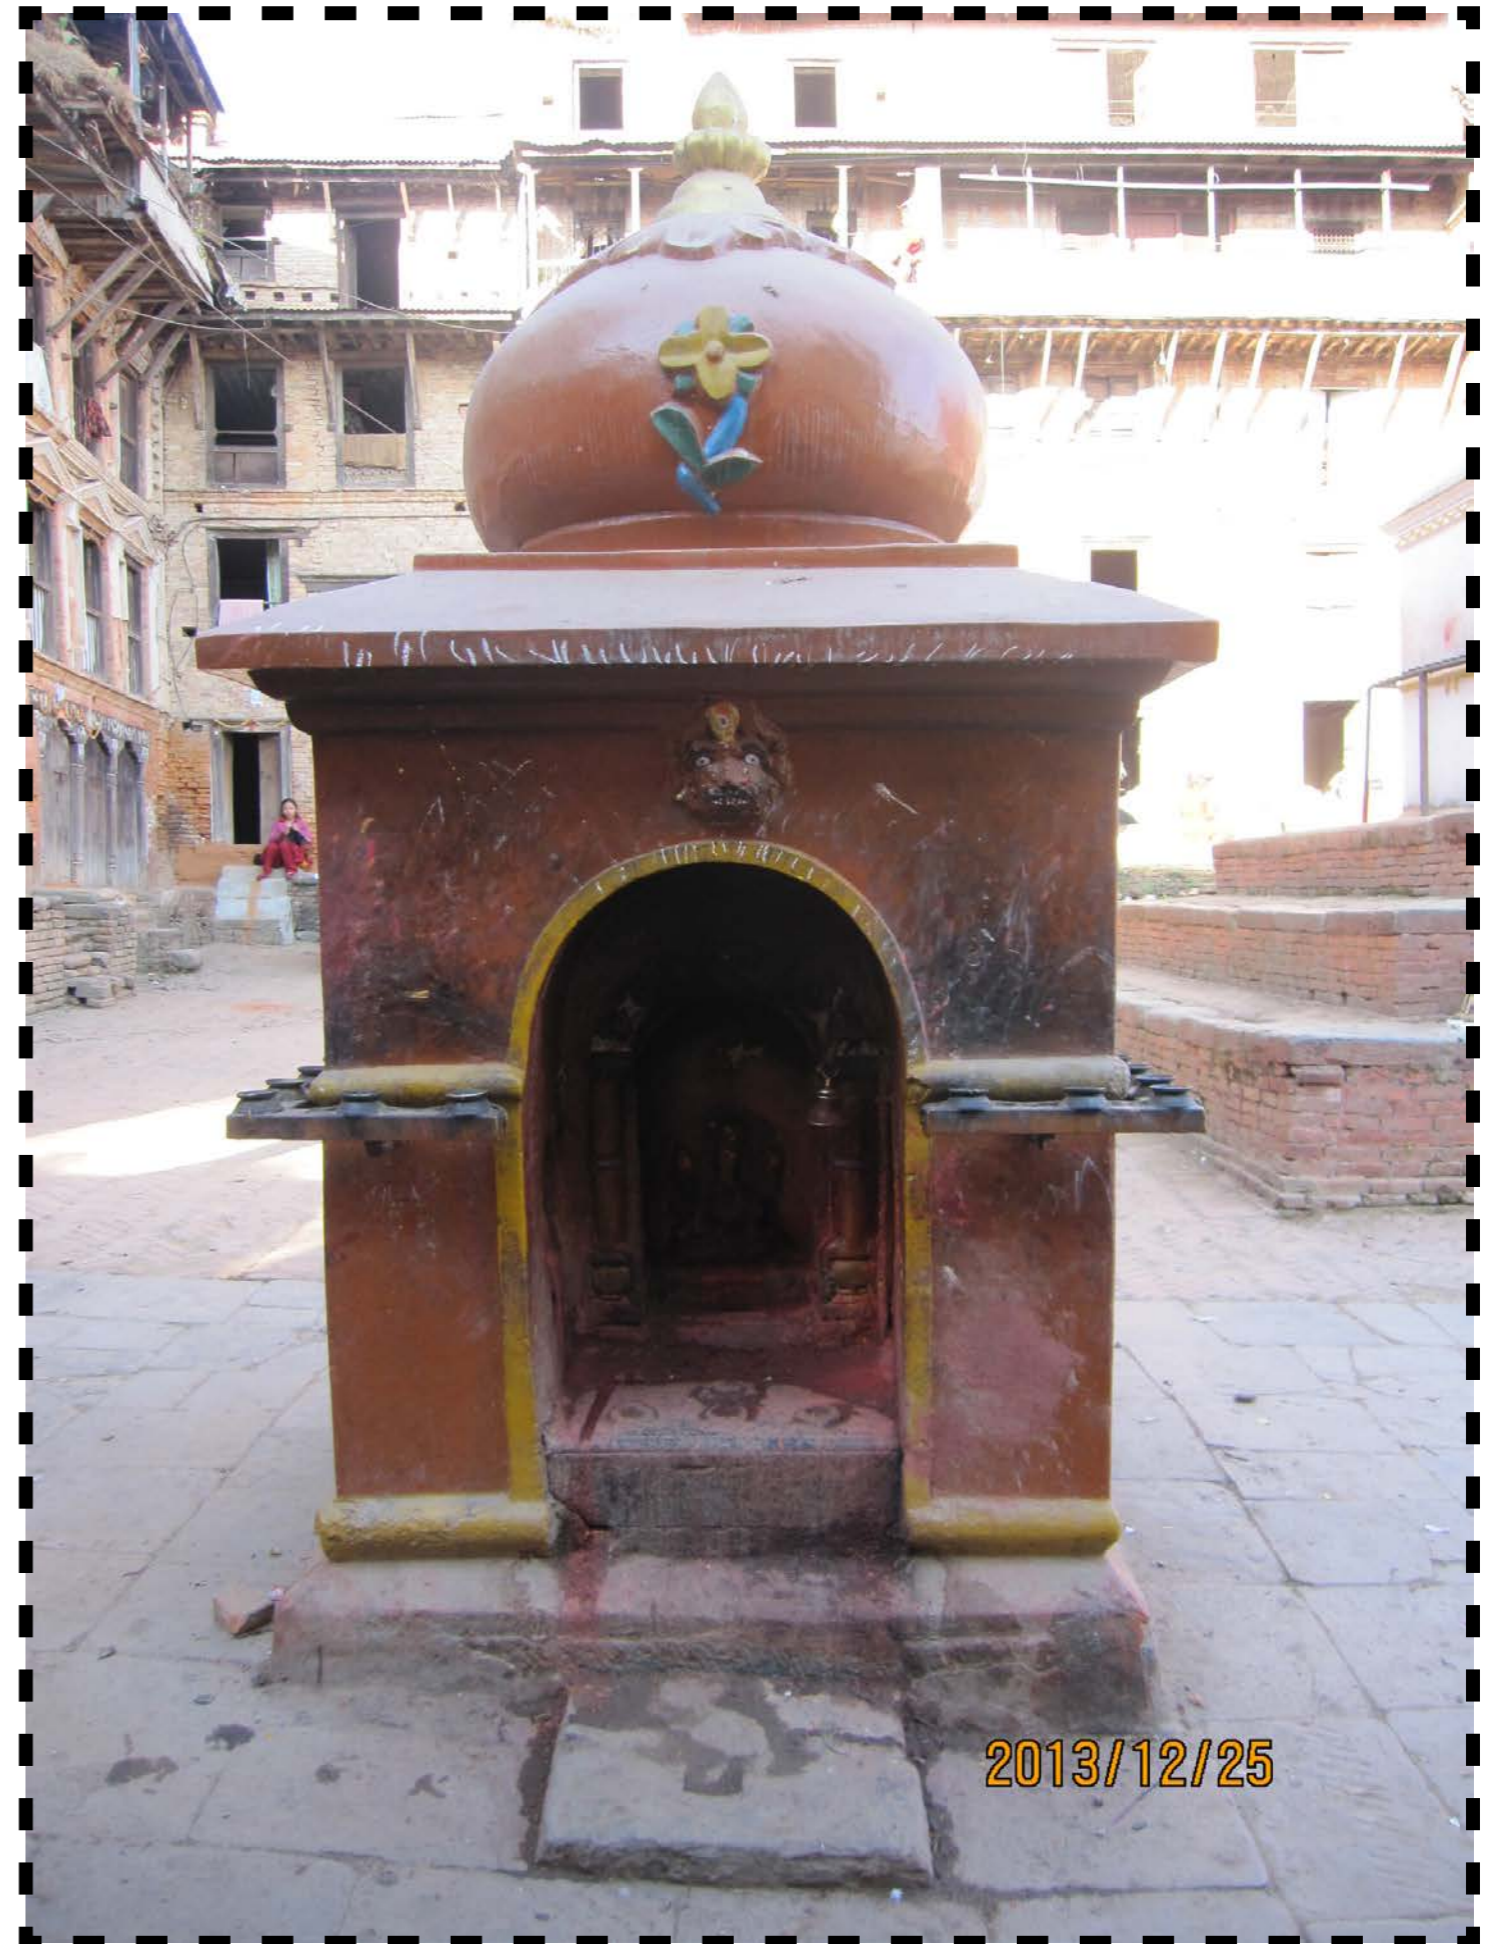
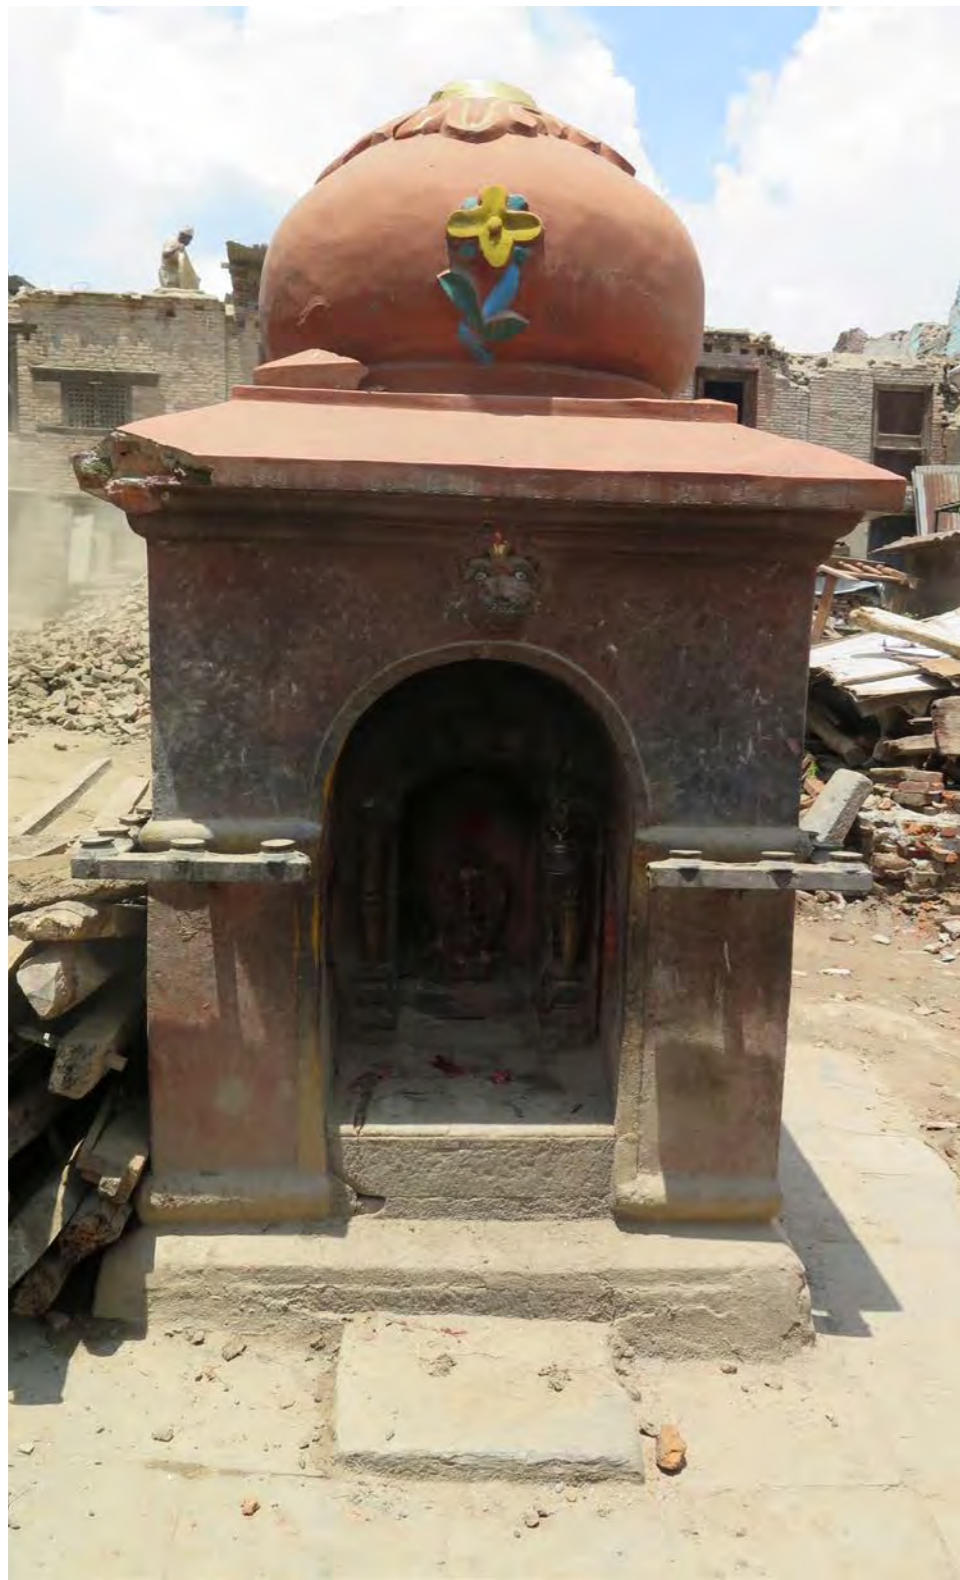
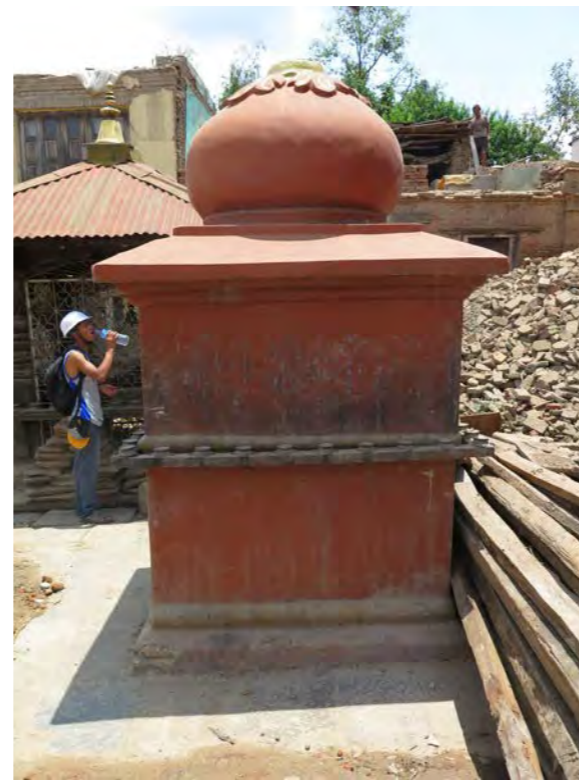
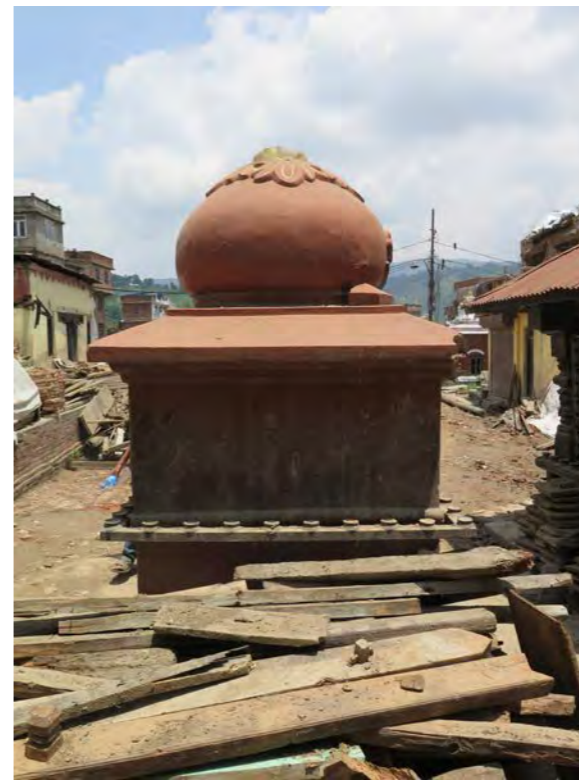
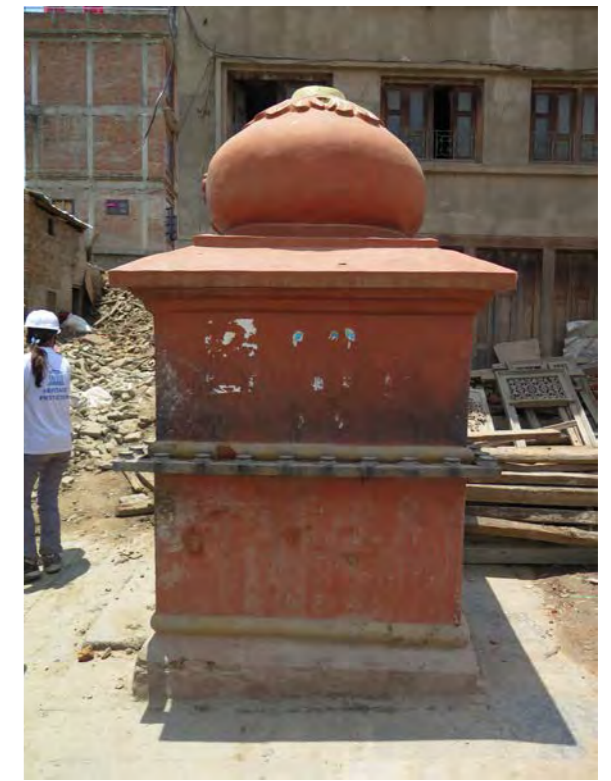
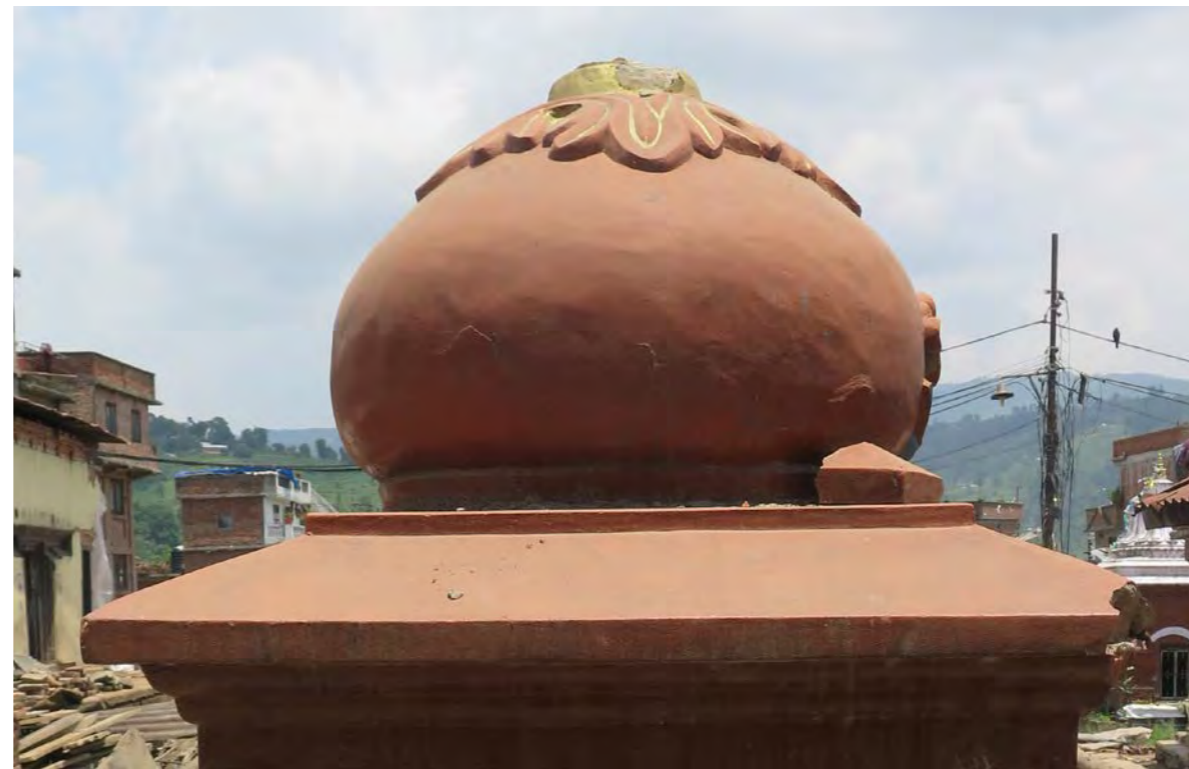
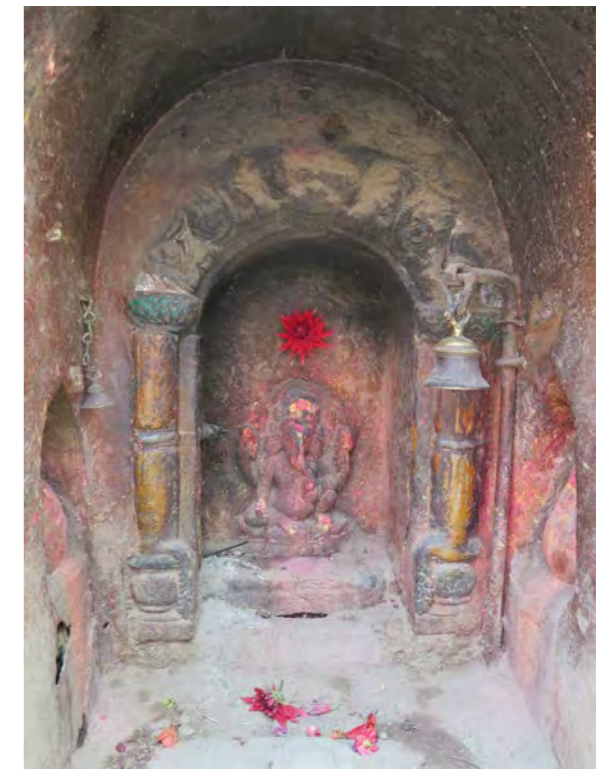
E-18 GANESH TEMPLE

NUMBER	NAME	ESTABLISHED DATE (A.D.)	TYPOLOGY	GENERAL DESCRIPTION	PROBLEMS DESCRIPTION	DANGER/ DESTROY
E-18	Ganesh Temple		Temple	Temple with dome	South west part has fallen piece. Stone gajur missing while using dozer.

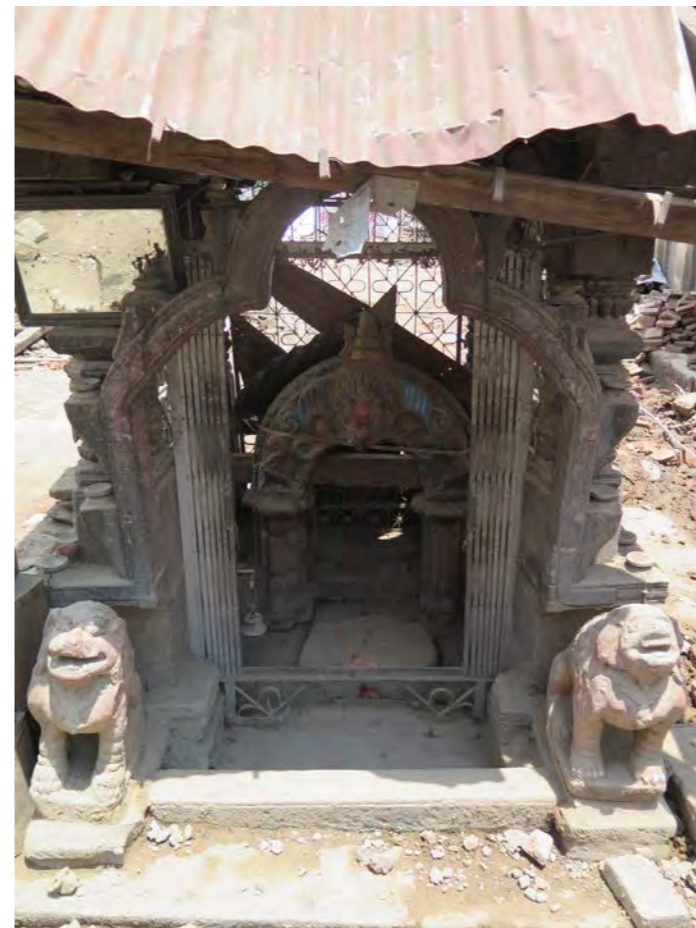
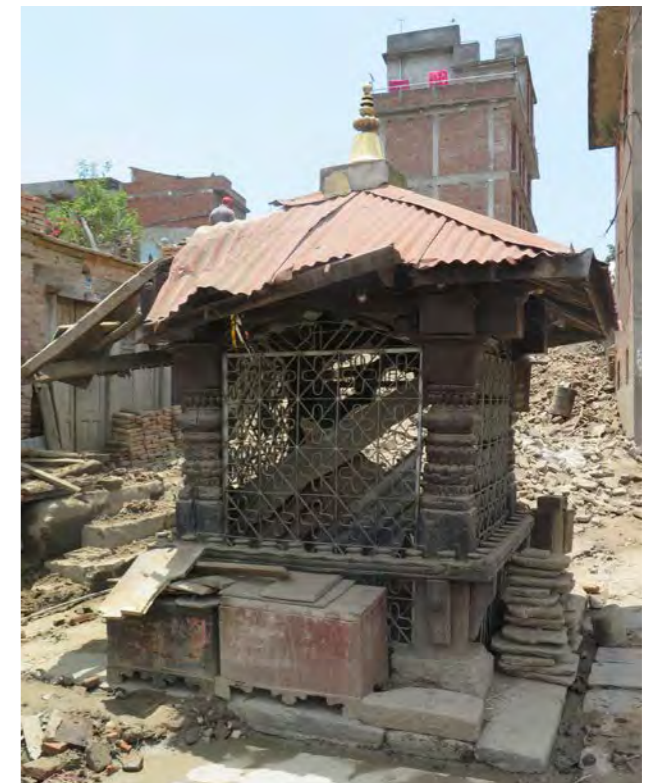
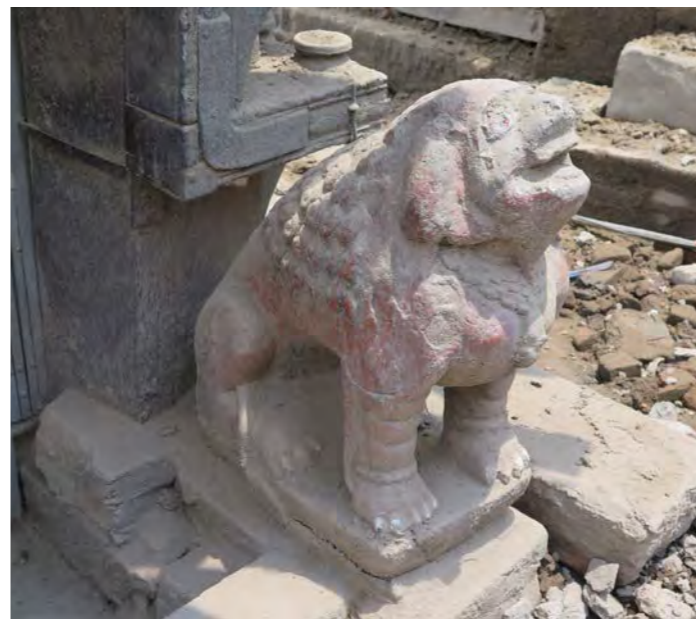
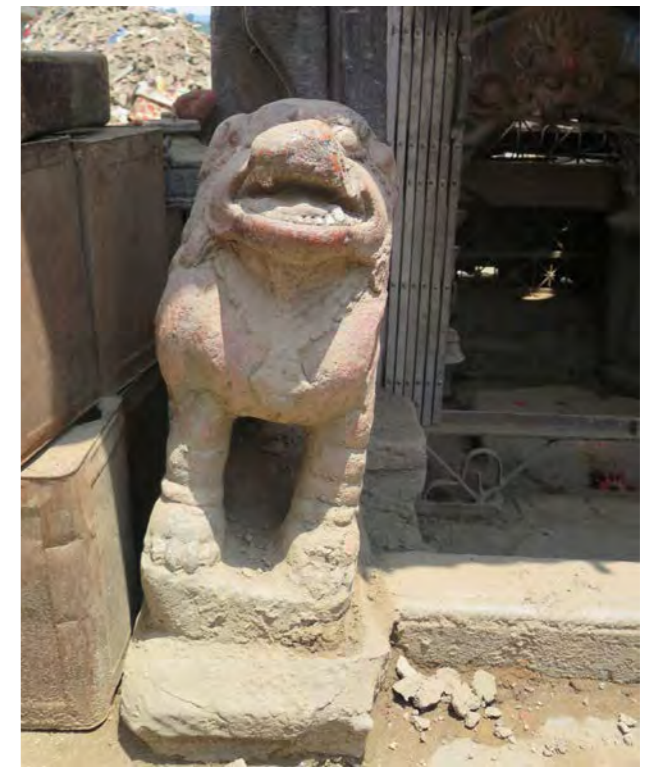
NUMBER	NAME	DATE A.D.	TYPOLOGY	GENERAL DESCRIPTION	PROBLEMS DESCRIPTION	DANGER/ DESTROY
E-19	Aajima Temple		Temple	Single tiered temple with CGI roofing	Roof damaged at south west corner. Temple bounded by iron channels. Base of Pinnacle damaged.

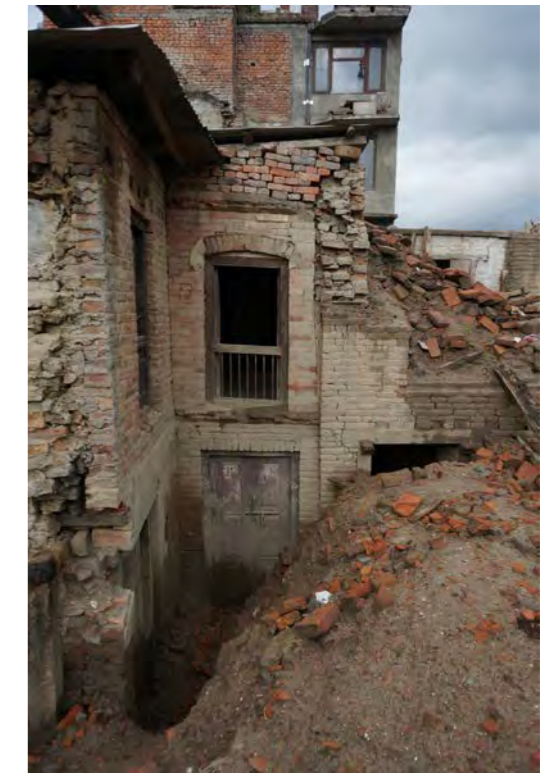
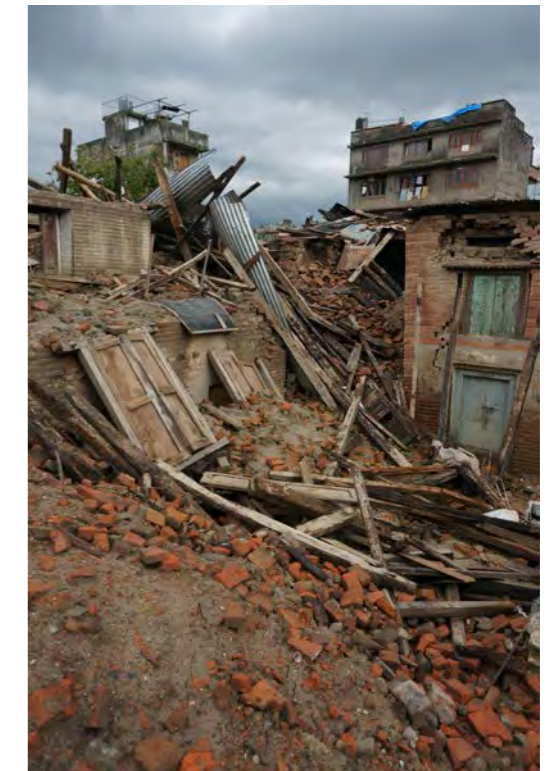
F-02 DYO CHHEN

NUMBER	NAME	ESTABLISHED DATE (A.D.)	TYPOLOGY	GENERAL DESCRIPTION	PROBLEMS DESCRIPTION	DANGER/ DESTROY
F-02			Dyo Chen	G+4 Uncooked and cooked brick structure Pagoda style on upper roof	3 floors collapsed.

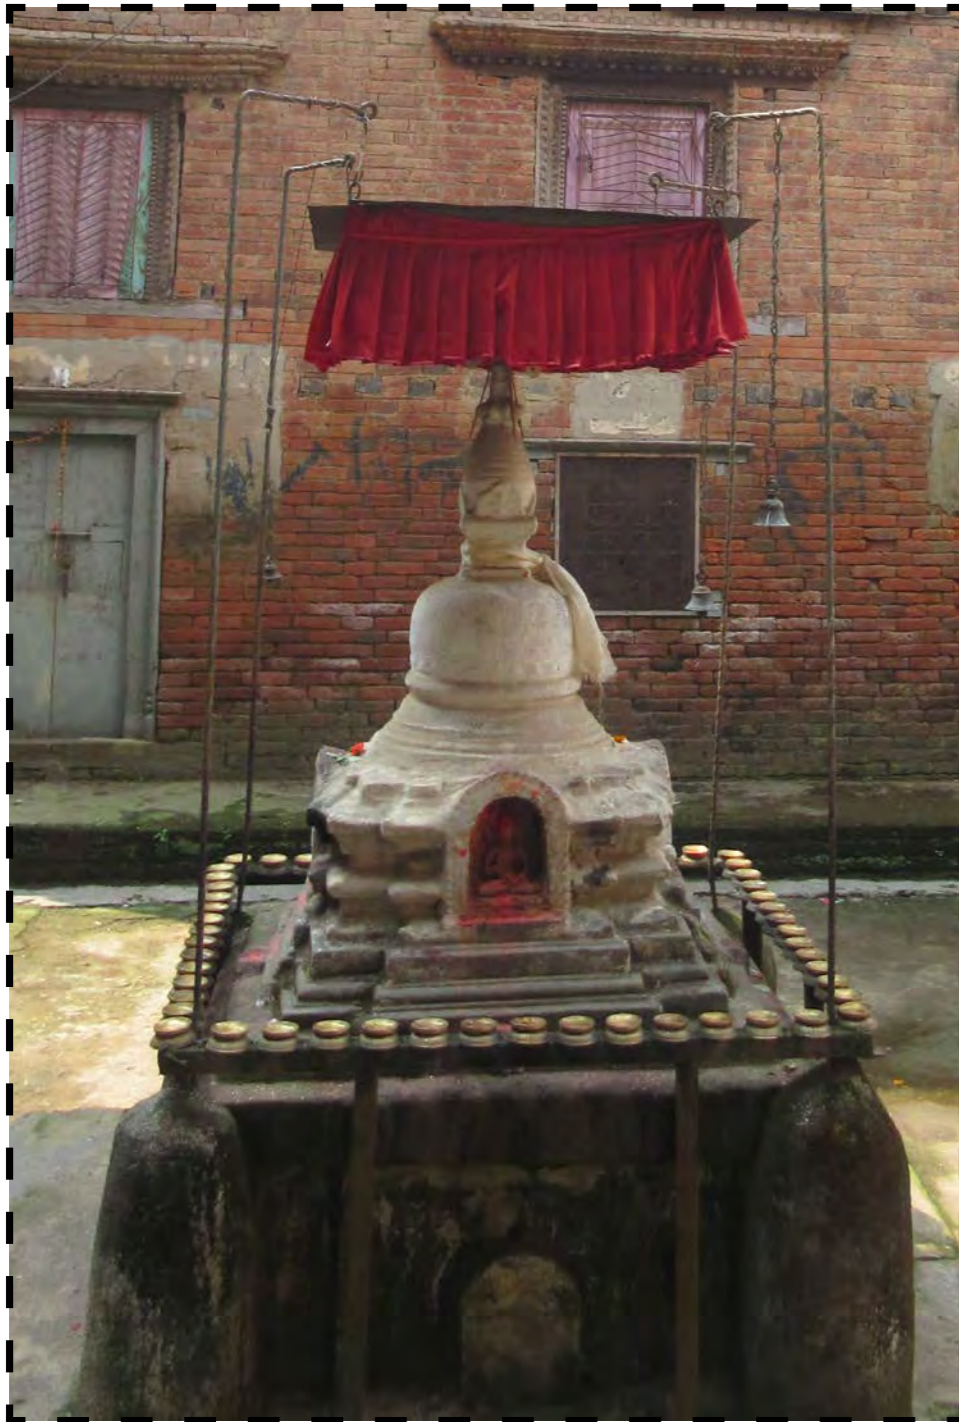
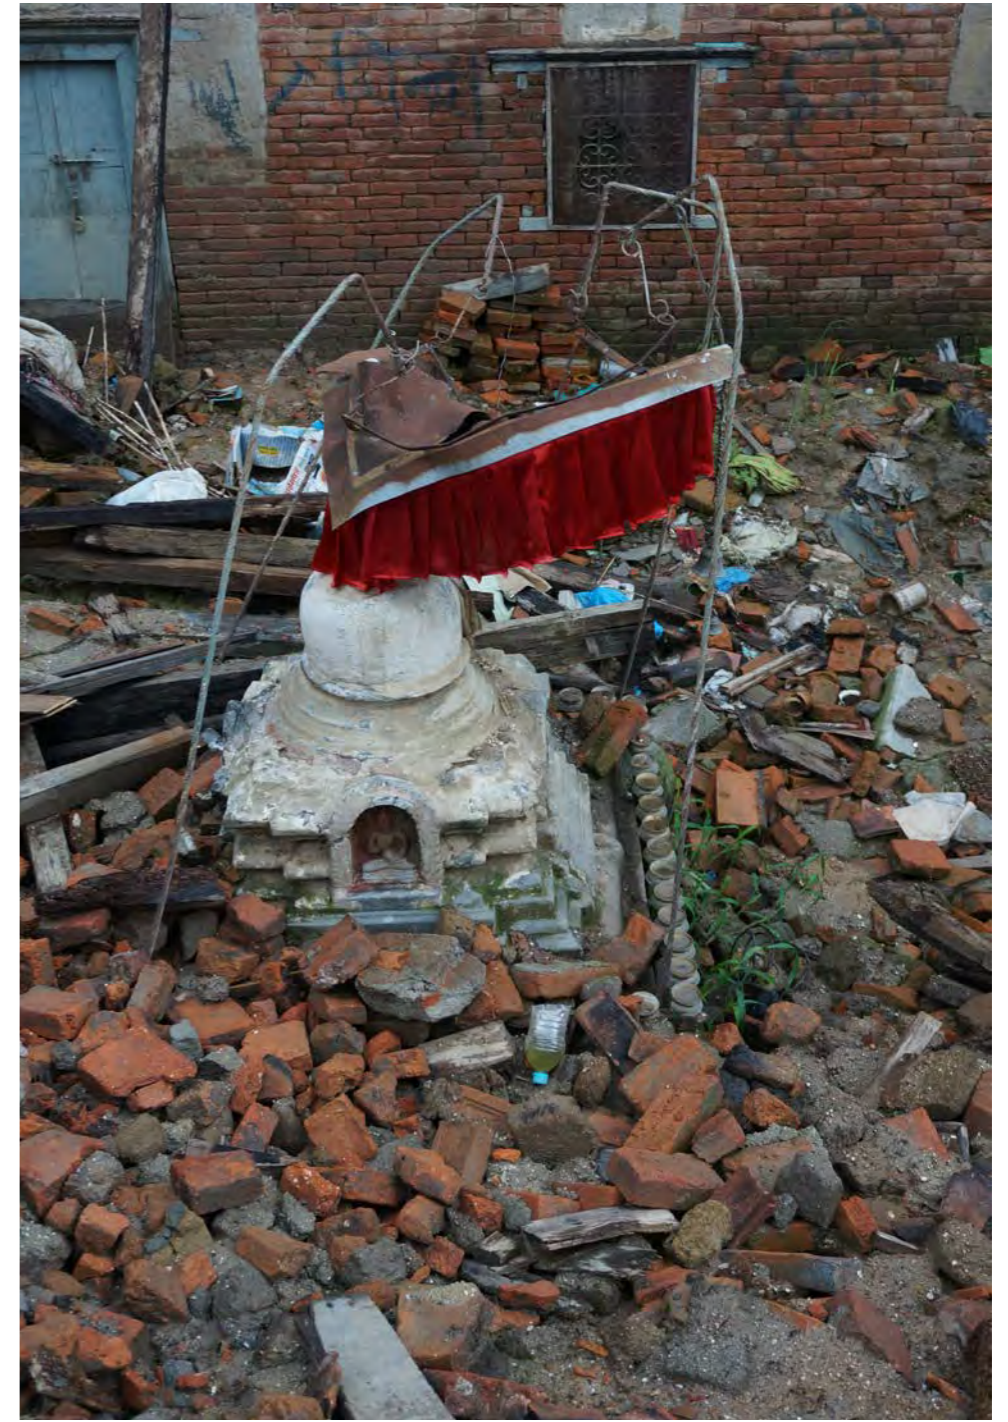
F-03 CHAITYA

NUMBER	NAME	DATE A.D.	TYPOLOGY	GENERAL DESCRIPTION	PROBLEMS DESCRIPTION	DANGER/ DESTROY	
F-03			Chaitya	Stone made chaitya	Roof collaped Chaitya under debris Needs maintainance

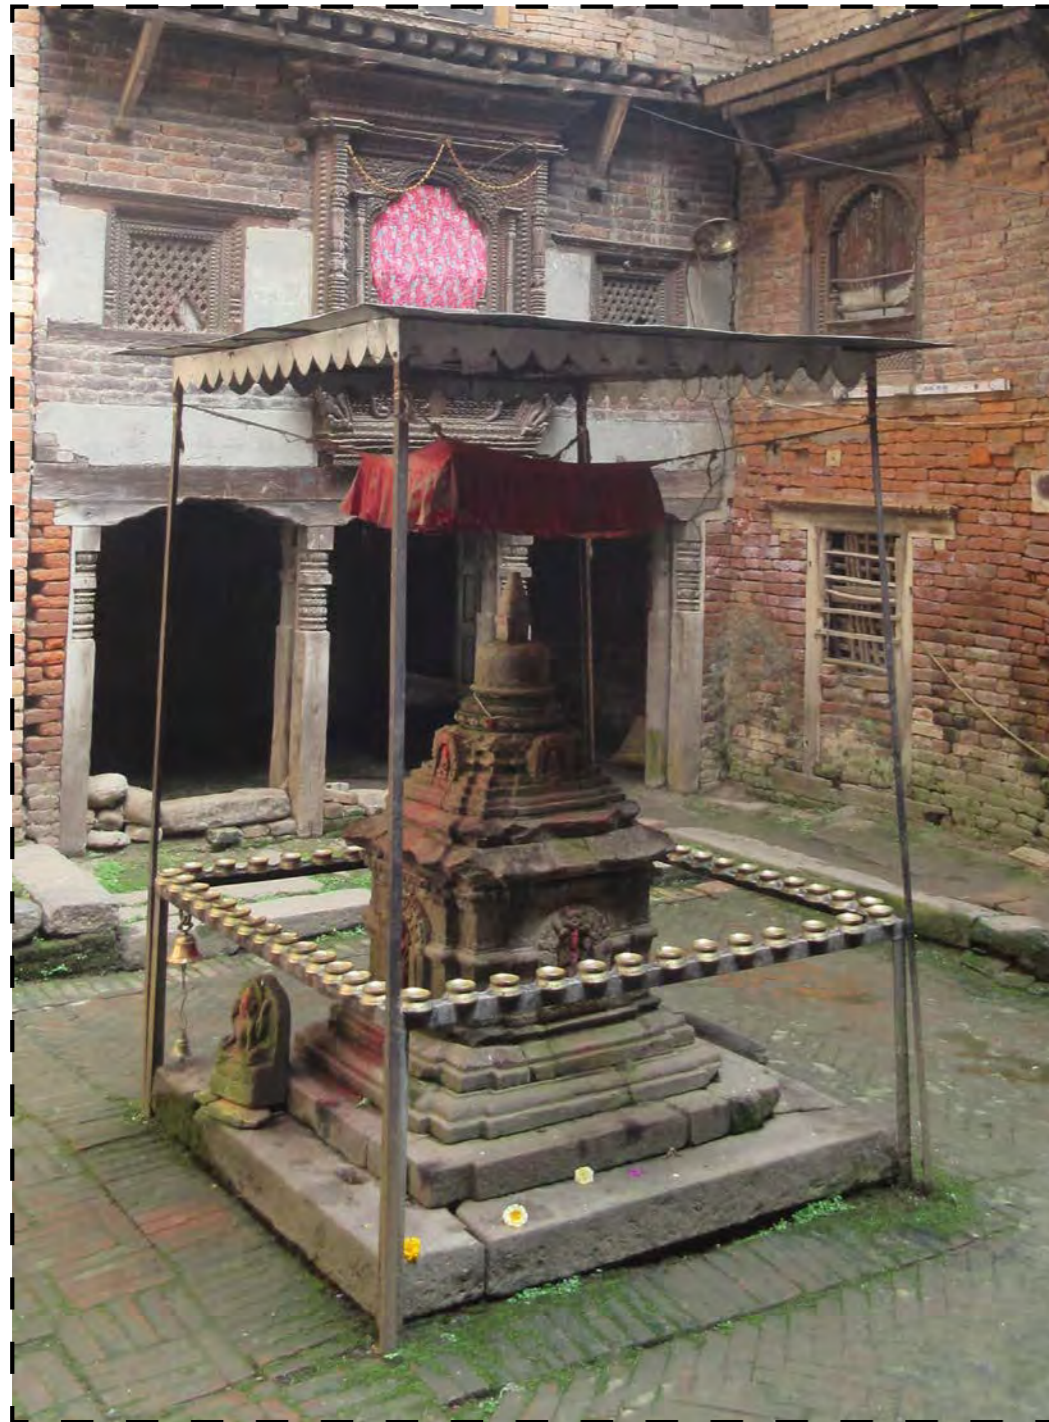
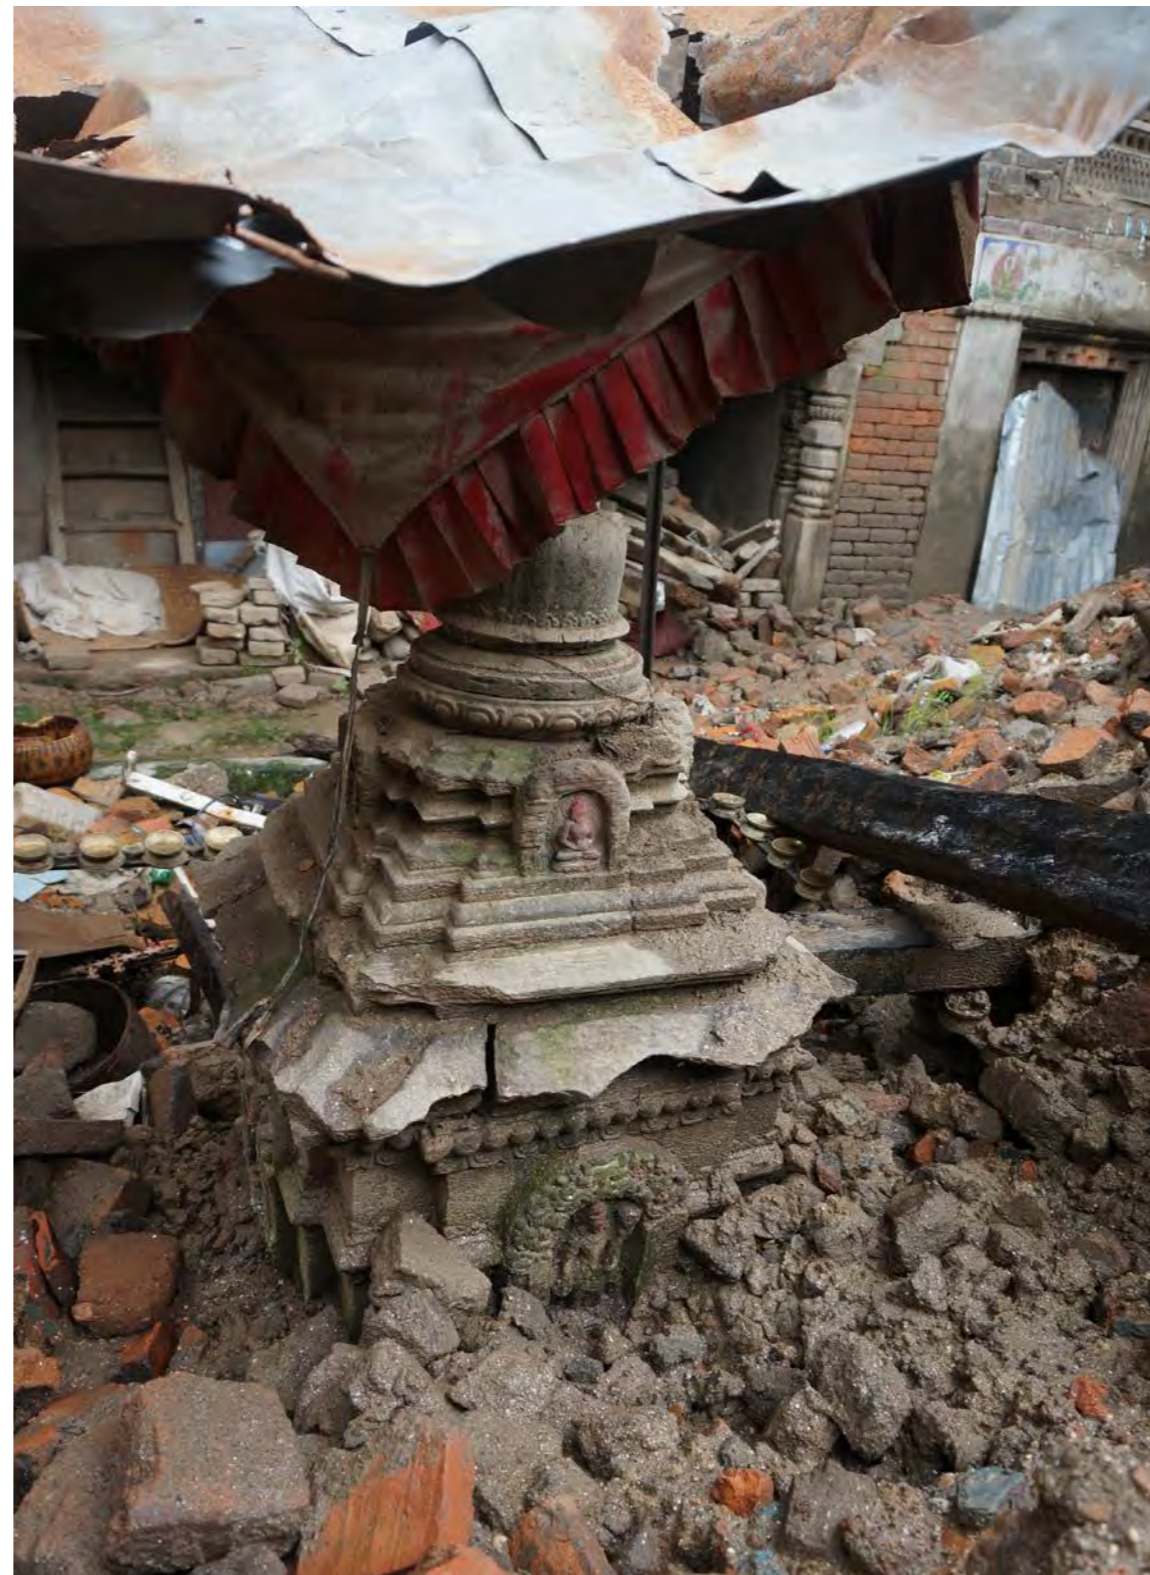
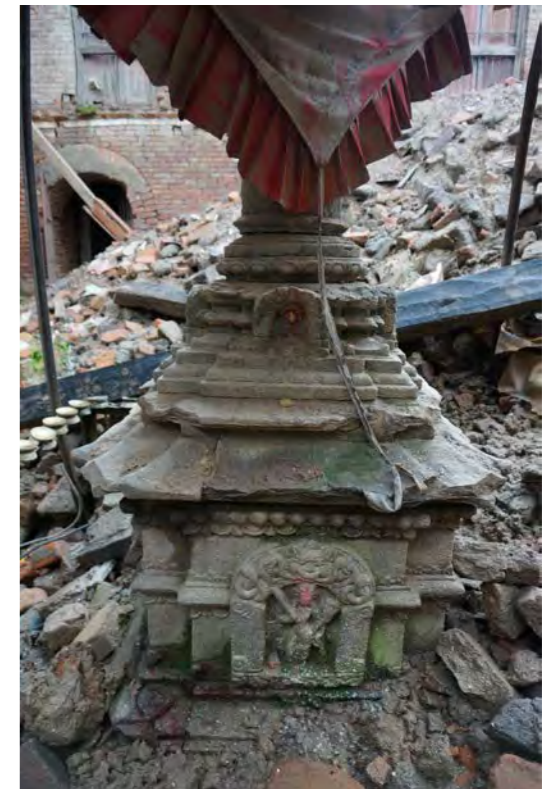
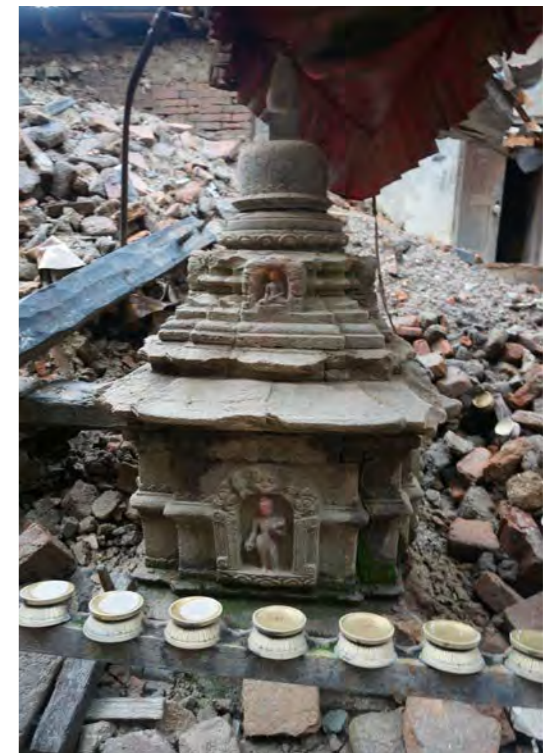
F-04 CHAITYA

NUMBER	NAME	ESTABLISHED DATE (A.D.)	TYPOLOGY	GENERAL DESCRIPTION	PROBLEMS DESCRIPTION	DANGER/ DESTROY
F-04			Chaitya	Stone made chaitya	Roof collaped Chaitya under debris Needs maintainance

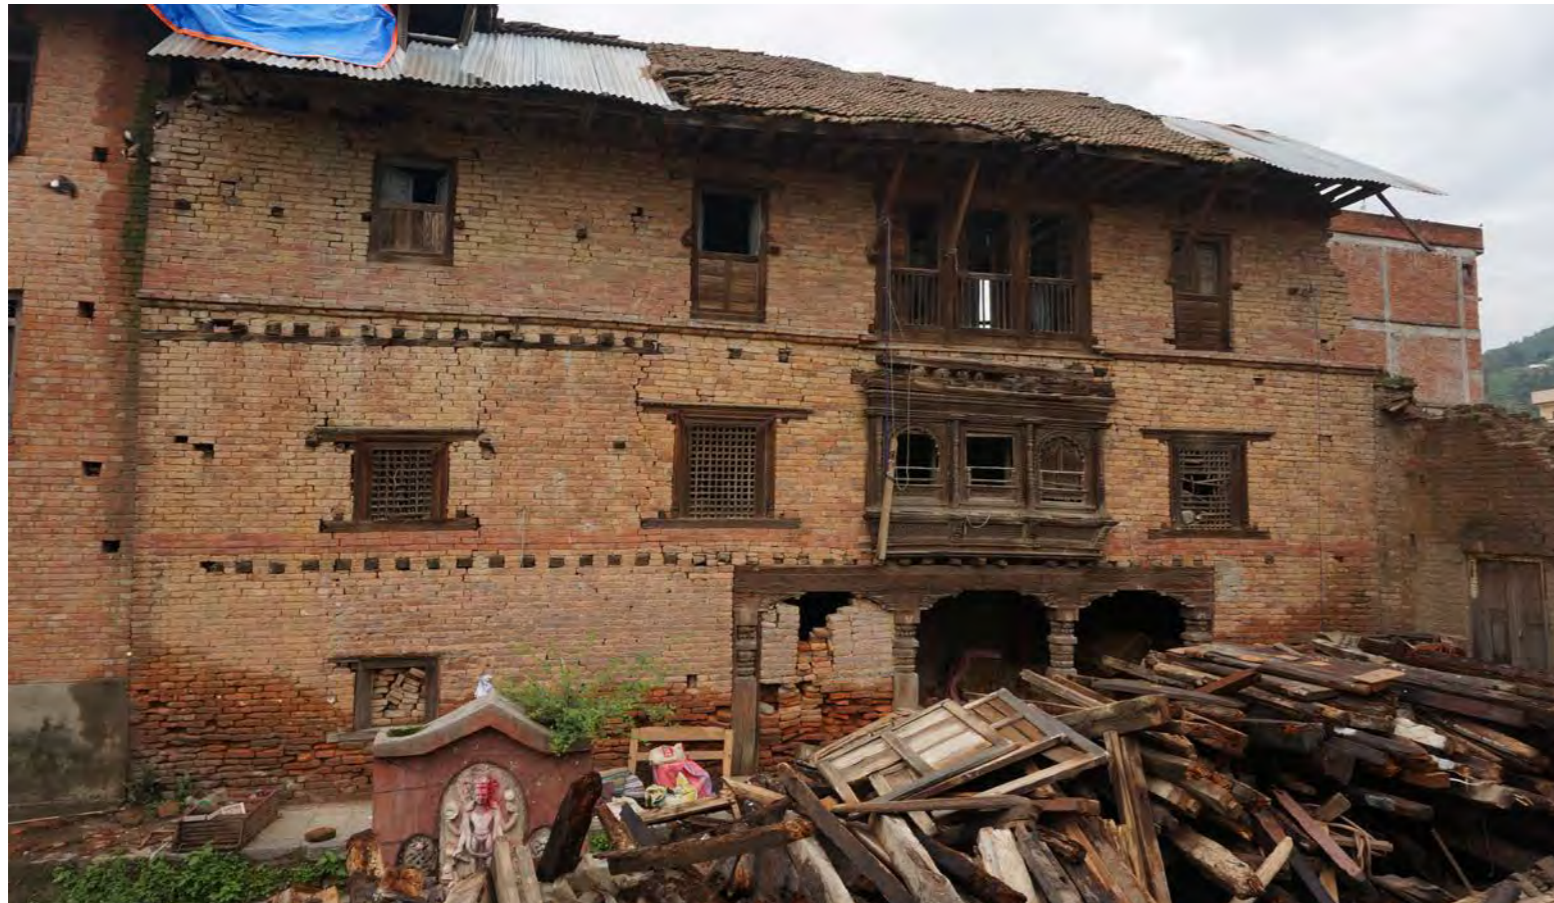
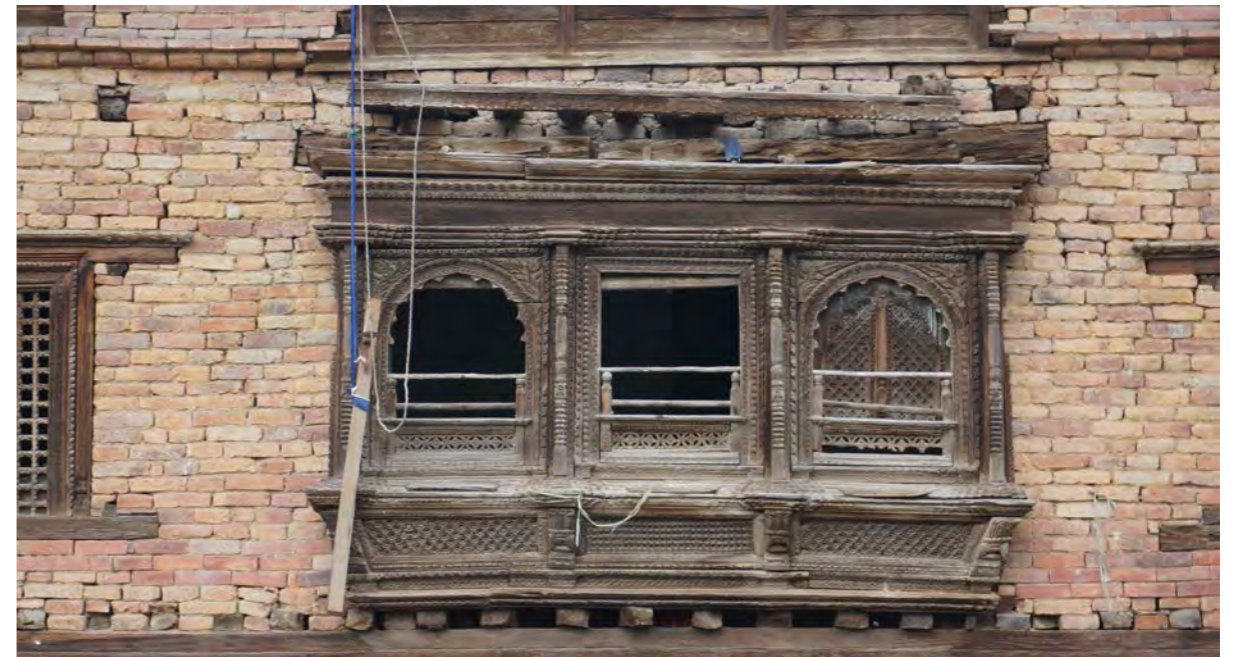
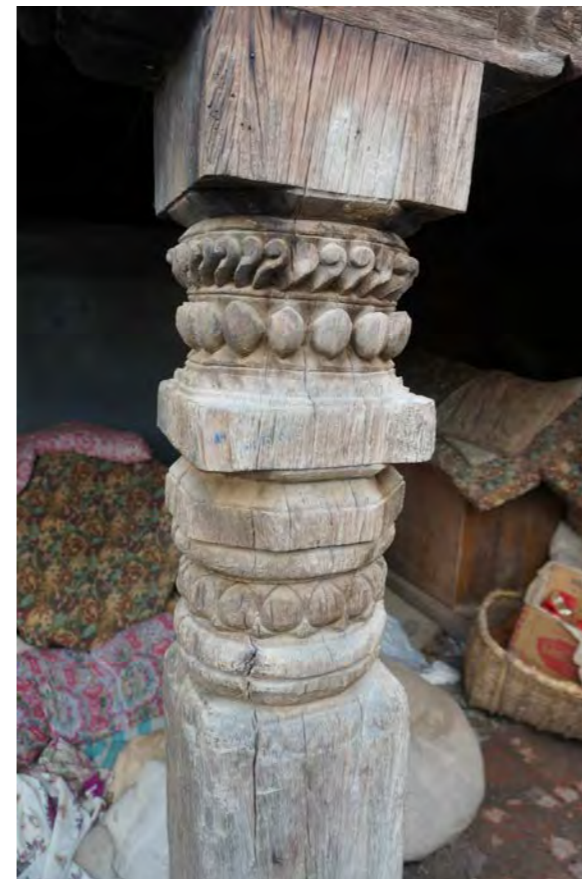
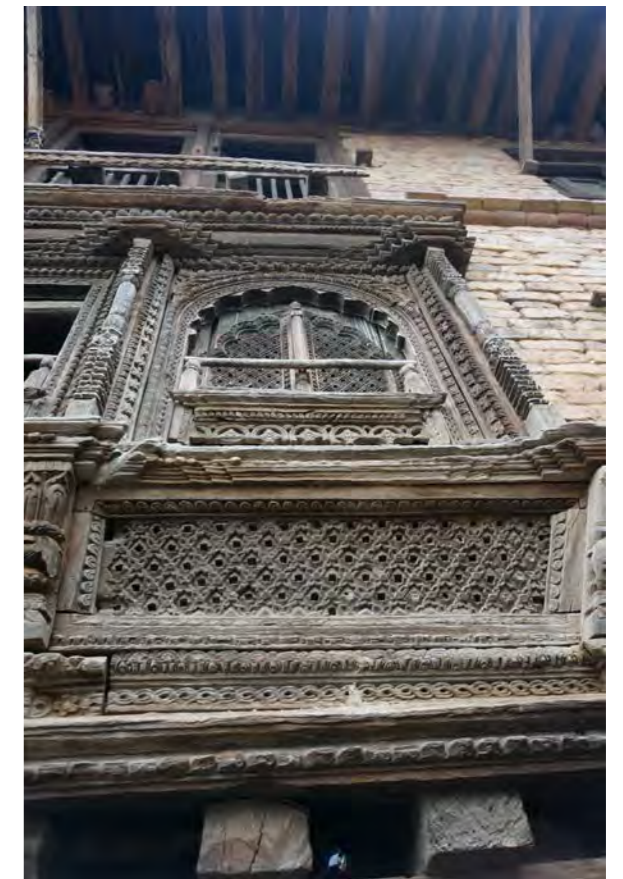
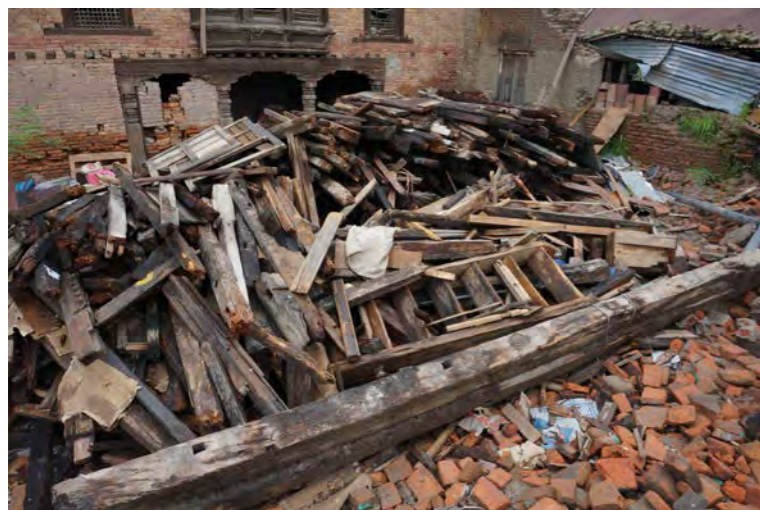
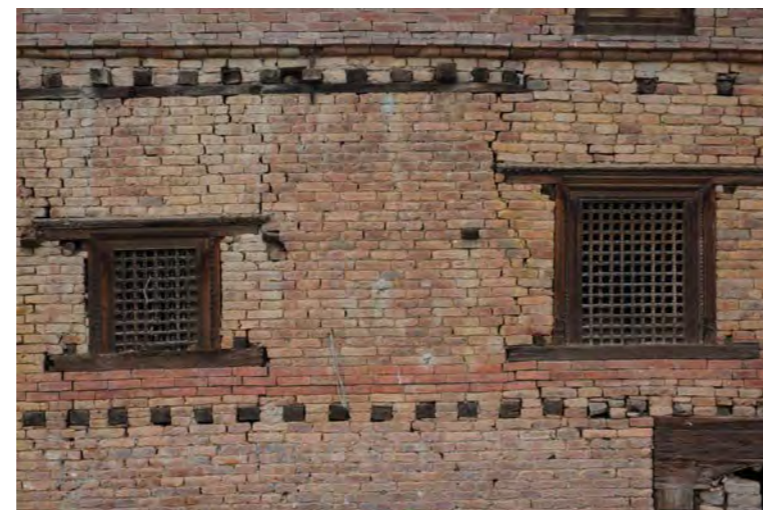
F-05 DYO CHHEN

NUMBER	NAME	DATE A.D.	TYPOLOGY	GENERAL DESCRIPTION	PROBLEMS DESCRIPTION	DANGER/ DESTROY
F-05	Balampuli Dya Chen		Dyo Chhen	G+2 Uncooked and cooked brick structure	Roof needs reconstruction Vertical and diagonal cracks in all facade	W!
