2015 Earthquake Damage Mapping

Sankhu

October 2015

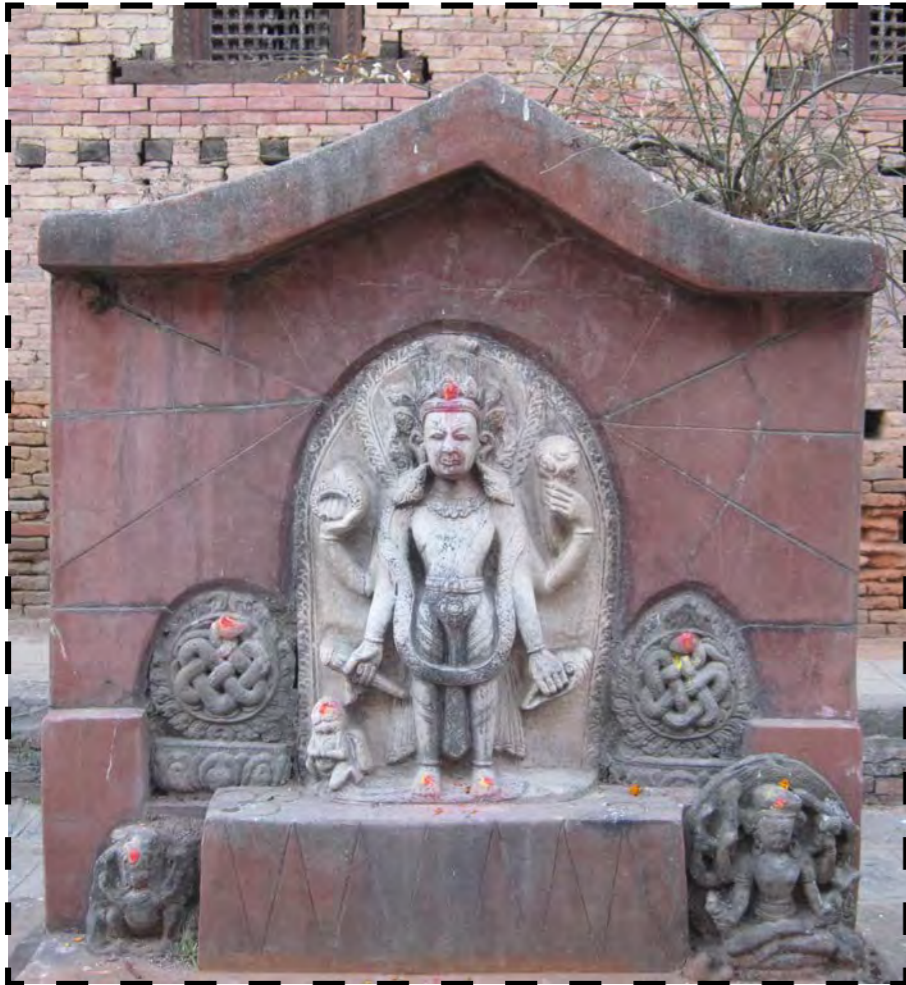
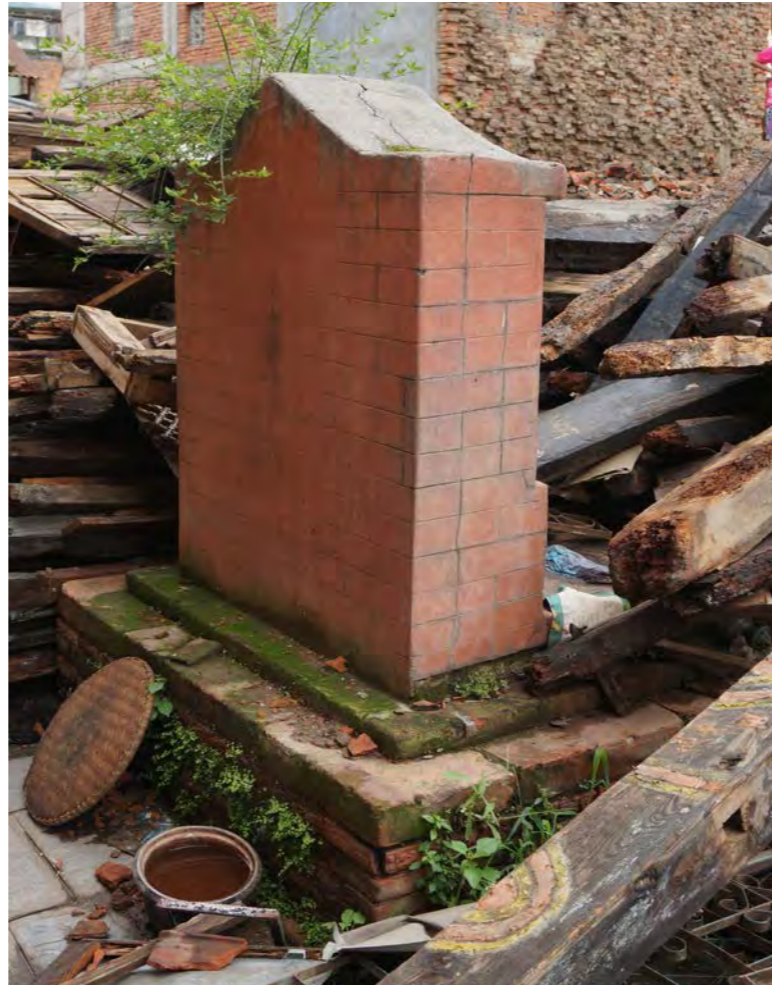
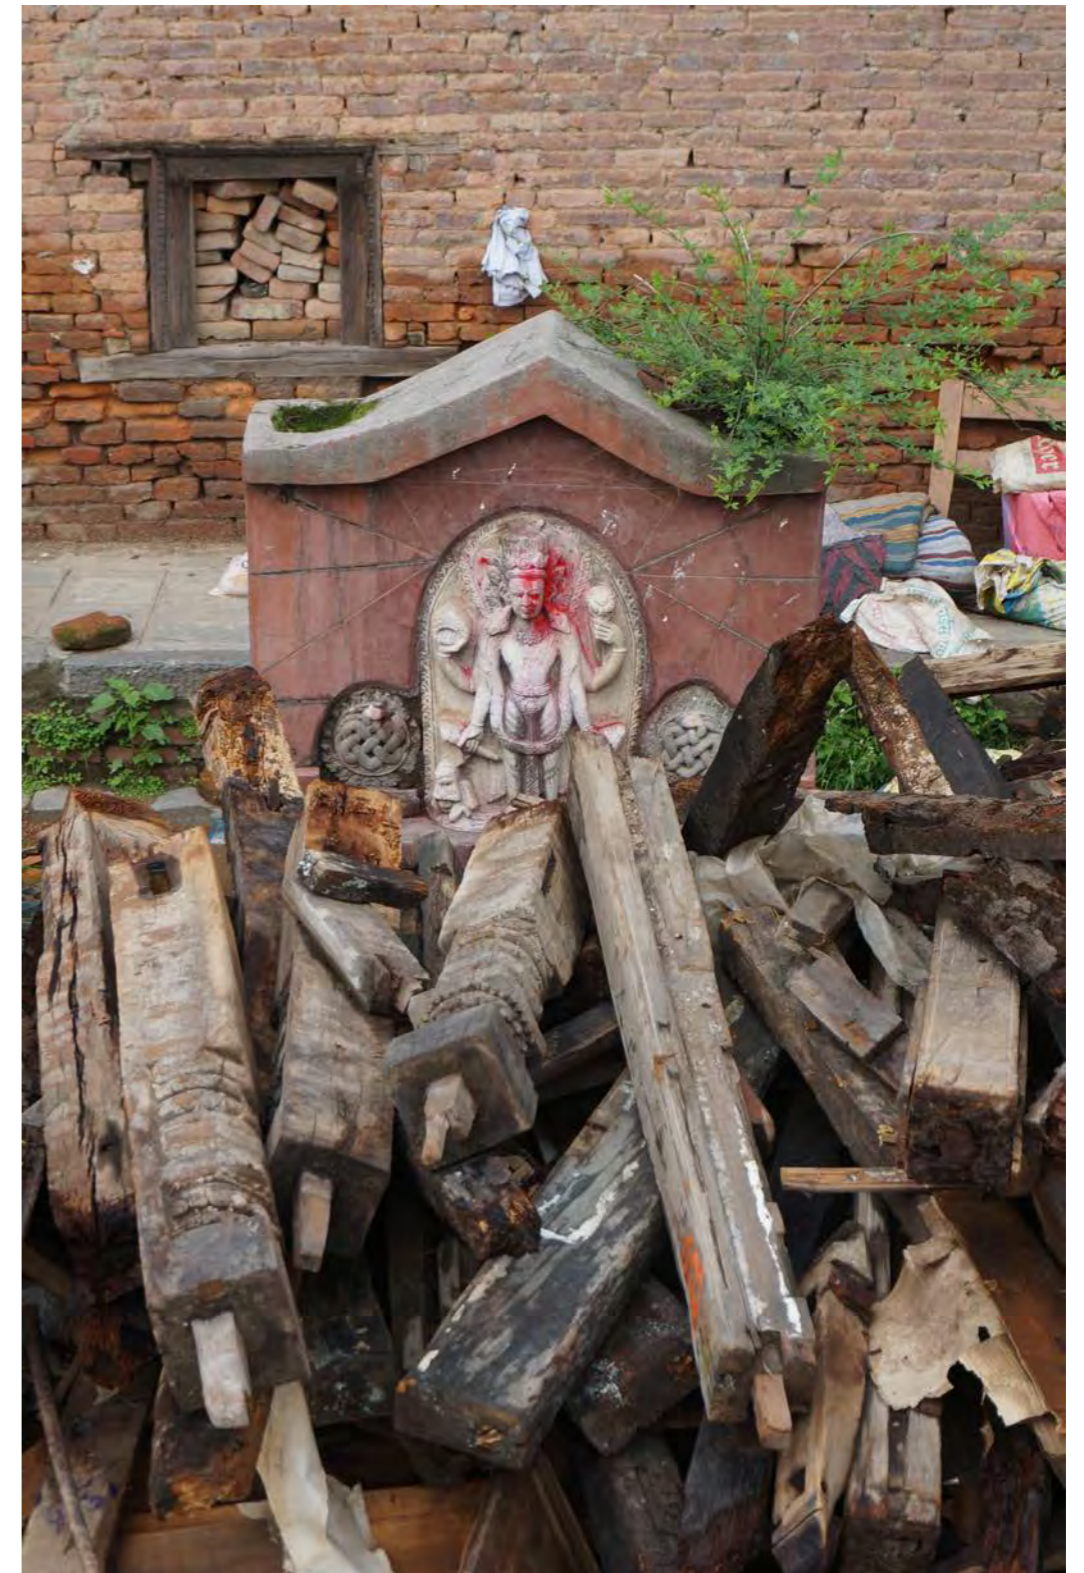
F-07 NARAYAN SHRINE

NUMBER	NAME	ESTABLISHED DATE (A.D.)	TYPOLOGY	GENERAL DESCRIPTION	PROBLEMS DESCRIPTION	DANGER/ DESTROY
F-07	Narayan Shrine		Narayan		Structure under piled up wooden joist and artefacts from Balampuli house

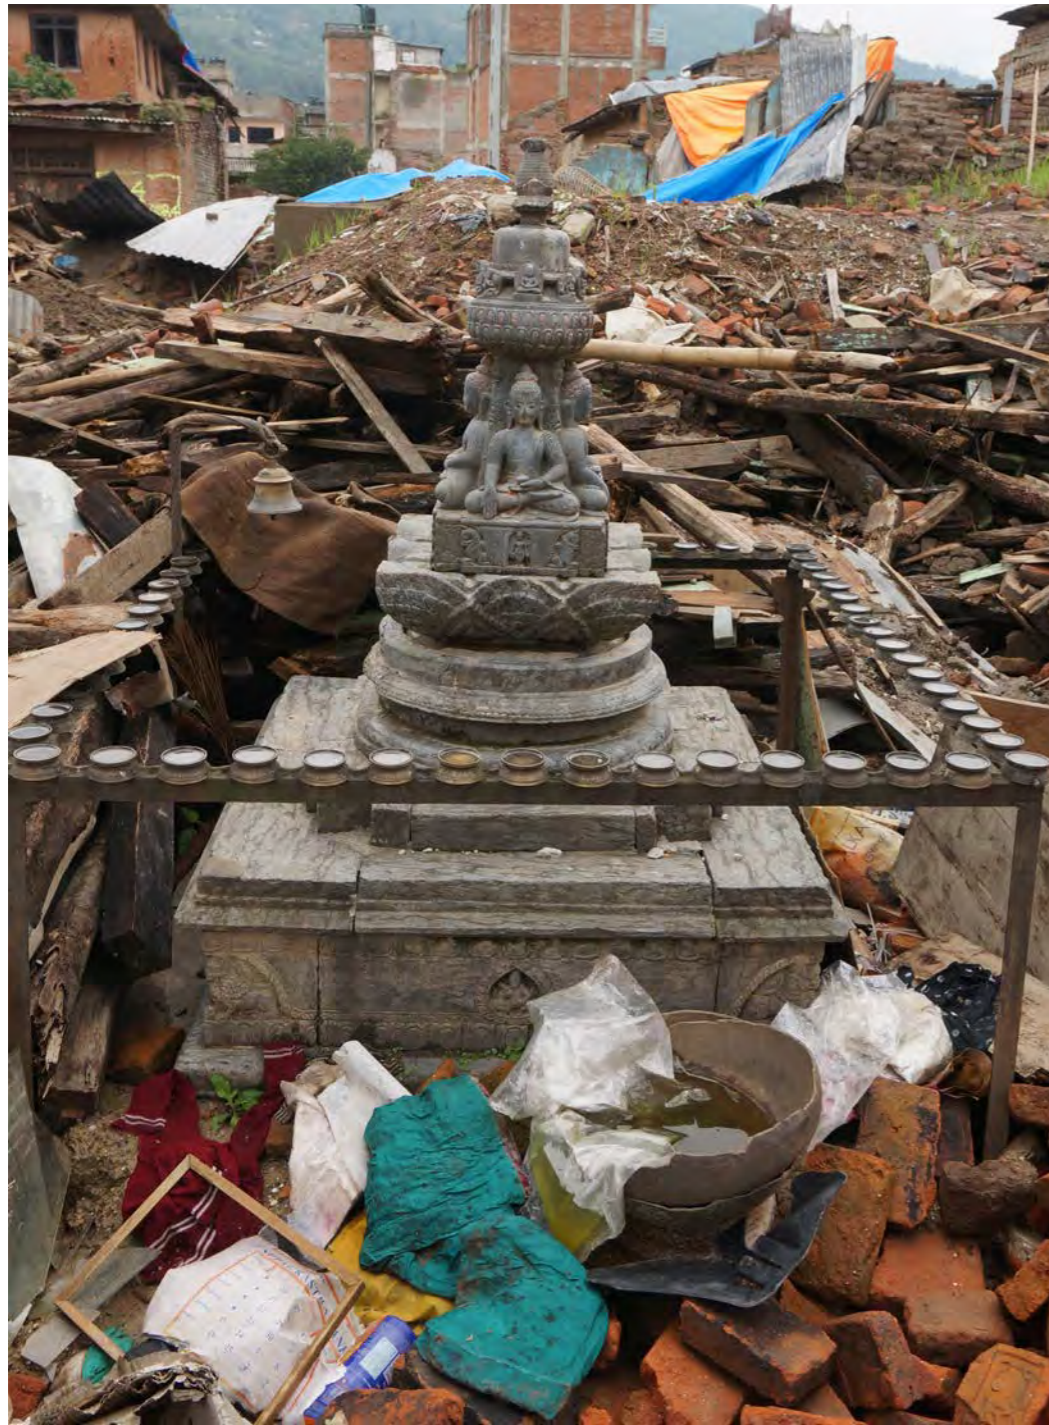
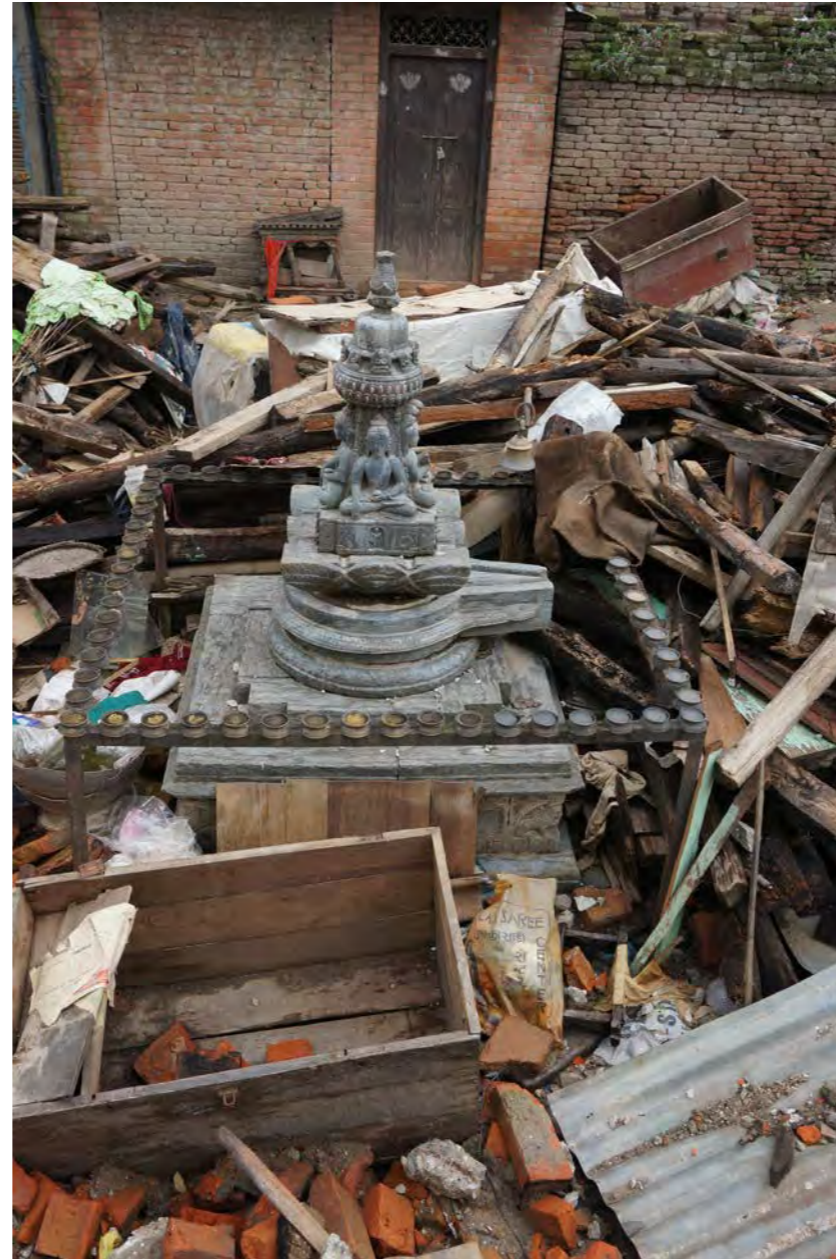
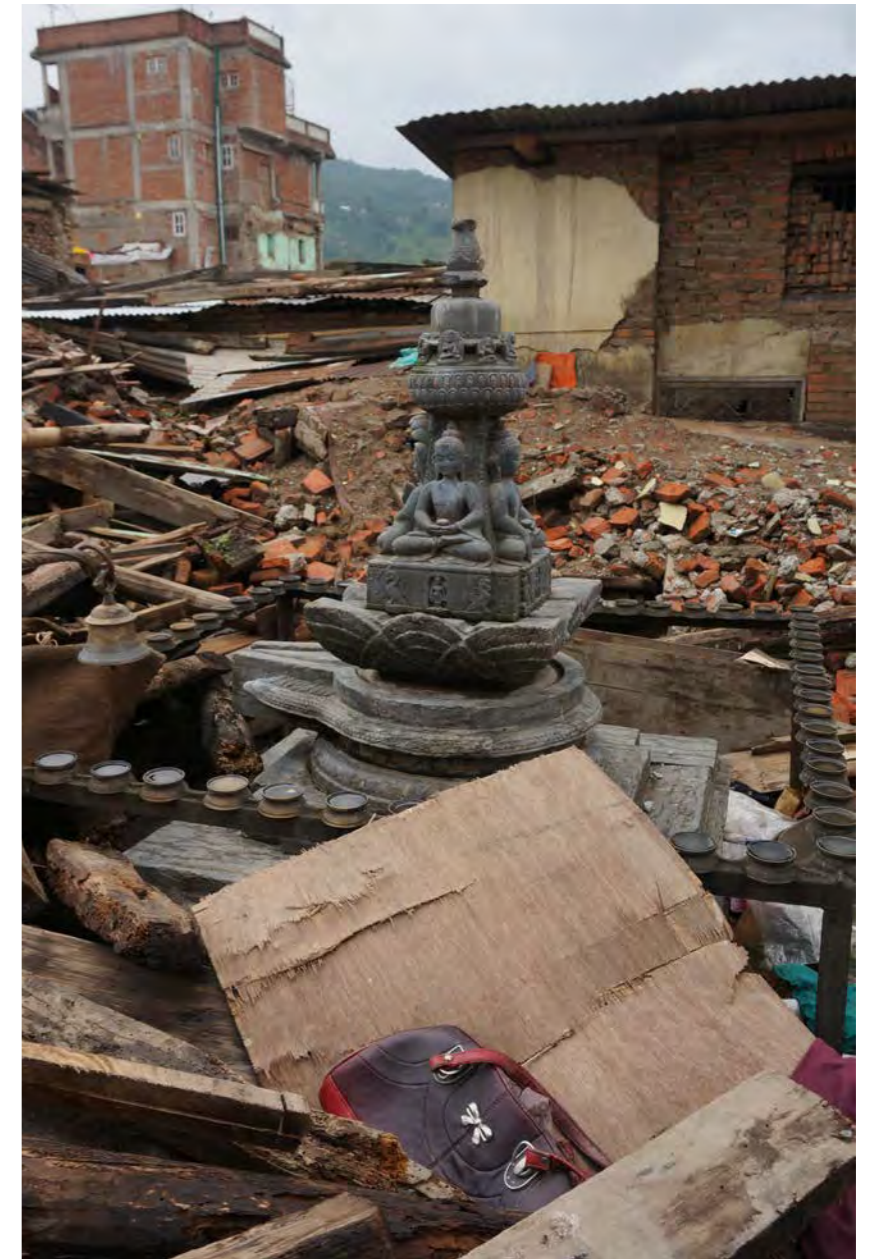
F-08 CHAITYA

NUMBER	NAME	DATE A.D.	TPOLOGY	GENERAL DESCRIPTION	PROBLEMS DESCRIPTION	DANGER/ DESTROY
F-08			Chaitya	Stone made chaitya	Under debris Needs debris clearance and maintainance

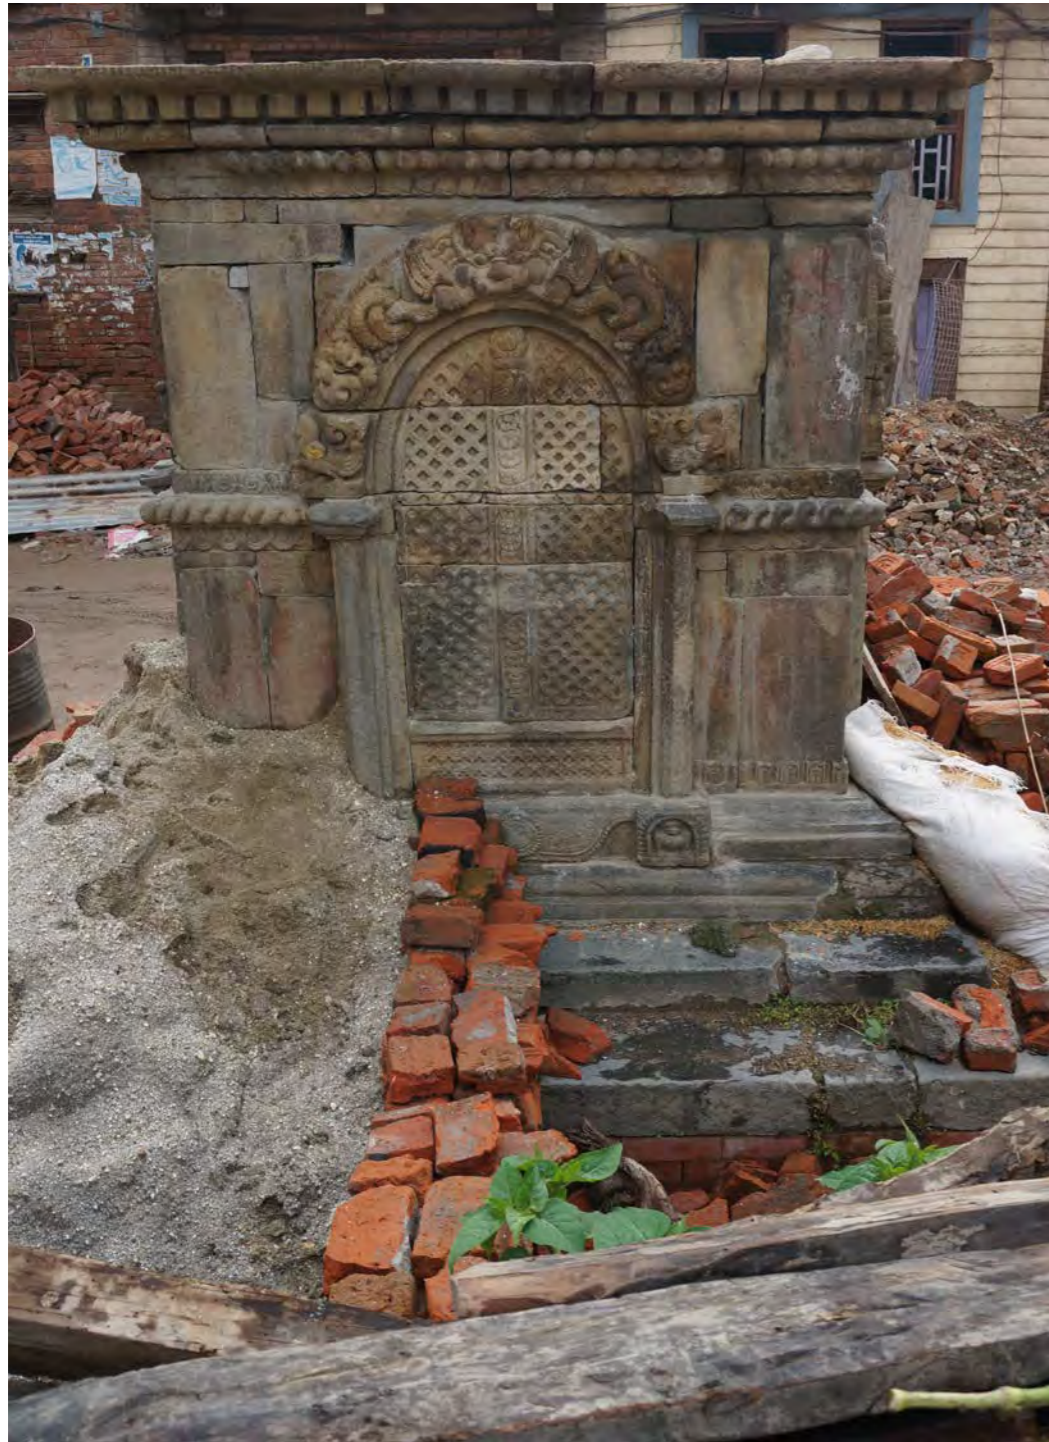
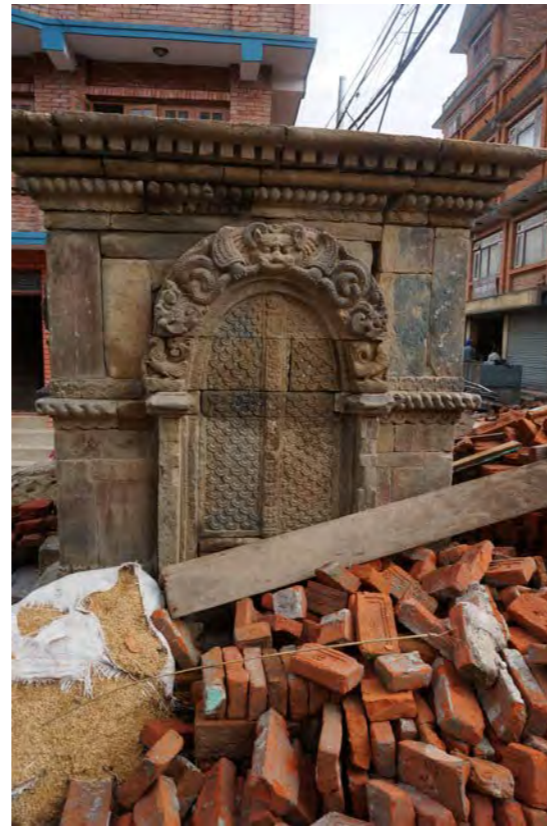
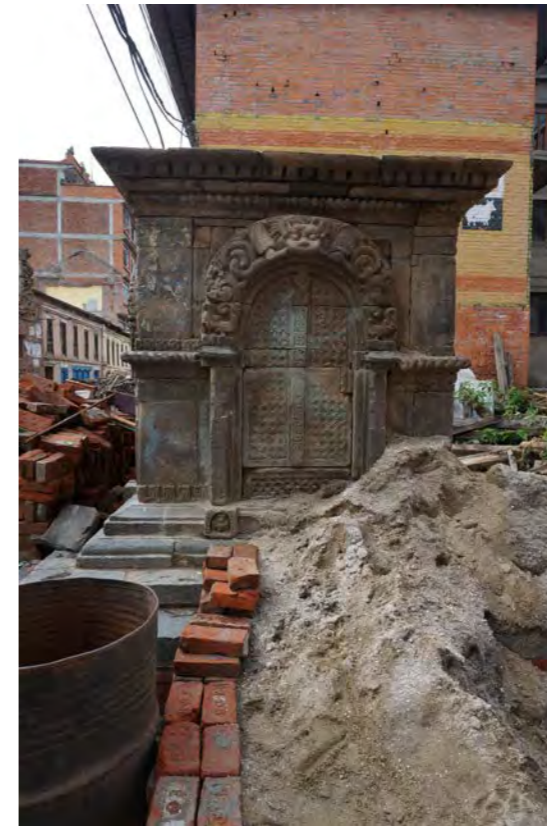
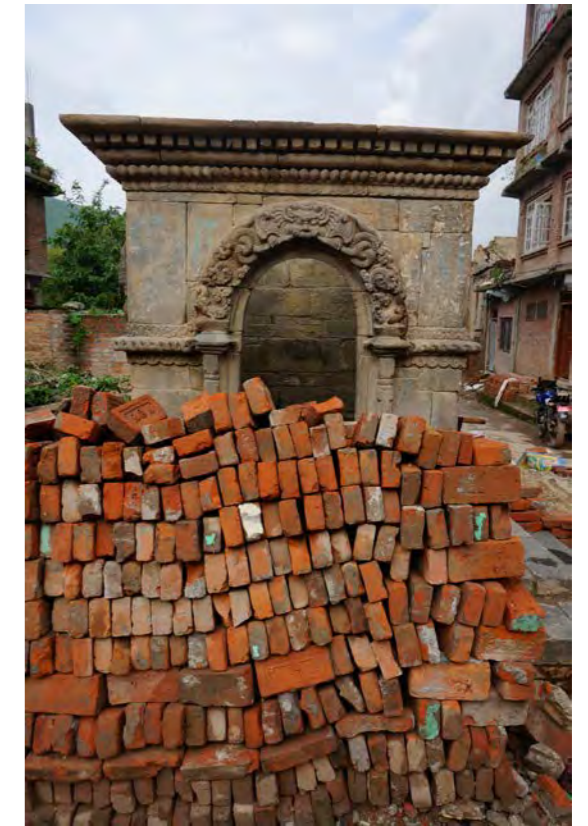
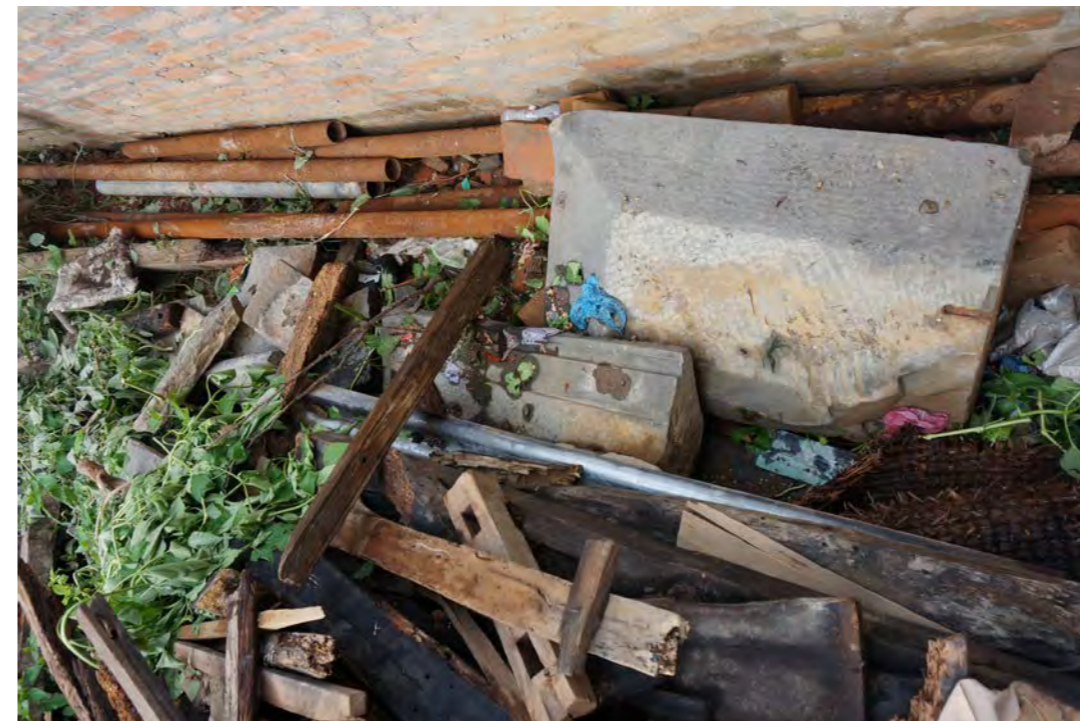
G-01 NARAYAN MANDIR

NUMBER	NAME	ESTABLISHED DATE (A.D.)	TYPOLOGY	GENERAL DESCRIPTION	PROBLEMS DESCRIPTION	DANGER/ DESTROY
G-01	Narayan Mandir		Enclosed Shrine	Under construction temple	Roof needs to be installed Statue of Narayan already stolen before Earthquake

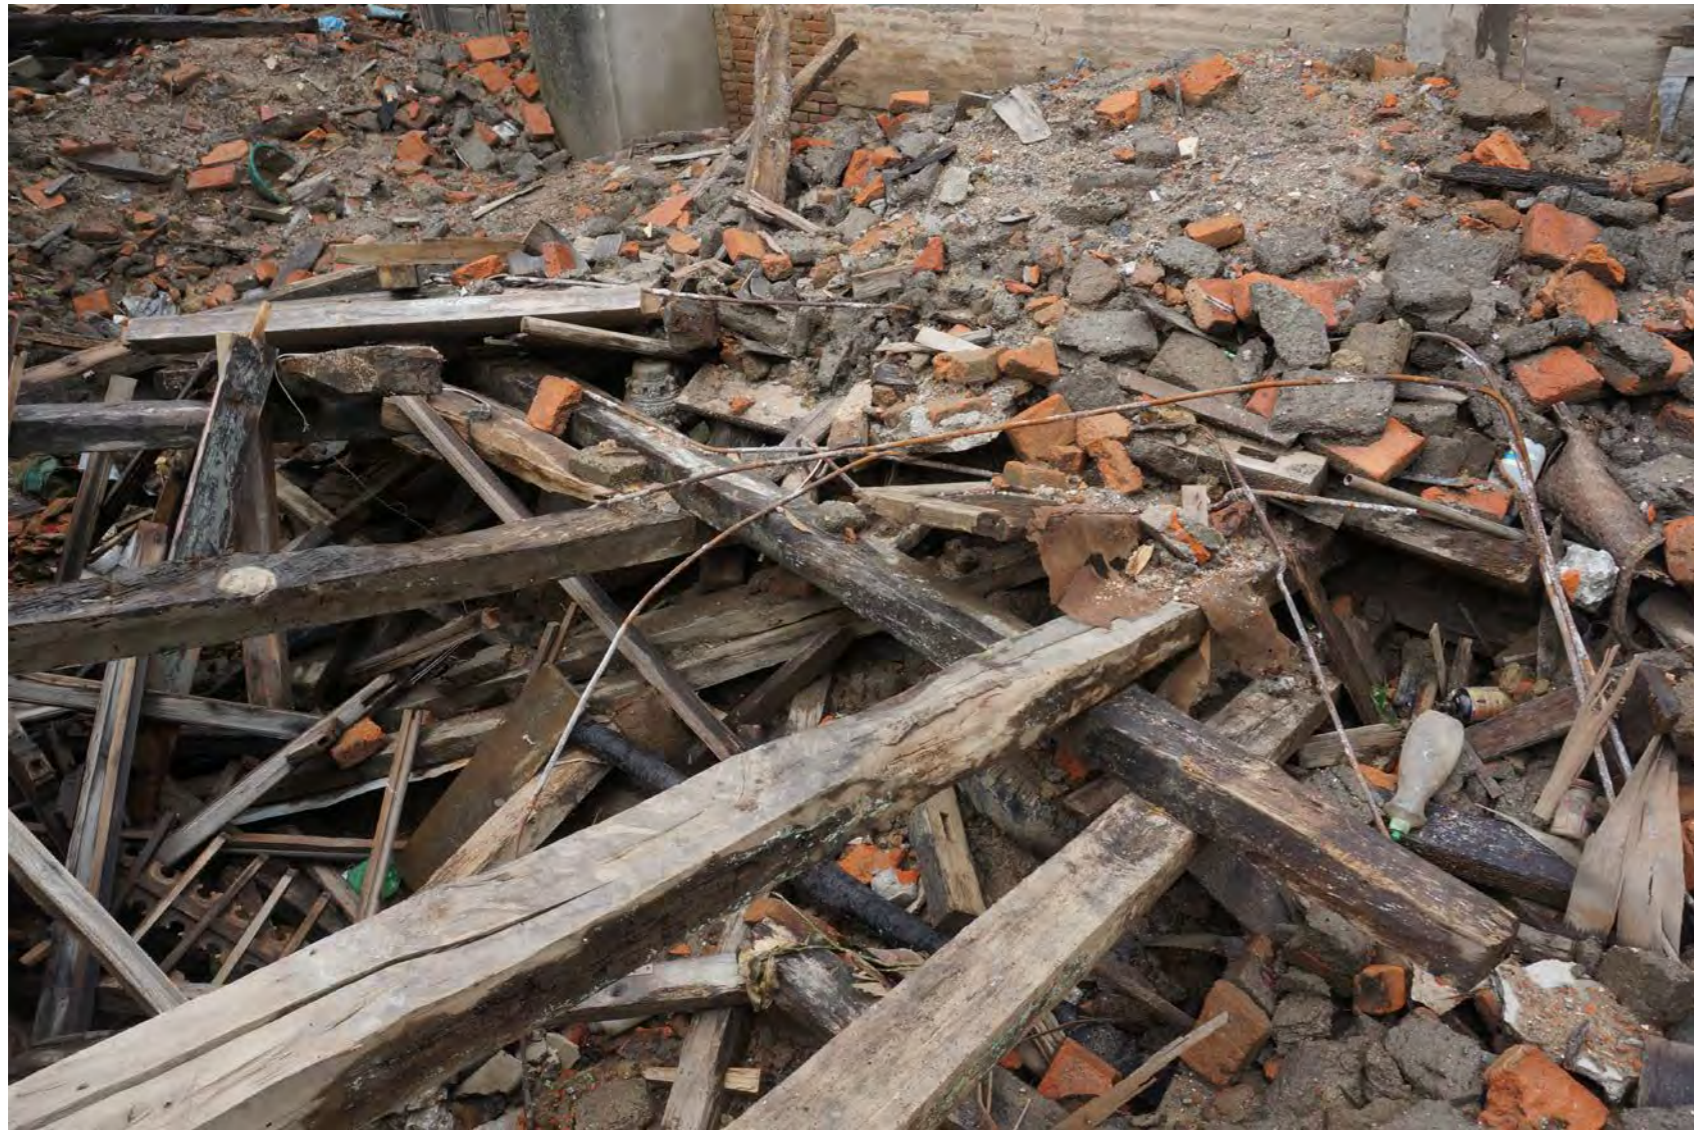
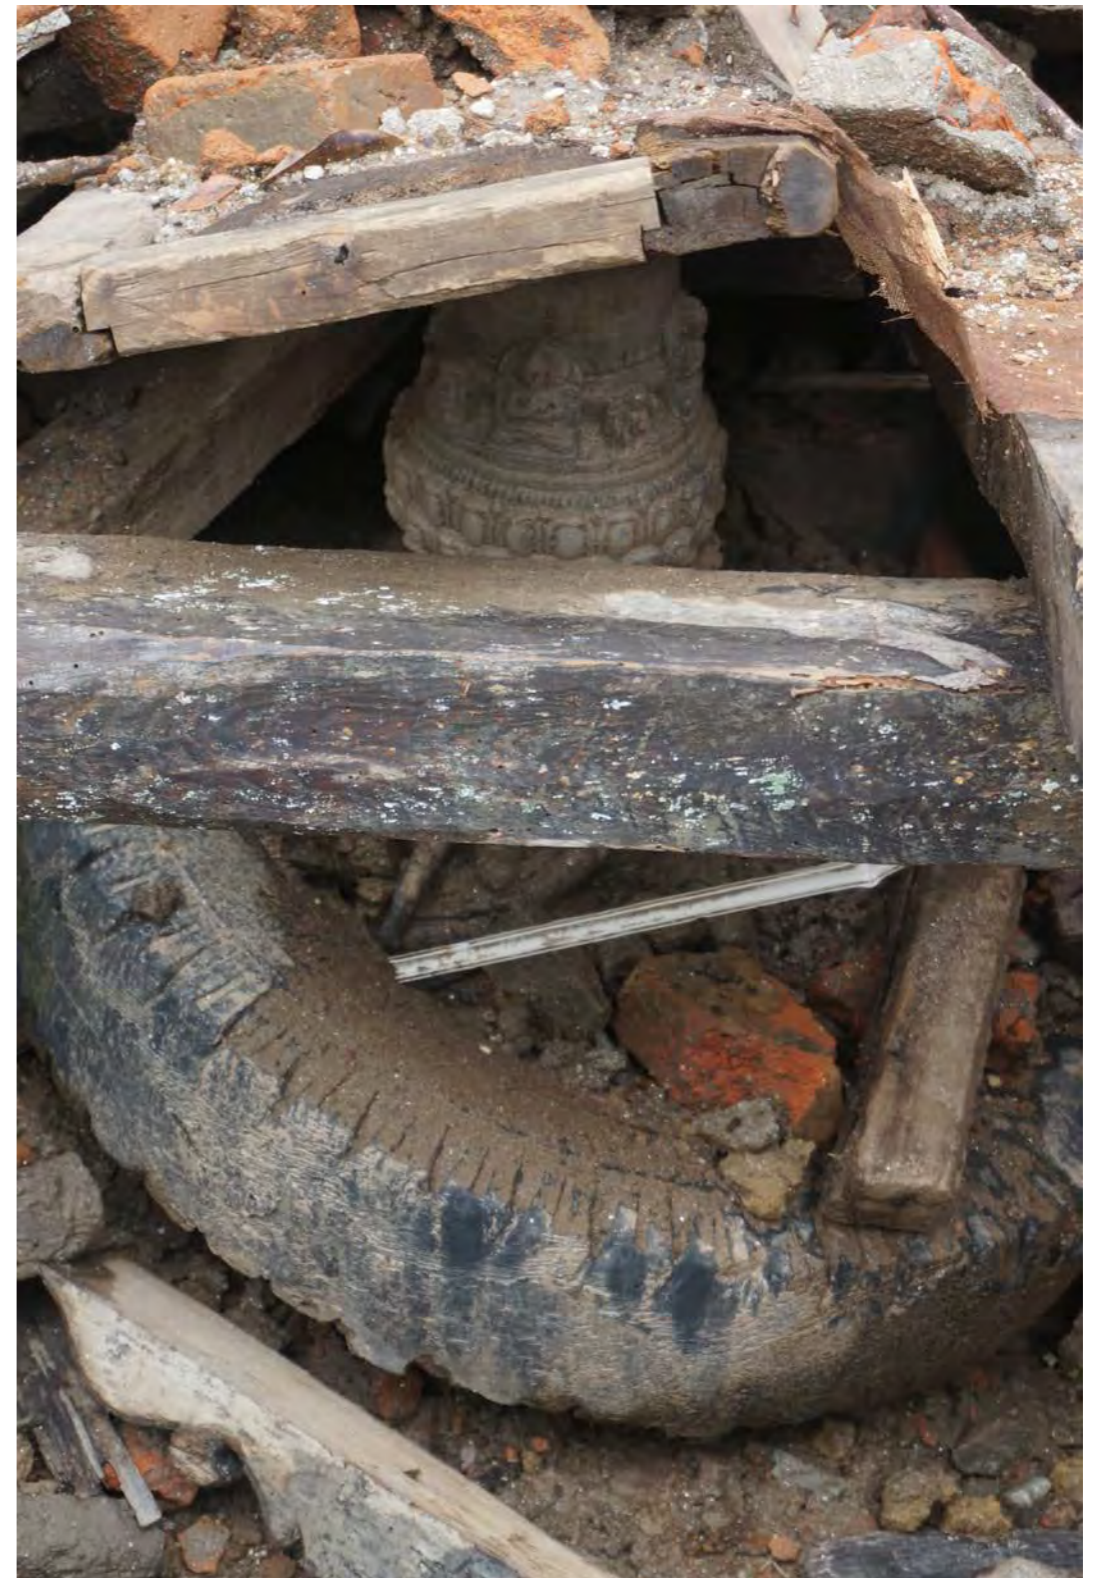
G-03 CHAITYA

NUMBER	NAME	DATE A.D.	TPOLOGY	GENERAL DESCRIPTION	PROBLEMS DESCRIPTION	DANGER/ DESTROY
G-03			Chaityas	Stone made Chaitya	Not clearly visible All under debris Needs immediate removal of debris and maintainance

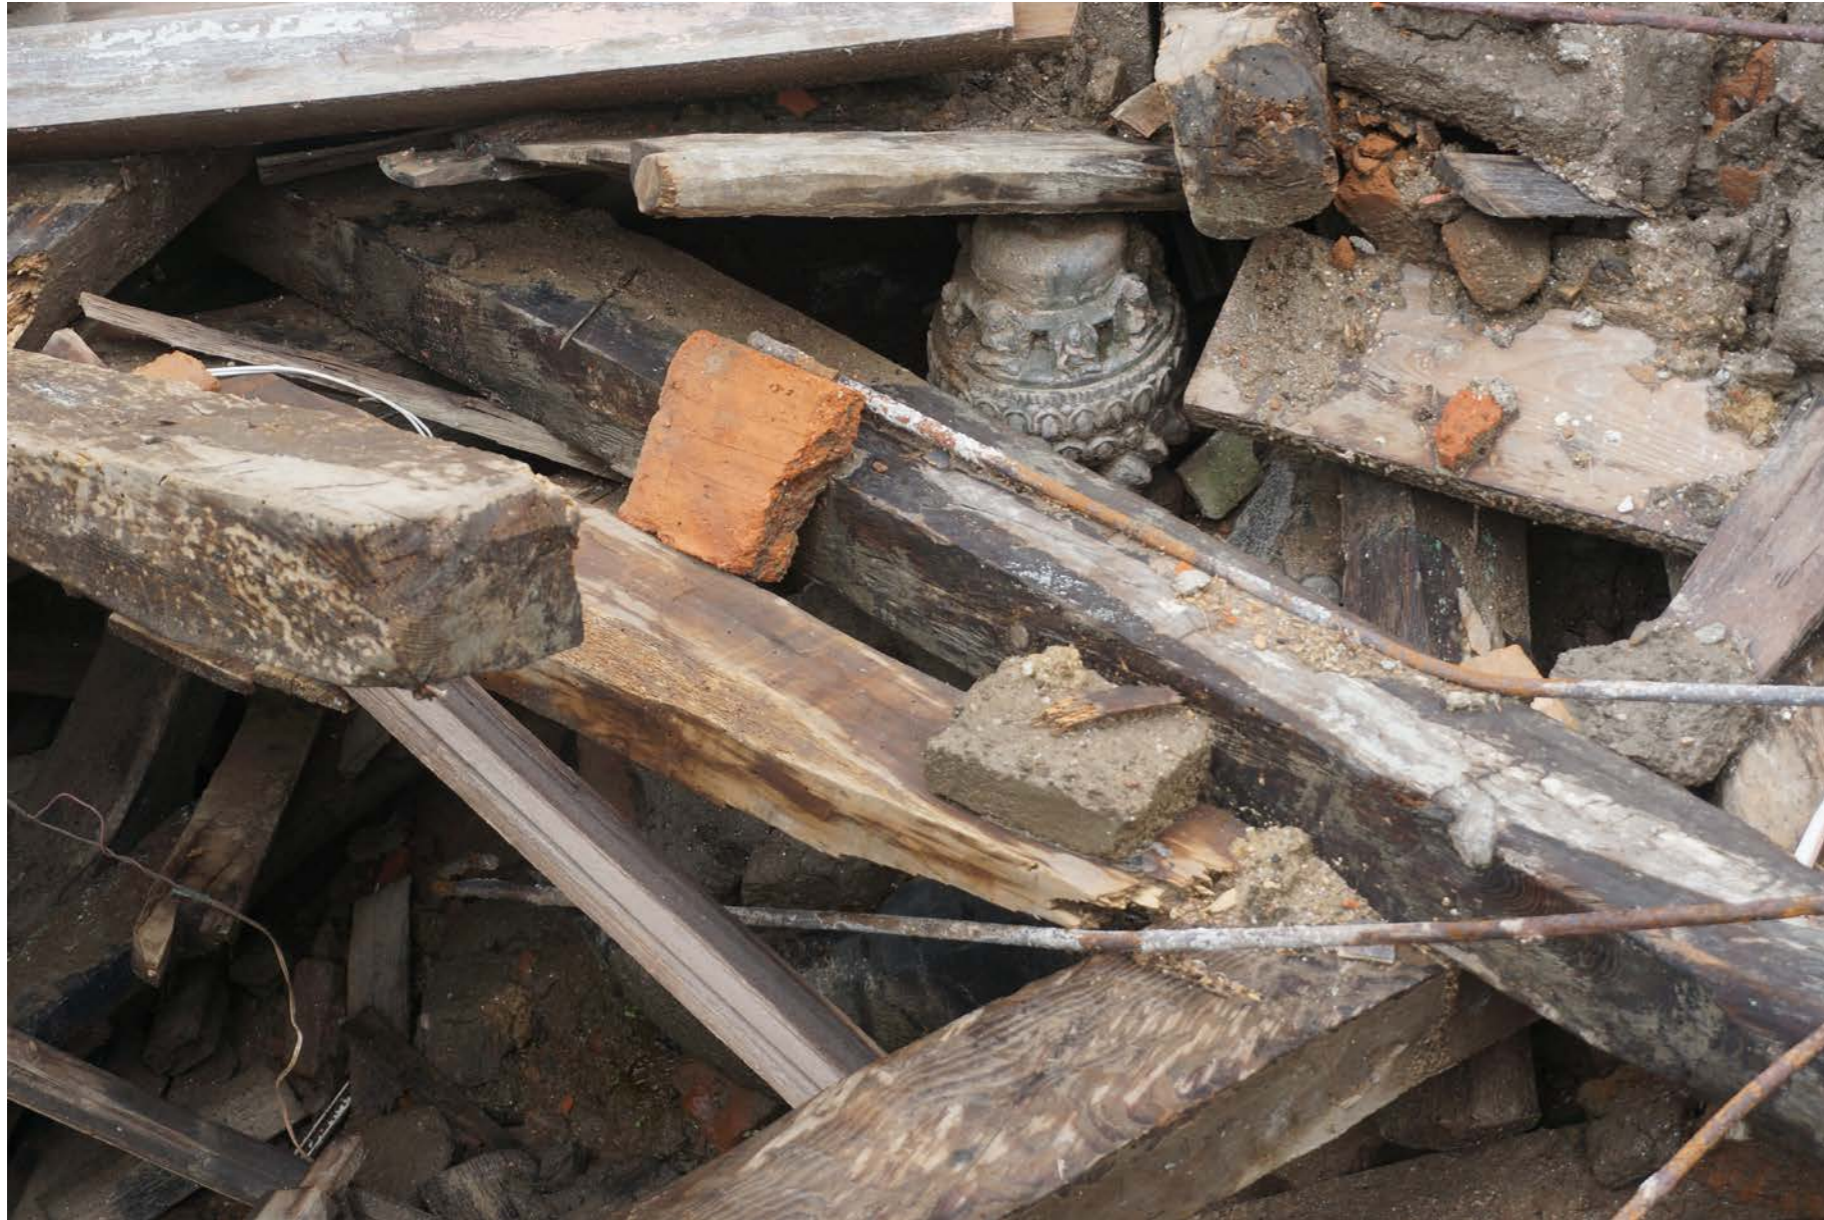
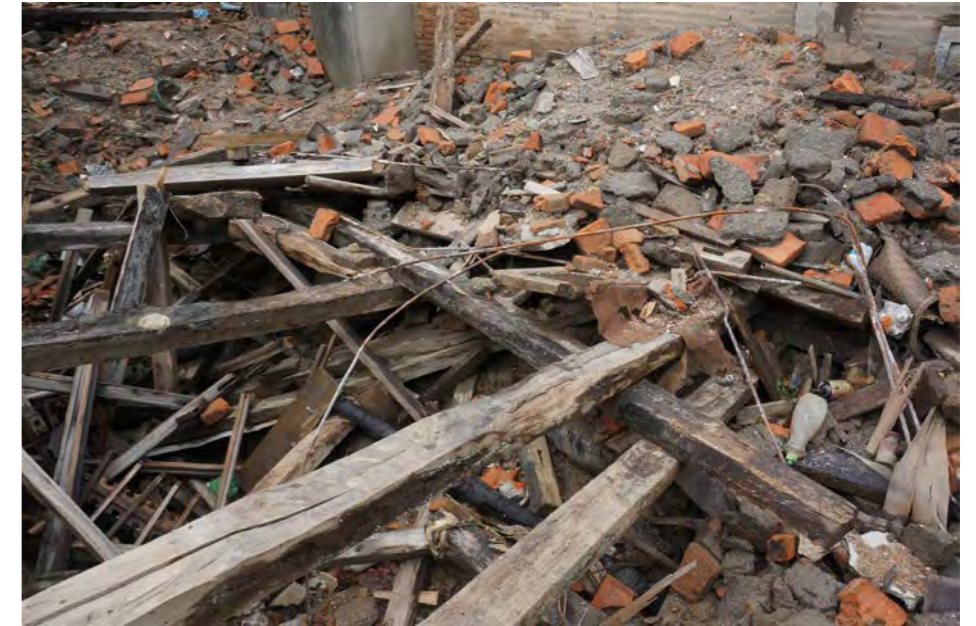
G-04 CHAITYA

NUMBER	NAME	ESTABLISHED DATE (A.D.)	TYPOLOGY	GENERAL DESCRIPTION	PROBLEMS DESCRIPTION	DANGER/ DESTROY
G-04			Chaitya	Stone made Chaitya	Not clearly visible All under debris Needs immediate removal of debris and maintainance

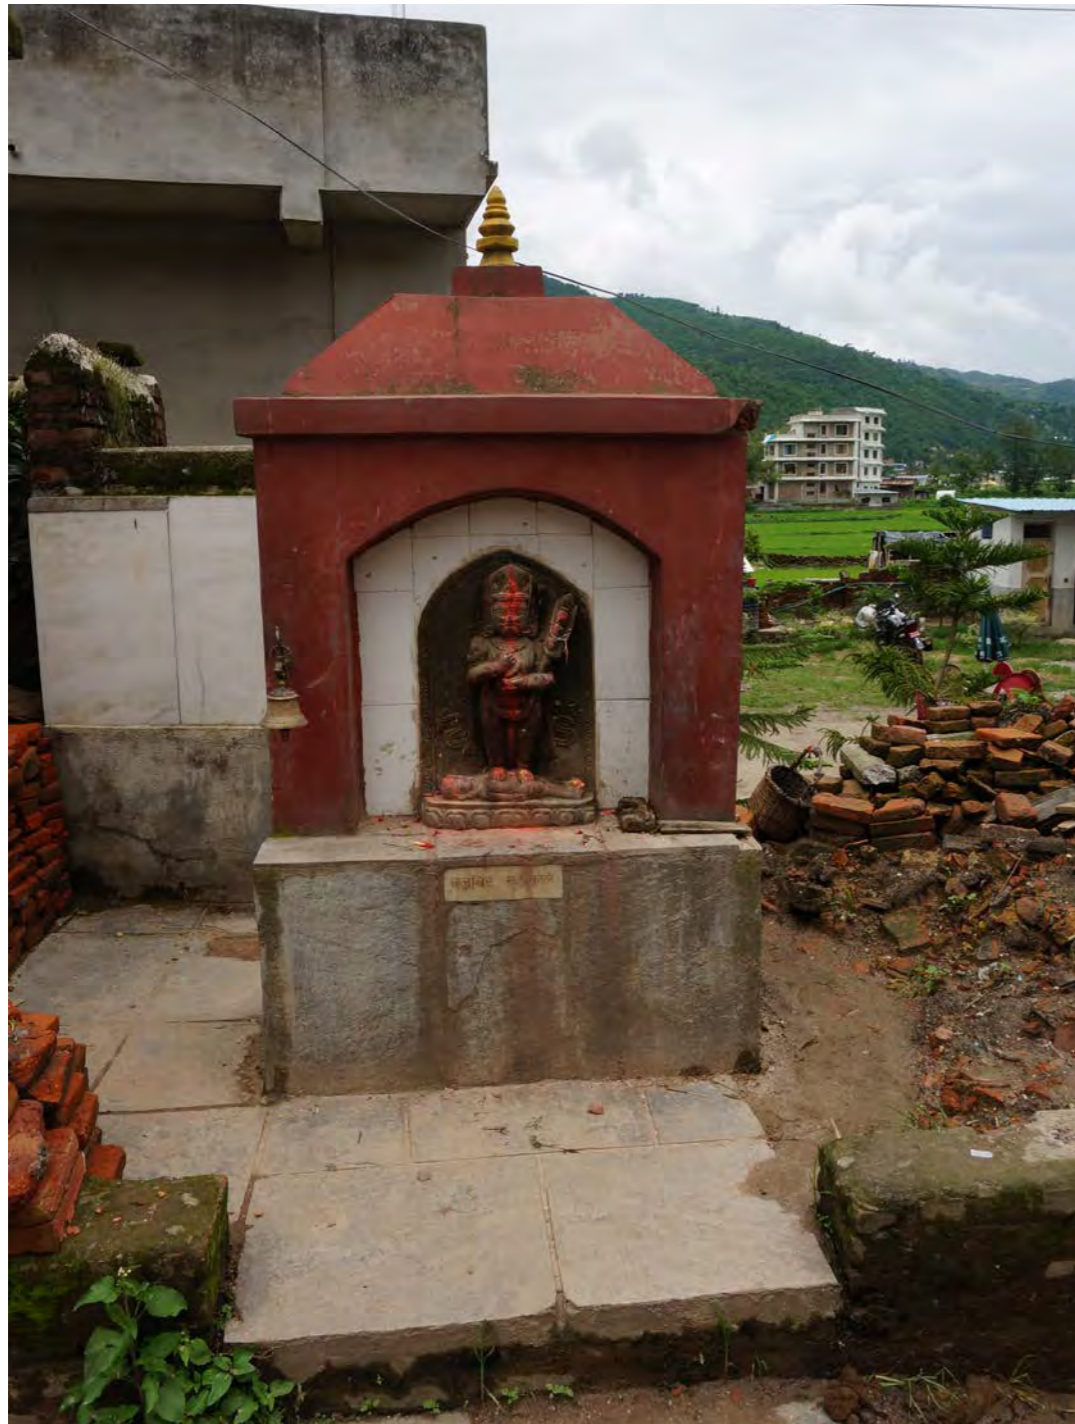
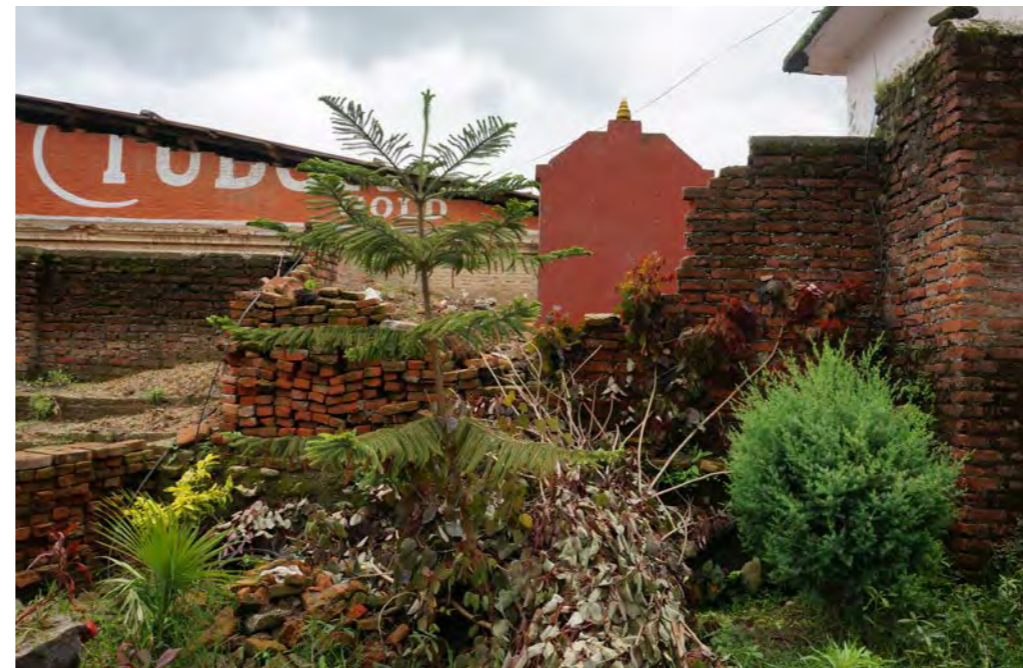
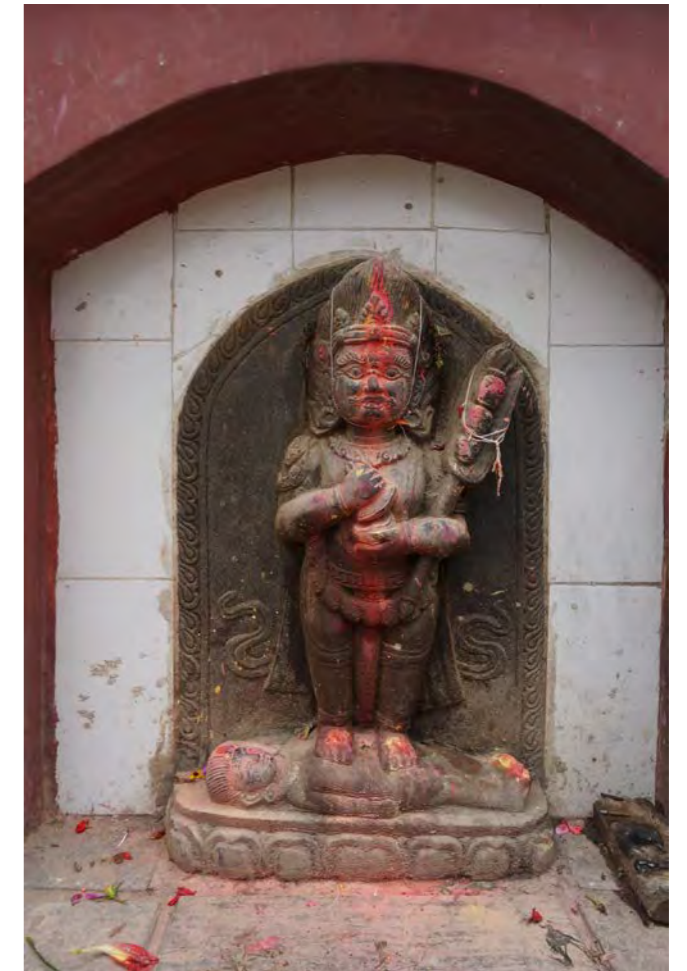
H-03 BAJRABIR MAHAKAL

NUMBER	NAME	DATE A.D.	TPOLOGY	GENERAL DESCRIPTION	PROBLEMS DESCRIPTION	DANGER/ DESTROY
H-03	Bajrabir Mahankaal		Open Shrine		No major damages
