2015 Earthquake Damage Mapping

Sankhu

October 2015

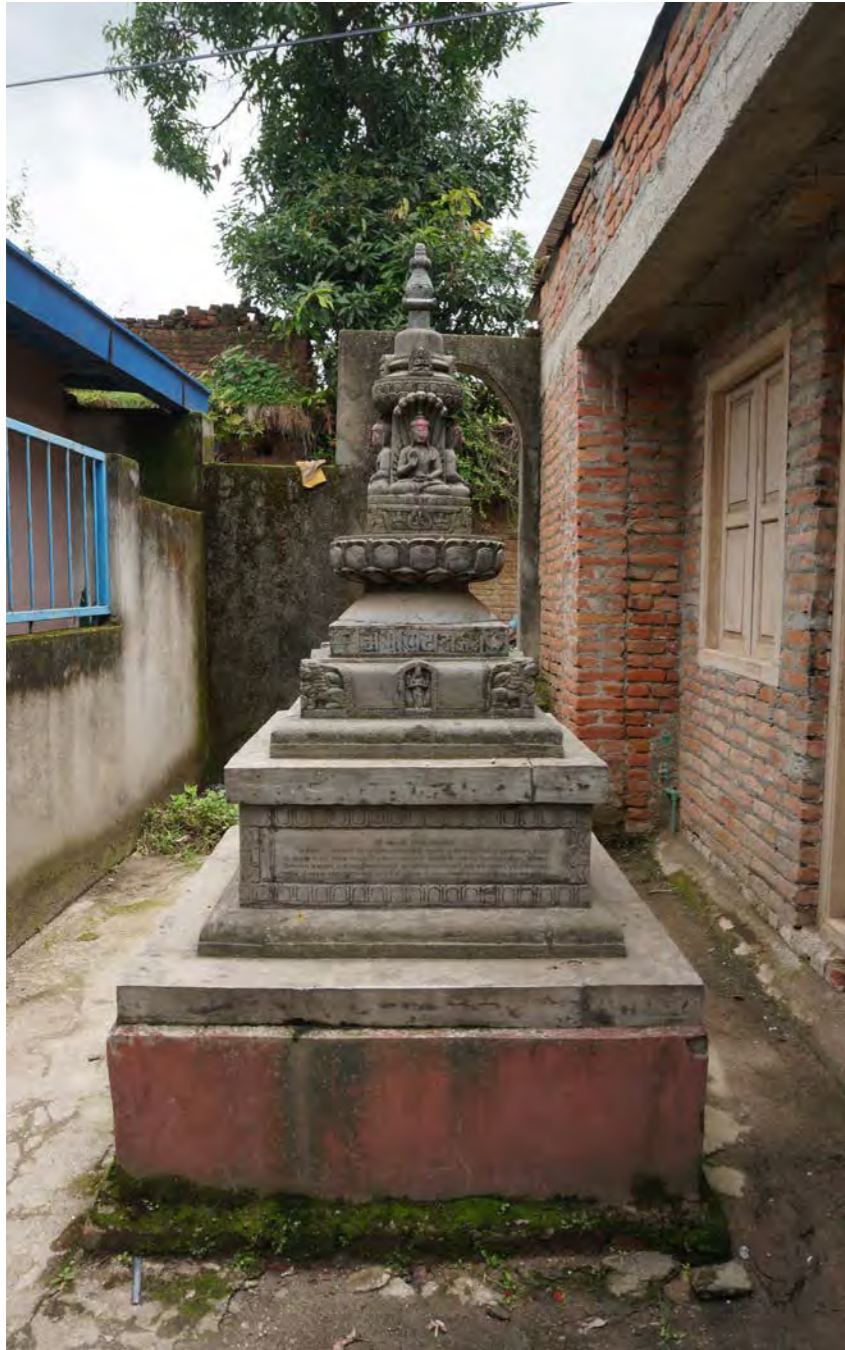
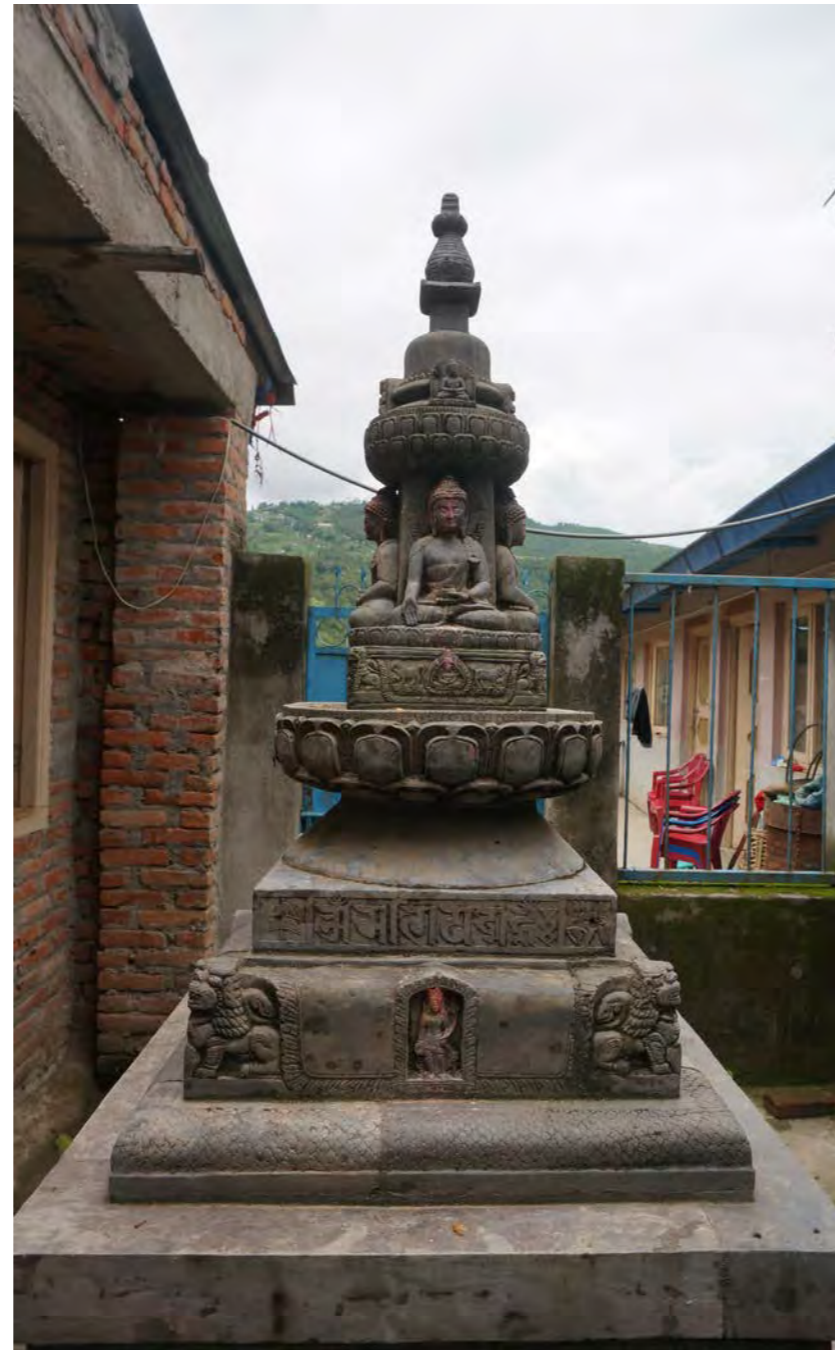
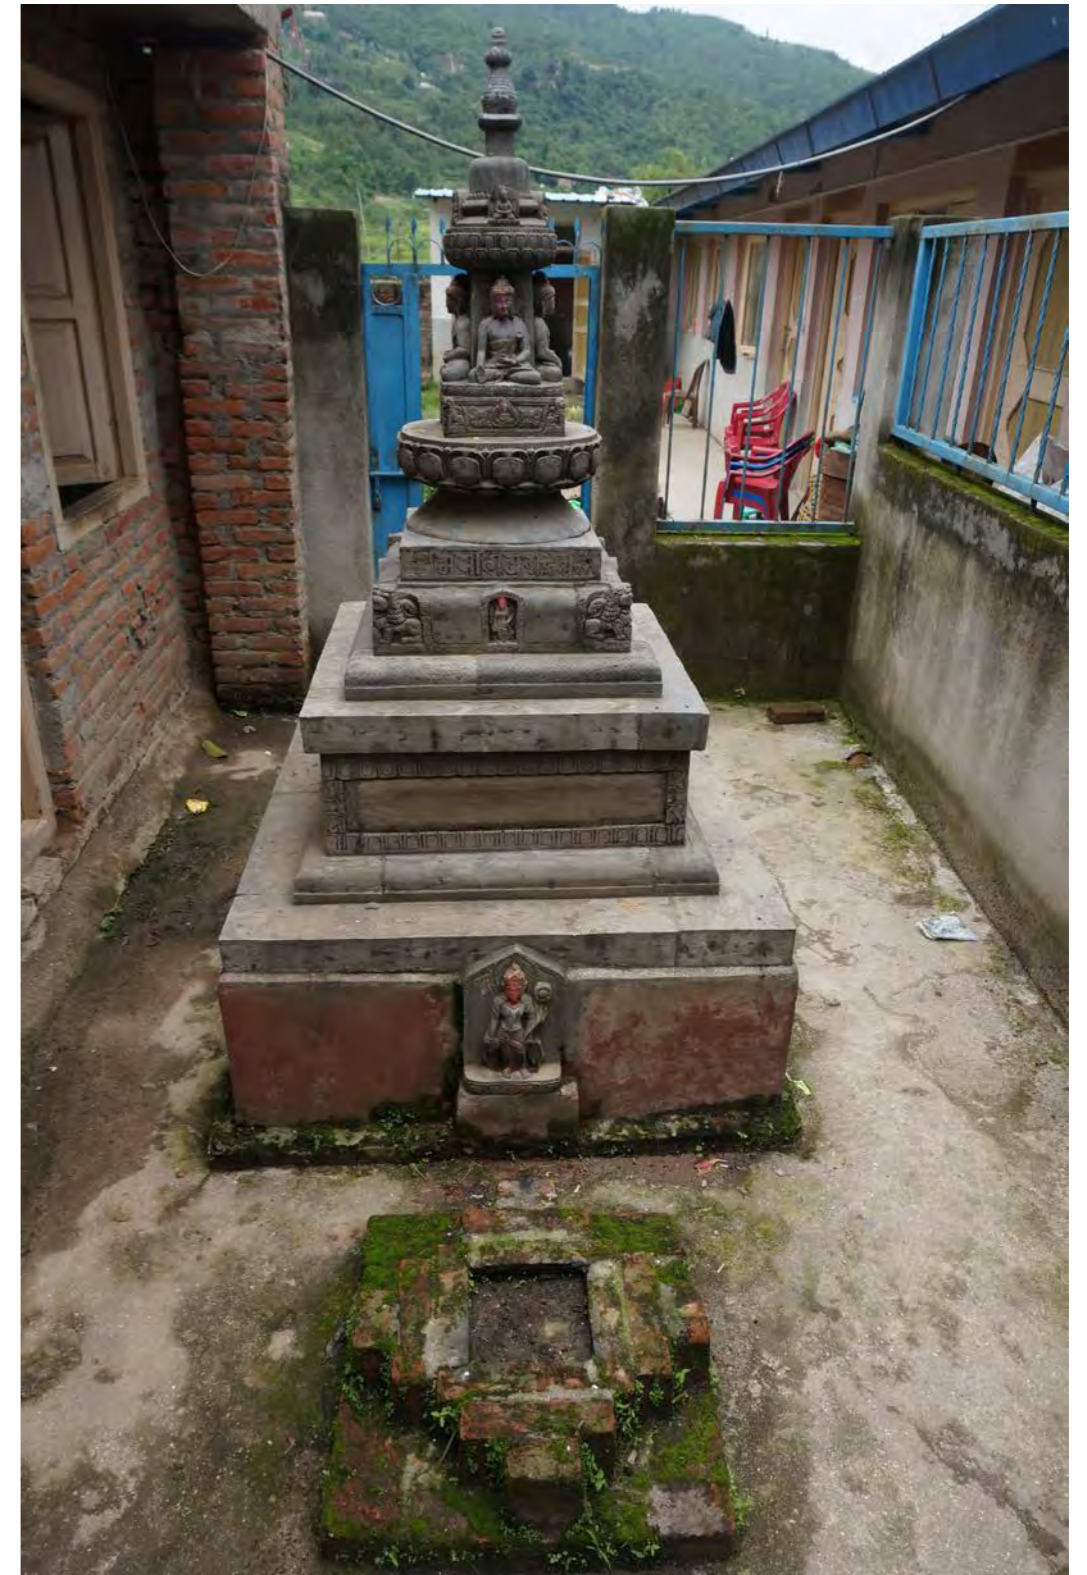
H-04 CHAITYA

NUMBER	NAME	ESTABLISHED DATE (A.D.)	TYPOLOGY	GENERAL DESCRIPTION	PROBLEMS DESCRIPTION	DANGER/ DESTROY
H-04			Chaitya	Stone made chaitya	Good Condition Needs minor repair

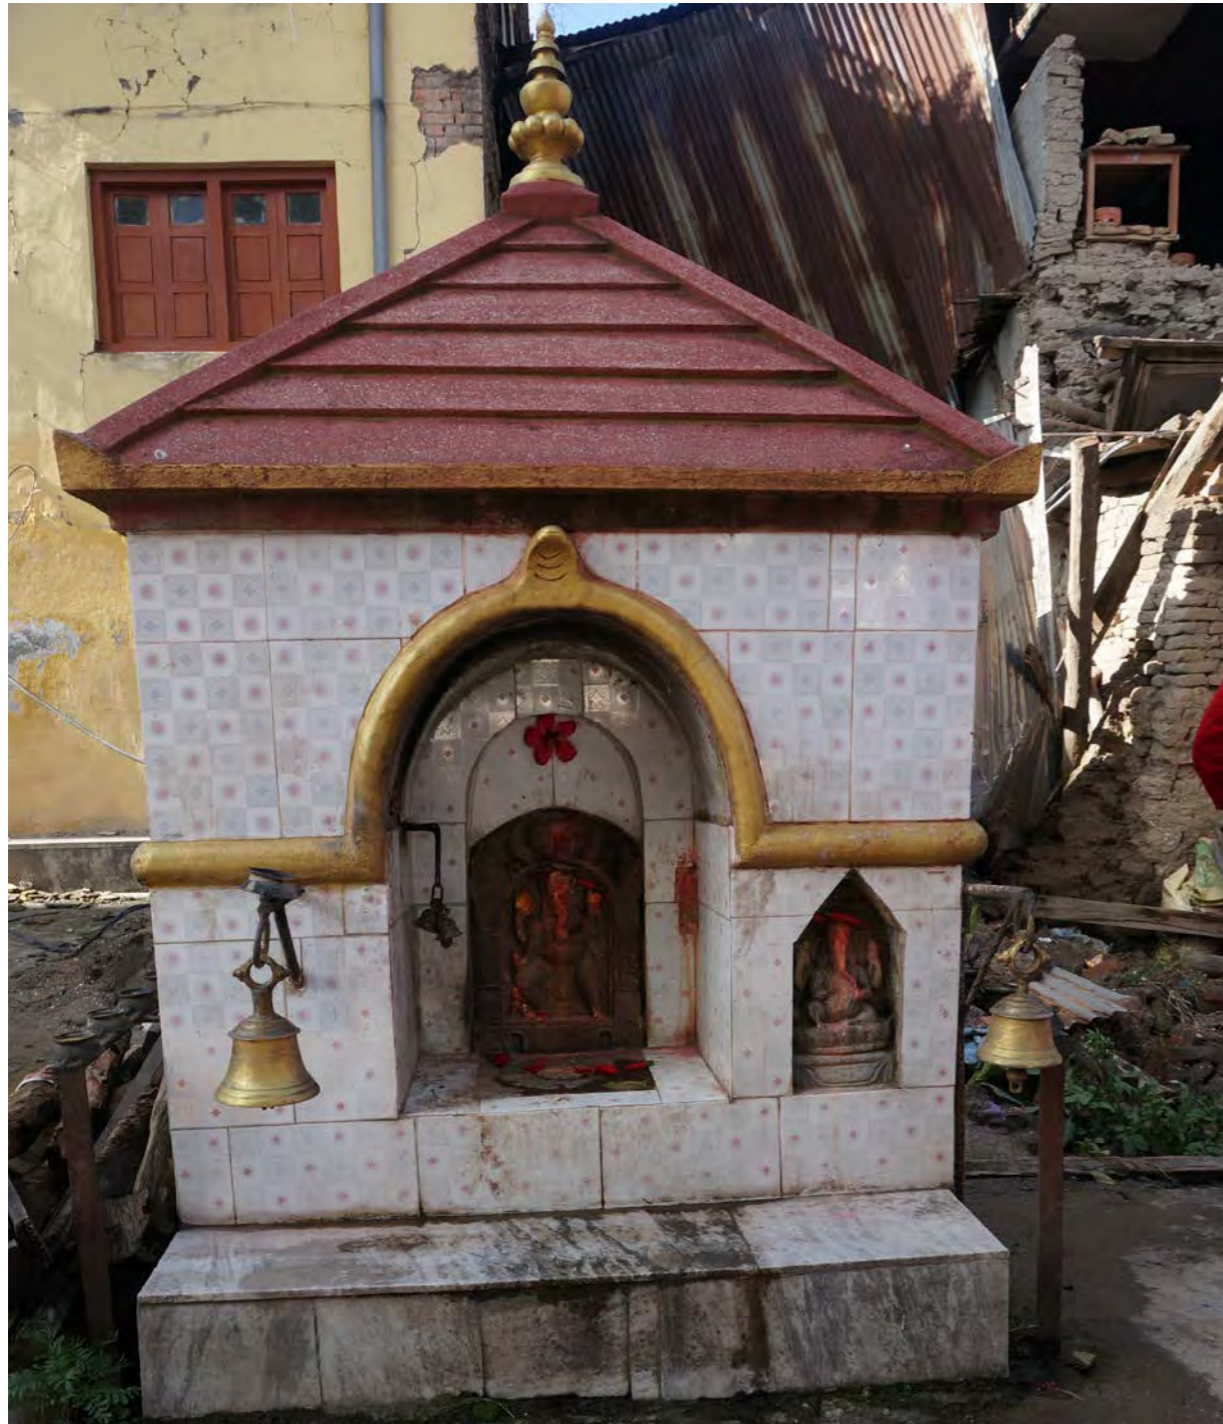
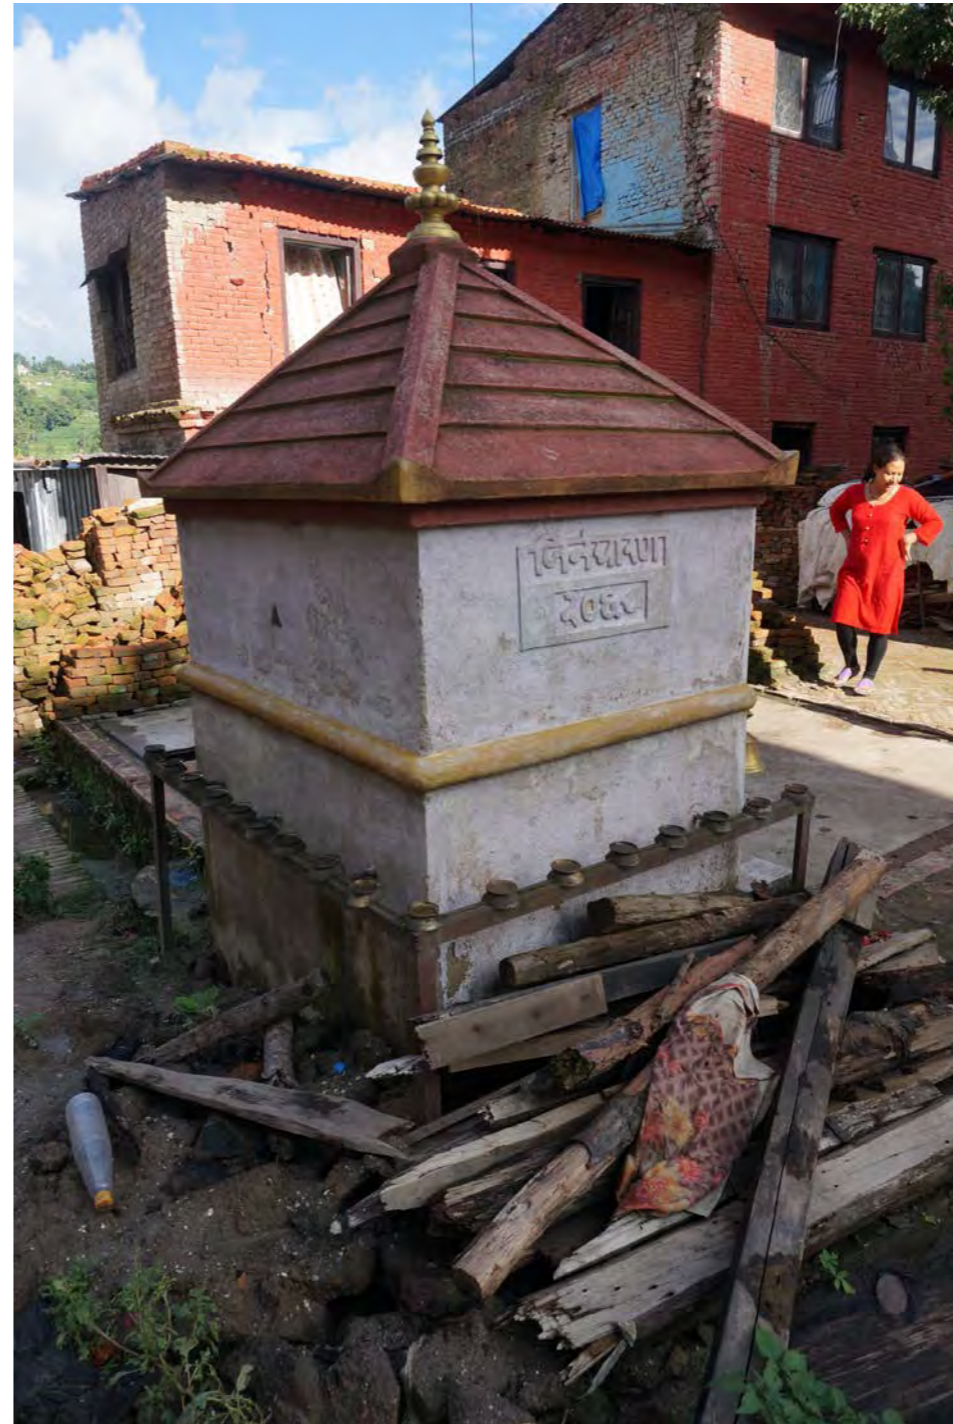
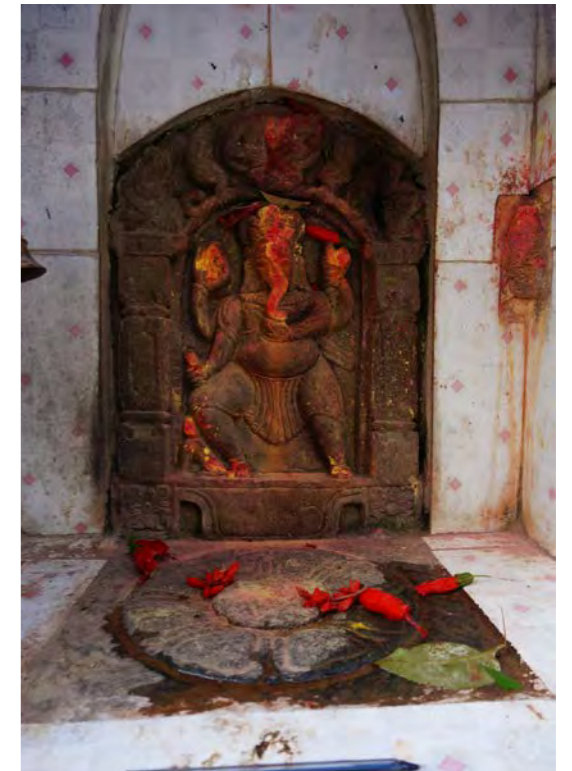
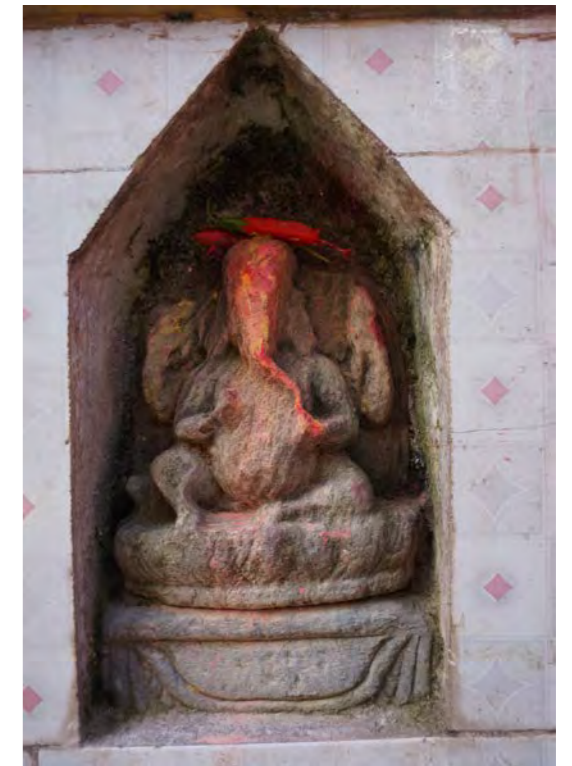
H-06 GANESH SHRINE

NUMBER	NAME	DATE A.D.	TPOLOGY	GENERAL DESCRIPTION	PROBLEMS DESCRIPTION	DANGER/ DESTROY
H-06	Ganesh Shrine		Enclosed Shrine		No visble damages

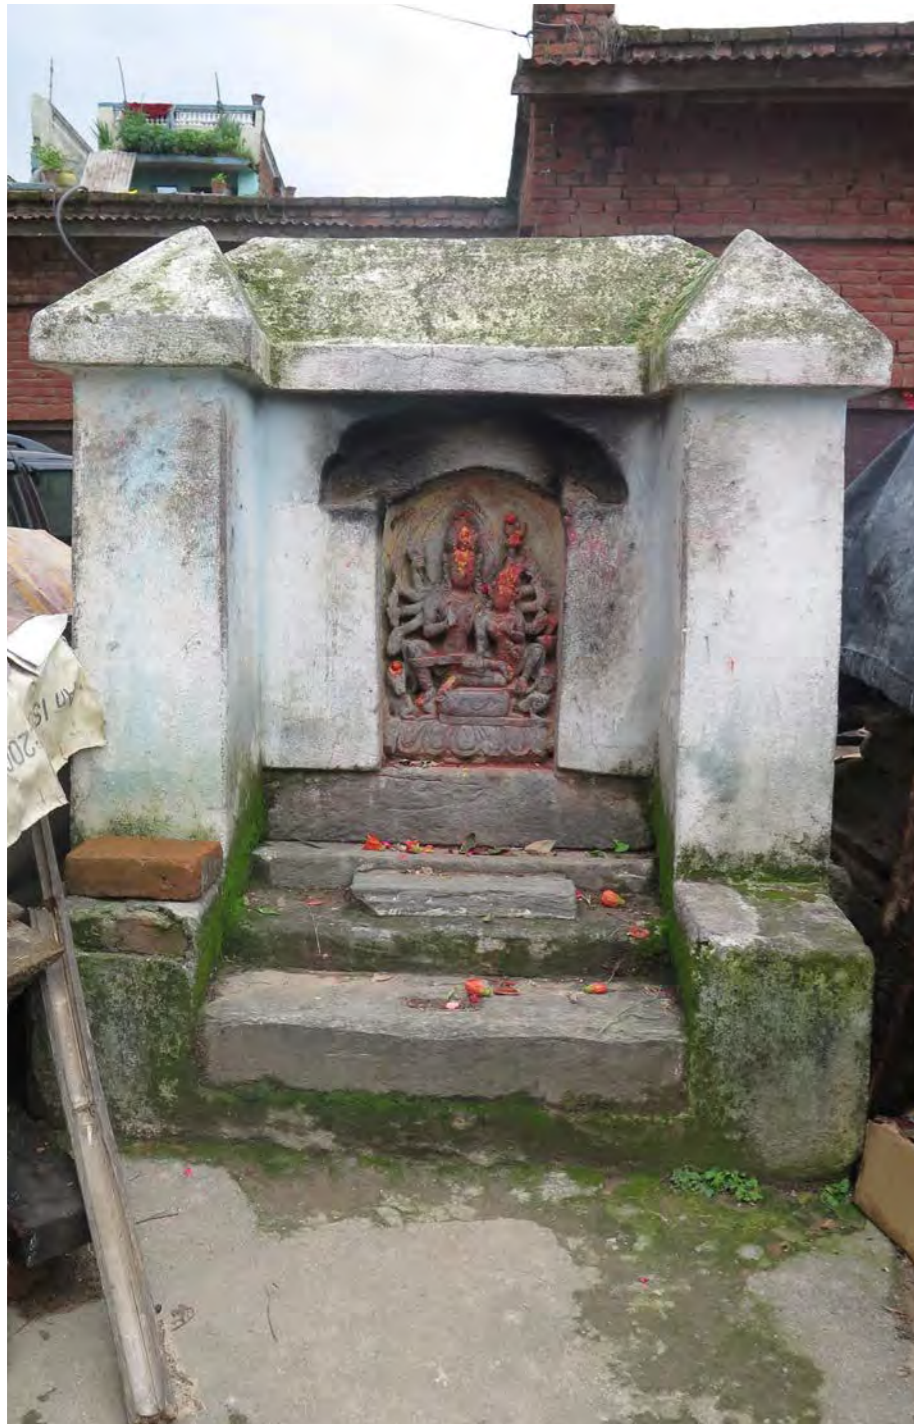
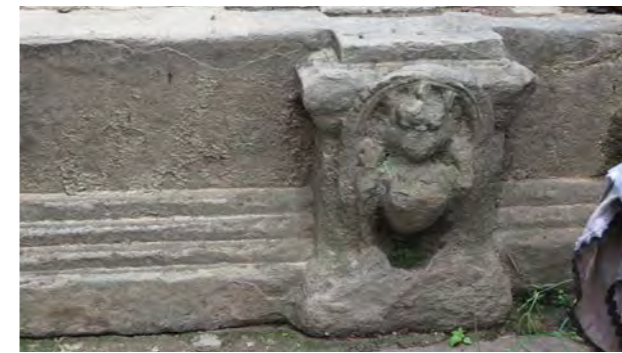
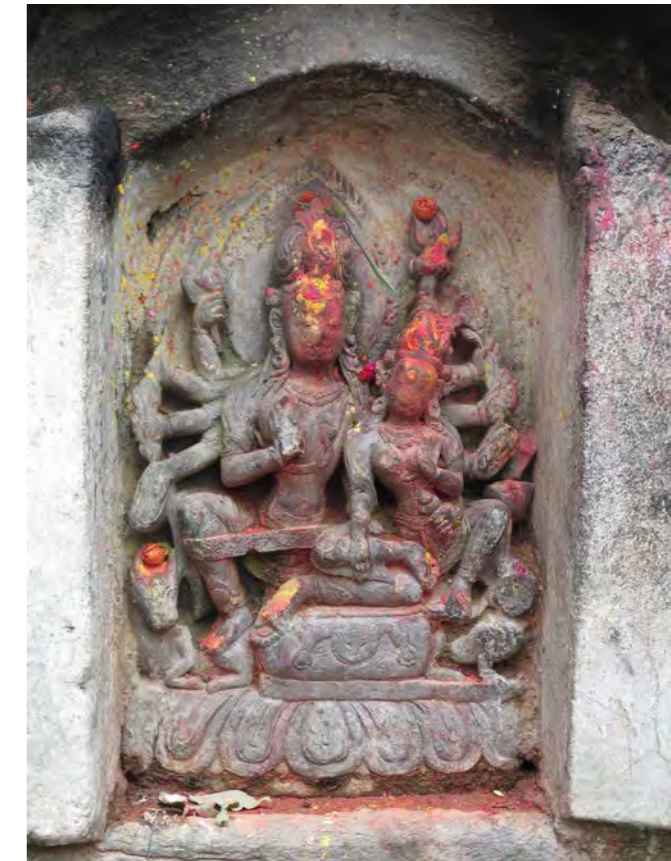
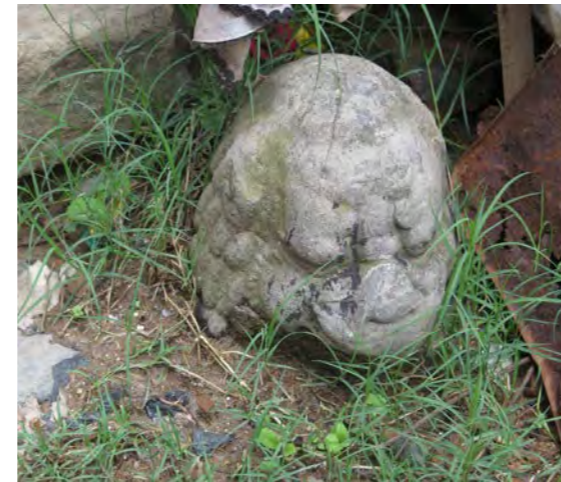
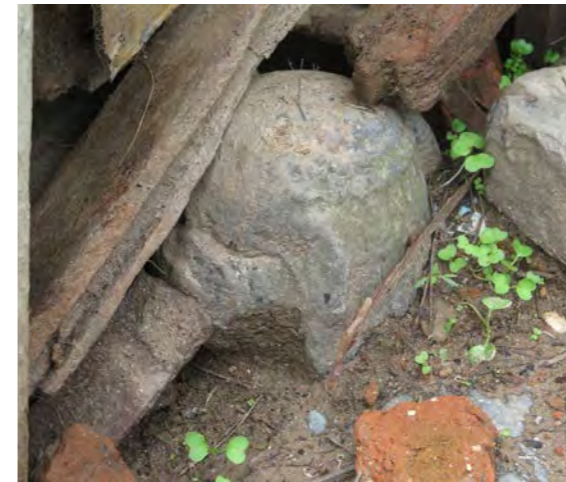
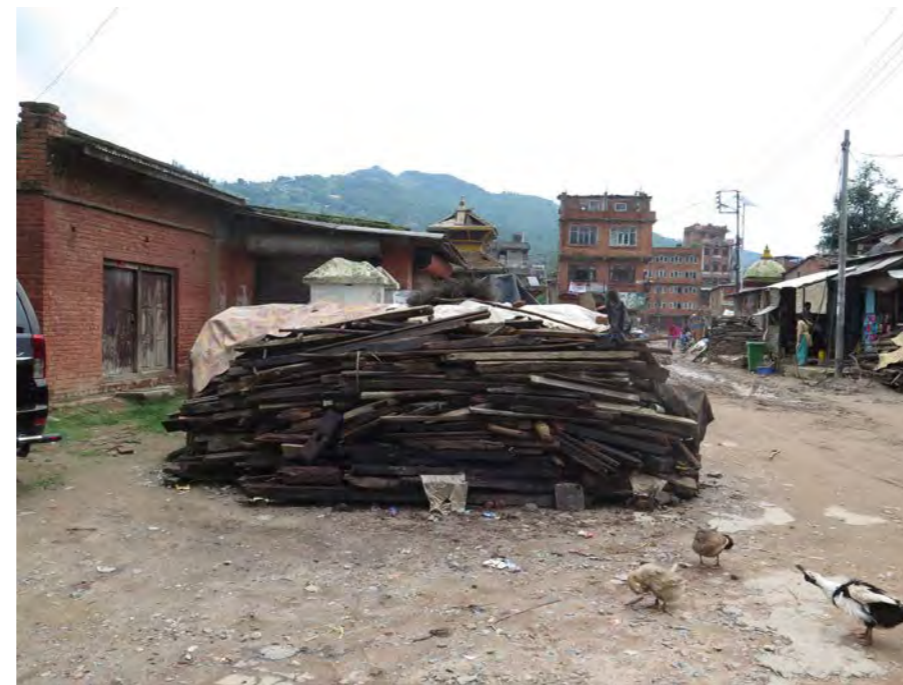
I-04 BISHNU SHRINE

NUMBER	NAME	ESTABLISHED DATE (A.D.)	TYPOLOGY	GENERAL DESCRIPTION	PROBLEMS DESCRIPTION	DANGER/ DESTROY
I-04	Bishnu Idol		Open Shrine	Brick Shrine on plinth	Plinth covered by wooden rubbles from nearby buildings. Entrance sculpture on left is disappeared. Stone lion covered unerground only head can be seen.

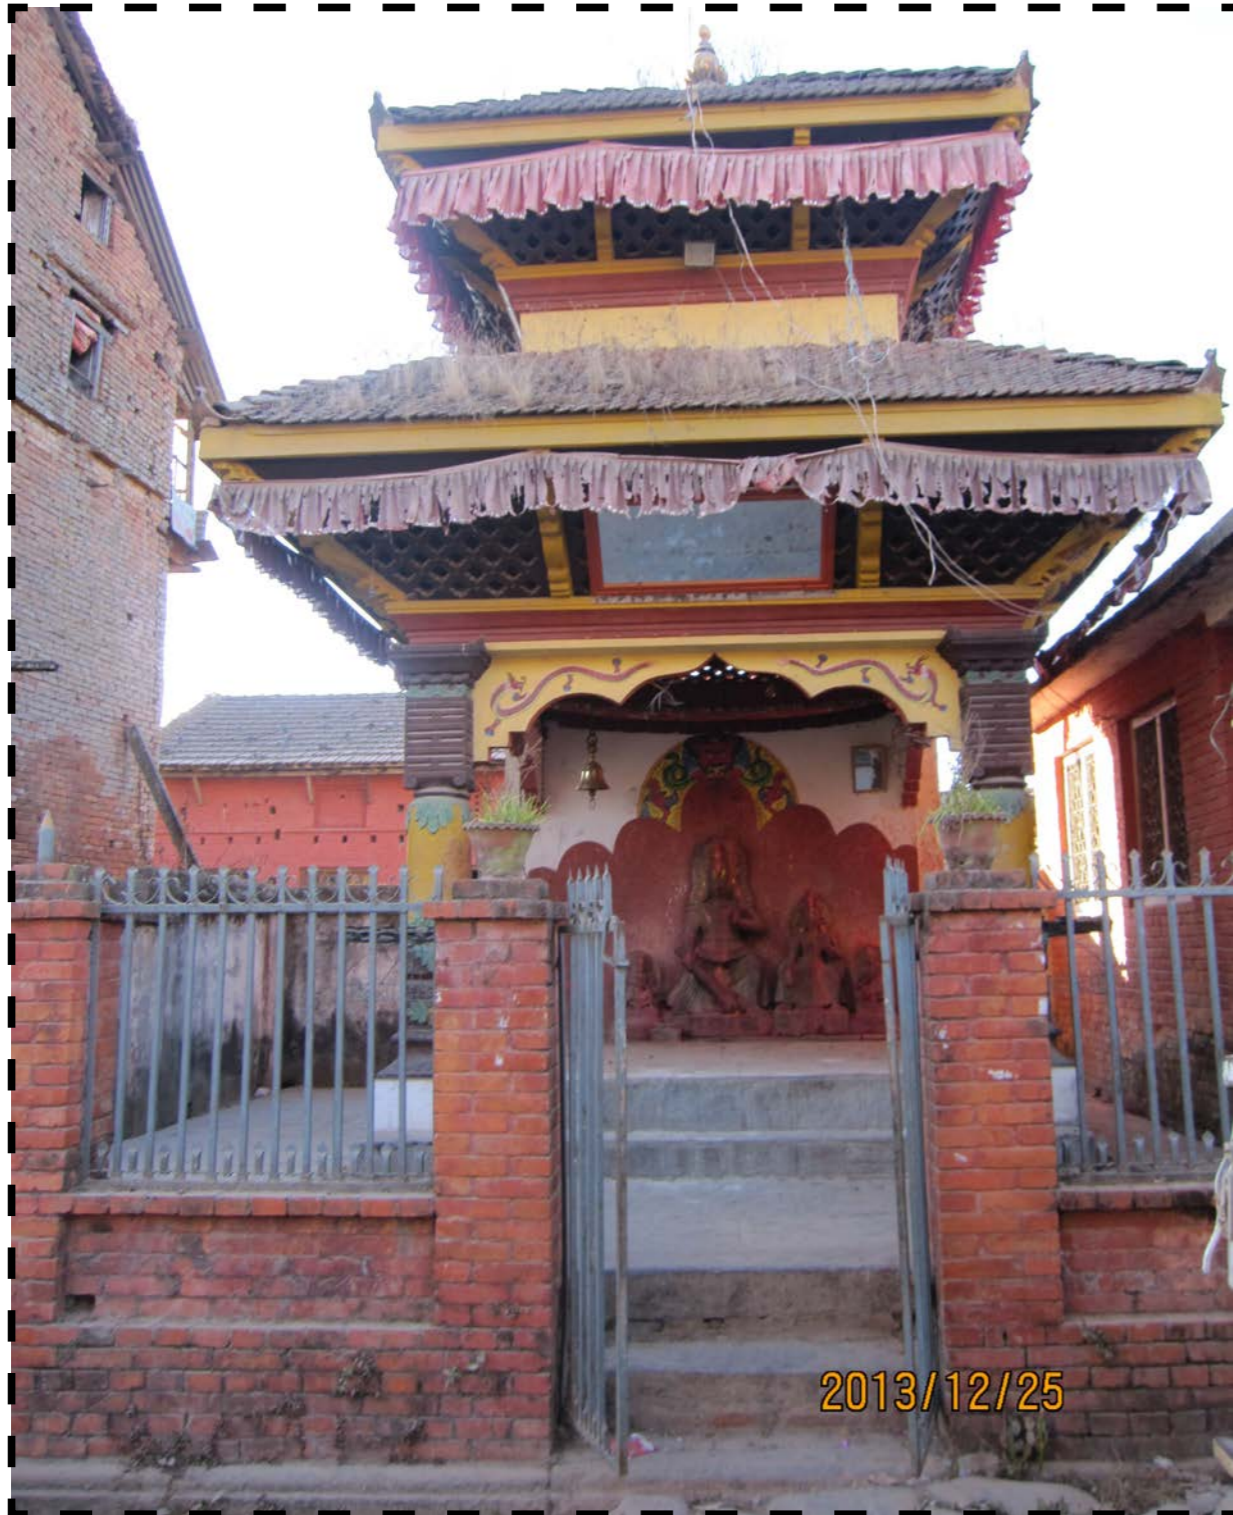
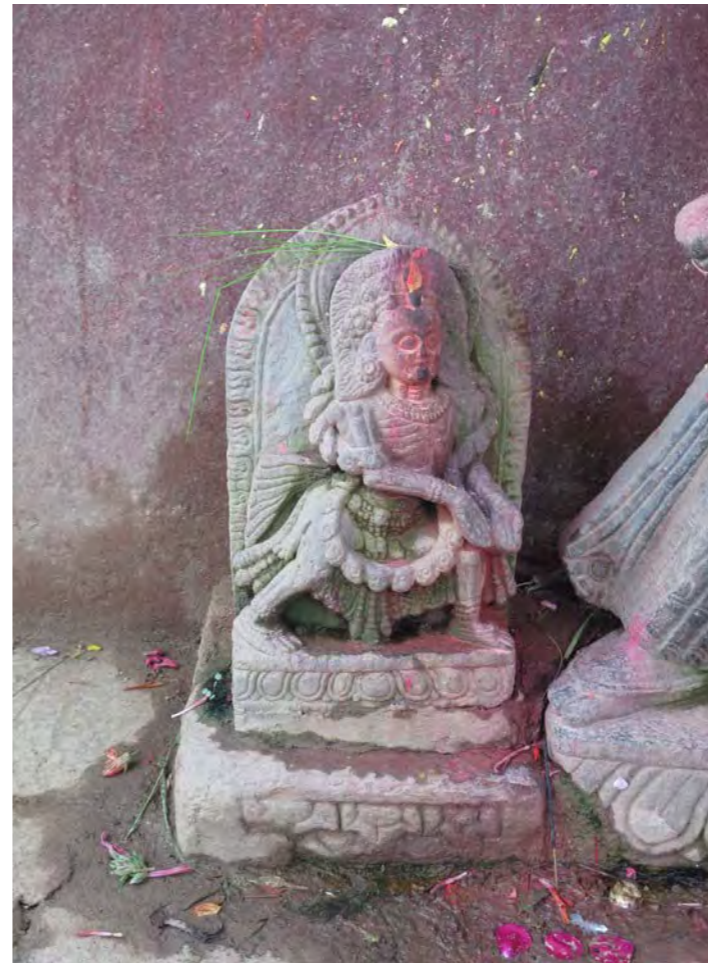
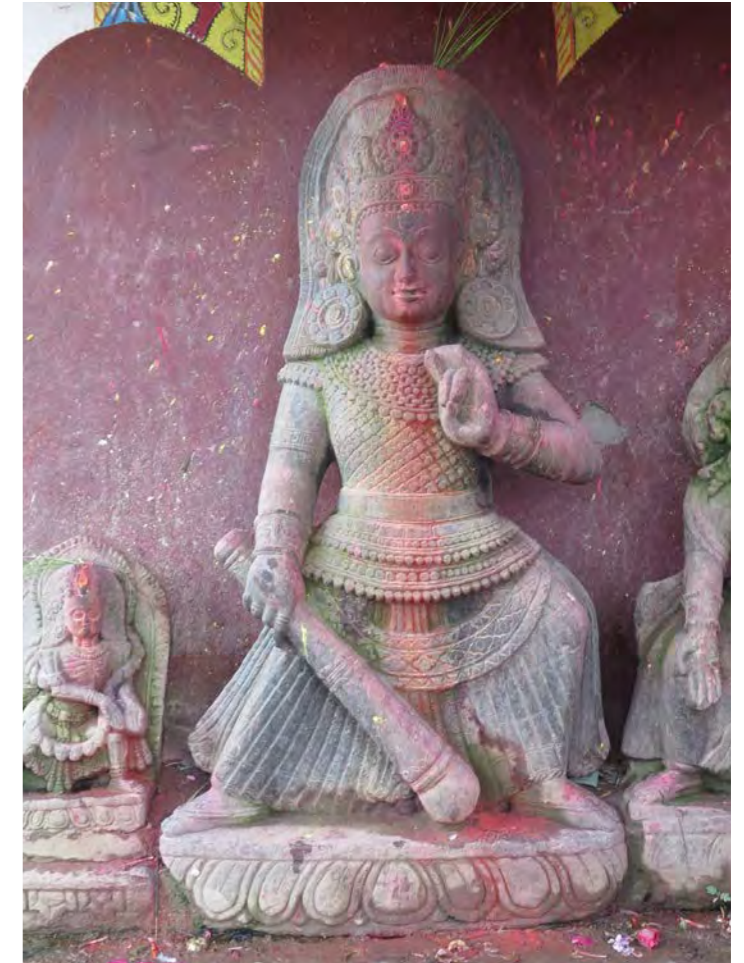
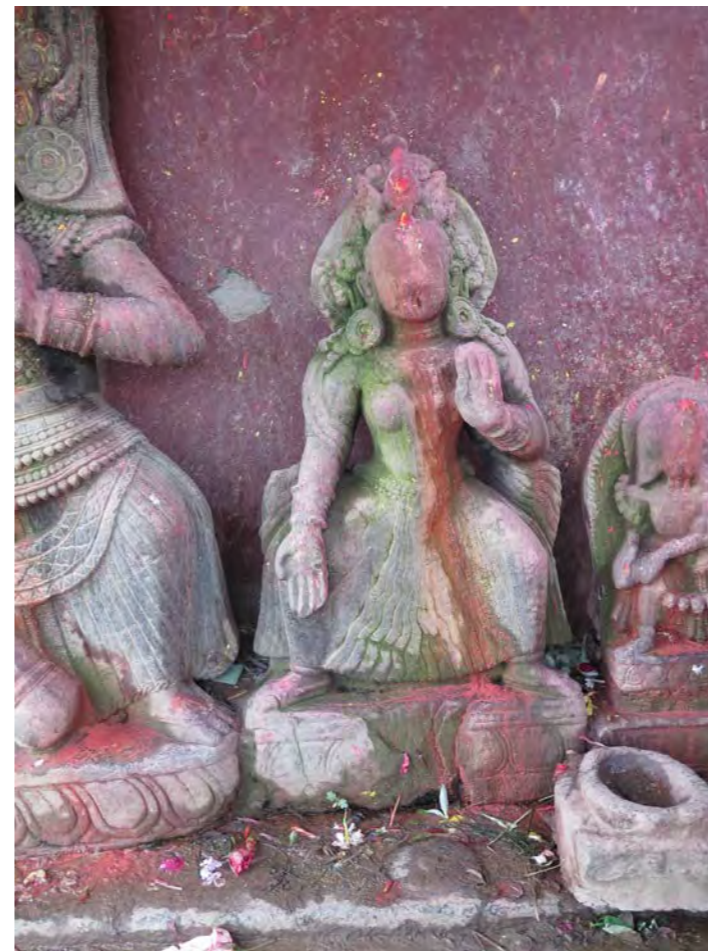
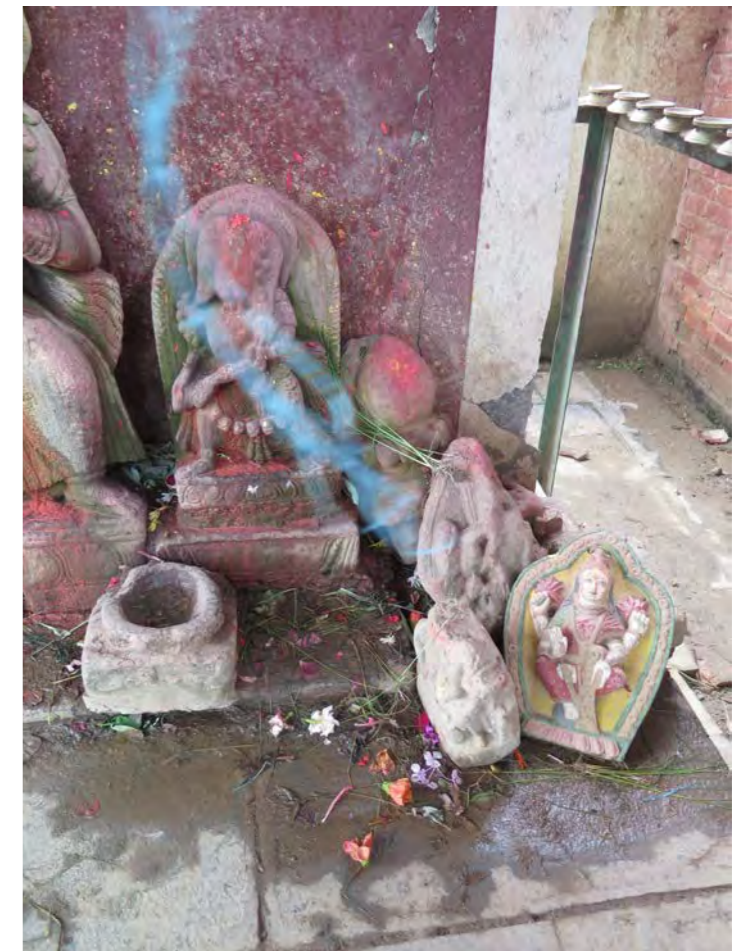
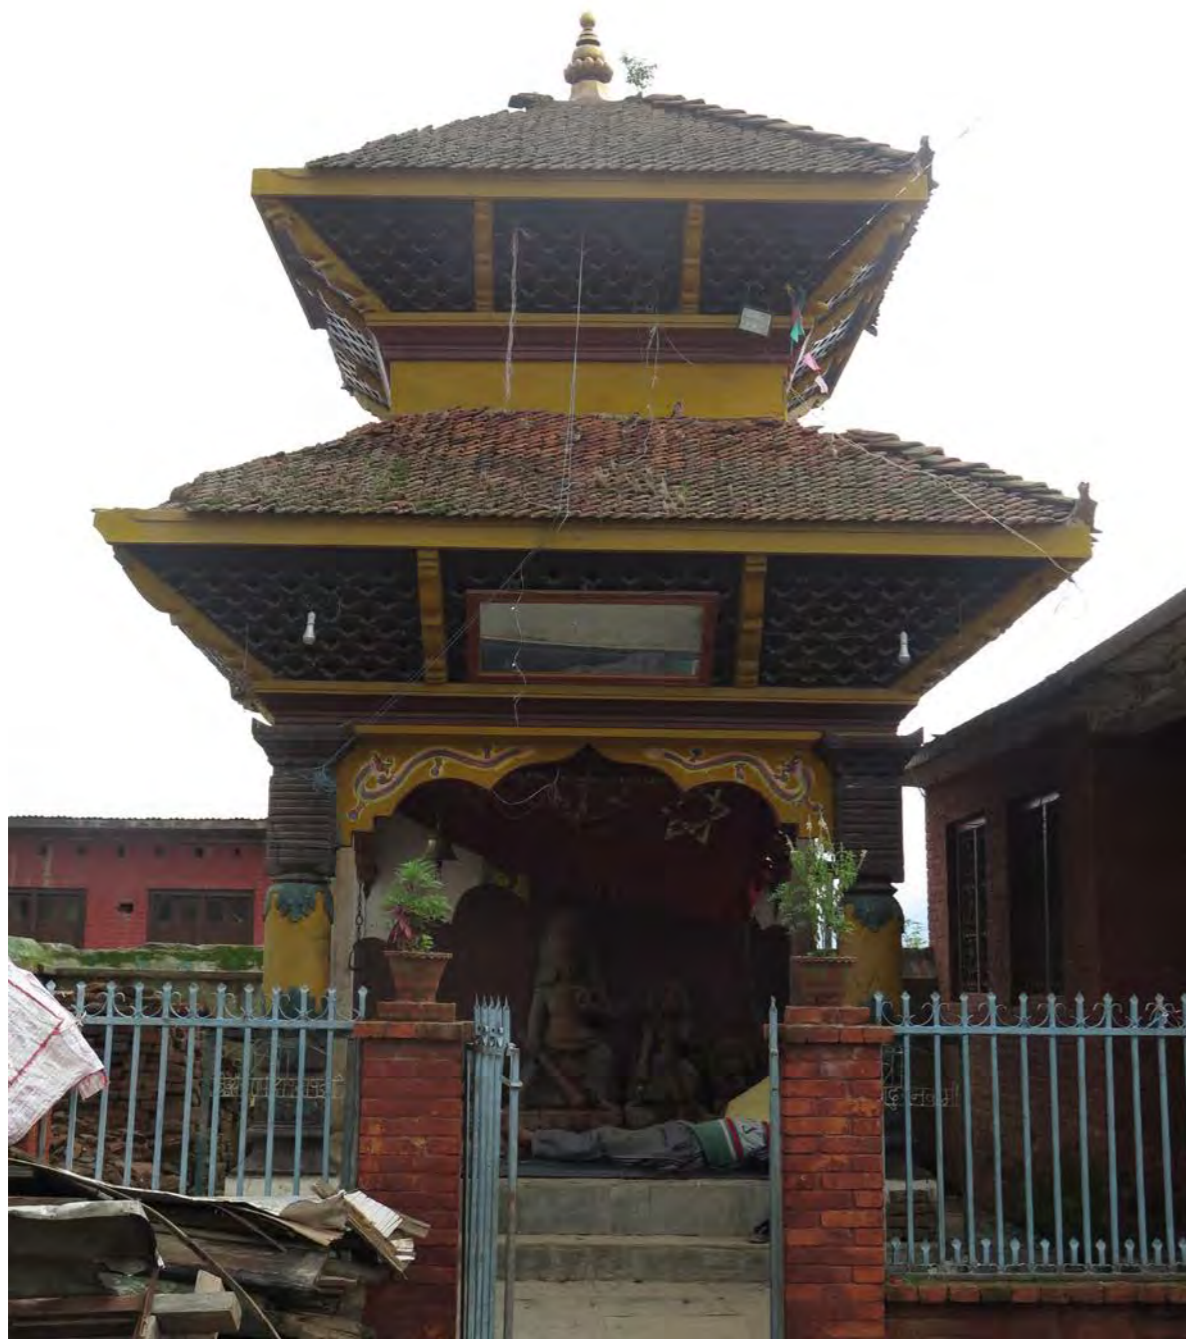
I-06 BHIMSEN TEMPLE

NUMBER	NAME	ESTABLISHED DATE (A.D.)	TYPOLOGY	GENERAL DESCRIPTION	PROBLEMS DESCRIPTION	DANGER/ DESTROY
I-06	Bhimsen Temple		Temple	6 idols and 3 stone sculpture. Concrete temple with 2 tired roof.	Southern roof collapsed by falling debris during earthquake of nearby building. Inner wooden members of roof collapse

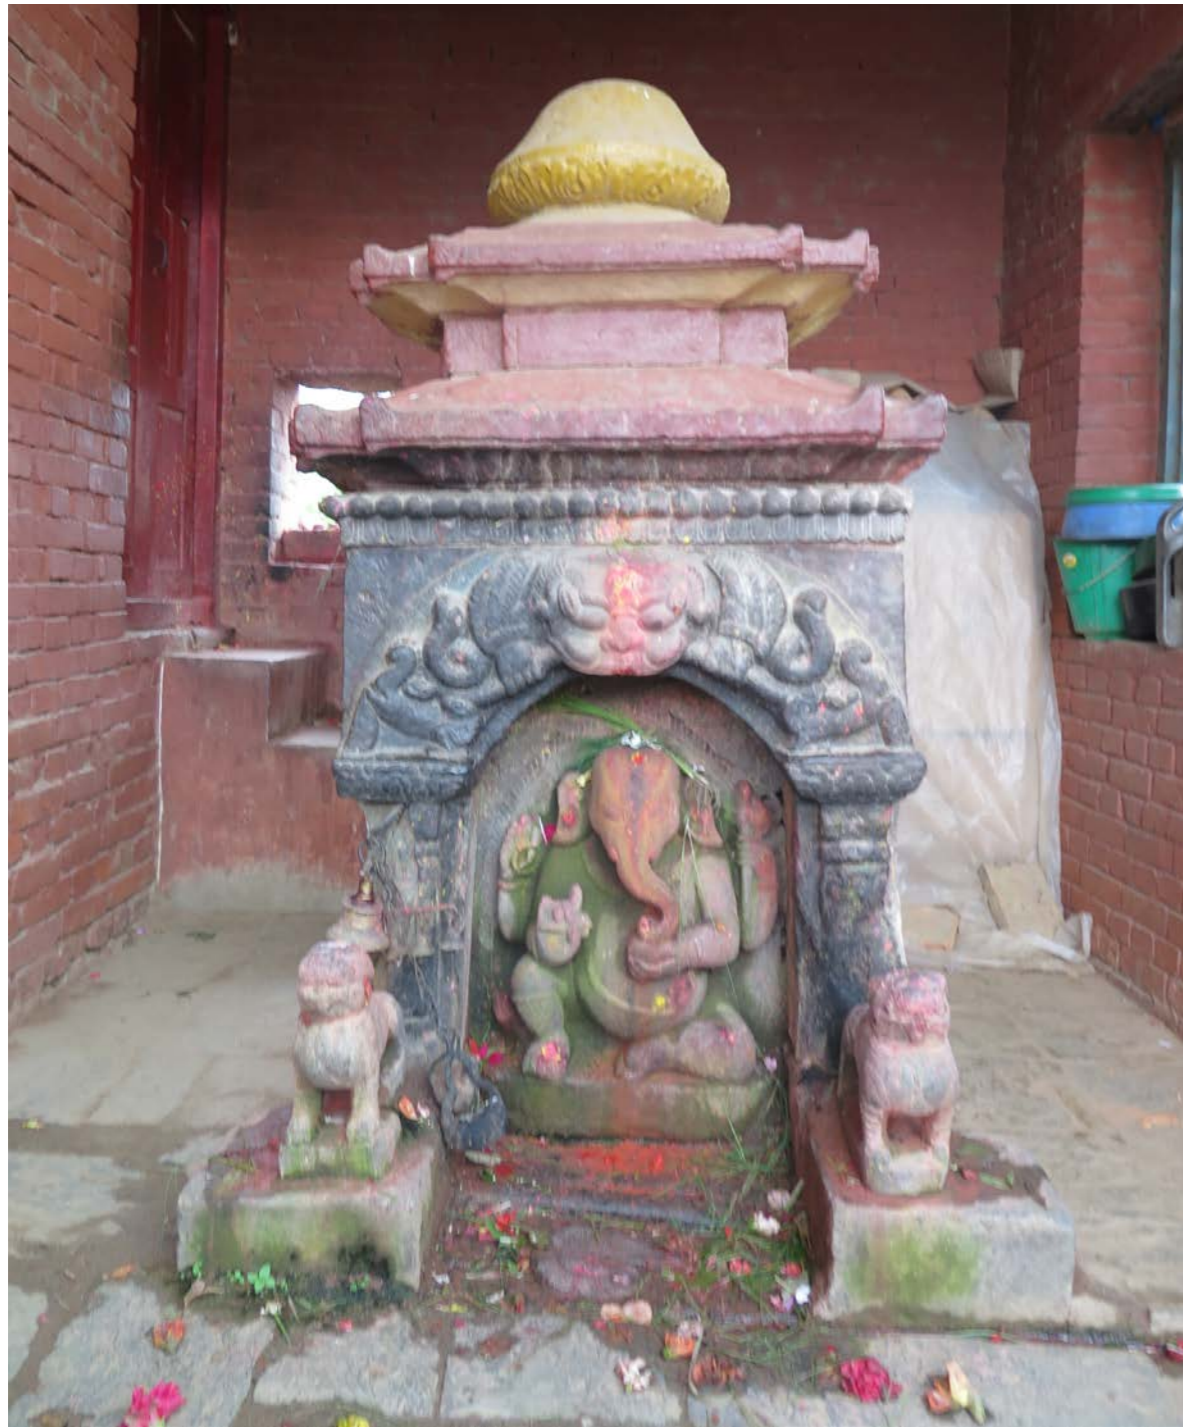
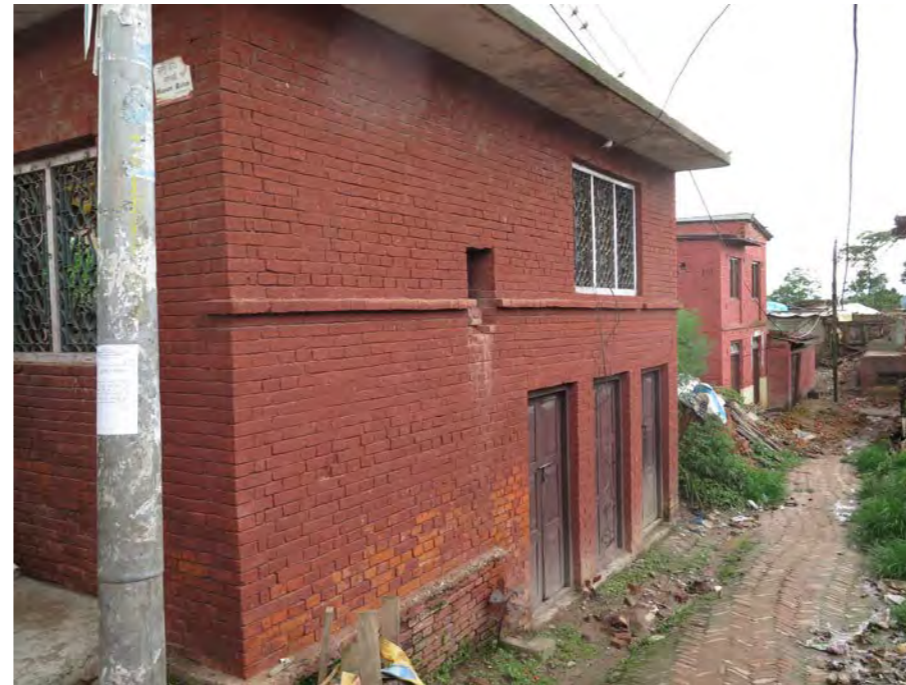
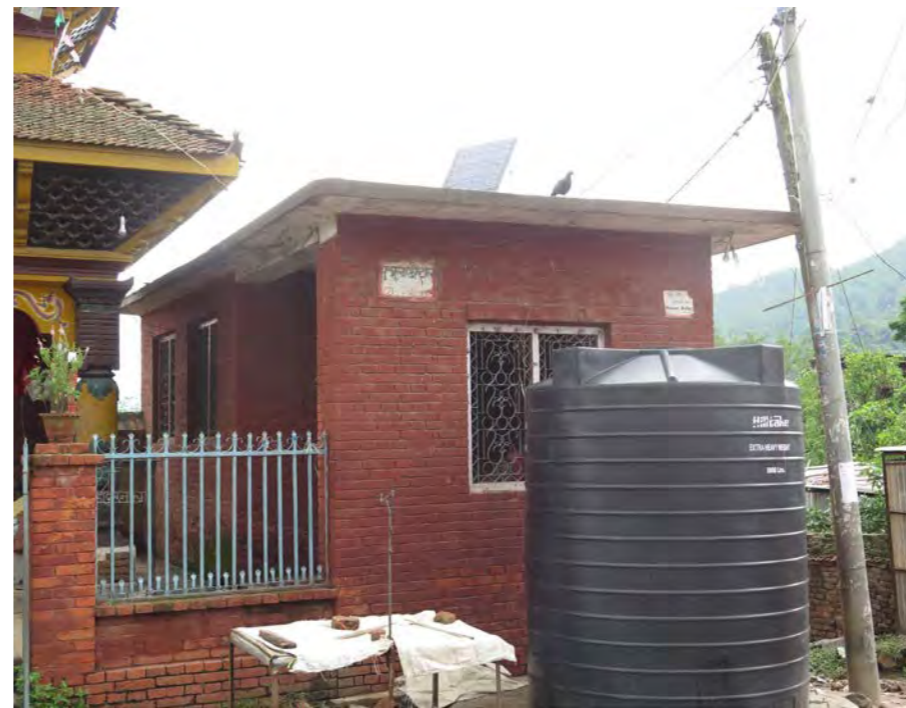
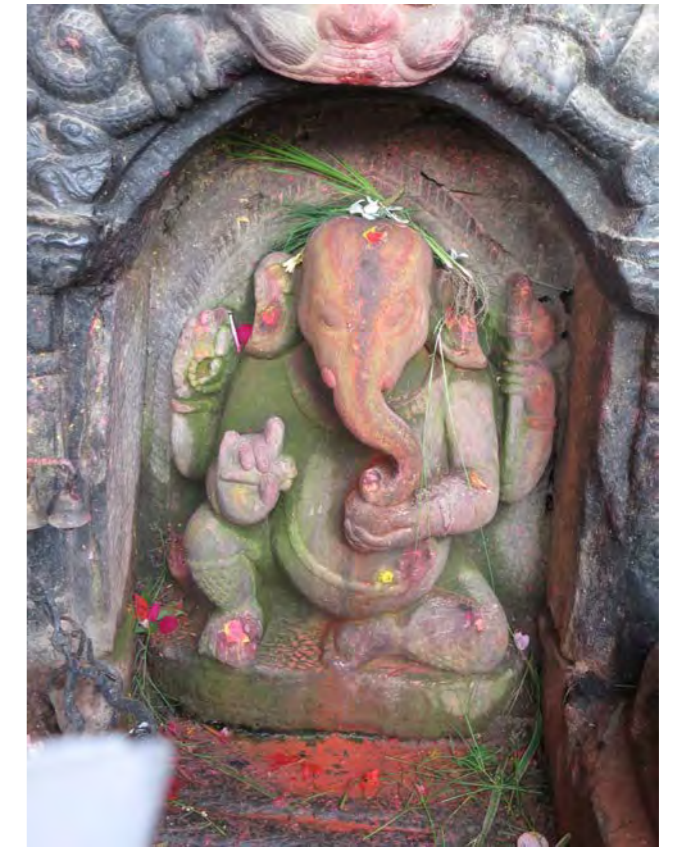
I-07 GANESH

NUMBER	NAME	DATE A.D.	TPOLOGY	GENERAL DESCRIPTION	PROBLEMS DESCRIPTION	DANGER/ DESTROY
I-07	Ganesh Temple		Open Shrine	G+1 Brick structure with concrete slab	Rising damp on south wall due to dirty surrounding.
