2015 Earthquake Damage Mapping

Sankhu

October 2015

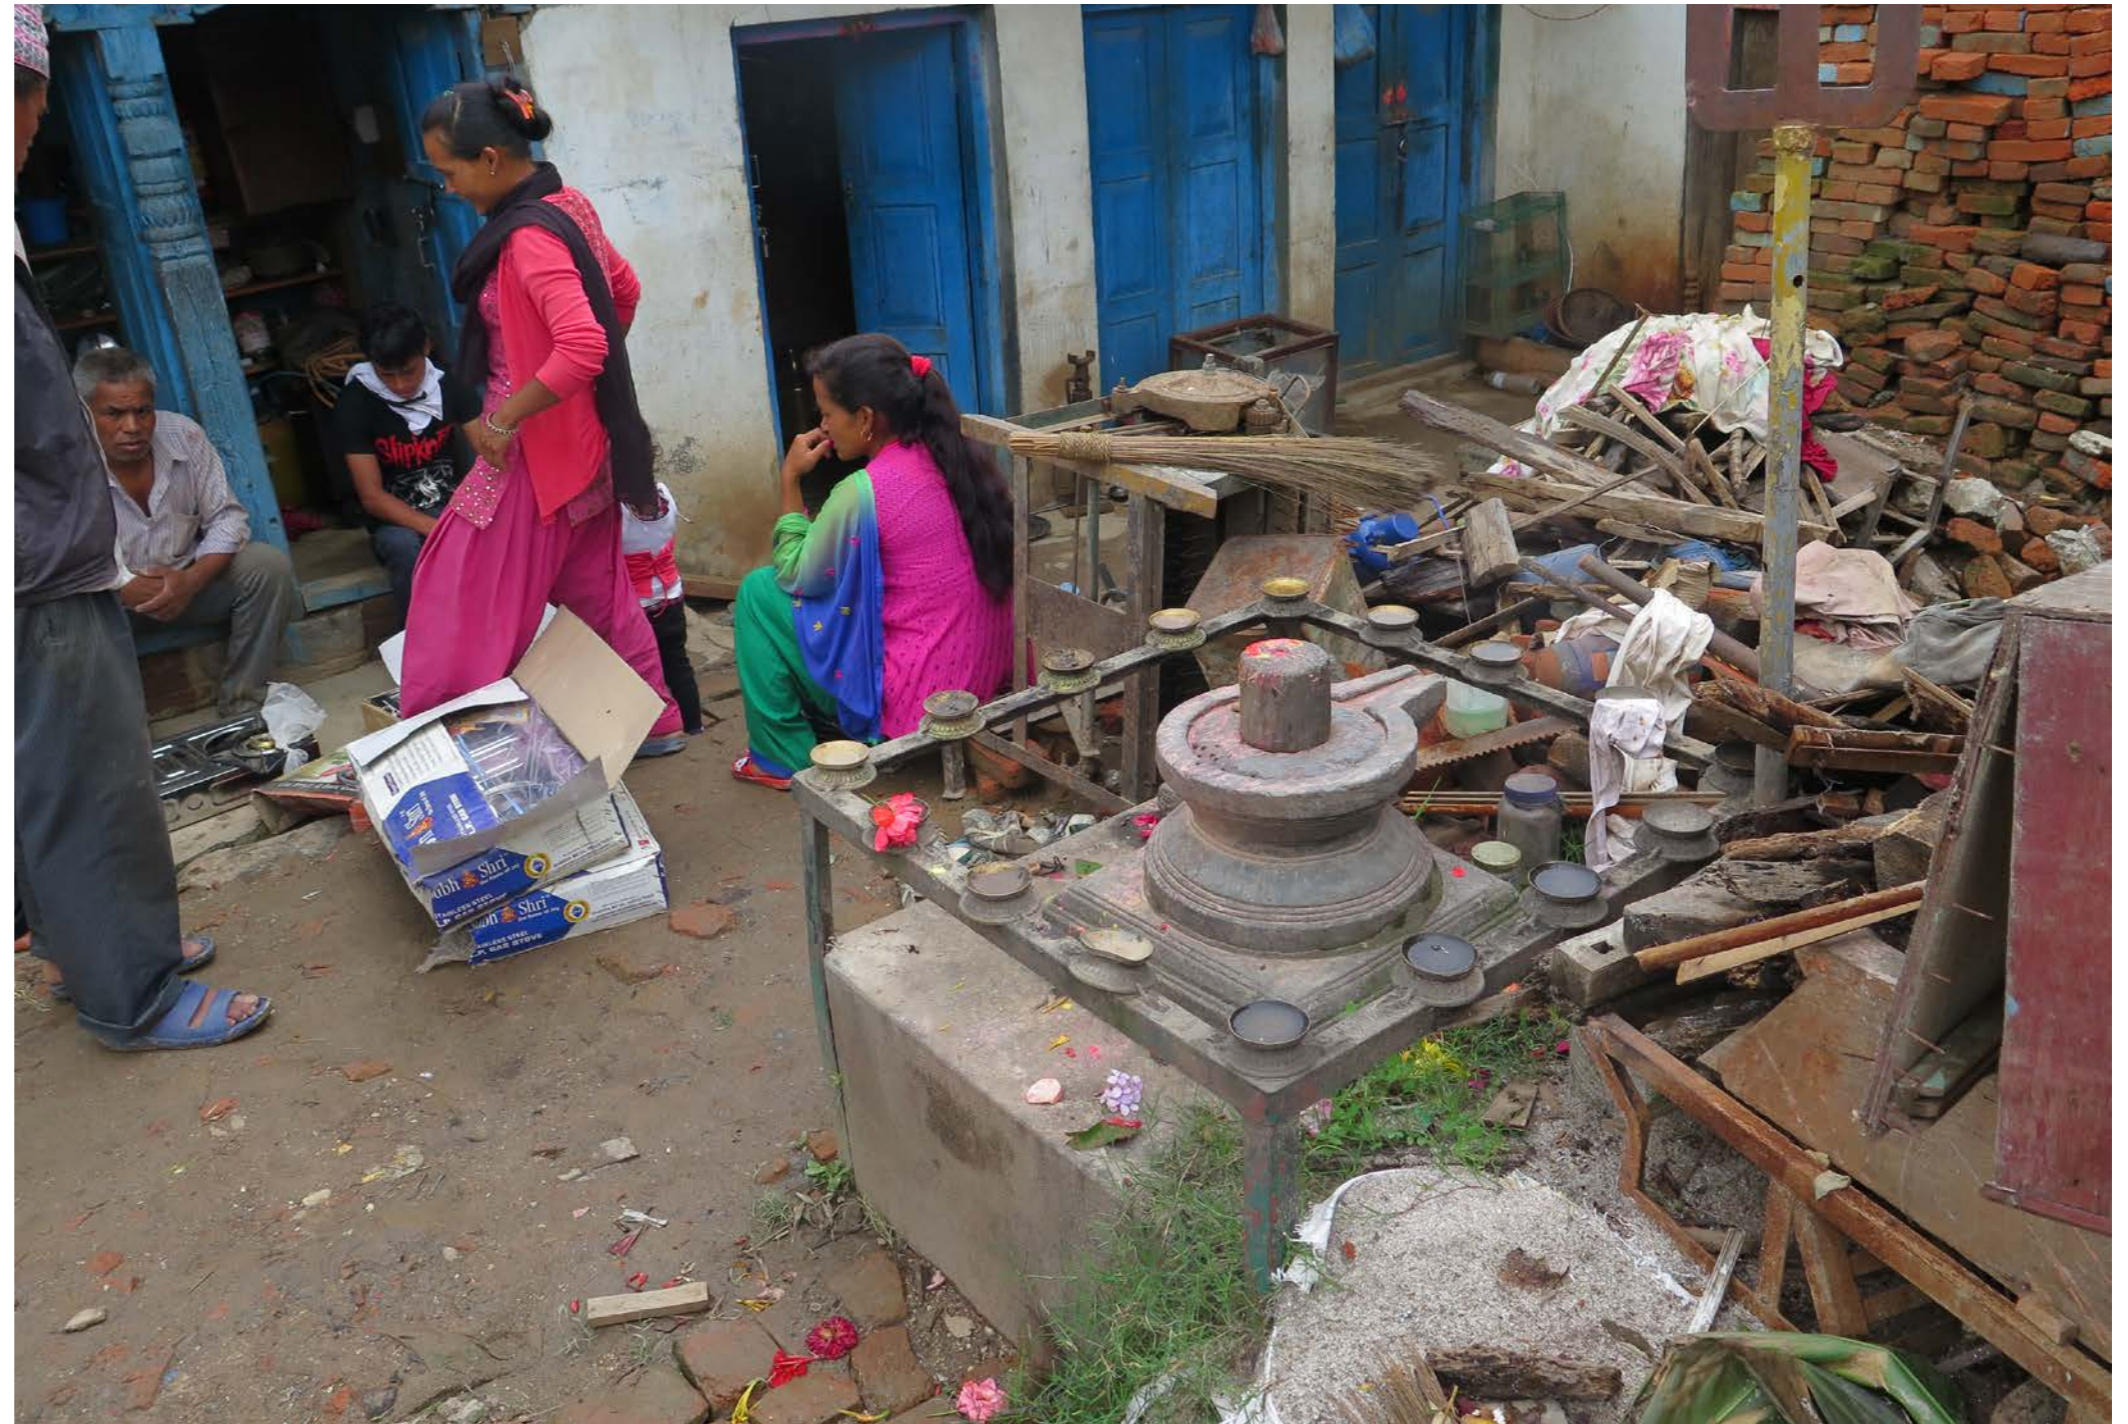
I-08 SHIVA LINGA

NUMBER	NAME	ESTABLISHED DATE (A.D.)	TYPOLOGY	GENERAL DESCRIPTION	PROBLEMS DESCRIPTION	DANGER/ DESTROY
I-08			Shiva Linga		Cement plastered plinth. Nandi Half burried

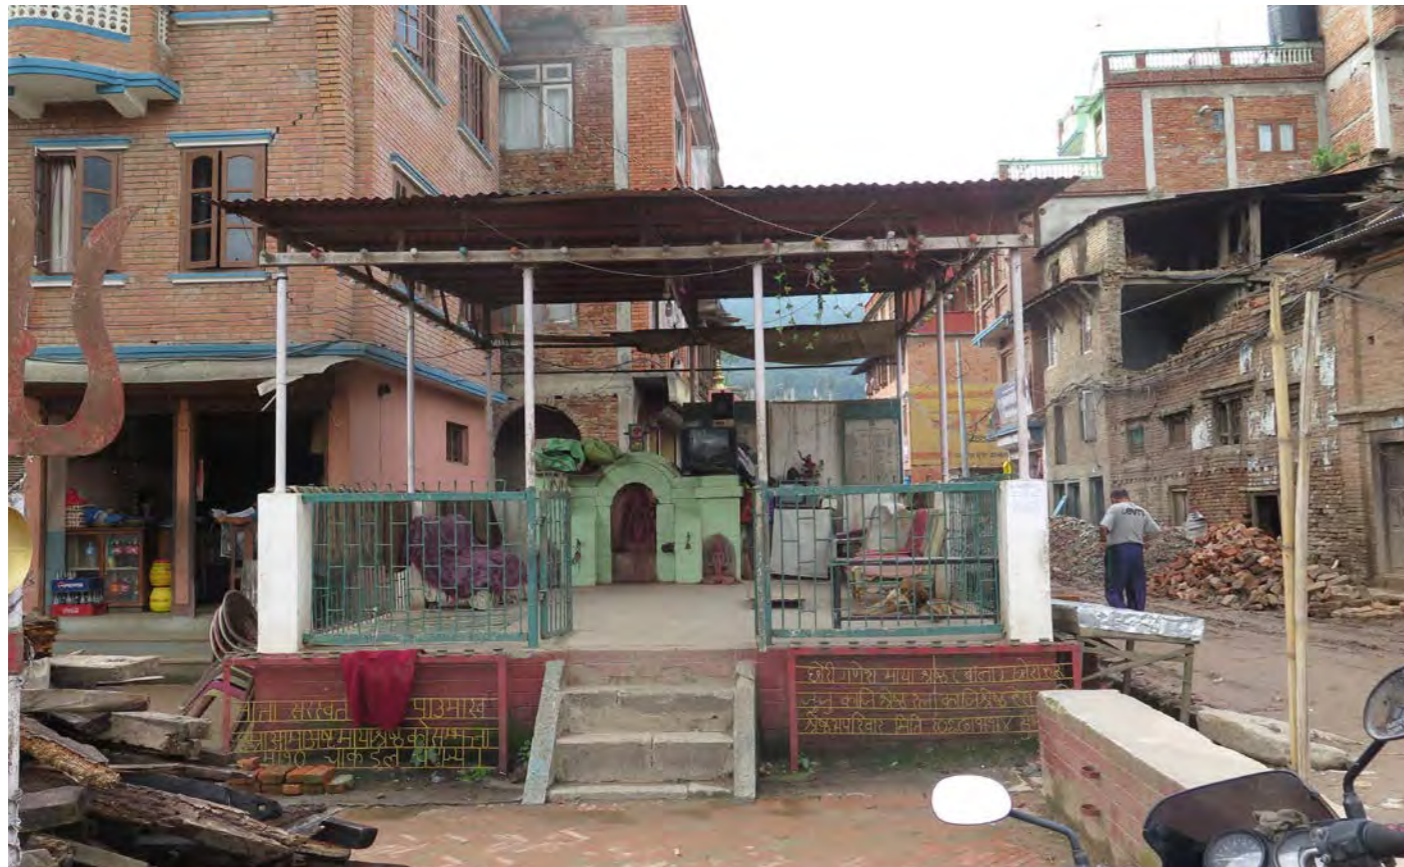
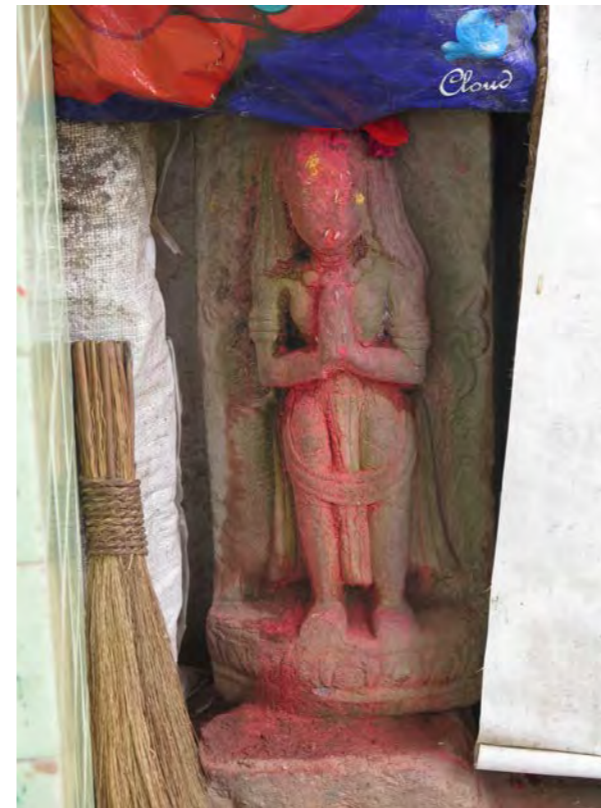
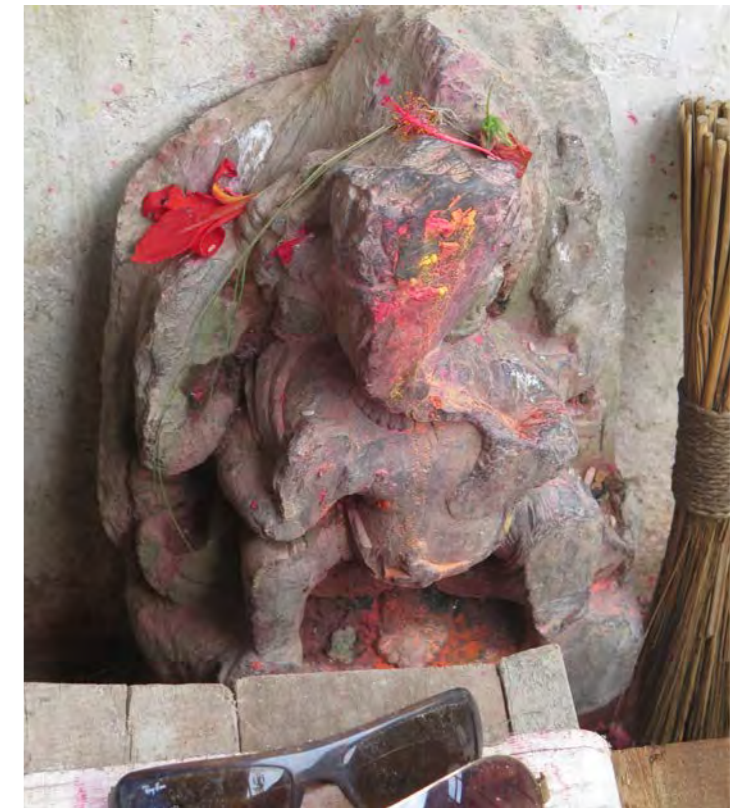
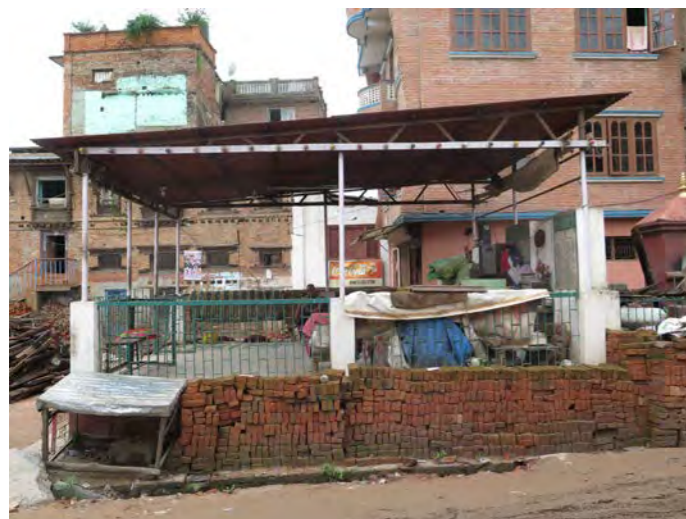
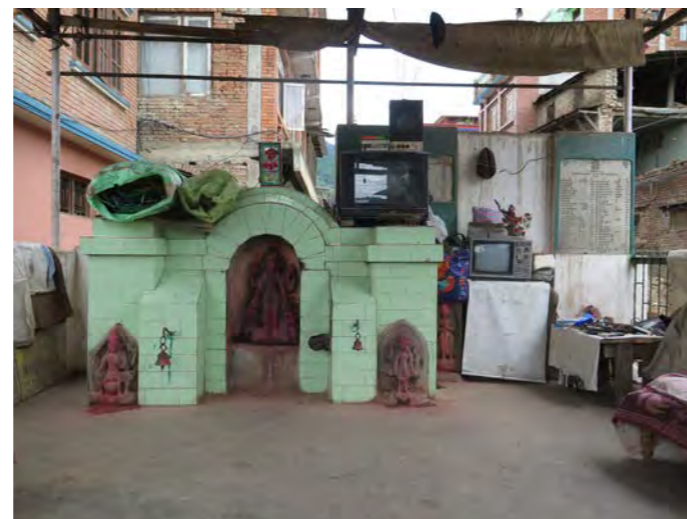
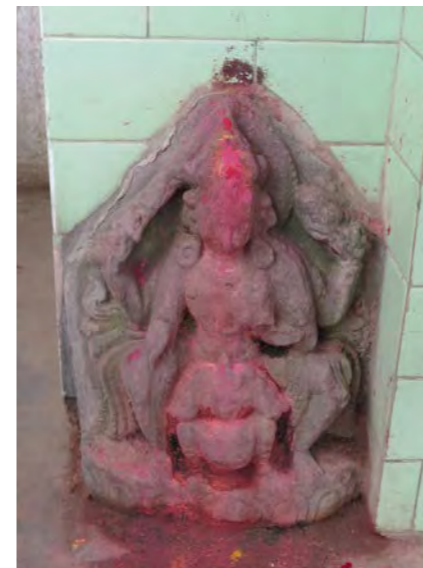
I-12 DHOLA NARAYAN

NUMBER	NAME	ESTABLISHED DATE (A.D.)	TPOLOGY	GENERAL DESCRIPTION	PROBLEMS DESCRIPTION	DANGER/ DESTROY
I-12	Dhola Narayan			Shrine covered by CGI roof. 5 statues	No visible damage. 2 statues are degraded. 1 arm of Ganesh missing.

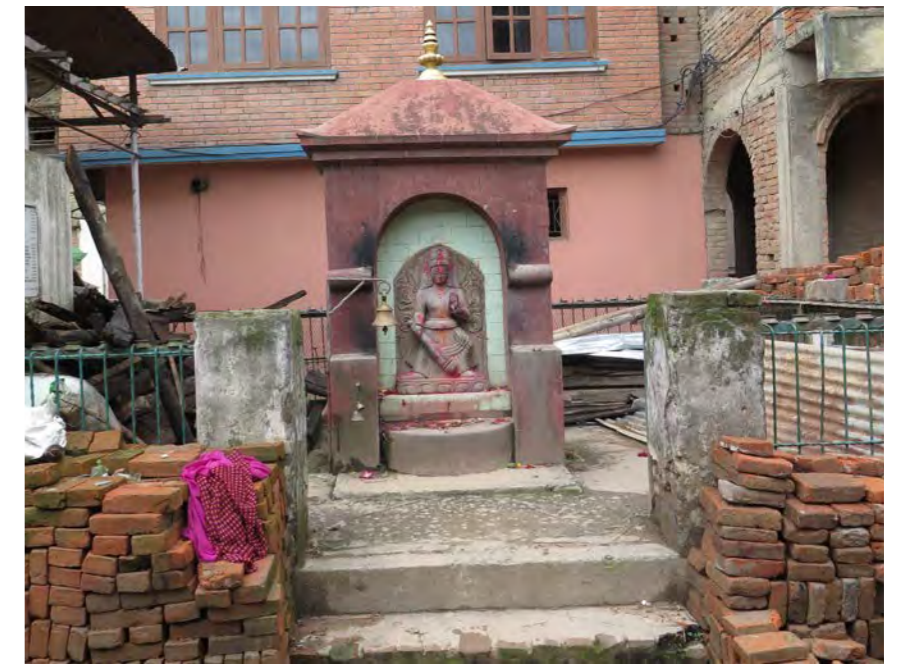
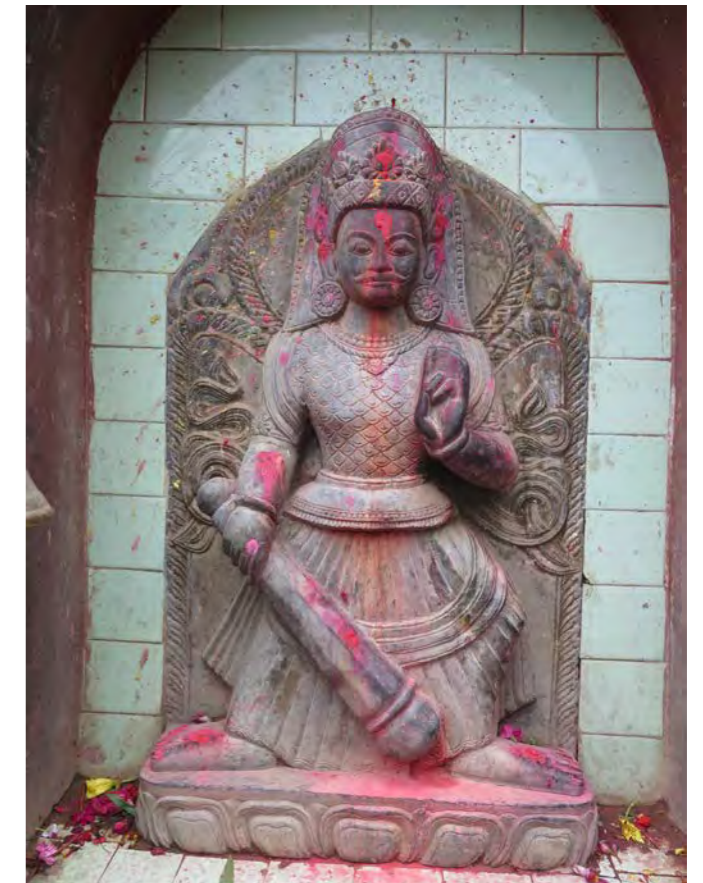
I-13 DHOLA BHIMSEN SHRINE

NUMBER	NAME	DATE A.D.	TPOLOGY	GENERAL DESCRIPTION	PROBLEMS DESCRIPTION	DANGER/ DESTROY
I-13	Dhola Bhimsen		Open Shrine		No visible damage.

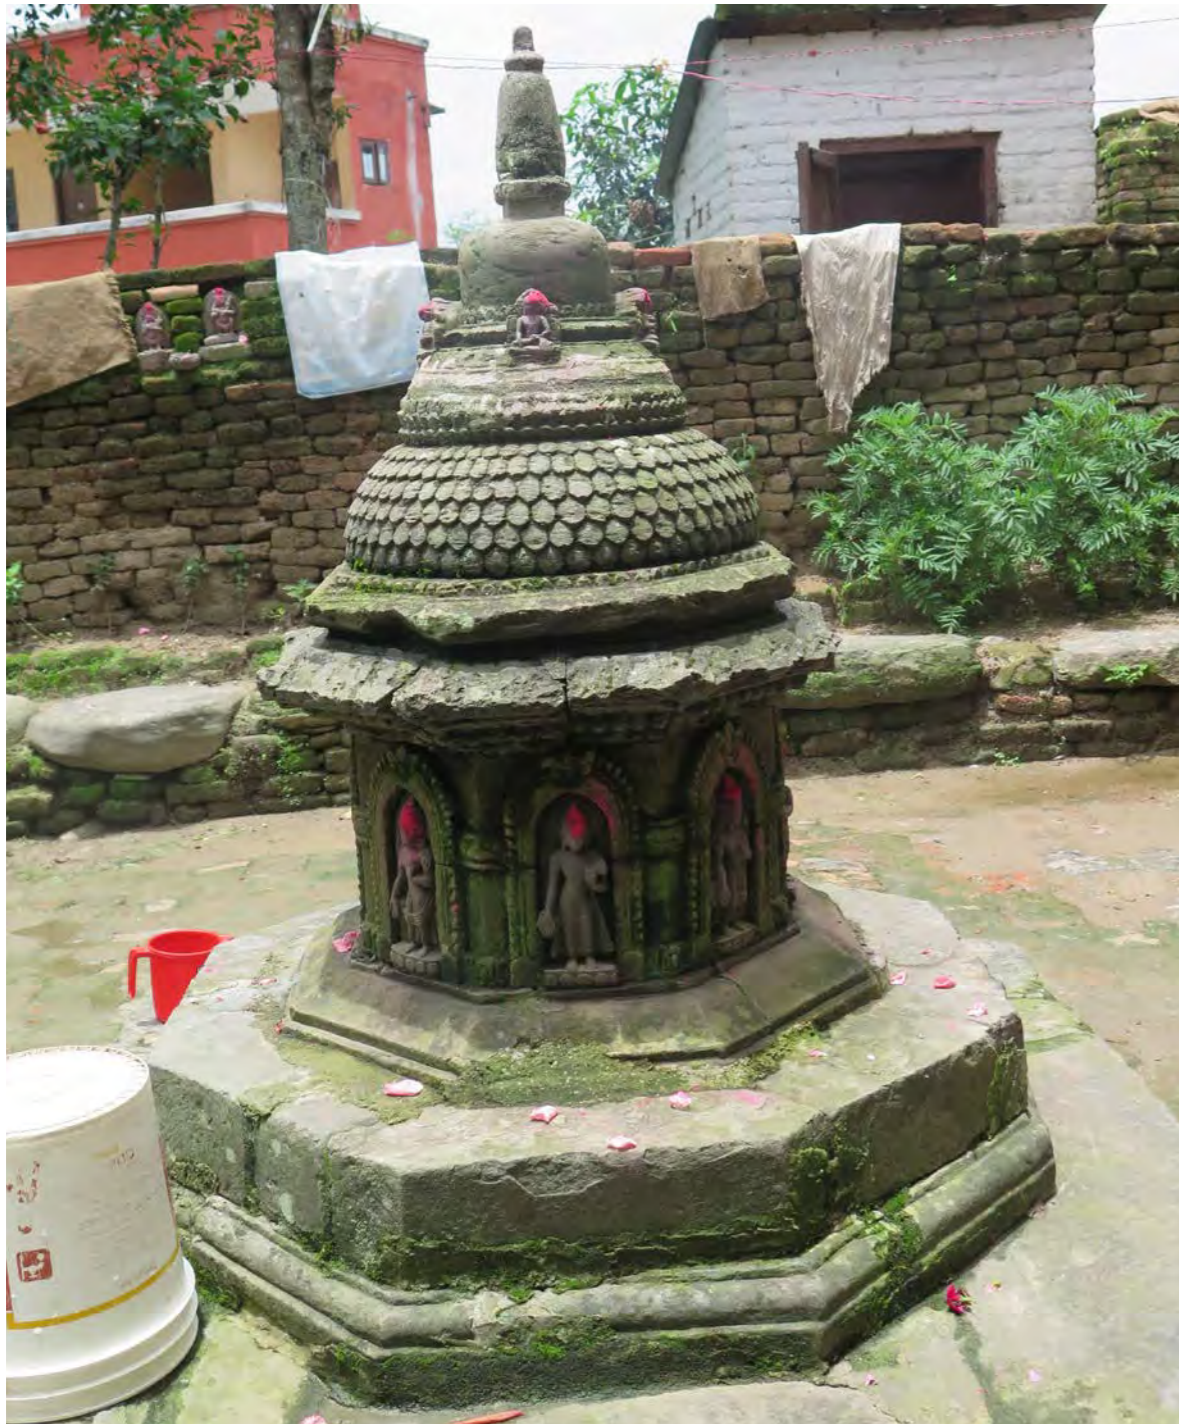
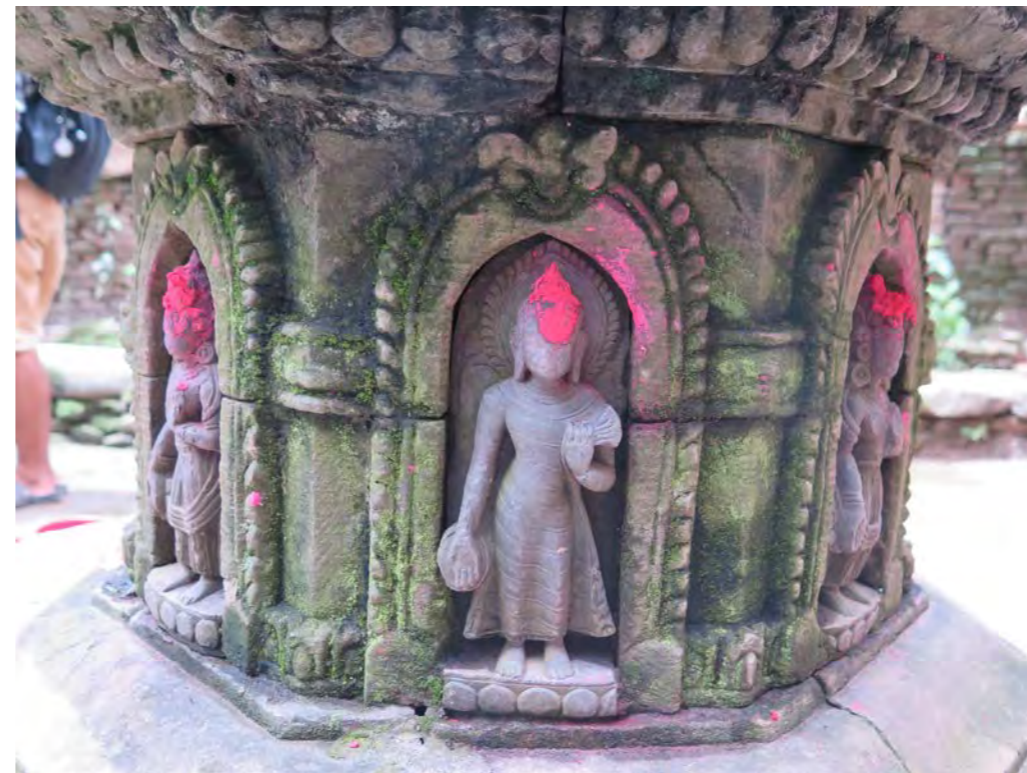
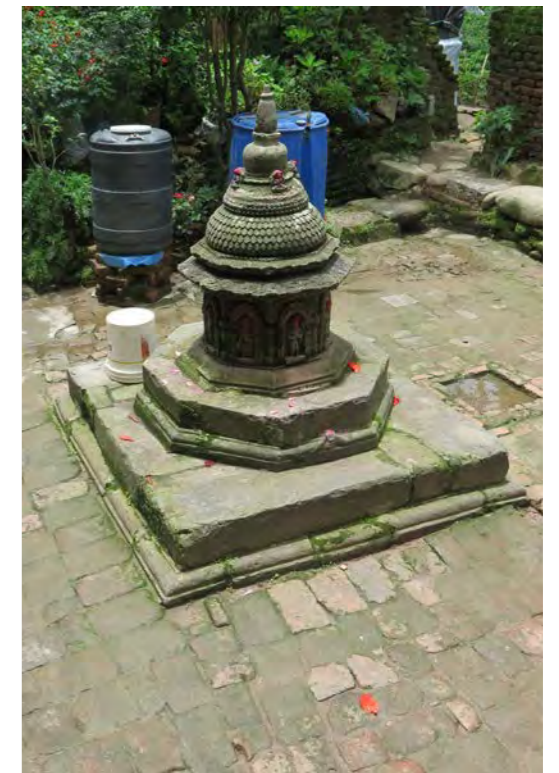
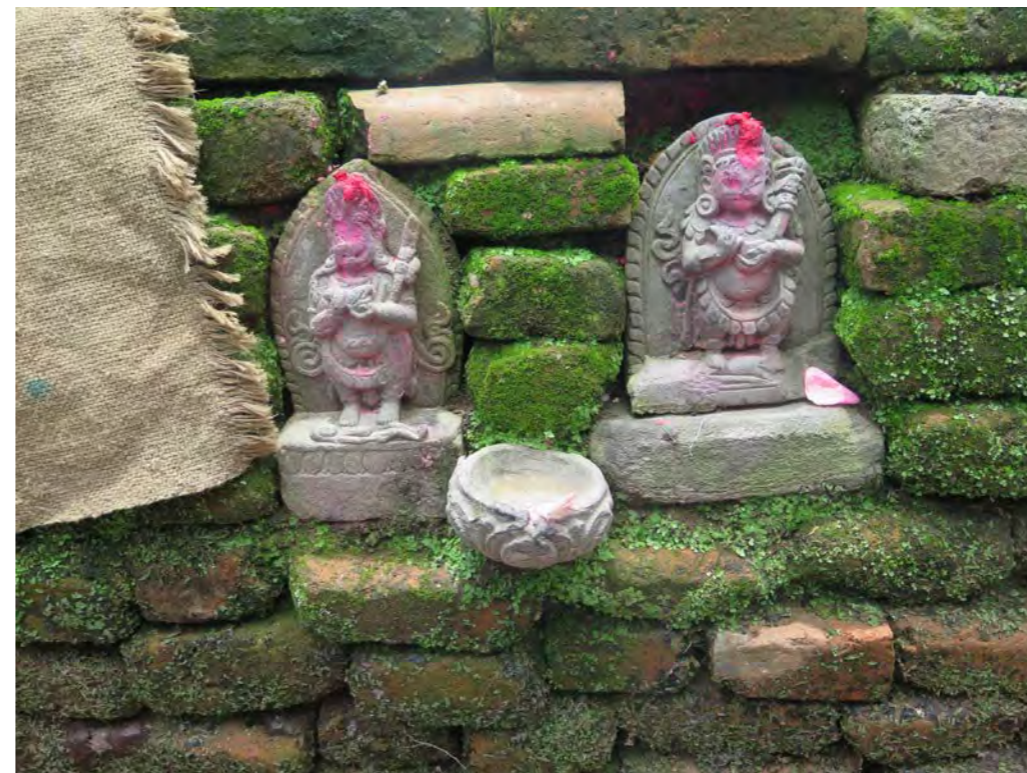
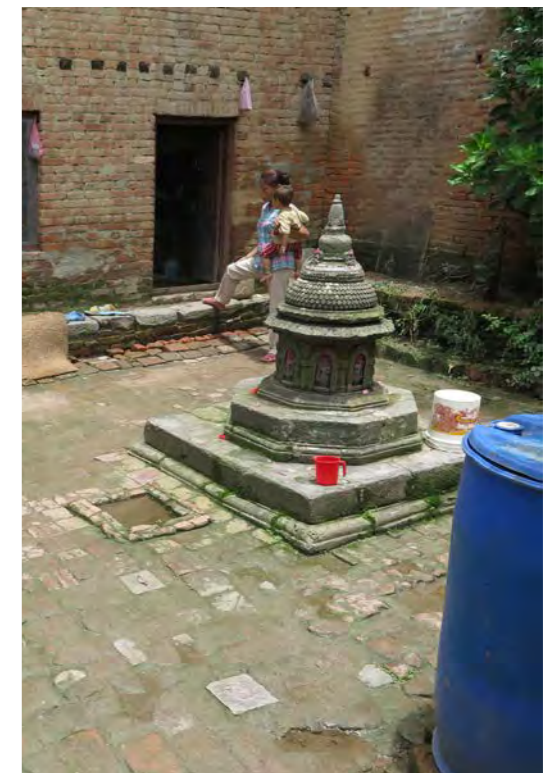
I-14 CHAITYA

NUMBER	NAME	ESTABLISHED DATE (A.D.)	TYPOLOGY	GENERAL DESCRIPTION	PROBLEMS DESCRIPTION	DANGER/ DESTROY
I-14			Chaitya	Chaitya with 8 images. 2 little statues on western wall of courtyard.	No visible damage.

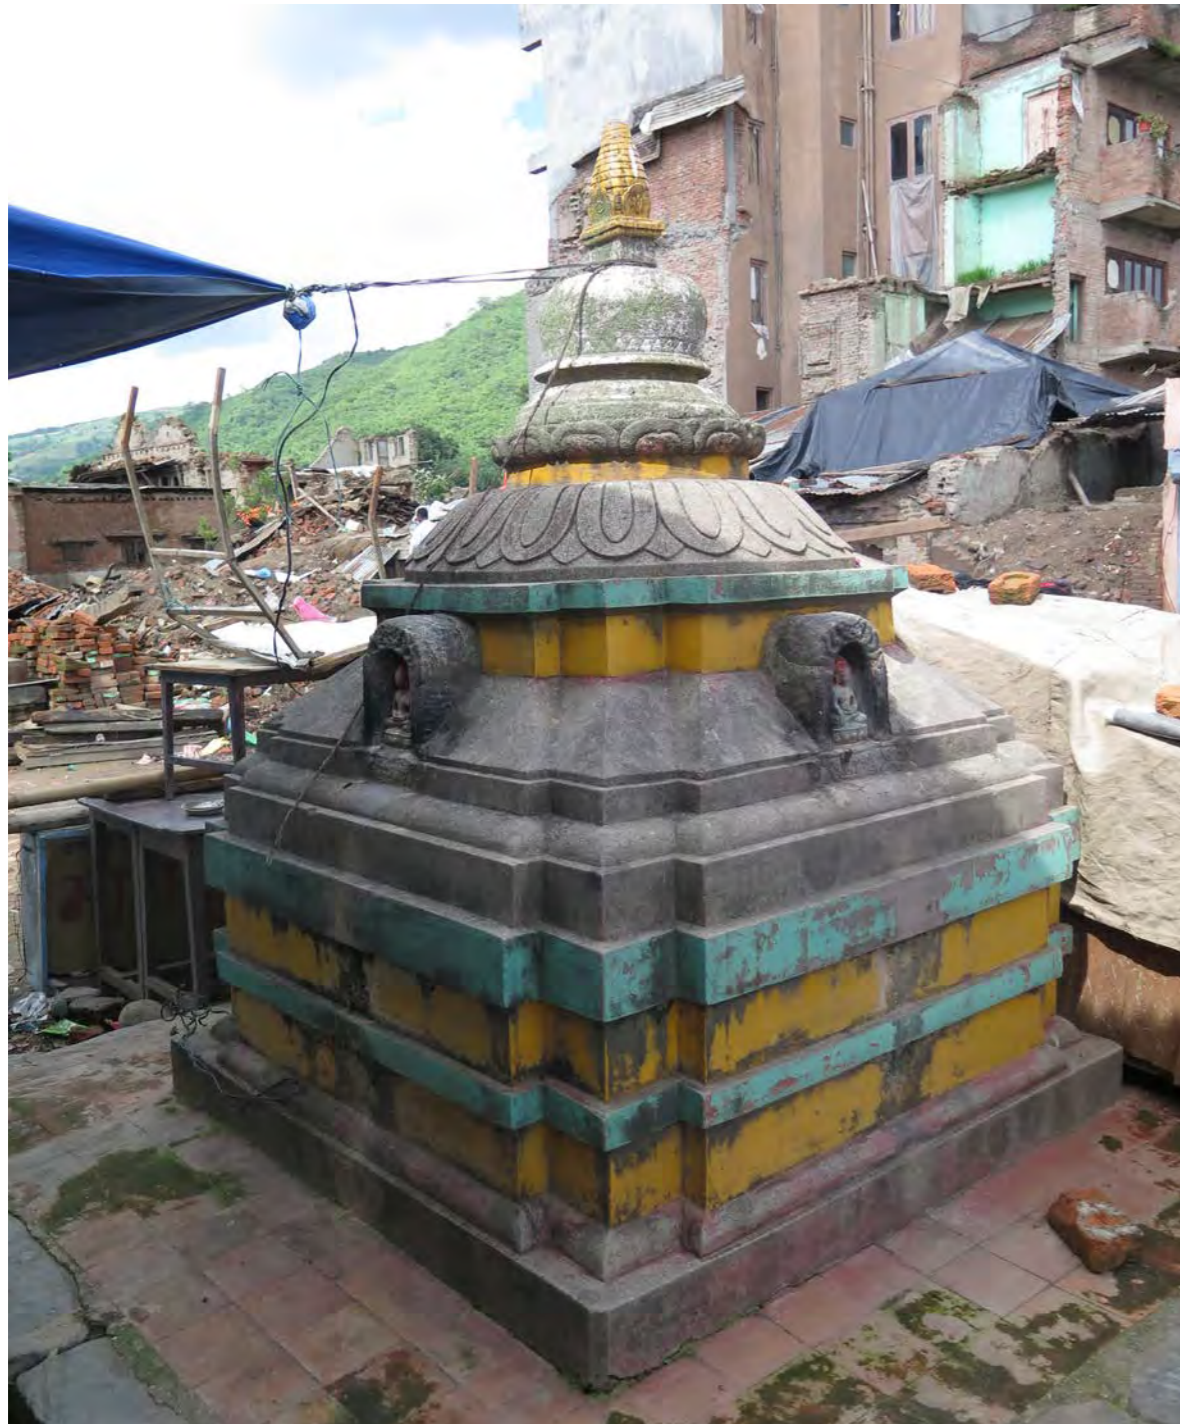
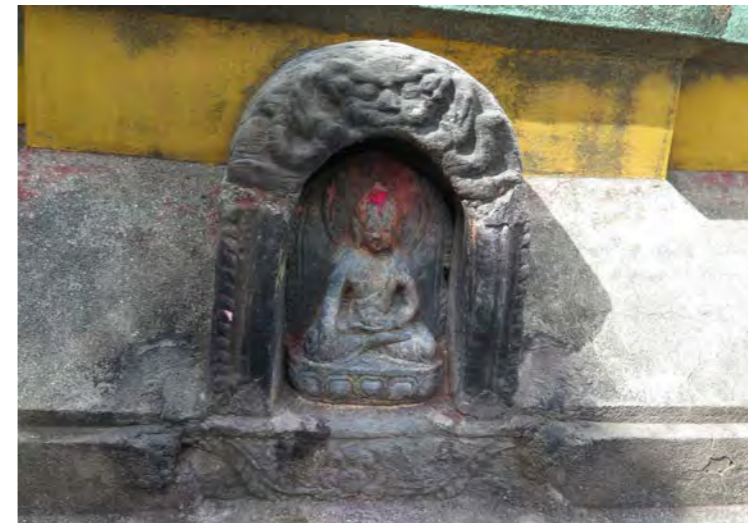
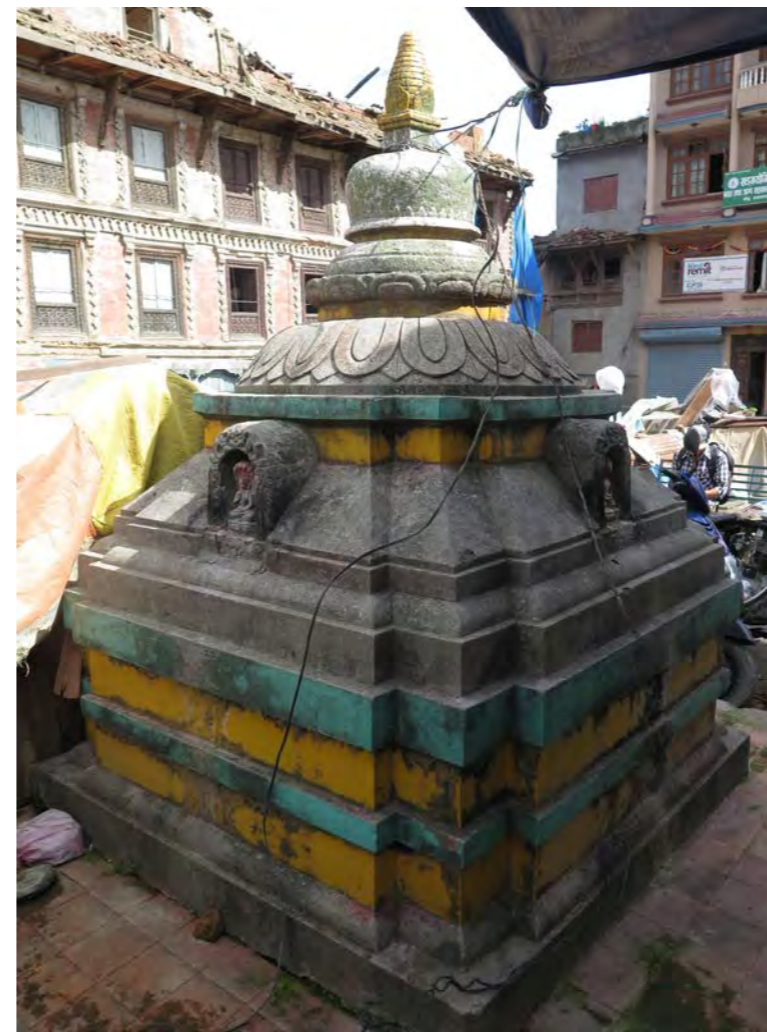
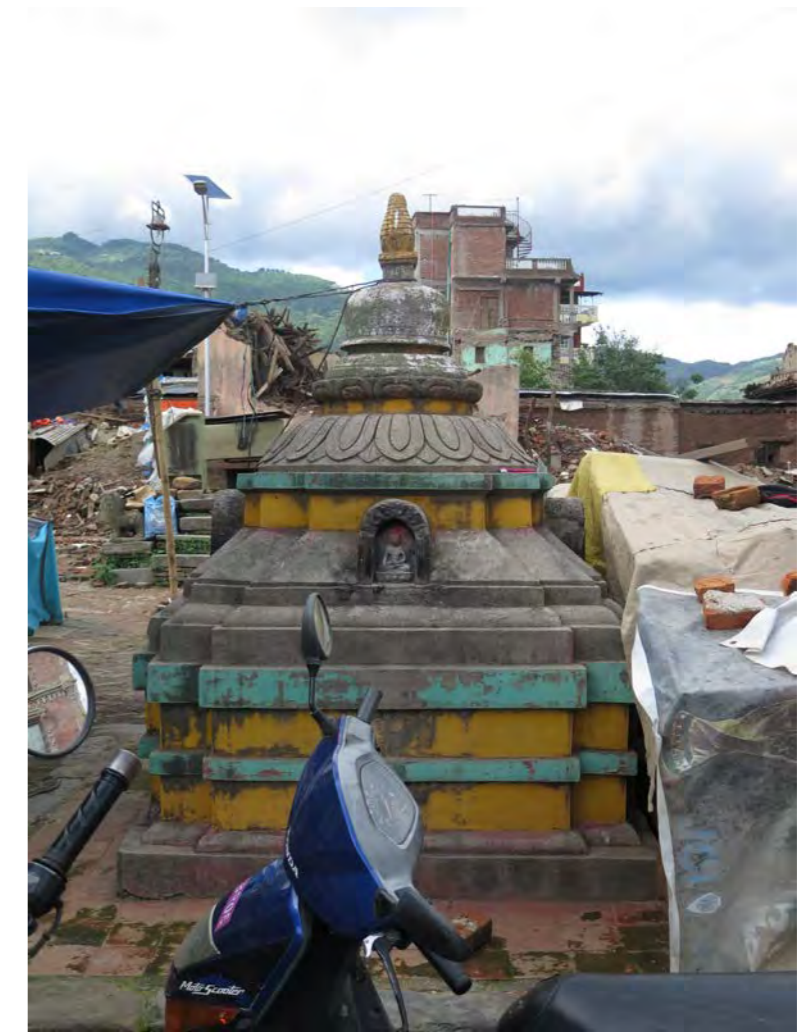
J-02 CHAITYA

NUMBER	NAME	DATE A.D.	TYPOLOGY	GENERAL DESCRIPTION	PROBLEMS DESCRIPTION	DANGER/ DESTROY
J-02			Chaitya	Brick chaitya plastered	In good condition

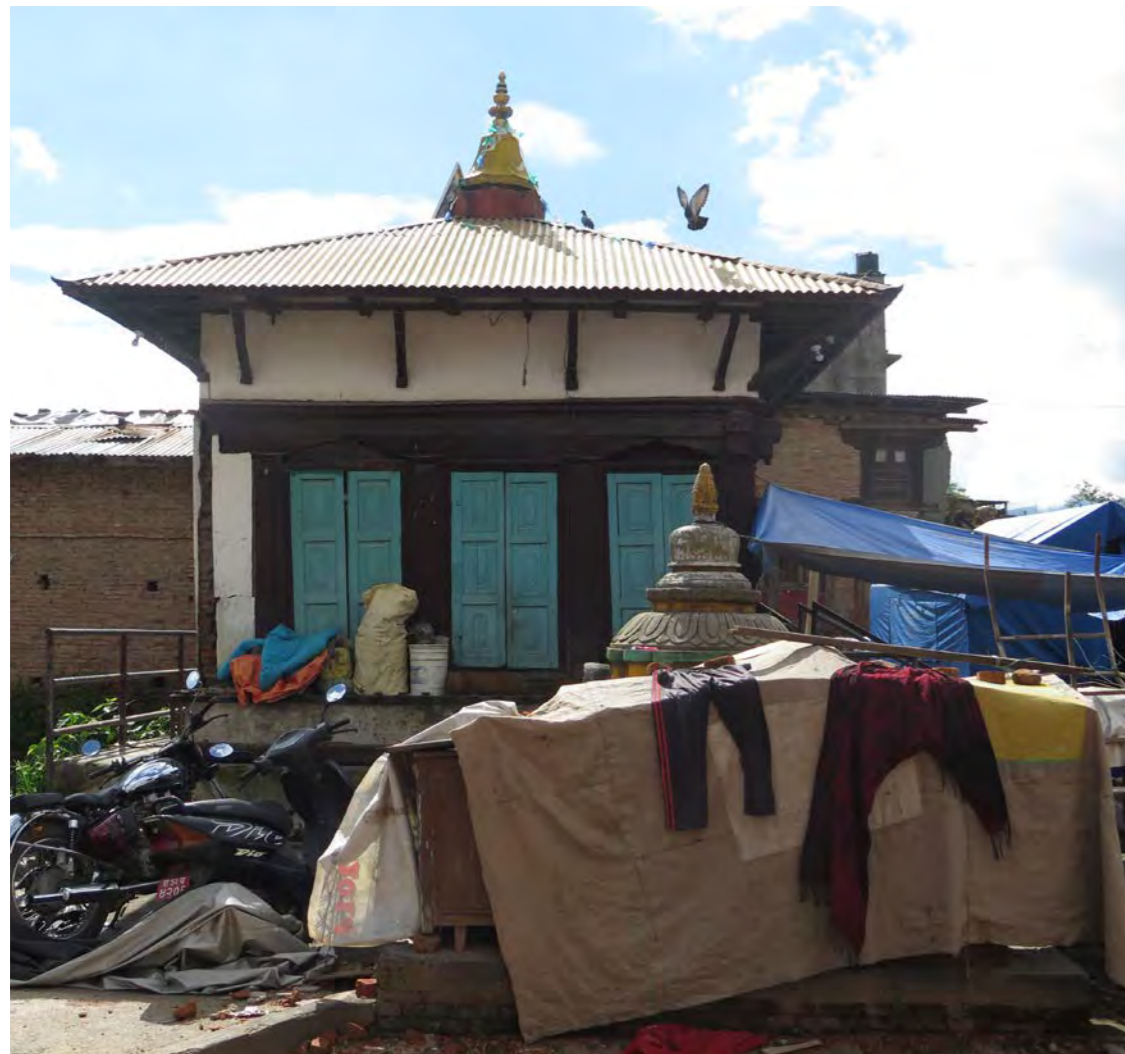
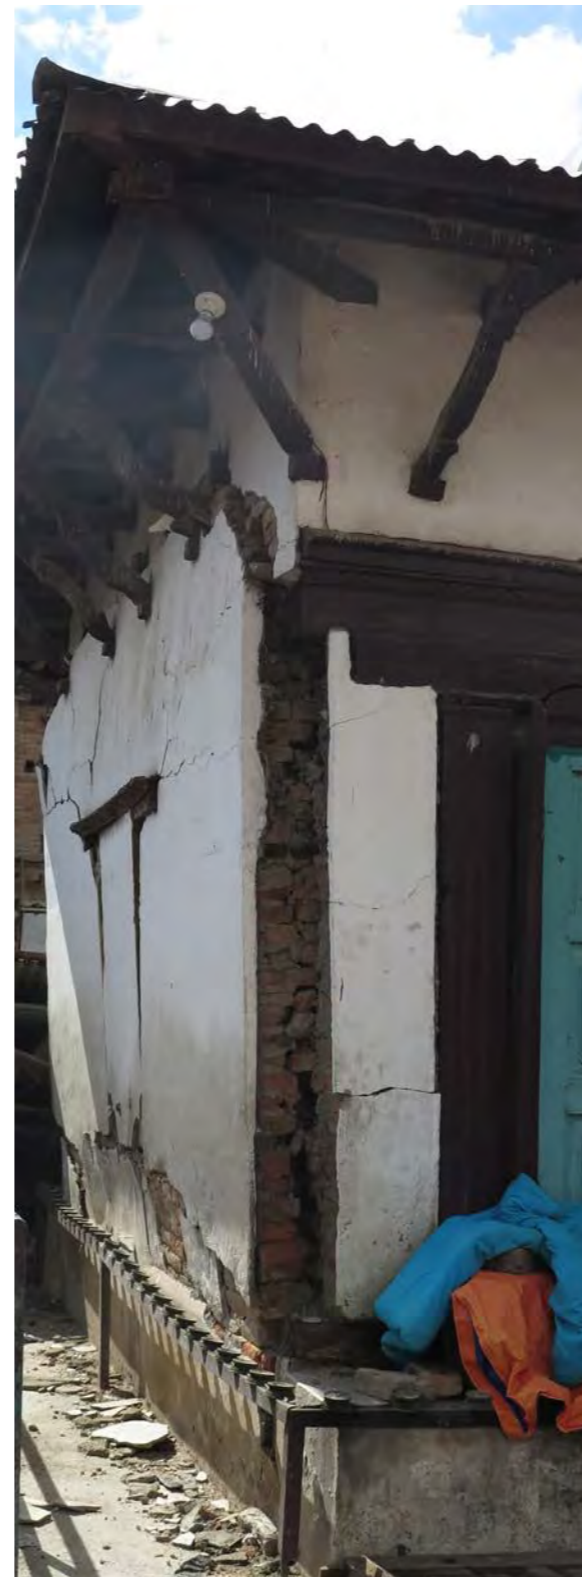
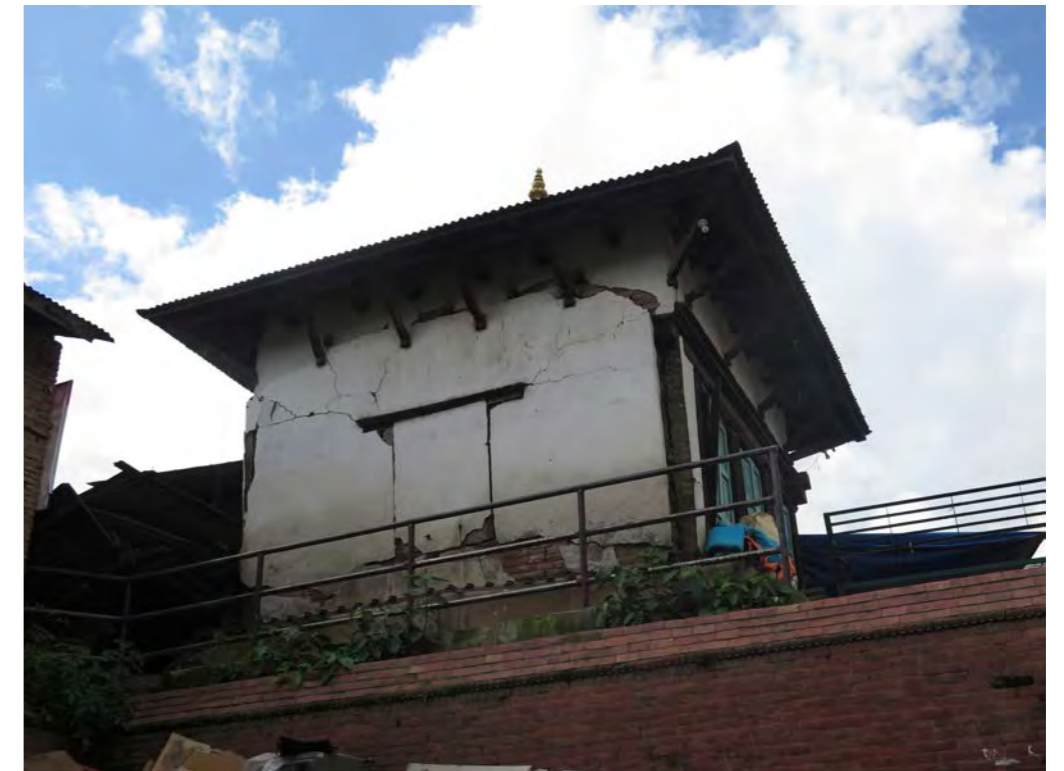
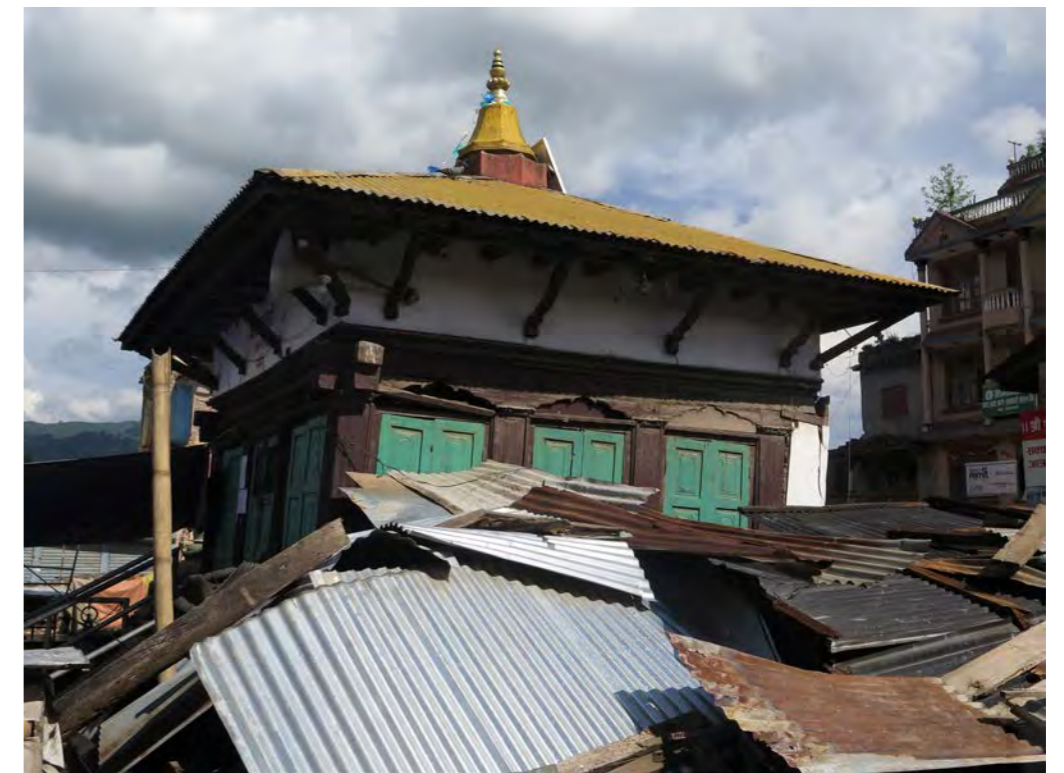
J-03 KUMARI MANDAP

NUMBER	NAME	ESTABLISHED DATE (A.D.)	TYPOLOGY	GENERAL DESCRIPTION	PROBLEMS DESCRIPTION	DANGER/ DESTROY
J-03	Kumari man-dap/ Shree Ram Jhupadi		Single Storey Temple	Bhajan Space 1 storey tired structure	Whole building tilting towards south. South wall cracking, seperating and offsetting.	D! R
