2015 Earthquake Damage Mapping

Sankhu

October 2015

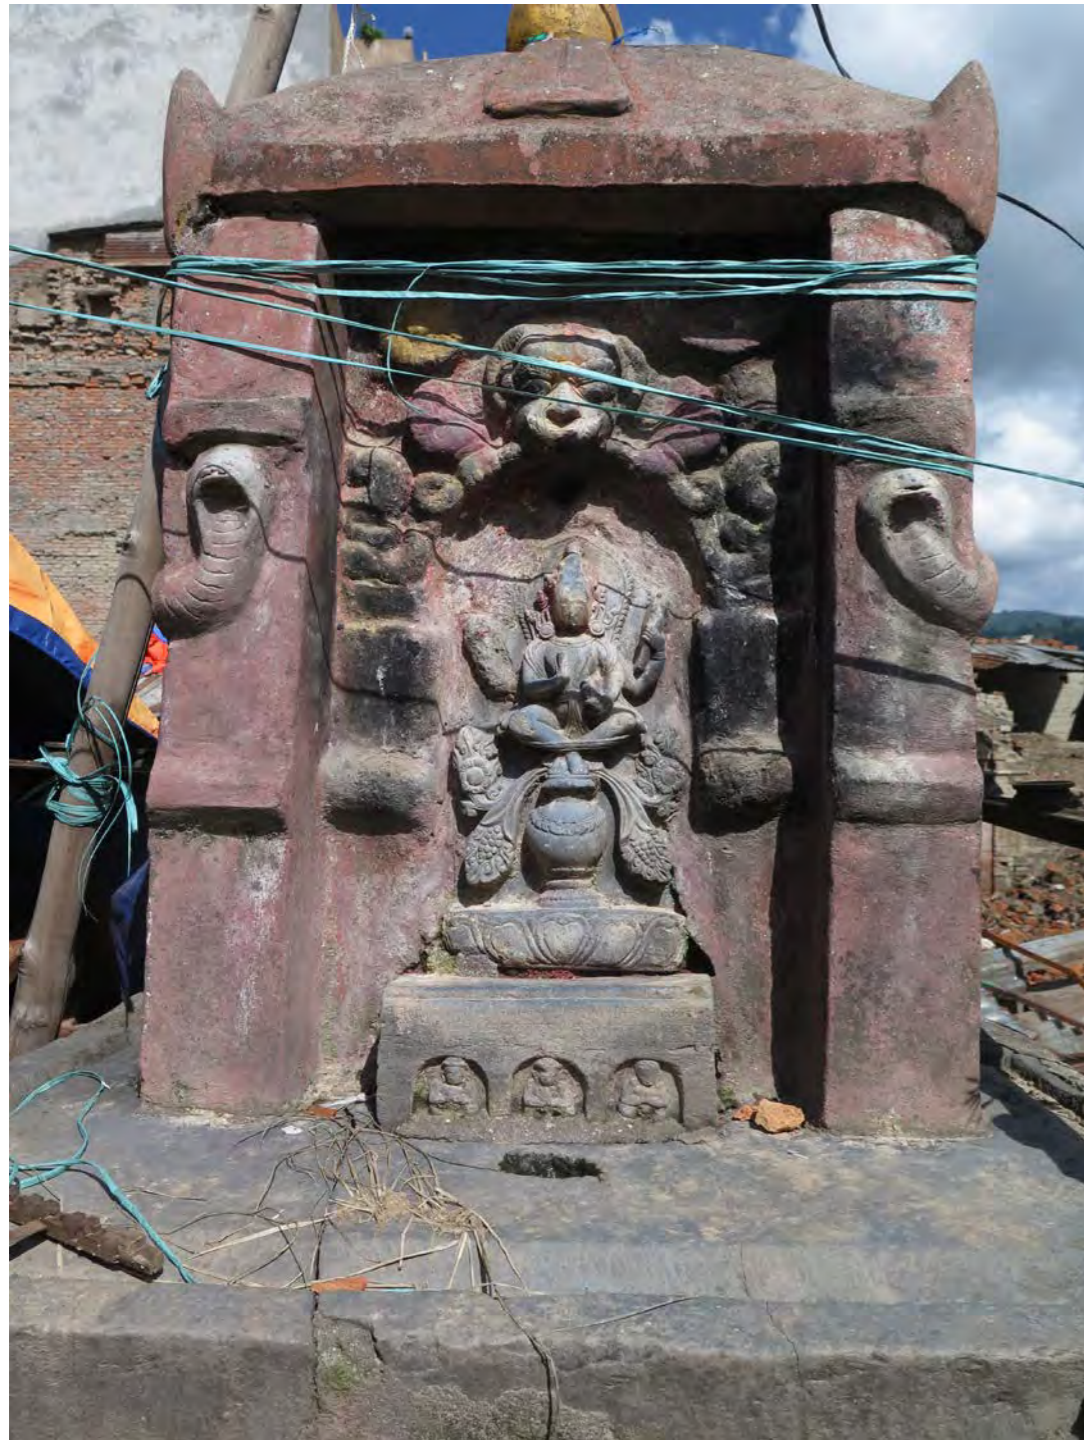
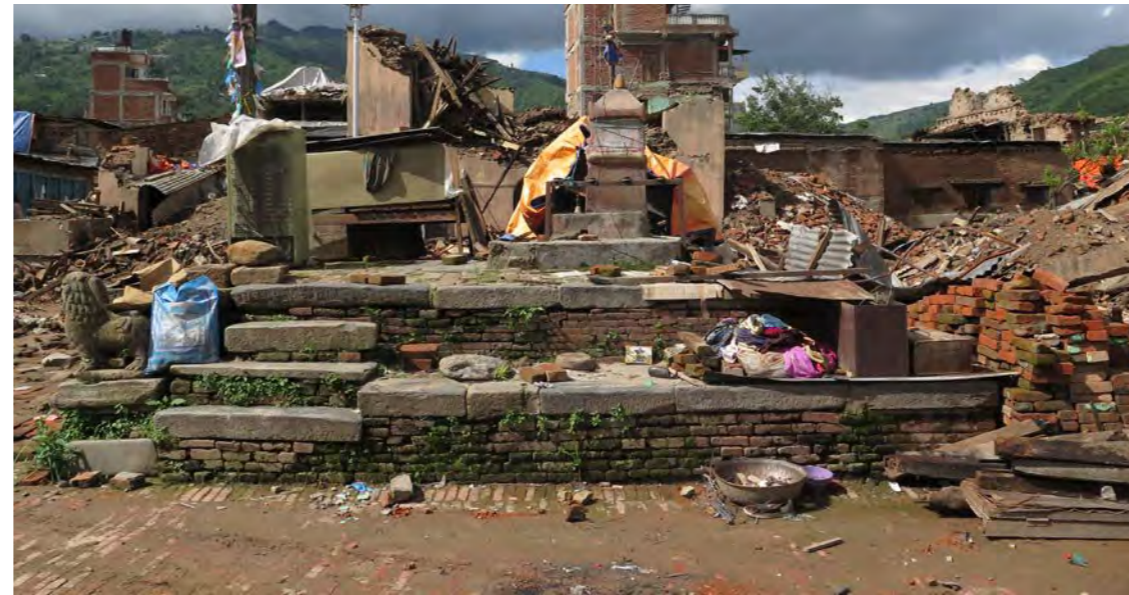
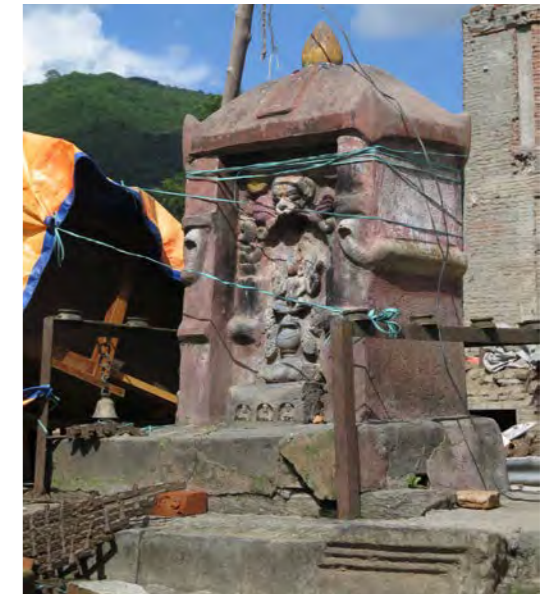
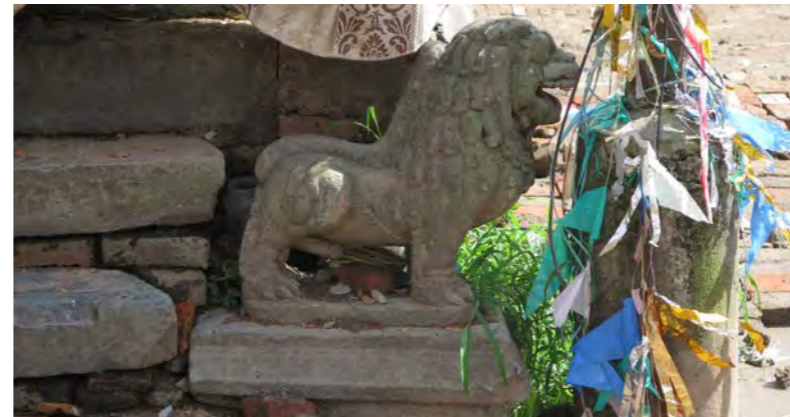
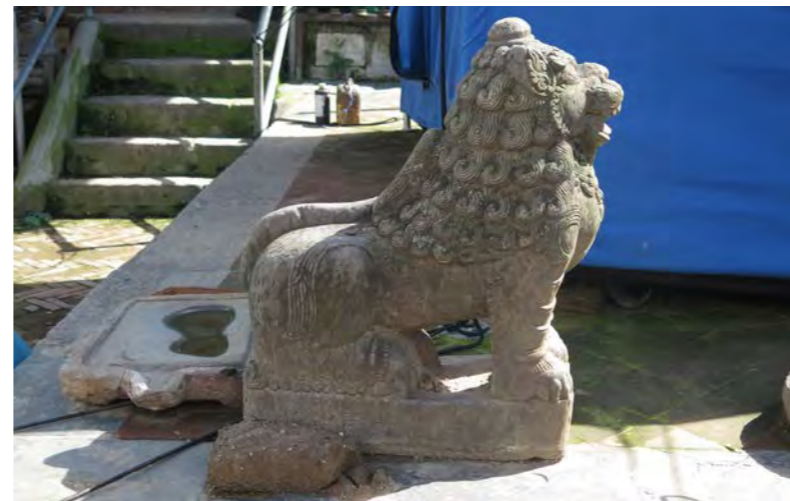
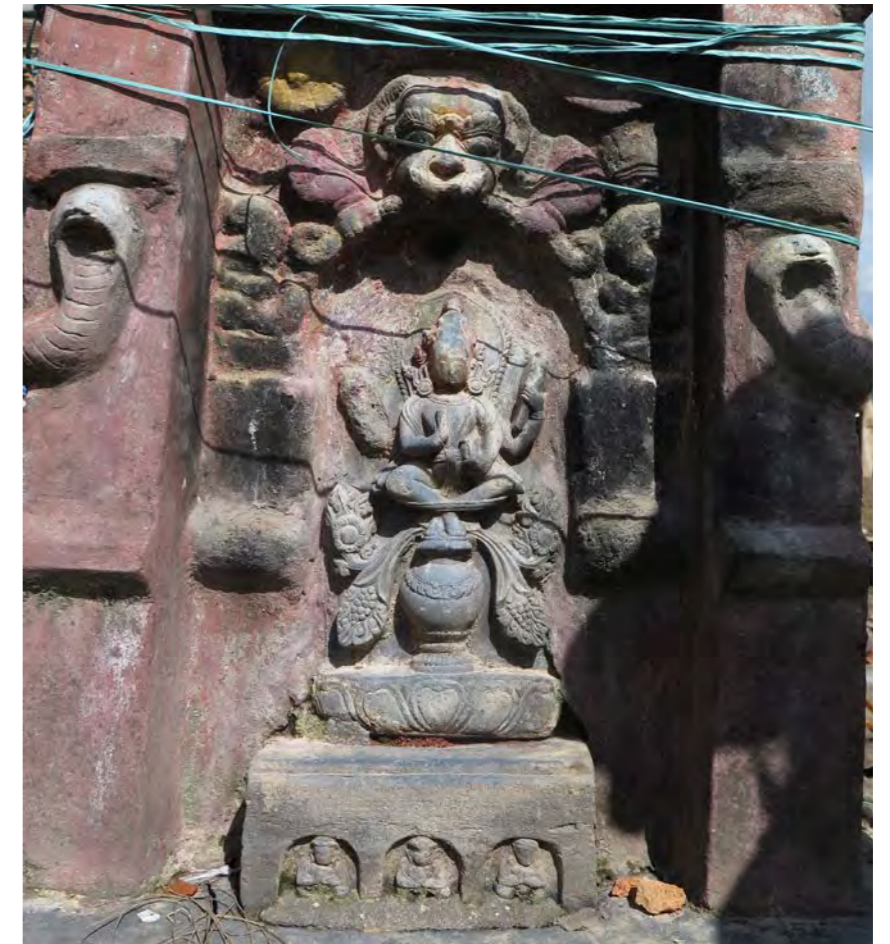
J-04 KALASH NARAYAN

NUMBER	NAME	DATE A.D.	TPOLOGY	GENERAL DESCRIPTION	PROBLEMS DESCRIPTION	DANGER/ DESTROY
J-04	Kalash Narayan		Open Shrine		Frame is degraded. Vegetation growing on platform and bricks out of place. Rising damp. South west corner tilting and offsetting. Nose of lion in south west lost.

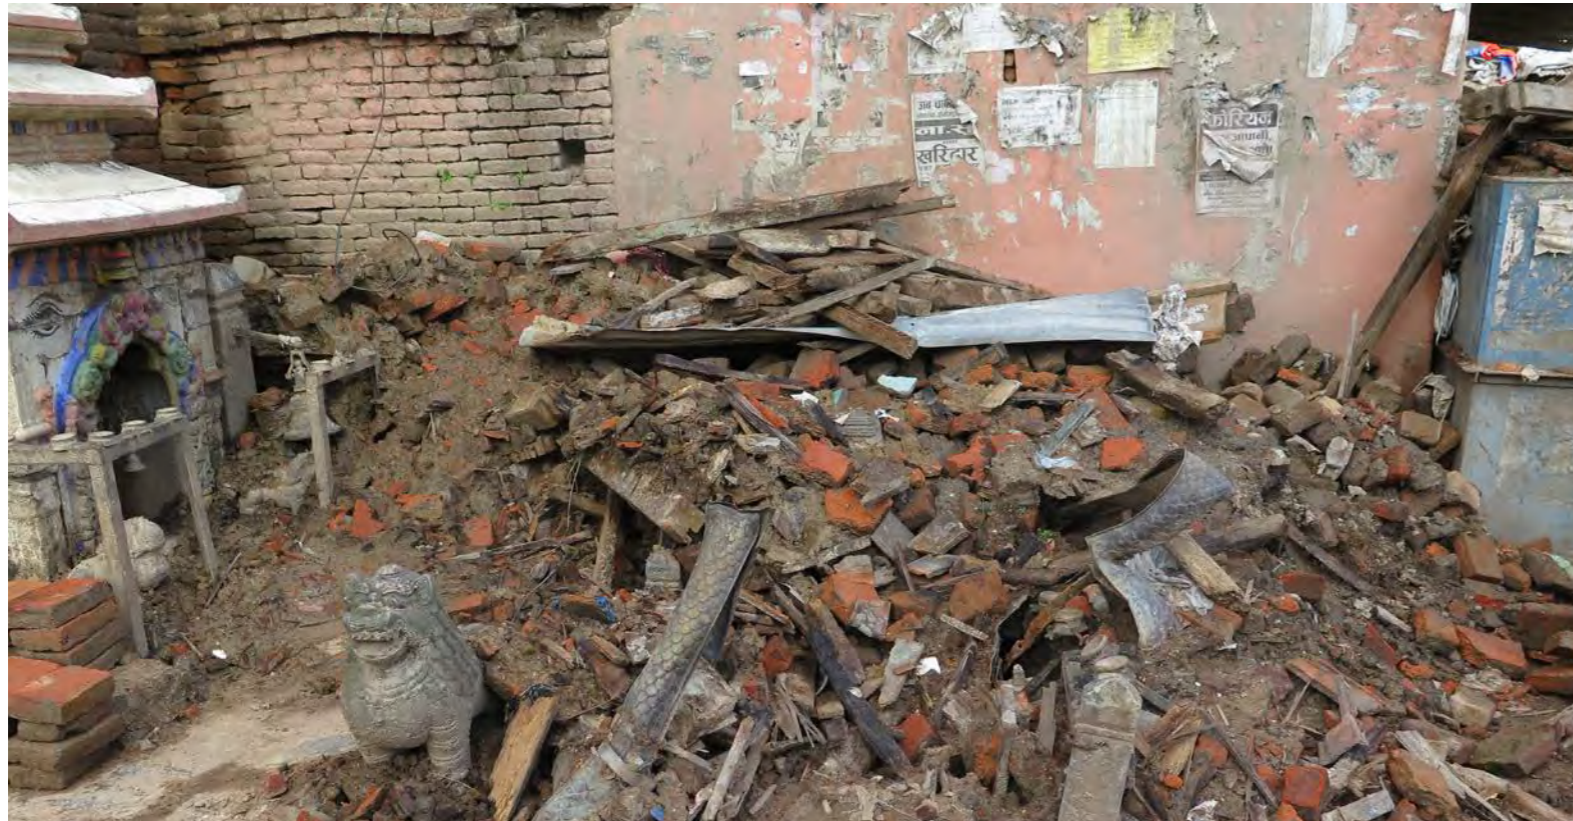
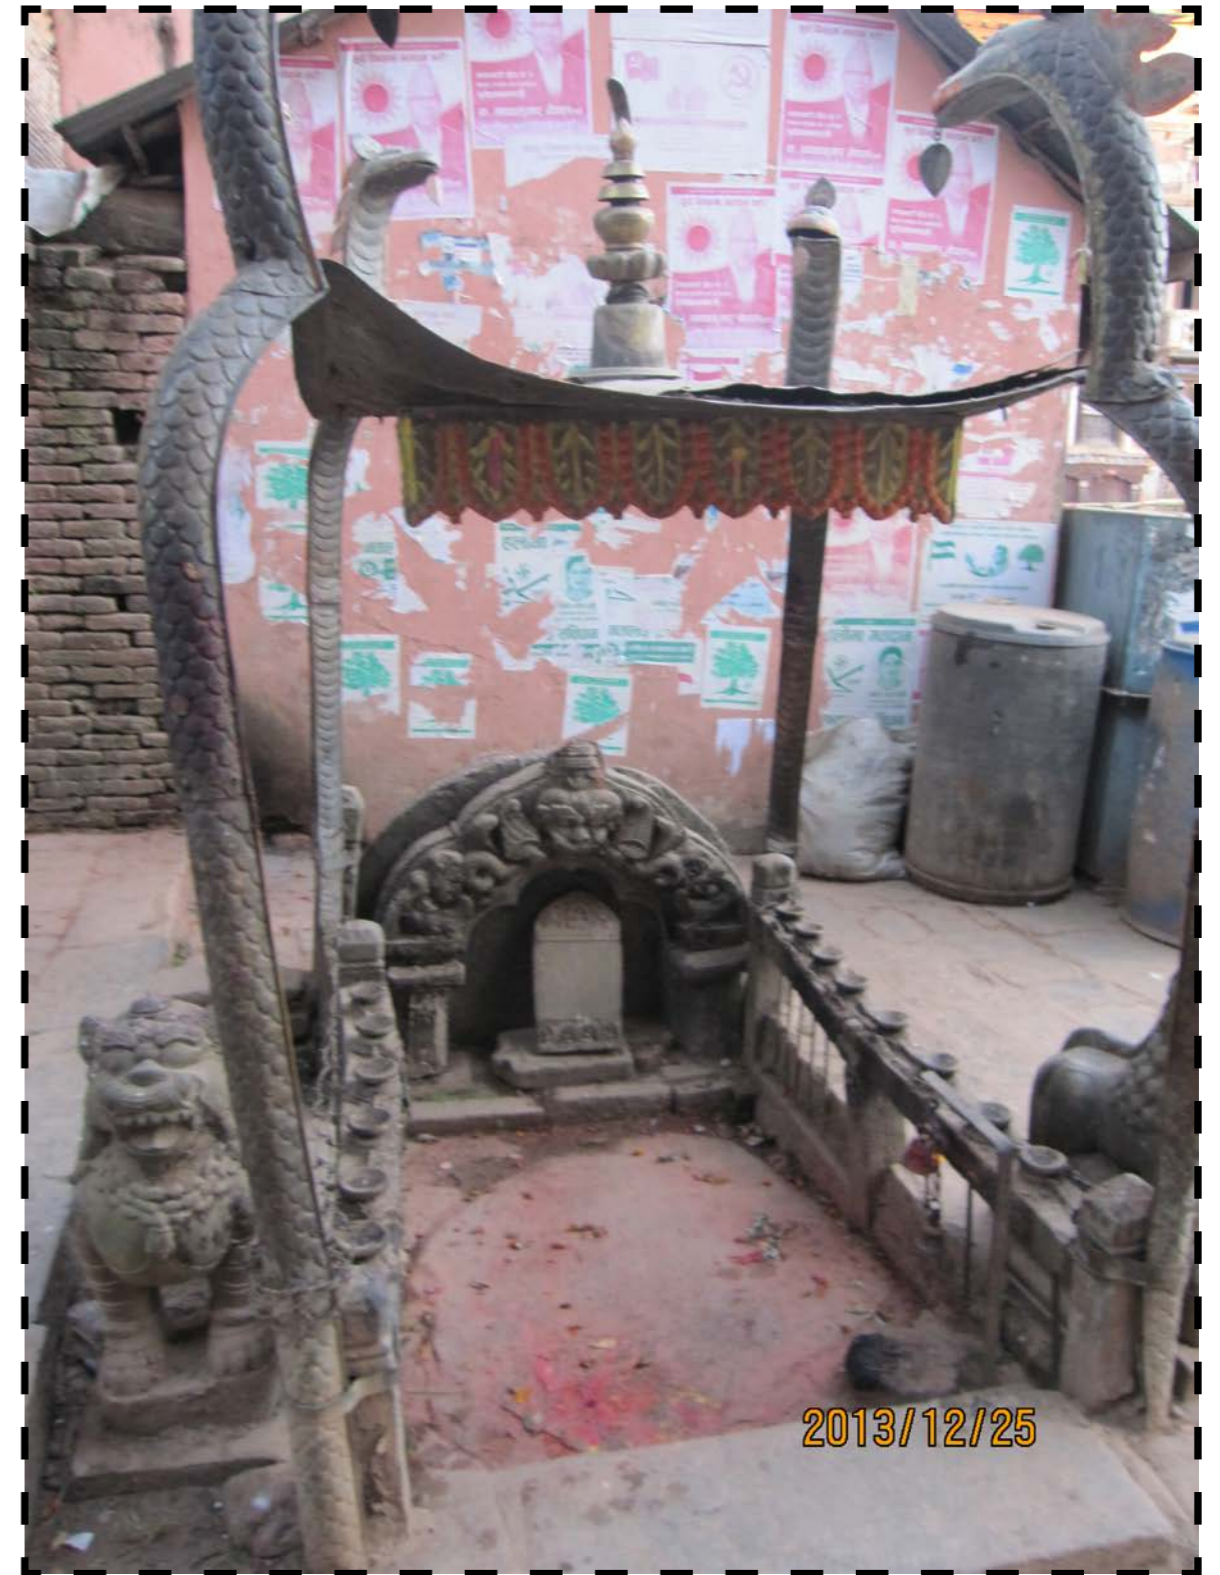
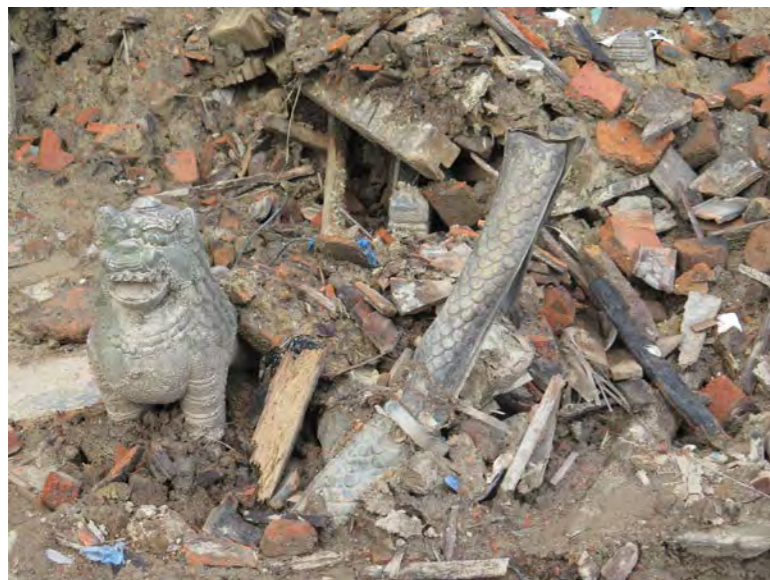
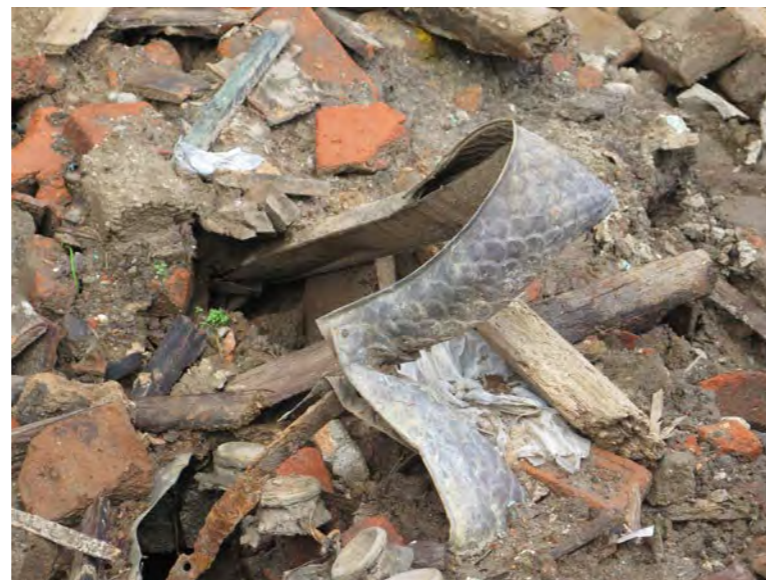
J-08 BHI LOAH SHRINE

NUMBER	NAME	ESTABLISHED DATE (A.D.)	TYPOLOGY	GENERAL DESCRIPTION	PROBLEMS DESCRIPTION	DANGER/ DESTROY
J-08	Bhi Loah		Open Shrine		Roof collapsed. Covered by rubbles.

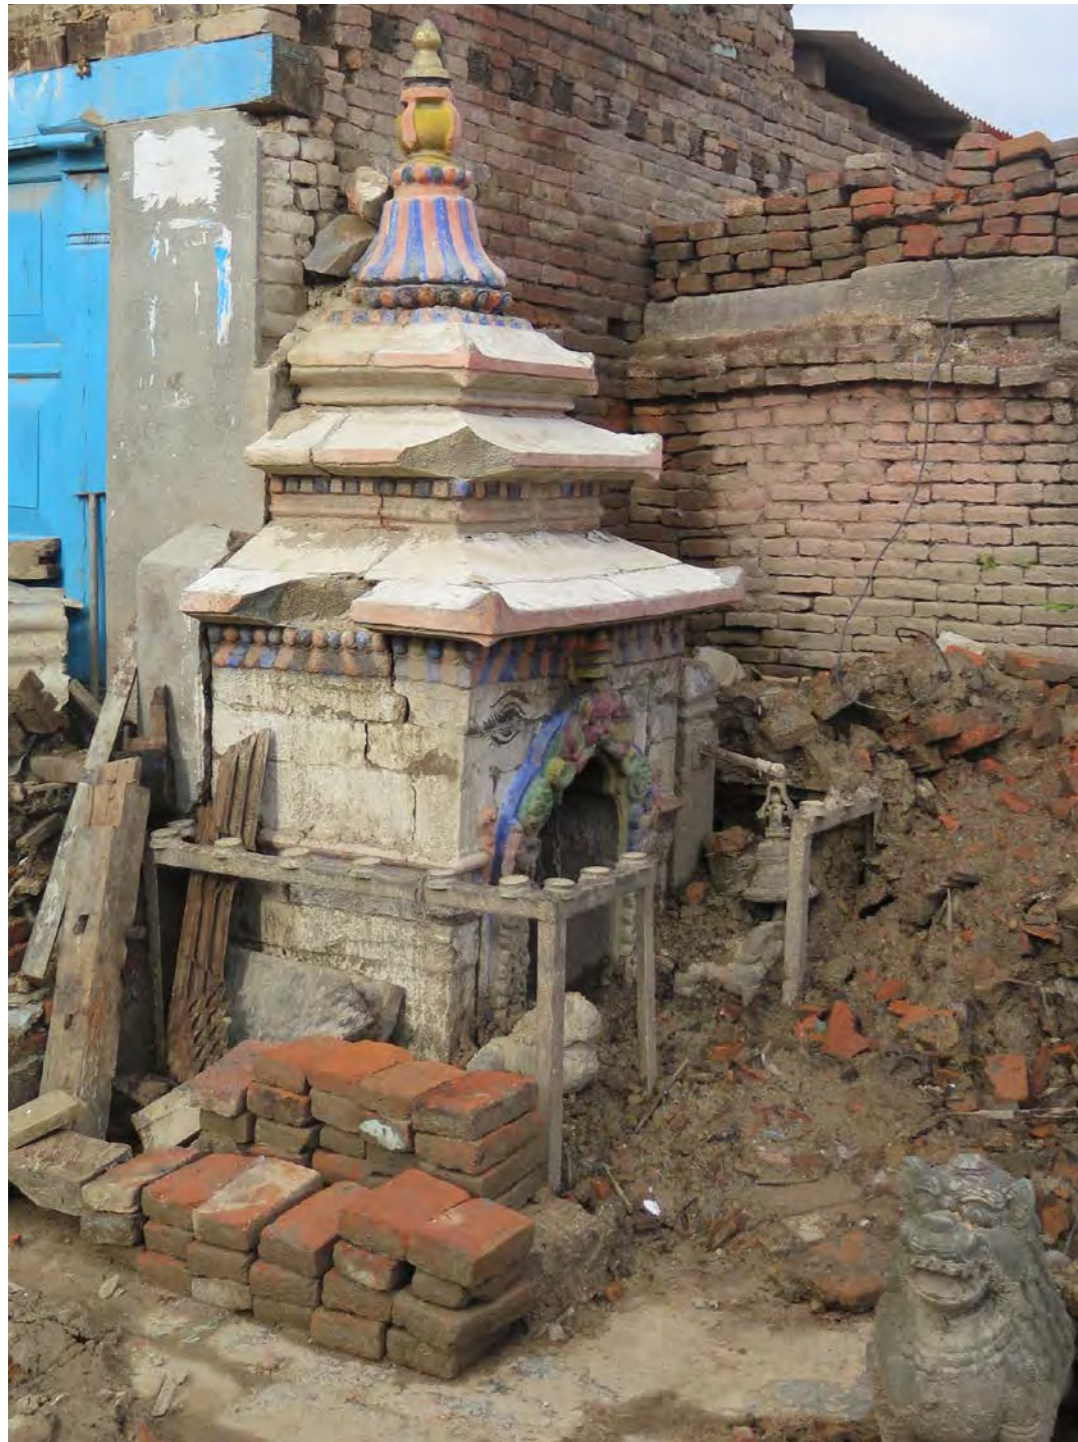
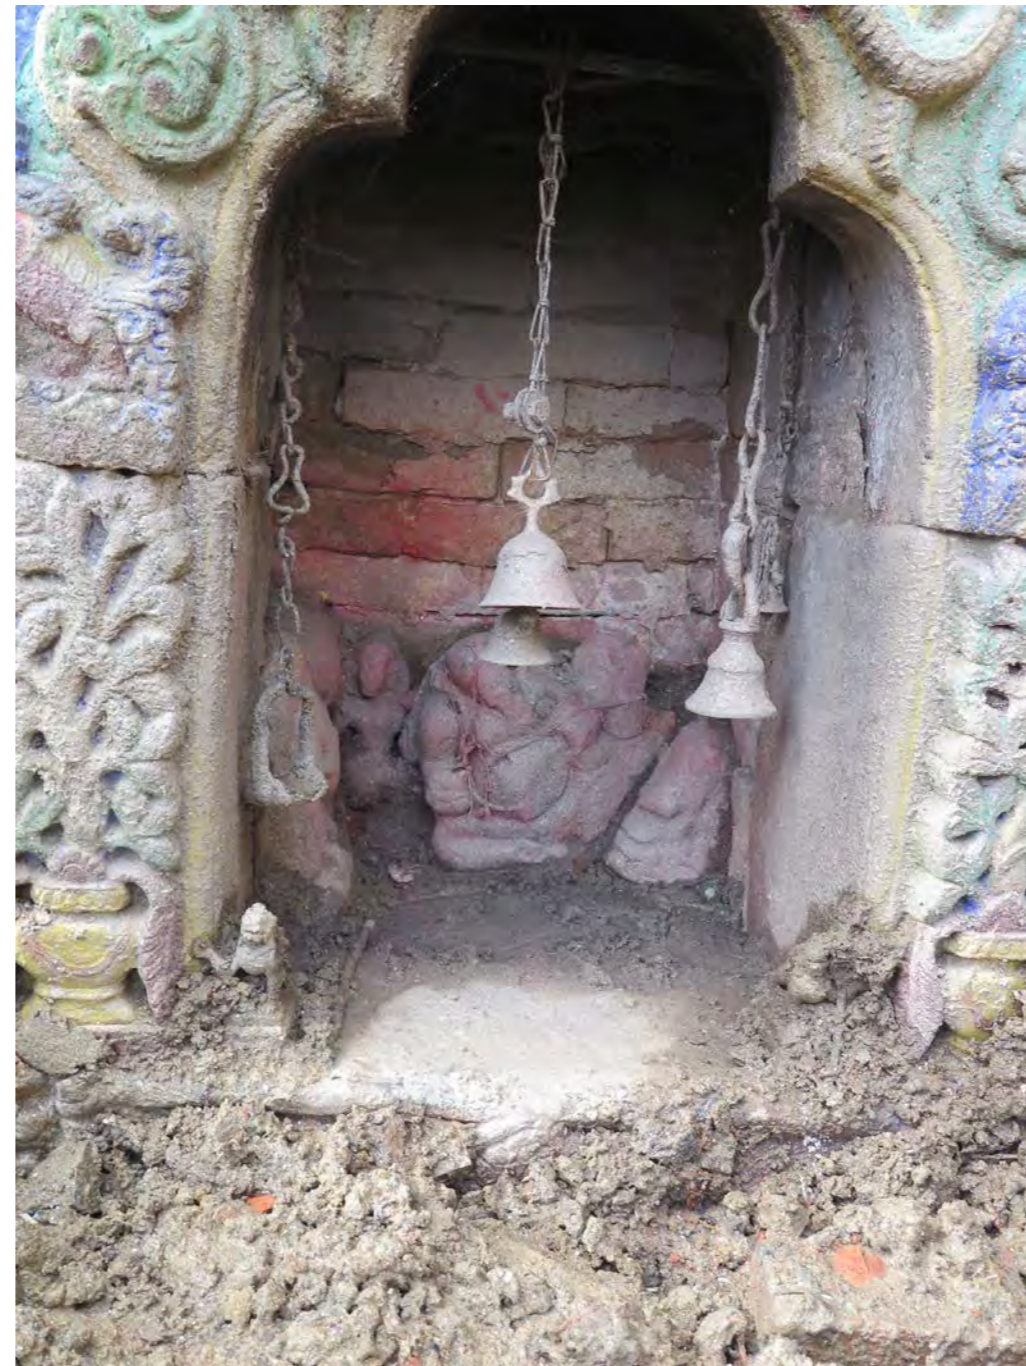
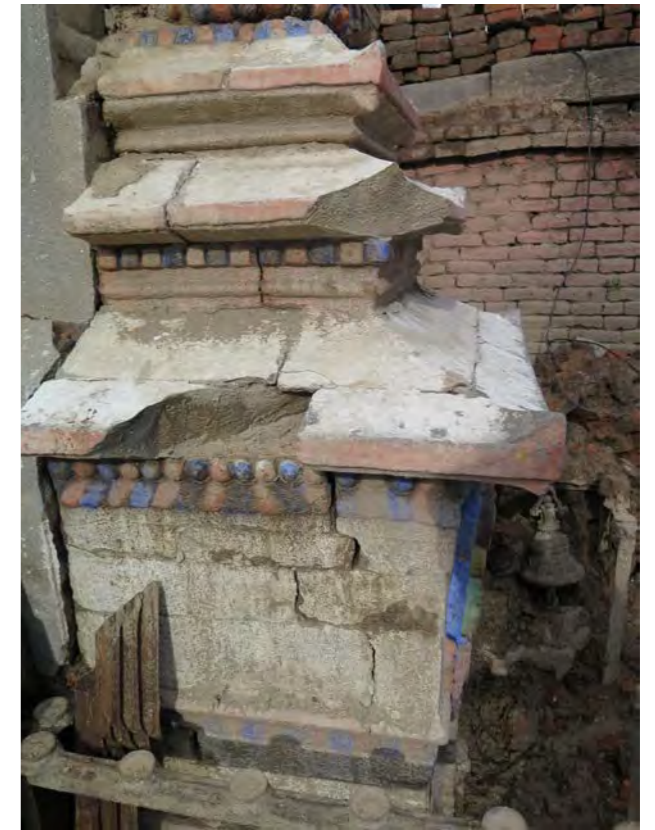
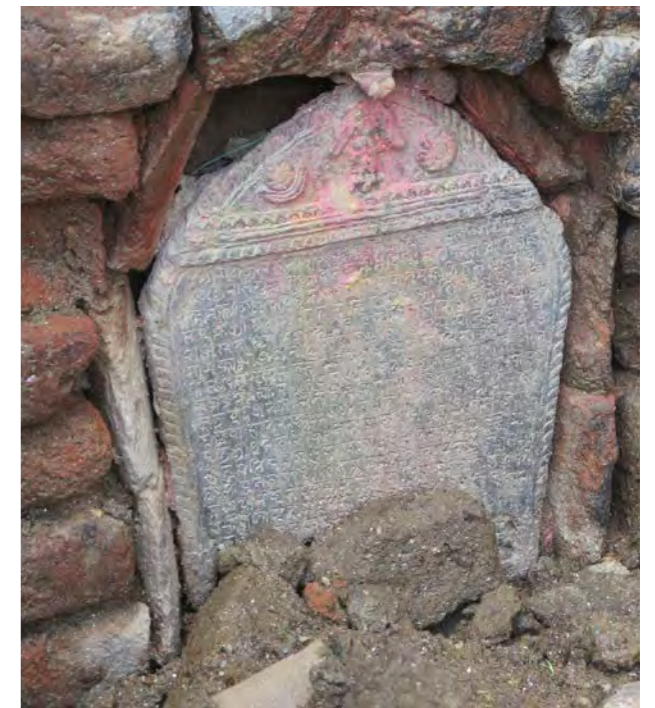
J-09 TWA GANESH

NUMBER	NAME	DATE A.D.	TPOLOGY	GENERAL DESCRIPTION	PROBLEMS DESCRIPTION	DANGER/ DESTROY
J-09	Twa Ganesh		Enclose Shrine	Inscription on the eastern side	Vertical crack on South west corner. South wall cracked. Western roof collapsed.

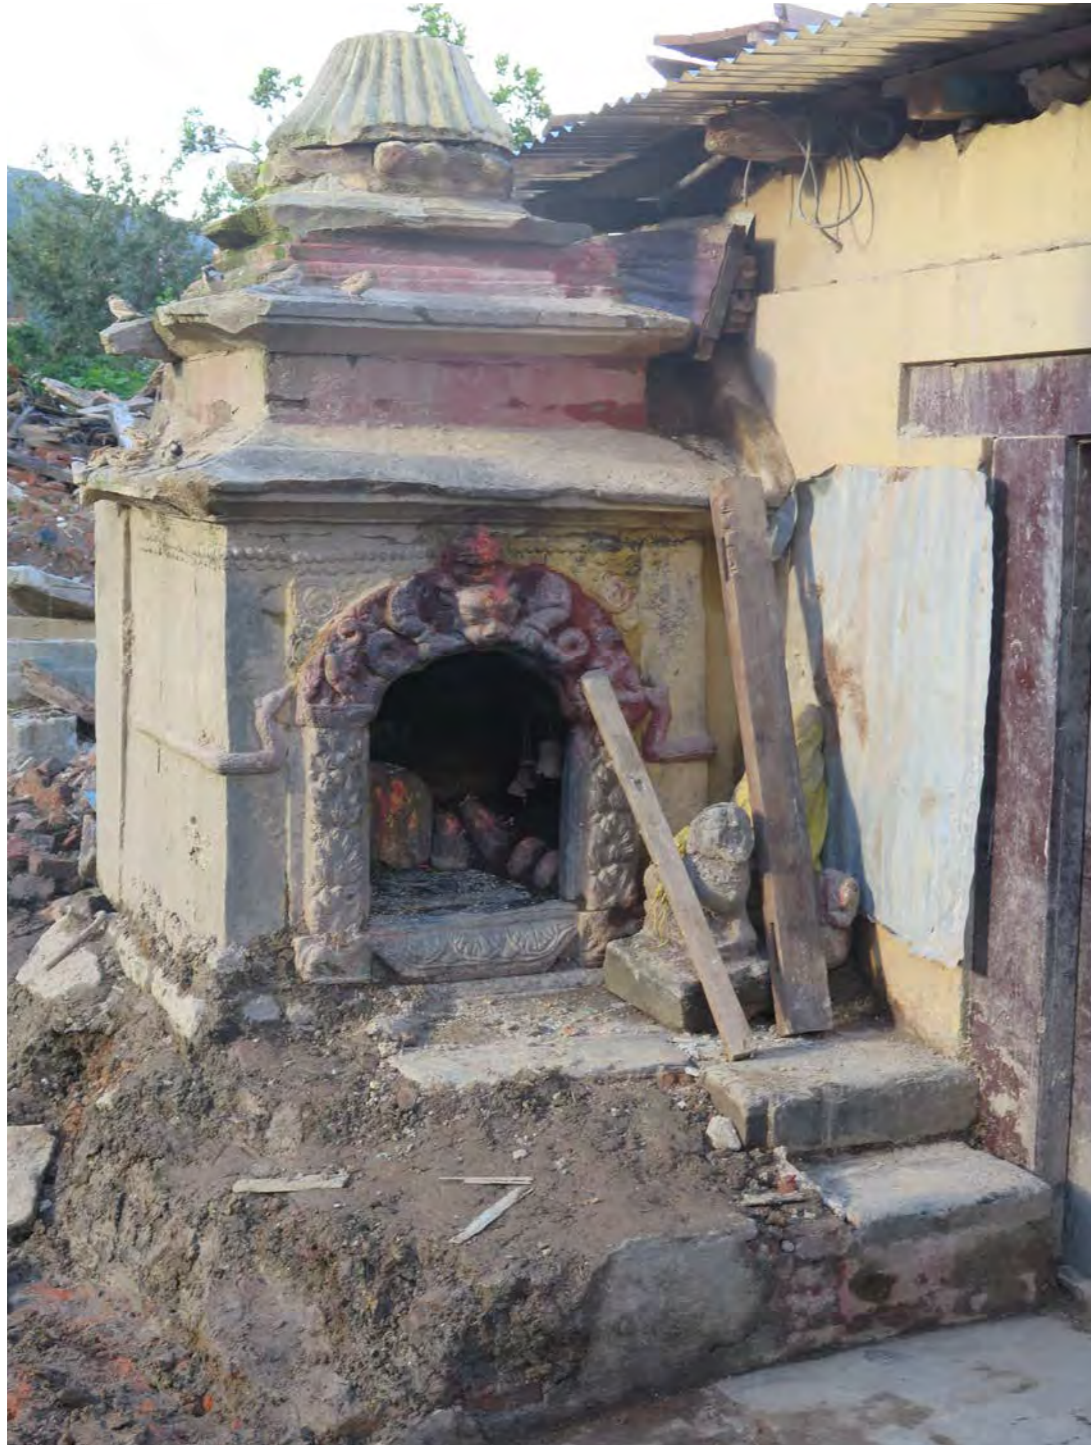
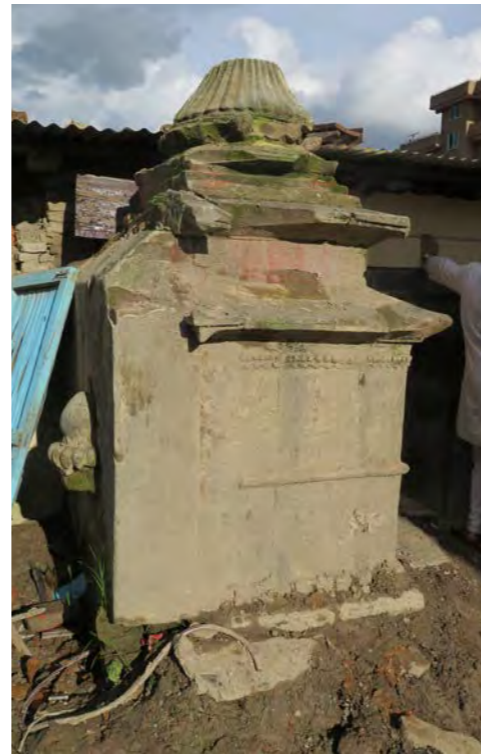
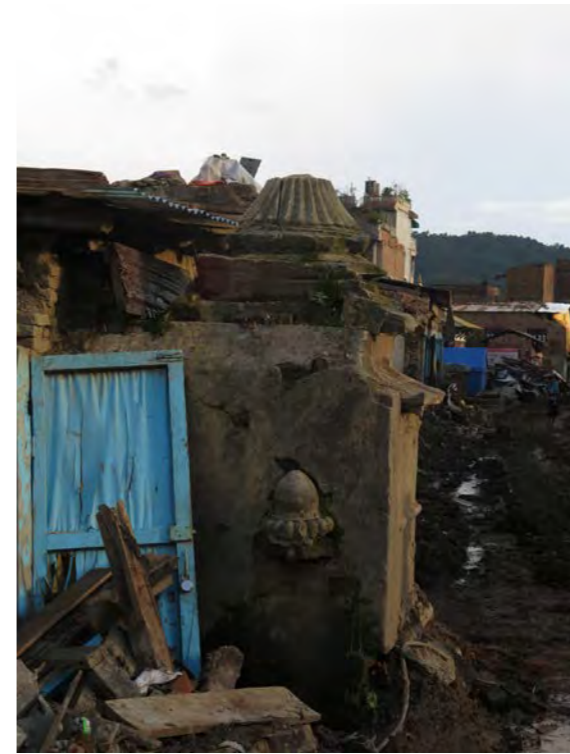
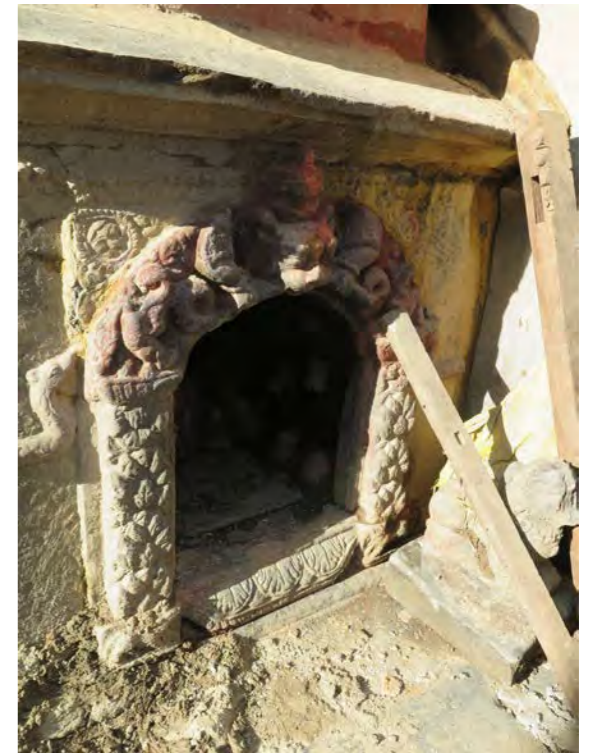
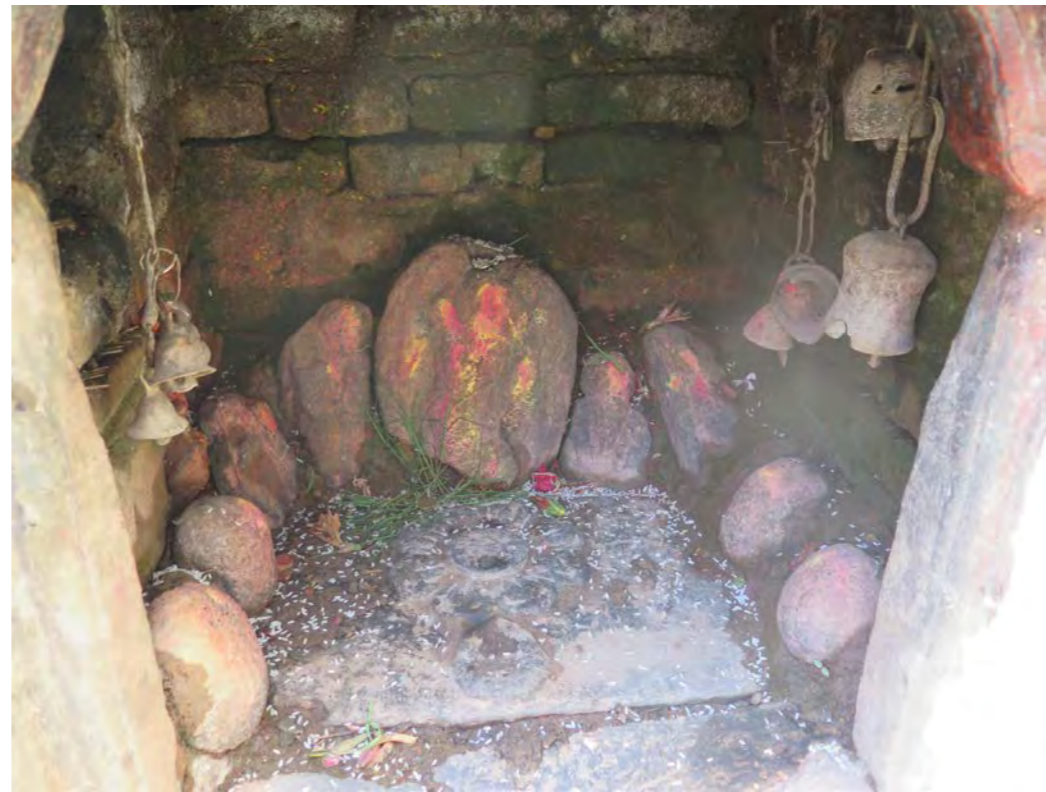
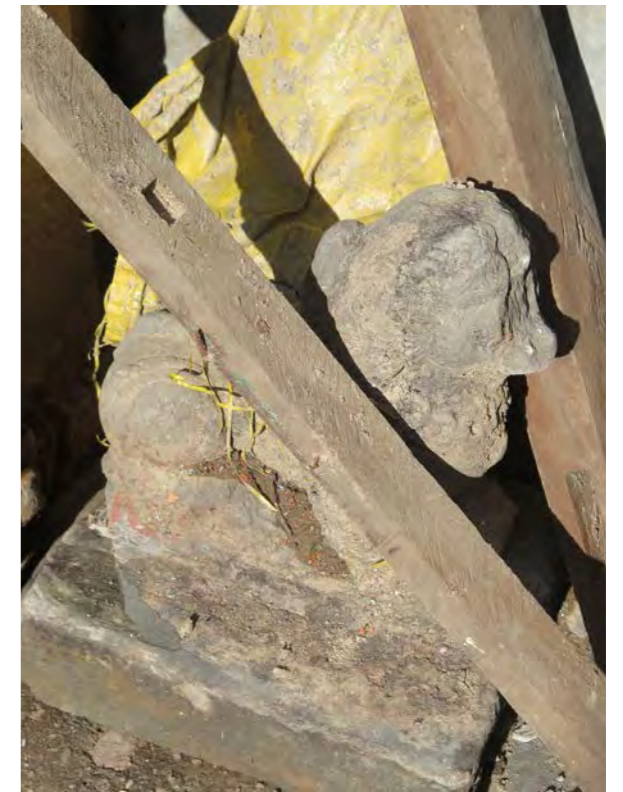
J-13 WAFAL GANESH

NUMBER	NAME	ESTABLISHED DATE (A.D.)	TYPOLOGY	GENERAL DESCRIPTION	PROBLEMS DESCRIPTION	DANGER/ DESTROY
J-13	Wafal Ganesh		Enclosed Shrine	Tap on North side of temple	West side heavily damaged. Pinnacle missing. West plinth and lion moved.

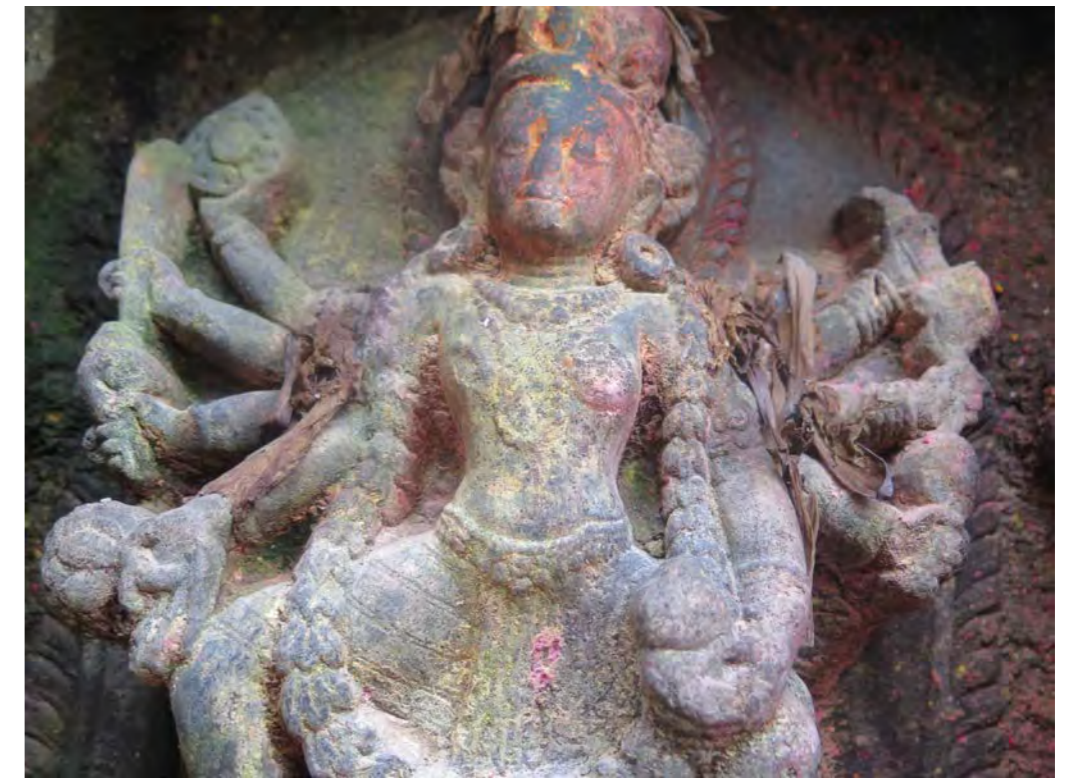
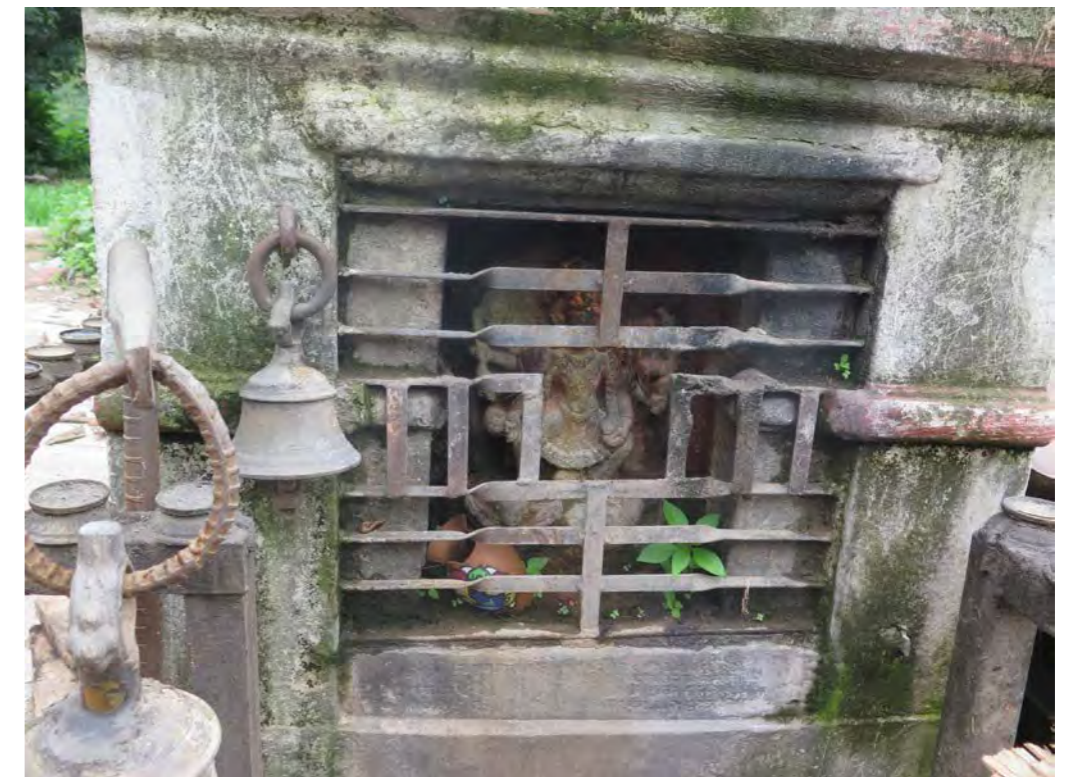
J-16 NARAYAN SHRINE

NUMBER	NAME	DATE A.D.	TPOLOGY	GENERAL DESCRIPTION	PROBLEMS DESCRIPTION	DANGER/ DESTROY
J-16	Narayan Shrine		Enclosed Shrine	Cement plastered	No visible damage

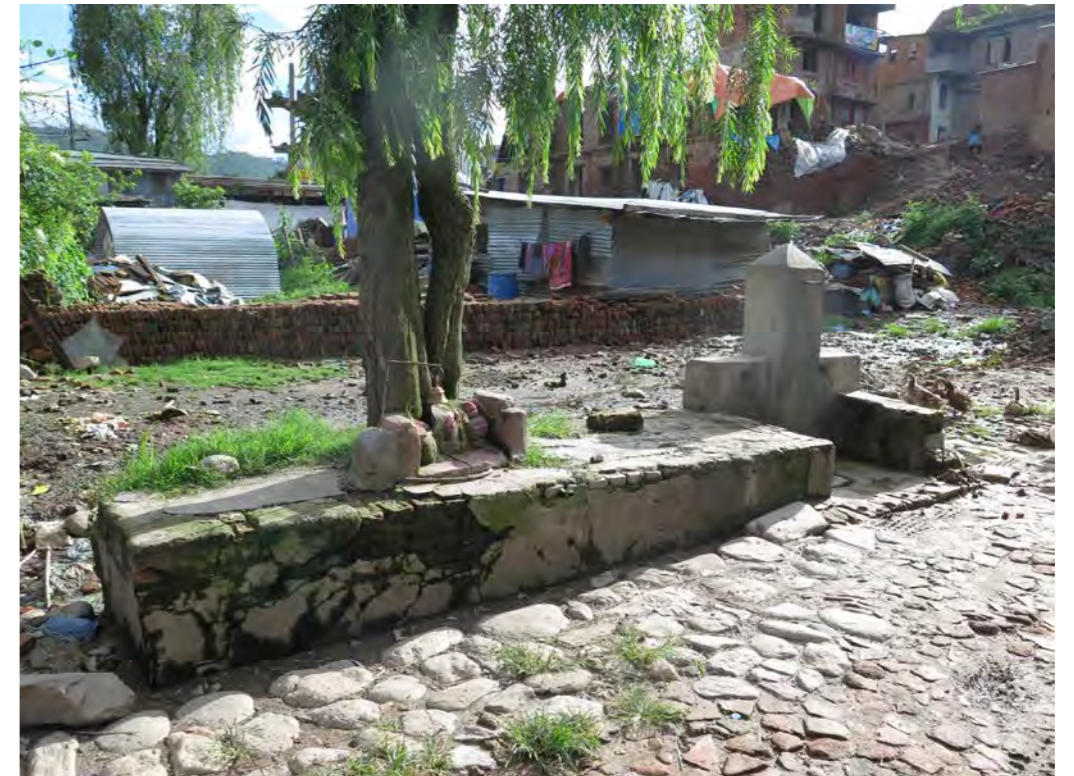
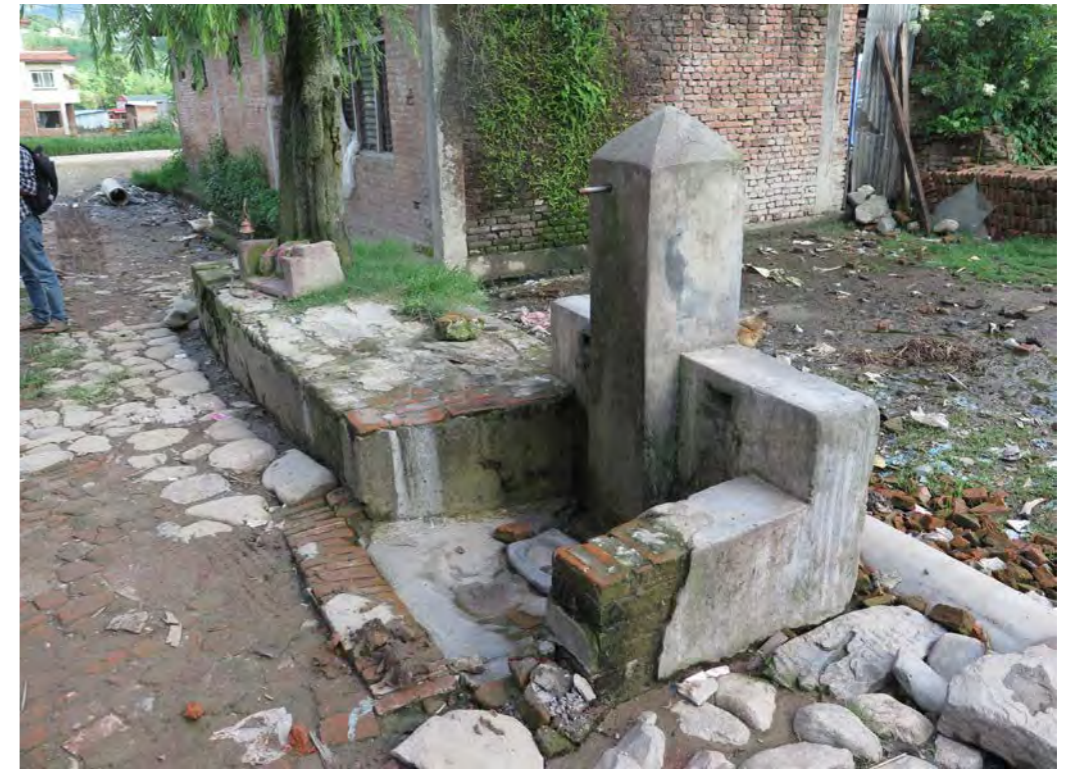
J-20 OPEN SHRINE

NUMBER	NAME	ESTABLISHED DATE (A.D.)	TYPOLOGY	GENERAL DESCRIPTION	PROBLEMS DESCRIPTION	DANGER/ DESTROY
J-20			Open Shrine	Shrine under roof	Base and side wall seperating

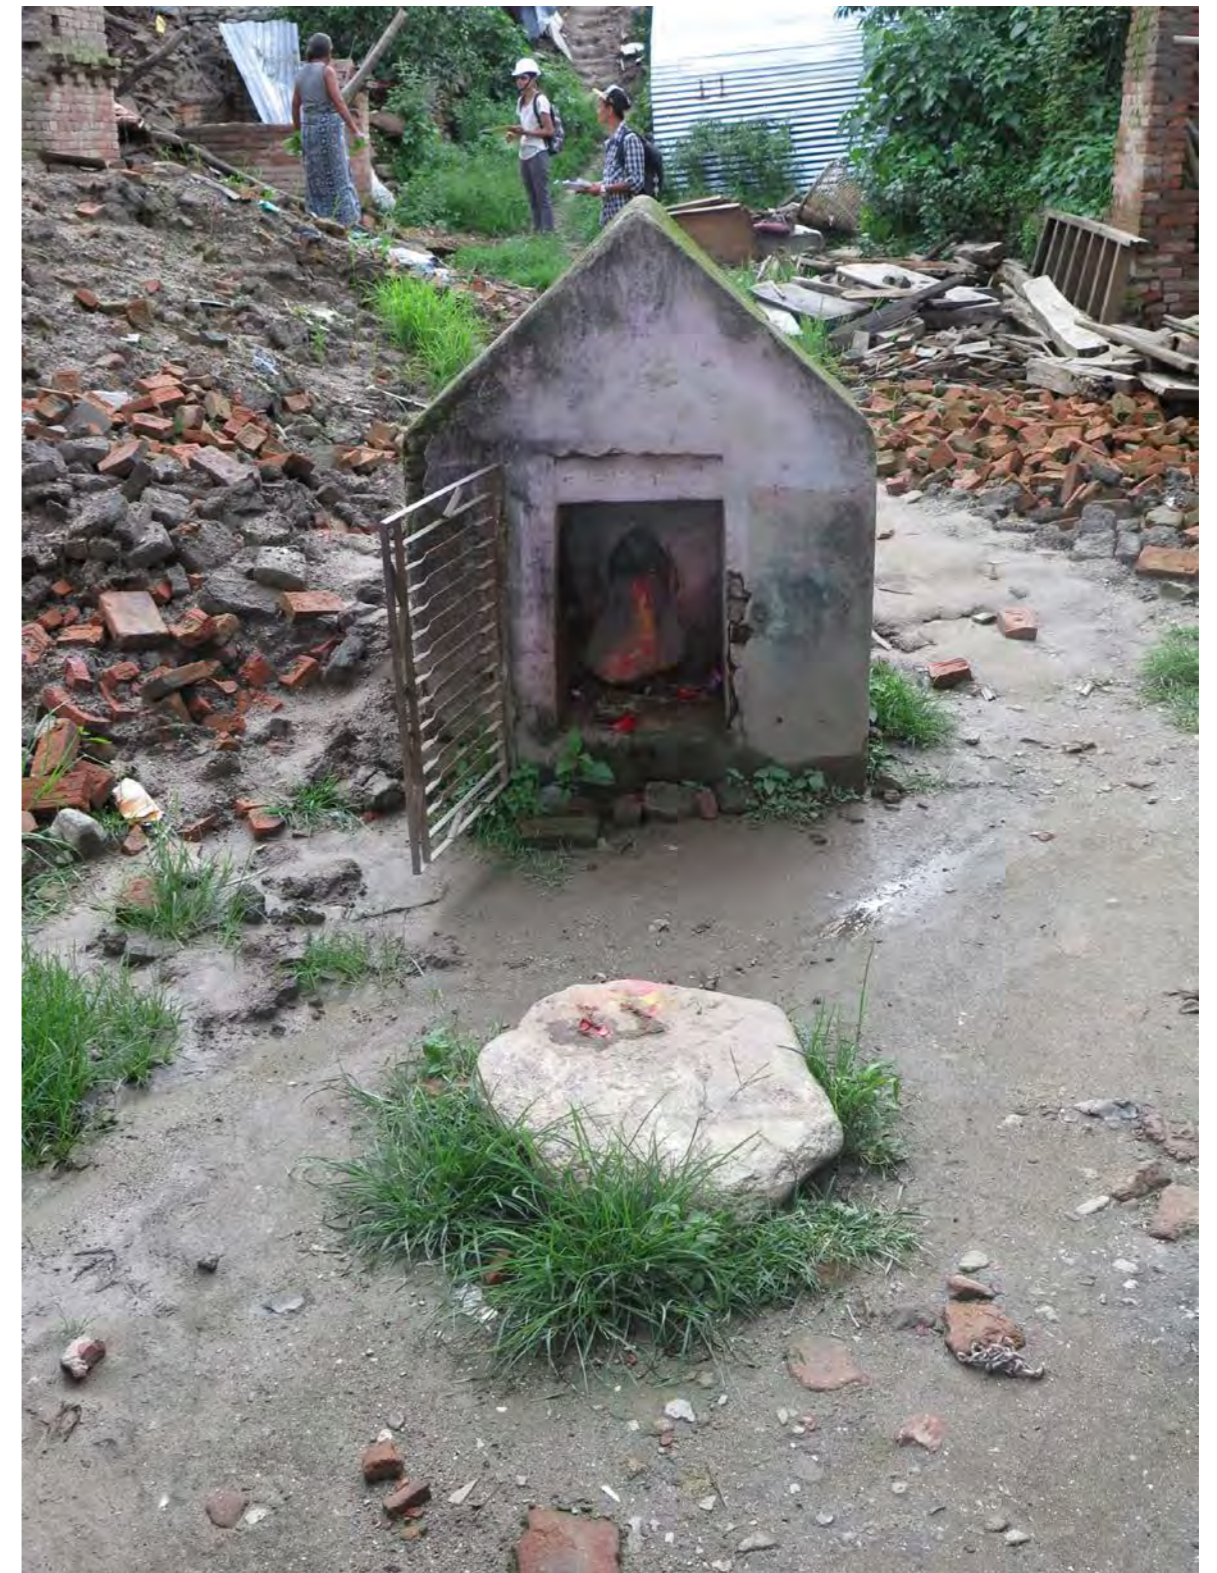
J-21 GANESH SHRINE

NUMBER	NAME	DATE A.D.	TPOLOGY	GENERAL DESCRIPTION	PROBLEMS DESCRIPTION	DANGER/ DESTROY	
J-21	Ganesh Shrine		Enclosed Shrine	Walls plastered with cement. Grill door on east	Rising damp
