2015 Earthquake Damage Mapping

Sankhu

October 2015

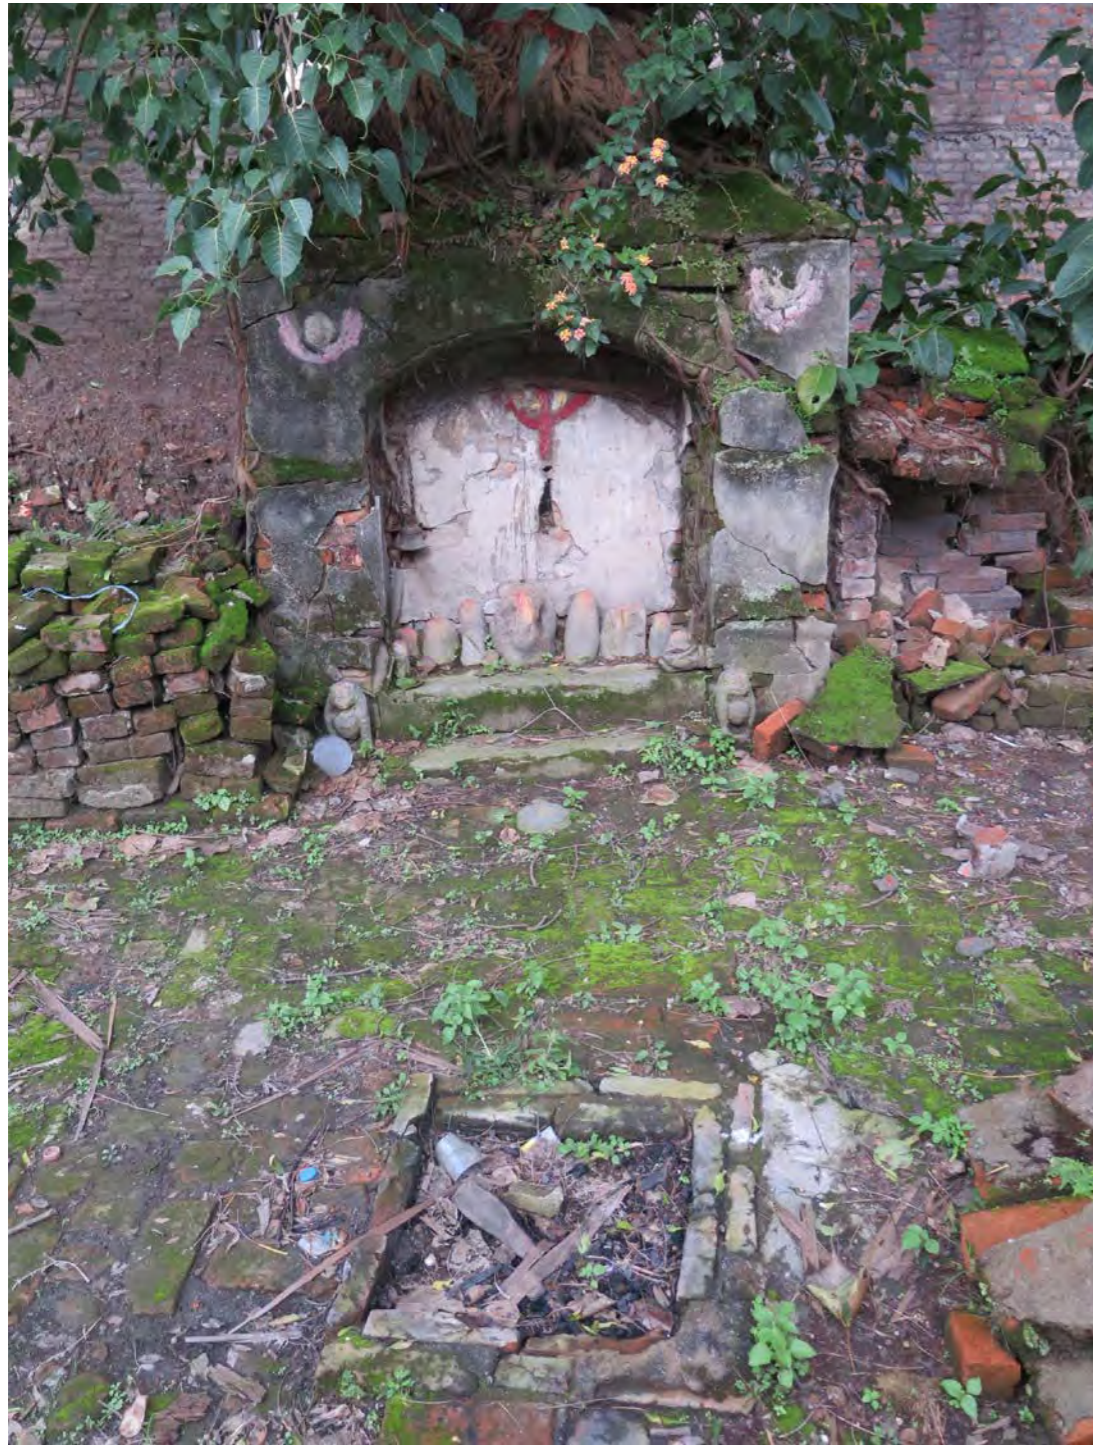
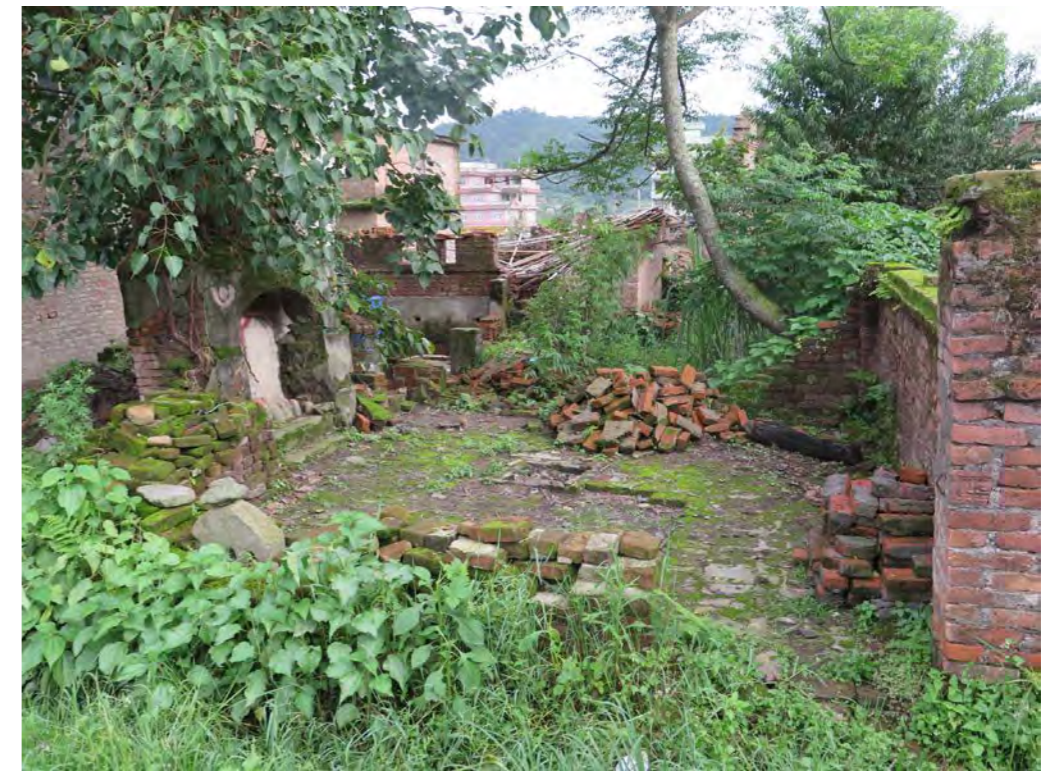
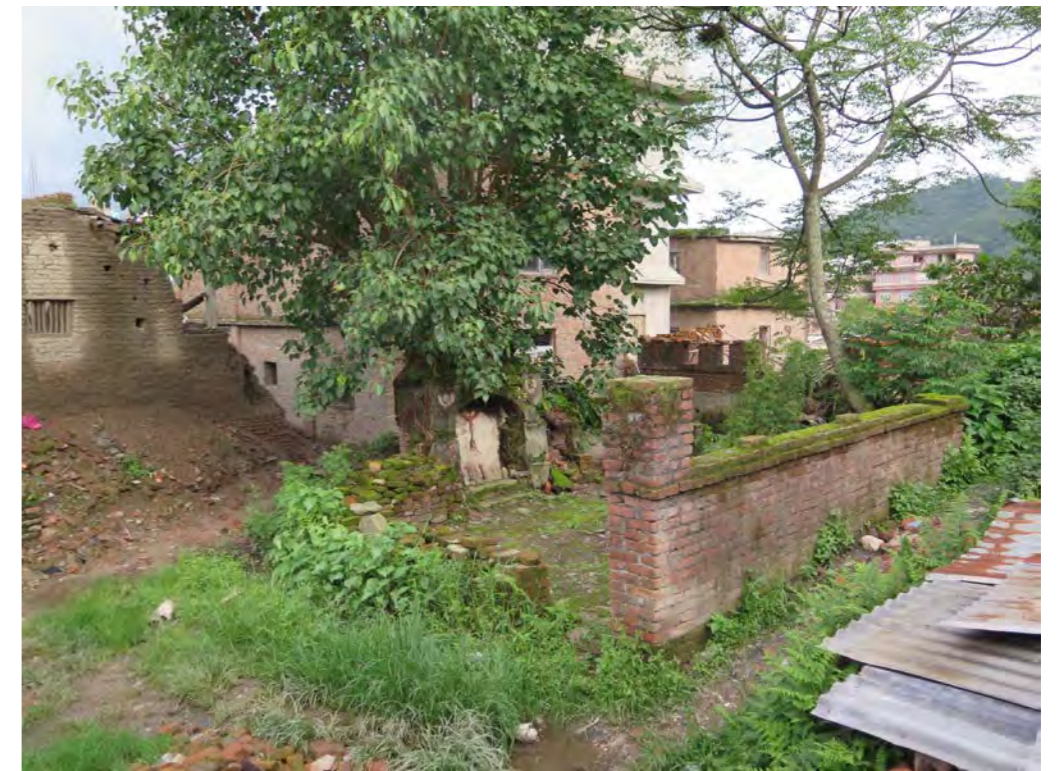
J-22 GANESH SHRINE

NUMBER	NAME	ESTABLISHED DATE (A.D.)	TYOLOGY	GENERAL DESCRIPTION	PROBLEMS DESCRIPTION	DANGER/ DESTROY
J-22	Ganesh Shrine		Open Shrine	Temple under peepal tree	Peepal roots growing all over walls.

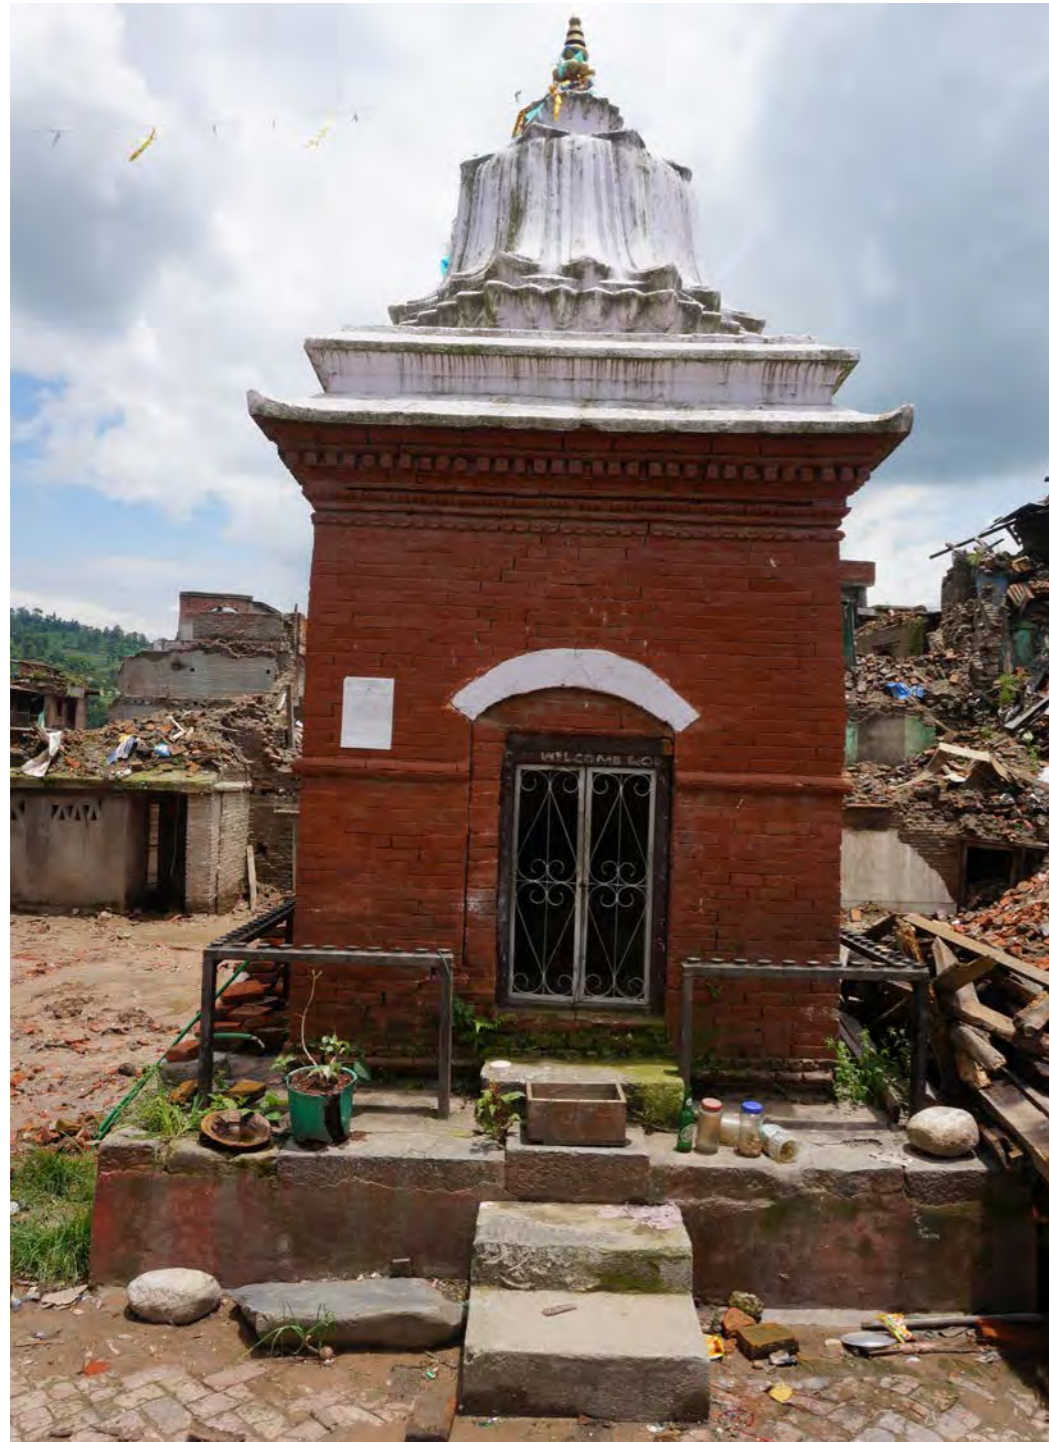
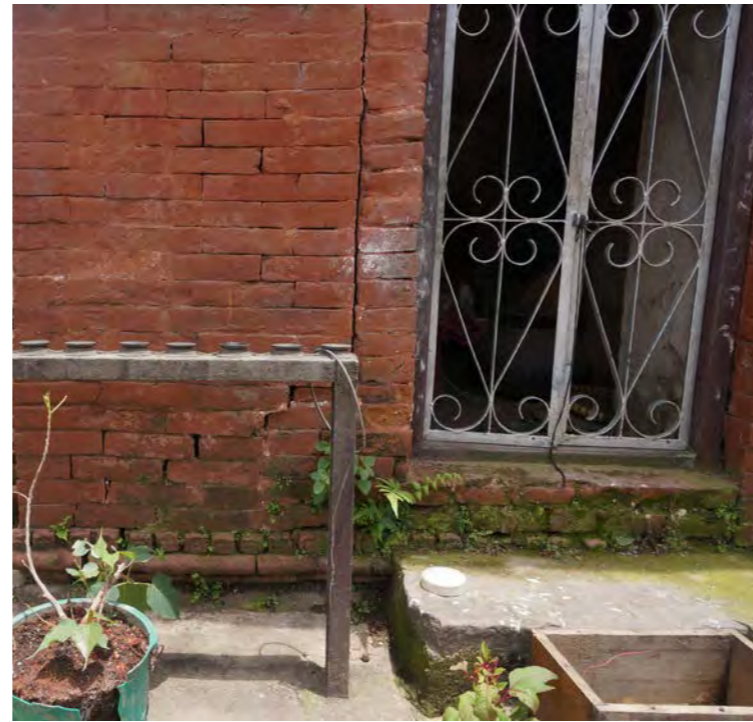
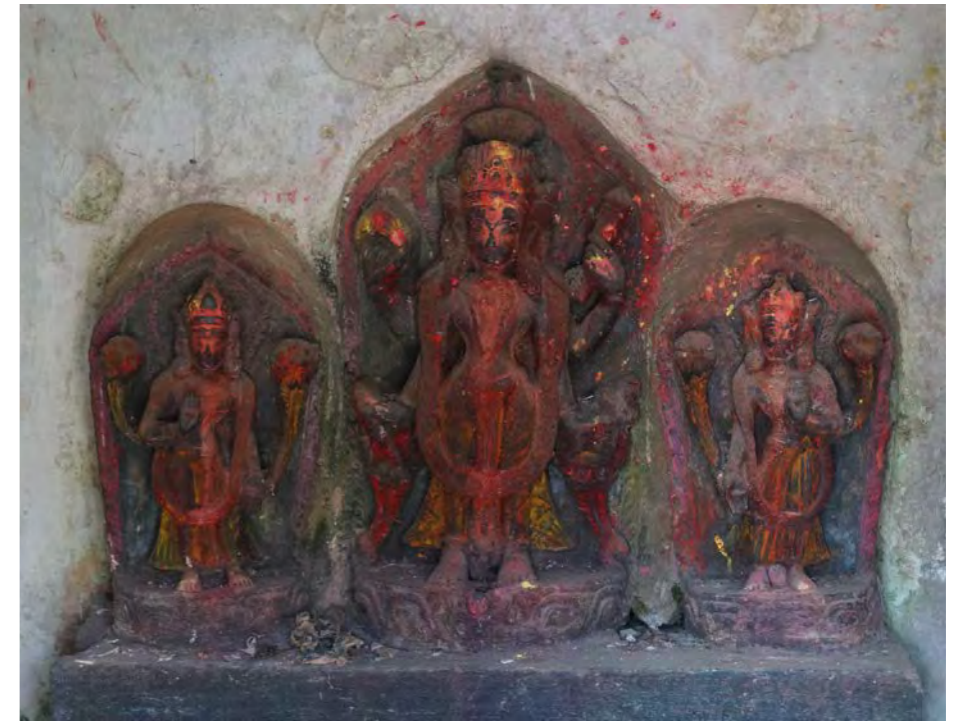
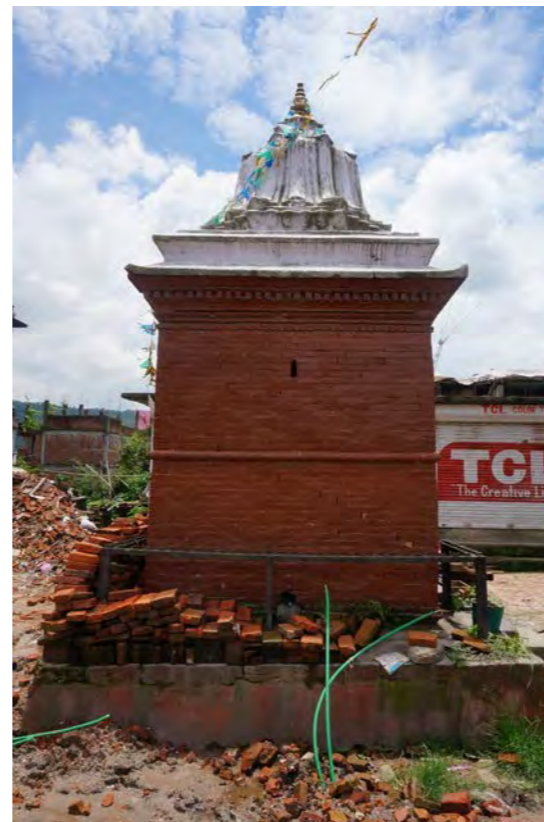
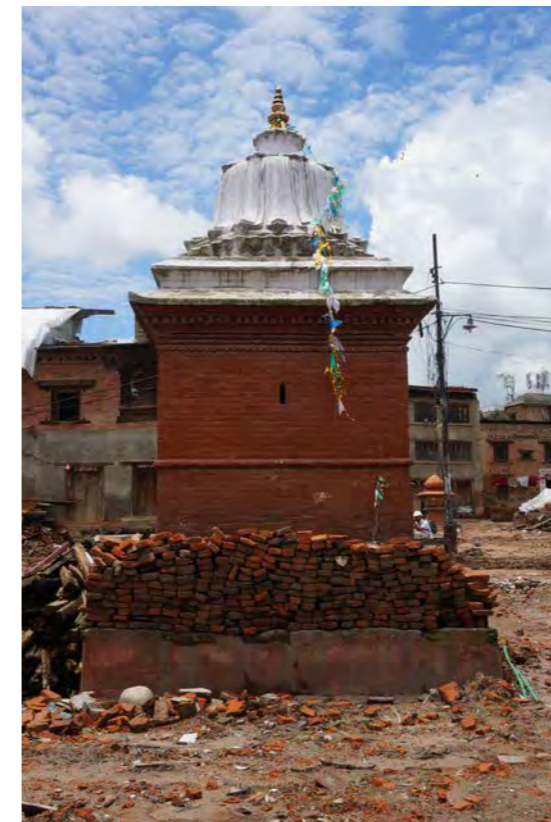
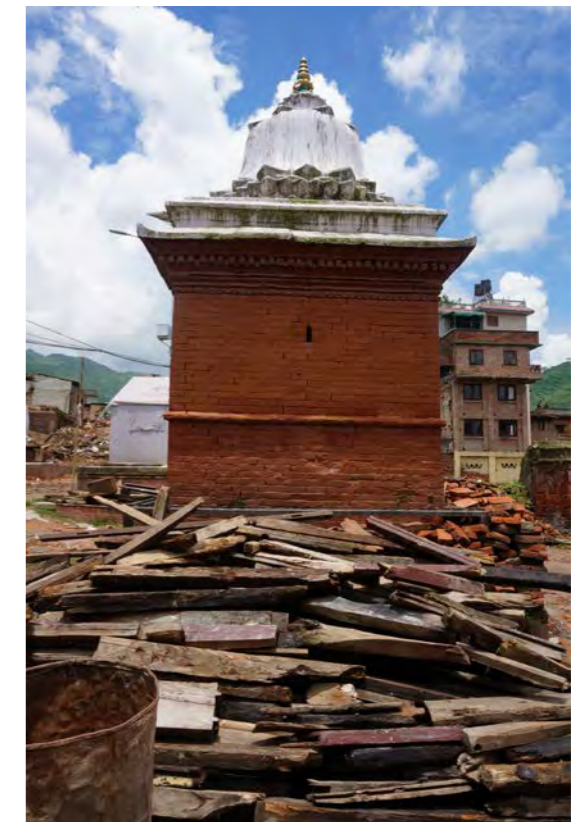
K-04 LAXMI NARAYAN TEMPLE

NUMBER	NAME	DATE A.D.	TYPOLOGY	GENERAL DESCRIPTION	PROBLEMS DESCRIPTION	DANGER/ DESTROY
K-04	Laxmi Narayan mandir		Enclosed shrine	Brick Structure	West facade with stepped cracks and rising damp problem at both corners North facade with stepped cracks Some vertical cracks above entrance opening”

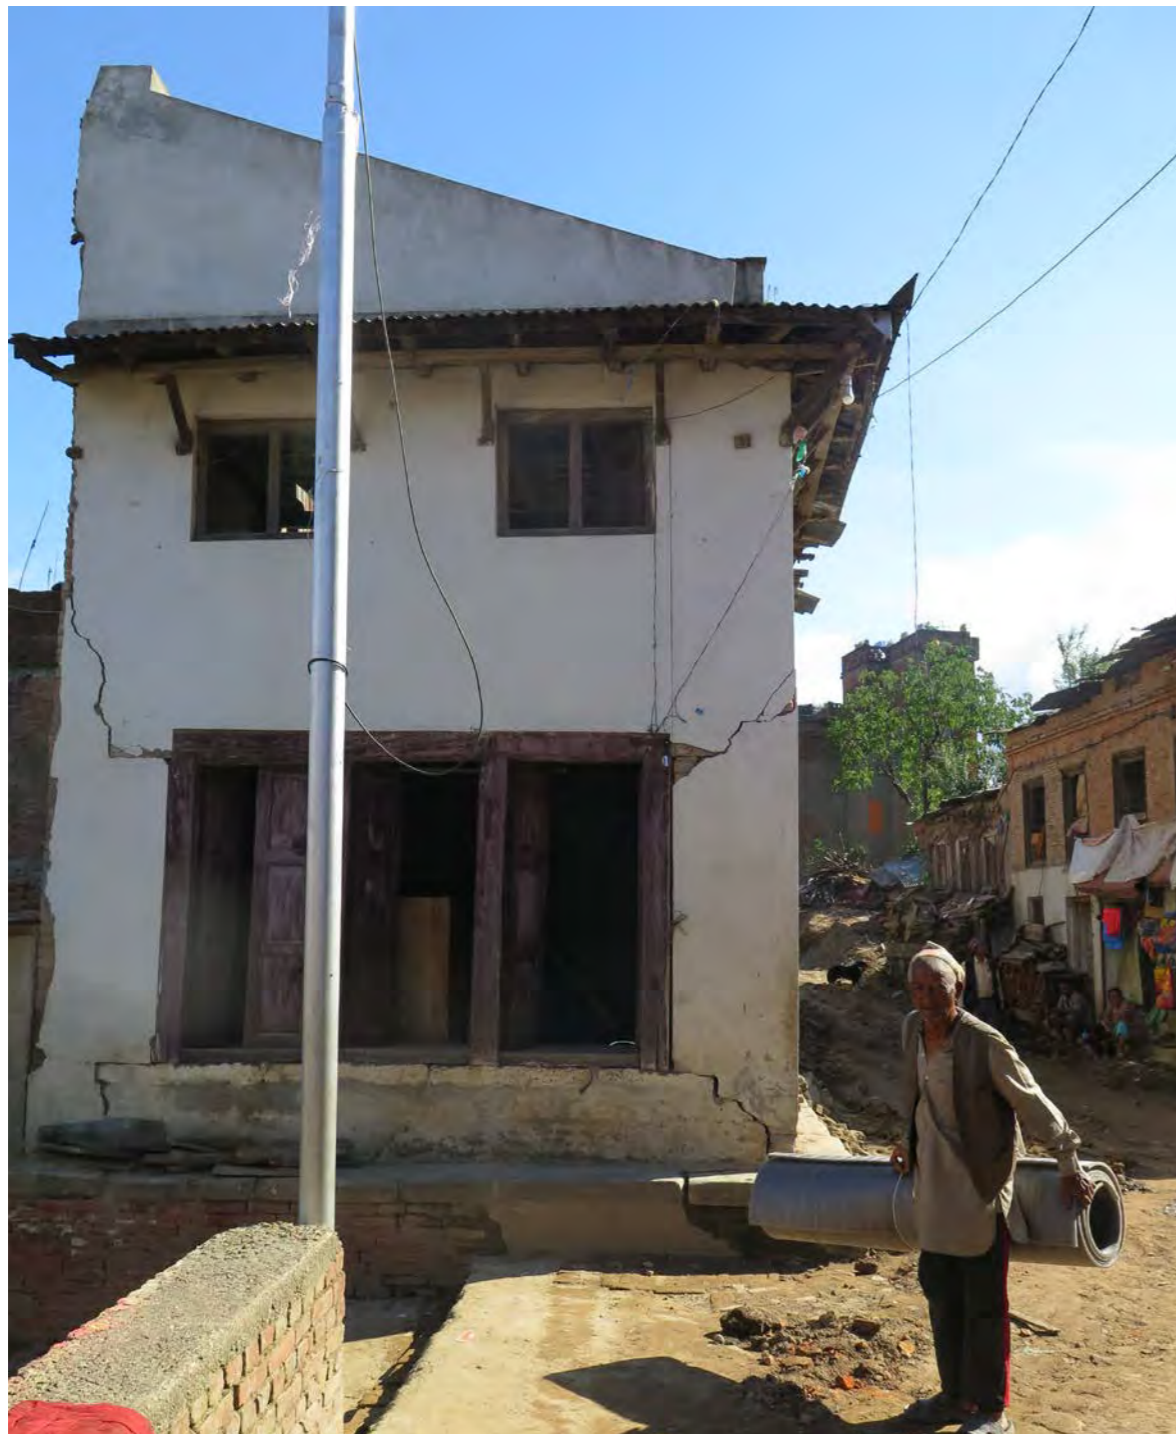
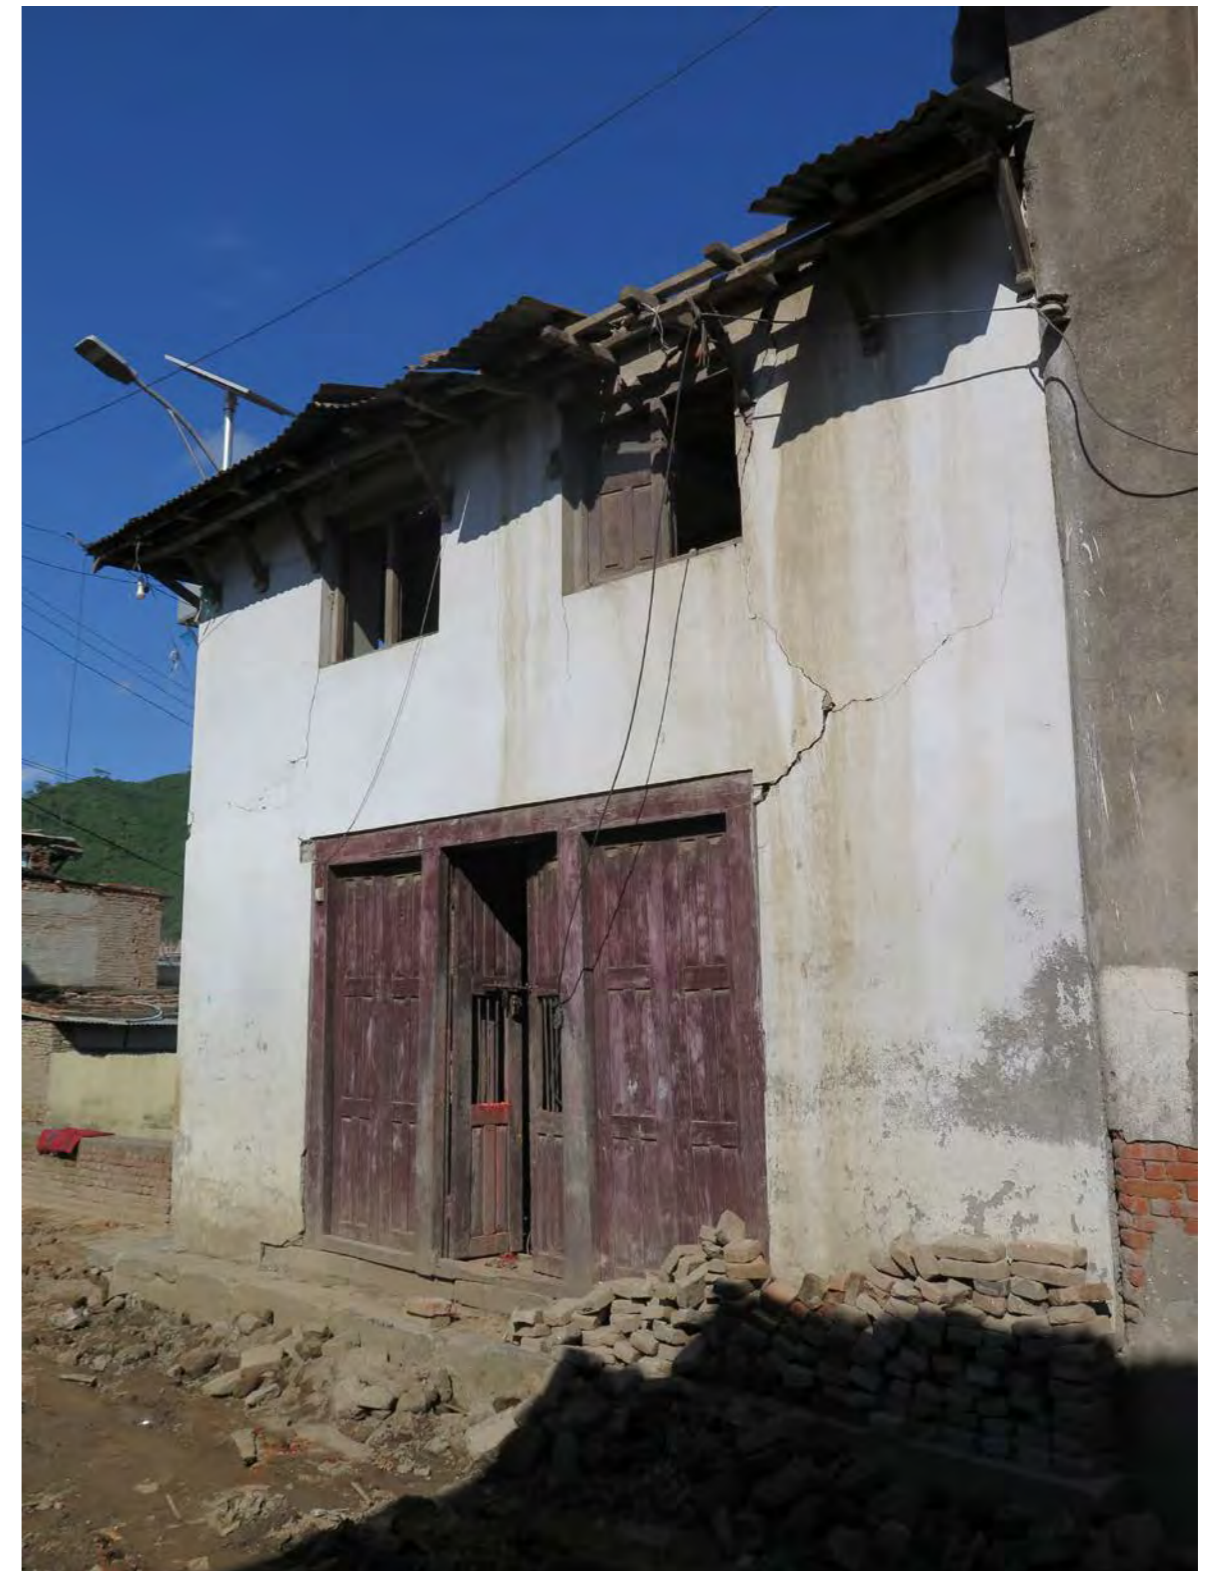
L-05 DYO CHHEN - KRISHNA MANDIR

NUMBER	NAME	ESTABLISHED DATE (A.D.)	TPOLOGY	GENERAL DESCRIPTION	PROBLEMS DESCRIPTION	DANGER/ DESTROY
L-05	Krishna Mandir		Dyo Chhen	Two storey building	Roof collapsed. Diagonal wall cracks on north.	D!

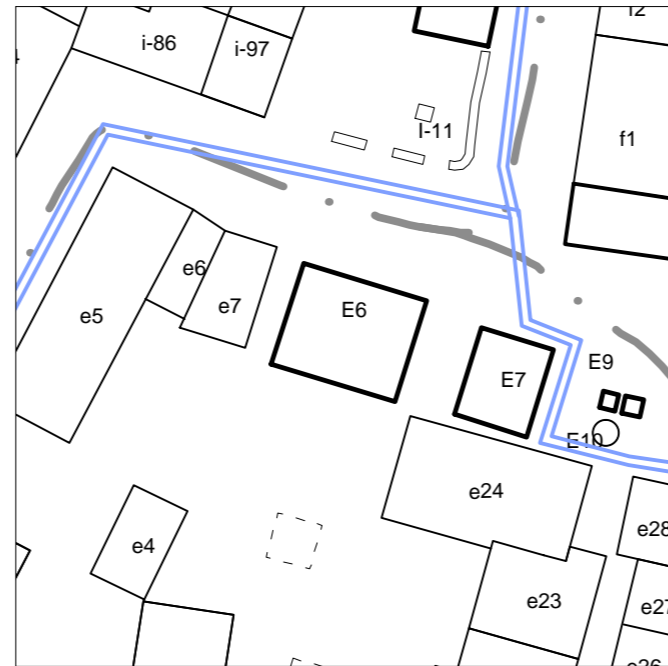
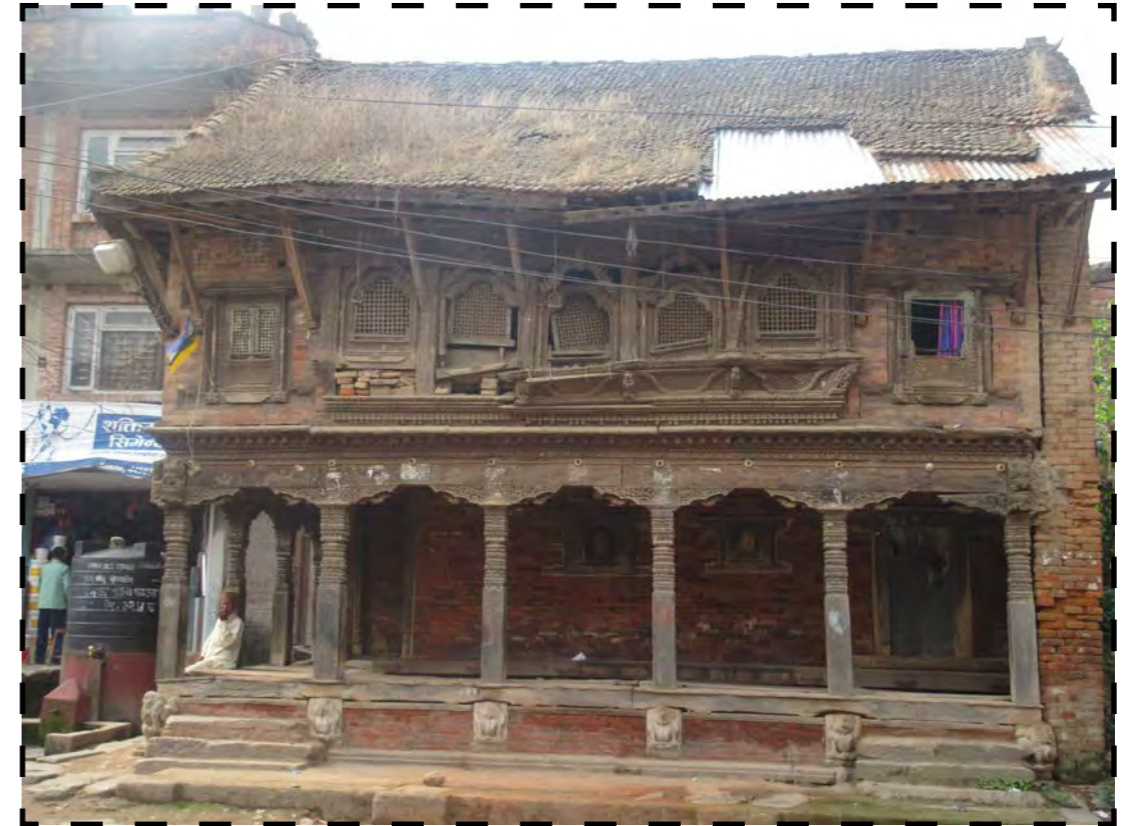
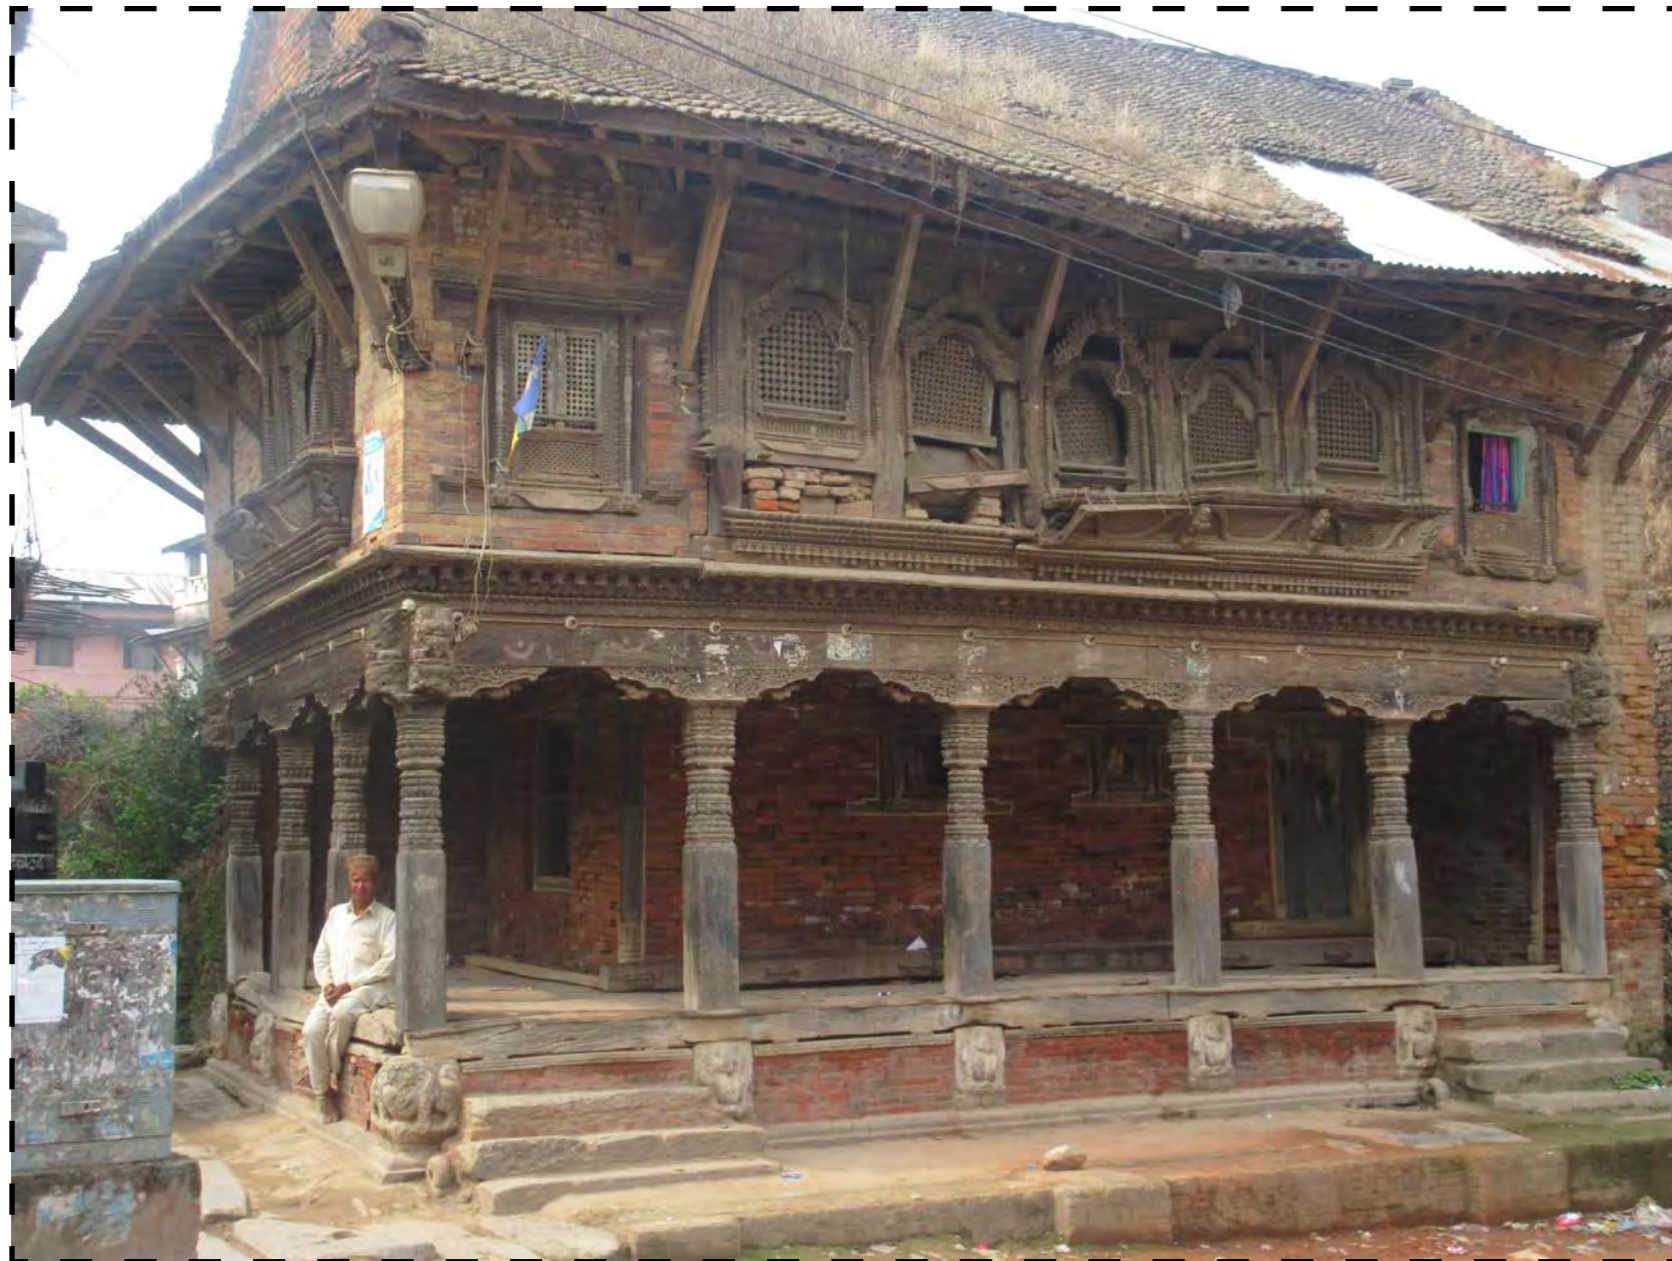
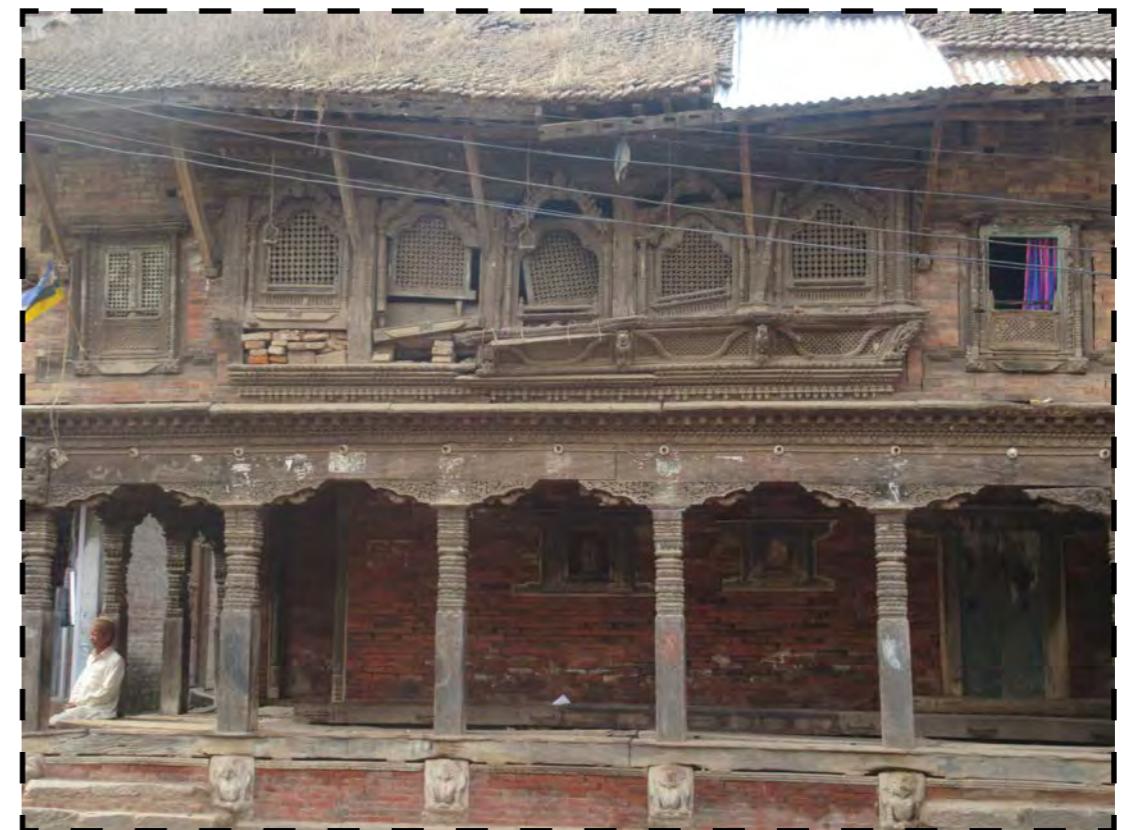
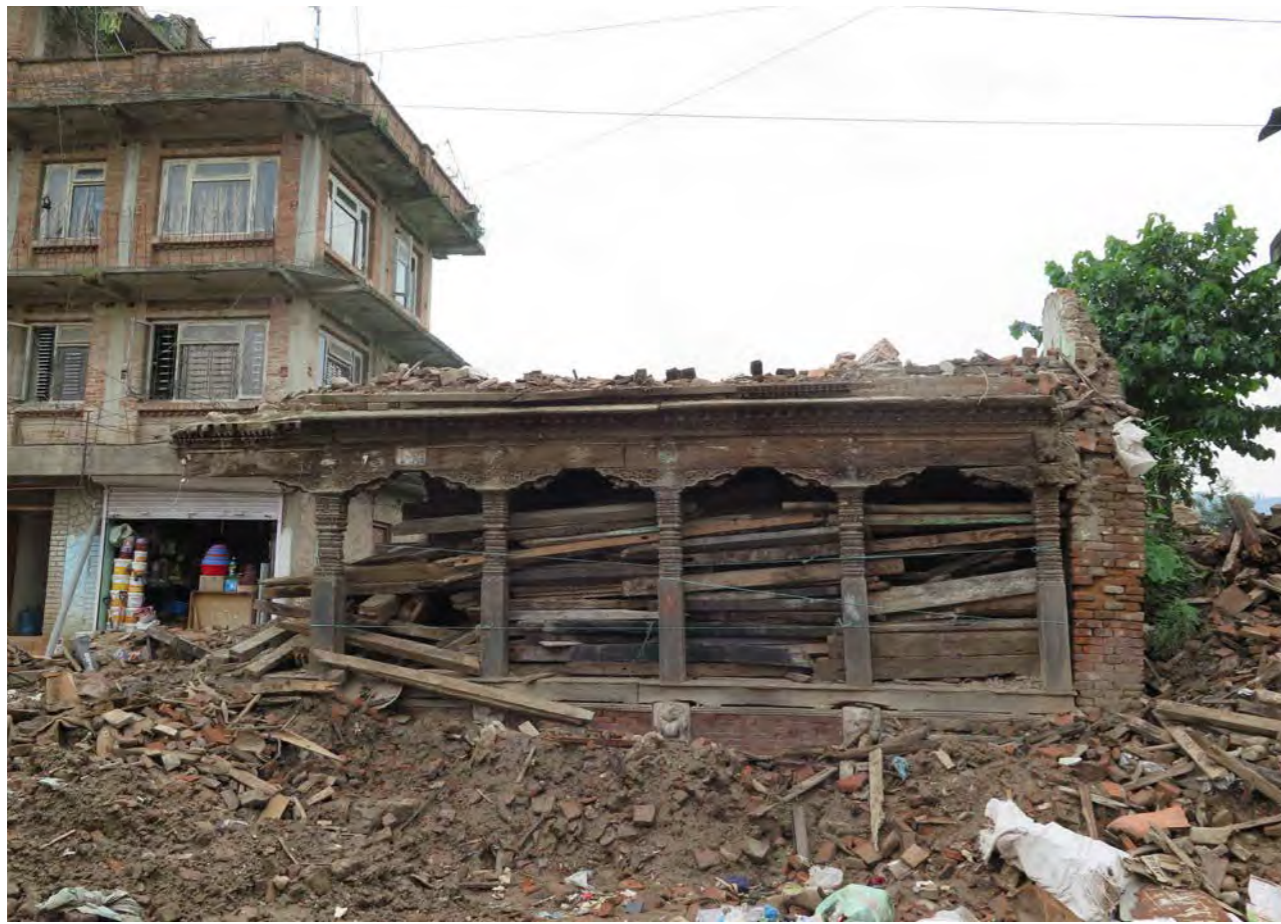
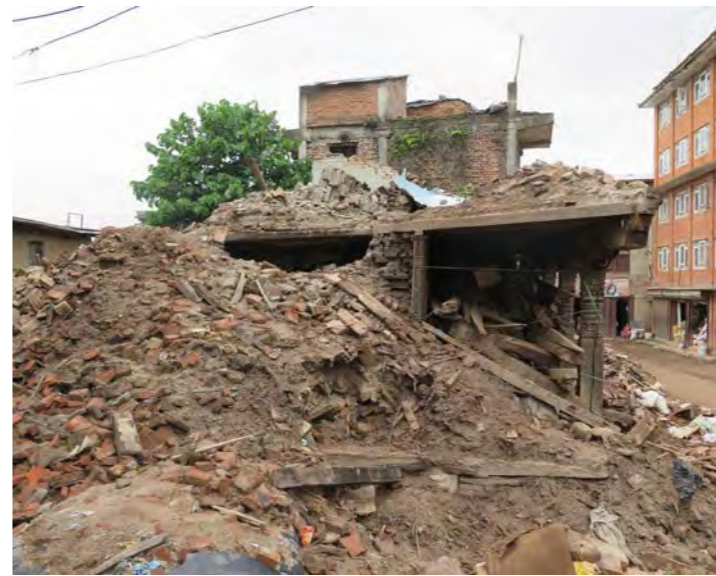
E-06 SATTAL - DHOLA FALCHA

NUMBER	NAME	DATE A.D.	TYPOLOGY	GENERAL DESCRIPTION	PROBLEMS DESCRIPTION	DANGER/ DESTROY	
E-06	Dhola Falcha		Sattal	Had unique windows	Only ground floor remaining. Plinth stone degraded by weathering. Carved pillars remaining but covered by rubbles	P ++ carved items protected by Bhintuna pucha

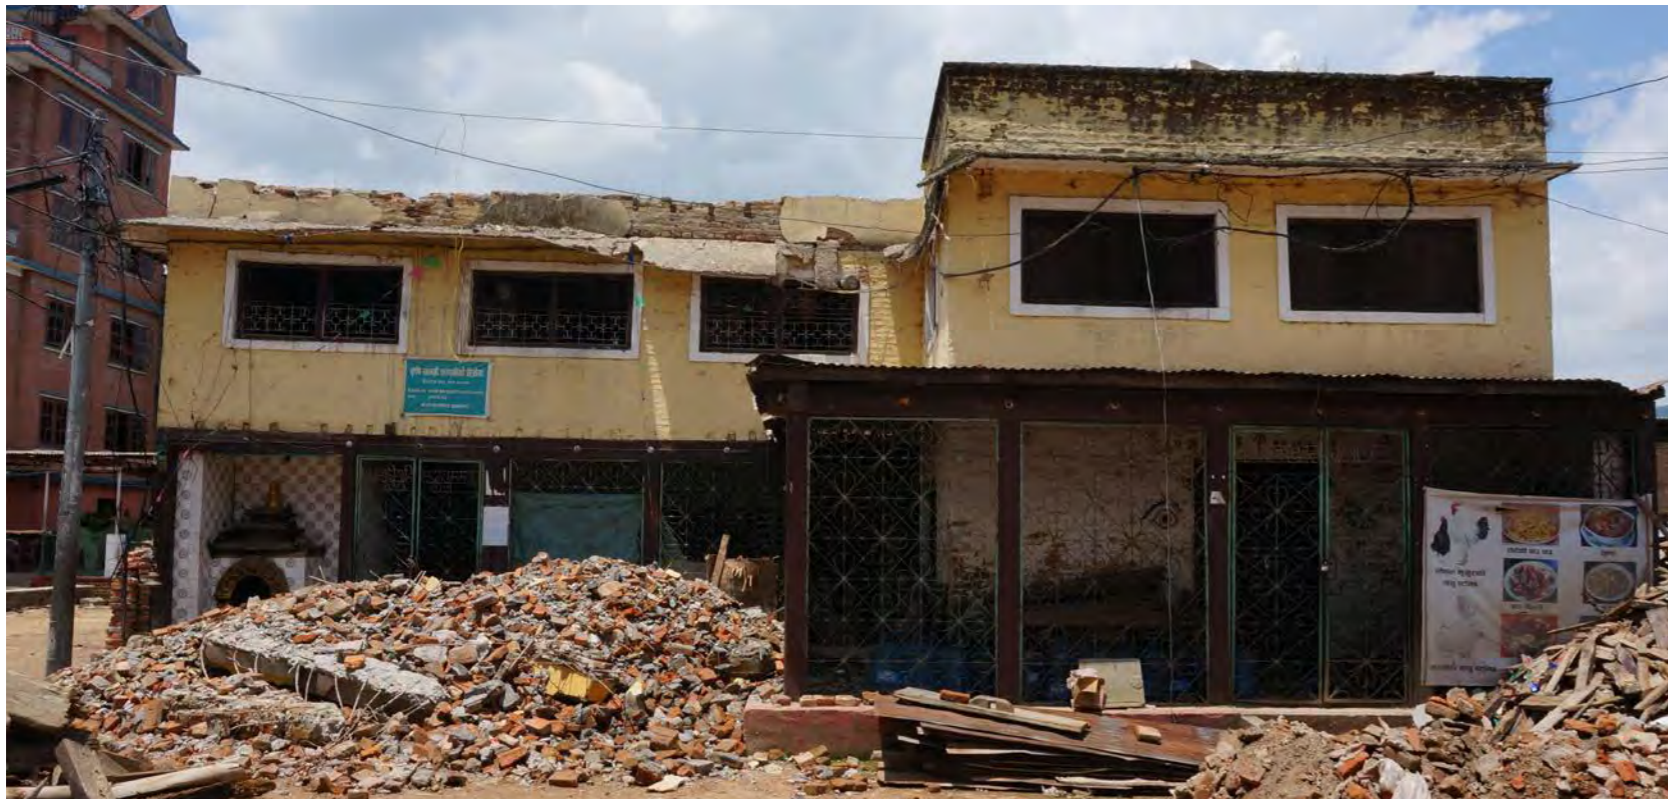
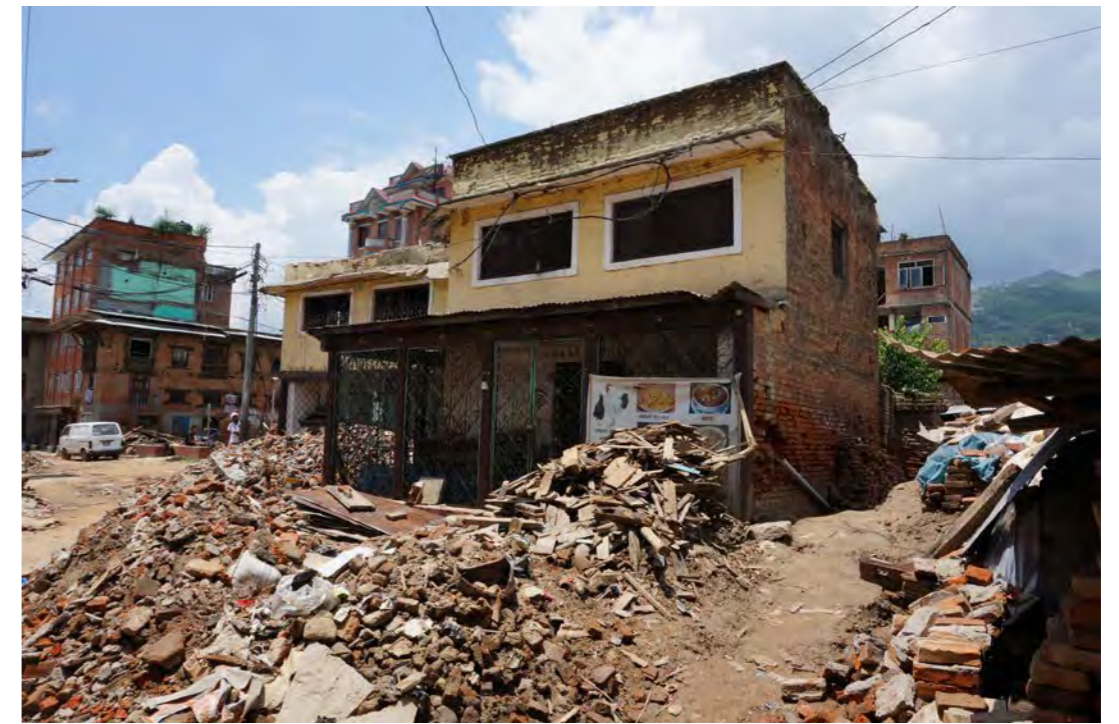
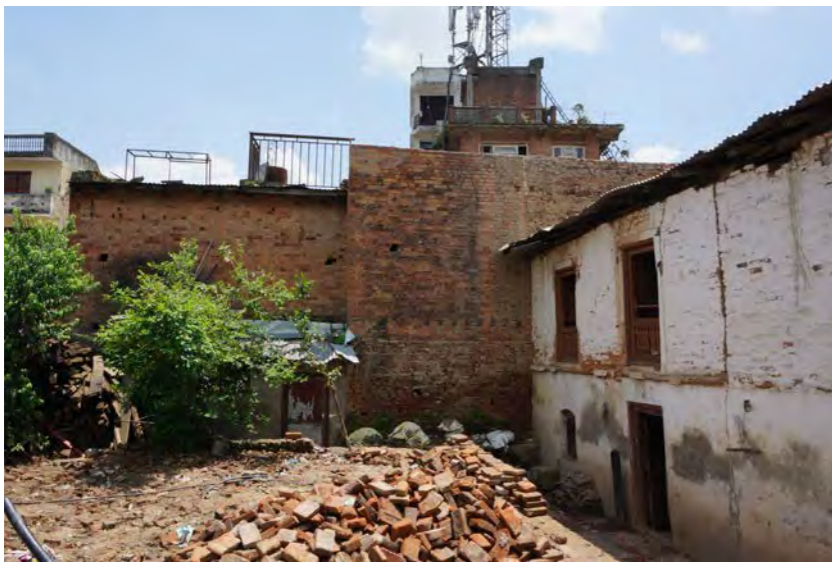
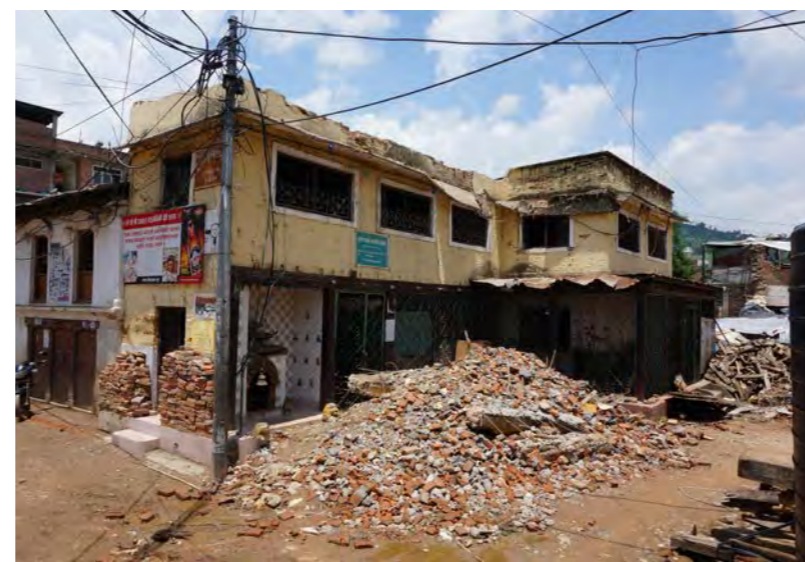
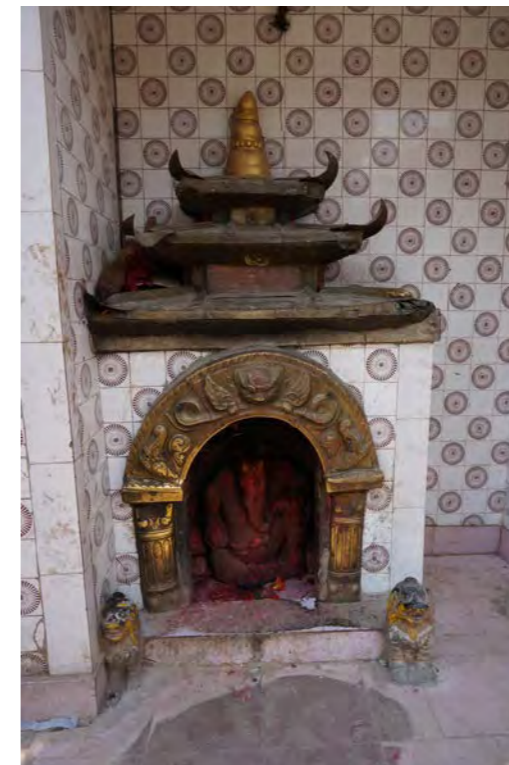
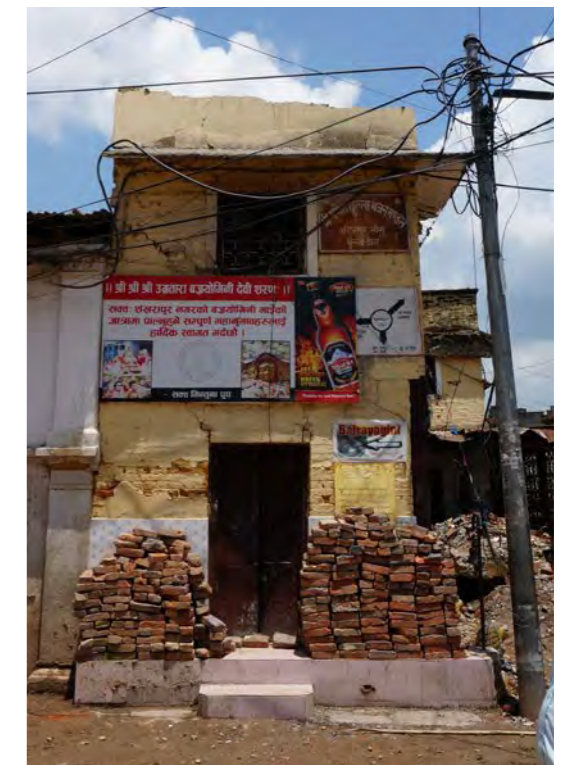
F-01 SATTAL

NUMBER	NAME	ESTABLISHED DATE (A.D.)	TYPOLOGY	GENERAL DESCRIPTION	PROBLEMS DESCRIPTION	DANGER/ DESTROY
F-01			Sattal	G+1 brick and wooden structure	Top terrace part collapsed Major stepped cracks on W-façade All façade have cracks
