2015 Earthquake Damage Mapping

Sankhu

October 2015

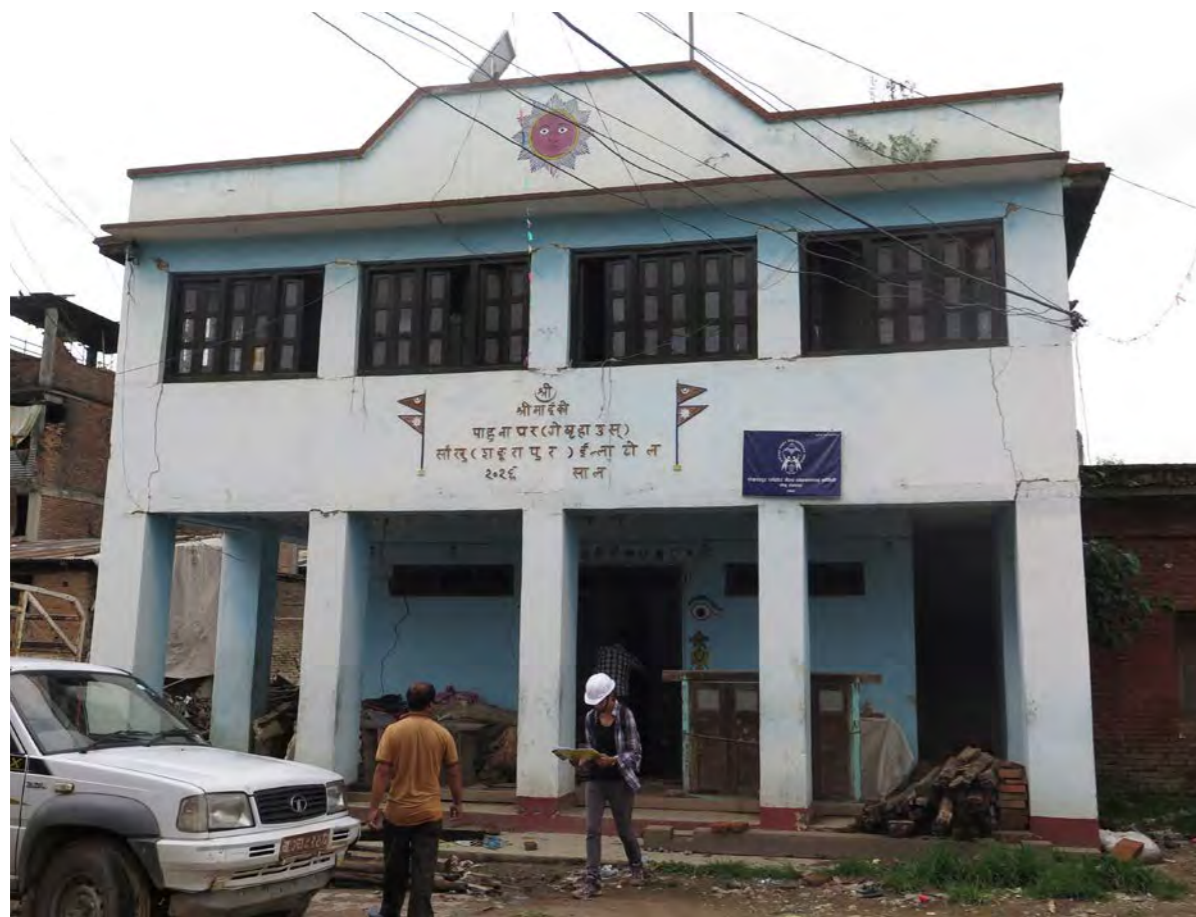
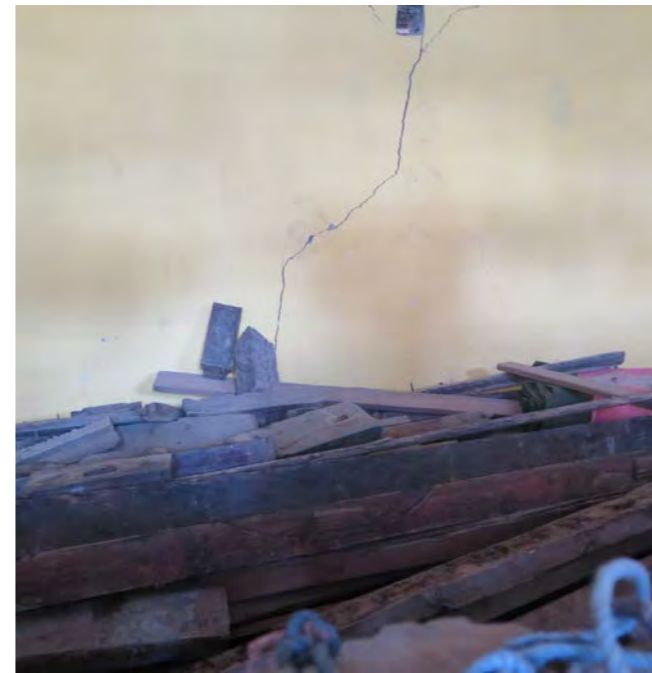
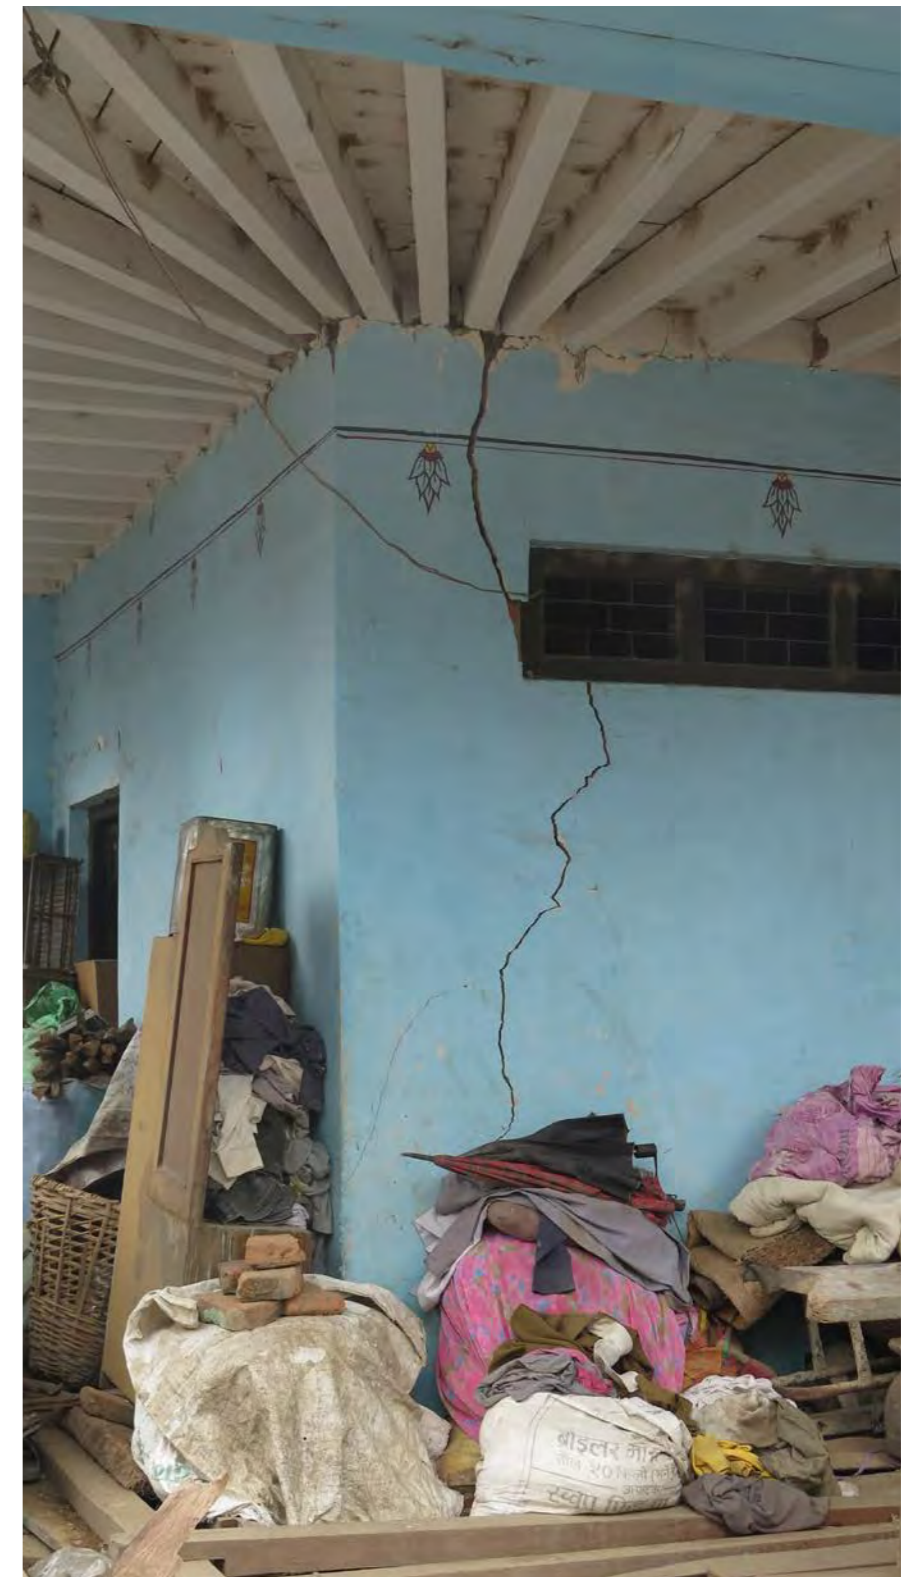
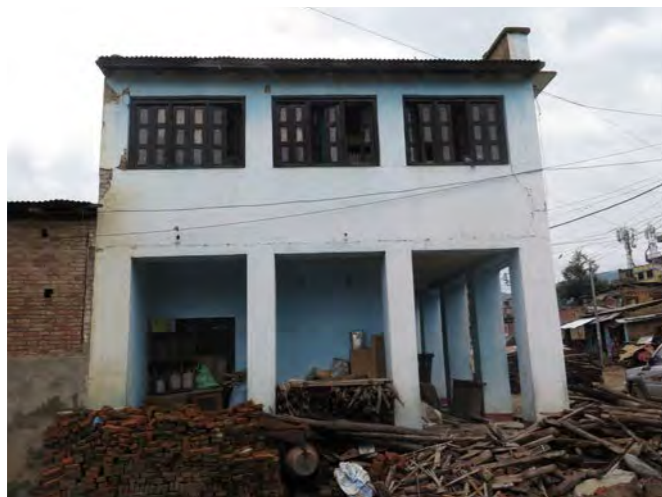
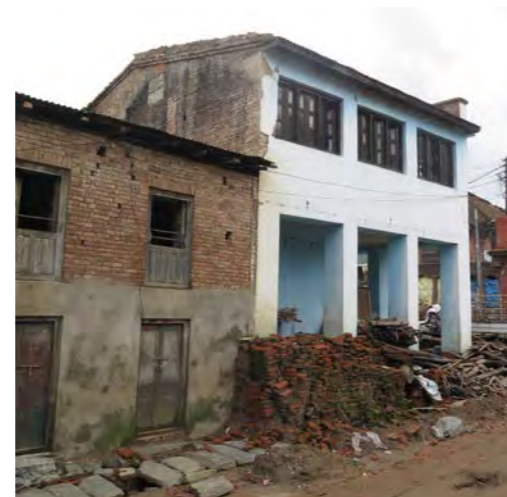
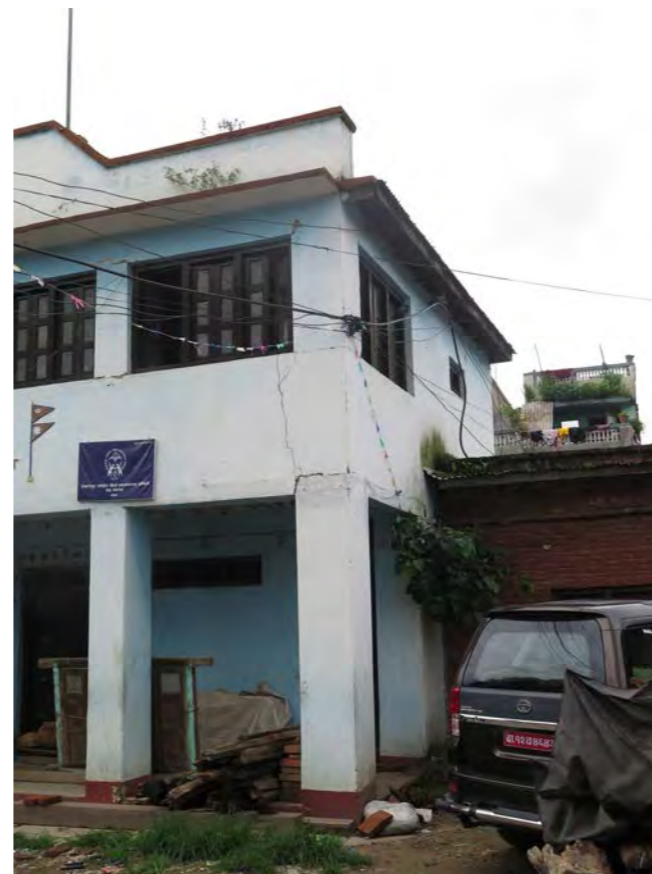
I-03 SATTAL - BAJRAYOGINI SATTAL

NUMBER	NAME	DATE A.D.	TYPOLOGY	GENERAL DESCRIPTION	PROBLEMS DESCRIPTION	DANGER/ DESTROY	
I-03	Pauna Ghar/ Bajrayogini Sattal		Sattal	G+1 Brick structure	Diagonal crack on east wall south east corner. Vertical crack on east wall south east corner >3cm. 2 Vertical cracks on northeast corner. Porch supporting brick pillar are weak.

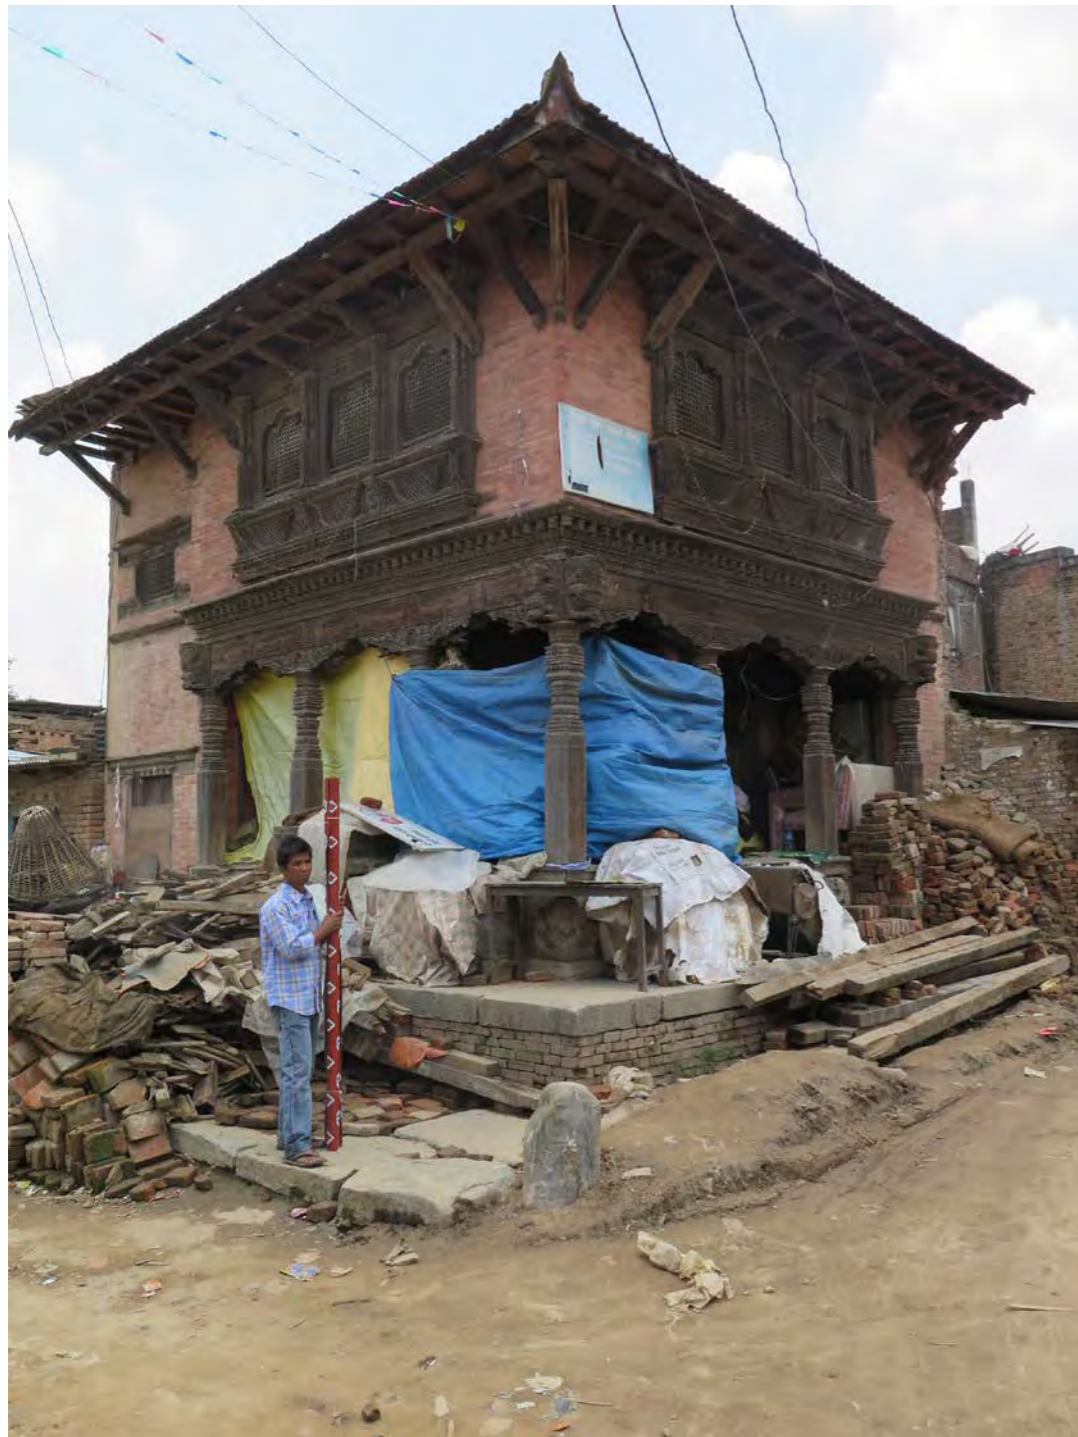
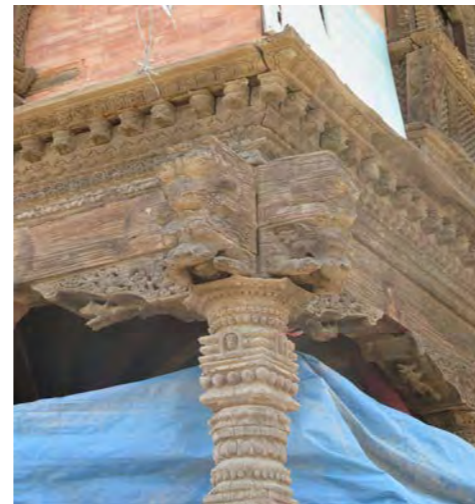
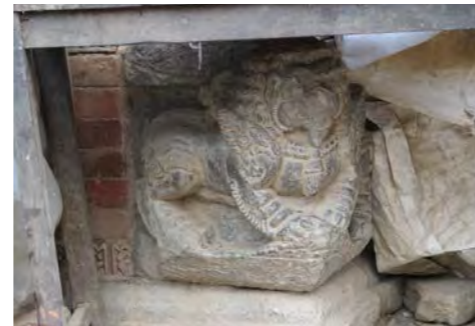
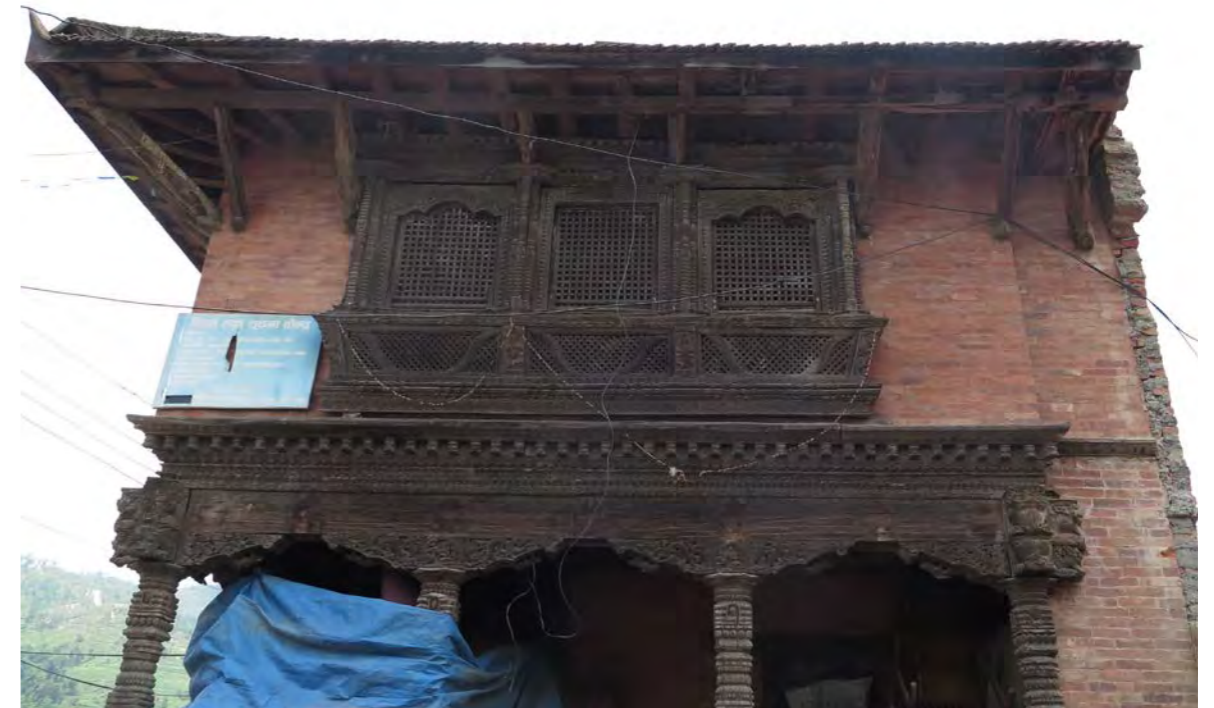
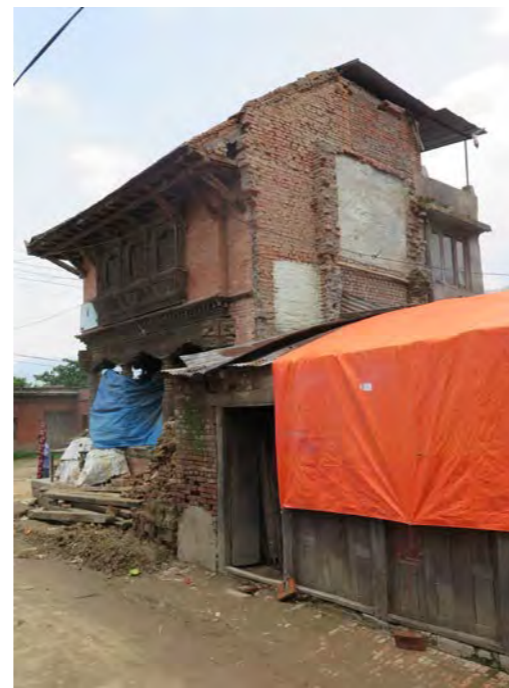
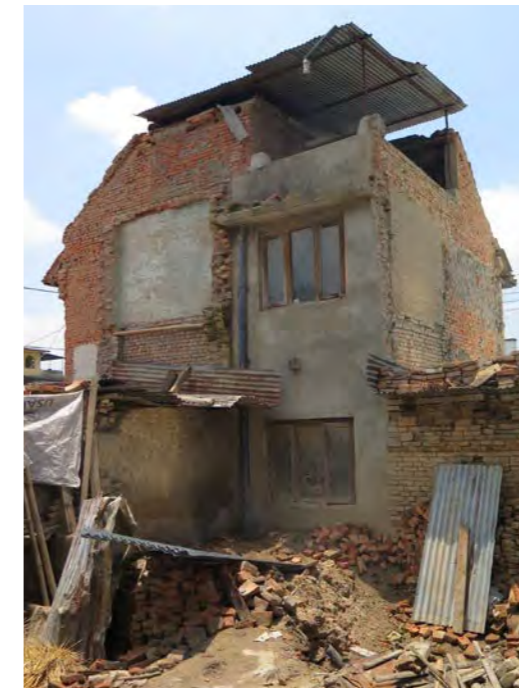
D-01 SATTAL - SARABAT

NUMBER	NAME	ESTABLISHED DATE (A.D.)	TYPOLOGY	GENERAL DESCRIPTION	PROBLEMS DESCRIPTION	DANGER/ DESTROY
D-01	Sarabat	Renovated in 2011	Sattal	G+1 Used to give donation to Jogis	Roof tiles falling on south east corner and ridge. Bricks falling form top end of north west corner.

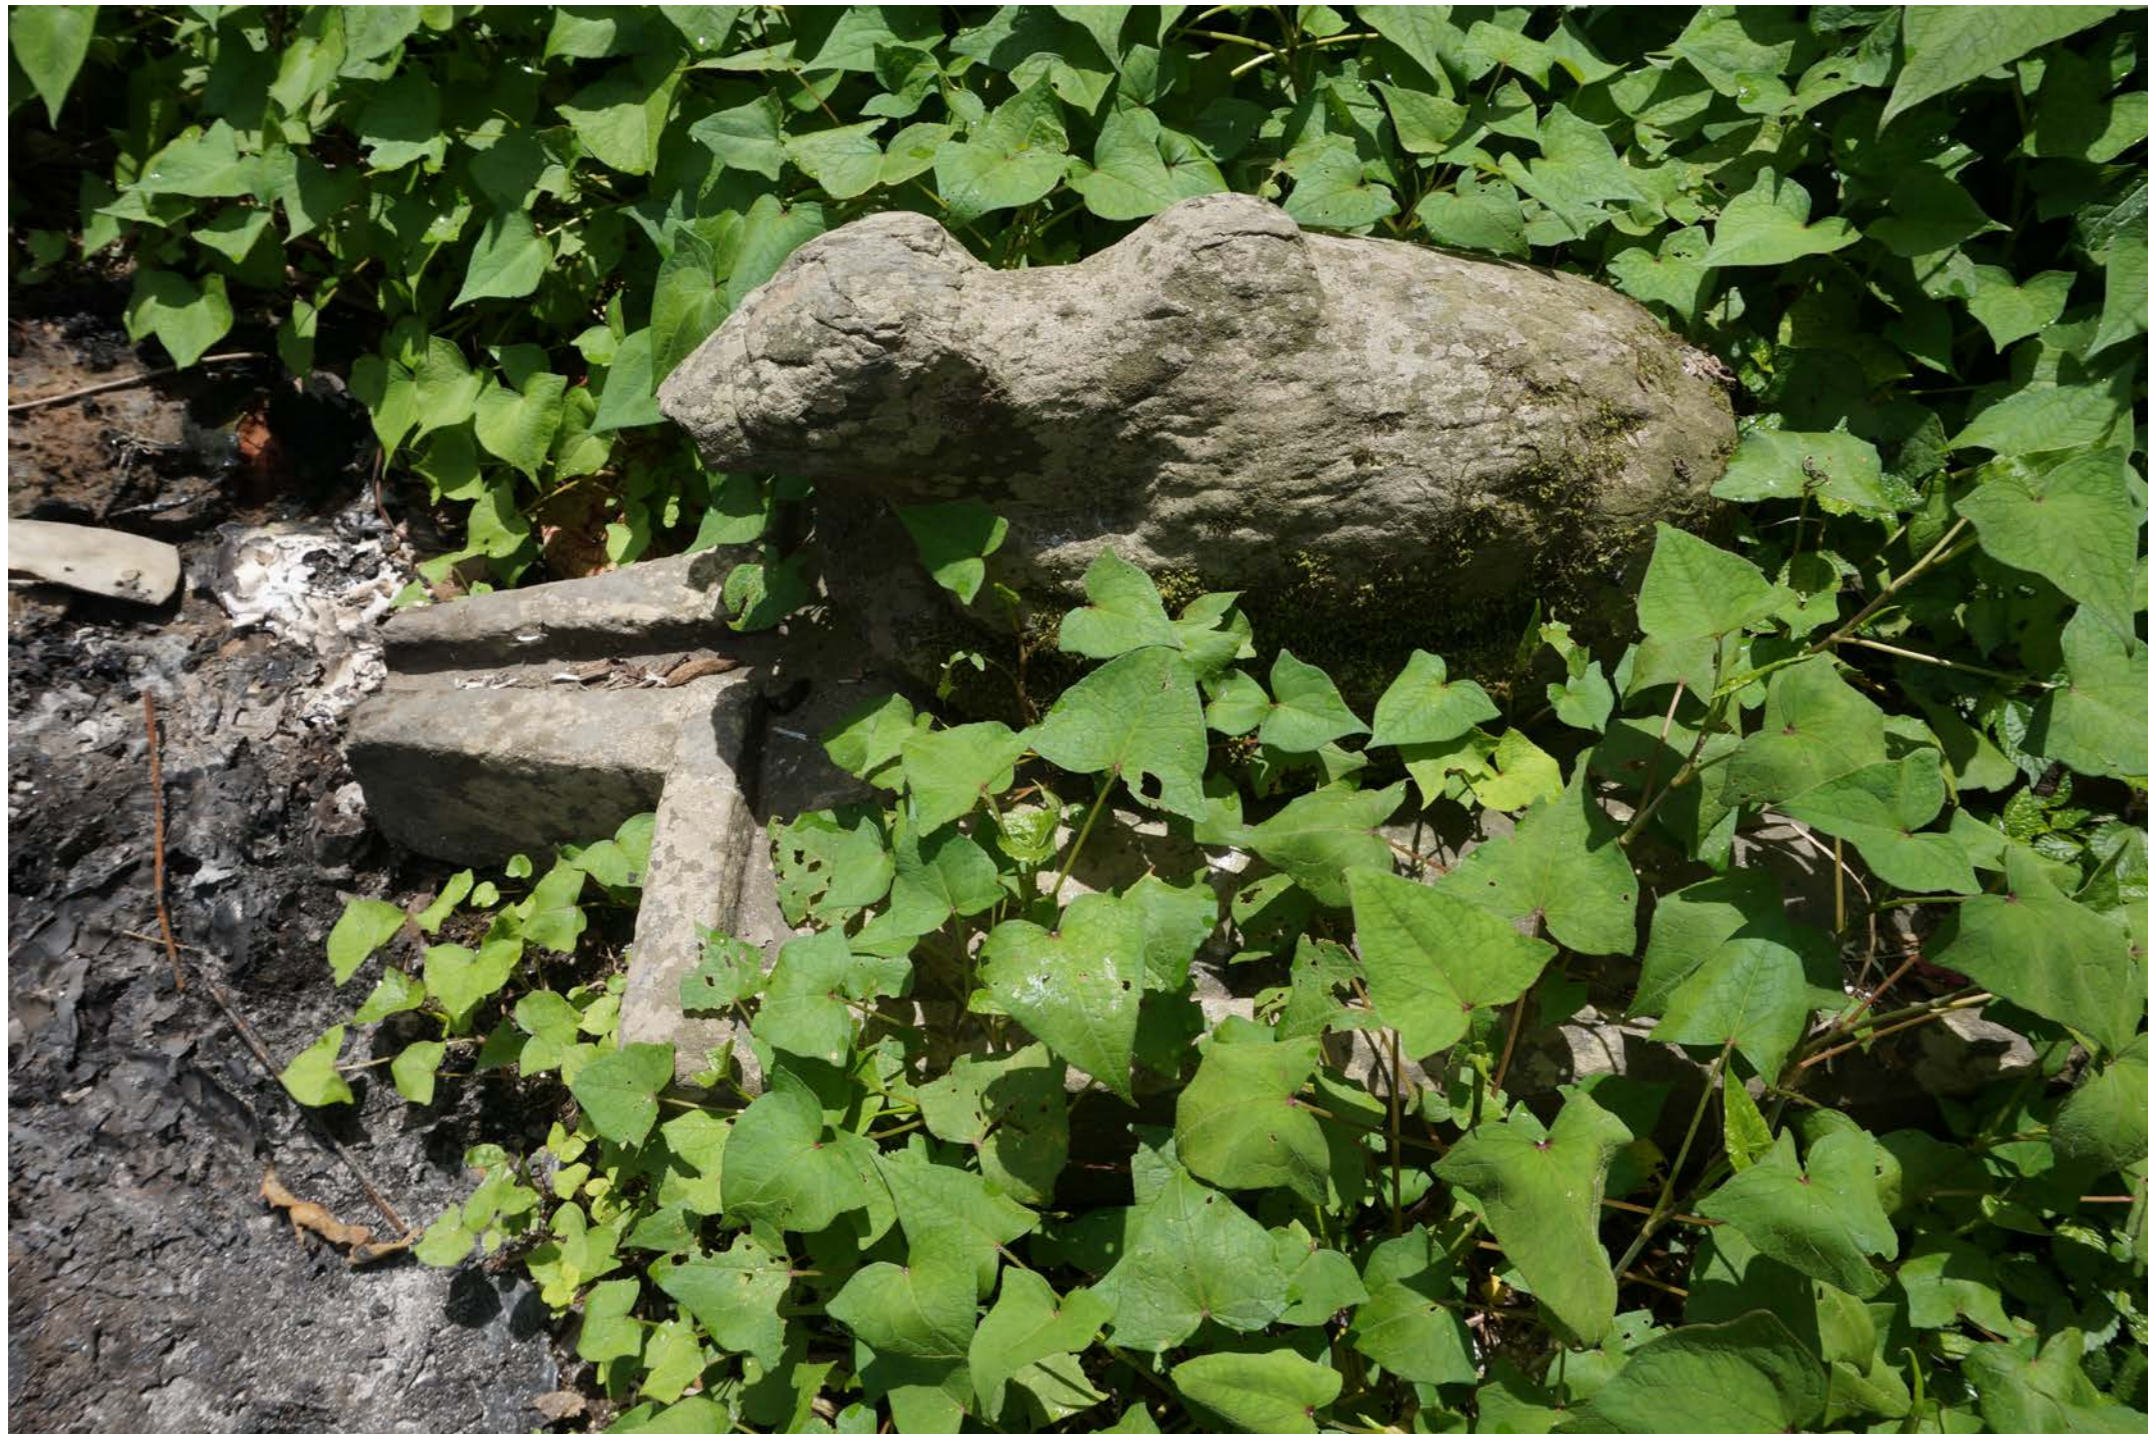
A-11 PATI - CHAKHUKIBA FALCHA

NUMBER	NAME	DATE A.D.	TPOLOGY	GENERAL DESCRIPTION	PROBLEMS DESCRIPTION	DANGER/ DESTROY
A-11	Chakhukiba Falcha		Pati	Brick and wooden structure	Totally collapsed. Remaining salvageable materials are already dumped away by the municipality

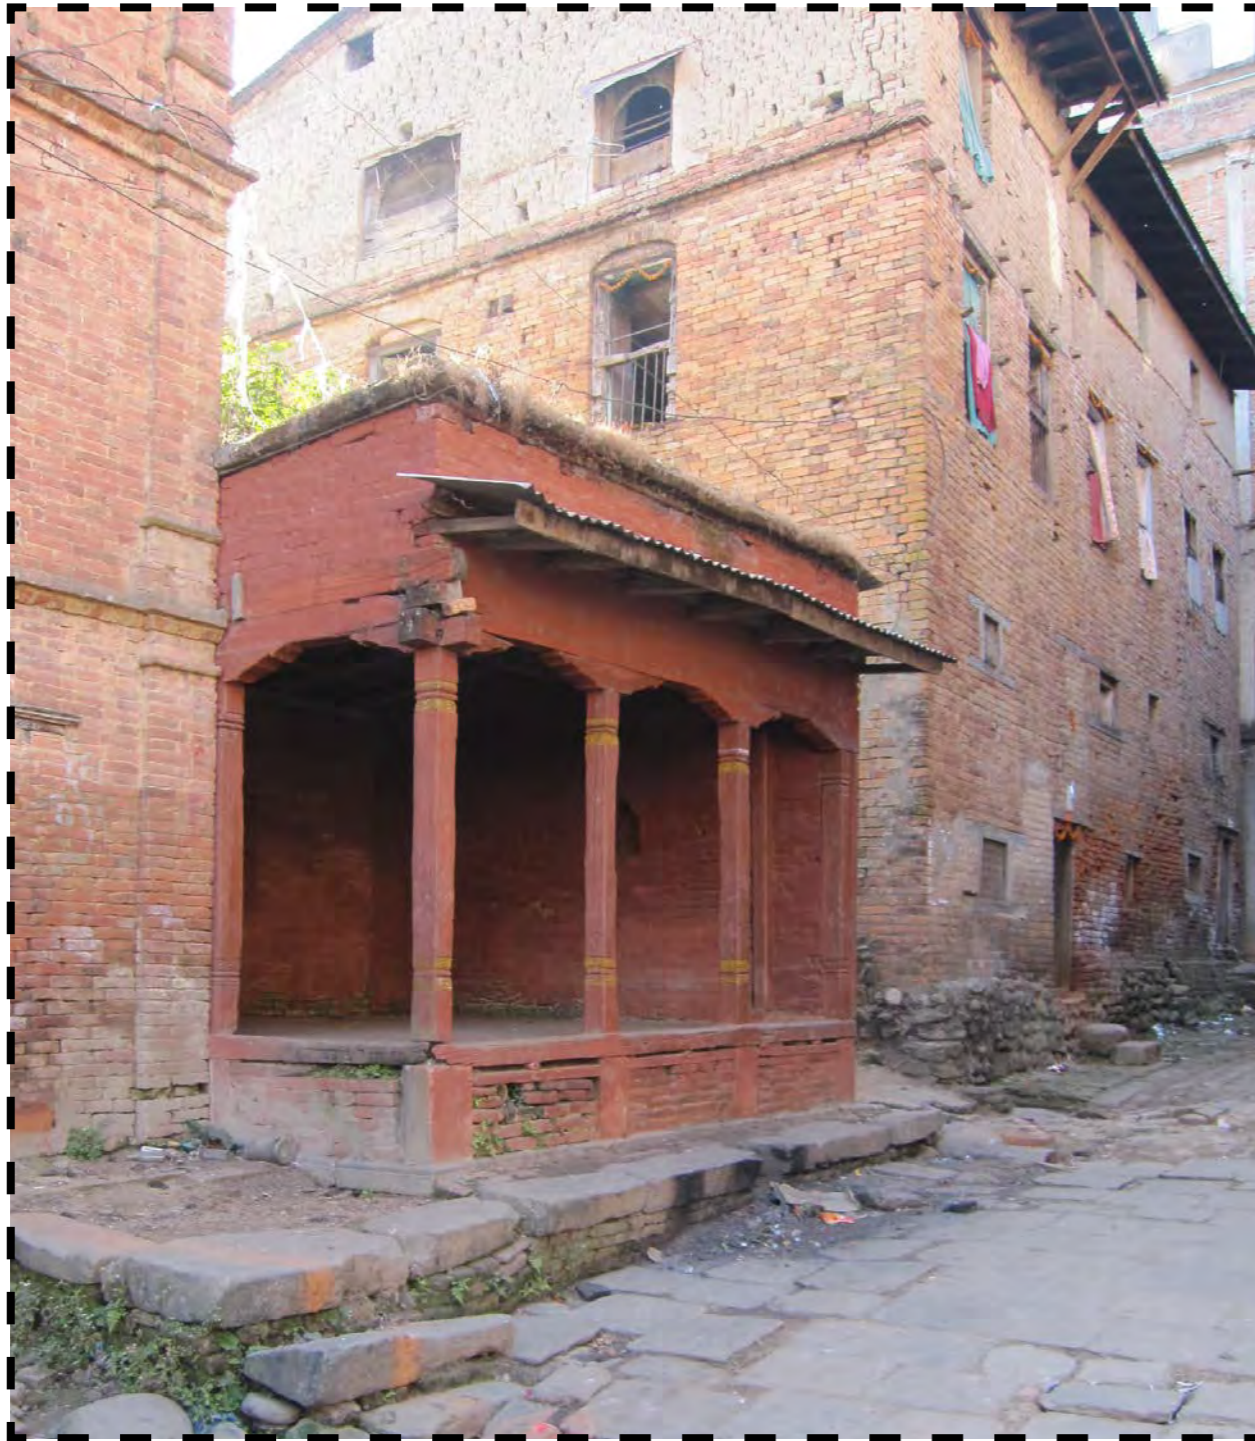
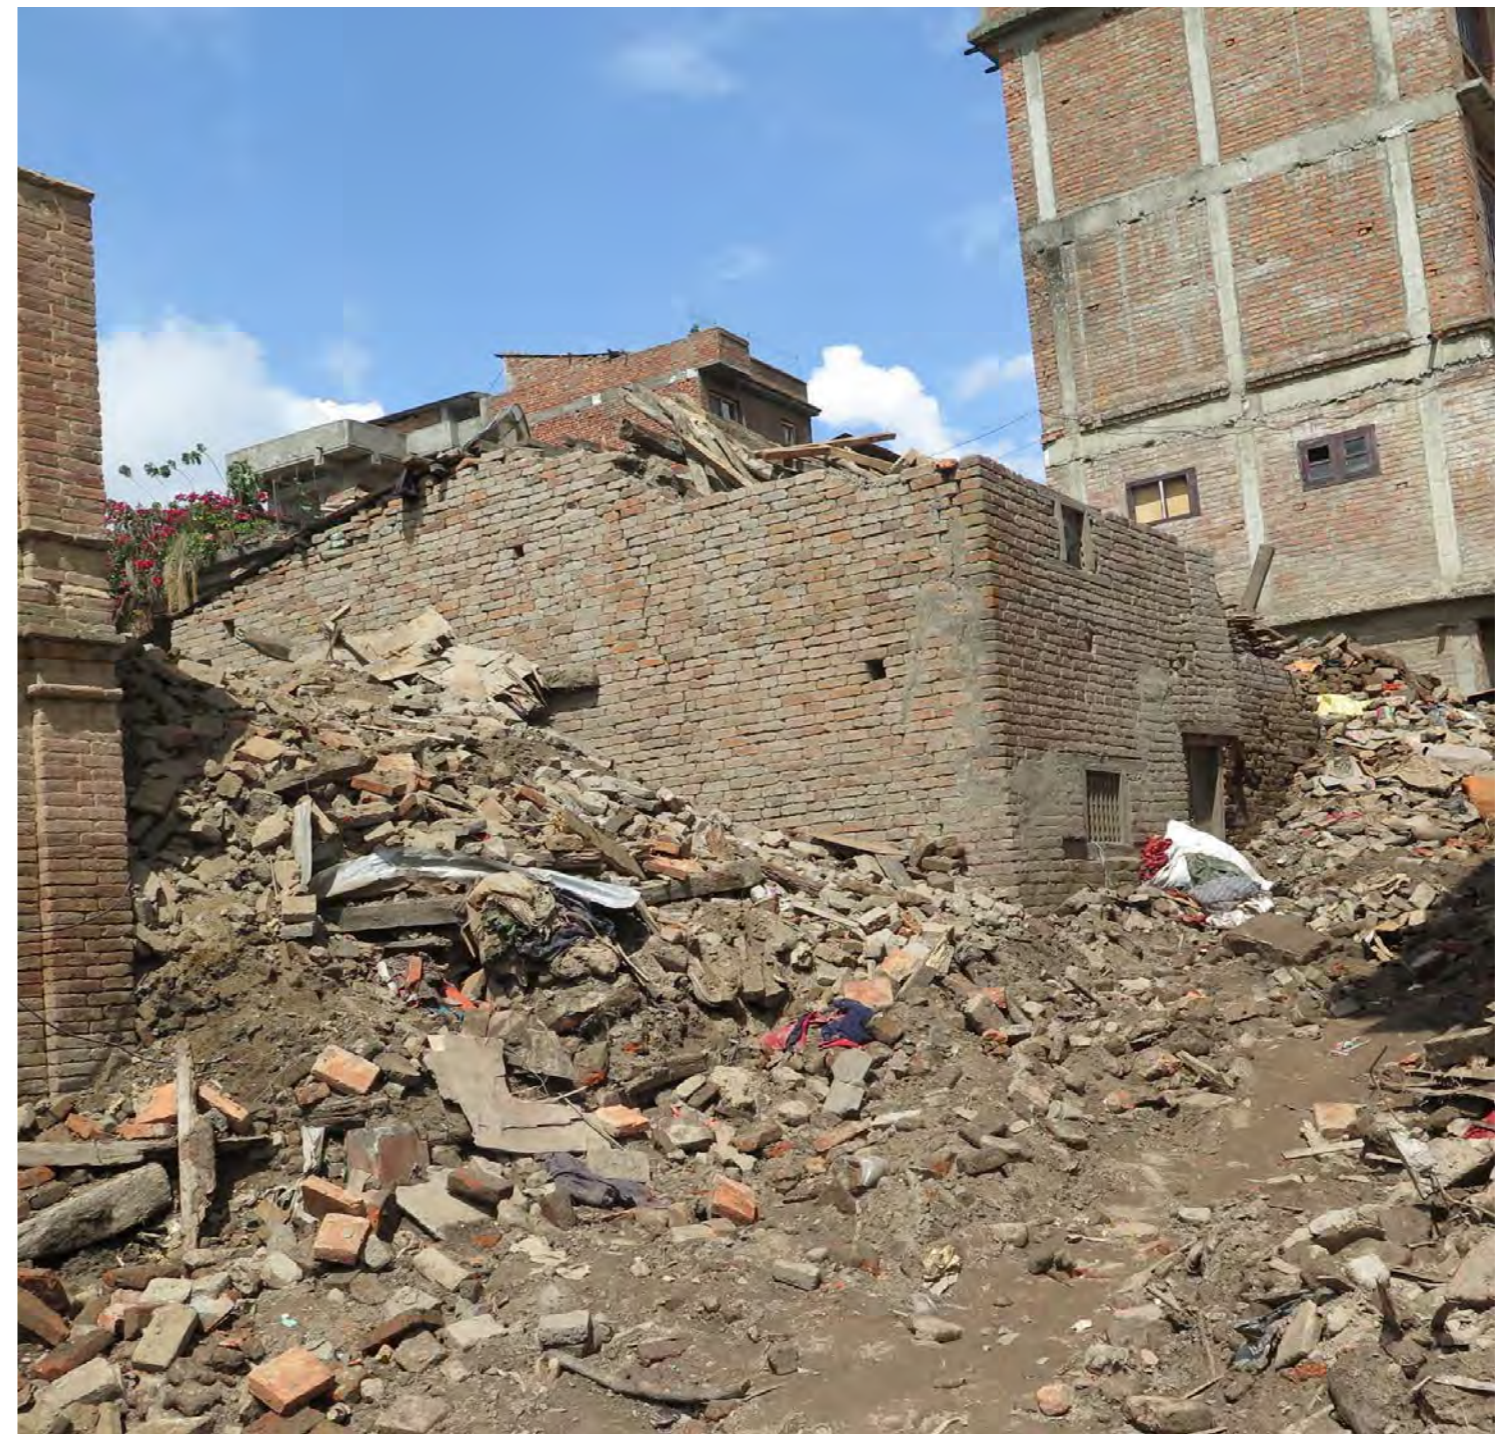
D-06 PATI - CHAKHUKIBA FALCHA

NUMBER	NAME	ESTABLISHED DATE (A.D.)	TYPOLOGY	GENERAL DESCRIPTION	PROBLEMS DESCRIPTION	DANGER/ DESTROY
D-06			Pati		Completely Destroyed

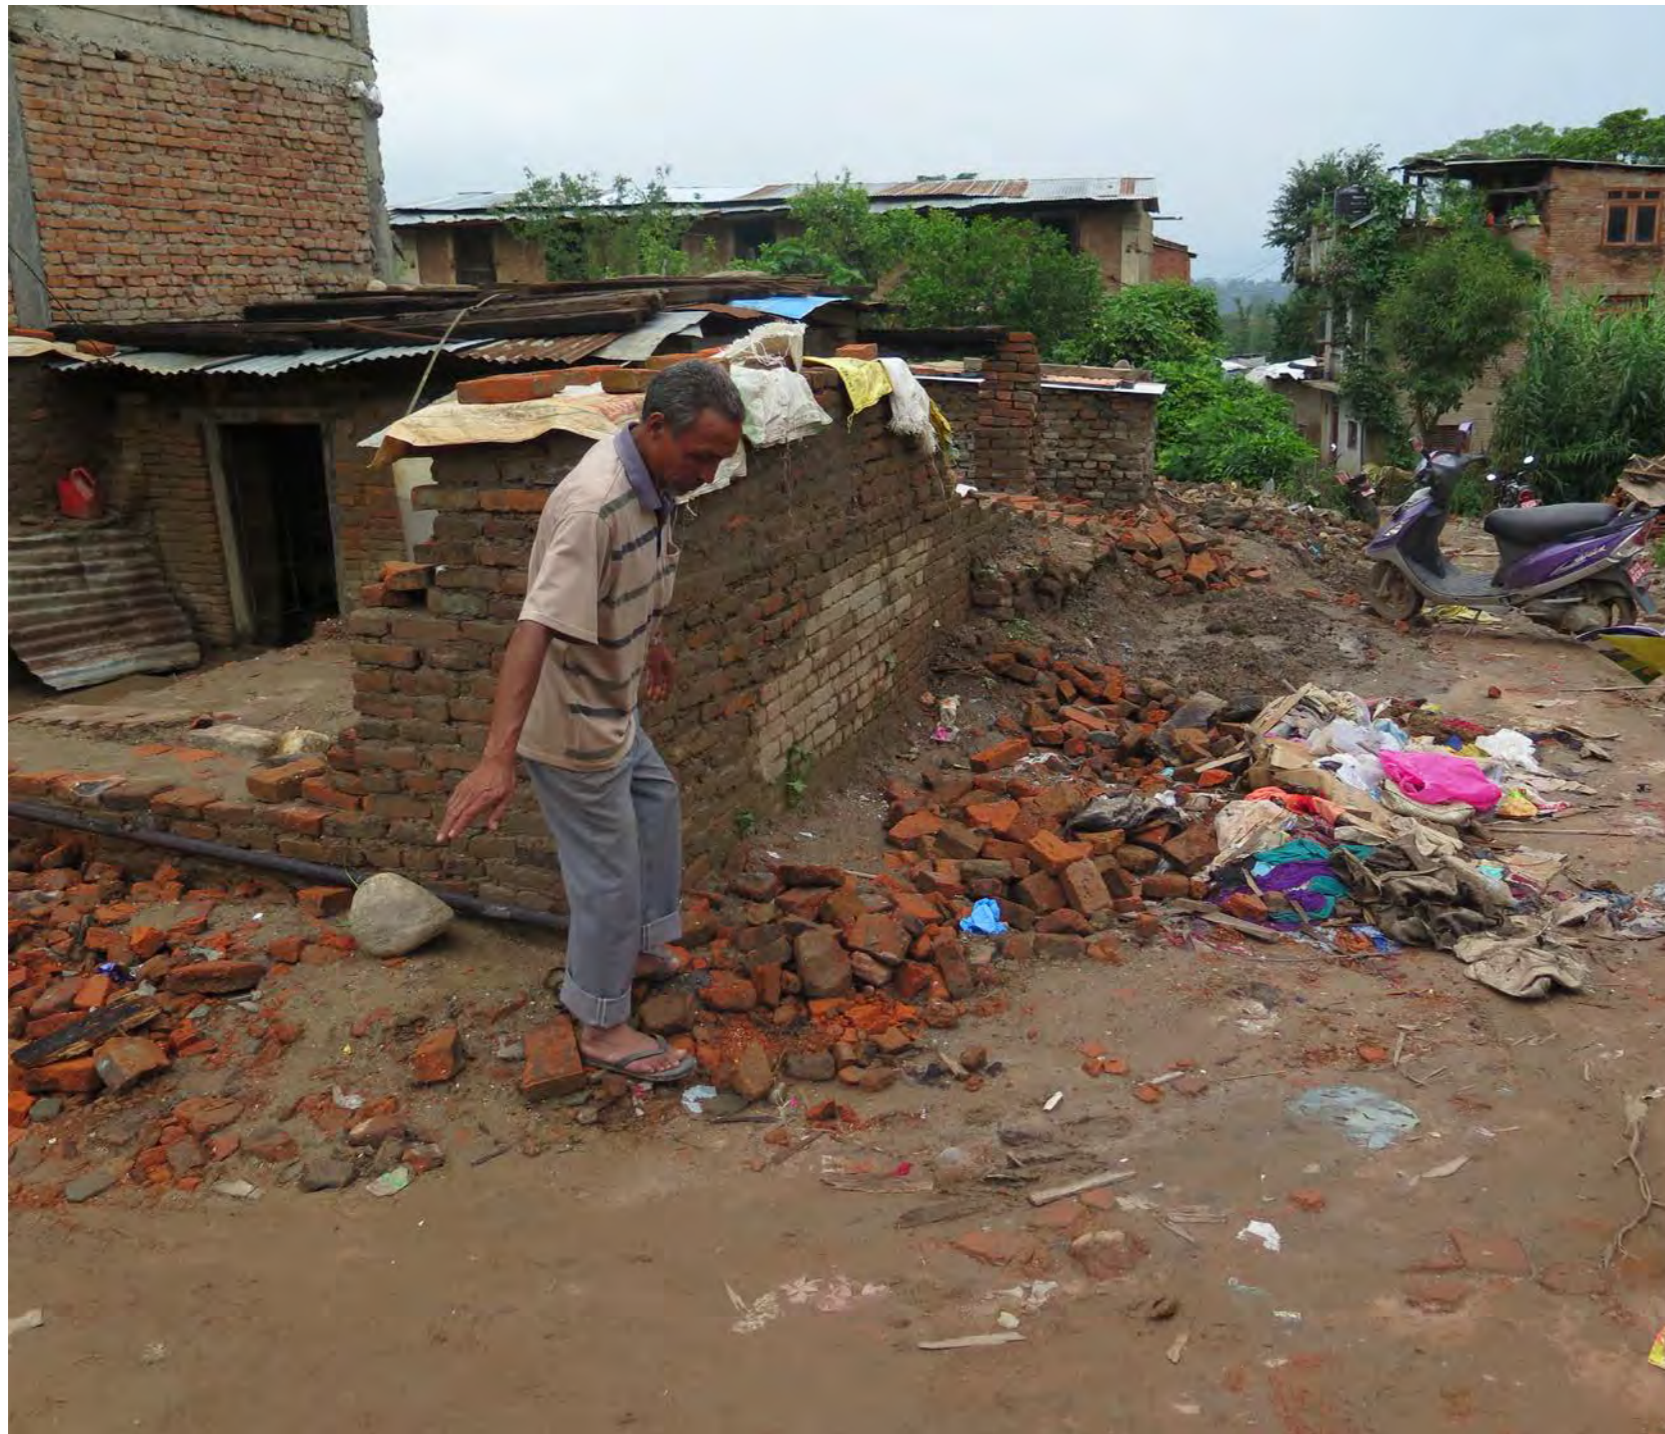
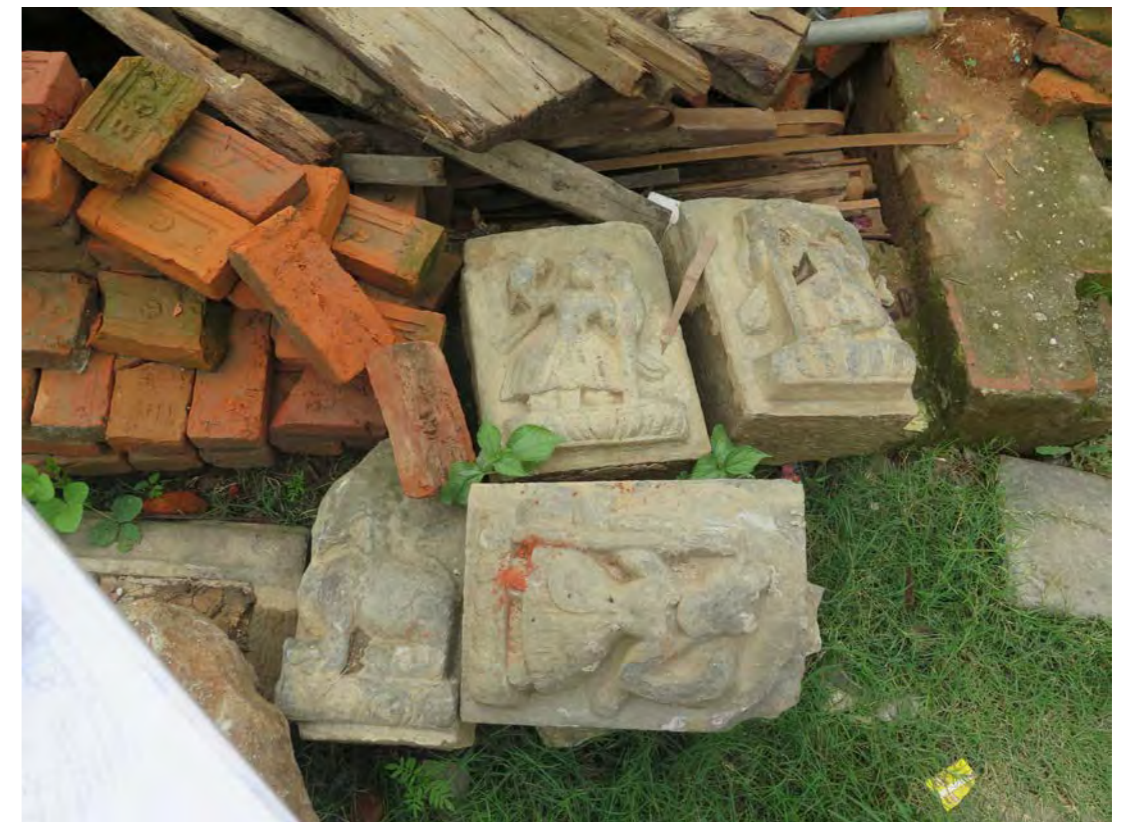
I-09 PATI

NUMBER	NAME	DATE A.D.	TPOLOGY	GENERAL DESCRIPTION	PROBLEMS DESCRIPTION	DANGER/ DESTROY
I-09			Pati	Ye ya punhi festival's feast is served here.	Only plinth was remaining before earthquake. Plinth has been demolished by dozer after earthquake. Plinth stones stored across the road and some of them were carried by dozer. Wooden carved members are dumped across road in rain.

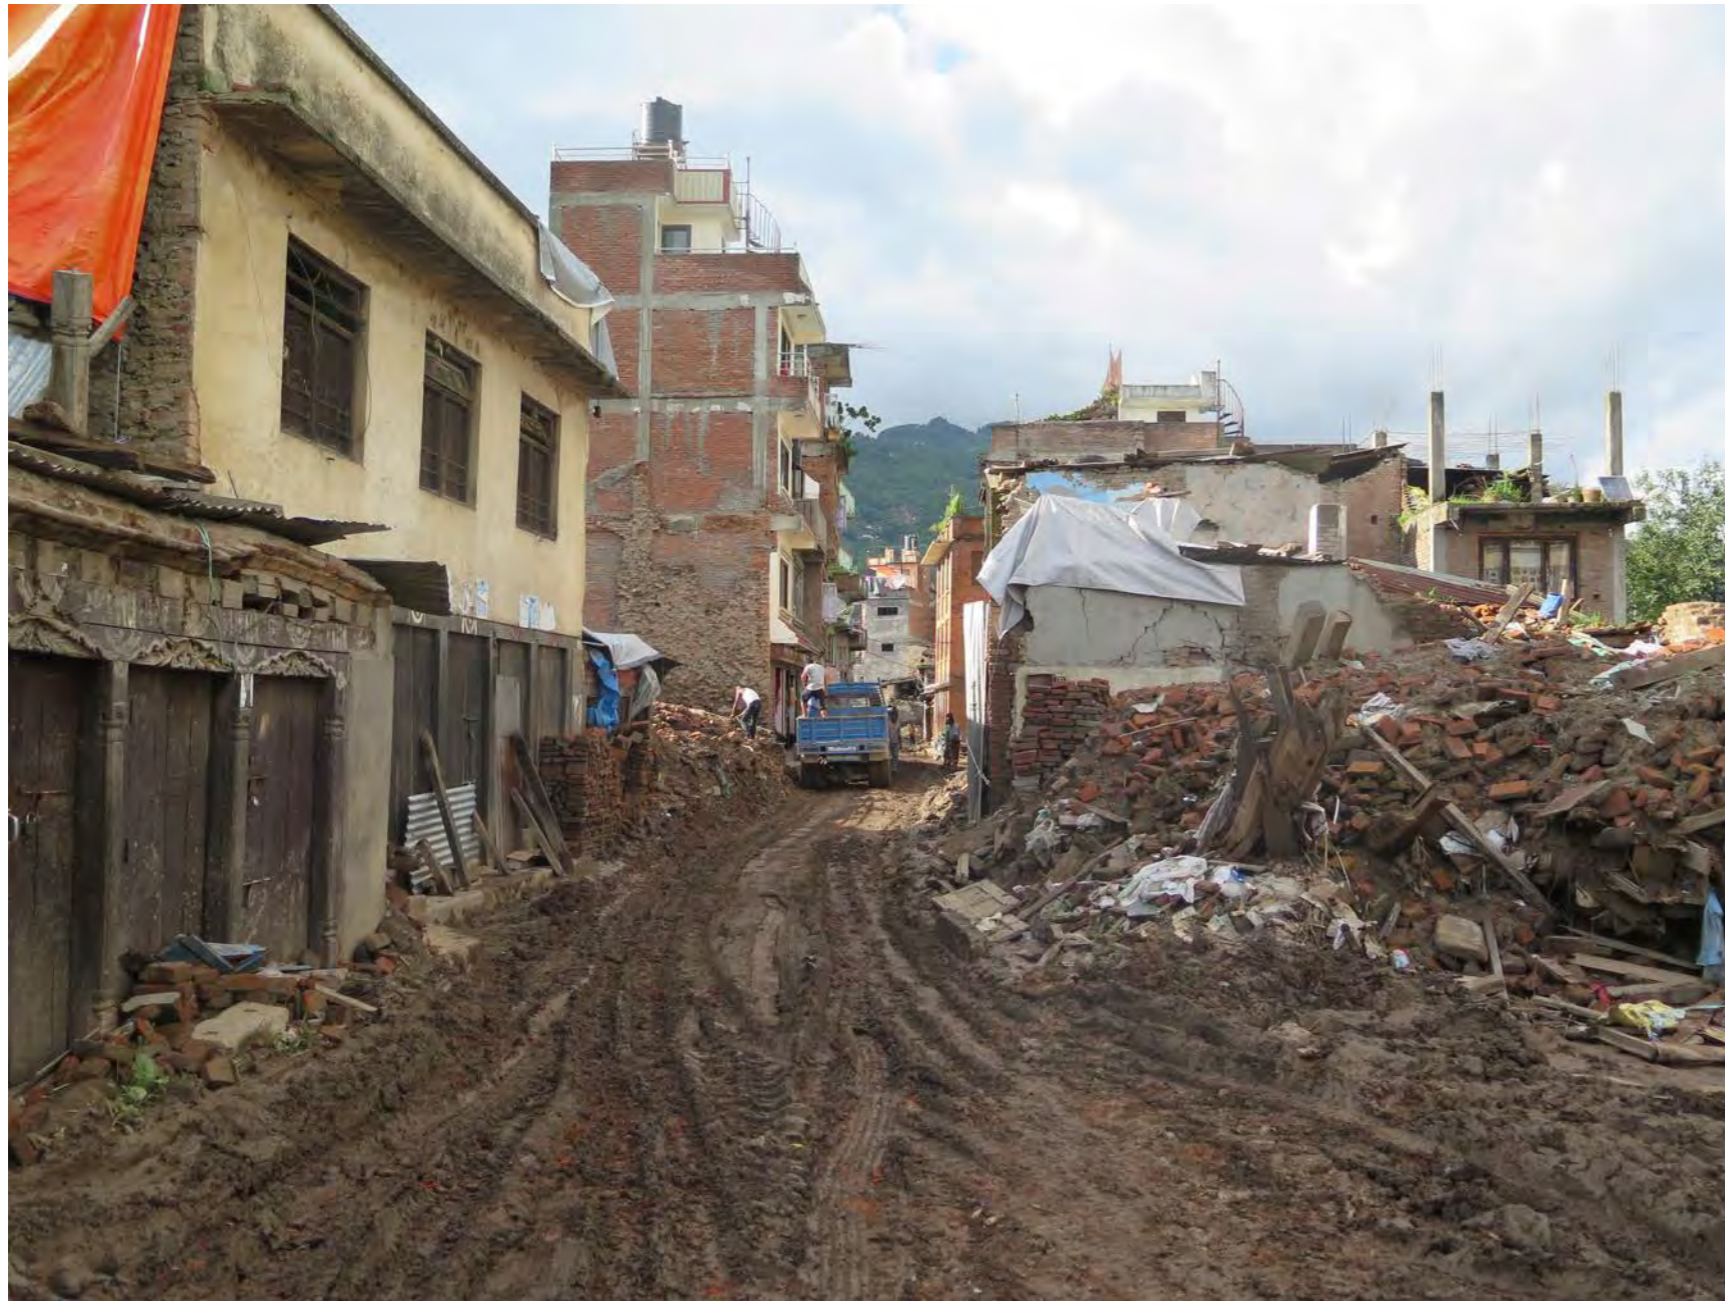
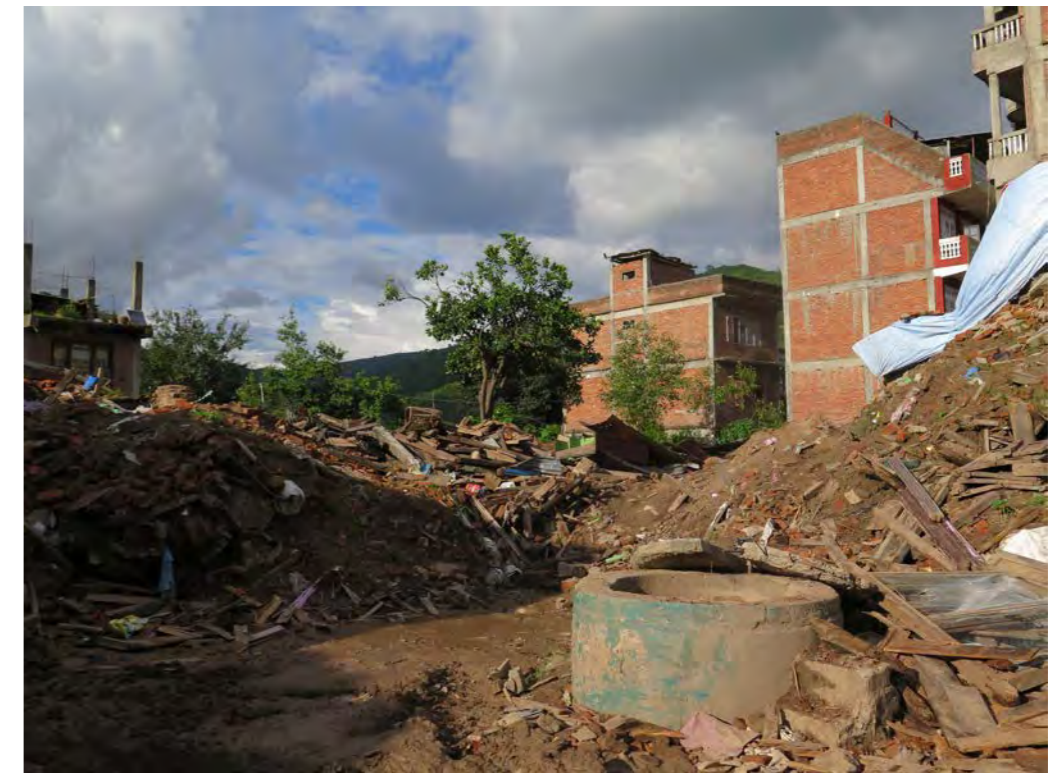
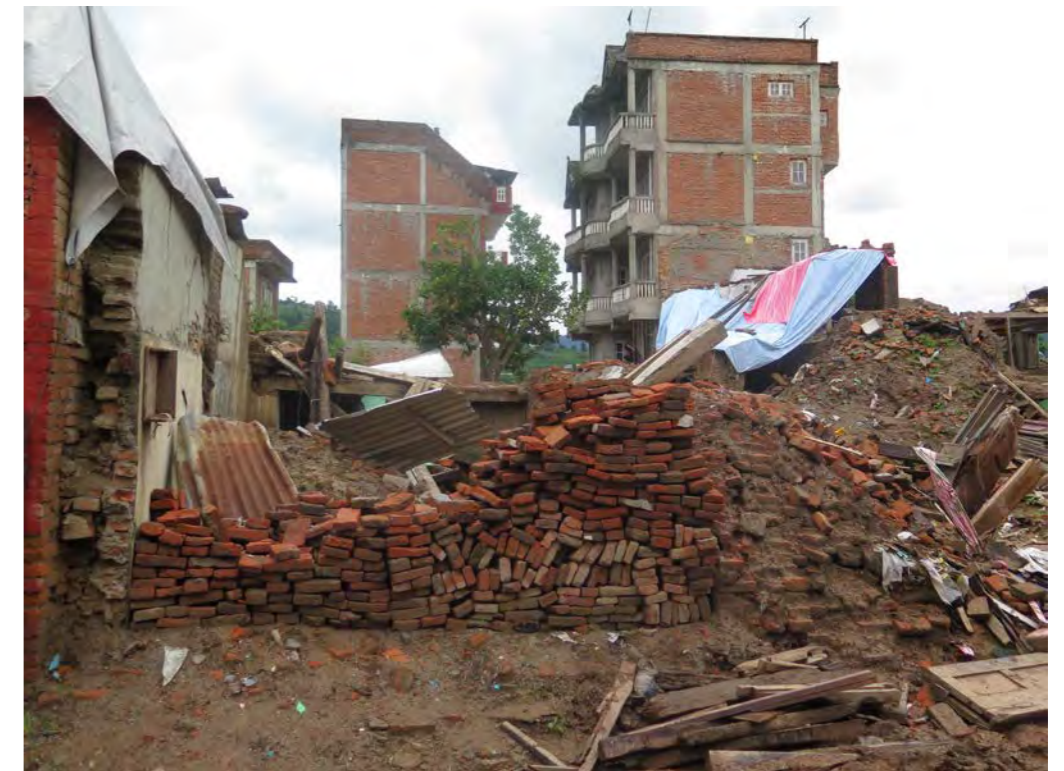
J-15 PATI - SALKHA PATI

NUMBER	NAME	DATE A.D.	TPOLOGY	GENERAL DESCRIPTION	PROBLEMS DESCRIPTION	DANGER/ DESTROY
J-15	Salkha pati		Pati		Totally collapsed. Wooden carvings lost while removing rubbles by dozer.
