2015 Earthquake Damage Mapping

Sankhu

October 2015

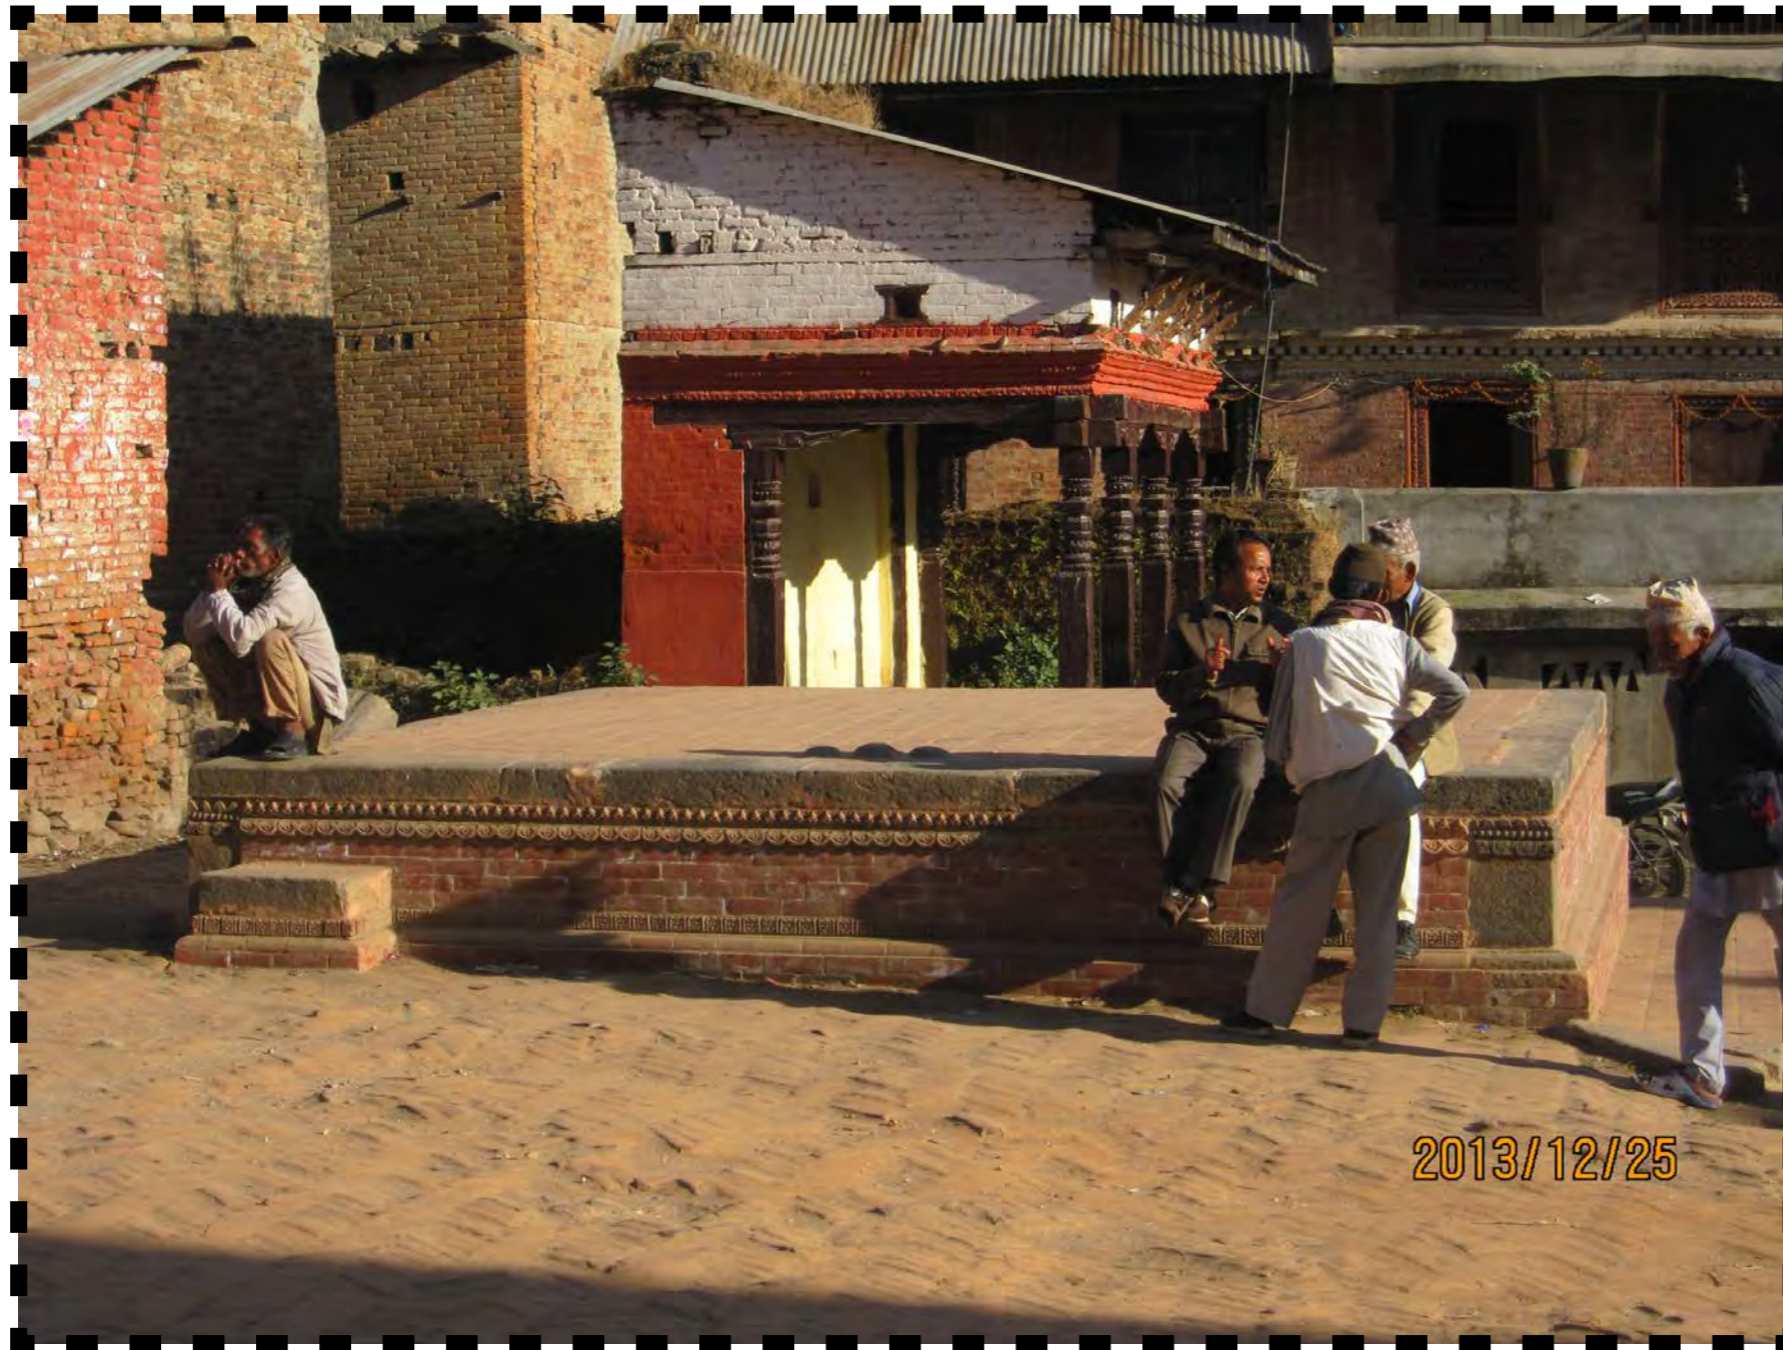
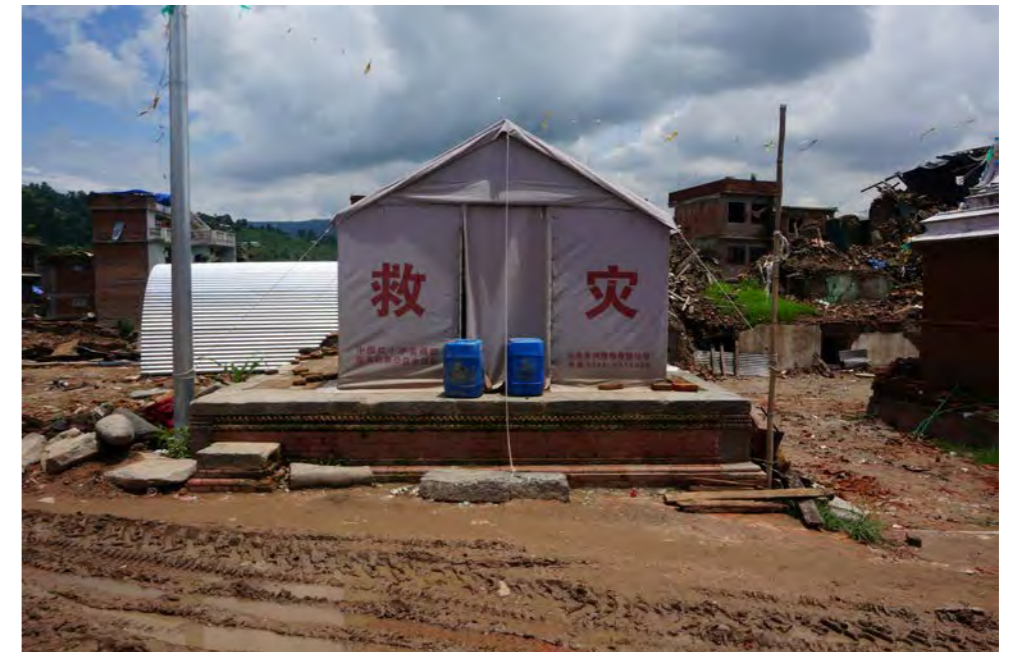
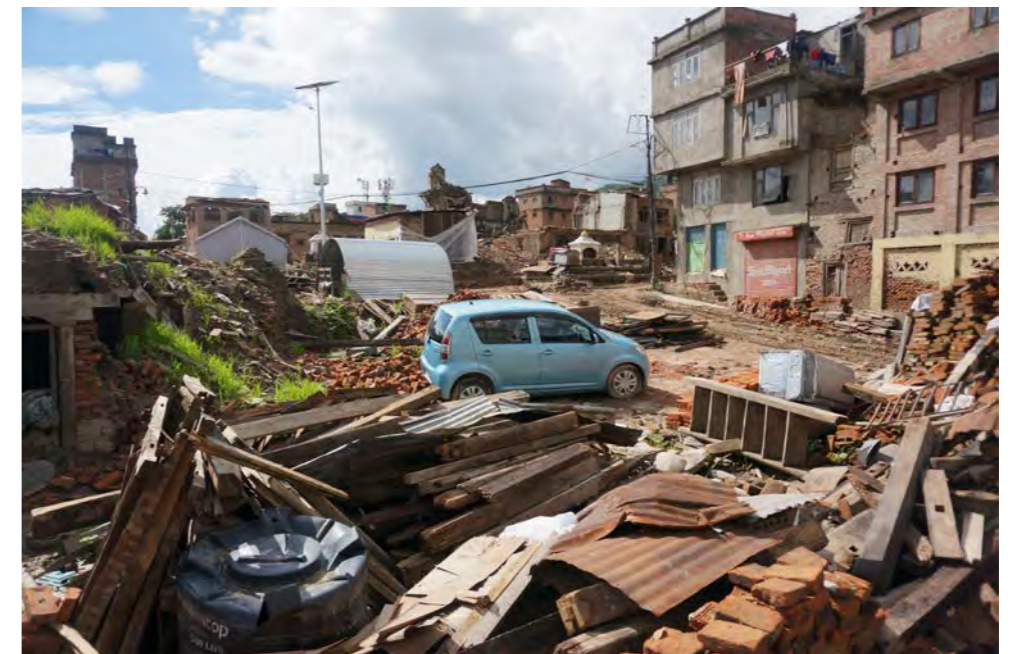
K-06 PATI - CHALAKHA PATI

NUMBER	NAME	ESTABLISHED DATE (A.D.)	TPOLOGY	GENERAL DESCRIPTION	PROBLEMS DESCRIPTION	DANGER/ DESTROY
K-06	Chalakha Falcha		Pati	Wooden Structure	Totally Collapsed All parts and artefacts are dumped away

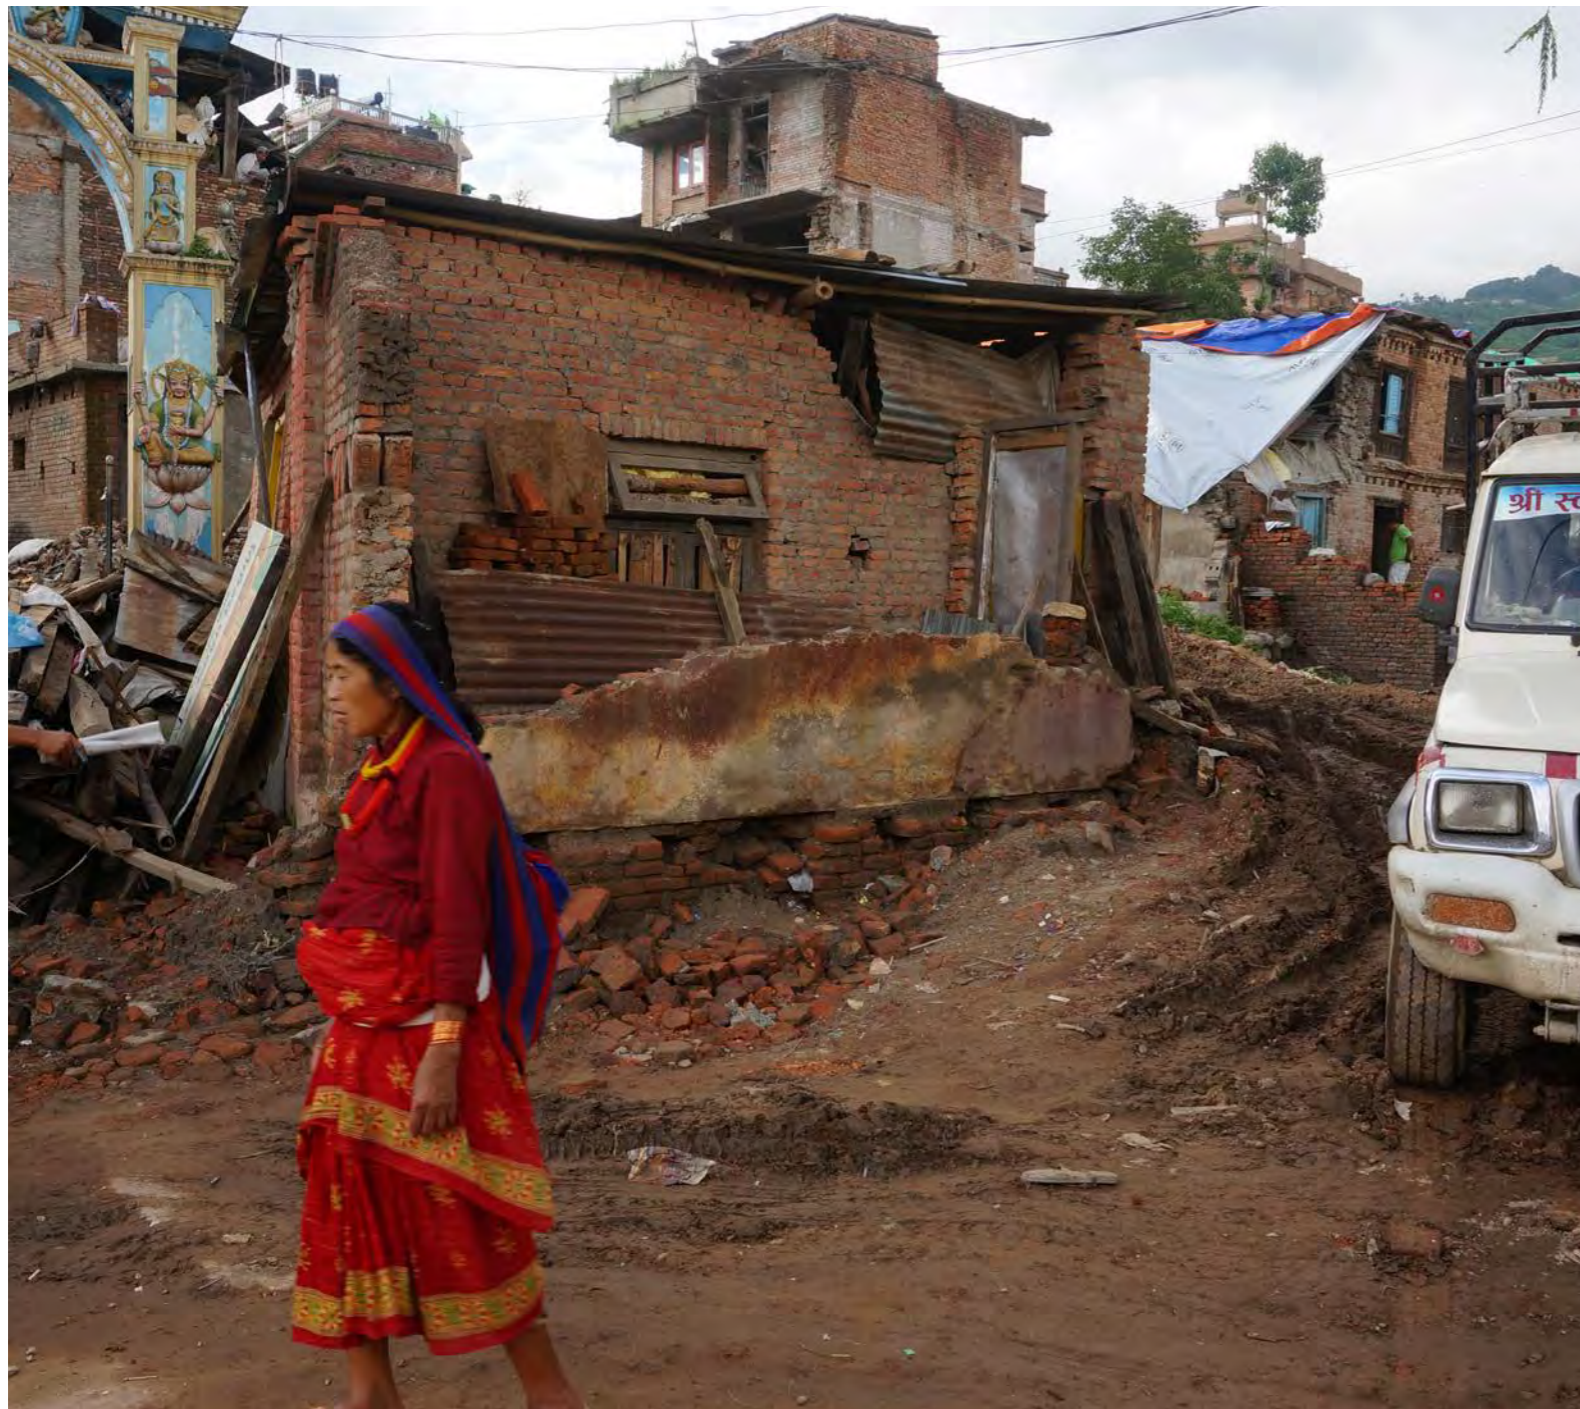
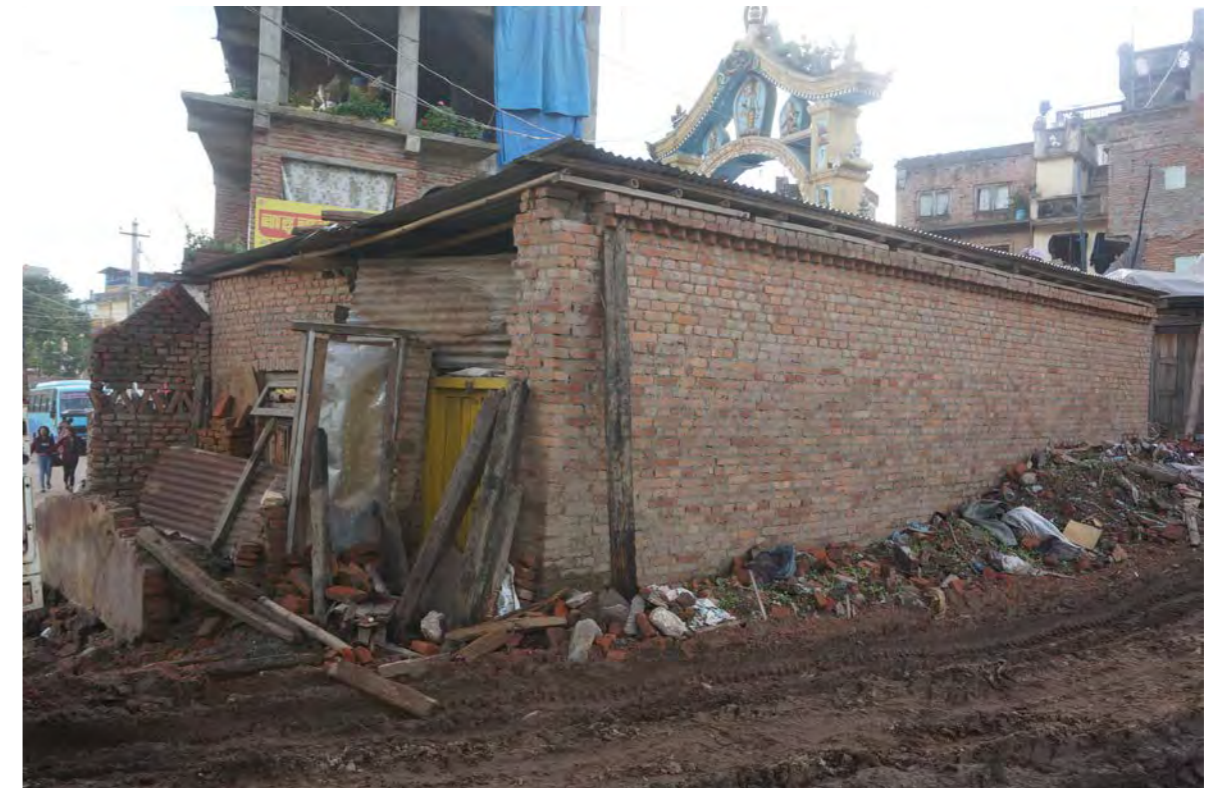
K-07 PATI

NUMBER	NAME	DATE A.D.	TPOLOGY	GENERAL DESCRIPTION	PROBLEMS DESCRIPTION	DANGER/ DESTROY
K-07			Pati	Wooden structure with W-side in brick	Totally Collapsed

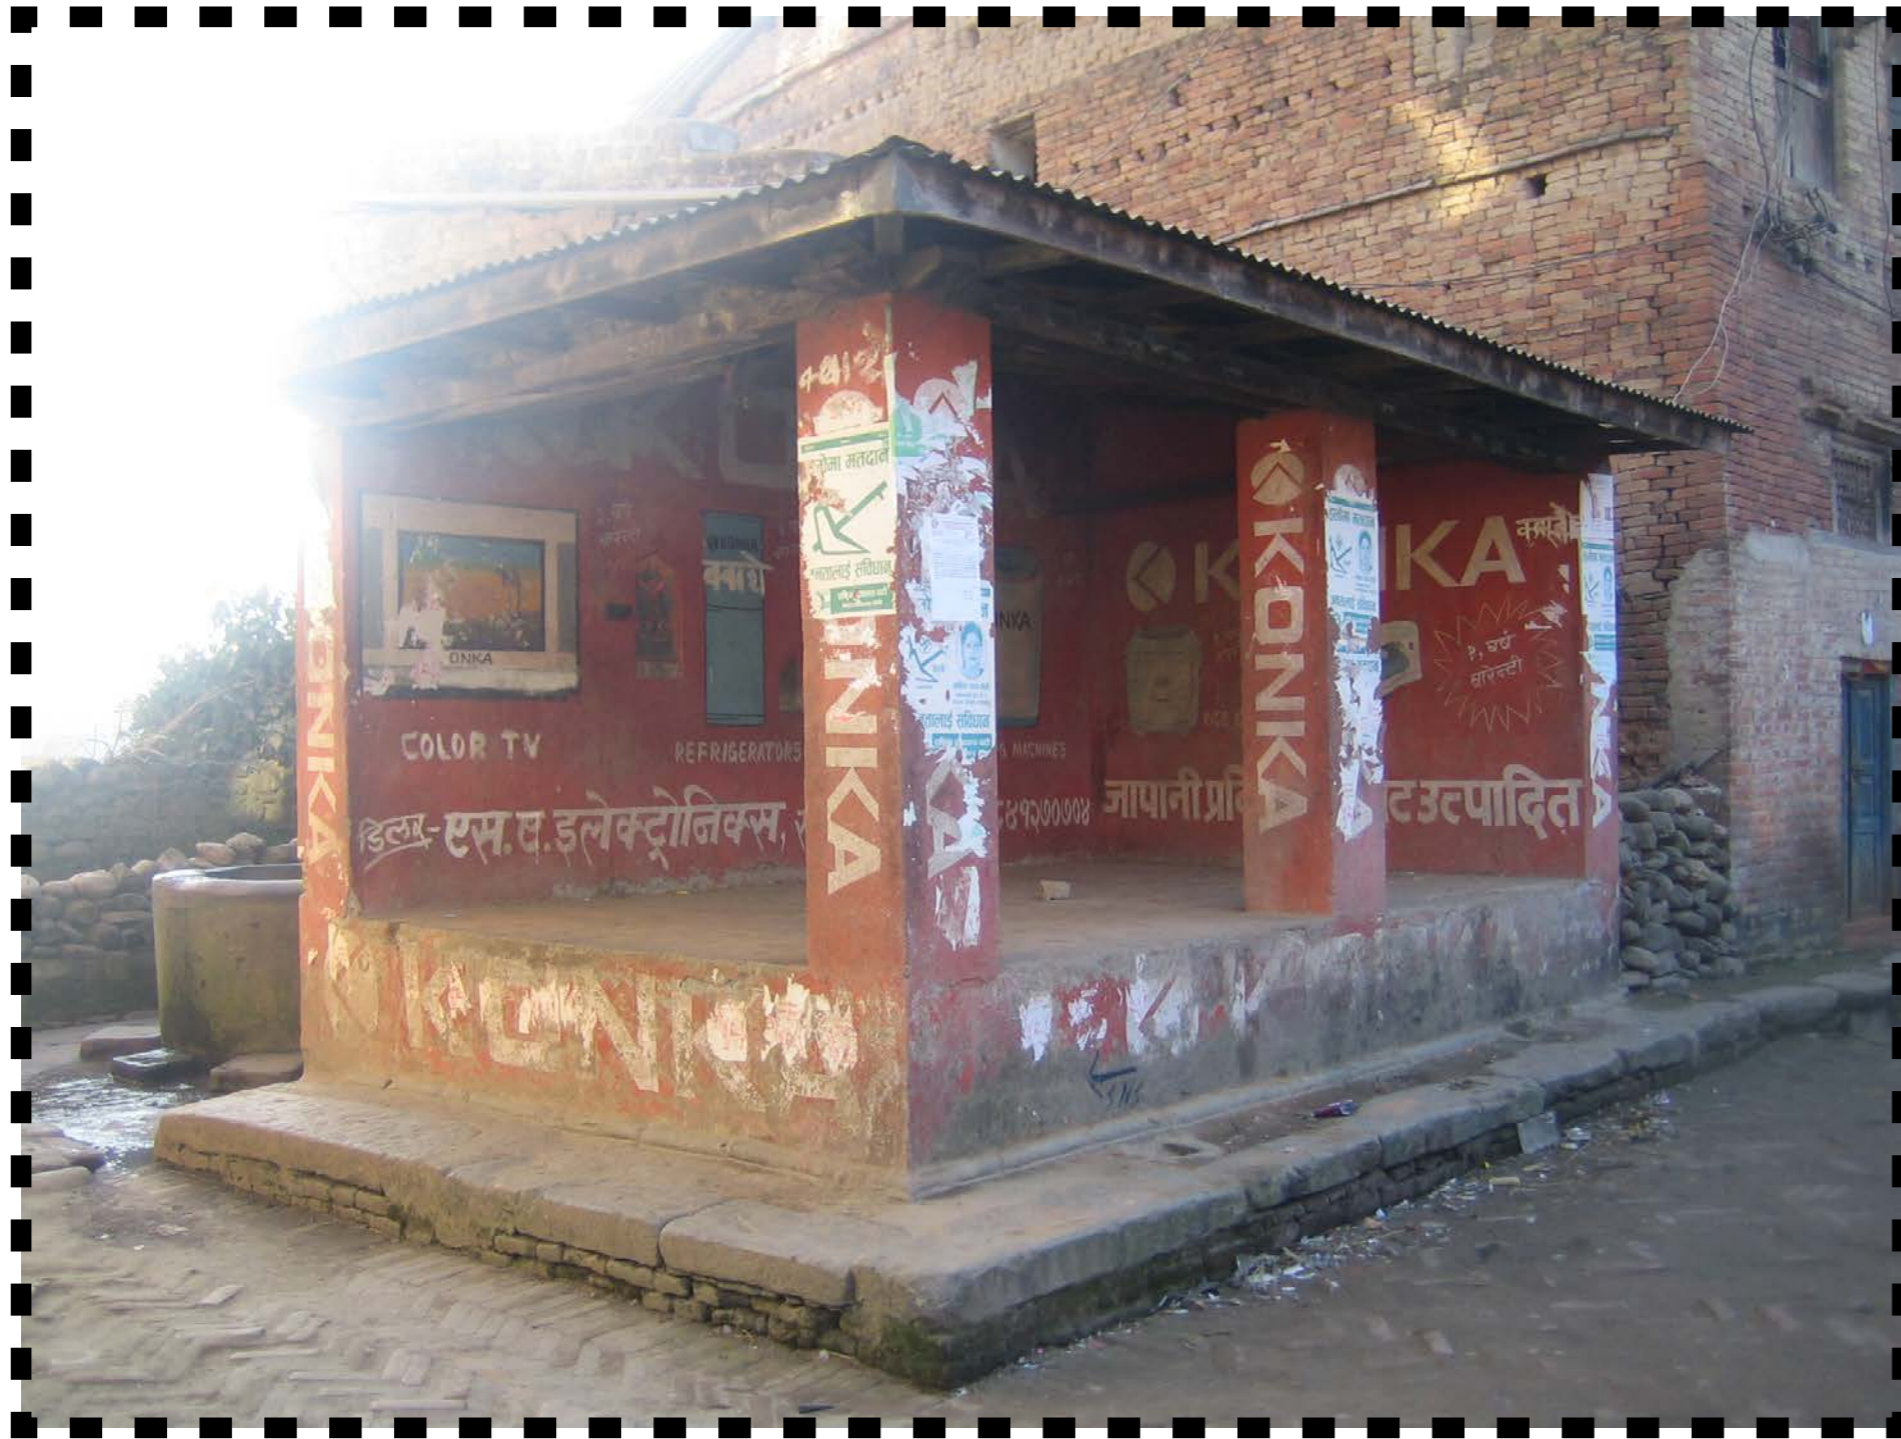
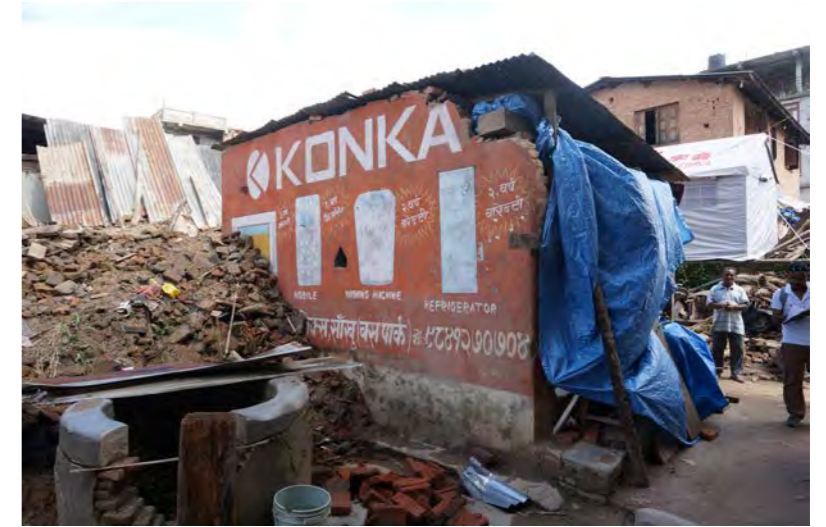
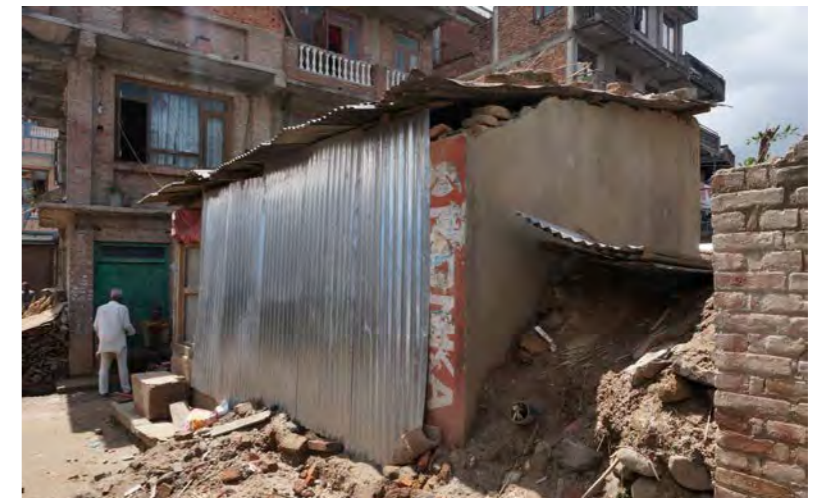
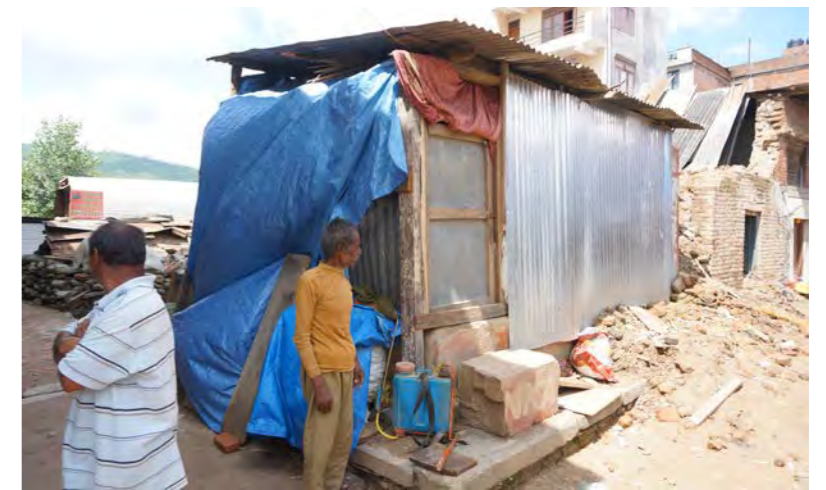
A-05 PATI

NUMBER	NAME	ESTABLISHED DATE (A.D.)	TYPOLOGY	GENERAL DESCRIPTION	PROBLEMS DESCRIPTION	DANGER/ DESTROY
A-05			Pati	Brick and concrete pillars were used for construction	Totally collapsed with portion of back and side walls remaining. Some stone inscription present at walls Used by some family as temporary shelter Needs reconstruction for public use

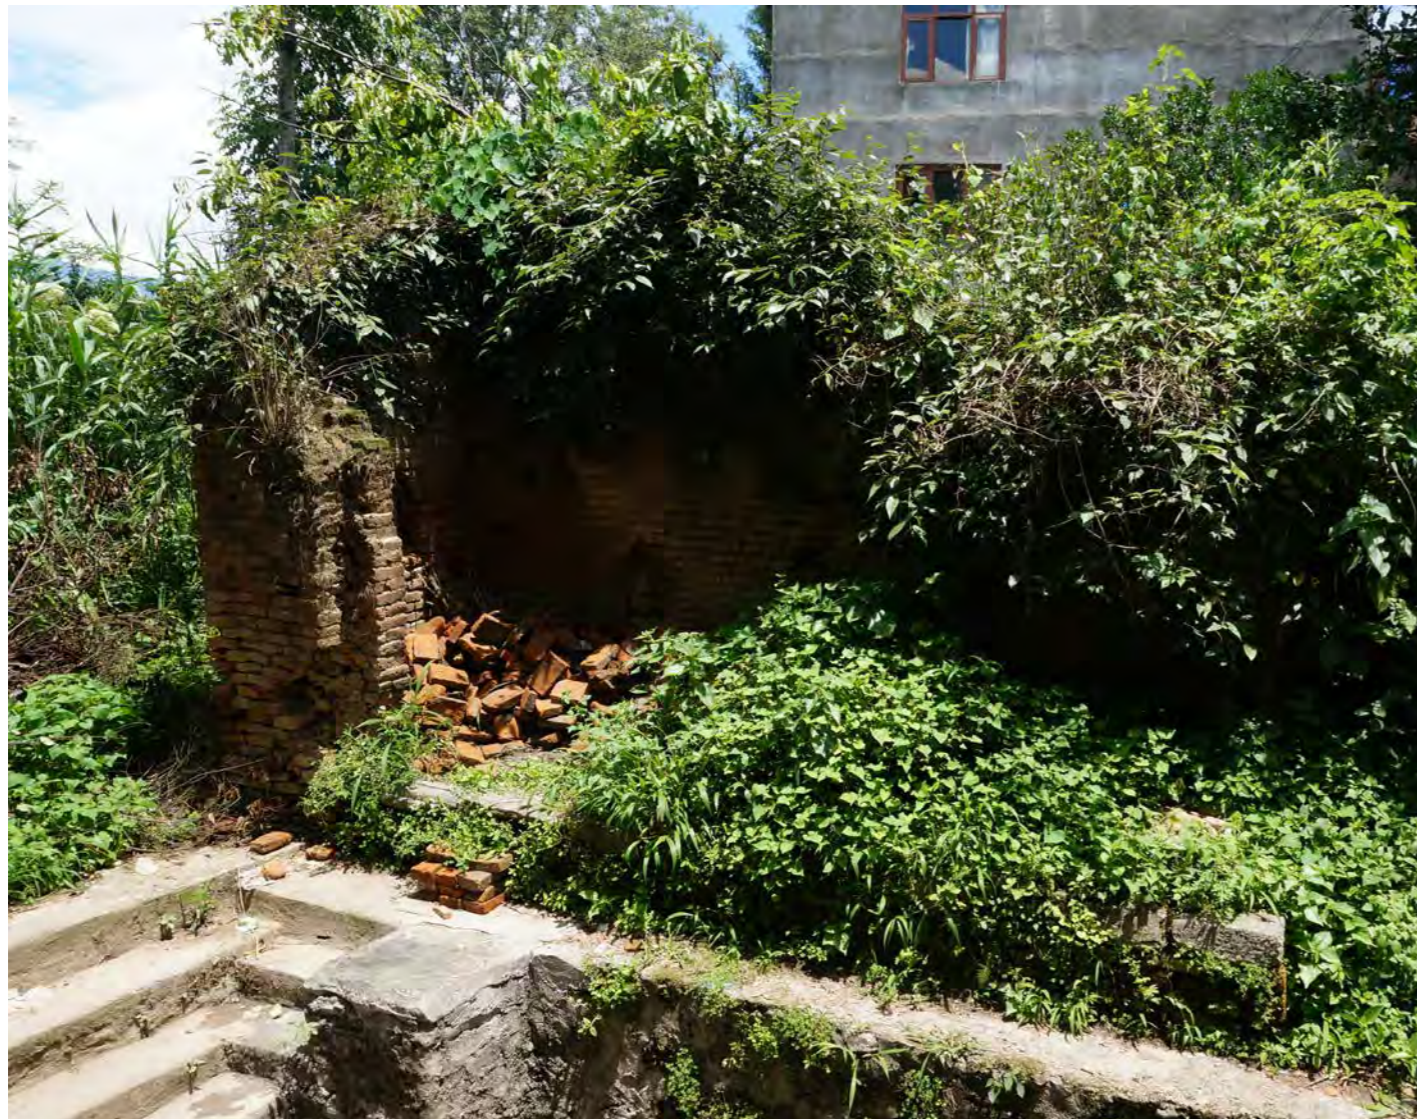
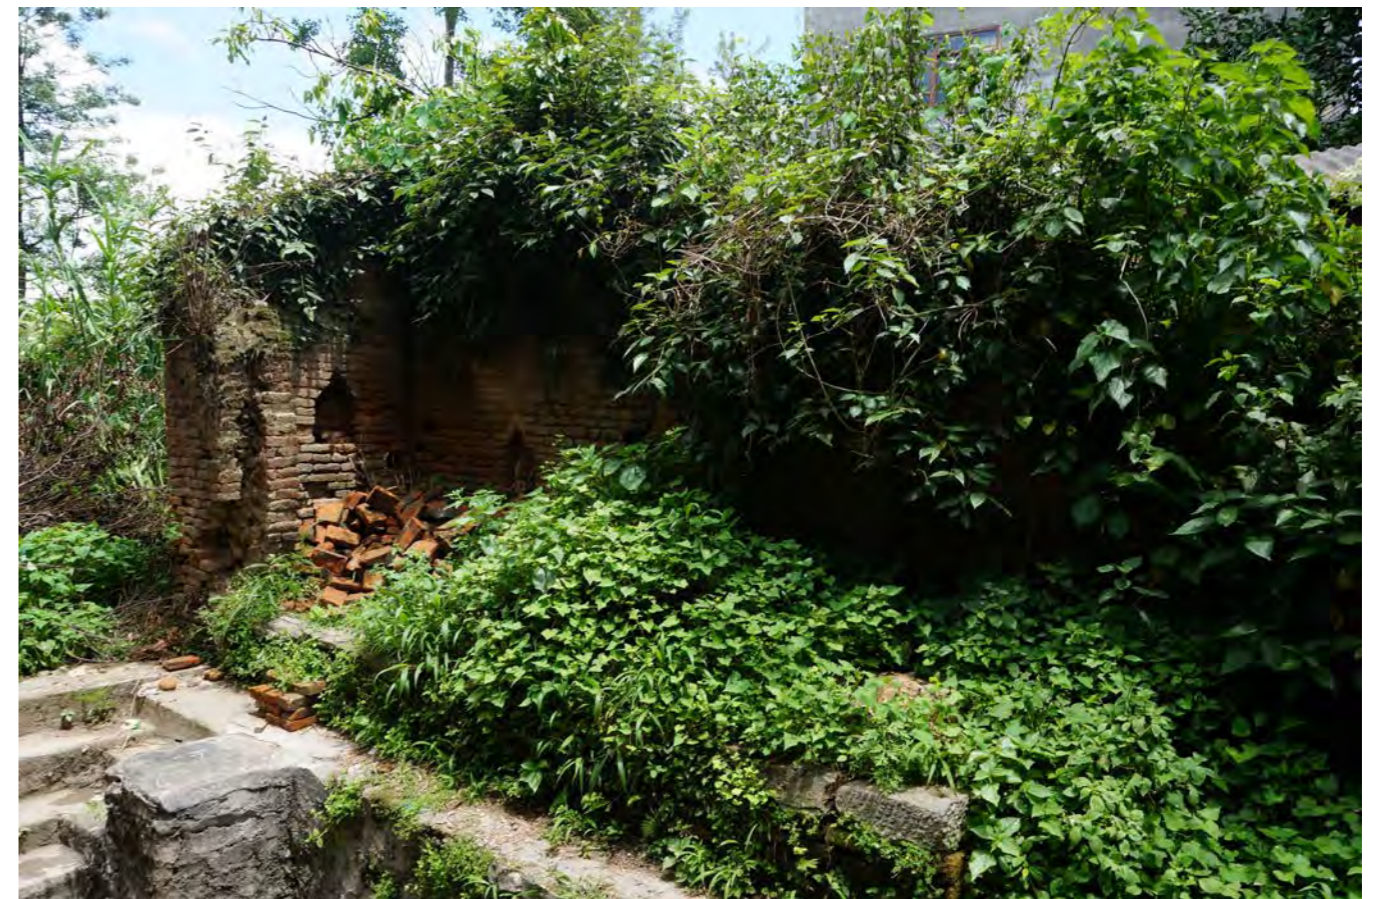
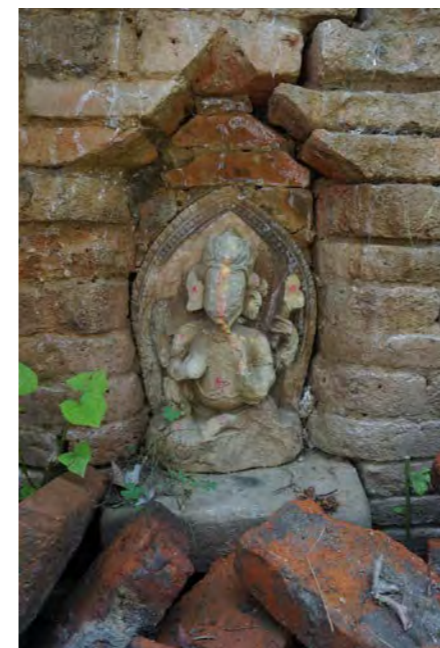
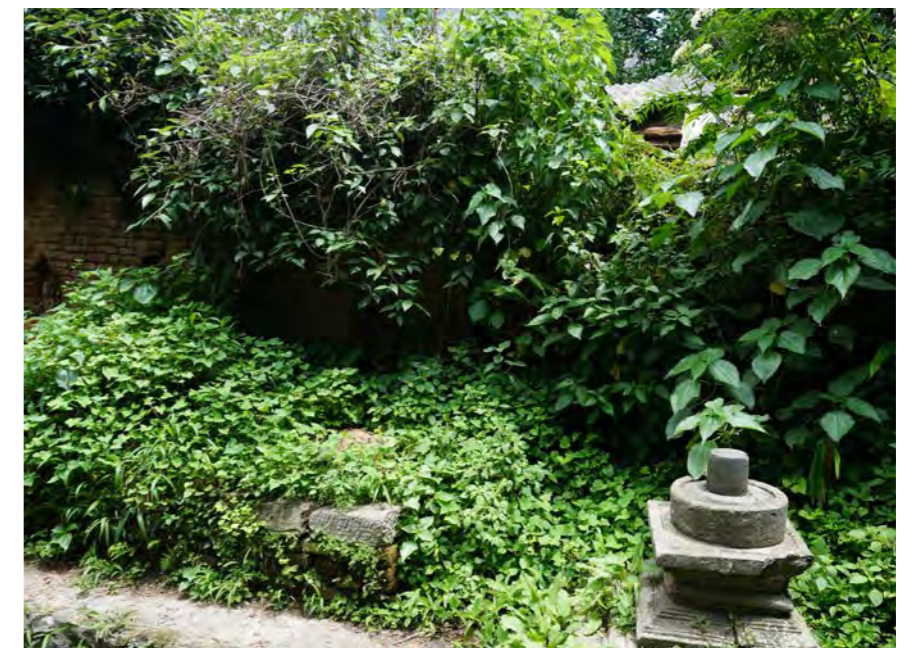
A-10 PATI

NUMBER	NAME	DATE A.D.	TYPOLOGY	GENERAL DESCRIPTION	PROBLEMS DESCRIPTION	DANGER/ DESTROY
A-10		Very ancient	Pati (adjacent to public place no 9)	More than 100 yrs old pati constructed with uncooked brick and clay	Totally collapsed (before Earthquake of 2072 BS). Small stone statue of Ganesha is still present and needs to be preserved. Near the pati, a very old and possibly only one kind ever made, Shivalinga with standing Shivas at top of linga was said to exist. But it was stolen long ago, according to the local person Sujan Shrestha (9803673953)

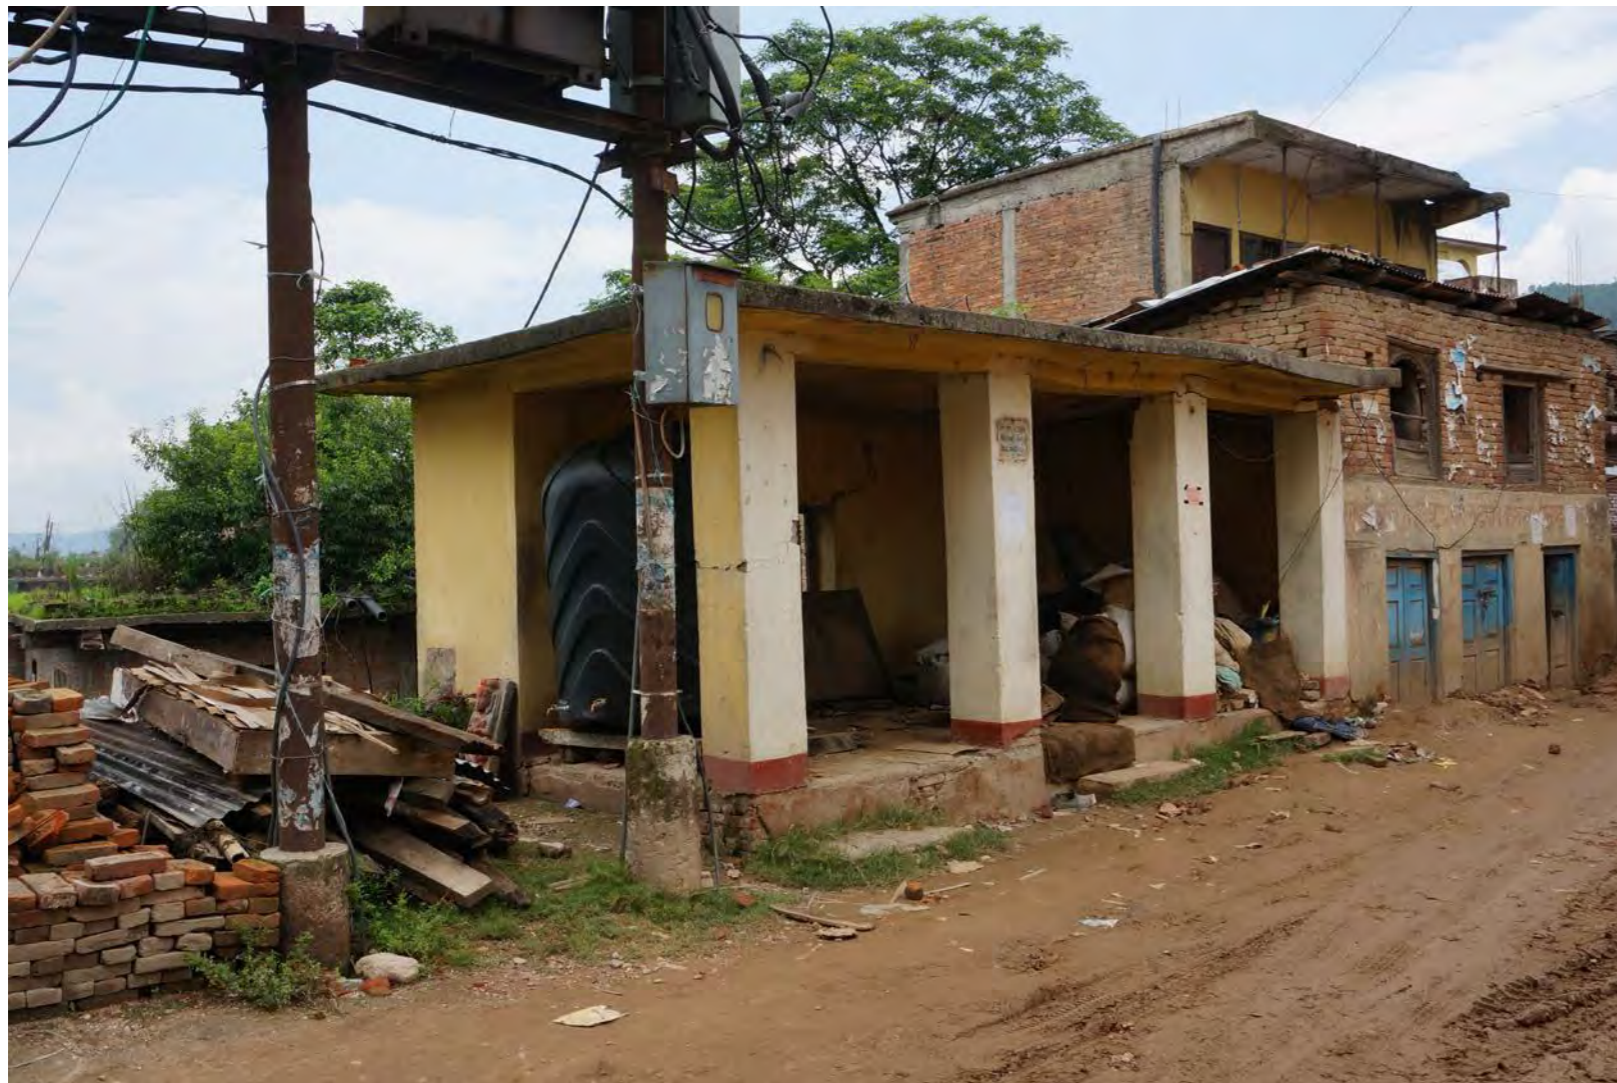
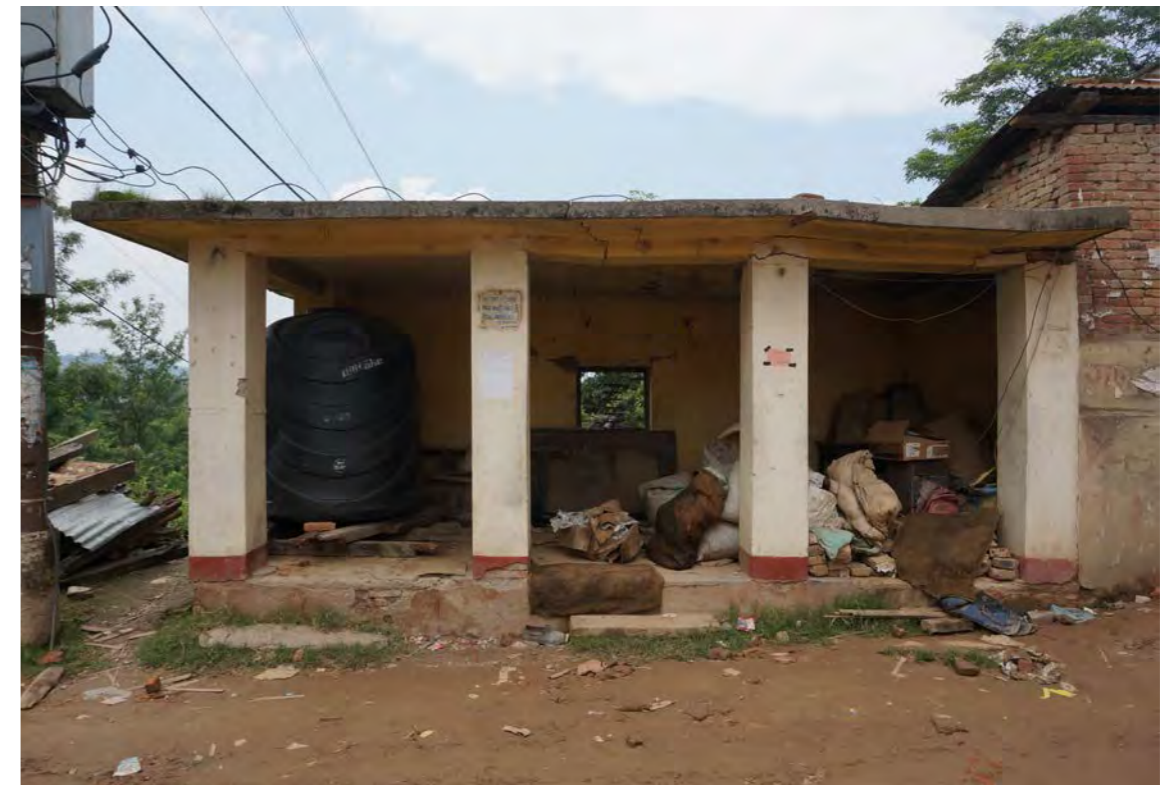
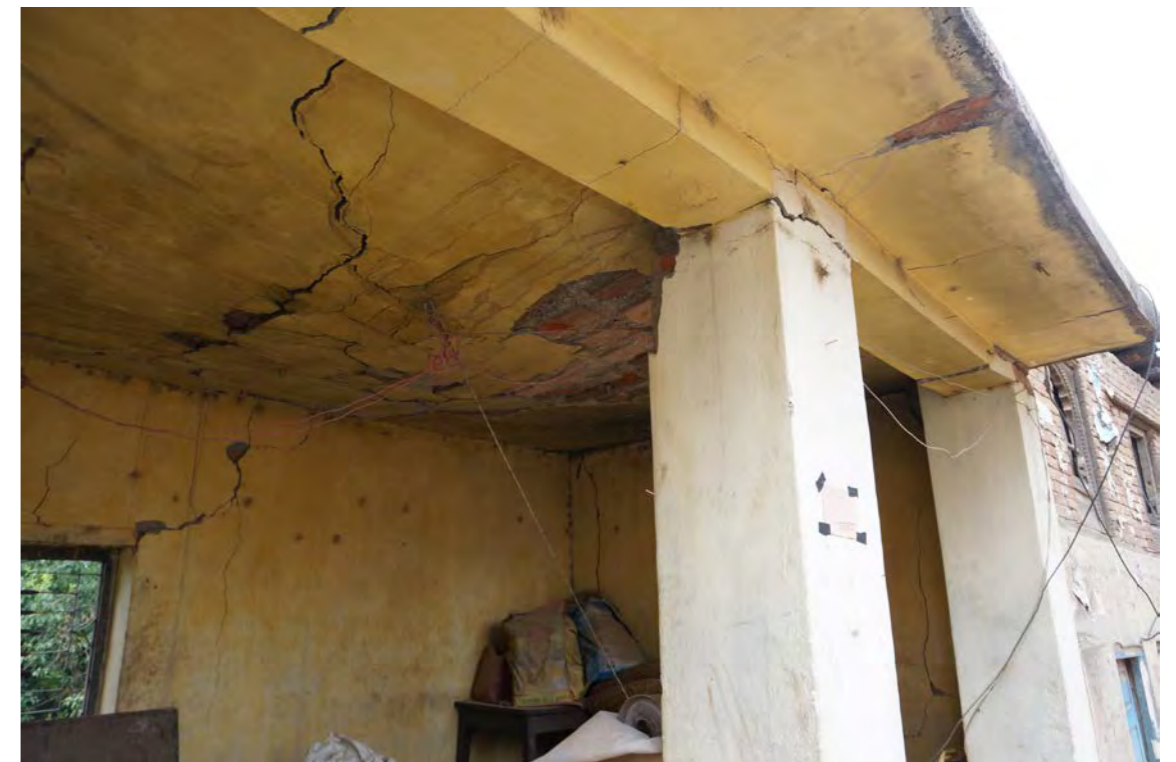
C-21 PATI - KRISHNA FALCHA

NUMBER	NAME	ESTABLISHED DATE (A.D.)	TYPOLOGY	GENERAL DESCRIPTION	PROBLEMS DESCRIPTION	DANGER/ DESTROY
C-21	Krishna Falcha		Pati	Brick structure with cement plaster and concrete slab	Severely damaged Roof is heavily damaged due to overhead tank Needs reconstruction

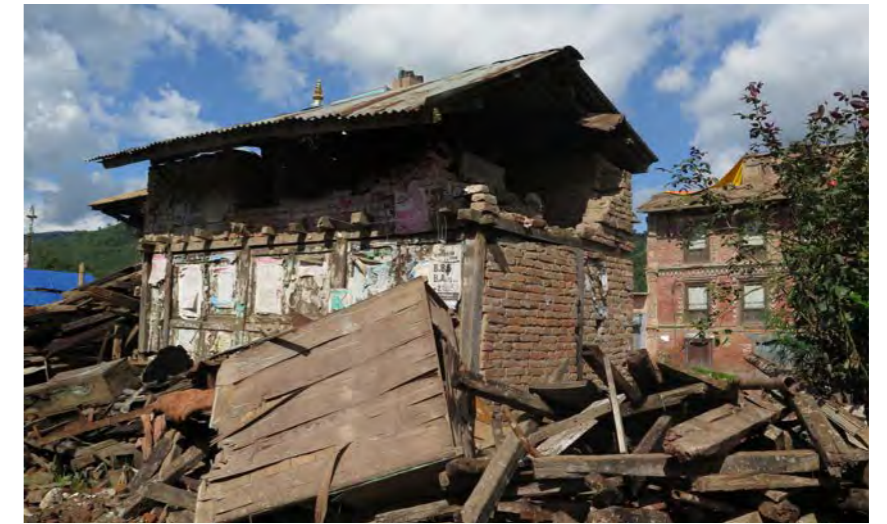
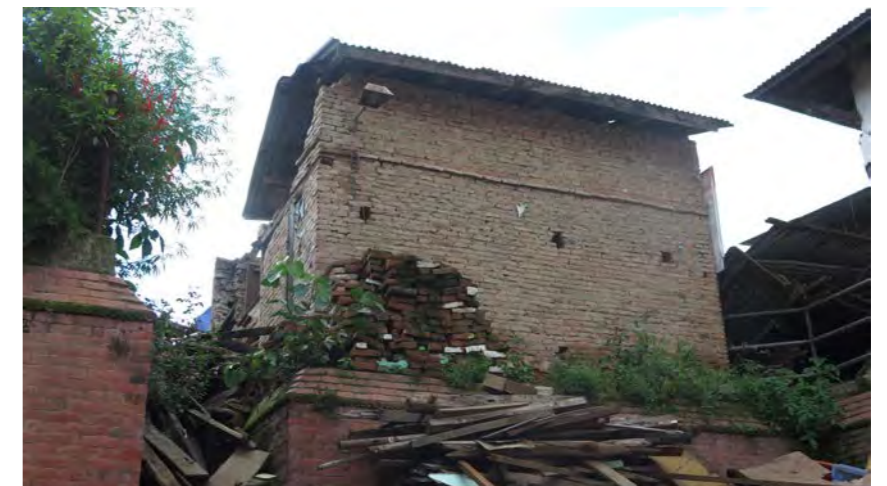
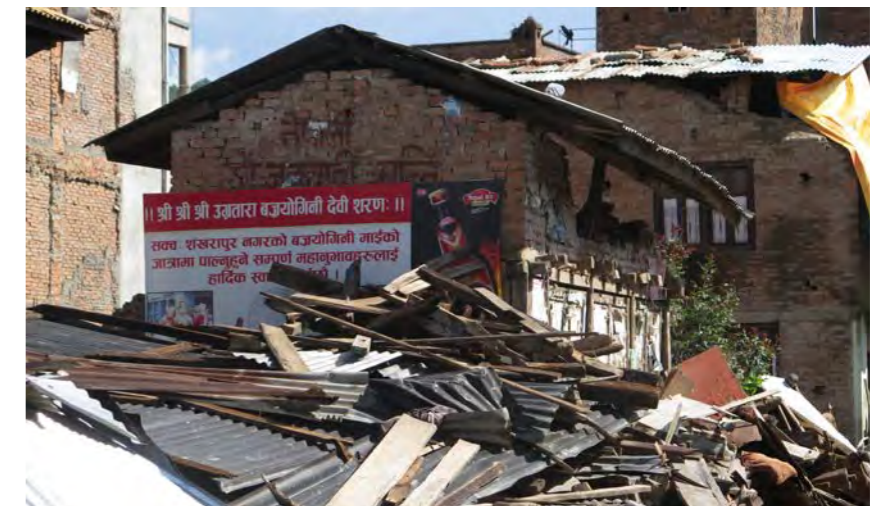
J-06 PATI

NUMBER	NAME	DATE A.D.	TPOLOGY	GENERAL DESCRIPTION	PROBLEMS DESCRIPTION	DANGER/ DESTROY	
J-06	Shop		Pati		Southern part fell down. Major cracks all over.
