2015 Earthquake Damage Mapping

Sankhu

October 2015

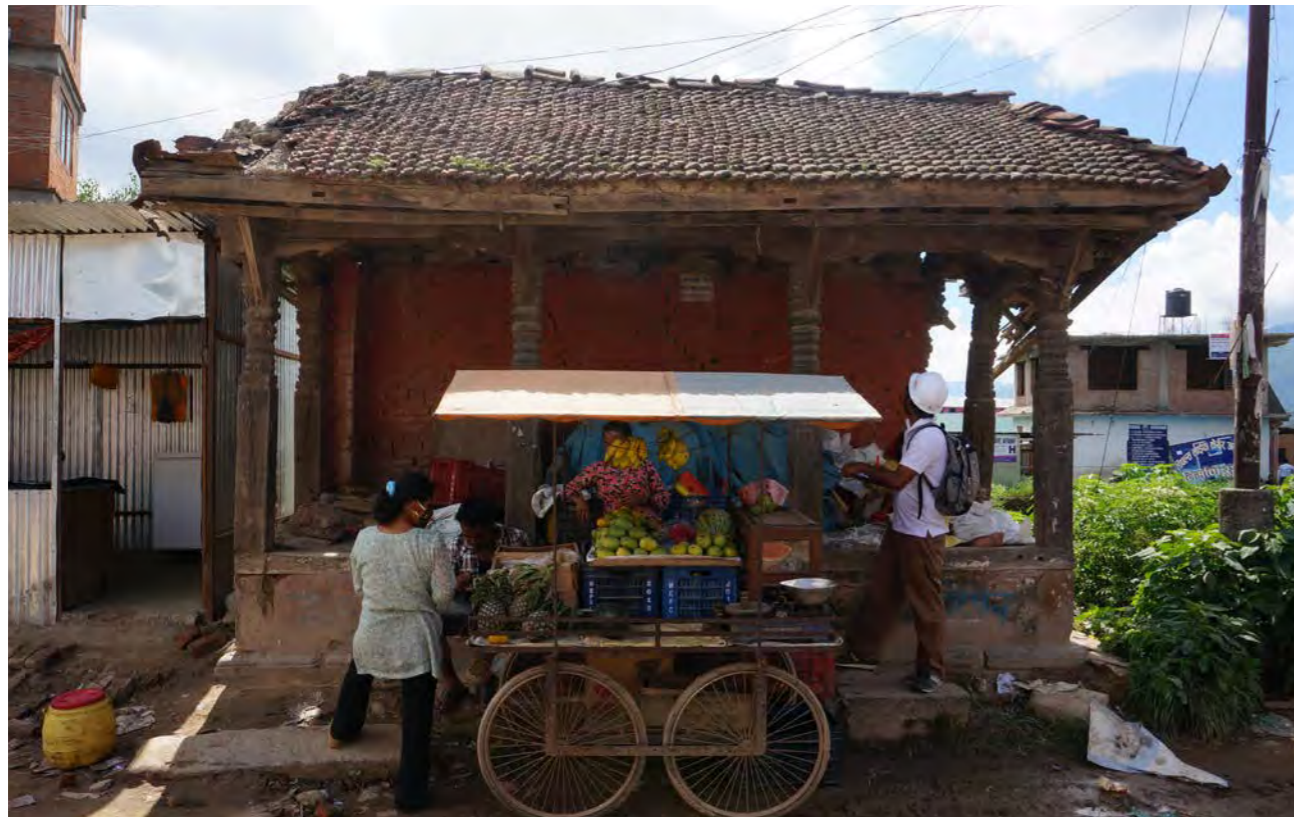
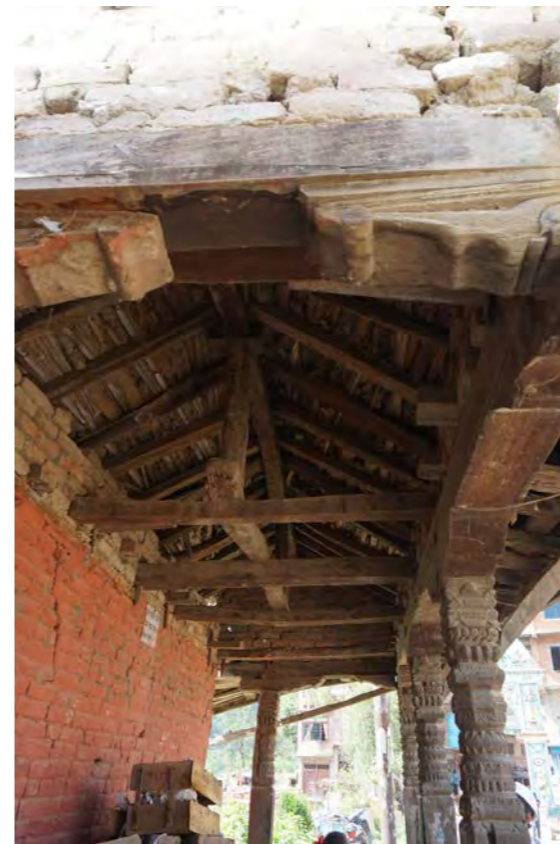
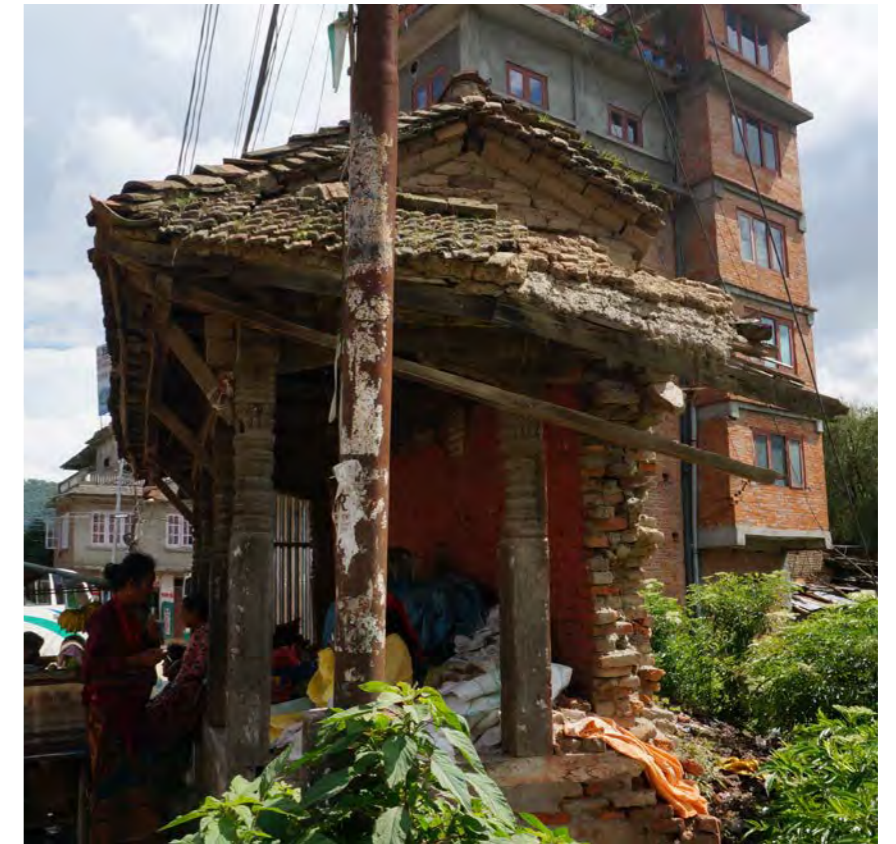
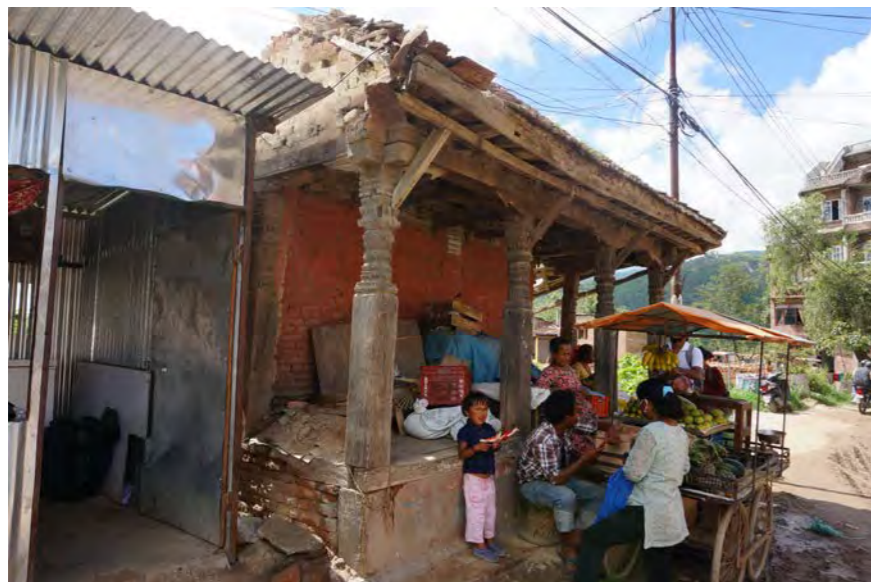
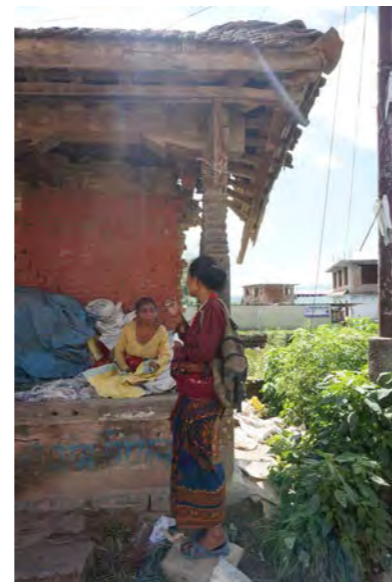
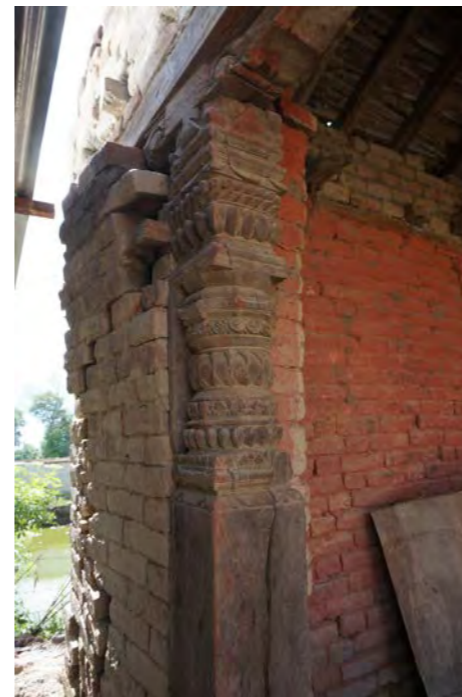
A-01 PATI - BHAU DEGA PATI

NUMBER	NAME	ESTABLISHED DATE (A.D.)	TYPOLOGY	GENERAL DESCRIPTION	PROBLEMS DESCRIPTION	DANGER/ DESTROY
A-01	Bhau Dega pati		Pati	Wooden pillars of about 2m high and x-section of about 15 x 15 cms	“Stepped cracks at W wall N-W corner part of wall collapsed Roofing at N- W corner half collapsed”	W!

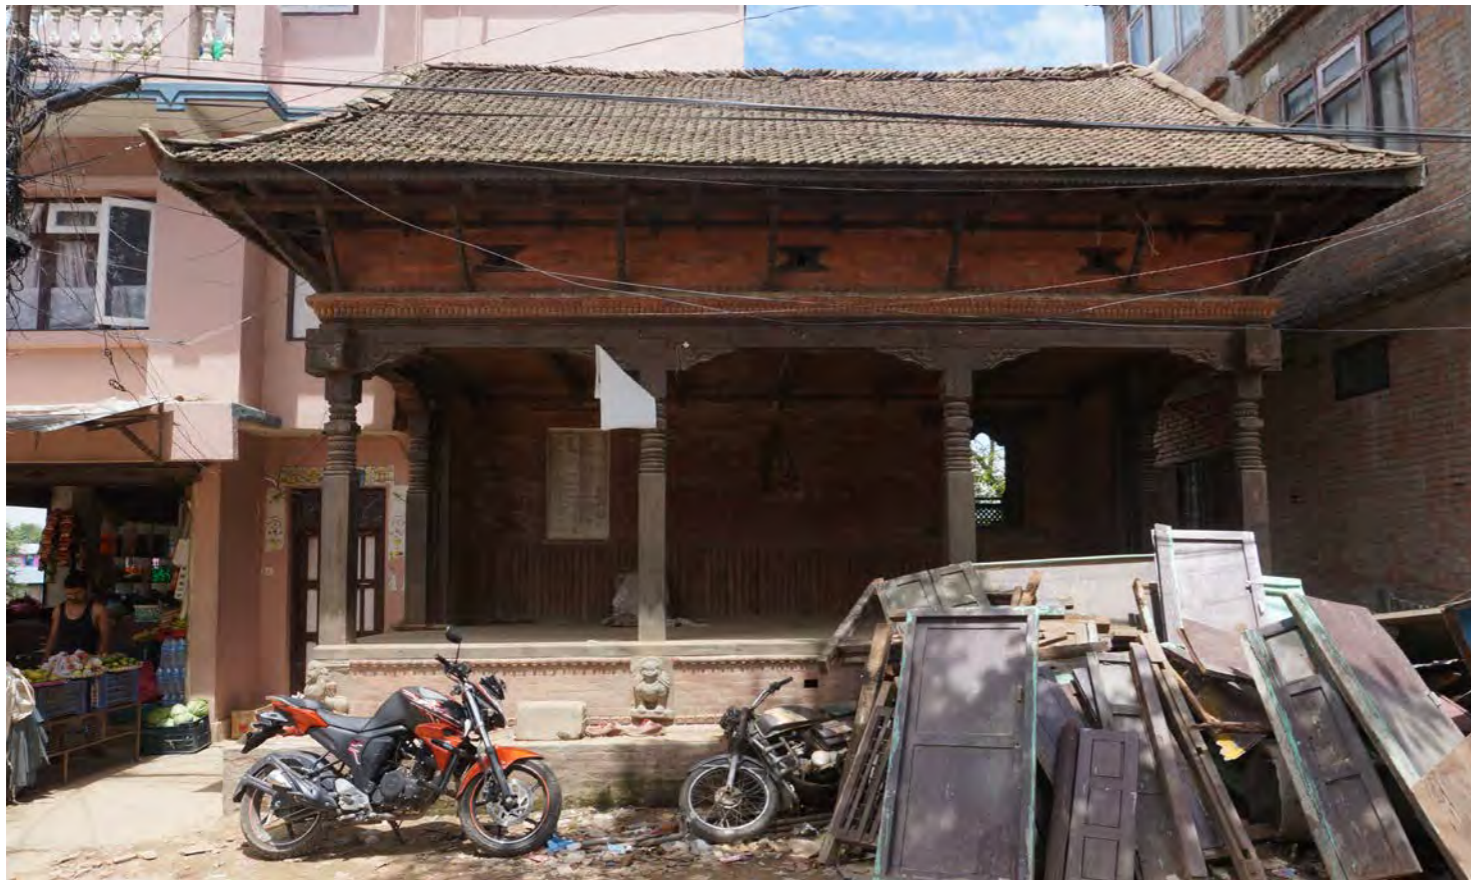
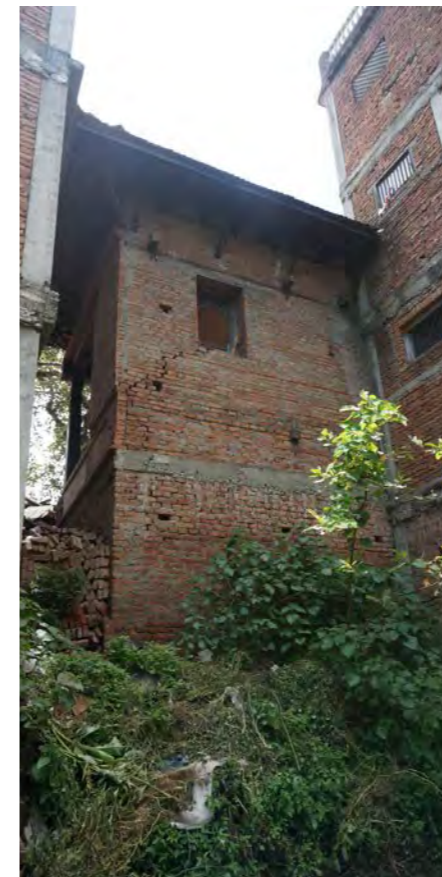
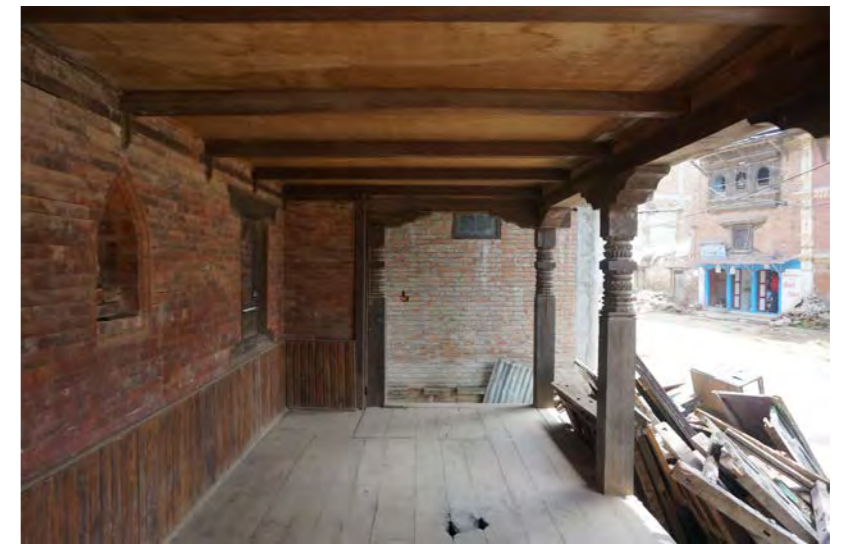
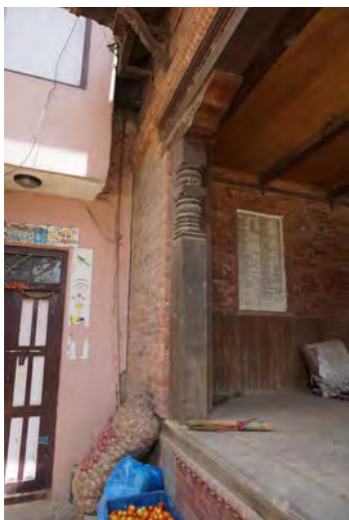
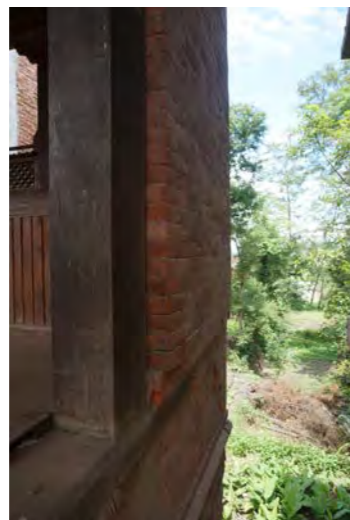
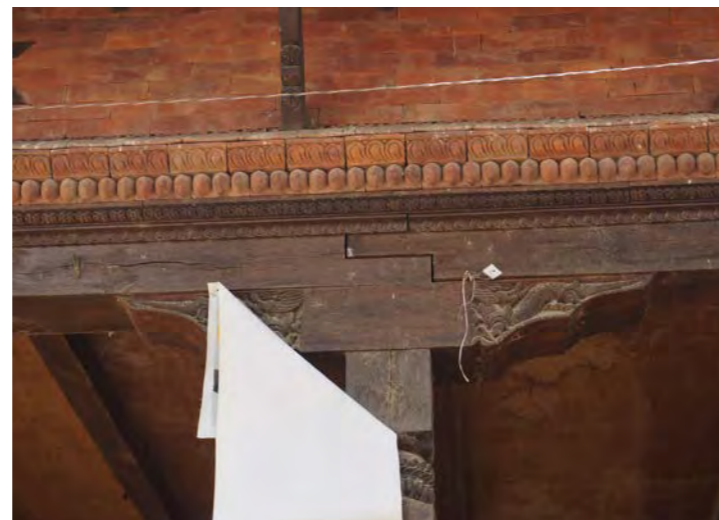
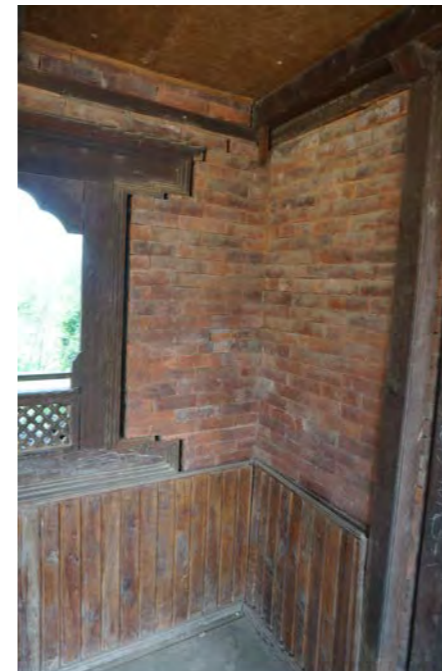
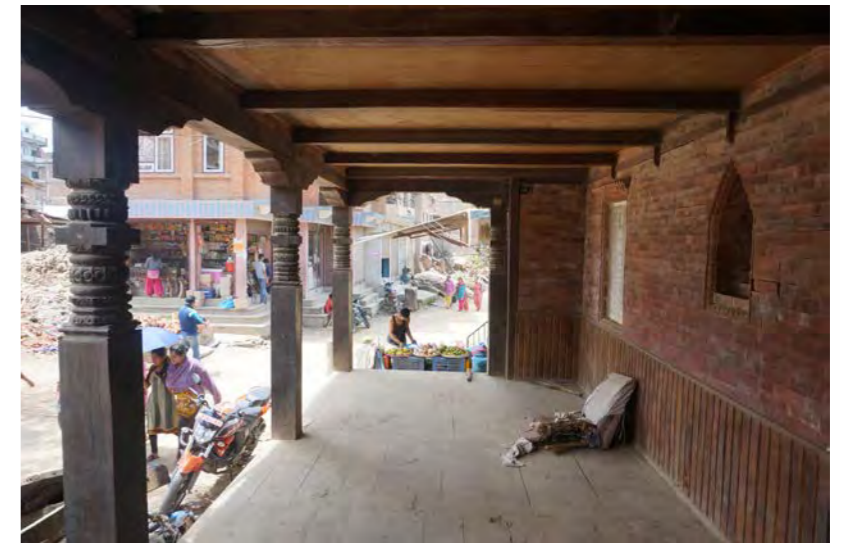
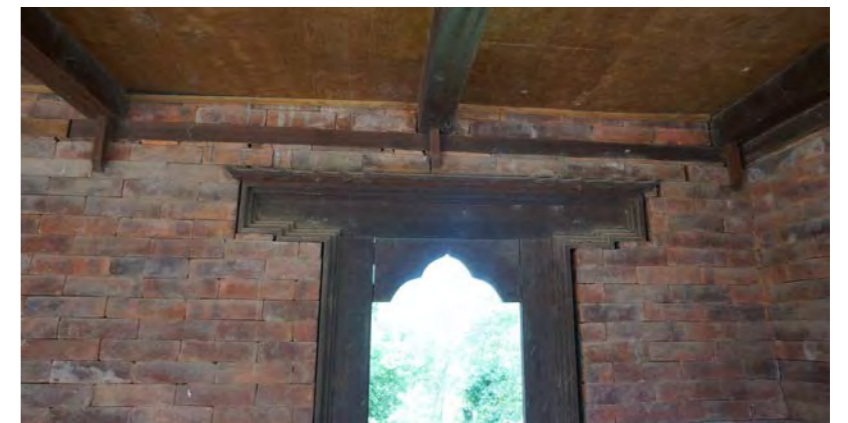
A-08 PATI - TAHA FALCHA

NUMBER	NAME	DATE A.D.	TYPOLOGY	GENERAL DESCRIPTION	PROBLEMS DESCRIPTION	DANGER/ DESTROY
A-08	Taha Falcha	Renovated 2005 A.D.	Pati	Recent structure made of Dachhi appa facings with wooden pillars and joists and concrete flooring	N-W corner joint separation towards North Joint separation between wall and window at N-W corner Similar problem at S-W corner W-façade with major diagonal cracks”

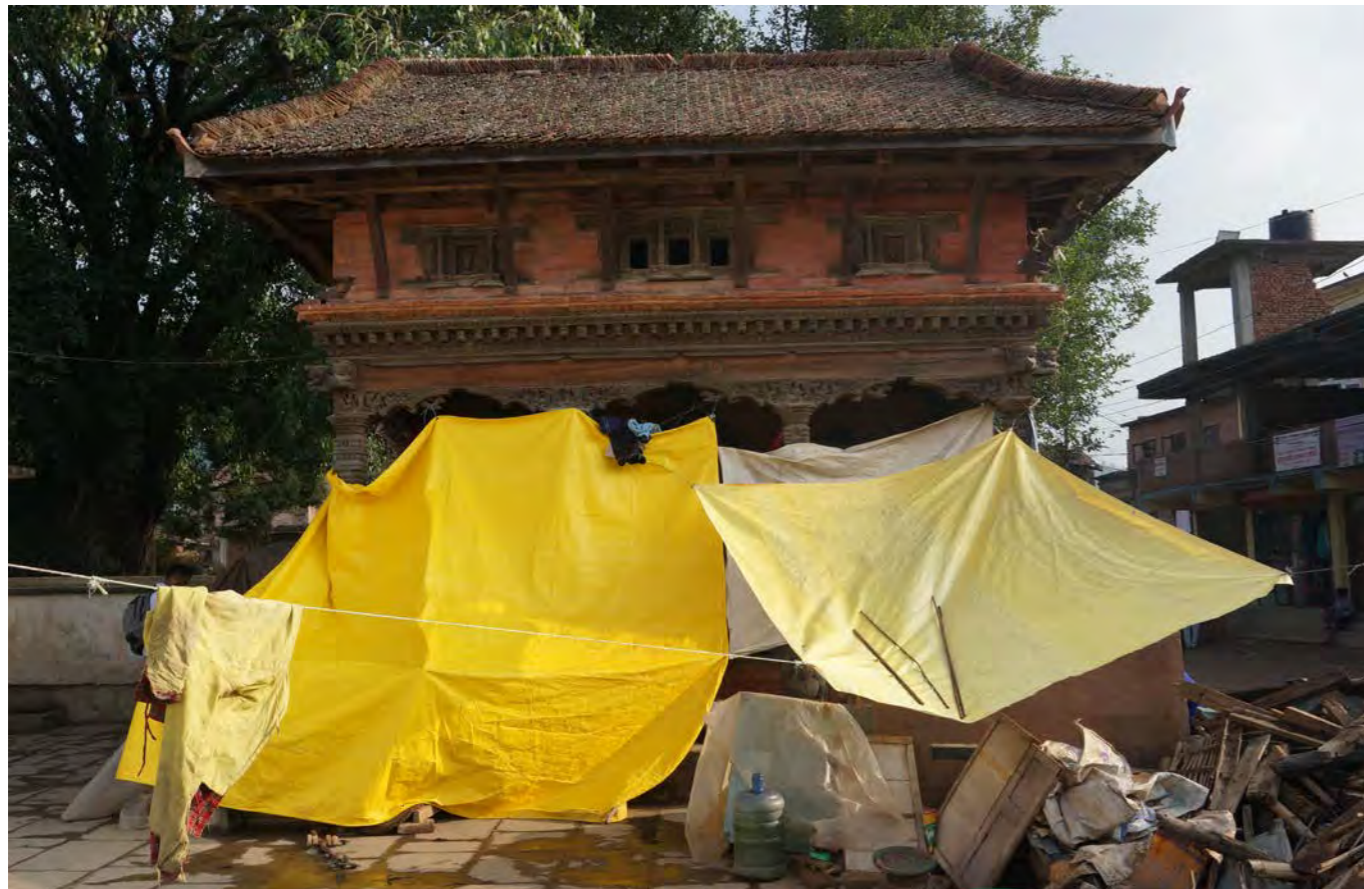
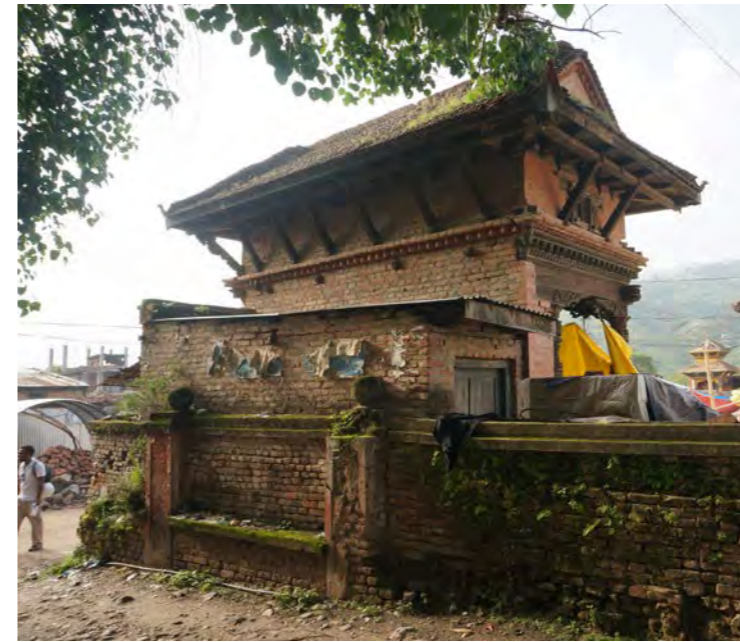
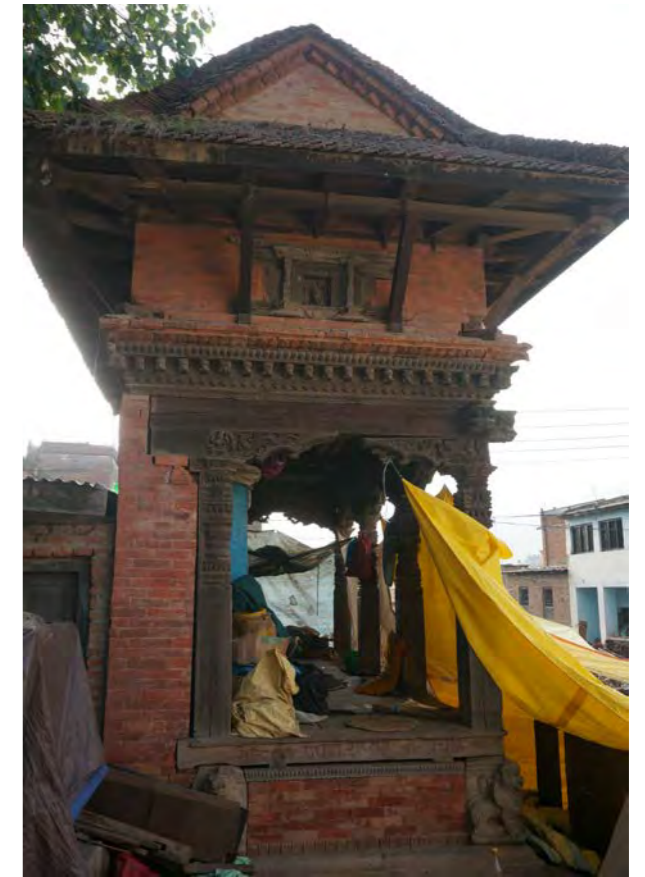
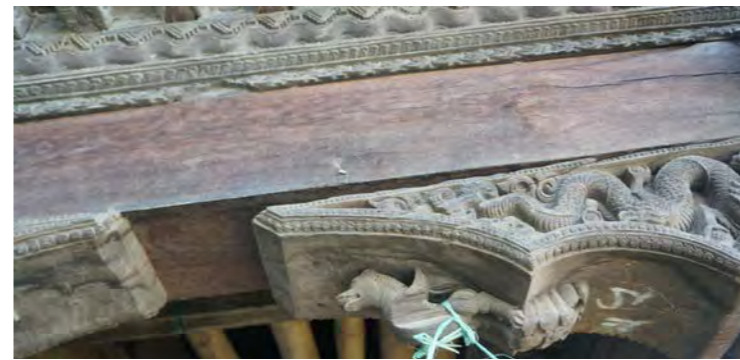
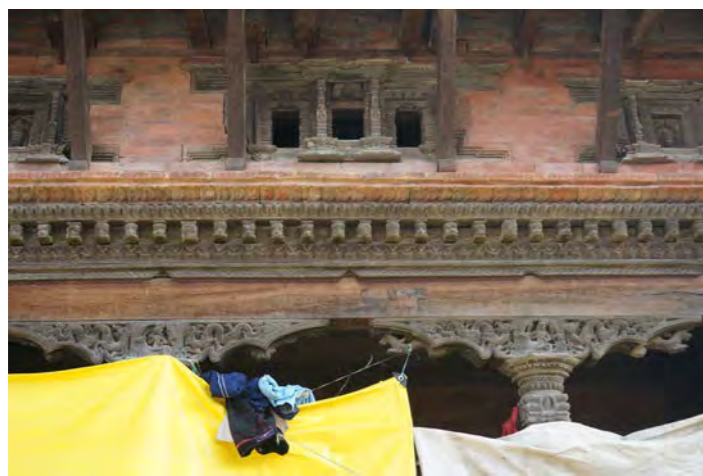
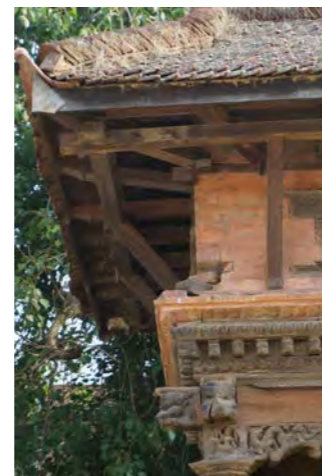
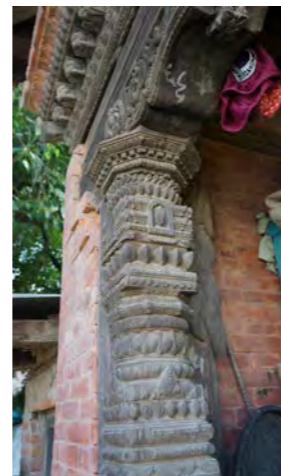
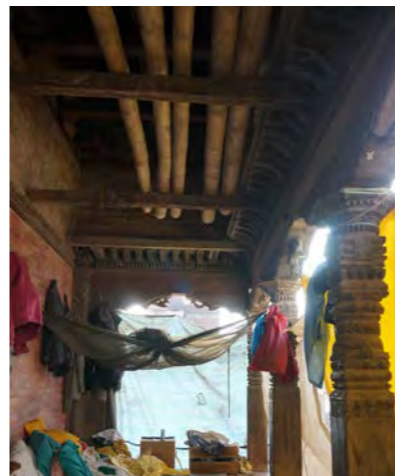
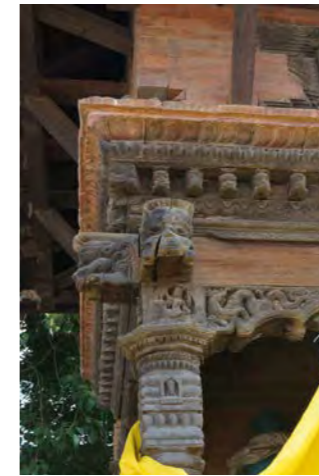
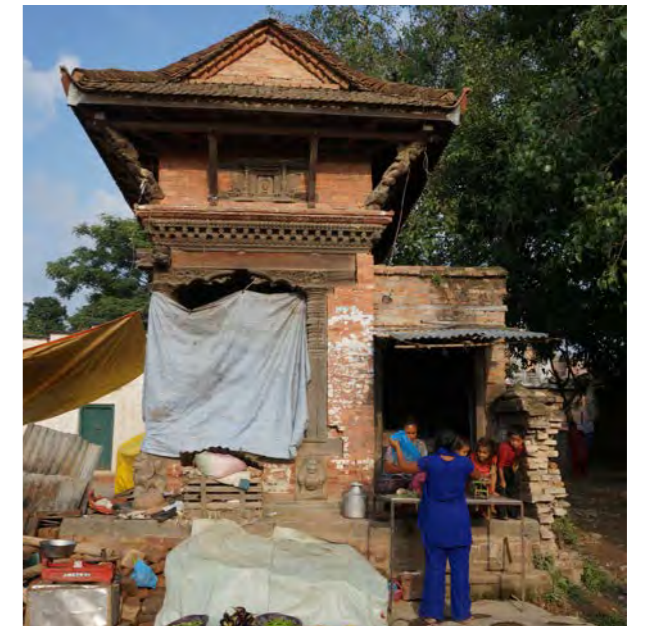
C-04 PATI - PATI AT INLA TOLE

NUMBER	NAME	ESTABLISHED DATE (A.D.)	TYPOLOGY	GENERAL DESCRIPTION	PROBLEMS DESCRIPTION	DANGER/ DESTROY
C-04	Pati at Inla Tole		Pati	Brick structure with wooden pillars and joist and Jhingati tiled roof	Joint separation between wall and wooden joist at S-façade Some longitudinal cracks in wooden joist and posts Two wooden struts at N-E and S-E corner stolen some 3 years ago	W! Very old and beautifully carved wooden joist and posts

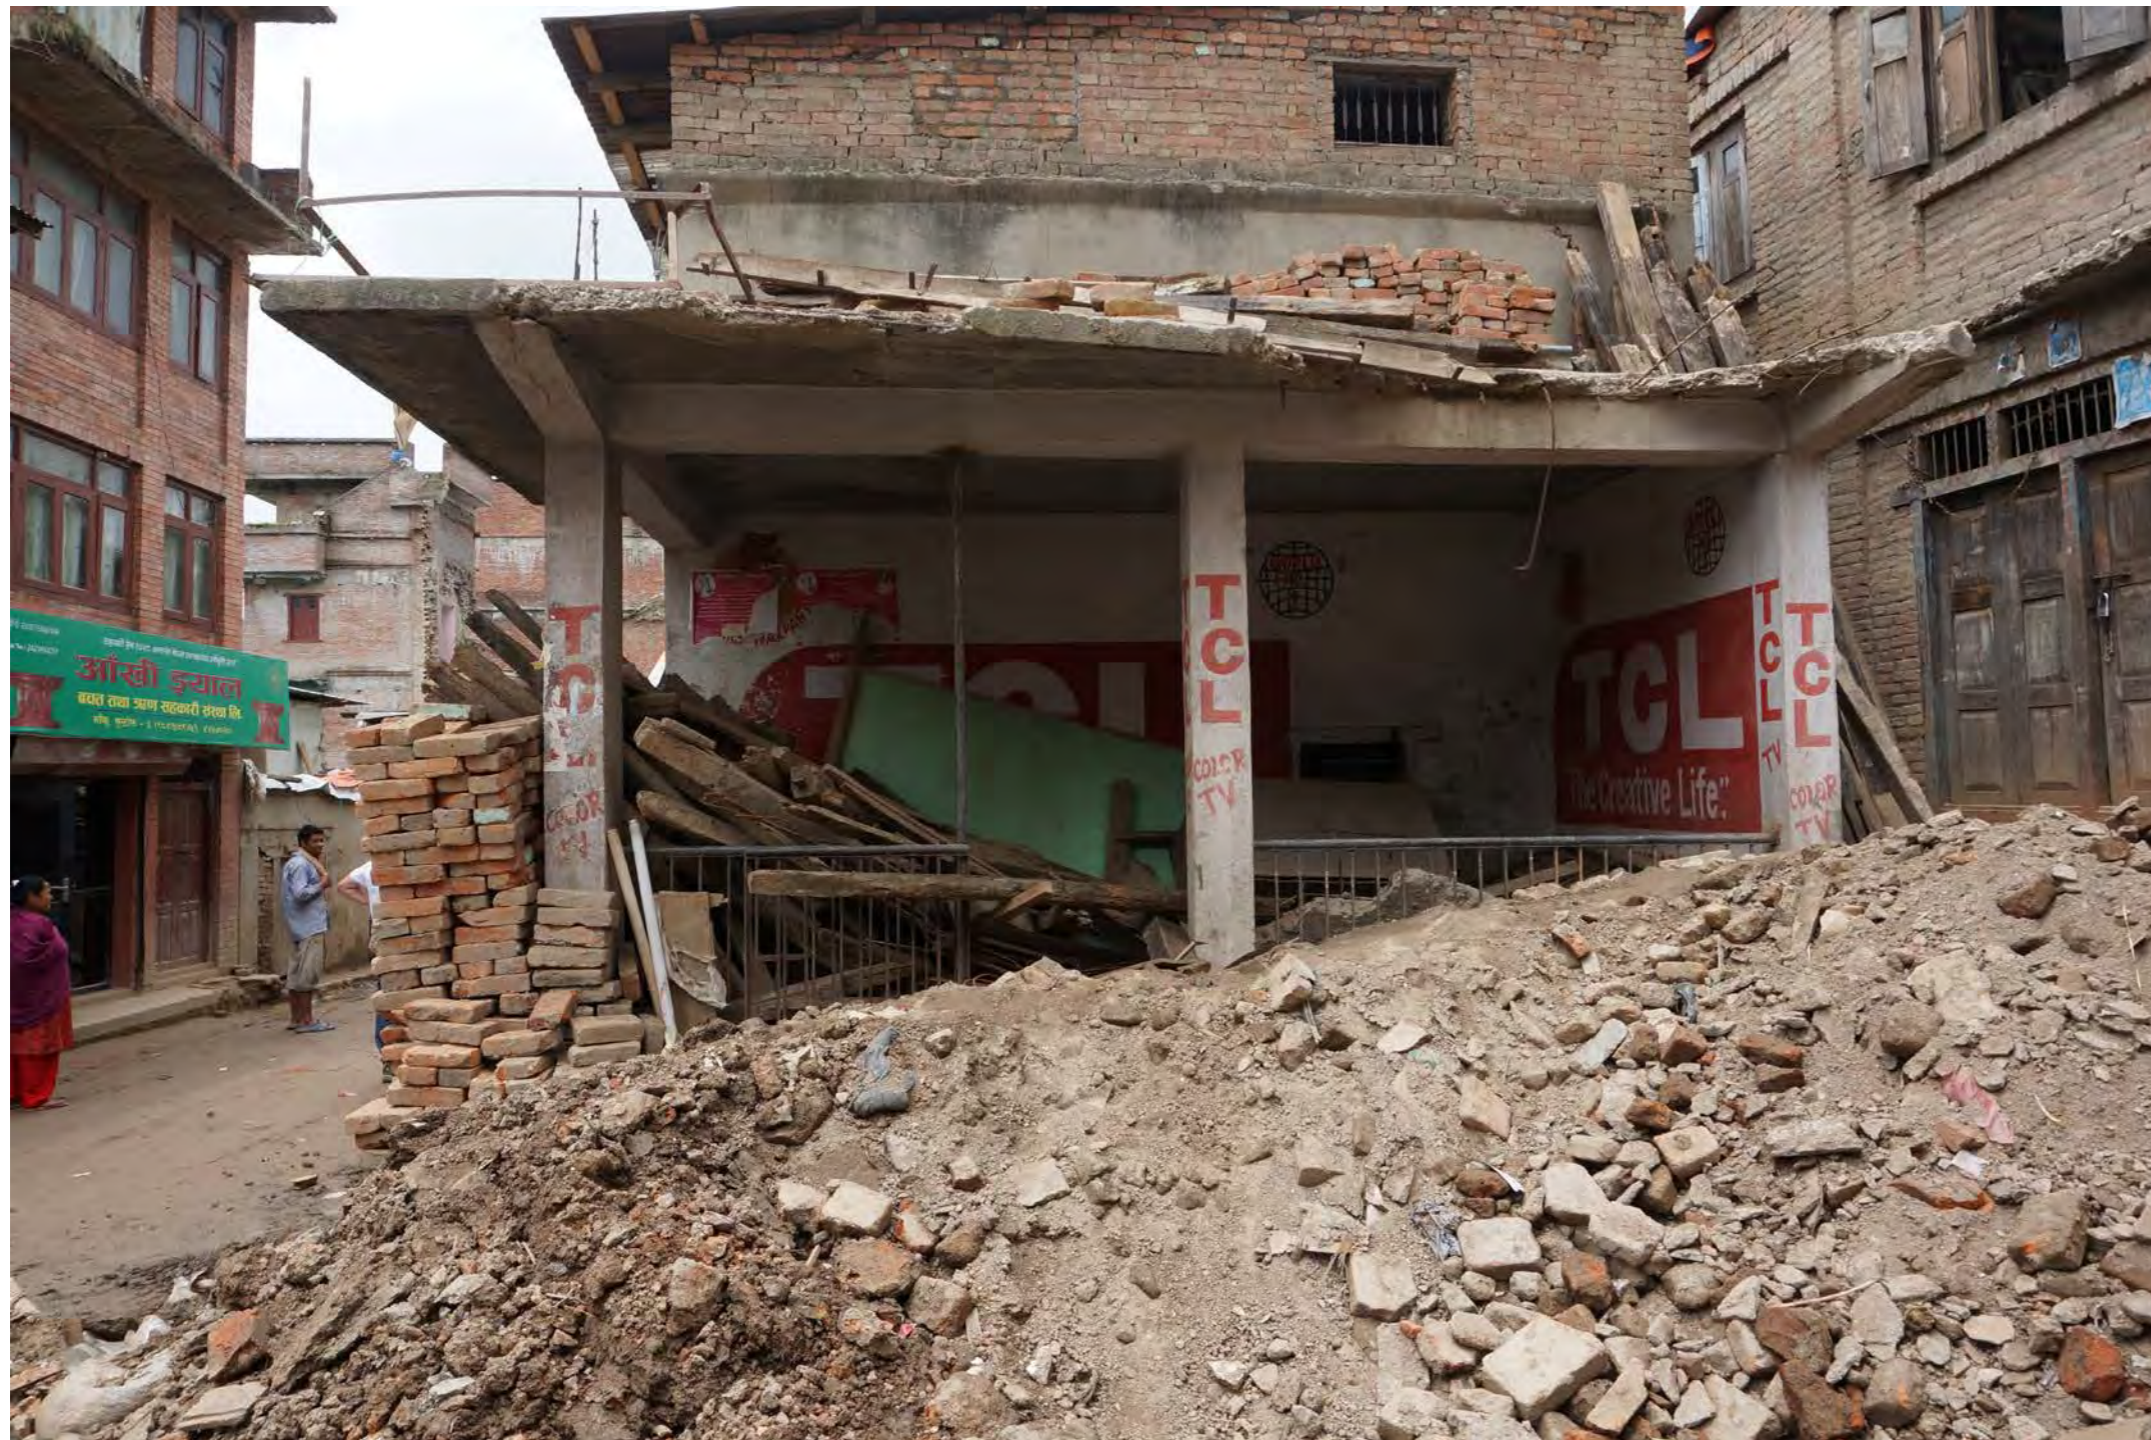
C-16 PATI

NUMBER	NAME	DATE A.D.	TYPOLOGY	GENERAL DESCRIPTION	PROBLEMS DESCRIPTION	DANGER/ DESTROY
C-16			Pati	Newly constructed pati in brick and concrete	Slab portion collapsed Needs partial reconstruction

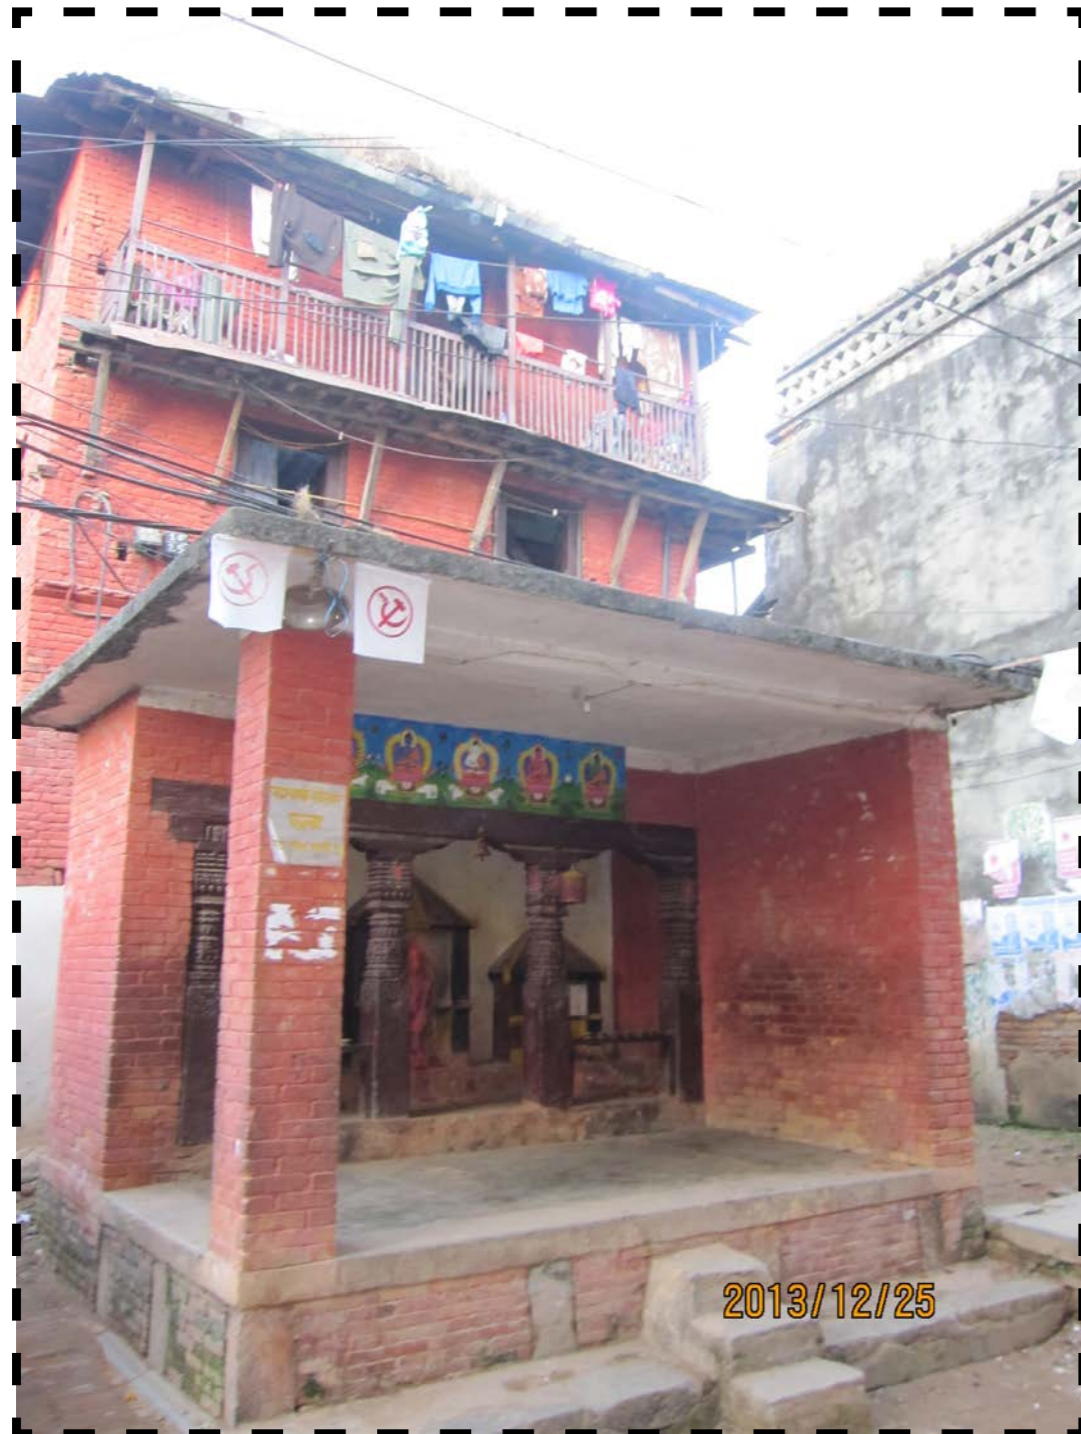
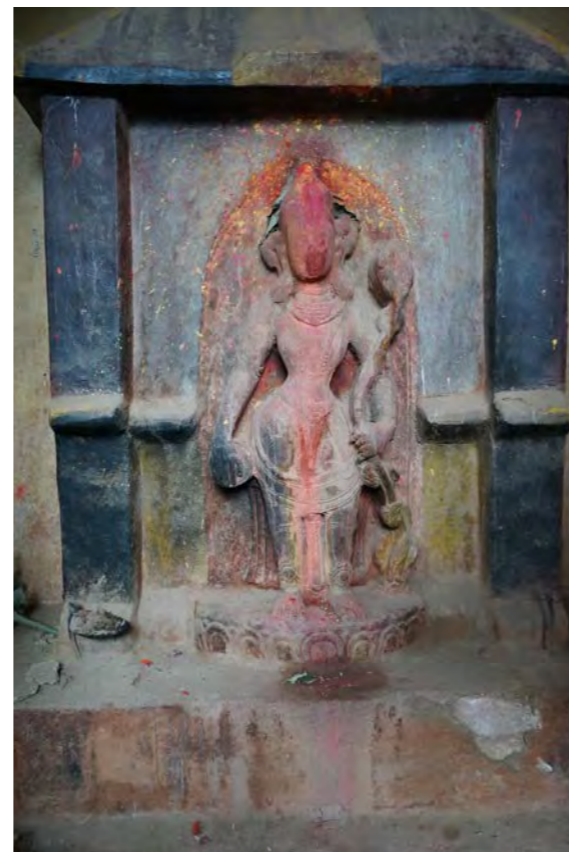
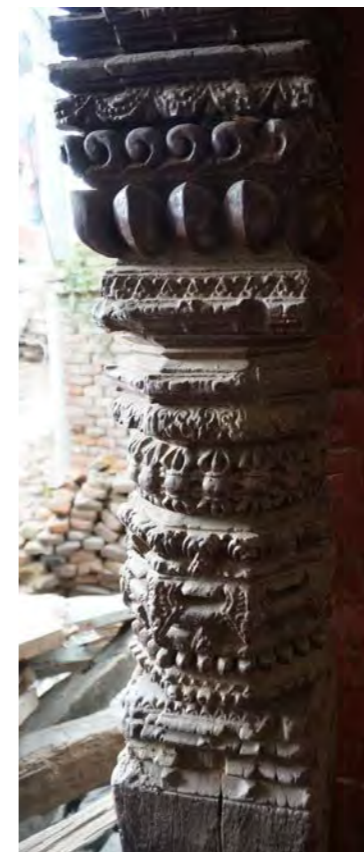
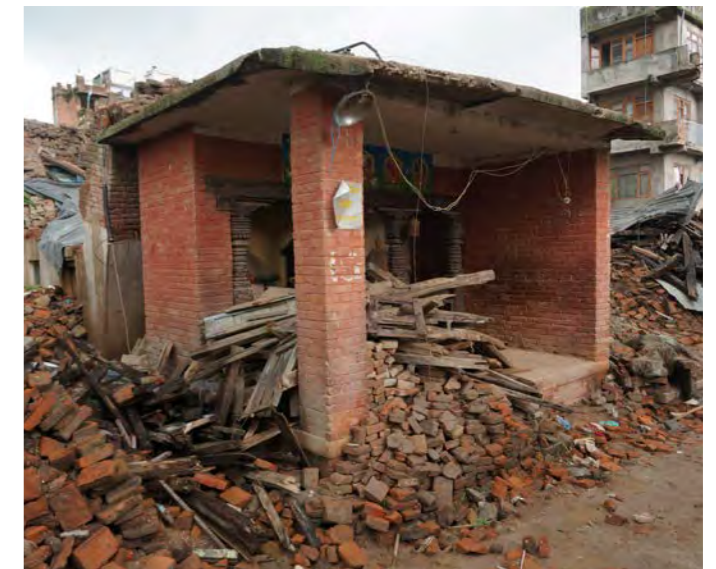
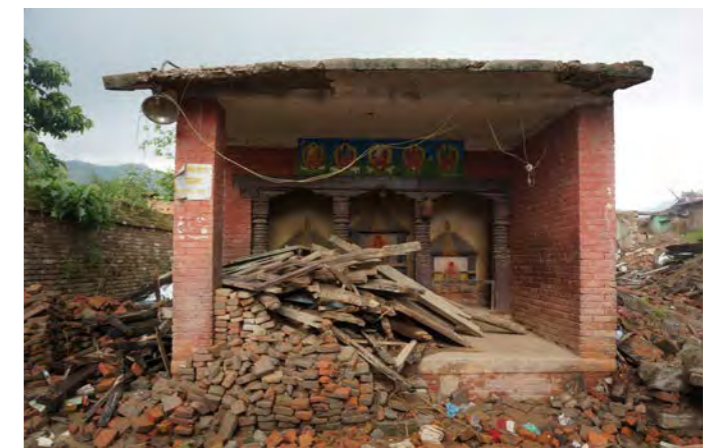
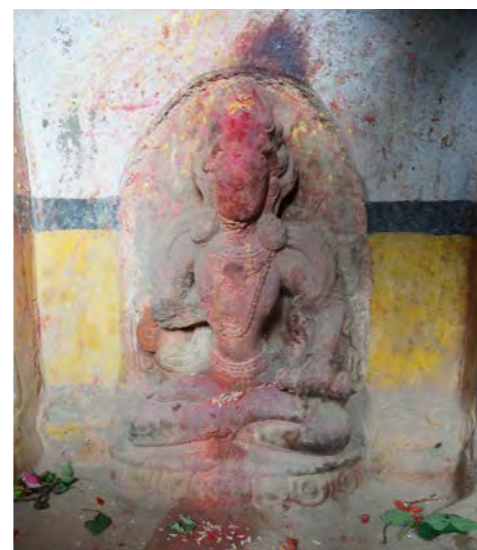
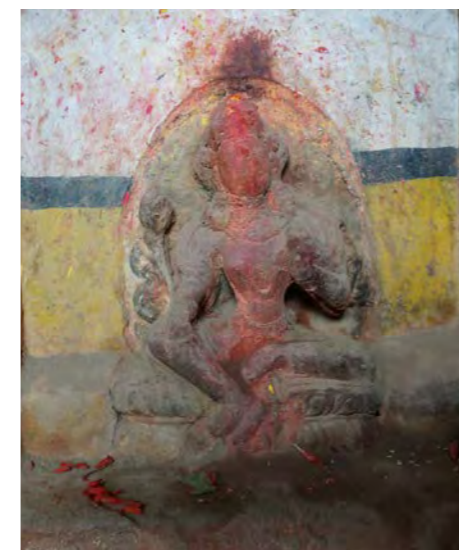
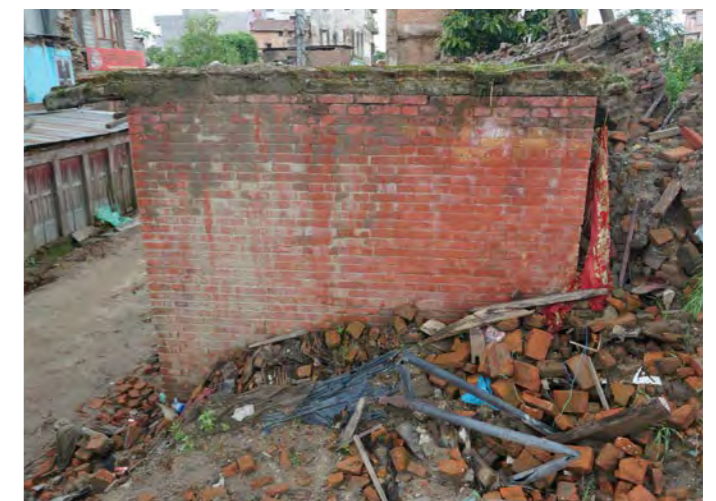
F-09 LASAKA FALCHA

NUMBER	NAME	ESTABLISHED DATE (A.D.)	TYPOLOGY	GENERAL DESCRIPTION	PROBLEMS DESCRIPTION	DANGER/ DESTROY
F-09	Laska Falcha		Pati	Constructed of brick structure with concrete slab	S-W corner part of slab cracked and falling down Risk form house no. 38 at N-façade of pati

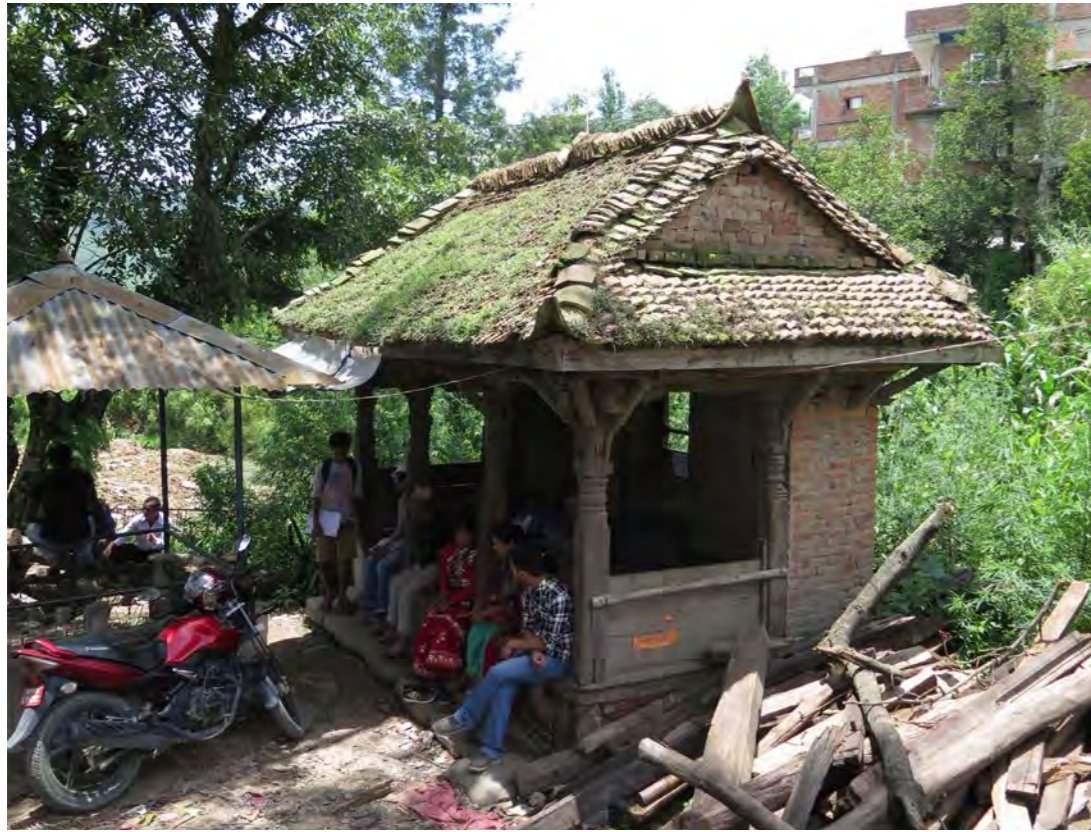
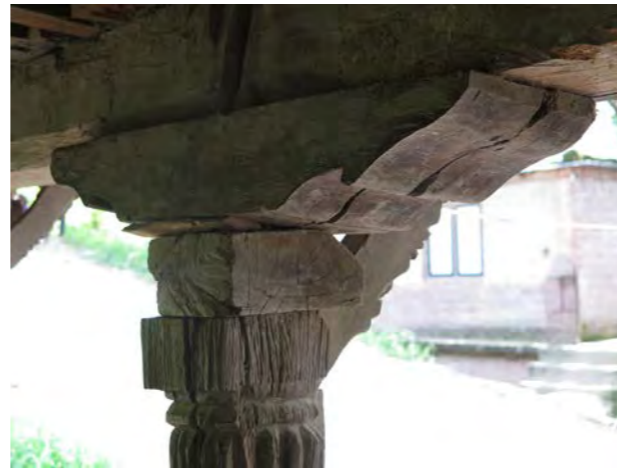
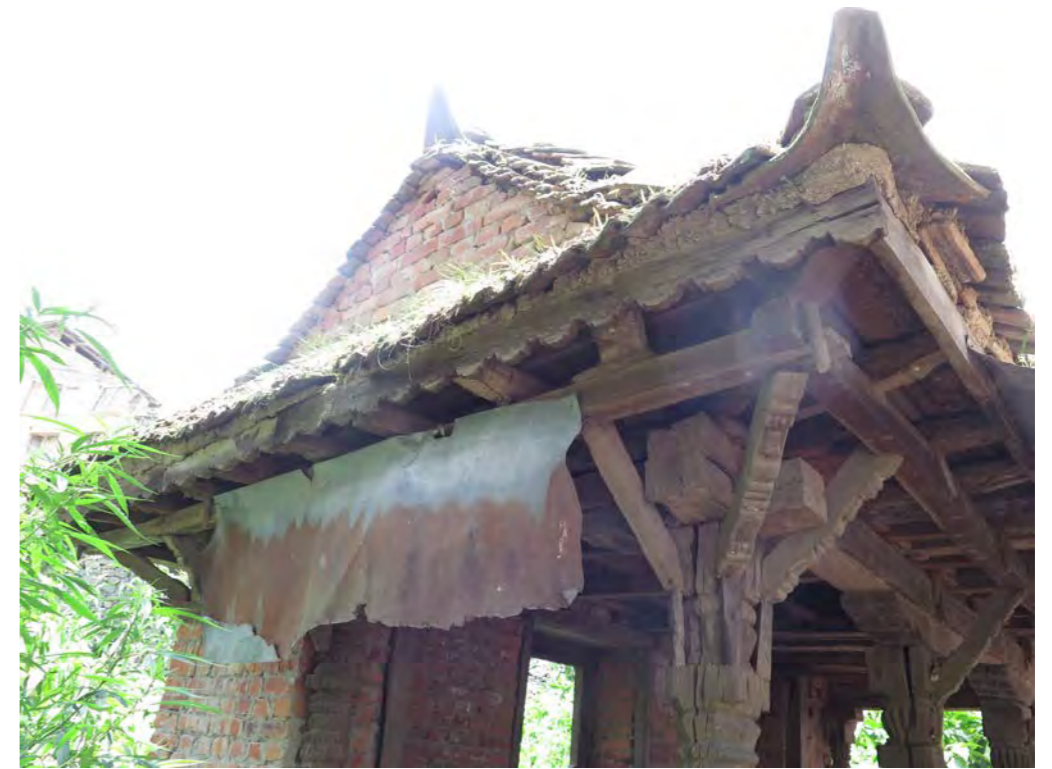
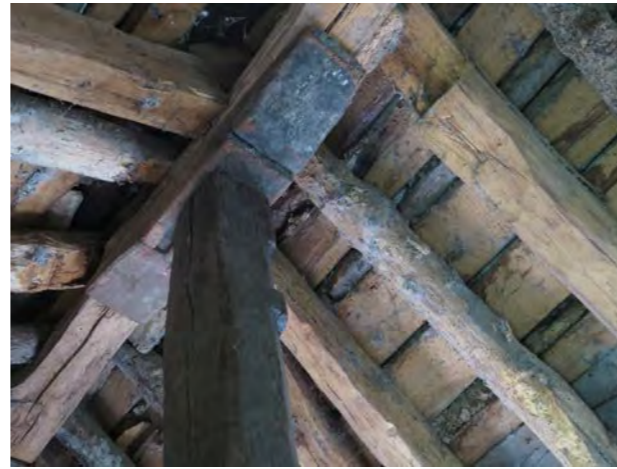
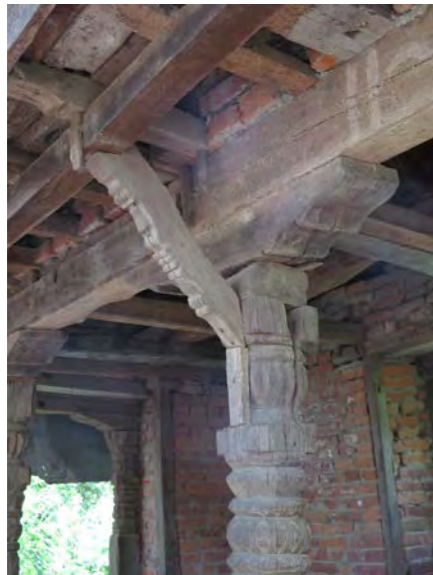
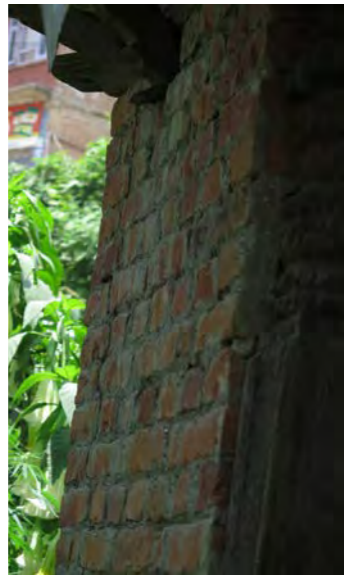
L-04 PATI

NUMBER	NAME	ESTABLISHED DATE (A.D.)	TPOLOGY	GENERAL DESCRIPTION	PROBLEMS DESCRIPTION	DANGER/ DESTROY
L-04	Pati near Mhya macha Dhoka		Pati	Pati with carved columns	Roof tiles out of place. Vegetation growth on roof. Bricks dislocated on east plinth and north east corner wall. Vertical cracks on south west corner. Wooden structure weakened by insects. Wooden planks on plinth deteriorated. Rising damp on North side of plinth.

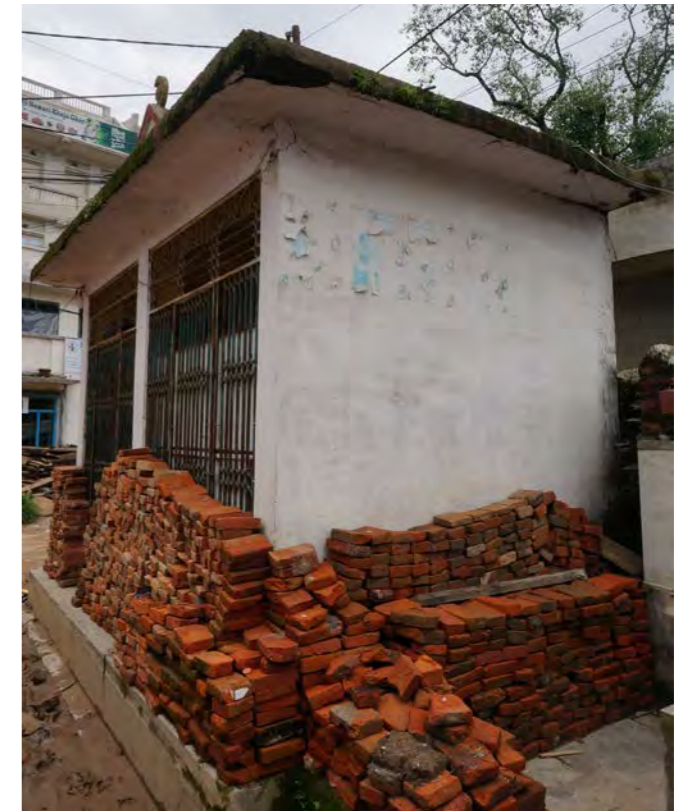
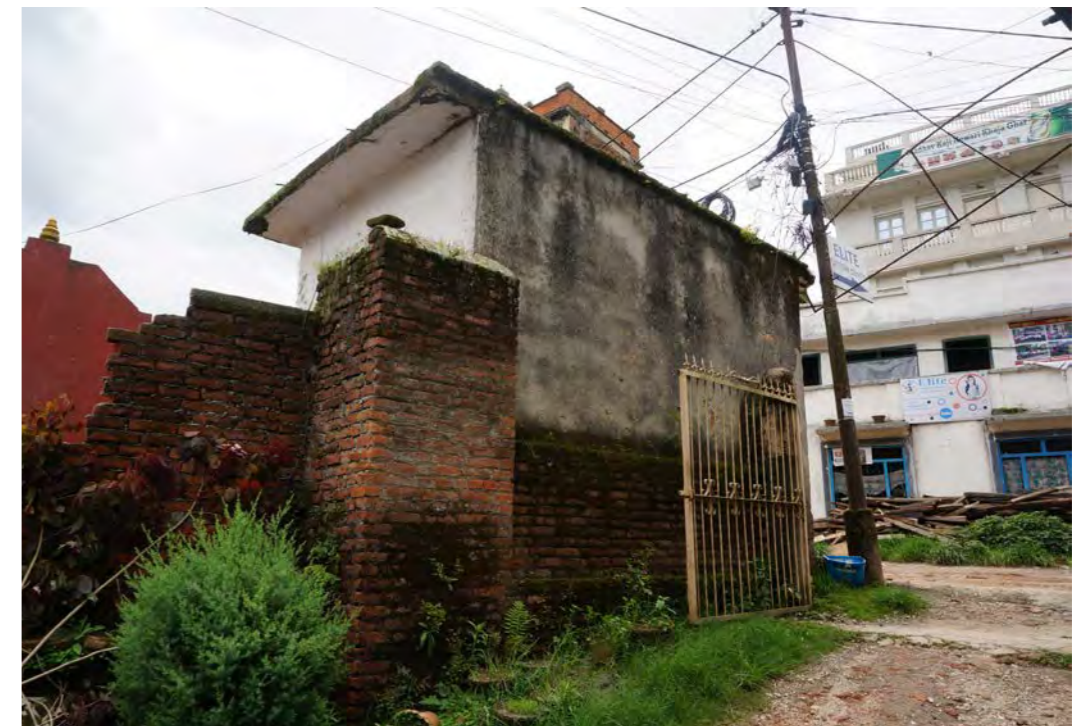
H-02 PATI - BASUNDHARA FALCHA

NUMBER	NAME	DATE A.D.	TYOLOGY	GENERAL DESCRIPTION	PROBLEMS DESCRIPTION	DANGER/ DESTROY
H-02	Basundhara Falcha		Pati	Brick masonry with concrete slab	Horizontal cracks on upper wall at E-facade Needs repair
