2015 Earthquake Damage Mapping

Sankhu

October 2015

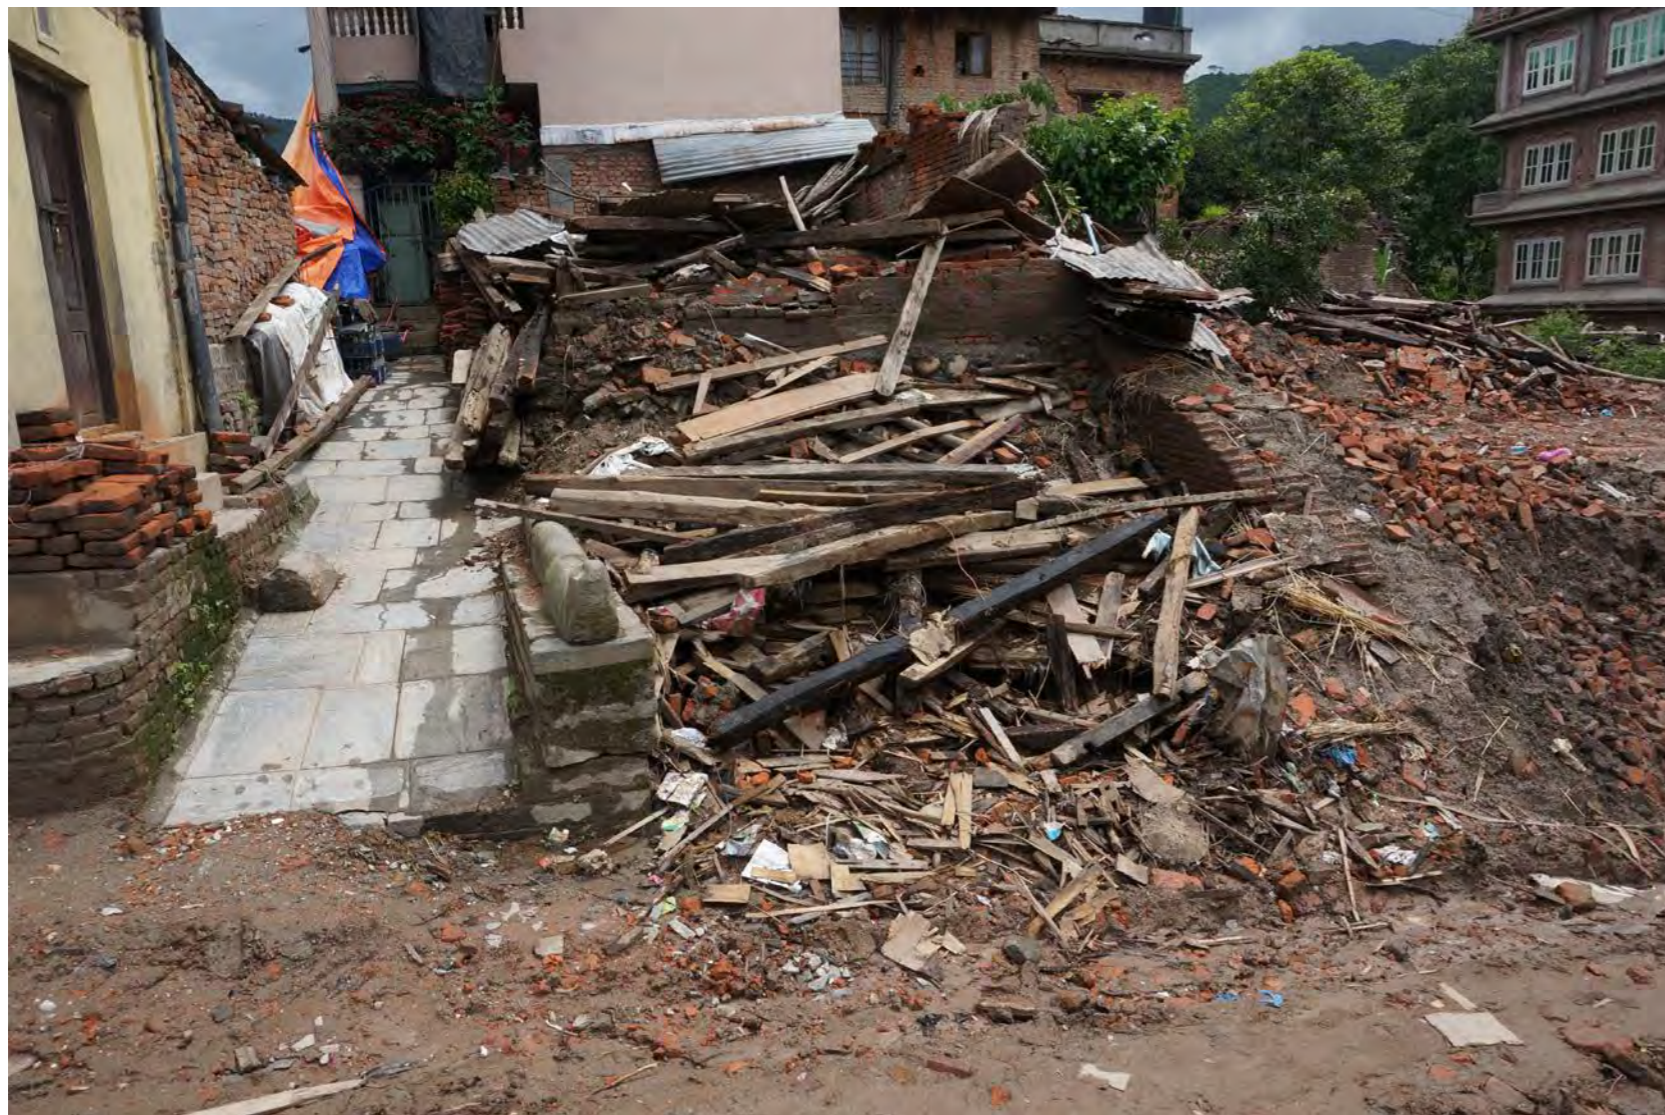
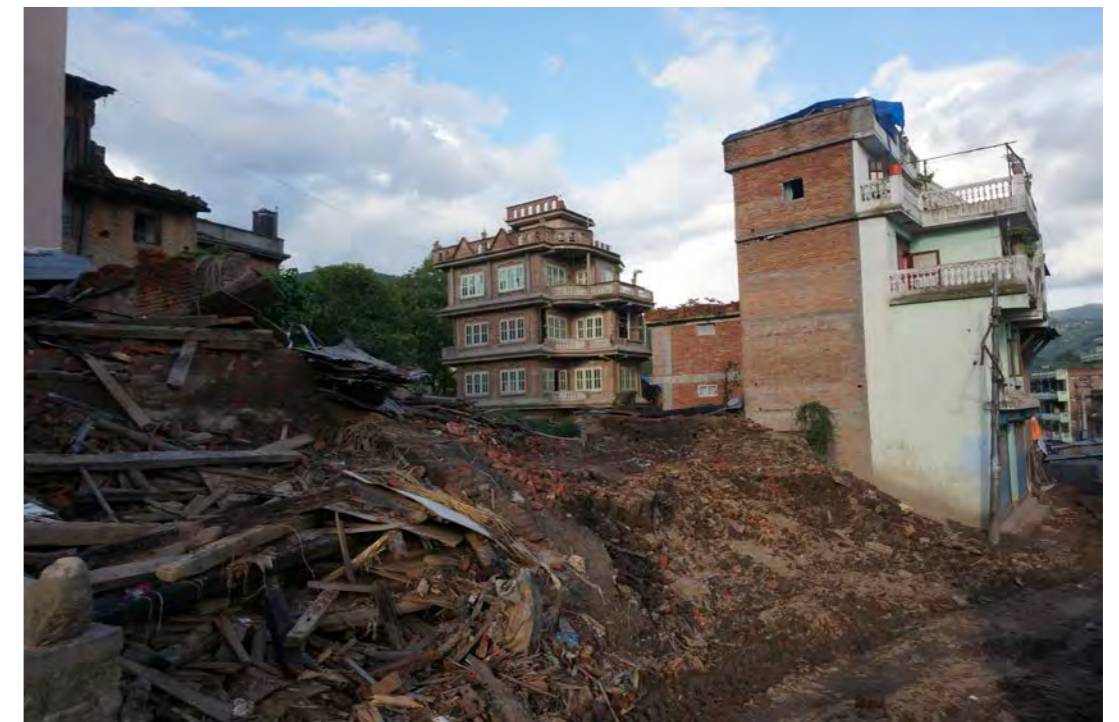
K-09 HITI

NUMBER	NAME	ESTABLISHED DATE (A.D.)	TYOLOGY	GENERAL DESCRIPTION	PROBLEMS DESCRIPTION	DANGER/ DESTROY
K-09			Stone water spout	Stone water fountain (2-3 feet depressed)	All under debris from neighbouring collapsed house Not visible due to debris

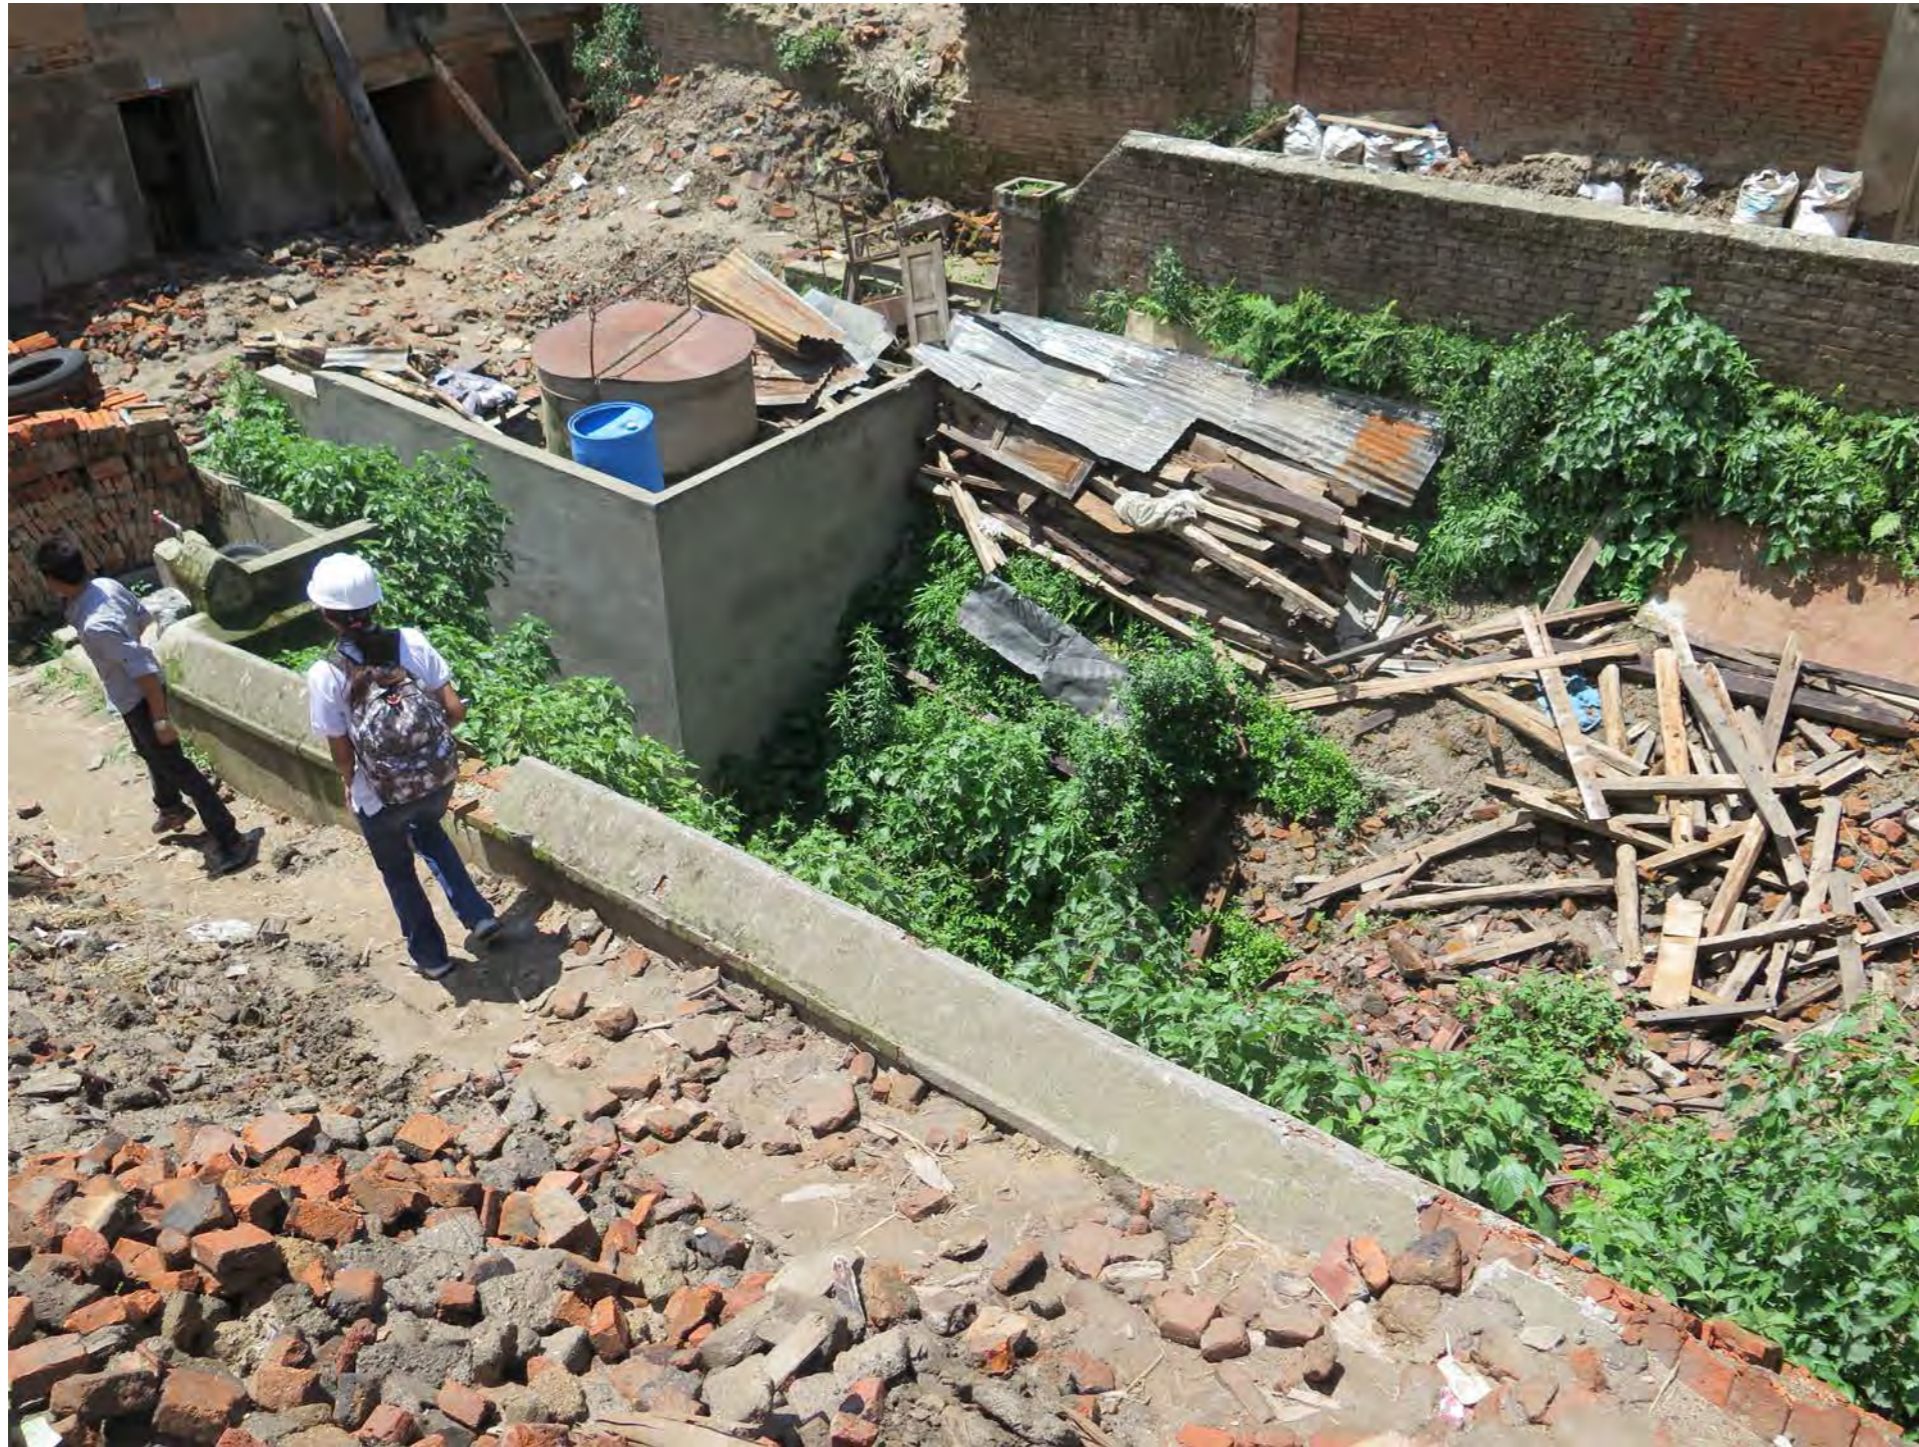
L-02 HITI- LANG KWE HITI

NUMBER	NAME	DATE A.D.	TPOLOGY	GENERAL DESCRIPTION	PROBLEMS DESCRIPTION	DANGER/ DESTROY
L-02	Lang Kwe Hiti		Hiti		Totally covered with vegetation and debris

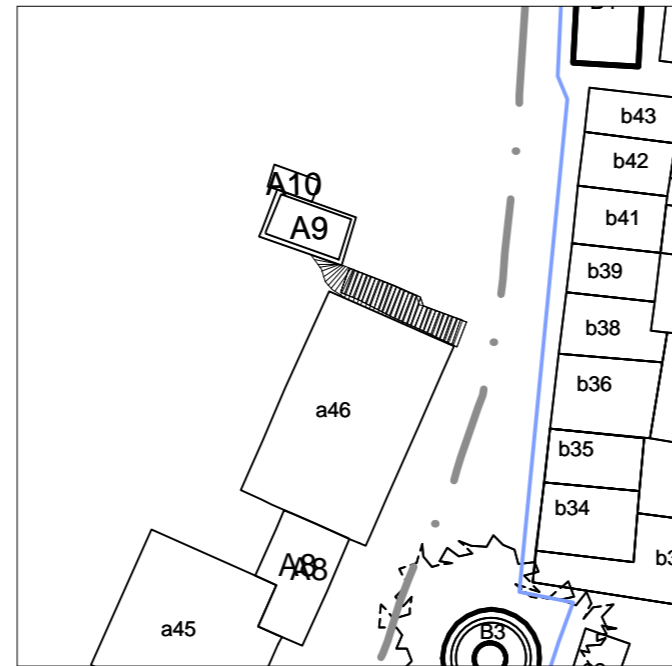
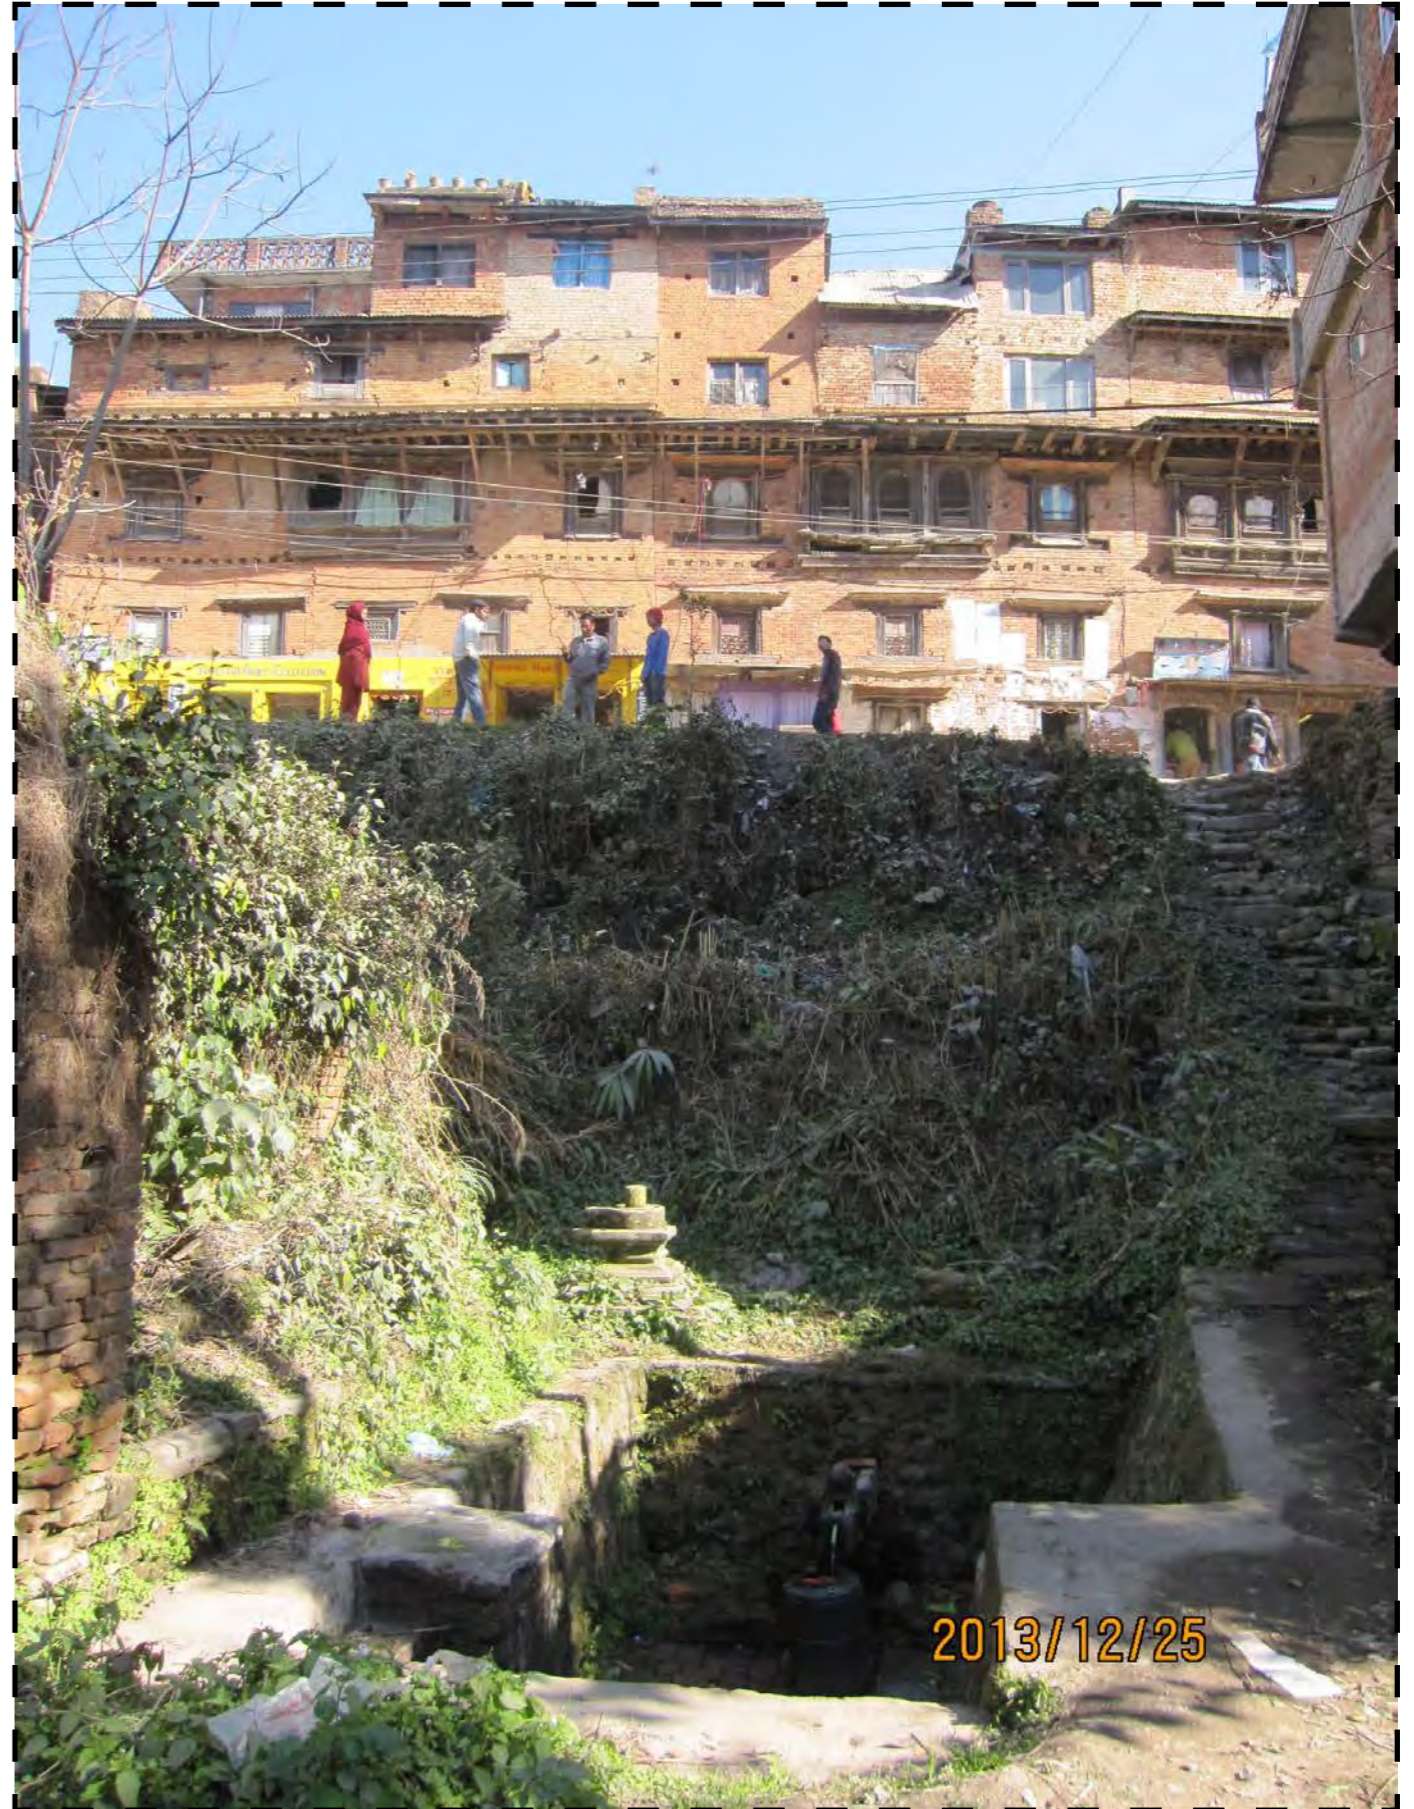
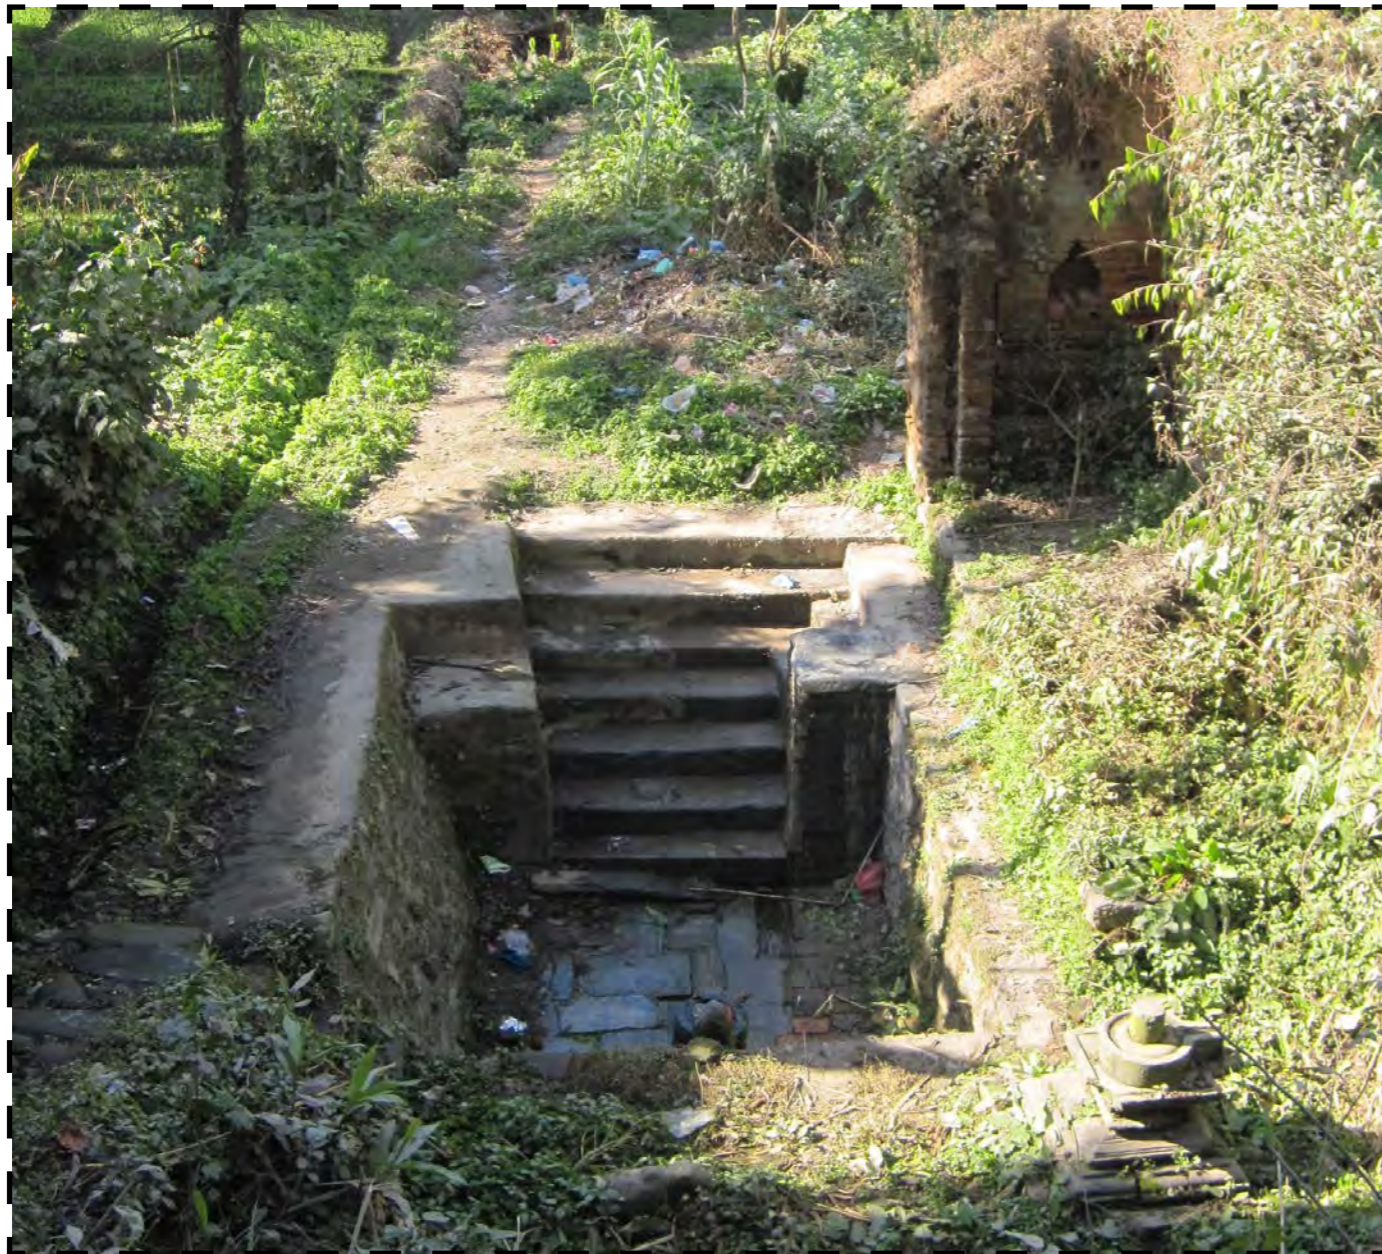
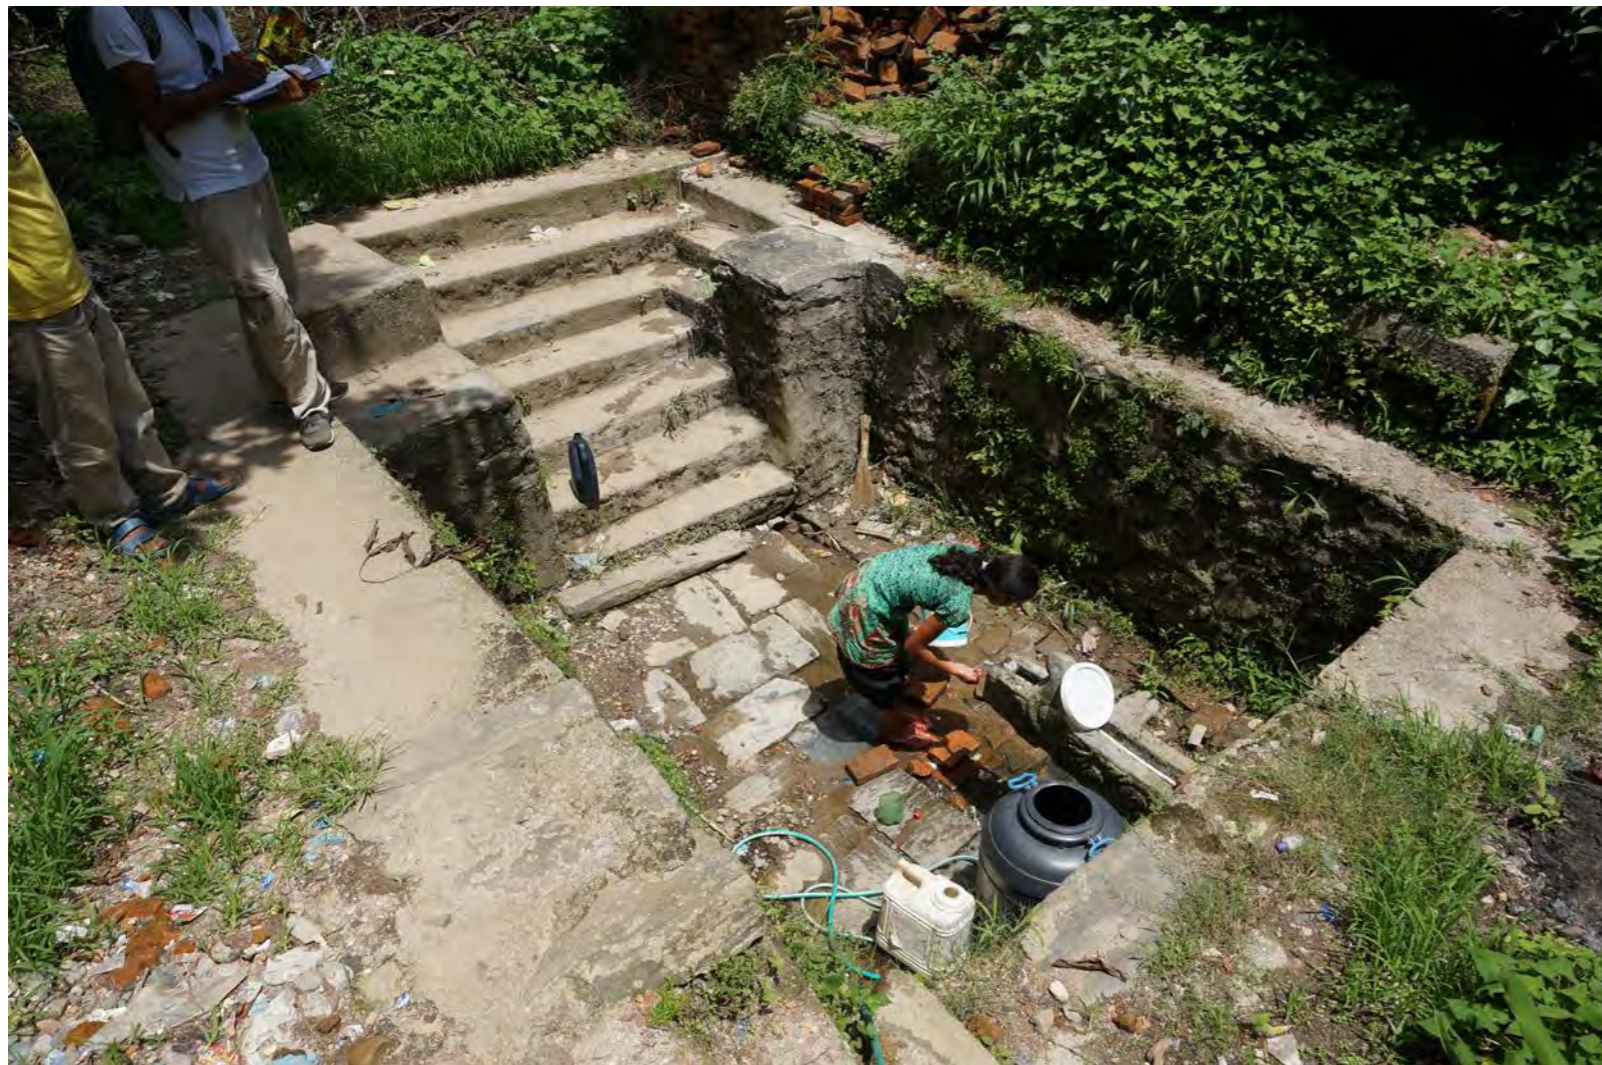
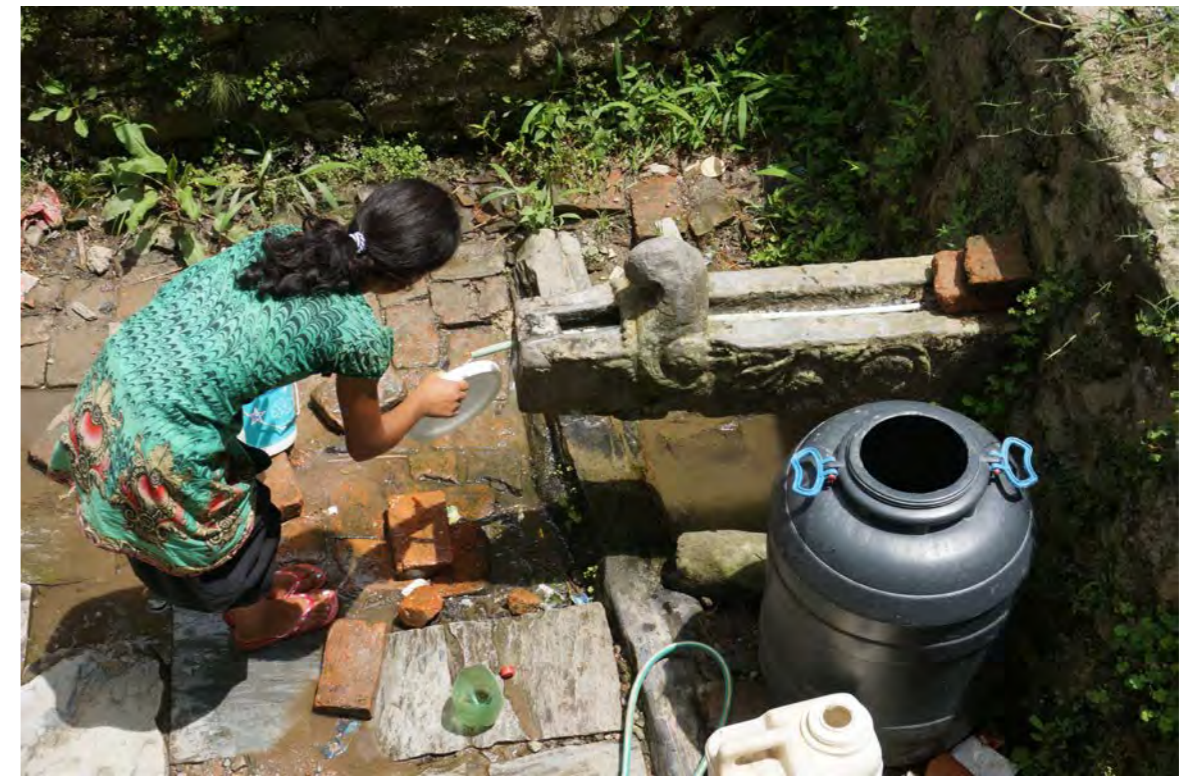
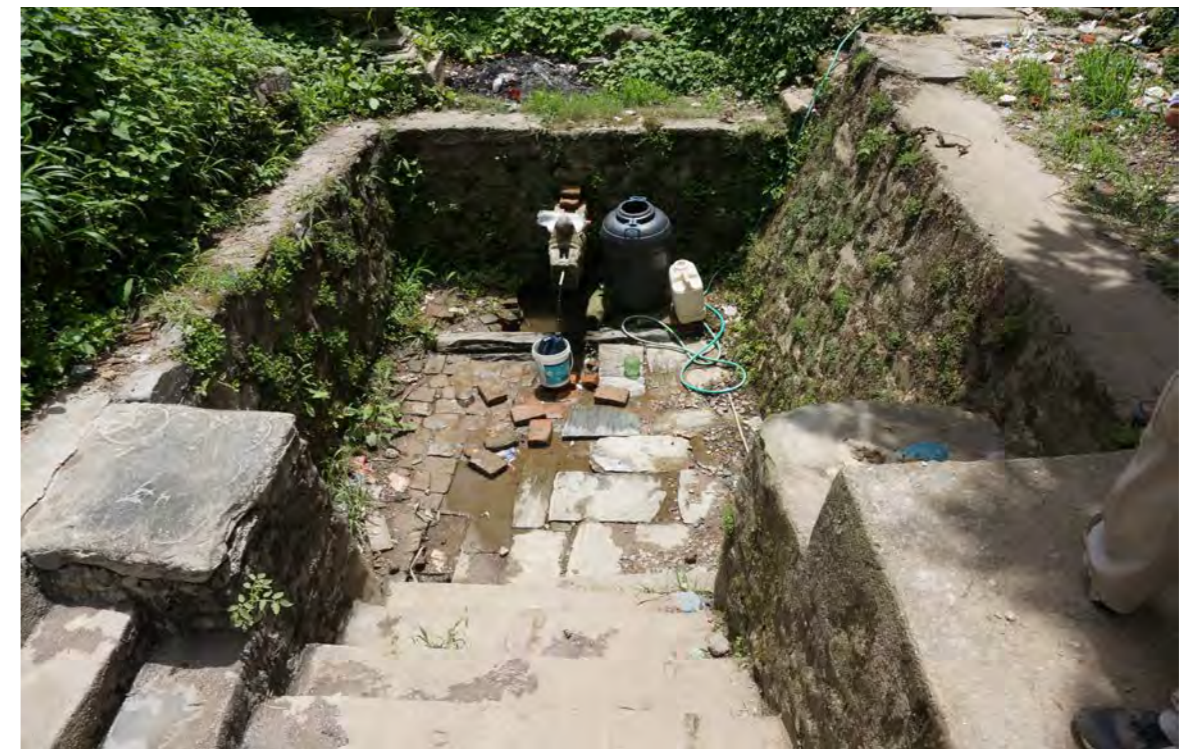
A-09 HITI

NUMBER	NAME	DATE A.D.	TPOLOGY	GENERAL DESCRIPTION	PROBLEMS DESCRIPTION	DANGER/ DESTROY	
A-09		Very ancient	Hiti	Very old stone fountain with small depressed surrounding made of brick and stones.	Not well maintained Natural source of water dried up due to unplanned constructions

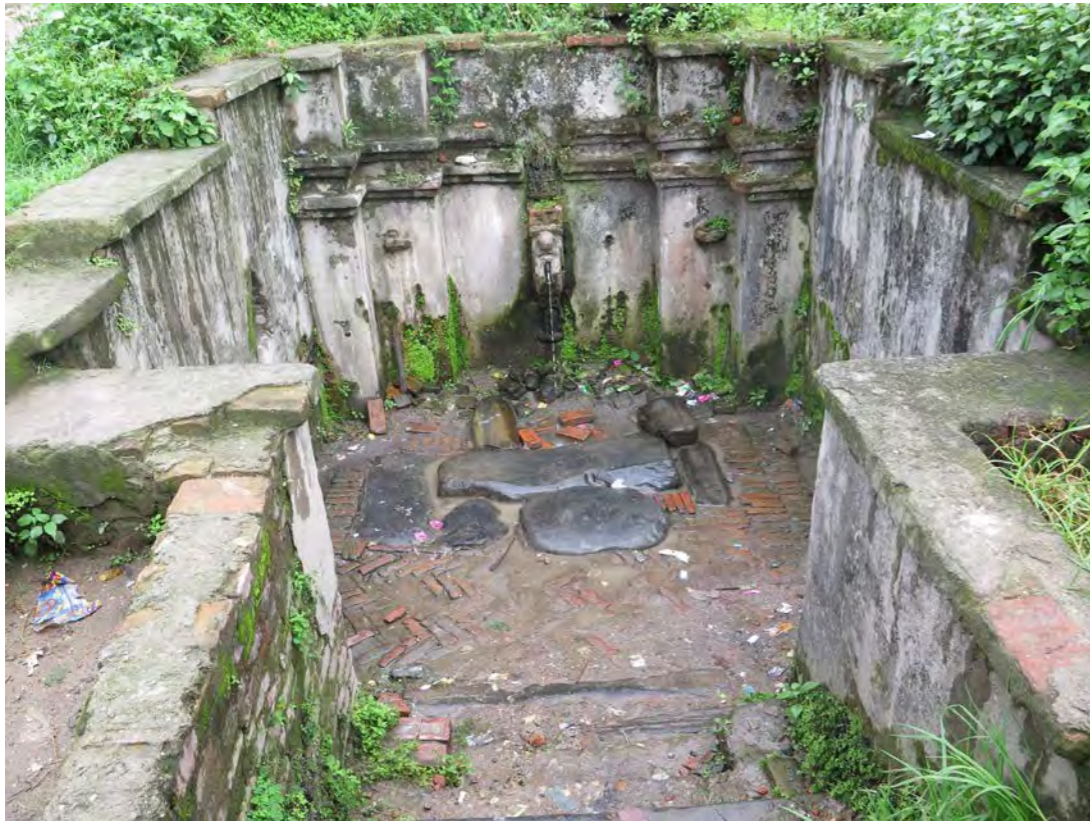
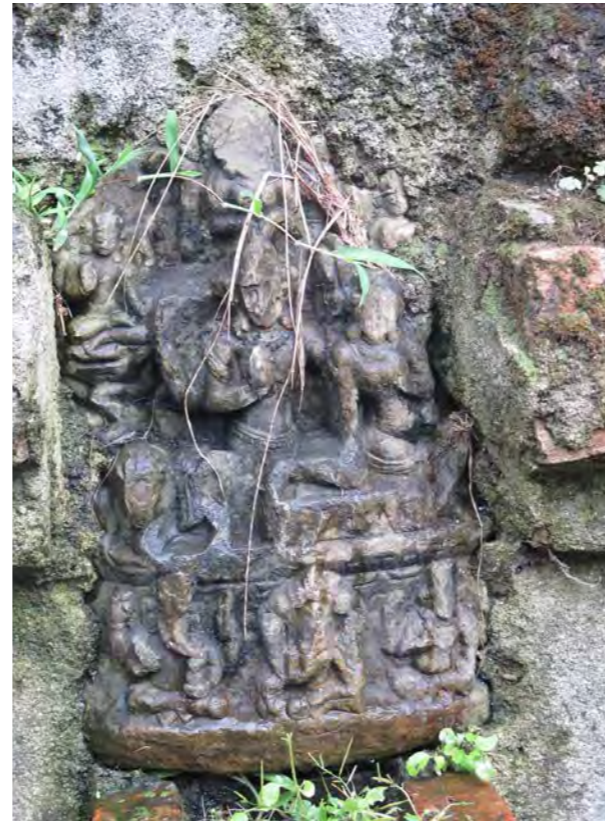
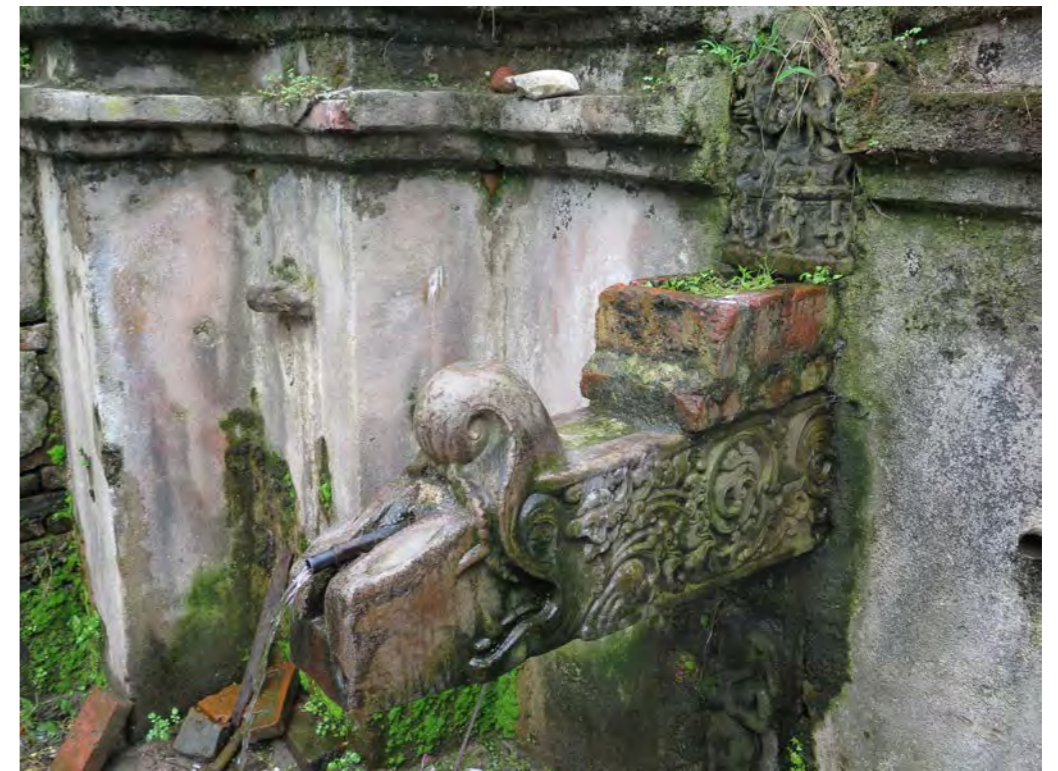
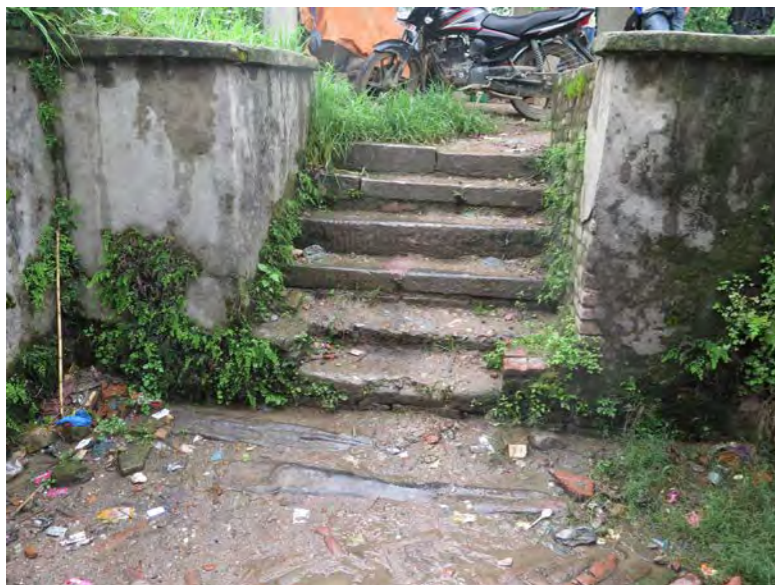
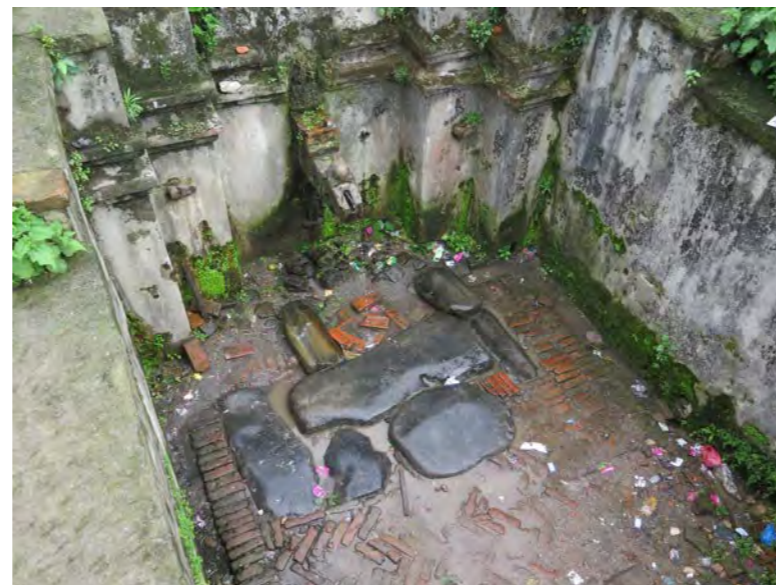
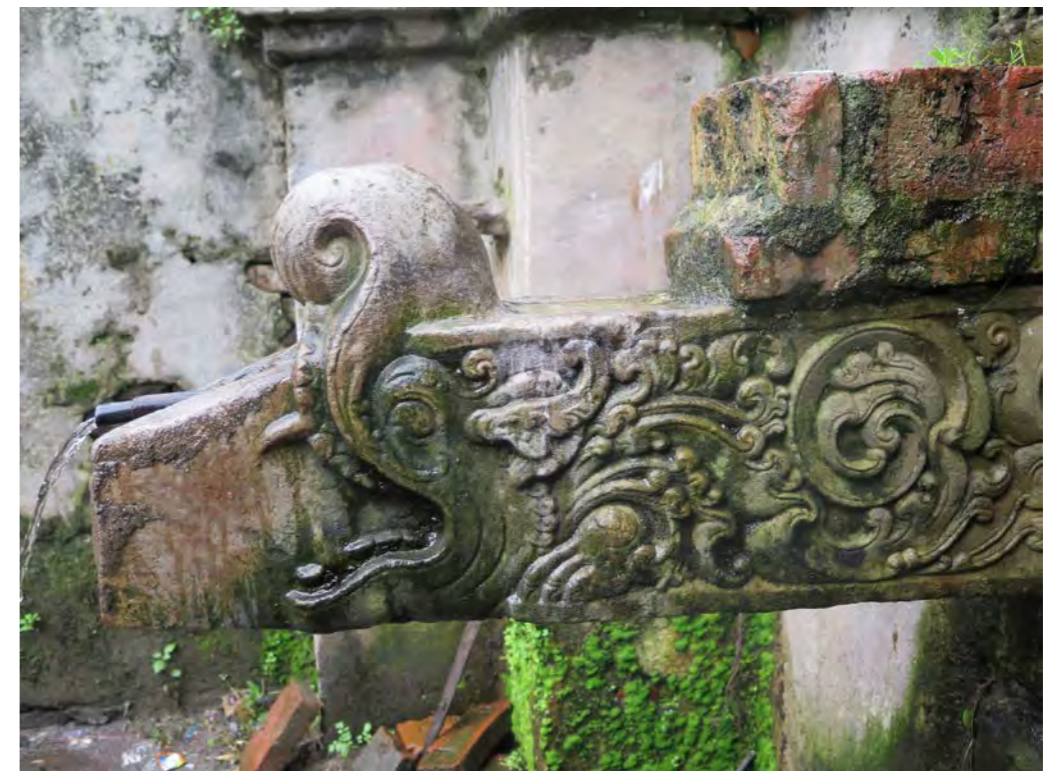
C-22 HITI

NUMBER	NAME	ESTABLISHED DATE (A.D.)	TYPOLOGY	GENERAL DESCRIPTION	PROBLEMS DESCRIPTION	DANGER/ DESTROY
C-22			Hiti	Water fountain with some stone sculpture above and below main fountain	Well functioning but need cleaning

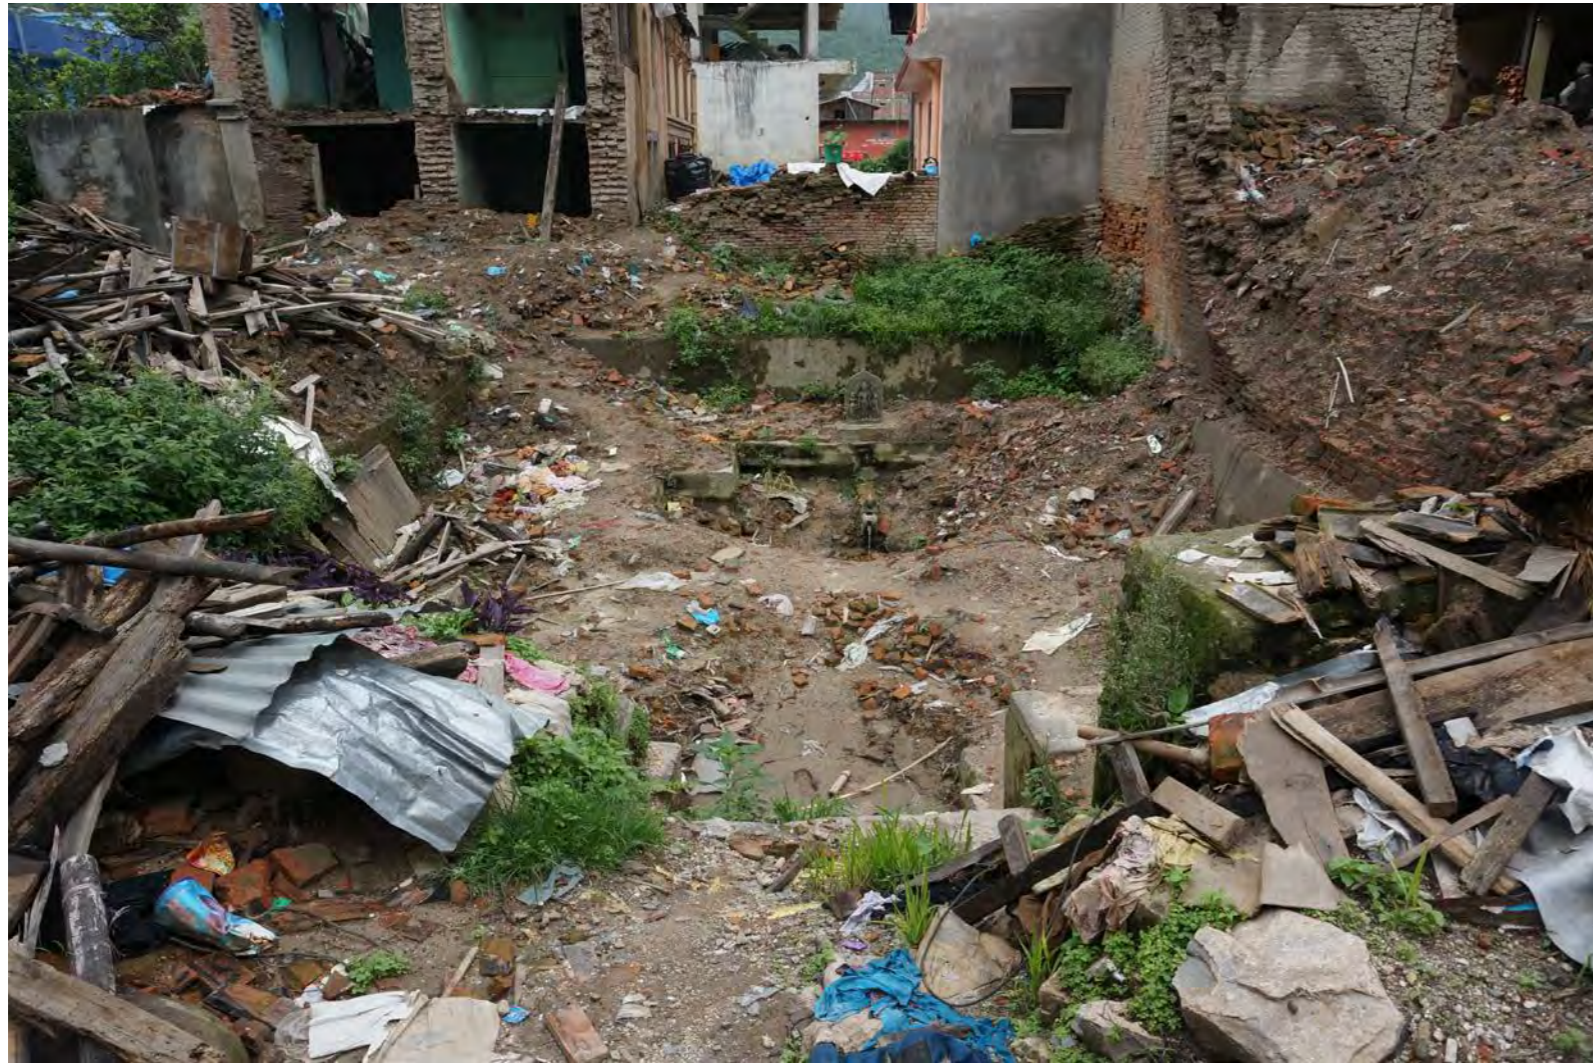
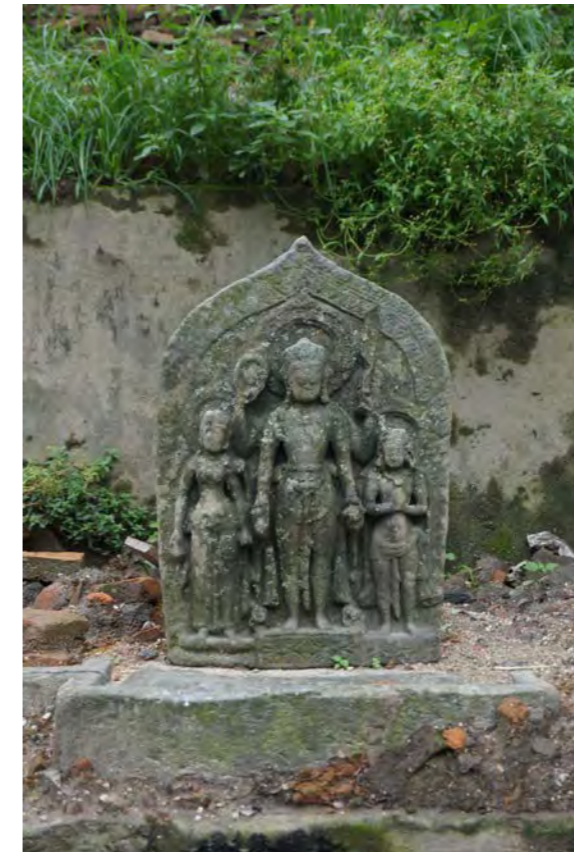
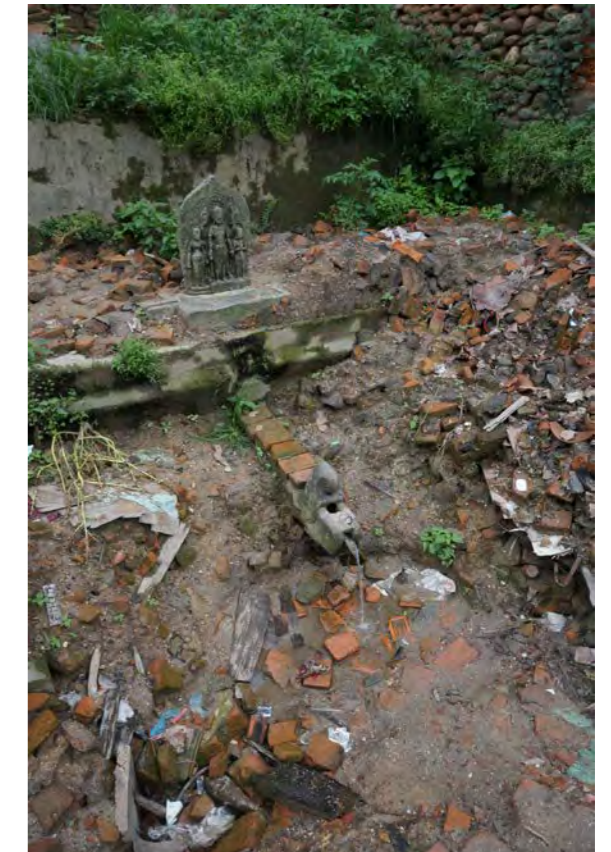
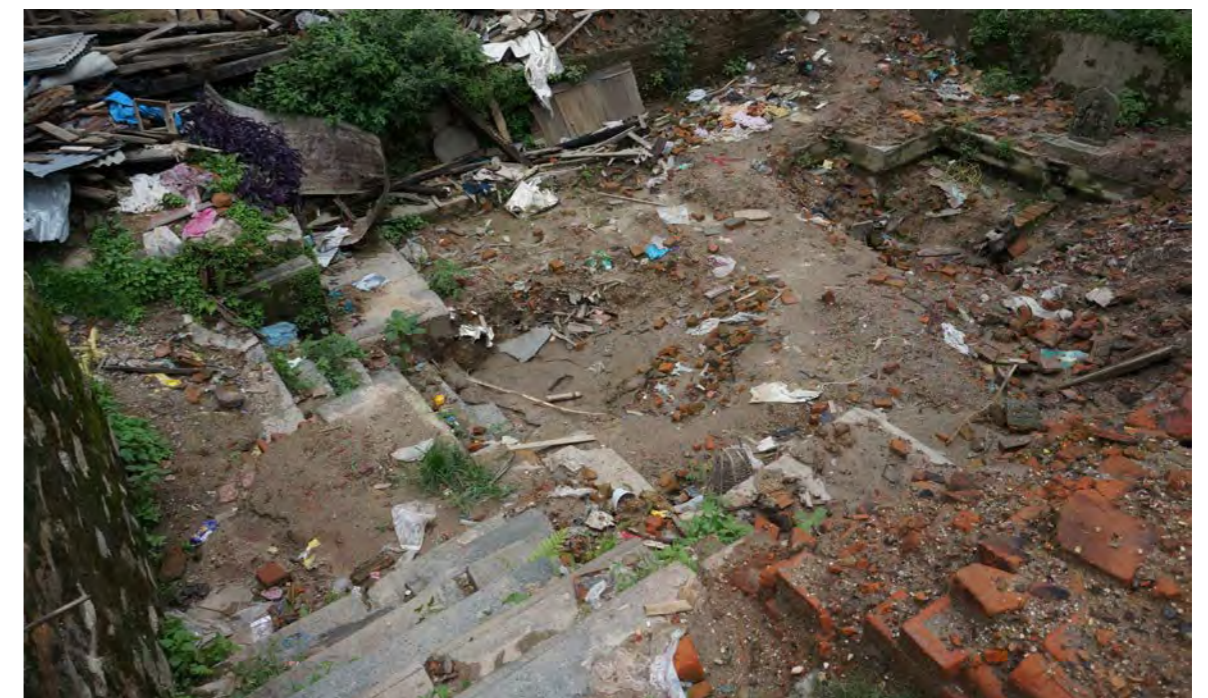
H-05 HITI

NUMBER	NAME	DATE A.D.	TYOLOGY	GENERAL DESCRIPTION	PROBLEMS DESCRIPTION	DANGER/ DESTROY
H-05			Deep water spout (Gahiti)	Stone made water fountain	Whole structure almost under debris Needs clearing and maintainanca
