2015 Earthquake Damage Mapping

Sankhu

October 2015

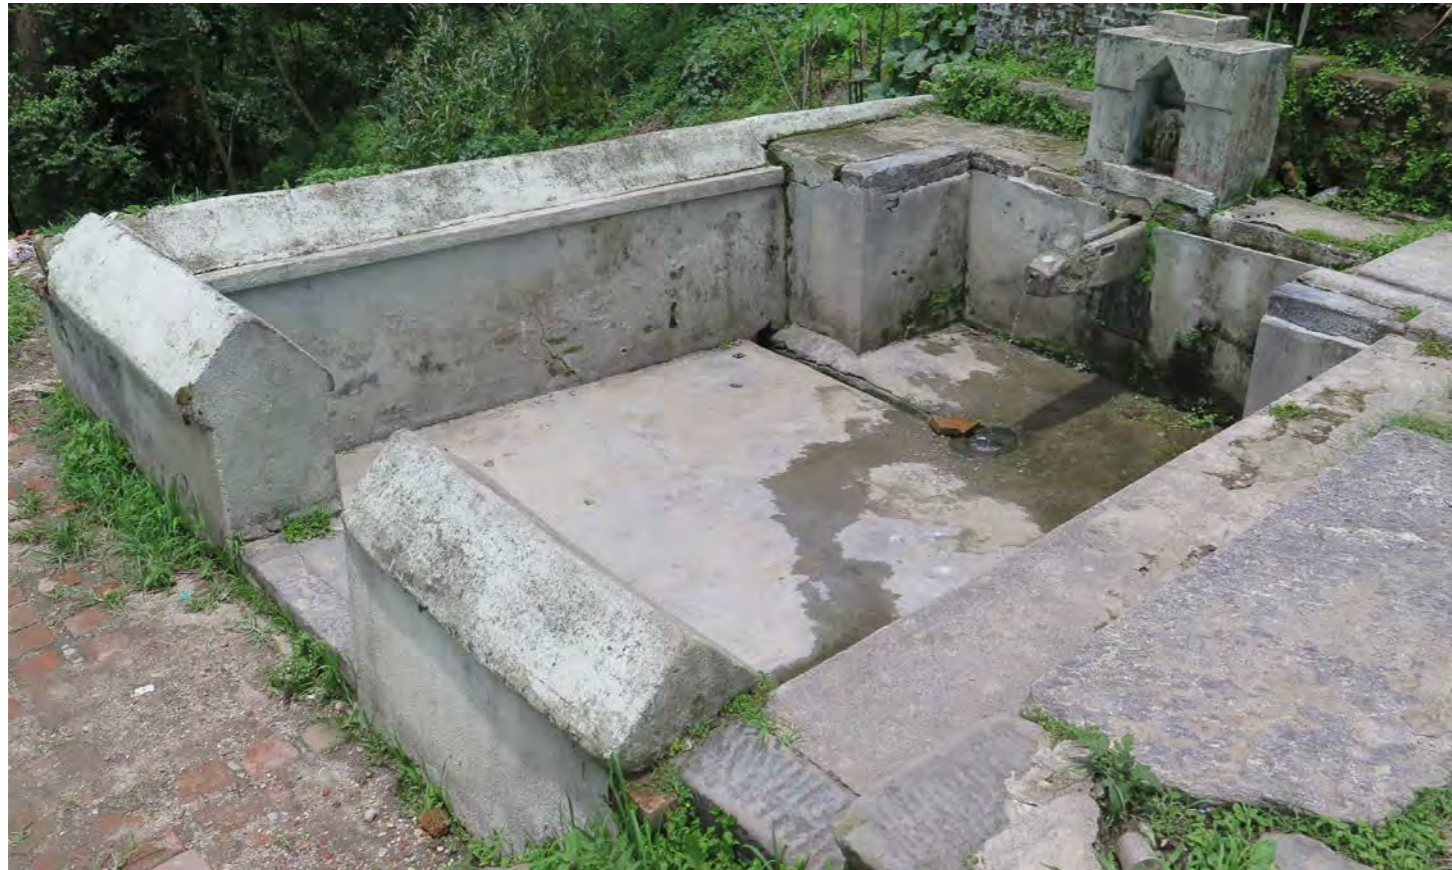
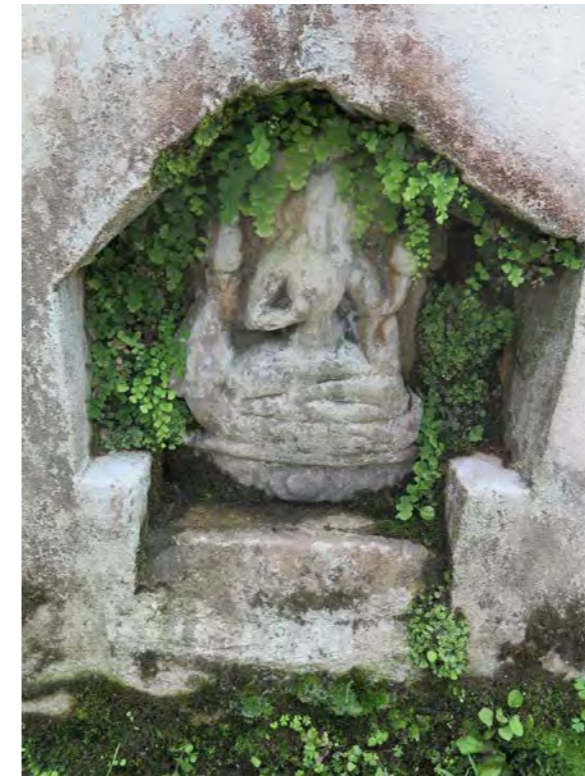
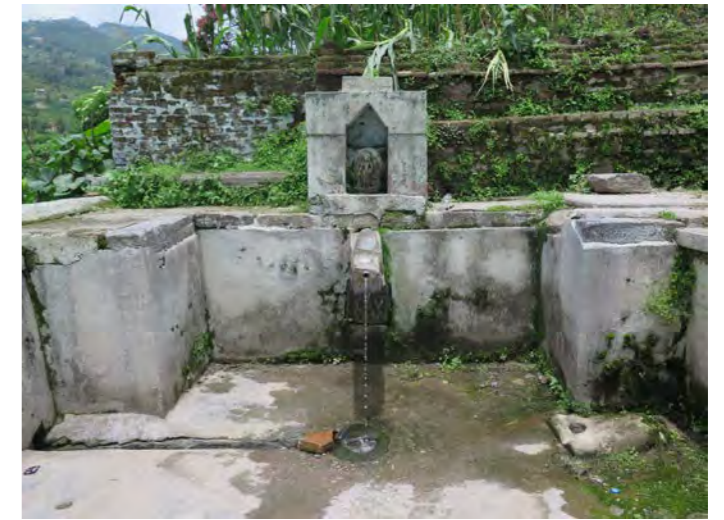
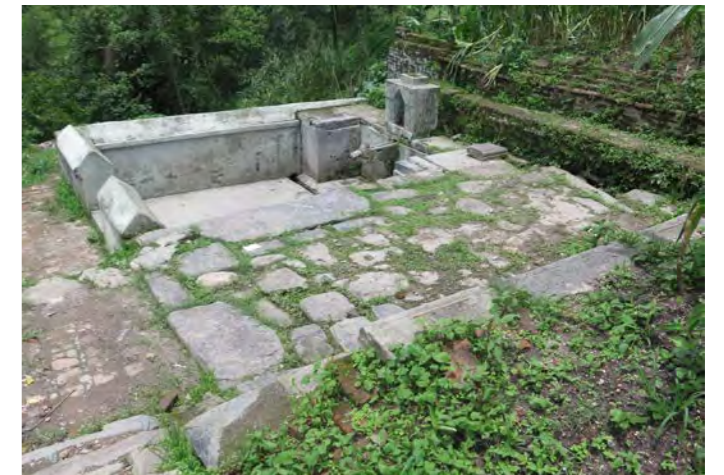
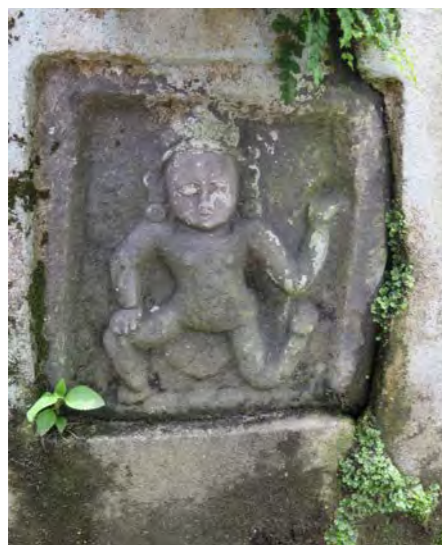
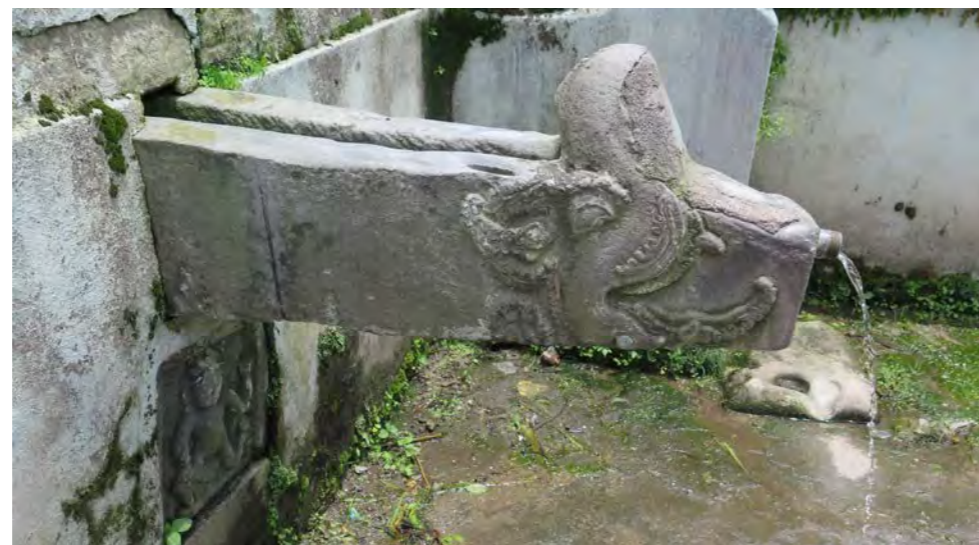
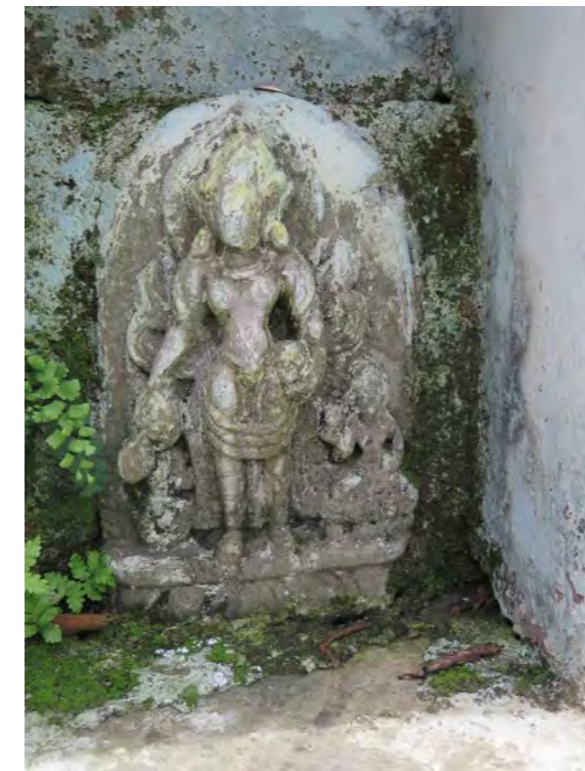
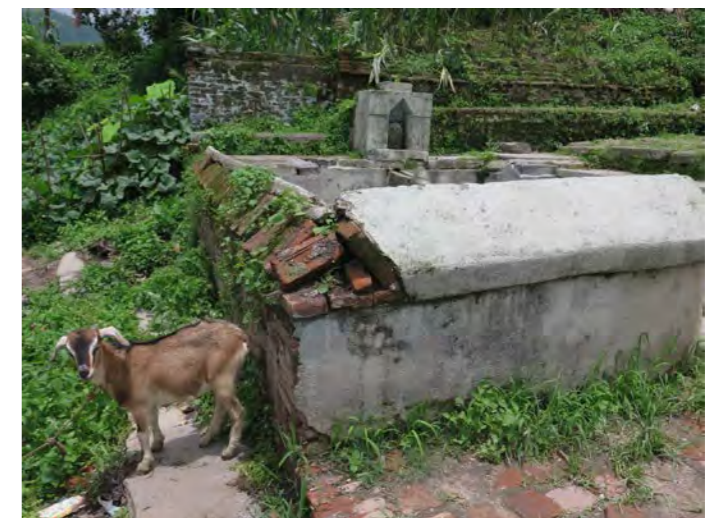
I-15 HITI

NUMBER	NAME	ESTABLISHED DATE (A.D.)	TYPOLOGY	GENERAL DESCRIPTION	PROBLEMS DESCRIPTION	DANGER/ DESTROY	
I-15			Hiti		In running condition. Brick offset on west wall upper part

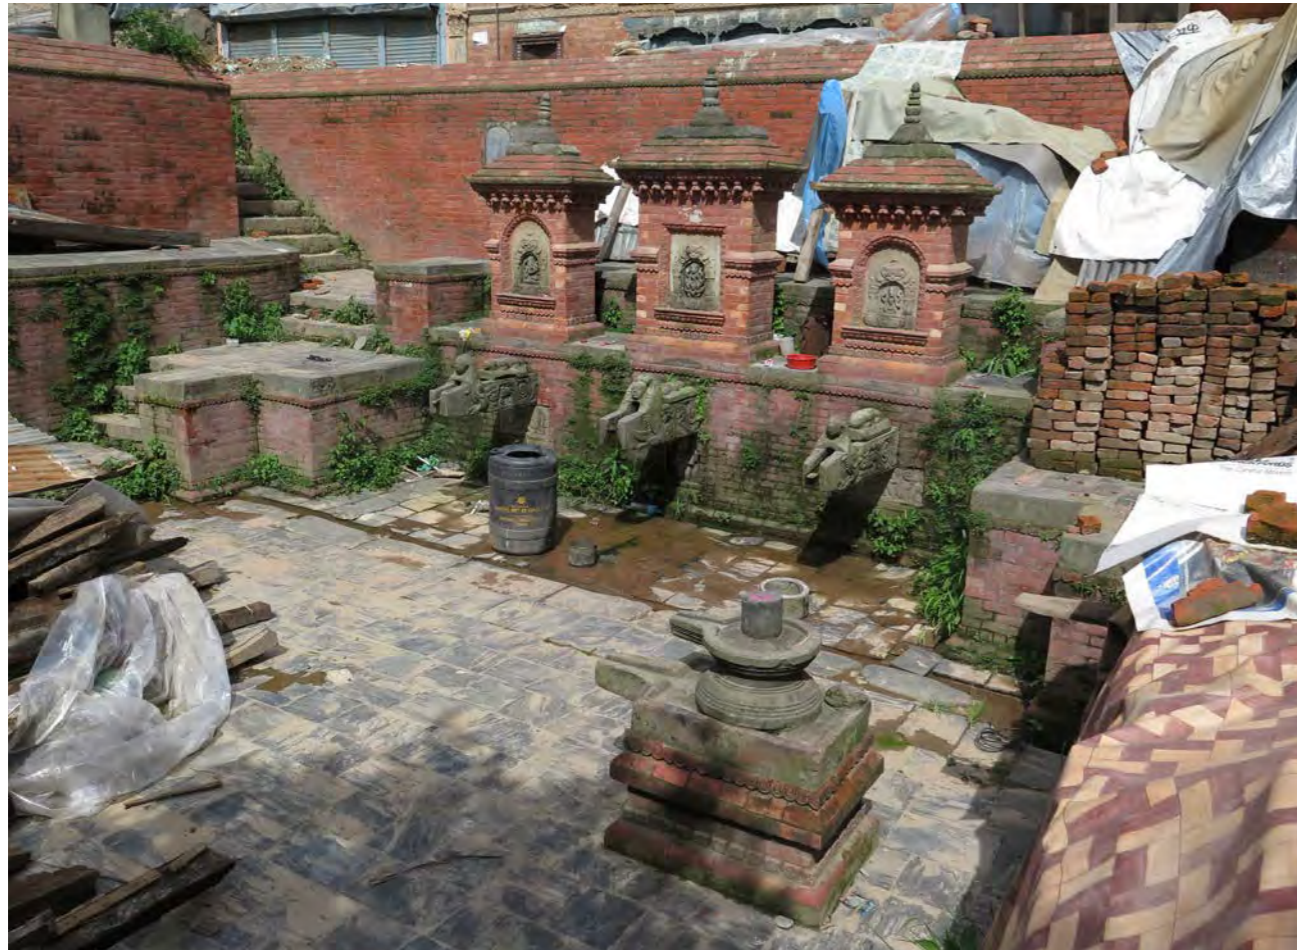
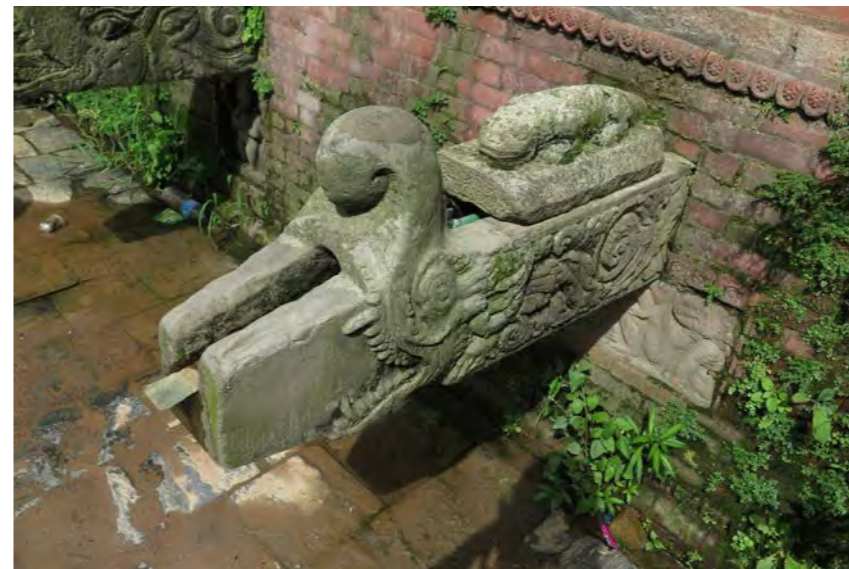
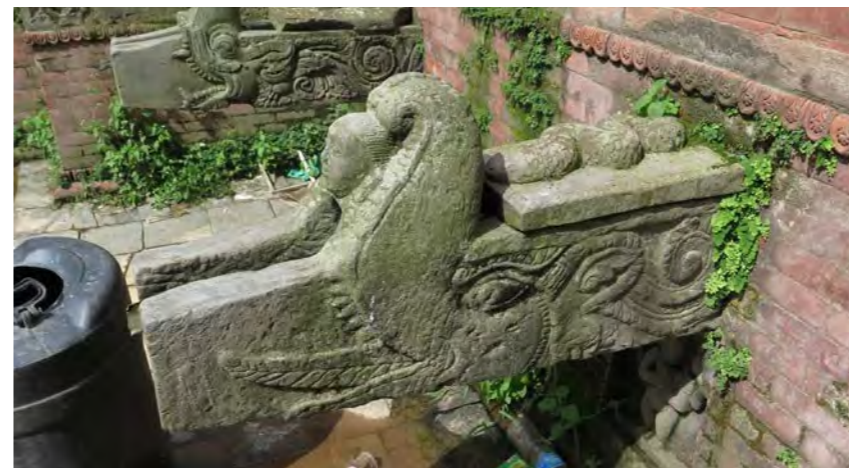
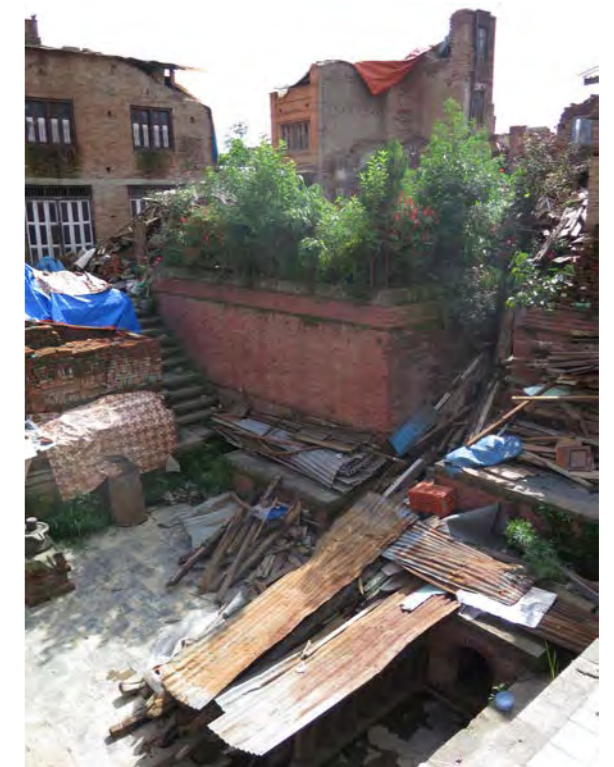
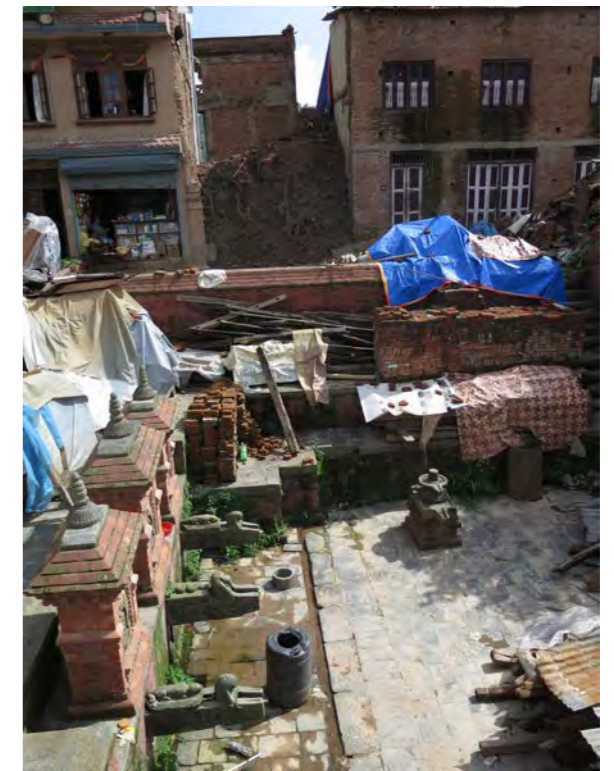
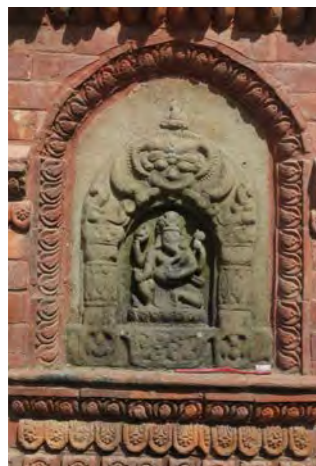
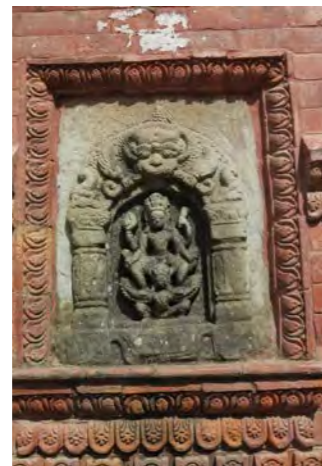
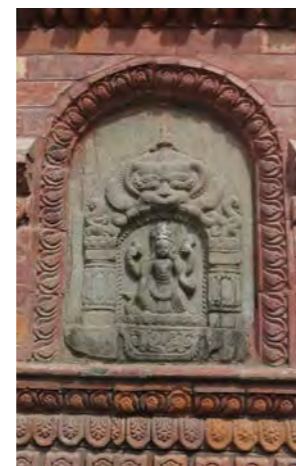
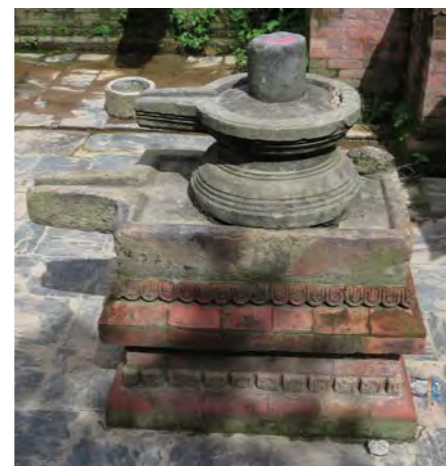
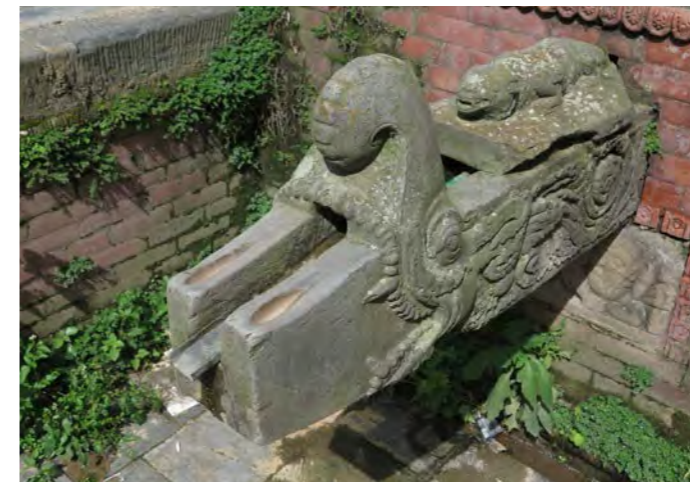
J-01 HITI - SALKHA GA HITI

NUMBER	NAME	DATE A.D.	TYPOLOGY	GENERAL DESCRIPTION	PROBLEMS DESCRIPTION	DANGER/ DESTROY
J-01	Salkha Ga Hiti		Water Fountain	3 fountains, Restored recently. 1 shiva linga and 3 idols above hiti and 3 idols below.	Vegetation all around. Covered by rubbles form nearby buildings.

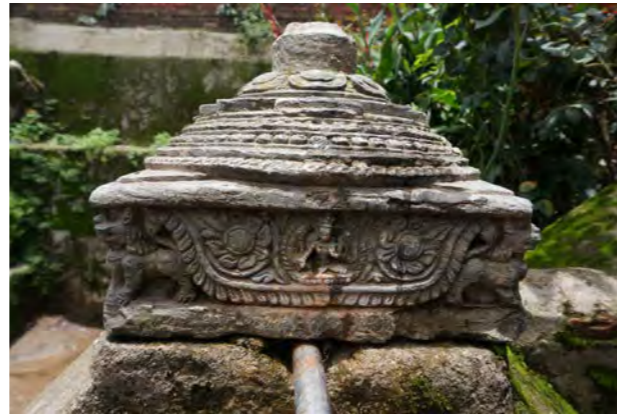
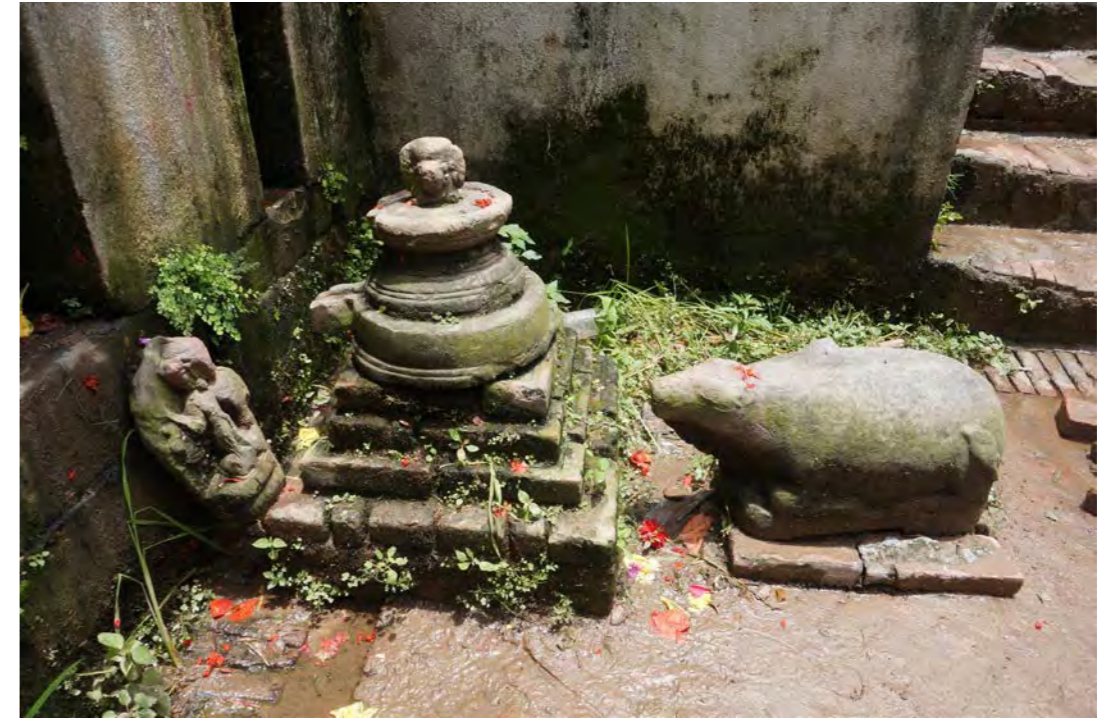
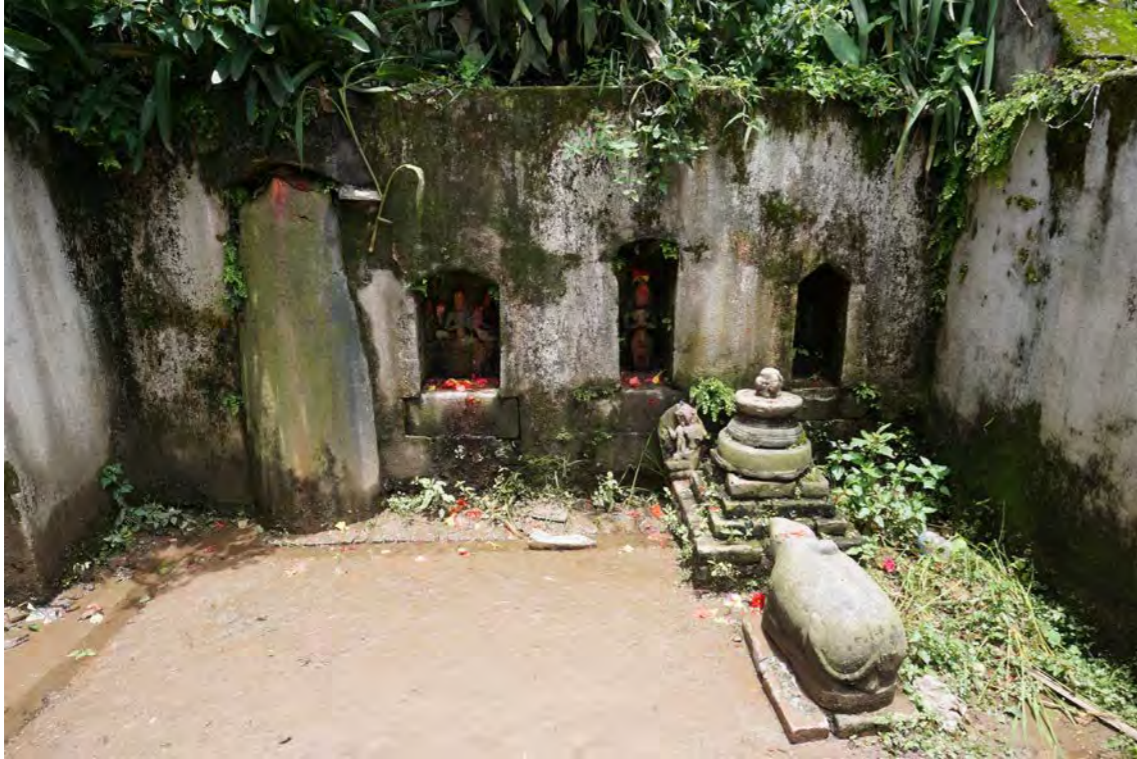
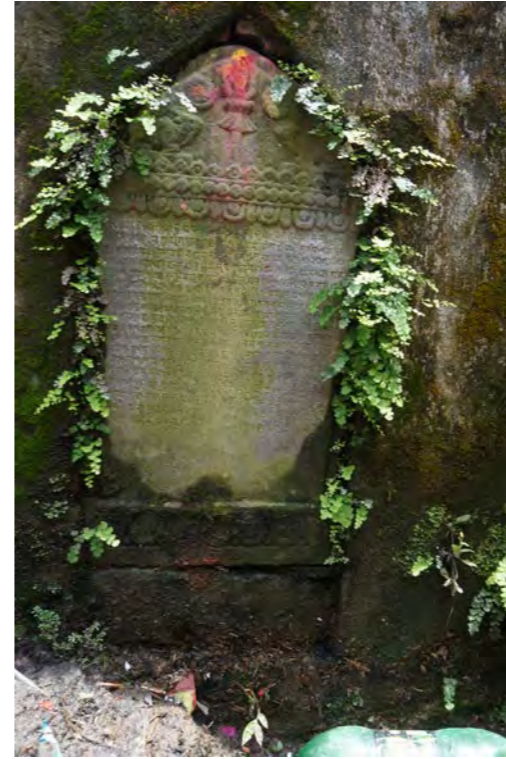
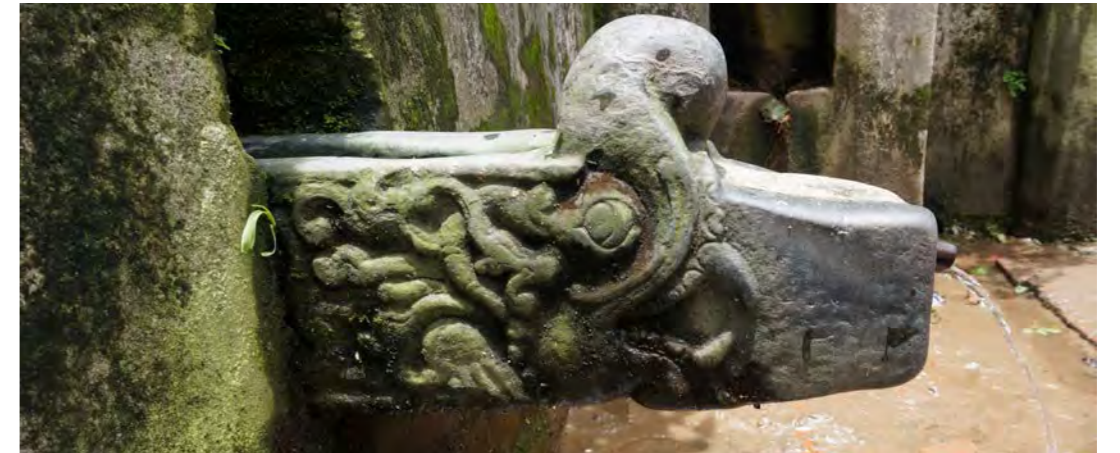
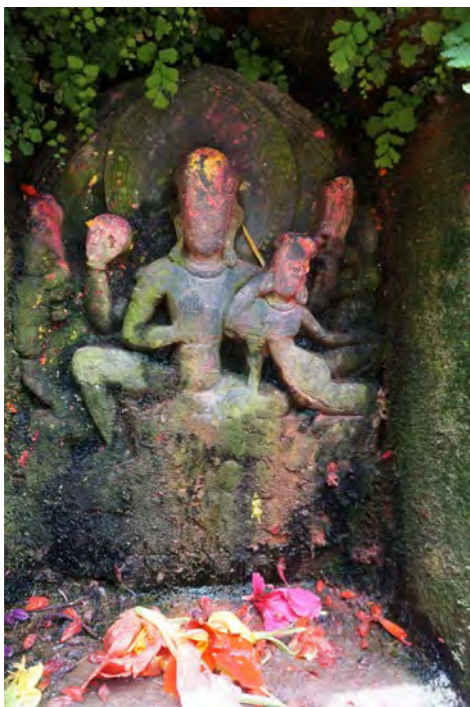
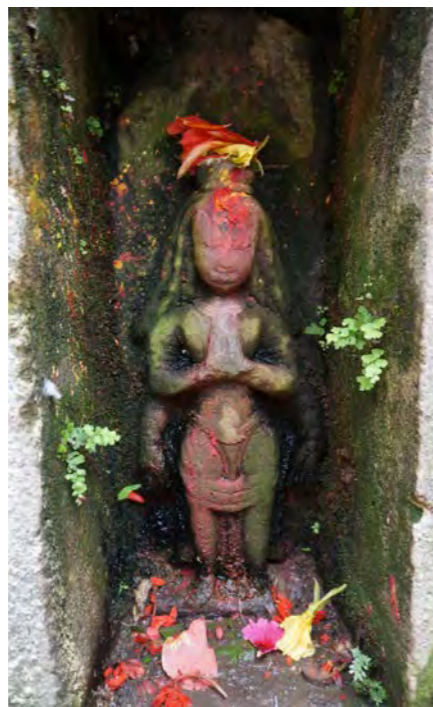
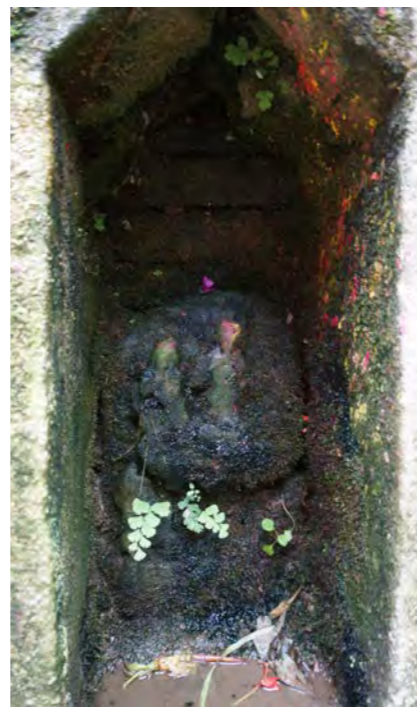
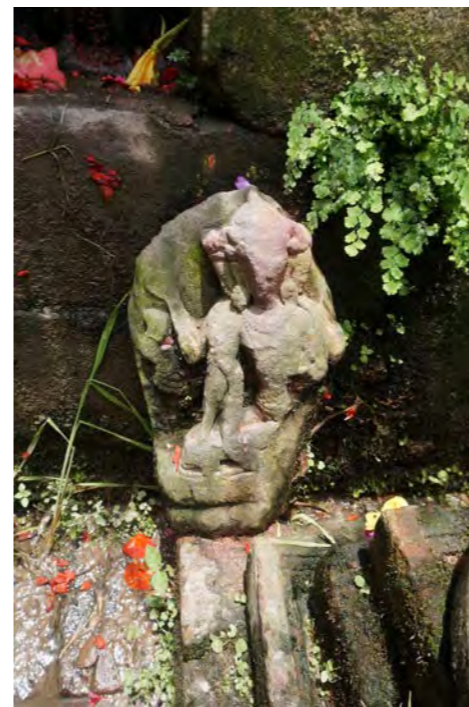
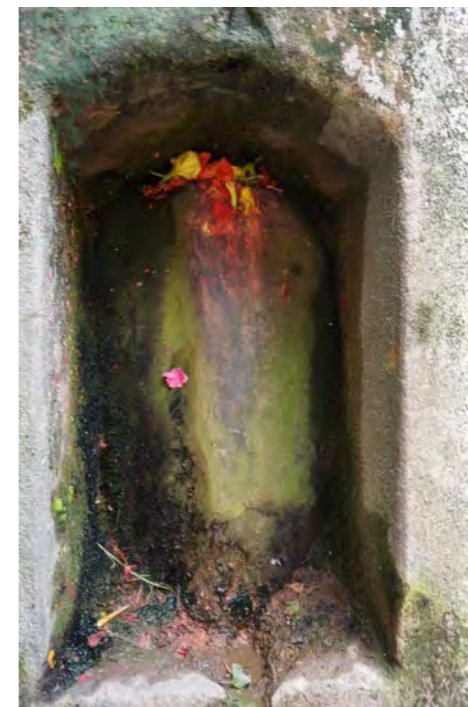
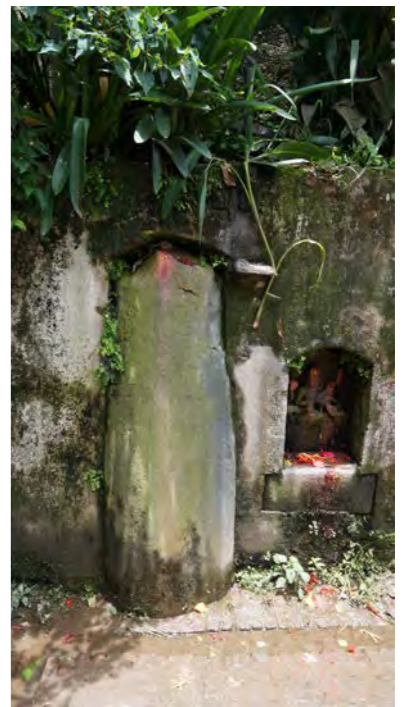
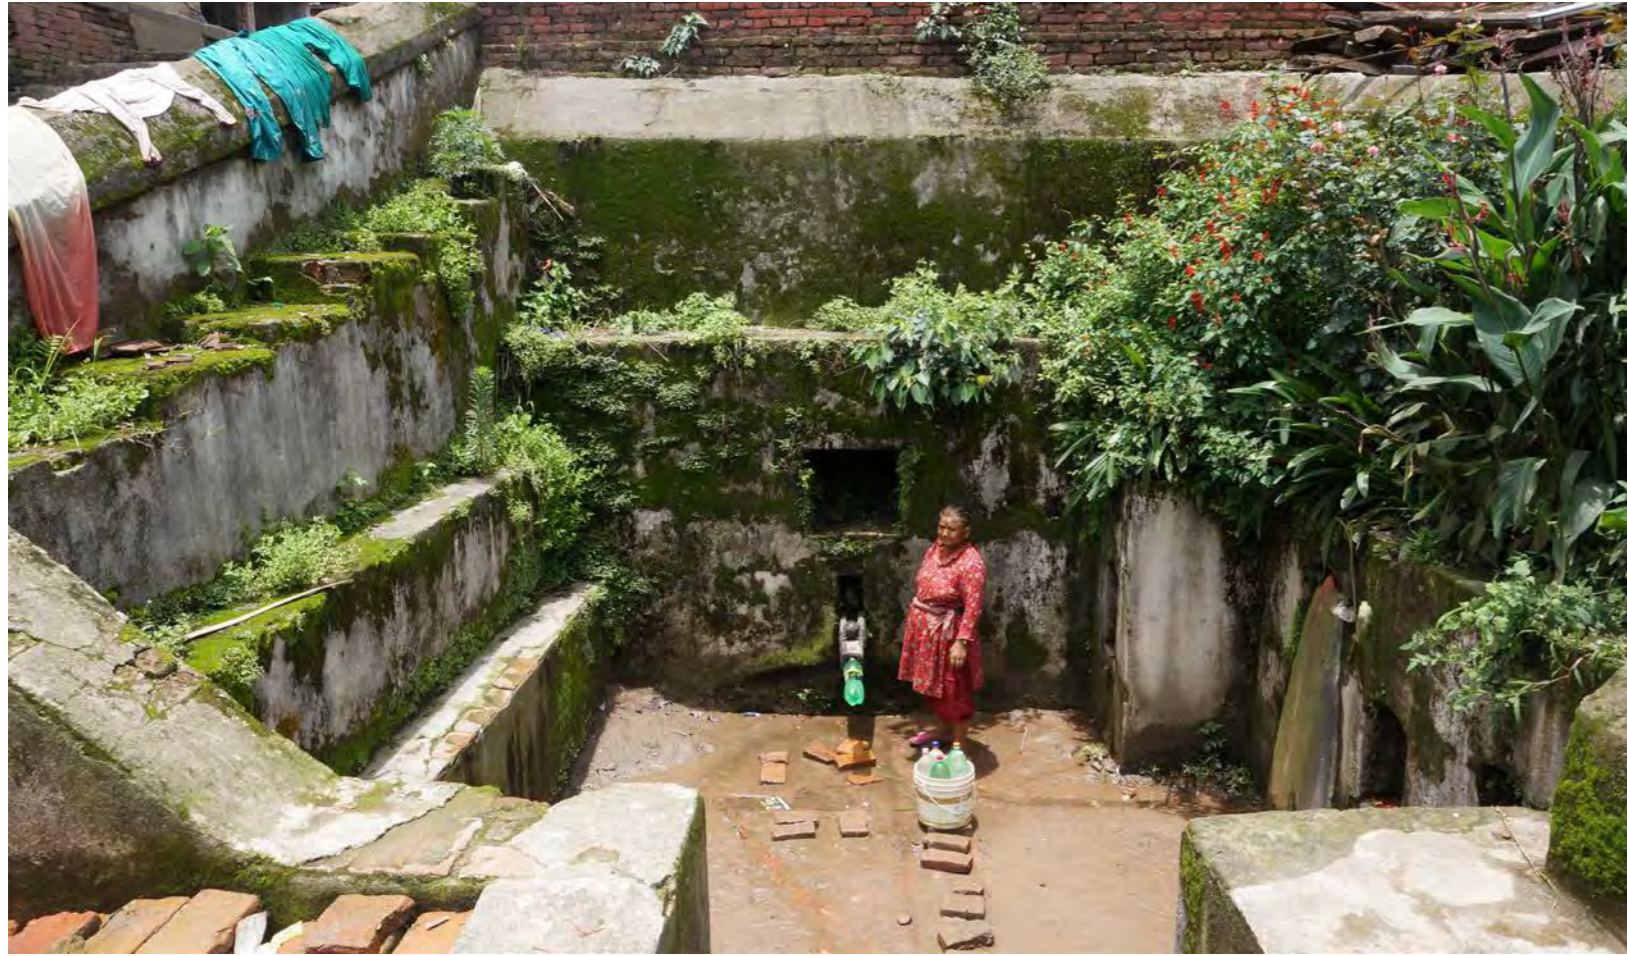
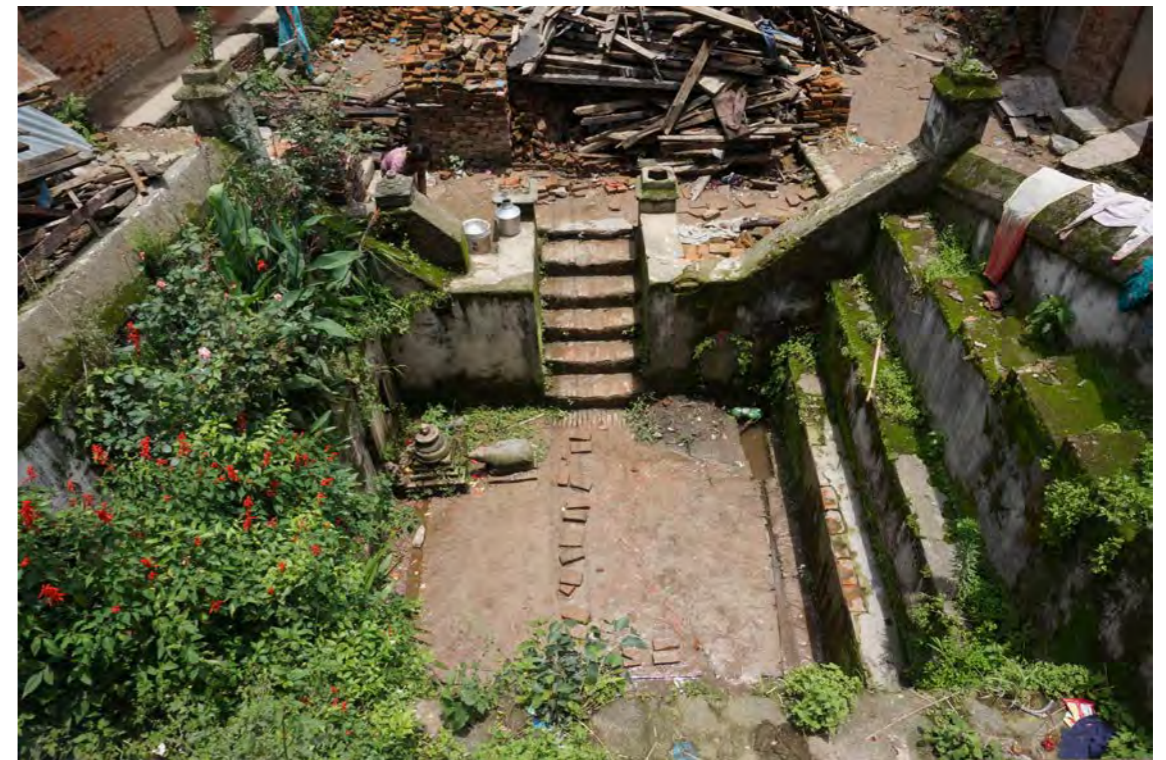
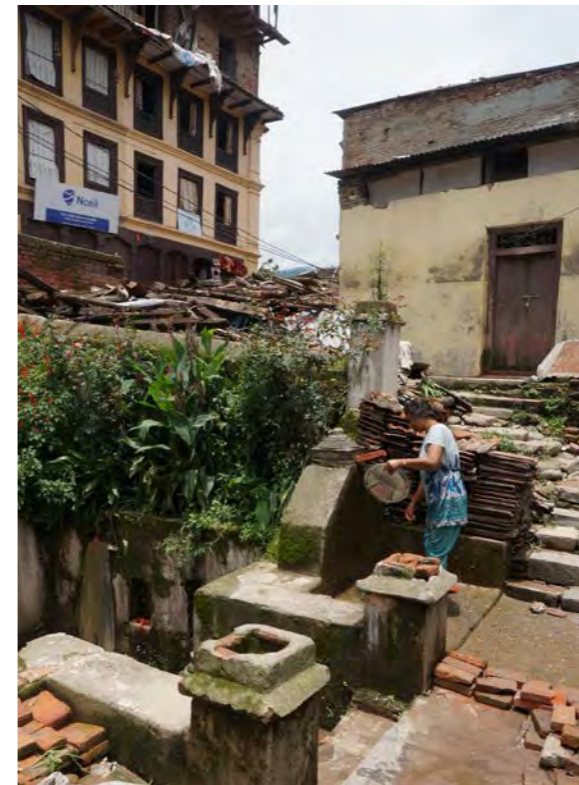
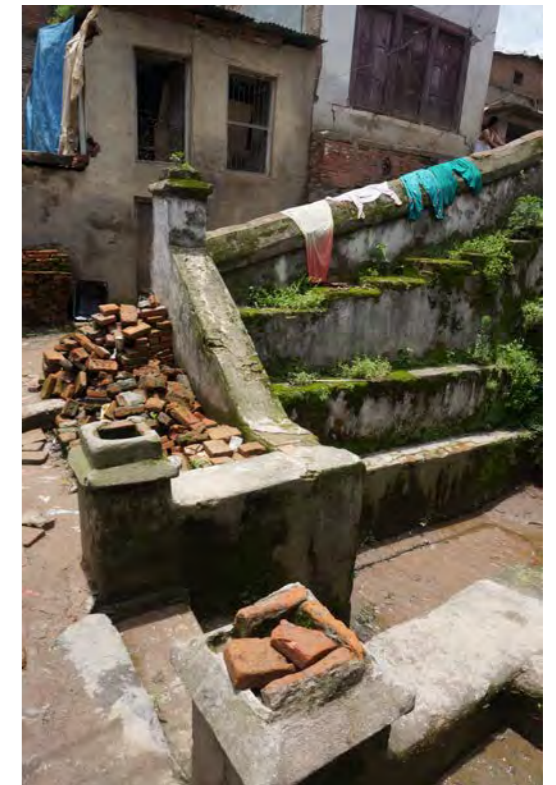
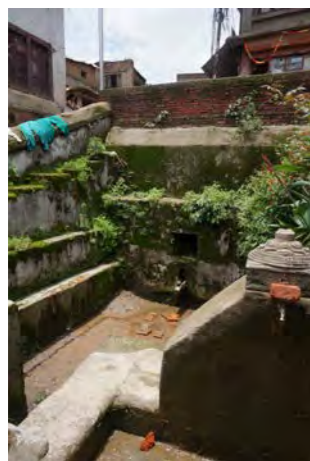
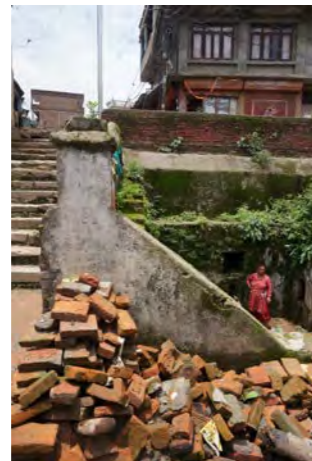
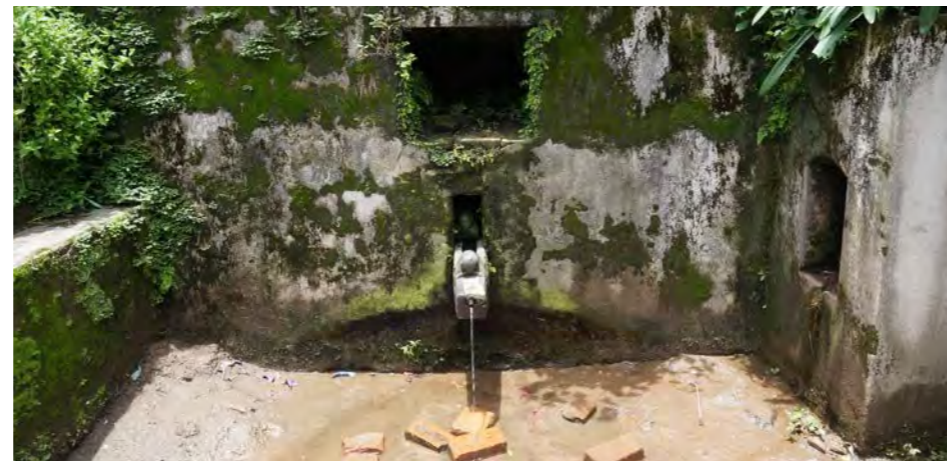
K-01 HITI

NUMBER	NAME	DATE A.D.	TYPOLOGY	GENERAL DESCRIPTION	PROBLEMS DESCRIPTION	DANGER/ DESTROY
K-01			Hiti	Very old stone water spout with stone shivalinga and other stone statues surrounding	Degraded. Needs maintainance

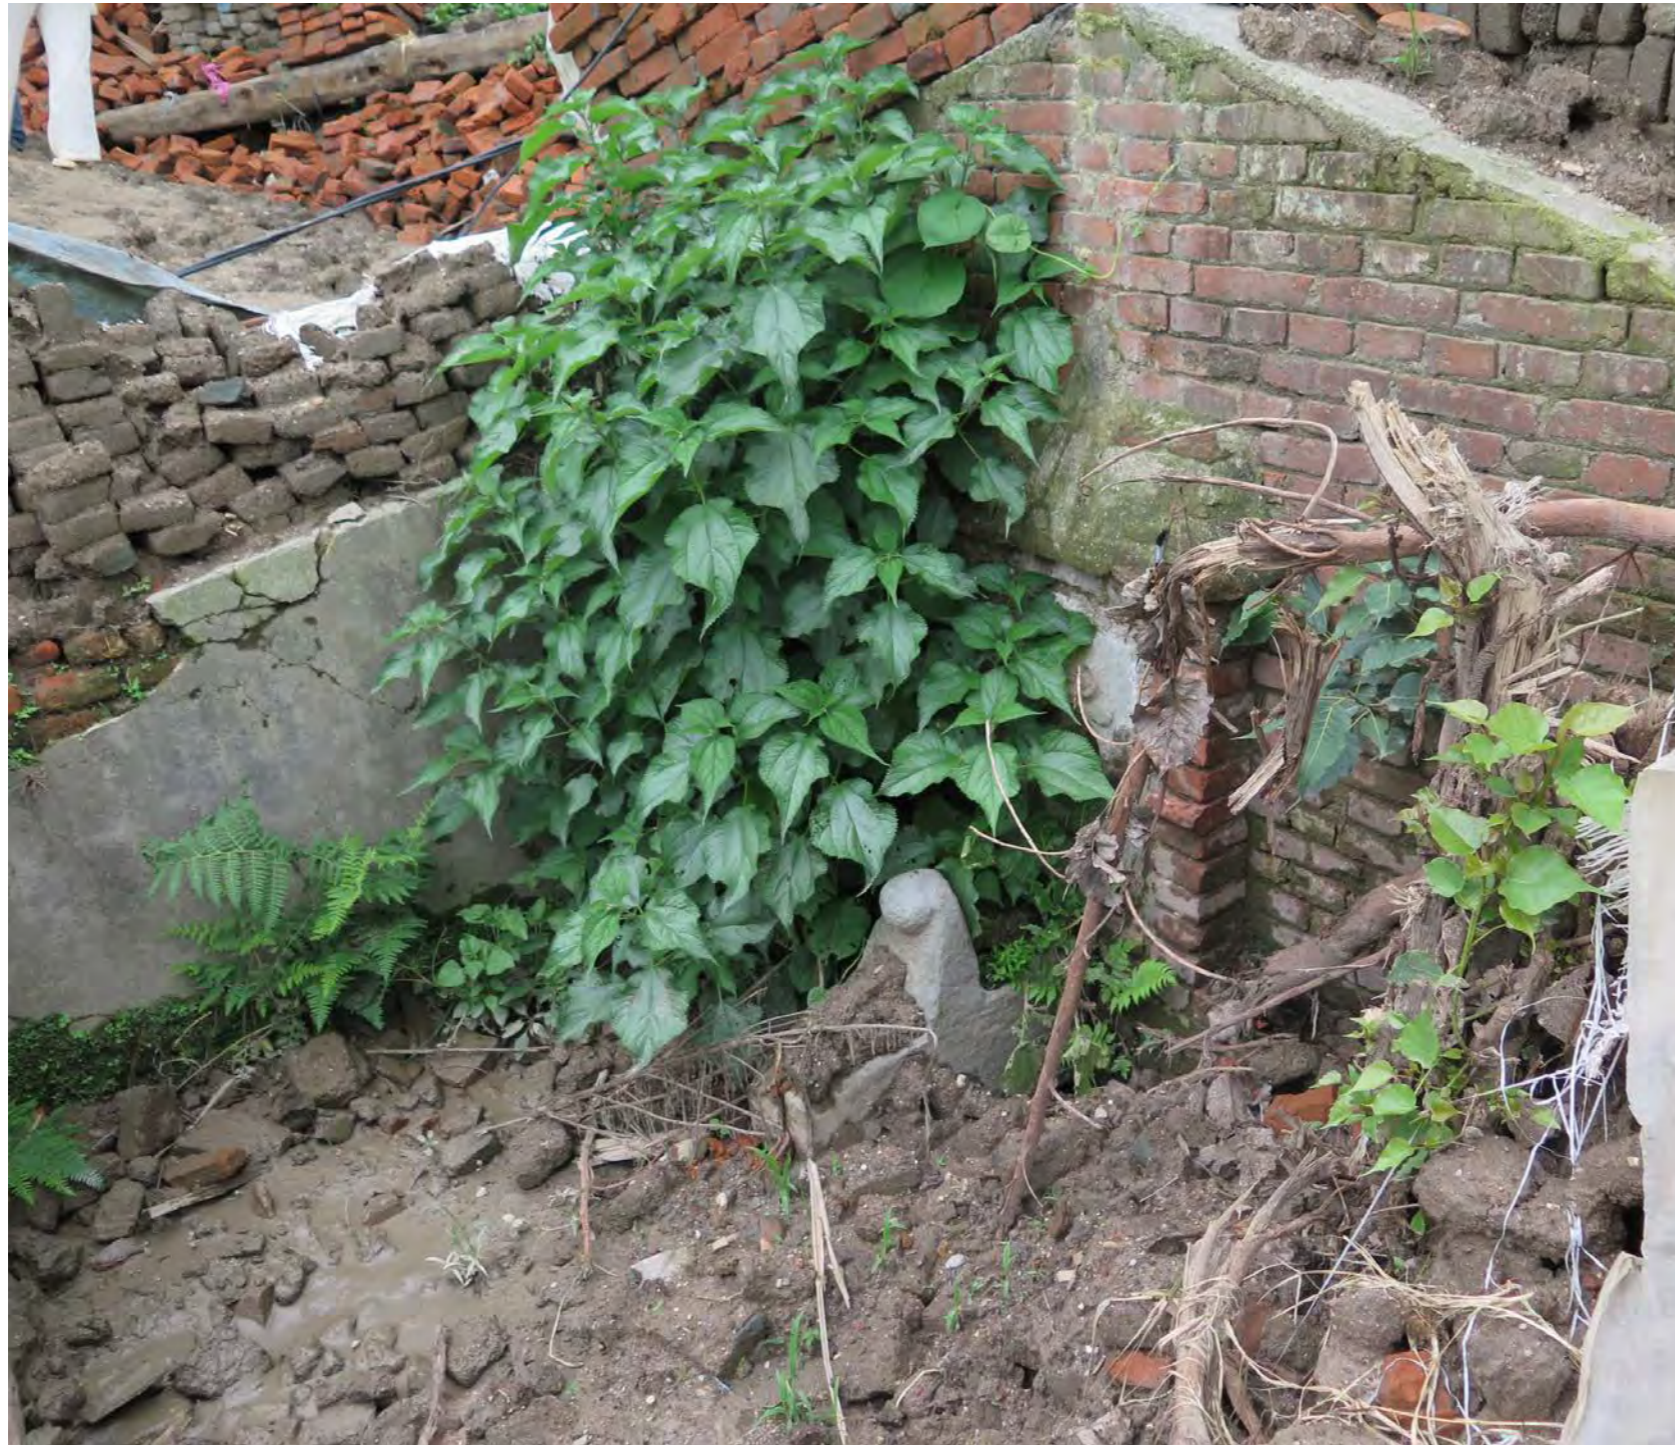
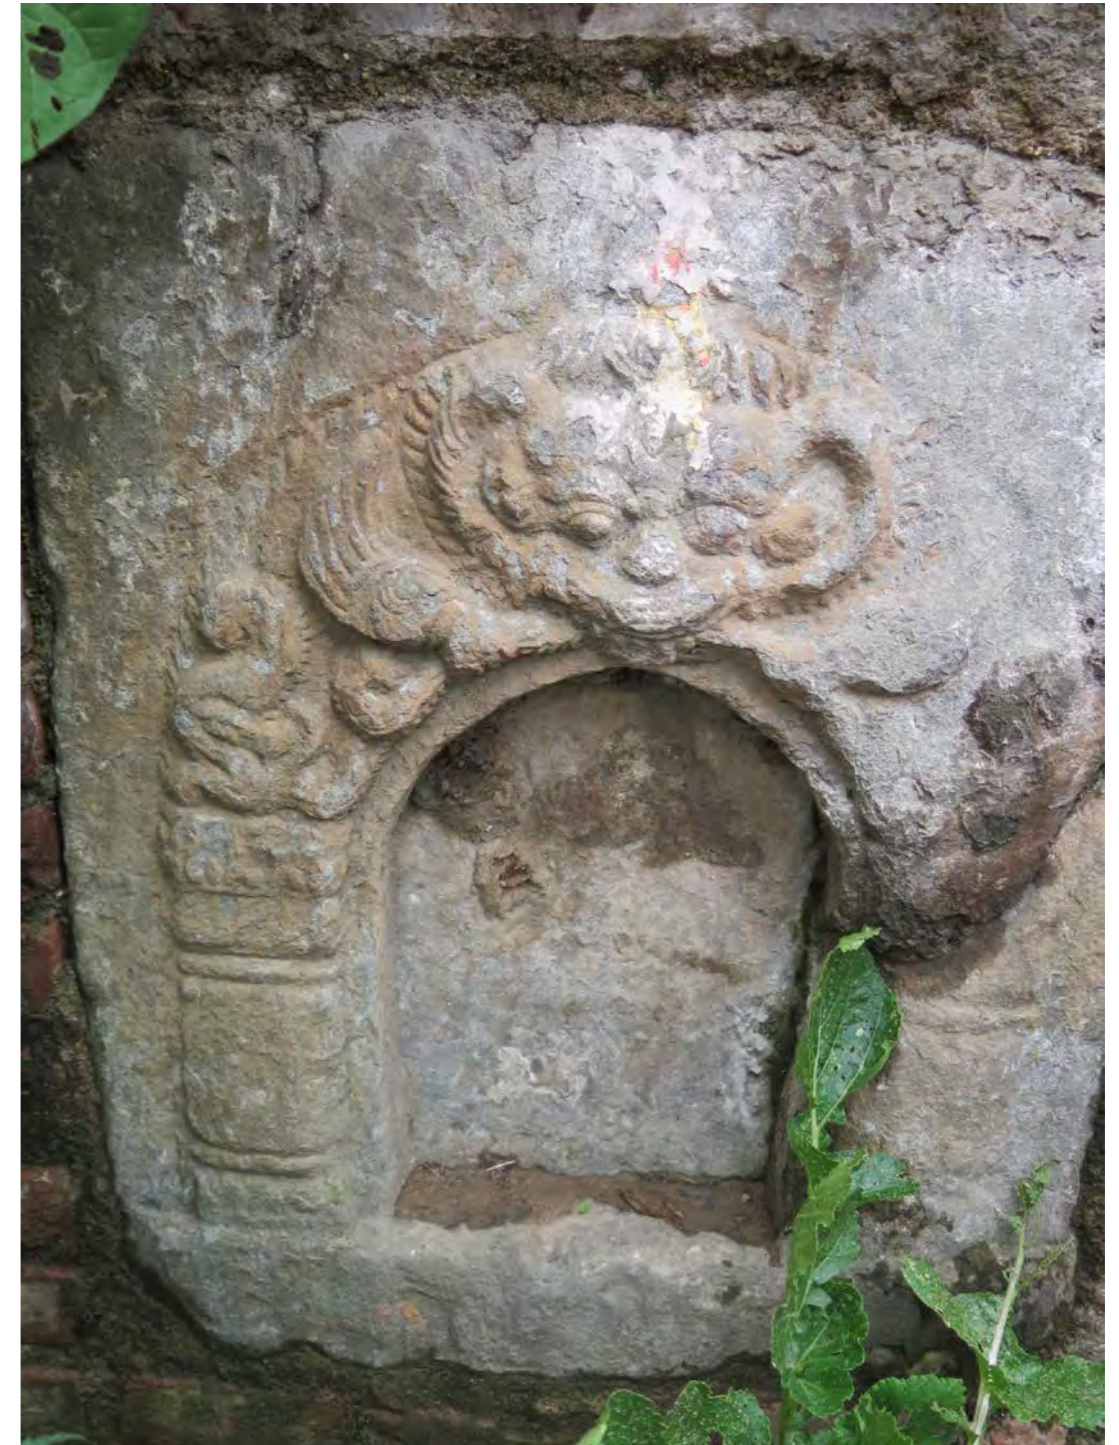
J-18 HITI

NUMBER	NAME	ESTABLISHED DATE (A.D.)	TPOLOGY	GENERAL DESCRIPTION	PROBLEMS DESCRIPTION	DANGER/ DESTROY
J-18			Hiti		Totally under rubbles.
