2015 Earthquake Damage Mapping

Sankhu

October 2015

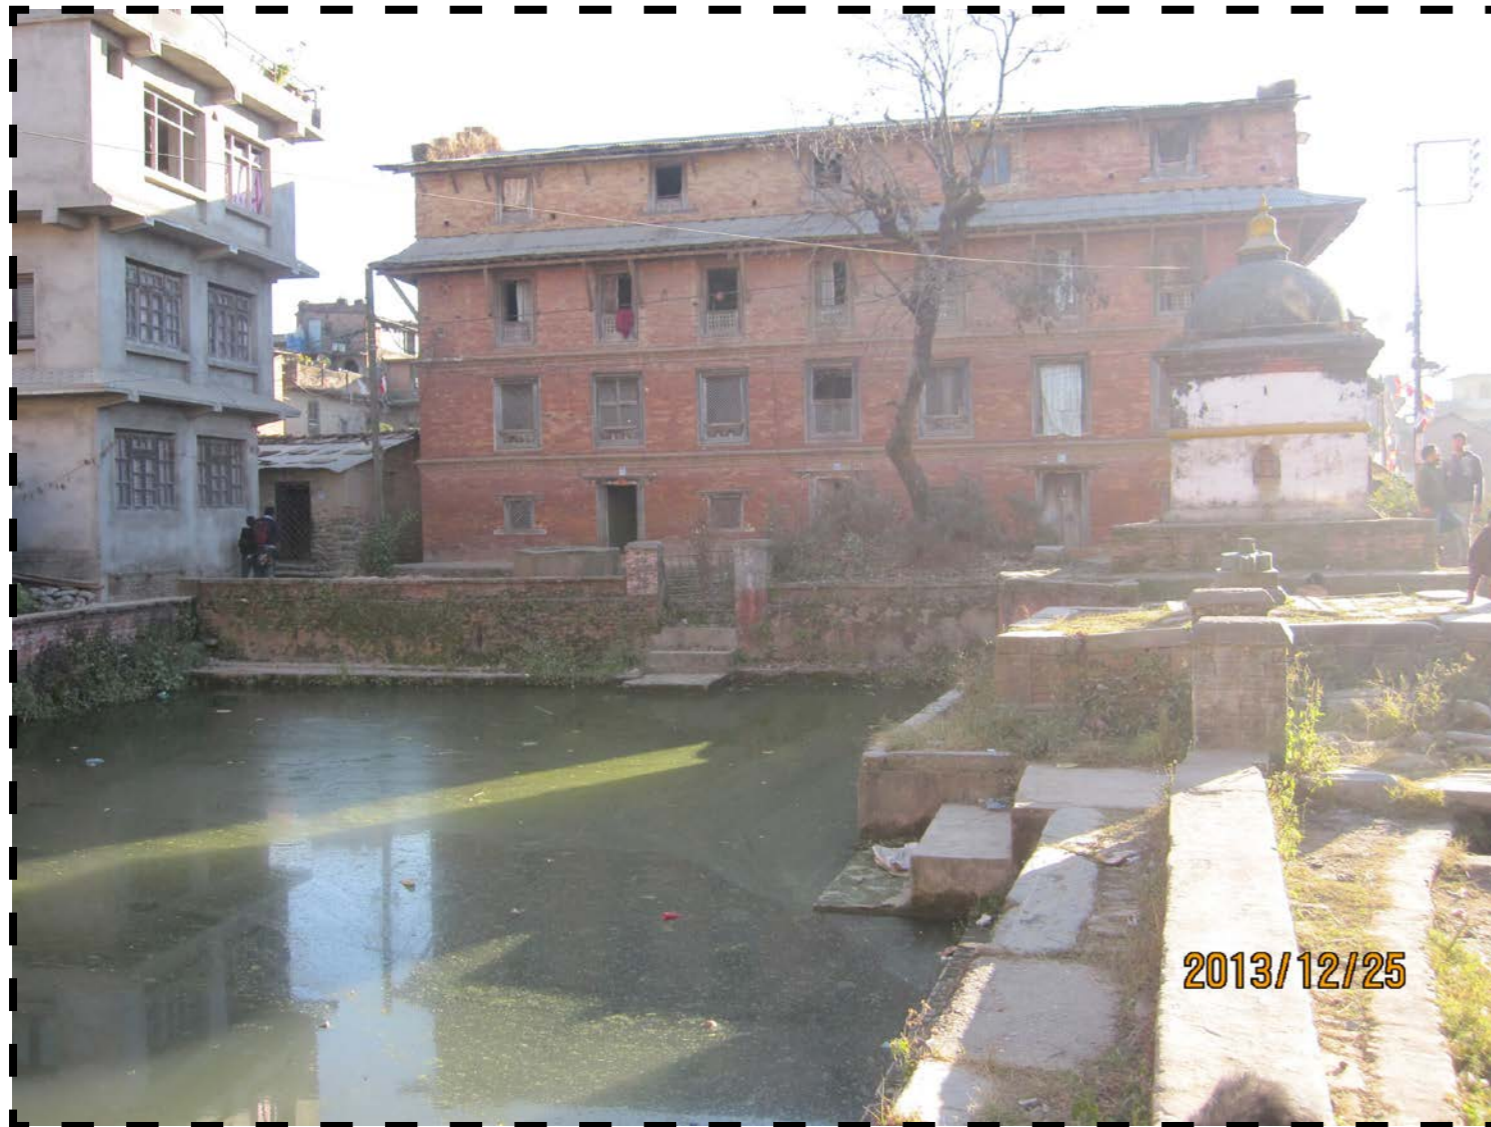
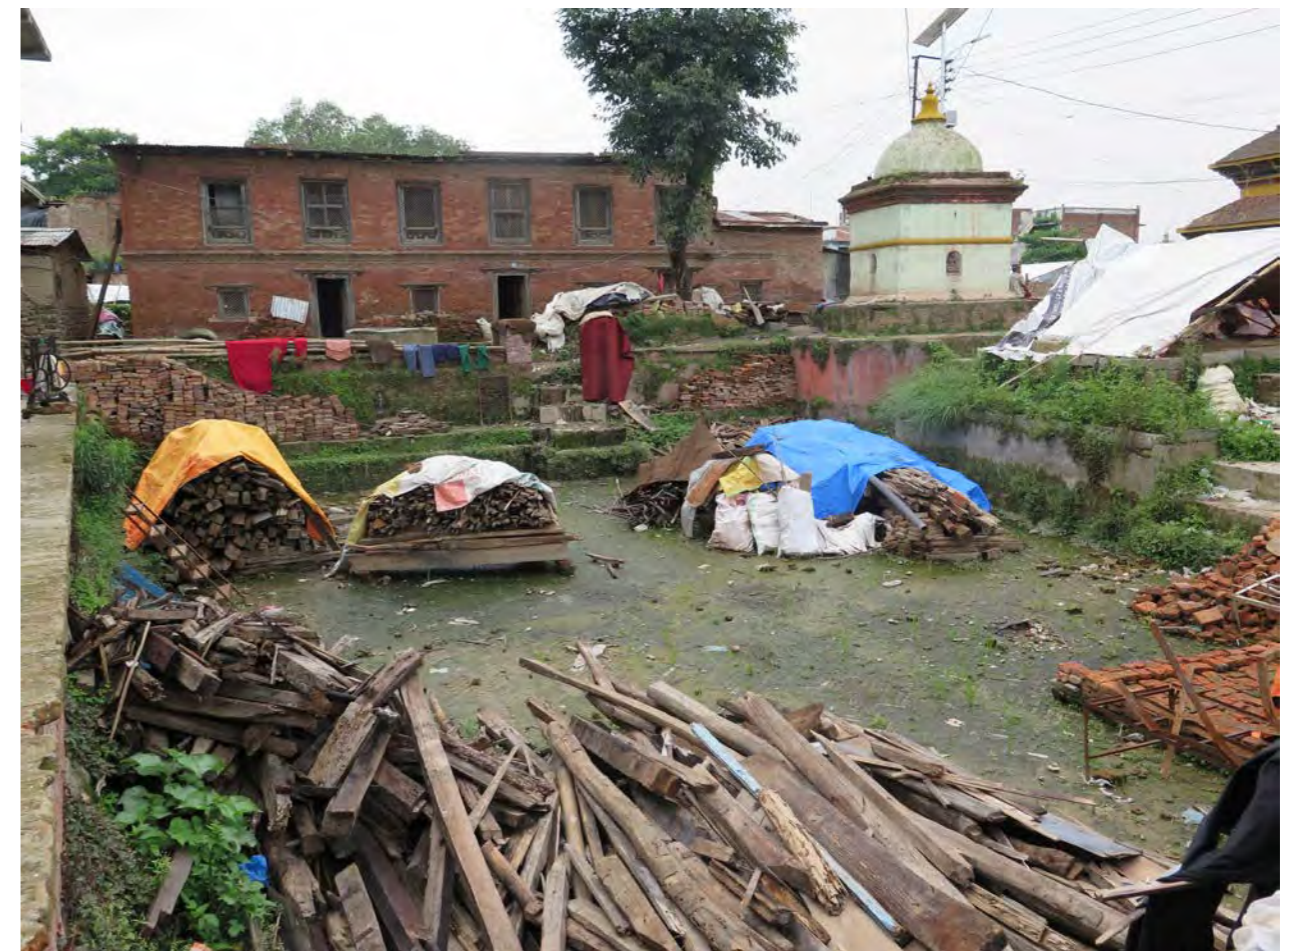
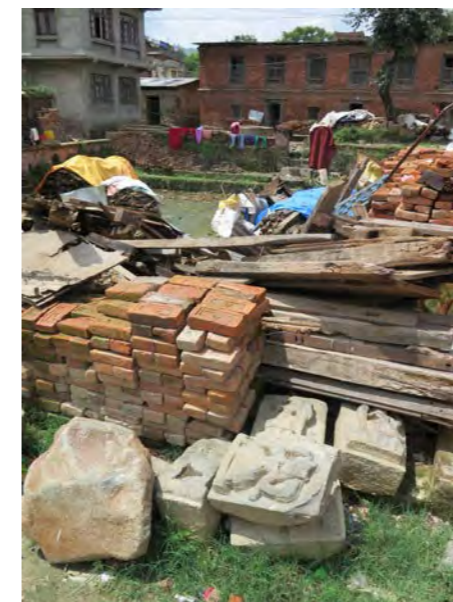
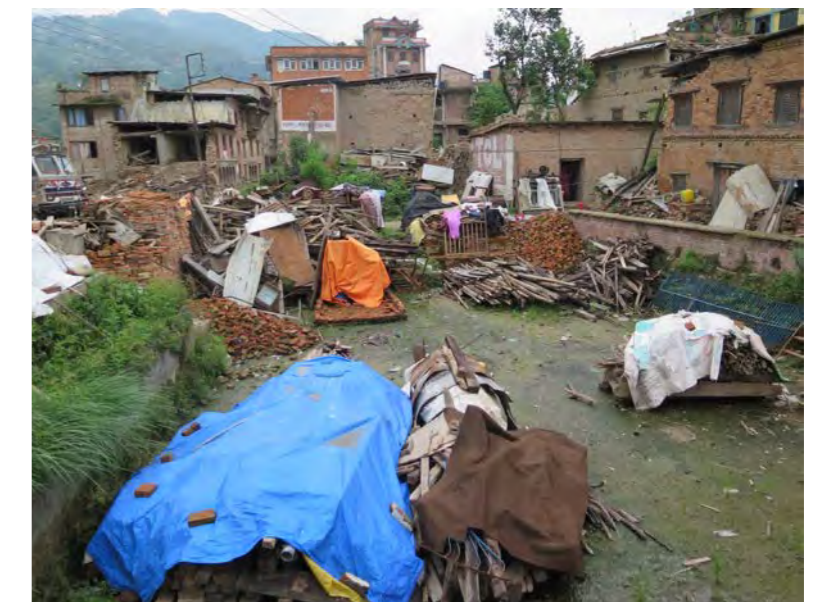
E-05 POND - PUKHULACHHI POND

NUMBER	NAME	ESTABLISHED DATE (A.D.)	TPOLOGY	GENERAL DESCRIPTION	PROBLEMS DESCRIPTION	DANGER/ DESTROY
E-05	Pukhulachi Pond			Used for bathing during Gathamuga festival.	Water drained out to place items during earthquake. Vegetation growing all around. Plinth stone of nearby pati scattered.	R

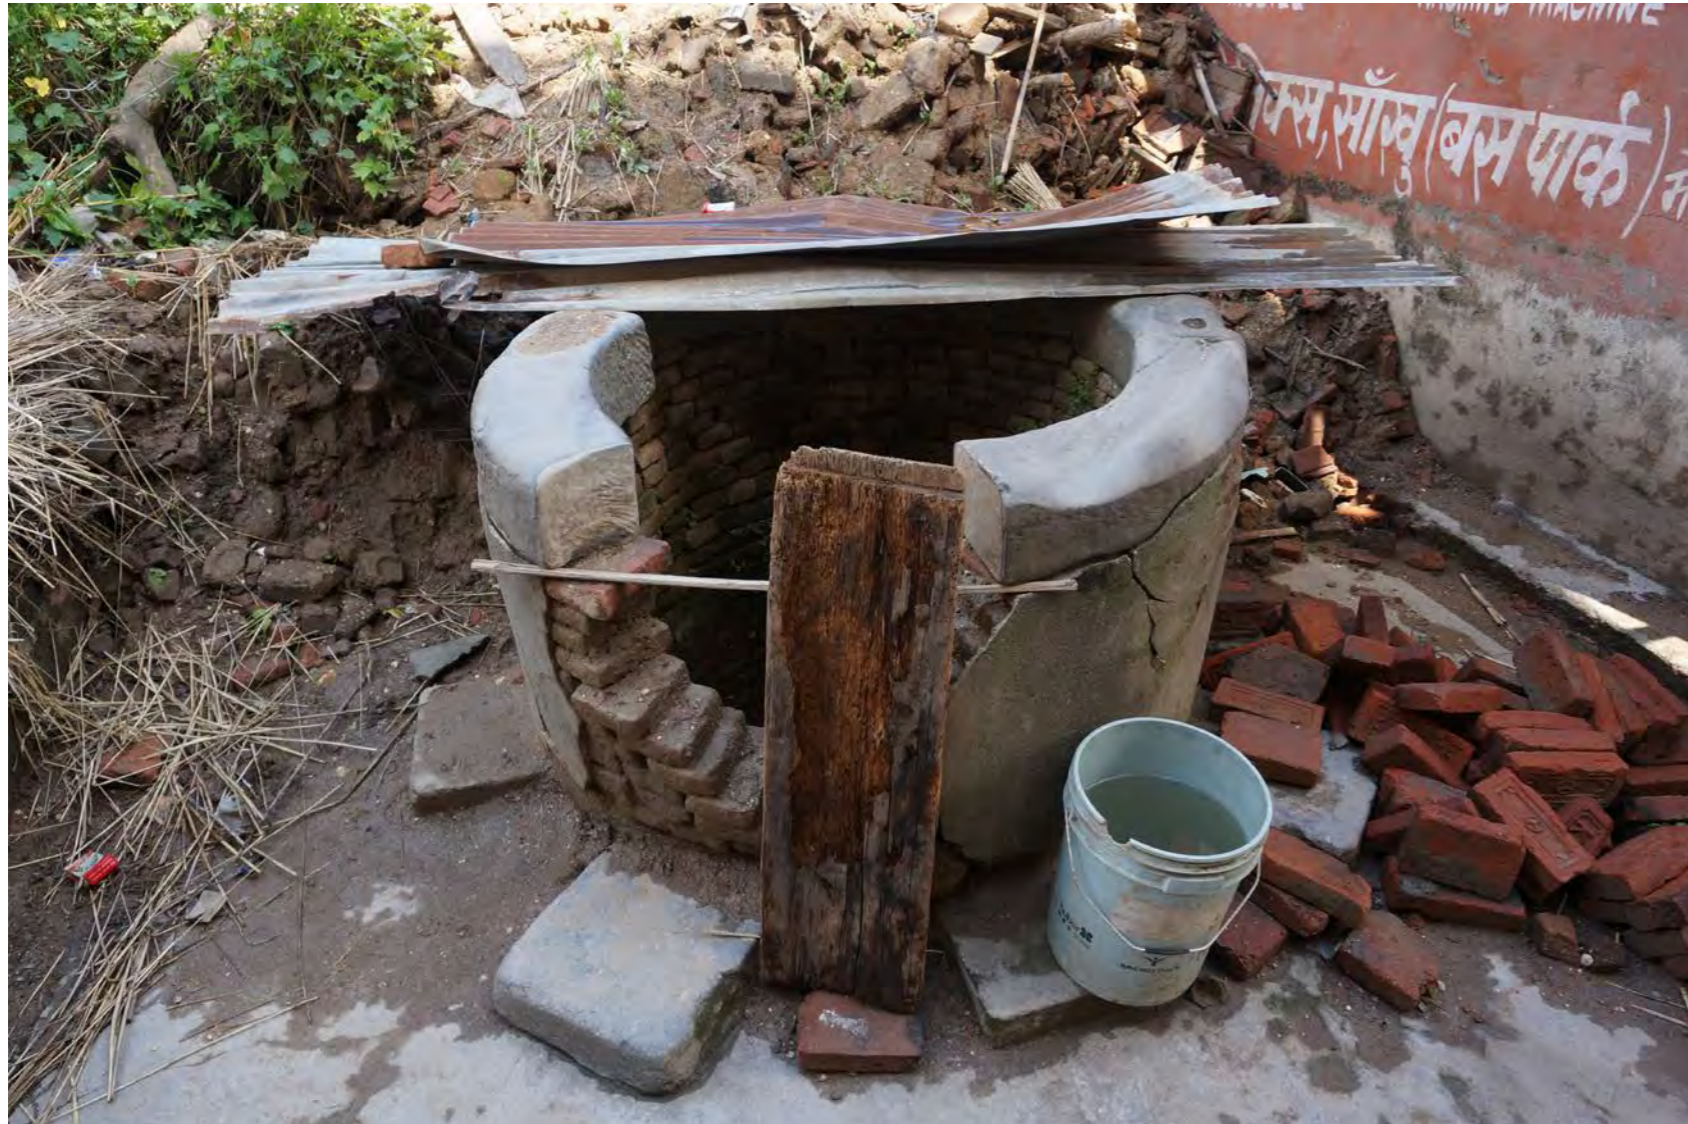
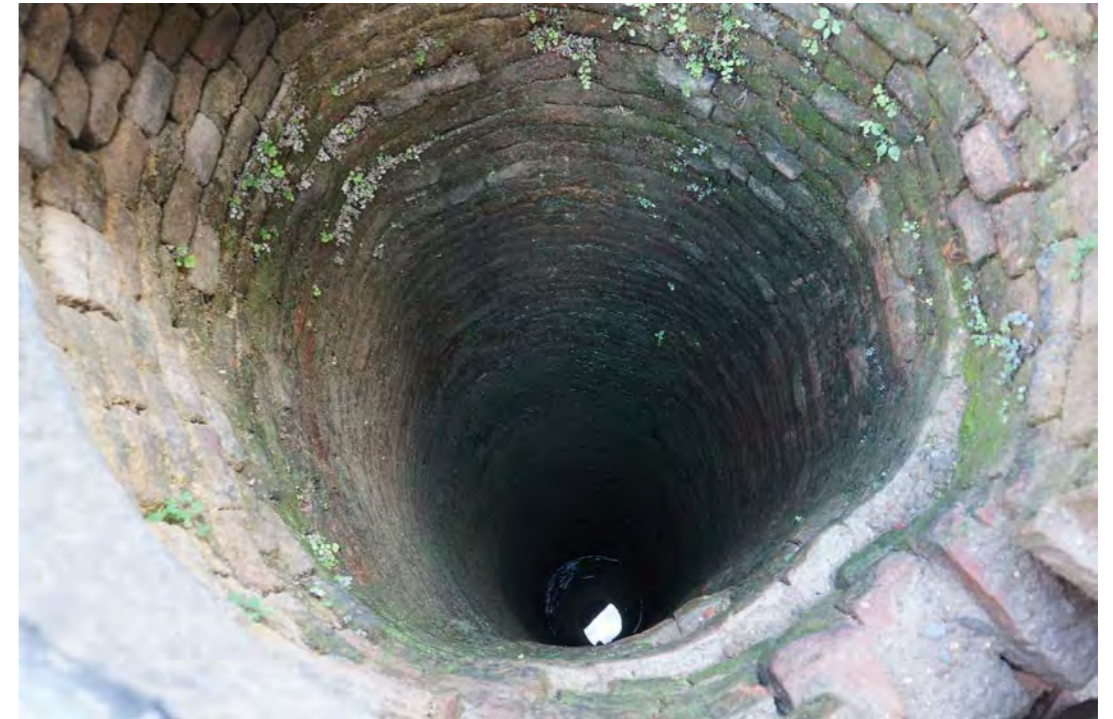
A-06 WELL

NUMBER	NAME	DATE A.D.	TPOLOGY	GENERAL DESCRIPTION	PROBLEMS DESCRIPTION	DANGER/ DESTROY
A-6			Well	Round brick well with stone blocks at outer top layer	“One stone block is missing Outer portion of brick are cracked and some portion col-lapsed”

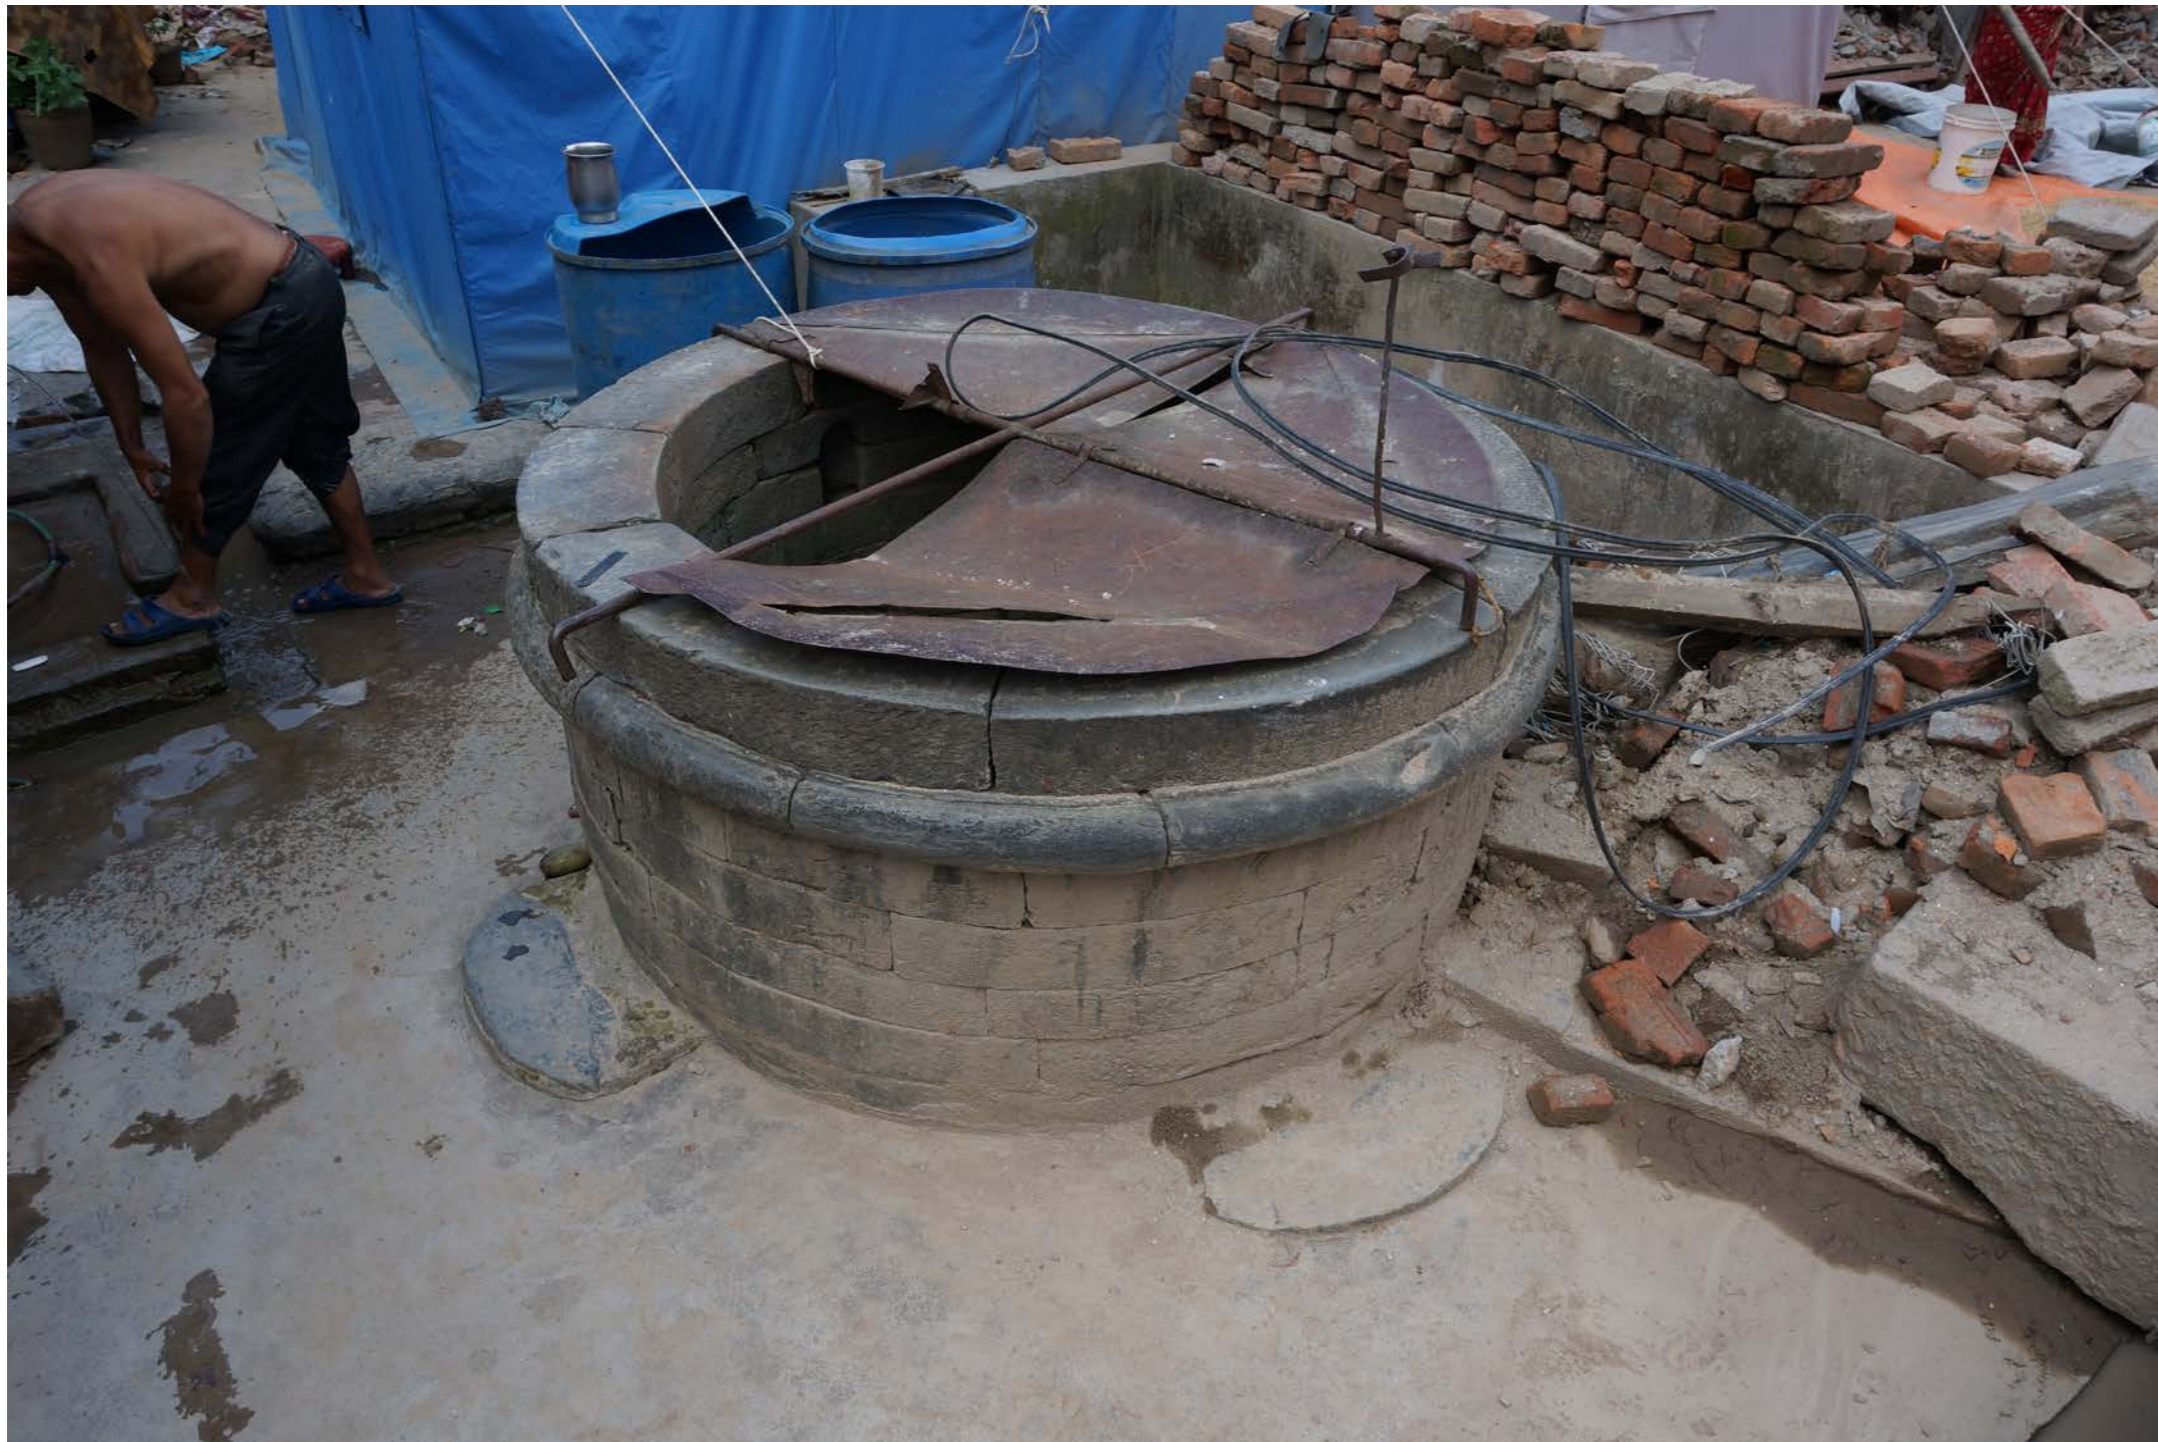
C-11 WELL

NUMBER	NAME	DATE A.D.	TYOLOGY	GENERAL DESCRIPTION	PROBLEMS DESCRIPTION	DANGER/ DESTROY
C-11			Well	Brick well with stone blocks at the outer top ring	Needs maintaiance

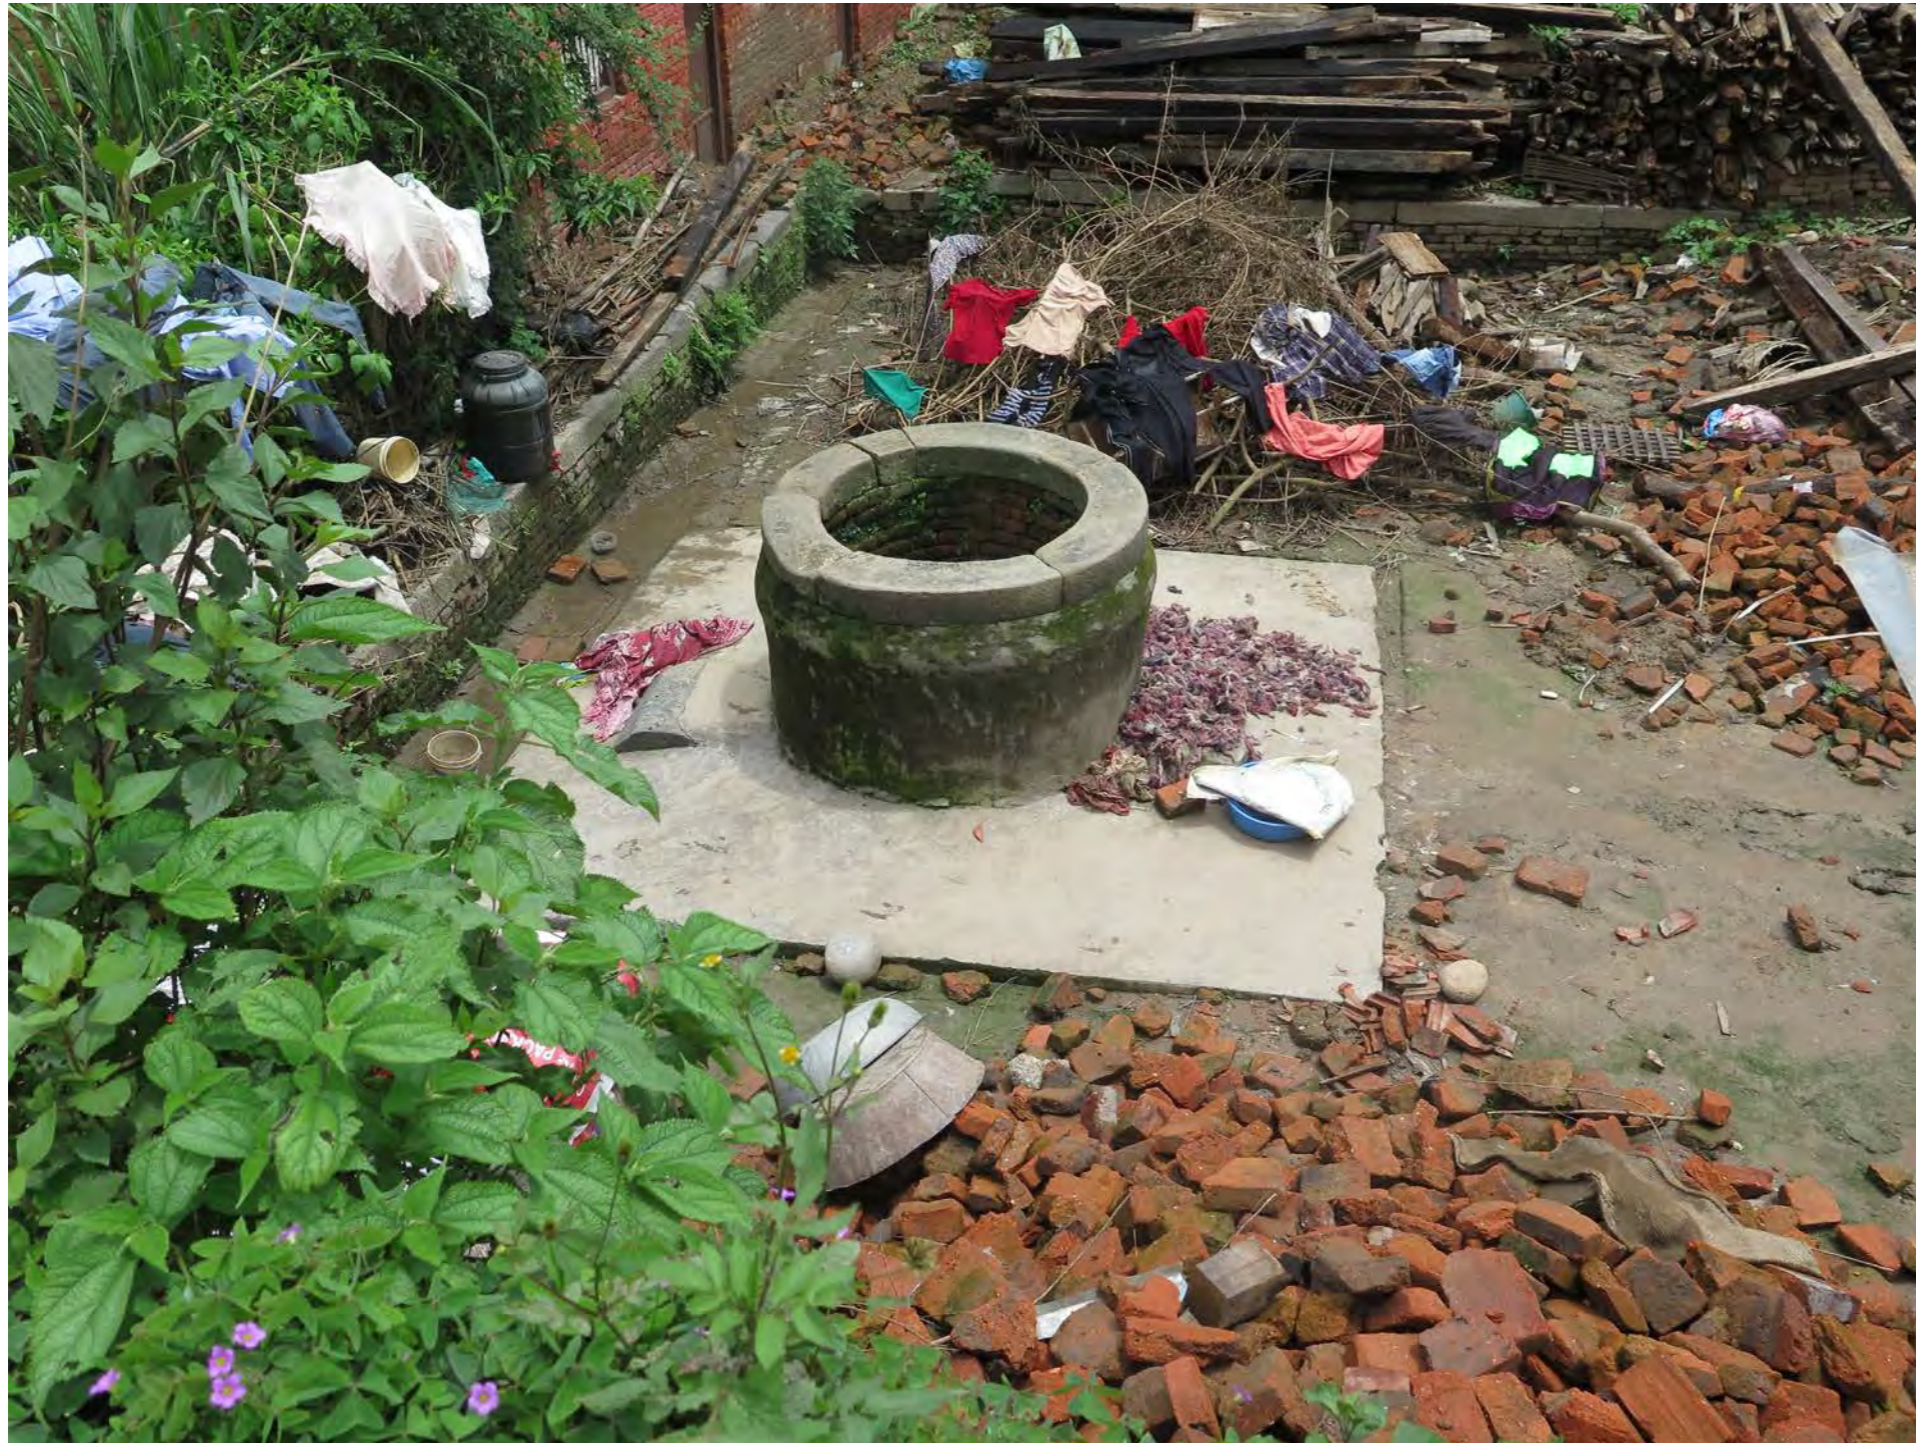
I-05 WELL

NUMBER	NAME	ESTABLISHED DATE (A.D.)	TYPOLOGY	GENERAL DESCRIPTION	PROBLEMS DESCRIPTION	DANGER/ DESTROY
I-05			Well	Brick Well with stone blocks at outer top part.	Water is present but dirty.

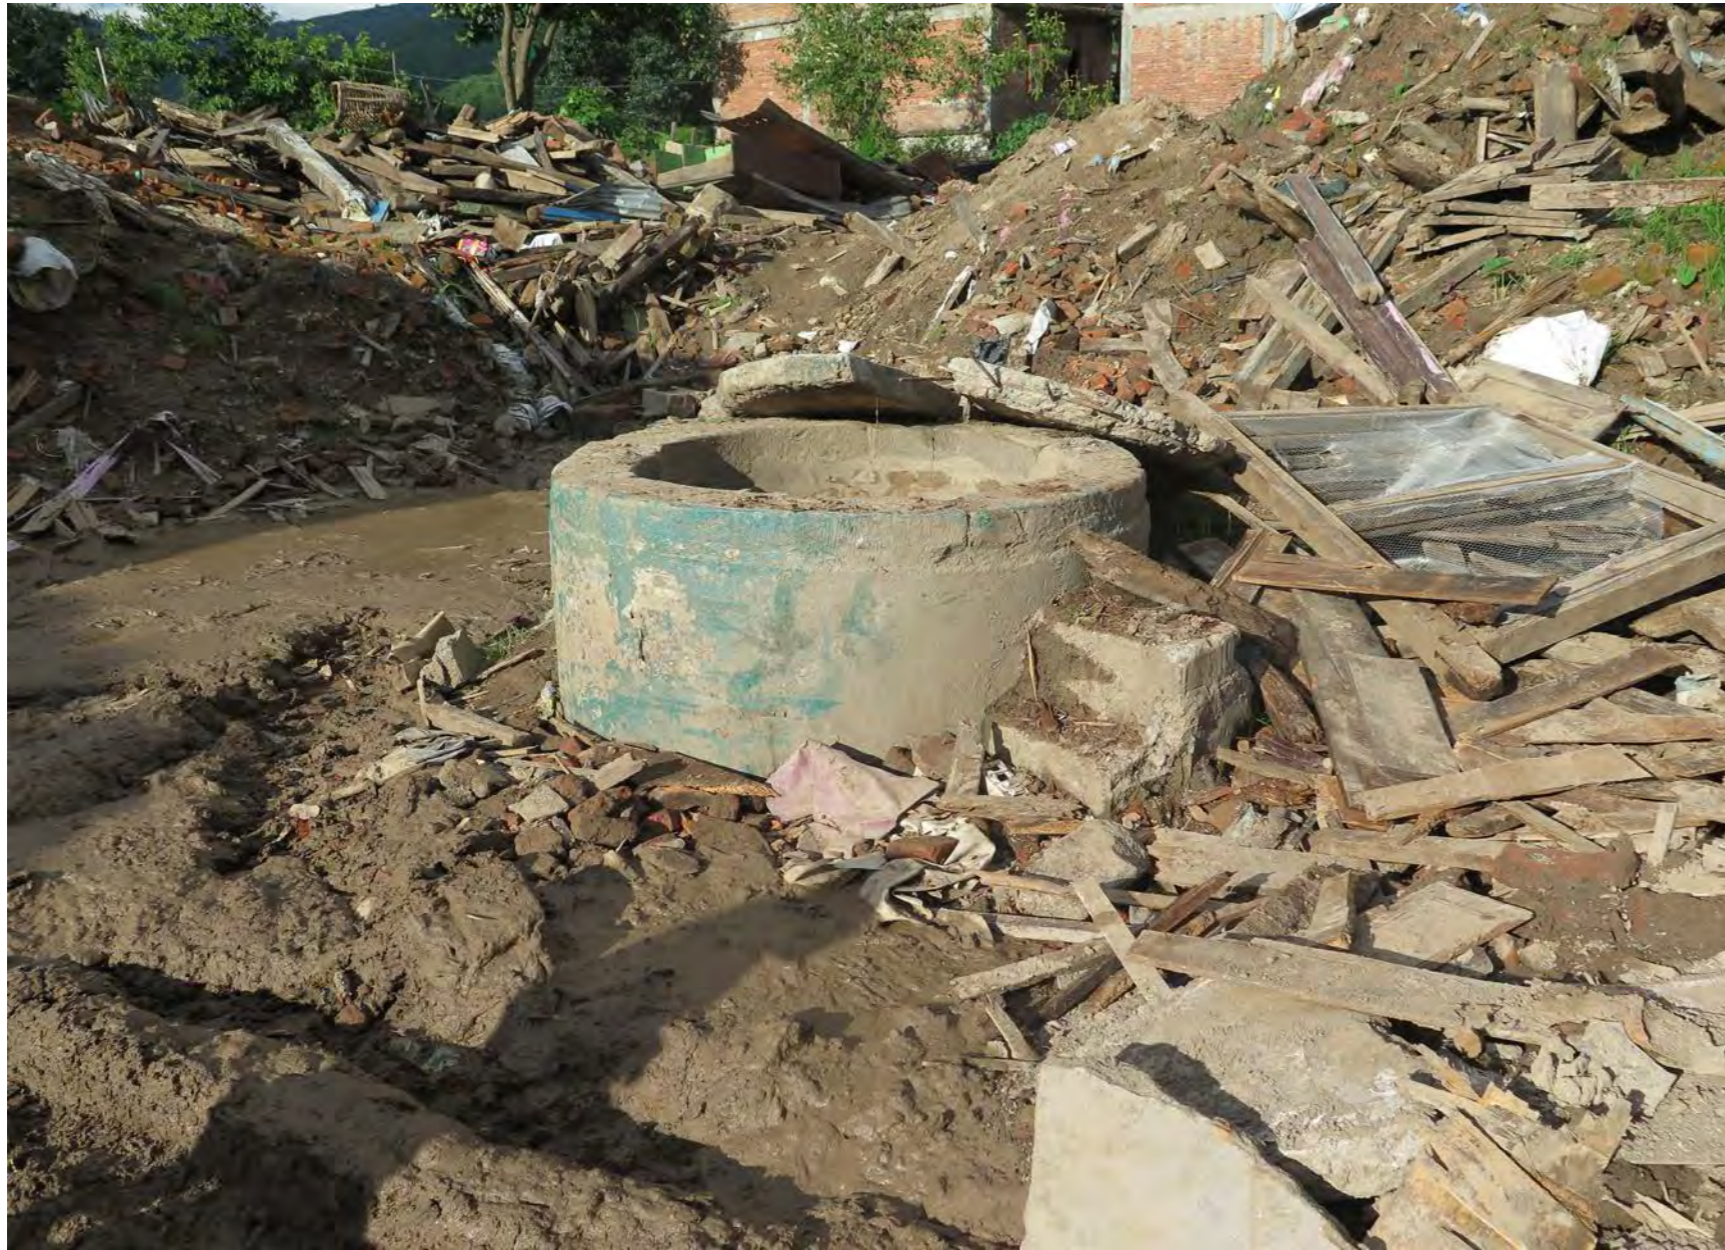
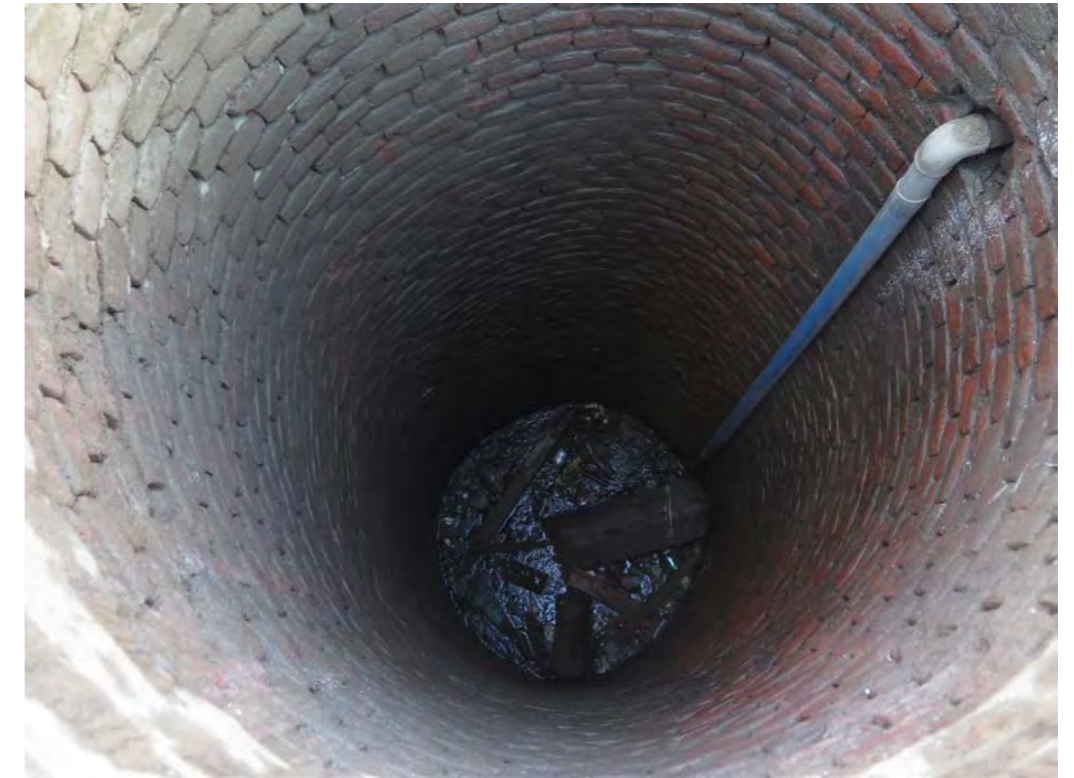
J-14 WELL

NUMBER	NAME	DATE A.D.	TPOLOGY	GENERAL DESCRIPTION	PROBLEMS DESCRIPTION	DANGER/ DESTROY
J-14			Well		Filled with dirt and rubbles.

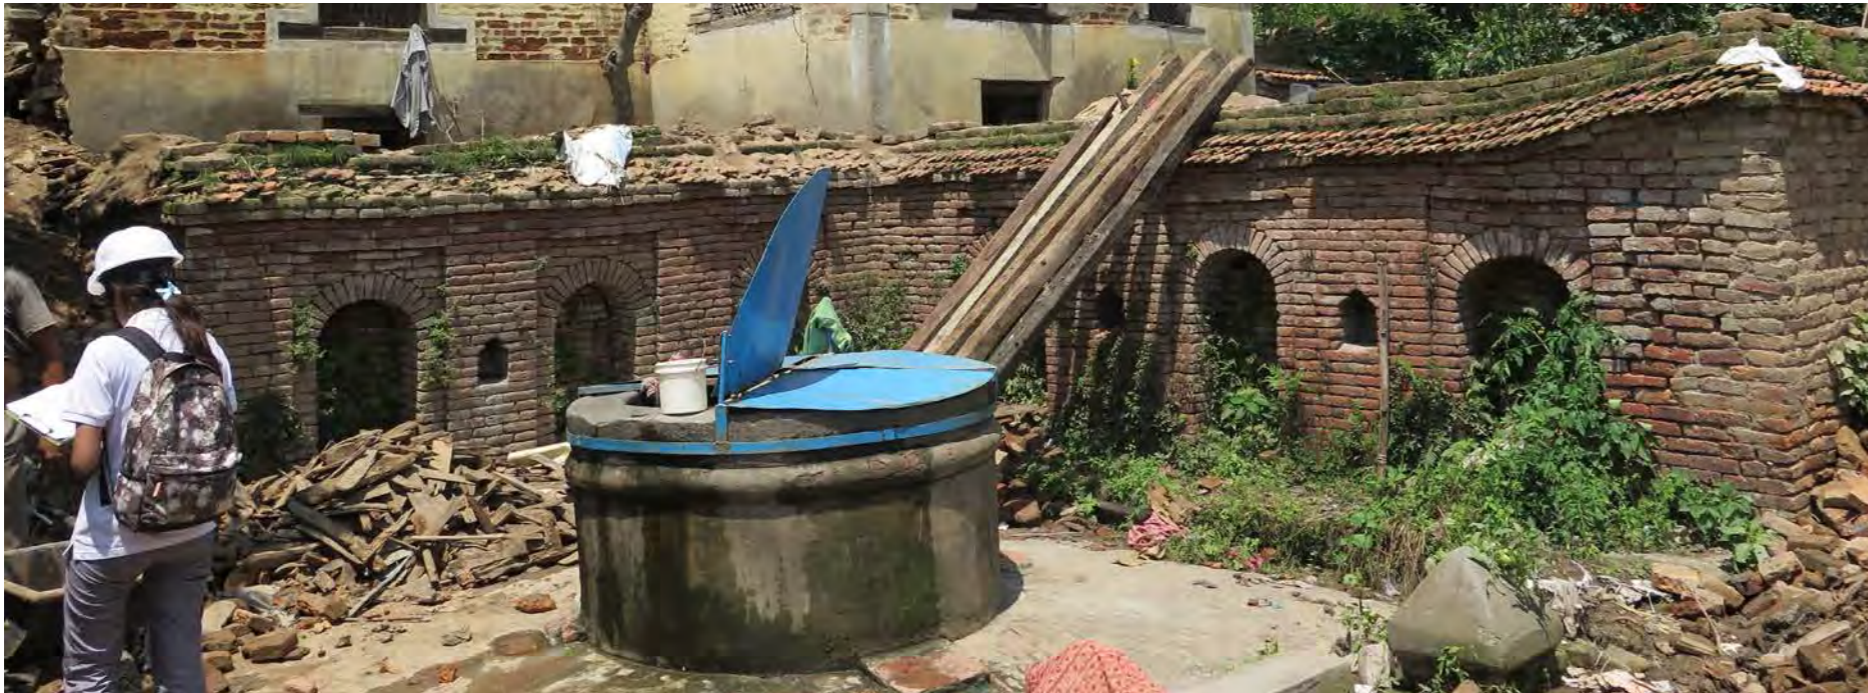
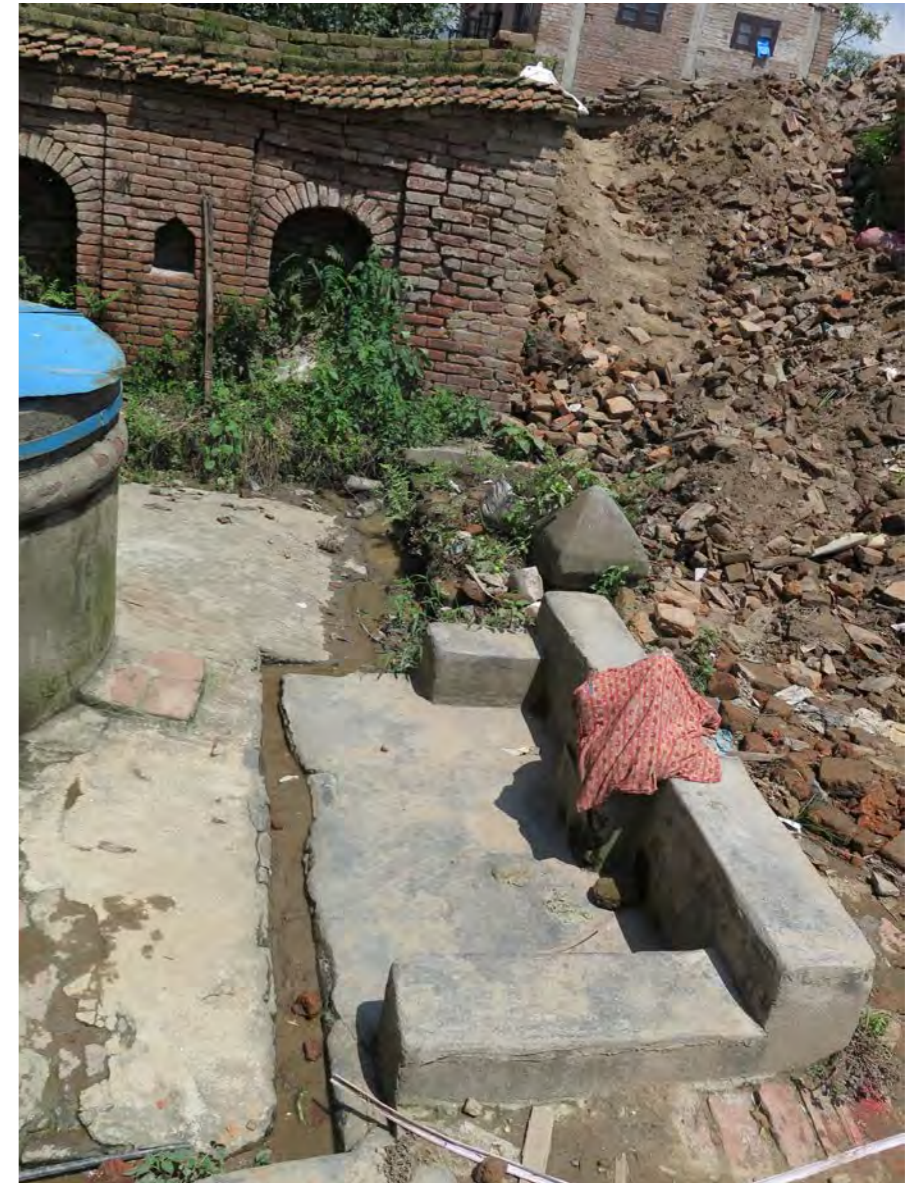
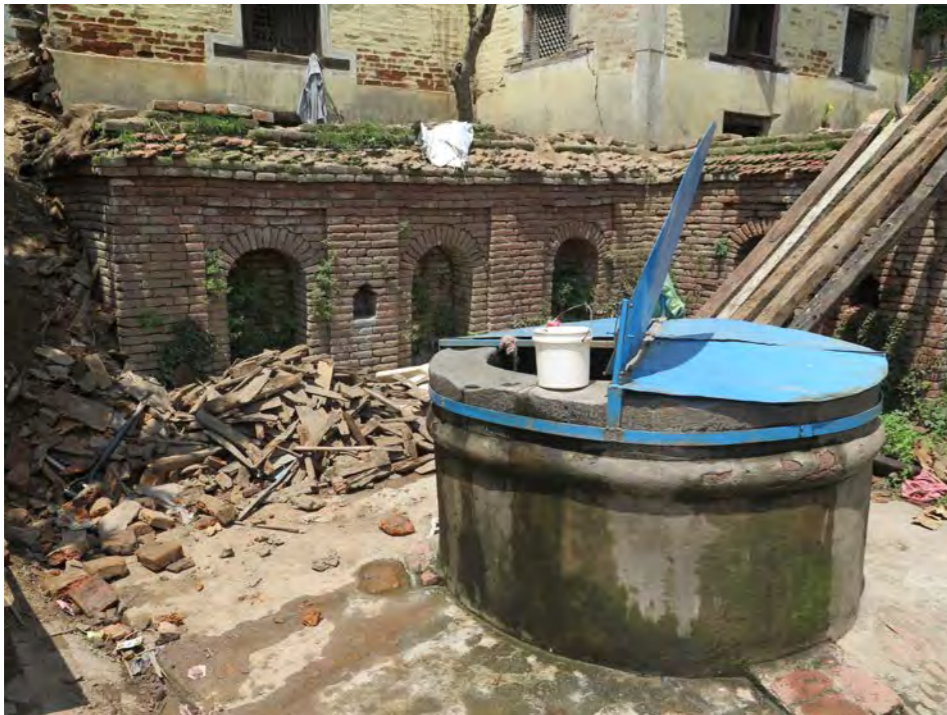
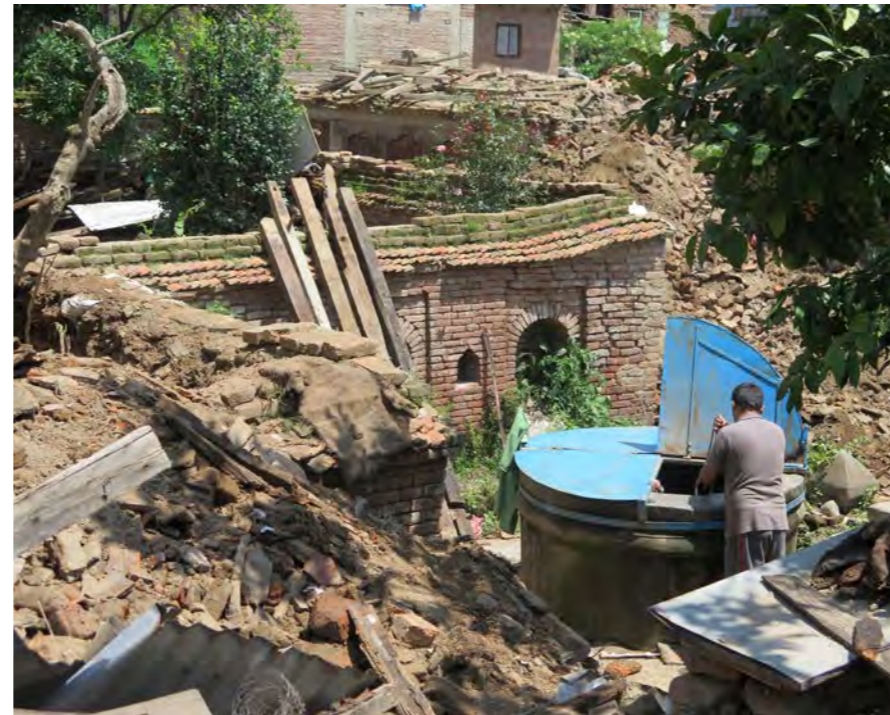
I-15 HITI

NUMBER	NAME	ESTABLISHED DATE (A.D.)	TYPOLOGY	GENERAL DESCRIPTION	PROBLEMS DESCRIPTION	DANGER/ DESTROY	
I-15			Hiti		In running condition. Brick offset on west wall upper part

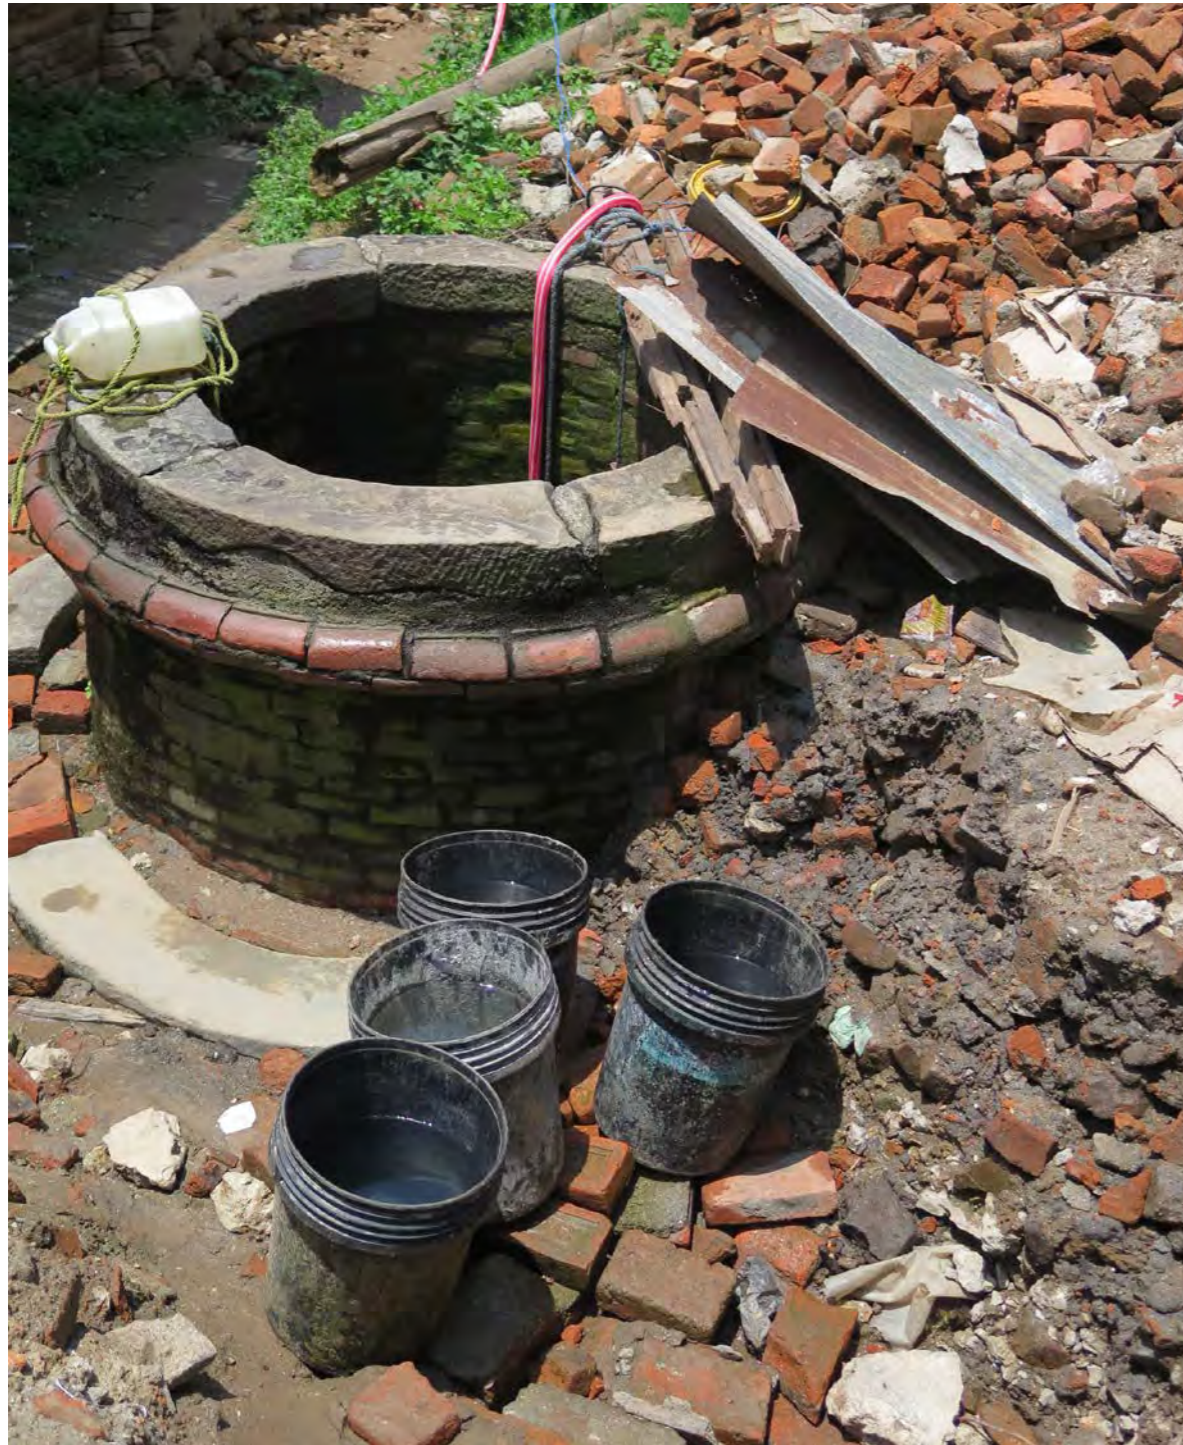
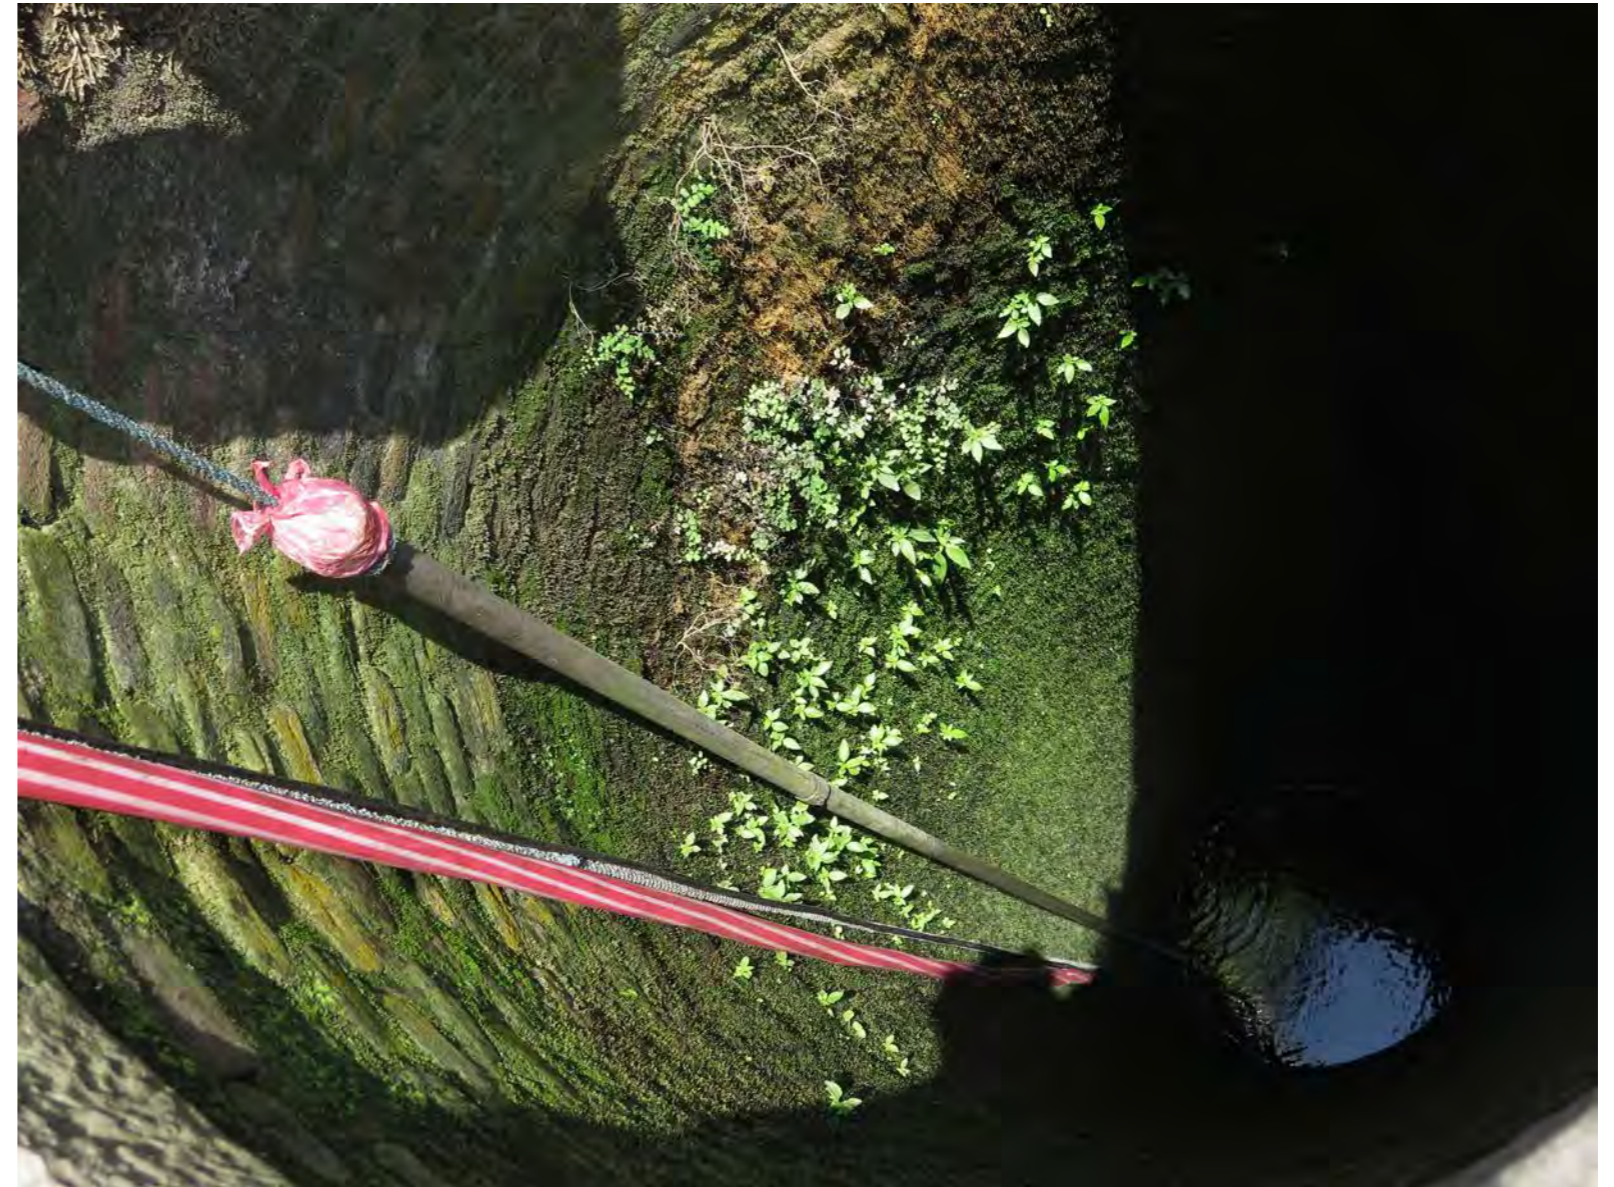
D-02 WELL

NUMBER	NAME	DATE A.D.	TYOLOGY	GENERAL DESCRIPTION	PROBLEMS DESCRIPTION	DANGER/ DESTROY
D-02			Well	Brick Well with stone blocks at outer top part.	In good condition
