2015 Earthquake Damage Mapping

Sankhu

October 2015

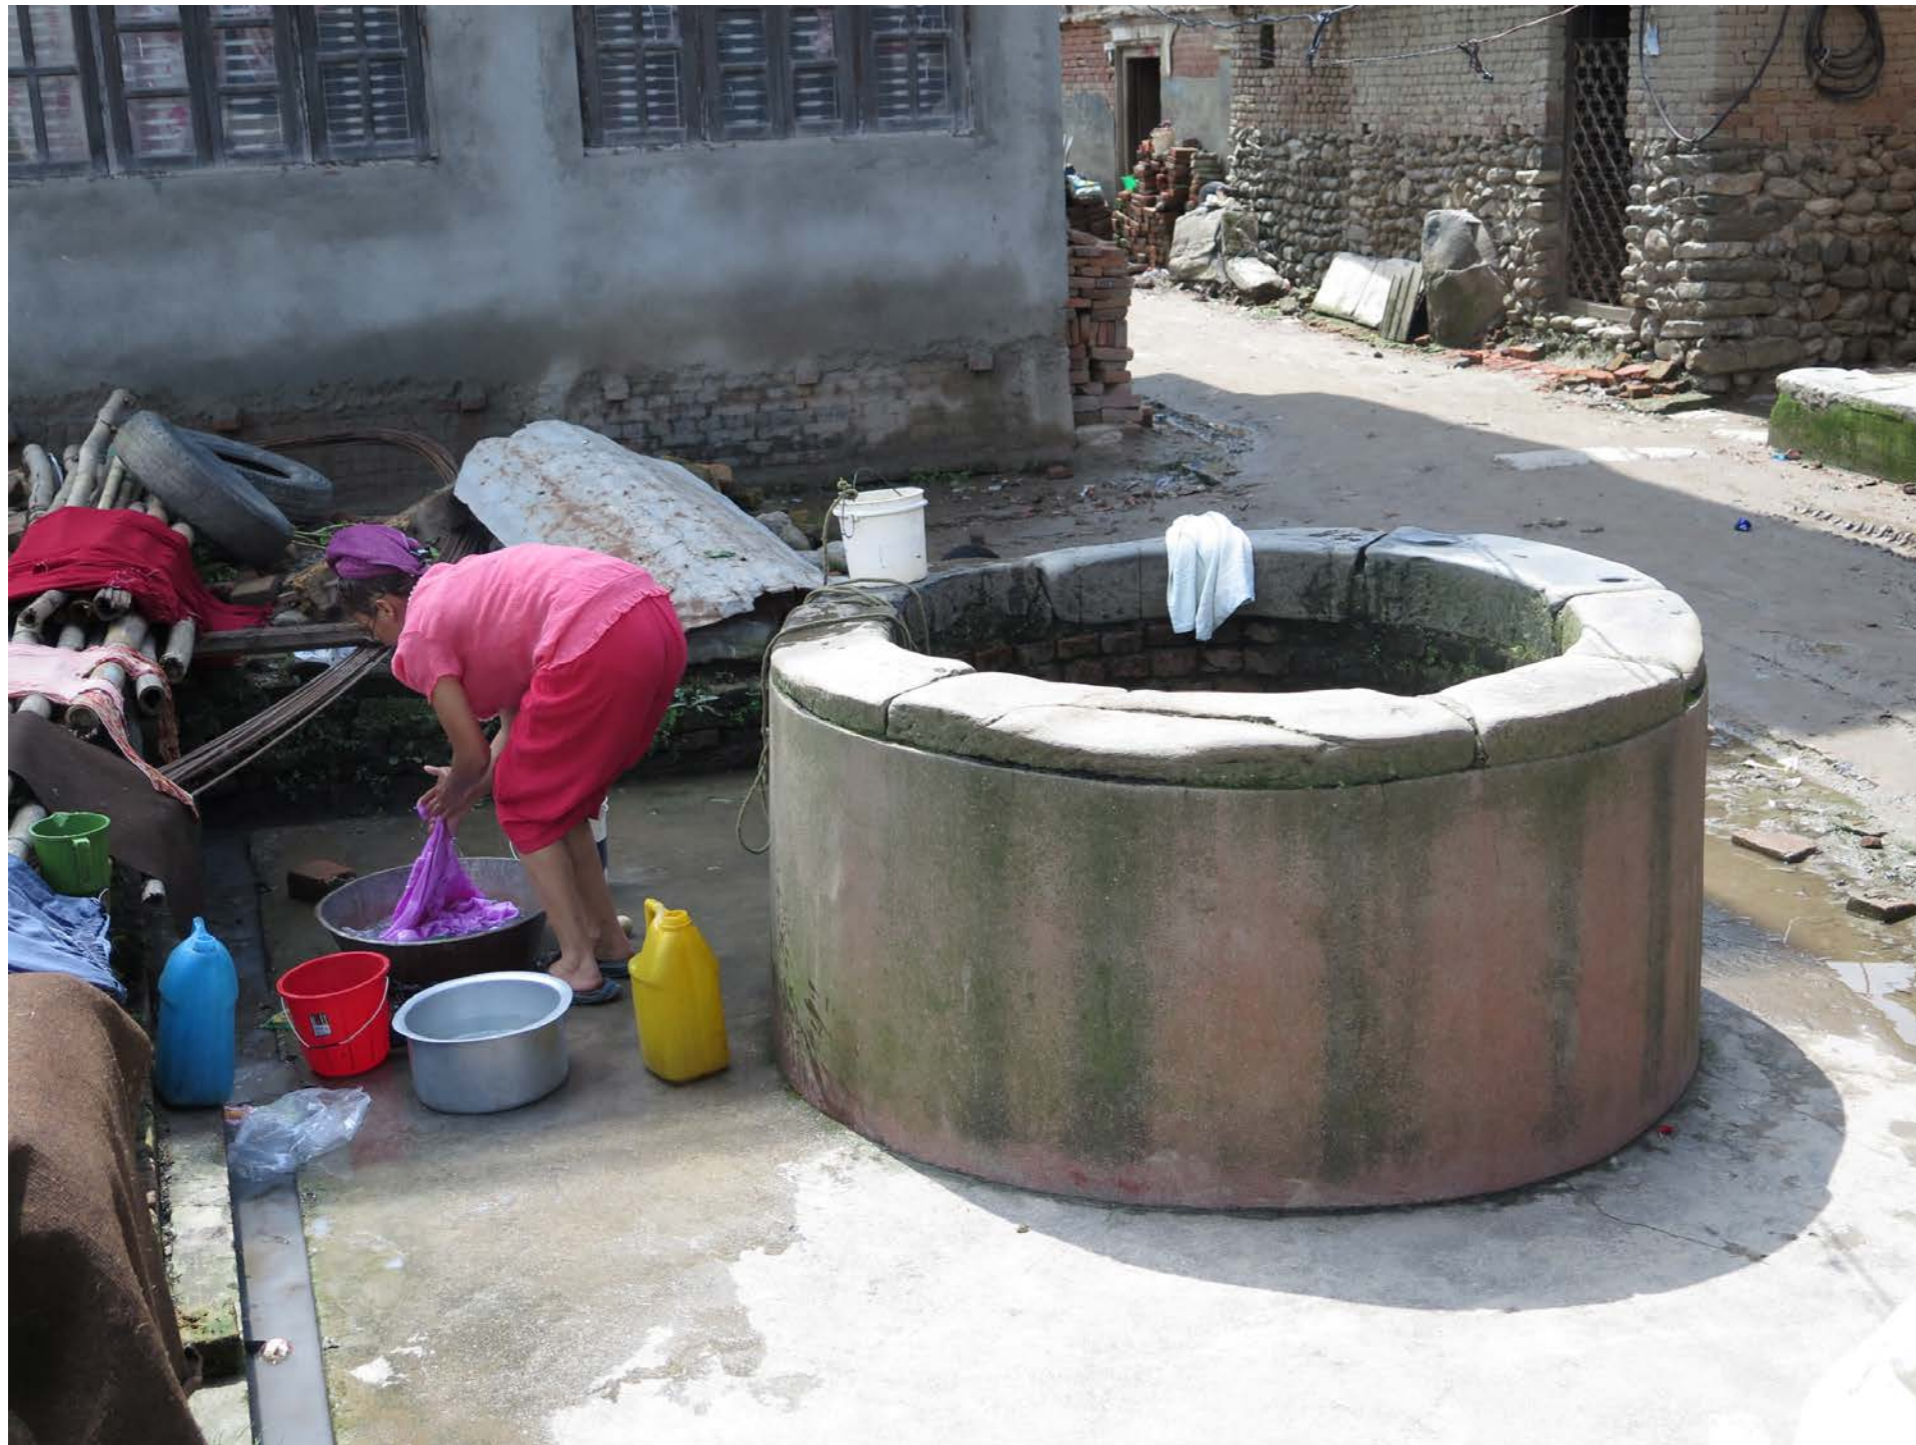
E-01 POND

NUMBER	NAME	ESTABLISHED DATE (A.D.)	TYPOLOGY	GENERAL DESCRIPTION	PROBLEMS DESCRIPTION	DANGER/ DESTROY
E-01			Well	Brick Well with stone blocks at outer top part.	Well functioning

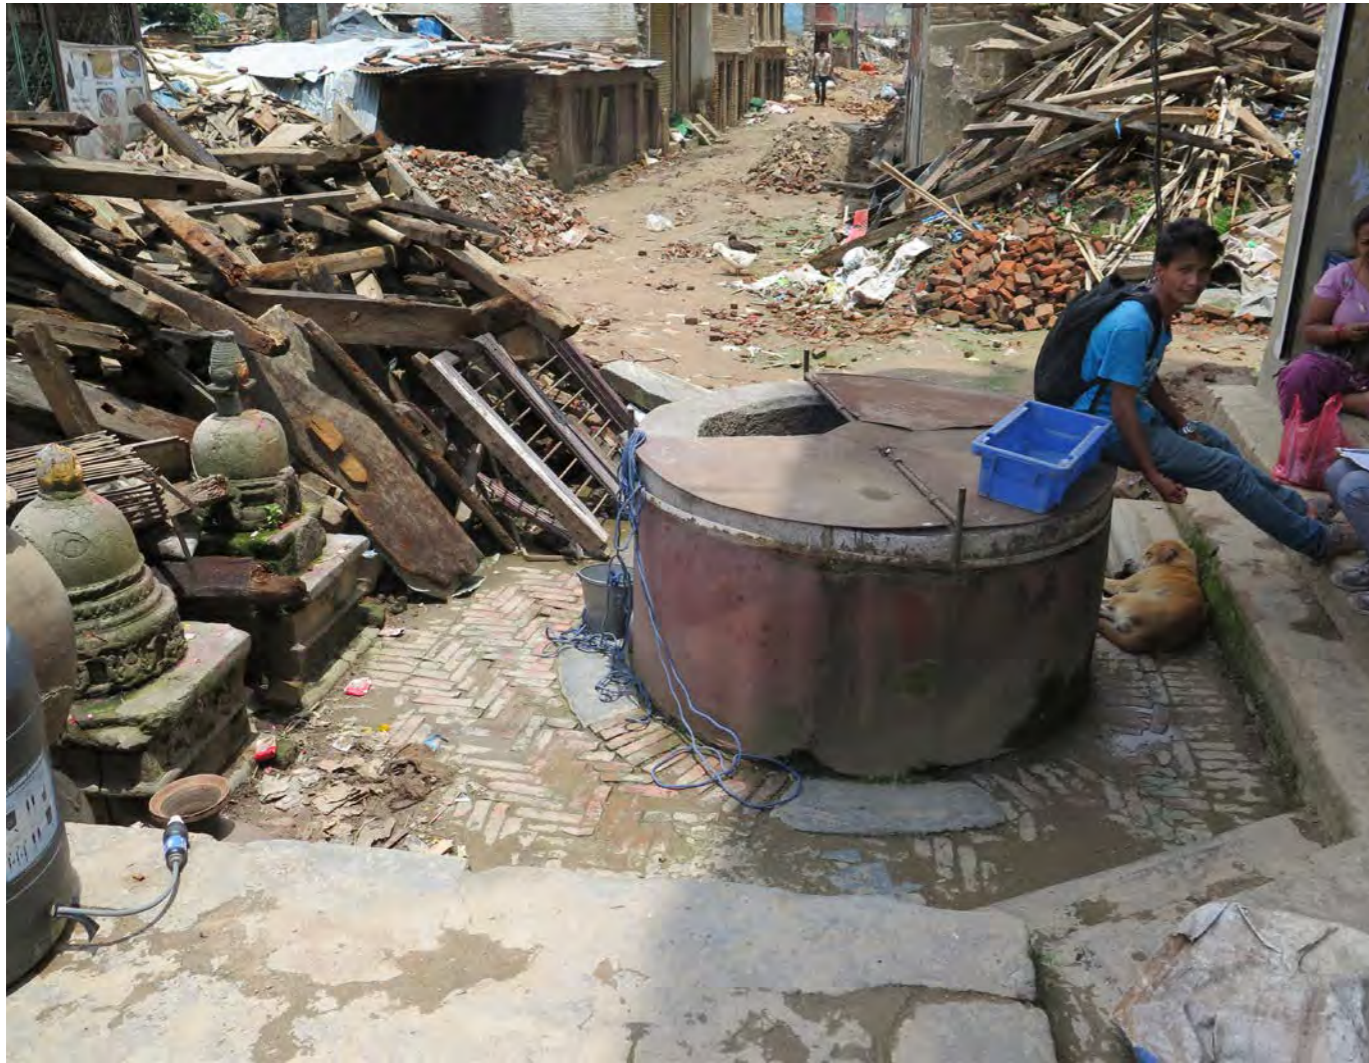
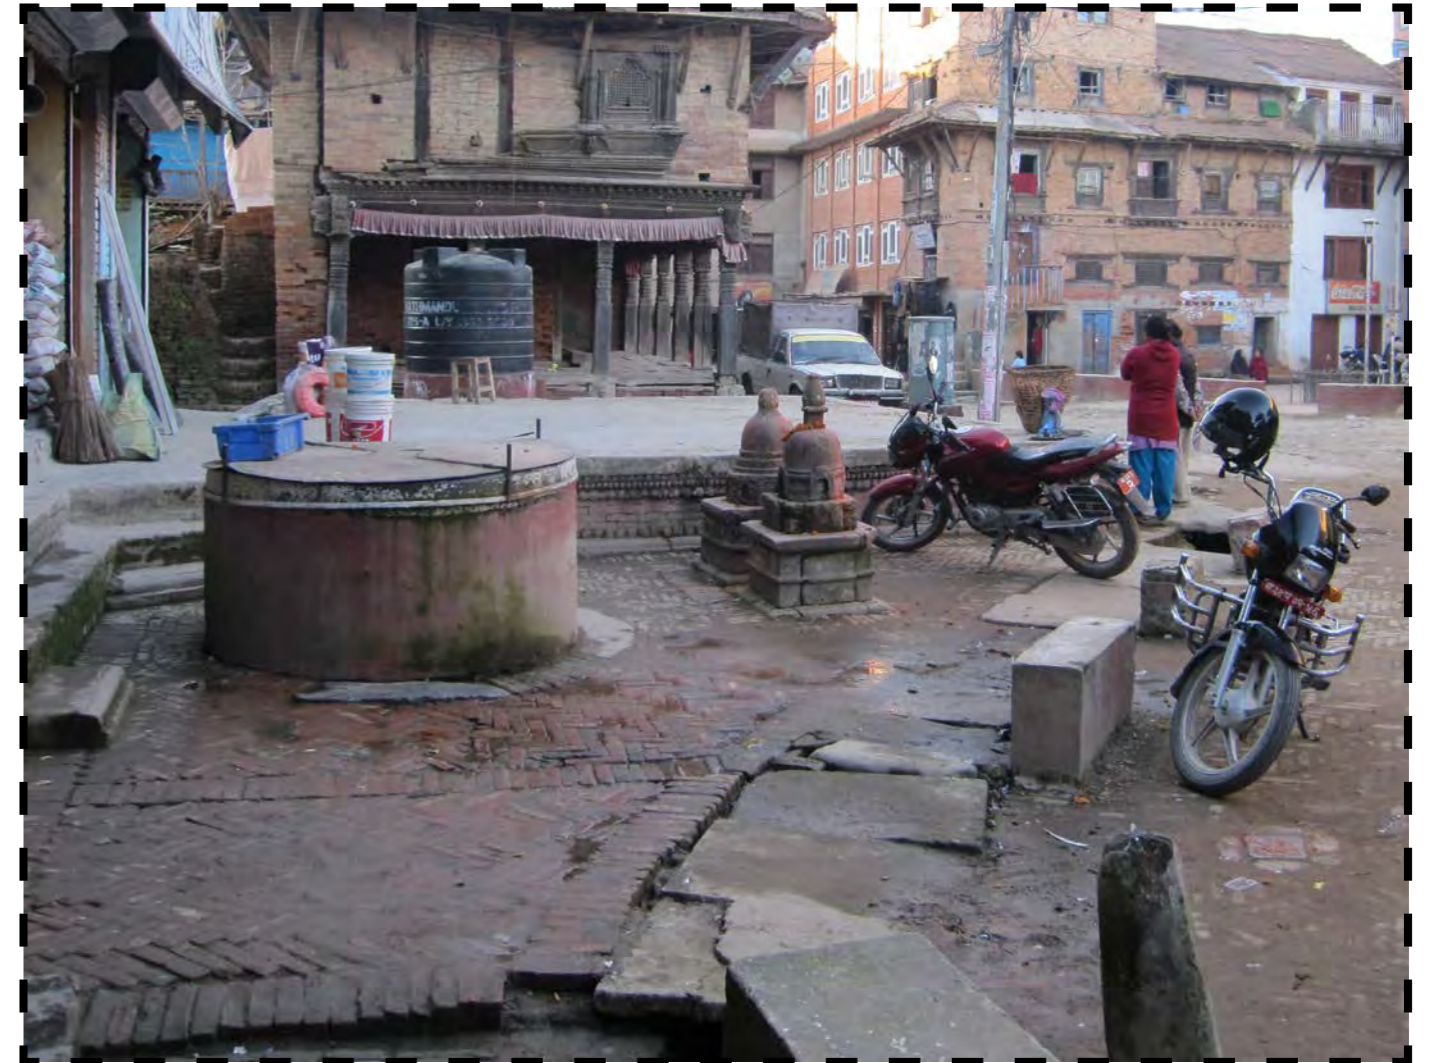
E-10 WELL

NUMBER	NAME	DATE A.D.	TYOLOGY	GENERAL DESCRIPTION	PROBLEMS DESCRIPTION	DANGER/ DESTROY	
E-10			Well	Brick Well with stone blocks at outer top part.	Well functioning

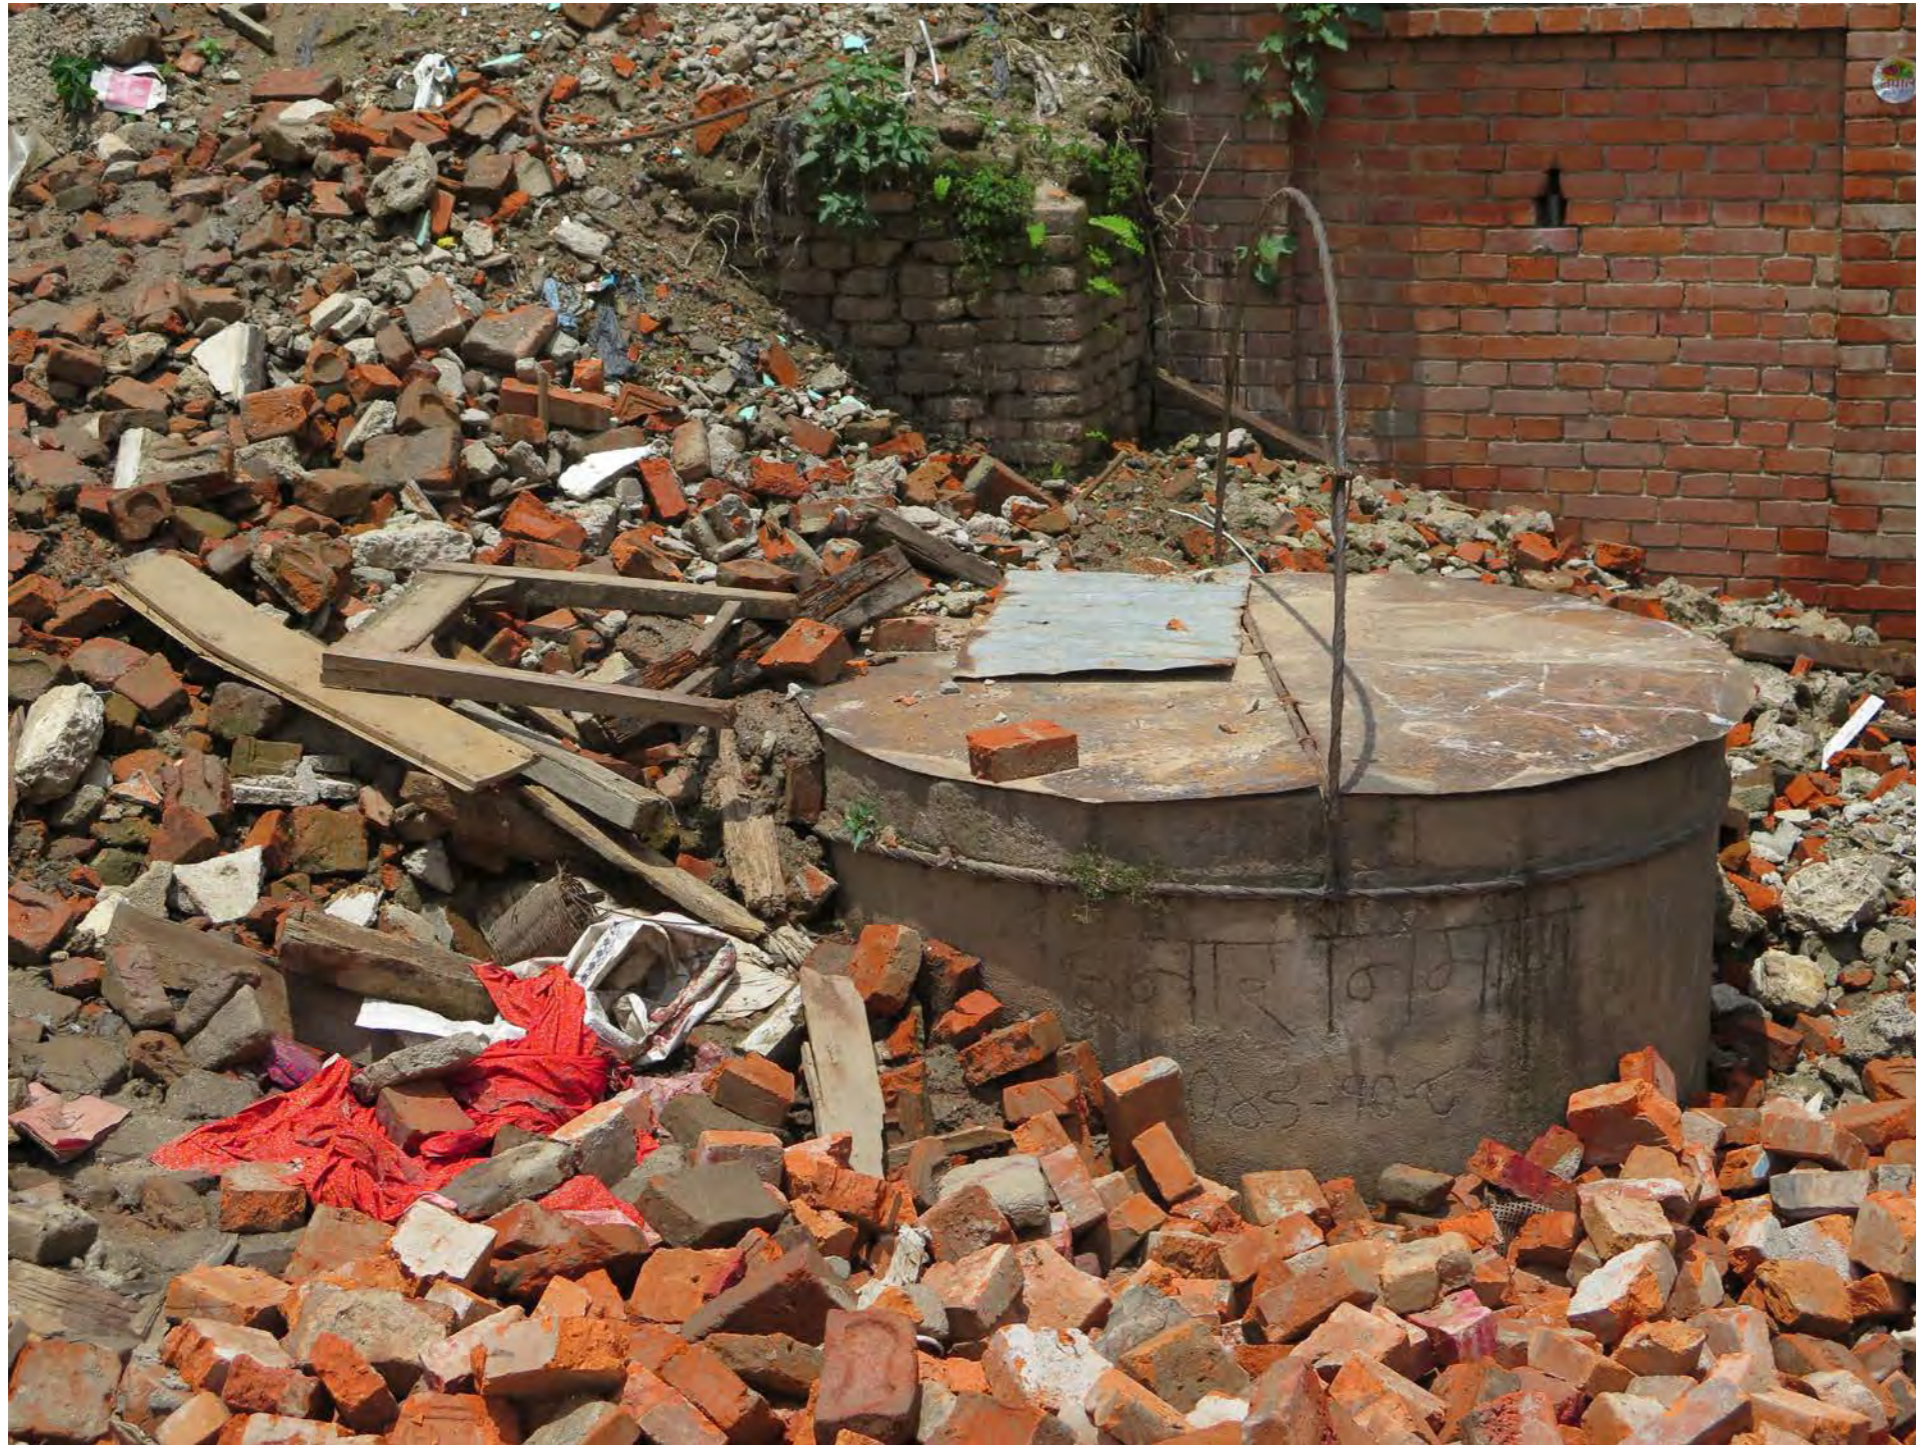
E-14 WELL

NUMBER	NAME	ESTABLISHED DATE (A.D.)	TYPOLOGY	GENERAL DESCRIPTION	PROBLEMS DESCRIPTION	DANGER/ DESTROY
E-14			Well	Brick Well with stone blocks at outer top part.	Well functioning

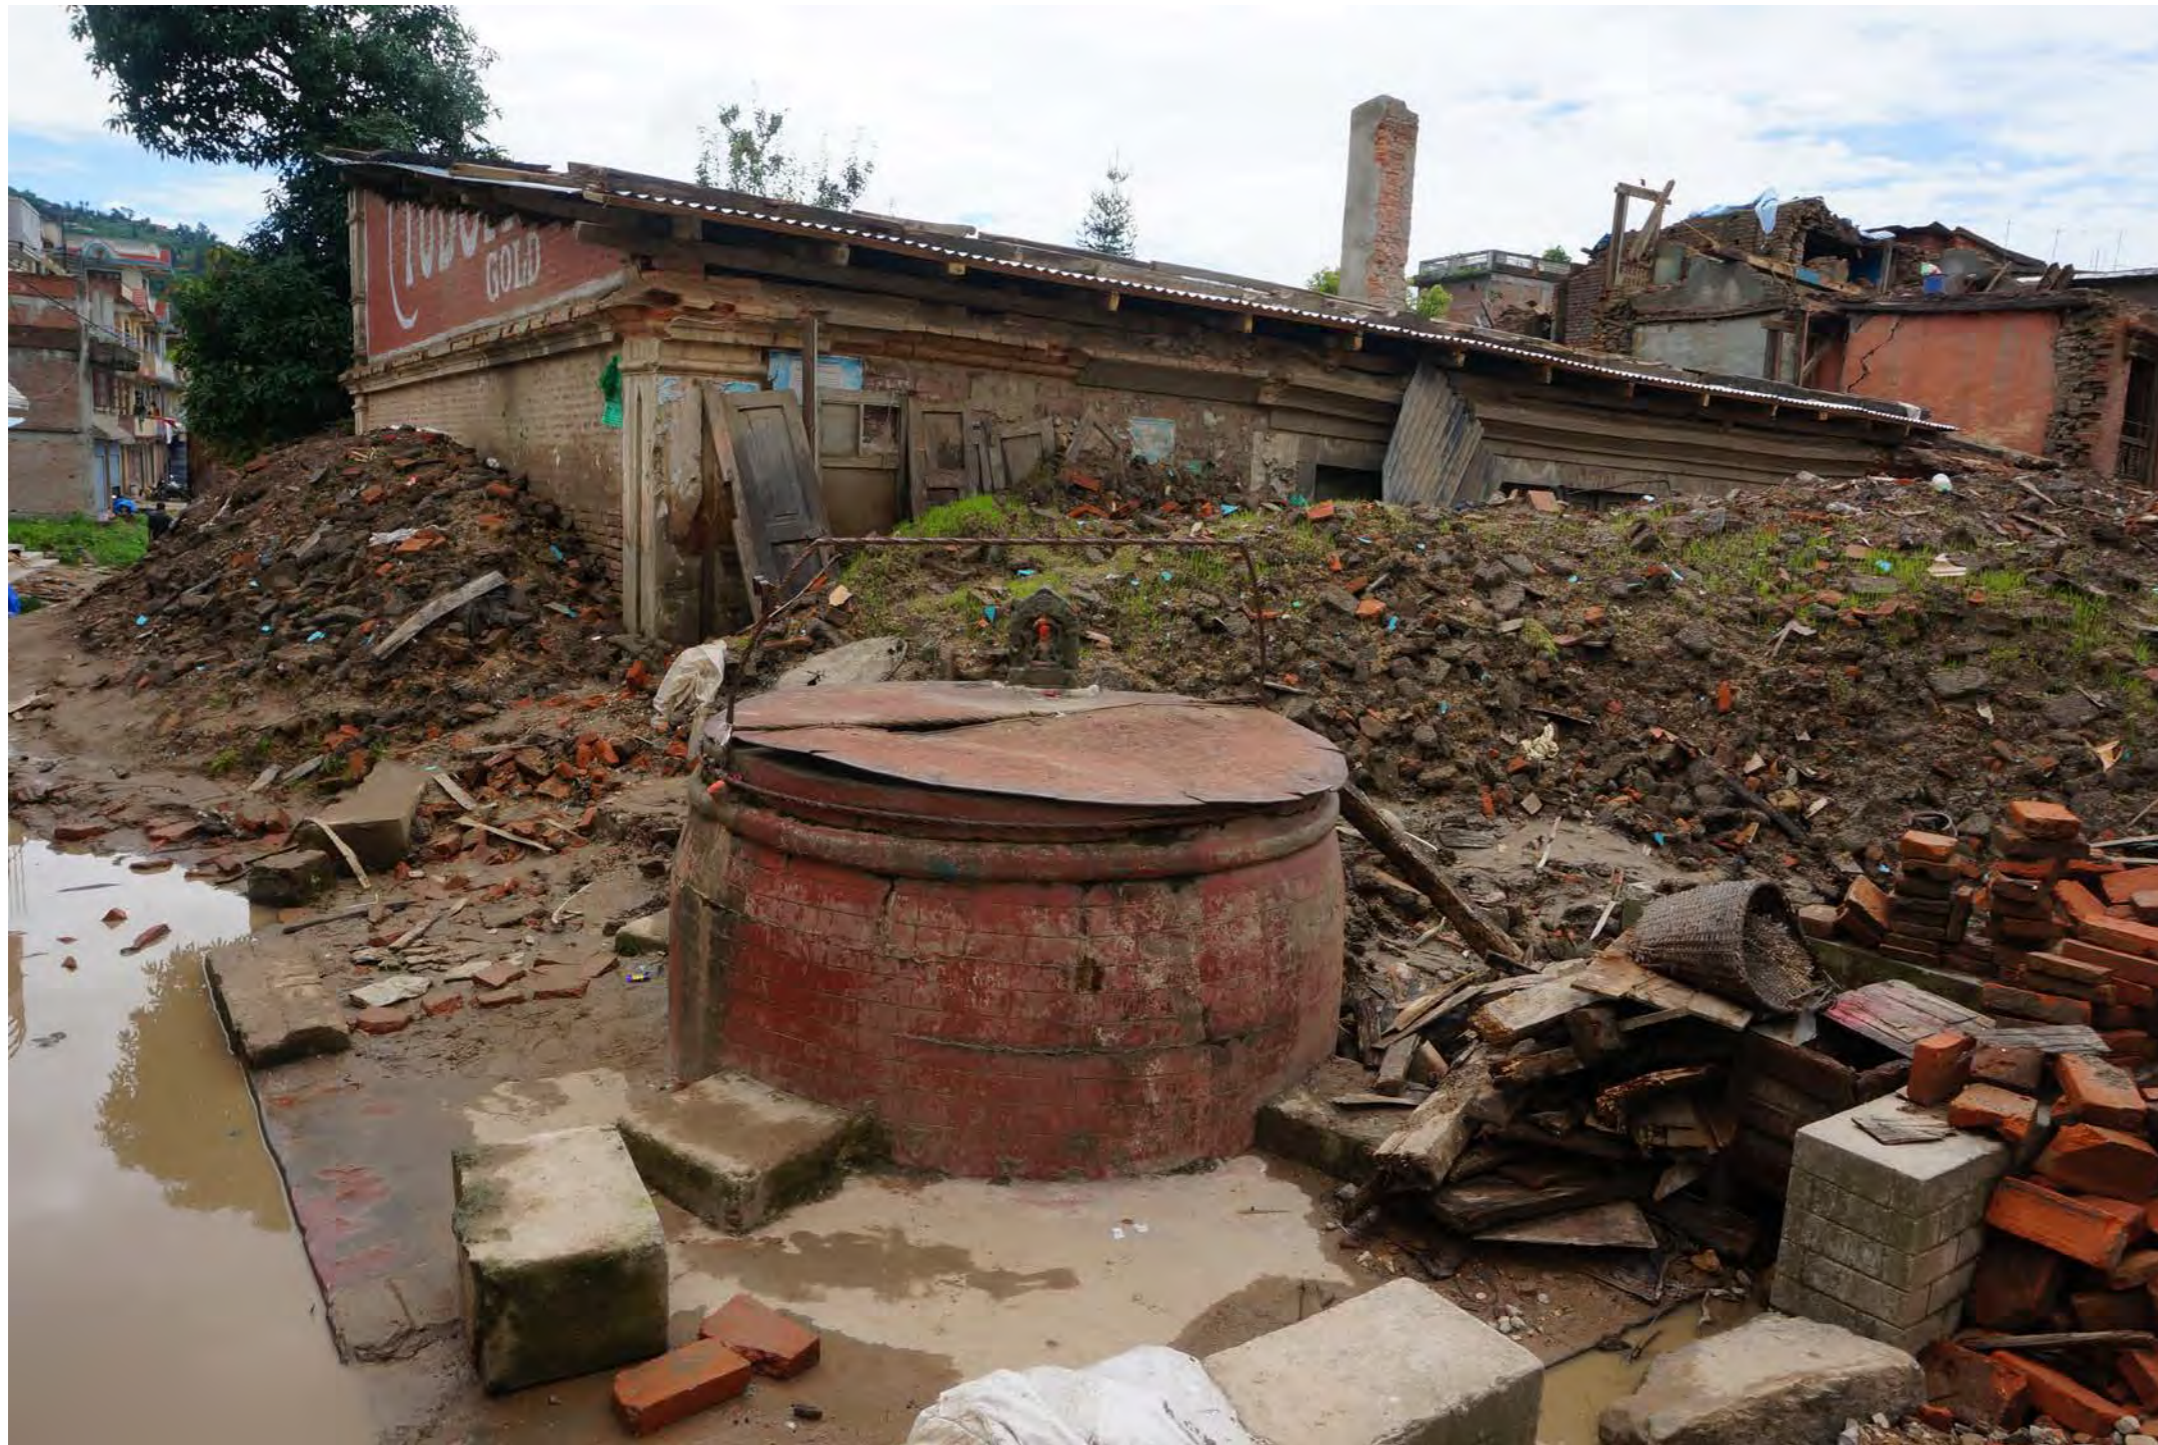
G-02 WELL

NUMBER	NAME	DATE A.D.	TYOLOGY	GENERAL DESCRIPTION	PROBLEMS DESCRIPTION	DANGER/ DESTROY
G-2			Well	Brick well with stone blocks at the outer top ring Covered with iron sheet	Good Condition

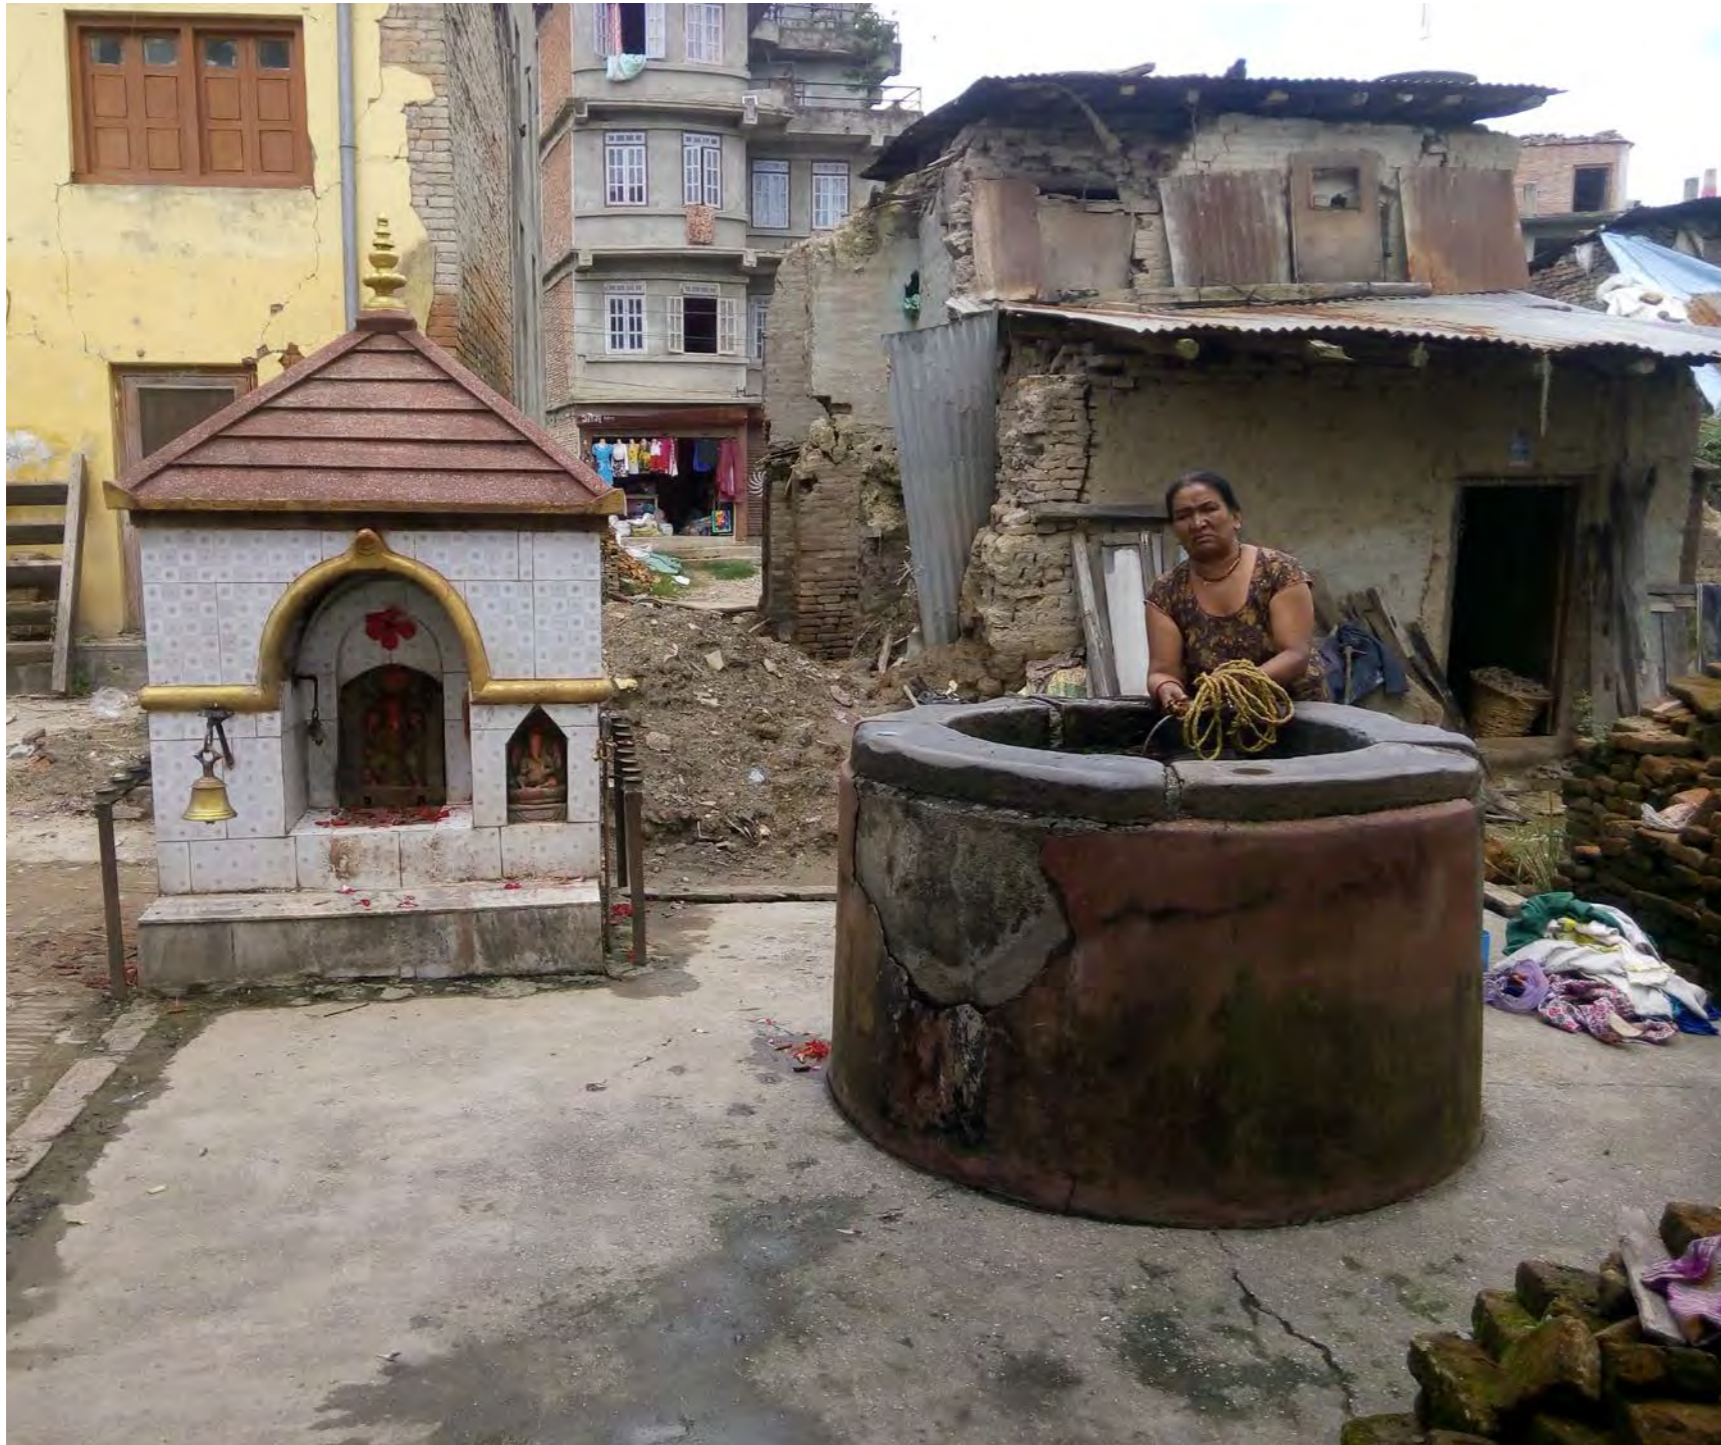
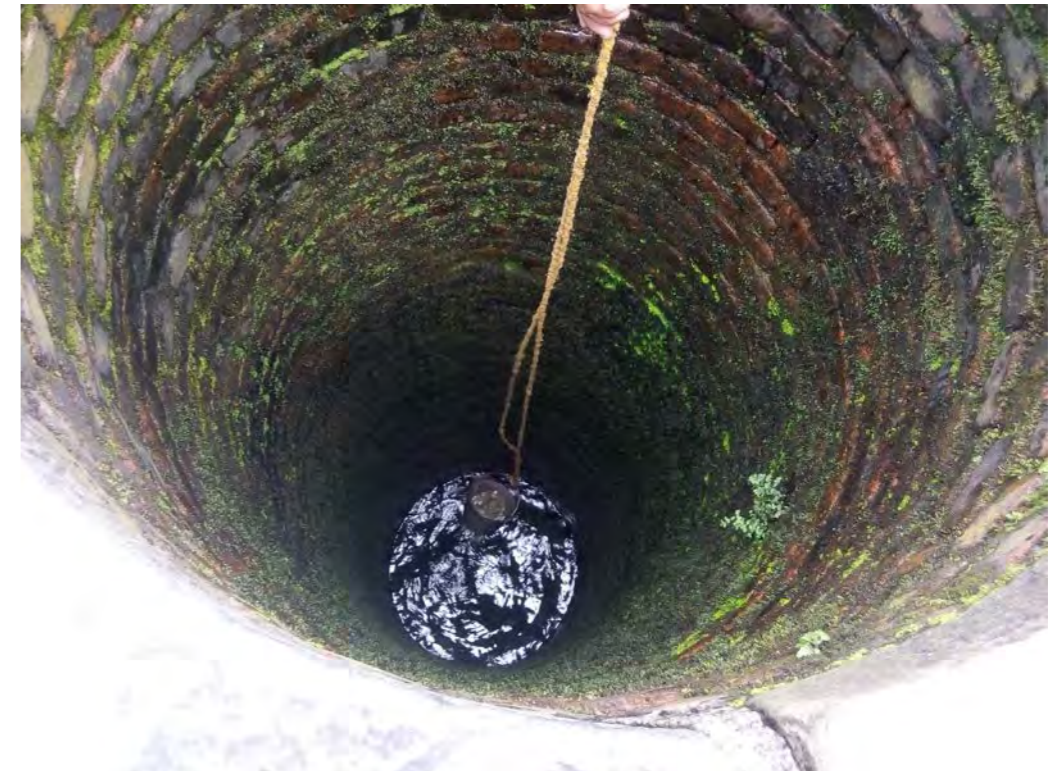
H-07 WELL

NUMBER	NAME	ESTABLISHED DATE (A.D.)	TYPOLOGY	GENERAL DESCRIPTION	PROBLEMS DESCRIPTION	DANGER/ DESTROY
H-7			Well	Well made of brick with stone blocks at outer top ring	Needs maintaince

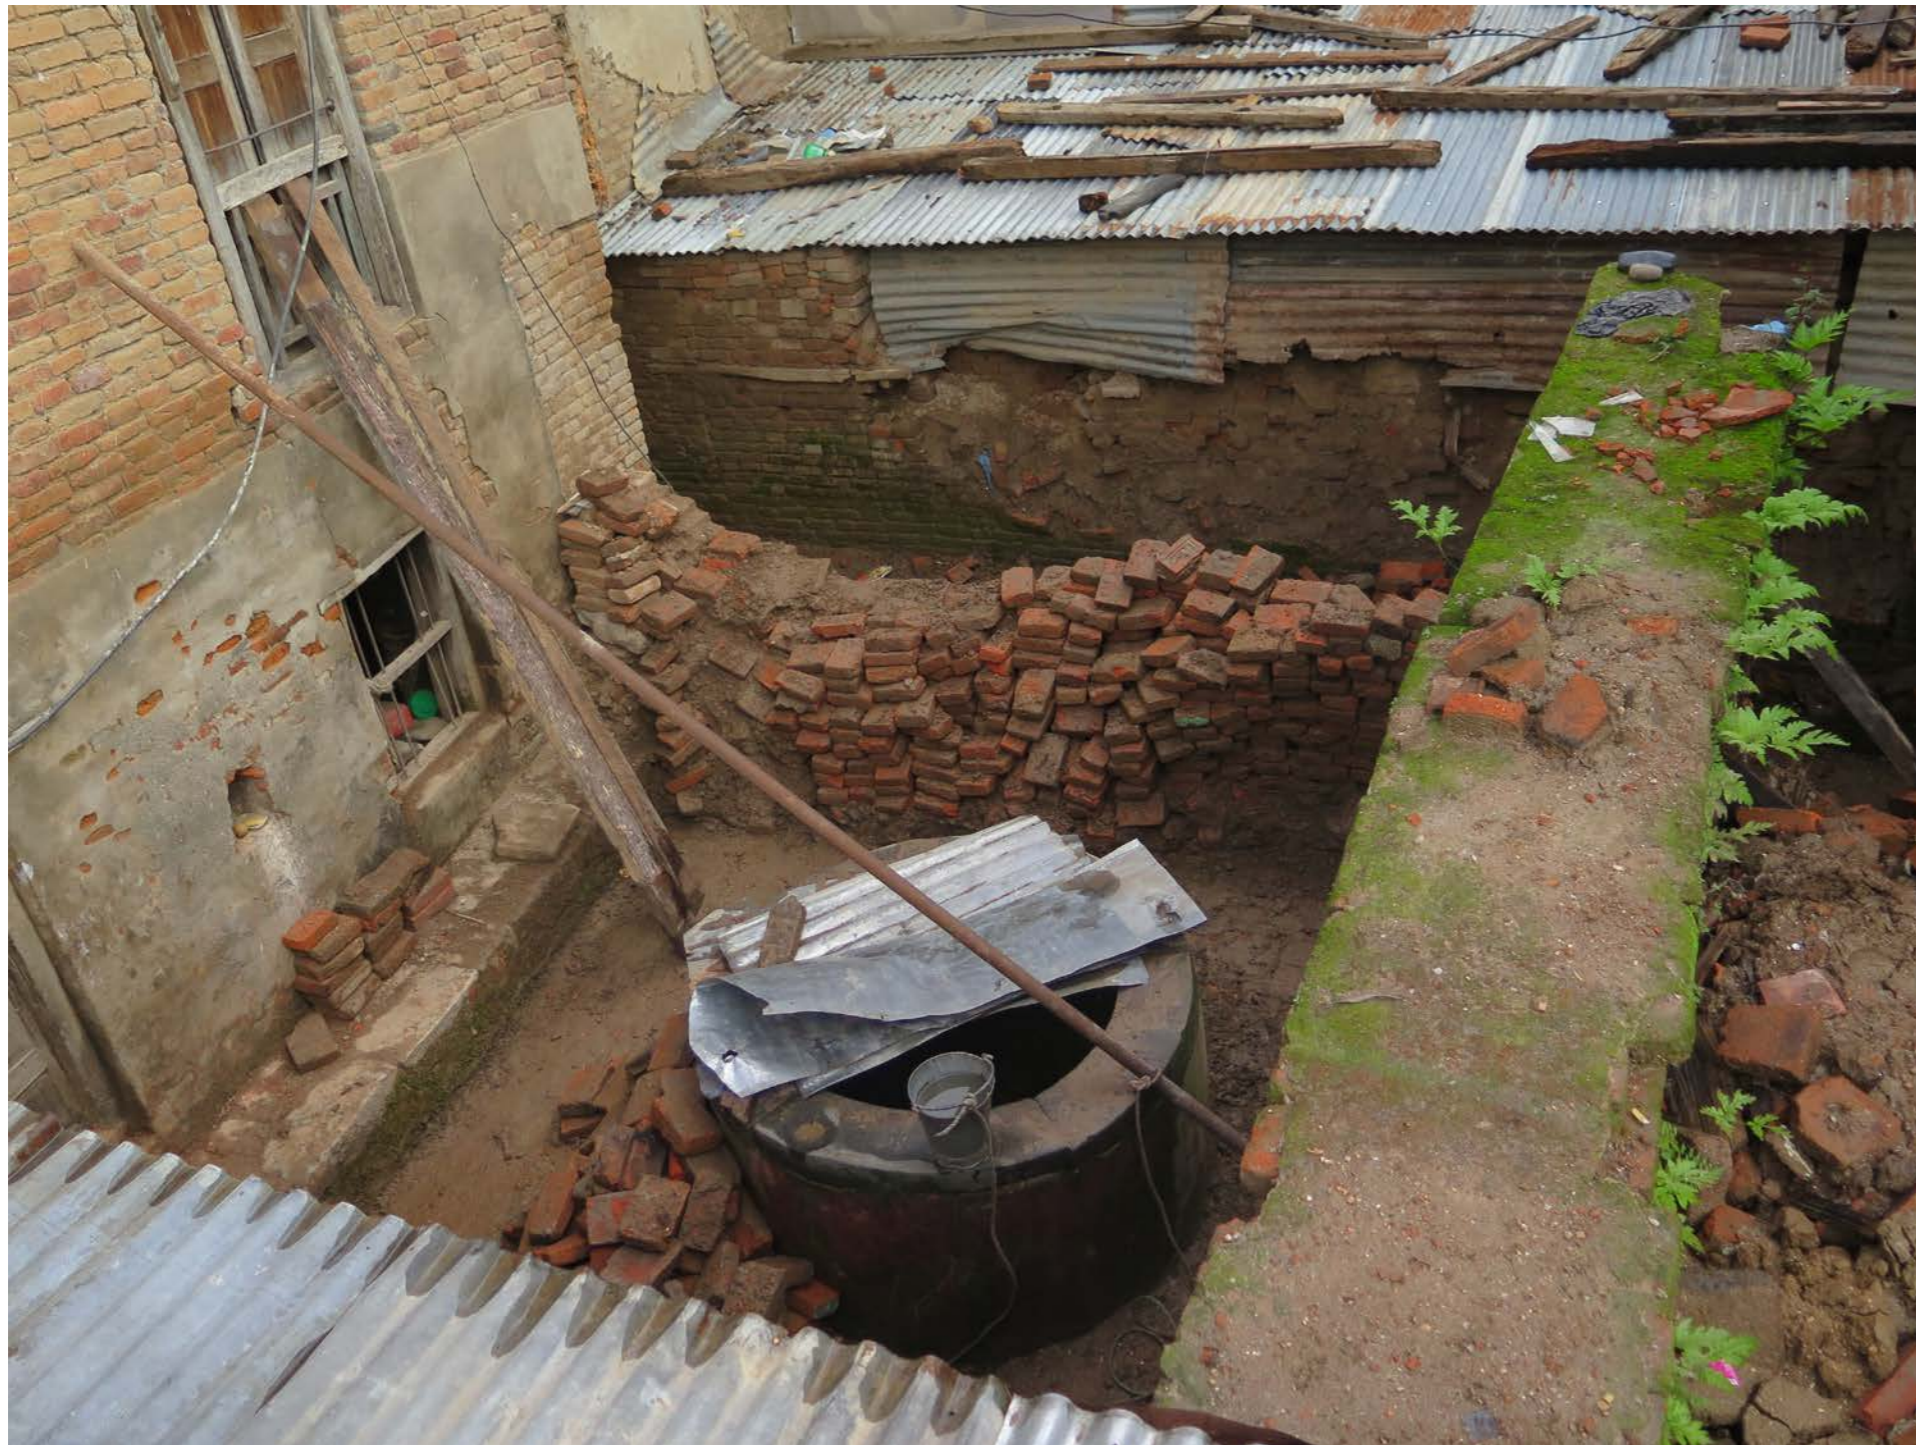
I-10 HITI

NUMBER	NAME	DATE A.D.	TYPOLOGY	GENERAL DESCRIPTION	PROBLEMS DESCRIPTION	DANGER/ DESTROY
I-10			Well	Brick Well with stone blocks at outer top part.	Well functioning.

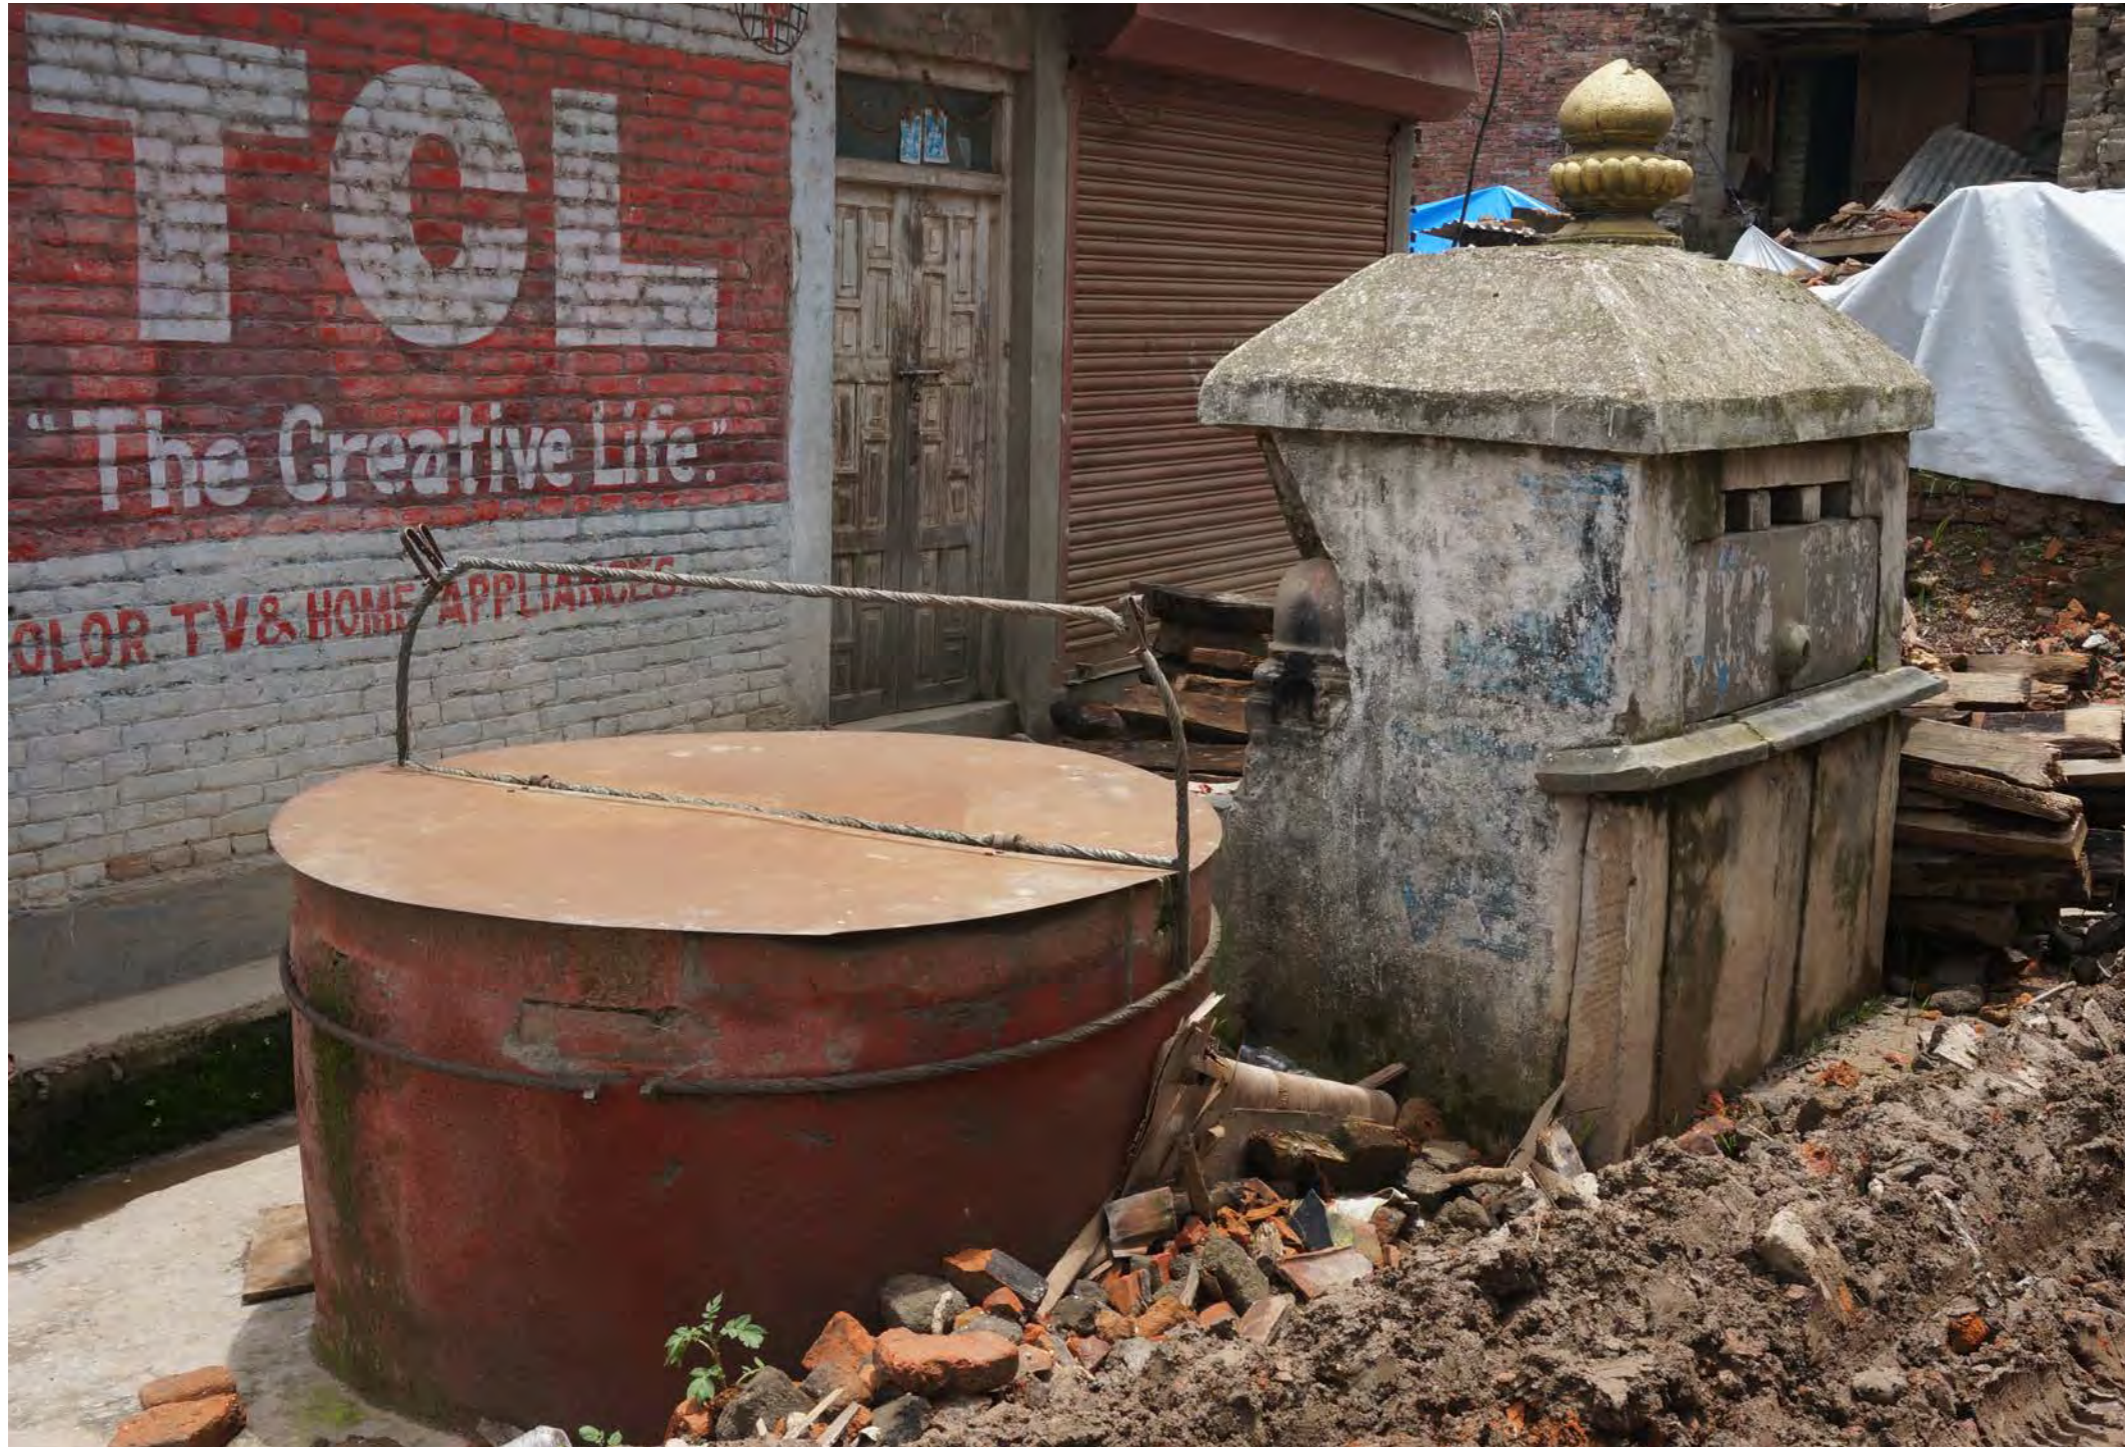
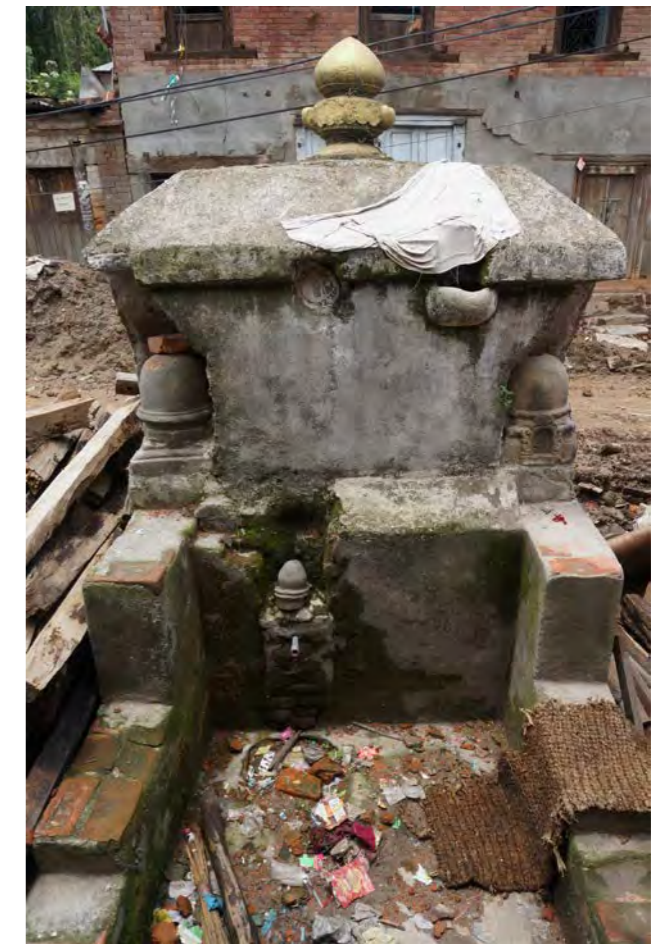
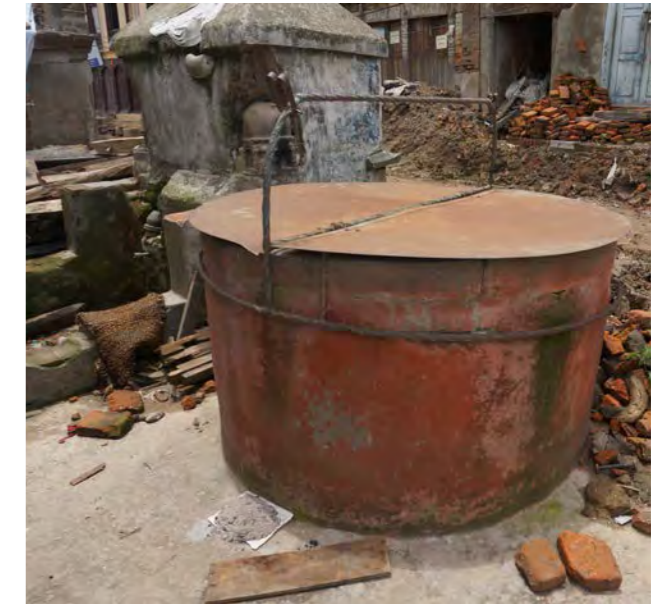
K-02 JHARU AND WELL

NUMBER	NAME	ESTABLISHED DATE (A.D.)	TYPOLOGY	GENERAL DESCRIPTION	PROBLEMS DESCRIPTION	DANGER/ DESTROY
K-2			Jharu and well	Well made of brick	"Slight dilapidated Needs maintainance"
