2015 Earthquake Damage Mapping

Sankhu

October 2015

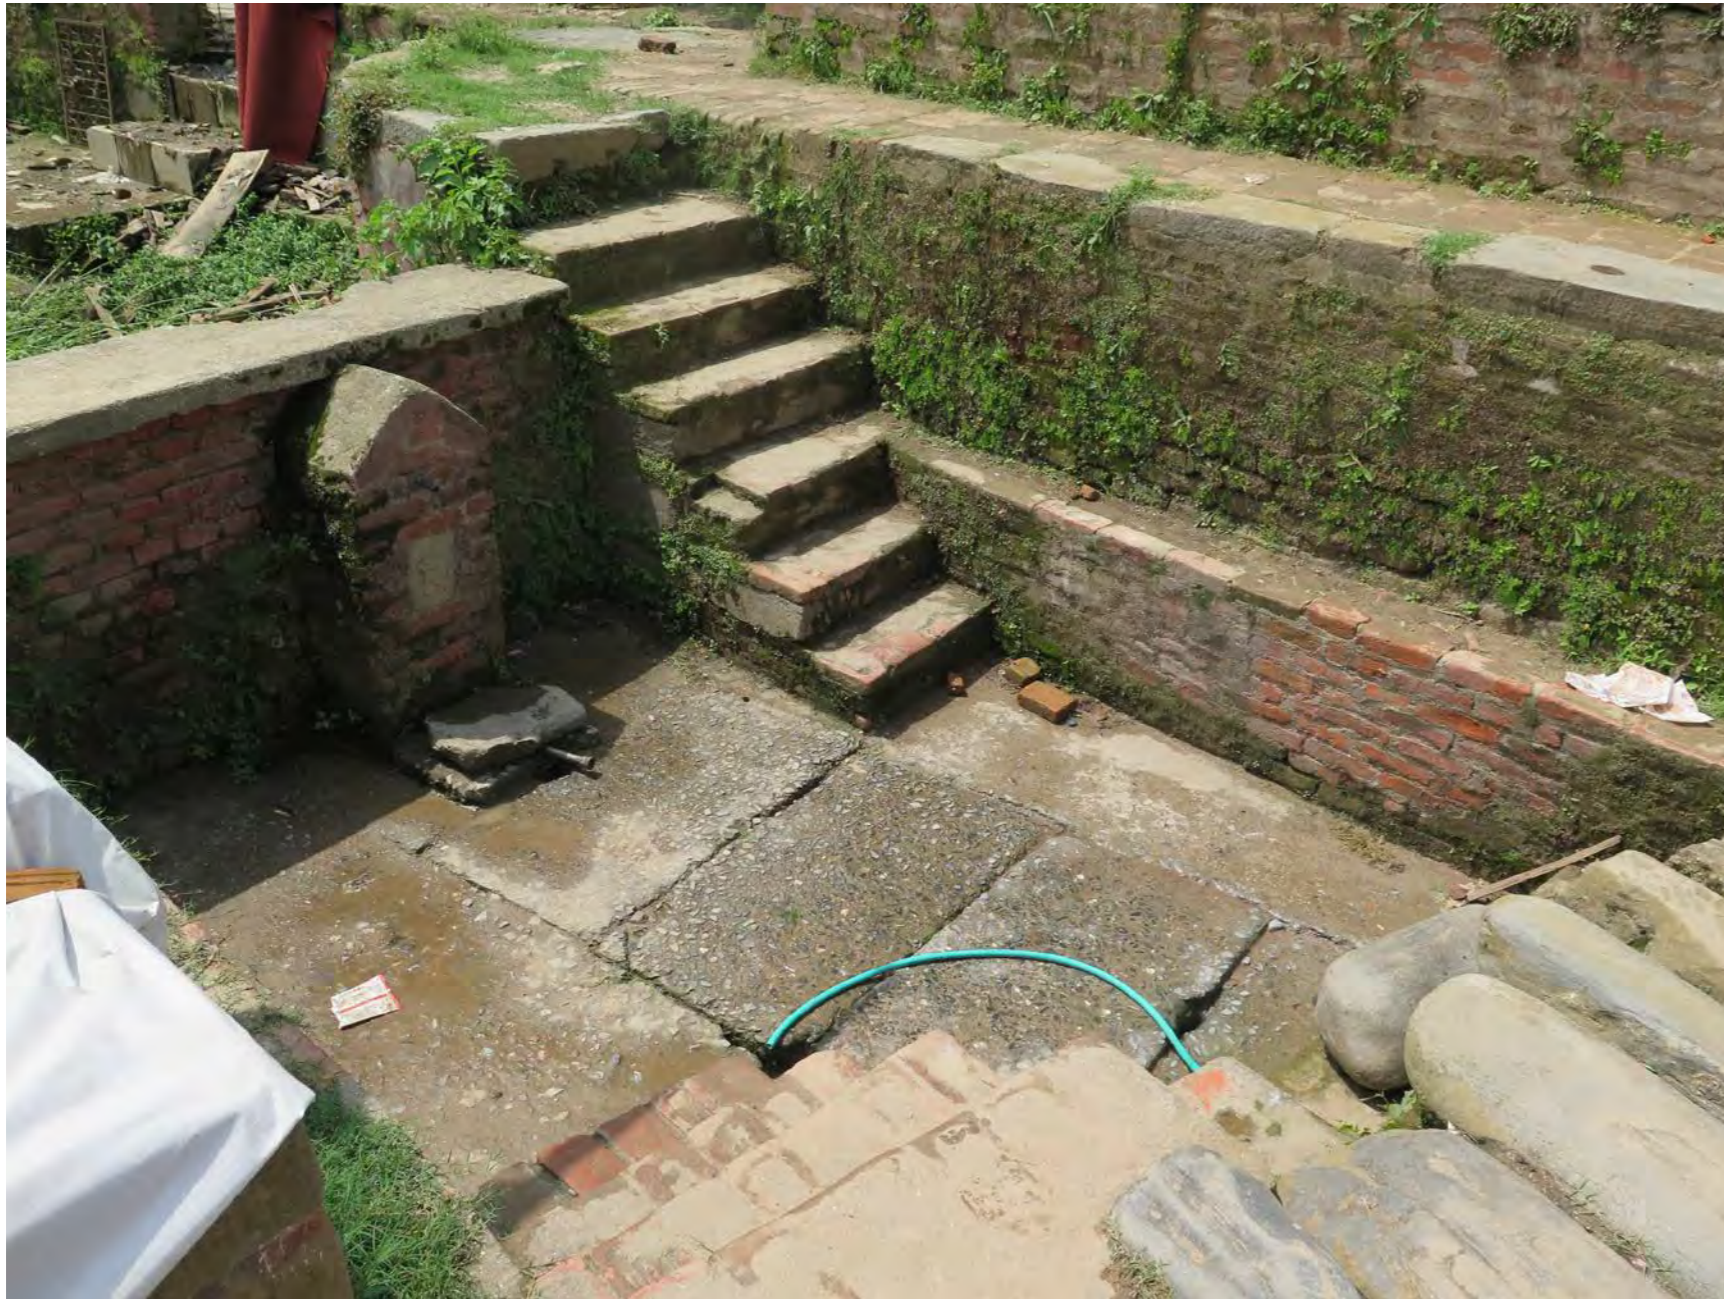
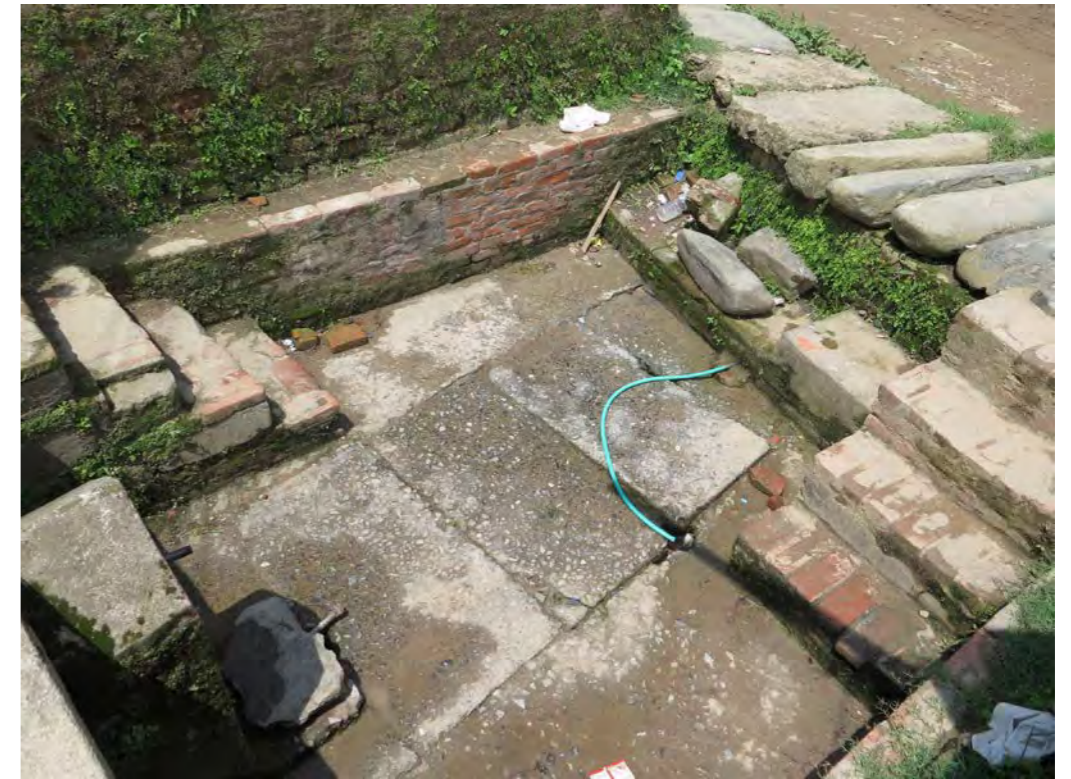
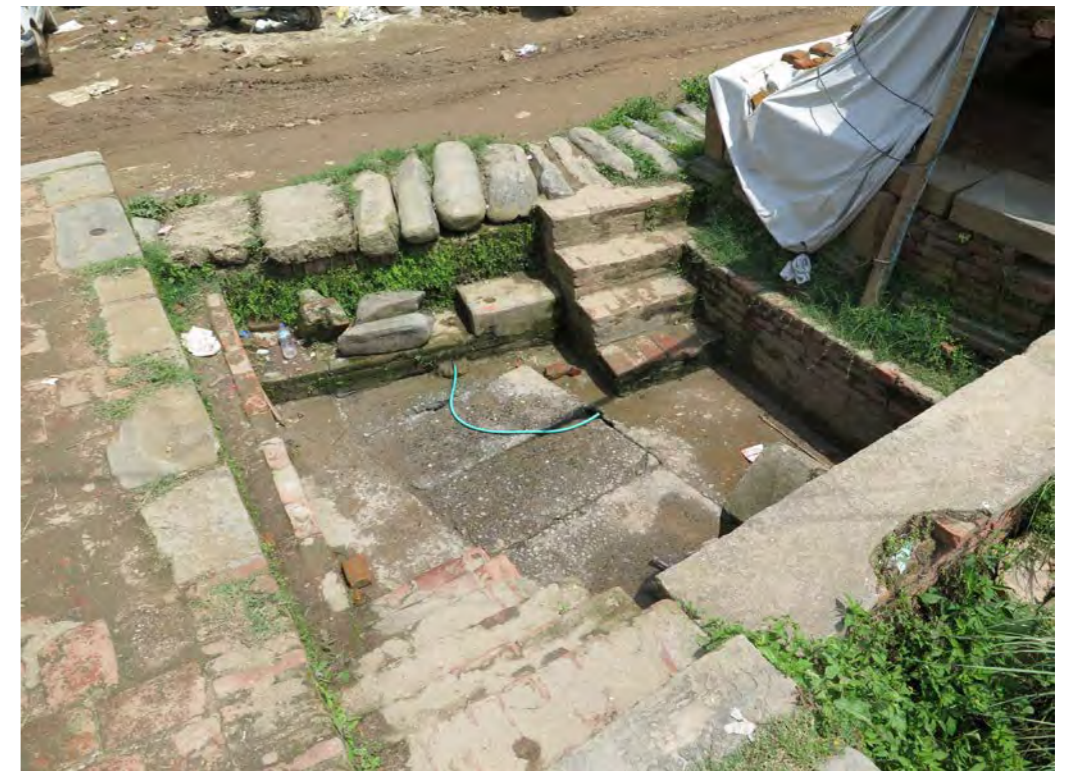
E-03 TAP

NUMBER	NAME	DATE A.D.	TPOLOGY	GENERAL DESCRIPTION	PROBLEMS DESCRIPTION	DANGER/ DESTROY
E-03			Tap	Small delepatad Hanuman idol.	No water supply

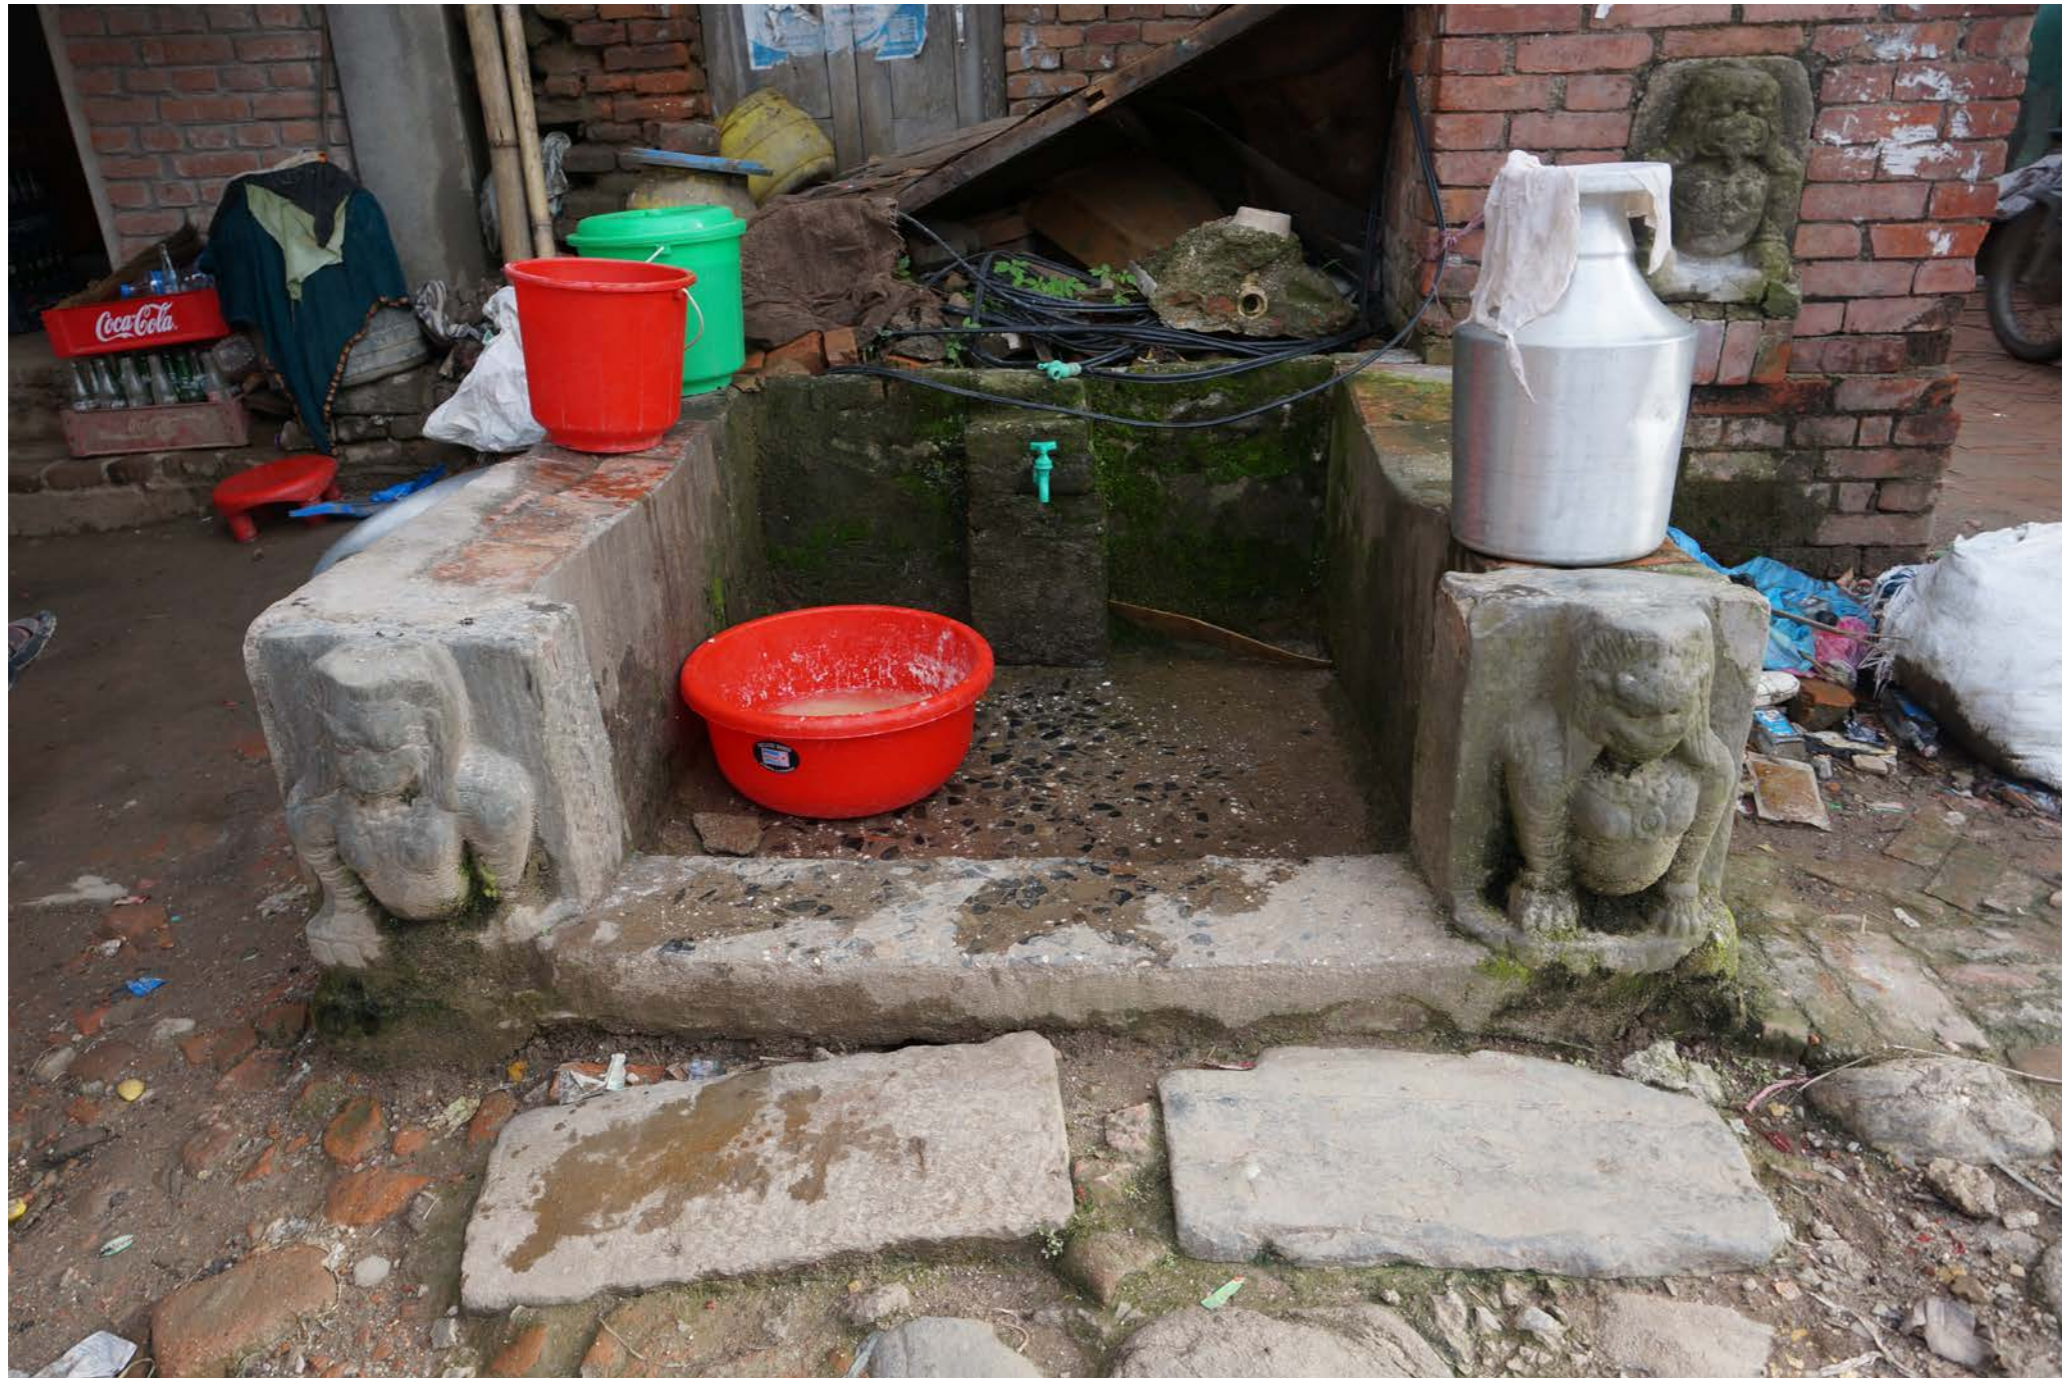
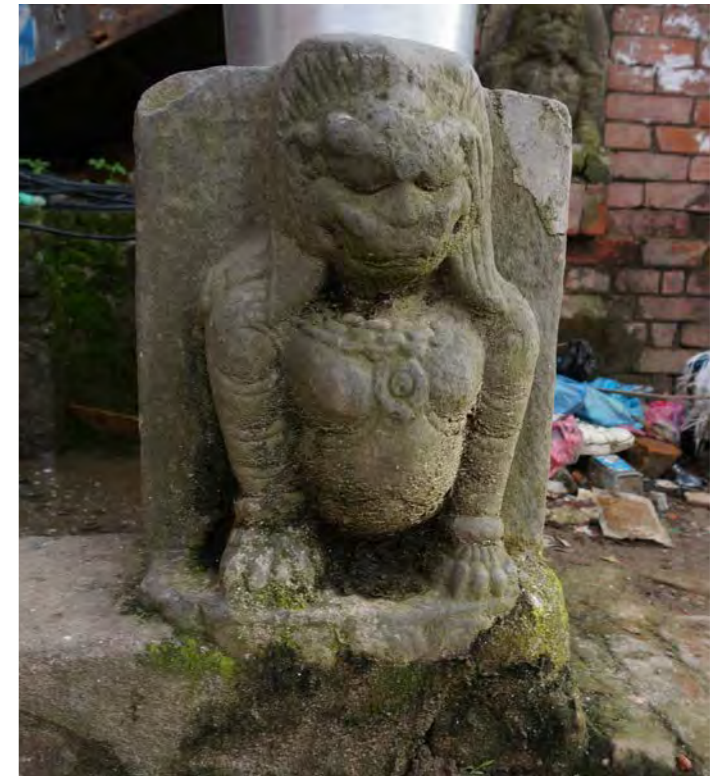
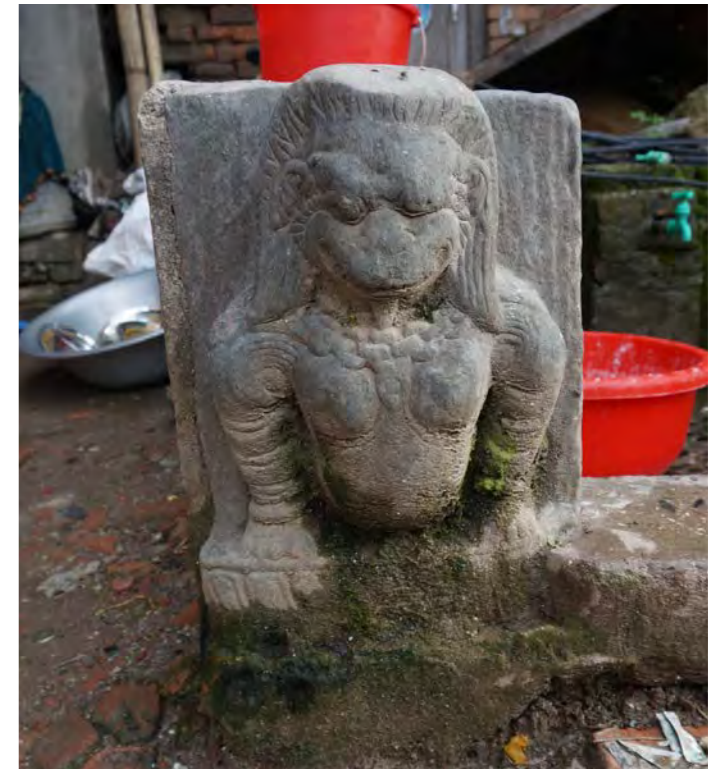
H-08 PUBLIC TAP

NUMBER	NAME	ESTABLISHED DATE (A.D.)	TYPOLOGY	GENERAL DESCRIPTION	PROBLEMS DESCRIPTION	DANGER/ DESTROY
H-8			Public tap	Brick structure with cement plaster	“Presence of stone statue of Garuda Needs protection and maintainance”

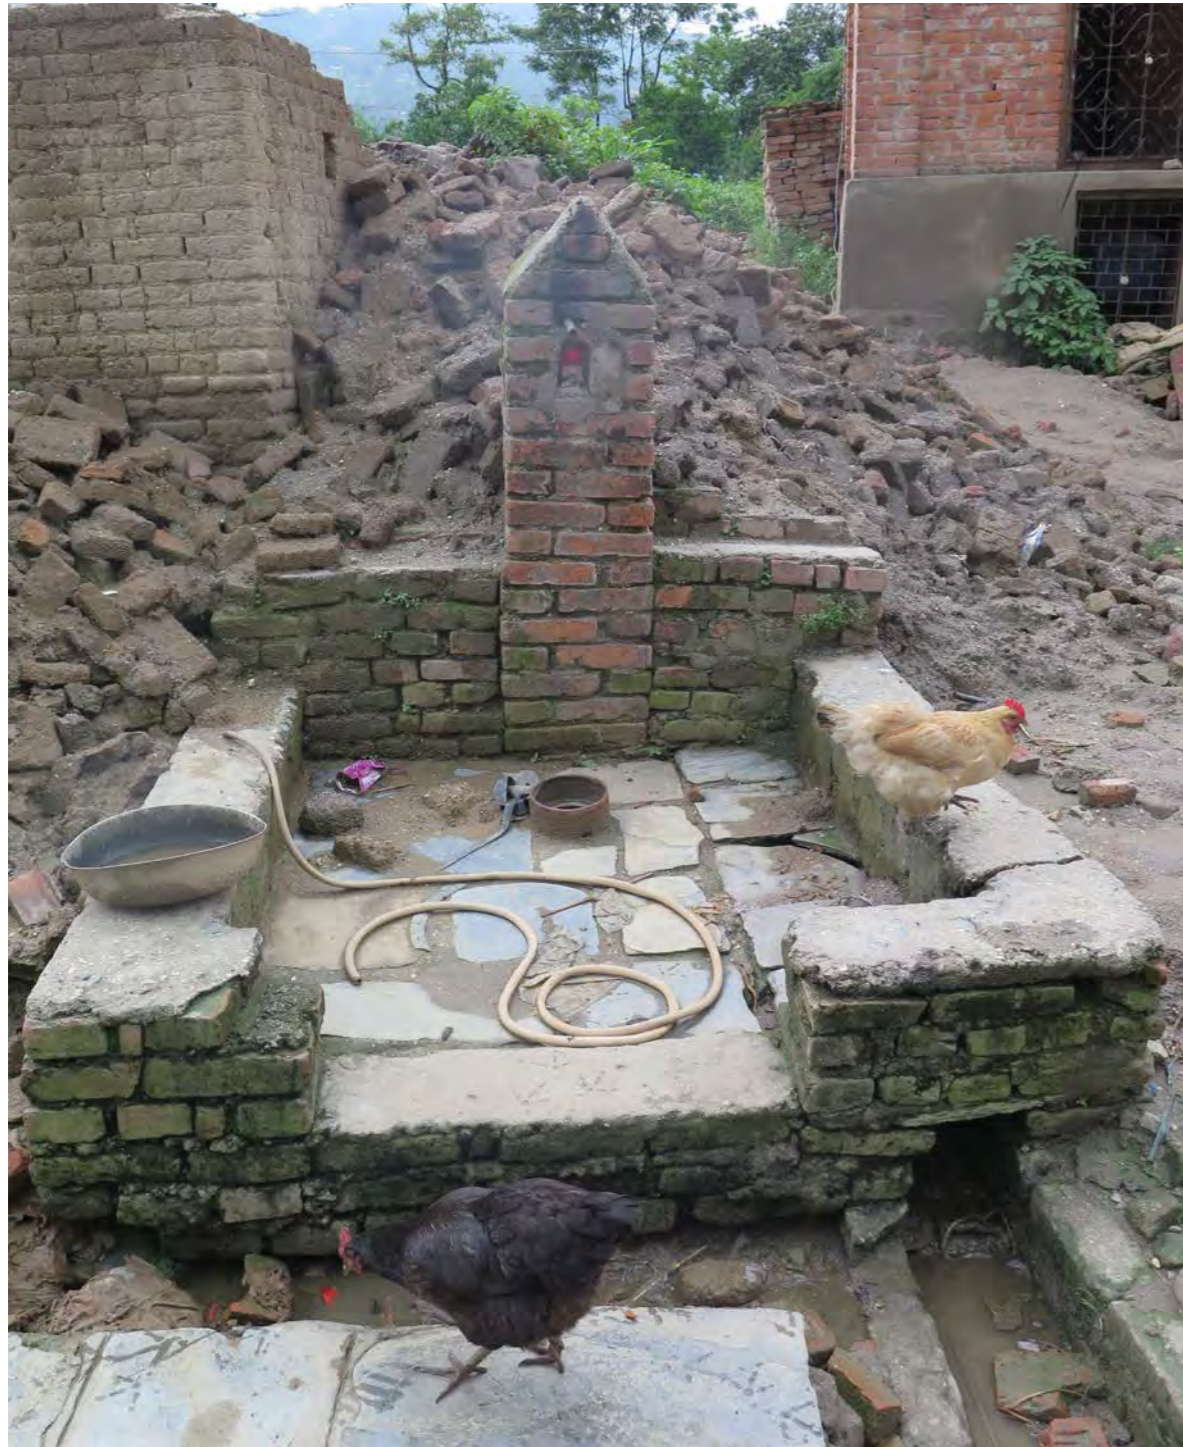
I-01 TAP

NUMBER	NAME	DATE A.D.	TPOLOGY	GENERAL DESCRIPTION	PROBLEMS DESCRIPTION	DANGER/ DESTROY
I-01			Tap		In degradated condition

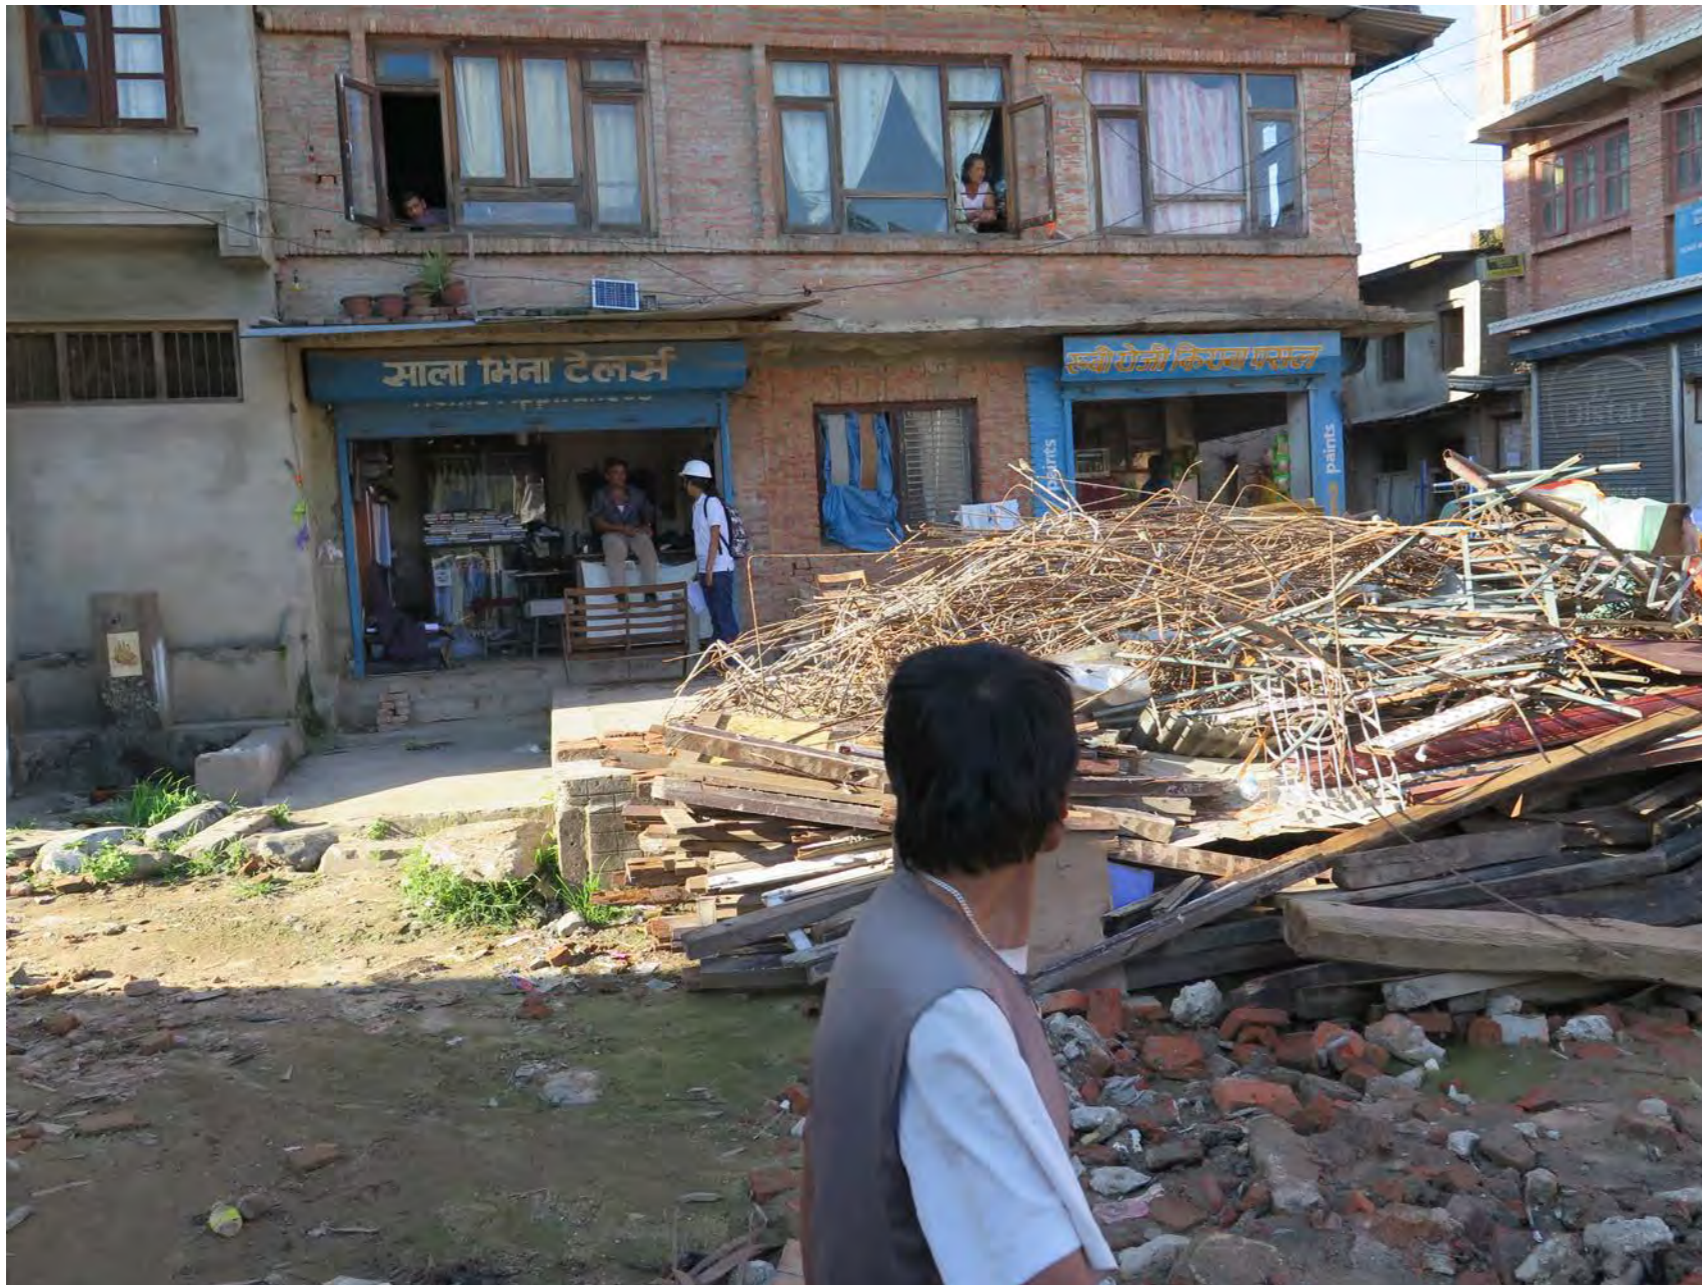
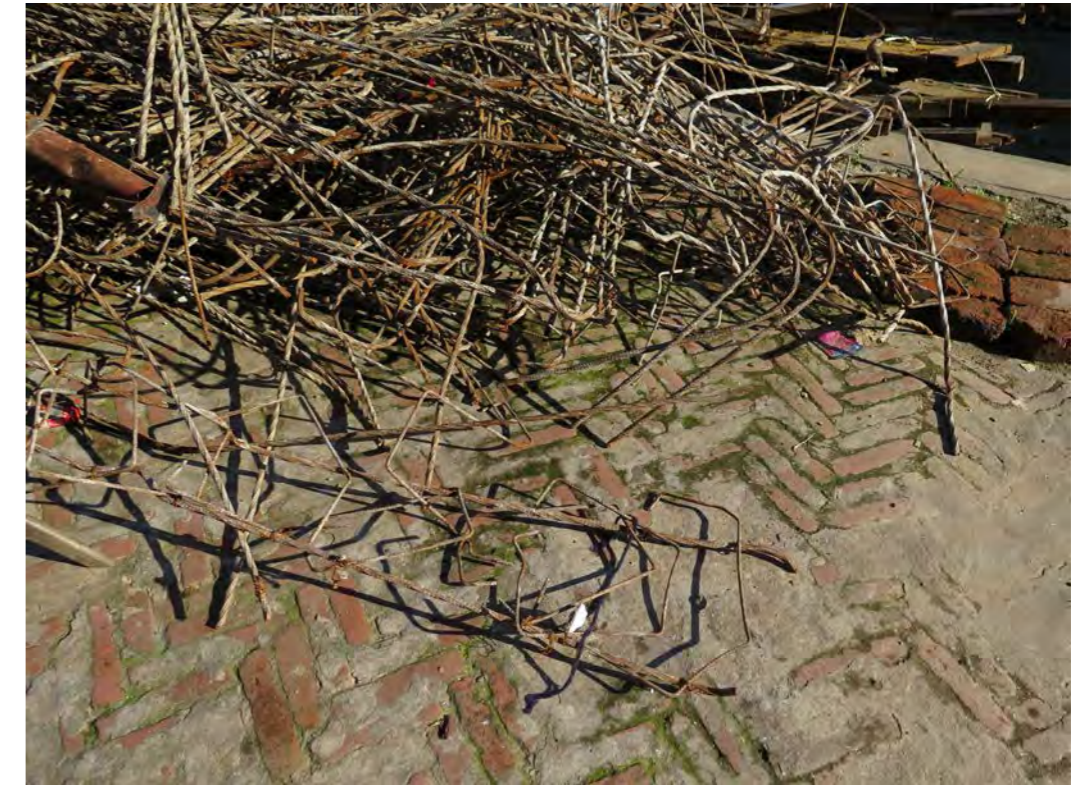
B01 DABALI

NUMBER	NAME	DATE A.D.	TPOLOGY	GENERAL DESCRIPTION	PROBLEMS DESCRIPTION	DANGER/ DESTROY
B-01			Platform		No visible damage

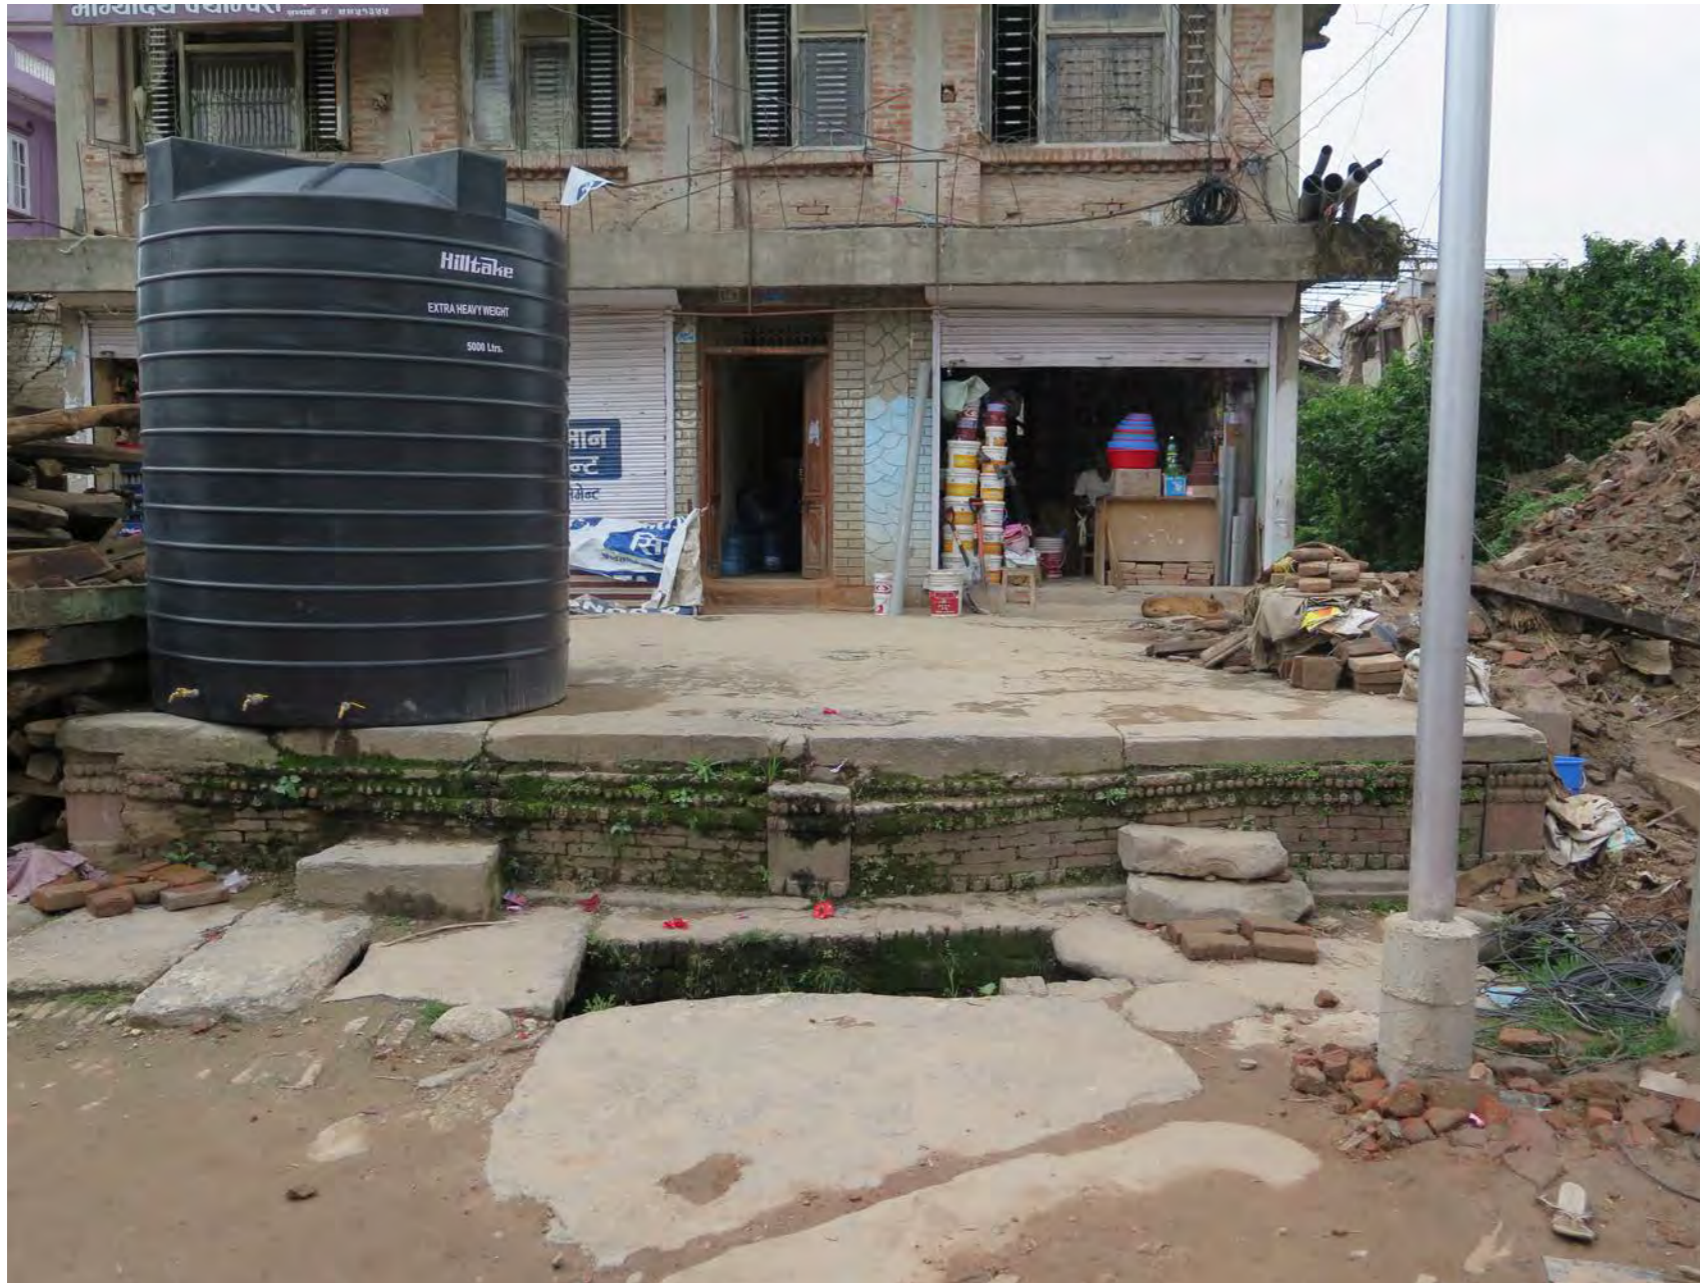
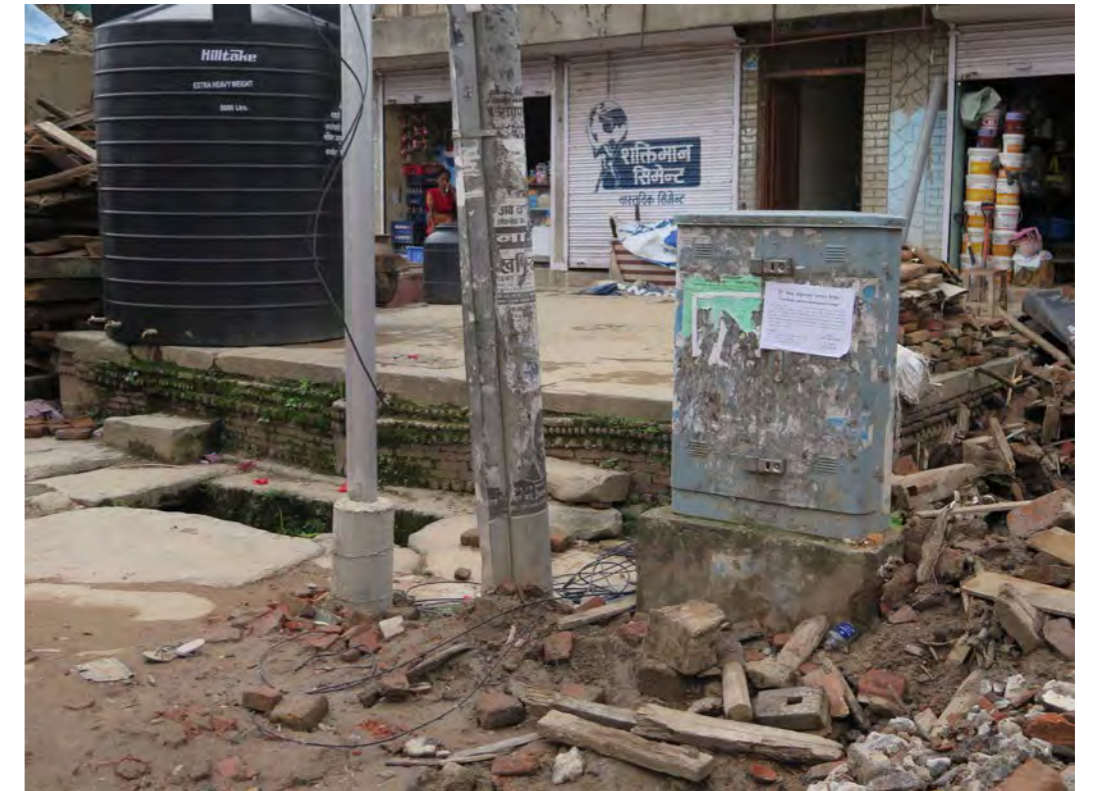
E07 DHOLA DABALI

NUMBER	NAME	ESTABLISHED DATE (A.D.)	TYPOLOGY	GENERAL DESCRIPTION	PROBLEMS DESCRIPTION	DANGER/ DESTROY
E-07	Dhola Dabali		Platform	Water source on eastern side of dabali	Little brick disorder

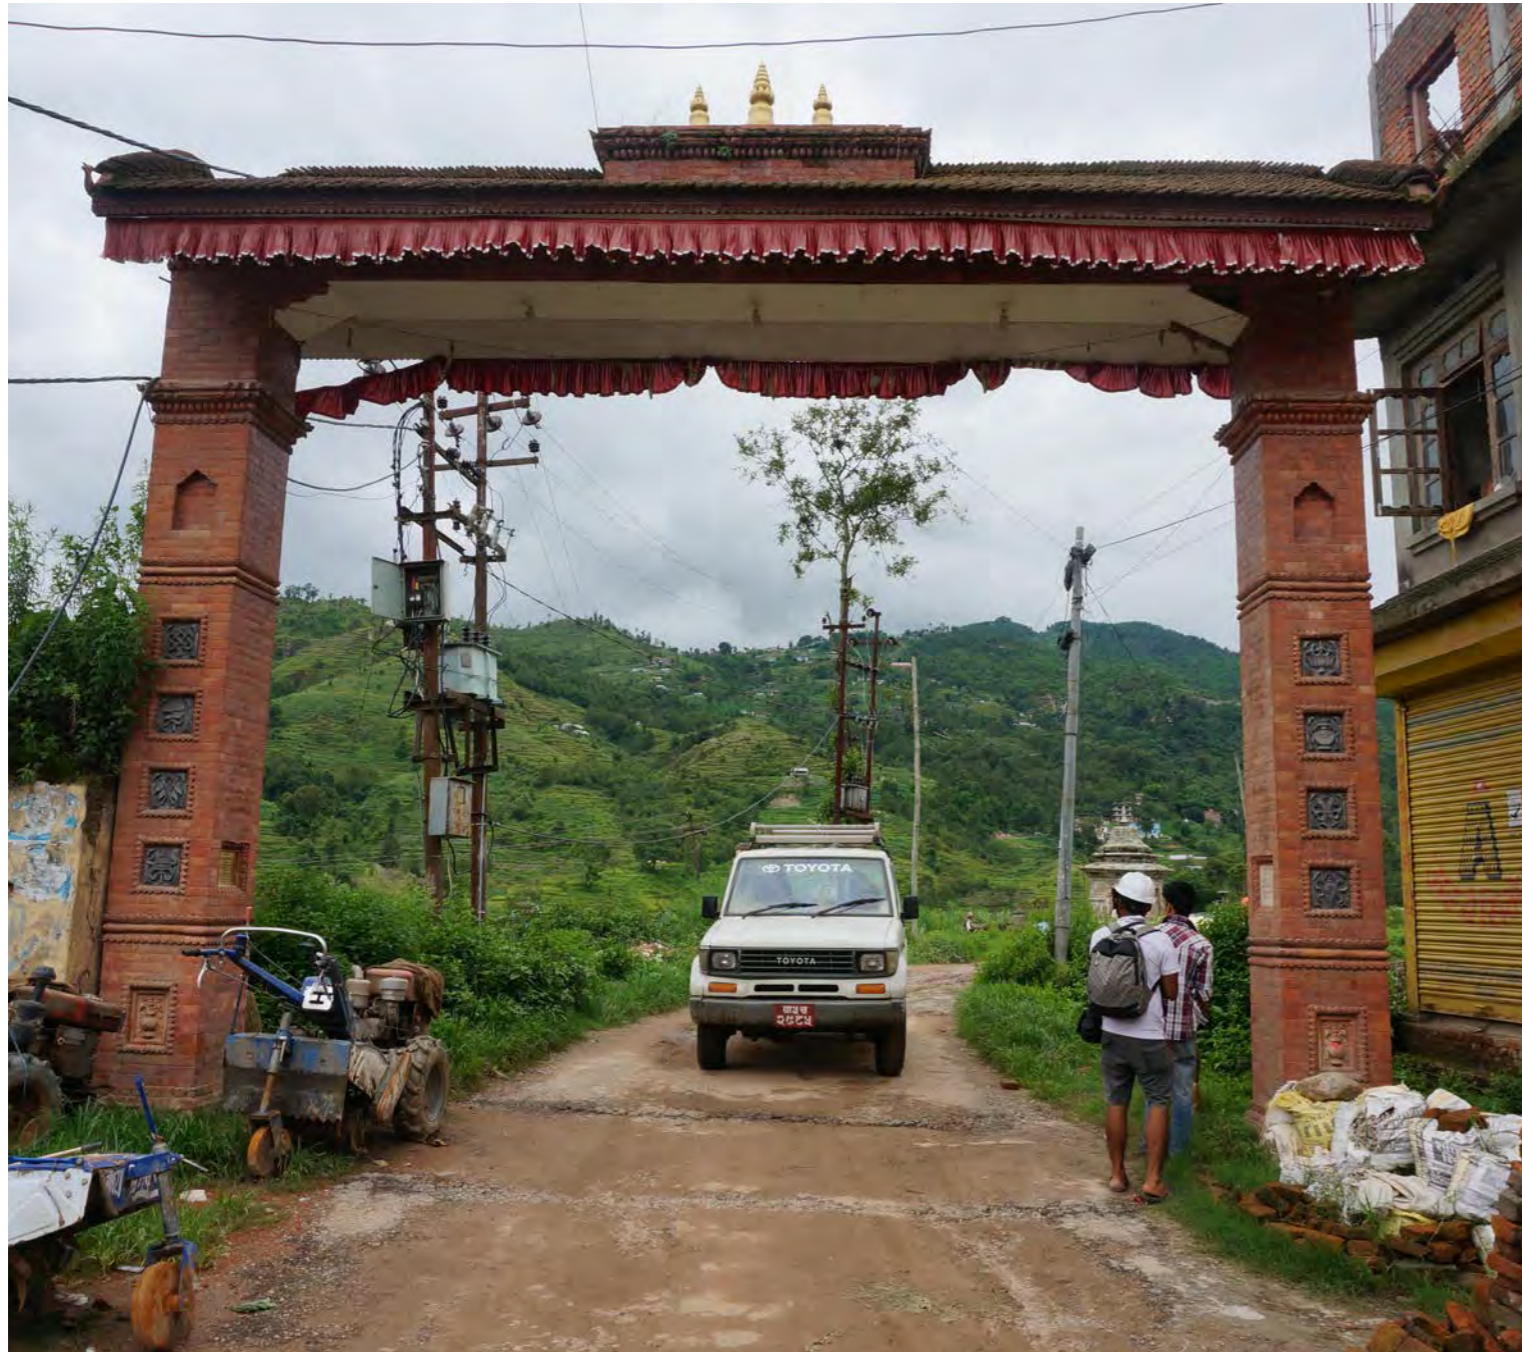
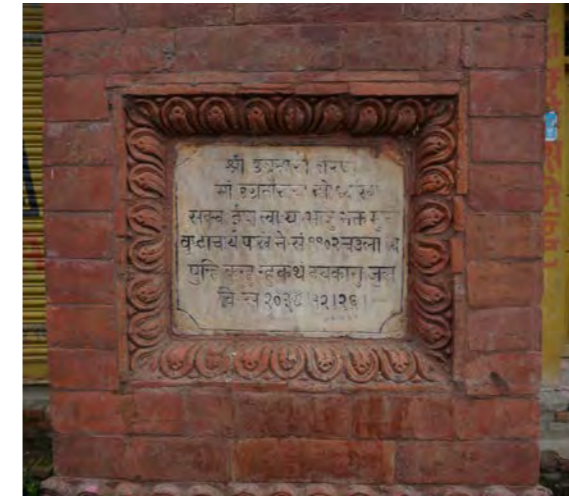
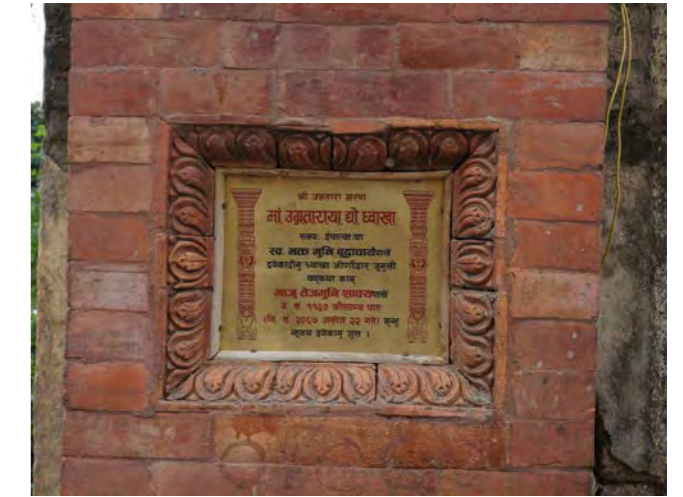
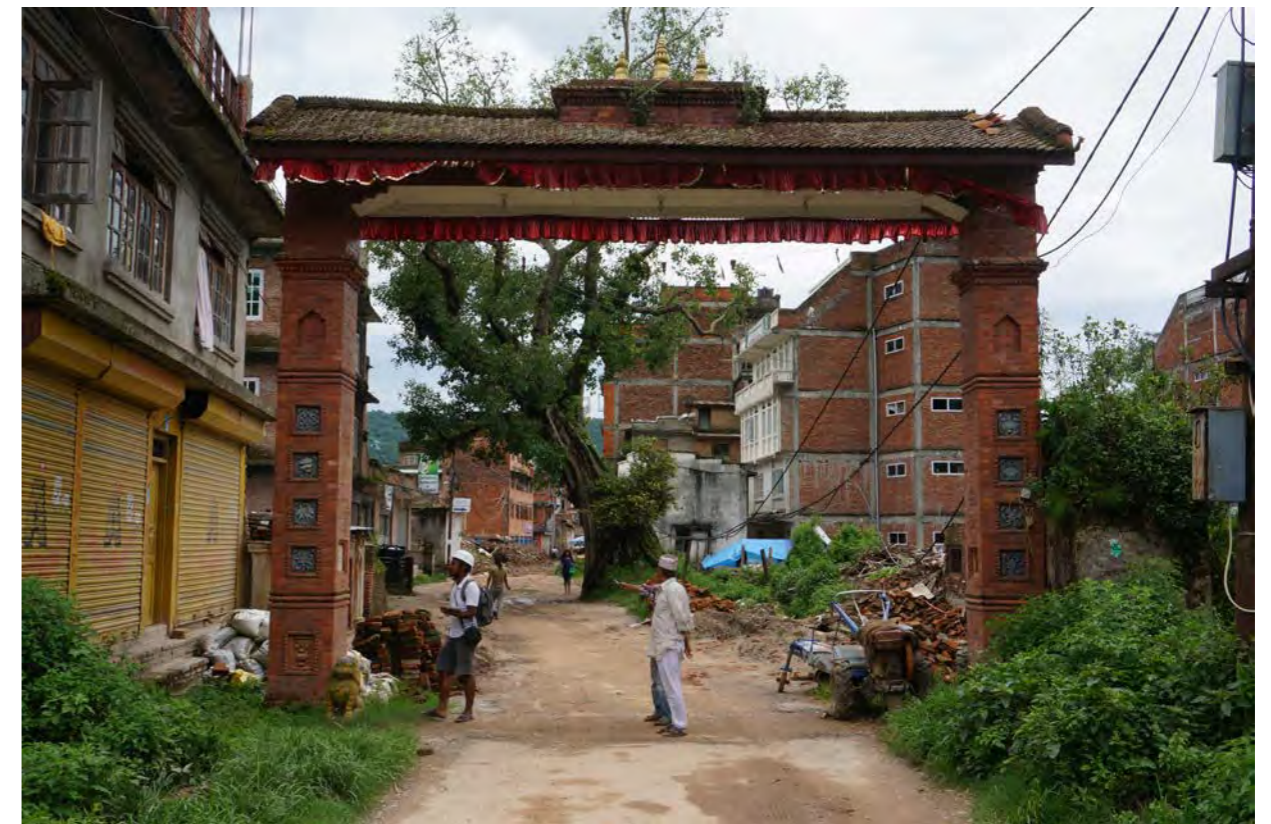
H01 GATE- BAJRAYOGINI GATE

NUMBER	NAME	DATE A.D.	TPOLOGY	GENERAL DESCRIPTION	PROBLEMS DESCRIPTION	DANGER/ DESTROY
H-01	Bajrayogini gate at Dhola	6/22/2067 (22 Sept 2010)	Gate	Brick made gate in cement plaster	Eastern end tiles falling
