2015 Earthquake Damage Mapping

Sankhu

October 2015

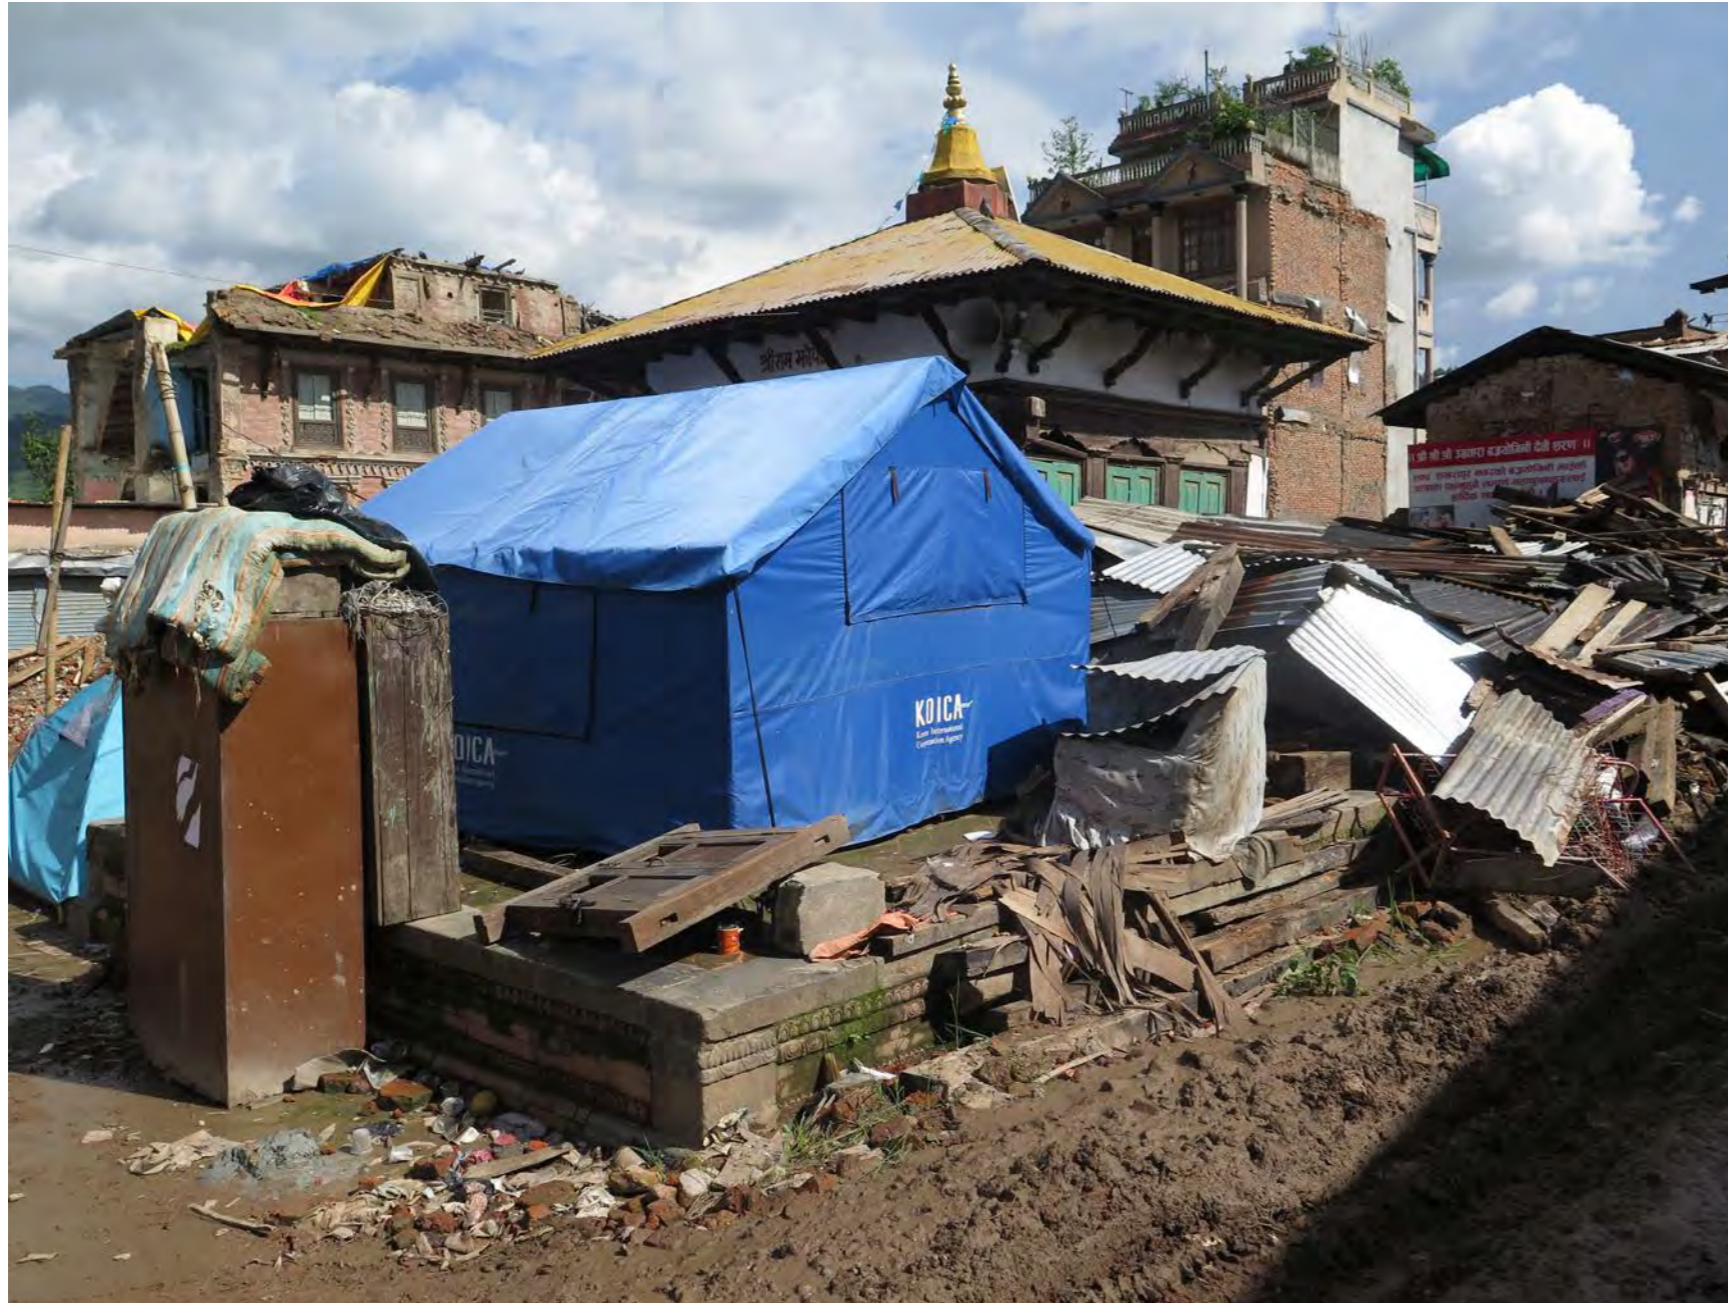
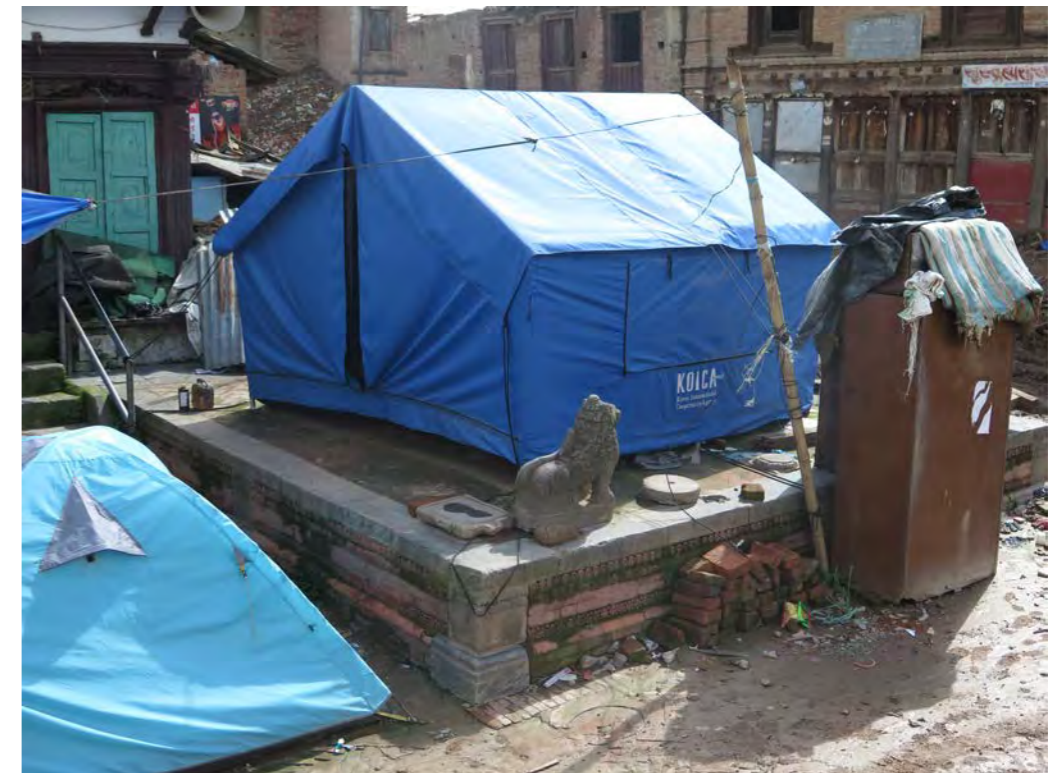
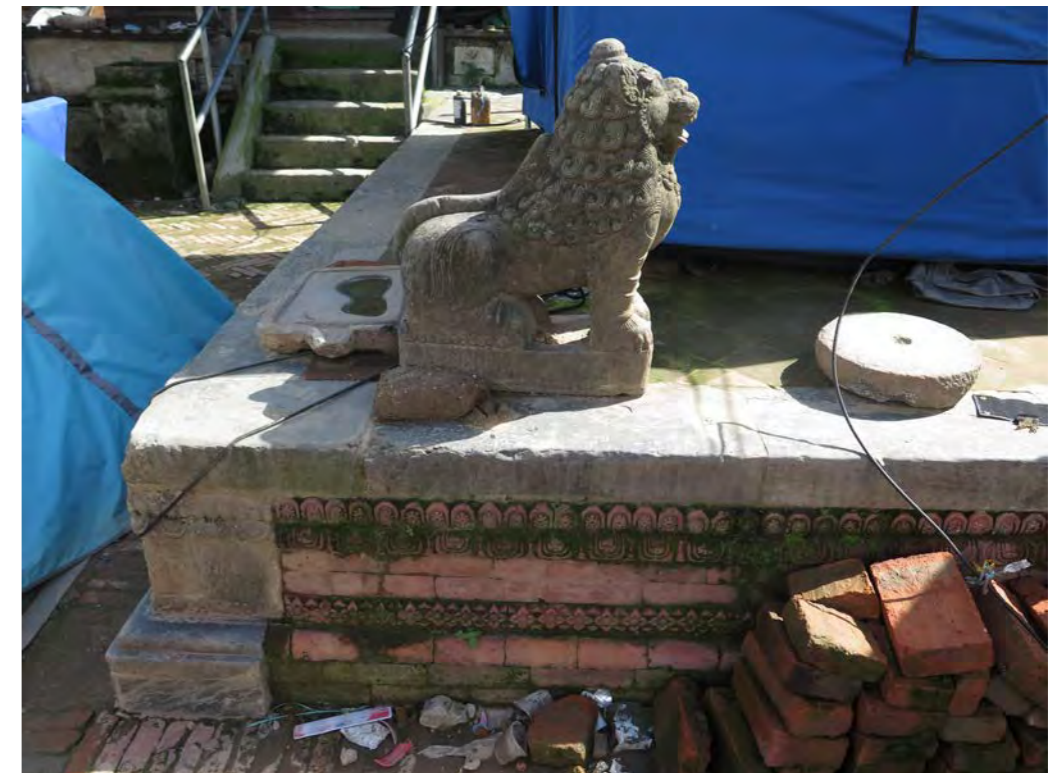
J05 SALKHA DABALI

NUMBER	NAME	ESTABLISHED DATE (A.D.)	TYPOLOGY	GENERAL DESCRIPTION	PROBLEMS DESCRIPTION	DANGER/ DESTROY
J-05	Salkha Dabali for Devi Nach		Platform	Dabali at Salkha Tole for Devi Naach.	Rising damp and vegetation growth. Full of rubbles.

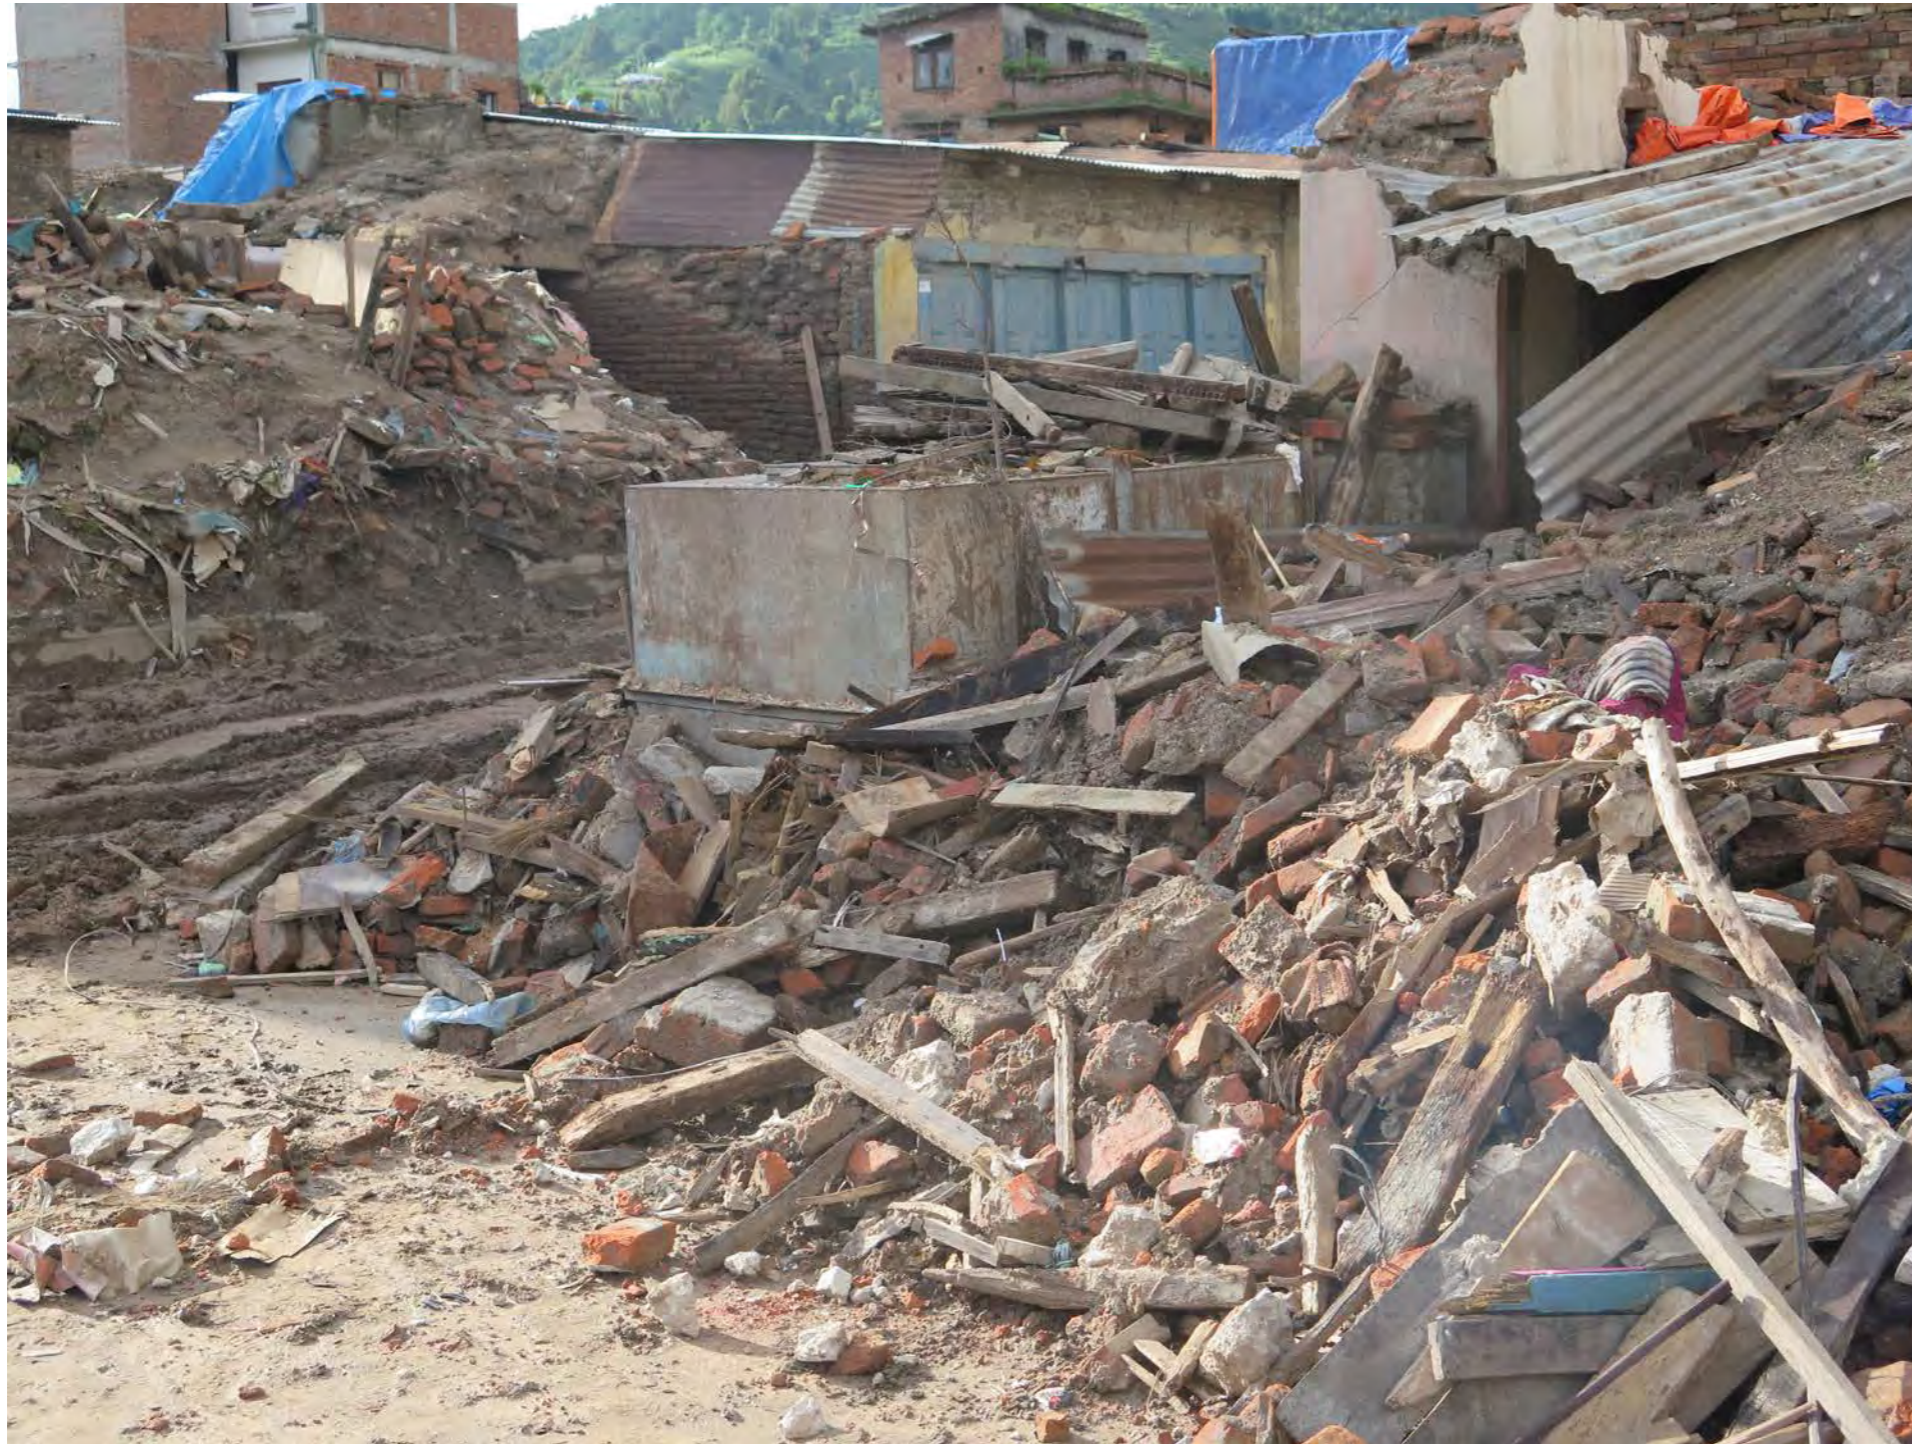
J07 MAN DABALI

NUMBER	NAME	DATE A.D.	TPOLOGY	GENERAL DESCRIPTION	PROBLEMS DESCRIPTION	DANGER/ DESTROY
J-07	Man Dabali		Platform	Dabali for Bhajan	Totally collapsed.

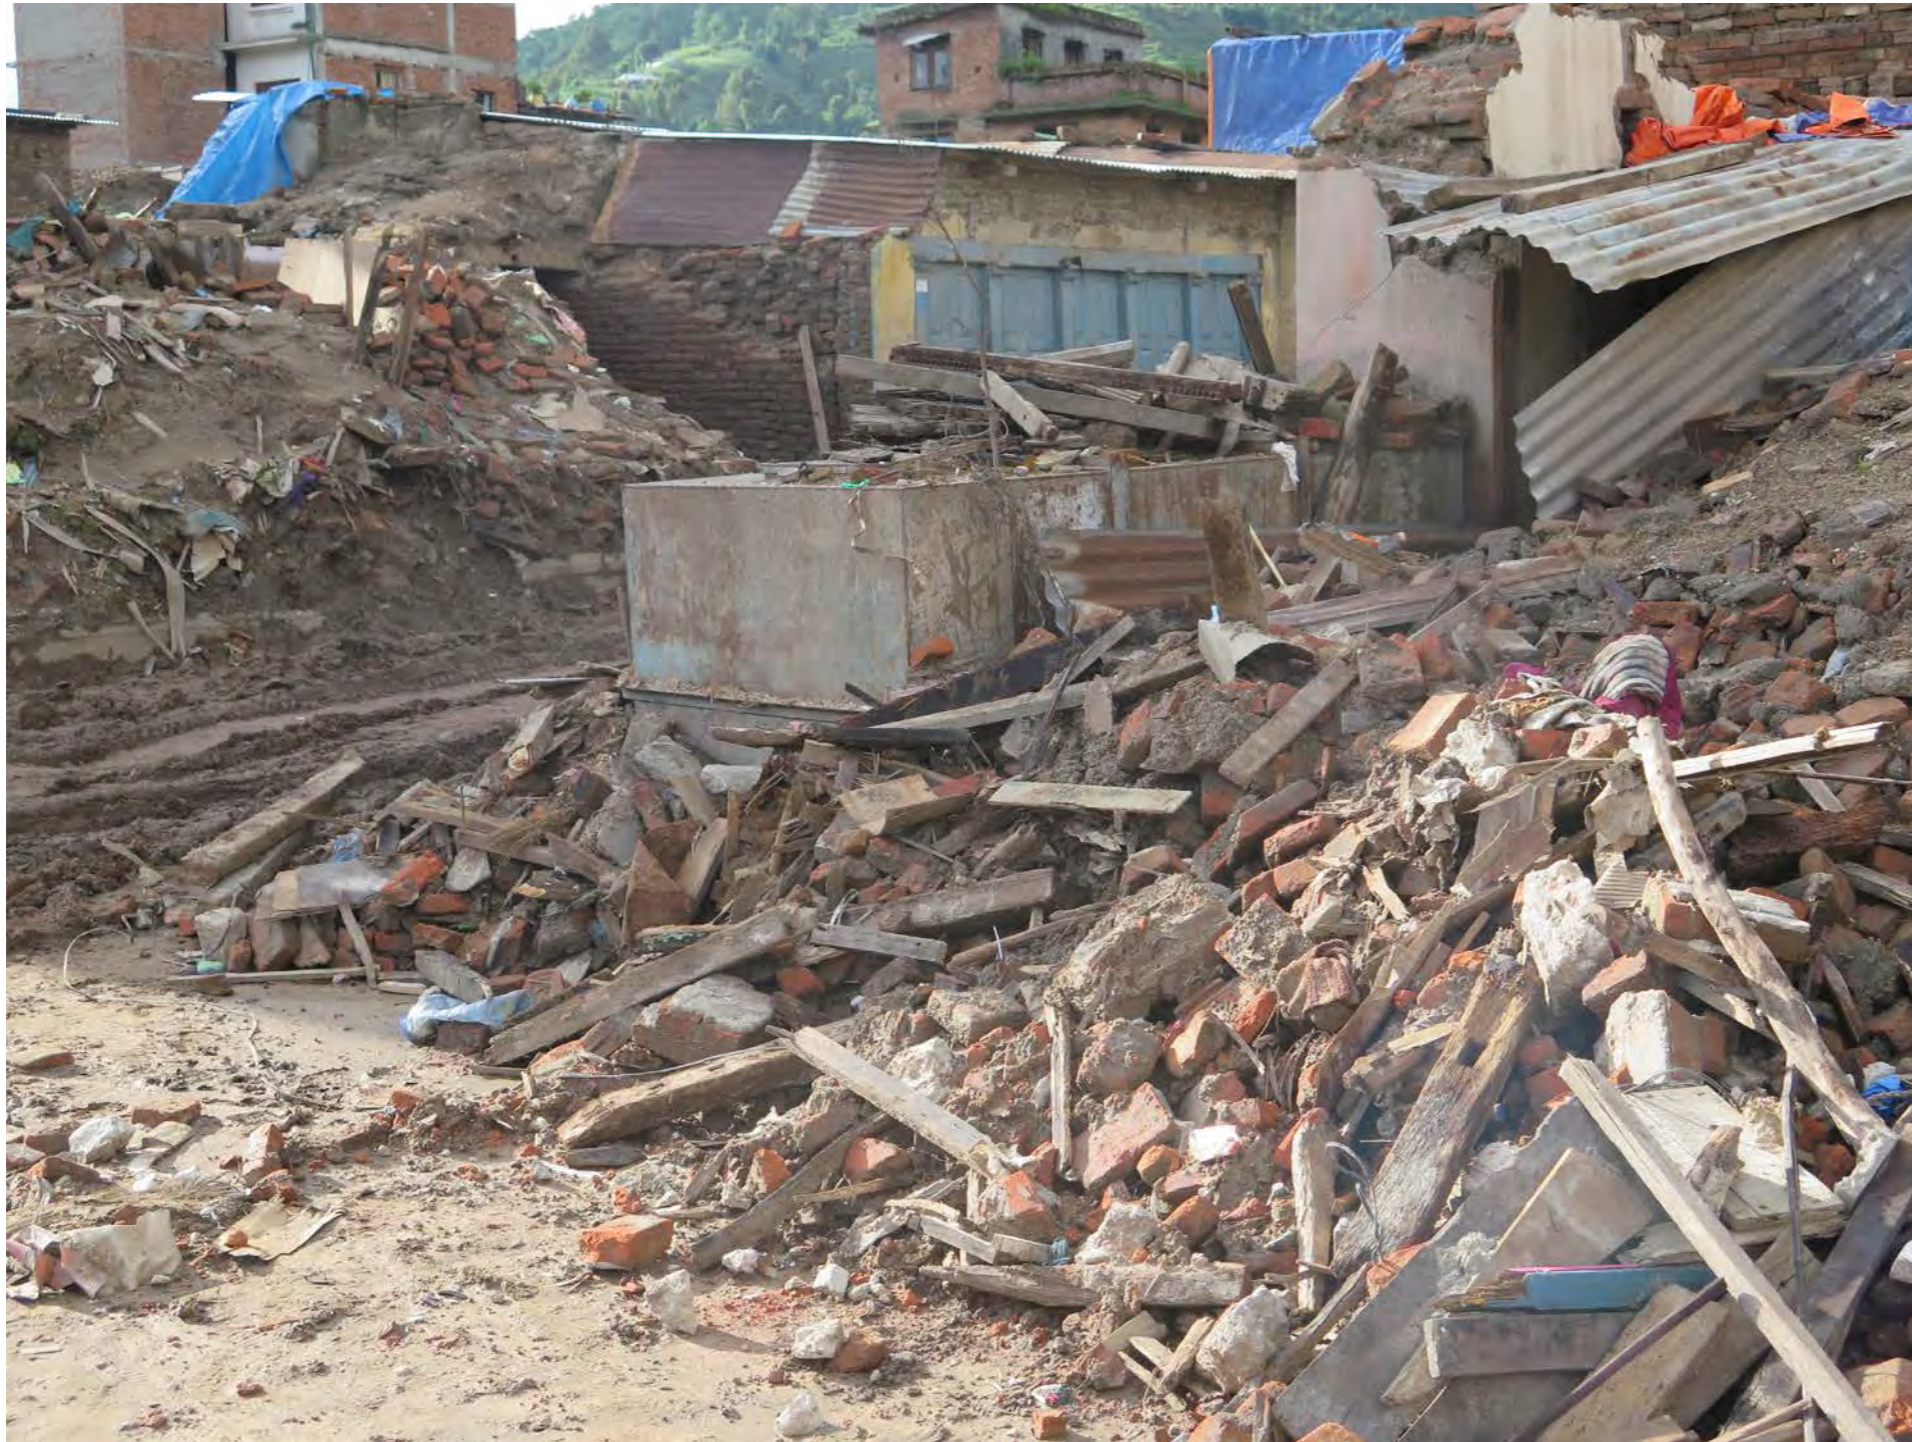
J10 MANDAP

NUMBER	NAME	ESTABLISHED DATE (A.D.)	TPOLOGY	GENERAL DESCRIPTION	PROBLEMS DESCRIPTION	DANGER/ DESTROY
J-10	Mandap		Platform	On eastern side of Twa Ganesh	Covered by rubbles.

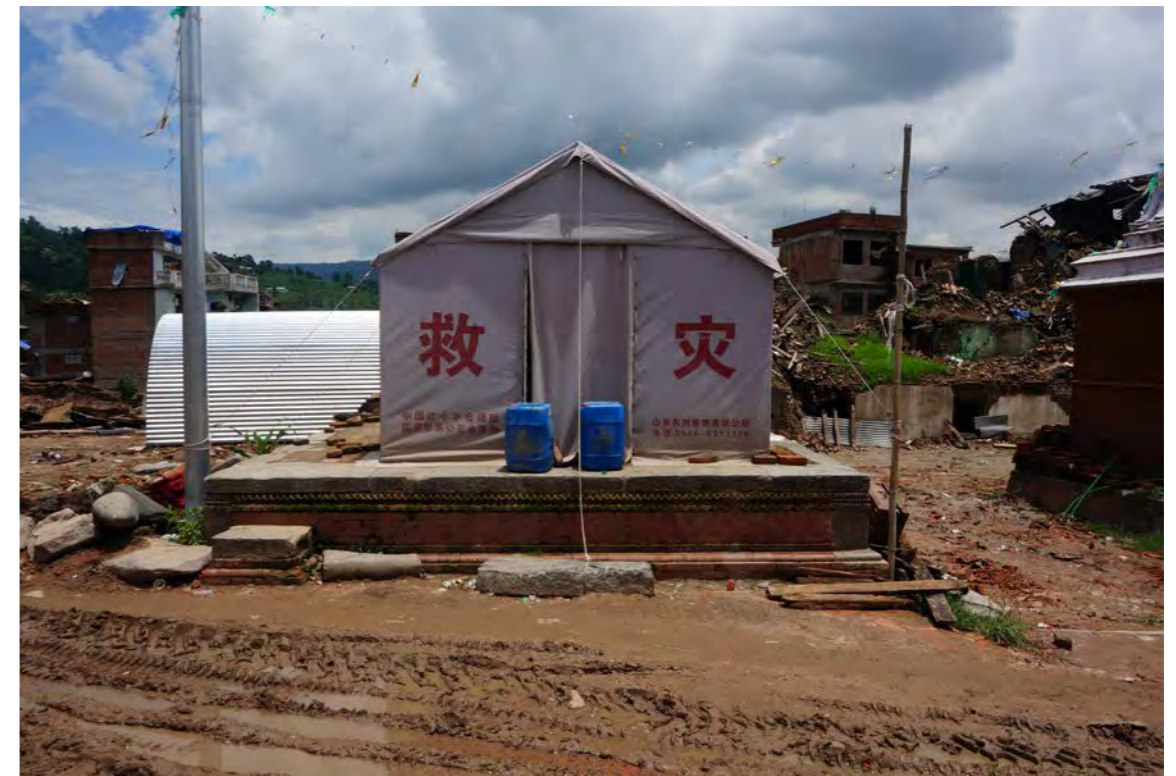
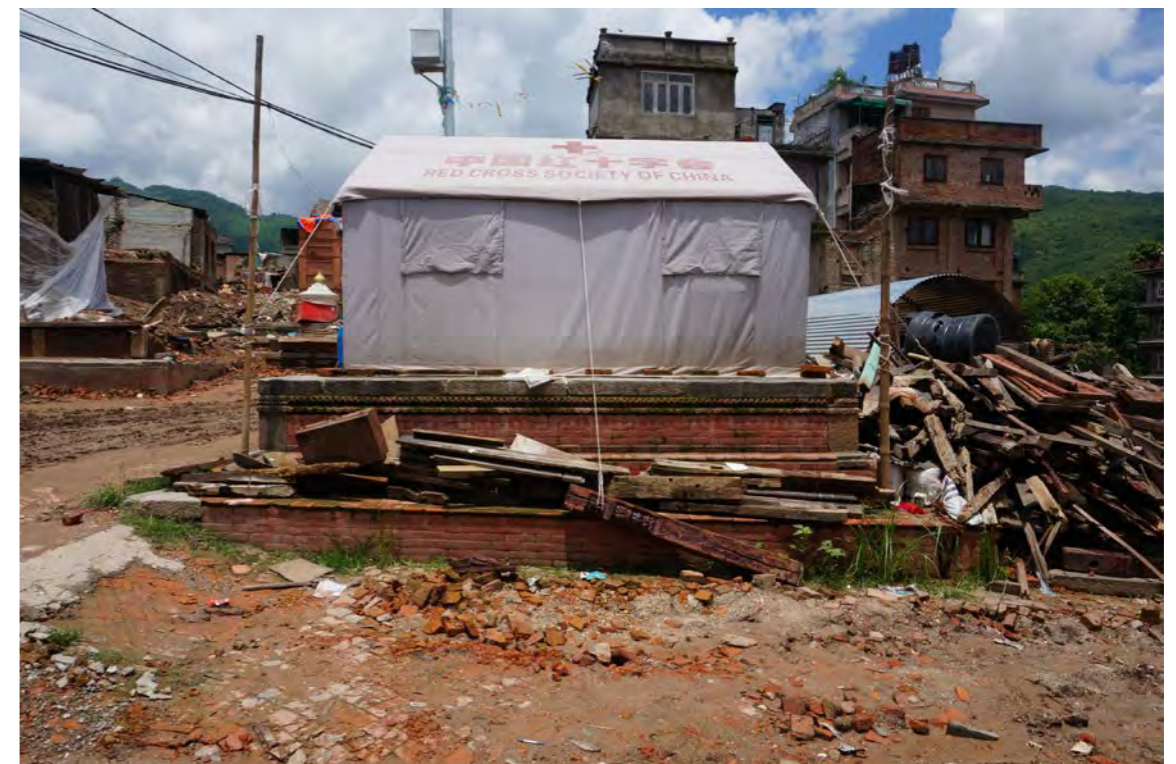
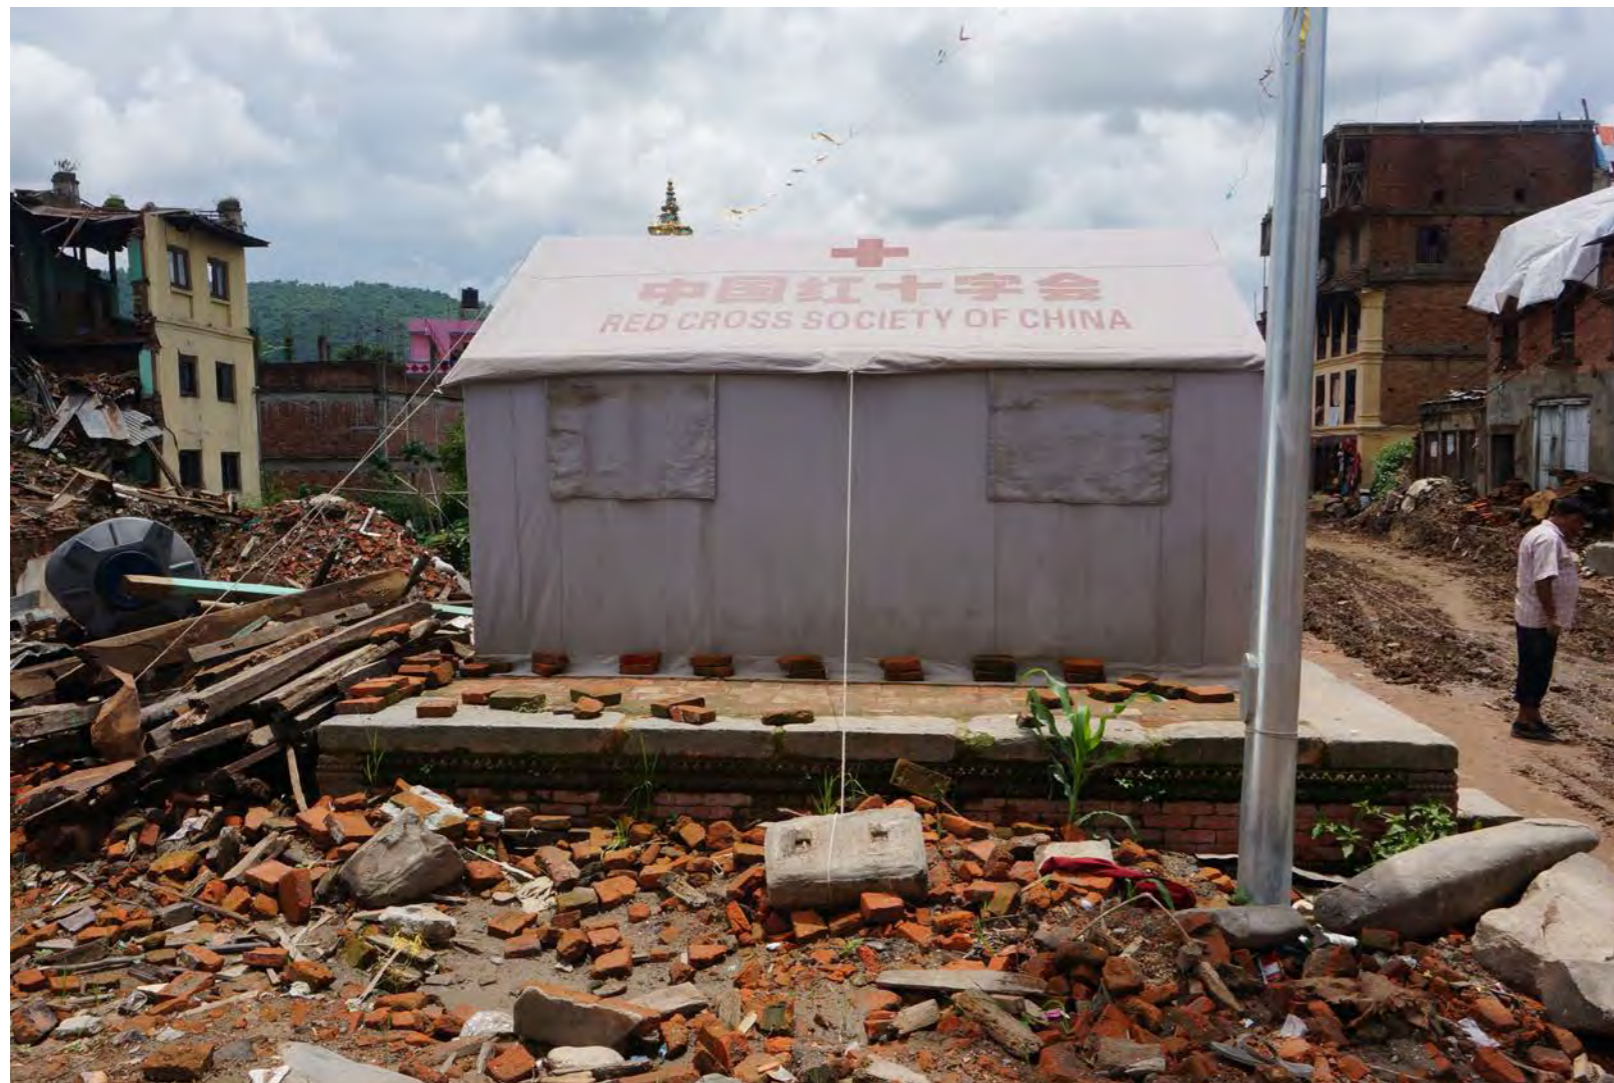
K05 DABALI

NUMBER	NAME	DATE A.D.	TPOLOGY	GENERAL DESCRIPTION	PROBLEMS DESCRIPTION	DANGER/ DESTROY
K-05			Platform	Stone platform with brick laying	Needs maintaiance

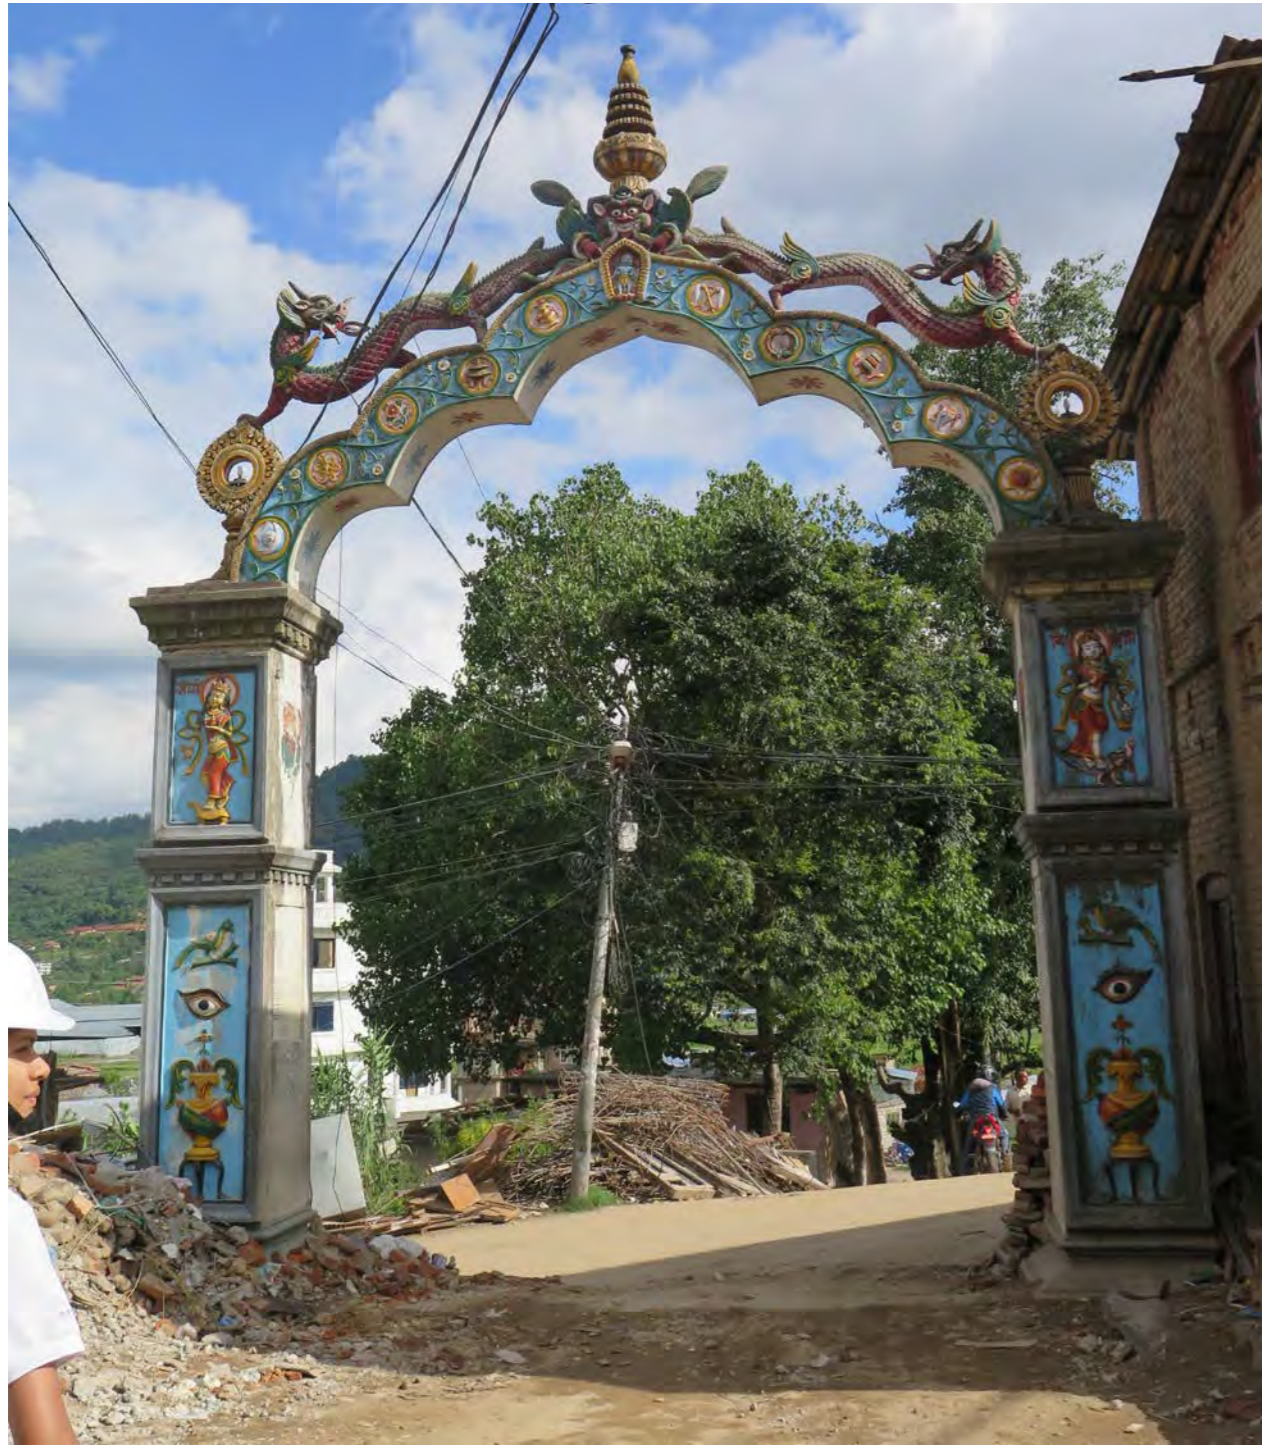
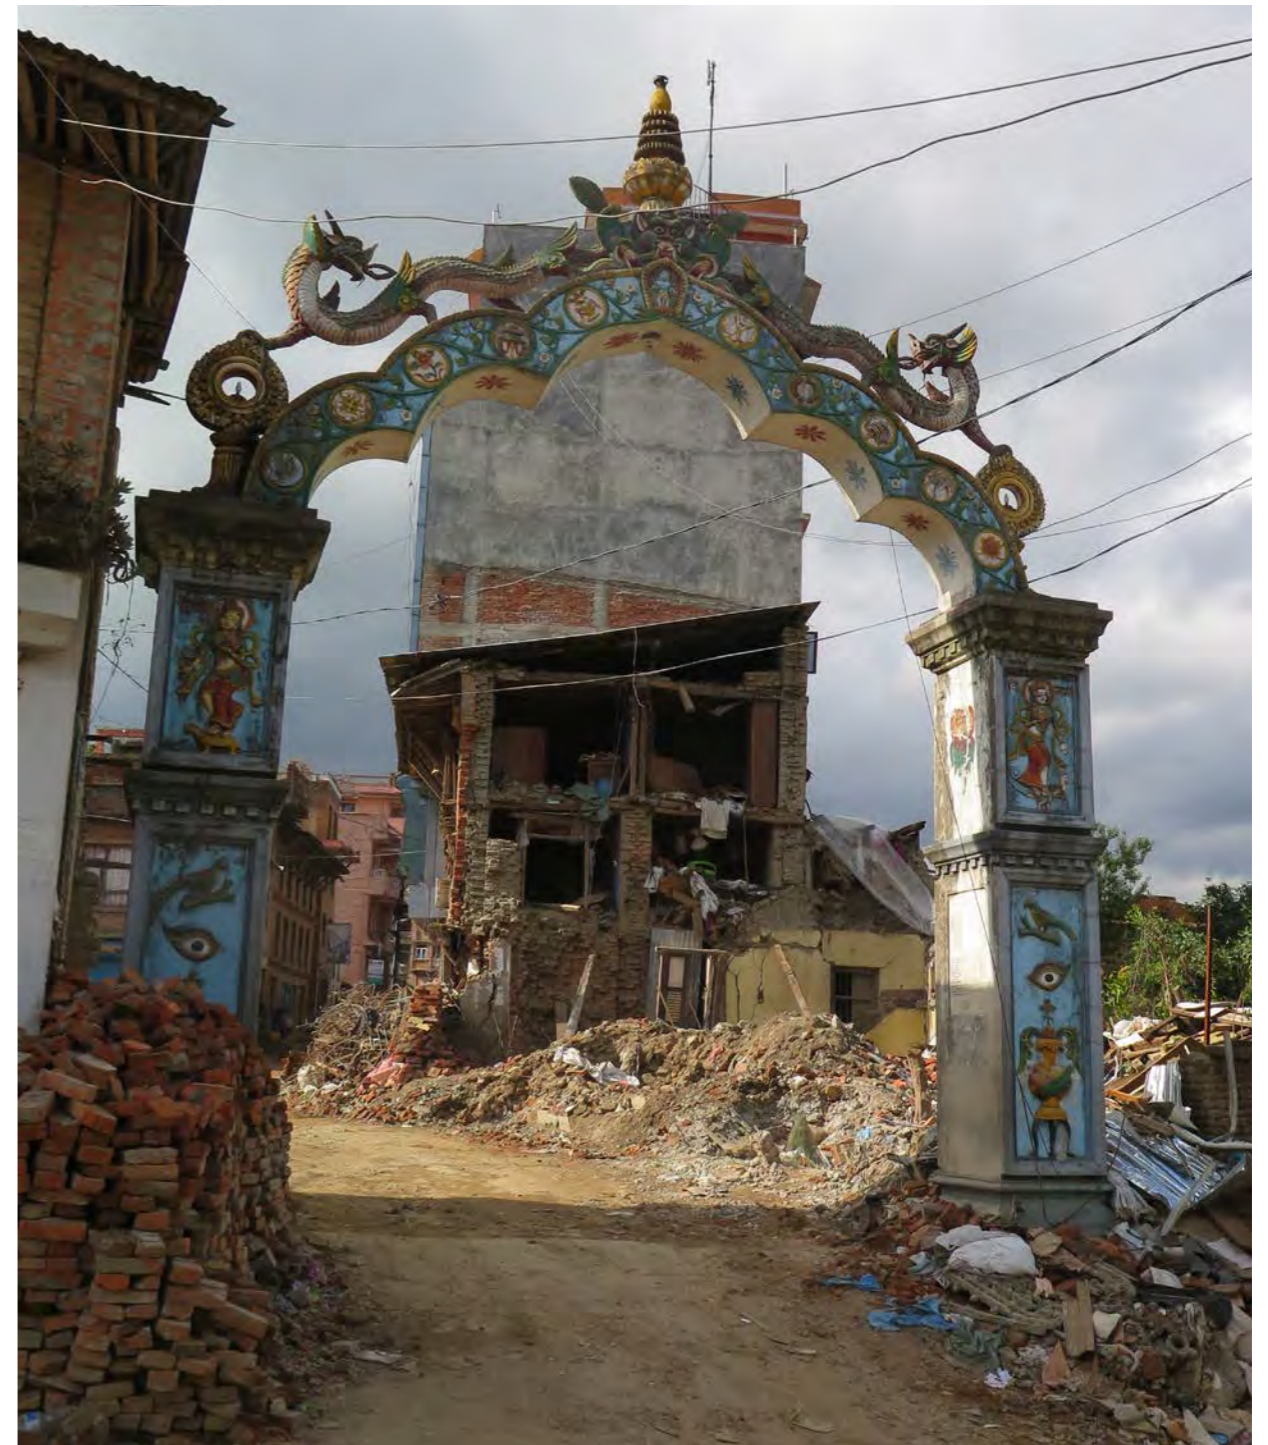
L01 MHYAMACHA DHAWKA

NUMBER	NAME	ESTABLISHED DATE (A.D.)	TYPOLOGY	GENERAL DESCRIPTION	PROBLEMS DESCRIPTION	DANGER/ DESTROY
L-01	Mhyamacha Dhawka		Gate	Concrete and Brick recent structure	No visible damage.

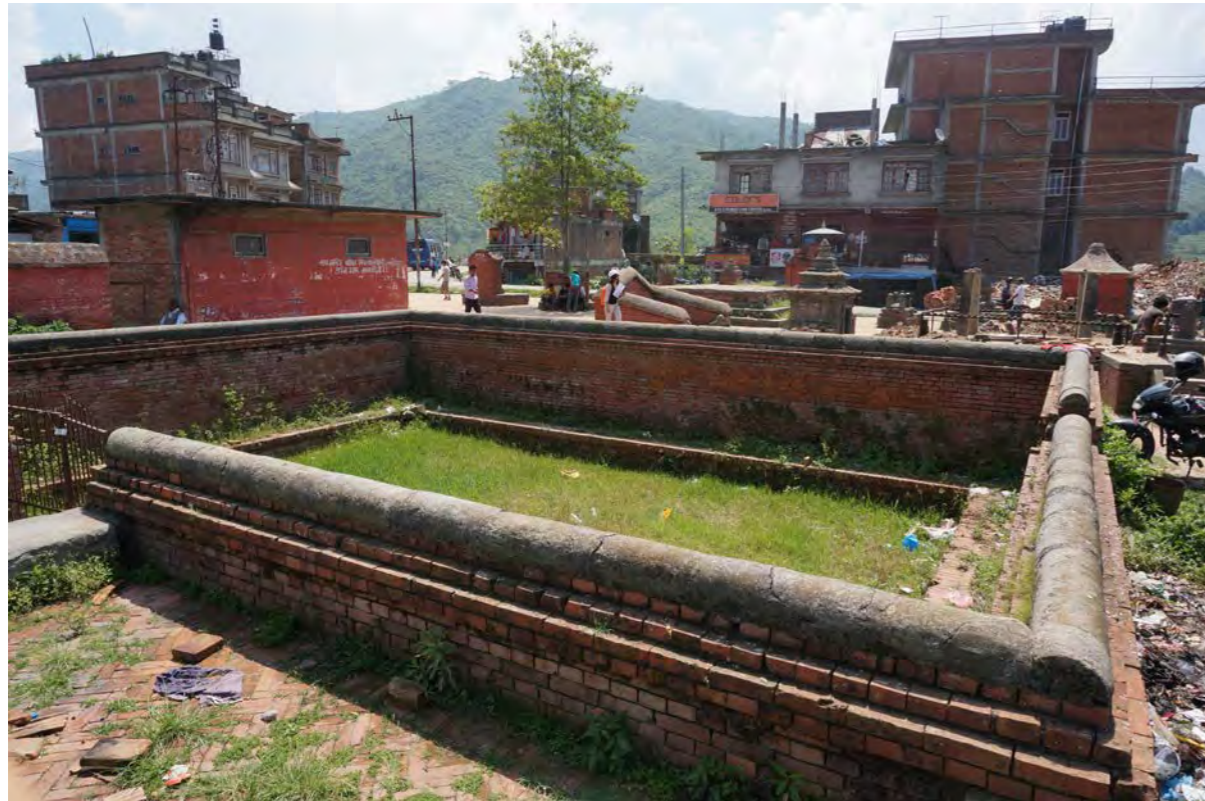
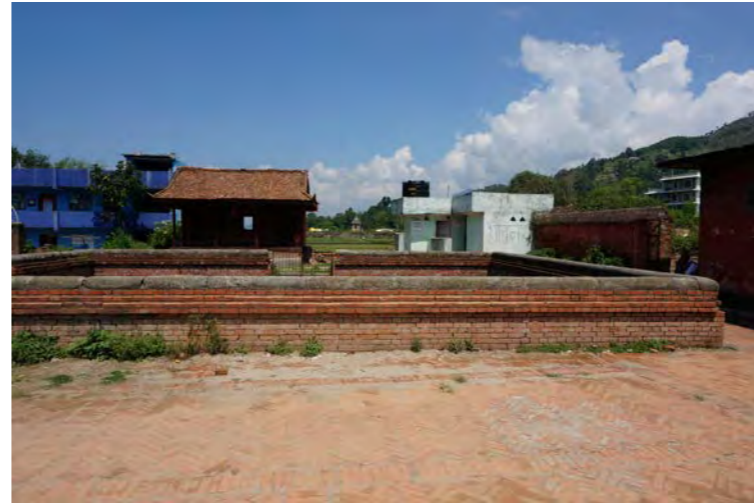
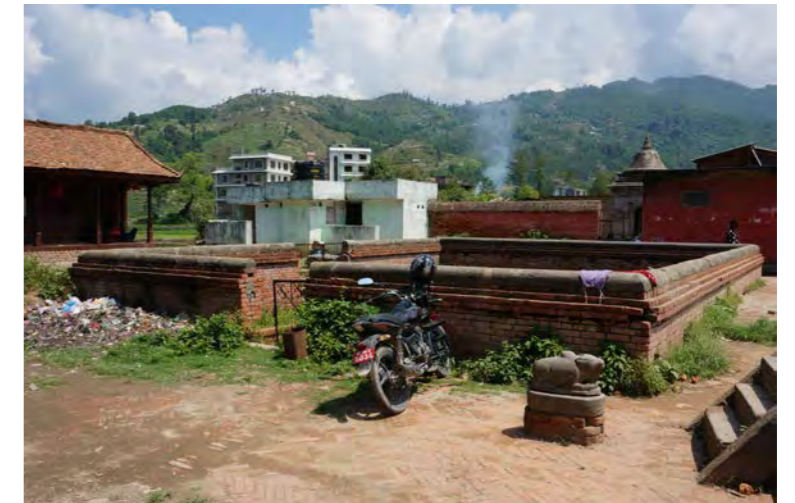
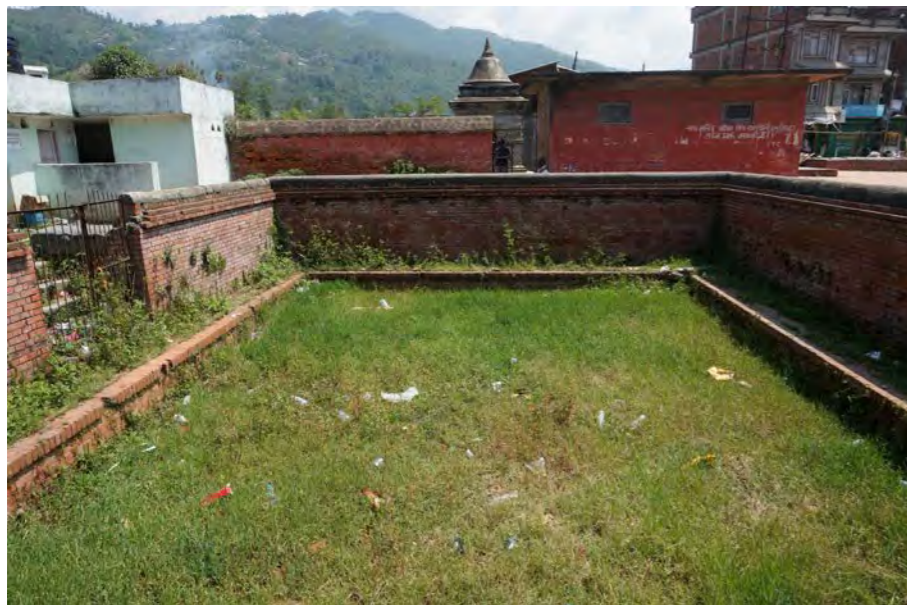
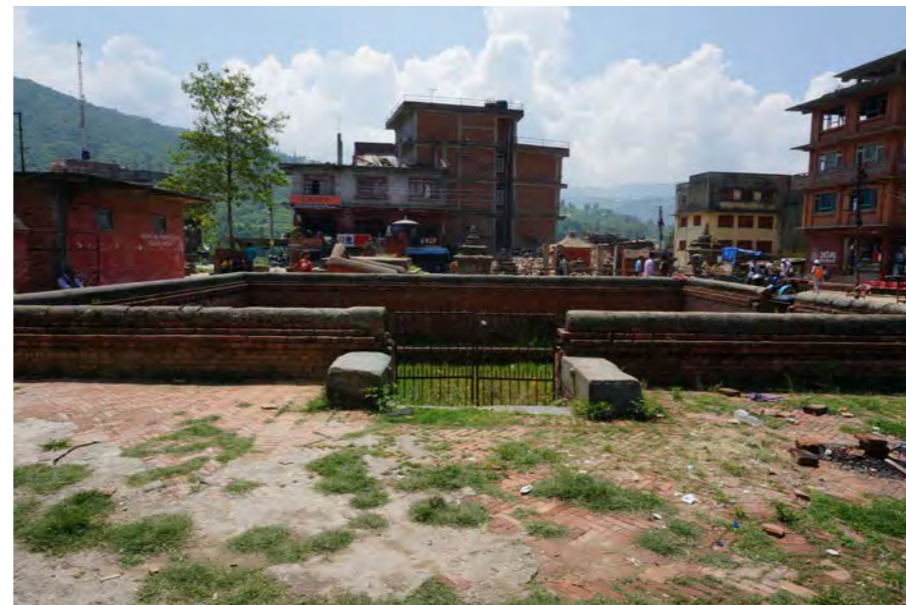
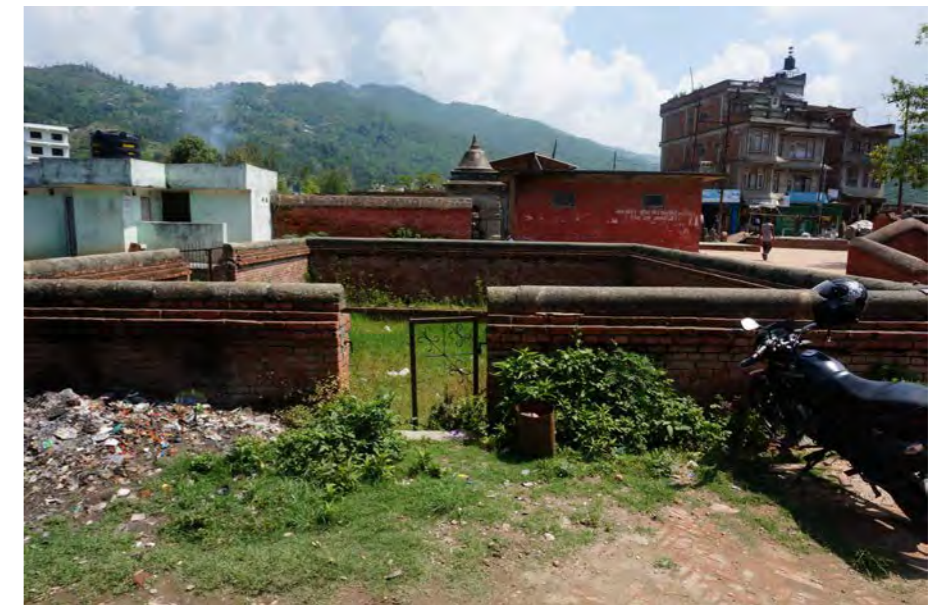
M01 POND

NUMBER	NAME	ESTABLISHED DATE (A.D.)	TYPOLOGY	GENERAL DESCRIPTION	PROBLEMS DESCRIPTION	DANGER/ DESTROY	
M01			Pond		South entrance damaged. First step inside with broken bricks on the west.

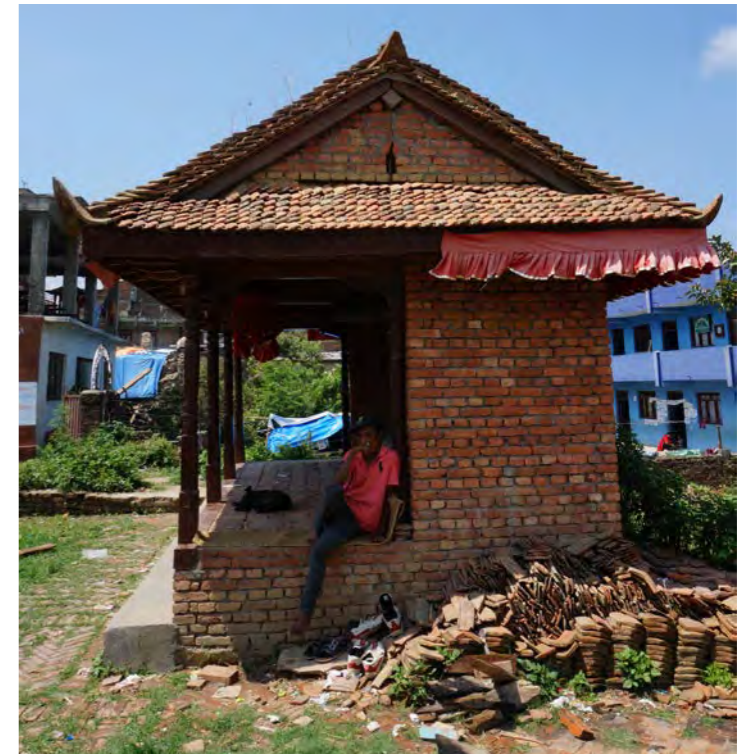
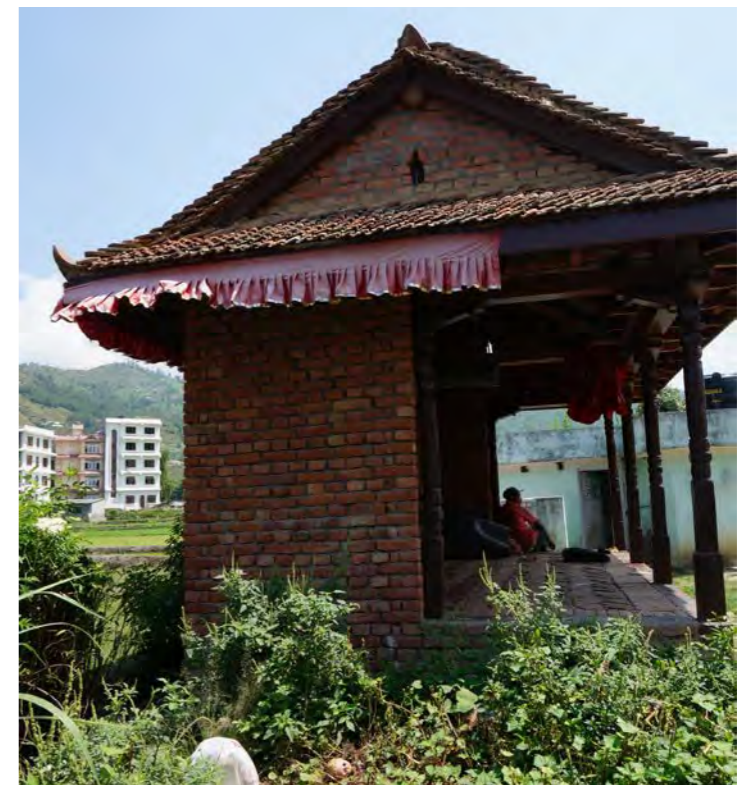
M02 PATI

NUMBER	NAME	DATE A.D.	TYPOLOGY	GENERAL DESCRIPTION	PROBLEMS DESCRIPTION	DANGER/ DESTROY	
M02			Pati	Brick wall and new pillars.	No visible damage.
