2015 Earthquake Damage Mapping

Sankhu

October 2015

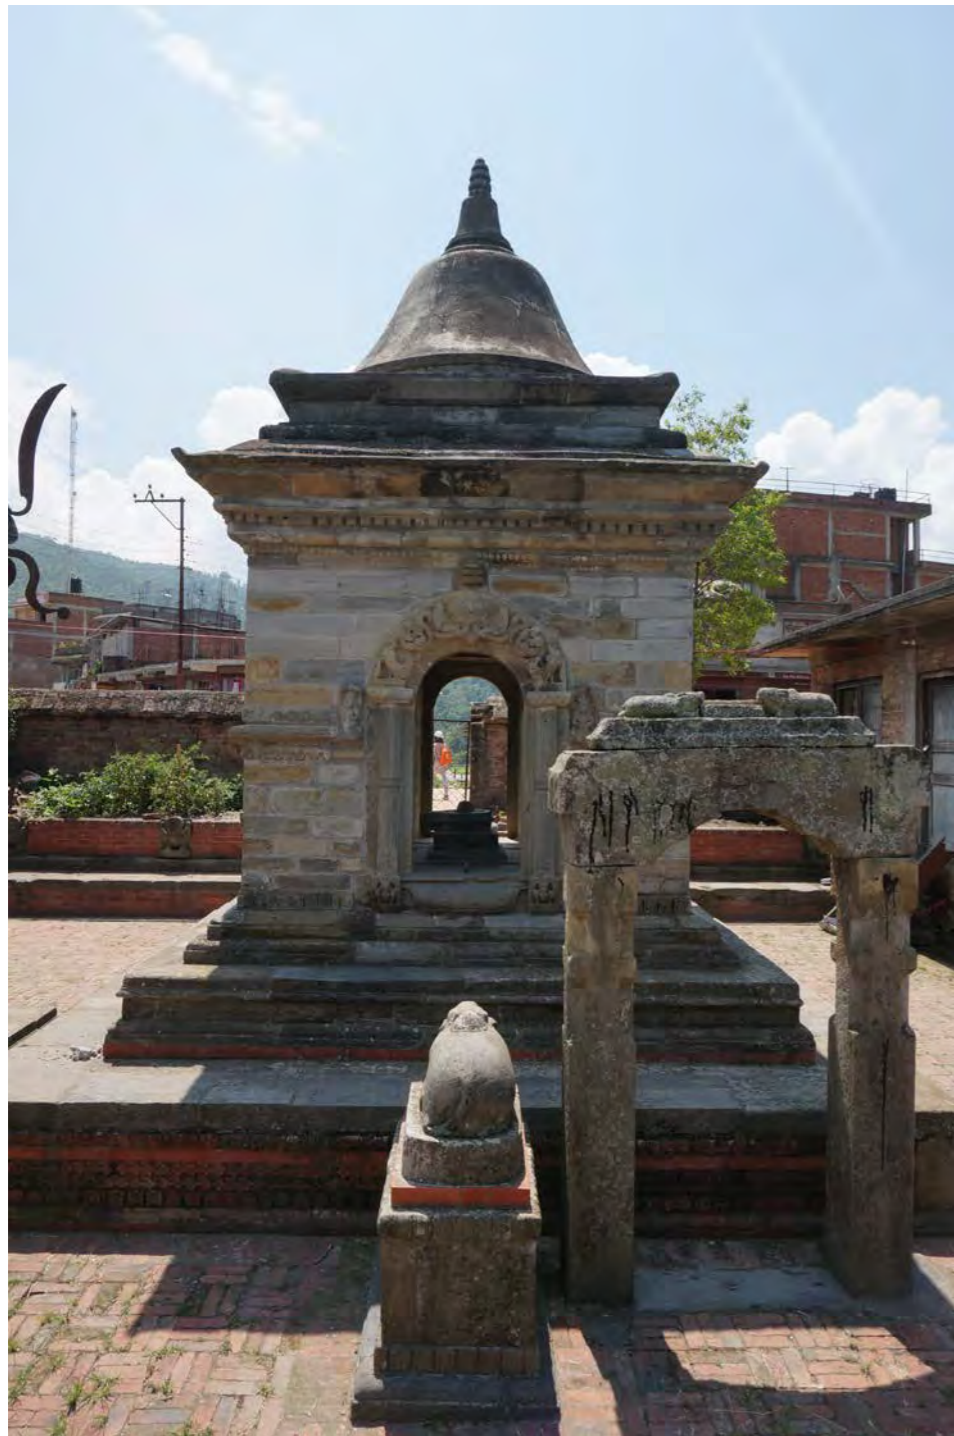
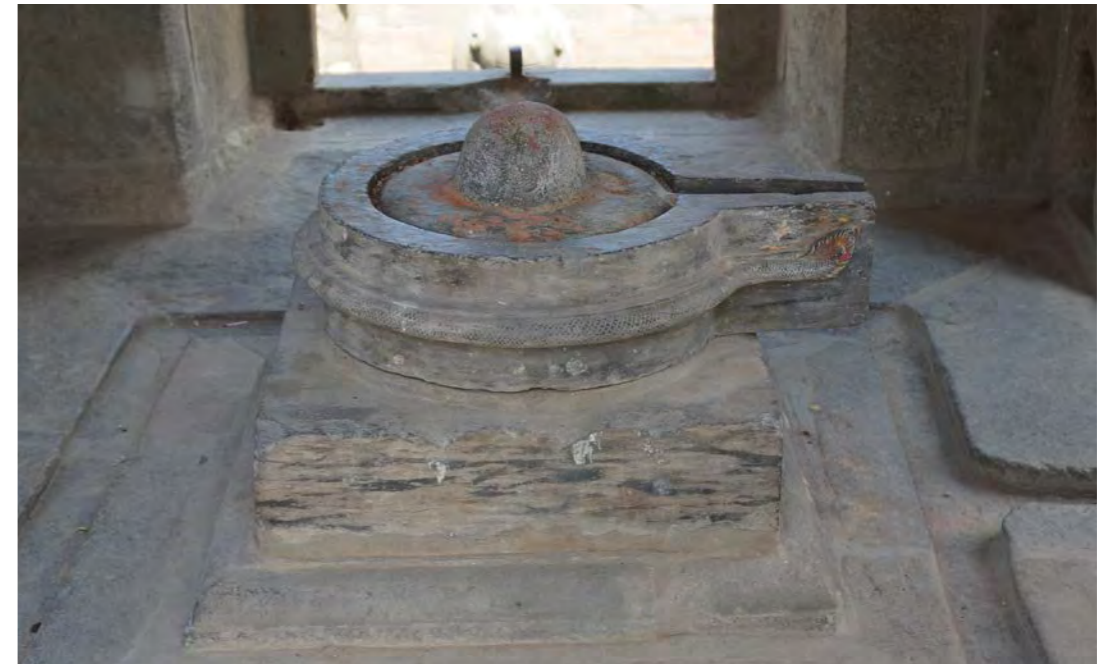
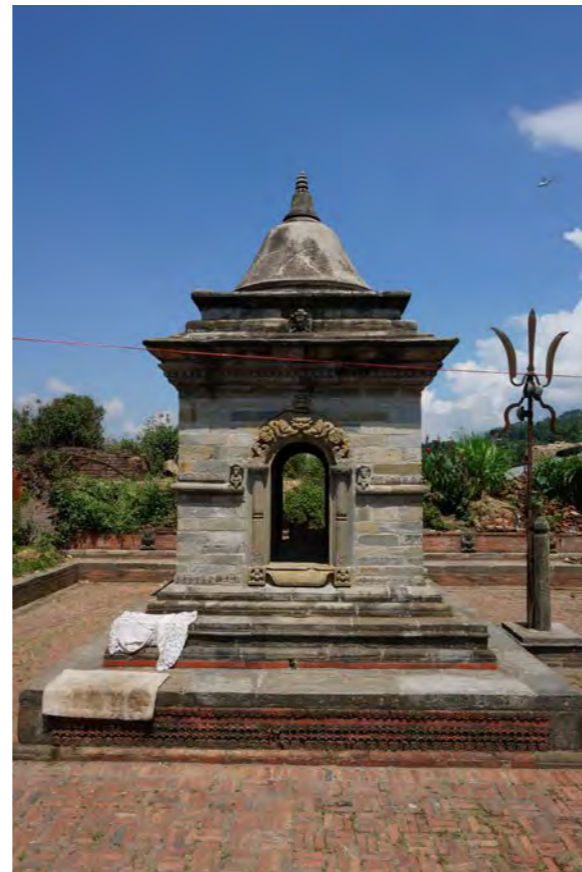
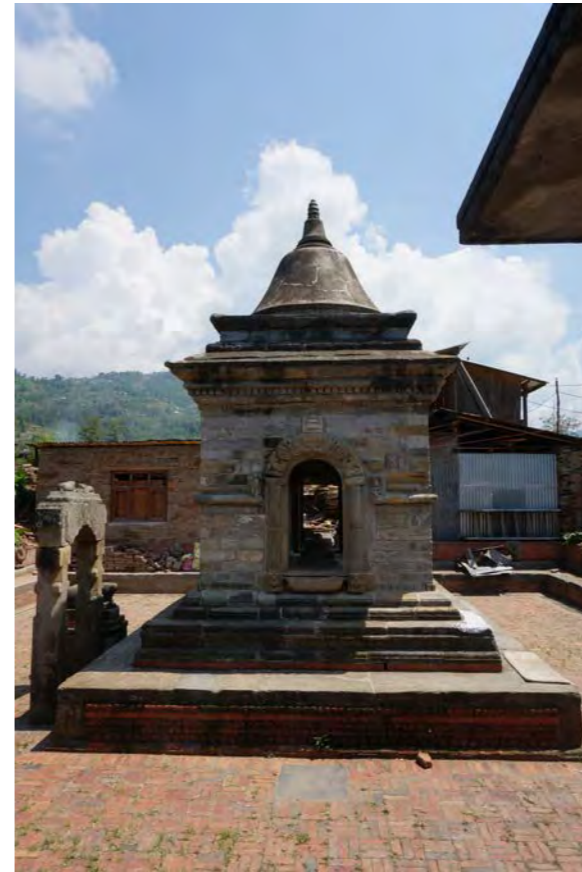
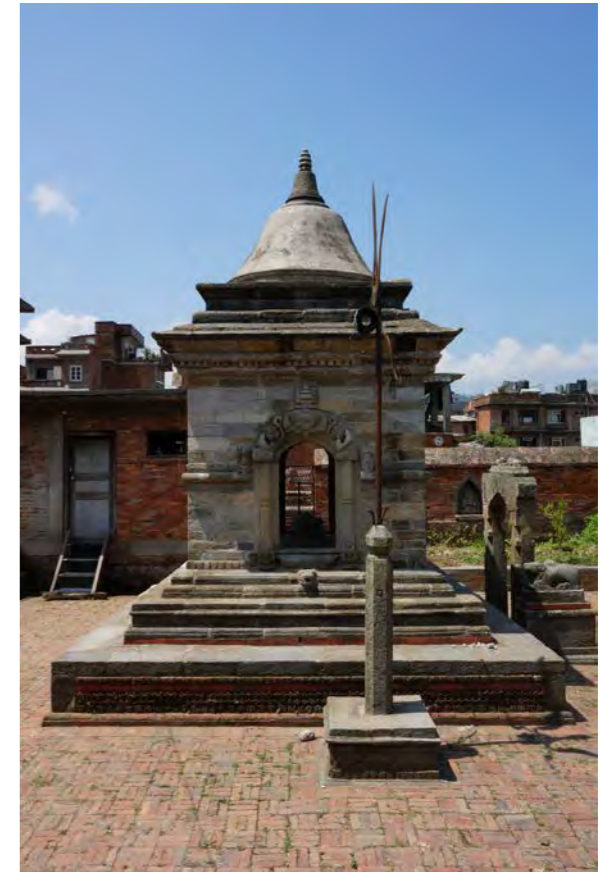
M04 SHIVA TEMPLE

NUMBER	NAME	ESTABLISHED DATE (A.D.)	TYPOLOGY	GENERAL DESCRIPTION	PROBLEMS DESCRIPTION	DANGER/ DESTROY	
M04	Shiva temple		Enclosed Shrine	Stone structure with cement plaster dome. Privatized temple by family Guthi.	No visible damage.

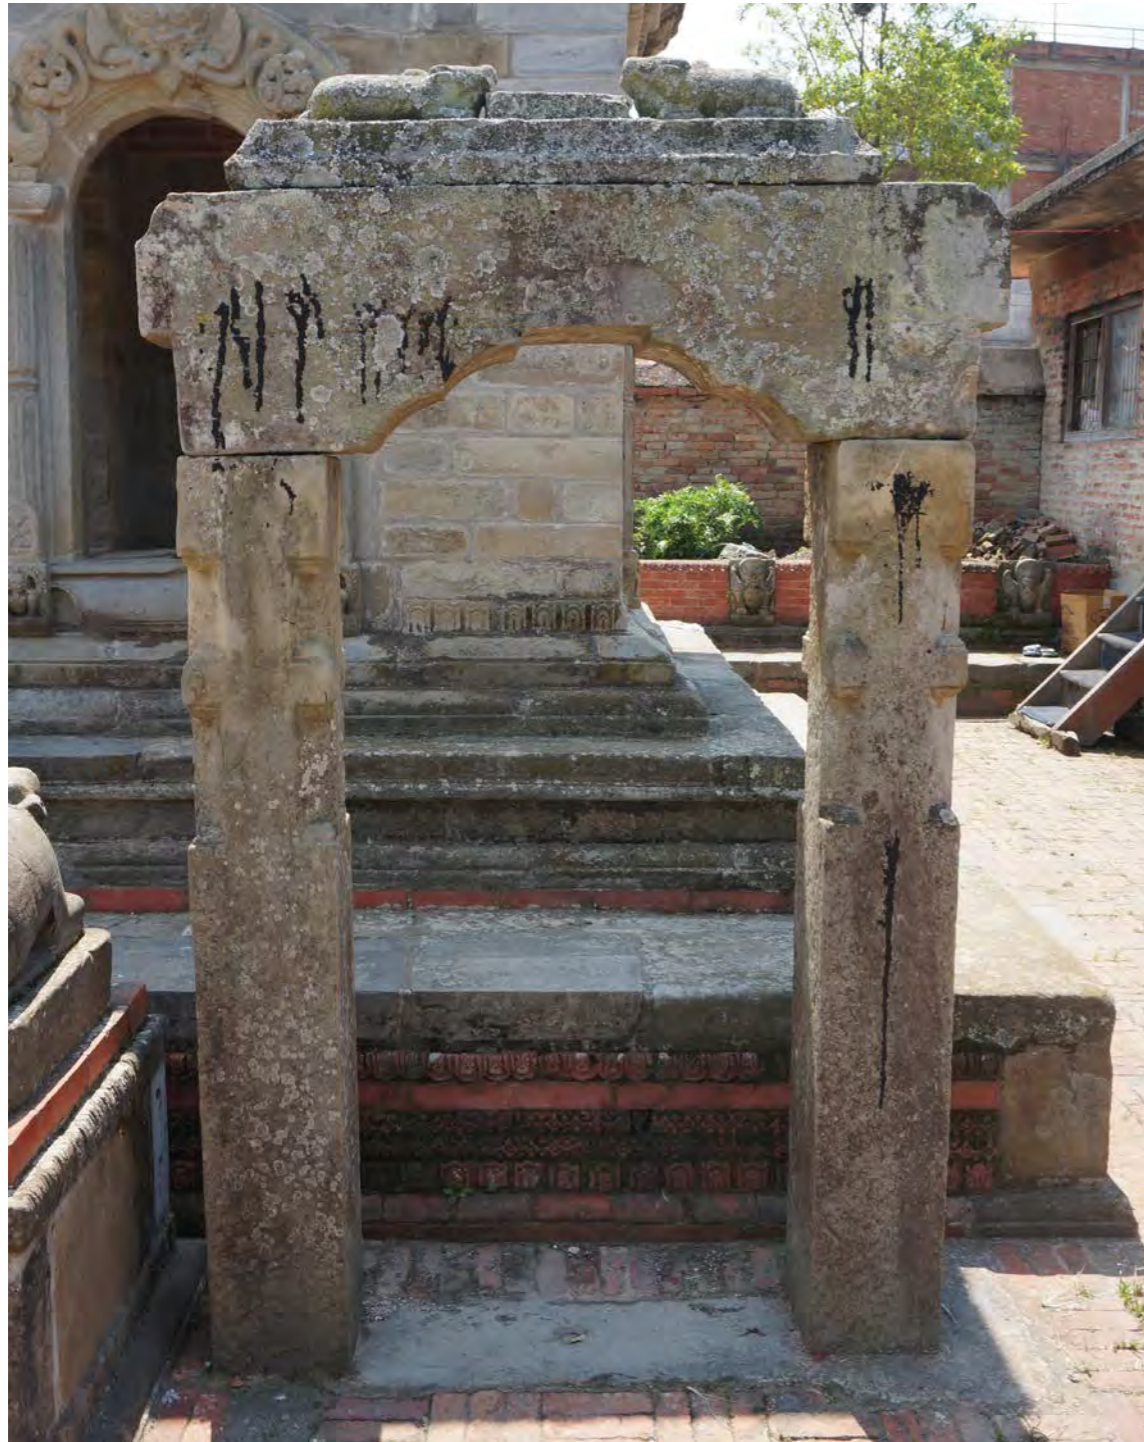
M05 BELL AND NANDI

NUMBER	NAME	DATE A.D.	TYPOLOGY	GENERAL DESCRIPTION	PROBLEMS DESCRIPTION	DANGER/ DESTROY	
M05	Stone frame and Nandi		Bell and statue	Renovated 5-6 years ago.	Bell missing from the frame.		
M06	Stone post with metal trishul		Post		No visible damage.

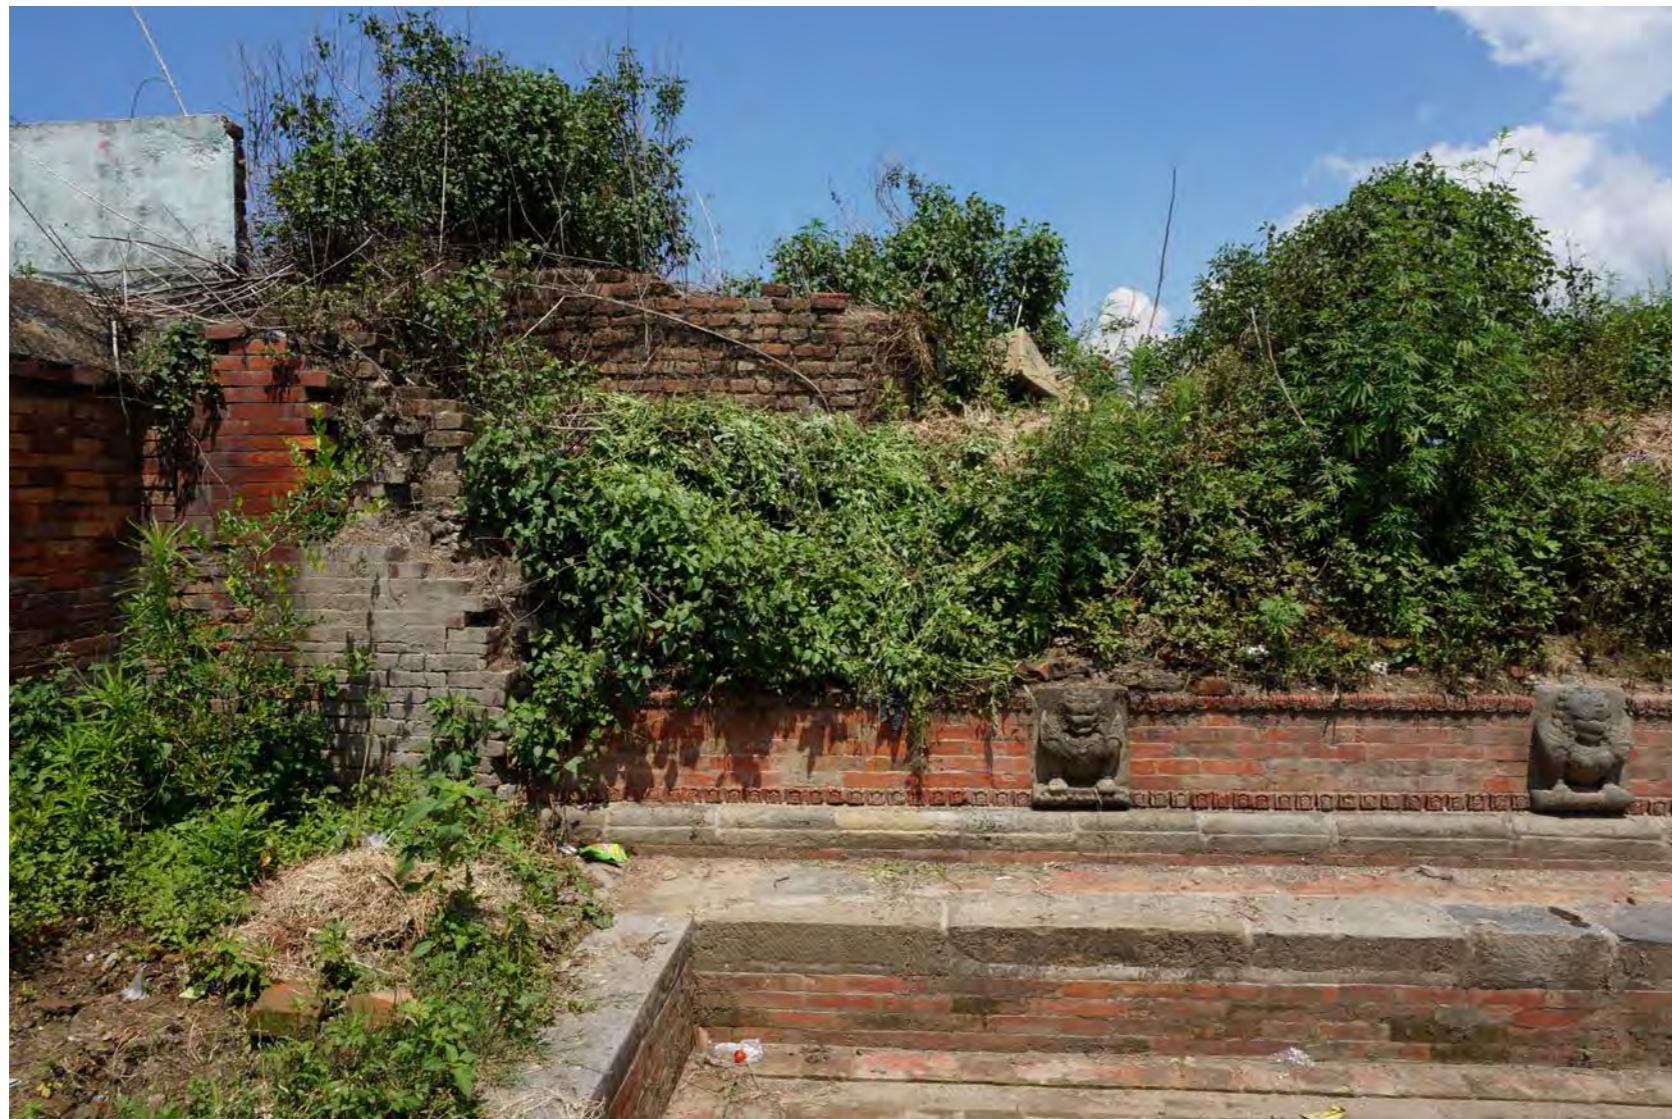
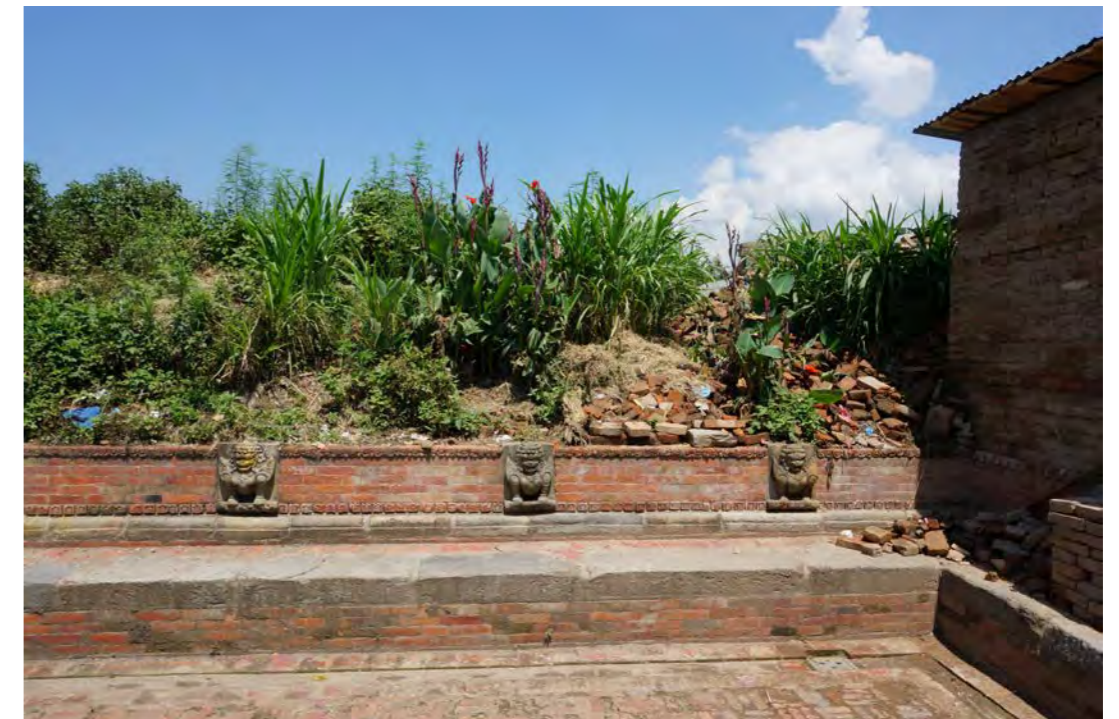
M07 SATTAL

NUMBER	NAME	ESTABLISHED DATE (A.D.)	TYPOLOGY	GENERAL DESCRIPTION	PROBLEMS DESCRIPTION	DANGER/ DESTROY	
M07			Sattal	In private guthi property	Collapsed before earthquake. Base of south wall is shifted.

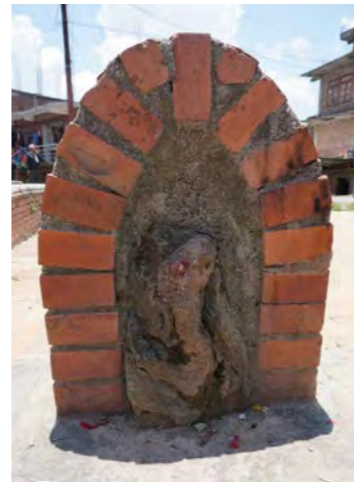
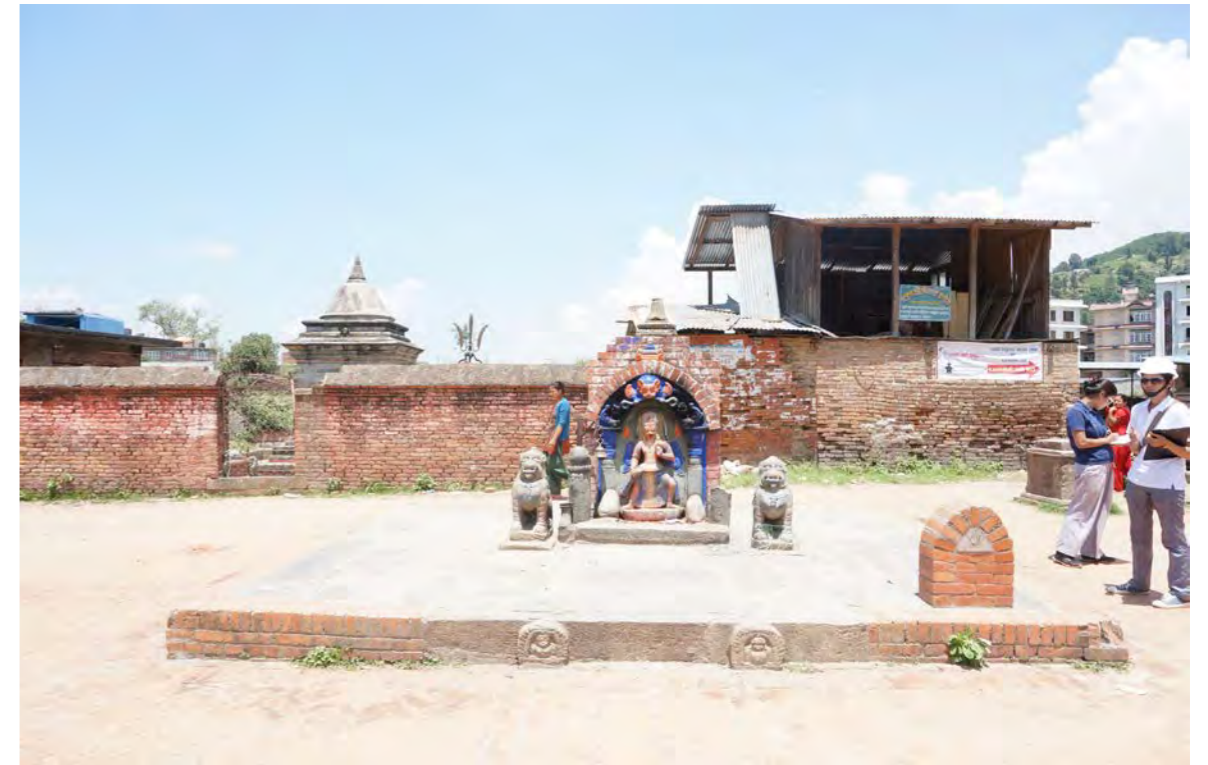
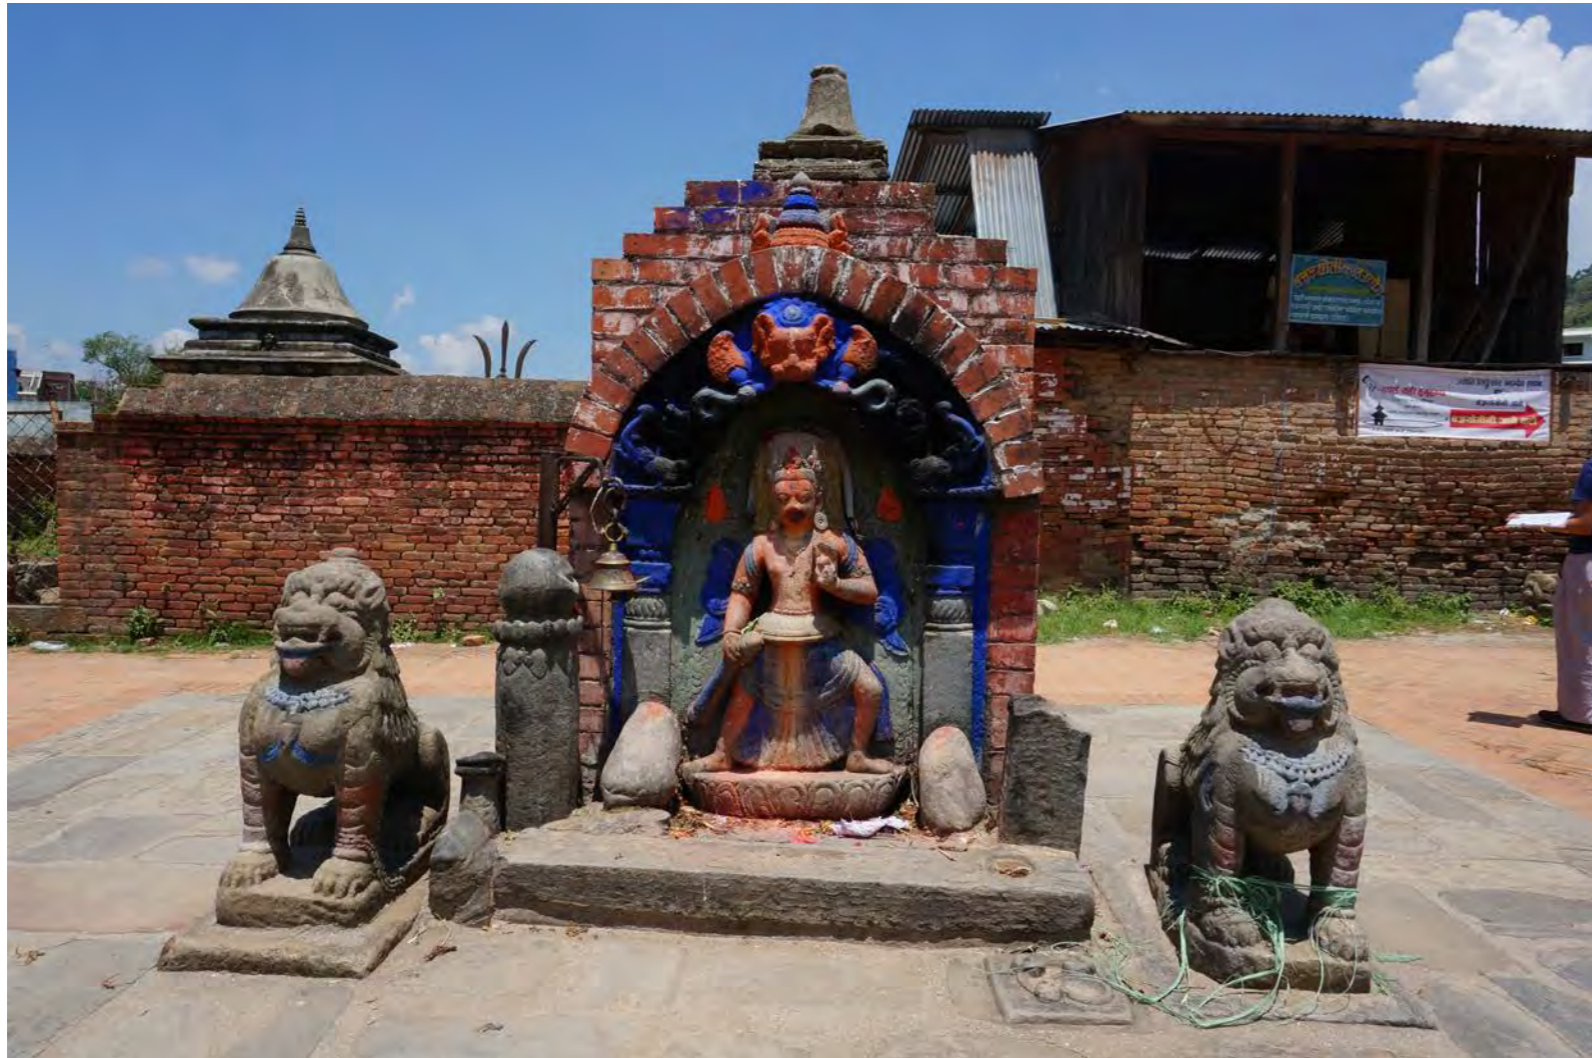
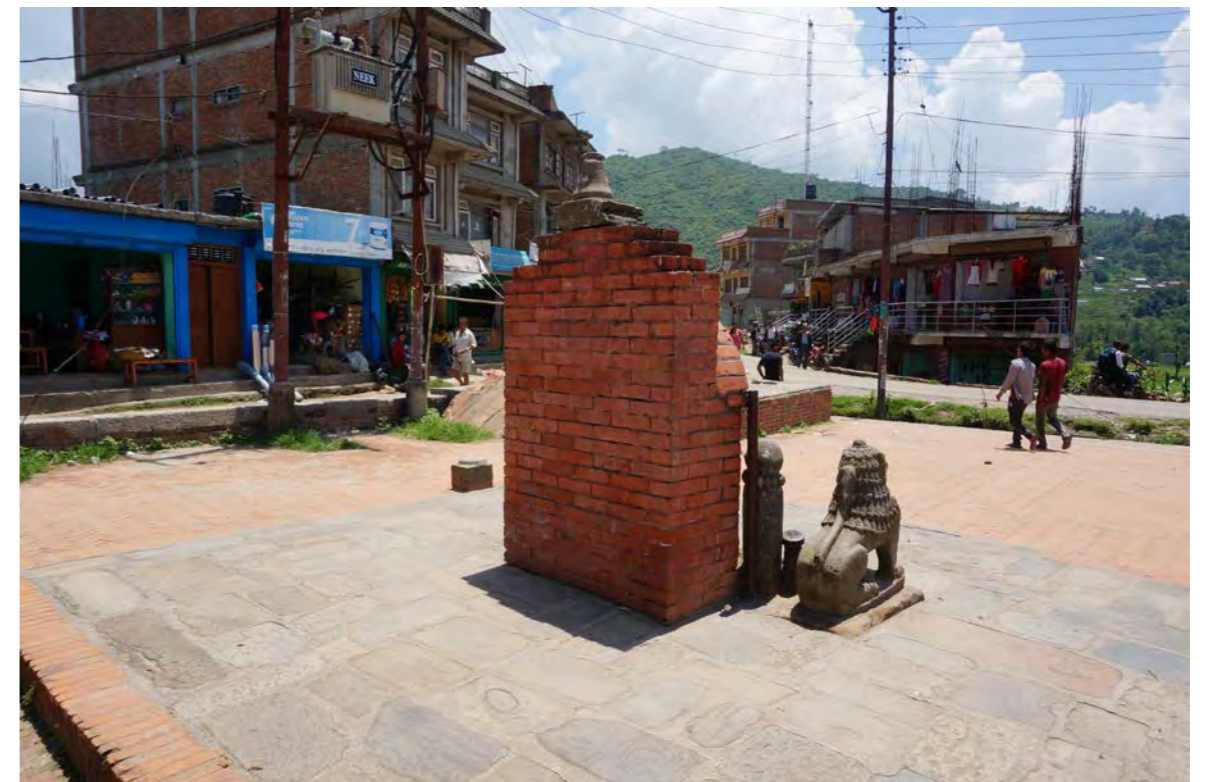
M08 BHIMSEN

NUMBER	NAME	DATE A.D.	TYPOLOGY	GENERAL DESCRIPTION	PROBLEMS DESCRIPTION	DANGER/ DESTROY
M08	Bhimsen on platform		Open Shrine	Cement plastered on idol and coloured.	Upper gajur shifted. Broken stone post.

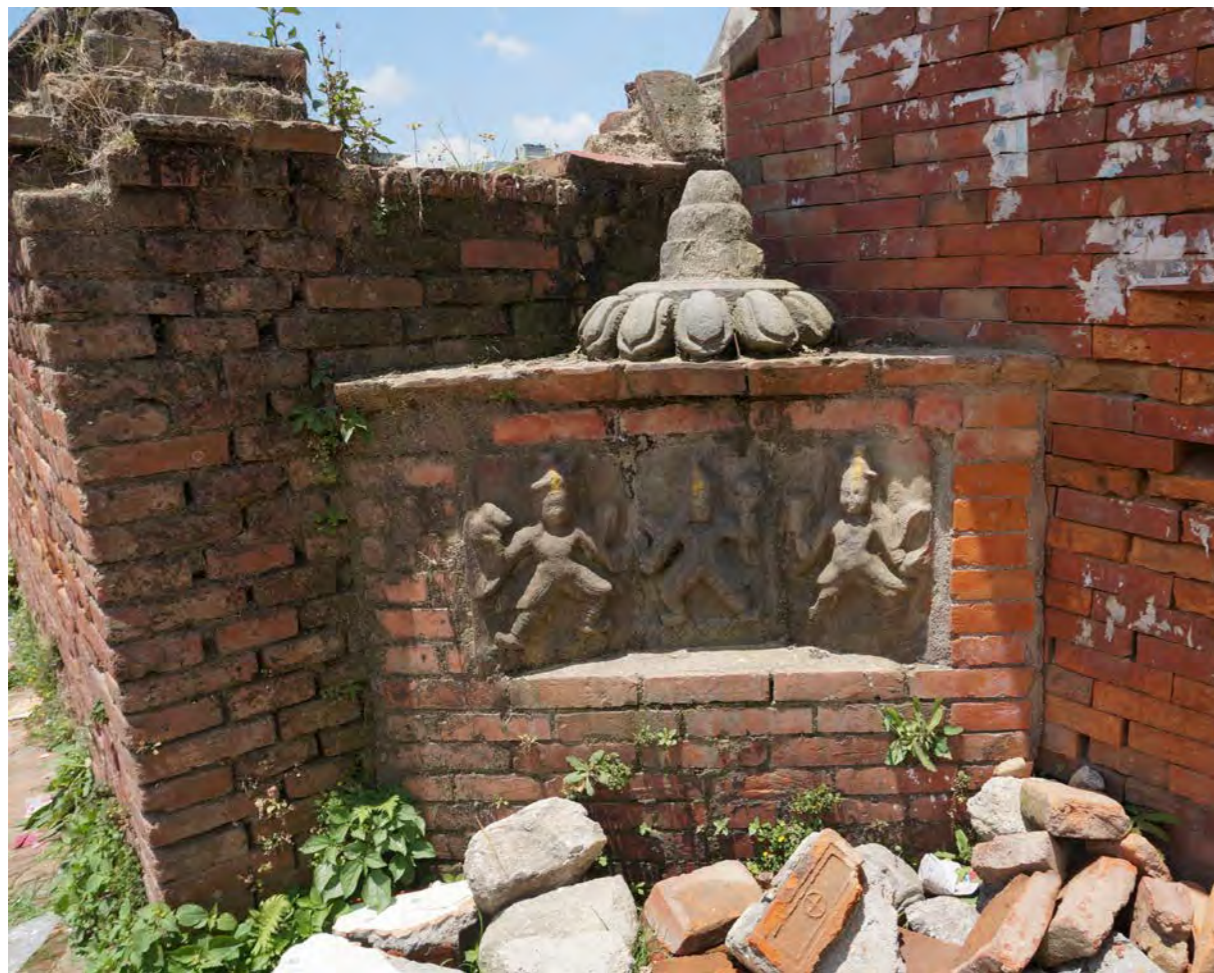
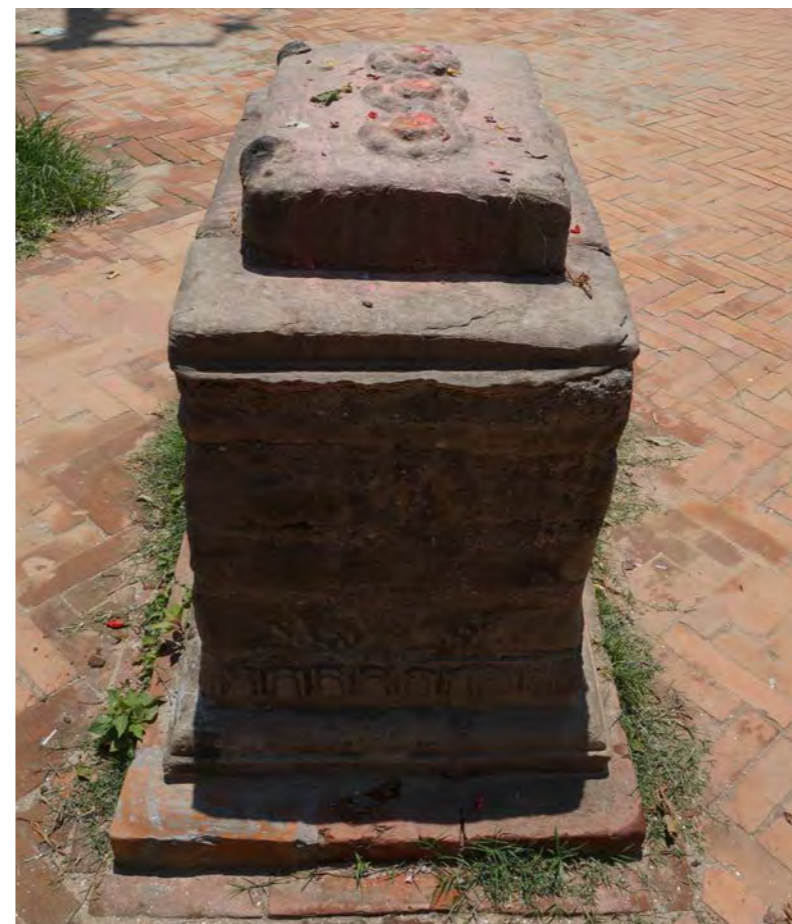
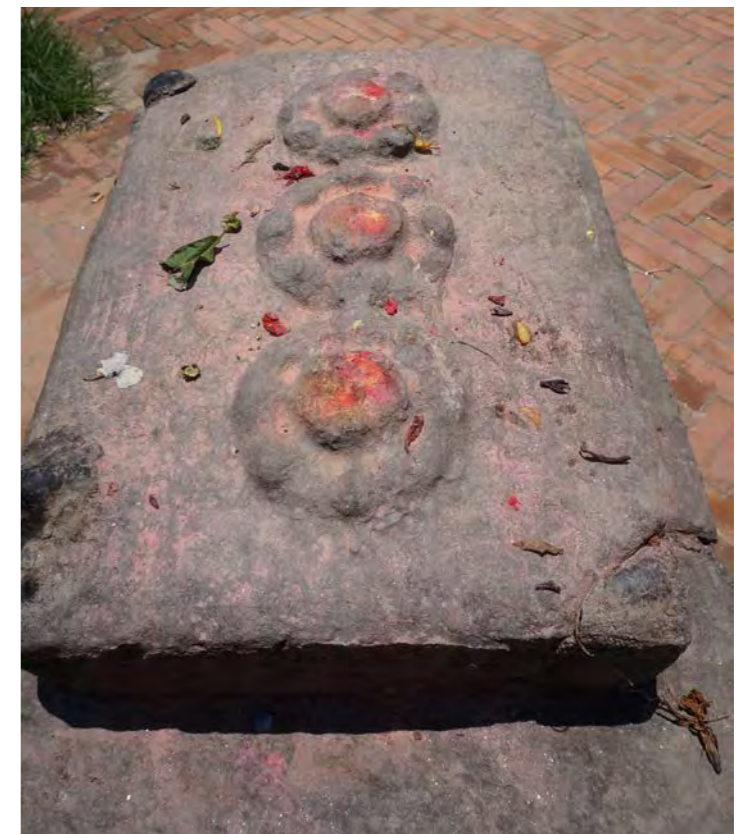
NUMBER	NAME	ESTABLISHED DATE (A.D.)	TYPOLOGY	GENERAL DESCRIPTION	PROBLEMS DESCRIPTION	DANGER/ DESTROY	
M09			Open Shrine	3 stone sculptures on a curved brick wall with stone gajur.	Rising damp. Wall is slightly damaged.		
M10			Open Shrine	3 circular stone motifs on a stone wall. Cement mortar is used in the wall.	No visible damage.

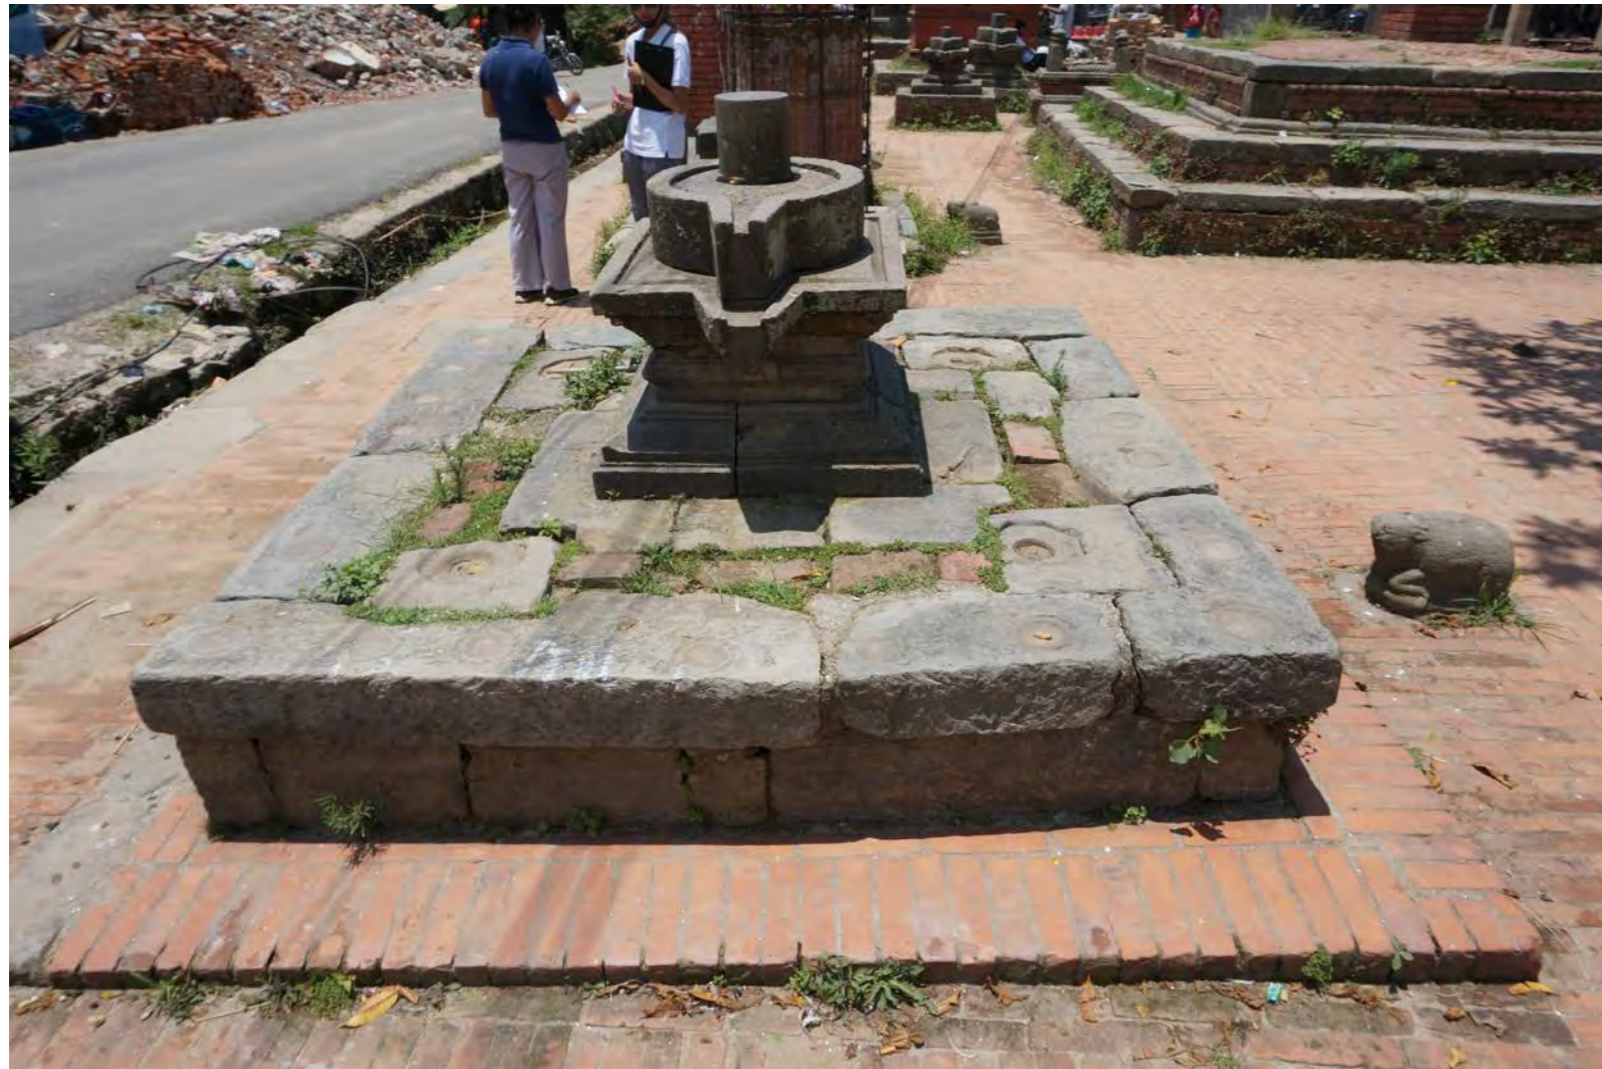
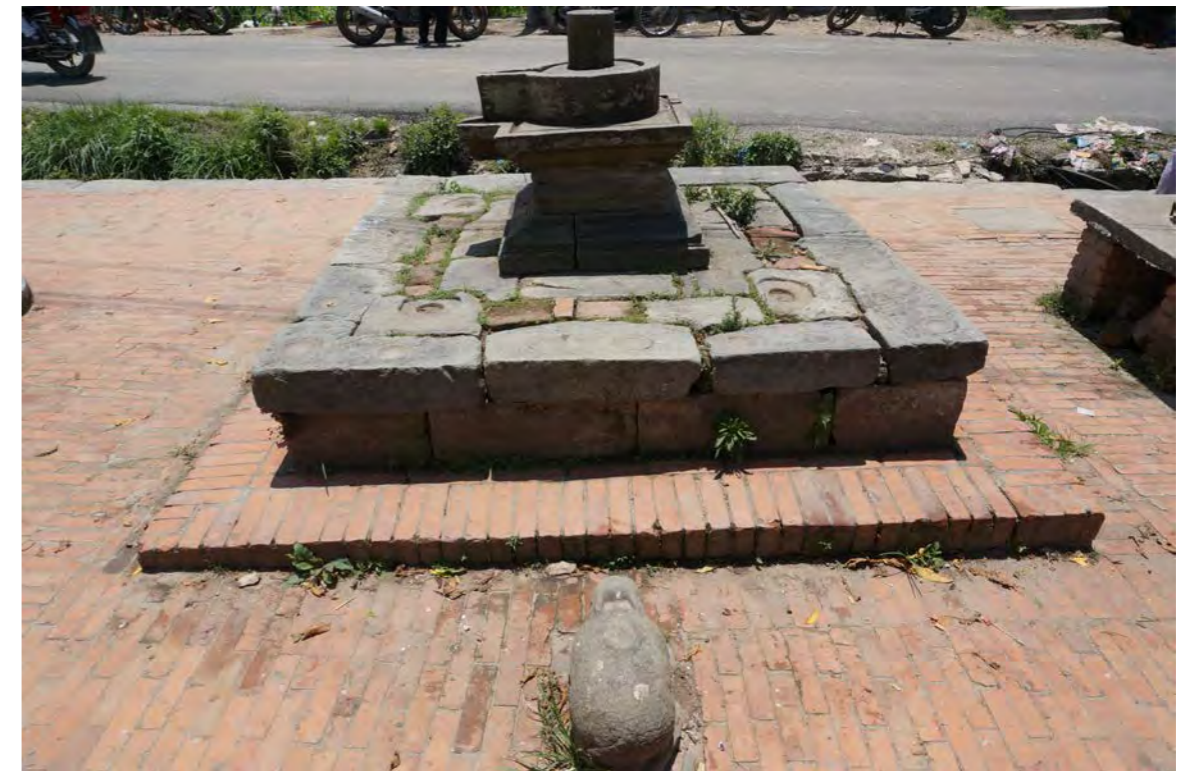
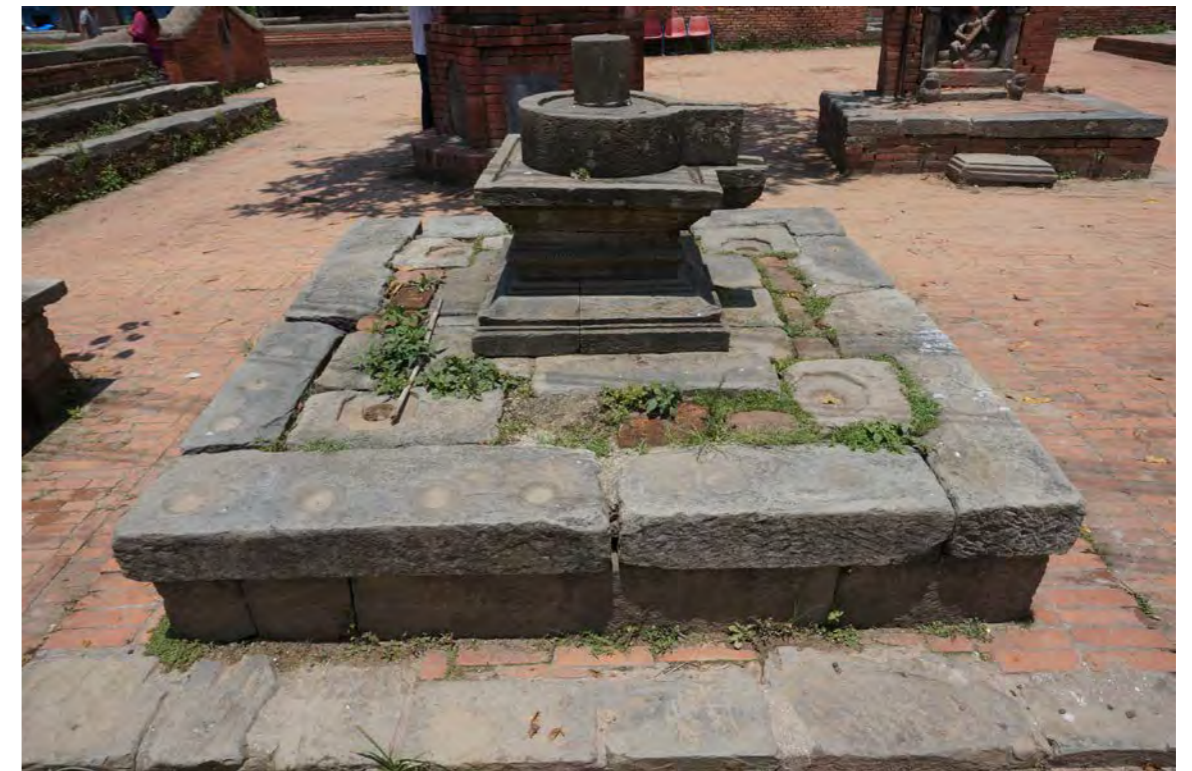
M12 SHIVA LINGA

NUMBER	NAME	ESTABLISHED DATE (A.D.)	TYPOLOGY	GENERAL DESCRIPTION	PROBLEMS DESCRIPTION	DANGER/ DESTROY	
M12			Shiva linga	Shiva linga on a stone platform. Some bricks are used in the platform. Nandi on the west.	Vegetation growth on platform.

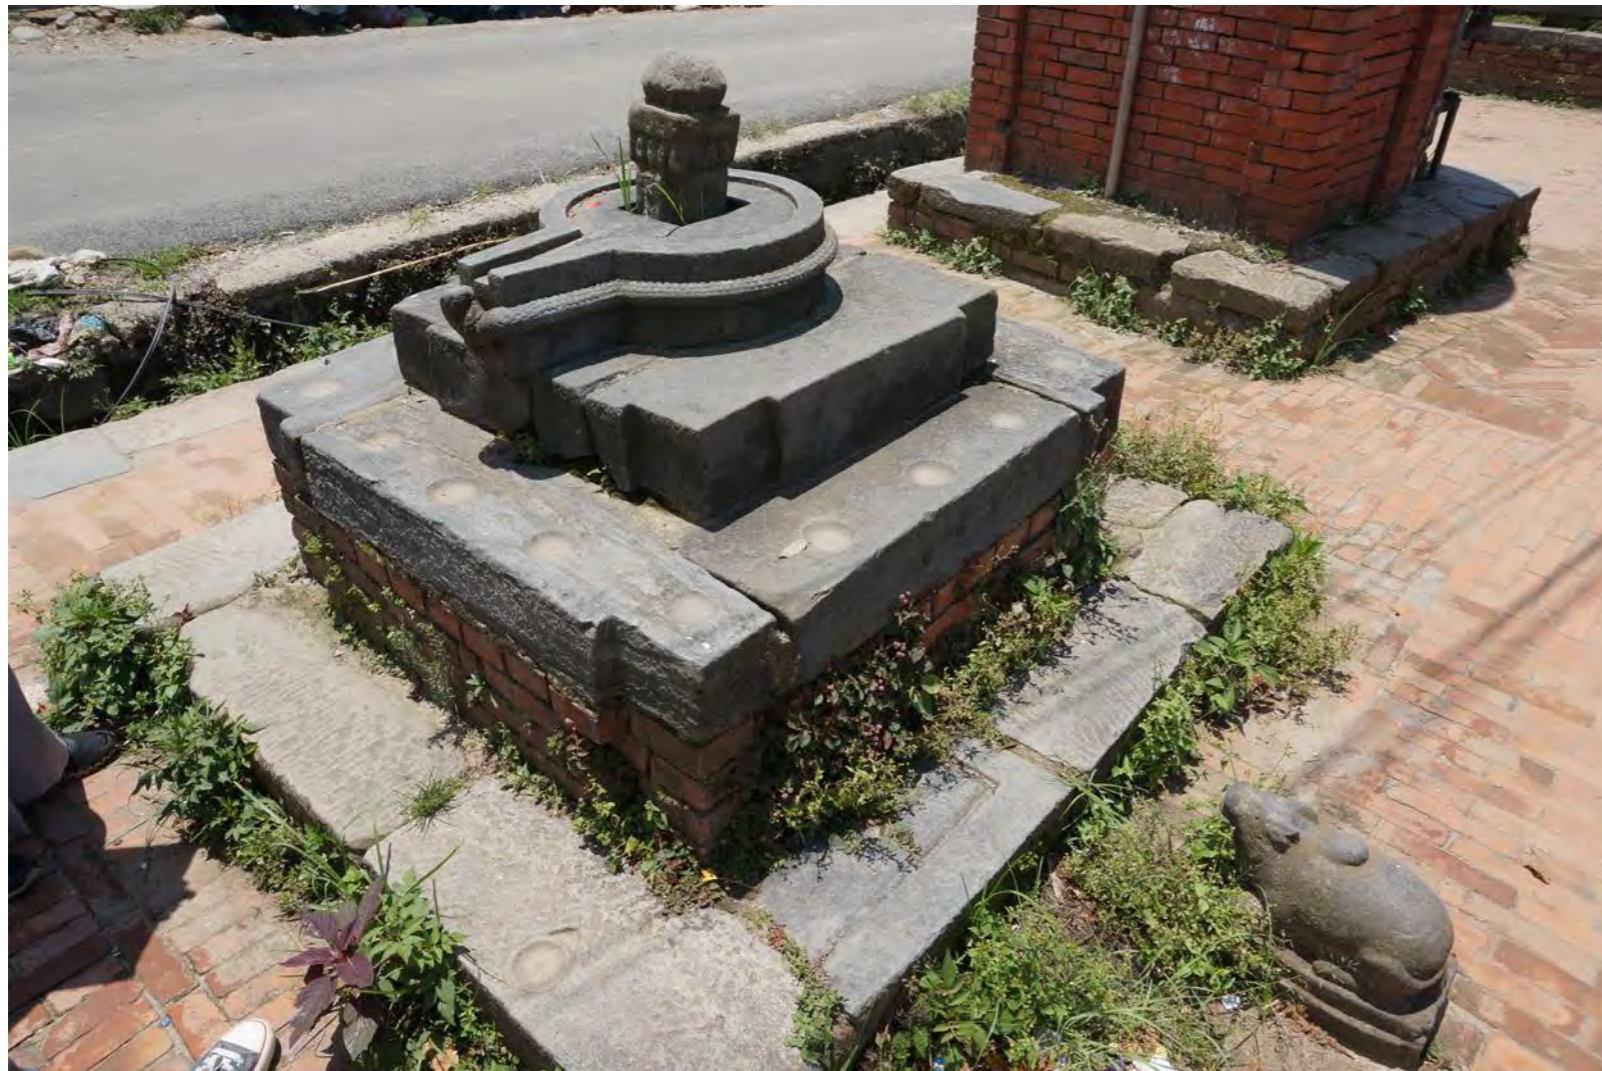
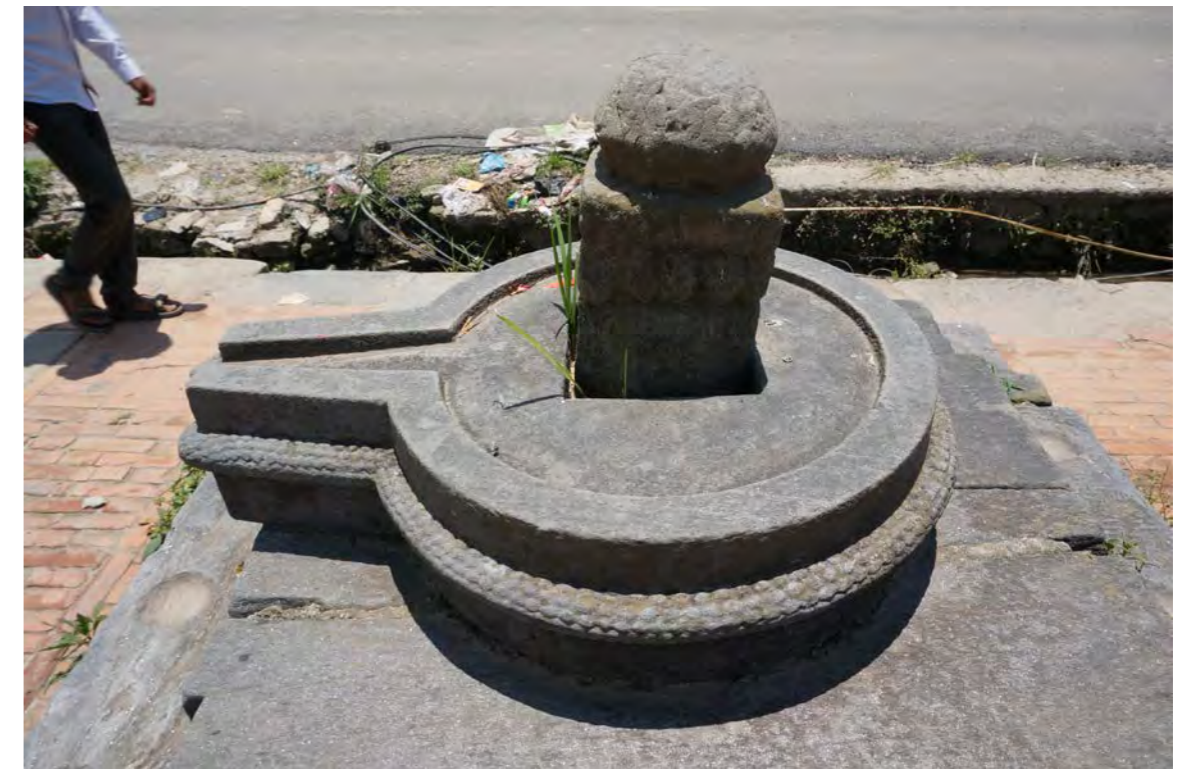
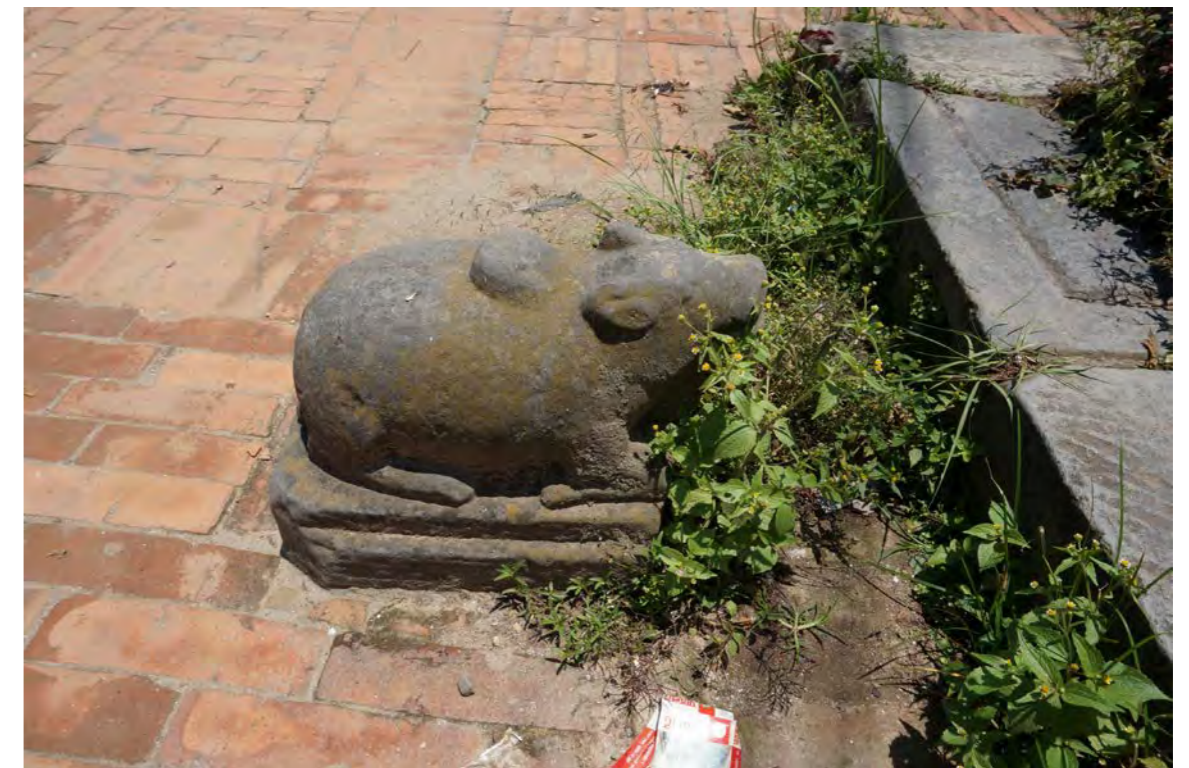
M13 SHIVA LINGA

NUMBER	NAME	DATE A.D.	TPOLOGY	GENERAL DESCRIPTION	PROBLEMS DESCRIPTION	DANGER/ DESTROY	
M13			Shiva linga	Shiva linga on brick walled platform with stone top. Old post from somewhere else seem to be added. Nandi on the west. Cement mortar in stone face of platform	Vegetation growth on the base.
