2015 Earthquake Damage Mapping

Sankhu

October 2015

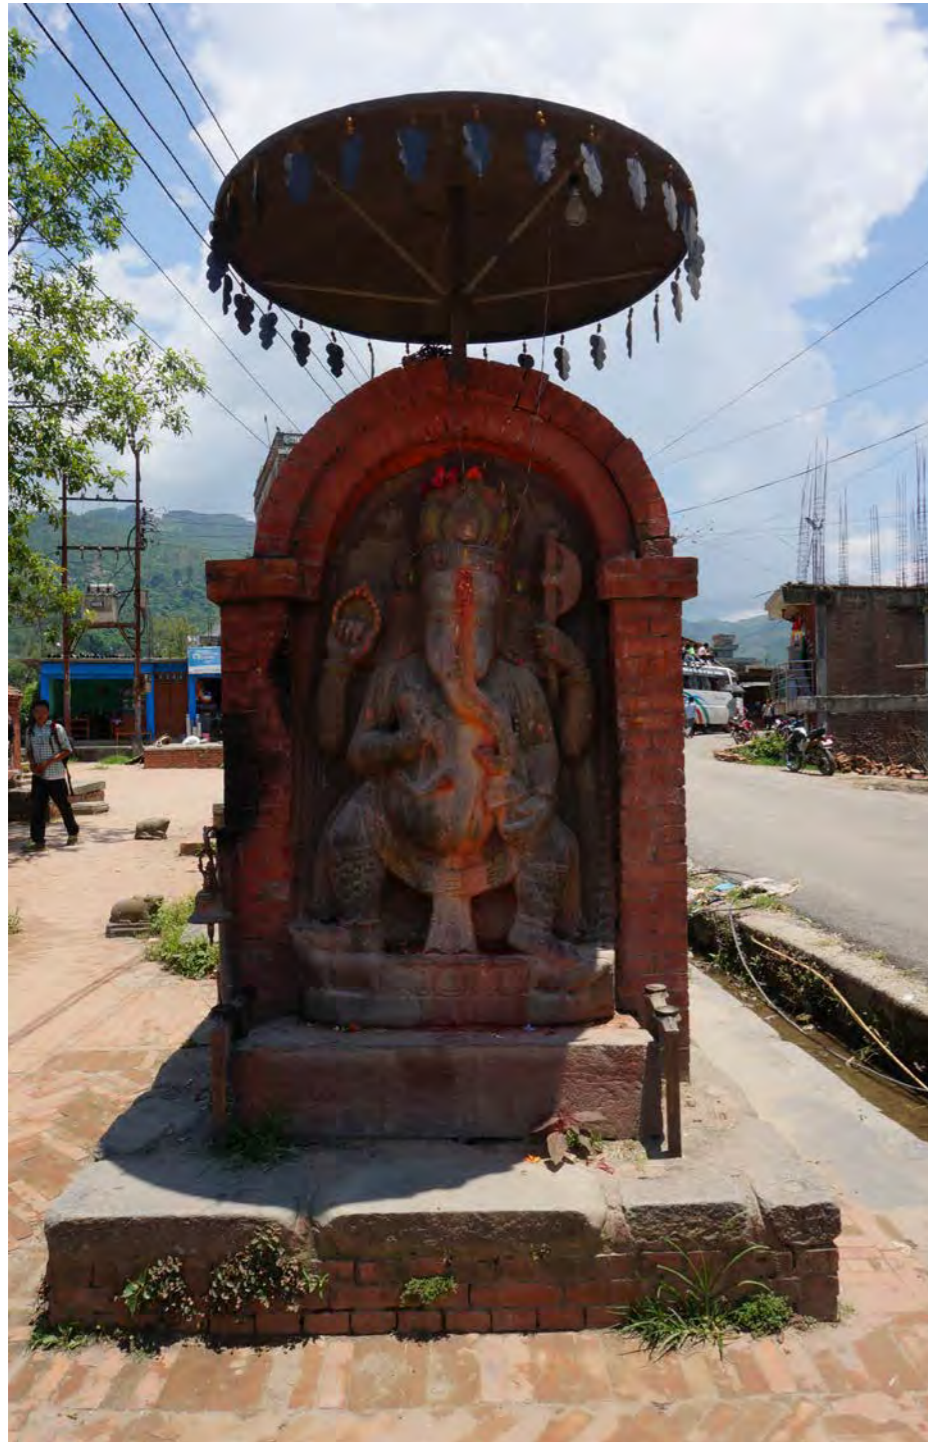
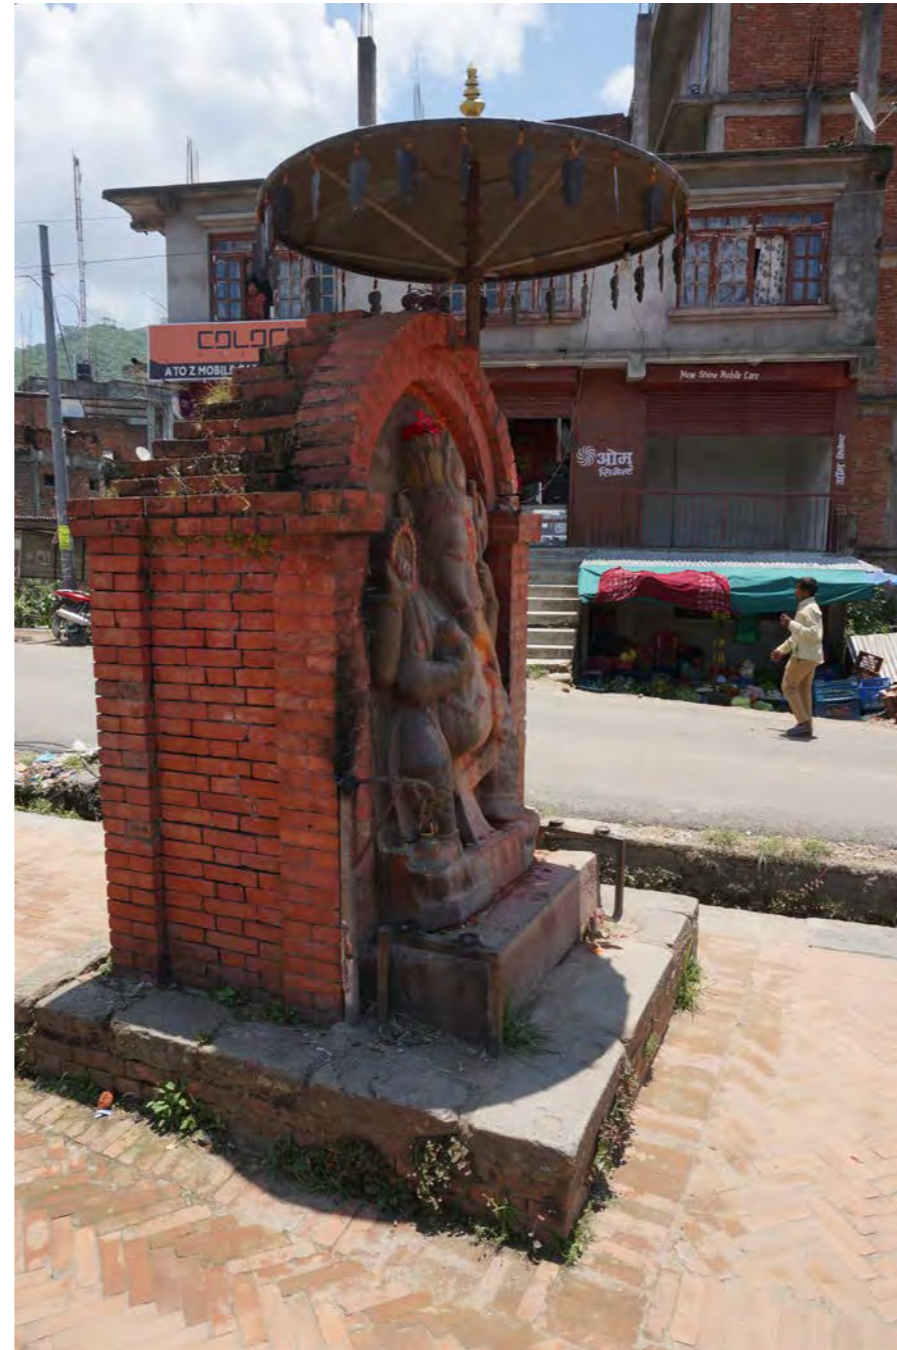
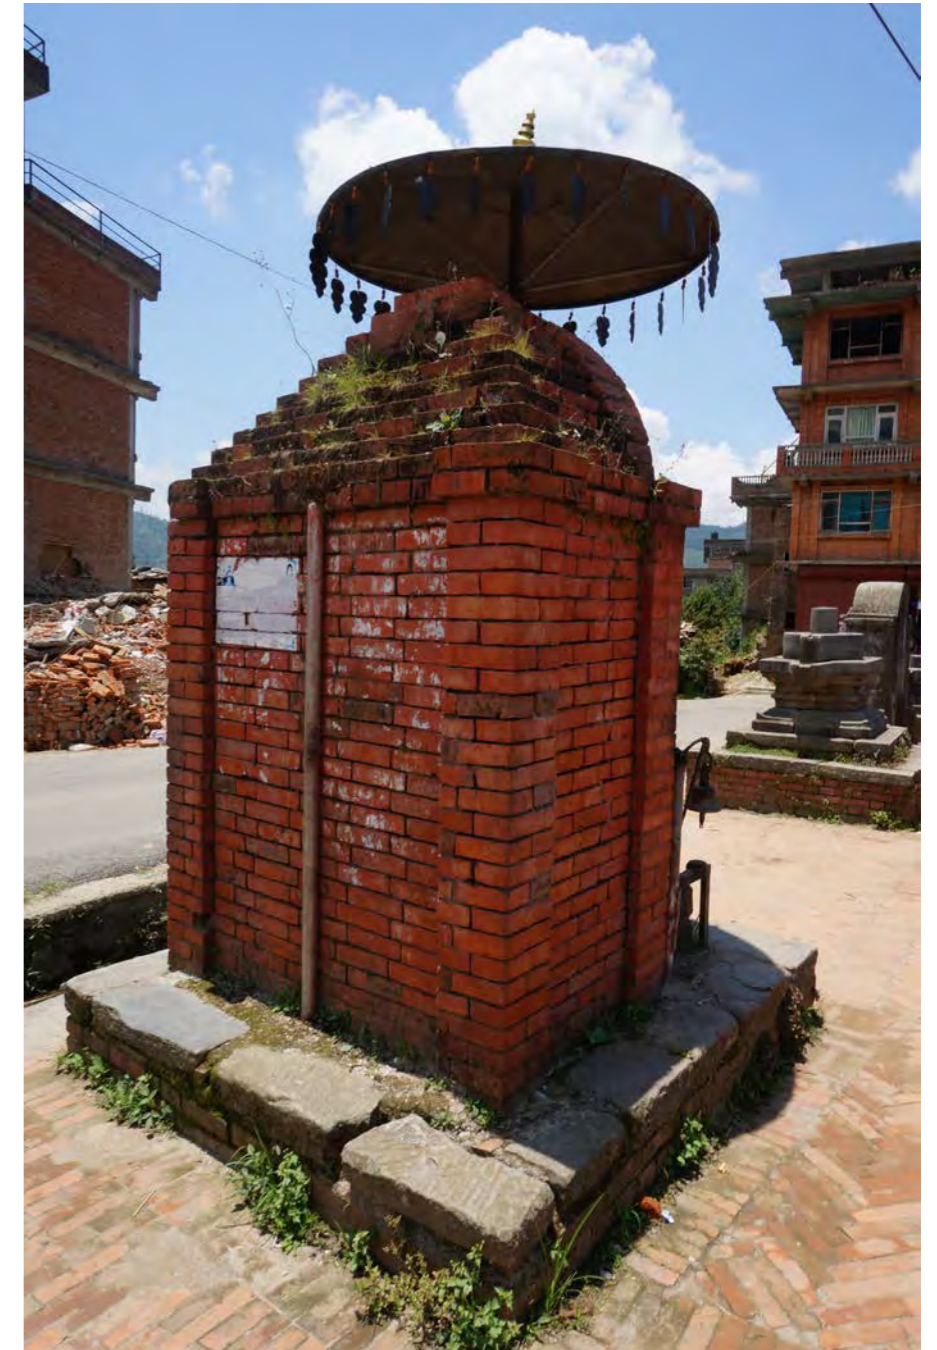
M14 GANESH SHRINEV

NUMBER	NAME	ESTABLISHED DATE (A.D.)	TPOLOGY	GENERAL DESCRIPTION	PROBLEMS DESCRIPTION	DANGER/ DESTROY	
M14	Ganesh Shrine		Open Shrine	Large stone idol of Ganesh on brick arch. Metal chattri on top. Small bell on left of image. Stone plinth.	Vegetation growth on brick. North west corner stone seperated from the plinth. Part of arch is seperated in east. No visible damage to the stone sculpture.

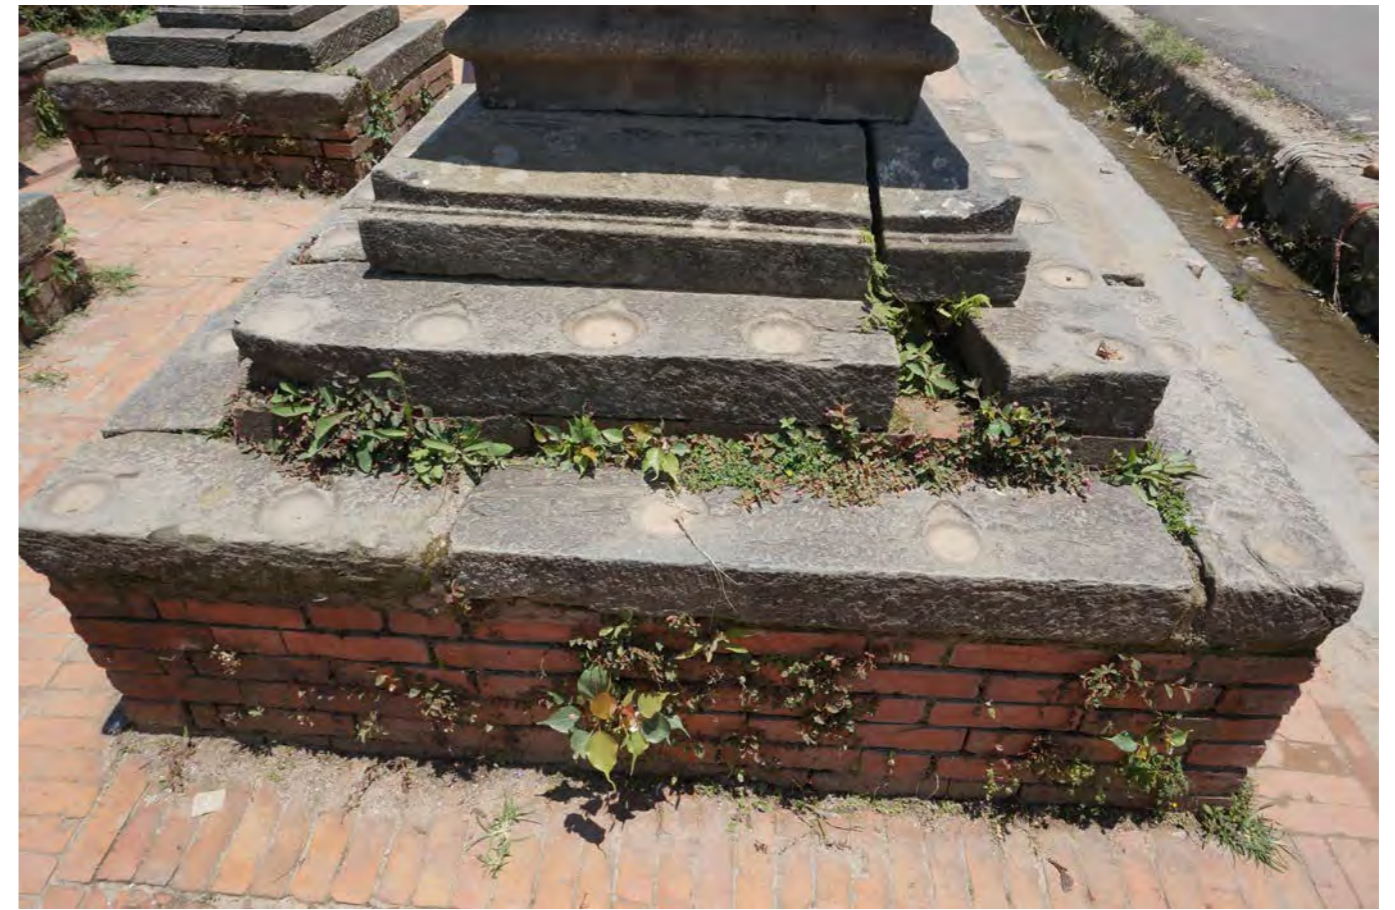
M15 SHIVALINGA

NUMBER	NAME	DATE A.D.	TPOLOGY	GENERAL DESCRIPTION	PROBLEMS DESCRIPTION	DANGER/ DESTROY	
M15			Shiva linga	Shiva linga on two jalaharis one on top of another. The second jalahari is relatively new. Stone faced platform on brick wall.	Seperation on joints of stone wall. Part of stone base to the south is broken. Vegetation growth at joints.

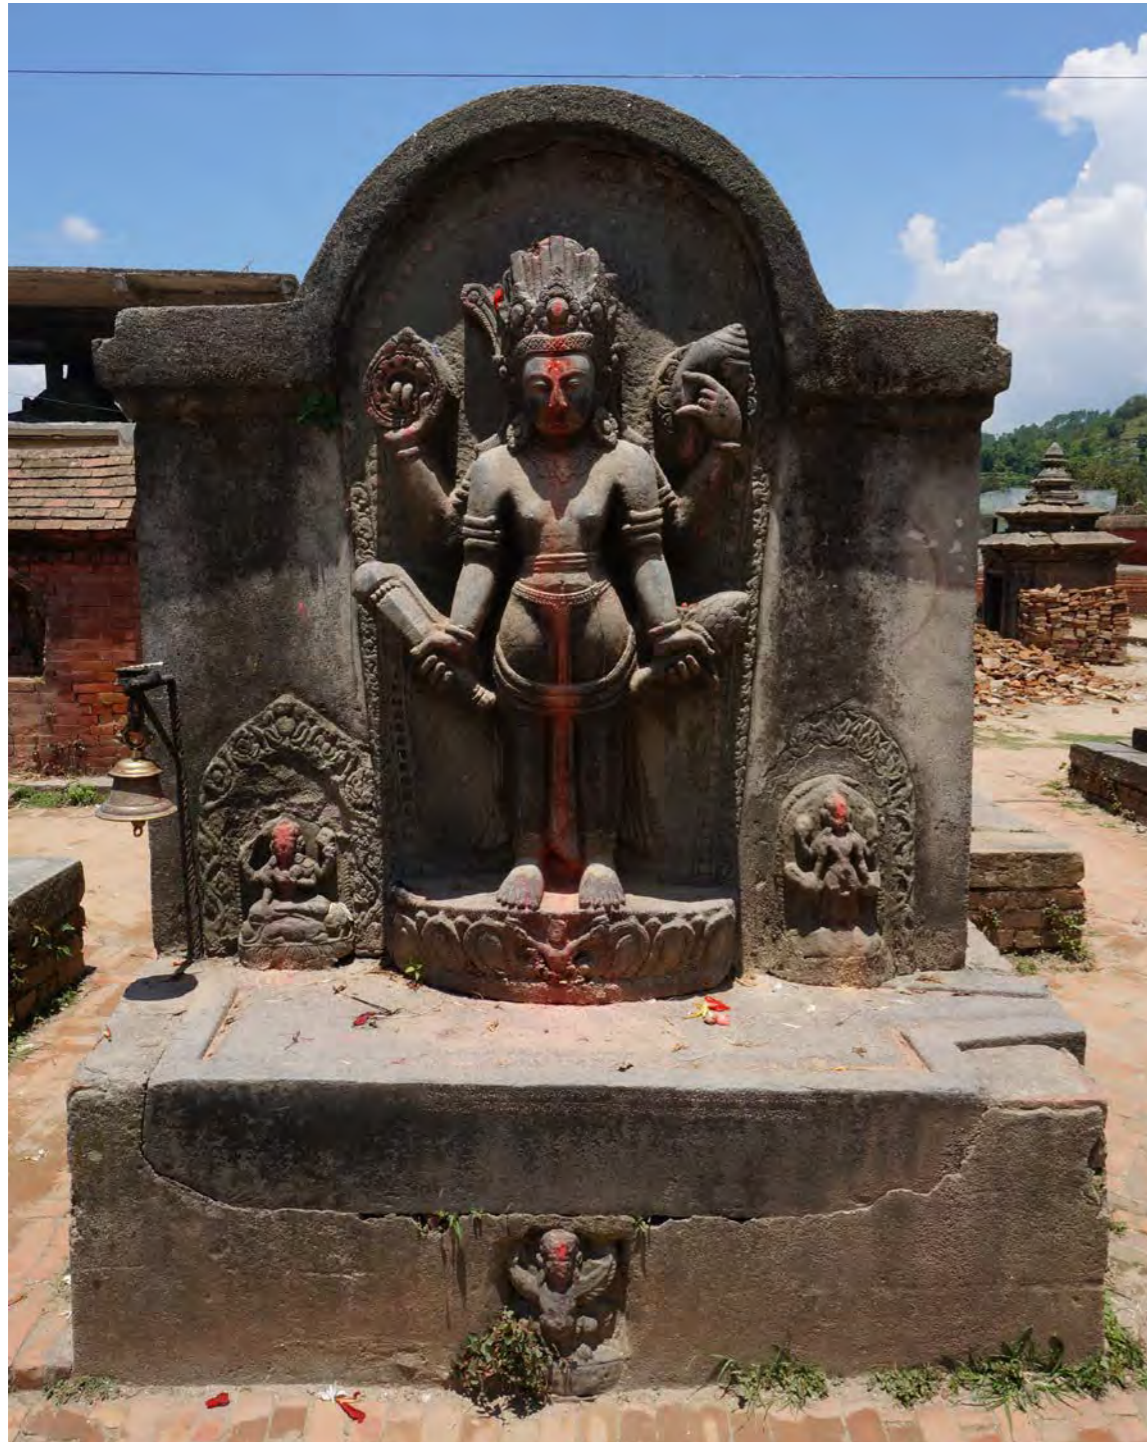
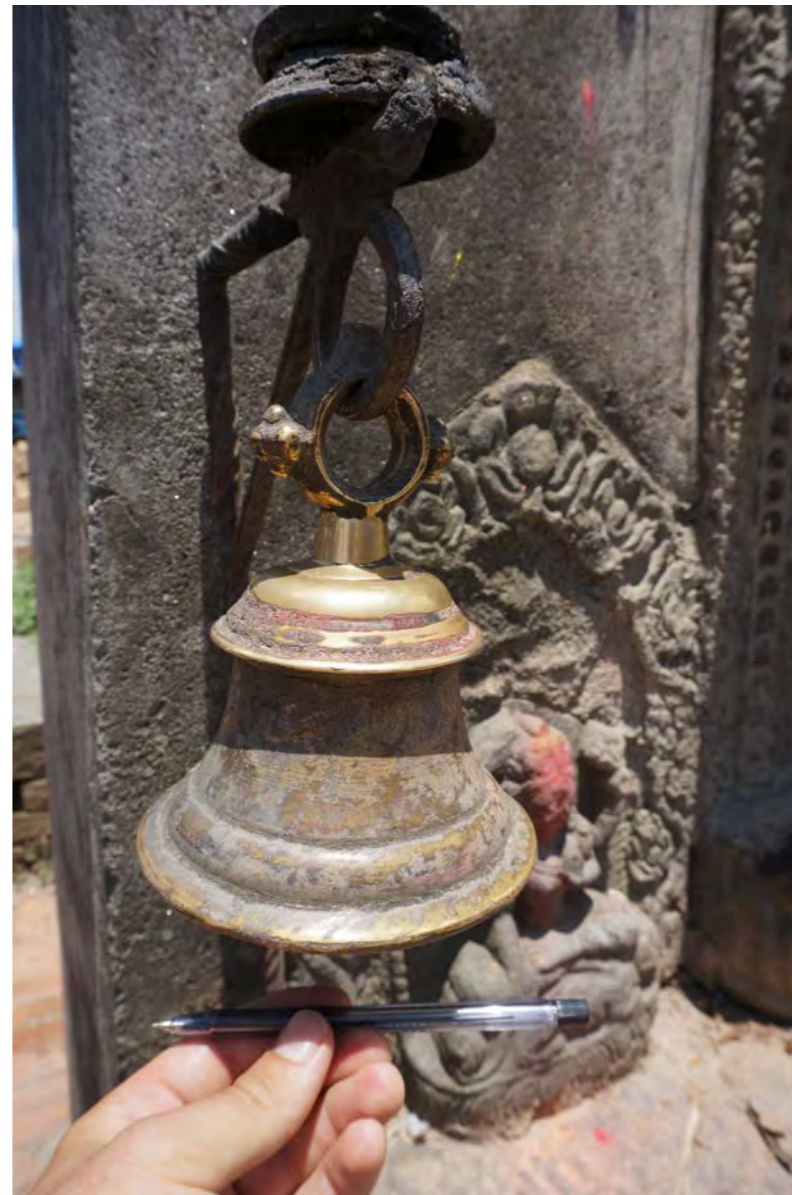
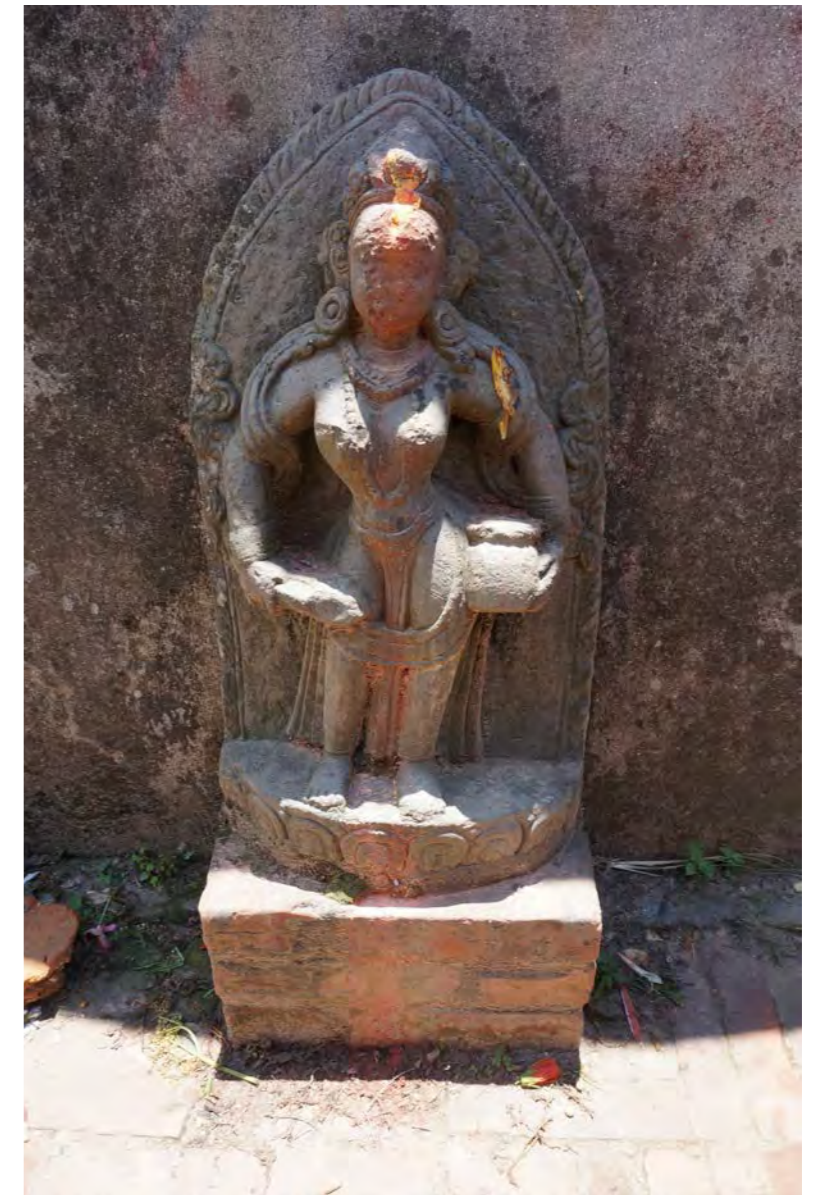
M16 VISHNU SHRINE

NUMBER	NAME	ESTABLISHED DATE (A.D.)	TYOLOGY	GENERAL DESCRIPTION	PROBLEMS DESCRIPTION	DANGER/ DESTROY
M16	Vishnu Idol		Open Shrine	Vishnu idol standing on stone Jalahari with brick wall and cement plaster. Two small idols on the either side of standing Vishnu. Small stone image of female on back side of shrine.	Vegetation growth on the base.

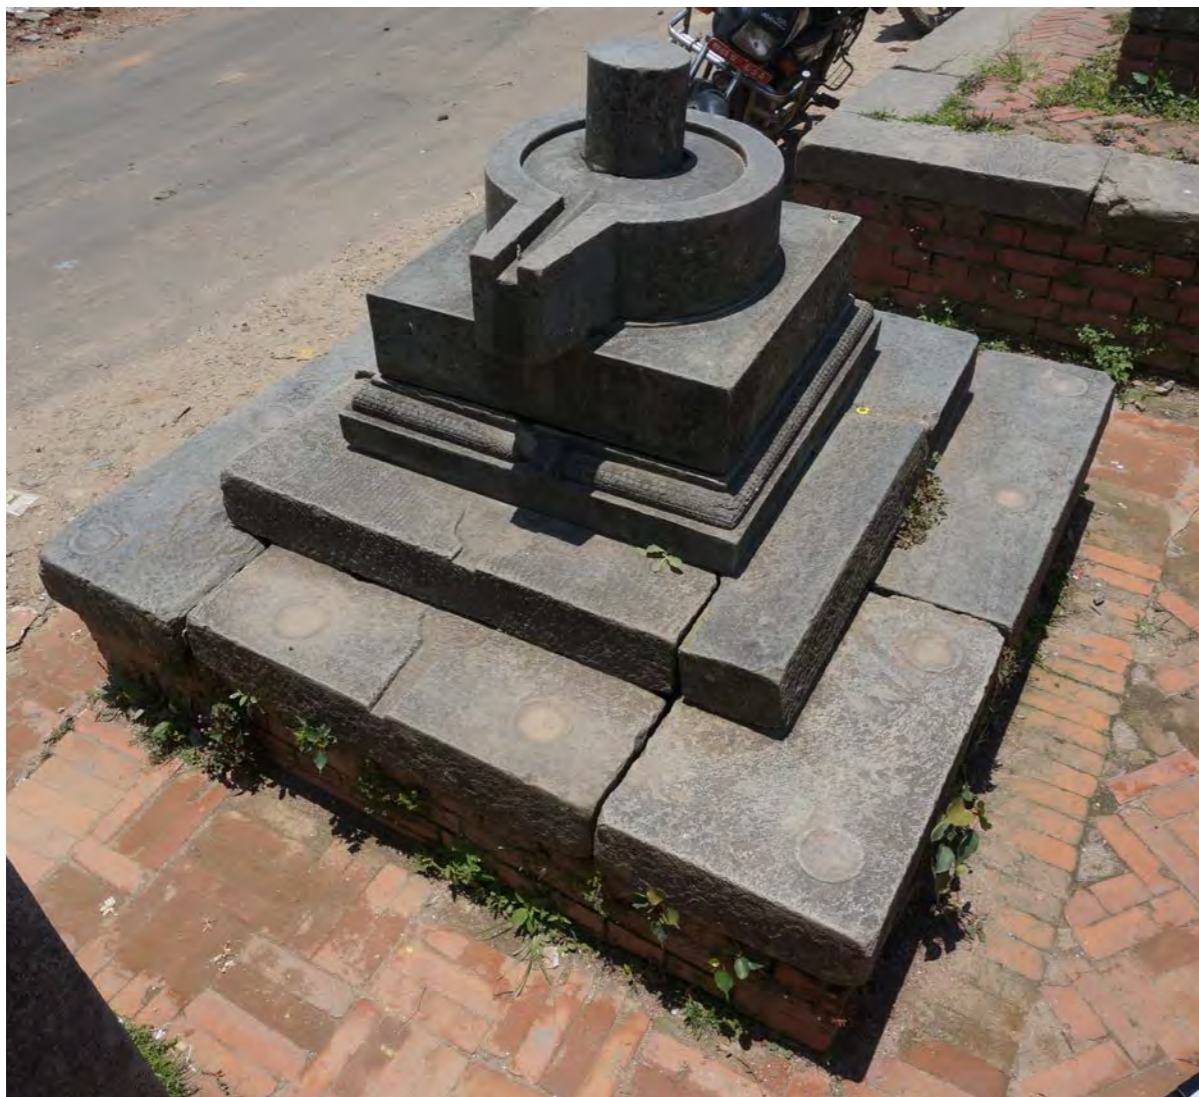
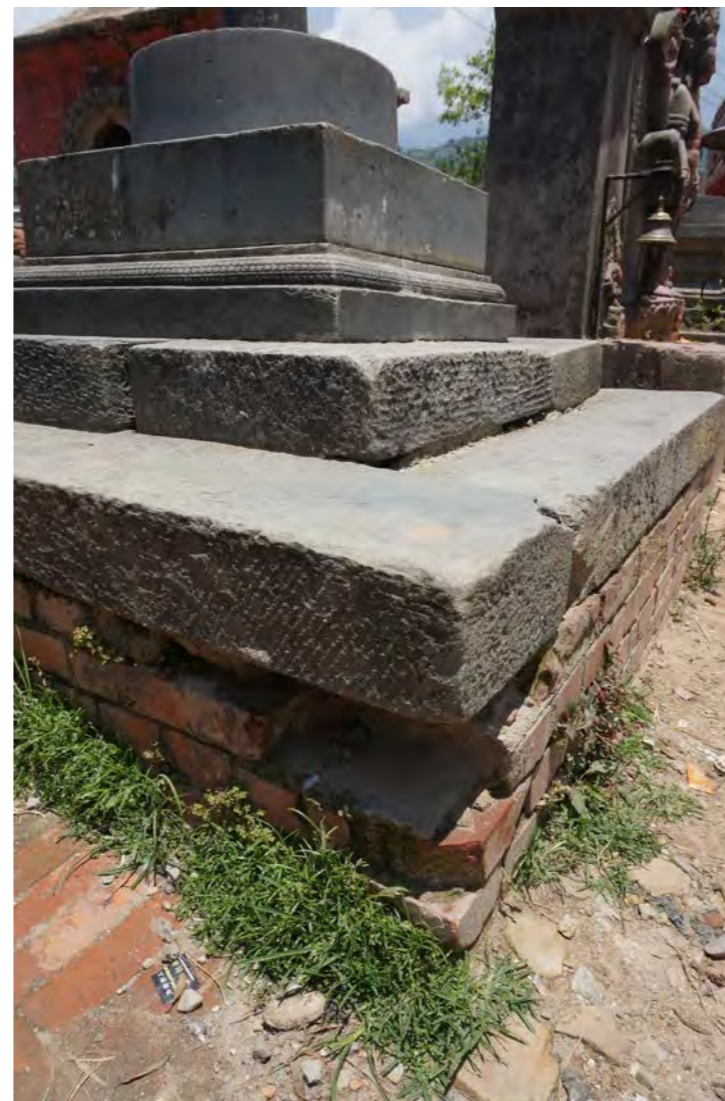
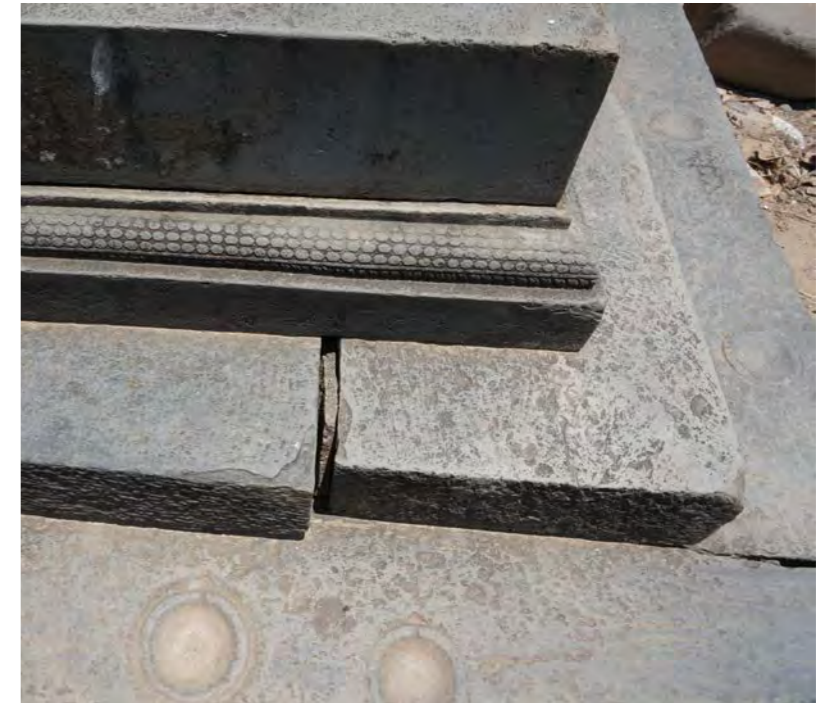
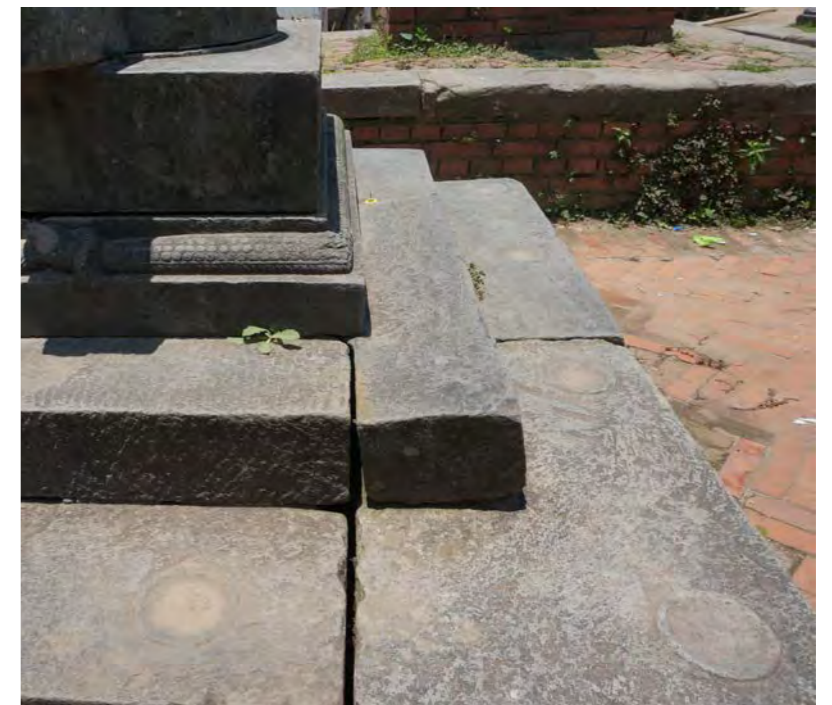
M17 SHIVA LINGA

NUMBER	NAME	DATE A.D.	TPOLOGY	GENERAL DESCRIPTION	PROBLEMS DESCRIPTION	DANGER/ DESTROY
M17			Shiva linga	Shiva Linga on a brick walled stone faced platform	Bricks to south west corner of the platform are missing. Cracks at joints.

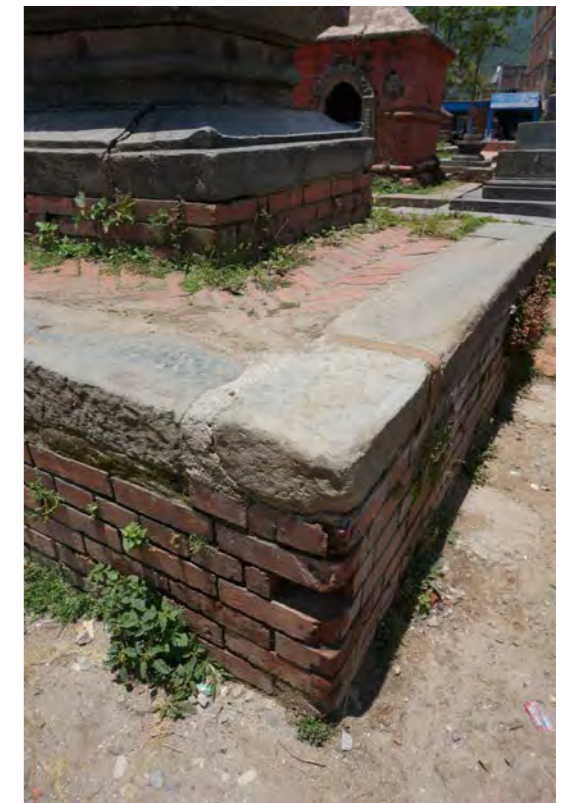
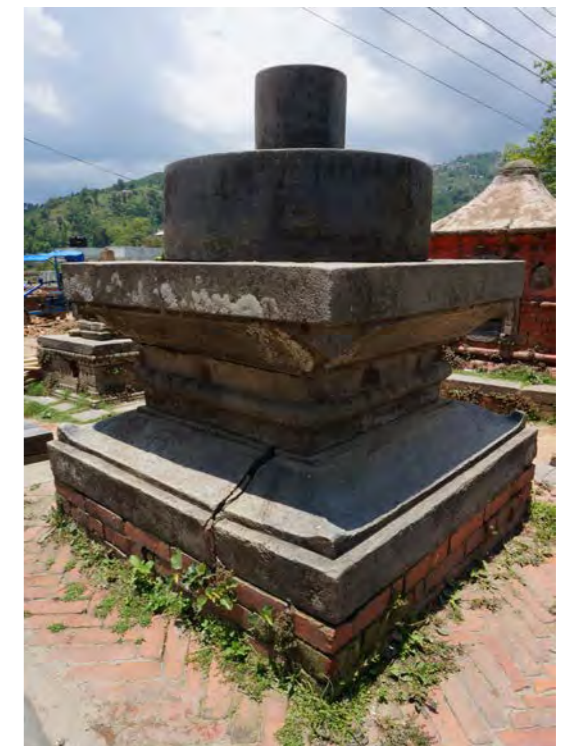
M18 SHIVA LINGA

NUMBER	NAME	ESTABLISHED DATE (A.D.)	TPOLOGY	GENERAL DESCRIPTION	PROBLEMS DESCRIPTION	DANGER/ DESTROY
M18			Shiva linga	Two jalaharis on brick wall base.	Bricks on south east corner missing. Vegetation growth on platform.

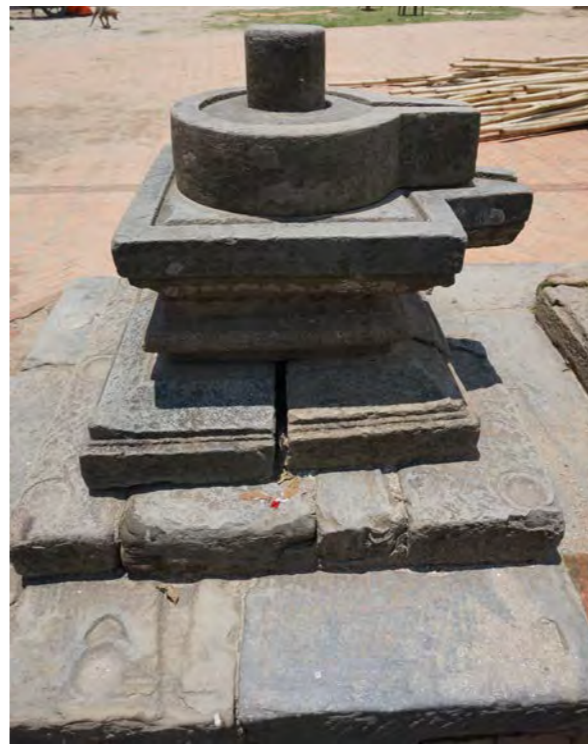
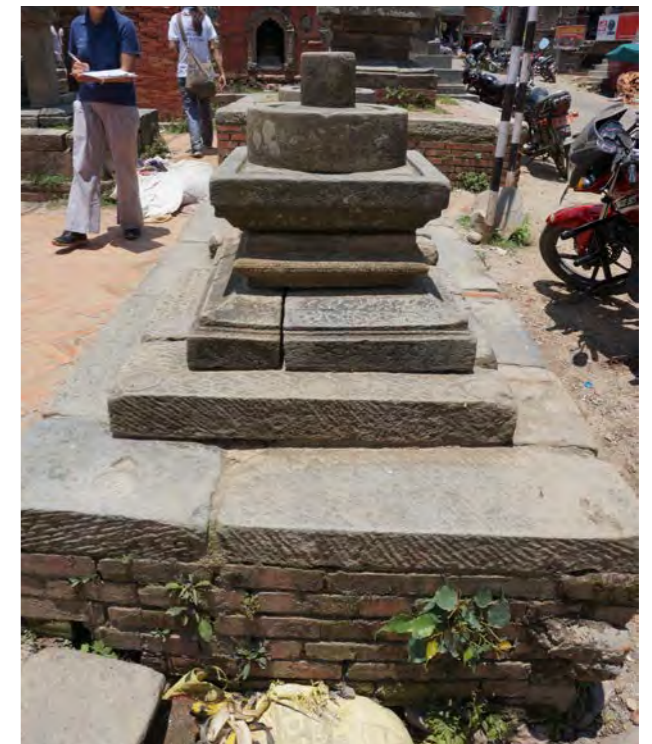
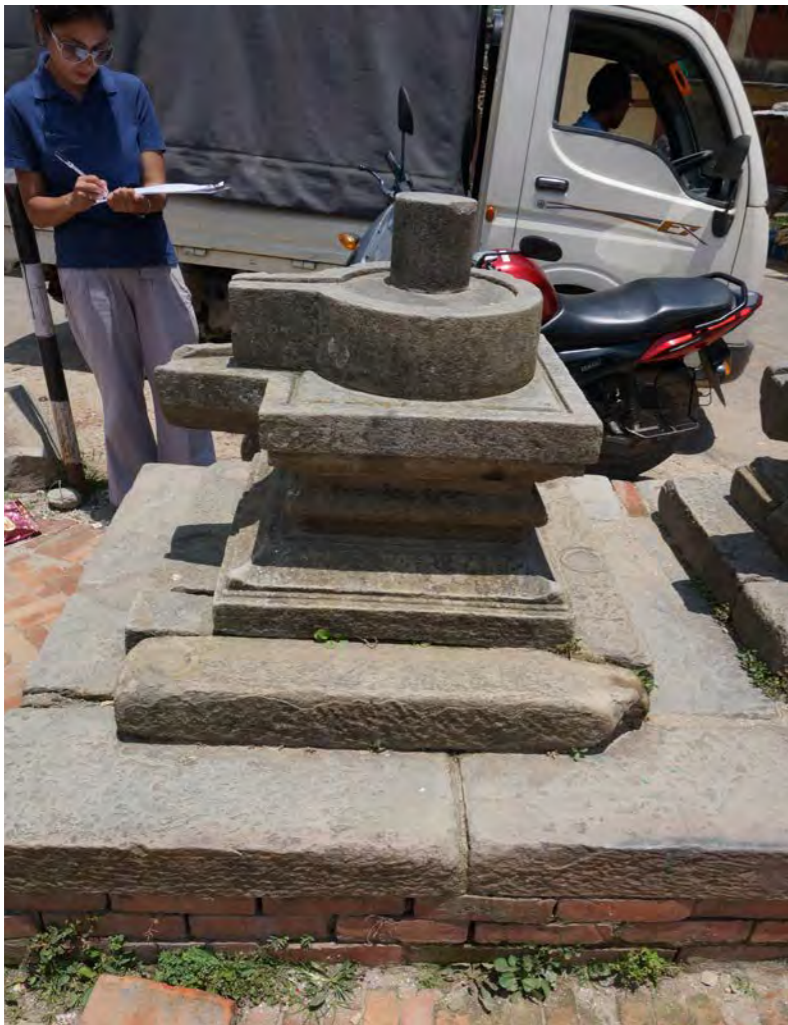
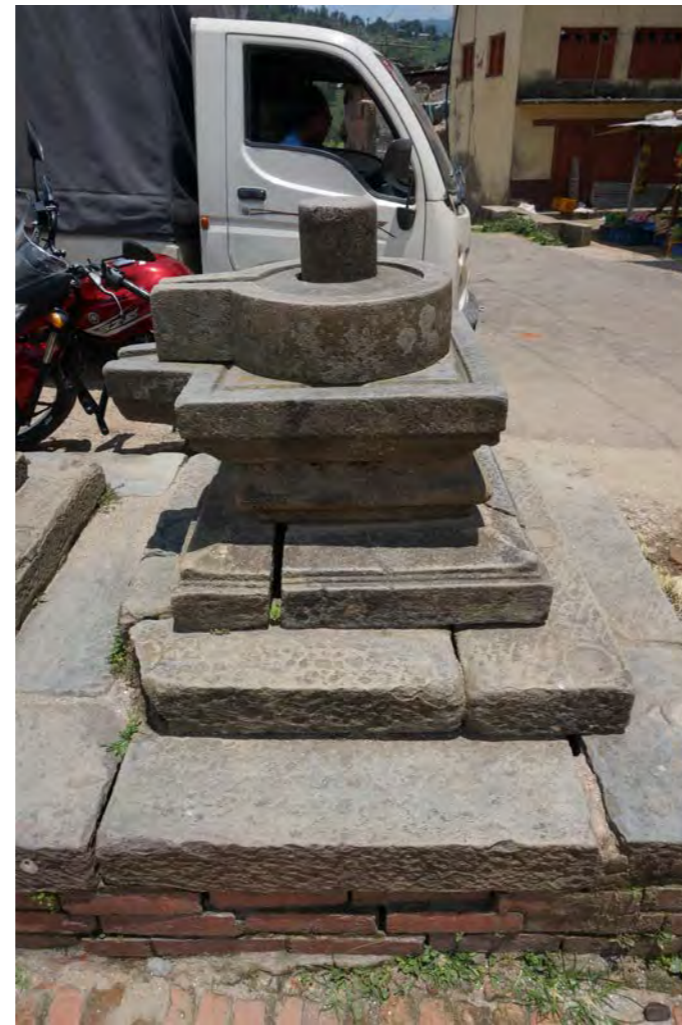
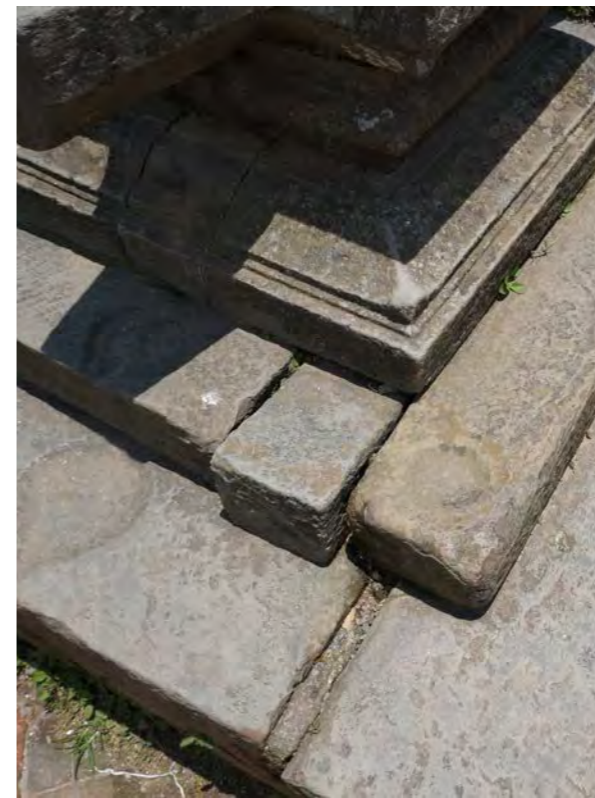
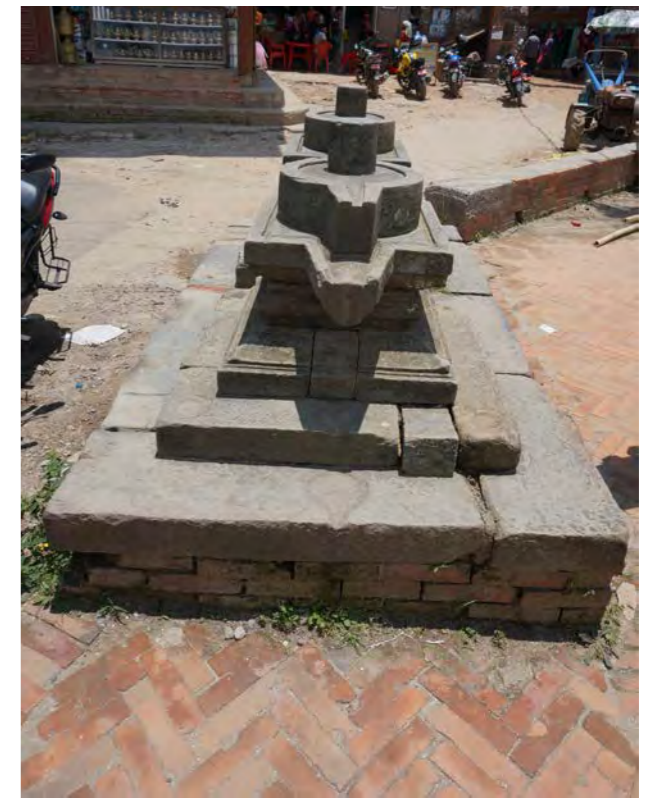
M19 SHIVA LINGA

NUMBER	NAME	DATE A.D.	TYPOLOGY	GENERAL DESCRIPTION	PROBLEMS DESCRIPTION	DANGER/ DESTROY
M19	2 shiva lingas		Shiva linga	Two shiva lingas both on two jalaharis. Brick wall based. Stone paved platform.	Cracks on stone wall. Vegetation growth on the platform. Stone of N-W corner is broken

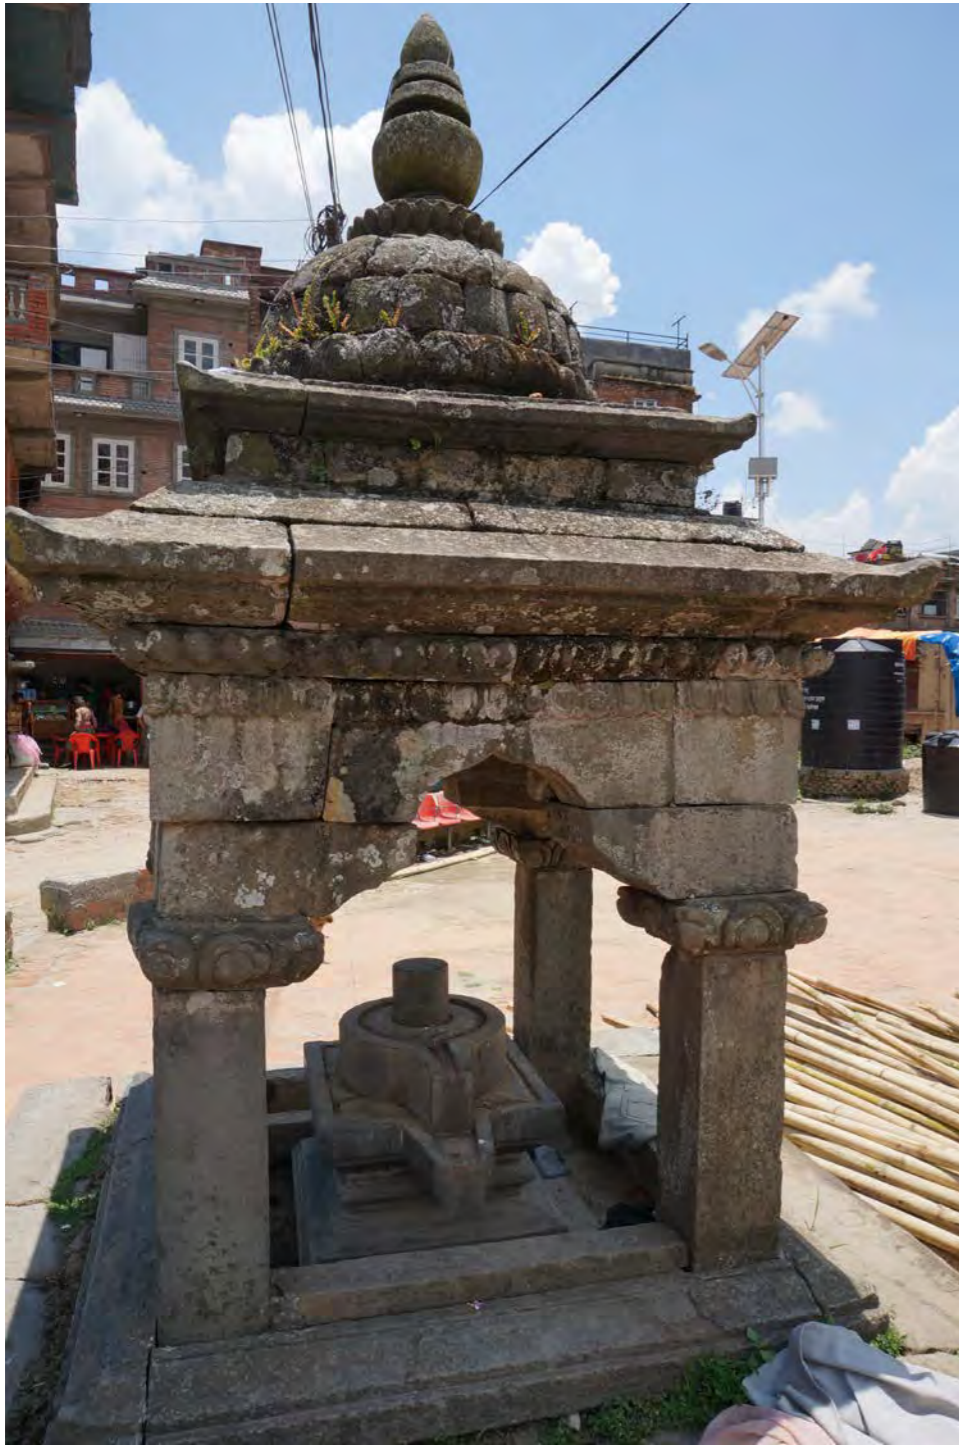
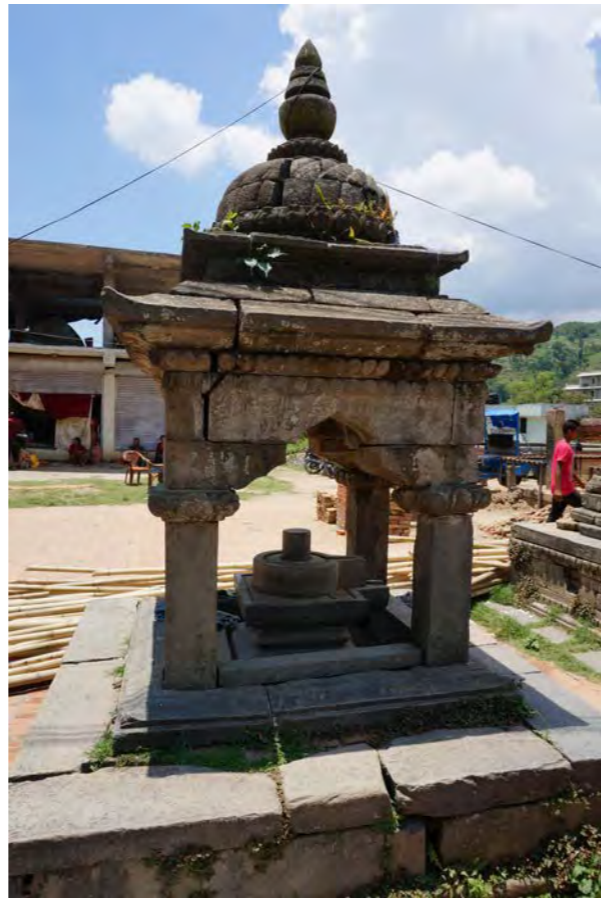
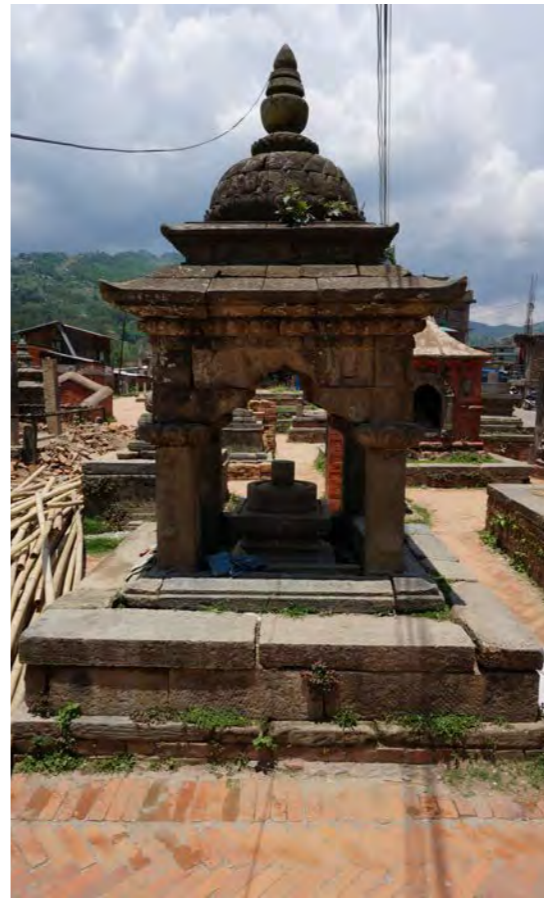
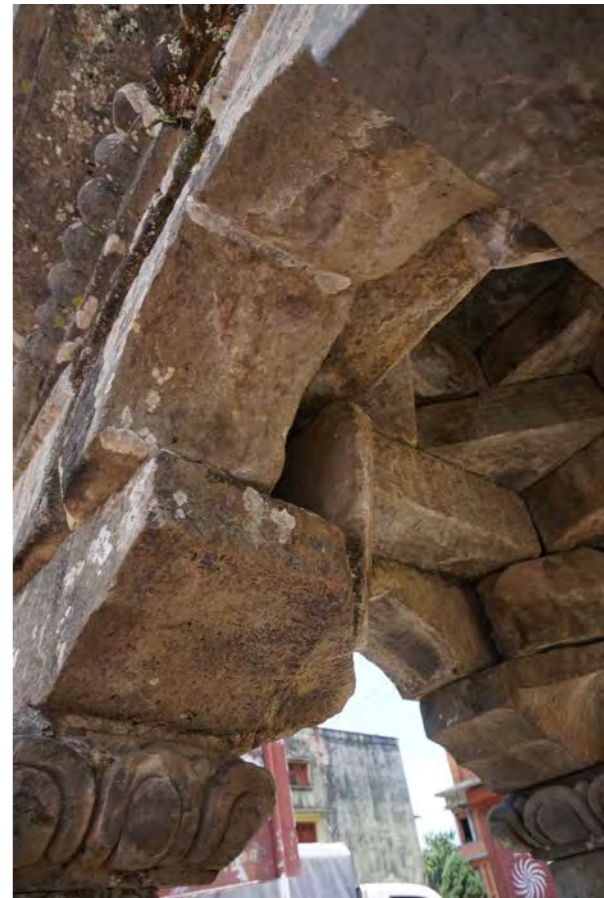
M20 ENCLOSED SHRINE

NUMBER	NAME	ESTABLISHED DATE (A.D.)	TYPOLOGY	GENERAL DESCRIPTION	PROBLEMS DESCRIPTION	DANGER/ DESTROY	
M20			Enclosed Shrine	Enclosed shrine with shiva linga inside.	Cracks on joints of north east side of the structure. Slightly tilted towards east.

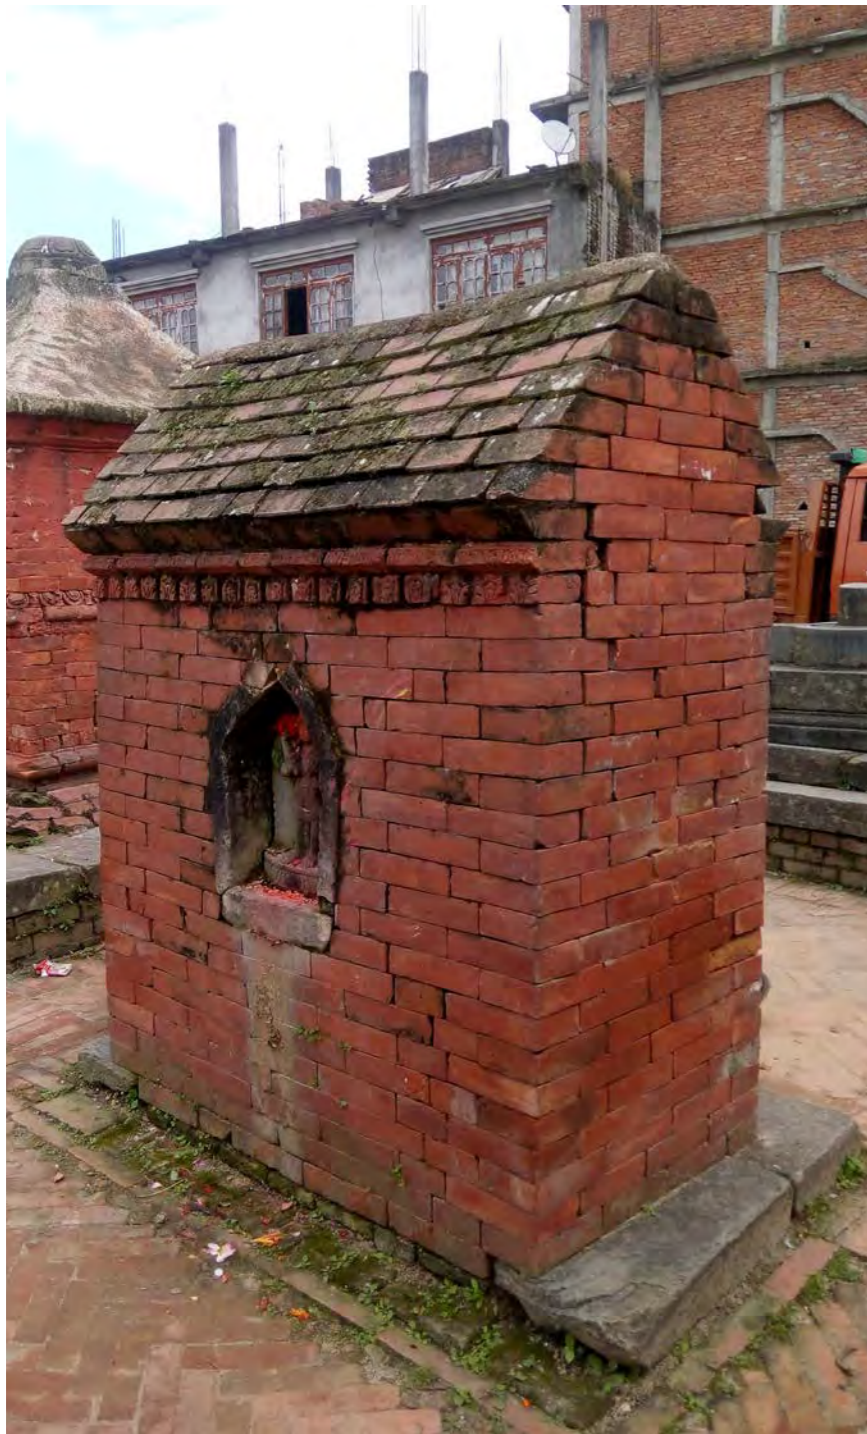
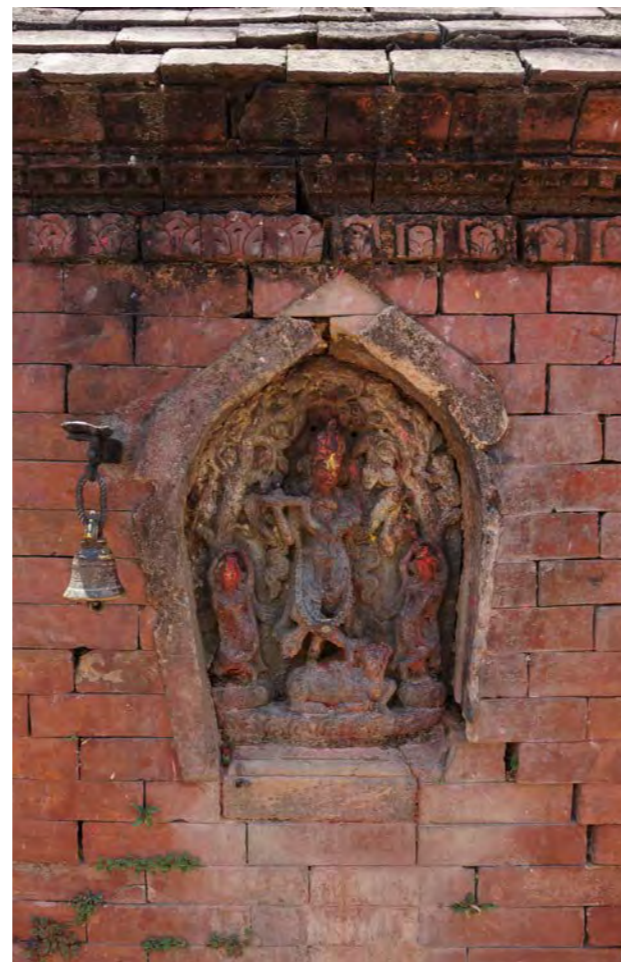
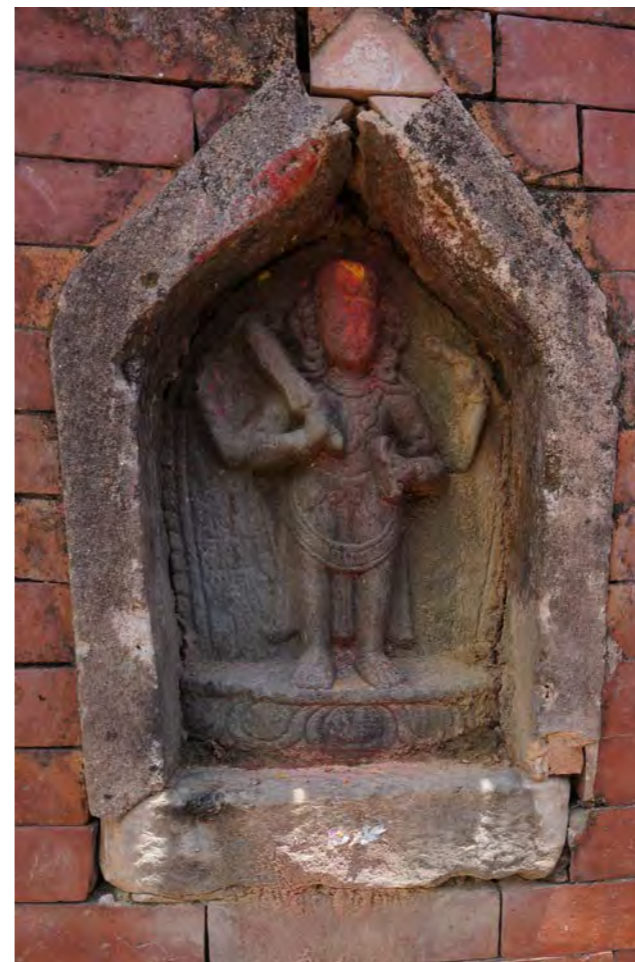
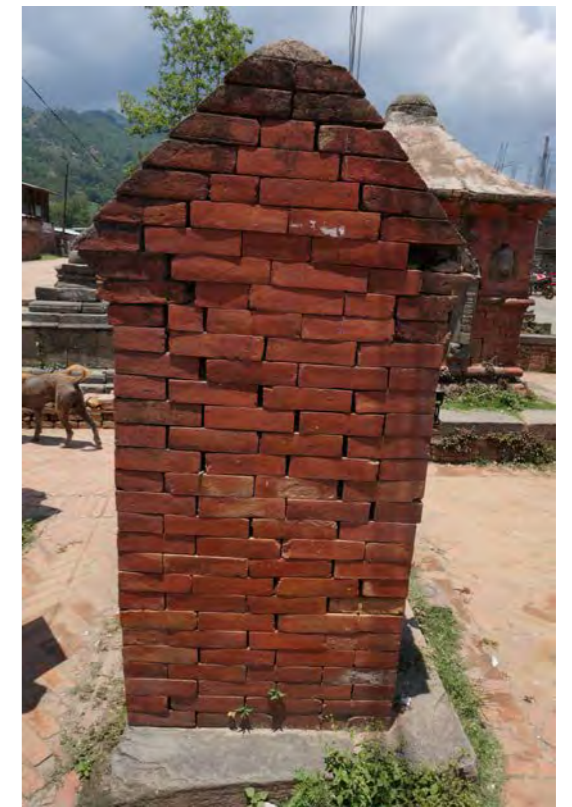
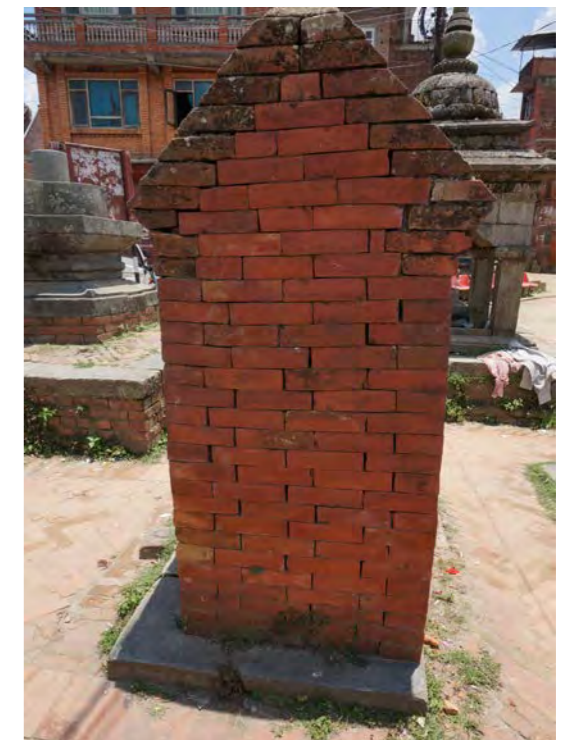
M21 OPEN SHRINE

NUMBER	NAME	DATE A.D.	TPOLOGY	GENERAL DESCRIPTION	PROBLEMS DESCRIPTION	DANGER/ DESTROY
M21			Open Shrine	Brick wall	Bricks on right side of image are dislocated. Brick on south east corner roof is missing. West side buldging.
