2015 Earthquake Damage Mapping

Sankhu

October 2015

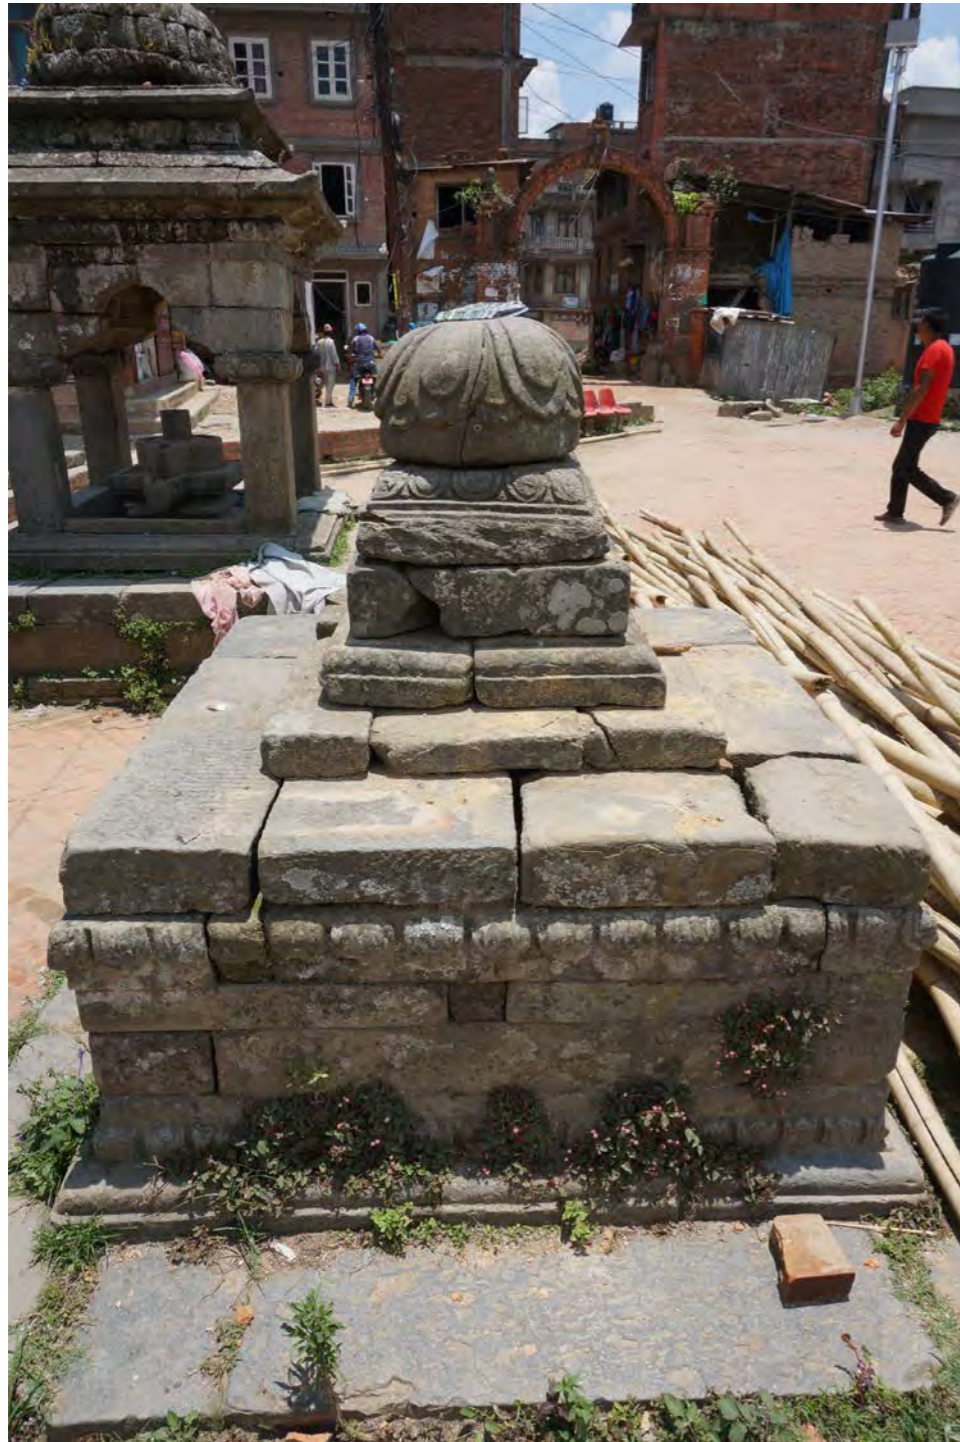
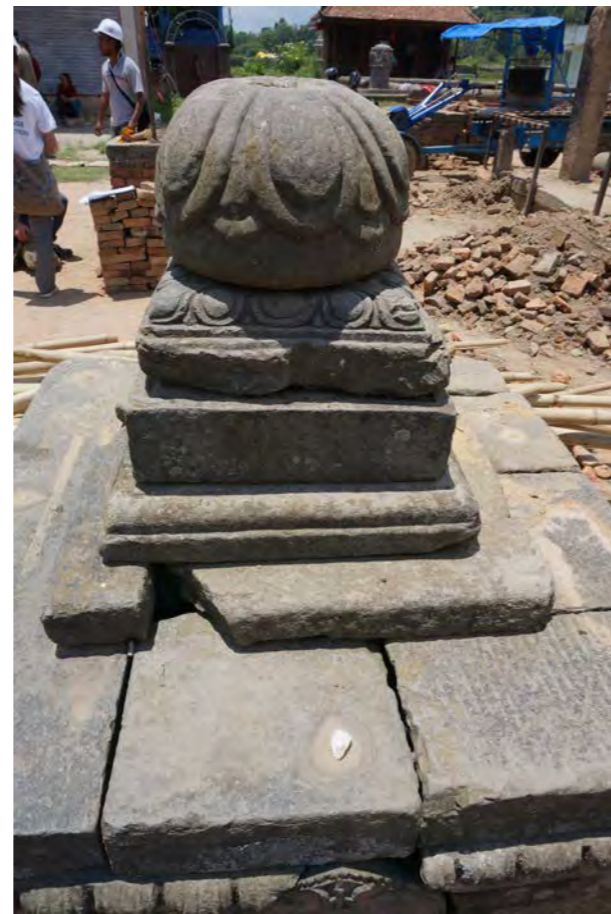
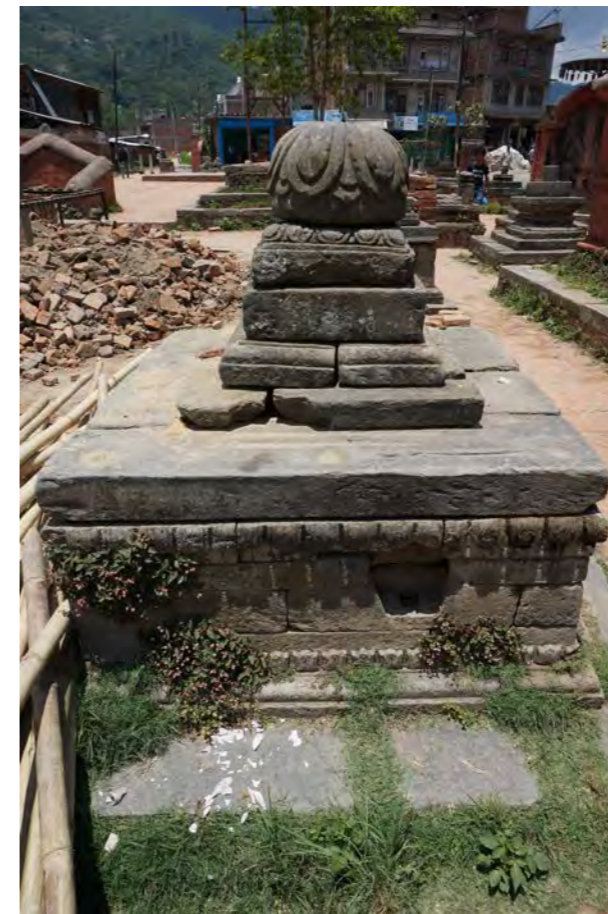
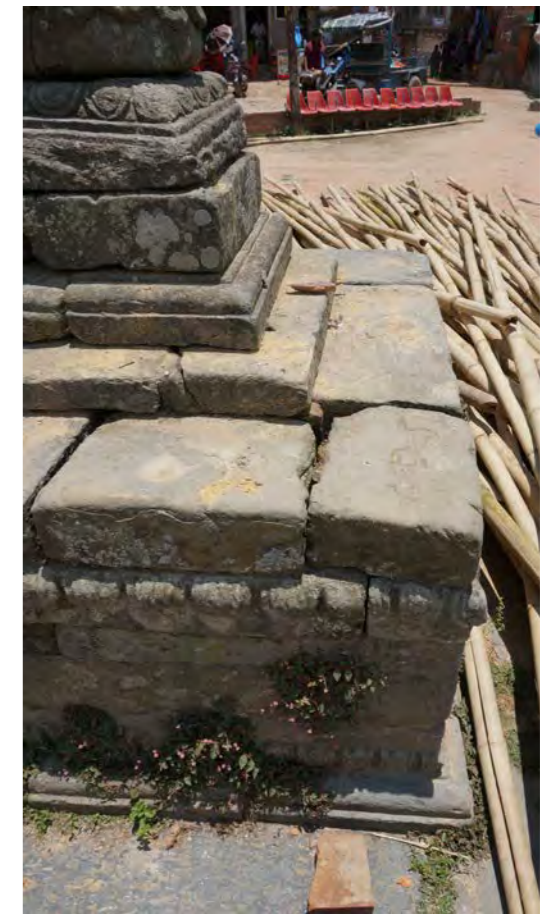
NUMBER	NAME	ESTABLISHED DATE (A.D.)	TYPOLOGY	GENERAL DESCRIPTION	PROBLEMS DESCRIPTION	DANGER/ DESTROY
M22				Lotus motif on stone platform.	Cracks at joints. Two layer stone is broken at east. Stone part missing at south. Top of lotus is broken. Vegetation growth at base.

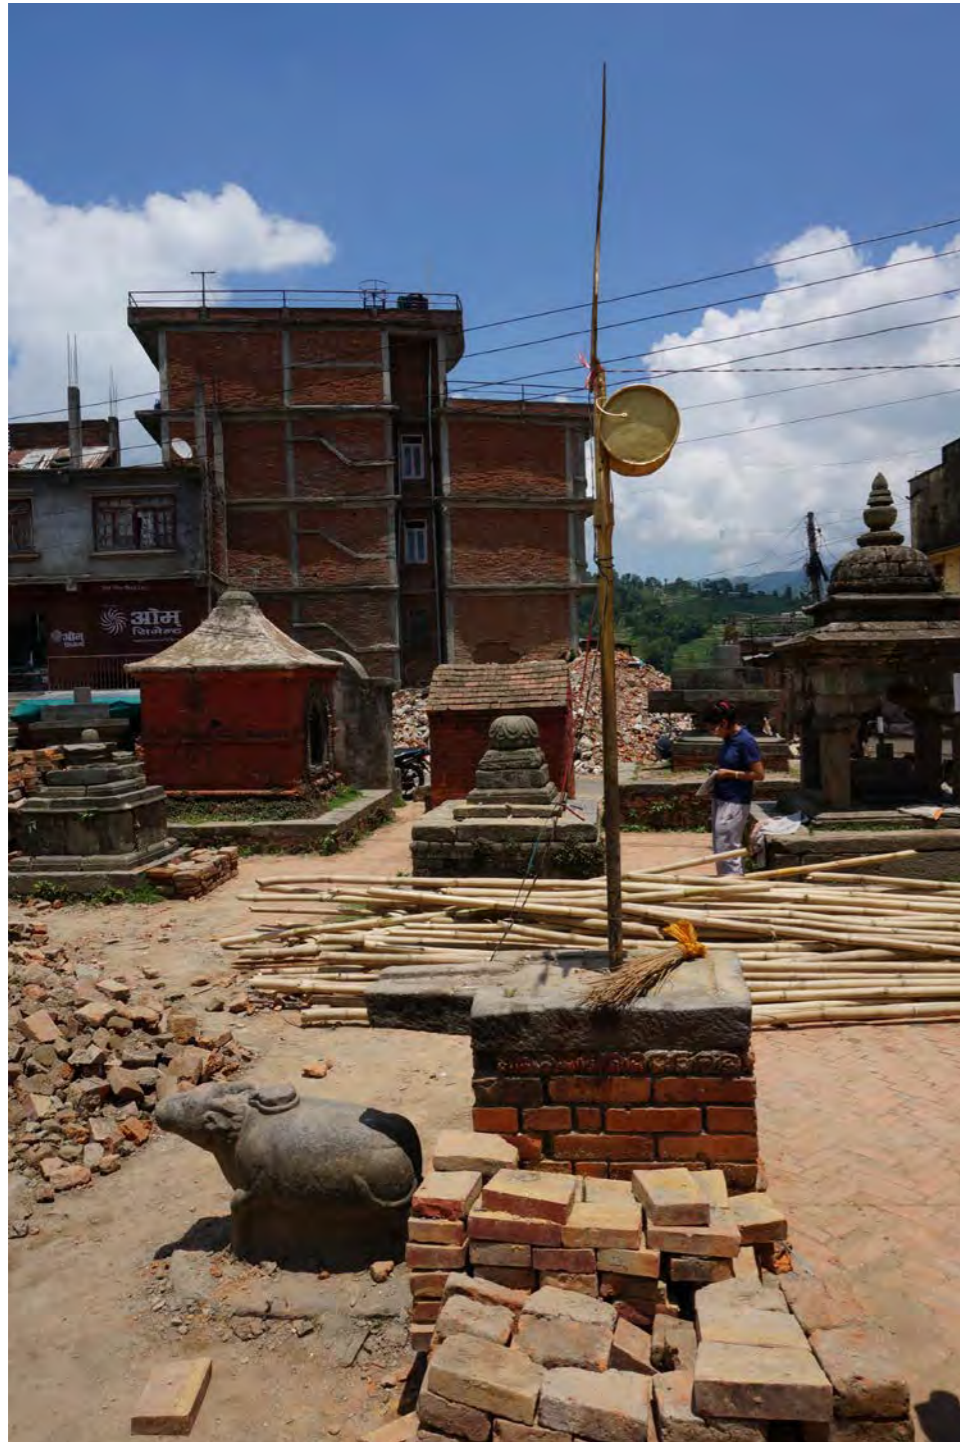
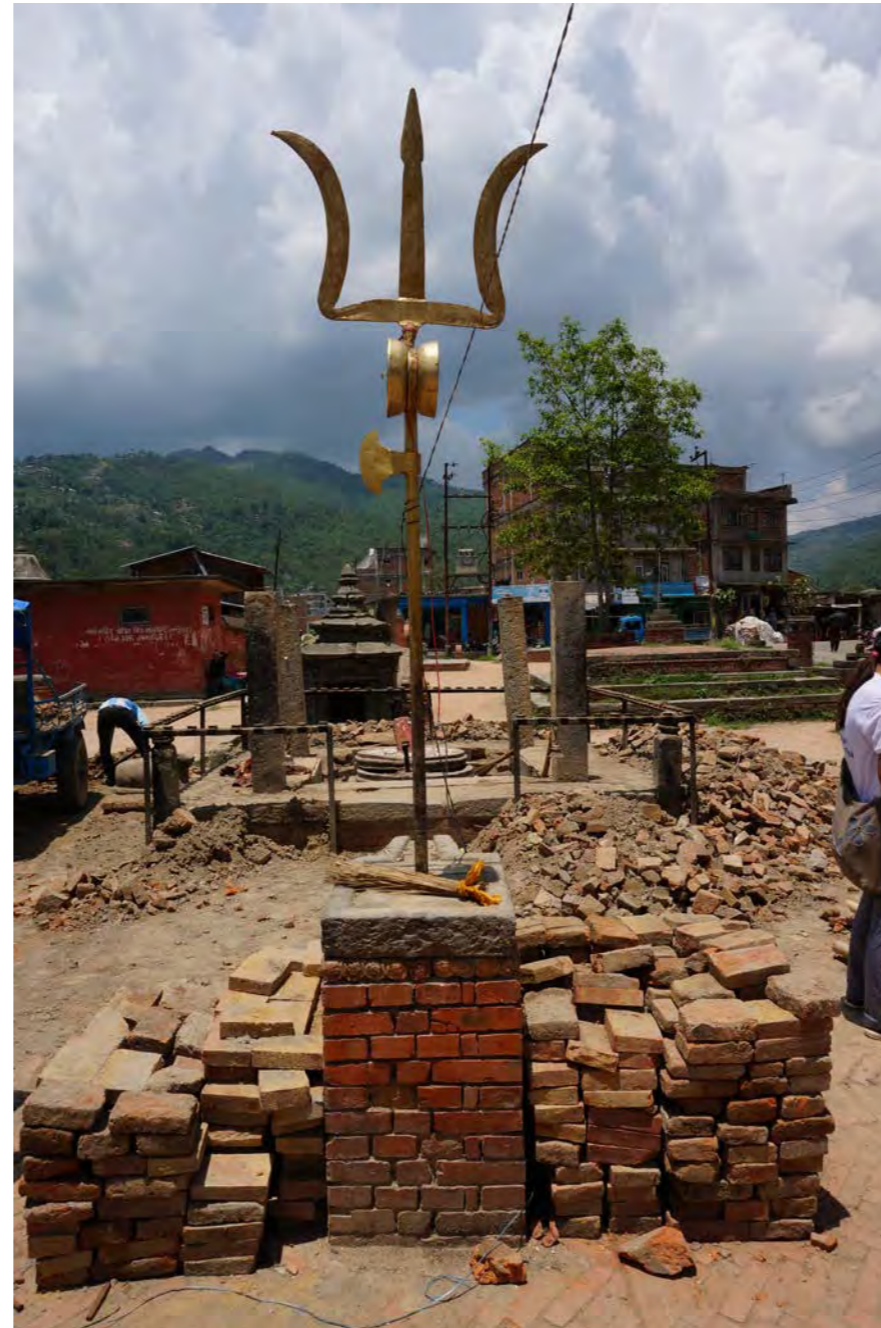
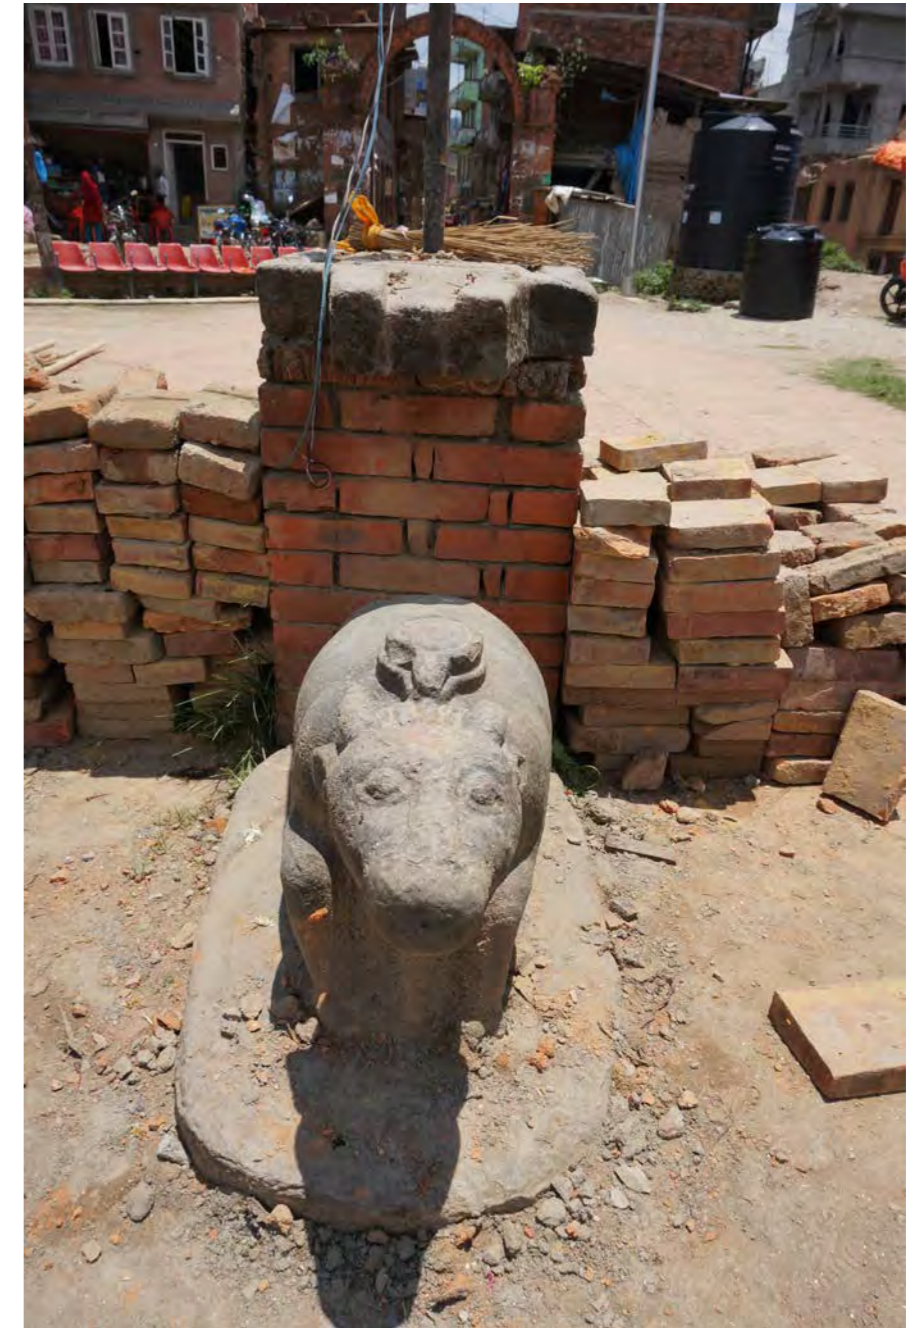
NUMBER	NAME	DATE A.D.	TPOLOGY	GENERAL DESCRIPTION	PROBLEMS DESCRIPTION	DANGER/ DESTROY	
M23				1. Metal trisul and stone Jalahari on brick base. 2. Stone Nandi	One ear of Nandi is broken.

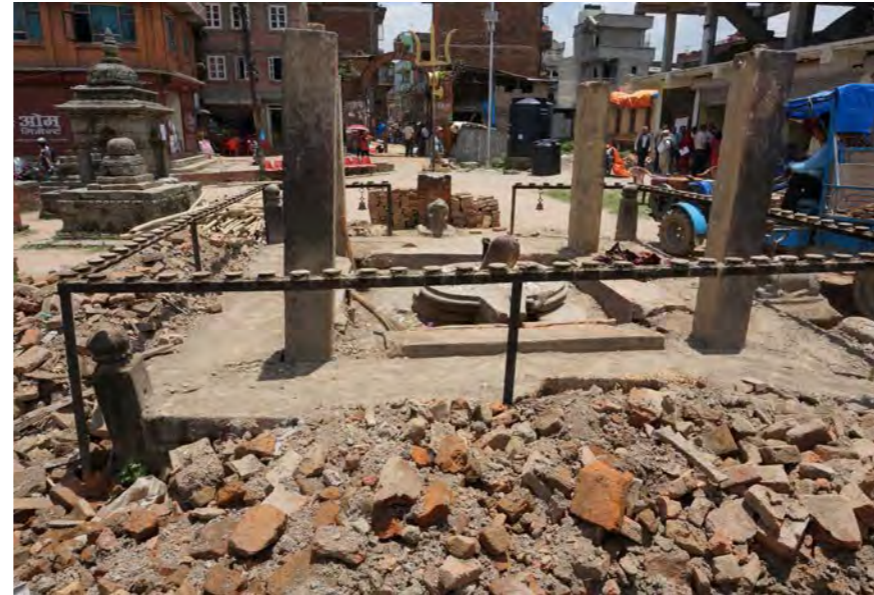
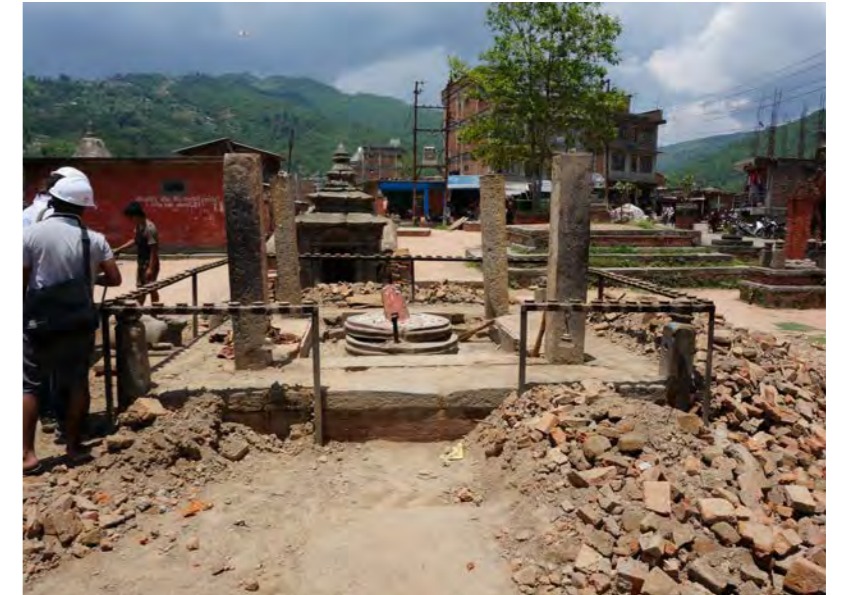
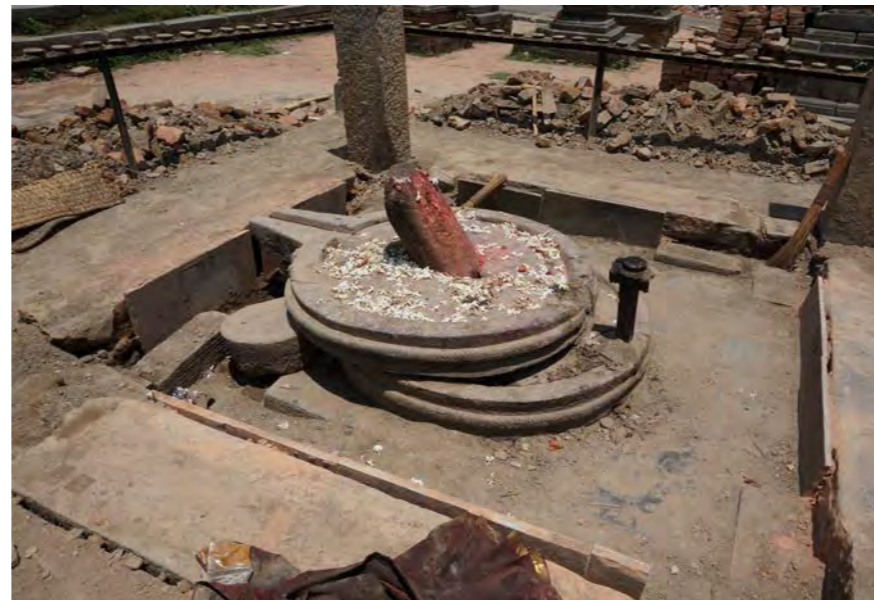
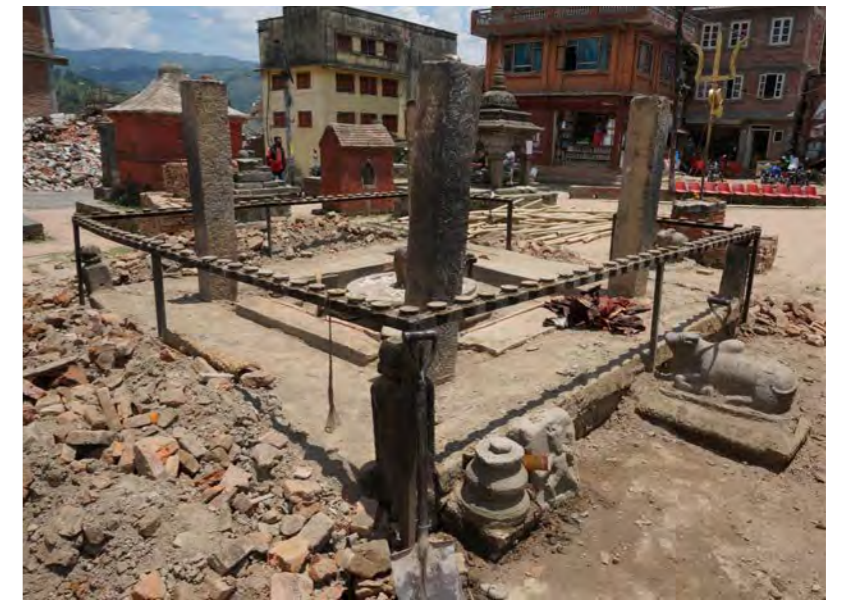
NUMBER	NAME	ESTABLISHED DATE (A.D.)	TYPOLOGY	GENERAL DESCRIPTION	PROBLEMS DESCRIPTION	DANGER/ DESTROY
M24	Madhav Narayan Temple		Multi tired temple	Dismantled under supervision of DOA.	Only four stone pillars and central shiva linga remaining.

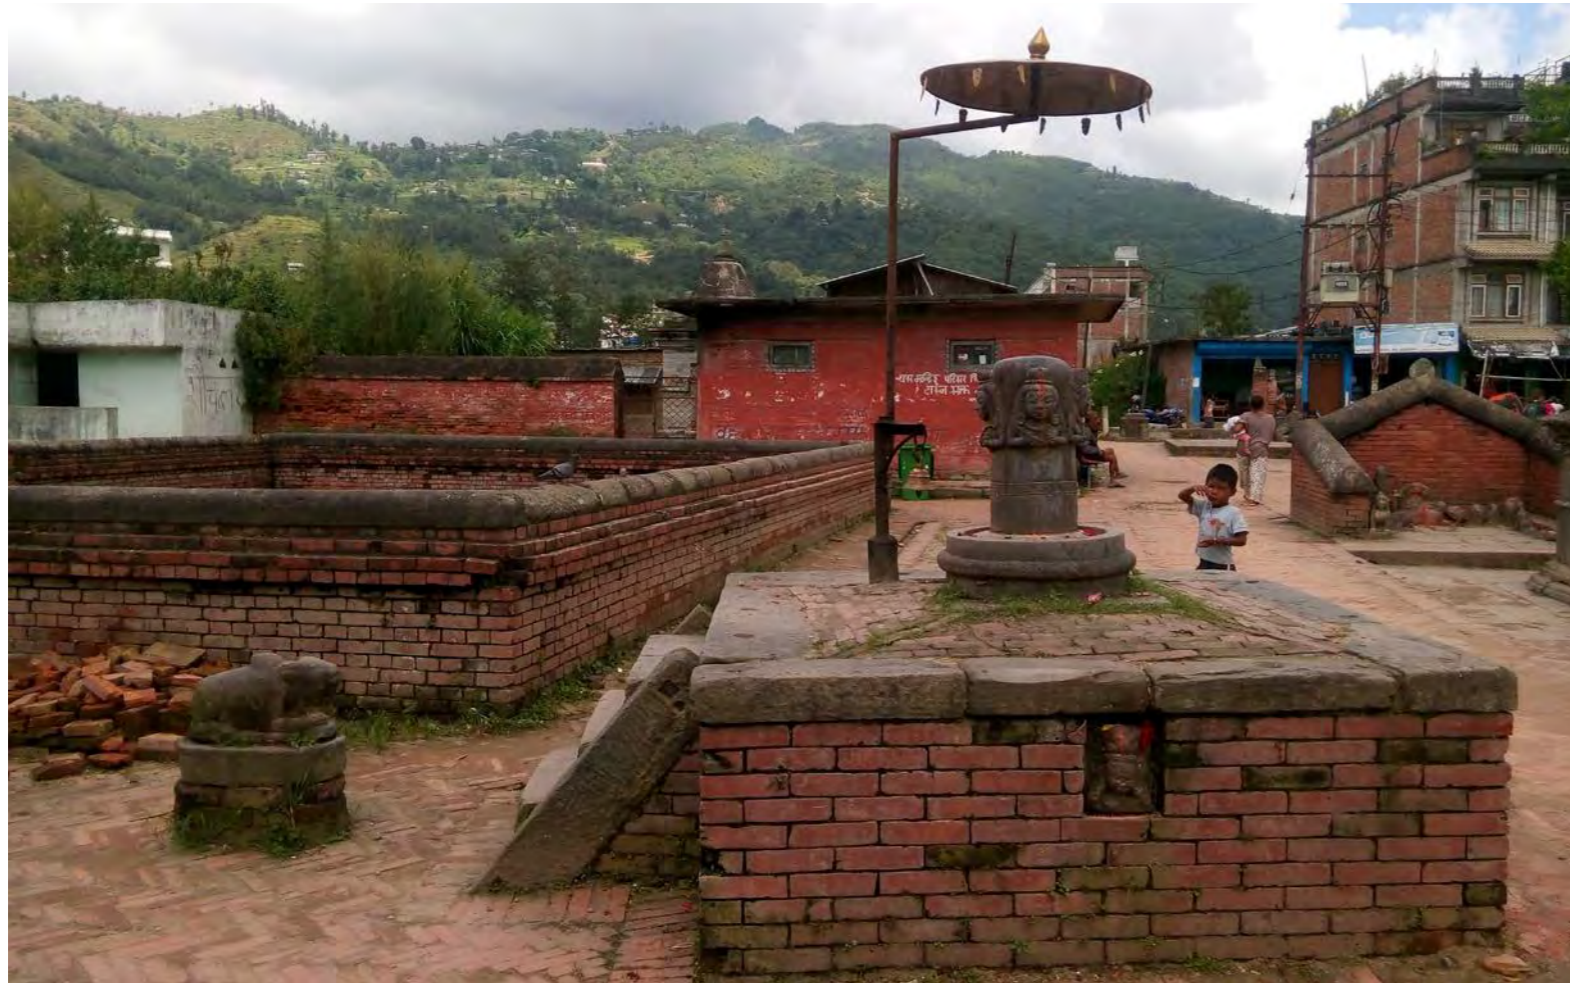
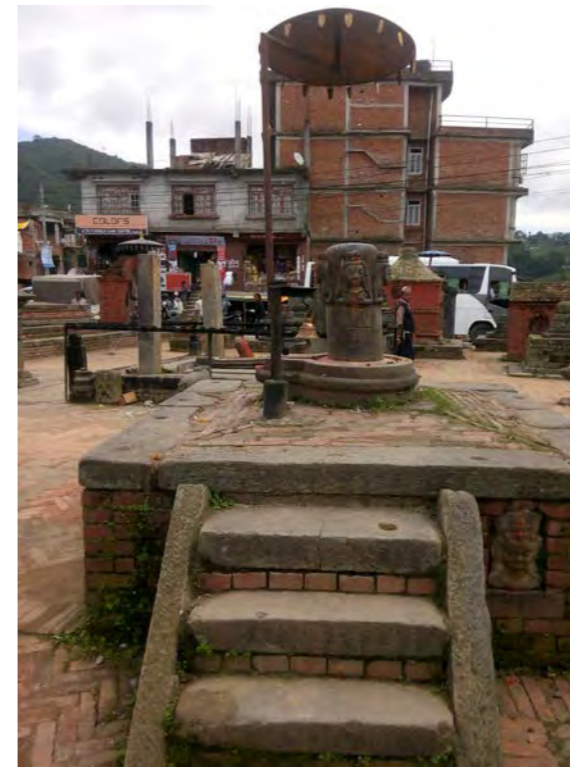
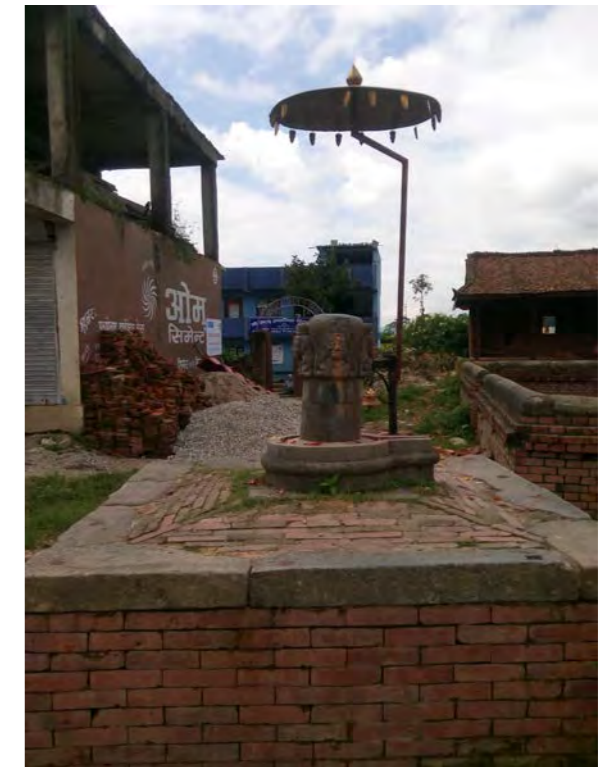
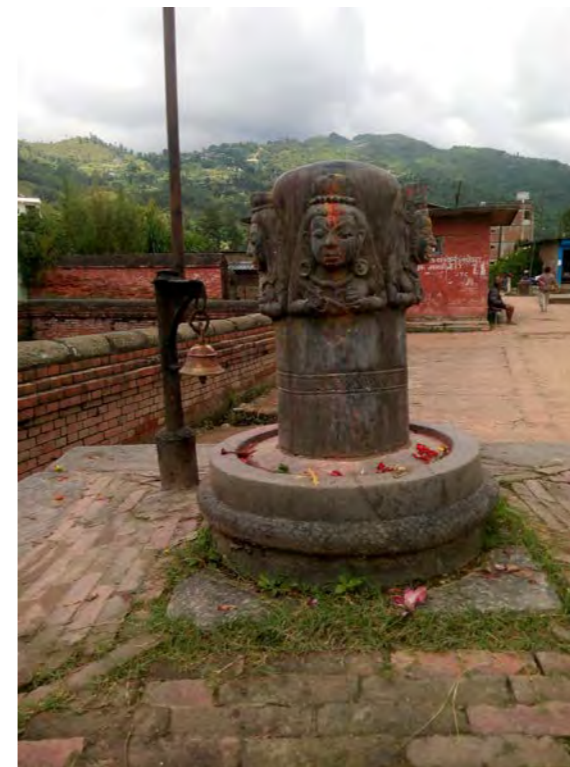
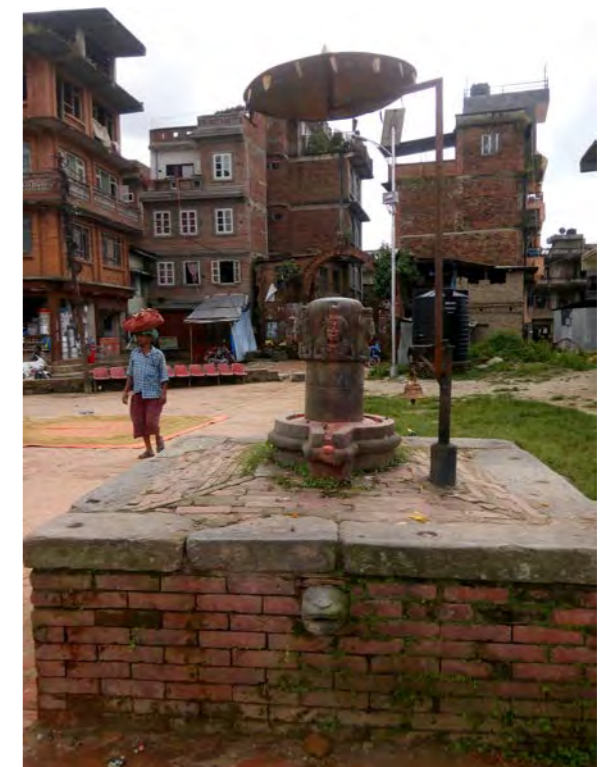
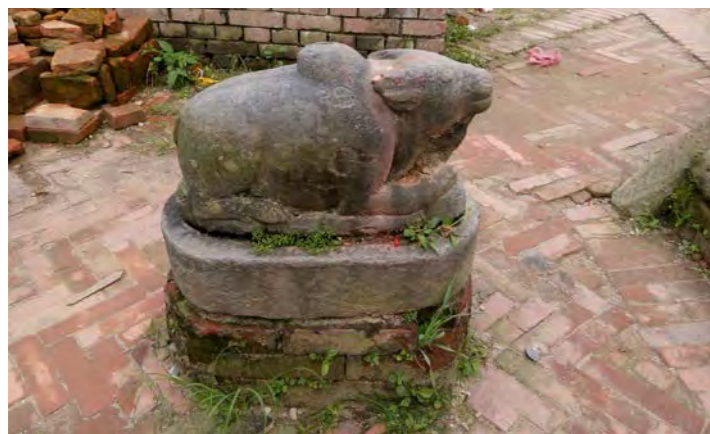
M25 SHIVA LINGA

NUMBER	NAME	DATE A.D.	TPOLOGY	GENERAL DESCRIPTION	PROBLEMS DESCRIPTION	DANGER/ DESTROY
M25			Shiva linga	4 mukhe shivalinga on Jalahari. Brick wall with stone edge platform. Nandi and small bell.	Cracks on stone joints on south and west side.

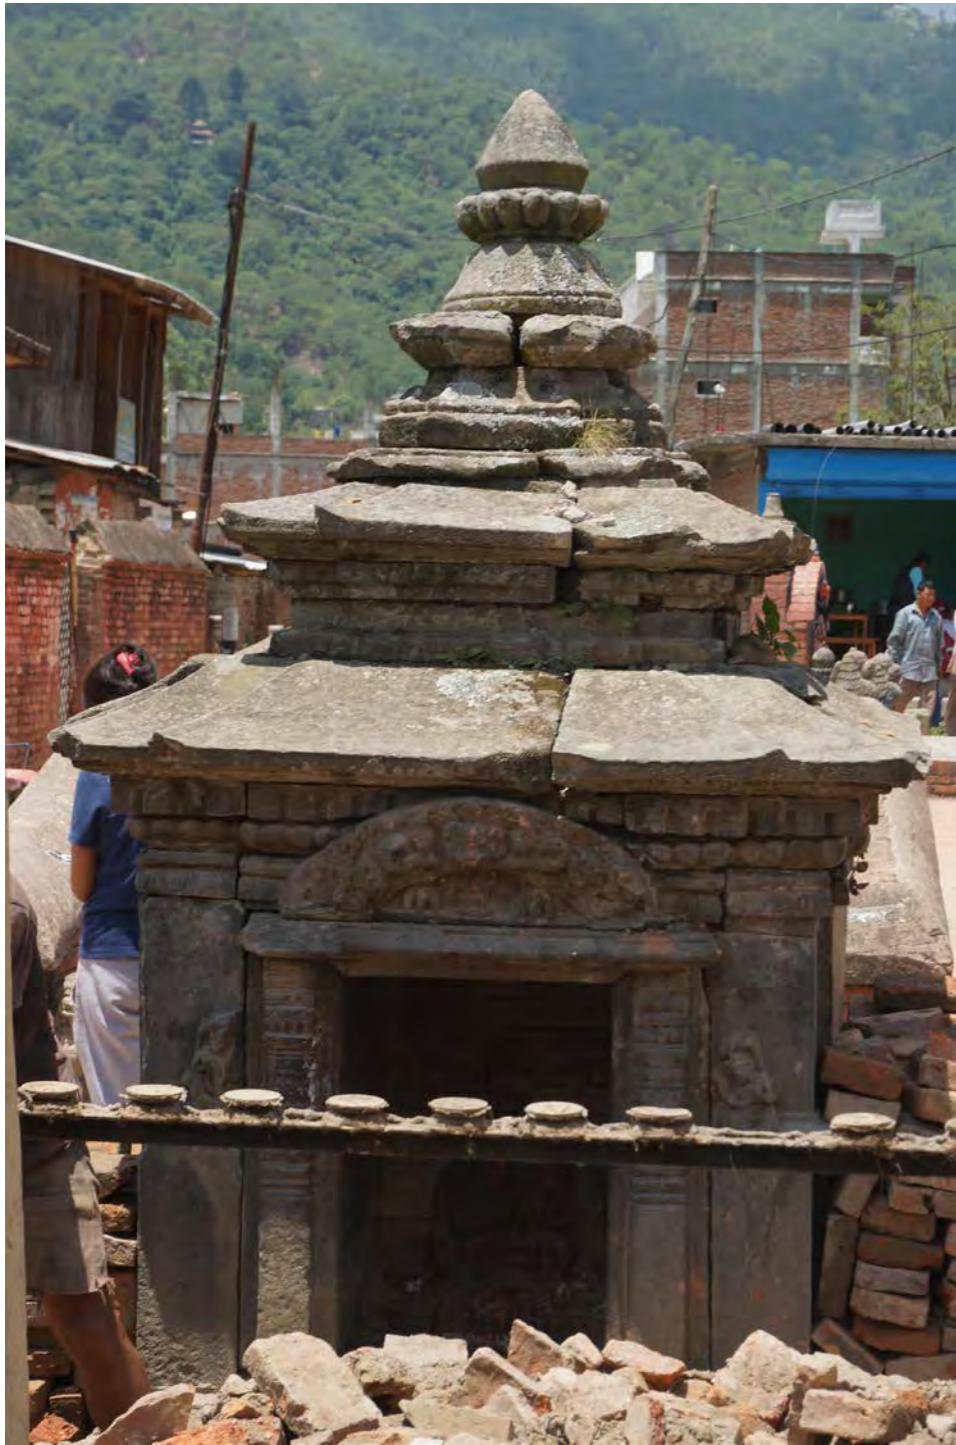
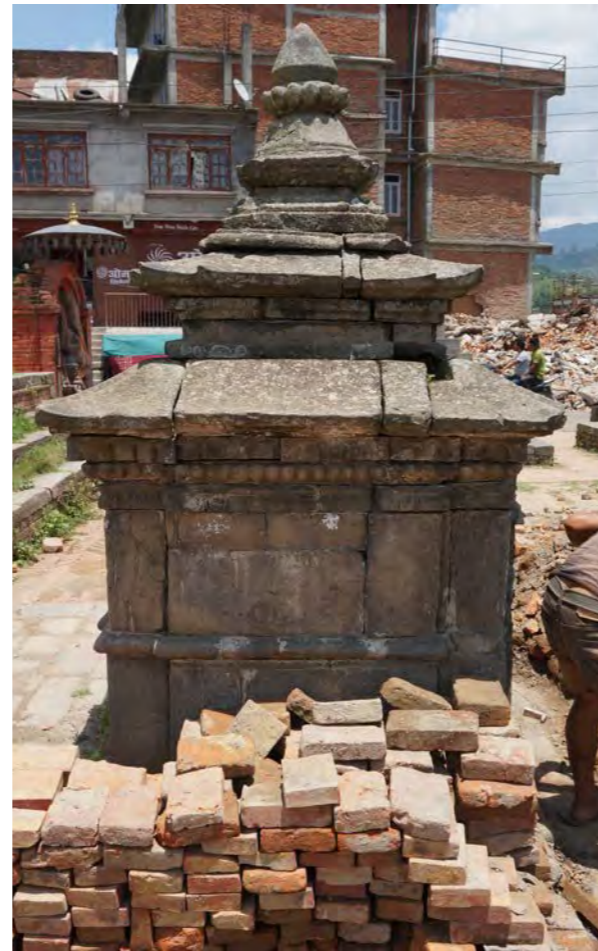
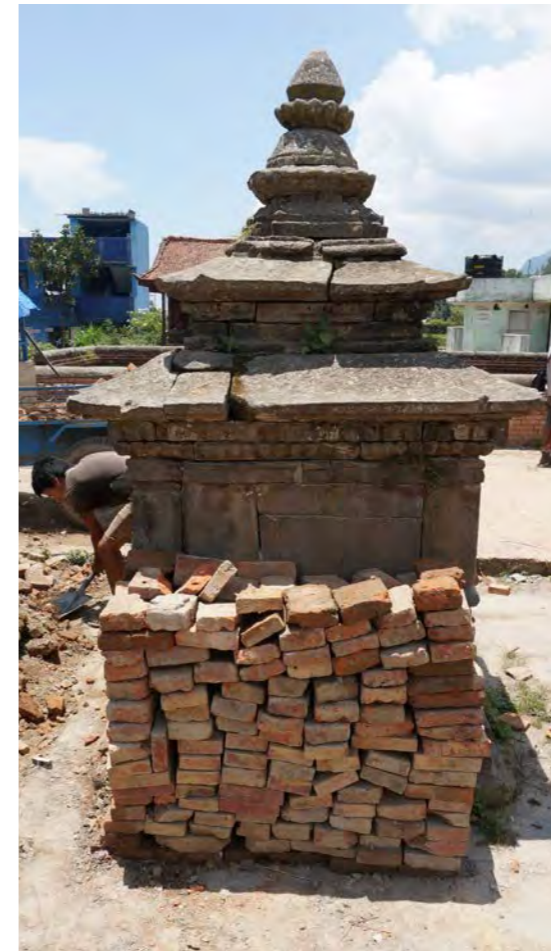
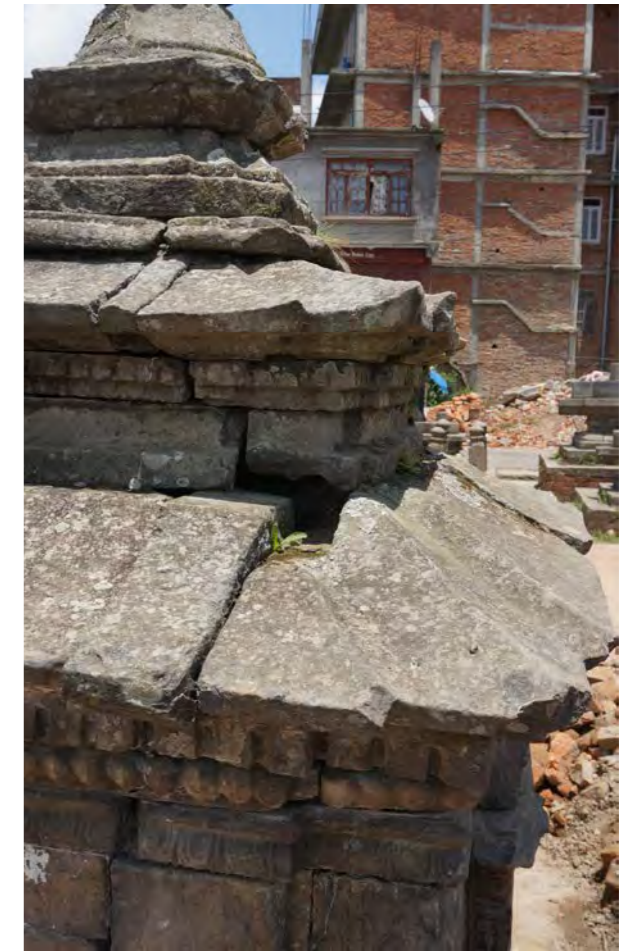
M26 UMA MAHESHWOR

NUMBER	NAME	ESTABLISHED DATE (A.D.)	TYPOLOGY	GENERAL DESCRIPTION	PROBLEMS DESCRIPTION	DANGER/ DESTROY	
M26	Umamaheshwor		Enclosed Shrine		Major cracks on south. Whole structure is tilted to south.

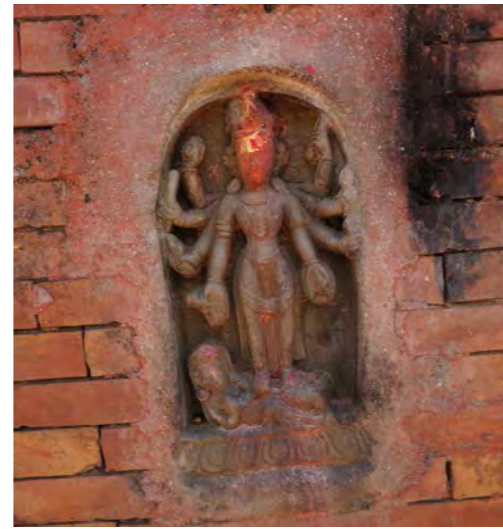
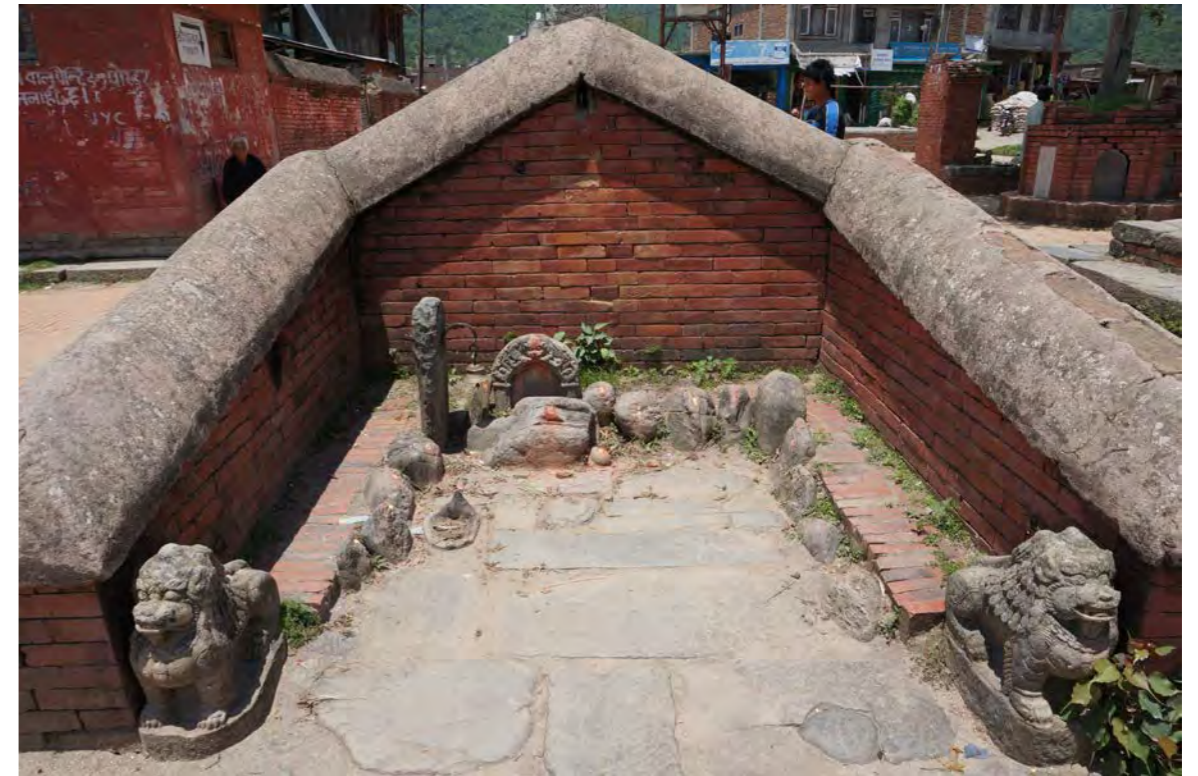
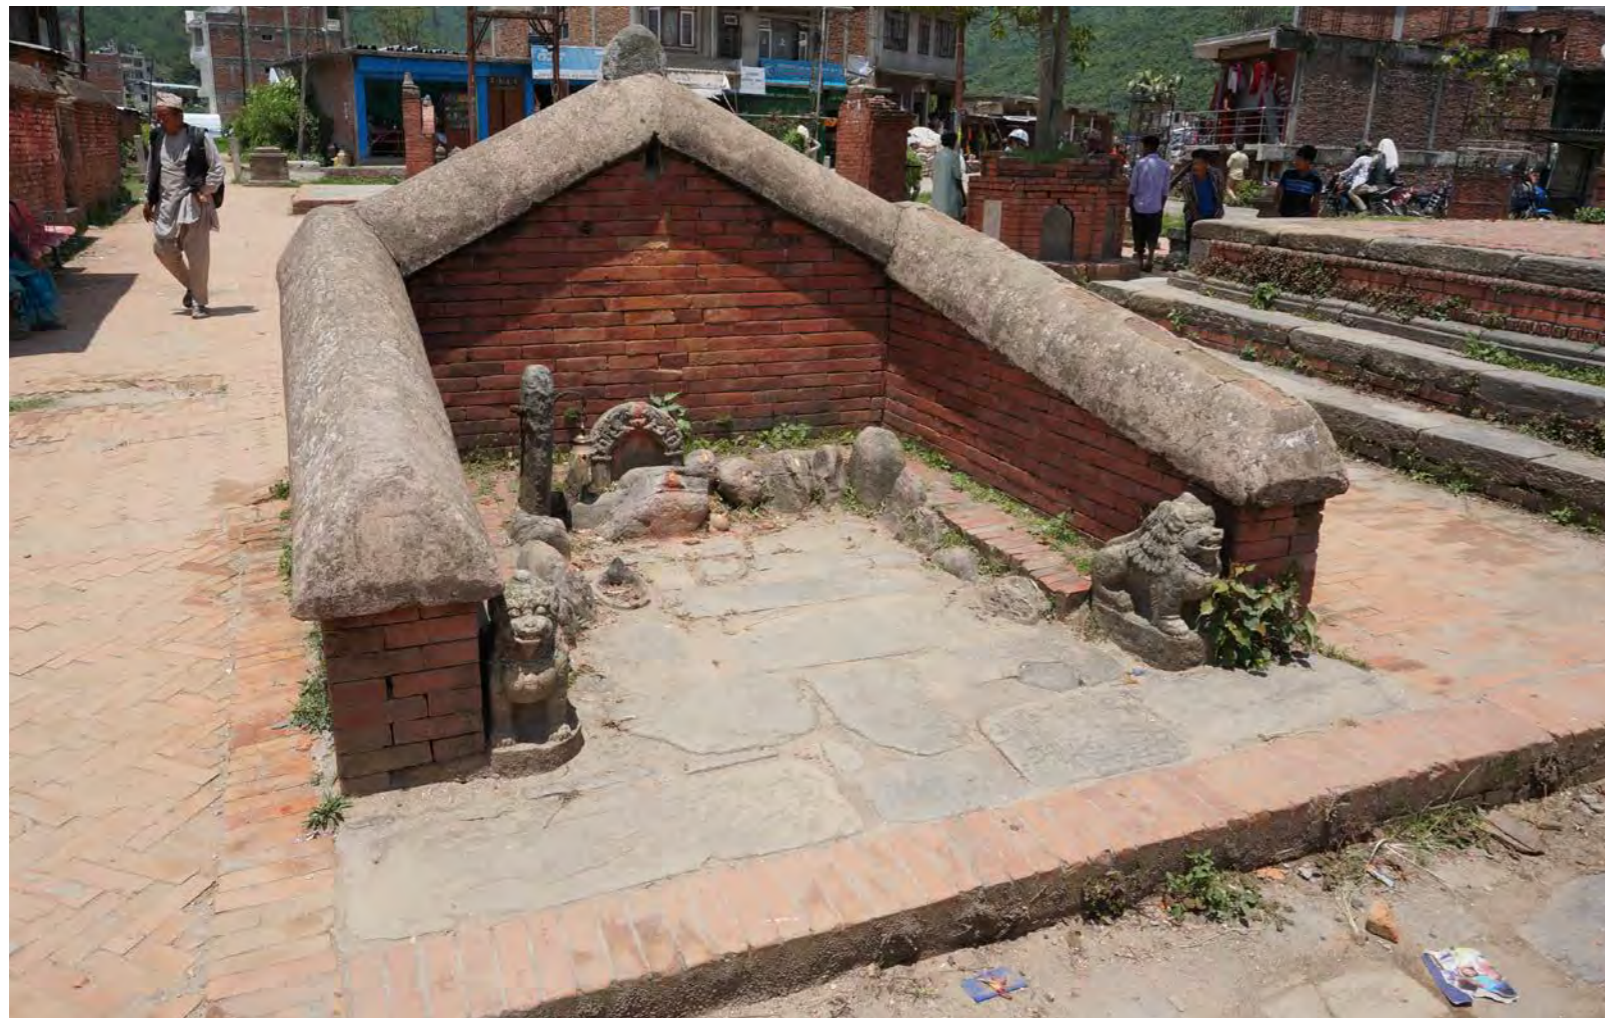
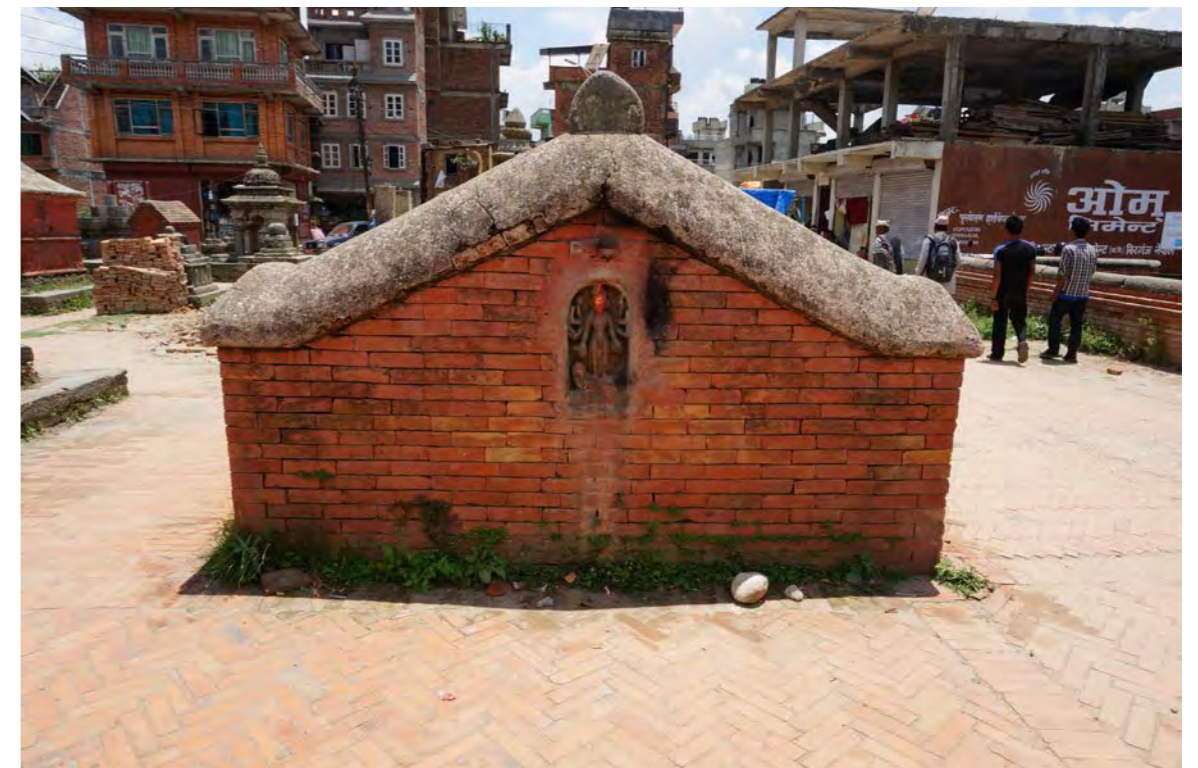
M27 OPEN SHRINE

NUMBER	NAME	DATE A.D.	TPOLOGY	GENERAL DESCRIPTION	PROBLEMS DESCRIPTION	DANGER/ DESTROY
M27			Open Shrine	1. Multiple stone dieties 2. two stone lions 3. A bell 4. brick wall on three sides Ce- ment plaster on top of brick wall	vegetation growth.
