2015 Earthquake Damage Mapping

Sankhu

October 2015

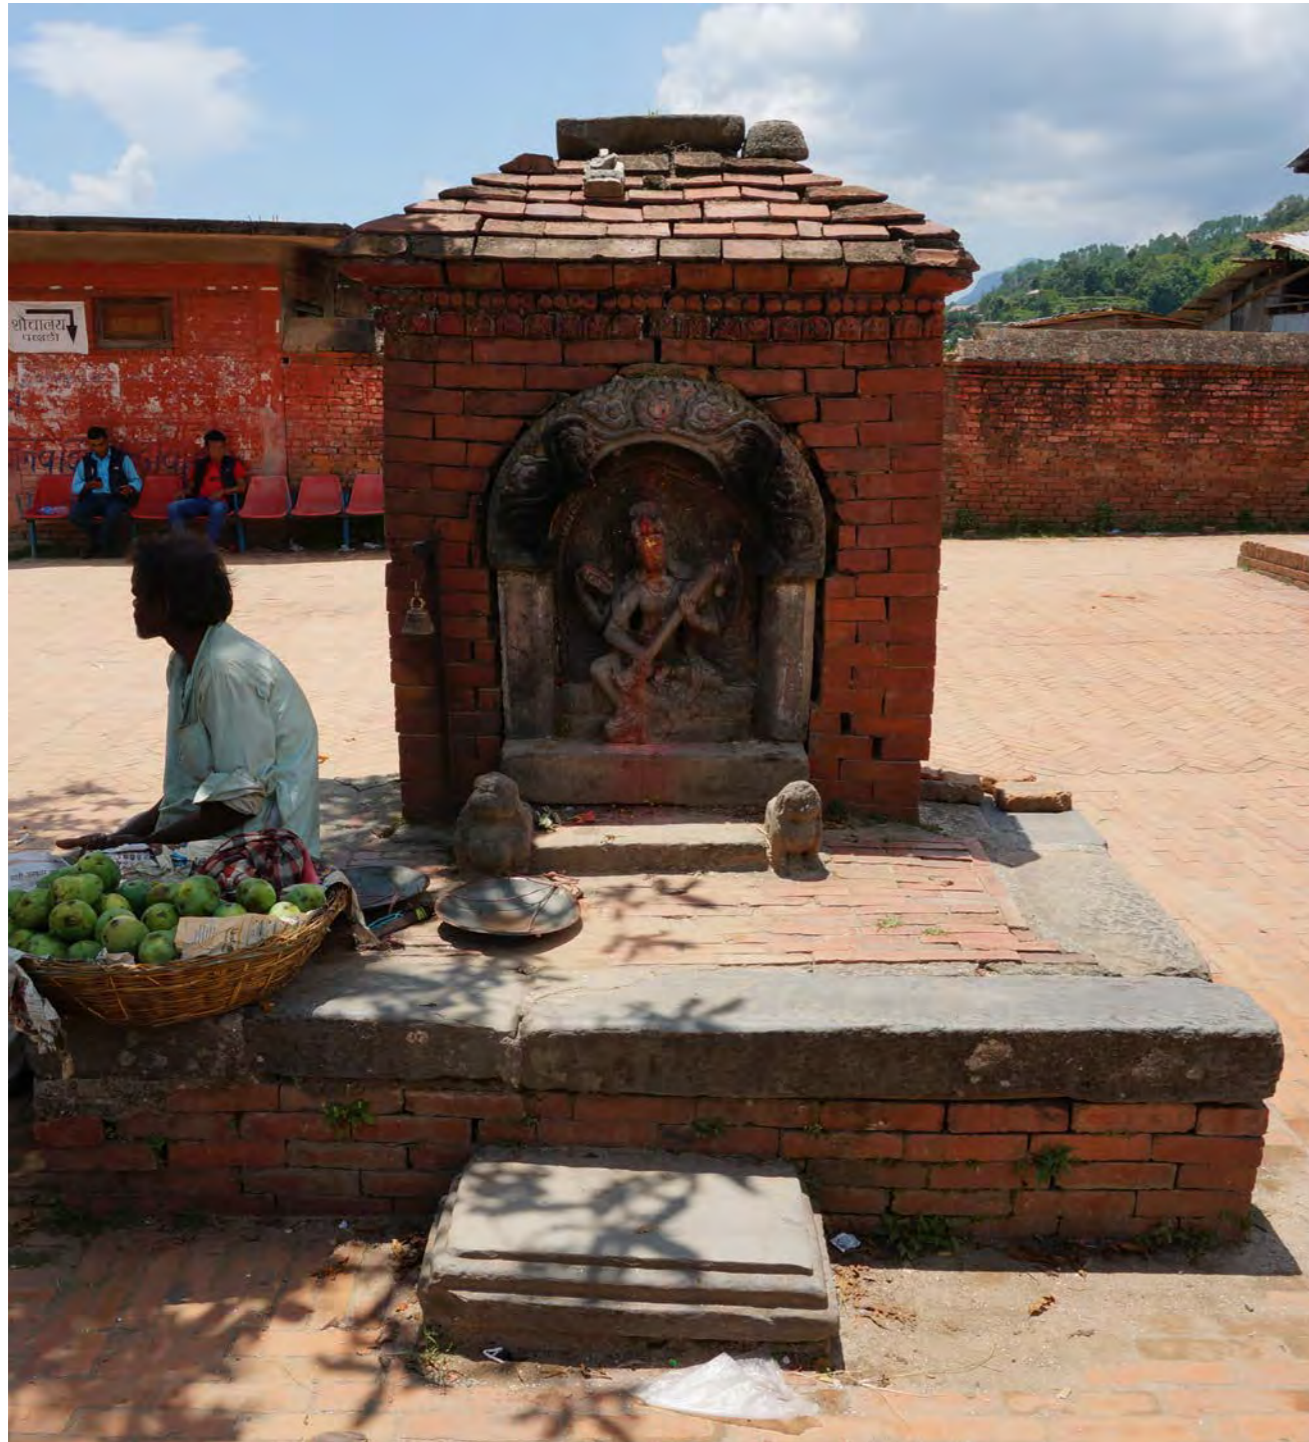
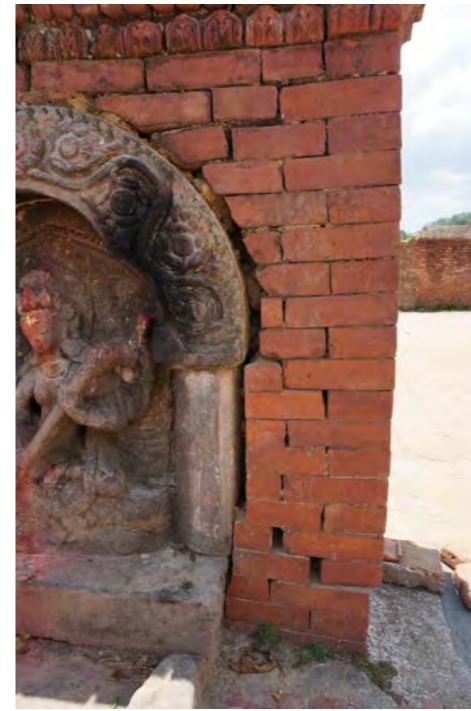
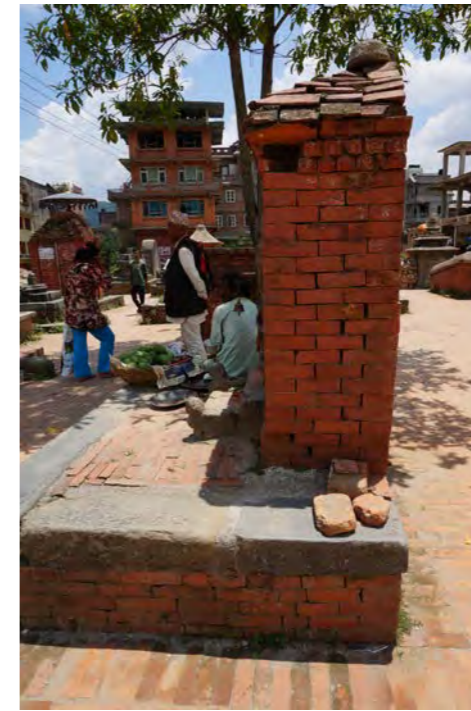
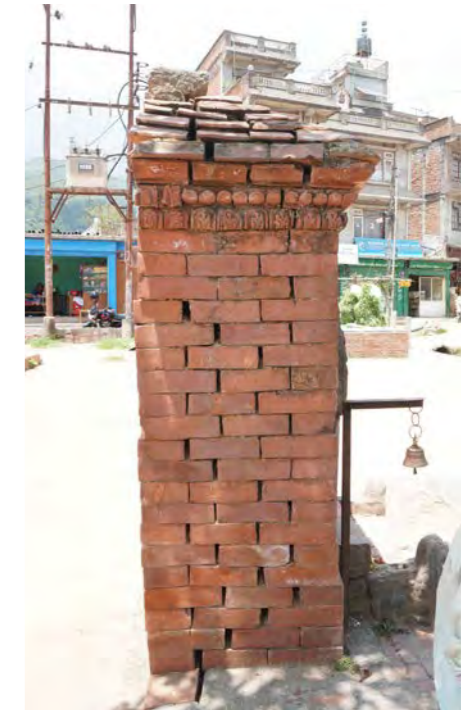
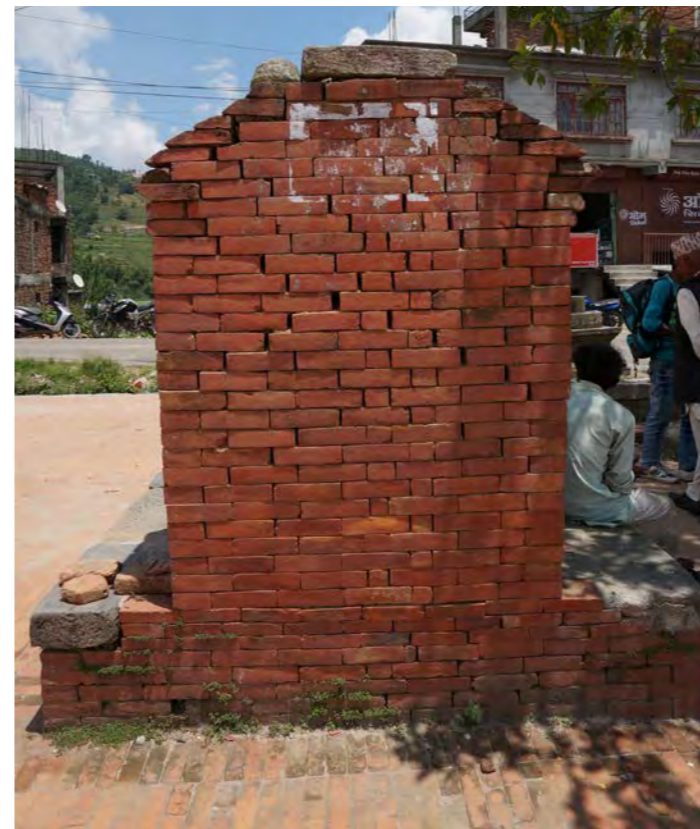
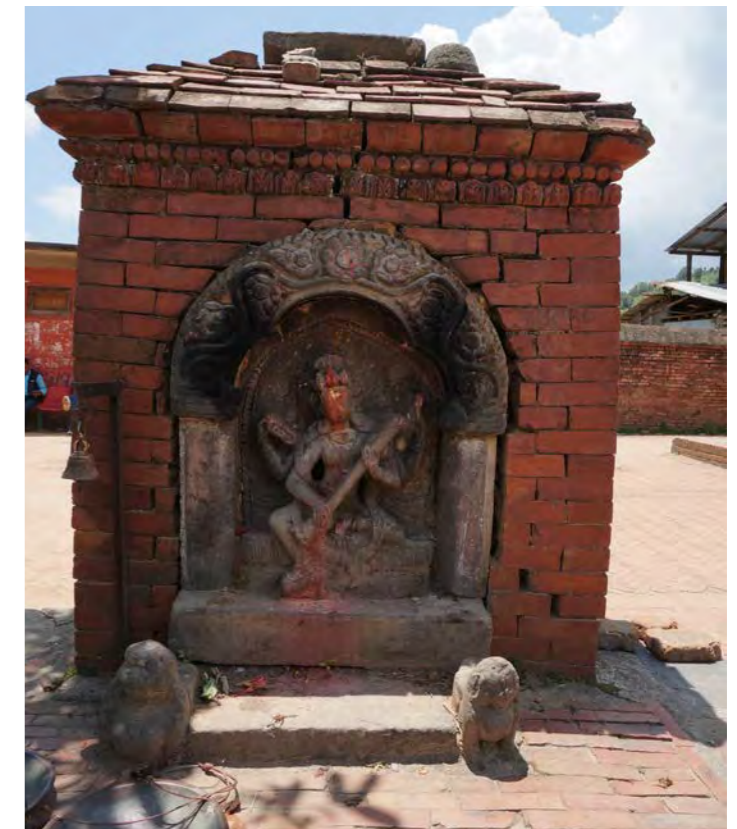
M28 OPEN SHRINE - SARASWATI

NUMBER	NAME	ESTABLISHED DATE (A.D.)	TYPOLOGY	GENERAL DESCRIPTION	PROBLEMS DESCRIPTION	DANGER/ DESTROY	
M28	Saraswati Shrine		Open Shrine	Brick wall with stone edge platform. Clay tile roof. Stepping stone. A small bell on back of wall is bulging out.	Brick wall around the image is collapsing. Cracks on roof.	⚠️

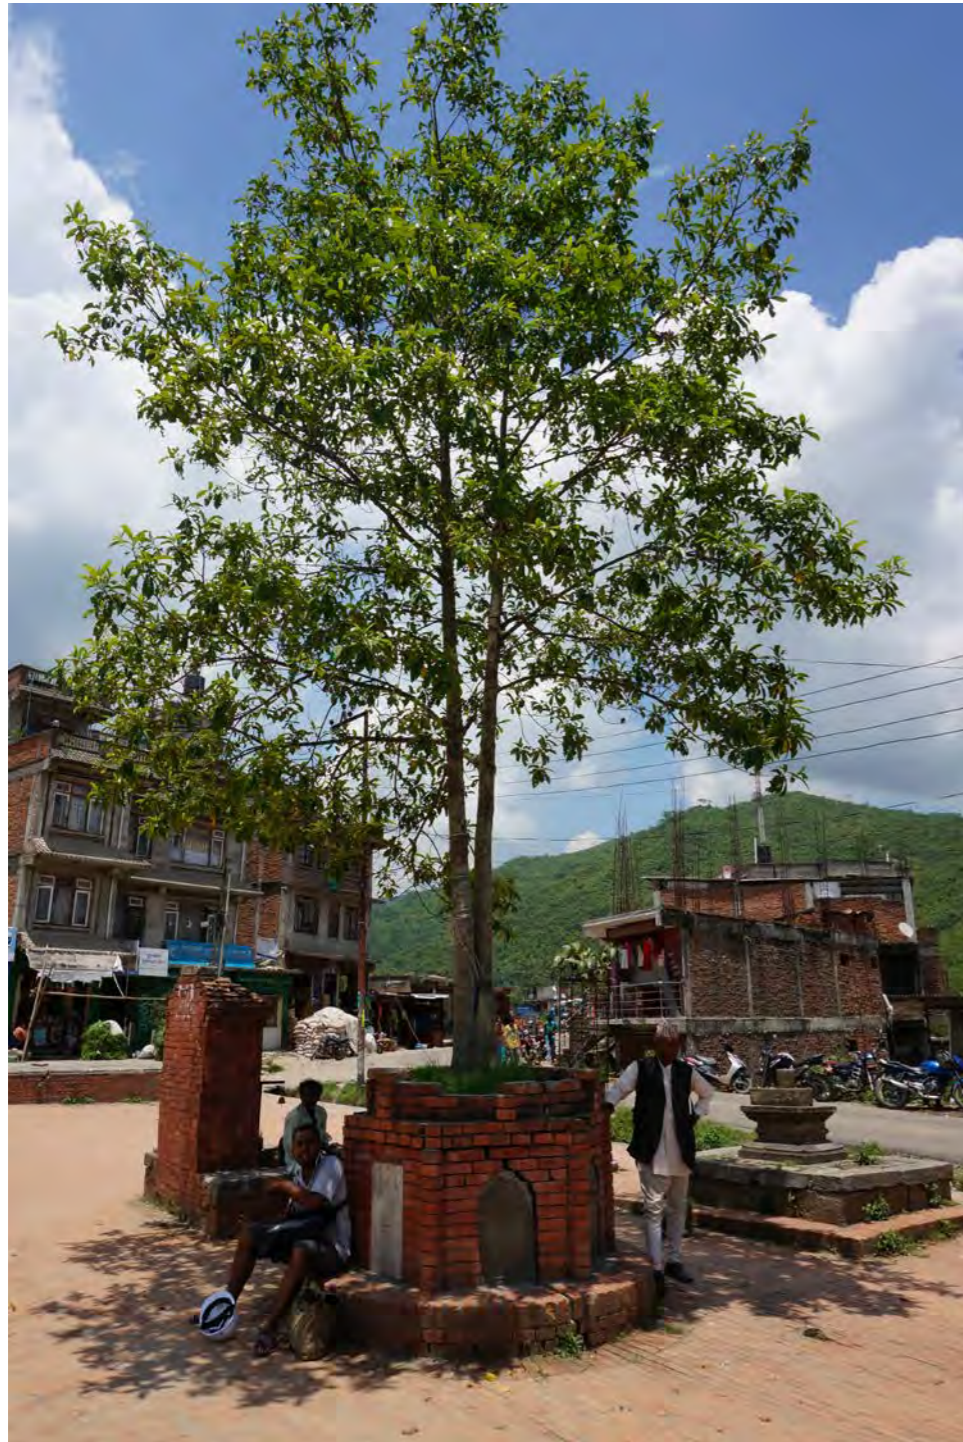
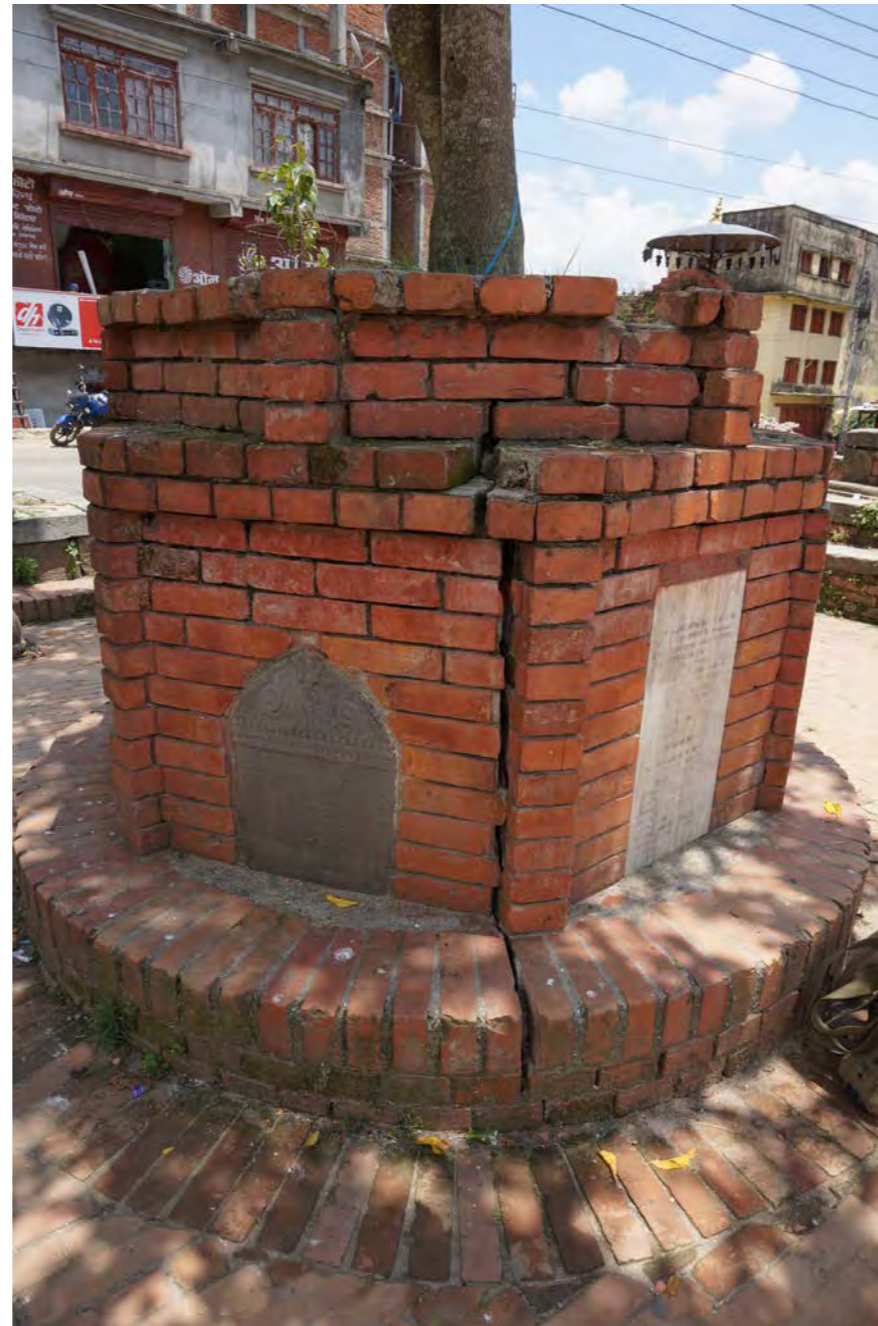
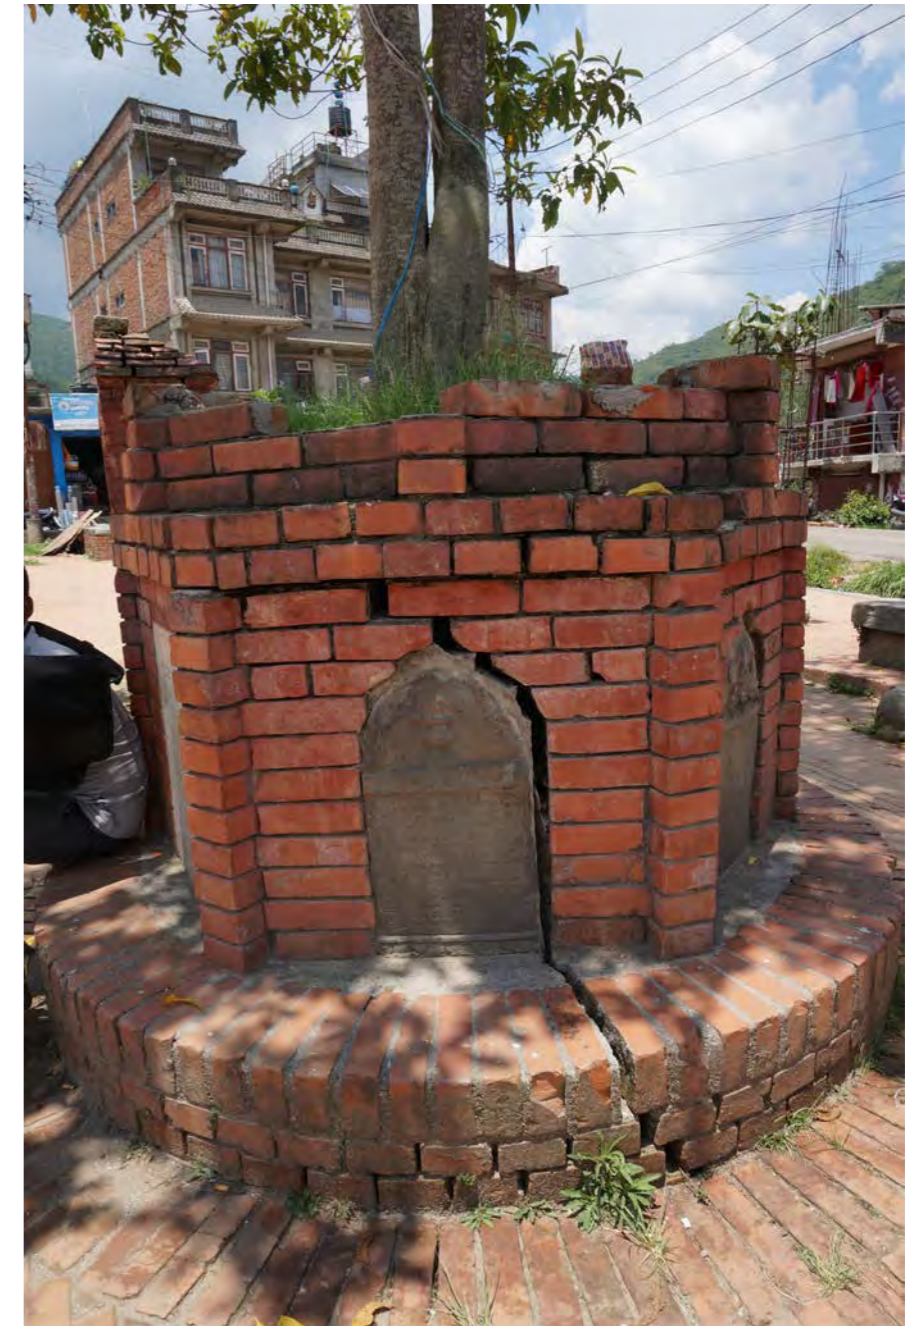
M29 TREE

NUMBER	NAME	DATE A.D.	TYPOLOGY	GENERAL DESCRIPTION	PROBLEMS DESCRIPTION	DANGER/ DESTROY	
M29				Tree on hexagonal platform. Each side of hexagon has stone or marble inscription.	Major cracks on north and south.

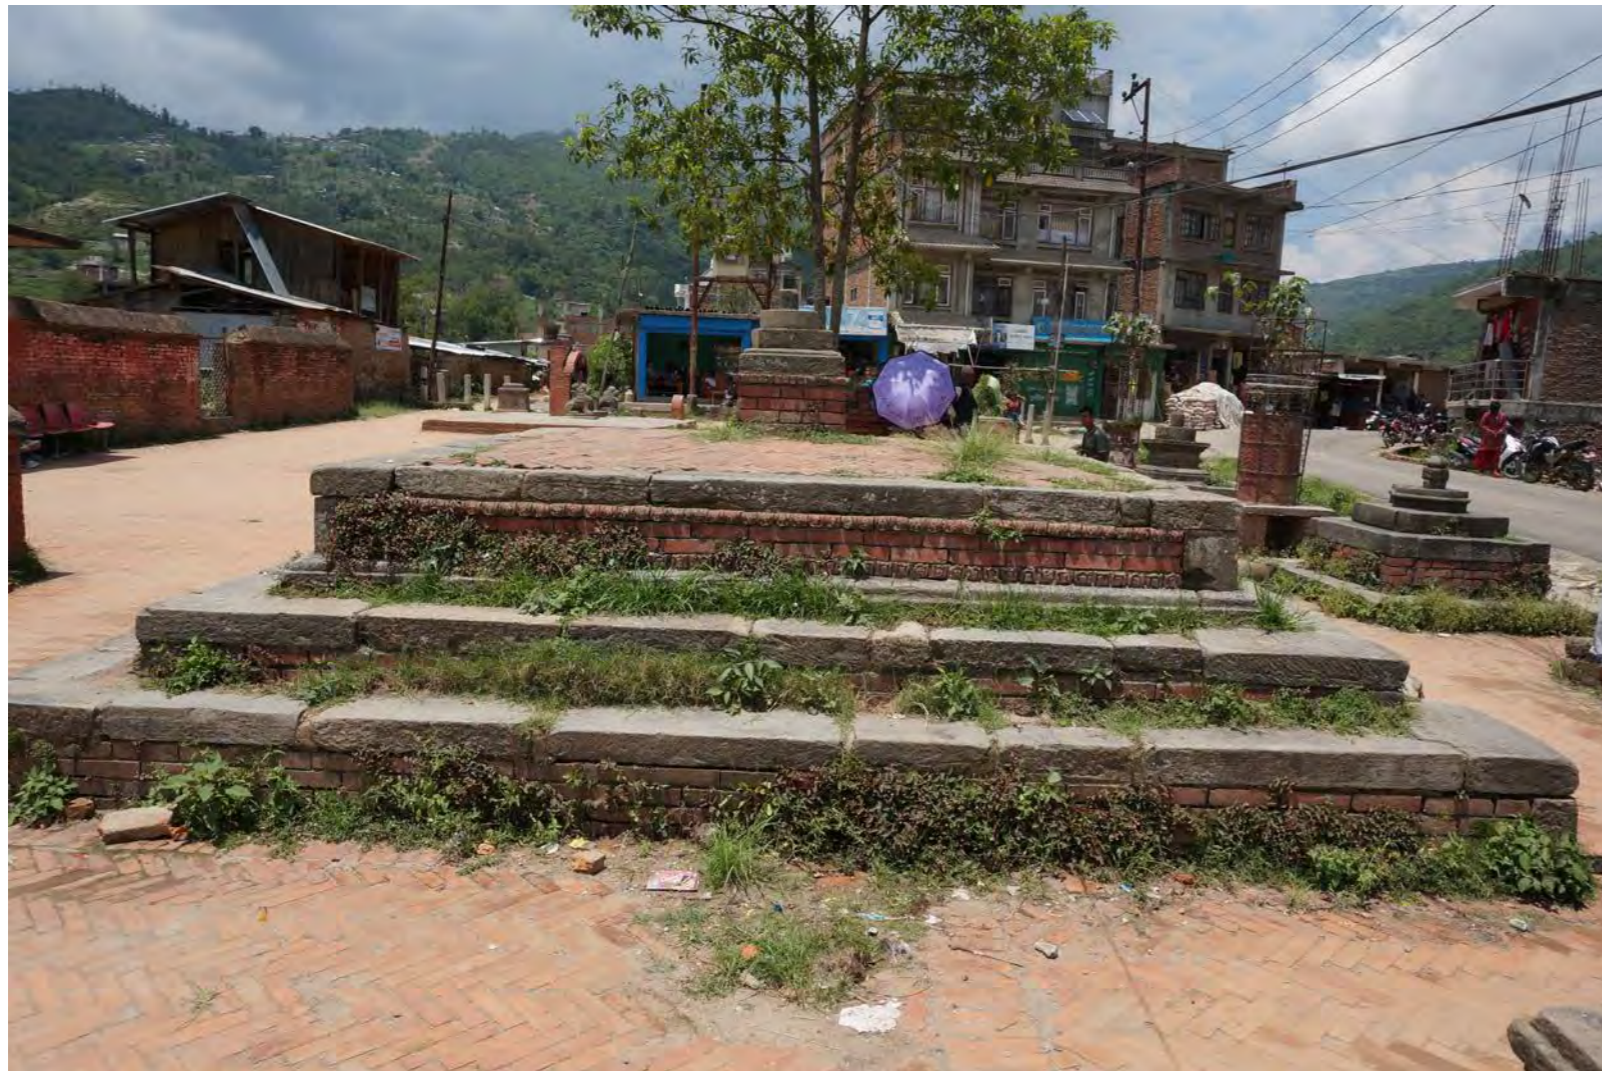
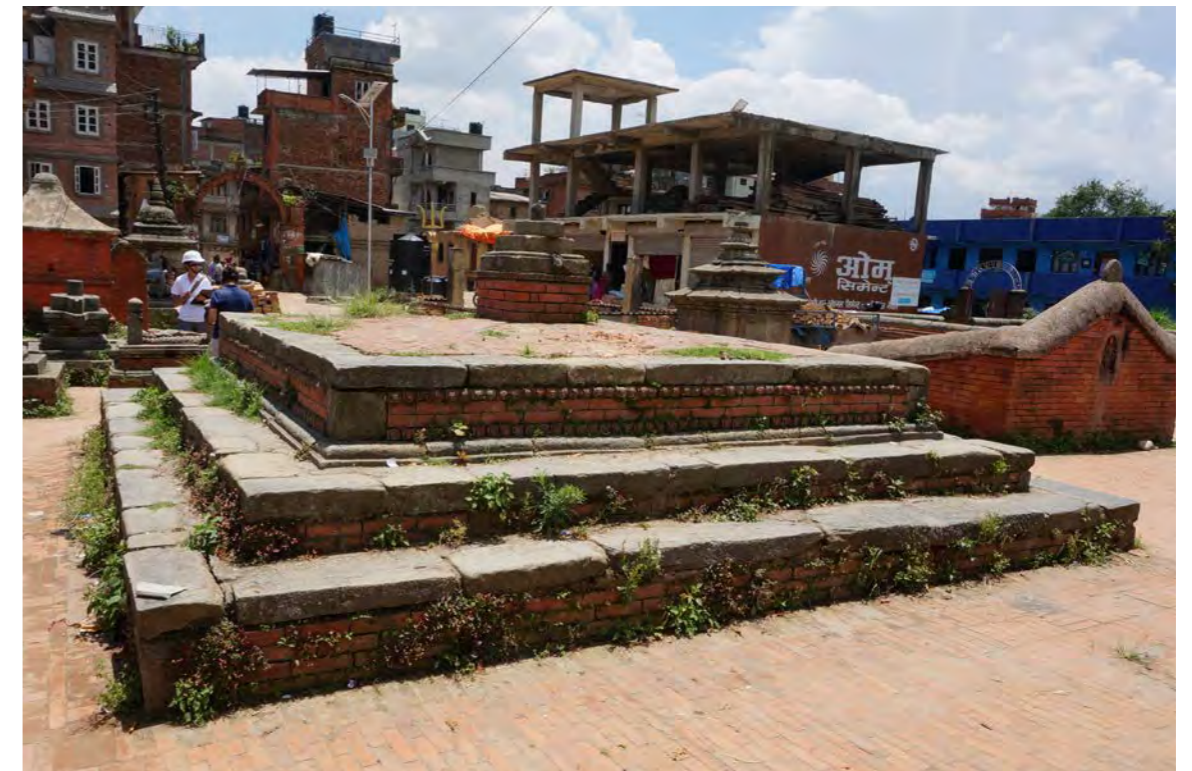
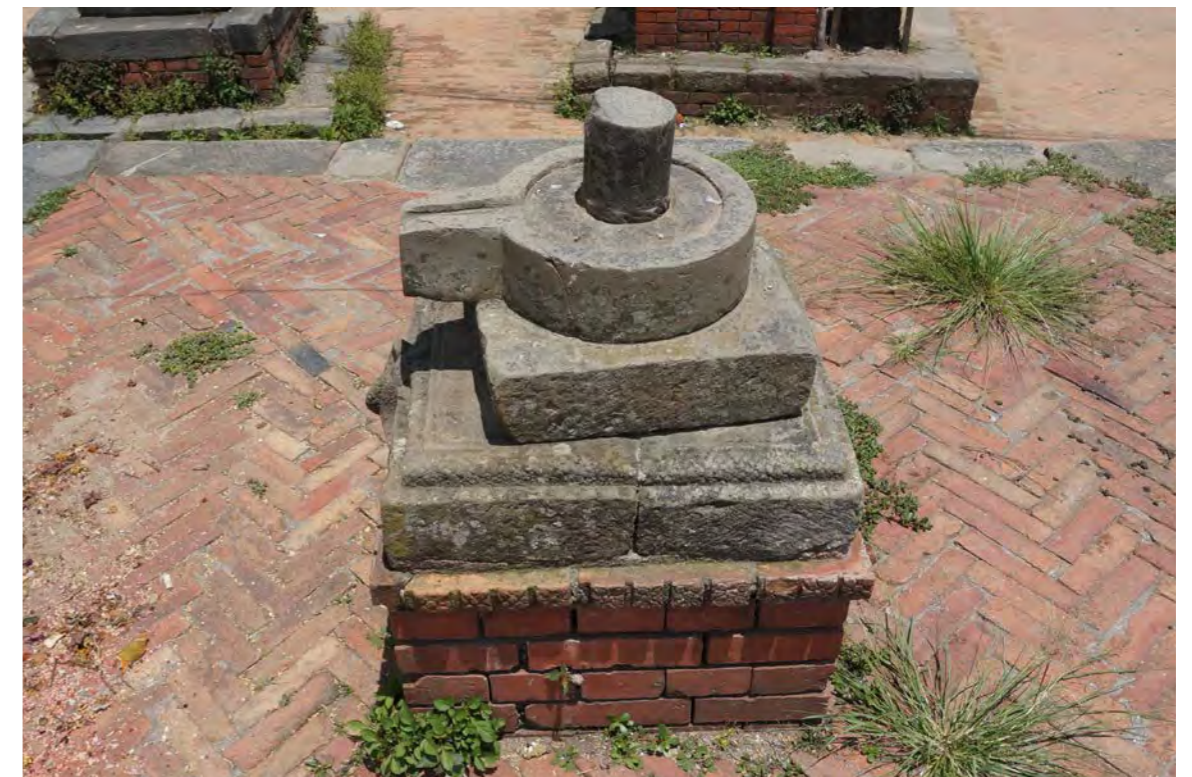
M30 SHIVA LINGA

NUMBER	NAME	ESTABLISHED DATE (A.D.)	TYPOLOGY	GENERAL DESCRIPTION	PROBLEMS DESCRIPTION	DANGER/ DESTROY	
M30			Shiva linga	Shiva linga with Jalahari on 3 layered platform	Vegetation growth all around. Stone seperating at north east corner (lower level). Jalahari twisted.

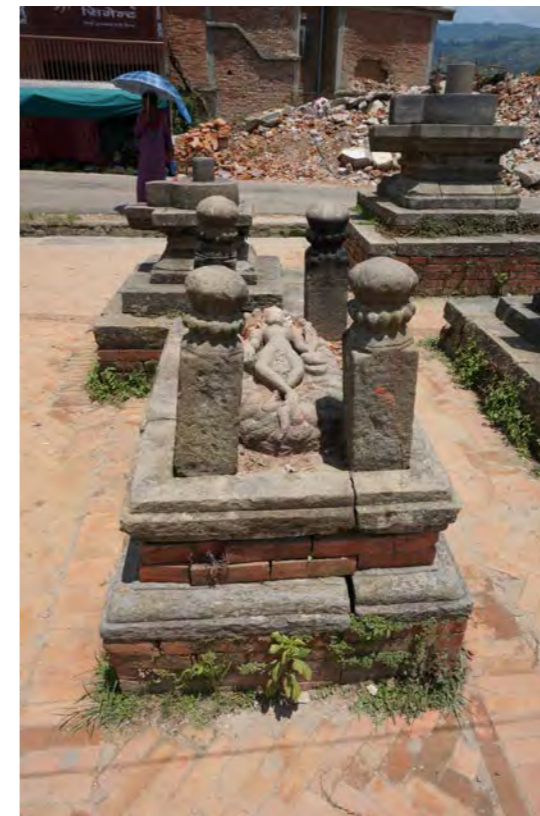
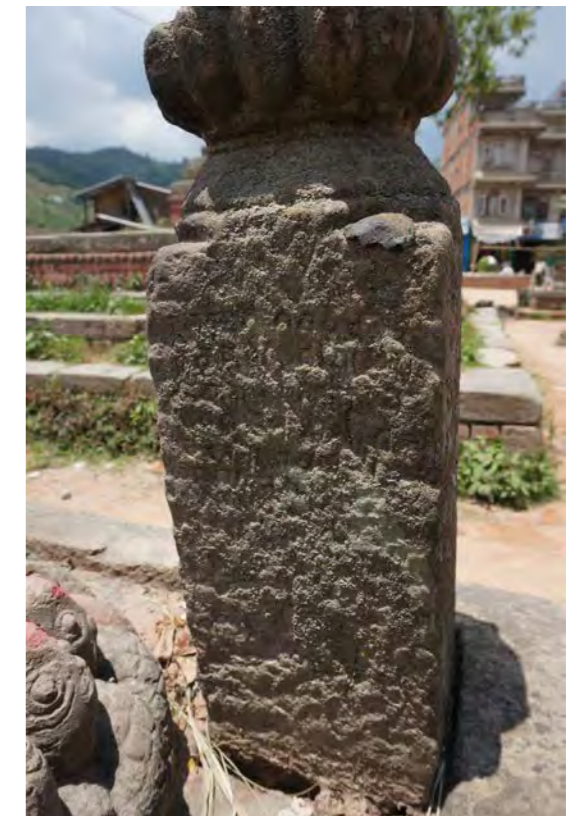
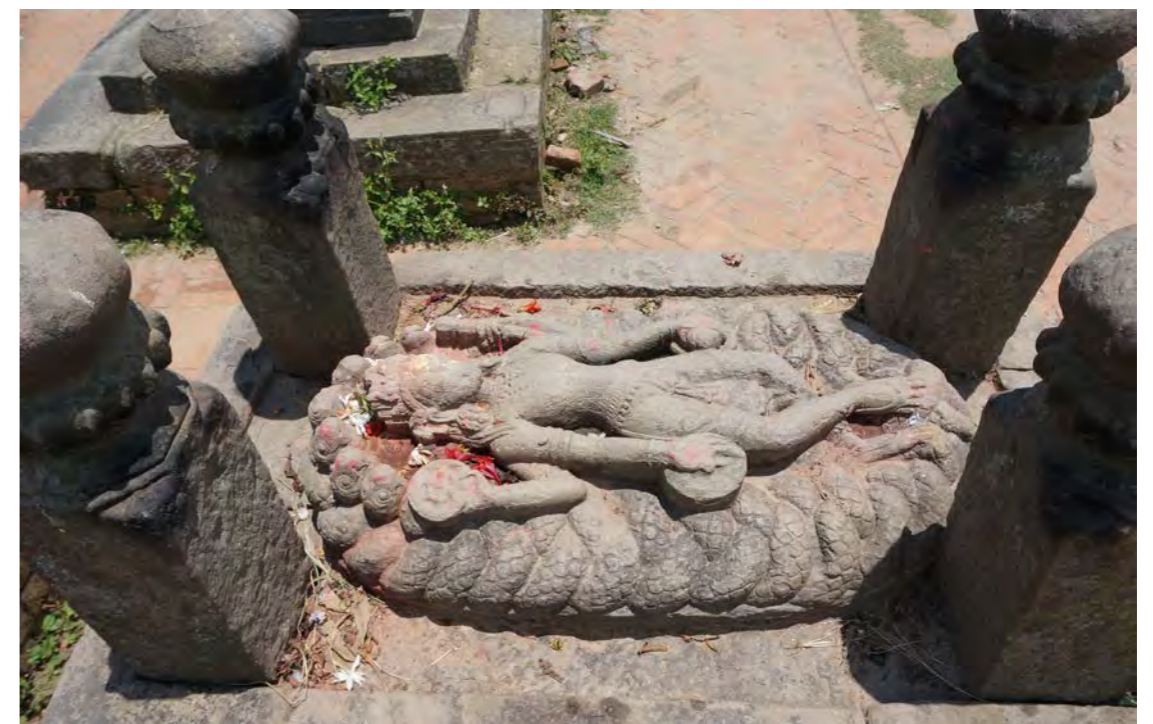
M31 OPEN SHRINE - VISHNU IDOL

NUMBER	NAME	DATE A.D.	TPOLOGY	GENERAL DESCRIPTION	PROBLEMS DESCRIPTION	DANGER/ DESTROY	
M31	Vishnu Idol		Open Shrine	Jalashai Vishnu with four stone post on top of brick and stone platform.	Crack on bricks and stone wall at north west. Bricks are displaced on 3 sides (except south).

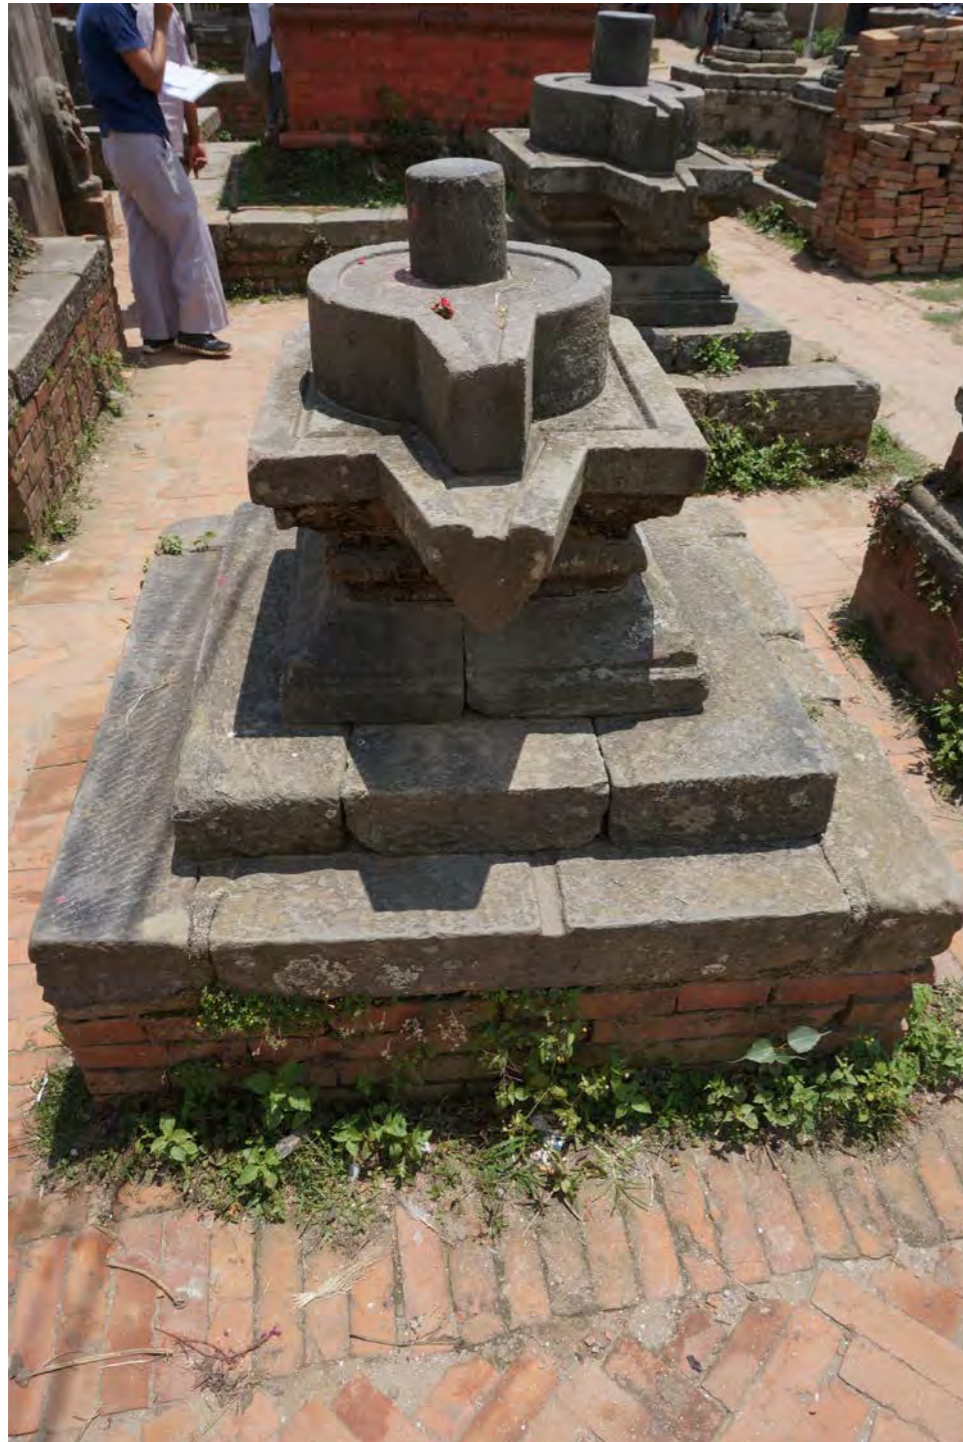
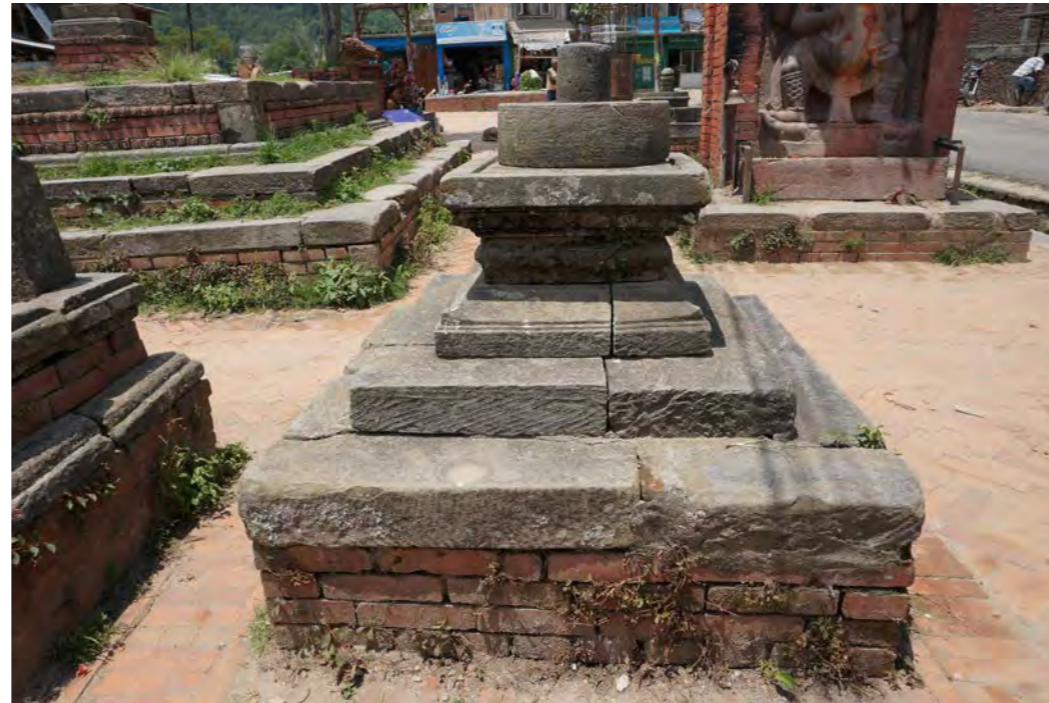
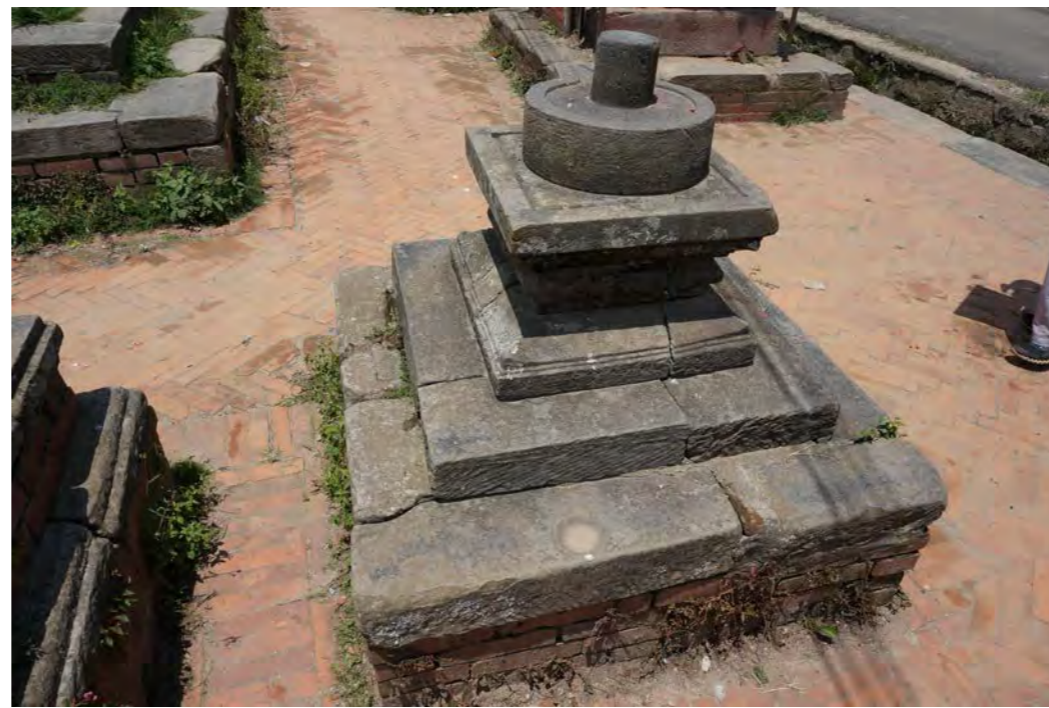
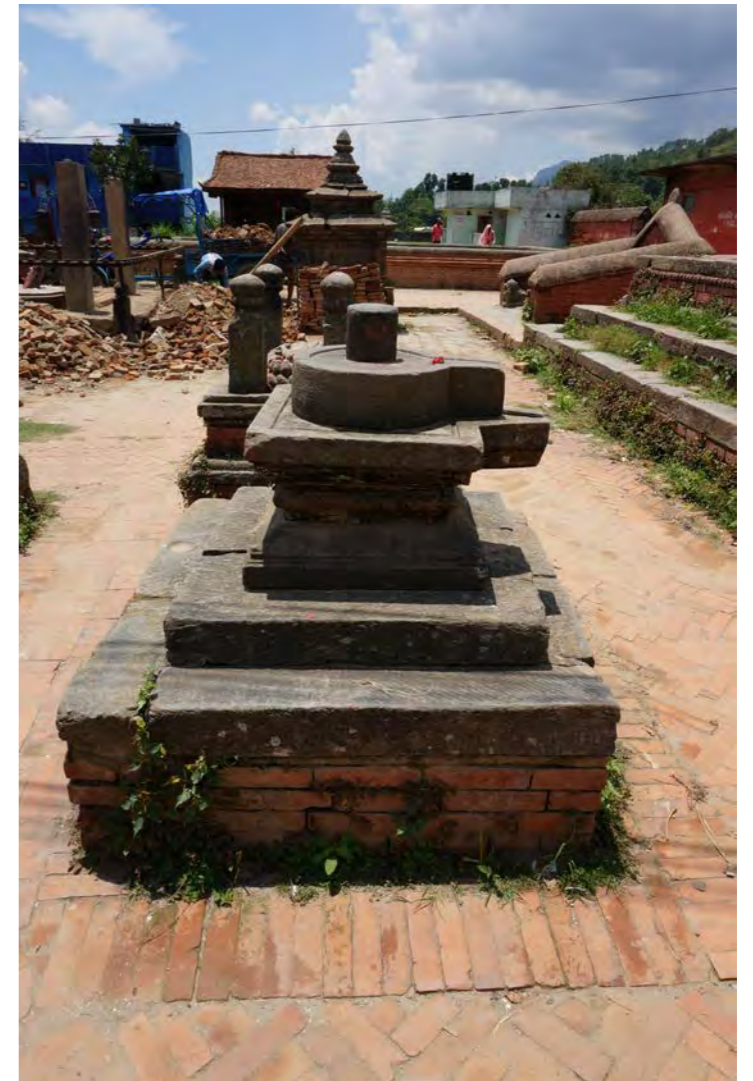
M32 SHIVA LINGA

NUMBER	NAME	ESTABLISHED DATE (A.D.)	TYPOLOGY	GENERAL DESCRIPTION	PROBLEMS DESCRIPTION	DANGER/ DESTROY
M32			Shiva linga	Brick wall stone paved platform. 2 jalaharis.	Vegetation growth.

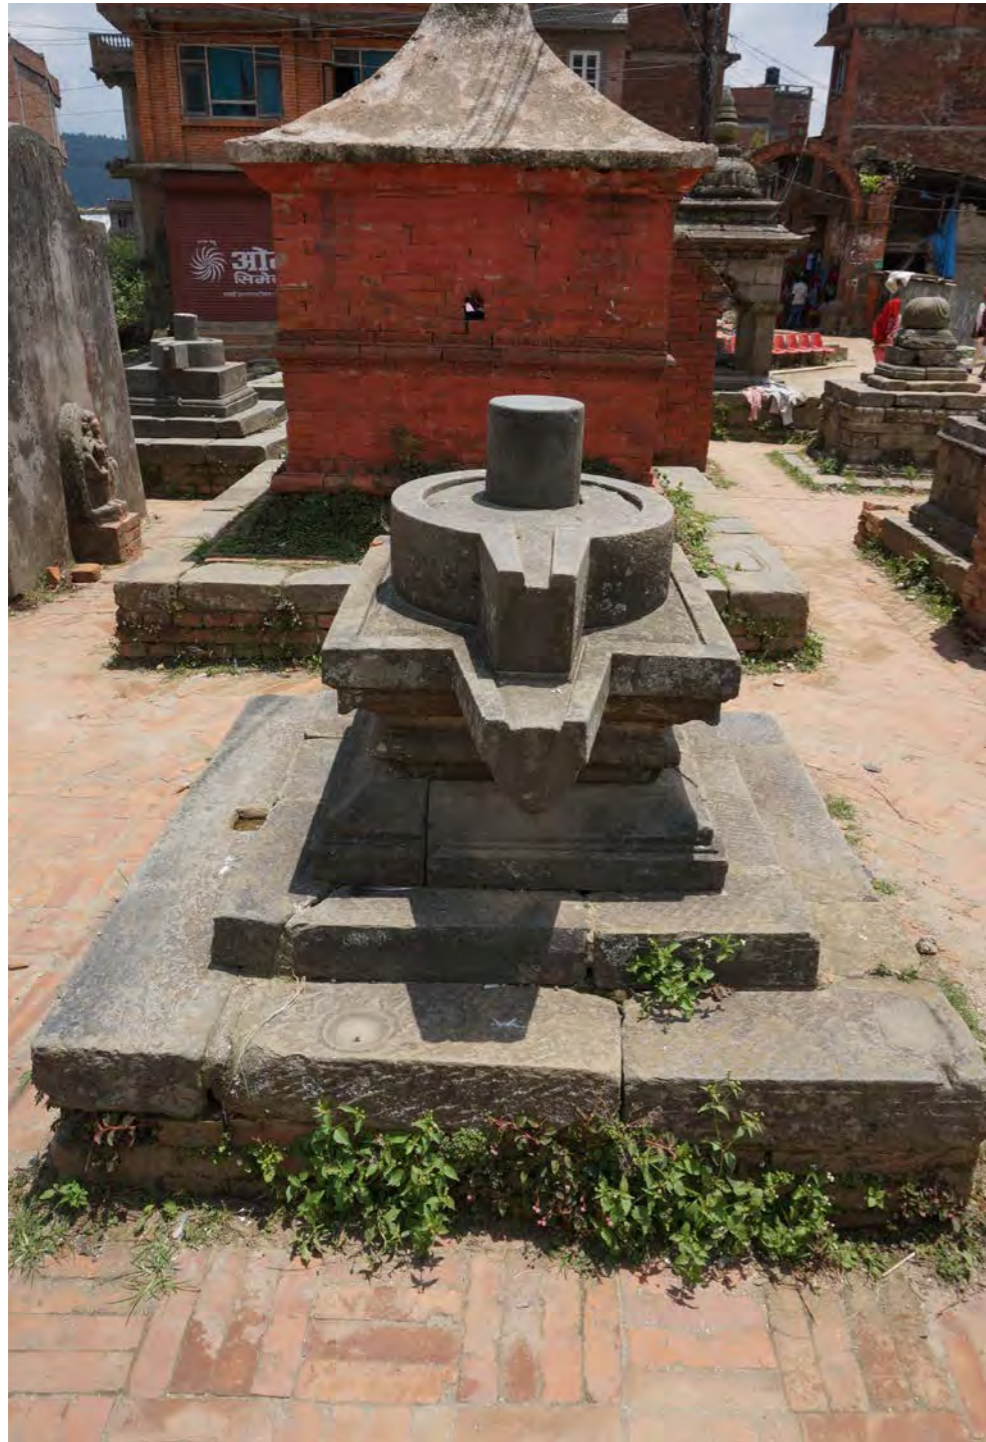
M33 SHIVA LINGA

NUMBER	NAME	DATE A.D.	TYPOLOGY	GENERAL DESCRIPTION	PROBLEMS DESCRIPTION	DANGER/ DESTROY
M33			Shiva linga	Brick wall stone paved platform. 2 jalaharis.	Settlement at the center. Cracks at joints.

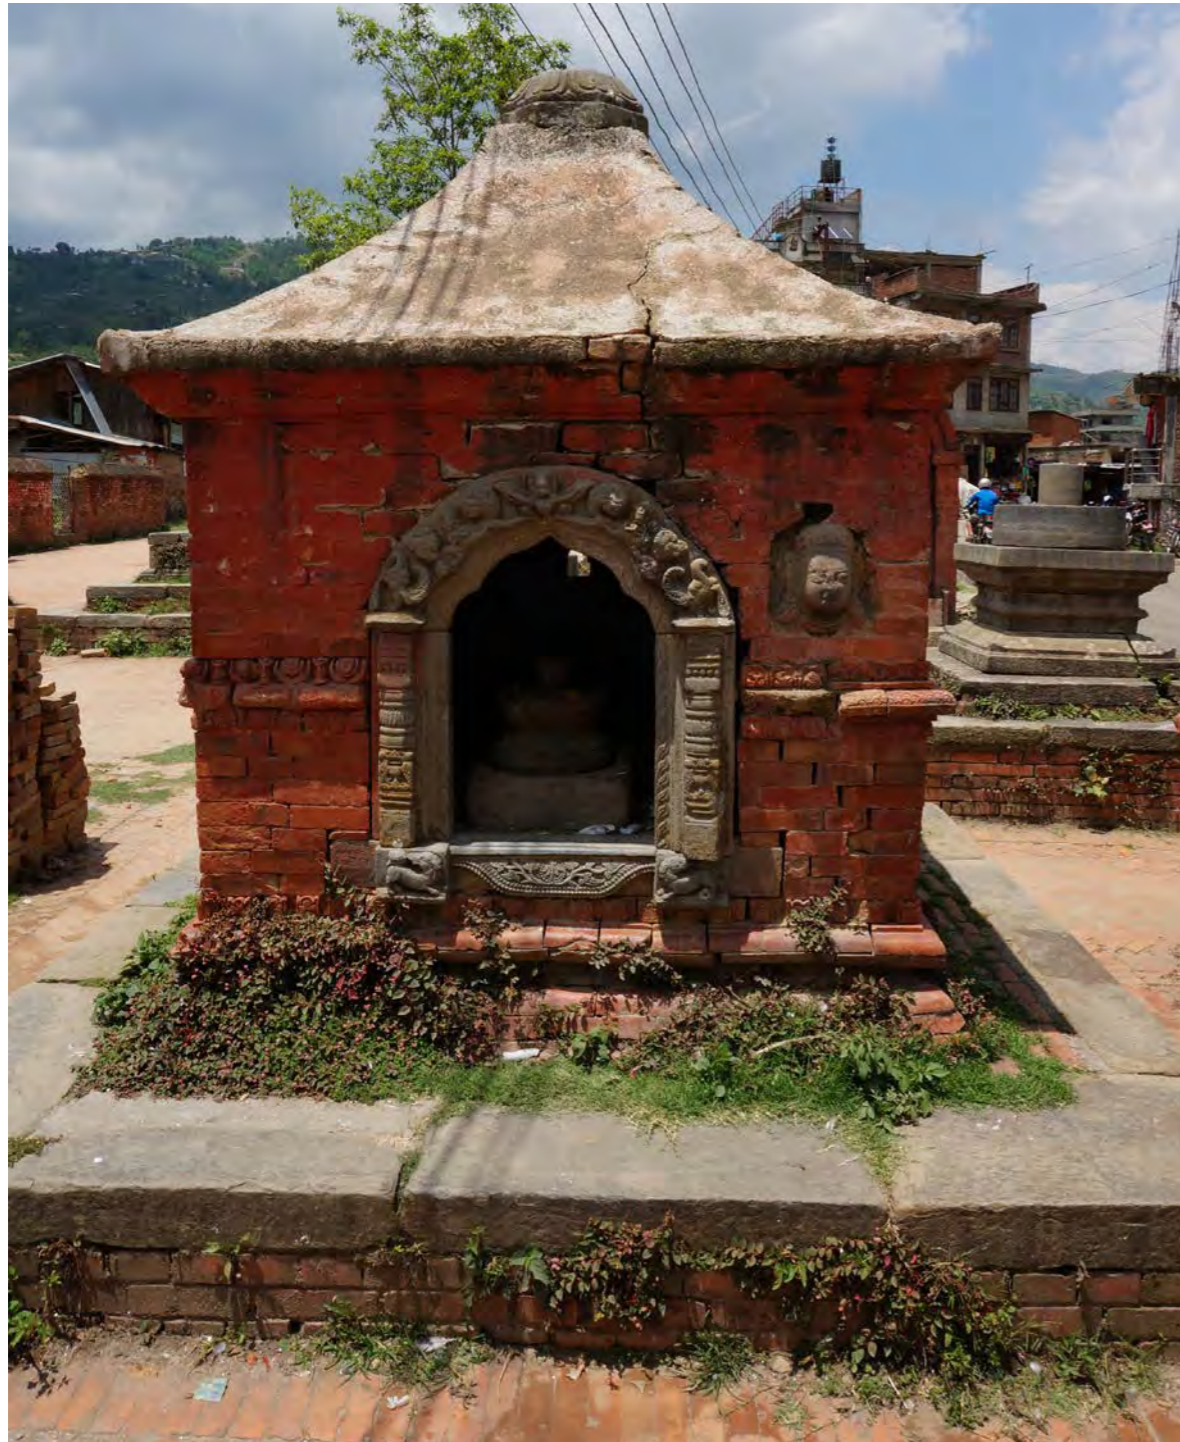
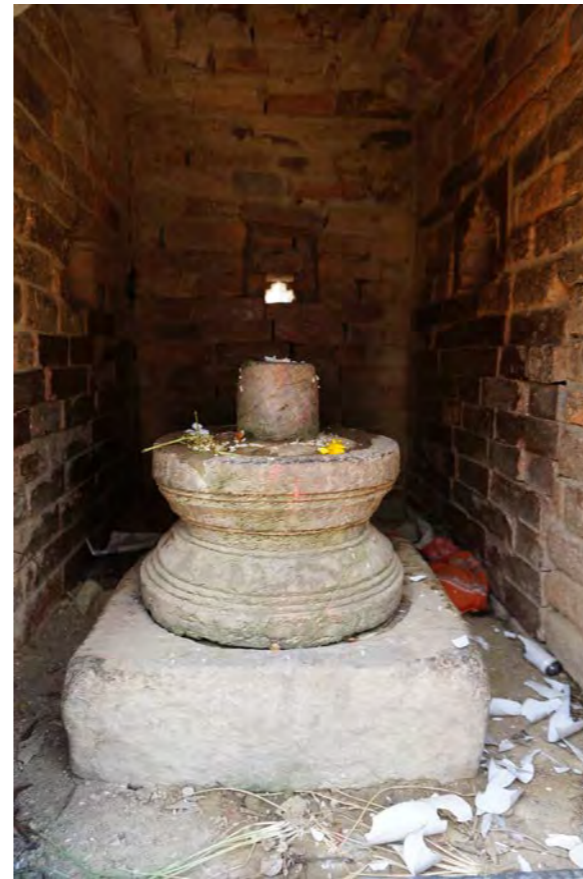
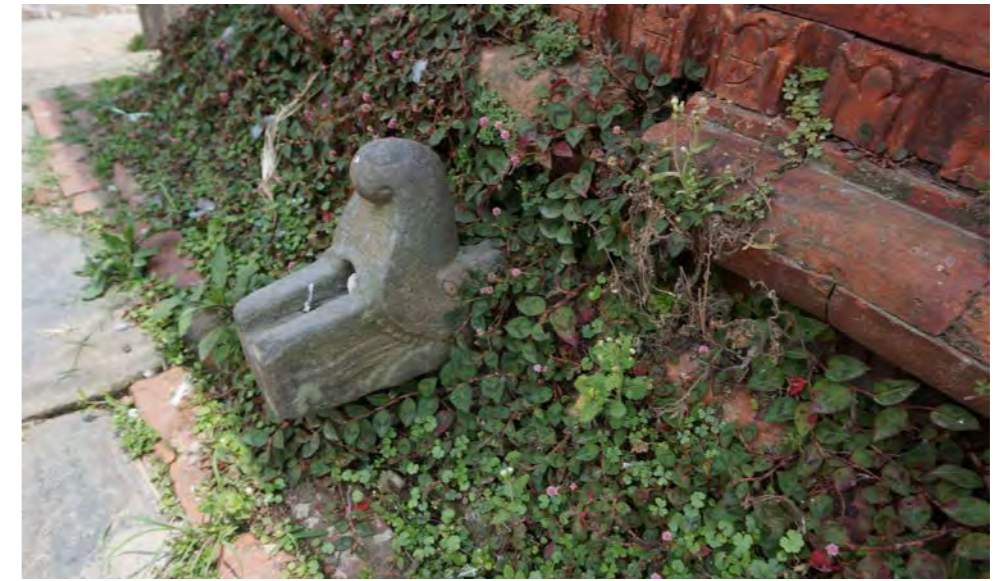
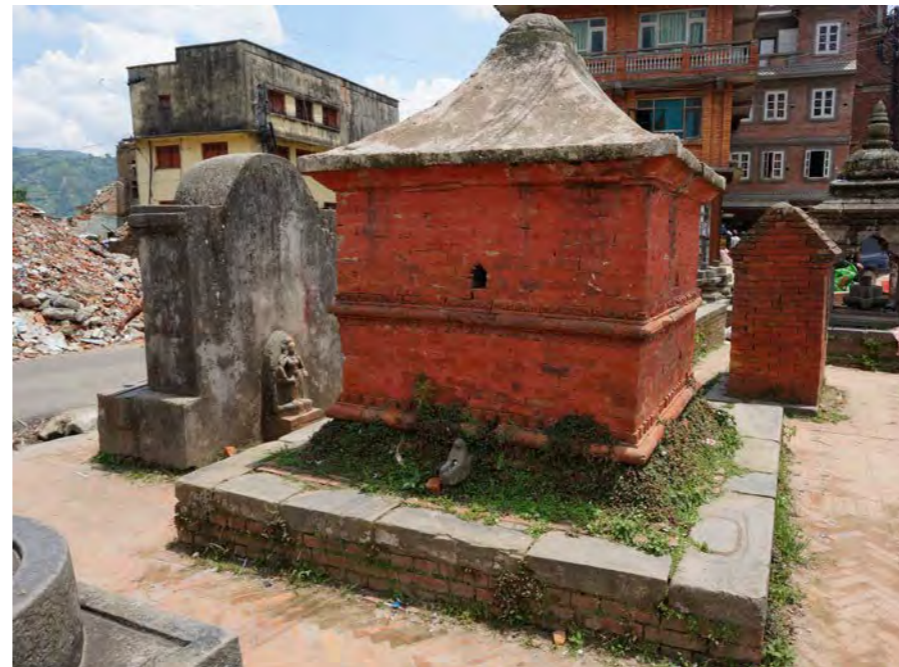
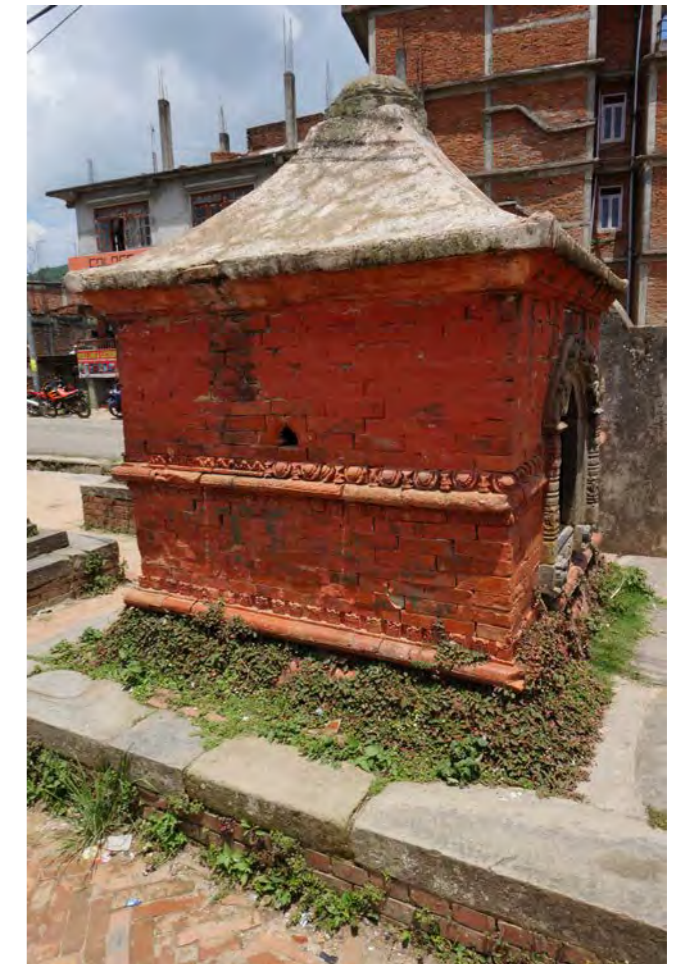
M34 SHIVALINGA

NUMBER	NAME	ESTABLISHED DATE (A.D.)	TYPOLOGY	GENERAL DESCRIPTION	PROBLEMS DESCRIPTION	DANGER/ DESTROY
M34			Shiva linga	Brick temple with plastered roof.	Gajur is missing. Large crack and separation of bricks on north and south side. North east wall seperating. Vegetation growth on platform.
