2015 Earthquake Damage Mapping

Sankhu

October 2015

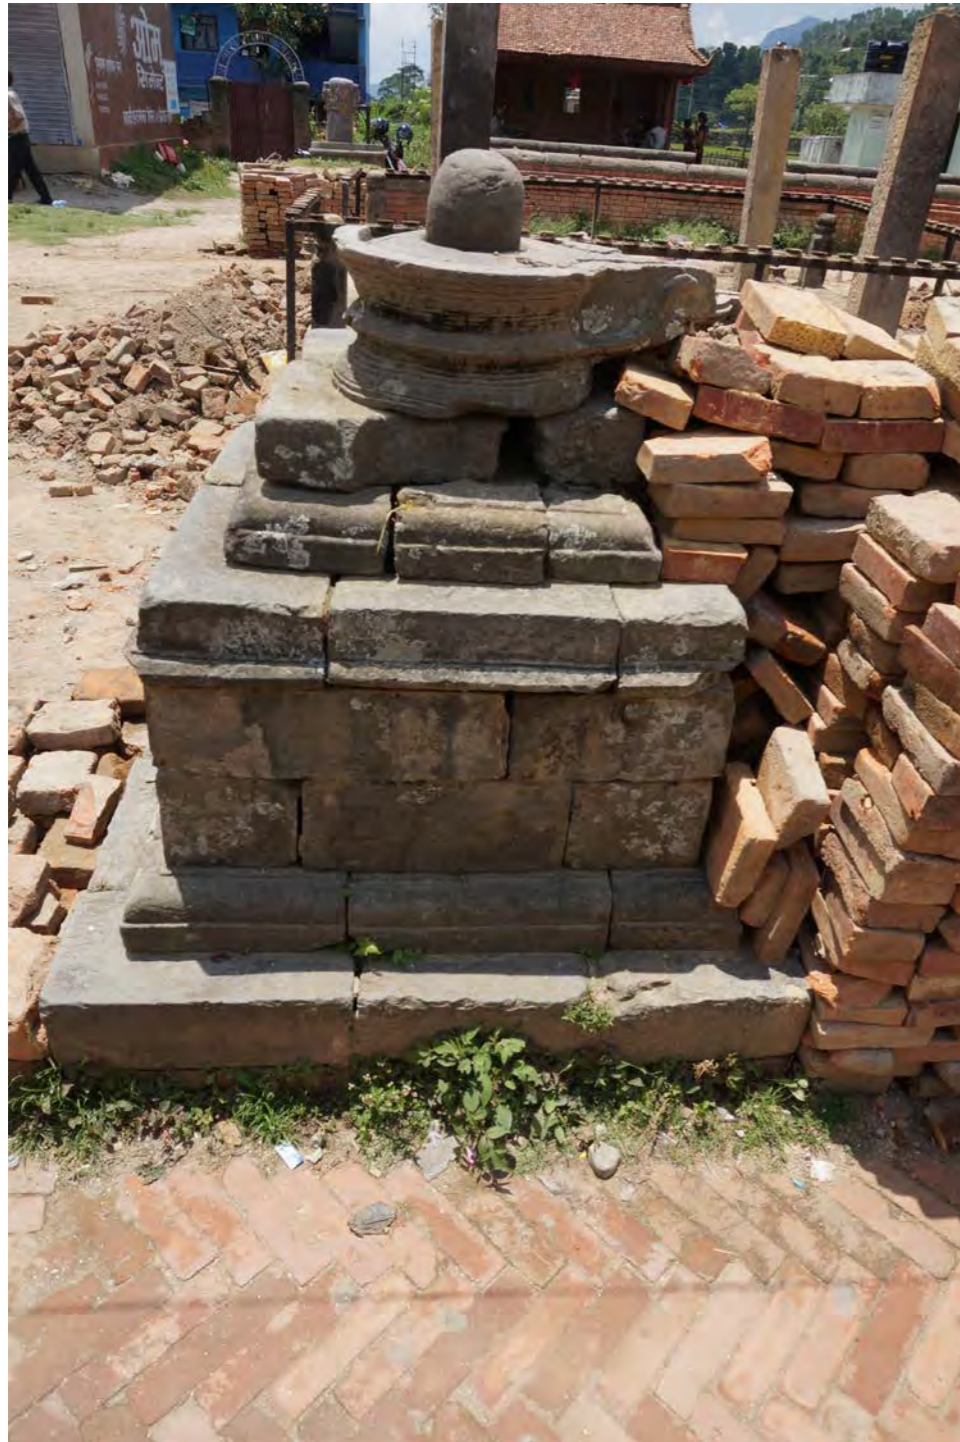
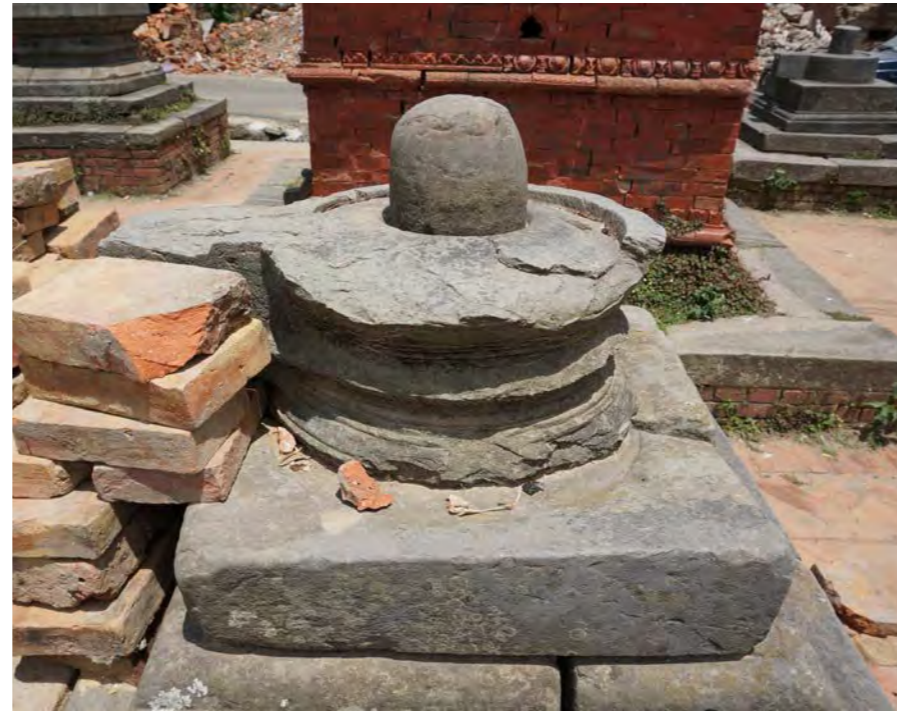
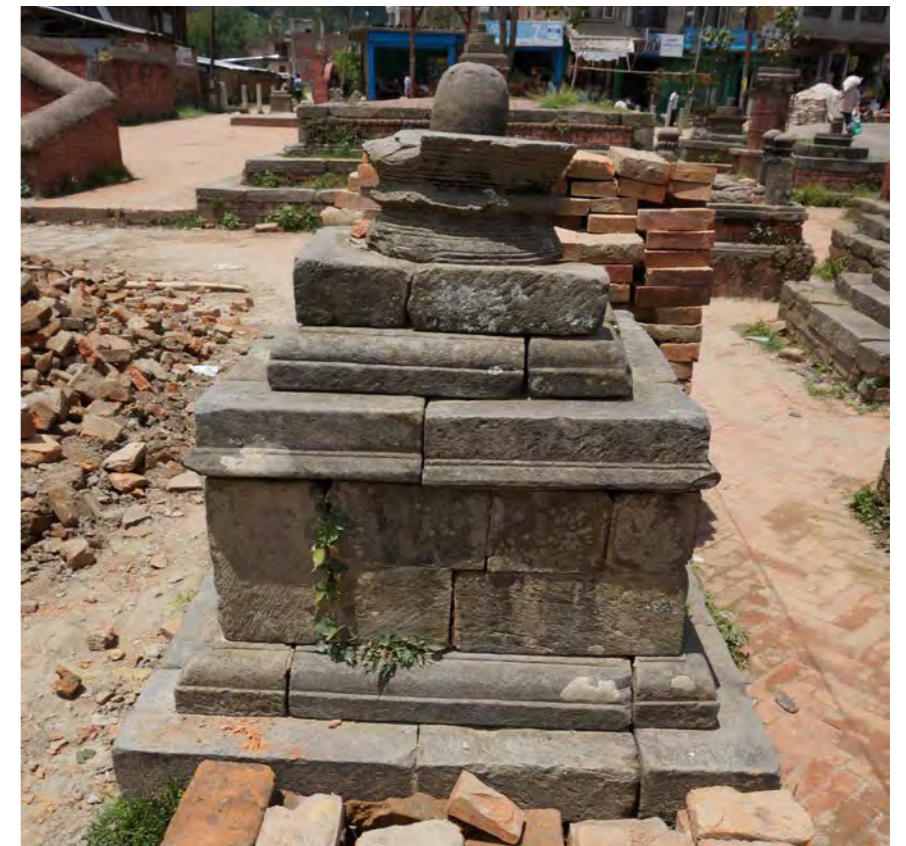
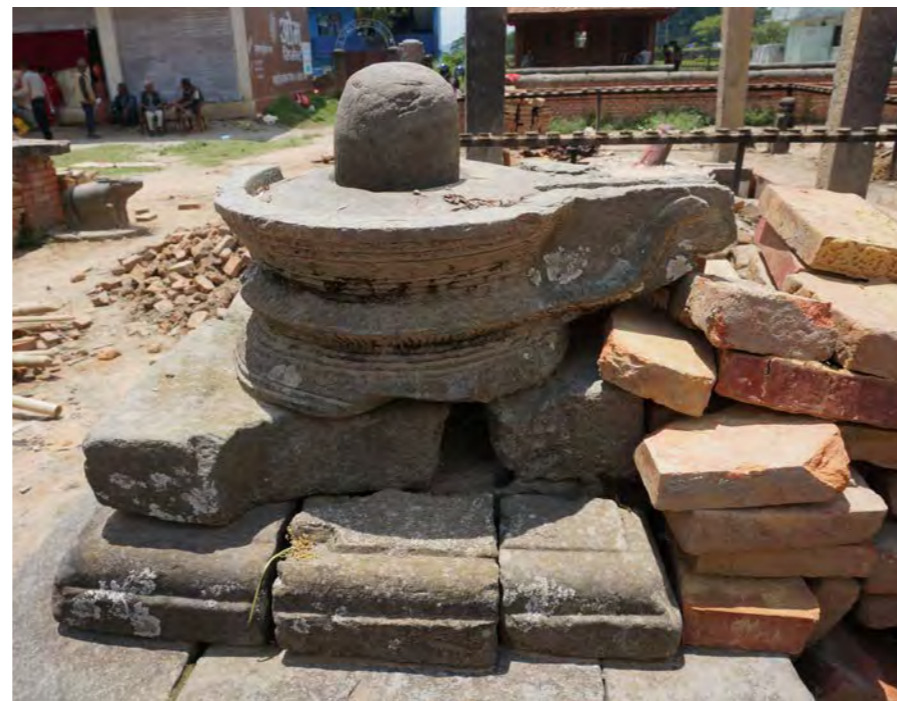
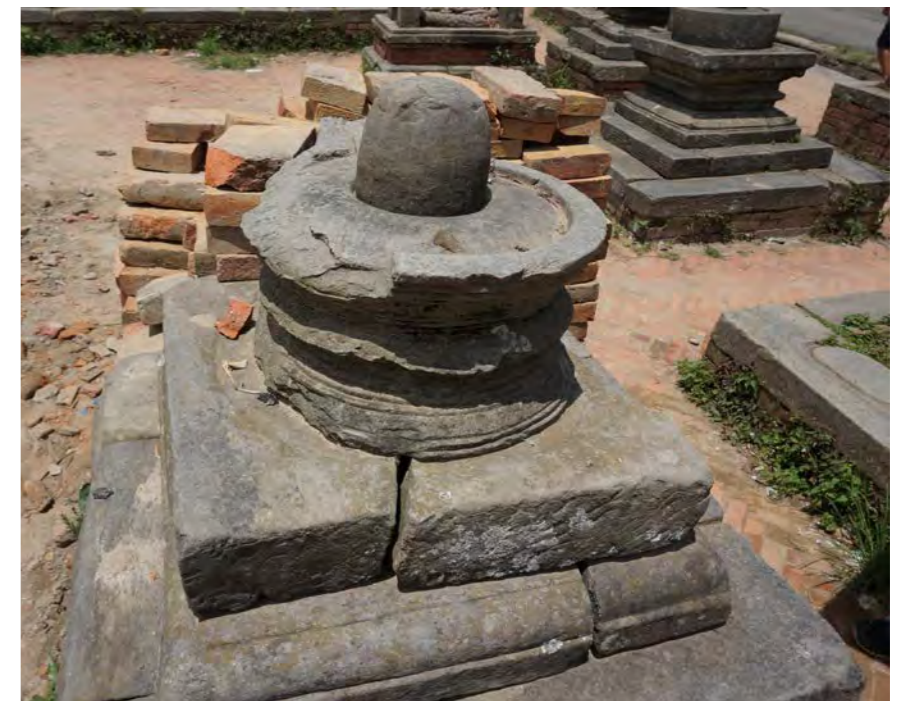
M35 SHIVALINGA

NUMBER	NAME	DATE A.D.	TYPOLOGY	GENERAL DESCRIPTION	PROBLEMS DESCRIPTION	DANGER/ DESTROY
M35			Shiva linga	Shiva linga on stone platform.	Cracks at joints. East and west part of Jalahari stone are broken.

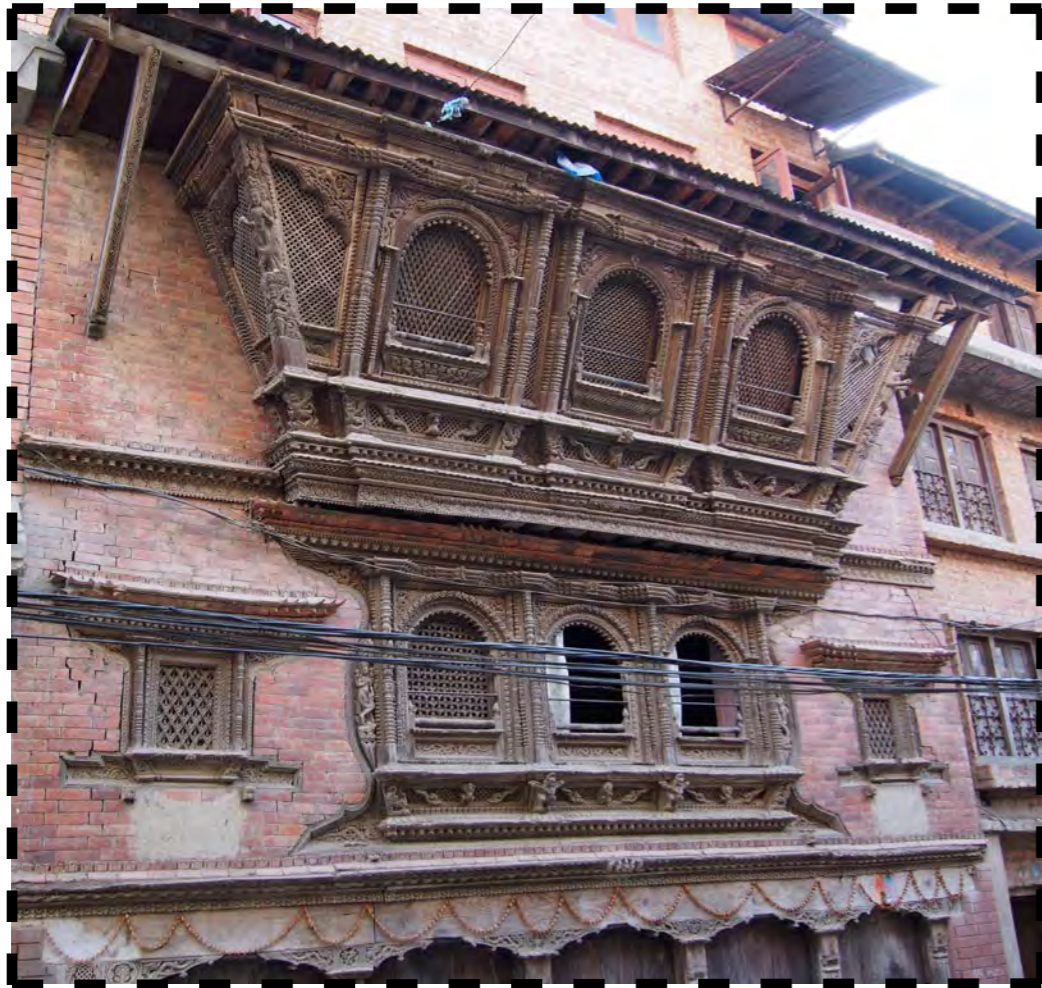
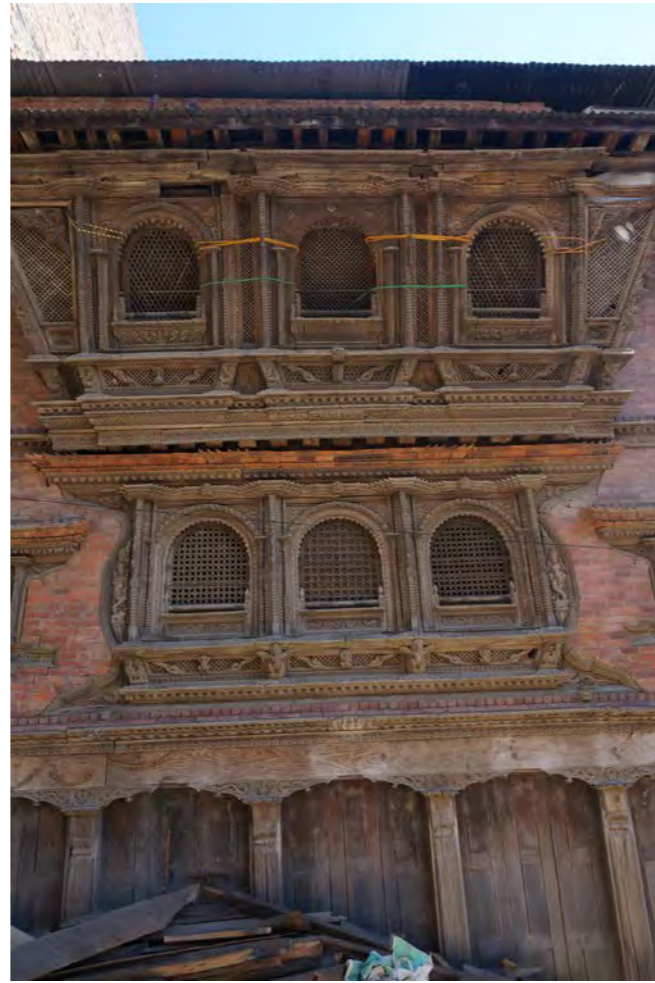
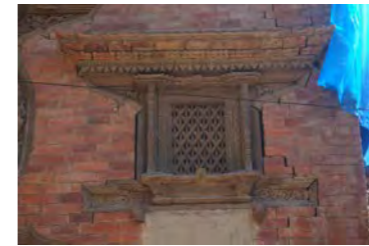
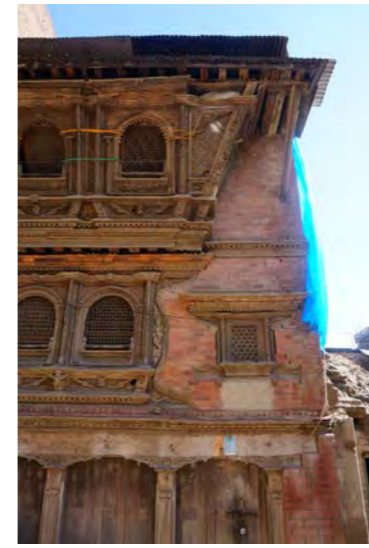
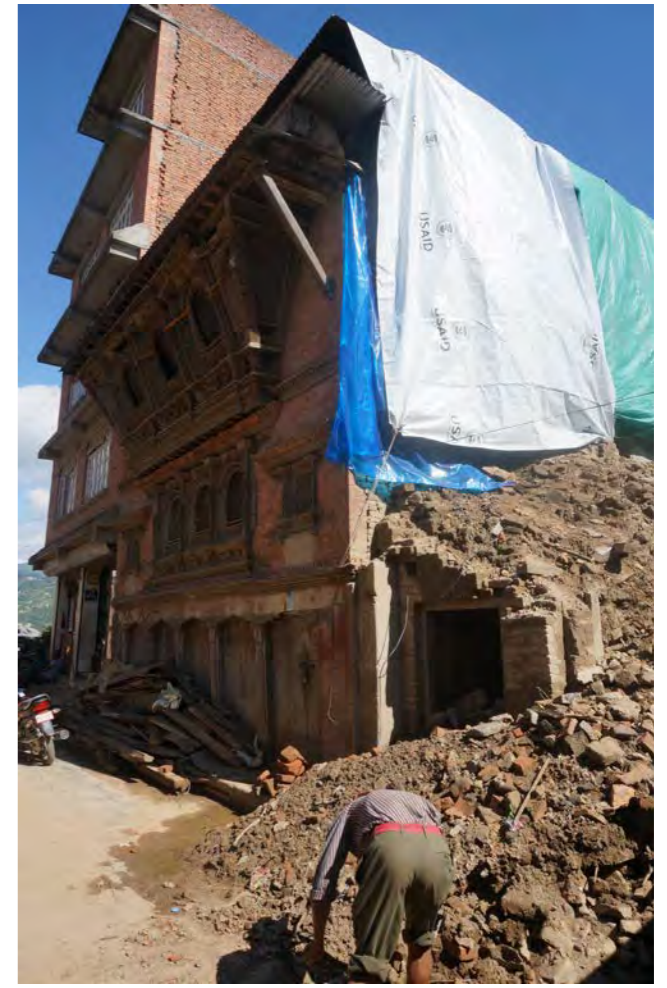
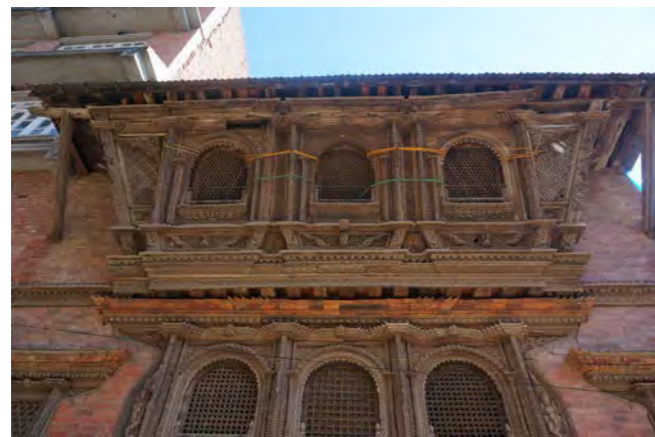
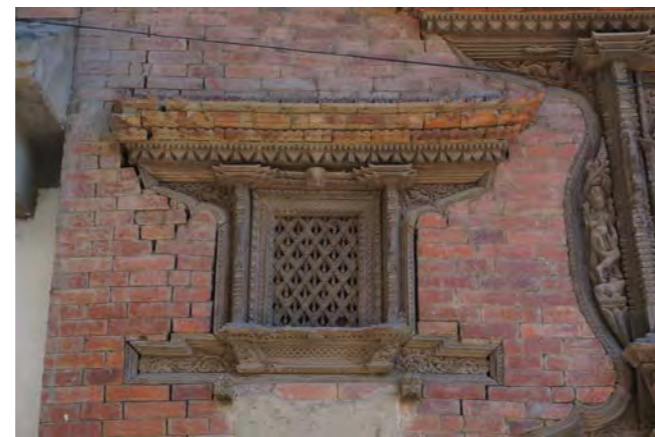
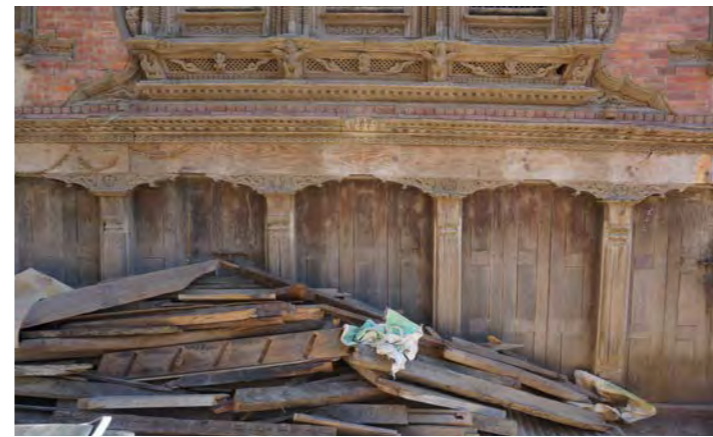
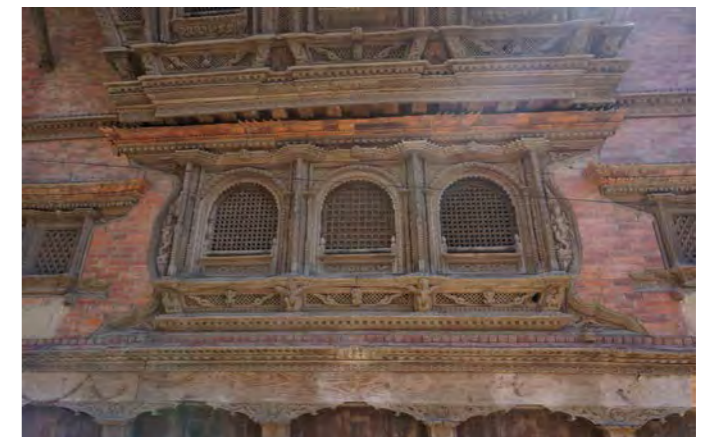
NUMBER	CONTACT	STOREY NO. RELATIVE POSITION	STRUCTURAL SYSTEM	PROBLEMS DESCRIPTION	DANGER	CONDITION
a29	Basanta Lal Shrestha 9849764998	G+4	B	Critically damaged Major cracks with S-wall façade collapsed Needs dismantle before reconstruction	⚠	W!

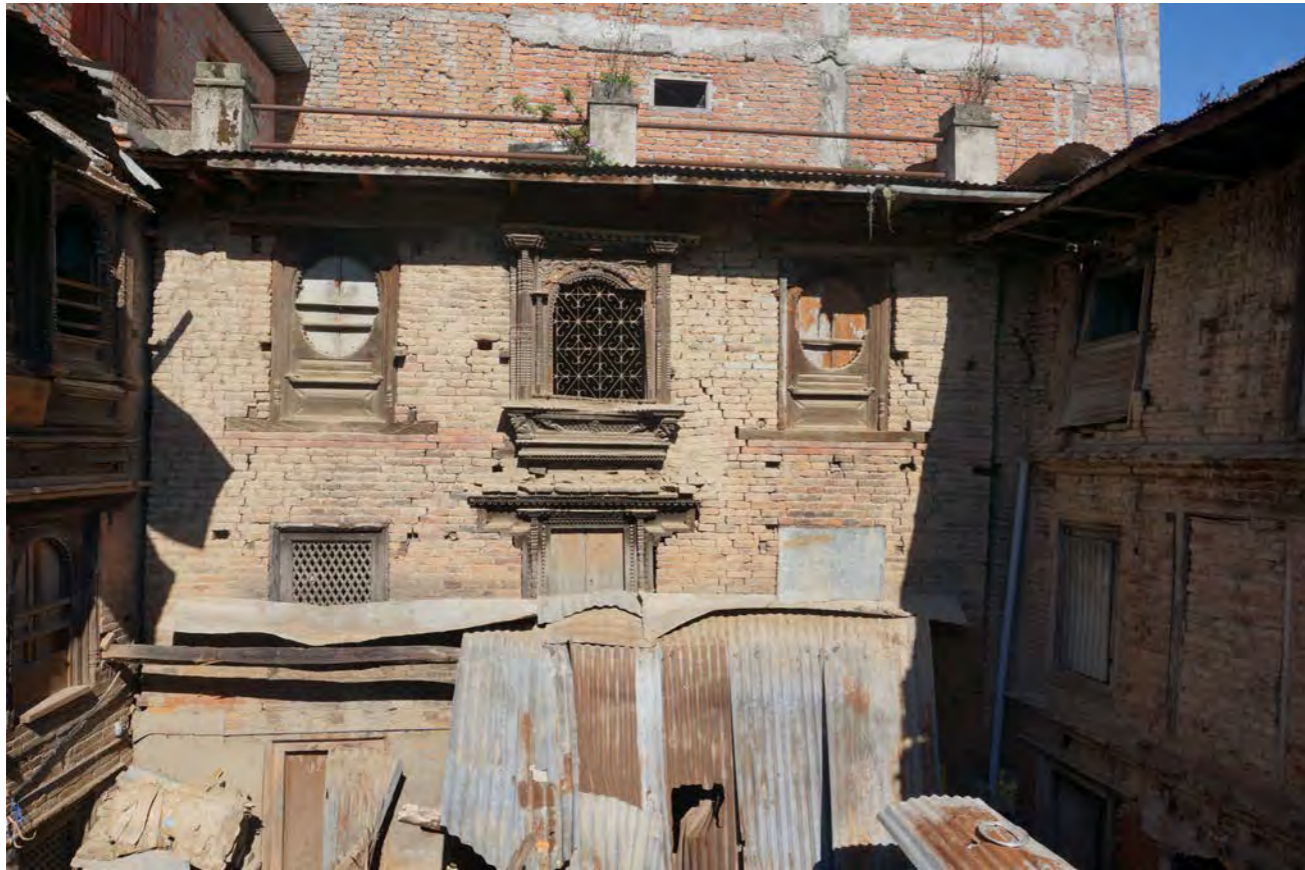
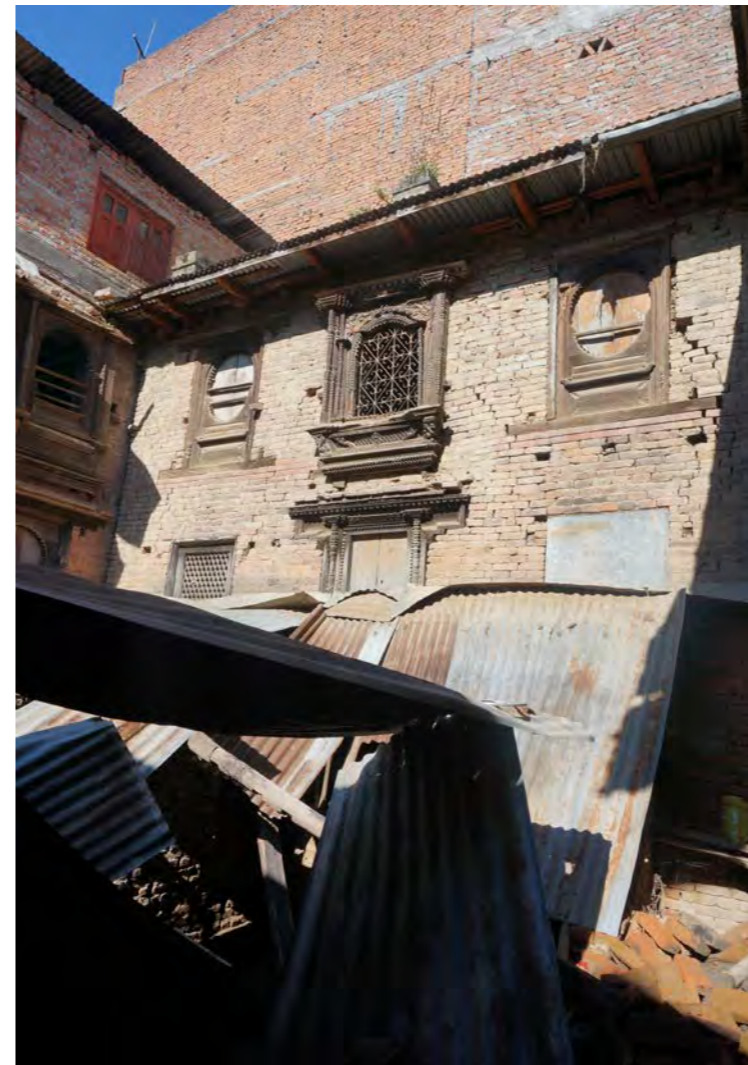
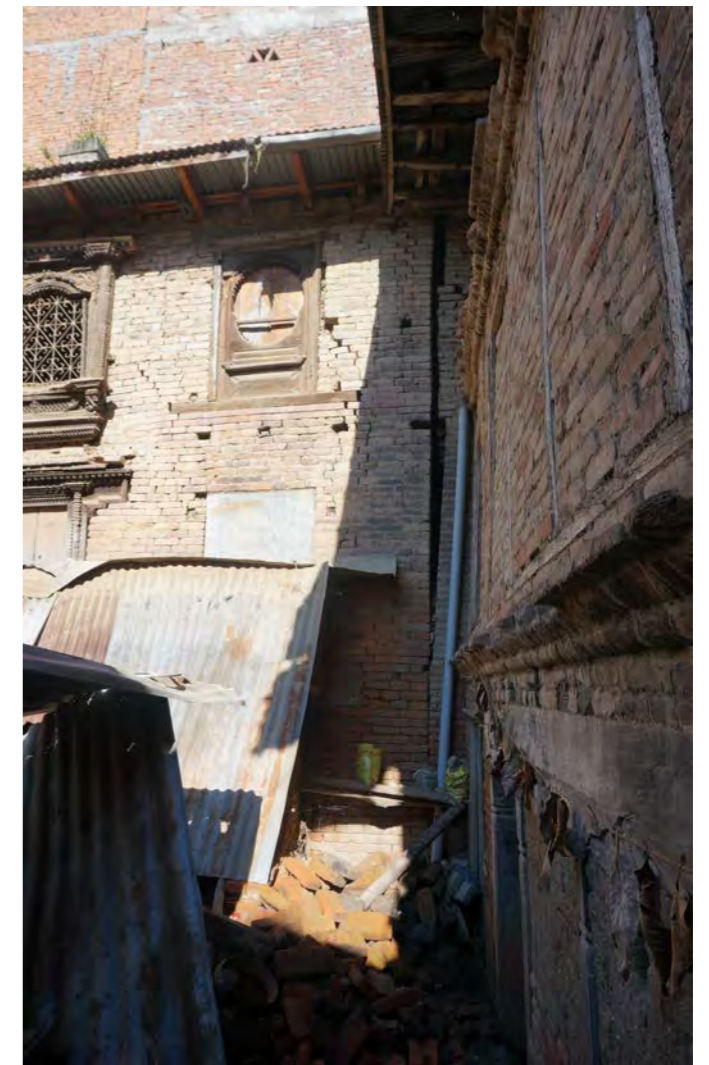
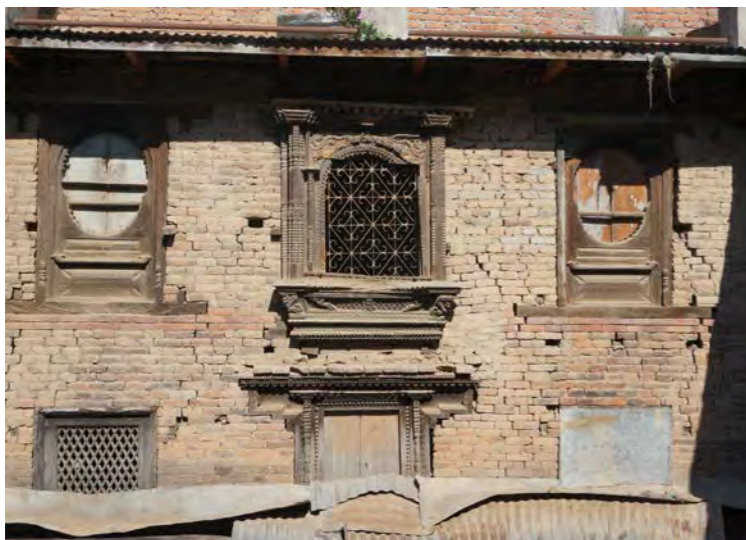
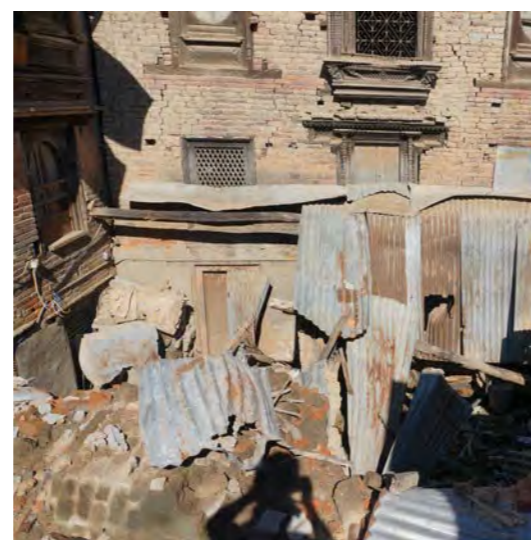
NUMBER	CONTACT	STOREY NO. RELATIVE POSITION	STRUCTURAL SYSTEM	PROBLEMS DESCRIPTION	DANGER	CONDITION	
a34	"Jivan Shrestha 9841422480"	G+2	UnB + B	"Severly damaged Needs dismantle before reconstruction"	⚠	W!

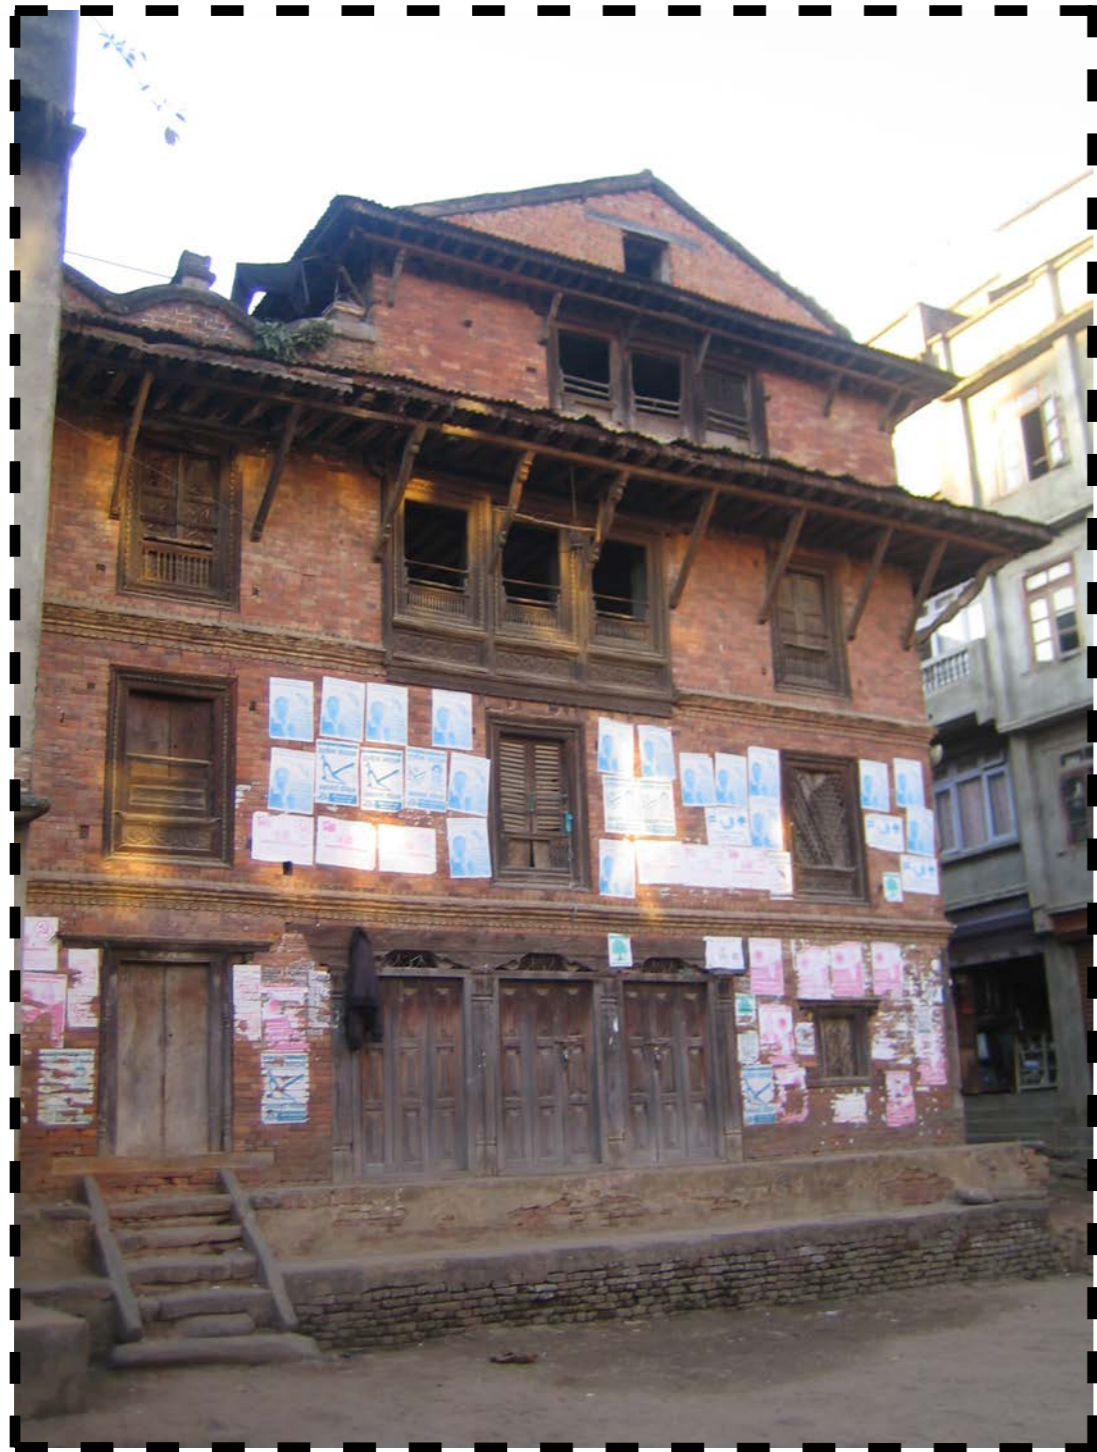
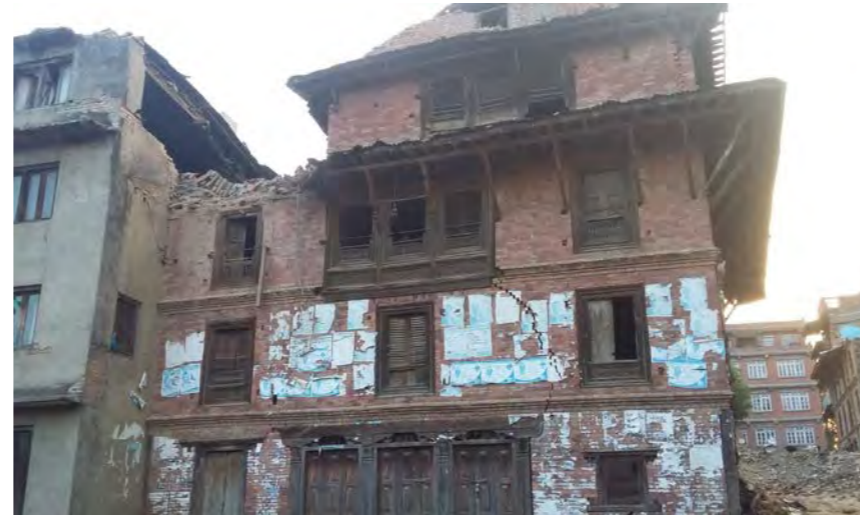
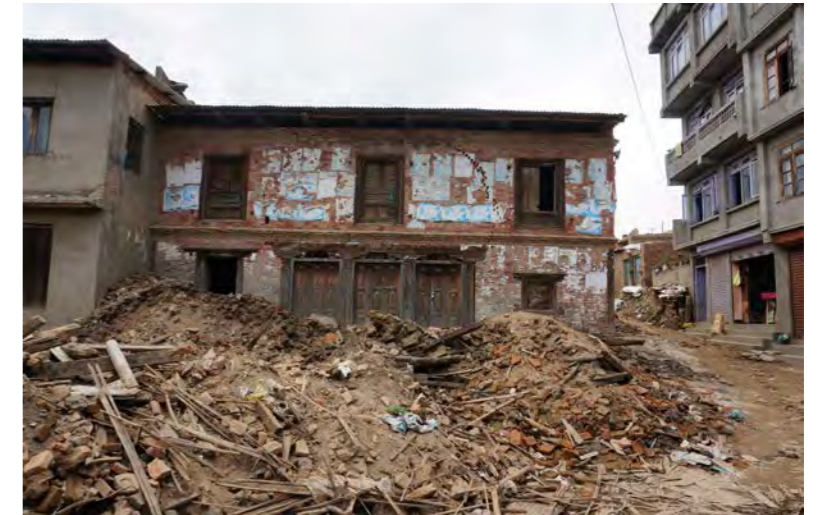
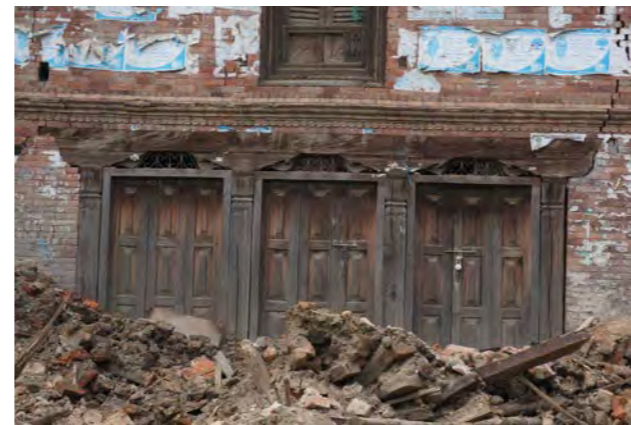
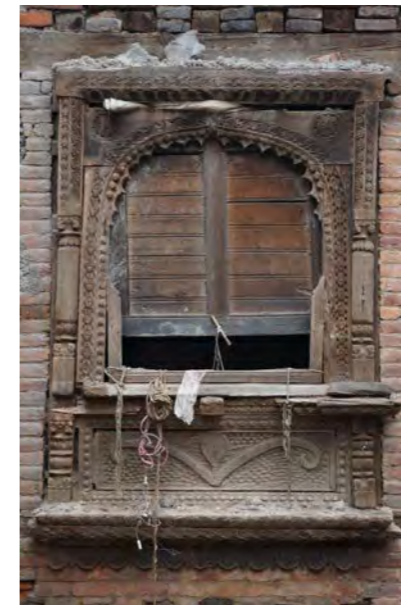
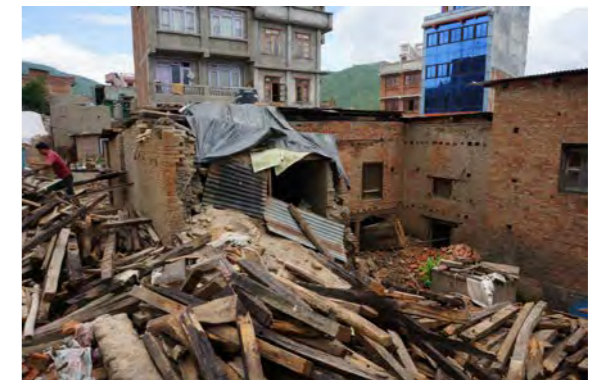
a69, a70, a71, a72

NUMBER	CONTACT	STOREY NO. RELATIVE POSITION	STRUCTURAL SYSTEM	PROBLEMS DESCRIPTION	DANGER	CONDITION
a69/ a70/ a71/ a72	Purna Lal Shrestha/ Prem Lal Shrestha/ Pravin Lal Shrestha/ Tika Lal Shrestha	G+2	B	“Upper two storey collapsed Vertical cracks at doors and windows, major cracks on inner wall of small courtyard and S-wall of west wing is collapsed on re- maining lower storey.”	⚠	“*P (wooden windows and artefacts stored by owner)”

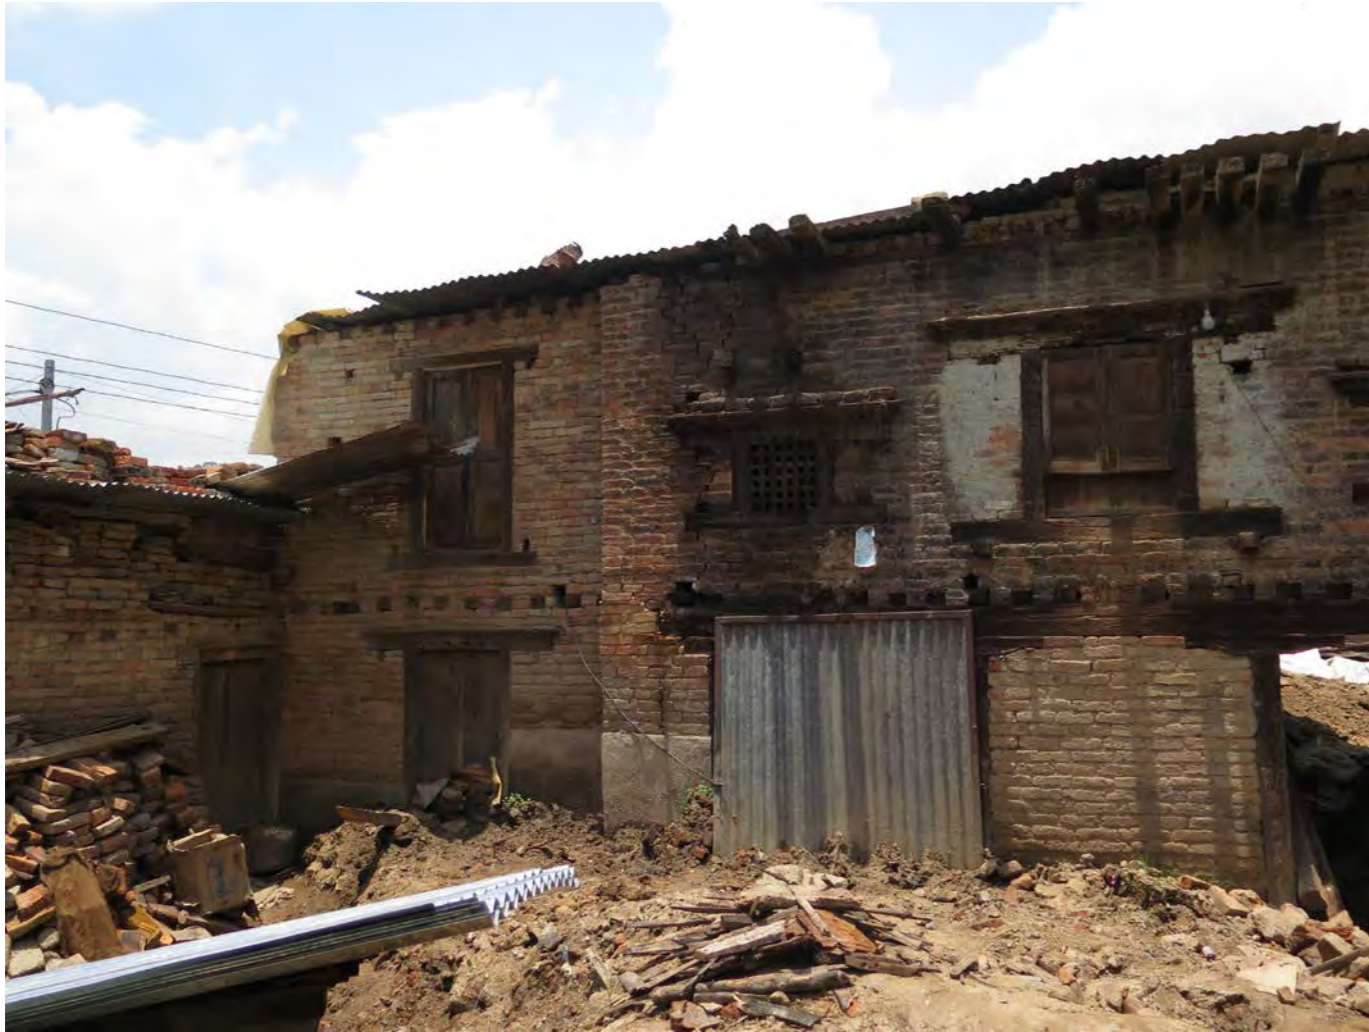
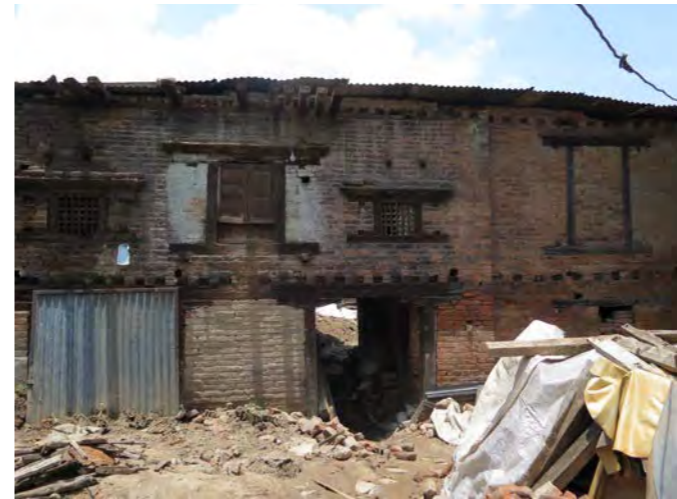
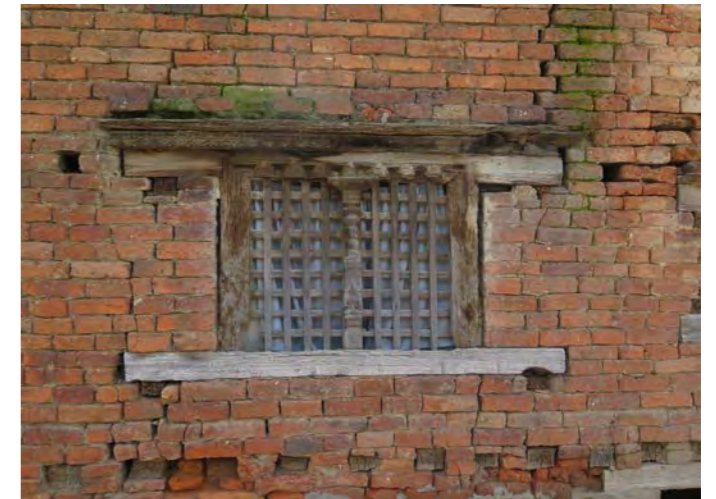
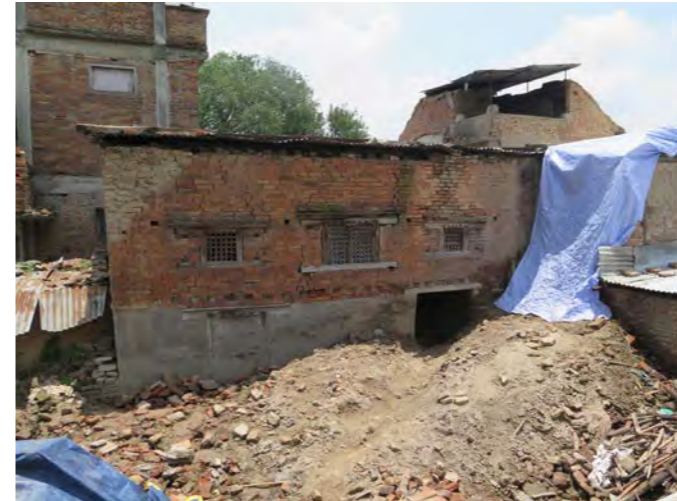
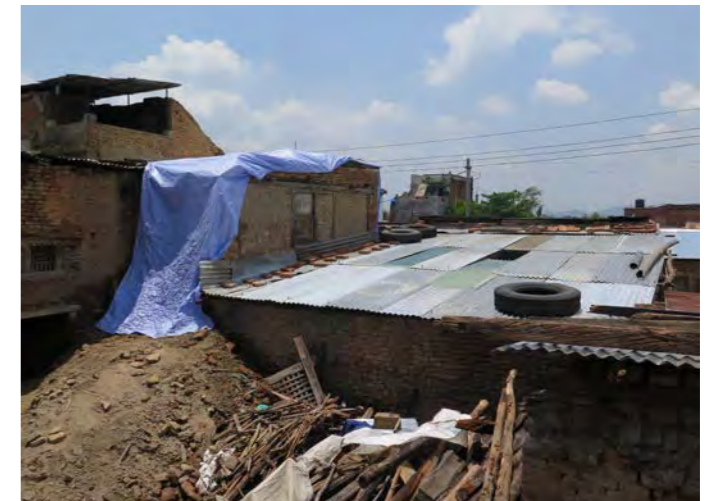
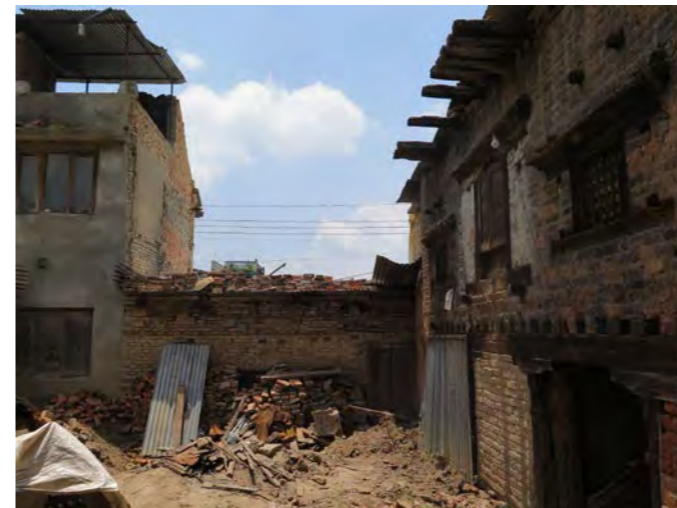
NUMBER	CONTACT	STOREY NO. RELATIVE POSITION	STRUCTURAL SYSTEM	PROBLEMS DESCRIPTION	DANGER	CONDITION	
d03	Dil Maya Shrestha	G+3	B	2 floors collapsed. Vertical cracks on southern wall

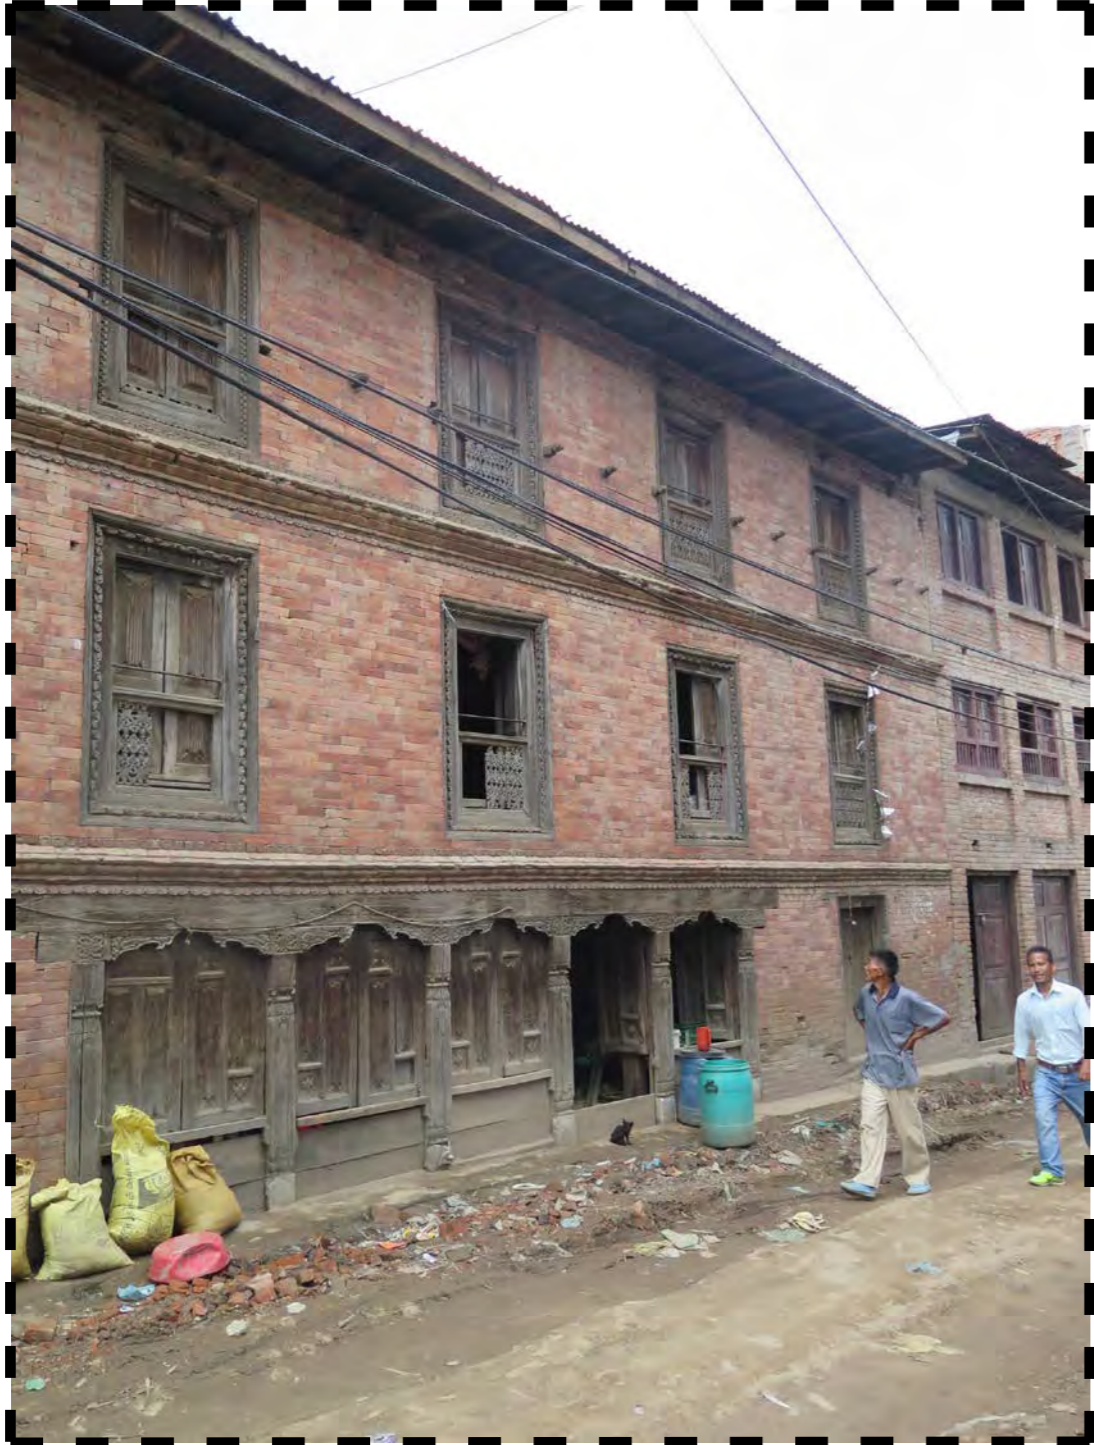
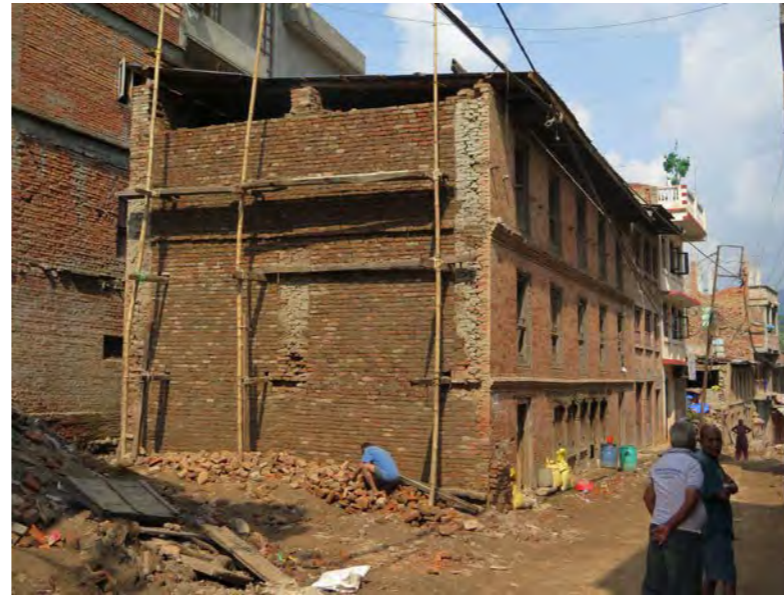
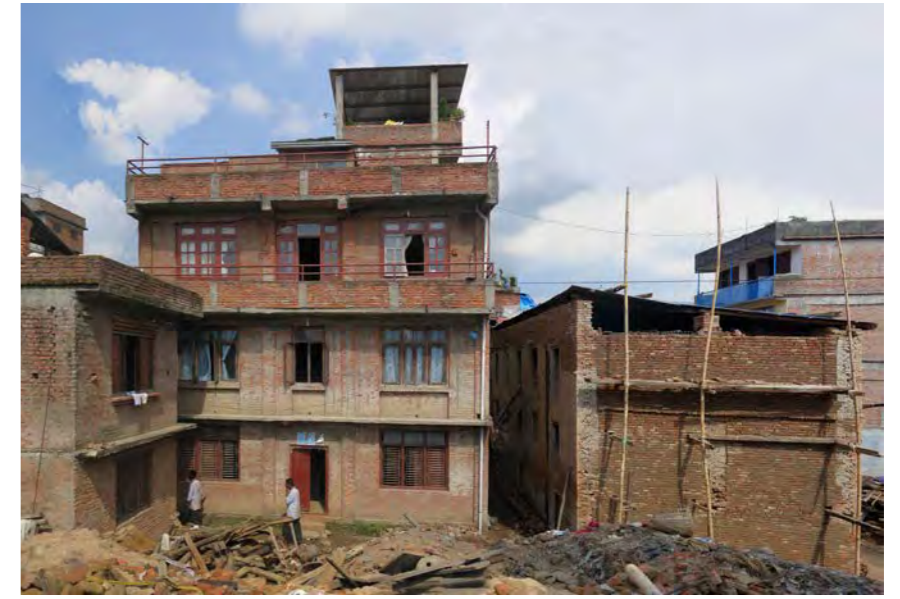
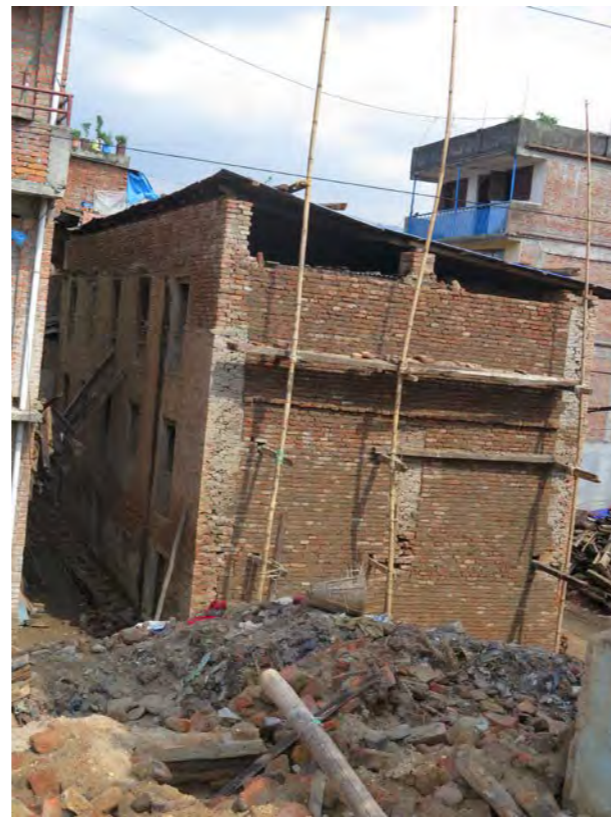
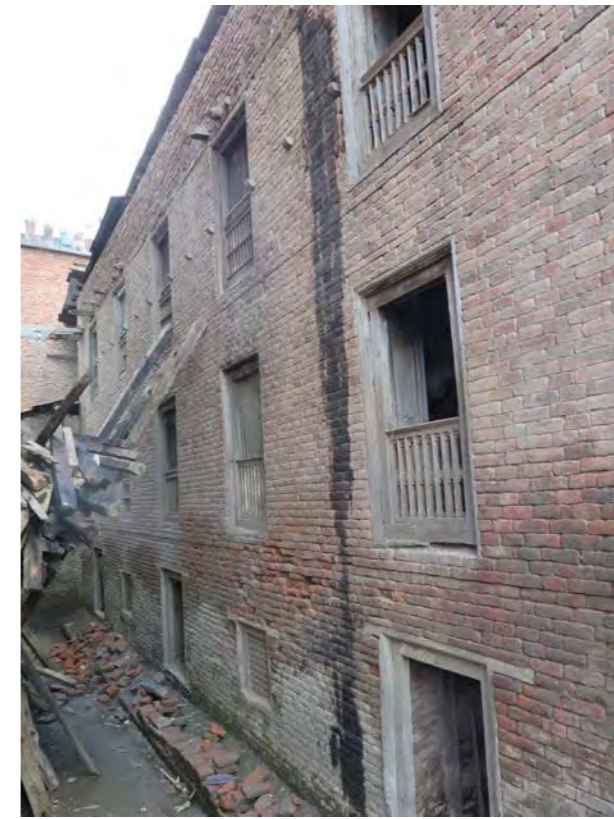
NUMBER	CONTACT	STOREY NO. RELATIVE POSITION	STRUCTURAL SYSTEM	PROBLEMS DESCRIPTION	DANGER	CONDITION	
d39	Ratna Lal Shrestha (9803451978)	G+3	B	1 floor demolished. Roof collapsed on northern wall. West wall collapsed. Rising damp.	1/3	++
