2015 Earthquake Damage Mapping

Sankhu

October 2015

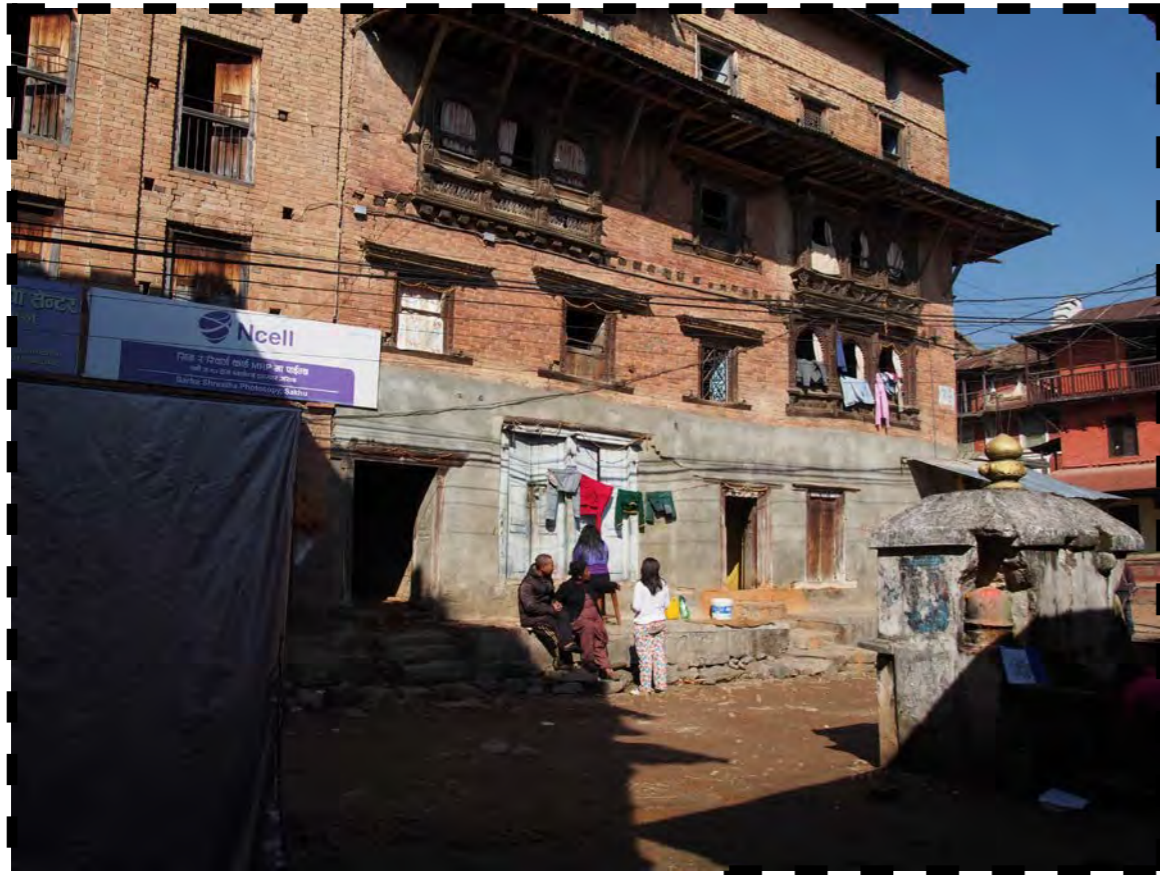
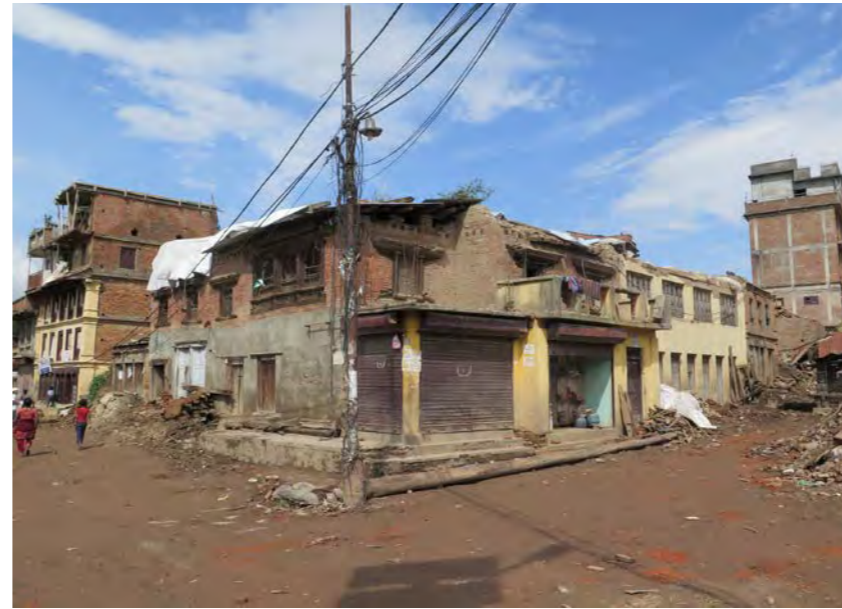
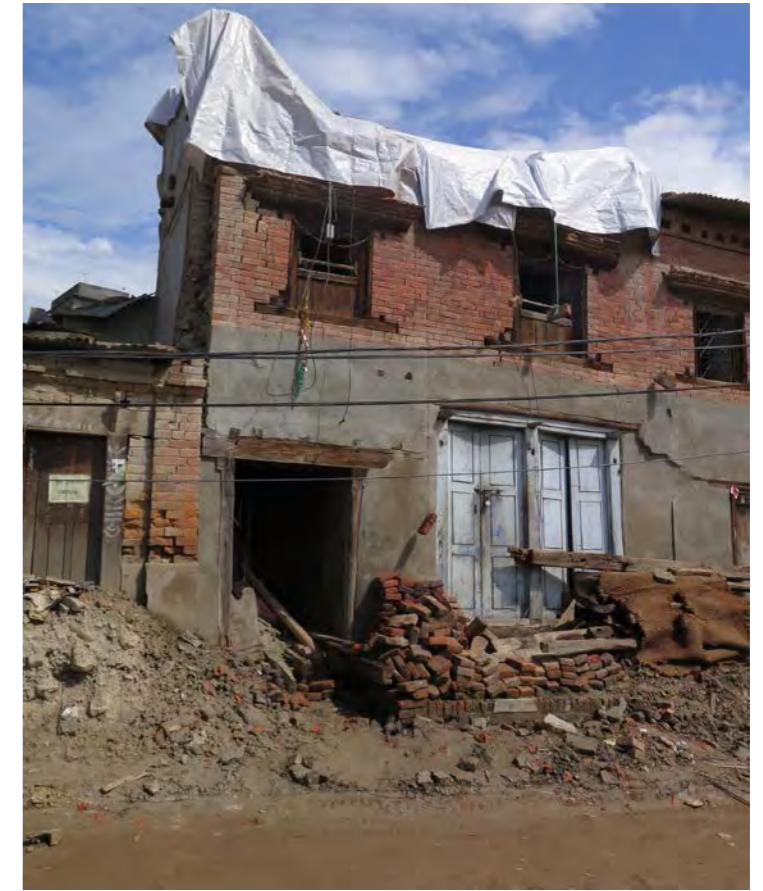
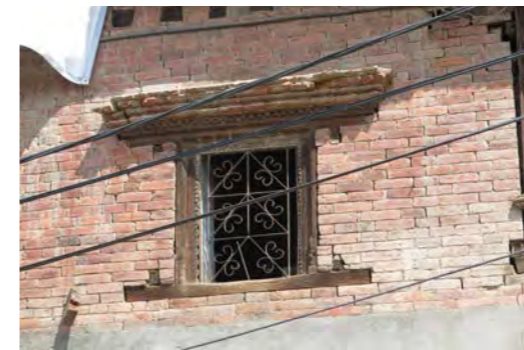
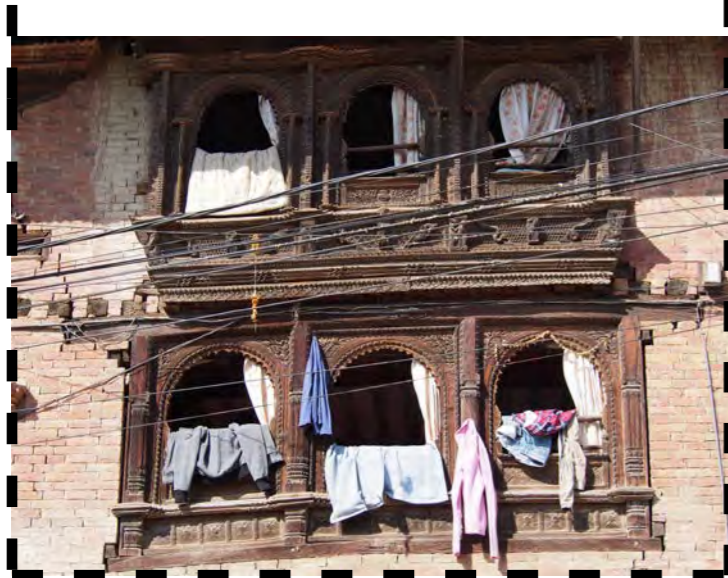
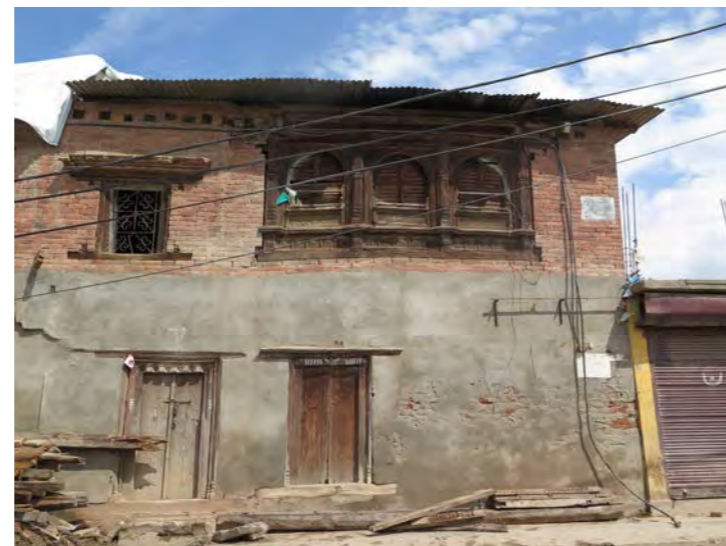
d54, d55

NUMBER	CONTACT	STOREY NO. RELATIVE POSITION	STRUCTURAL SYSTEM	PROBLEMS DESCRIPTION	DANGER	CONDITION	
d54	Sanu Kumar Shrestha (9841112899)	G+3	B	2 floors collapsed	1/2 ☒	“+P (wooden windows and artefacts stored by owner)”	
d55	Shyam Shrestha	G+3	B	2 floors collapsed	1/2 ☒

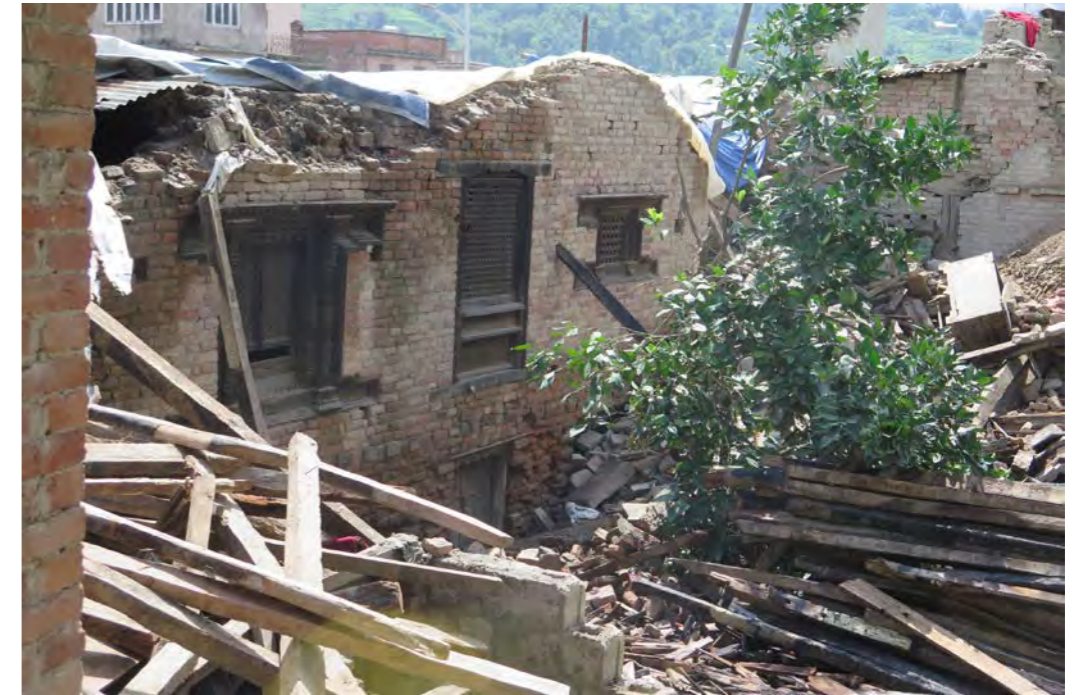
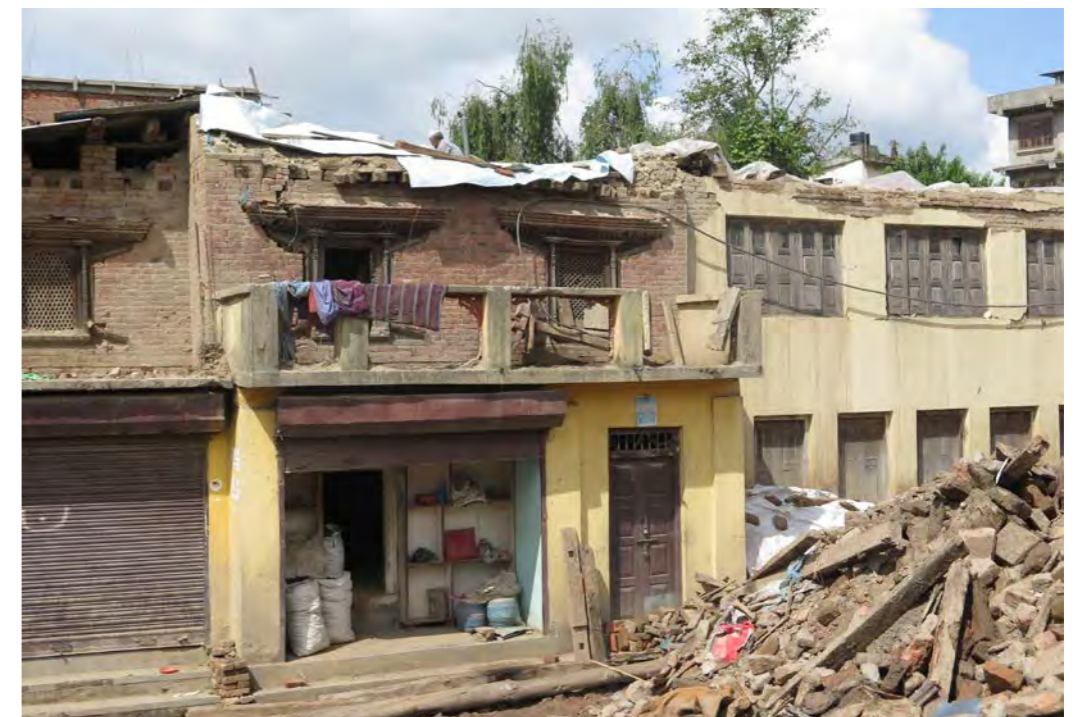
NUMBER	CONTACT	STOREY NO. RELATIVE POSITION	STRUCTURAL SYSTEM	PROBLEMS DESCRIPTION	DANGER	CONDITION
d57	Maheshwor Shrestha (9841436824)	G+3	B	2 floors collapsed	1/2 ☒

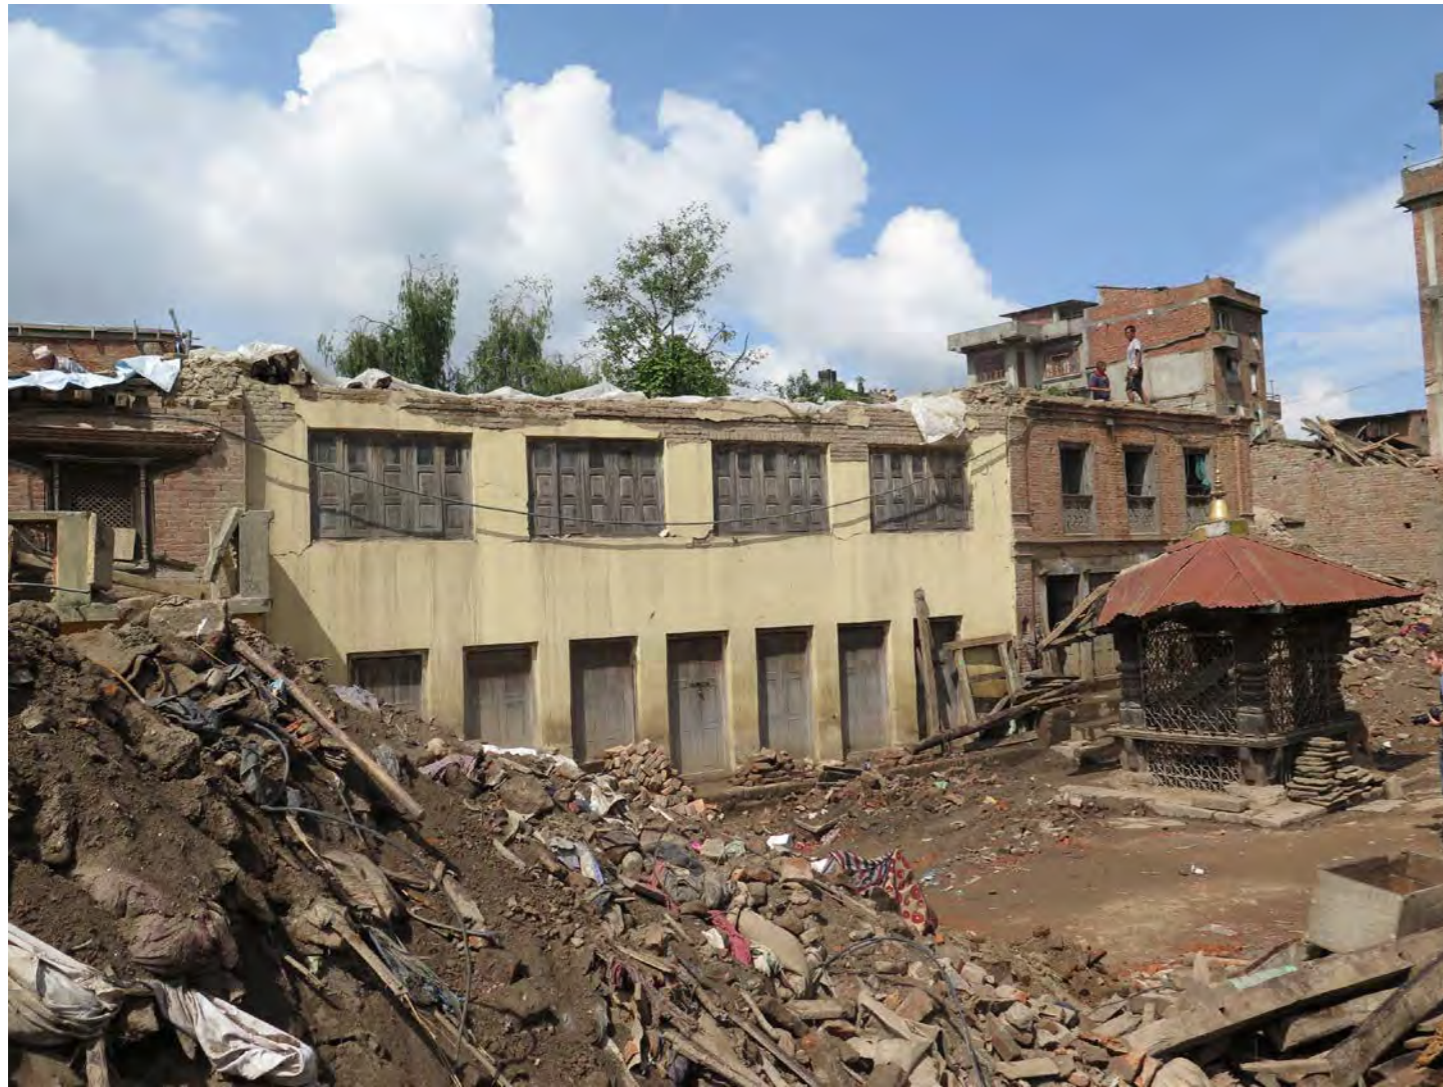
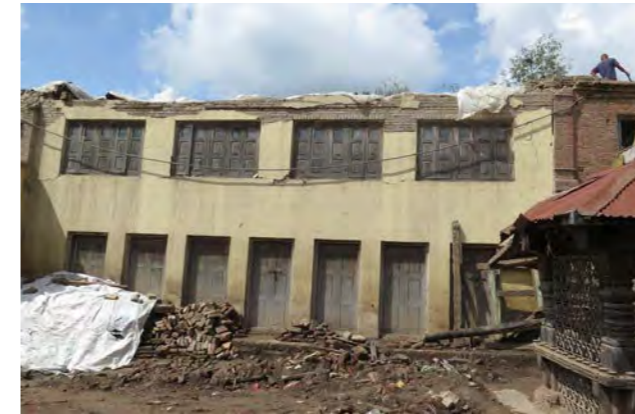
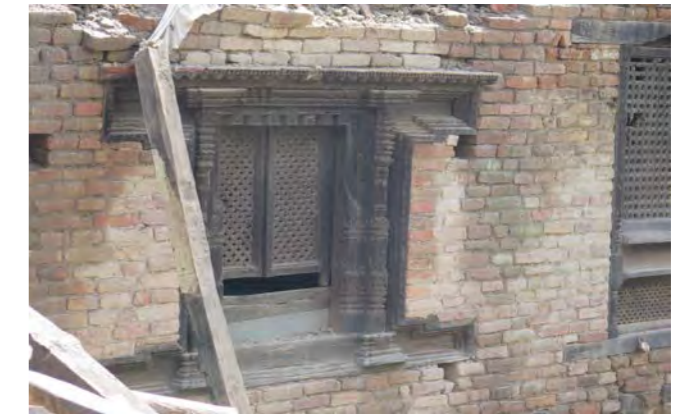
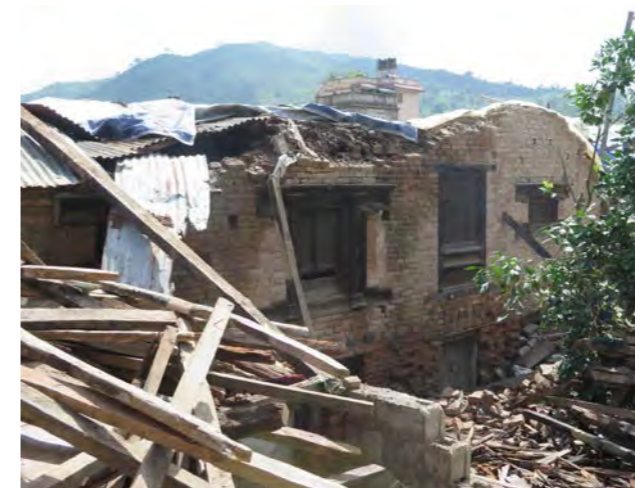
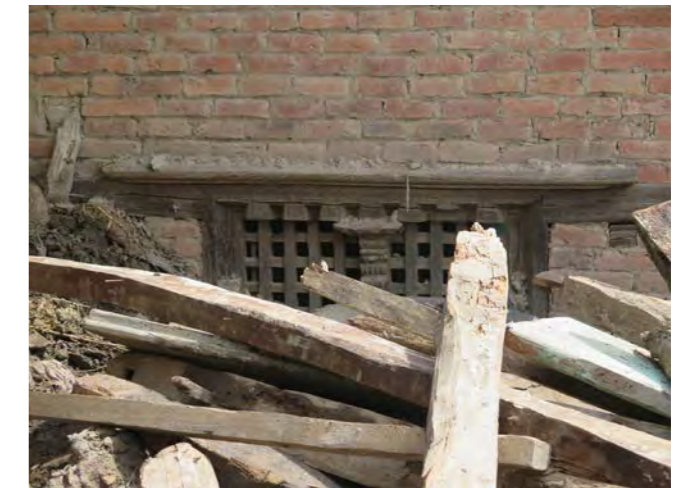
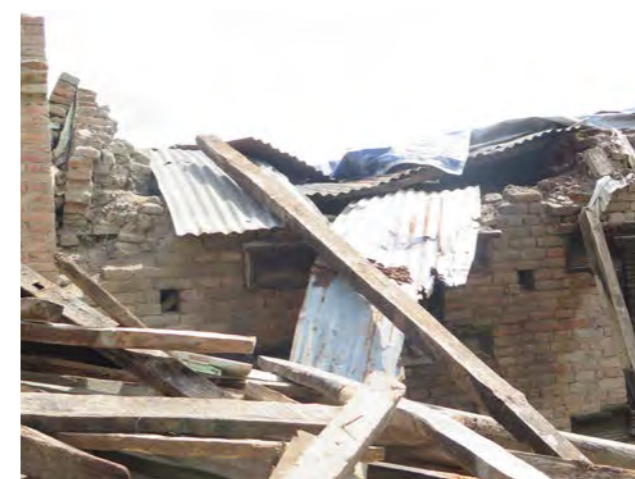
NUMBER	CONTACT	STOREY NO. RELATIVE POSITION	STRUCTURAL SYSTEM	PROBLEMS DESCRIPTION	DANGER	CONDITION
d58	Maheshwor Shrestha (9841436824)	G+3	B	2 floors collapsed	1/2 ☒

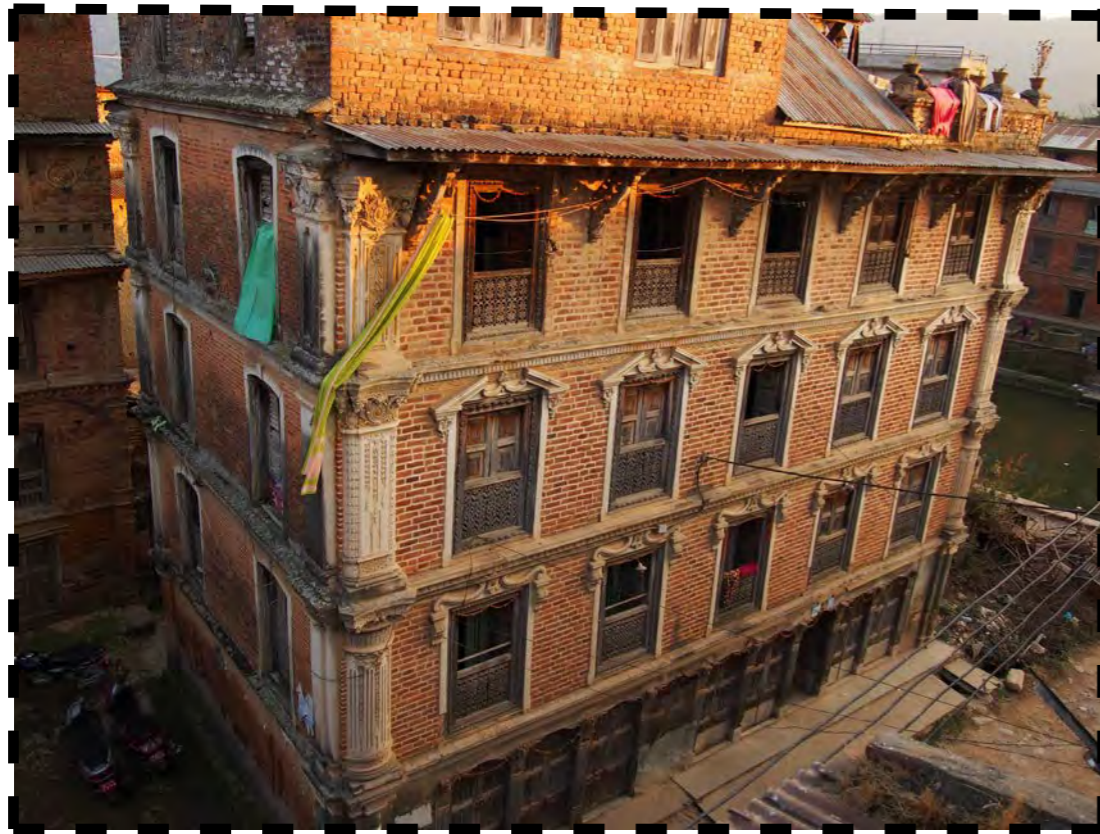
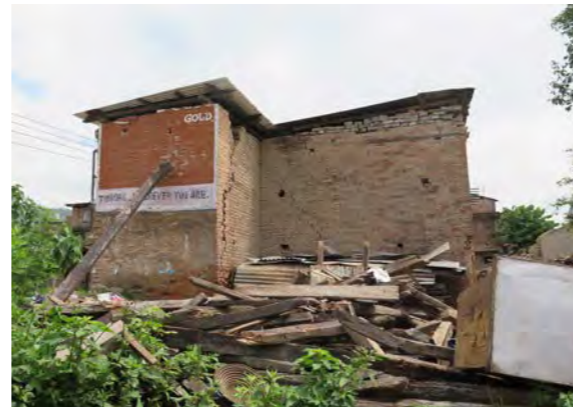
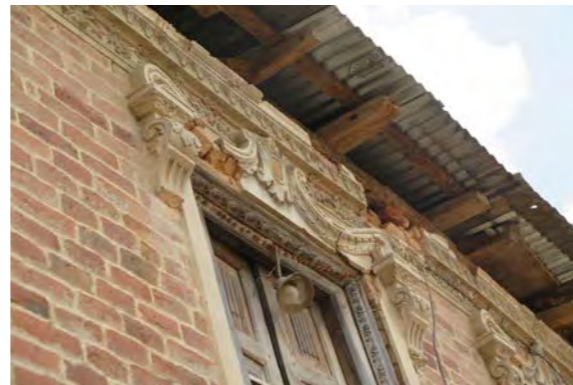
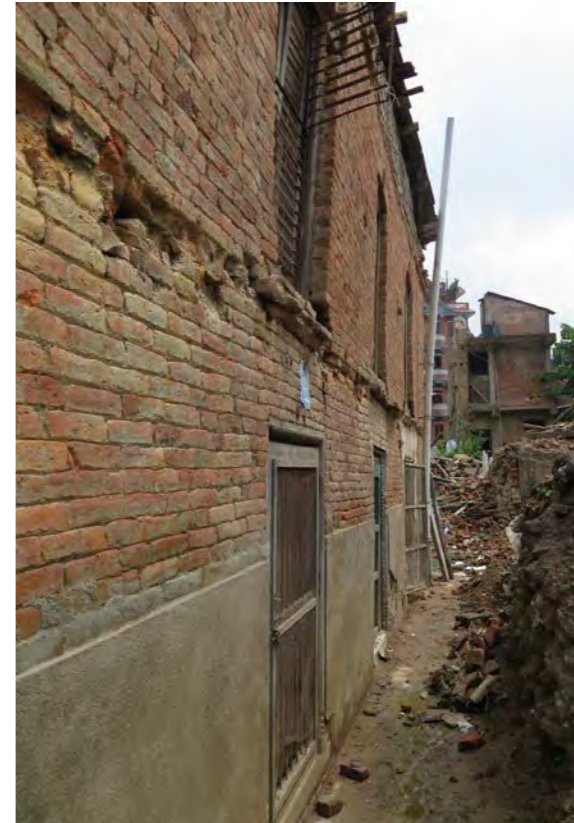
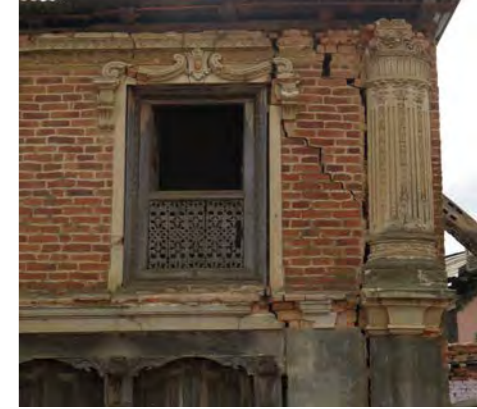
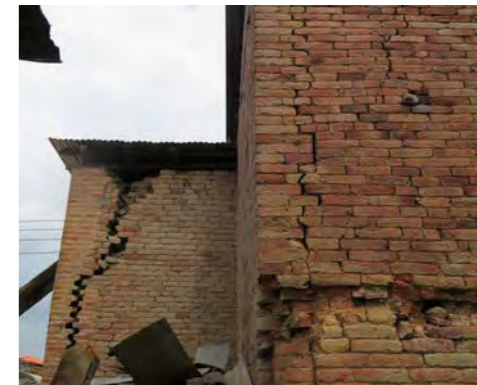
NUMBER	CONTACT	STOREY NO. RELATIVE POSITION	STRUCTURAL SYSTEM	PROBLEMS DESCRIPTION	DANGER	CONDITION
e02	Devendra Meher Shrestha, Ratna Meher Shrestha	G+4 (EH)	B	Diagonal crack on south. All walls seperataing out. East wall tilted. Cracks on west face	⚠ 1/2 ☒

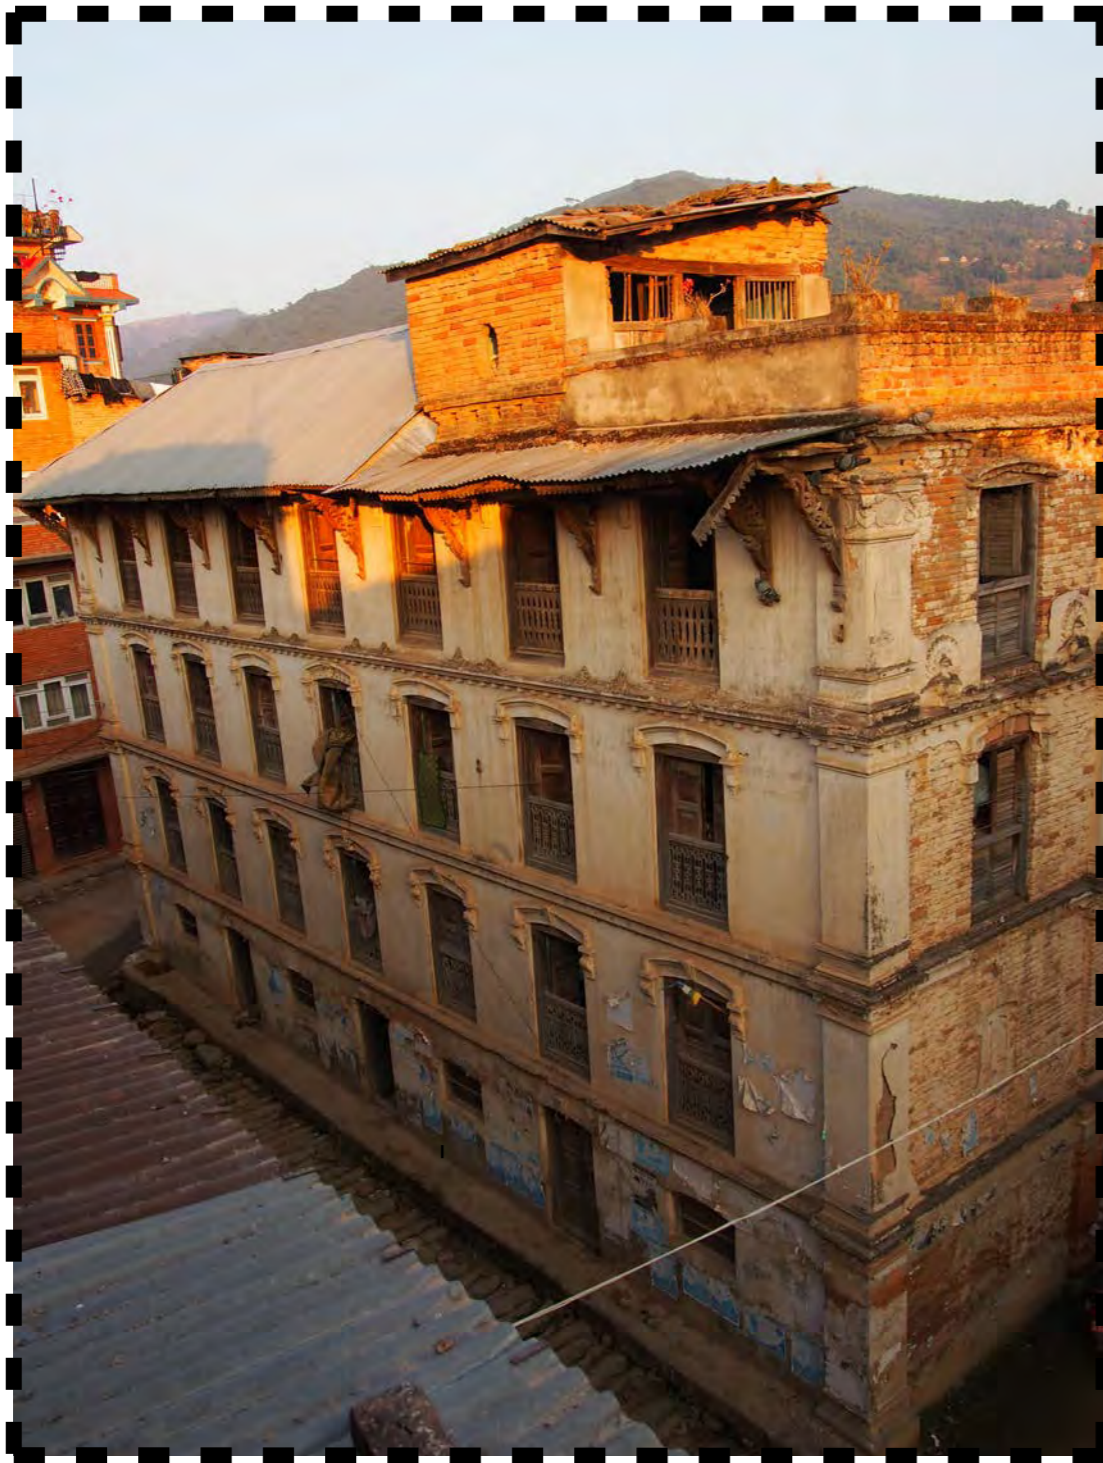
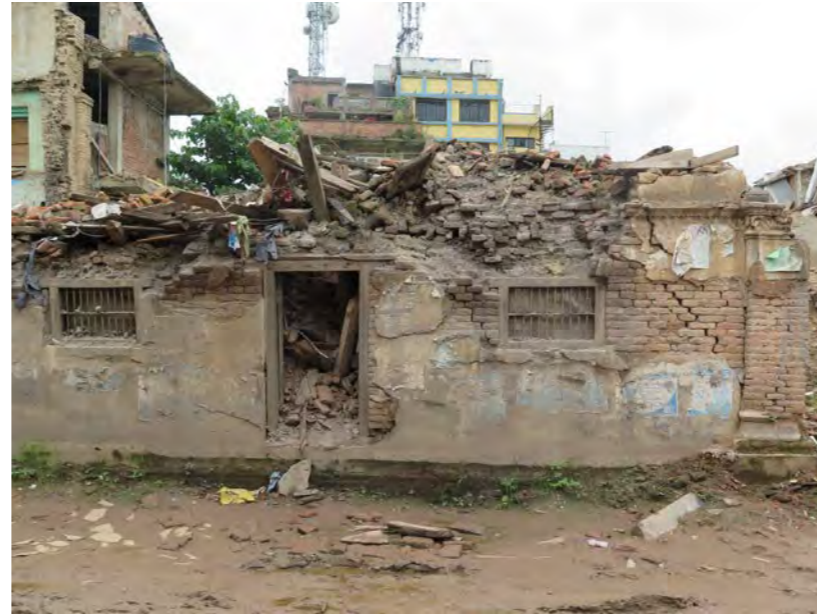
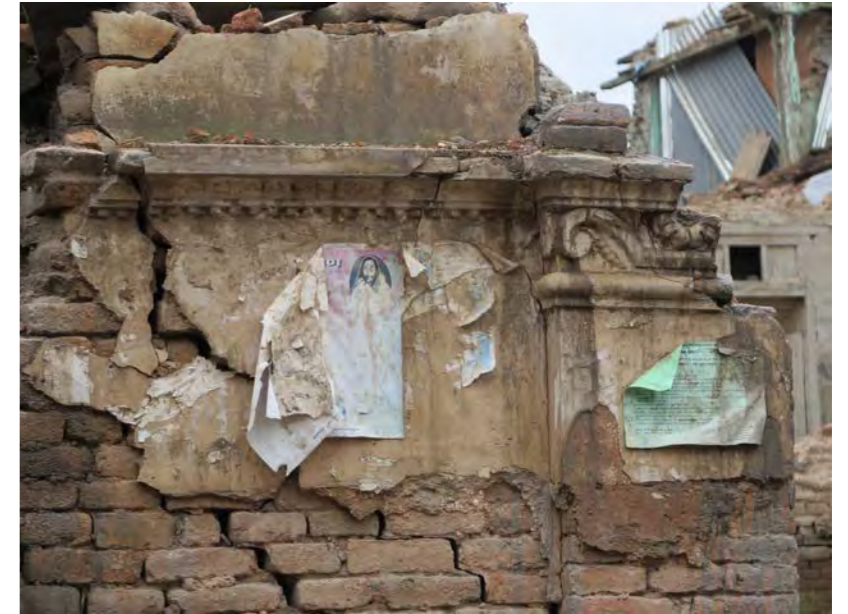
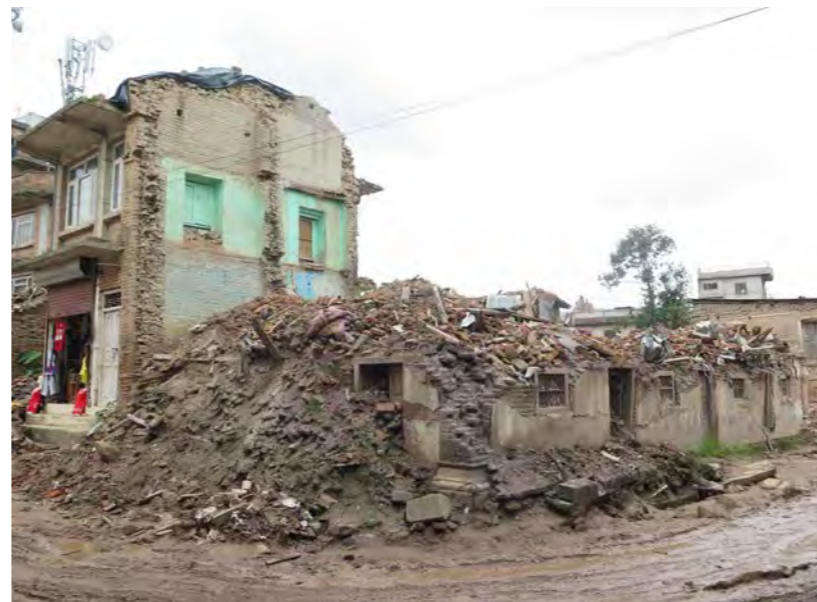
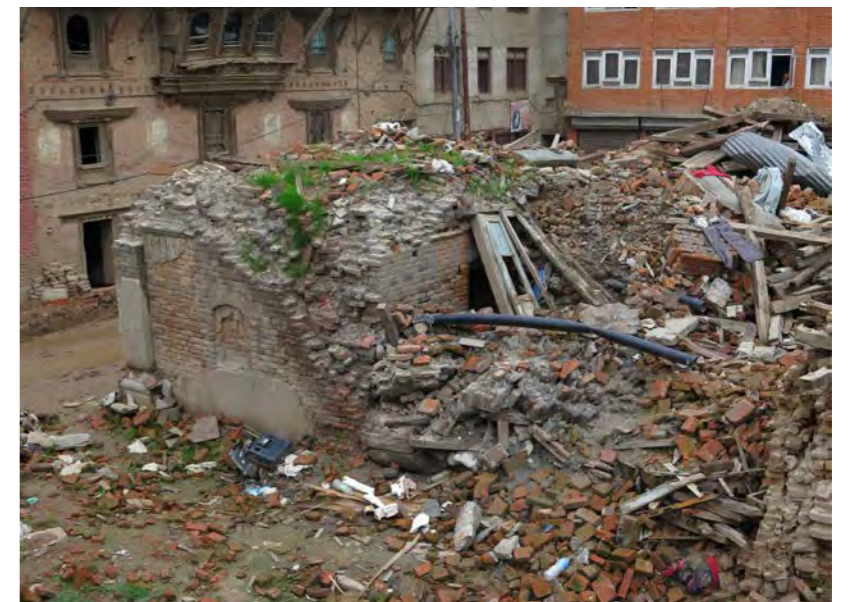
e05, e06

NUMBER	CONTACT	STOREY NO. RELATIVE POSITION	STRUCTURAL SYSTEM	PROBLEMS DESCRIPTION	DANGER	CONDITION
e05	Maheshwori Shrestha	G+3 (CH)	B	Totally collapsed. Ground floor covered with rubbles.	⊗	
e06	Maheshwori Shrestha	G+3	B+UnB	Totally collapsed.	⊗

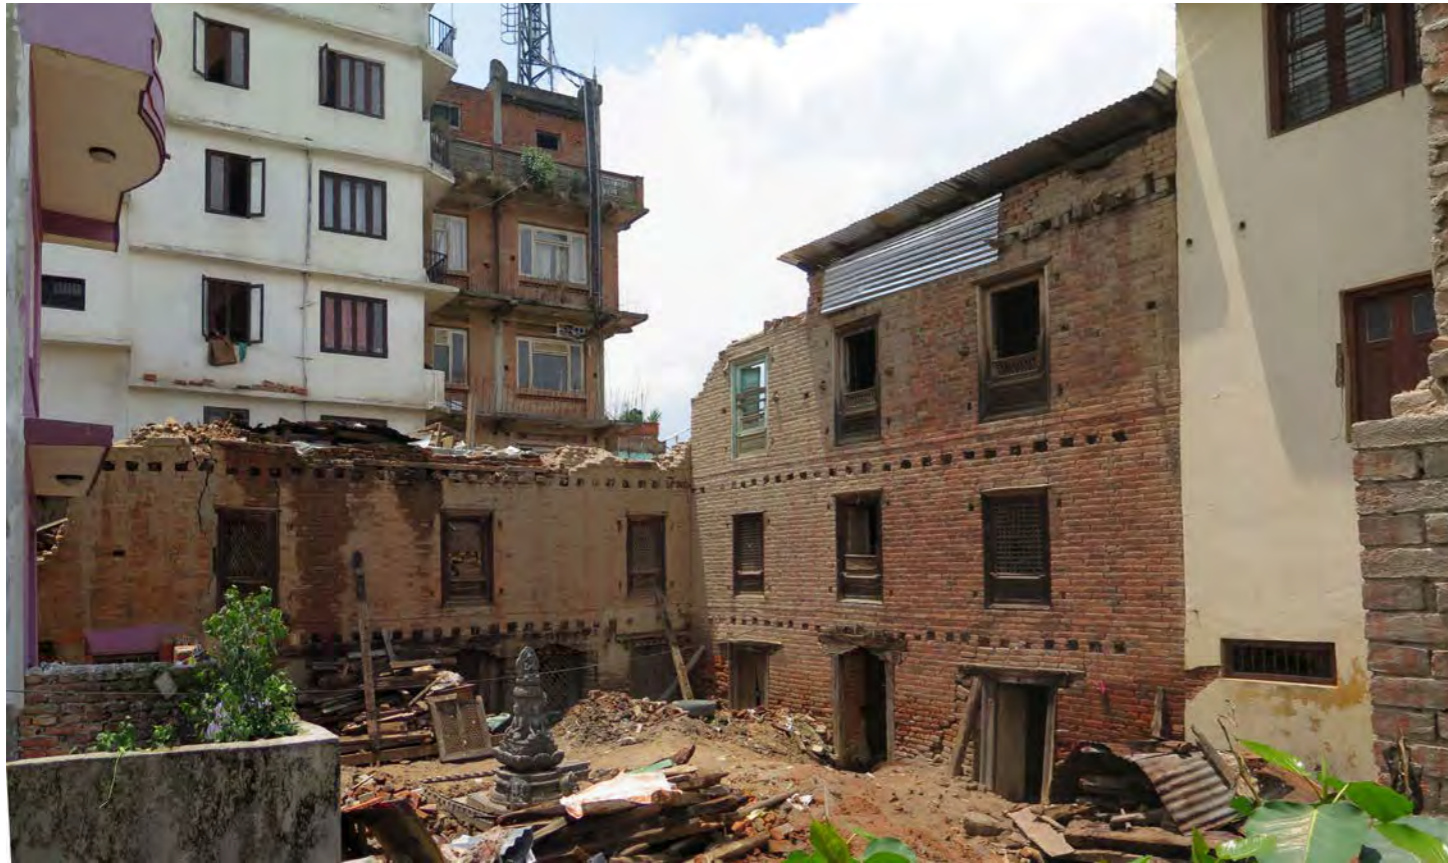
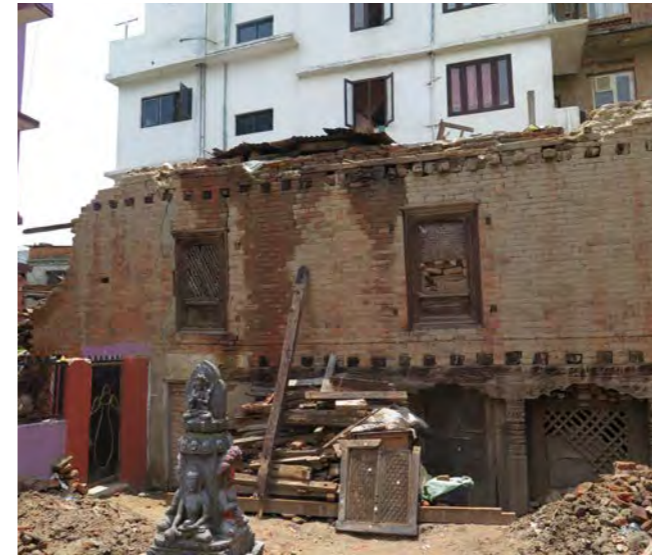
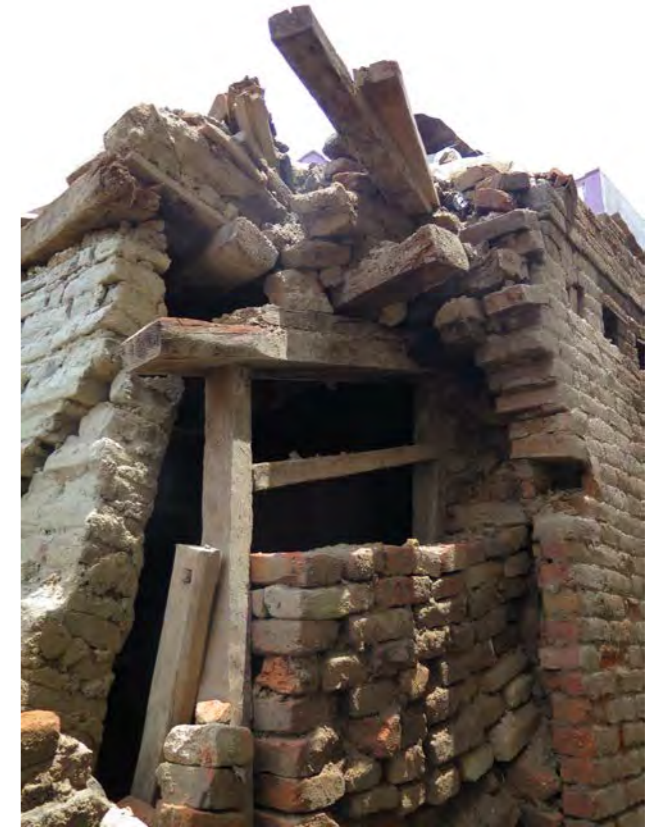
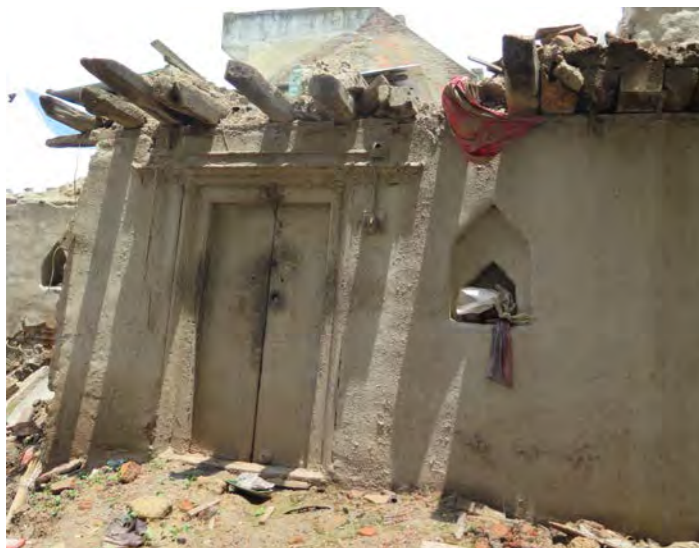
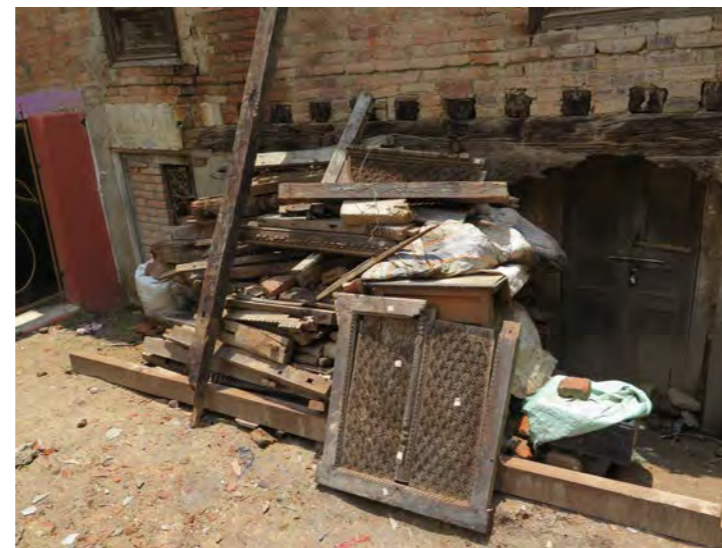
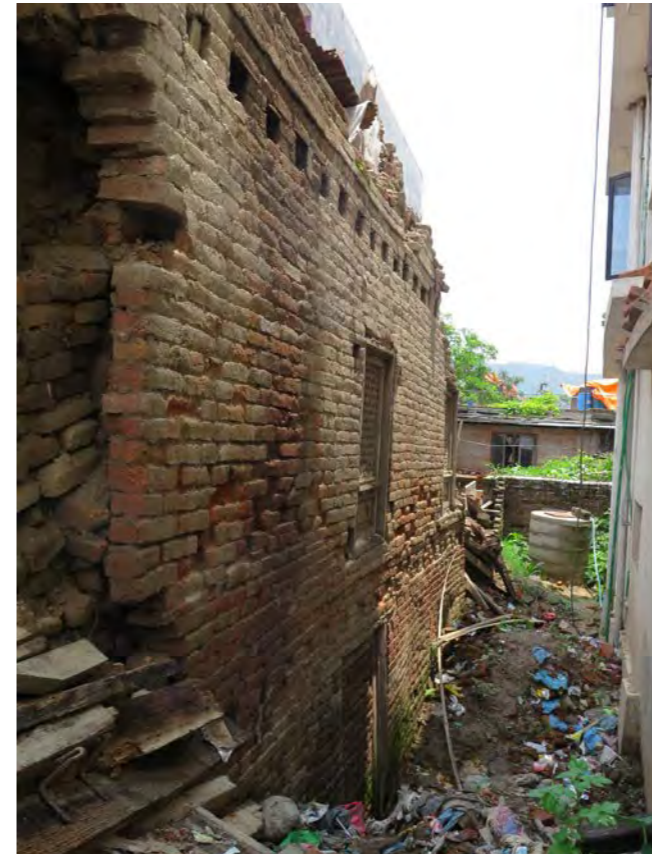
e26, e27

NUMBER	CONTACT	STOREY NO. RELATIVE POSITION	STRUCTURAL SYSTEM	PROBLEMS DESCRIPTION	DANGER	CONDITION
e26	Tej Maya Bajracharya	G+3	B	South face collapsed		R +
e27	Amrita Nanda Bajracharya	G+3	B	Totally collapsed		R +

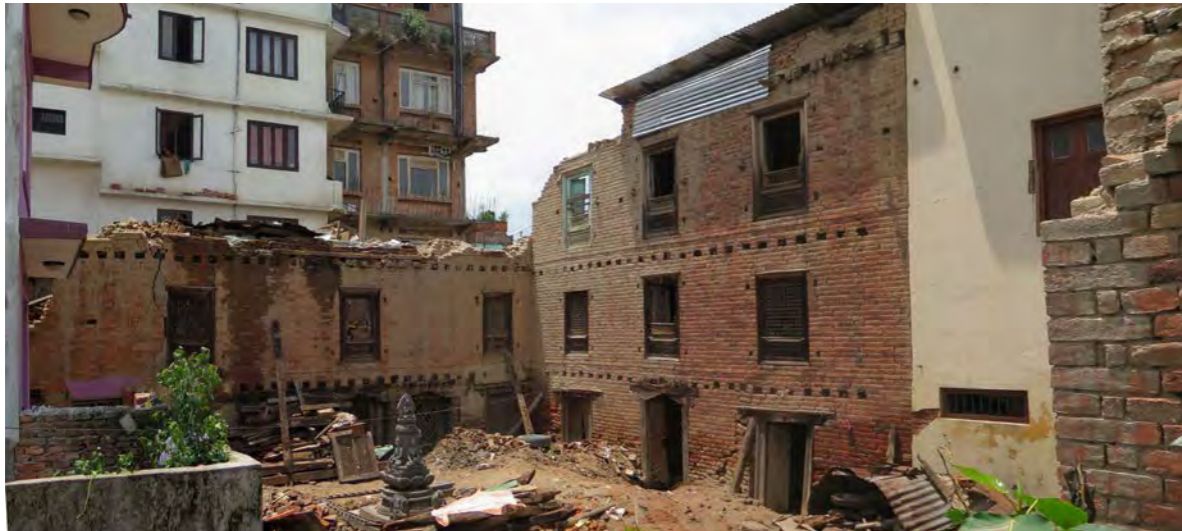
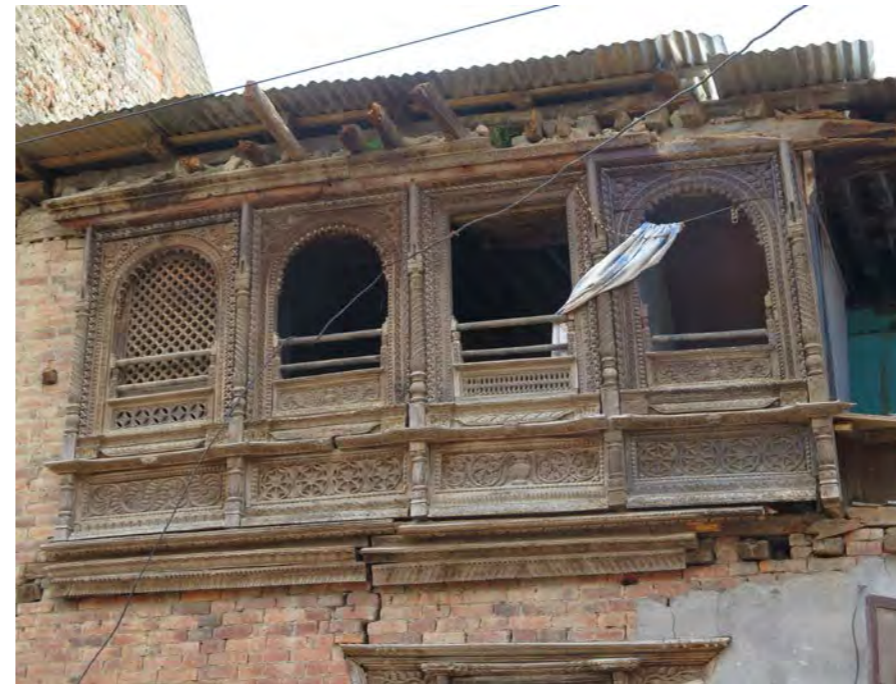
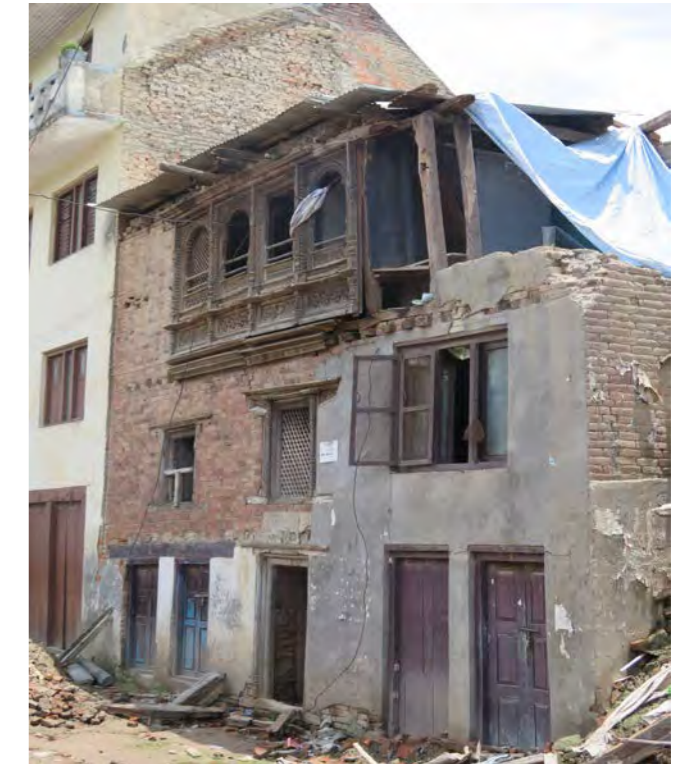
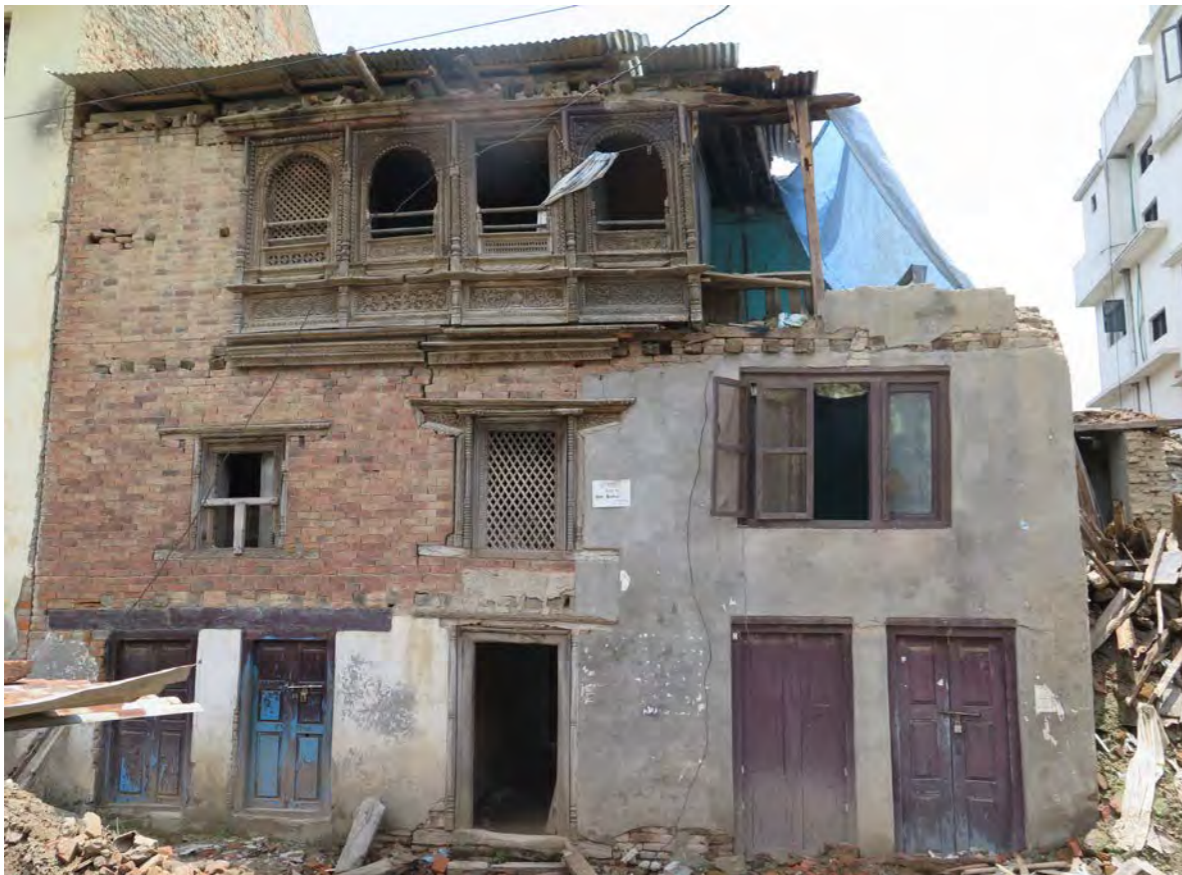
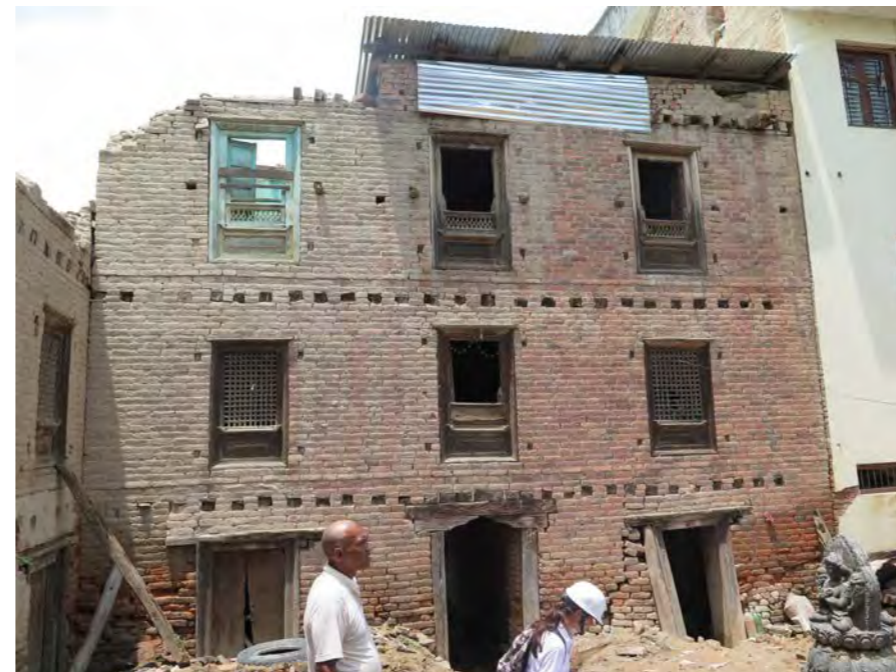
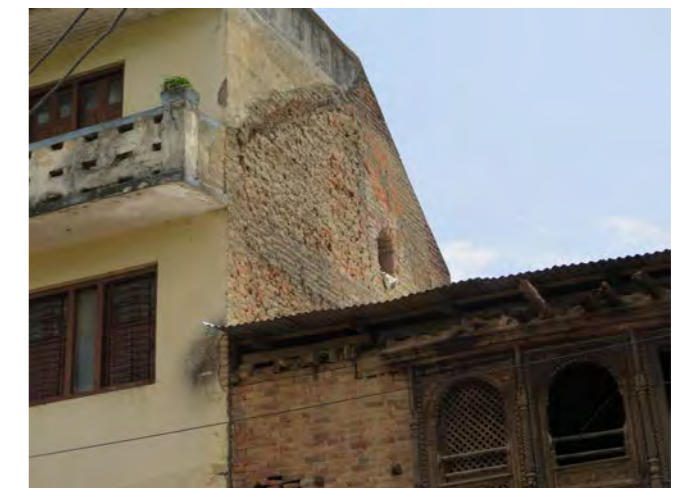
e29, e30, e31

NUMBER	CONTACT	STOREY NO. RELATIVE POSITION	STRUCTURAL SYSTEM	PROBLEMS DESCRIPTION	DANGER	CONDITION	
e29	Nem Kumari Bajracharya	G+3	B	2 floor collapsed.		++	
e30/e31	Maya Devi Bajracharya / Meera Bajracharya	G+3	B	1 floor collapsed.		++
