2015 Earthquake Damage Mapping

Sankhu

October 2015

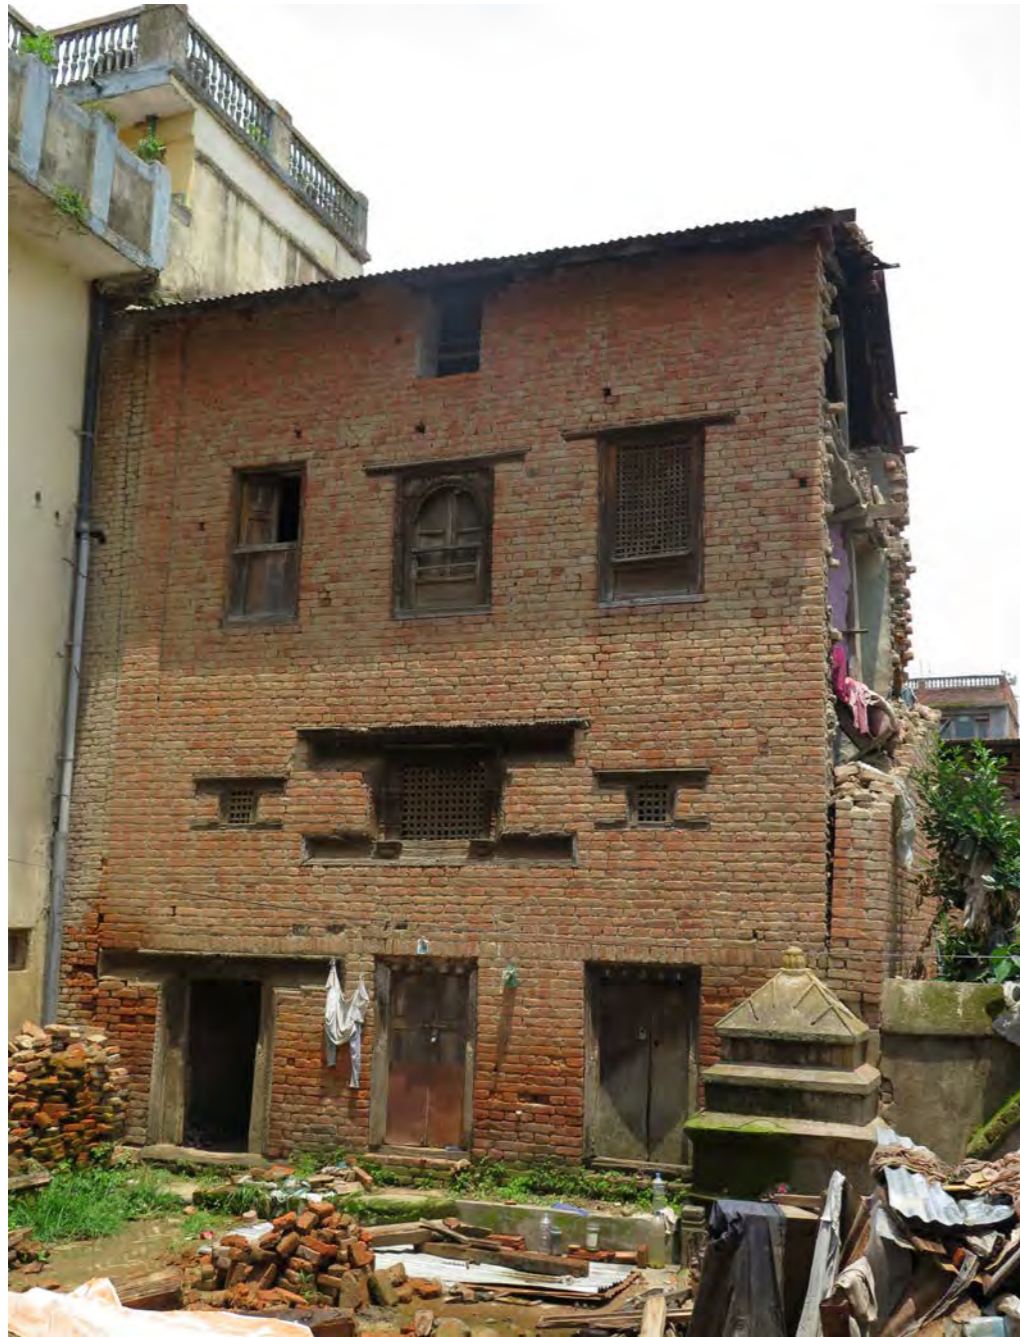
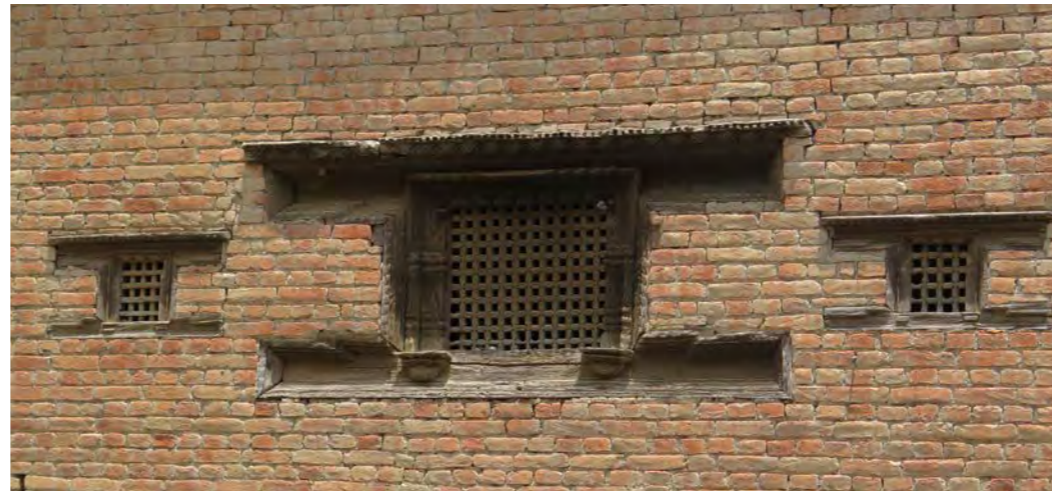
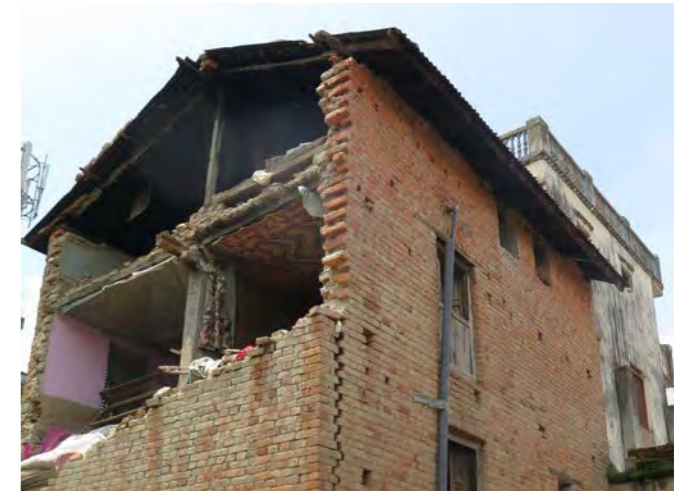
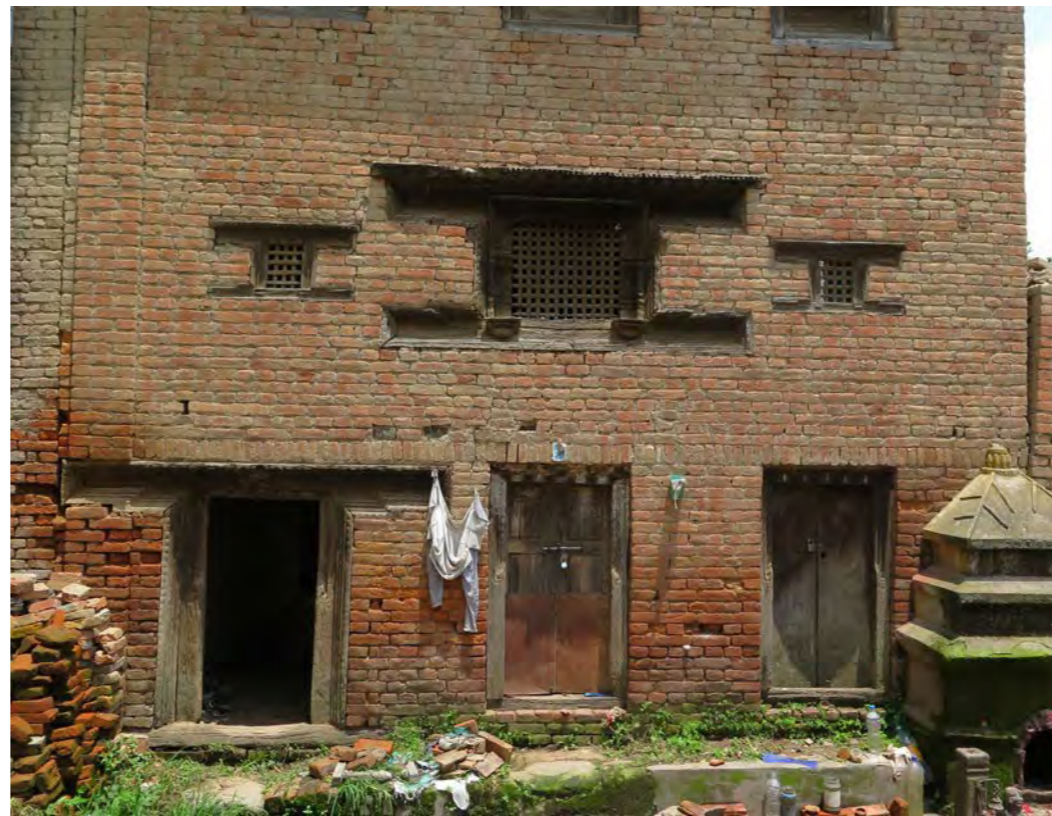
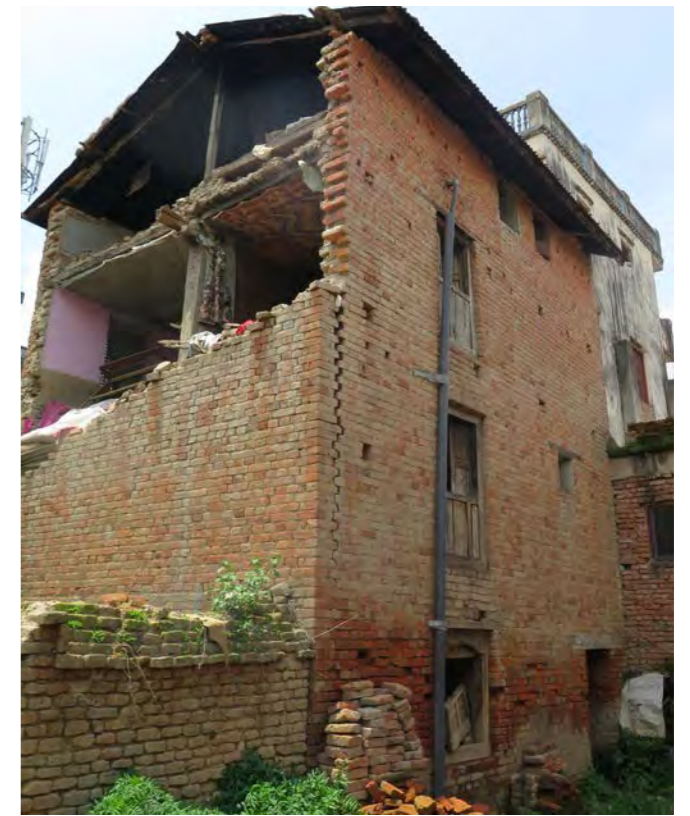
NUMBER	CONTACT	STOREY NO. RELATIVE POSITION	STRUCTURAL SYSTEM	PROBLEMS DESCRIPTION	DANGER	CONDITION
e33	Kedar Shrestha	G+3	B	South wall totally collapsed. Rising damp.	⚠

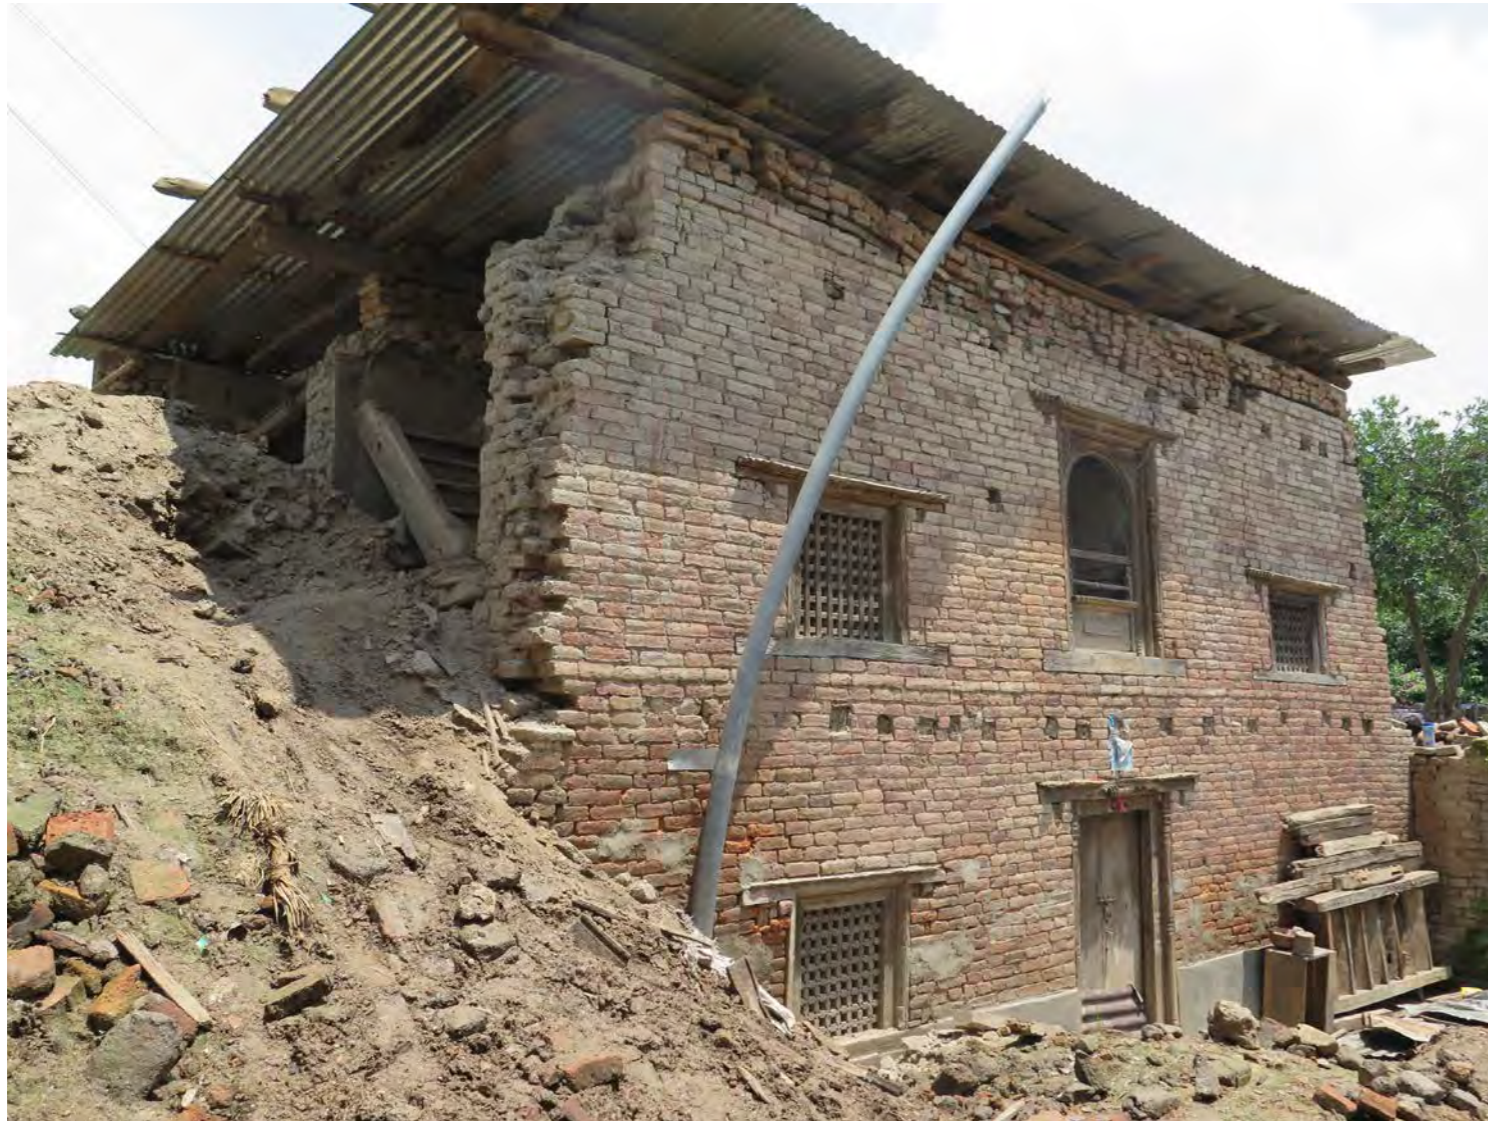
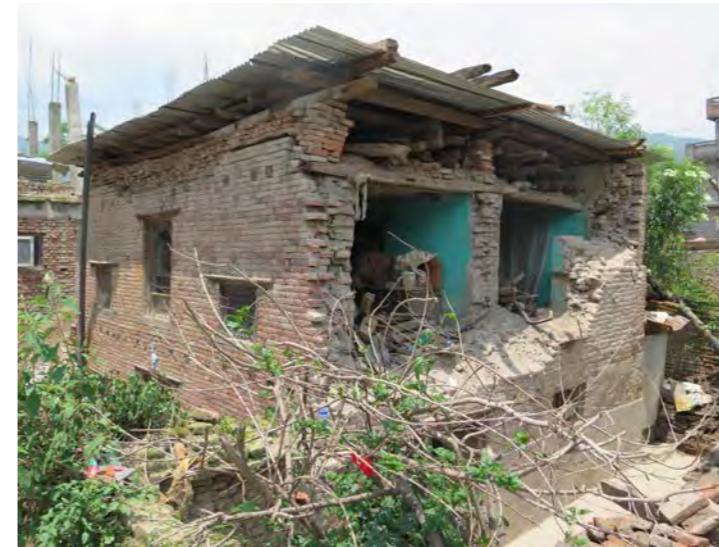
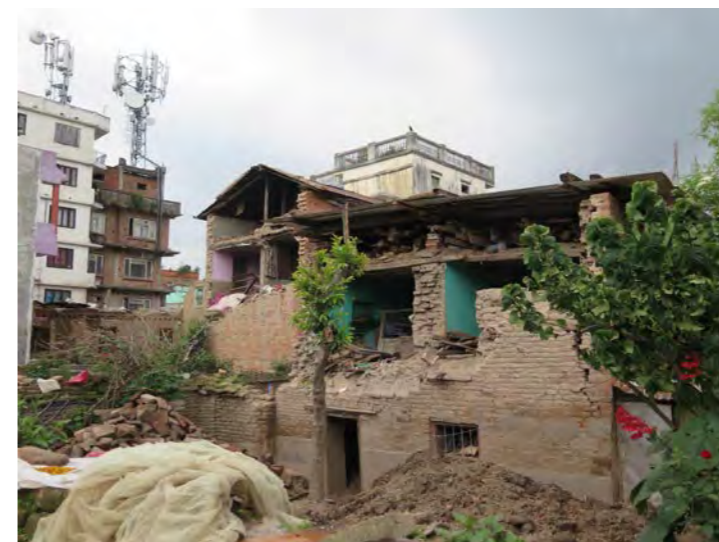
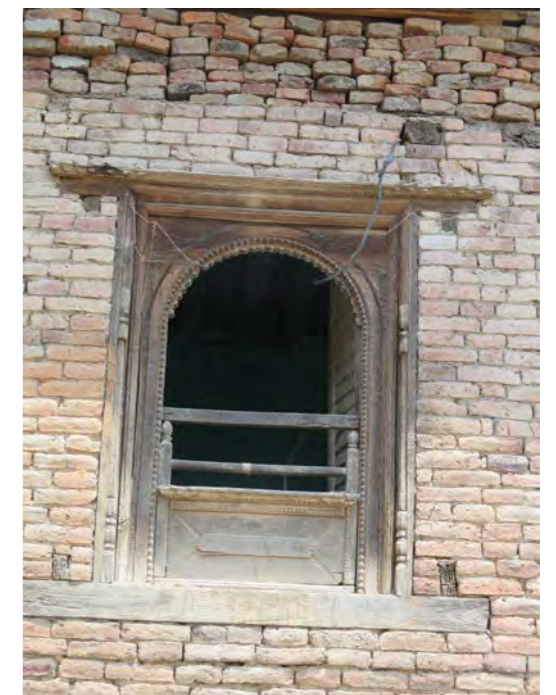
NUMBER	CONTACT	STOREY NO. RELATIVE POSITION	STRUCTURAL SYSTEM	PROBLEMS DESCRIPTION	DANGER	CONDITION
e35	Arjun Lal Shrestha	G+2 (SH)	B	1 floor demolished. North and south wall collapsed. East wall buldging. Rising Damp.	1/2 ☒

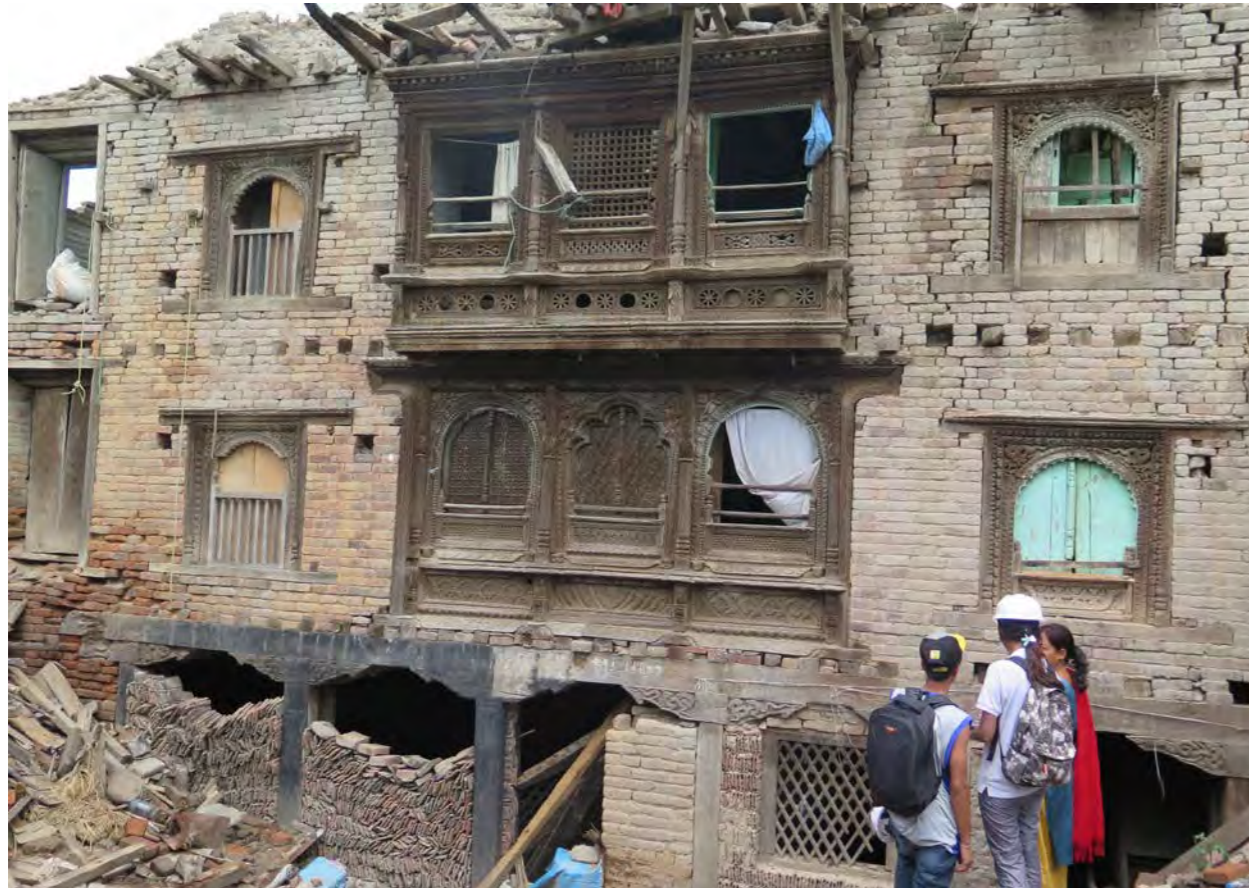
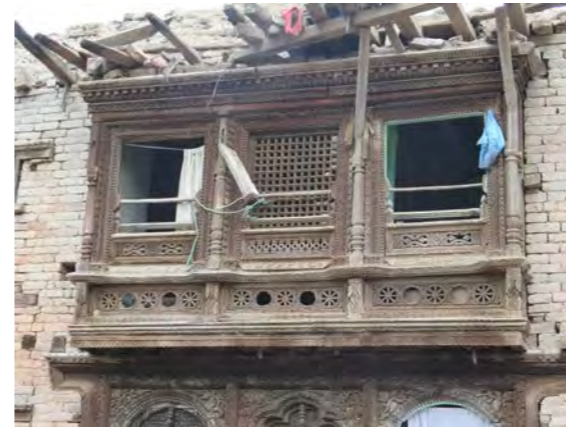
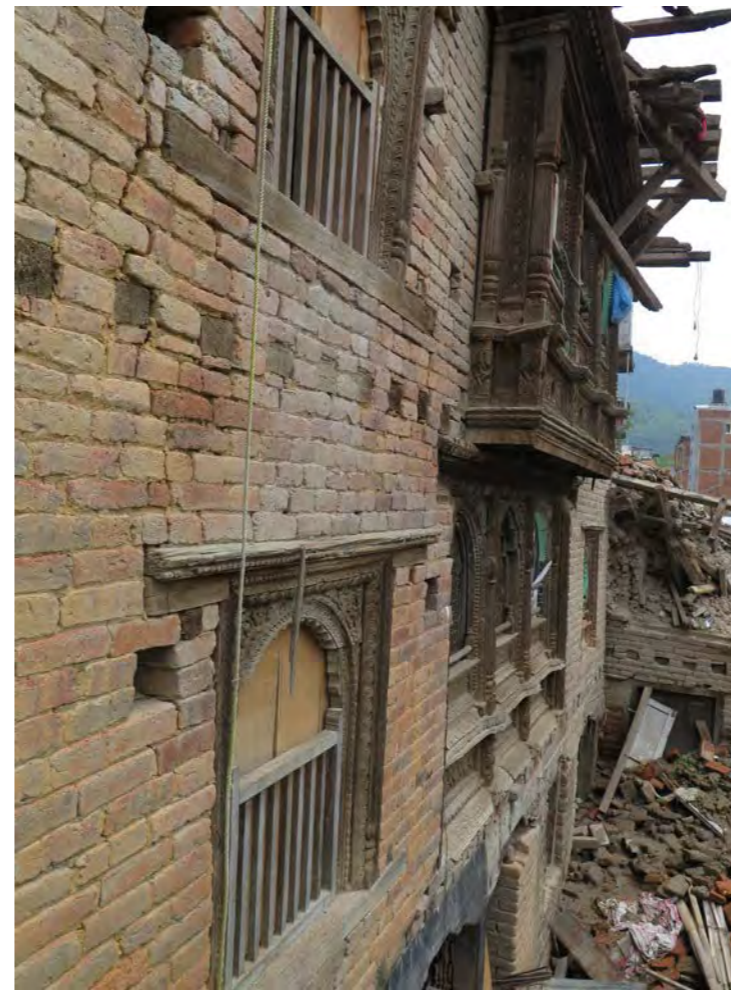
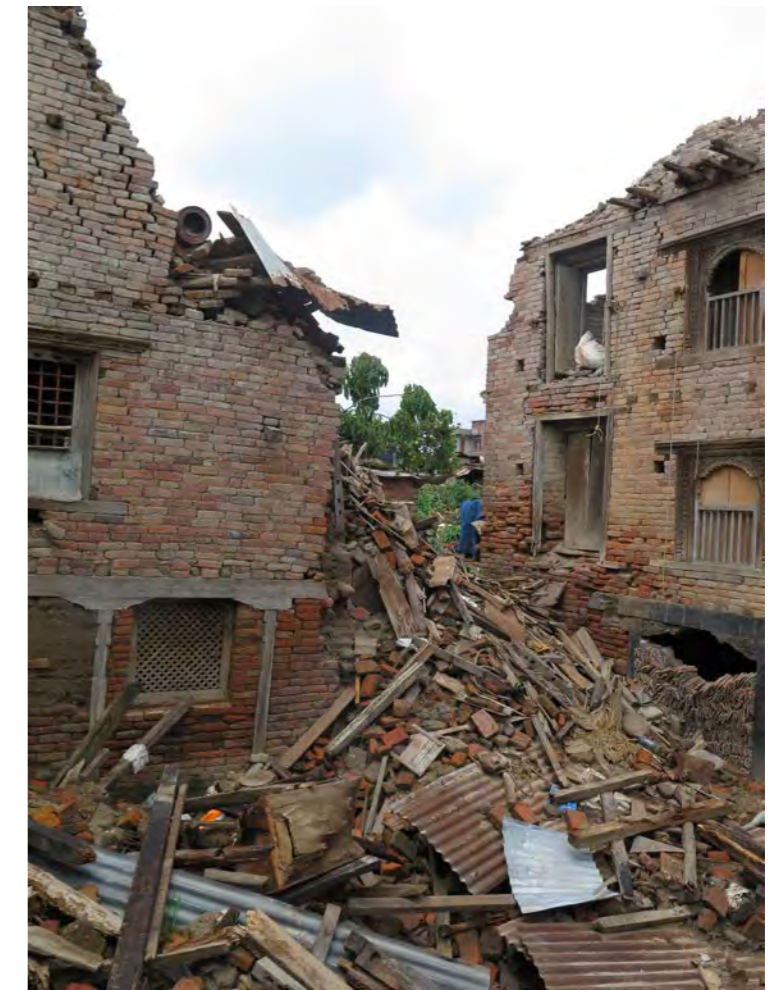
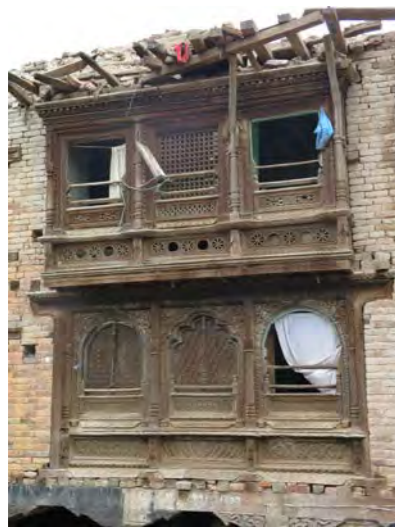
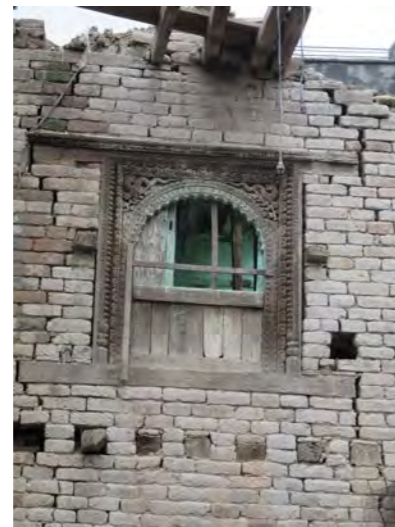
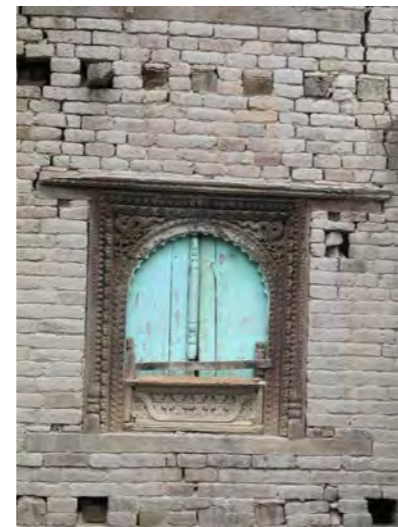
e55, e56

NUMBER	CONTACT	STOREY NO. RELATIVE POSITION	STRUCTURAL SYSTEM	PROBLEMS DESCRIPTION	DANGER	CONDITION
e55	Krishna Das Malla	G+3.5 (EH)	B	1 Floor collapsed. Vertical crack >5 cm on south east wall. Rising damp	⚠	W ++
e56	Ramesh Malla	G+3.5	B	1.5 floor collapsed. Rising damp	⚠	W ++

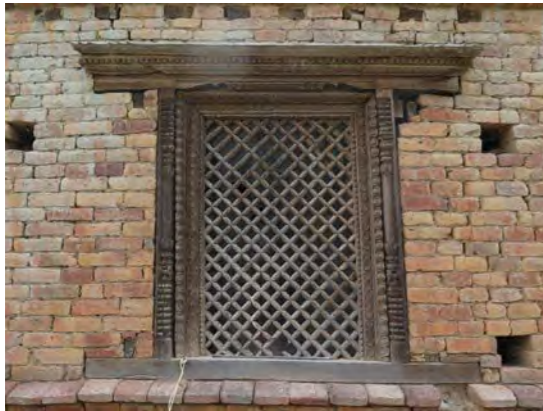
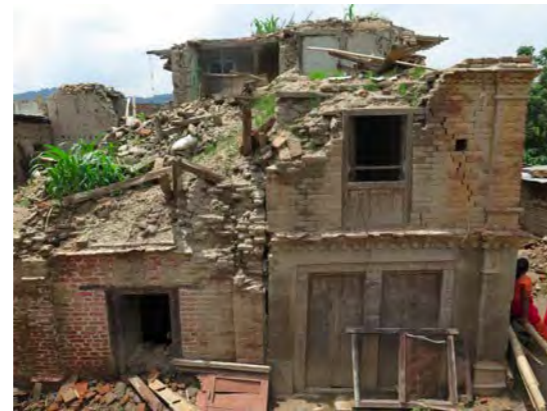
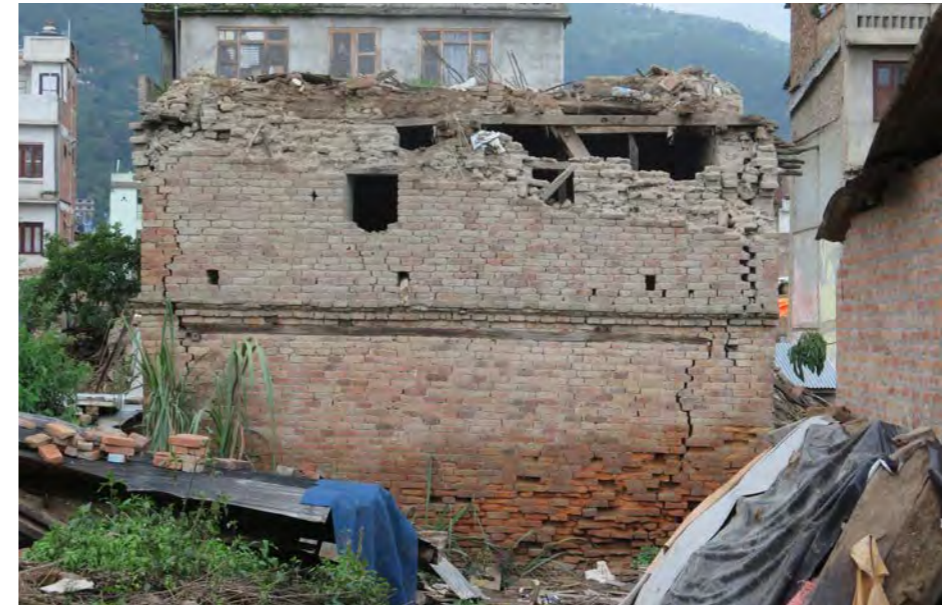
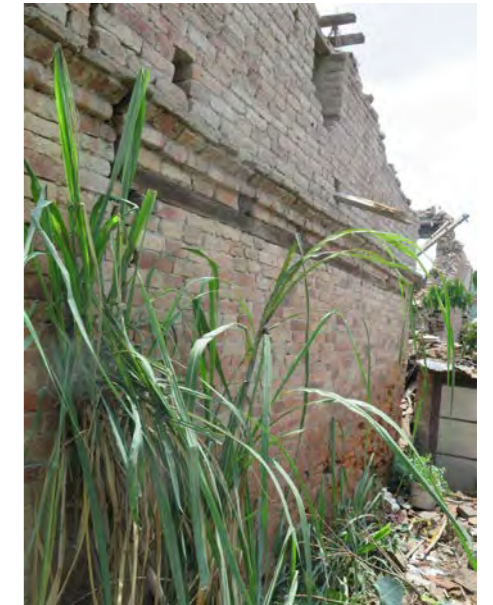
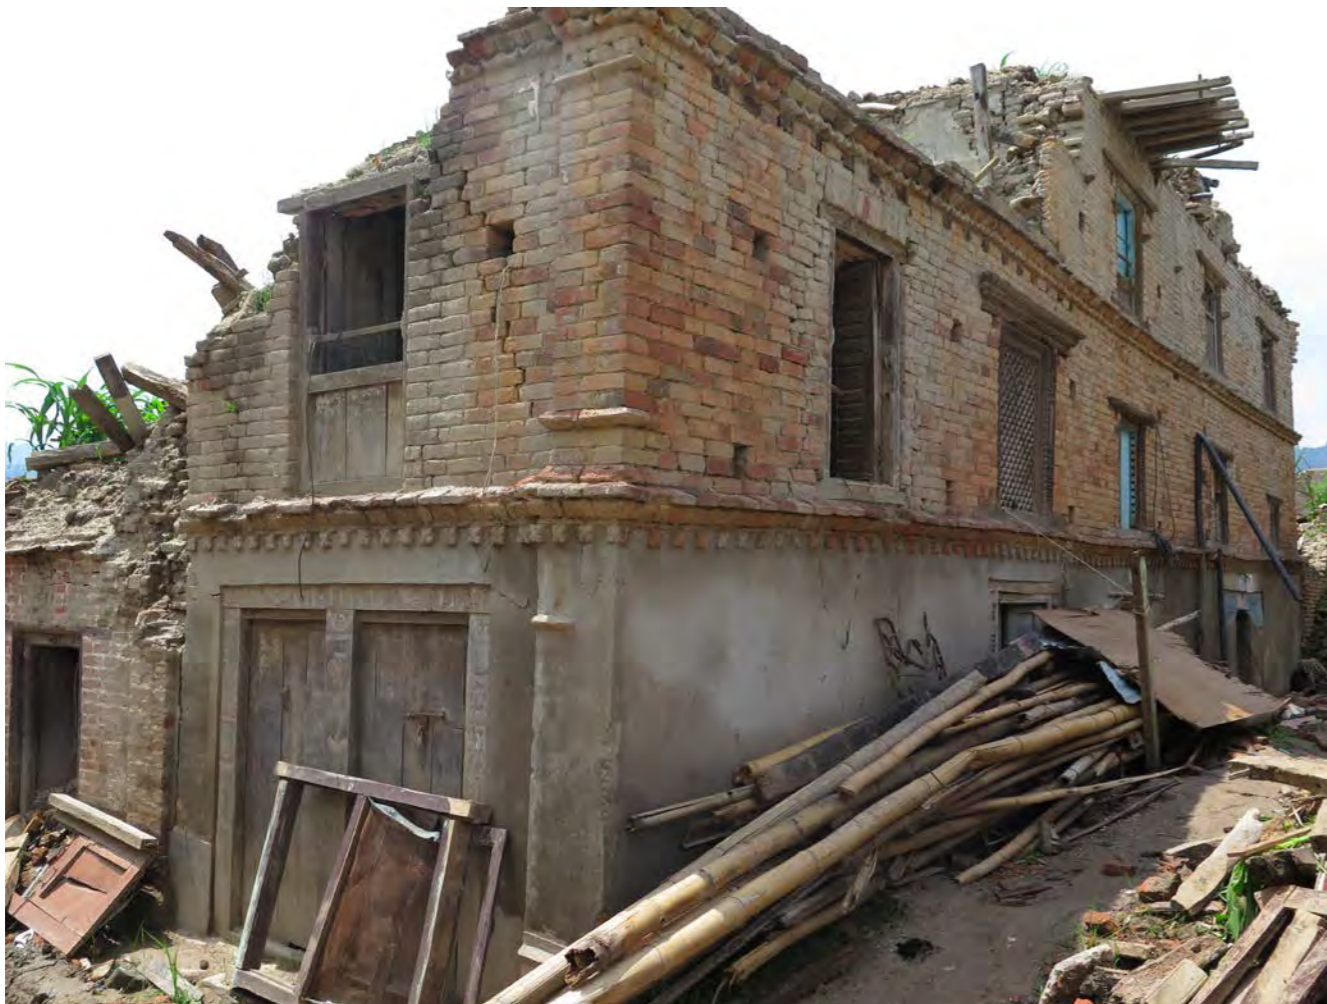
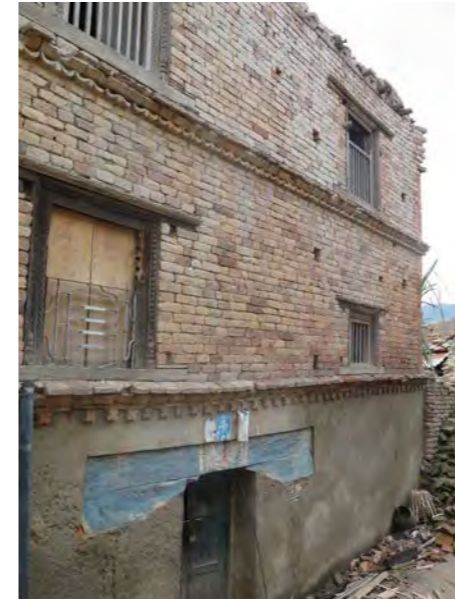
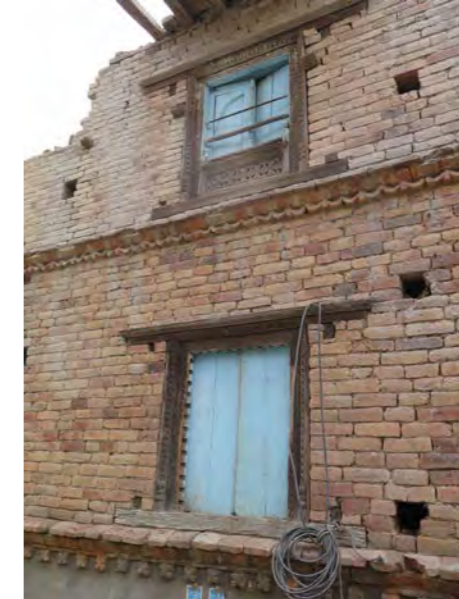
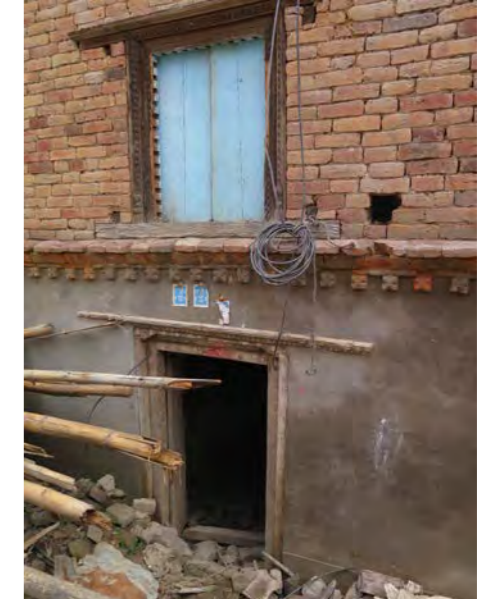
e57, e58

NUMBER	CONTACT	STOREY NO. RELATIVE POSITION	STRUCTURAL SYSTEM	PROBLEMS DESCRIPTION	DANGER	CONDITION
e57	Tulsi Malla	G+3.6	B	1 Floor collapsed. Rising damp.	⚠	+
e58	Sita Malla	G+3.7 (CH)	B	2 Floor collapsed. Rising damp. Vertical crack on north west corner.	⚠	W +

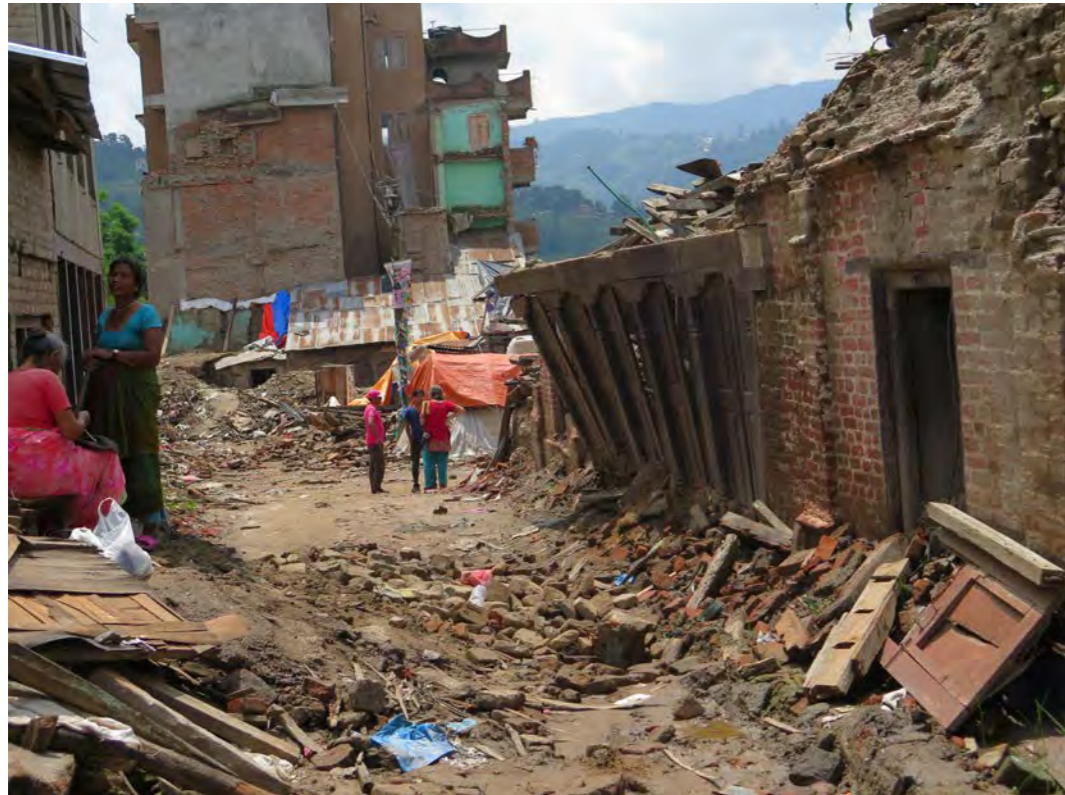
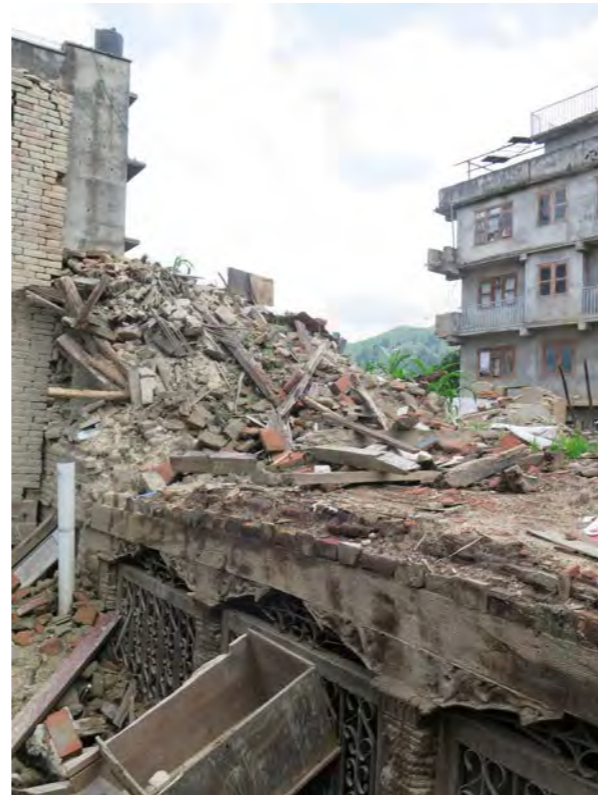
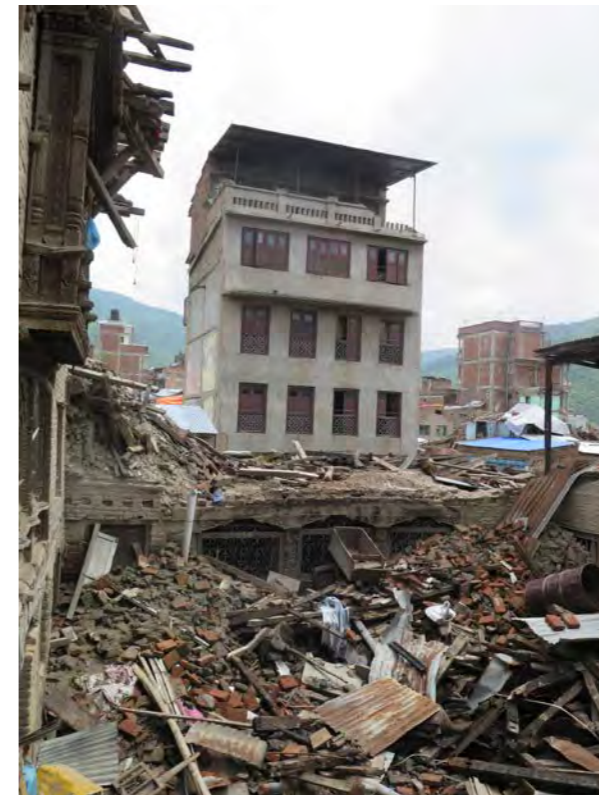
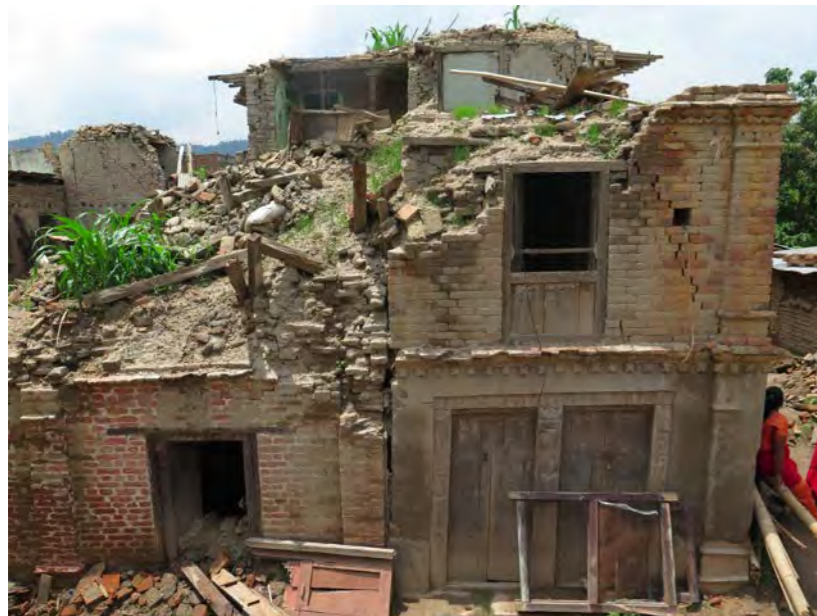
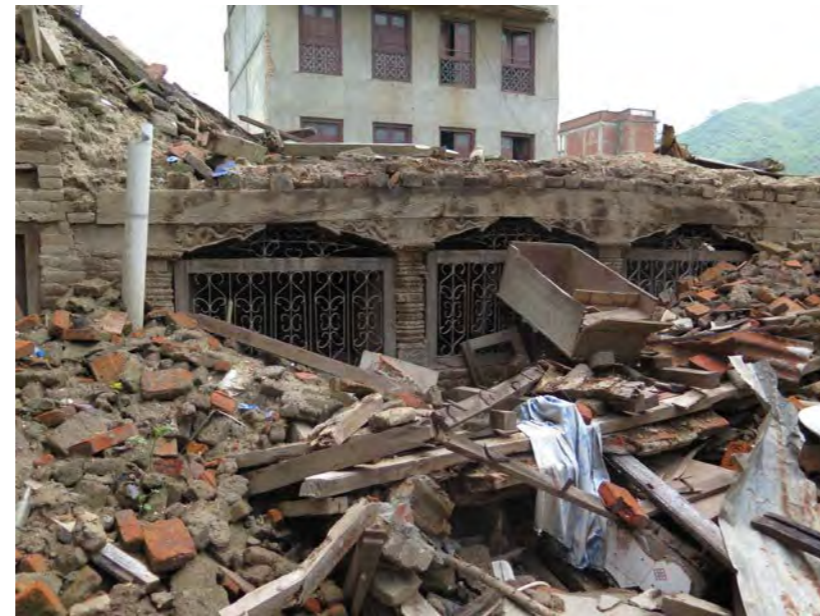
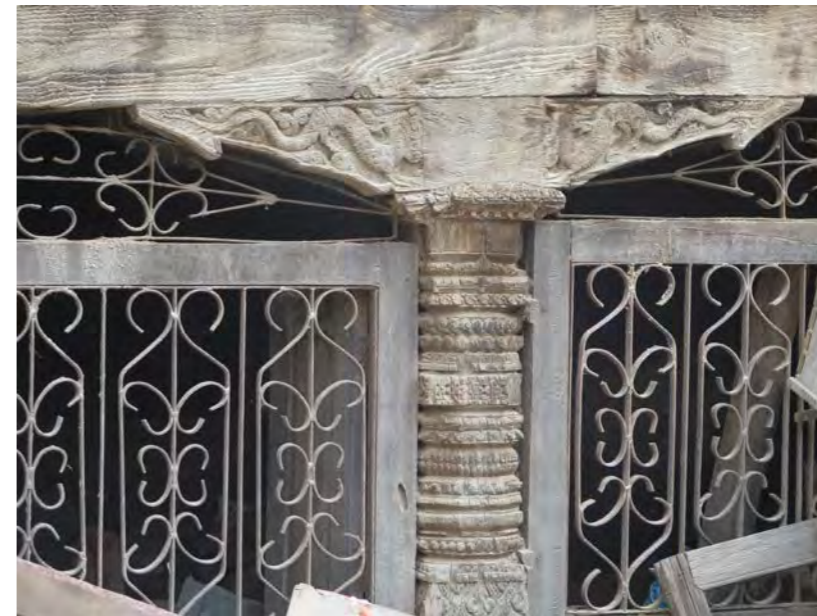
NUMBER	CONTACT	STOREY NO. RELATIVE POSITION	STRUCTURAL SYSTEM	PROBLEMS DESCRIPTION	DANGER	CONDITION
e59	Raj Bhai Malla	G+3.5	B	3.5 Floors collapsed. Covered by rubbles	⚠️ 3/4 ❌	! W ++

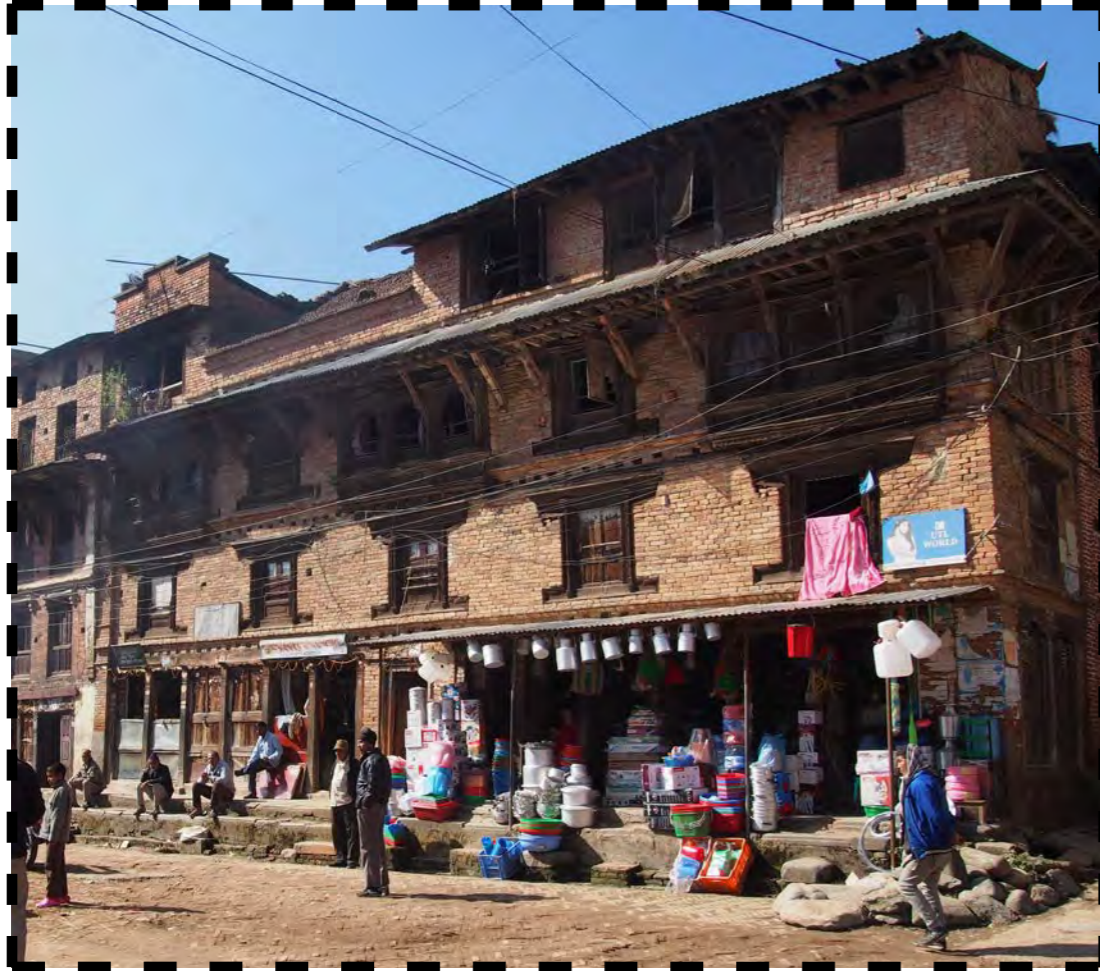
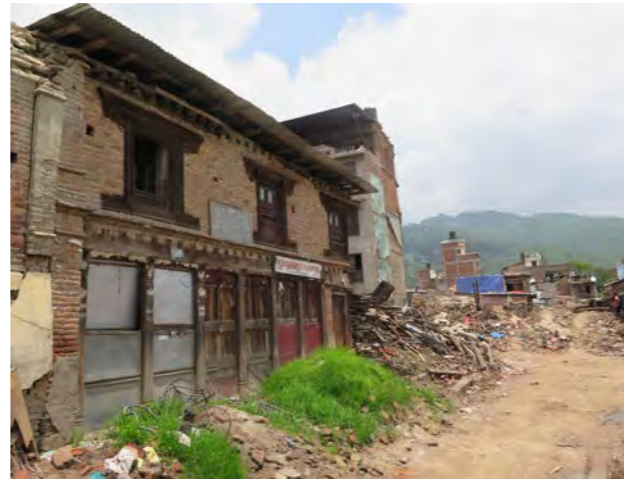
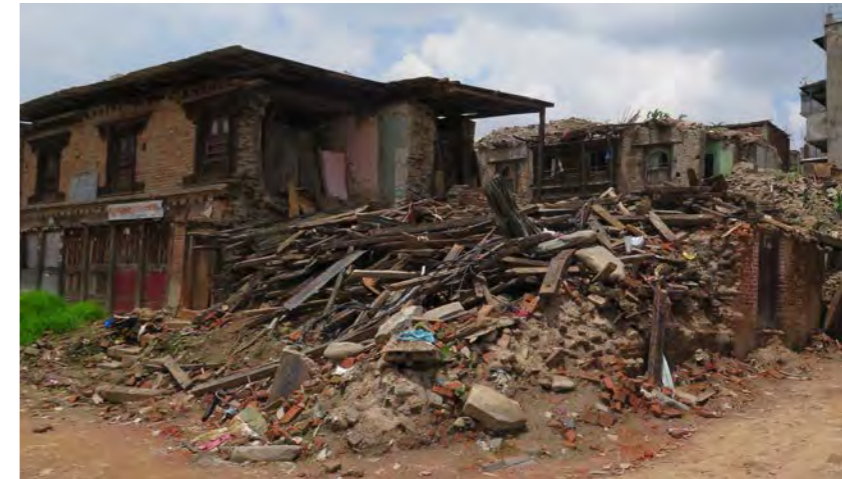
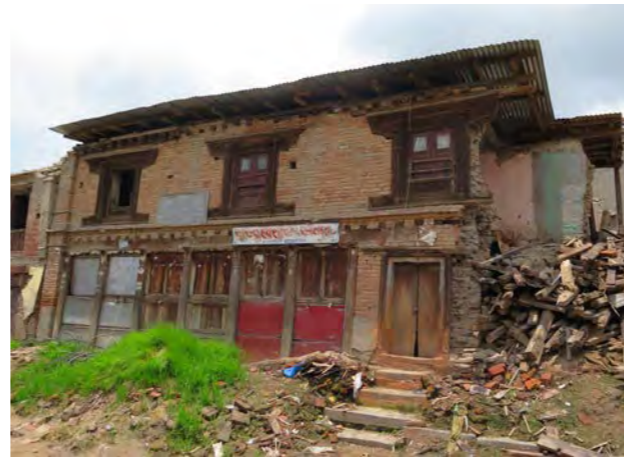
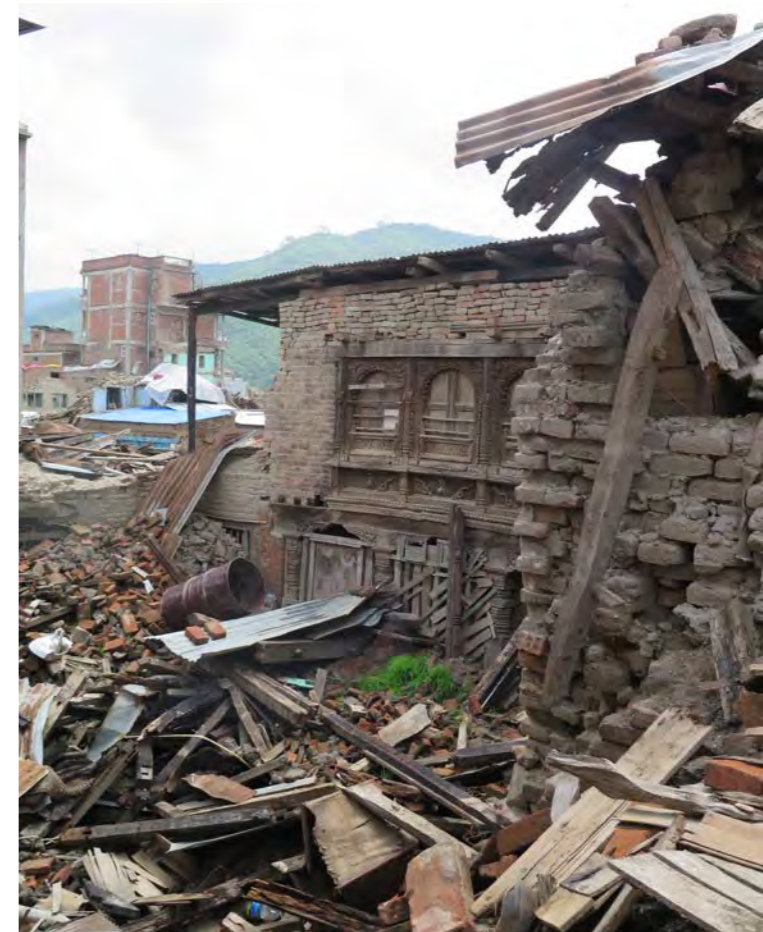
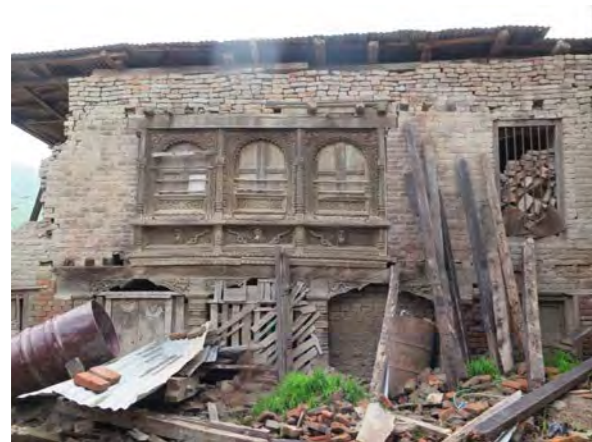
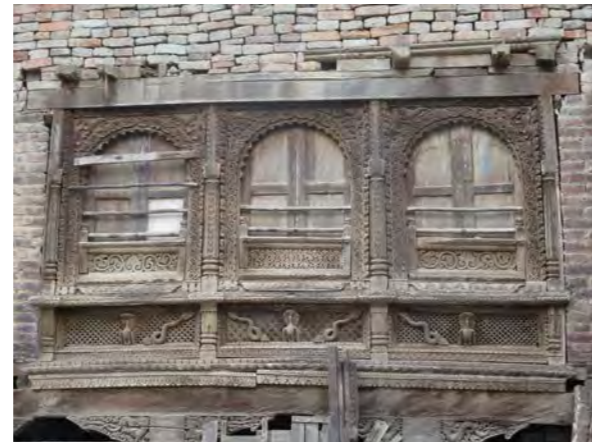
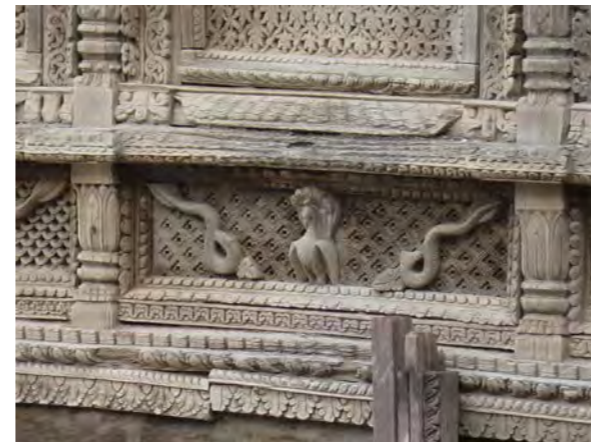
NUMBER	CONTACT	STOREY NO. RELATIVE POSITION	STRUCTURAL SYSTEM	PROBLEMS DESCRIPTION	DANGER	CONDITION	
e60	Bishnu Malla	G+3 (CH)	B	Eastern part totally collapsed. Western part upto second floor remaining.	⚠️ 1/2 ☒	! W ++
