2015 Earthquake Damage Mapping

Sankhu

October 2015

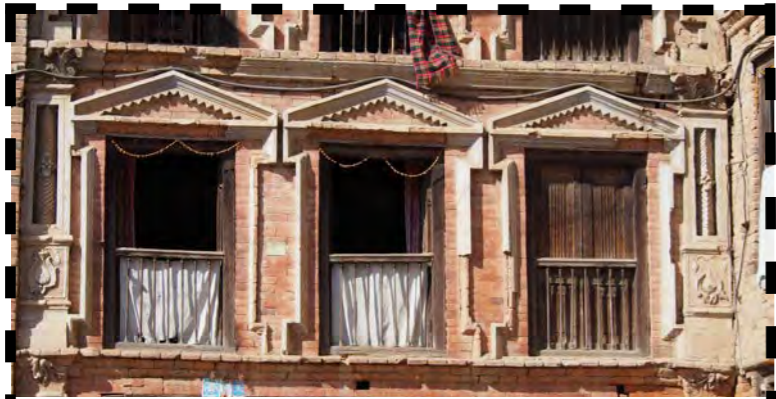
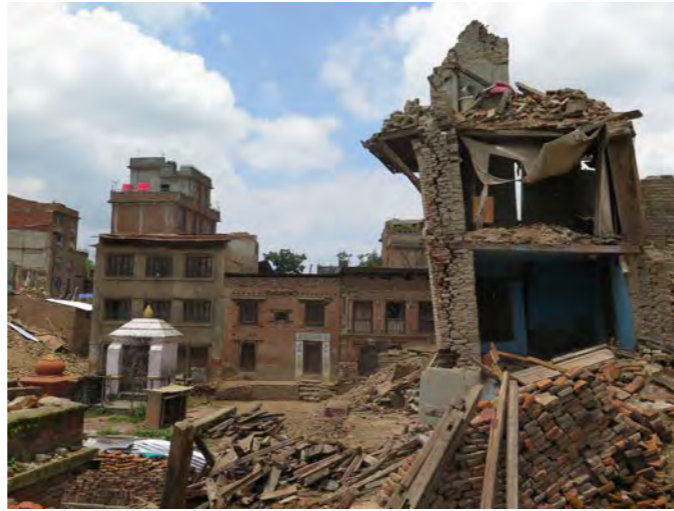
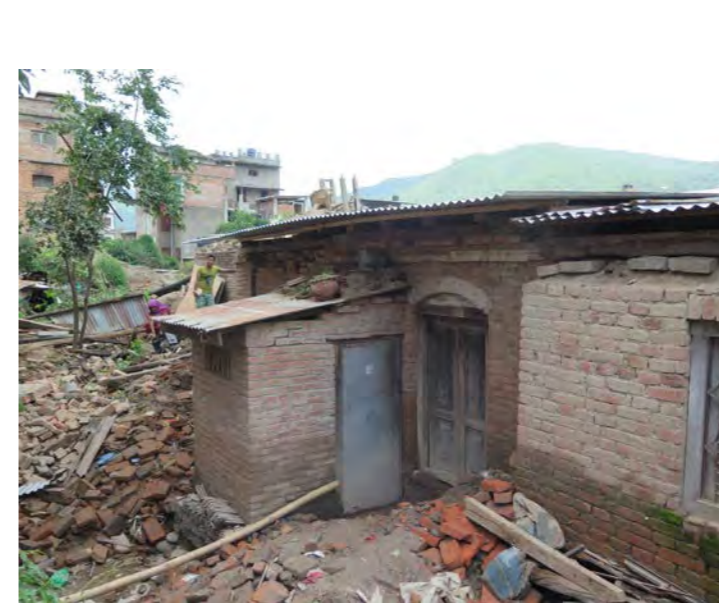
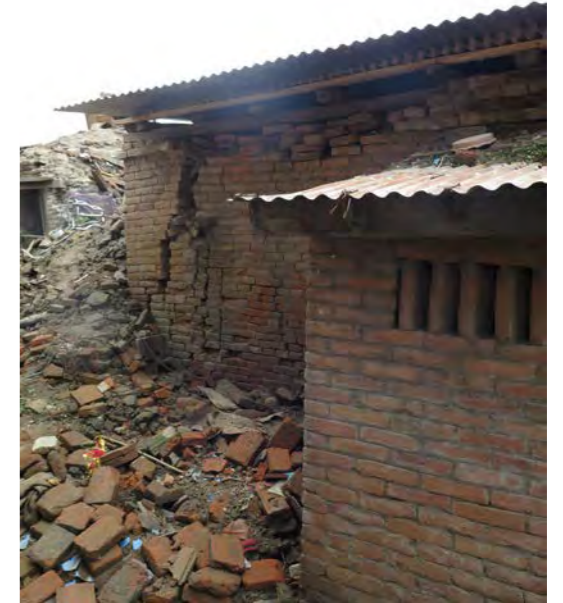
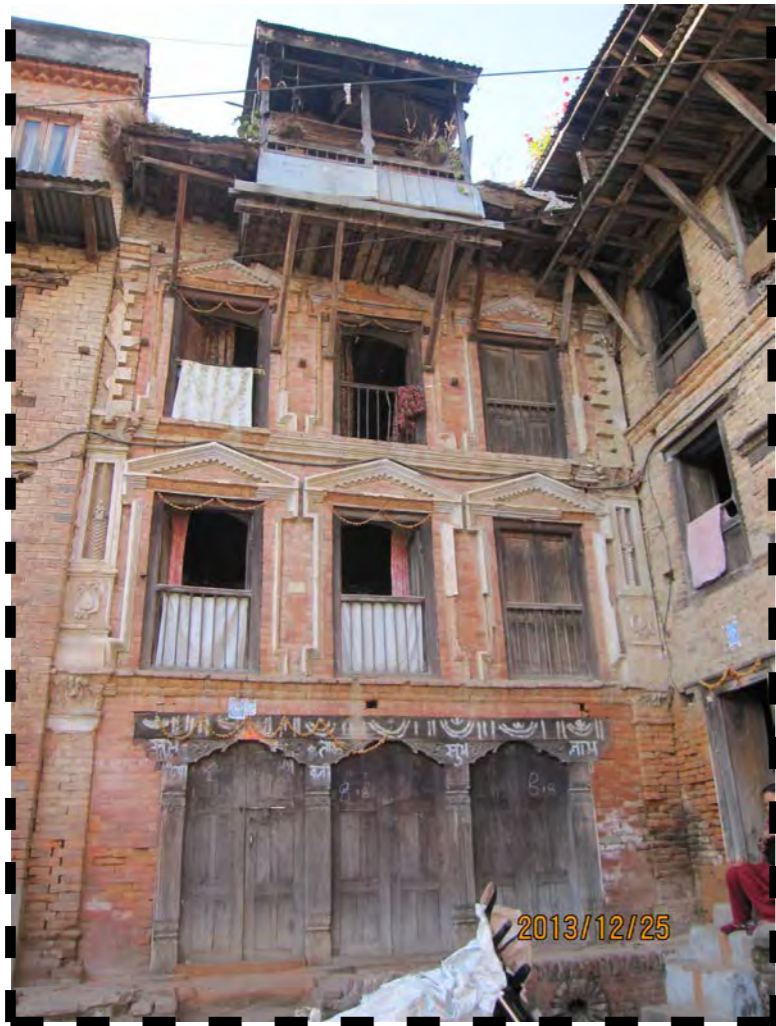
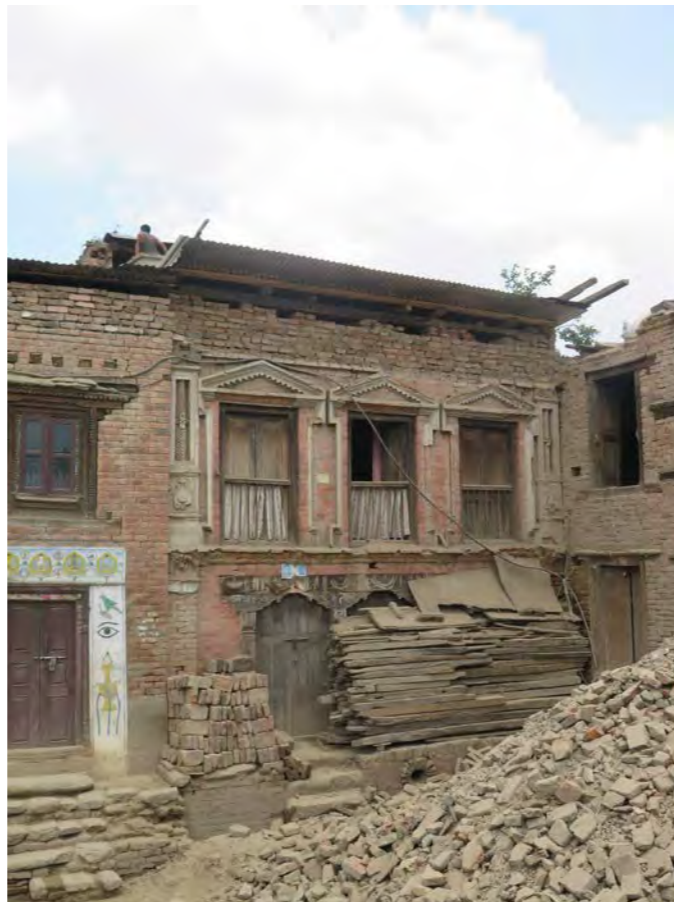
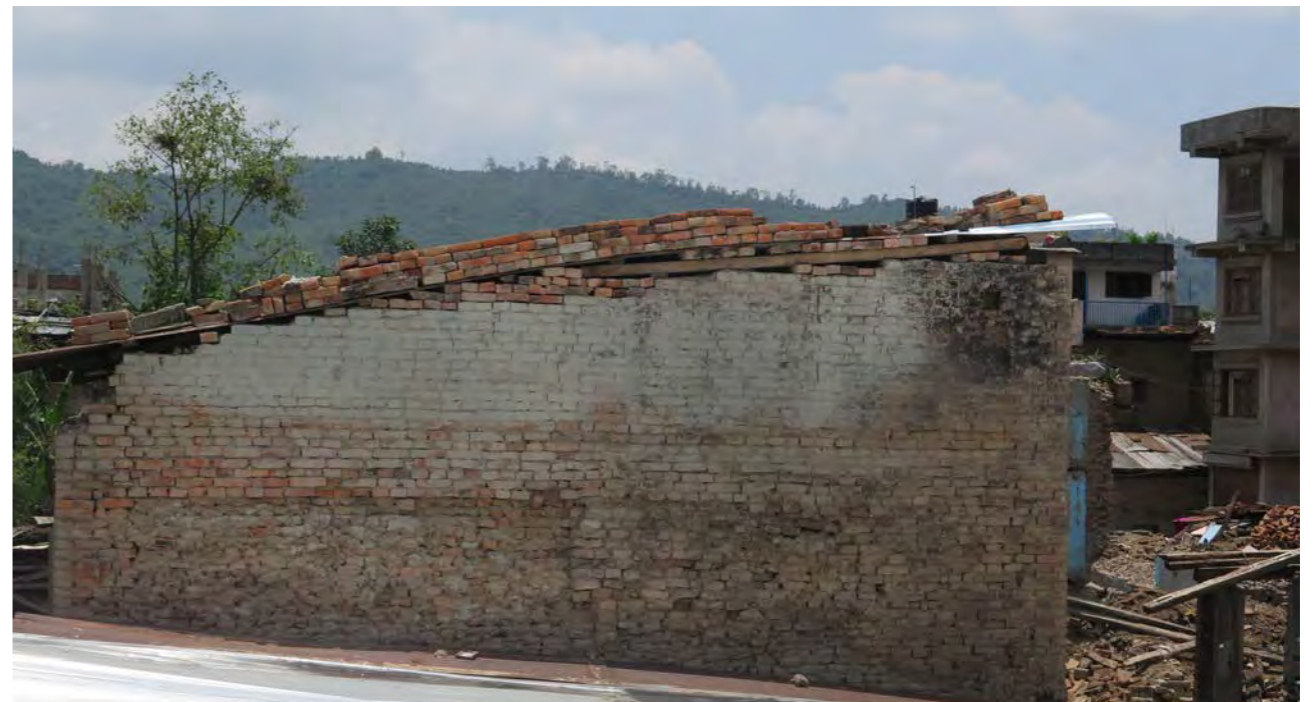
NUMBER	CONTACT	STOREY NO. RELATIVE POSITION	STRUCTURAL SYSTEM	PROBLEMS DESCRIPTION	DANGER	CONDITION	
e79	Madhav Narayan Ranjitkar	G+3	B	2 floors collapsed	1/2 ☒	! W ++

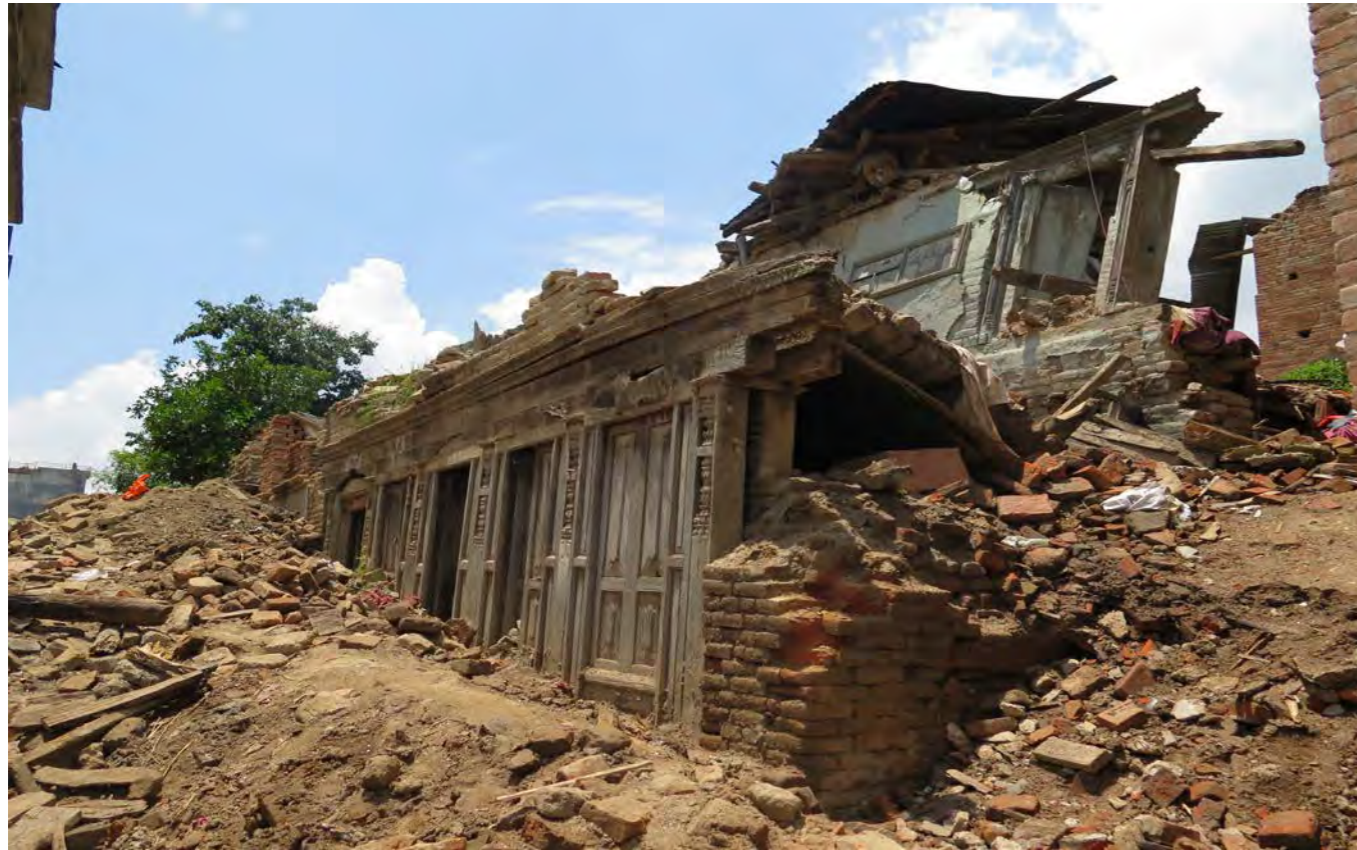
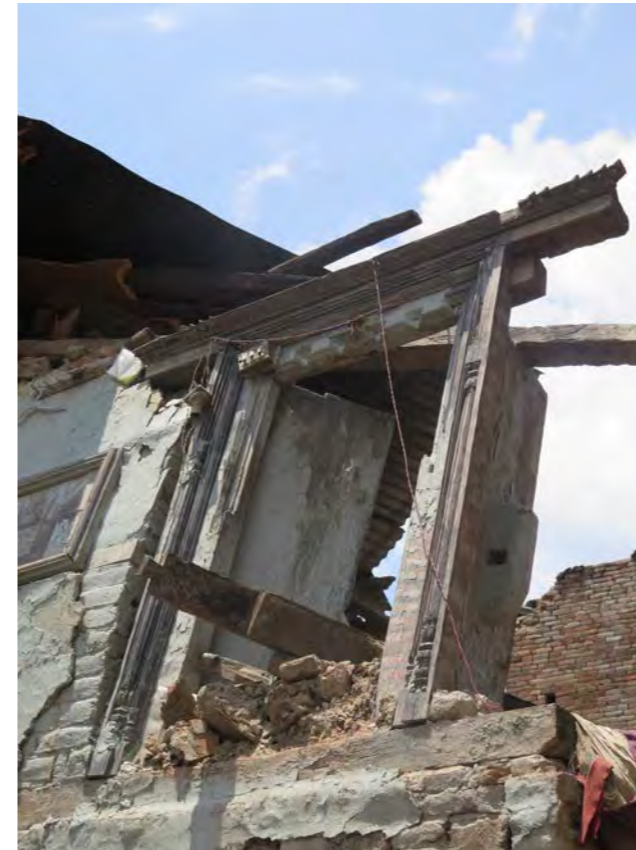
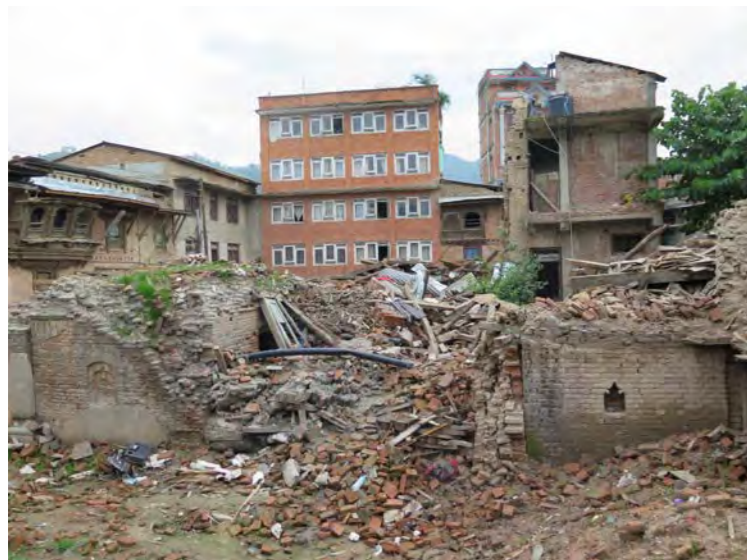
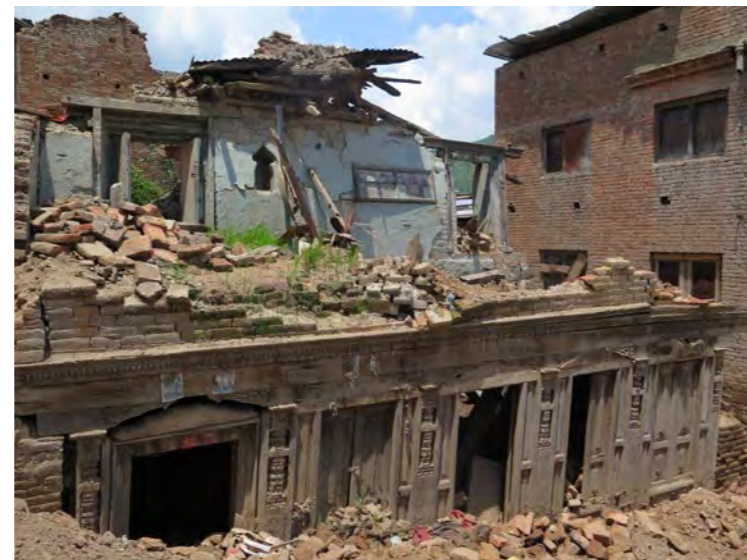
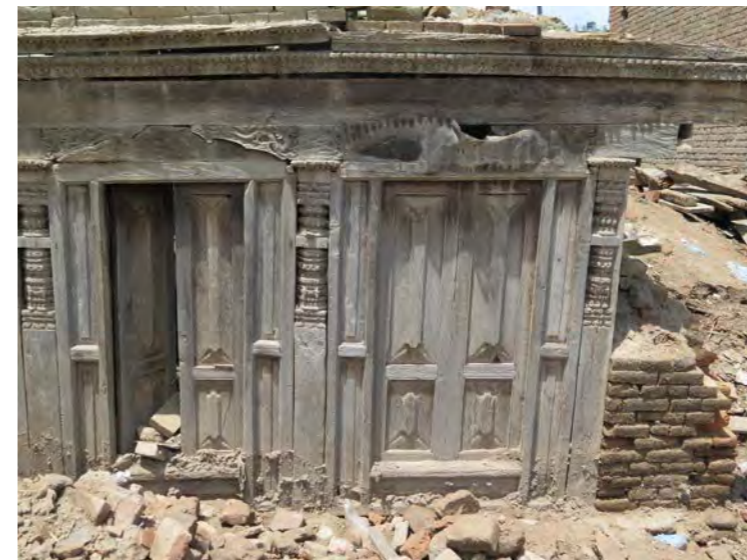
NUMBER	CONTACT	STOREY NO. RELATIVE POSITION	STRUCTURAL SYSTEM	PROBLEMS DESCRIPTION	DANGER	CONDITION
e83	Ram Maya Lawot	G+3	B	2 floors collapsed. South part collapsed till ground floor. Internal walls and dalan remaining	D! 3/4 ☒	!W

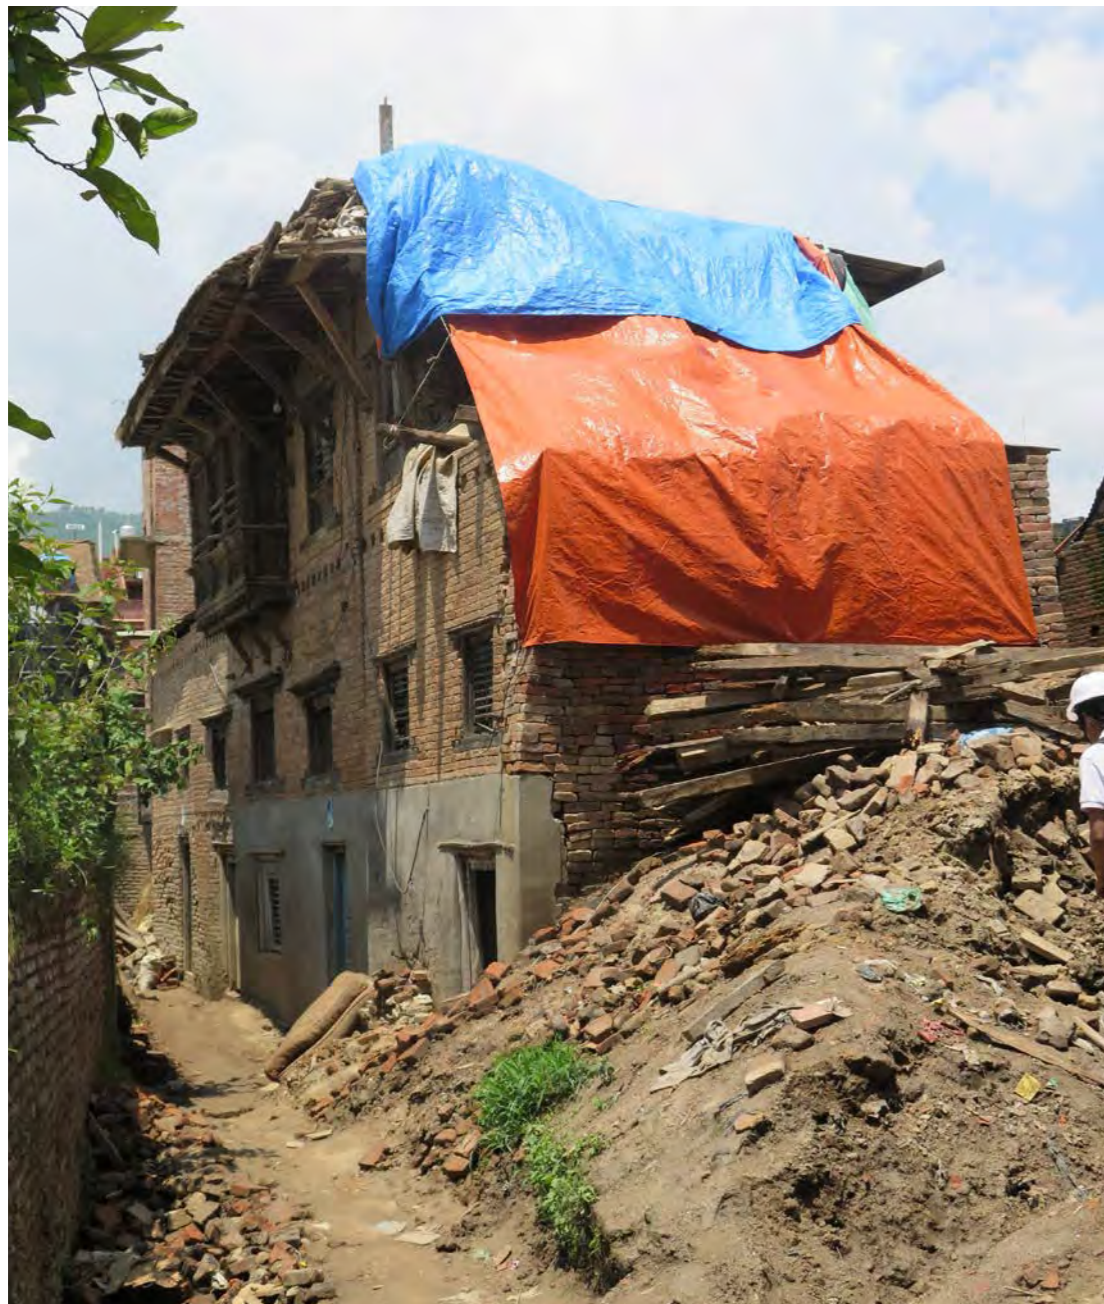
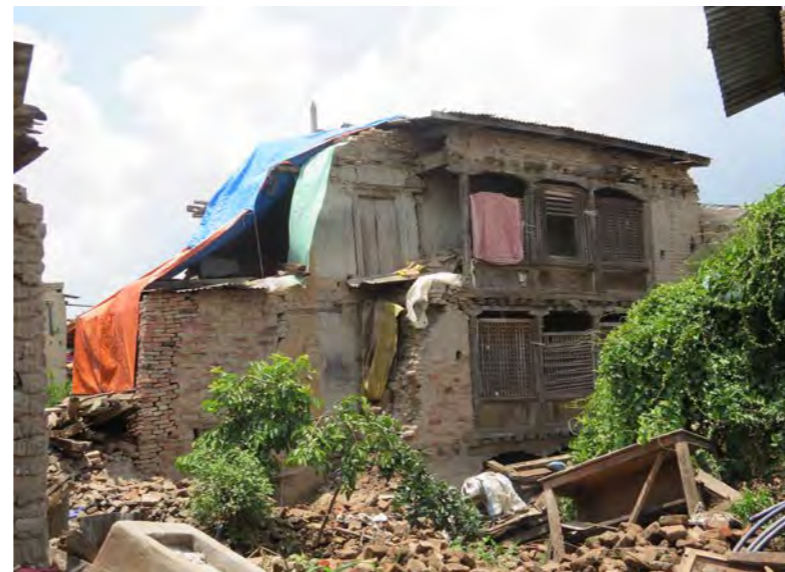
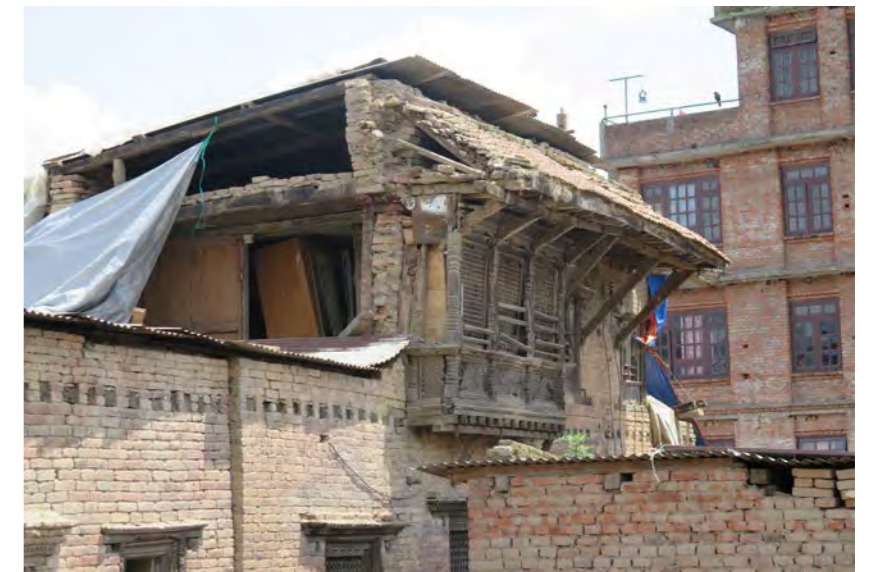
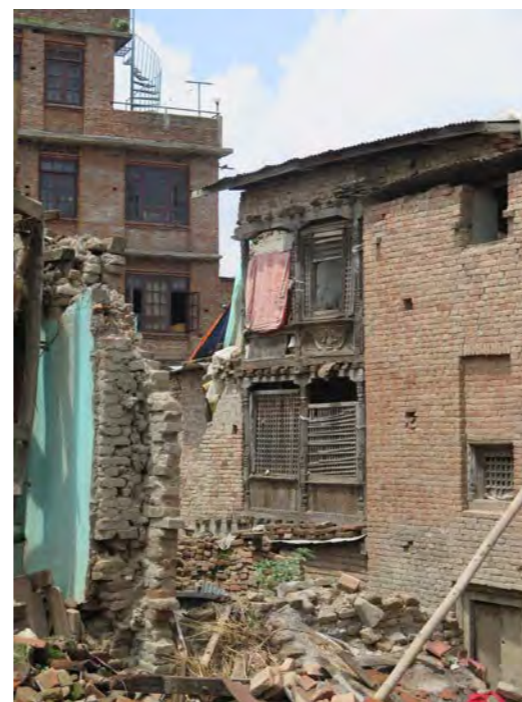
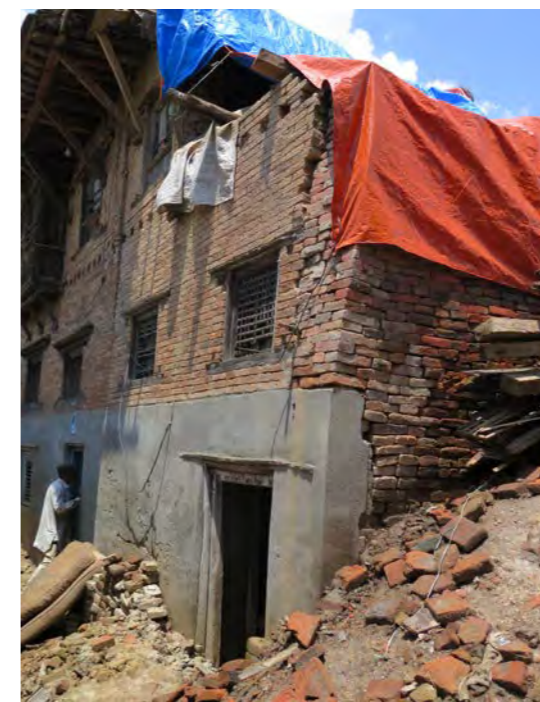
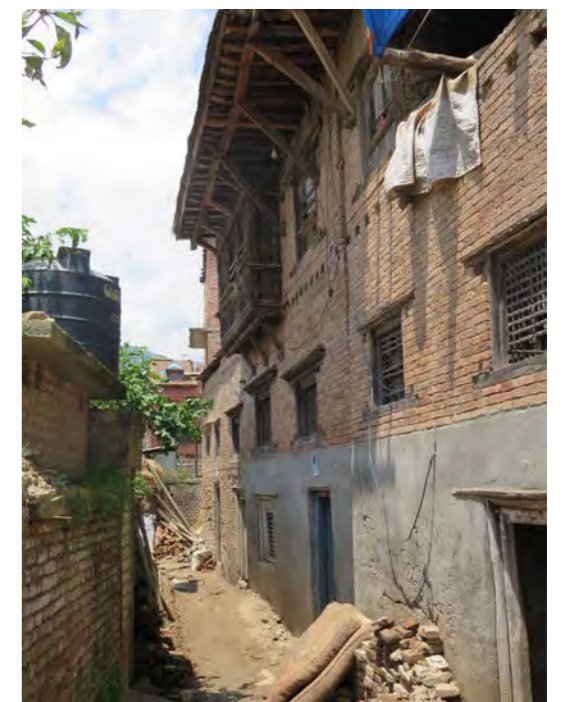
e86, e87, e88

NUMBER	CONTACT	STOREY NO. RELATIVE POSITION	STRUCTURAL SYSTEM	PROBLEMS DESCRIPTION	DANGER	CONDITION	
e86/ e87	Akkal Bahadur Ranjit (9803413700)/	G+3	B	1 floor collapsed. South part collapsed.

e88	Krishna Bahadur Pra-japati (9841660566)	G+3	B	1 floor collapsed. Cracks on west side upto ground floor. Rising damp.	1/2

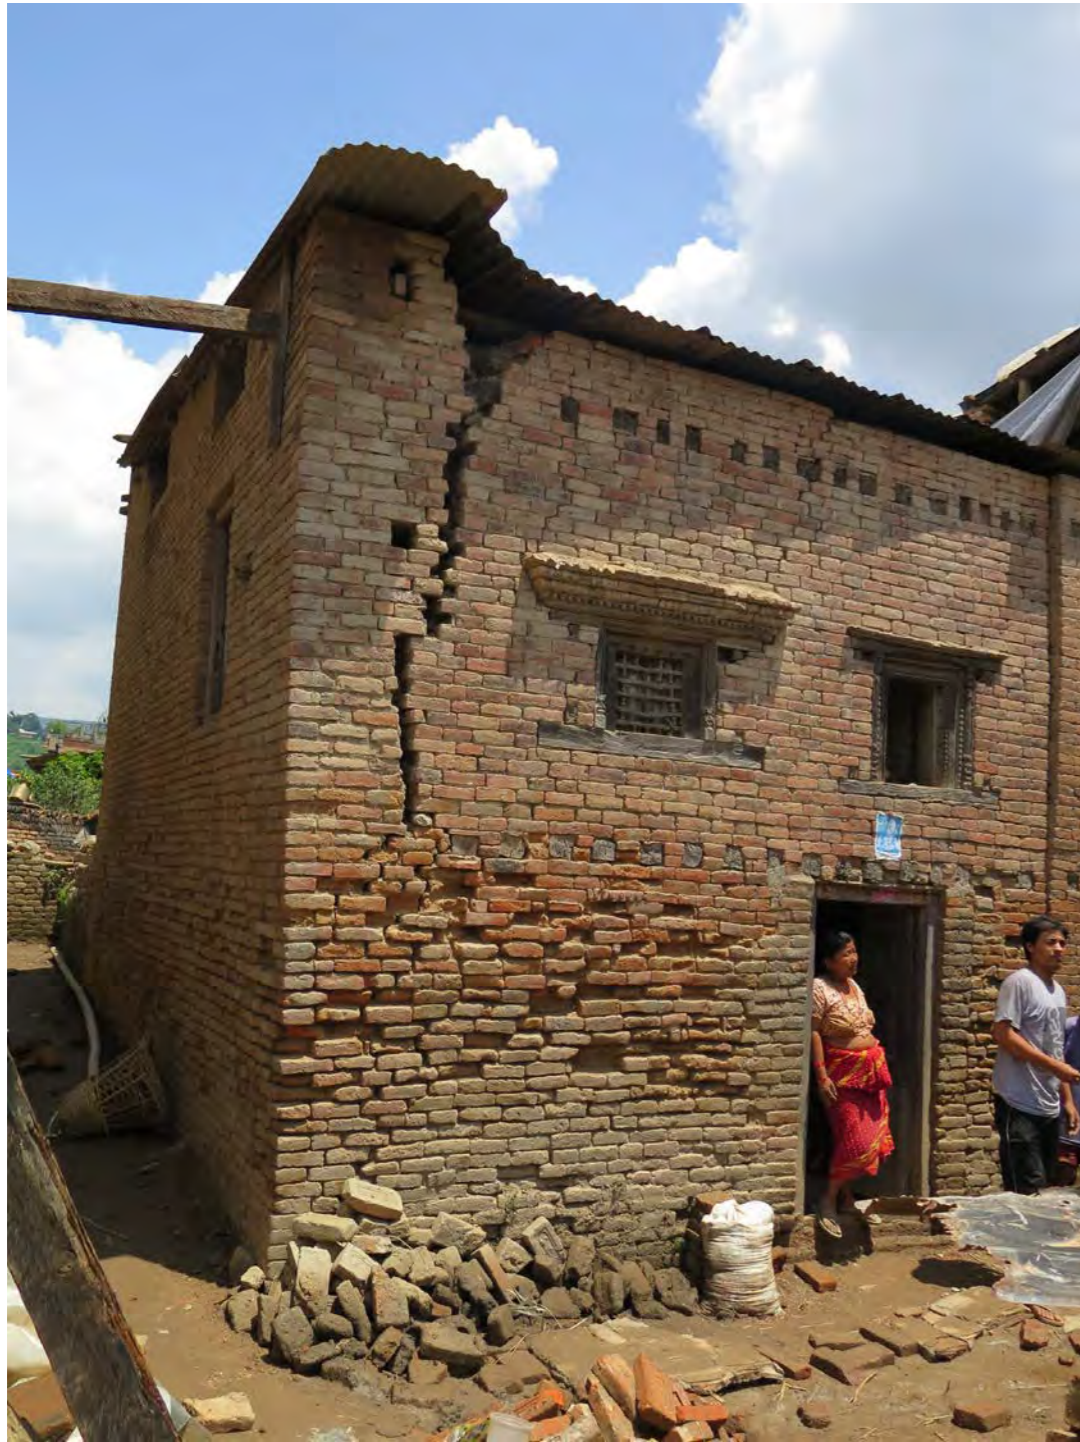
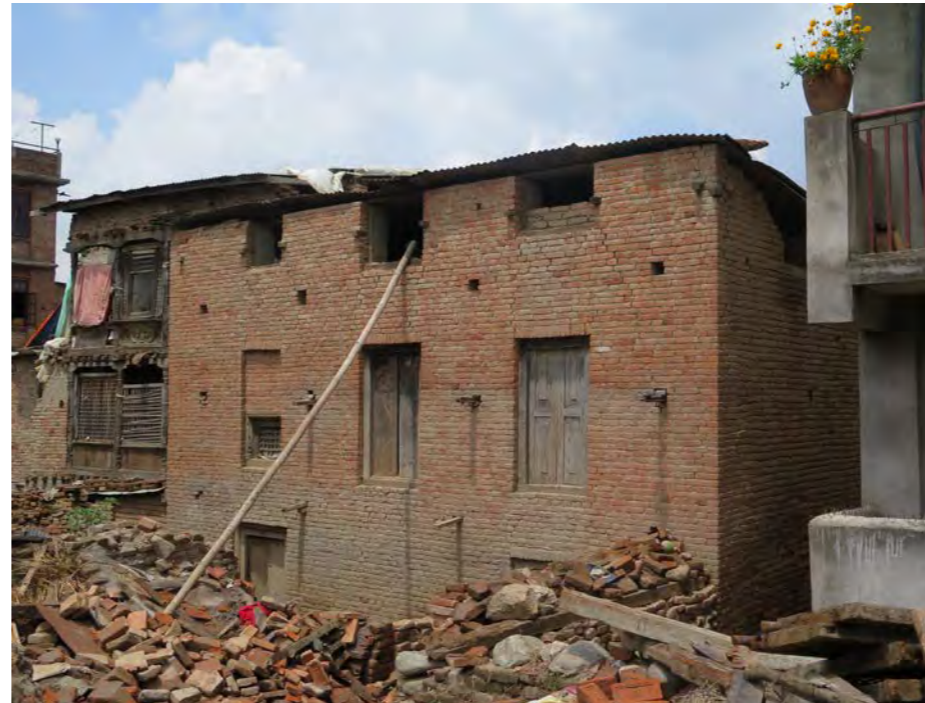
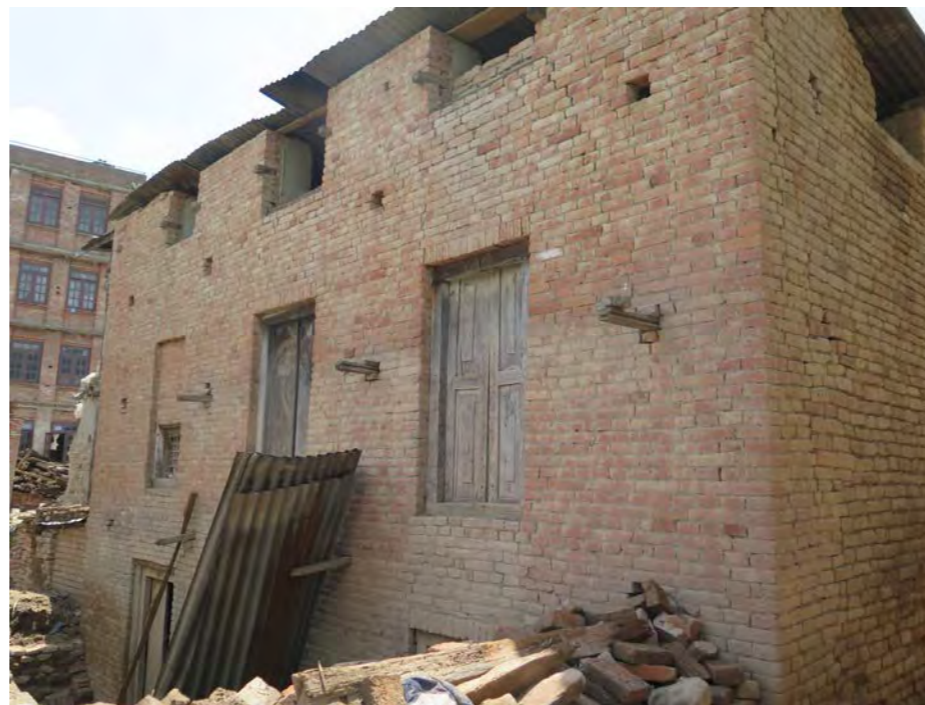
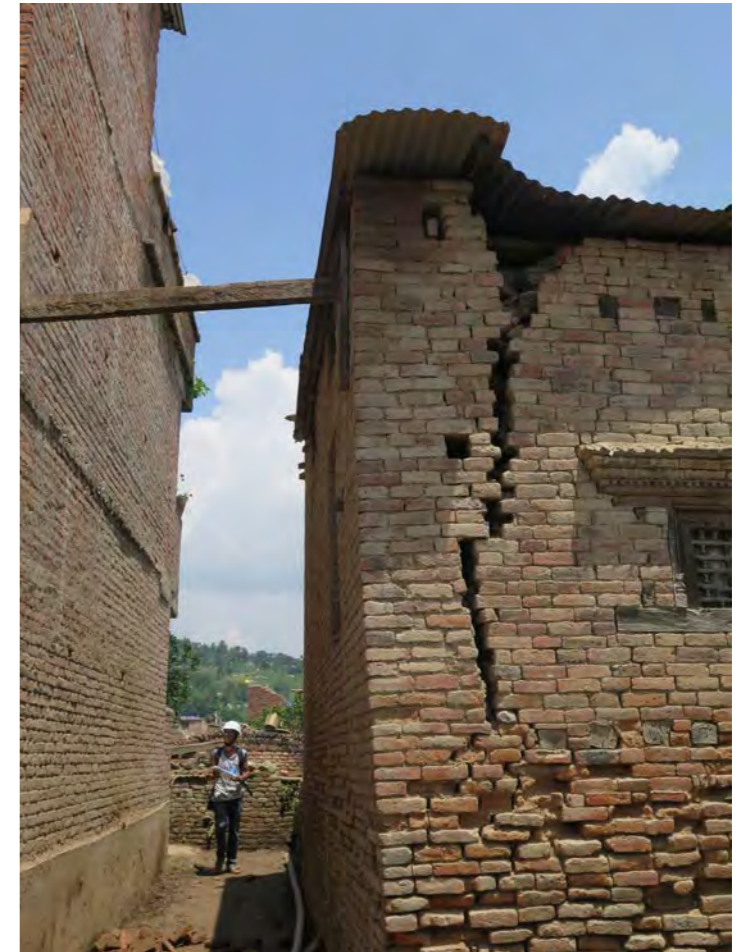
NUMBER	CONTACT	STOREY NO. RELATIVE POSITION	STRUCTURAL SYSTEM	PROBLEMS DESCRIPTION	DANGER	CONDITION	
e89		G+3	B	North wall and north west corner tilting out. Diagonal crack on east wall >15 cm.	⚠ 1/2 ☒	++

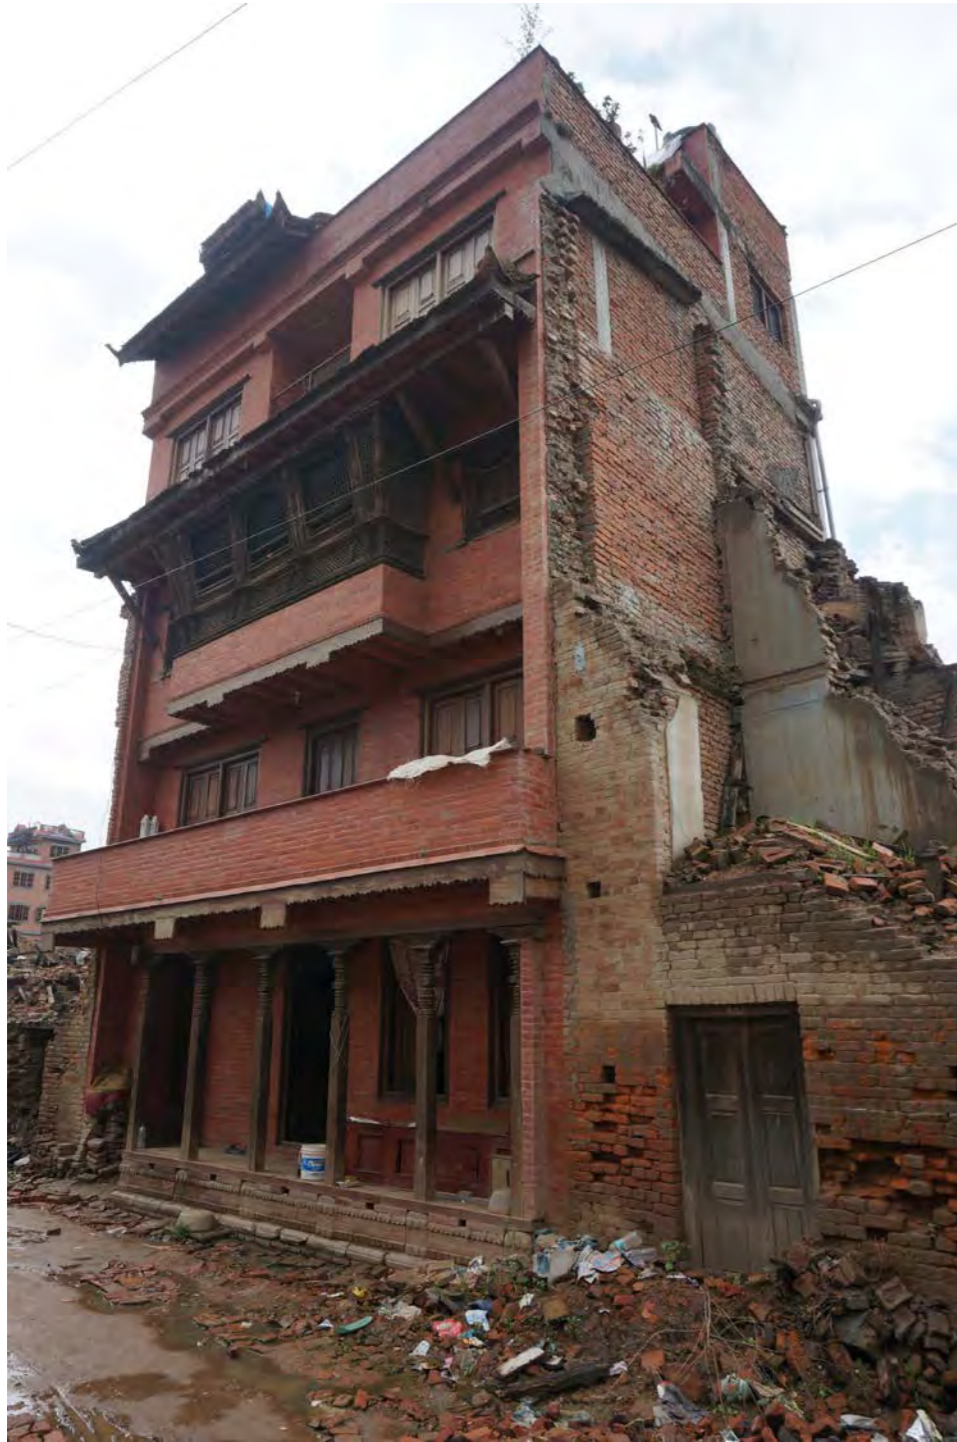
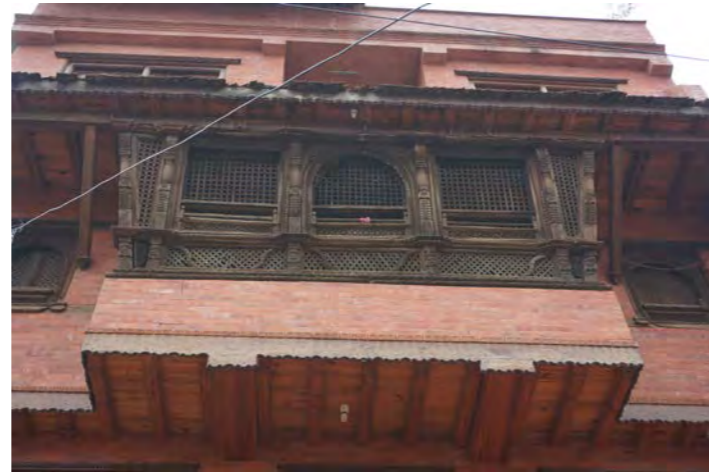
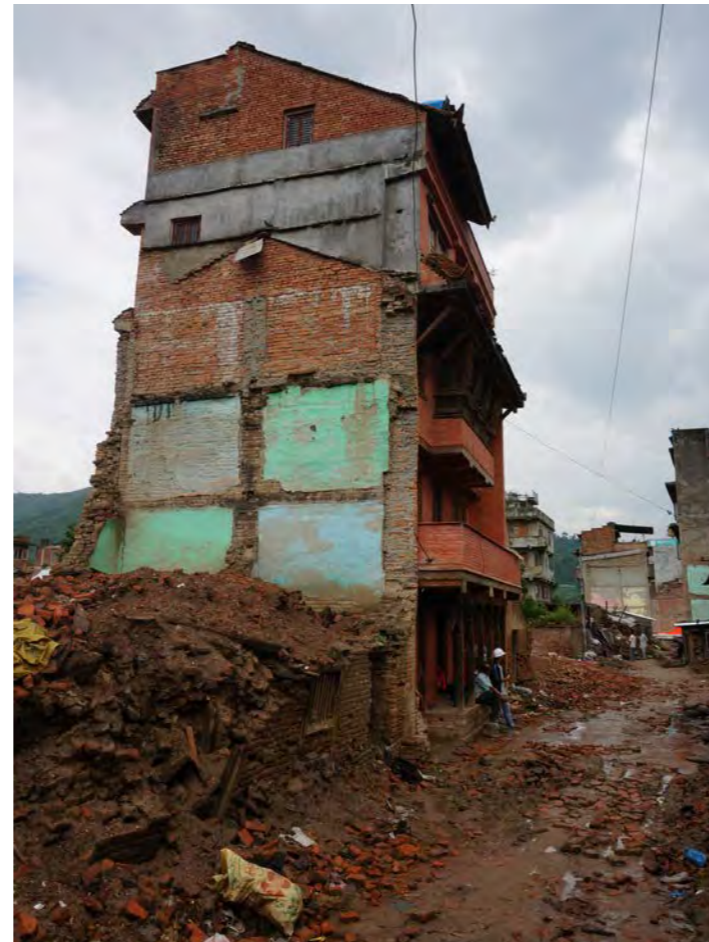
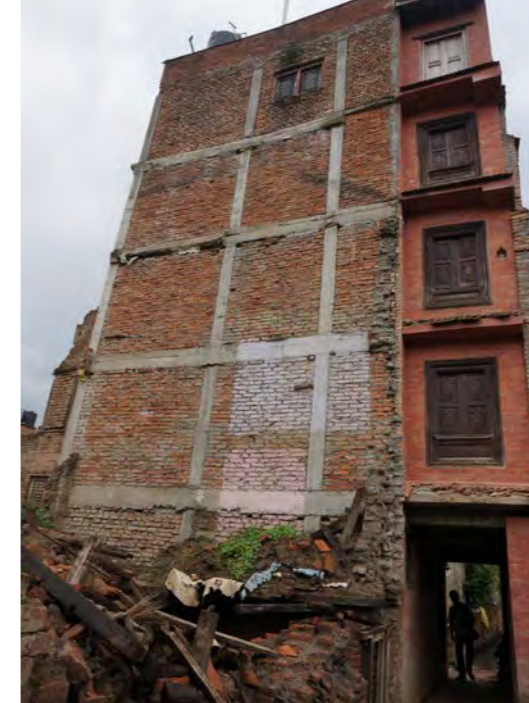
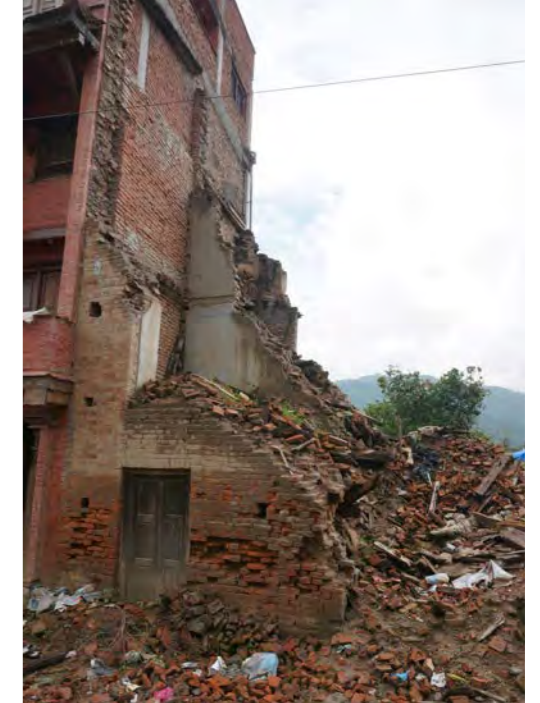
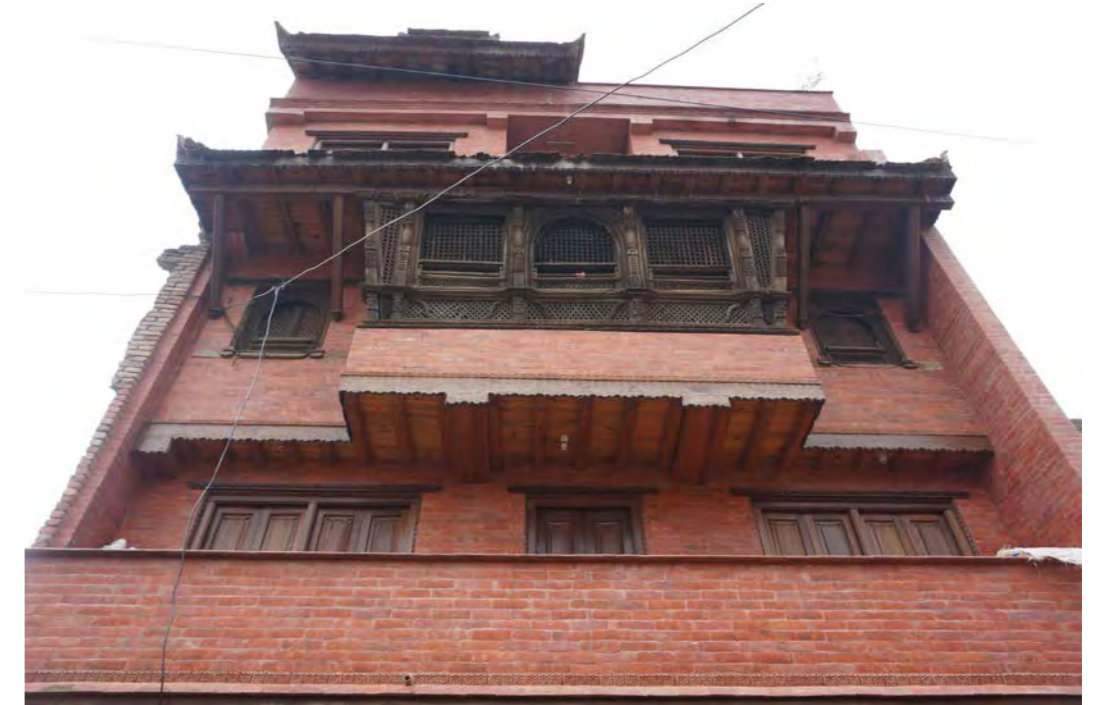
NUMBER	CONTACT	STOREY NO. RELATIVE POSITION	STRUCTURAL SYSTEM	PROBLEMS DESCRIPTION	DANGER	CONDITION	
f28	"Govinda Bol Shrestha 4450832"	G+4	C	Good Condition		++

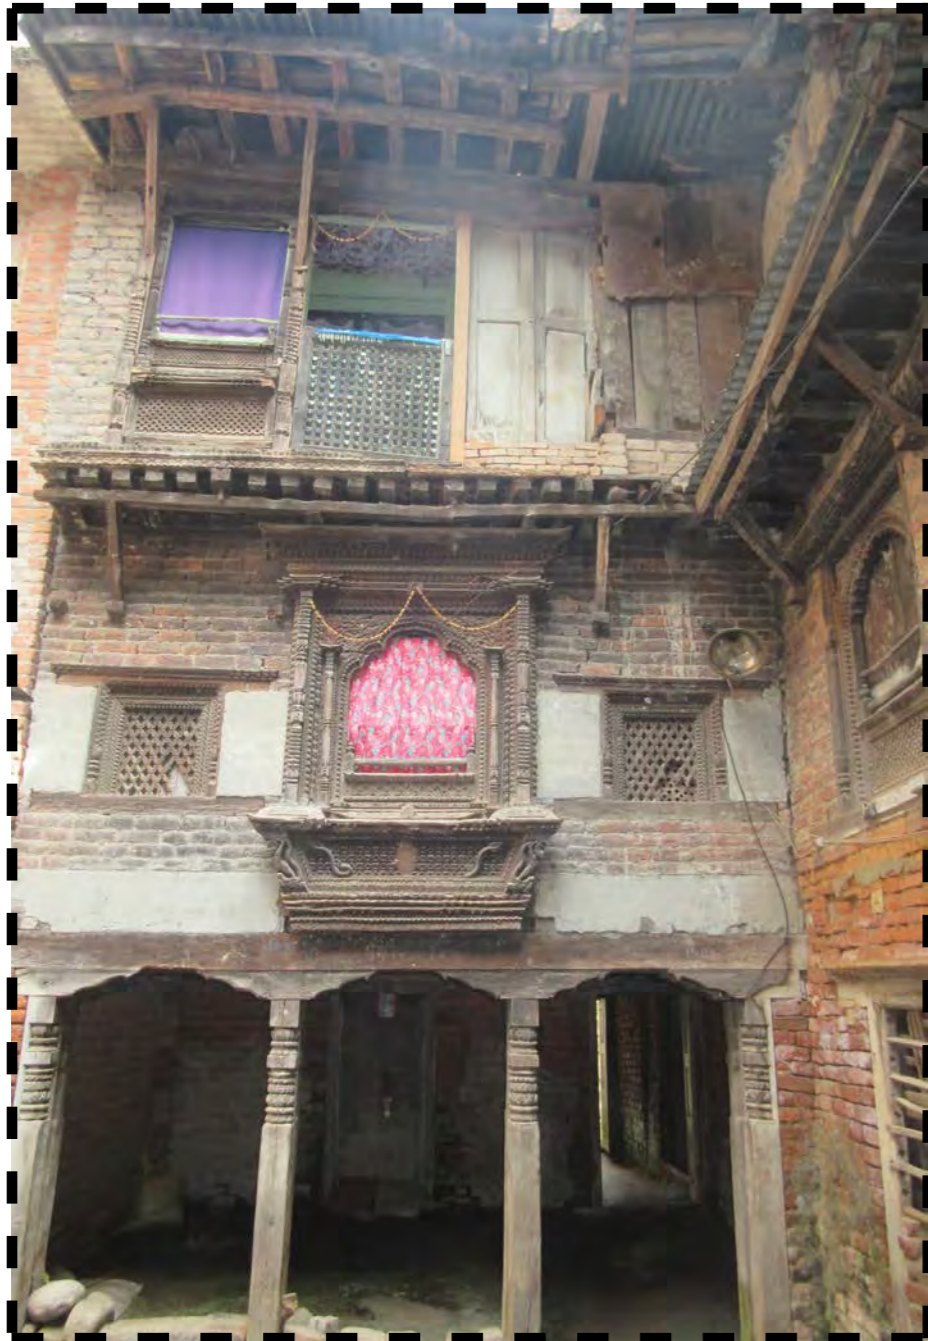
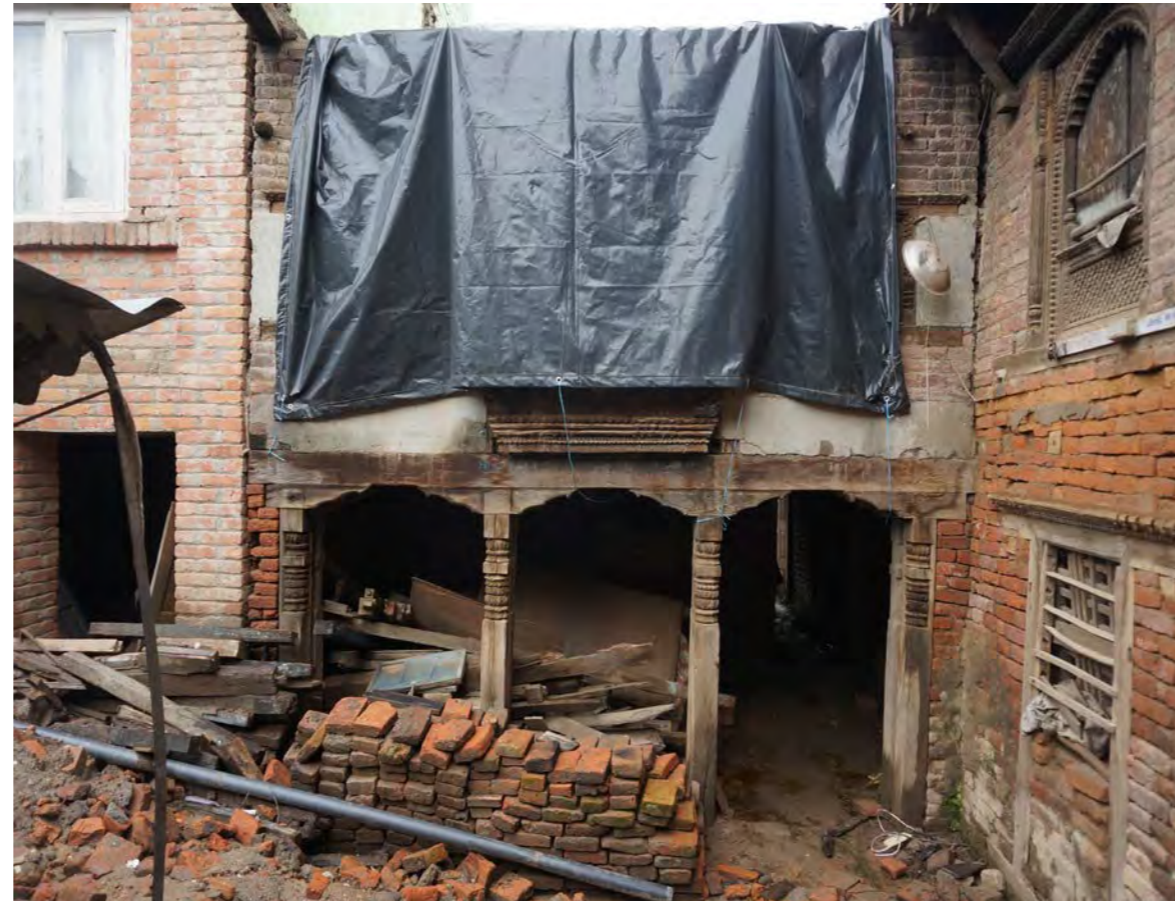
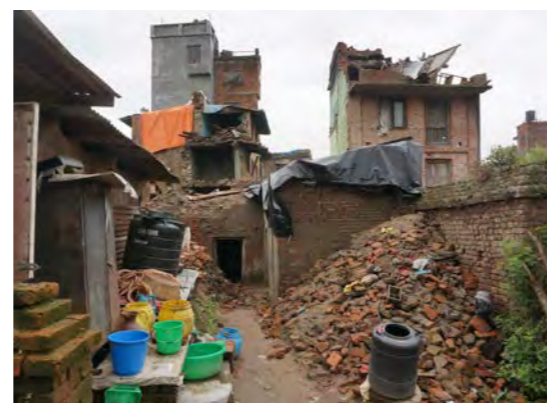
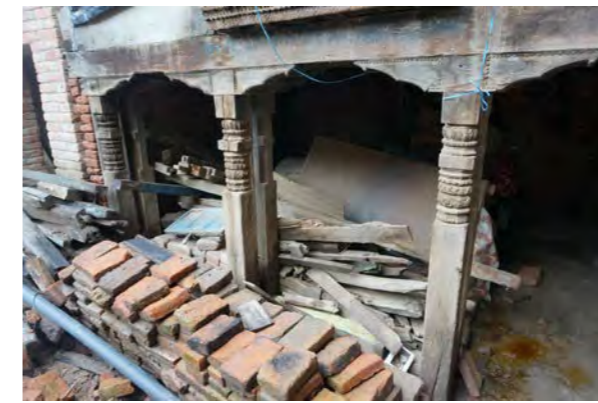
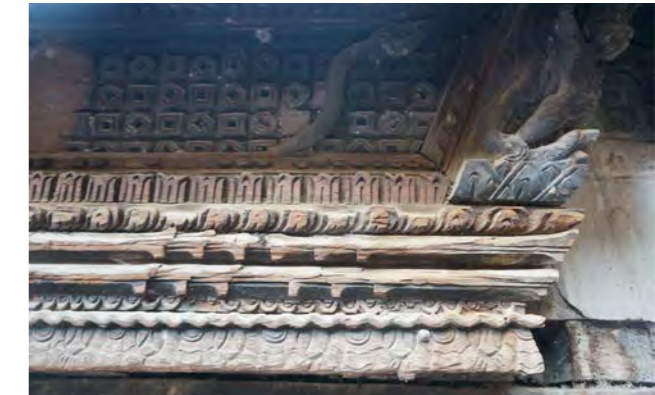
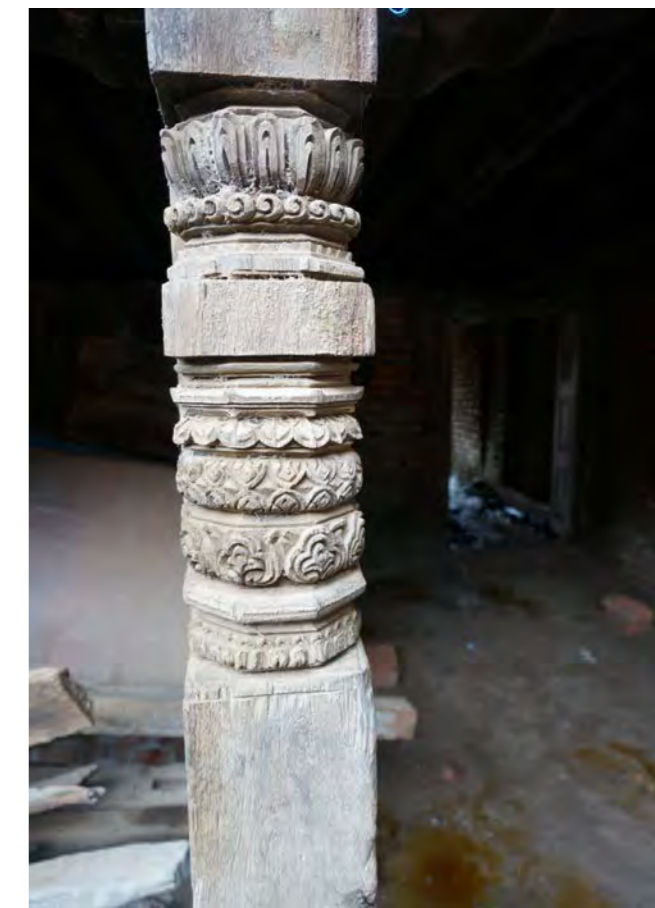
NUMBER	CONTACT	STOREY NO. RELATIVE POSITION	STRUCTURAL SYSTEM	PROBLEMS DESCRIPTION	DANGER	CONDITION
f41	"Babu Bhadra Bajracharya 9849758702"	G+3	UnB + B	Only lower two storey remaining		W! P! ++
