2015 Earthquake Damage Mapping

Sankhu

October 2015

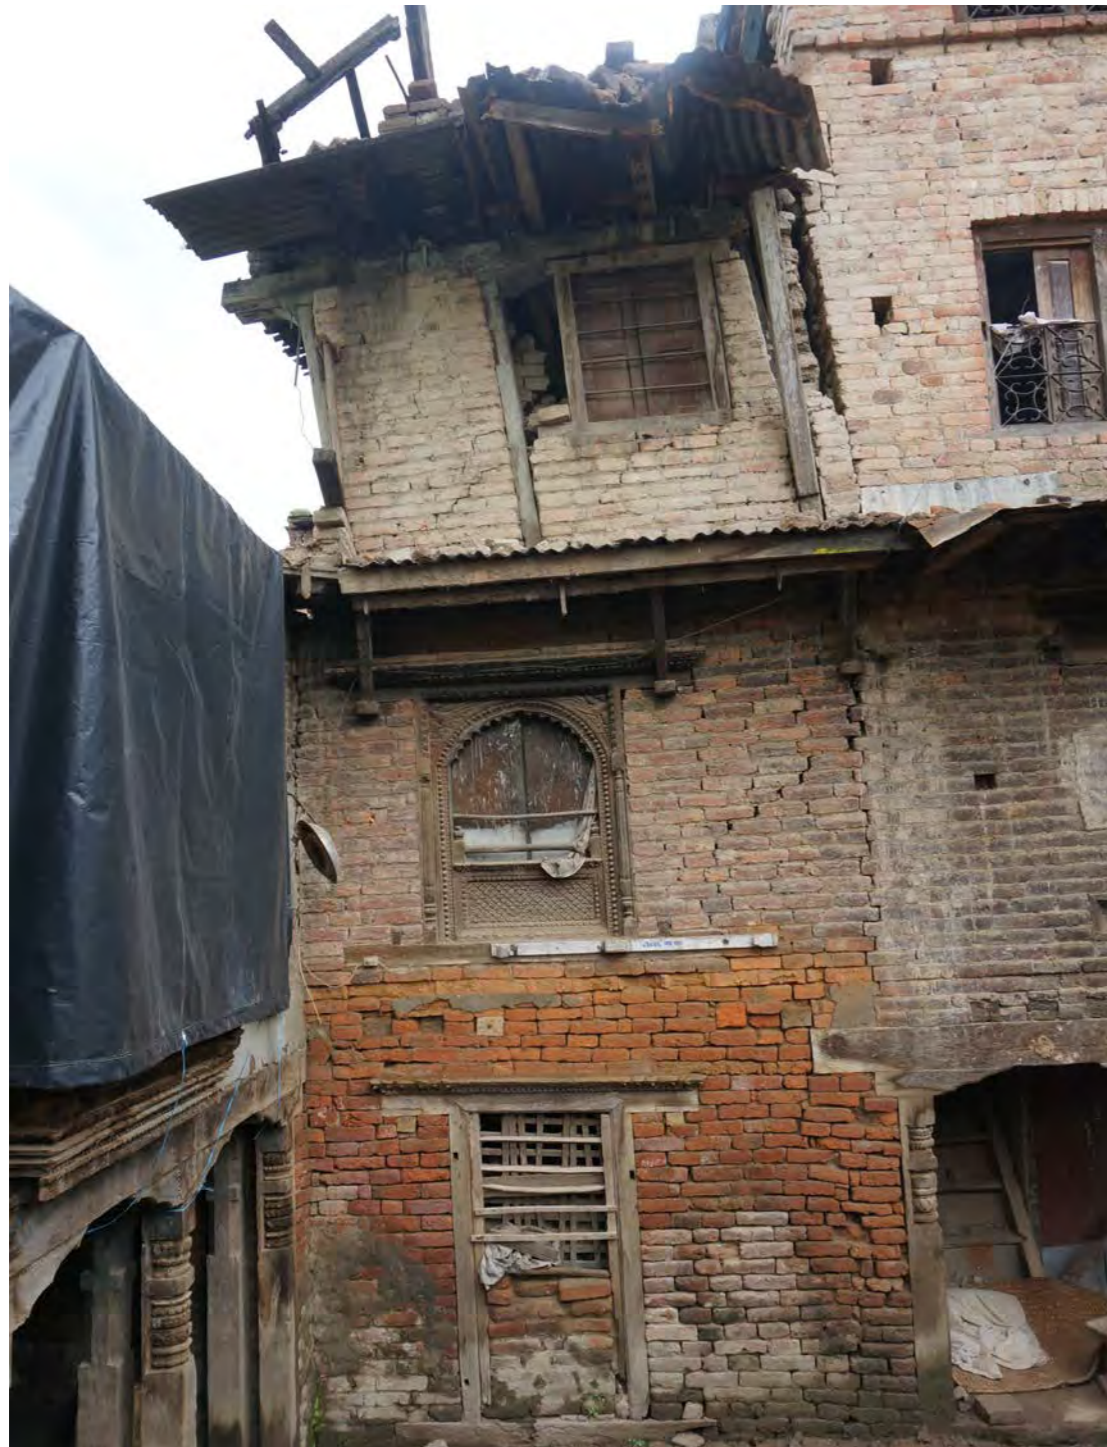
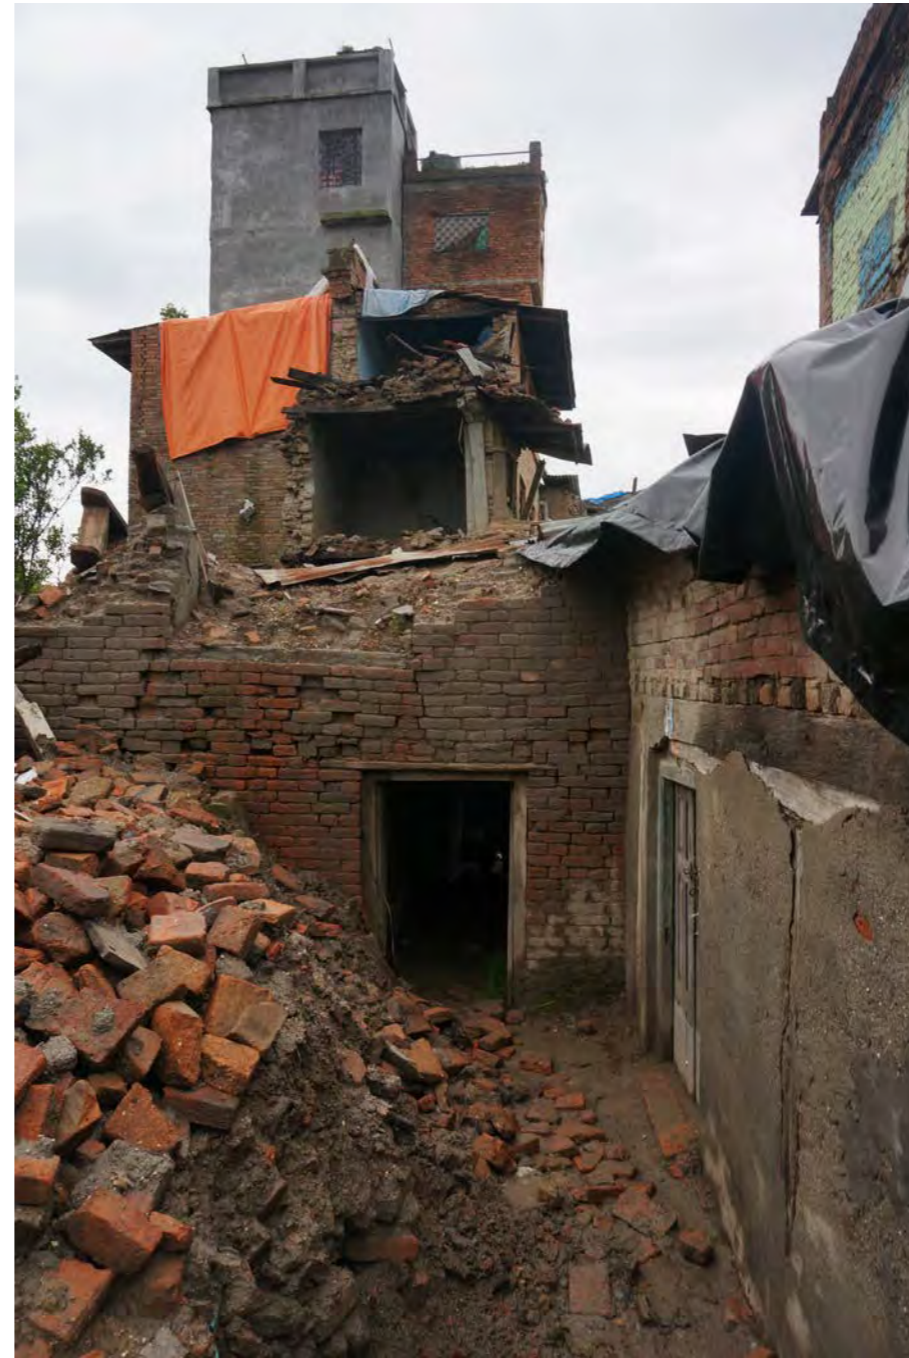
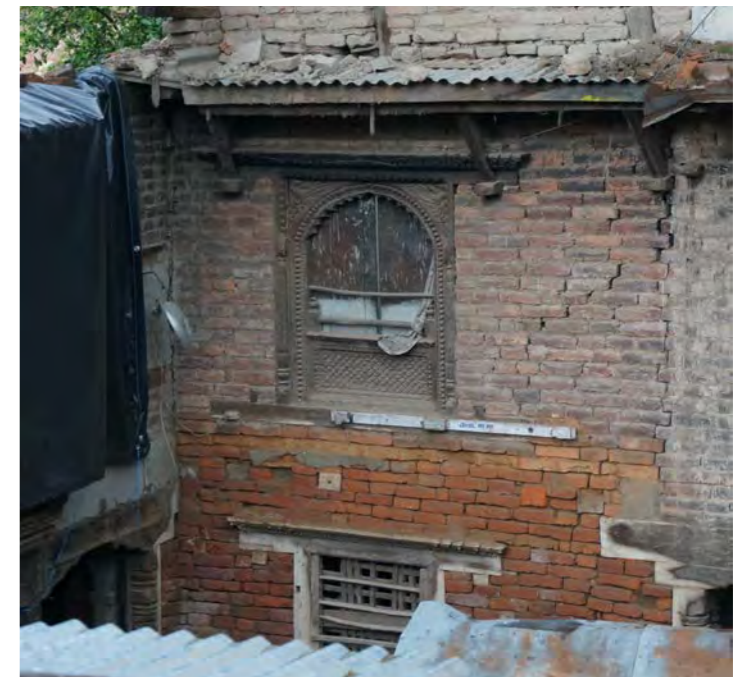
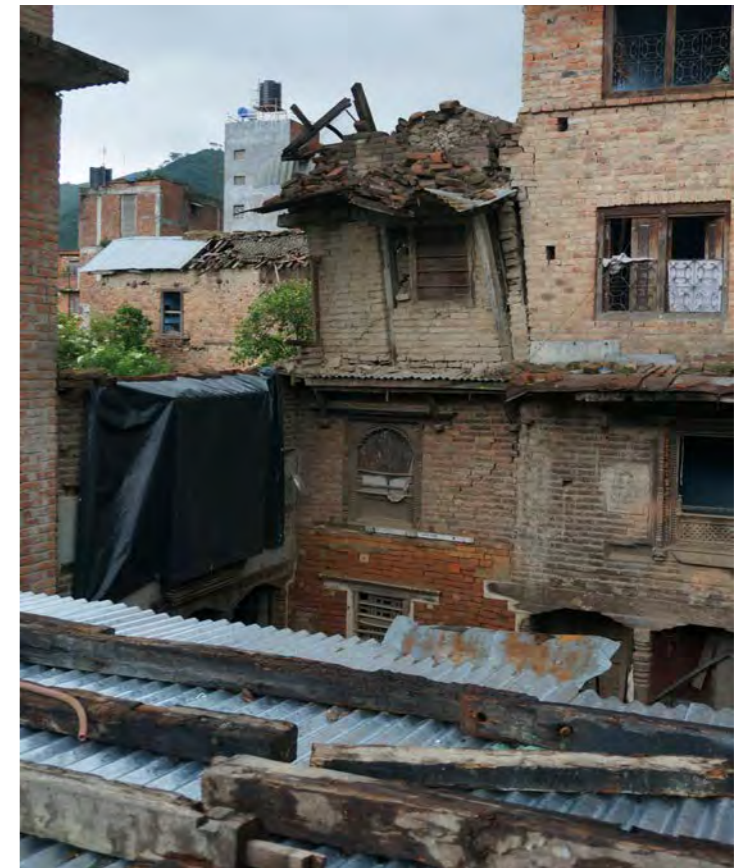
NUMBER	CONTACT	STOREY NO. RELATIVE POSITION	STRUCTURAL SYSTEM	PROBLEMS DESCRIPTION	DANGER	CONDITION
f42	Ananda Bajracharya	G+3	UnB + B	<p>“Upper top storey collapsed Second floor about to collapsed Needs total dismantle and reconstruction Rising Damp”</p>

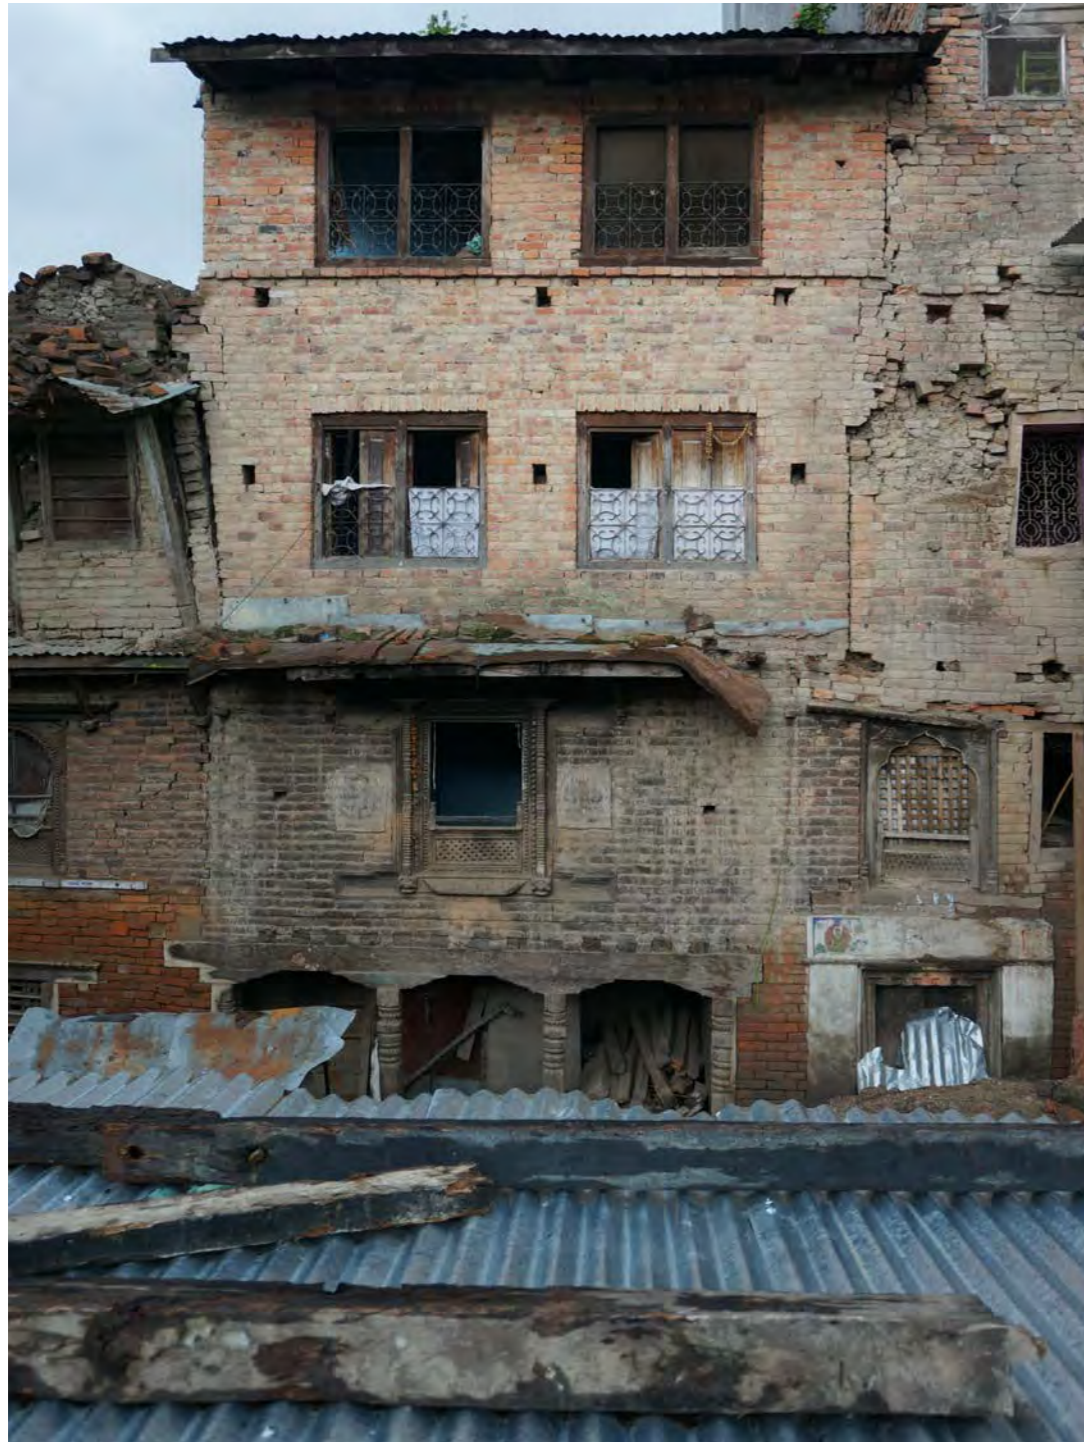
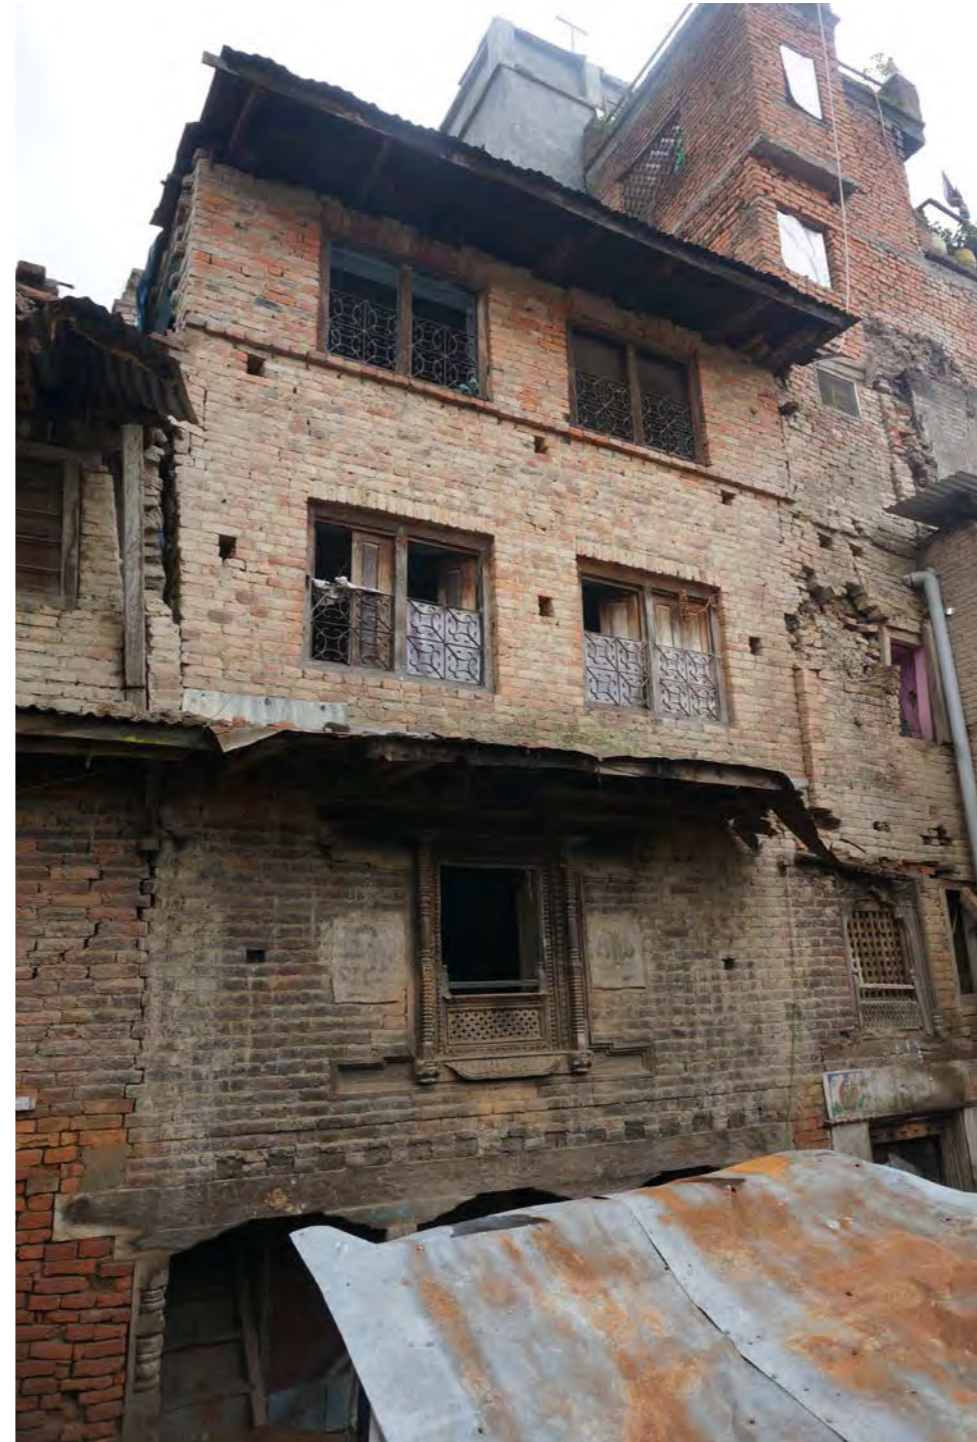
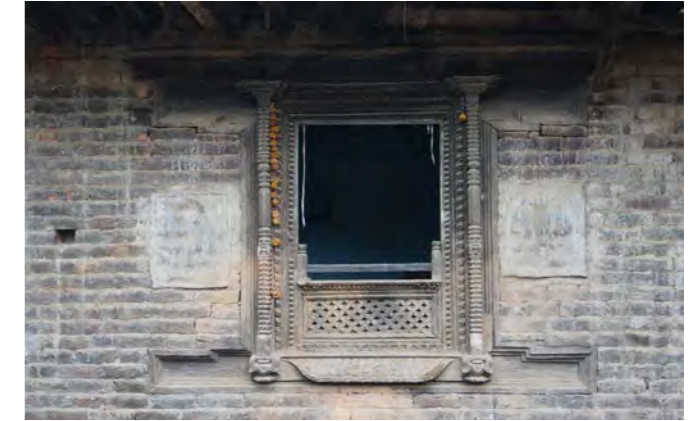
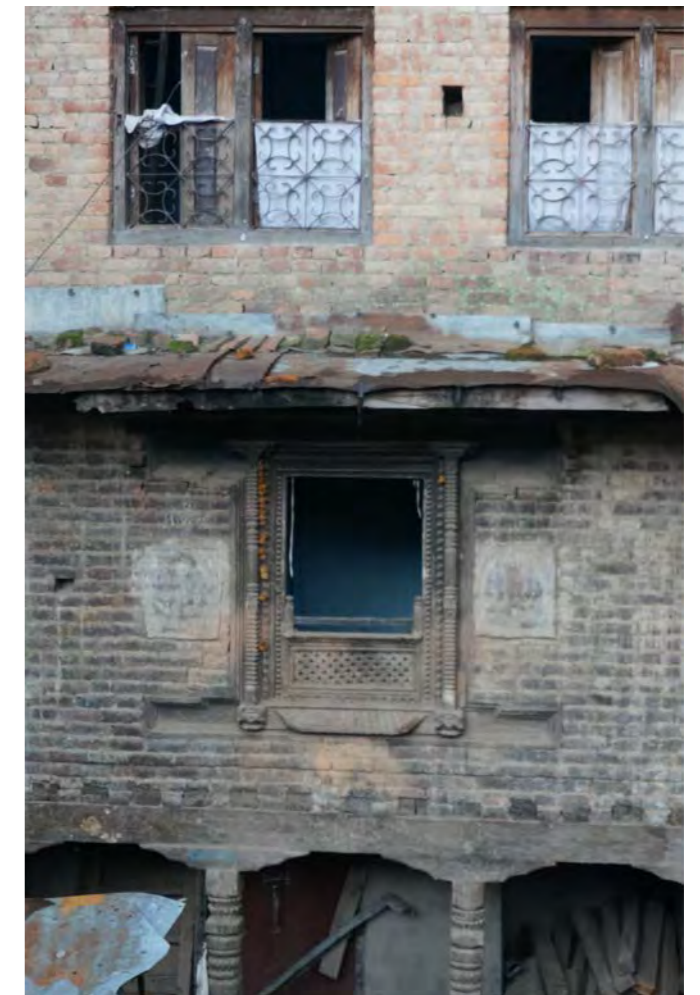
NUMBER	CONTACT	STOREY NO. RELATIVE POSITION	STRUCTURAL SYSTEM	PROBLEMS DESCRIPTION	DANGER	CONDITION
f43	Mohan Bajracharya	G+3	UnB + B	“N-façade wall collapsed at upper levels Problem of Delapidation”		W ! ++

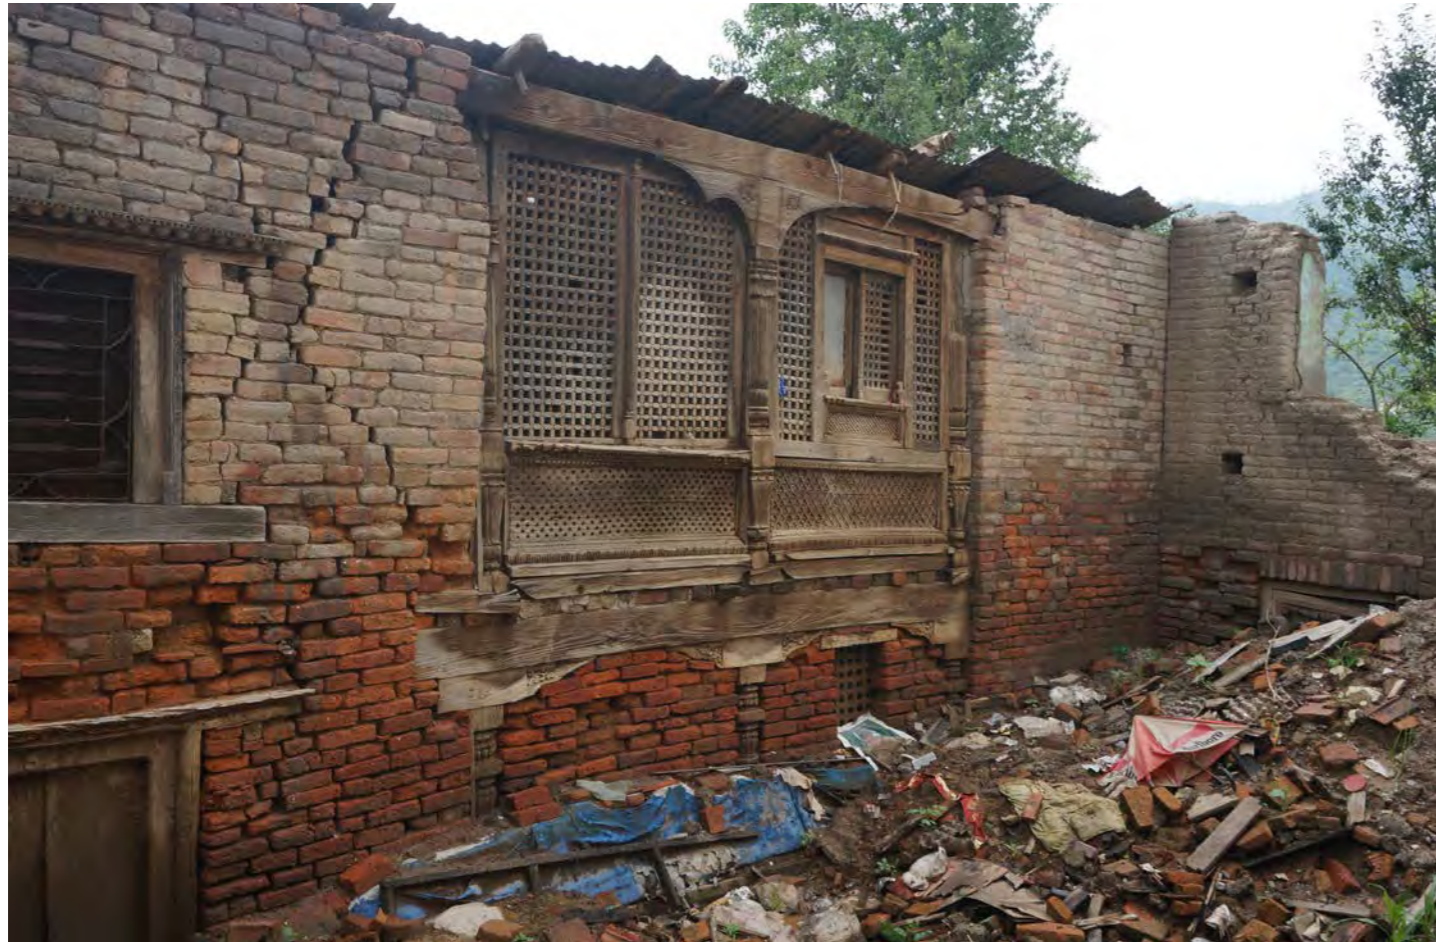
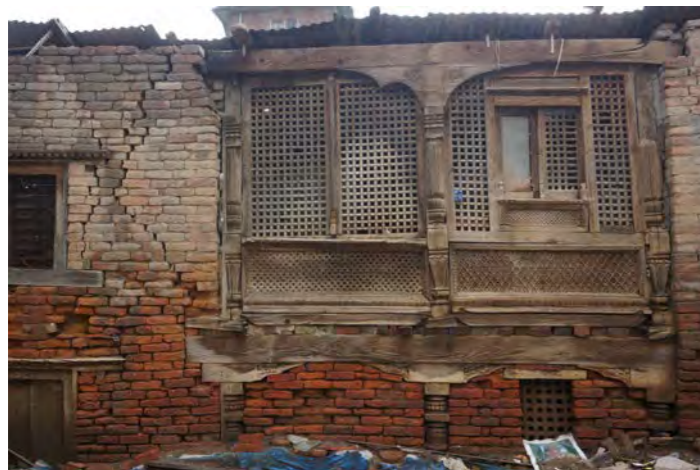
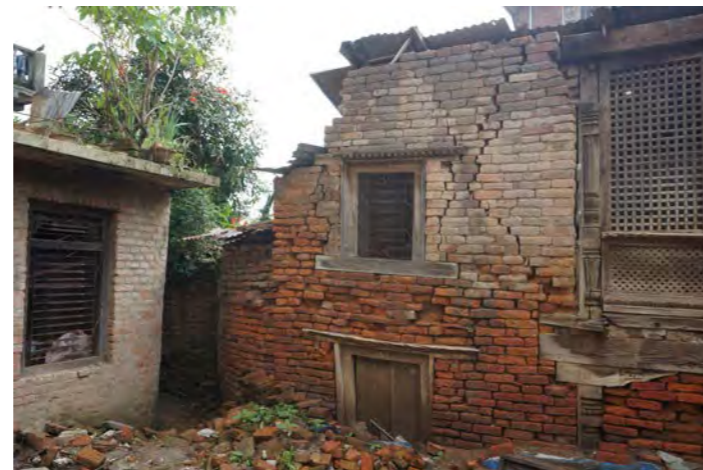
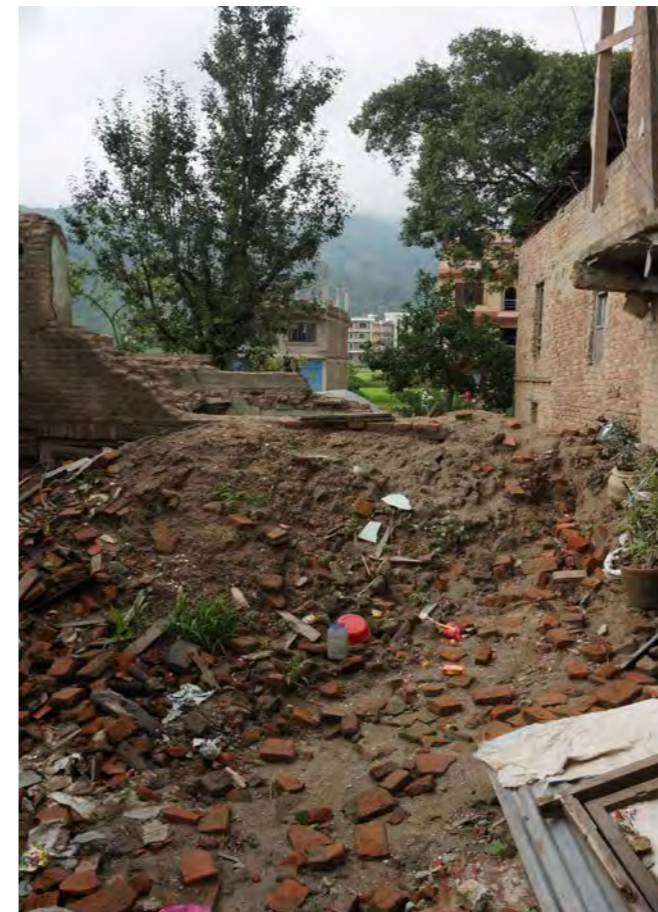
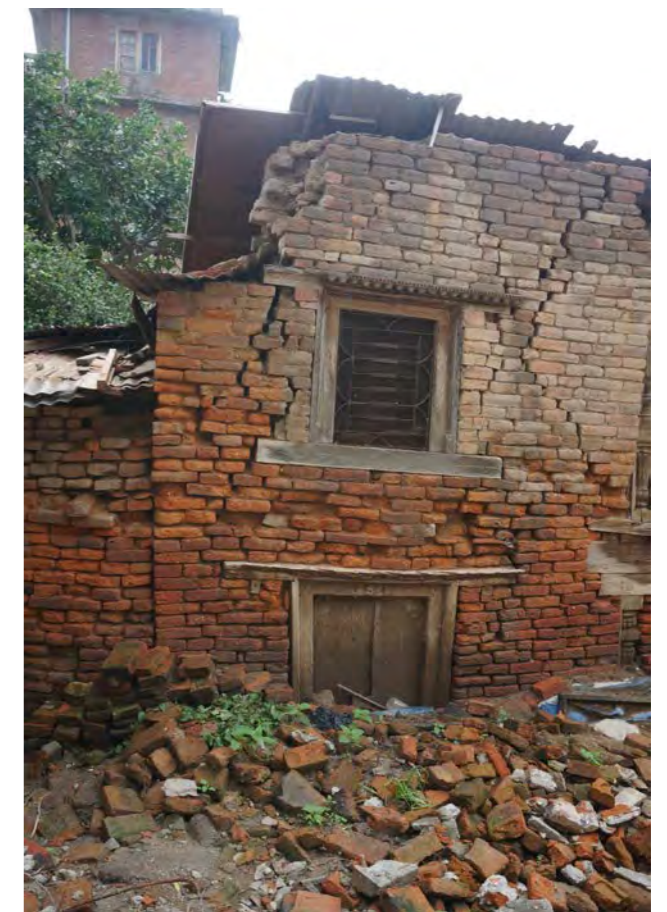
NUMBER	CONTACT	STOREY NO. RELATIVE POSITION	STRUCTURAL SYSTEM	PROBLEMS DESCRIPTION	DANGER	CONDITION
g20	“Surja Man Shrestha(Pukushi) 9841863845”	G+3	UnB + B	Totally Collapsed		W! ++

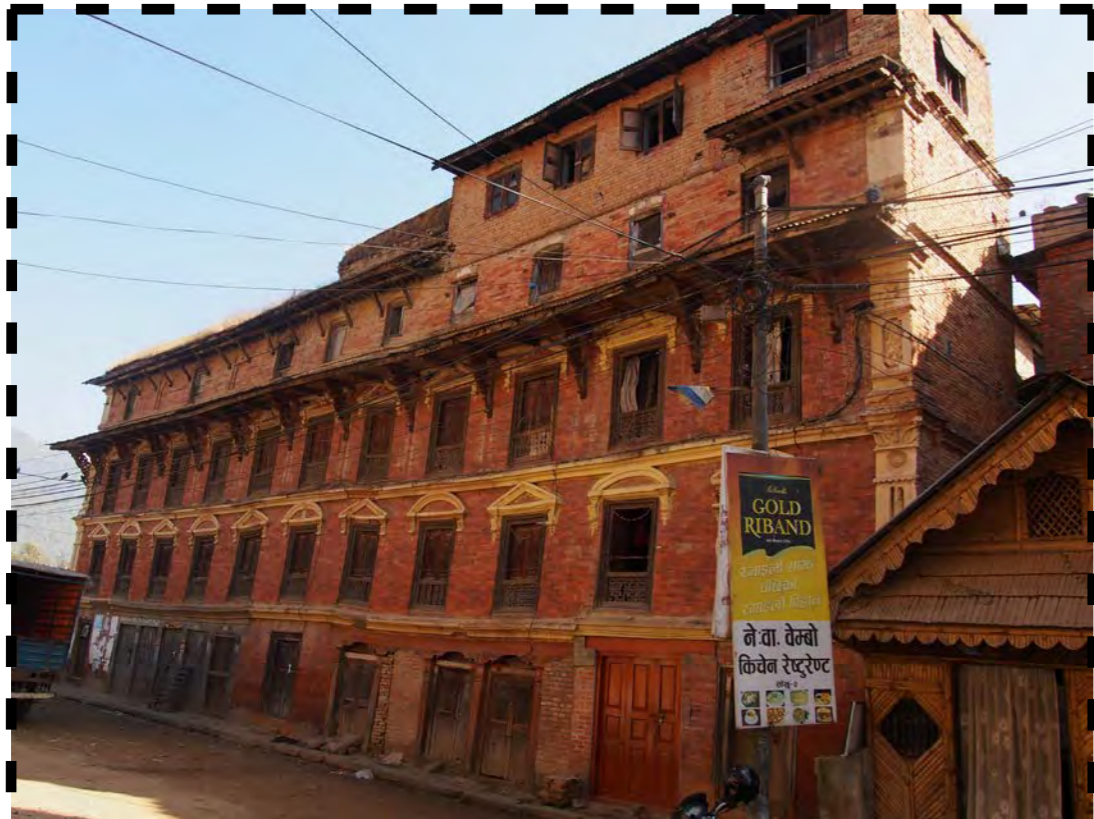
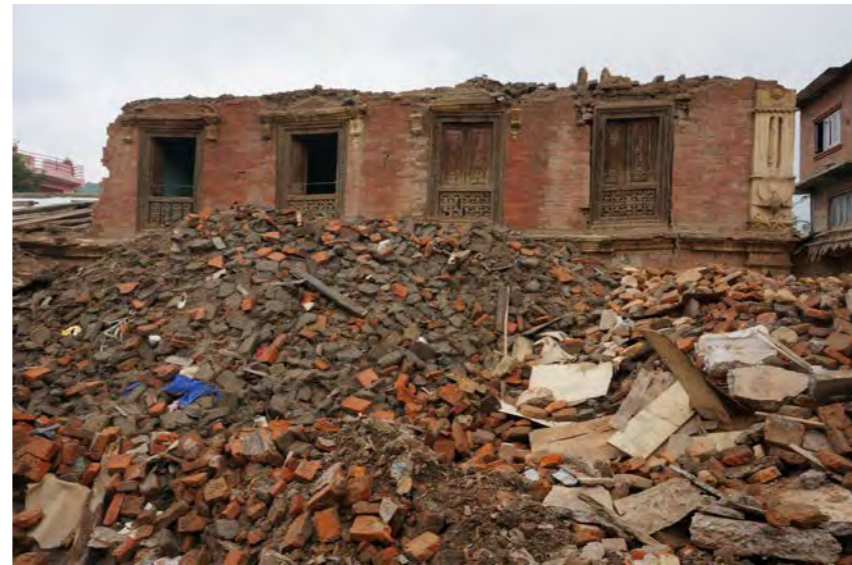
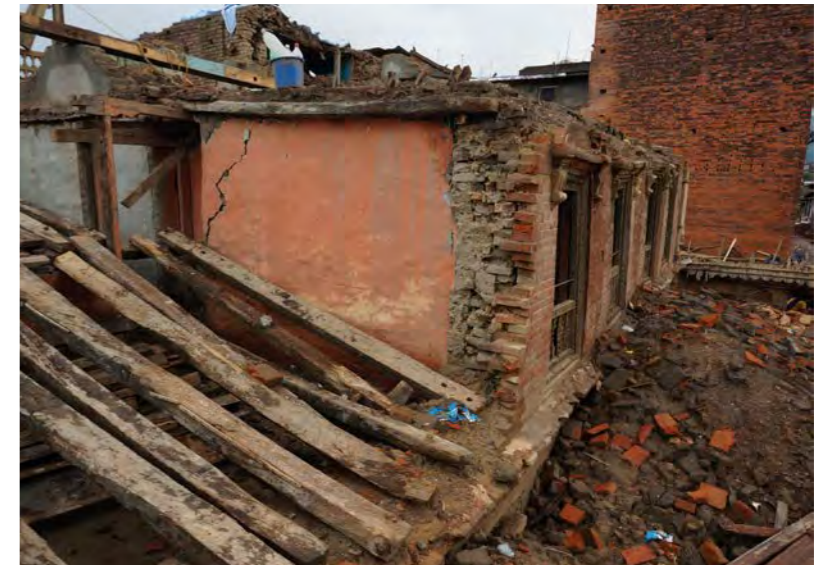
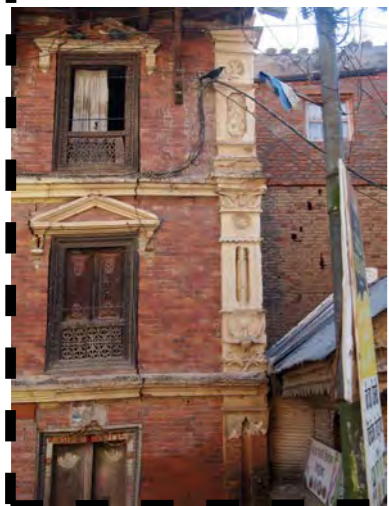
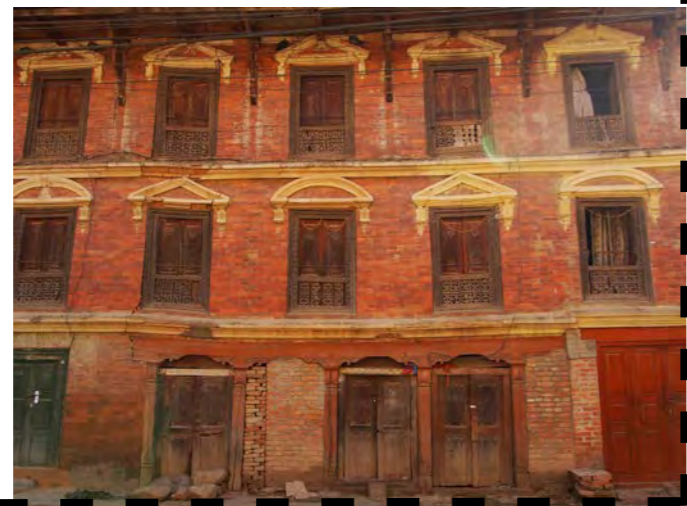
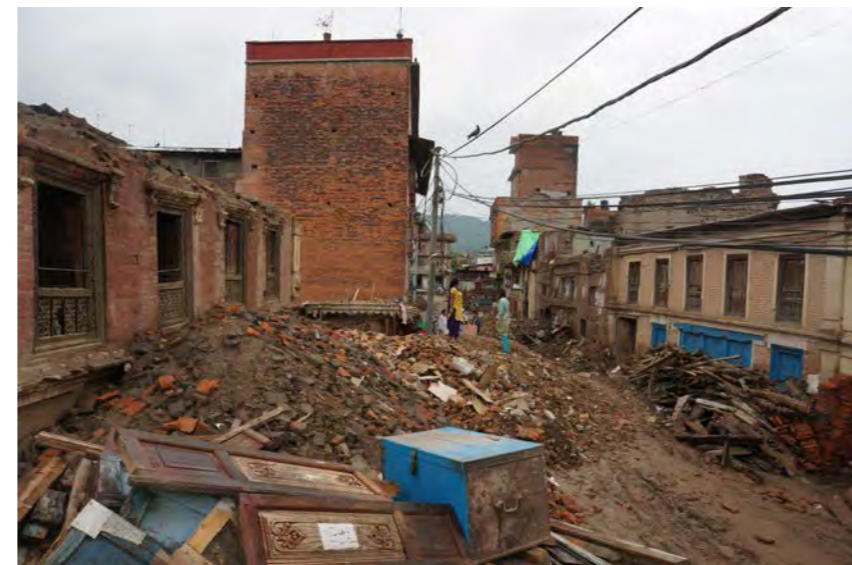
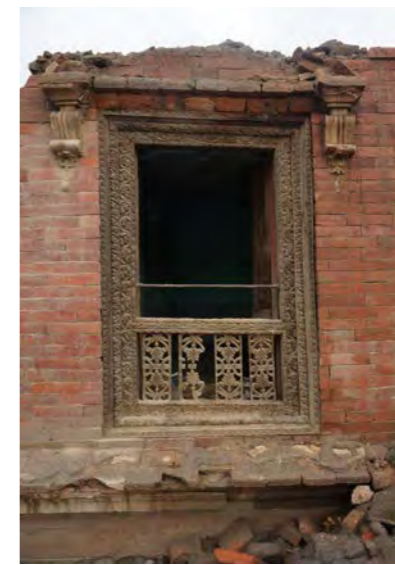
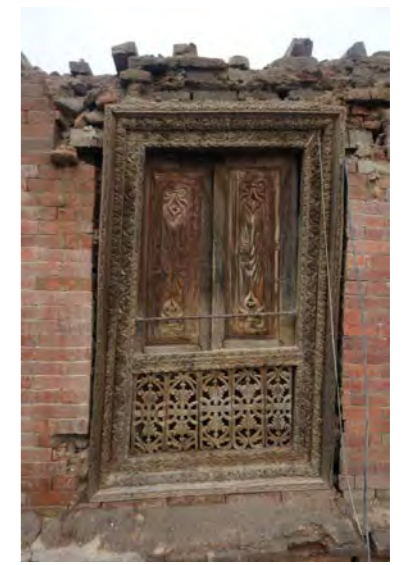
NUMBER	CONTACT	STOREY NO. RELATIVE POSITION	STRUCTURAL SYSTEM	PROBLEMS DESCRIPTION	DANGER	CONDITION
g33	Yuvananda Bajracharya	G+3	UnB + B	Totally Collapsed		W ++
g36	Devananda Bajracharya	G+3	UnB + B	Totally Collapsed		++

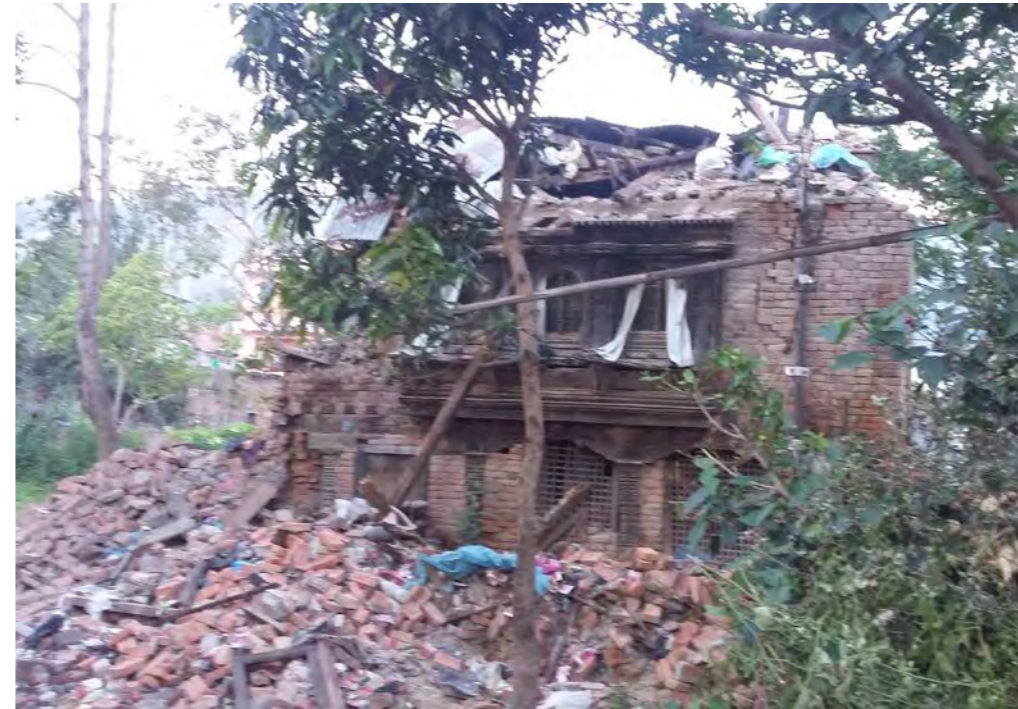
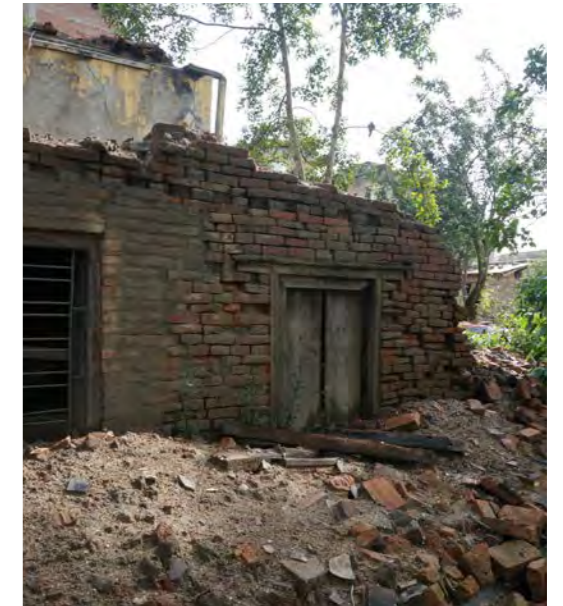
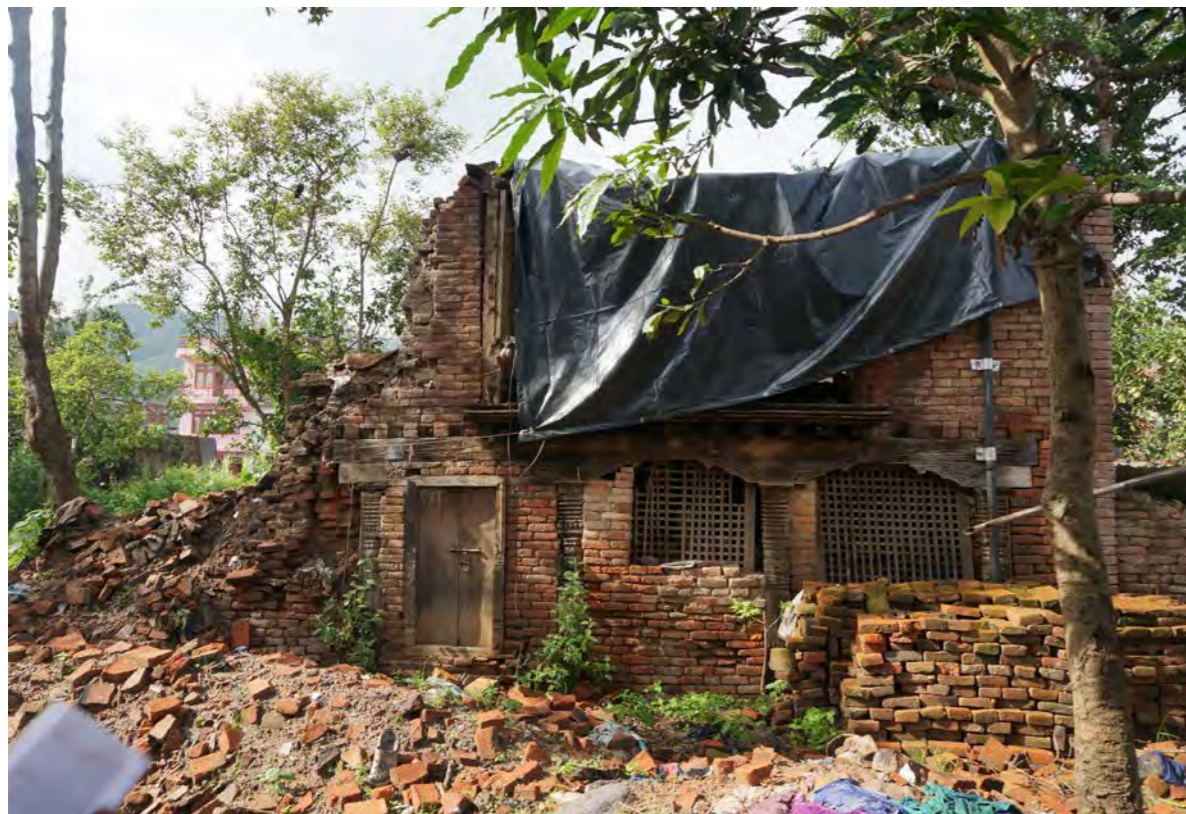
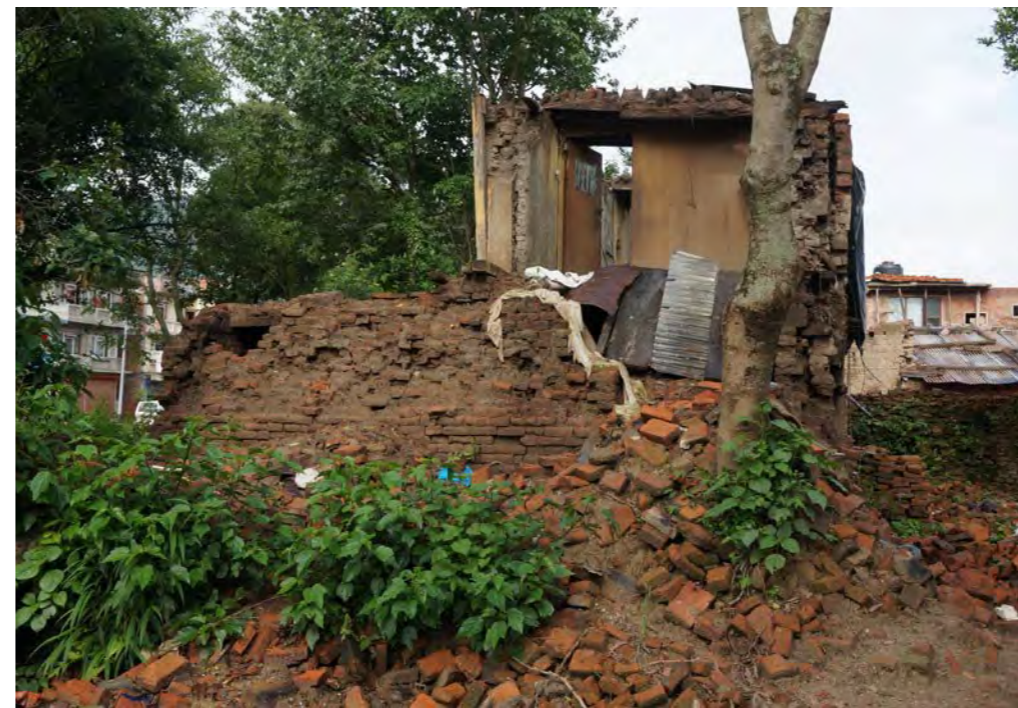
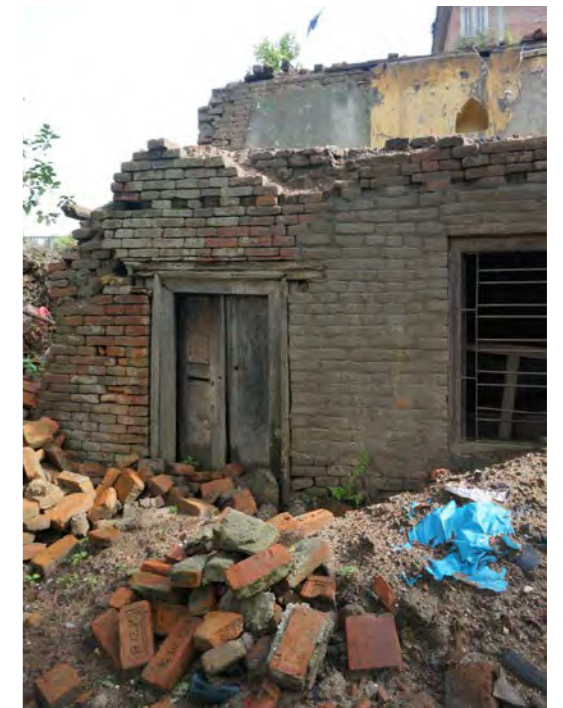
NUMBER	CONTACT	STOREY NO. RELATIVE POSITION	STRUCTURAL SYSTEM	PROBLEMS DESCRIPTION	DANGER	CONDITION	
g23	Sangita Shrestha	G+3	UnB + B	Totally Collapsed		++ P! (house no 78)

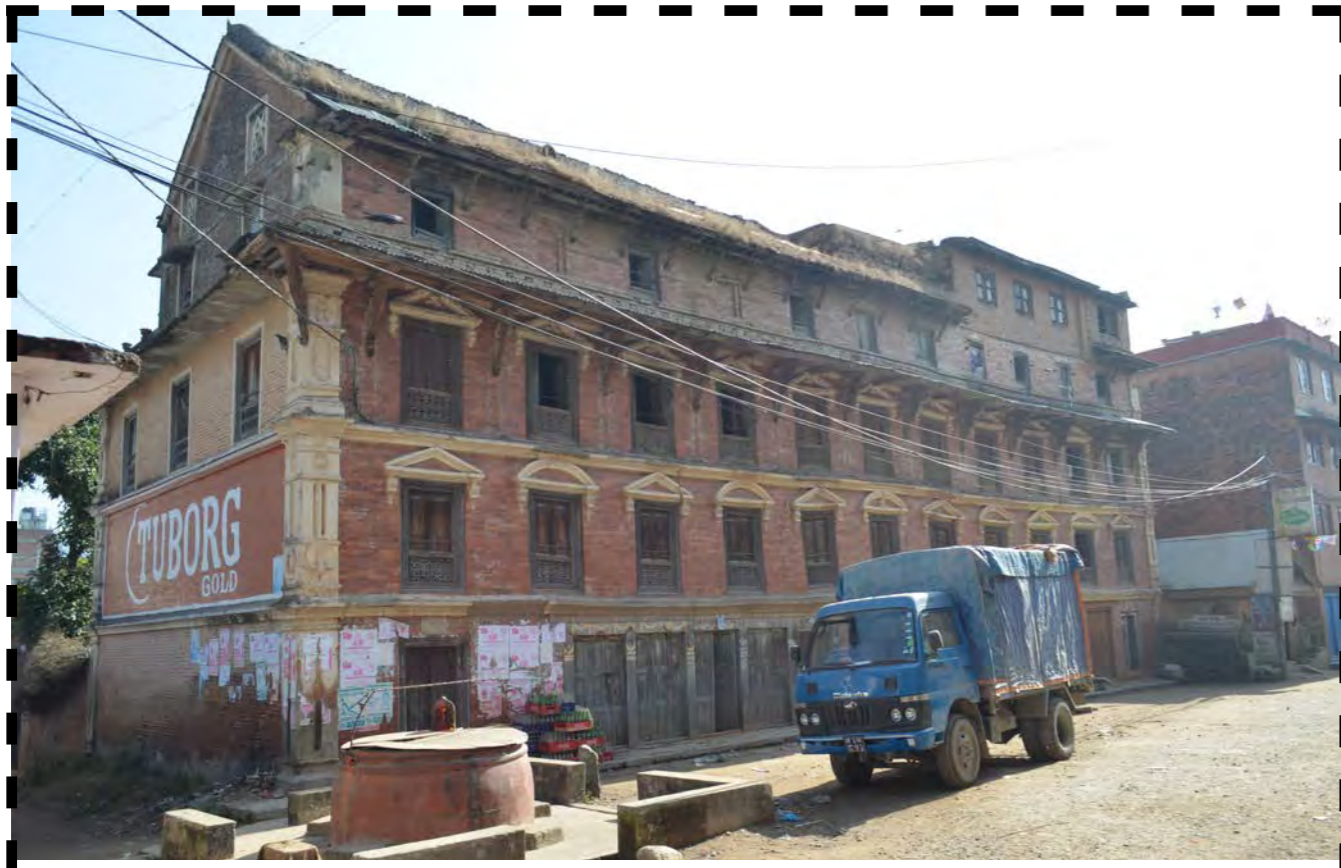
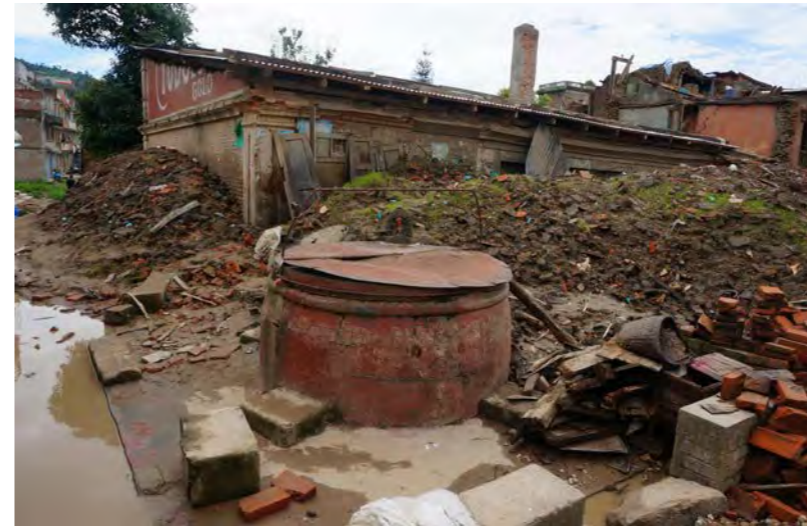
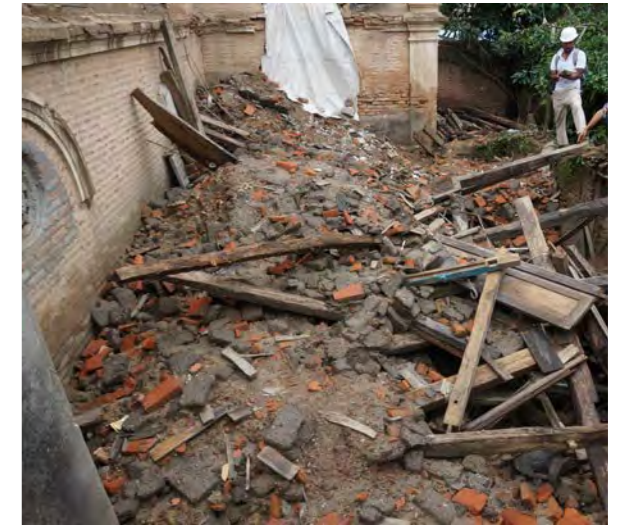
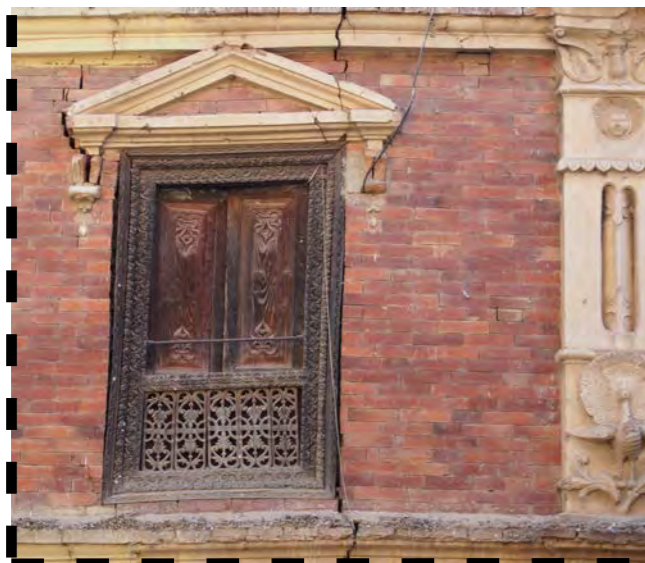
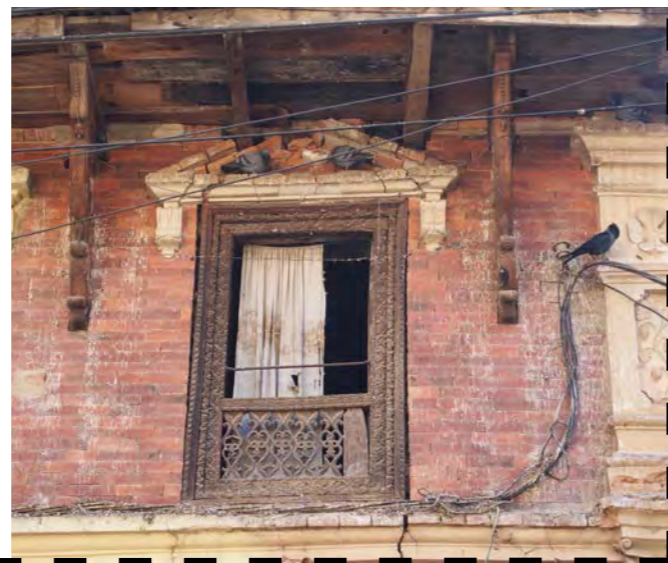
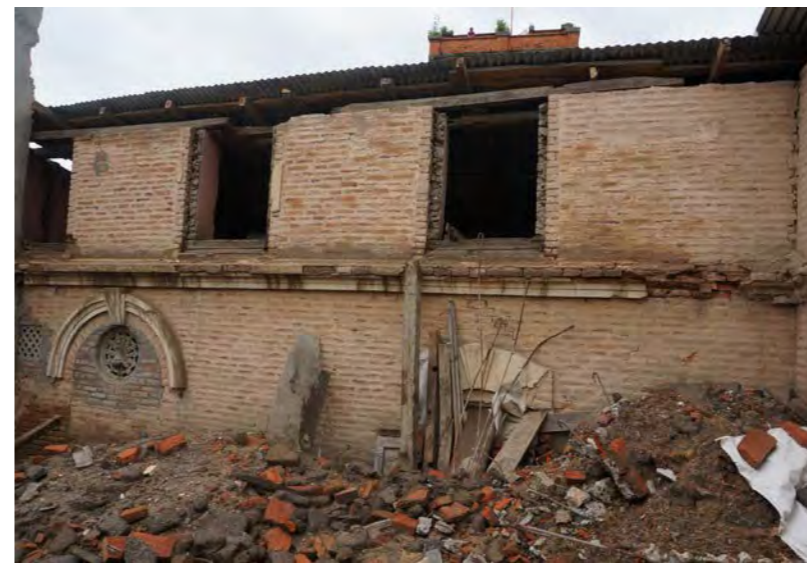
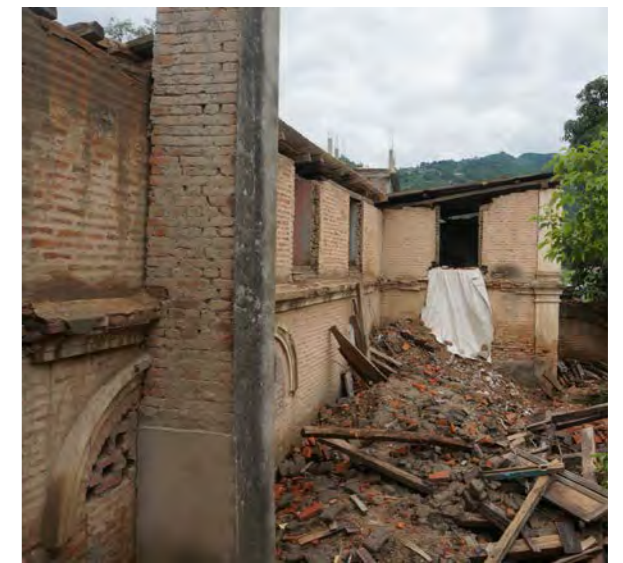
NUMBER	CONTACT	STOREY NO. RELATIVE POSITION	STRUCTURAL SYSTEM	PROBLEMS DESCRIPTION	DANGER	CONDITION
g37	“Yuvaraj Bajracharya Sanu Bajracharya 9841268775”	G+3	UnB + B	Totally Collapsed		++ ?!
